Storm Damage Reduction Project Design for Wallops Island, Virginia

Version 1.01

Final report

Abstract: Wallops Island, a barrier island on Virginia's eastern shore, is home to NASA and commercial rocket launch facilities, along with significant U.S. Navy and regional infrastructure. A succession of beach protection measures have had limited success in mitigating the island's chronic shoreline erosion problem, which has now reached a critical state.

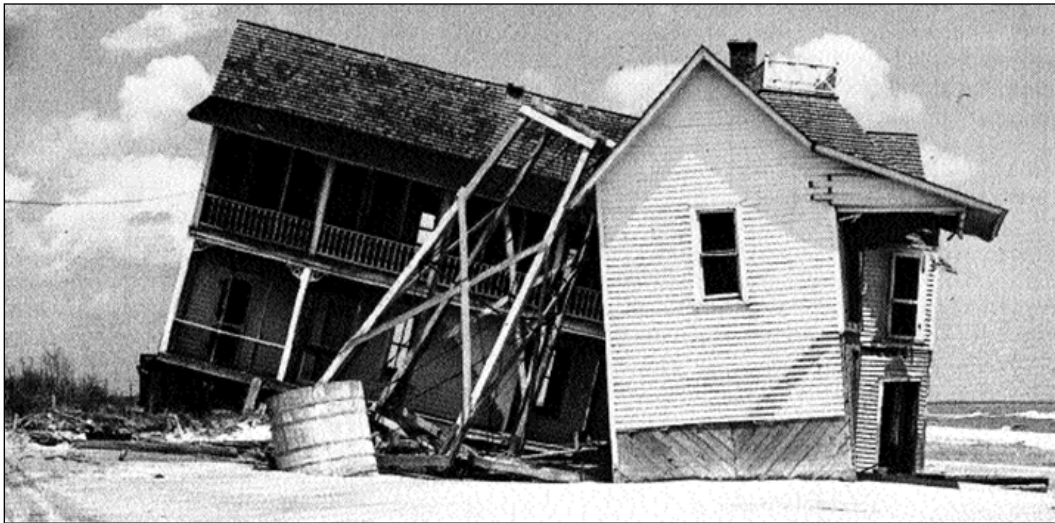
Figure 2-4. Wallops Island north end erosion damage, May 1949.

Figure 2-4 shows the erosion and storm damage to the Wallops Island Association Clubhouse at the north end of the island in May 1949. Figure 2-5, taken in October 1956, shows a portion of the exposed seawall. In May, 1956, the Beach Erosion Board again inspected the beach at Wallops Island and recommended that 8 groins be installed at 400 ft intervals along 2,800 feet of beach. These groins are seen in Figure 2-6, which was taken in December 1959. This figure also shows the causeway connecting Wallops Island to the mainland, which was constructed in 1959. The seawall was extended further to the north in 1960. The above information and Figures 2-3 through 2-7 are from Shortal (1978).

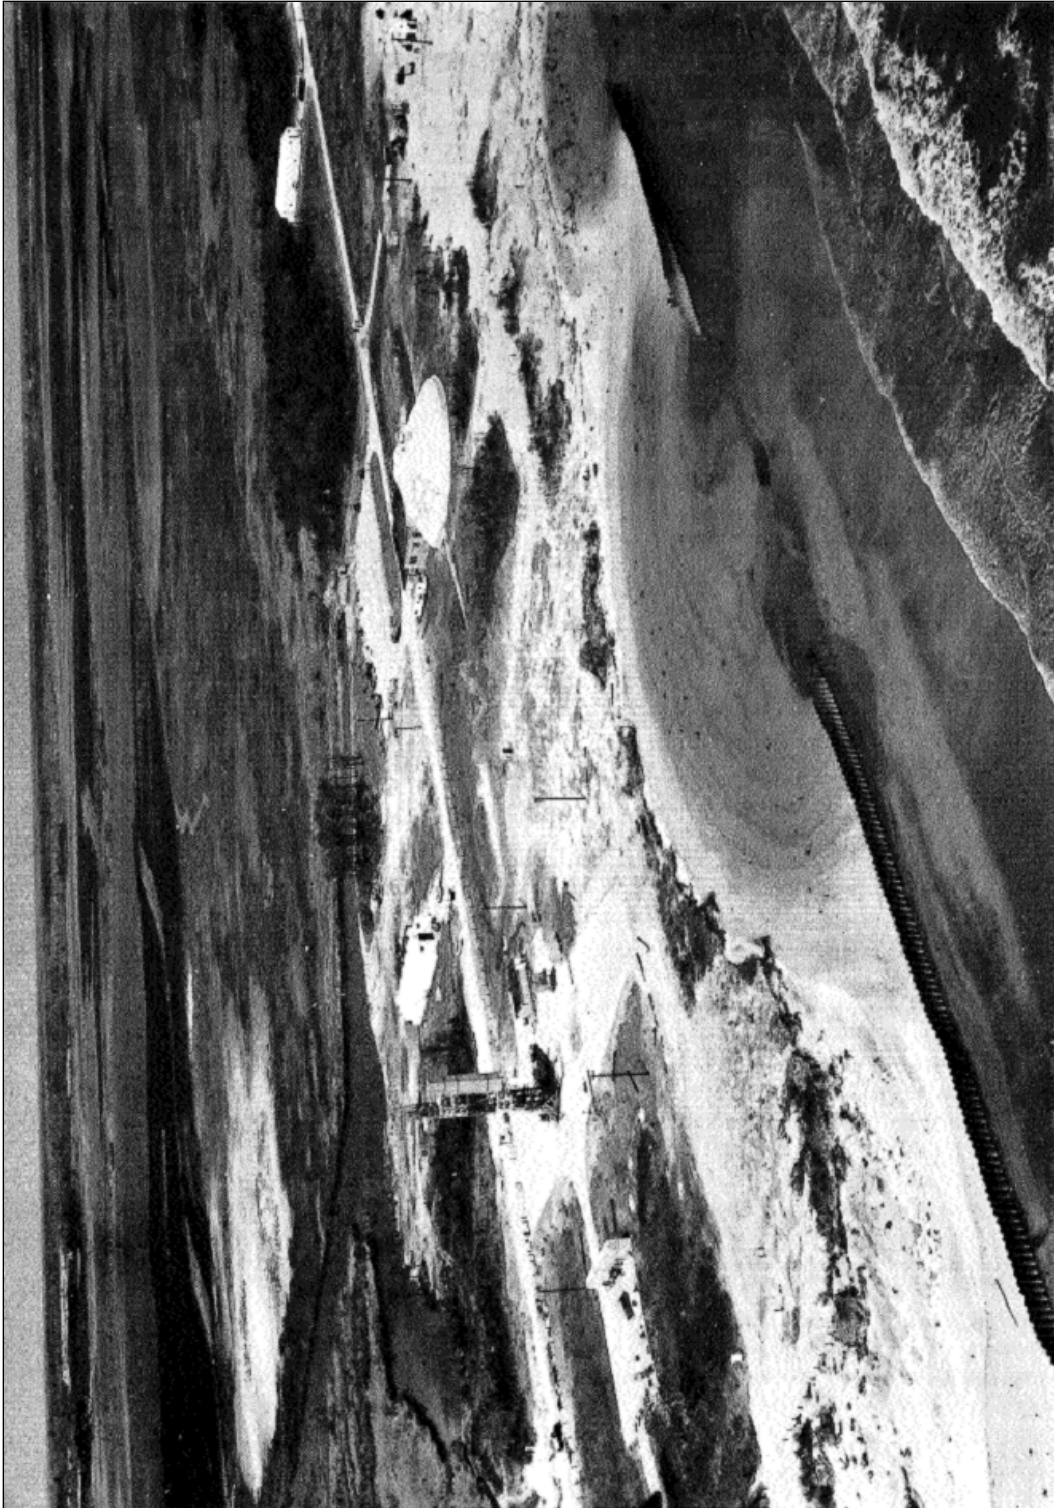
Figure 2-7. Seawall damage from Ash Wednesday Storm of April 1962.

Figure 2-7 shows failed sections of the sheet pile seawall following the Ash Wednesday storm of March 6-8, 1962. This nor'easter caused extensive damage along the eastern seaboard from New York to North Carolina and is considered one of the ten worst storms in the United States in the 20th century. The damage at Wallops Island was estimated at \$1,000,000.

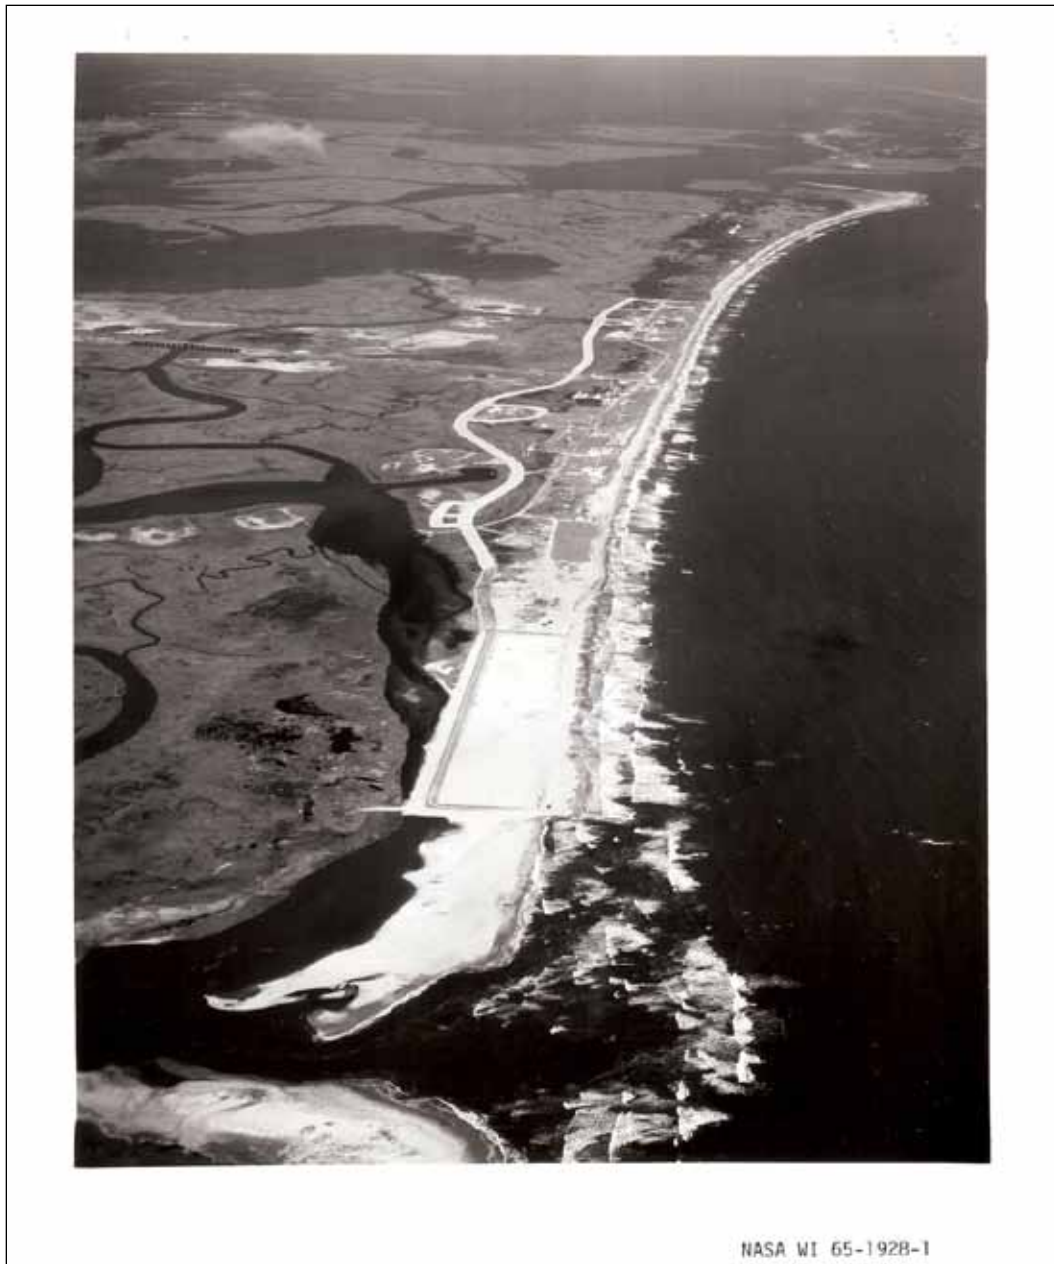
Figure 2-8. Mechanically filled section of the south end of Wallops Island following an Ash Wednesday Storm breach.

The storm also breached the south end of the island at the location of the present Unmanned Aerial Vehicle (UAV) runway and connected Hog Creek (Figure 2-3) directly with the ocean. This breach was mechanically closed with a large rectangular fill, as shown in the 1965 photo, Figure 2-8. The southern edge of this fill section is the location of the present day South Camera Stand.

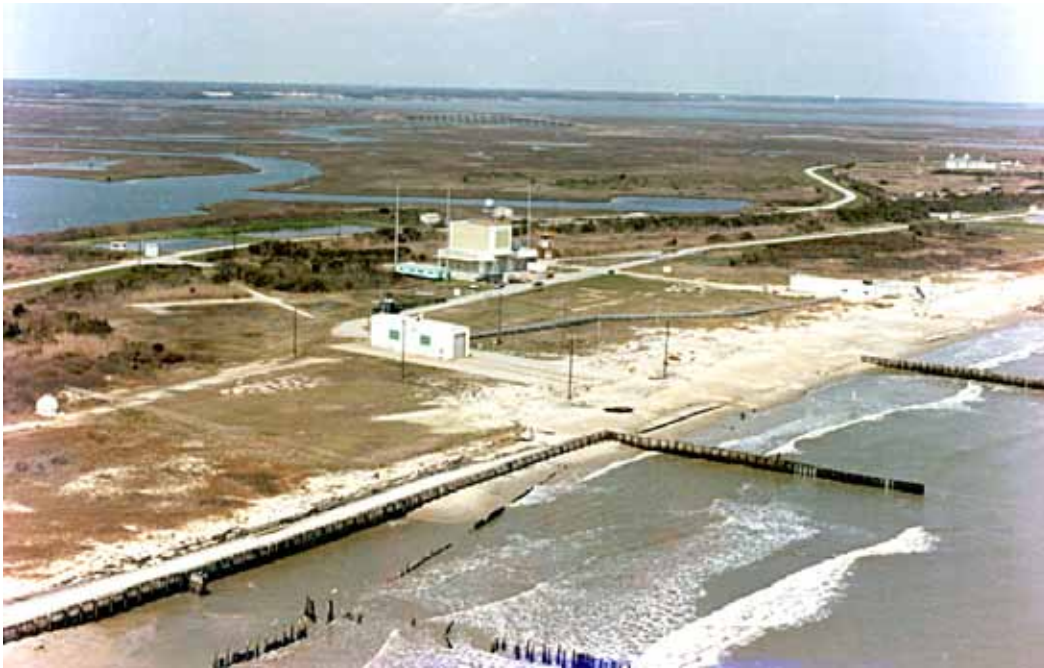
Figure 2-11. Condition of groins and seawall in 1983.

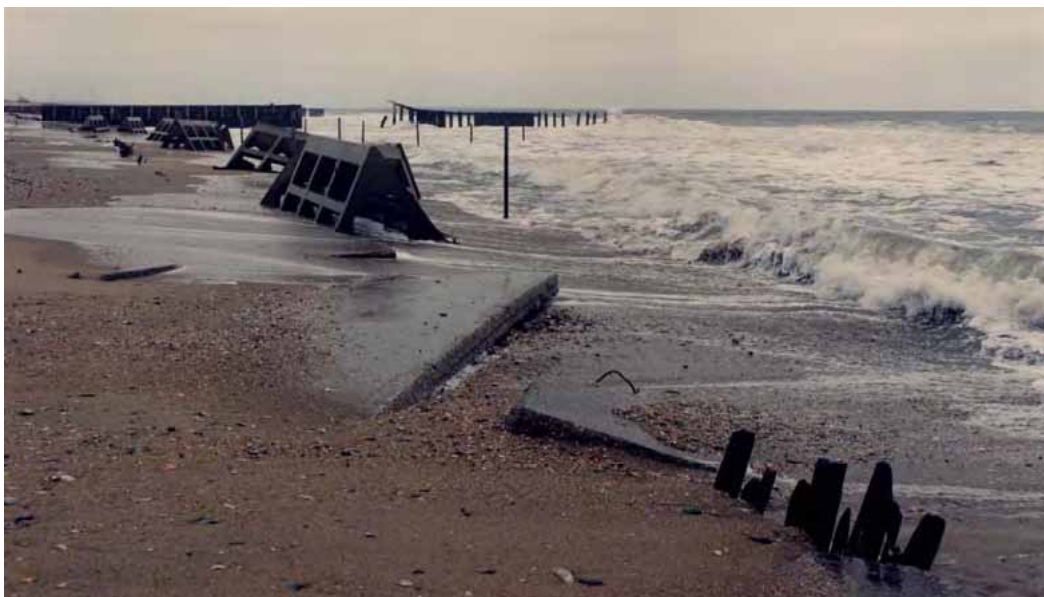
Figure 2-12. Experimental beach protection barriers.

that both types of experimental shore protection structures failed to provide any significant protection. Figure 2-12 (from Morang et al. 2006) shows “Beach Prism” sand retention units that are badly misaligned following an April 1988 storm.

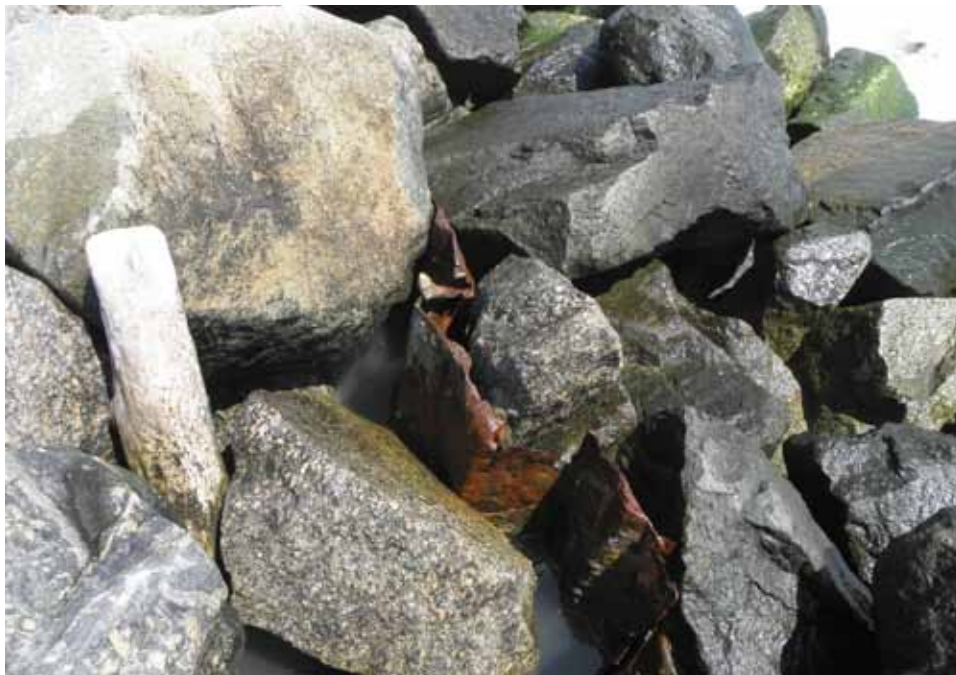
Figure 2-13. Remnants of wooden, steel sheet pile, and concrete seawalls can all be found within and adjacent to the rock seawall in the vicinity of building Y35B.

In the mid 1990s, NASA built the current rock seawall generally in the same location as the previous seawalls (Figures 2-13 and 2-14). The wooden groins were mostly removed at approximately the same time, although several short sections of wooden pilings still remain in place. Photos from the 1990s generally show a small section of beach remaining in front of the seawall. This rock seawall has substantially halted the shoreline retreat, although the sub-aerial beach has disappeared, except at the northern end. Further, the sub-aqueous beach seaward of the seawall has continued to erode, as discussed in Chapter 6. The rock seawall has suffered damage by undermining and stone displacement. Because the wall is porous, storm waves frequently penetrate it, causing flooding and eroding sand on the landward side. See further discussion of the rock seawall in Chapter 3. Figure 2-15 shows waves from Hurricane Dennis overtopping the rock seawall in September 1999. NASA has made frequent repairs to the seawall since the mid 1990s (Morang, Williams, and Swean 2006). In 2006, NASA placed a temporary geotextile tube along the beach south of the seawall, as shown in Figures 2-14 and 2-16. Large waves have occasionally damaged portions of this tube. In mid November 2009, a substantial nor'easter caused island flooding and substantial damage to the geotextile tube (Figure 2-17).

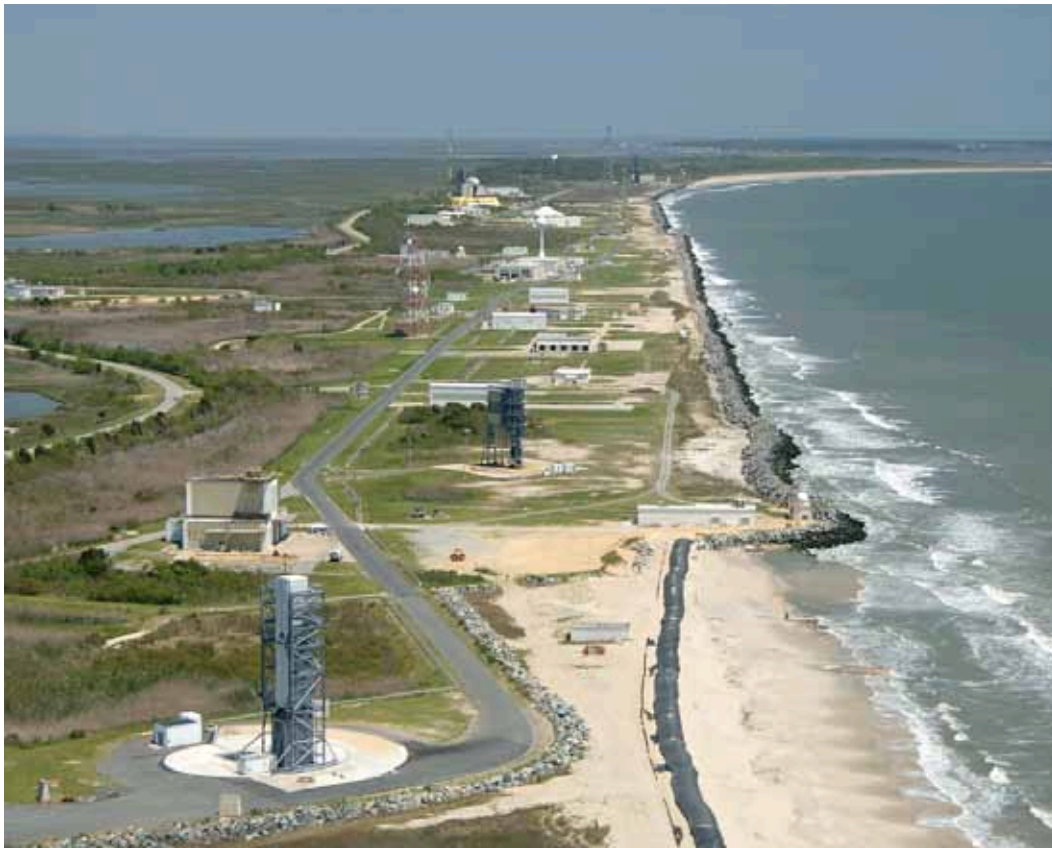
Figure 2-14. Rock seawall in 2007 looking north along Wallops Island.

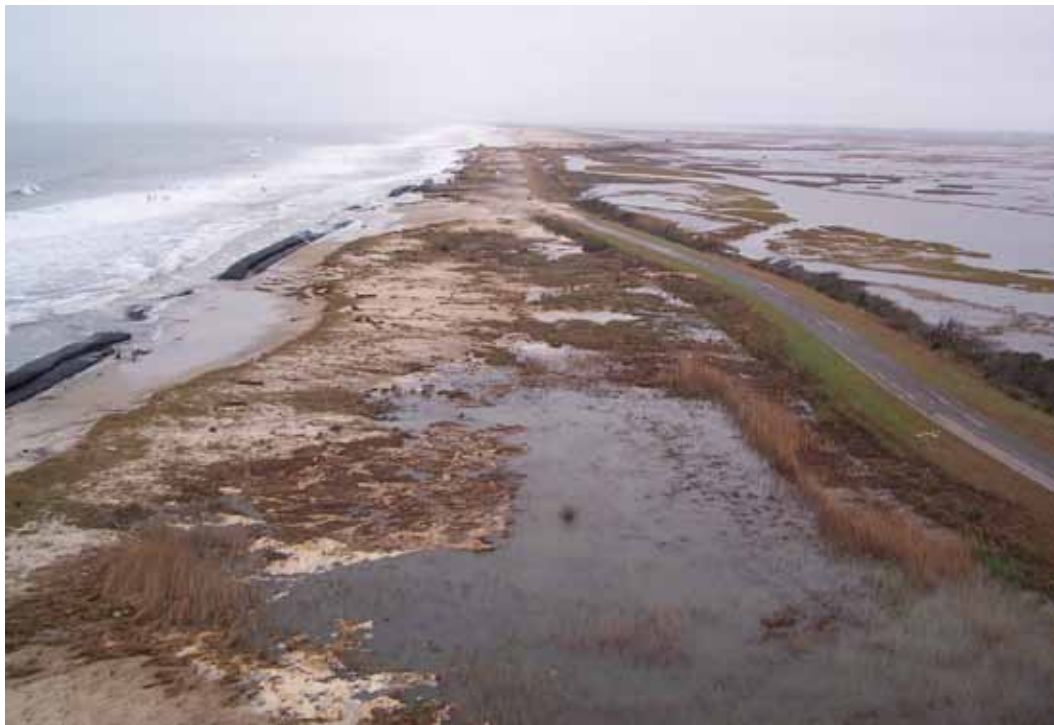
Figure 2-17. Damage to the south end of Wallops Island caused by the November 2009 nor'easter.

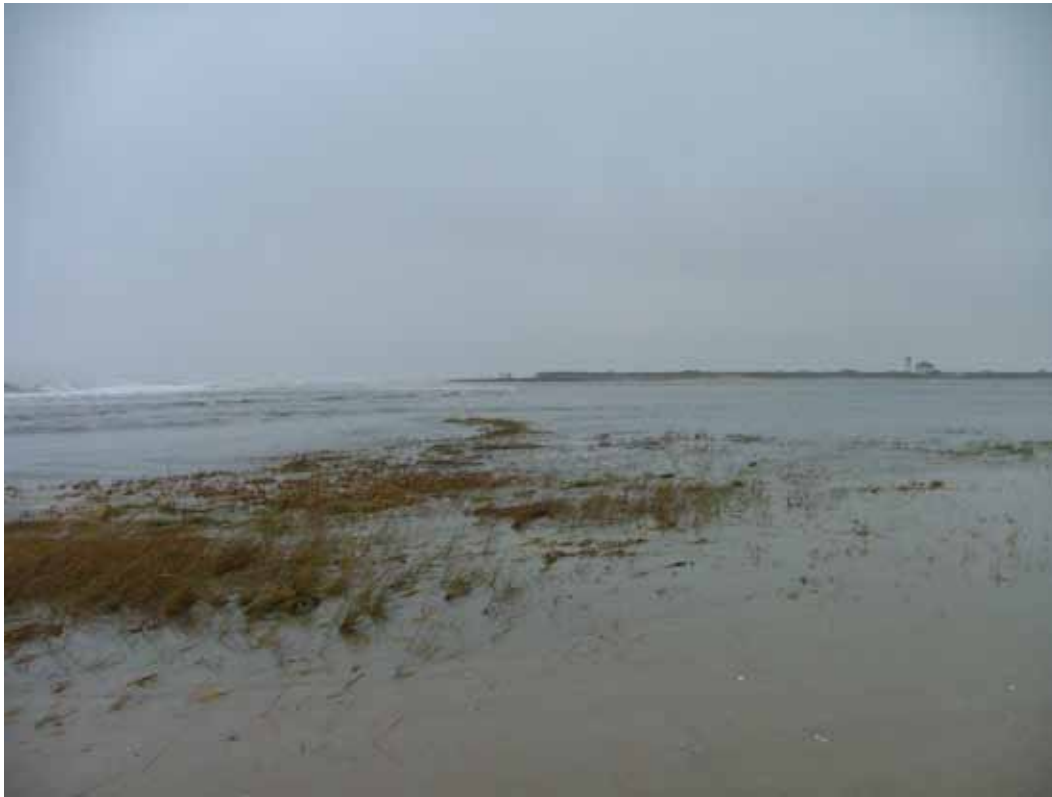
Figure 2-21. Looking south along Assateague Island at the breach into Tom's Cove caused by a November 2009 nor'easter.

Another shoreline change feature shown in Figure 2-19 is a narrowing strip of land separating Tom's Cove from the Atlantic. The rate at which the isthmus is narrowing makes it likely that there will be numerous storm-induced breaches between Tom's Cove and the Atlantic during the 50-year lifetime of this project. The first breach in this area occurred as a result of a November 2009 nor'easter (Figure 2-21). These breaches may close rapidly or they may cause a permanent or semi-permanent inlet(s) to form. Any new inlet would compete with Chincoteague Inlet for the tidal prism of Chincoteague Bay.

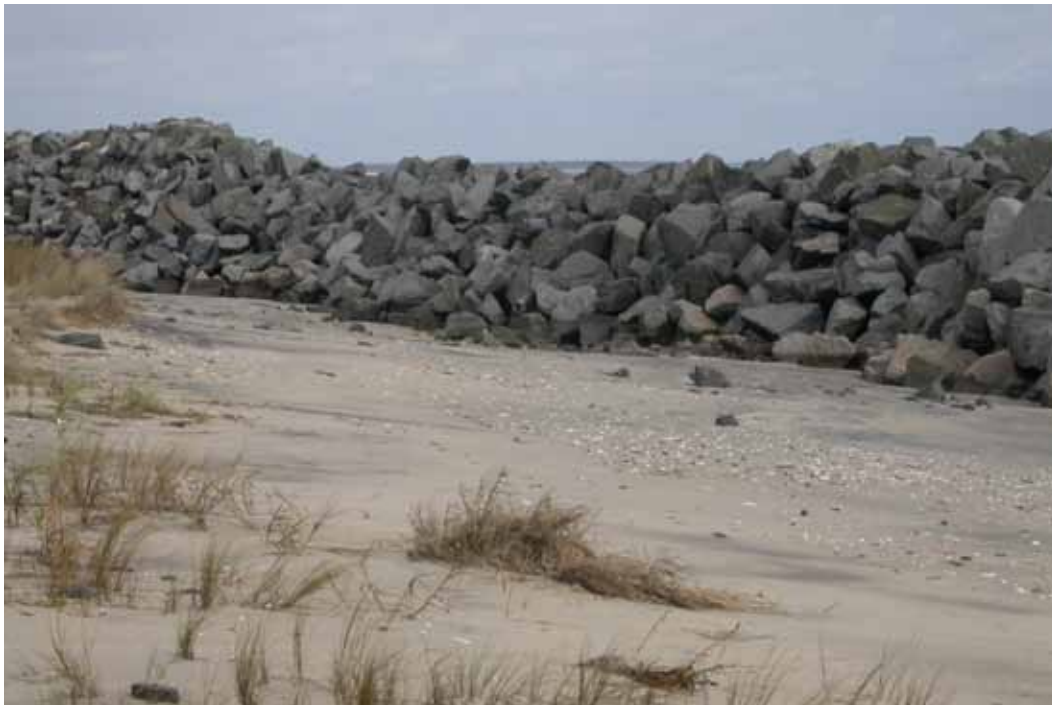
Figure 3-11. Area of decreased crest elevation on seawall.

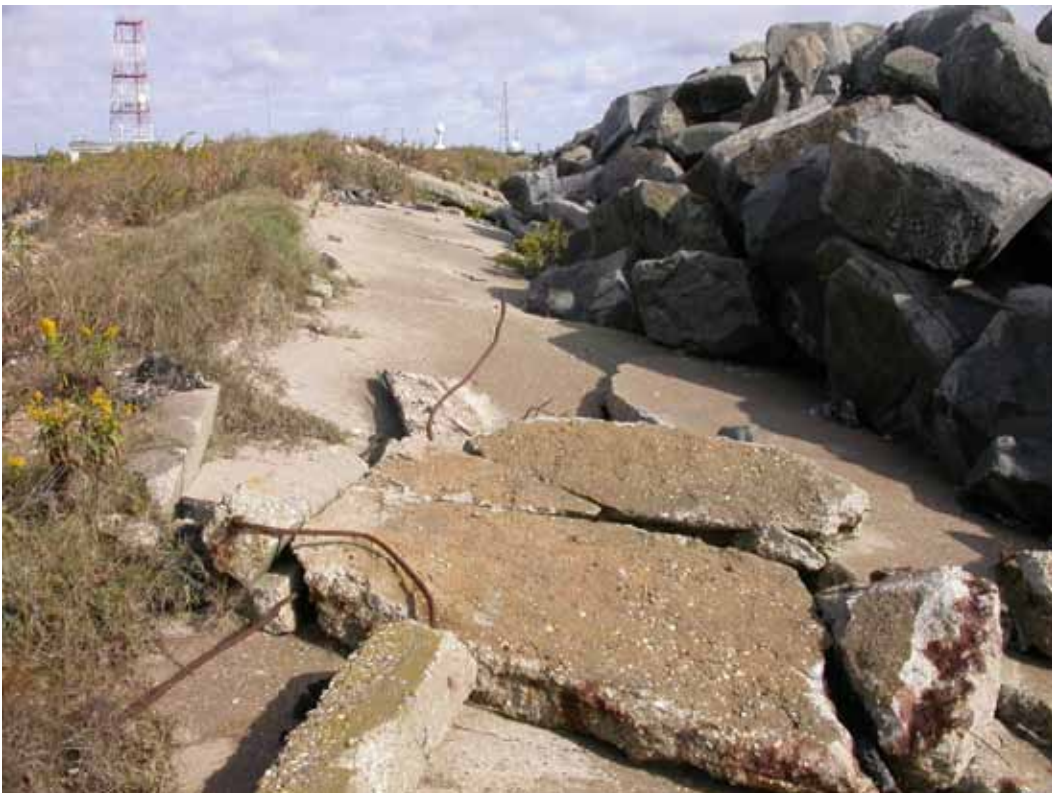
Figure 3-13. Washout under the concrete apron causing cracking and tilting.

North of radar gun tower Y-110 is a large area of washout behind the seawall. Material has washed out from under a concrete apron causing the concrete to crack with rocks sliding seaward (Figure 3-13).

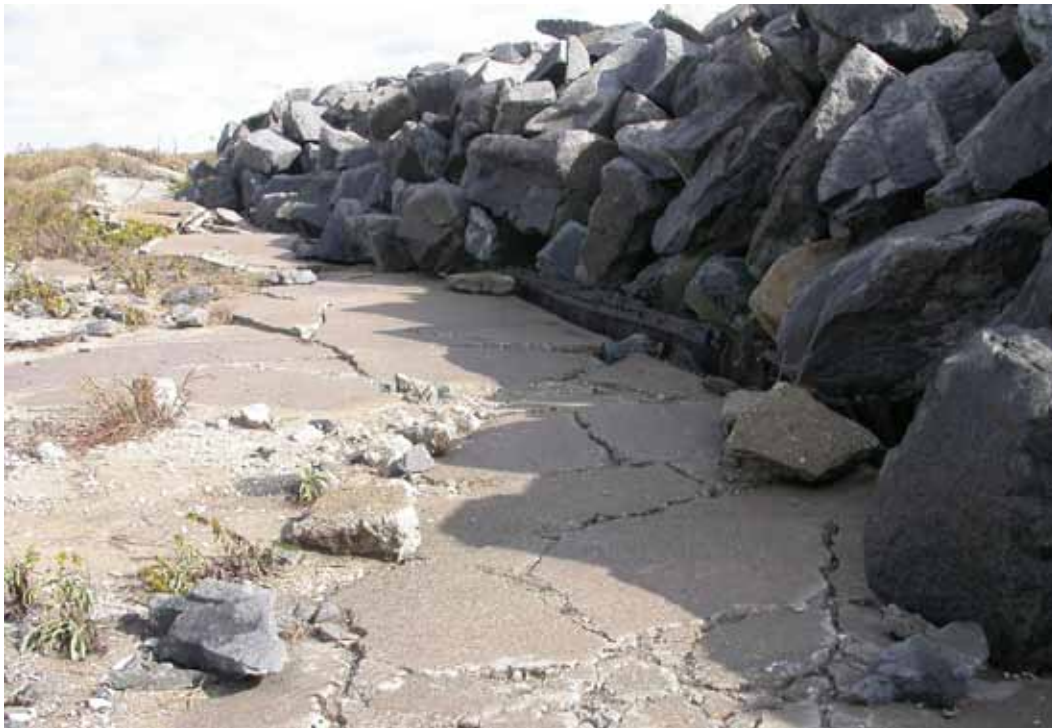
Figure 3-14. Remnants of concrete apron and timber pile wall.

In some areas, the remains of earlier seawalls constructed of timber piles (Figure 3-14) or steel sheet pile (Figure 3-15) were seen within or adjacent to the rubble-mound seawall. In sections, wave action moves freely through the seawall causing scour on the landward side (Figure 3-16). Large scour areas behind the seawall were found along approximately 50 percent of the length of the seawall, with the scour areas as much as 6 ft below the surrounding land area. Some of these scour holes have been filled with rubble, and the rubble repairs are working effectively at halting the localized scour (Figure 3-17).

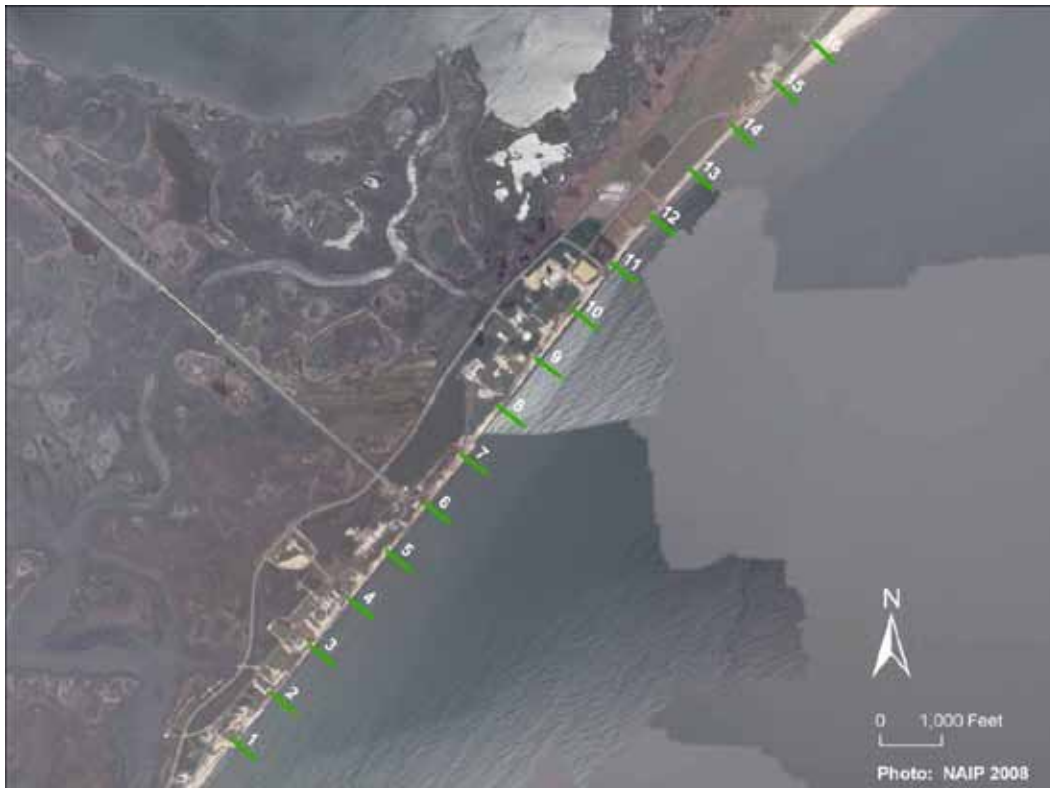
Figure 3-27. Locations of analysis cross-sections for seawall repair to +12 and +14 ft.

Sixteen seawall profiles were taken from the LIDAR data at 1,000 ft intervals along the seawall. Locations of these seawall cross-sections are shown in Figure 3-27. The same cross-sections were used for the +12 ft and +14 ft analyses. +12 ft and +14 ft design profiles were overlain on each of these existing cross-sections and the deficits for each were calculated. Where the existing profile exceeded the design profile, negative volumes were also calculated.

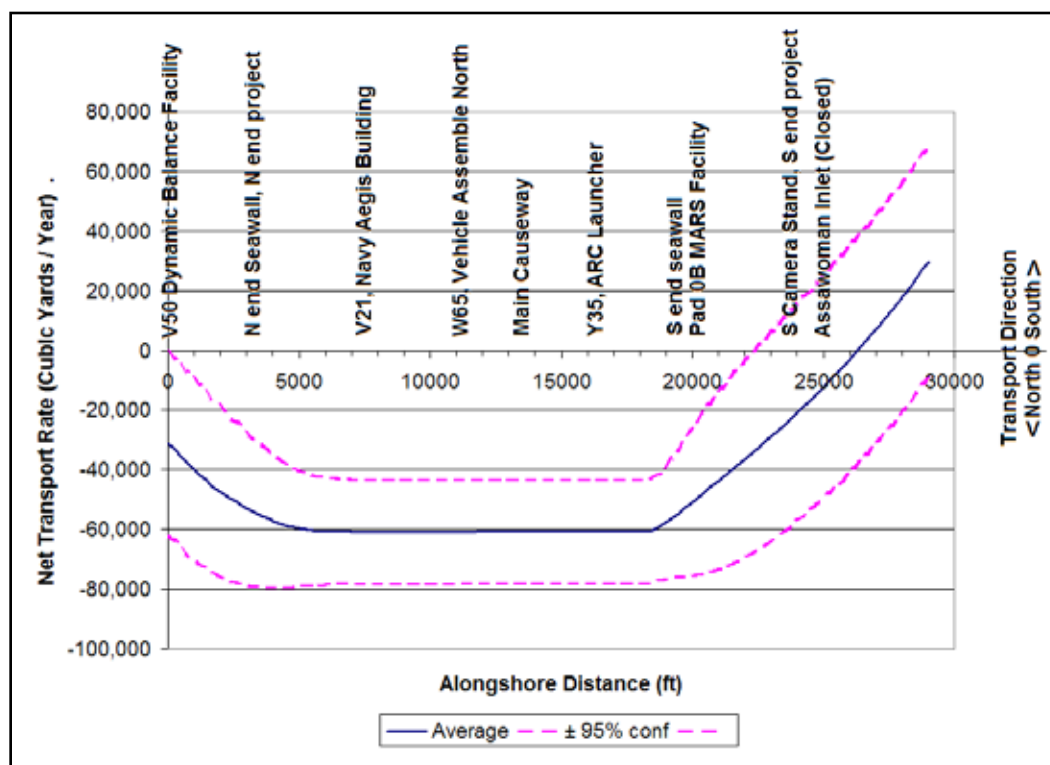
Figure 5-15. Wallops Island sediment budget.

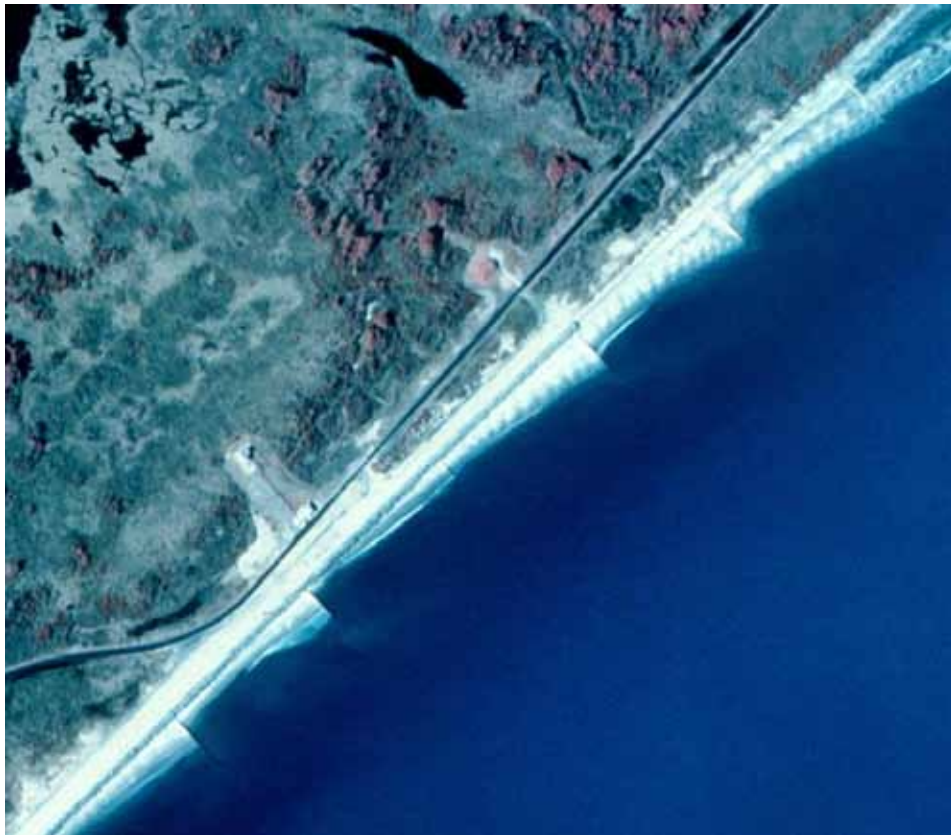
Figure 5-17. Groins field on Wallops Island showing transport direction to the north. Photo taken 20 March 1994.

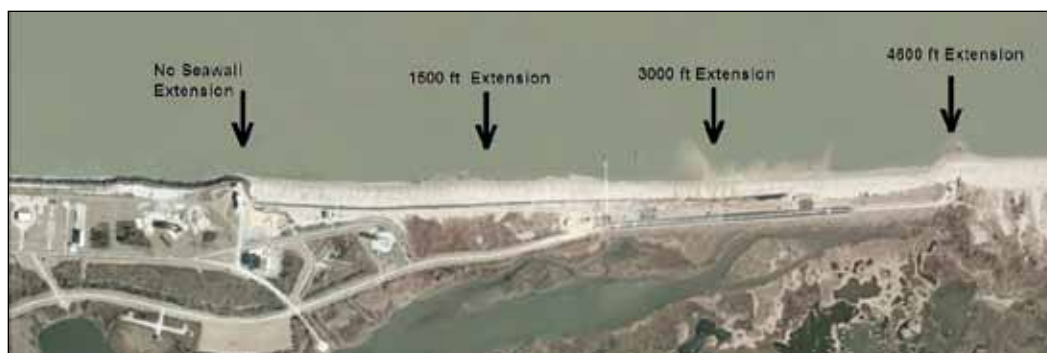
Figure 10-1. Potential seawall extensions modeled in this study.
