Monitoring Completed Navigation Projects (MCNP) Program

Montgomery Point Lock and Dam, White River, Arkansas

Final report

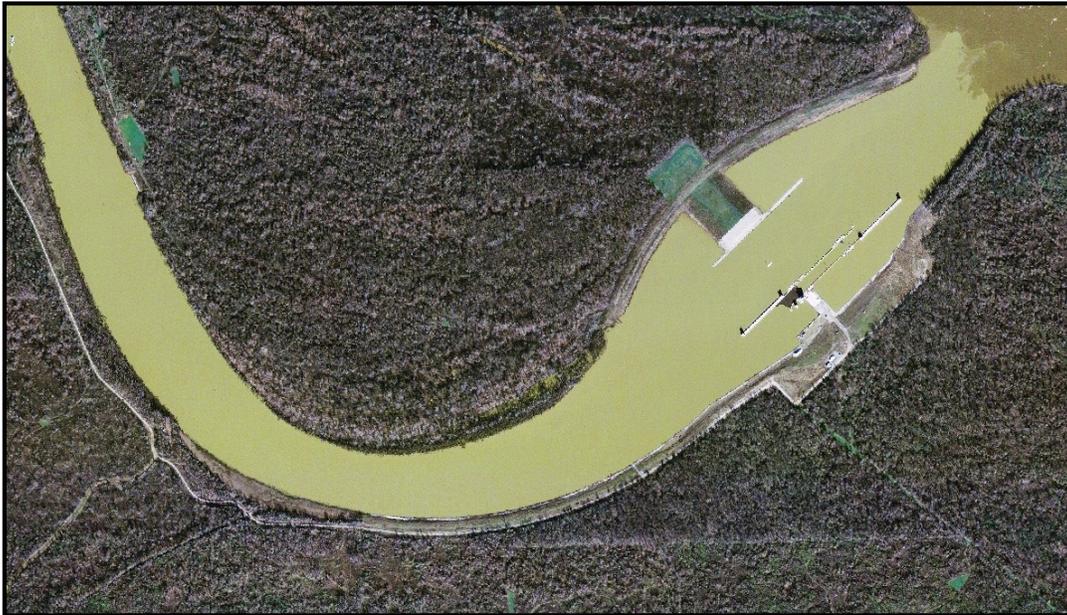
Figure 3. Features of MPLD at high water, by USACE AREC (Plate 2 of Cox et al. 2011; by permission).

Montgomery Point Lock and Dam consist of the following principal features that are shown in Figure 3 by USACE St. Louis District, Applied River Engineering Center (AREC) (Cox et al. 2011):

- single-chamber lock on the right descending bank (RDB) with usable dimensions 110 ft wide by 600 ft long, lock floor elevation 77.5 National Geodetic Vertical Datum of 1929 (NGVD29)
- floating upstream guide wall approximately 524 ft long
- floating downstream guide wall approximately 524 ft long
- unique, 300 ft wide, bottom-hinged, torque-tube crest gate navigable pass (crest elevation 102 ft [NGVD29], with ten 30 ft wide gates) located between the lock and a concrete abutment pier
- a 200 ft wide, fixed-crest concrete overflow spillway located between the concrete abutment pier and a spur dike attached to the left descending bank, crest elevation 115.0 ft (NGVD29)
- four submerged dikes (weirs) with minimal height and effect on flow (approximately 5 ft high), located along the RDB at RMs 0.74, 0.78, 0.85, and 0.90.

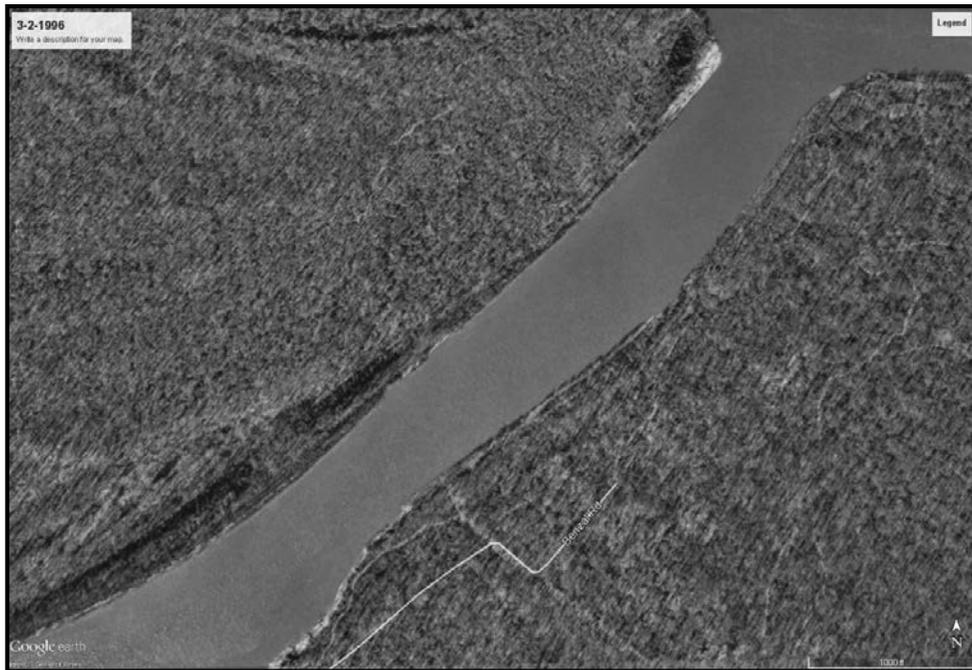
Figure 6. MPLD under construction, 24 January 2001 (photo from Google Earth).

Evolution of shorelines, revetments, and spur dike in the vicinity of MPLD are shown in Figures 5 through 13, as extracted from Google Earth.

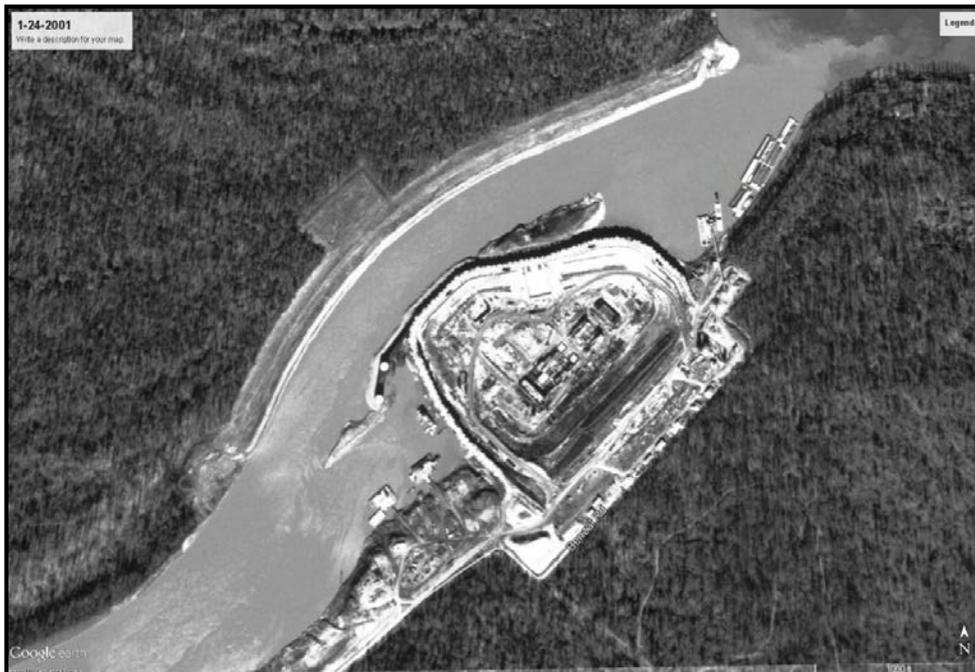
Figure 7. MPLD at low water, 10 November 2005, after being placed into service 24 August 2004 (photo from Google Earth).

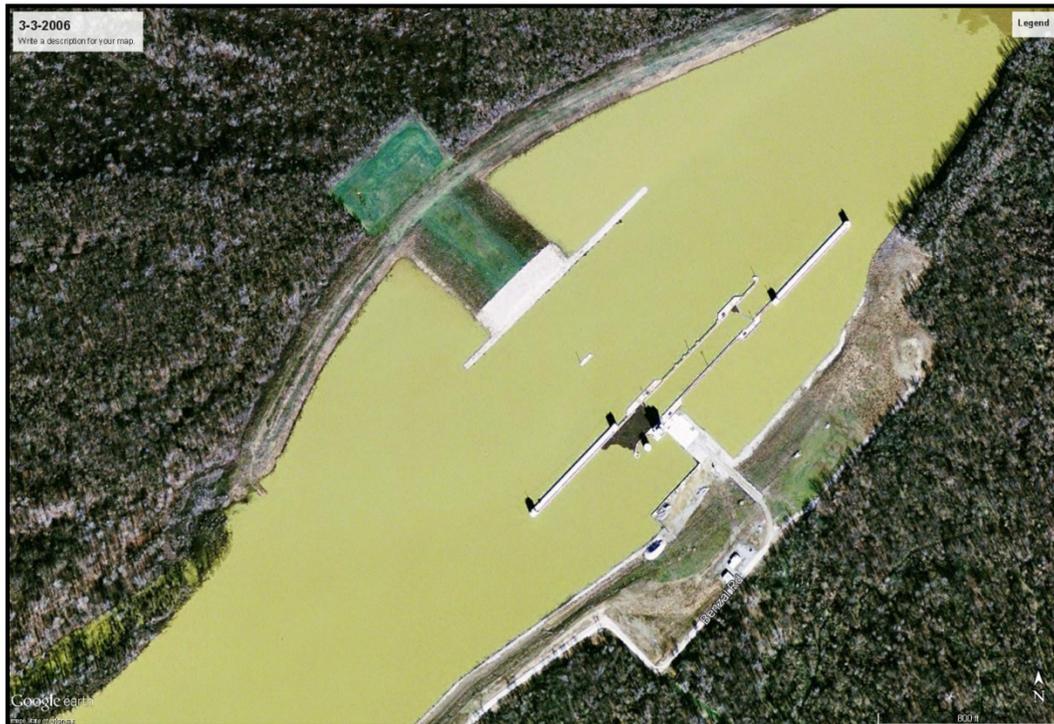
Figure 9. MPLD at low water, 19 September 2007, 3 years after construction. Note sediment accumulation upstream and downstream of earthen dam behind revetments (photo from Google Earth).

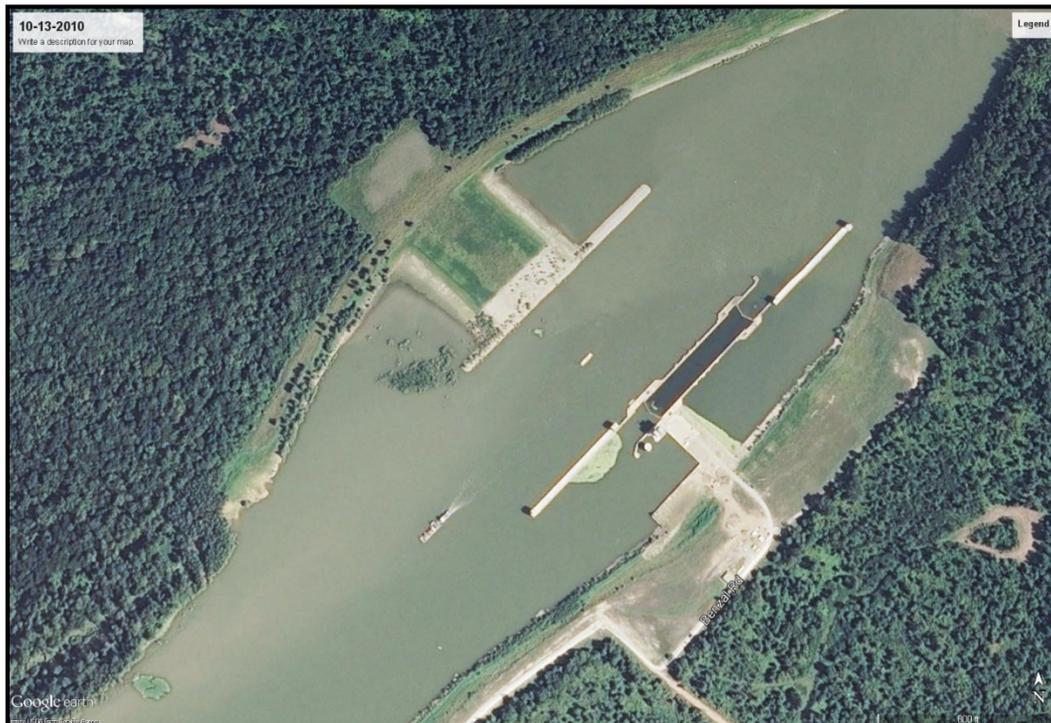
Figure 11. MPLD, 6 January 2013. Note continuing sediment accumulation upstream of earthen dam, infringing on navigation channel (photo from Google Earth).

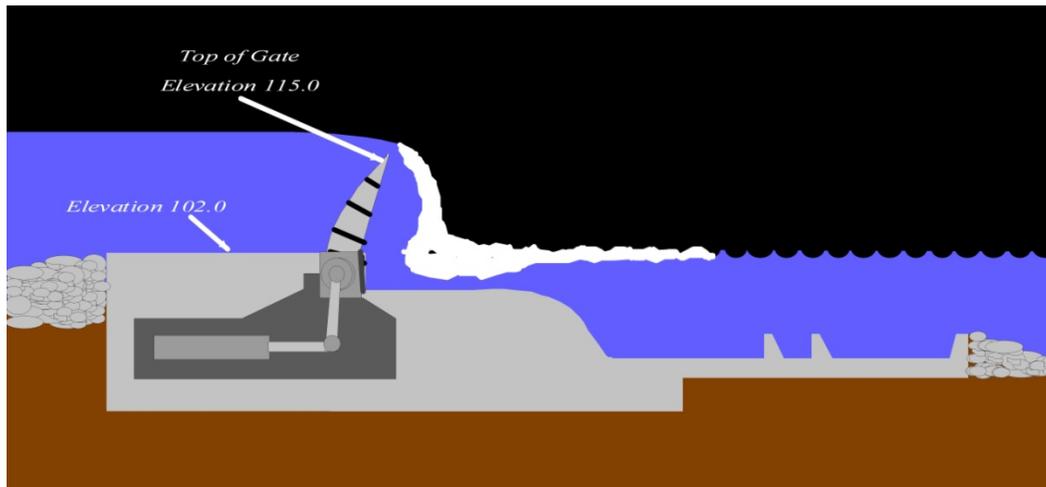
Figure 14. Schematic of hinged, torque-tube crest gate in raised position to create navigation pool upstream of MPLD.

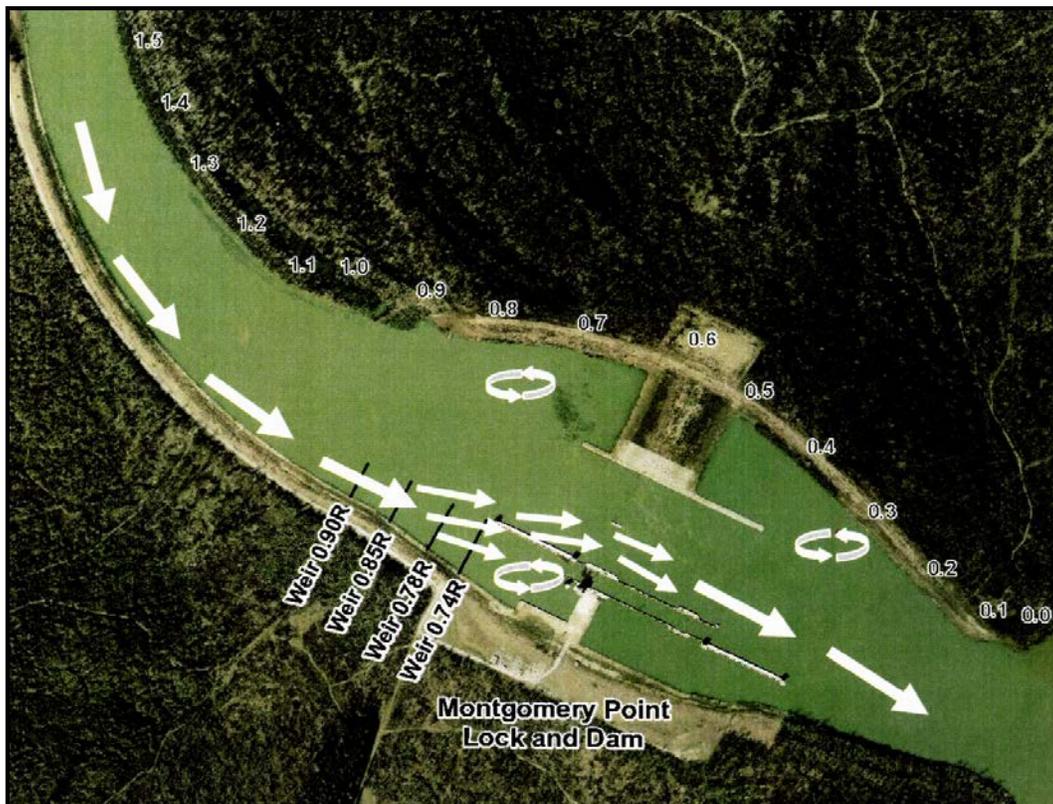
Figure 15. General flow trends indicated by ERDC and SWL ADCP field velocity surveys, as interpreted by USACE AREC. (Graphic 1 of Cox et al. 2011; by permission).

It is apparent that the flow exiting the bend at RM 1.0 was only slightly influenced by the weirs and split near the floating [guide] walls. The weirs do not have much of an effect on the flow because they have minimal section (approximately 5 ft) and are at an angle perpendicular to the bank line and the lock and dam. Generally weirs are angled such that the end of the weir in the channel is upstream of the portion of the weir tied into the bankline. The upstream angled weirs disperse high velocities across its section and direct some flow towards the inside of the bend or channel (Cox et al. 2011).

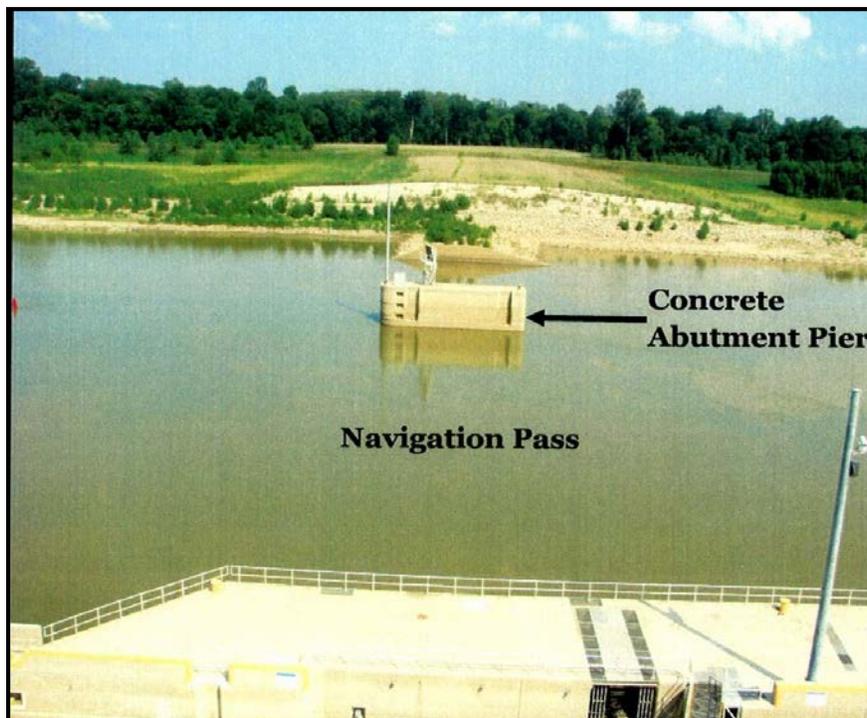
For most of the year, MPLD operates at open river with all of the gates down and tows utilize the navigation pass [Figure 16]. The gates are raised and the lock chamber used by tows (i.e., pool condition) when the tailwater of MPLD falls to an elevation of 115 ft National Geodetic Vertical Datum of 1929 (NGVD29) [Figure 17]. The tailwater elevation is controlled by the Mississippi River. The Montgomery Point upper pool must be operated within the limits of 115 to 119 ft NGVD29. The upper limit of the pool is derived from the elevation of a raised gate at 115 ft NGVD29, and the design maximum allowable head over the top of a raised gate at approximately 4 ft (Cox et al. 2011).

Figure 16. Hinged crest gates of the navigation pass lying flat on river bottom at high water on the Mississippi River. Tows travel through open river navigation pass at high water. Note concrete abutment pier.

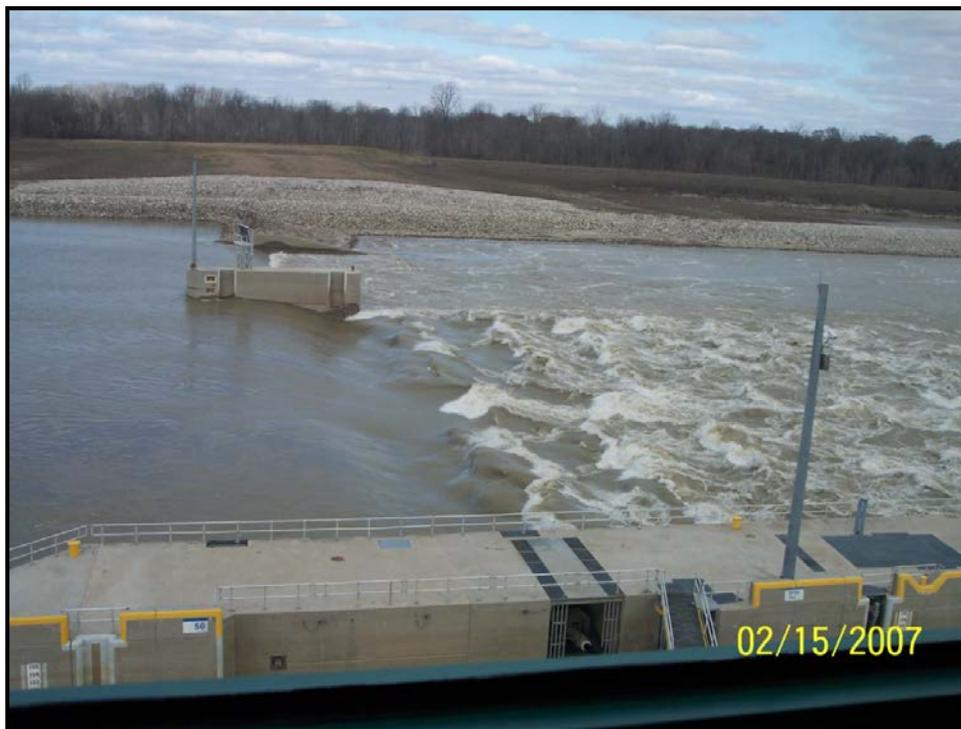
Figure 17. Hinged crest gates in raised position to create navigation pool upstream of MPLD at low water on the Mississippi River. Tows travel through the lock at low water.

To operate within pool limits, the Mississippi River elevation controls the position of the gates and the White River flow controls the number of gates raised. For example, when White River flow is approximately 19,000 cubic feet per sec (cfs), all 10 gates are raised in order to maintain a pool elevation of 119 ft NGVD29. However, if flow on the White River is approximately 53,000 cfs, only 5 gates are raised to maintain a pool elevation of 119 ft MSL. The lock chamber miter gates can only open when the river elevation is below 127 ft MSL (Cox et al. 2011).

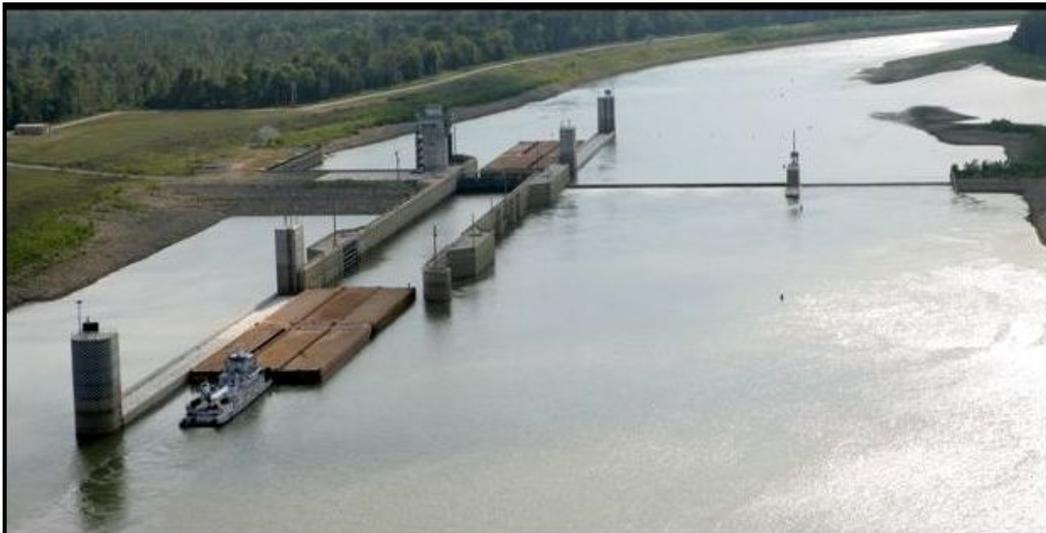
Figure 19. Barge tow entering MPLD navigable pass heading upstream at high water while a larger tow passes on the Mississippi River.

Figure 18 shows a tow entering the navigation lock moving upstream at low water. Figure 19 shows a tow entering the navigation pass moving upstream at higher water with a larger tow traveling on the Mississippi River in the background.

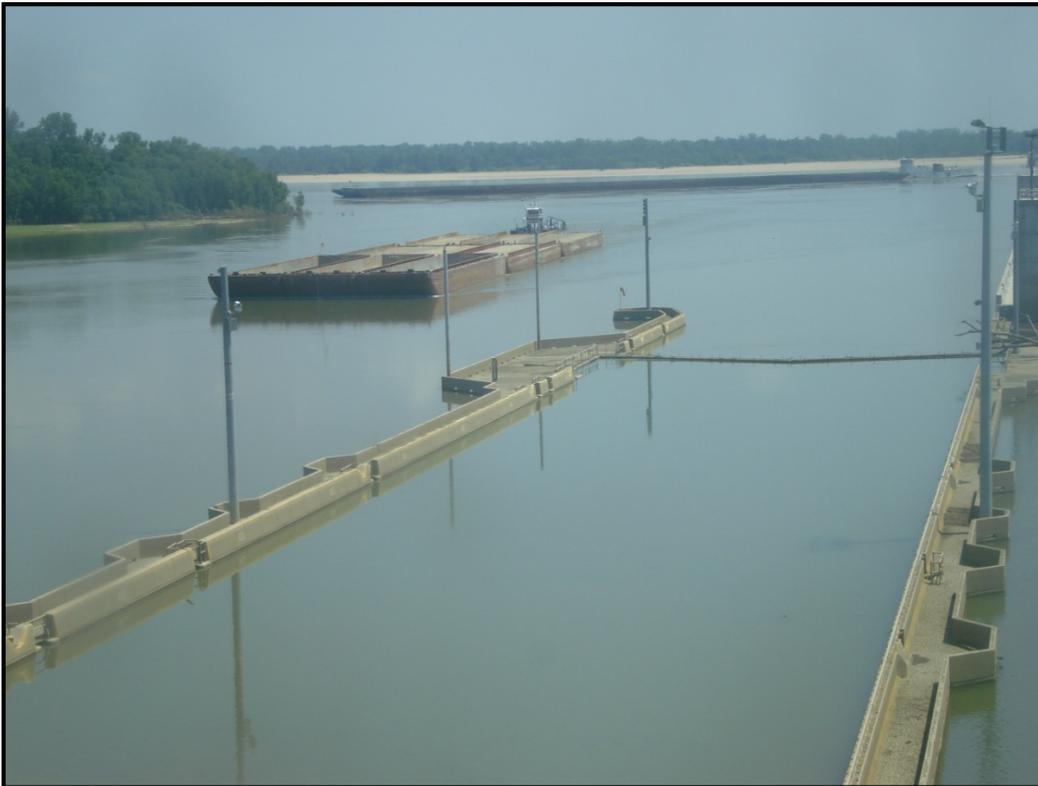
Figure 20. At higher water, the entire MPLD complex becomes submerged, except for the control tower and the lock guide walls abutment piers.

The entire MPLD complex is built below the White River bank line, except the control tower. At extreme high water on the Mississippi River, the entire MPLD complex will become submerged, except the control tower (Figure 20). The concrete navigation pass abutment pier (Figure 21) may then become a hazard to navigation. Figure 22 shows a tow boat sitting on top of the pier after an allision on 11 February 2005, shortly after MPLD was placed into service 24 August 2004. Since the opening of the lock, there have been at least five significant allisions.

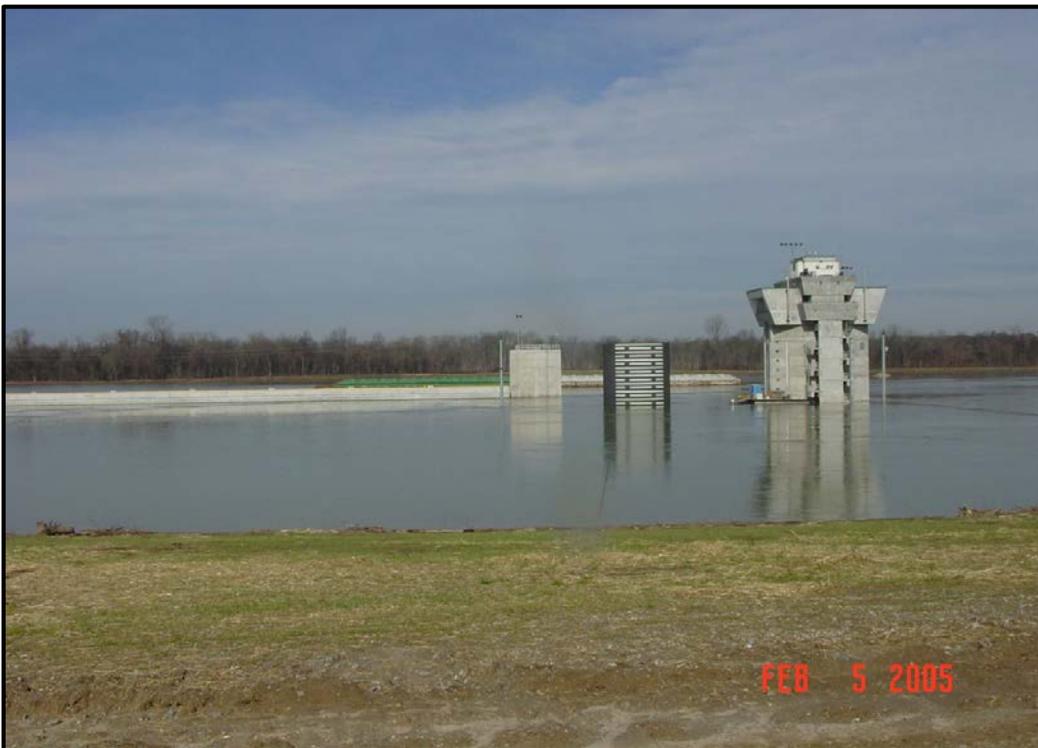
Figure 21. Navigation pass concrete abutment pier may become a hazard at high water.

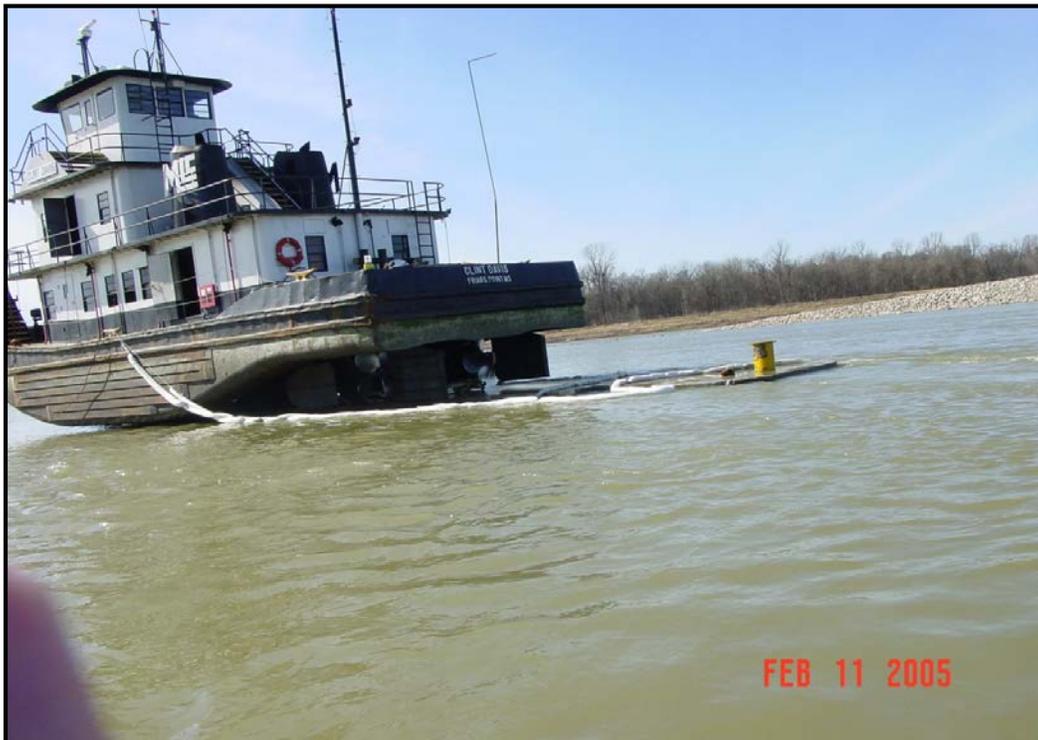
Figure 22. Tow boat allision with navigable pass concrete abutment pier at high water.

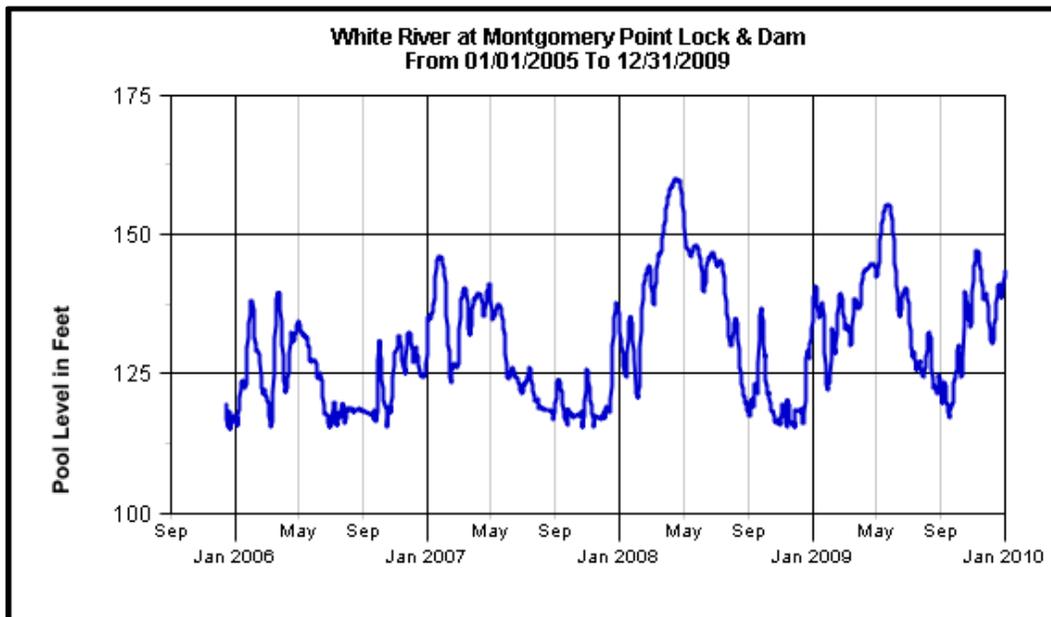
Figure 23. Pool elevations at MPLD.

The pool elevation was at high water all three time periods when ERDC conducted field surveys: (1) May 2008, elev. = 150 ft NGVD29, (2) September 2008, elev. = 125 ft NGVD29, and (3) June 2009, elev. = 135 ft NGVD29 (Figure 23). The gates were not in a raised position during the time of any of these ERDC field surveys. A necessary prerequisite for measuring spillway gate leakage and verifying the physical model estimates was that the gates must be in a raised position. Hence, it was not possible to accomplish this element that was originally scheduled to be monitored.

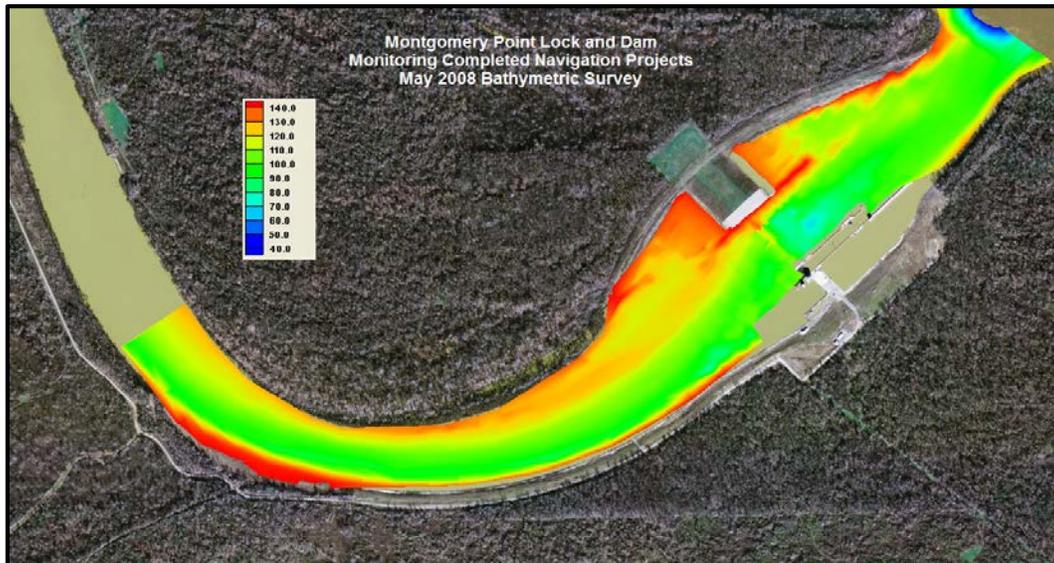
Figure 24. May 2008 bathymetric survey, White River, vicinity of MPLD, high water, pool elevation approximately 150 ft NGVD29. Scour hole bottom elevation approximately 68 ft NGVD29.

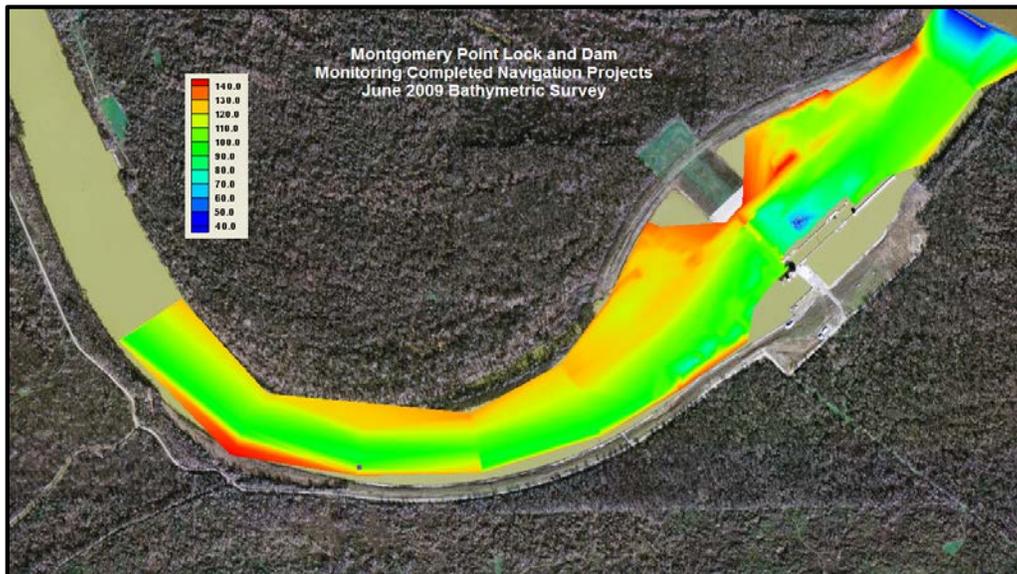
Figure 25. June 2009 bathymetric survey, White River, vicinity of MPLD, high water, pool elevation approximately 148 ft NGVD29. Scour hole bottom elevation approximately 45 ft NGVD29.

Figure 25 (June 2009 survey) shows additional deepening and widening in the area just downstream of the stone protection of the navigable pass stone and north of the lock stone protection to approximately elevation 45 ft NGVD29.

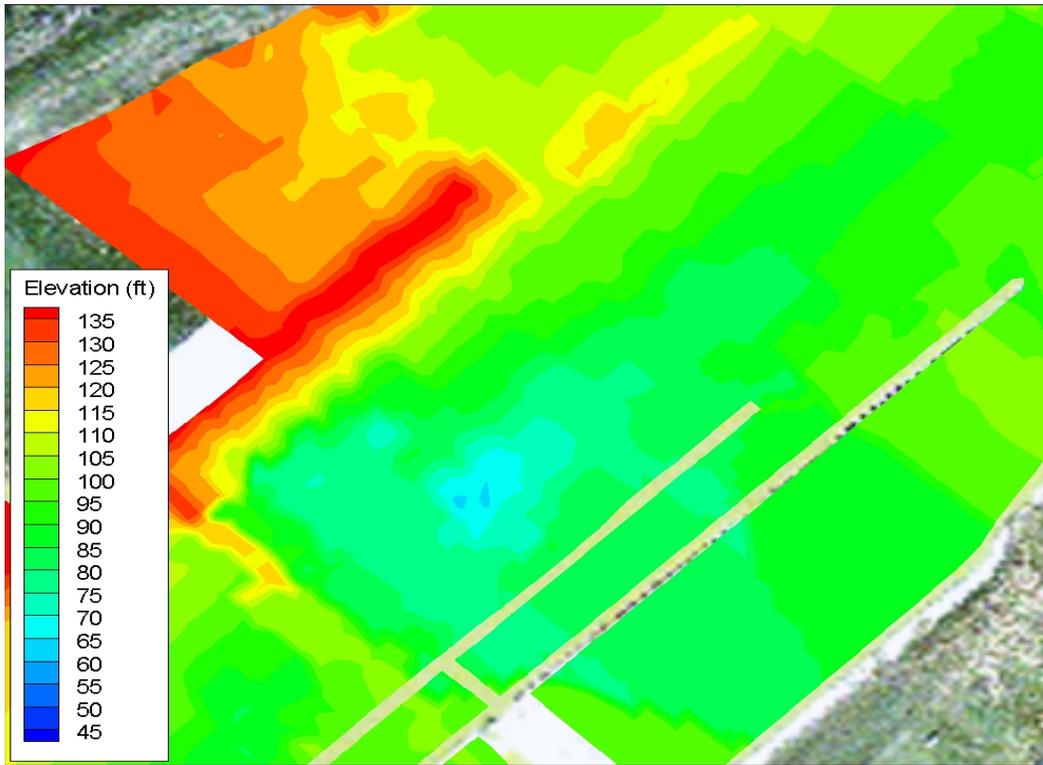
Figure 26. Closeup view of scour hole bathymetry downstream of MPLD navigation pass, May 2008. Scour hole bottom elevation approximately 68 ft NGVD29.

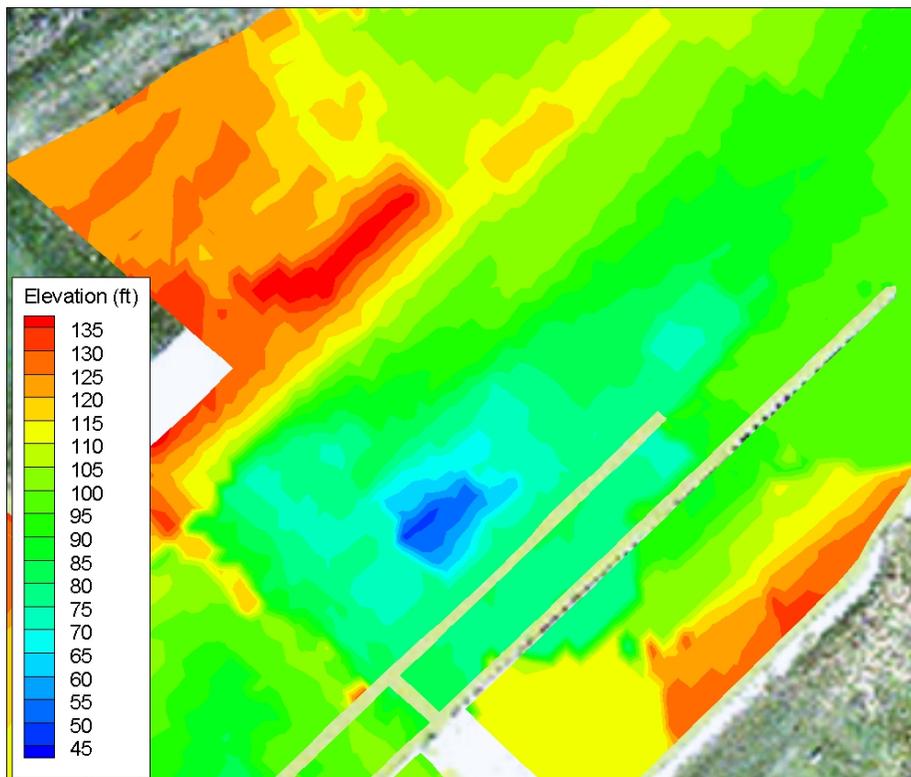
Figure 27. Closeup view of scour hole bathymetry downstream of MPLD navigation pass, June 2009. Scour hole bottom elevation approximately 45 ft NGVD29.

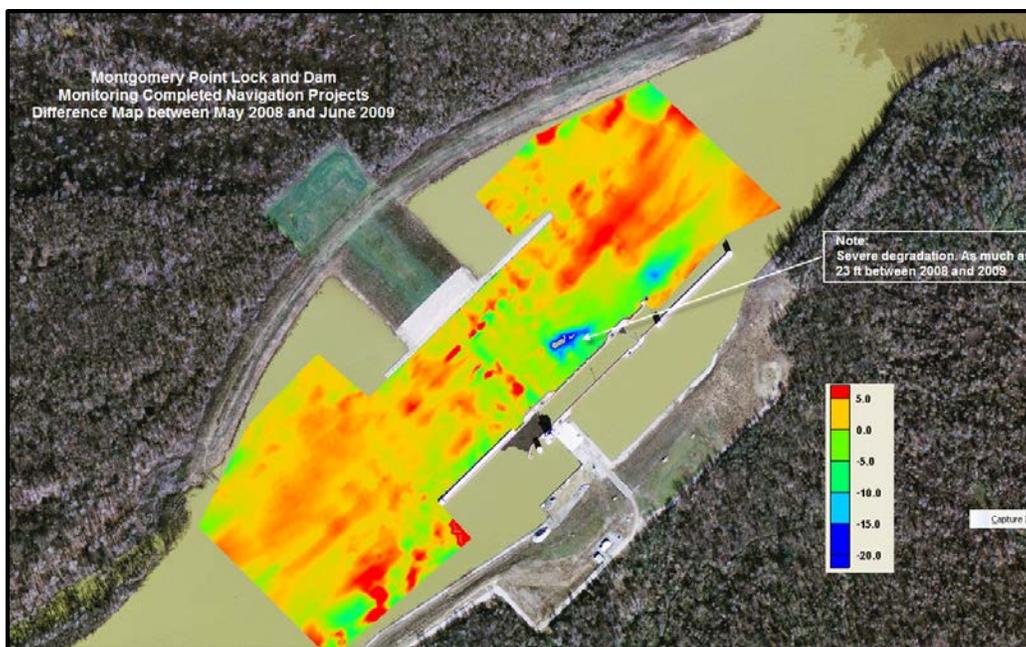
Figure 28. Difference map showing change in channel elevation between May 2008 and June 2009, vicinity of MPLD. Up to 23 ft of additional degradation occurred in scour hole below navigation pass during this time period.

Himstedt (2015, personal communication) stated that dredged material had been placed in the scour hole in 2007 and covered with four work-barge loads of stone, although the stone size was not available. The difference map between the May 2008 and June 2009 surveys (Figure 28) showed significant degradation and widening of the area just downstream of the stone protection of the navigable-pass stone and north of the lock stone protection. This comparison showed approximately 23 ft of additional degradation in this area, with more degradation farther downstream along the lock. The scour hole appeared to have widened and lengthened quite significantly during this time period. The scour hole was approximately 115 ft wide and 260 ft long, according to the survey of June 2009.

The scour hole developed at this specific location because river flow at high water over the fixed-bed navigation pass is analogous to high-velocity turbulent flow over a weir. The resulting high-velocity currents provide forces capable of scouring the movable bed material comprising the river bottom in this vicinity. Based on these survey data showing significant scour hole enlargement between May 2008 and June 2009, it was recommended that SWL fill and stabilize the scour hole with stone sufficiently large enough to prevent scour hole enlargement with resulting potential endangerment of the navigation structures.

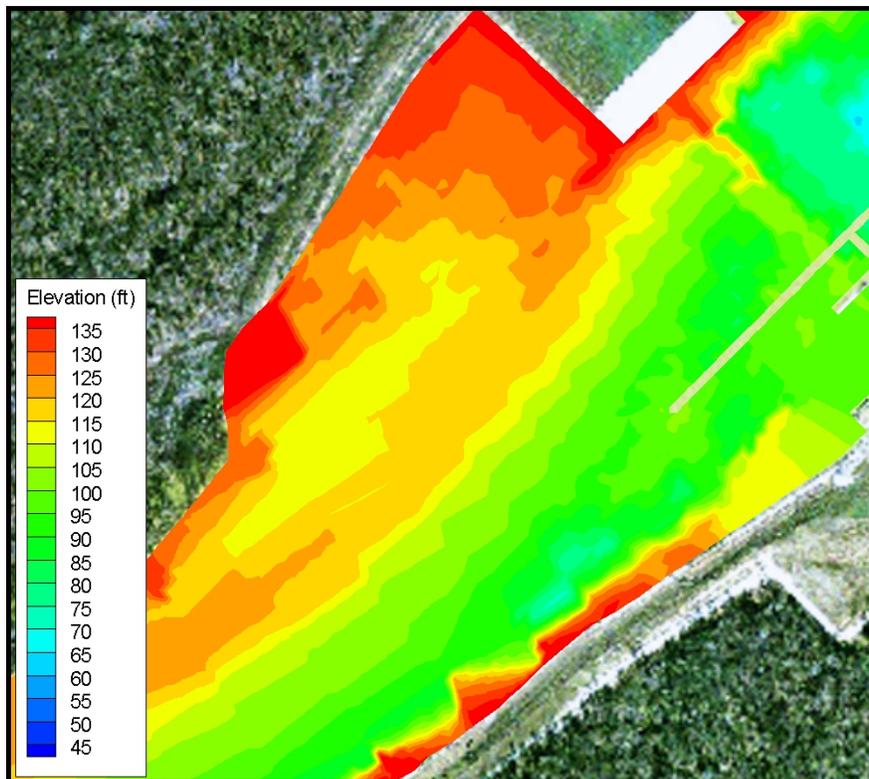
Figure 29. Close-up view of bathymetry of the MPLD upstream lock approach, May 2008.

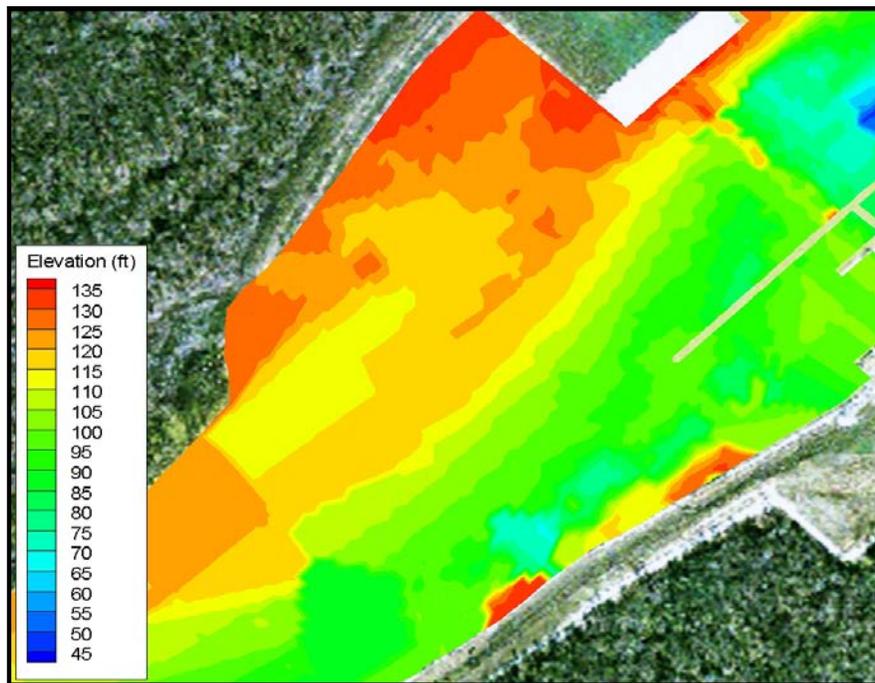
Figure 30. Close-up view of bathymetry of the upstream lock approach, June 2009.

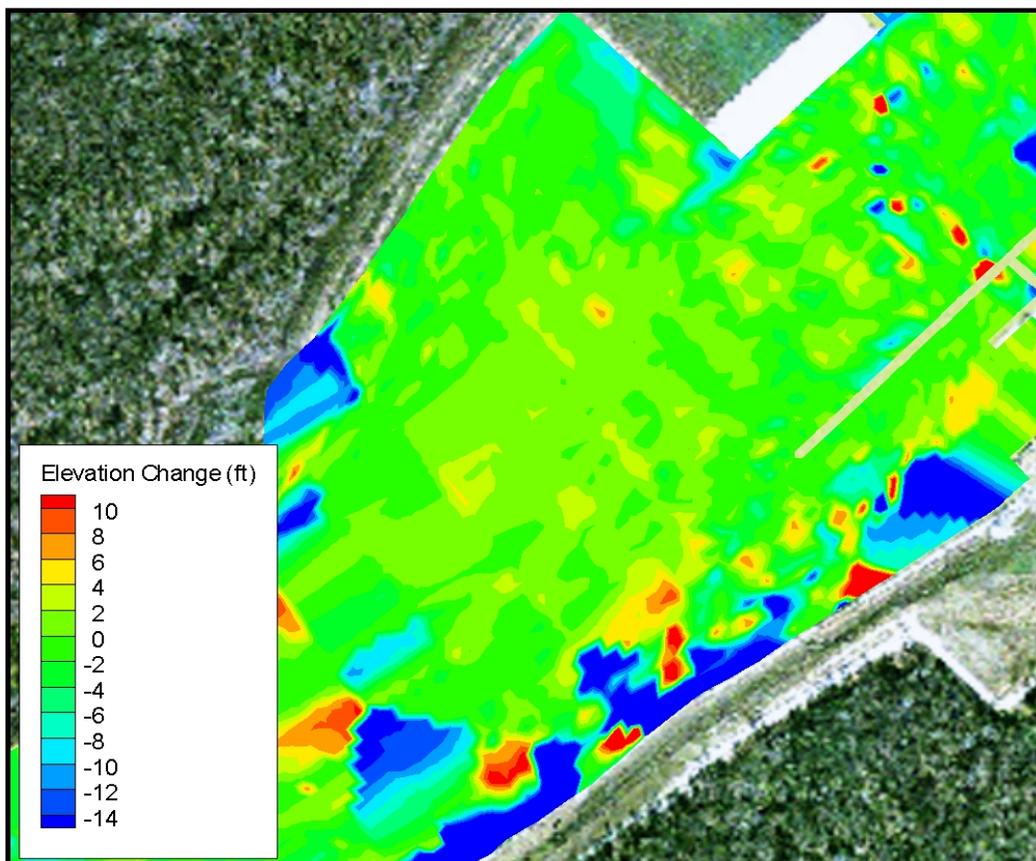
Figure 31. Difference map showing change in upstream lock approach channel elevation between May 2008 and June 2009, vicinity of MPLD.

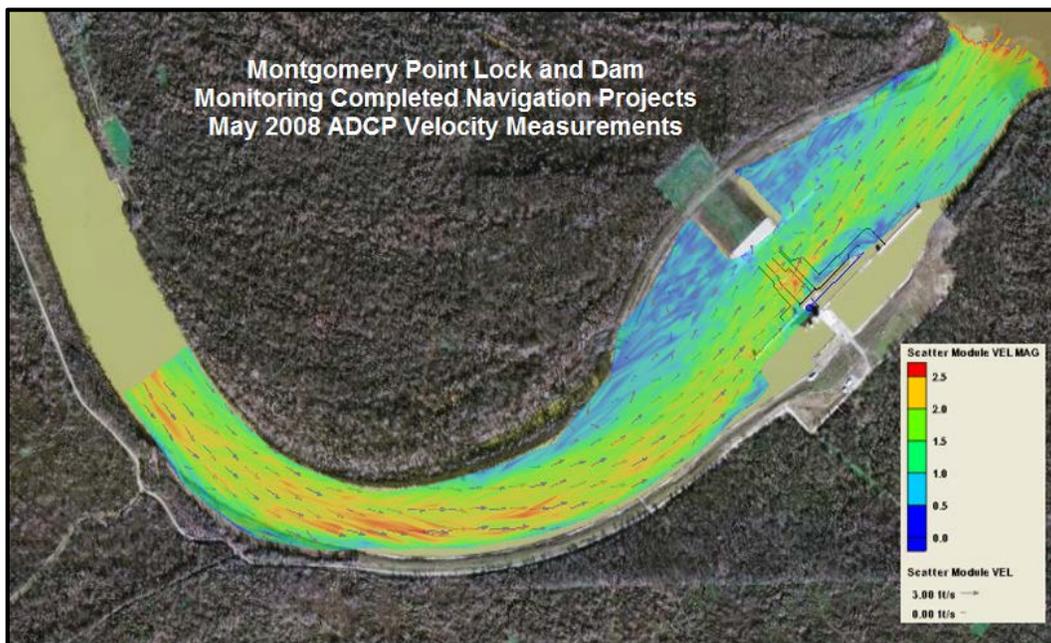
Figure 32. May 2008 ADCP velocity measurements.

The ADCP discharge measurement for the May 2008 survey was approximately 57,000 cfs at a water level approximately 148.0 ft NGVD29. Current magnitudes and direction data obtained from the ADCP data indicated that flow was concentrated along the RDB in the bend upstream of the lock and into the upper lock approach. Current magnitudes ranged from 2.0 to 2.5 fps in these areas. Once past the upper lock approach, the flow through the navigable pass tended to be concentrated toward the left end of the navigable pass in the vicinity of the pier separating the navigable pass and overflow weir. Large, slow-moving eddies with current magnitudes of 0.5 to 1.0 fps were observed upstream and downstream of the dam along the right bank.

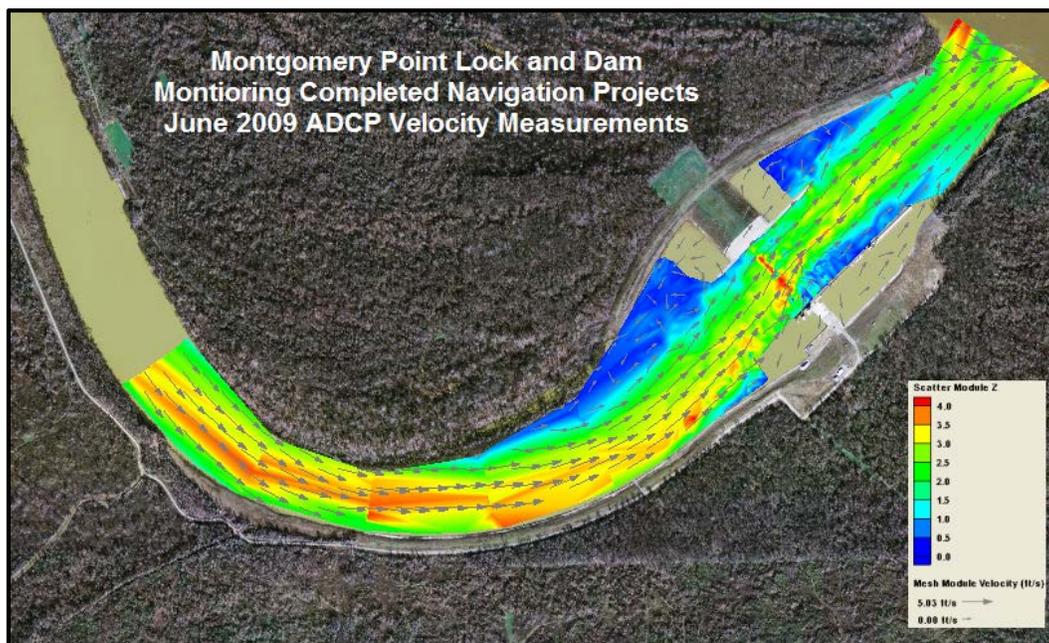
The flow field for the June 2009 survey is shown in Figure 34.

Figure 34. June 2009 ADCP velocity measurements.

The ADCP discharge measurement for the June 2009 survey was approximately 80,000 cfs and a water level approximately 148.0 ft NGVD29. Current magnitudes and direction data obtained from the ADCP data indicate the same trend as those observed in the May 2008 survey; however, current magnitudes were greater and ranged from 3.0 to 3.5 fps. This should be expected since the discharge was greater and the water level was the same. Current magnitudes through the navigable pass and the overflow weir were approximately 4.0 fps. Large, slow-moving eddies with current magnitudes of 0.5 to 1.0 fps were also observed upstream and downstream of the dam along the right bank.

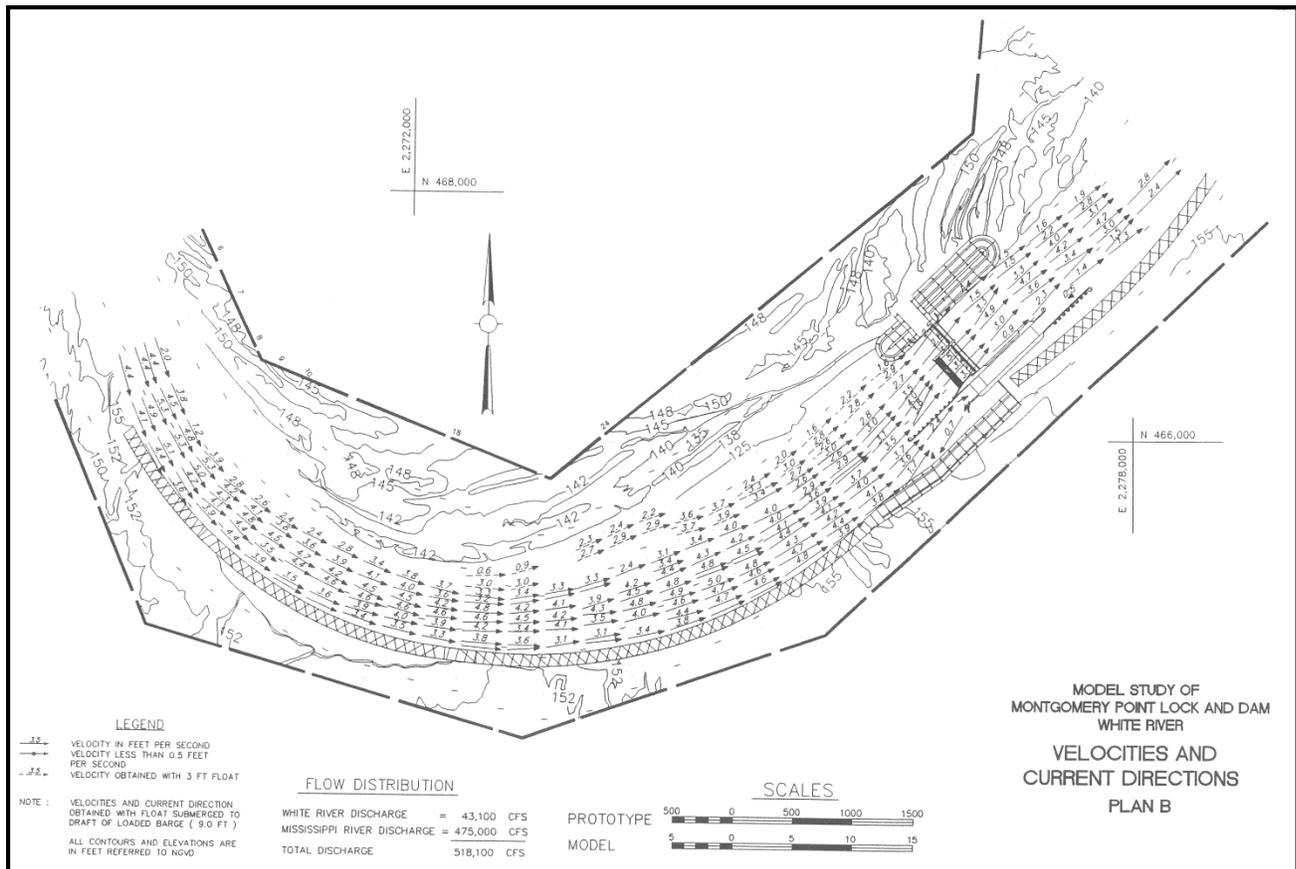
Figure 35 shows the physical model current magnitude and direction data collected with a similar plan as shown in Figures 32 and 34 but with a White River discharge of 43,100 cfs and a tailwater elevation of 125.0 ft. There were no data collected in the physical model precisely for the discharges and tailwater elevations observed in the May 2008 and June 2009 surveys. However, flow patterns can be compared. The ERDC physical hydraulic model indicated flow patterns very similar to those observed with the prototype data collected in May 2008 and June 2009 surveys. The physical model also indicated a concentration of the flow toward the RDB upstream of the lock and into the upper lock approach. The flow then moved under the floating guide wall, around the lock, and over the navigable pass and overflow spillway. The physical model data also indicated that the flow is

Figure 35. ERDC physical model results: White River discharge = 43,100 cfs; tailwater elevation = 125.0 ft.

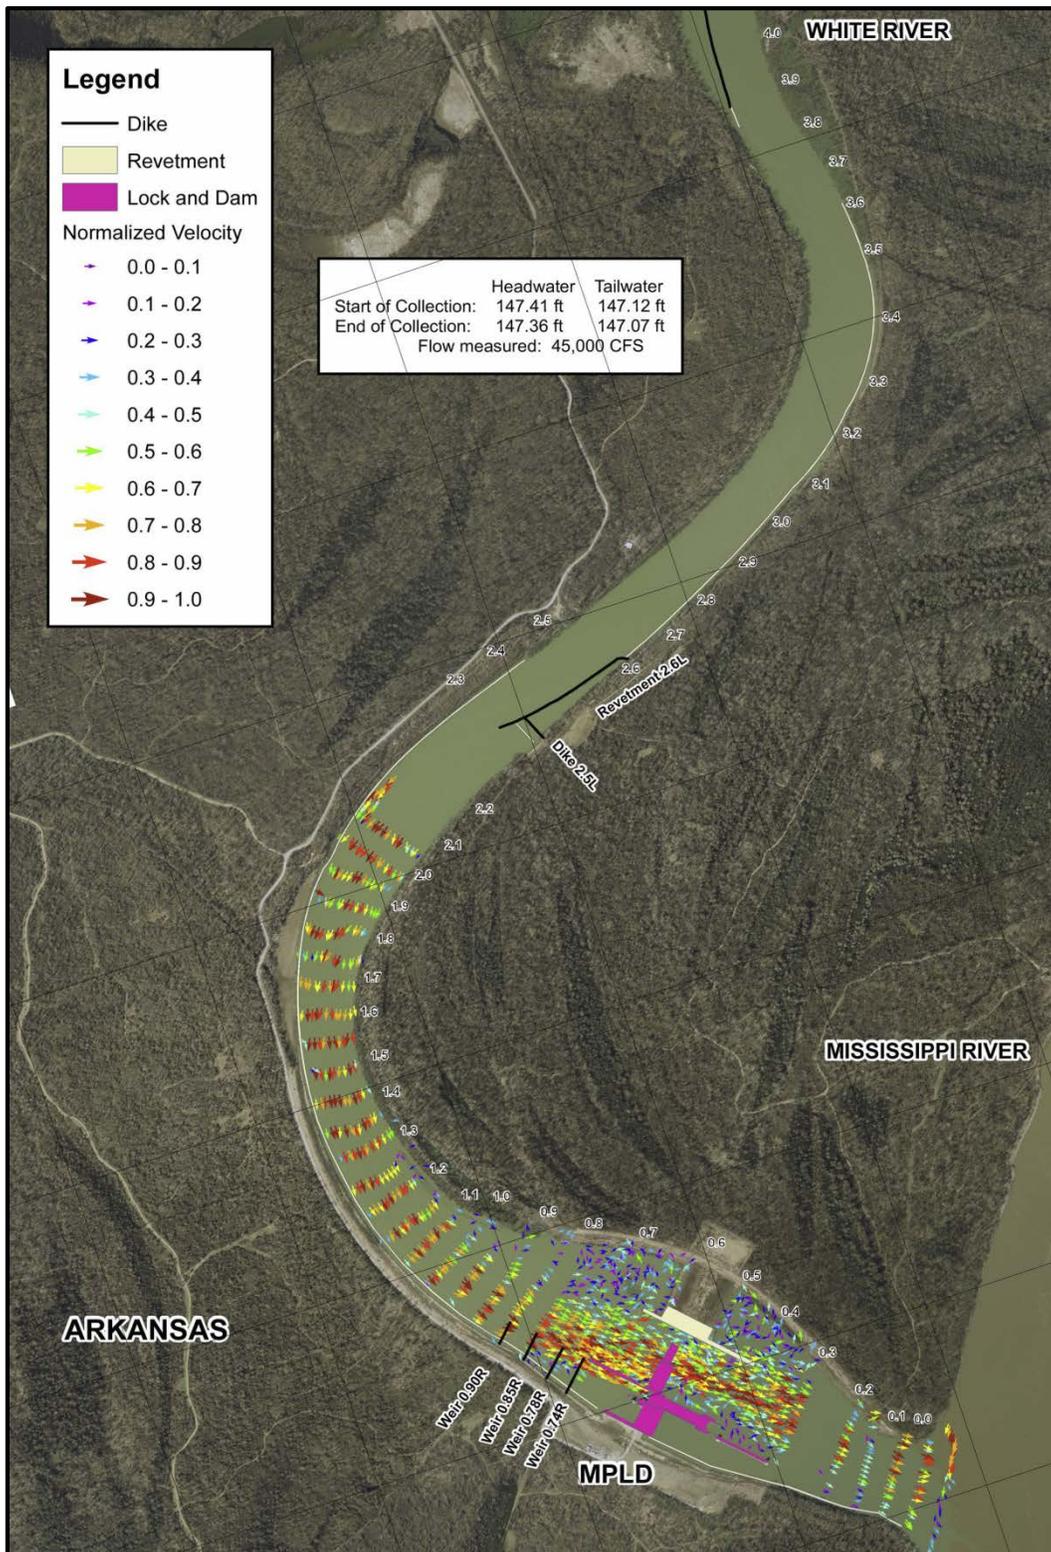
Figure 36. ERDC ADCP velocity data, May 2008. Normalized and interpreted by USACE AREC (Plate 23 of Cox et al. 2011; by permission).
