Monitoring Completed Navigation Projects (MCNP) Program

Montgomery Point Lock and Dam, White River, Arkansas

Final report

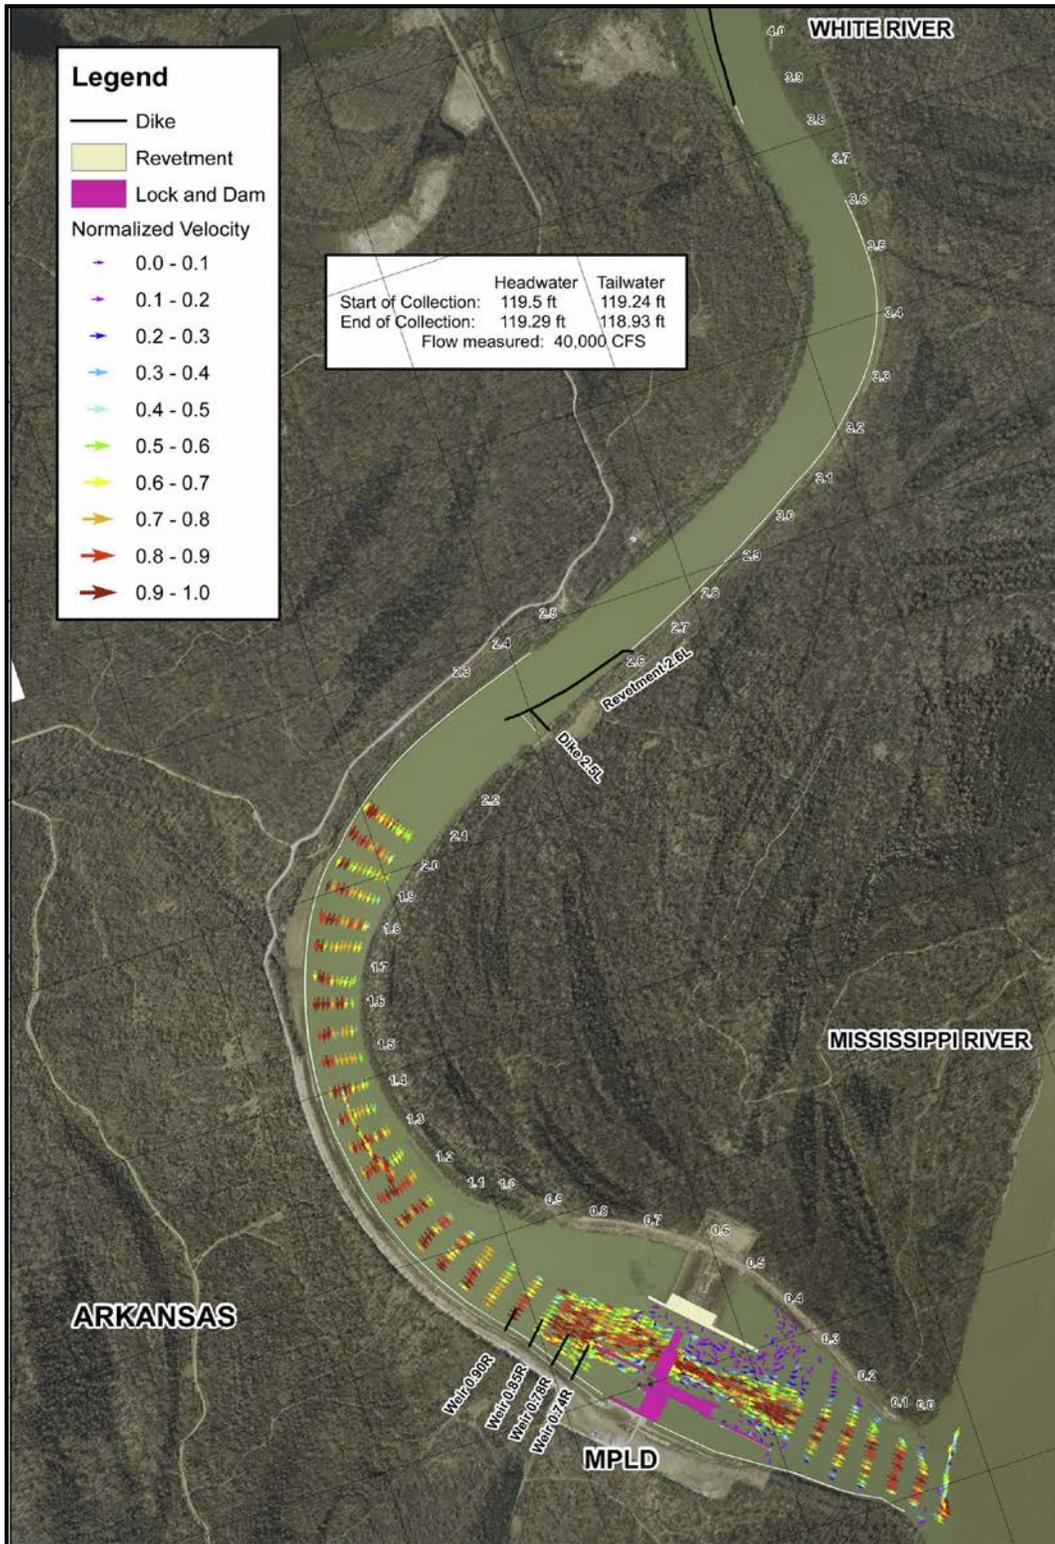
Figure 37. ERDC ADCP velocity data, September 2008. Normalized and interpreted by USACE AREC (Plate 24 of Cox et al. 2011; by permission).

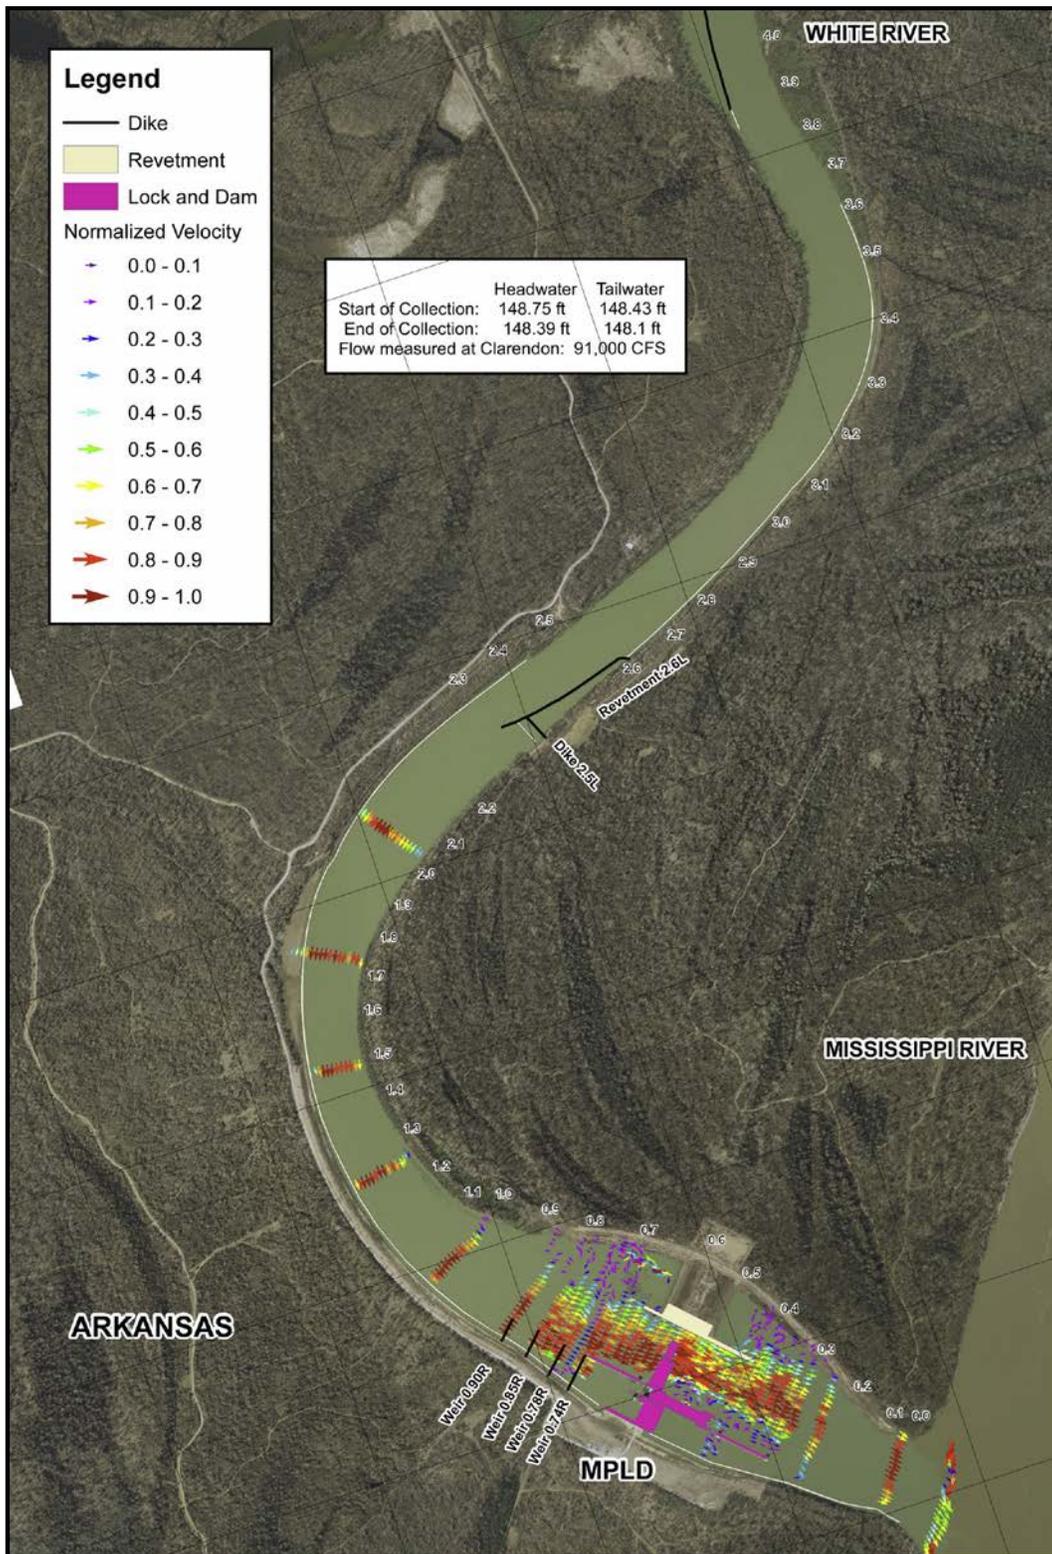
Figure 38. ERDC ADCP velocity data, June 2009. Normalized and interpreted by USACE AREC (Plate 25 of Cox et al. 2011; by permission).

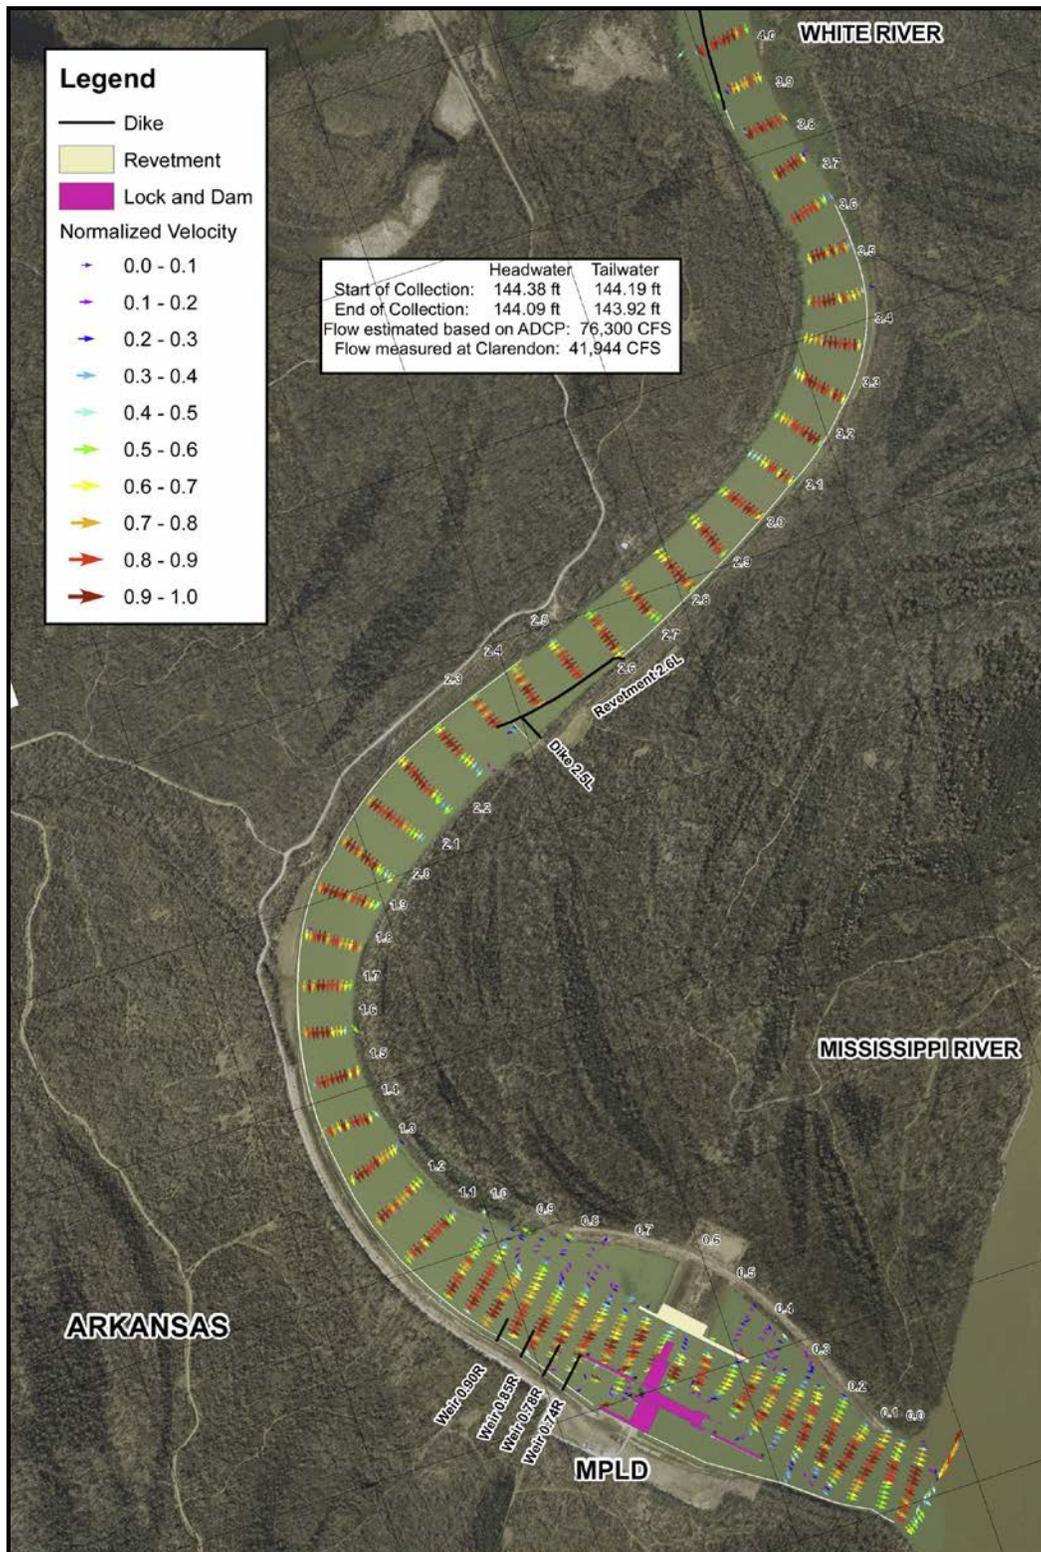
Figure 39. SWL ADCP velocity data, June 2010. Normalized and interpreted by USACE Applied River Engineering Center (Plate 26 of Cox et al. 2011; by permission).

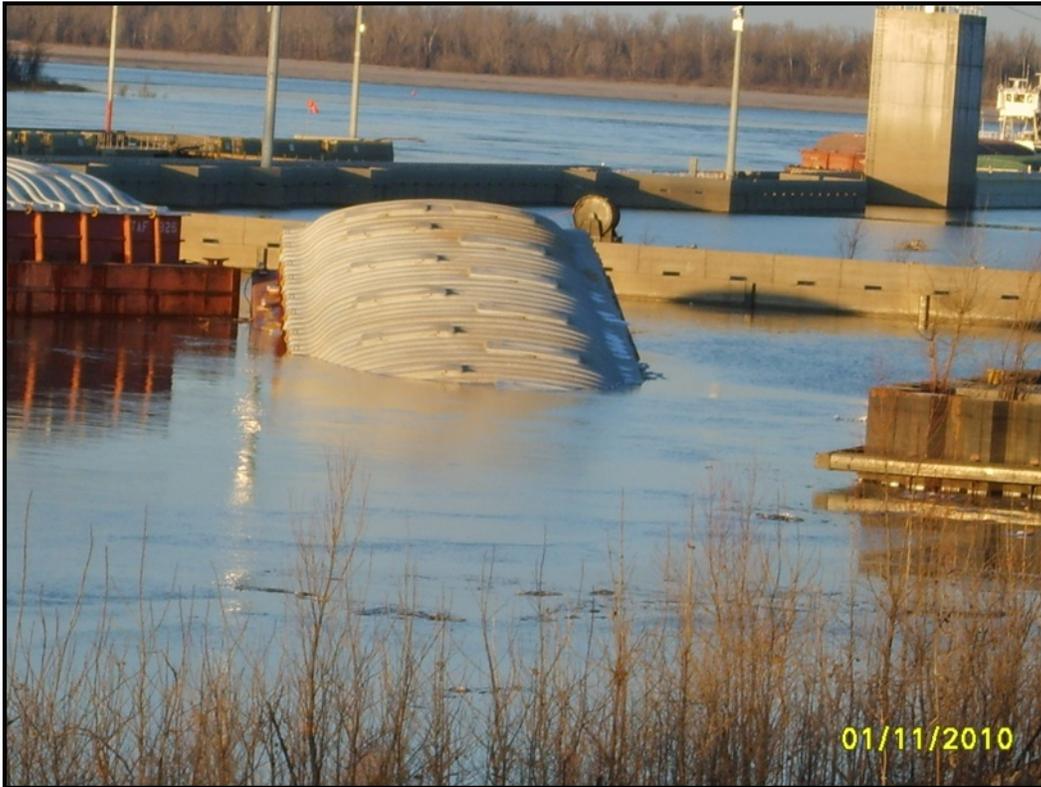
There have been five significant allisions since the lock was opened, such as the barge striking the navigation lock wall in January 2010 (Figures 40 and 41). Figure 42 shows the upstream lock guide wall that is also subject to allisions. Time-lapse video equipment was installed at the project to observe tows transiting via the navigable pass or the lock under outdraft conditions and redirected currents toward the navigable pass.

Figure 40. Barge damage after allision with MPLD navigation structure, January 2010.

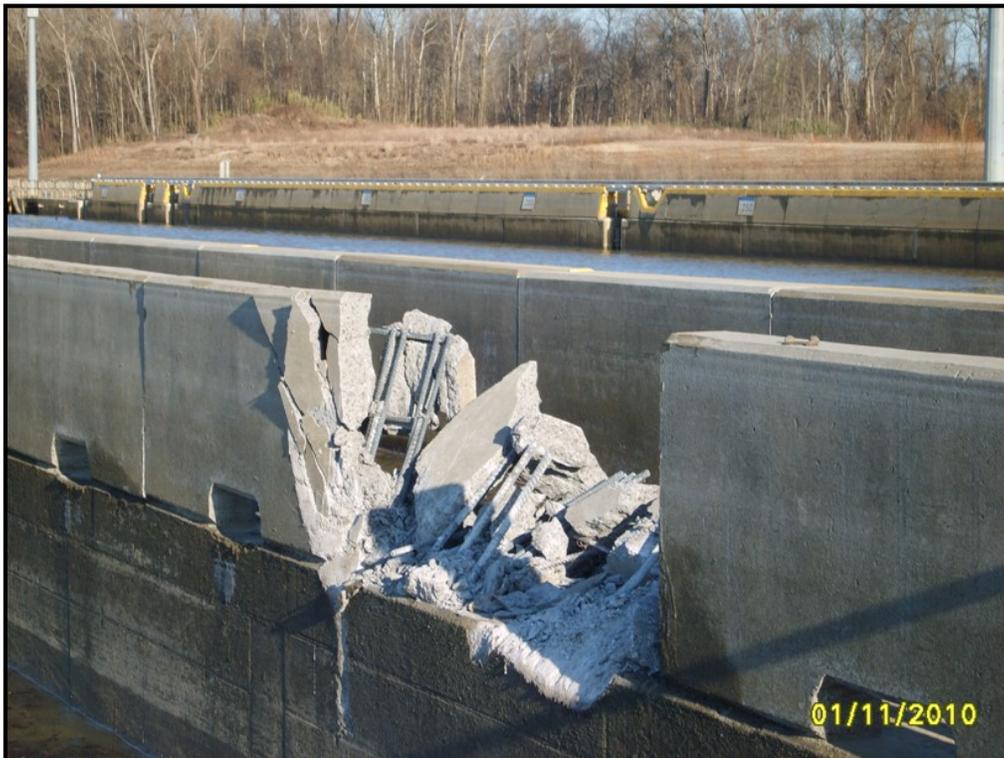
Figure 41. MPLD navigation lock parapet wall damage after being struck by barge, January 2010.

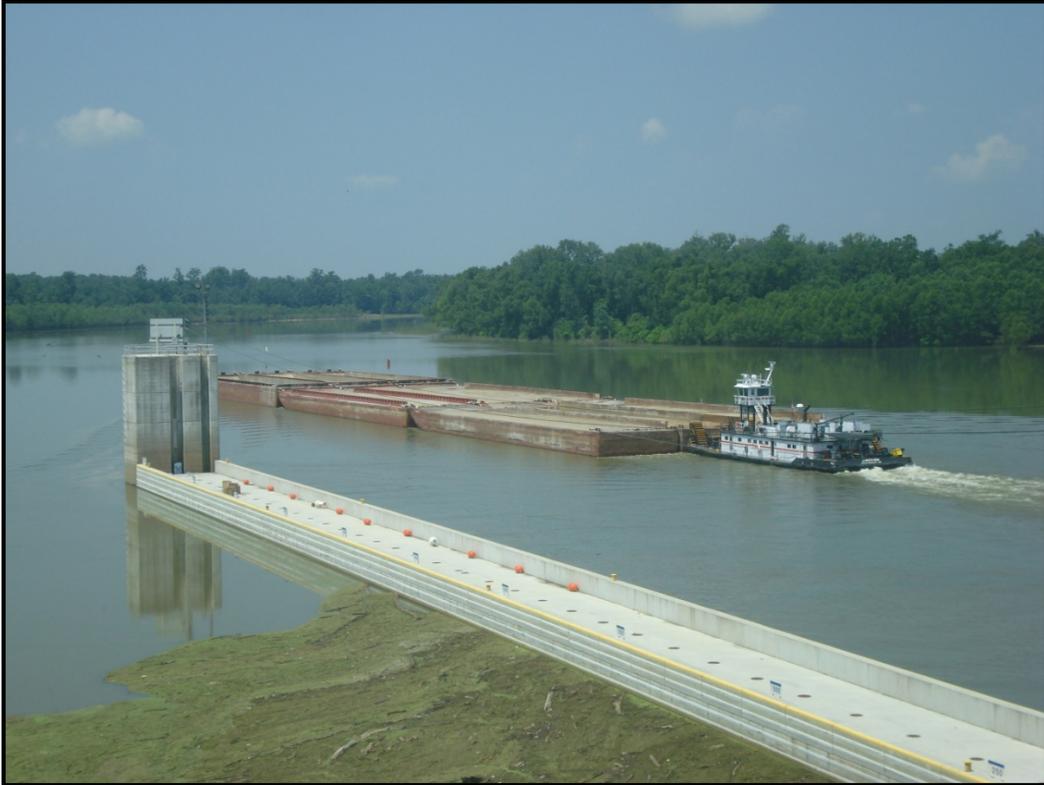
Figure 42. MPLD upstream navigation pass floating guide wall subject to allisions.

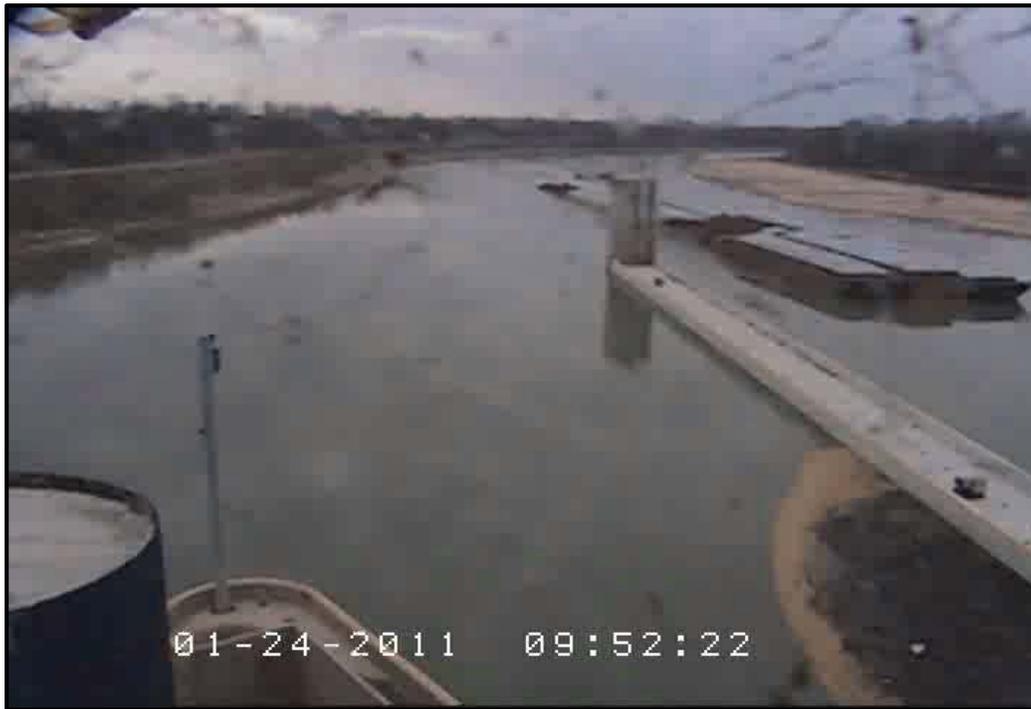
Figure 46. Looking downstream; same downbound tow as shown in Figure 45 transiting the navigable pass and proceeding to the Mississippi River.

The collection of time-lapse video information (examples shown in Figures 45 through 48) would allow project personnel to retrieve the video and observe how vessels had transited the lock or navigable pass, coupled with the flow conditions at the time of the transit. Also, in case of an accident, provided the vessel was in view, judgment as to what may have caused such an accident could be deduced. No untoward barge vessel incidences occurred during the 1-year time interval (January–December 2011) when the video cameras were in place at MPLD.

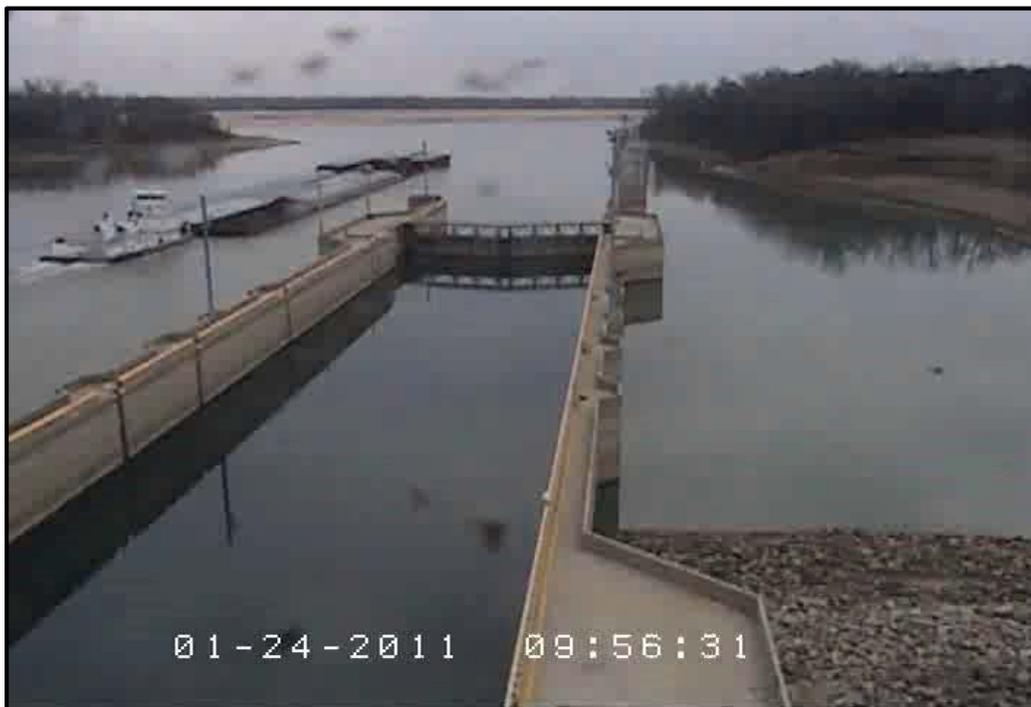
Figure 47. Looking downstream; upbound tow entering the White River and proceeding upstream through the navigable pass.

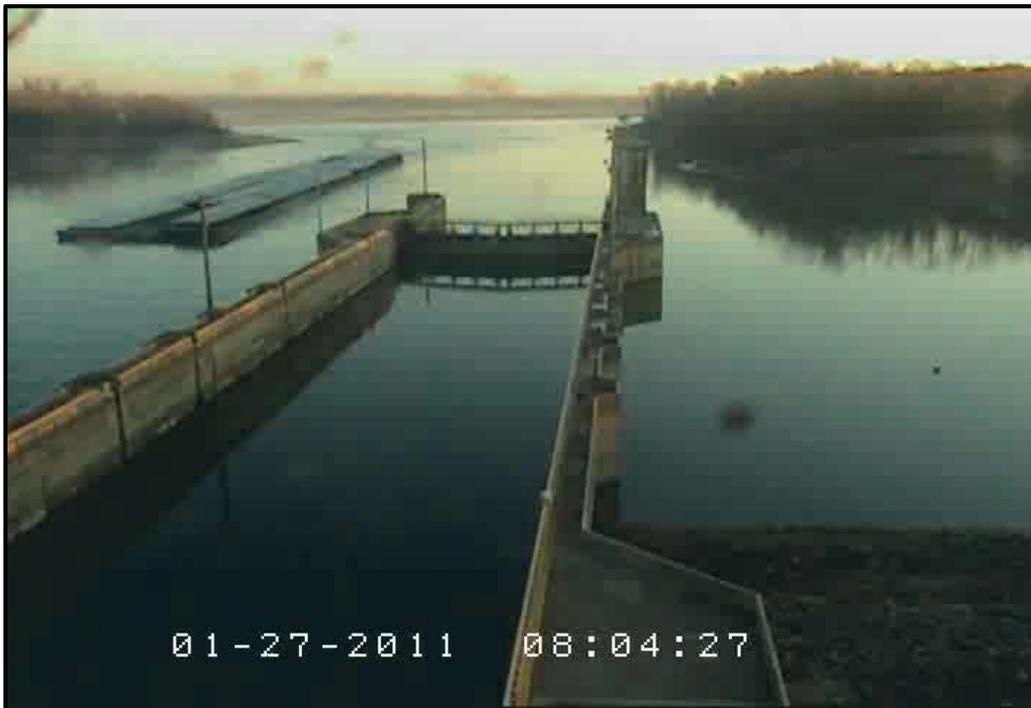
Figure 48. Looking upstream; same upbound tow as shown in Figure 47 transiting the navigable pass and proceeding upstream on the White River.

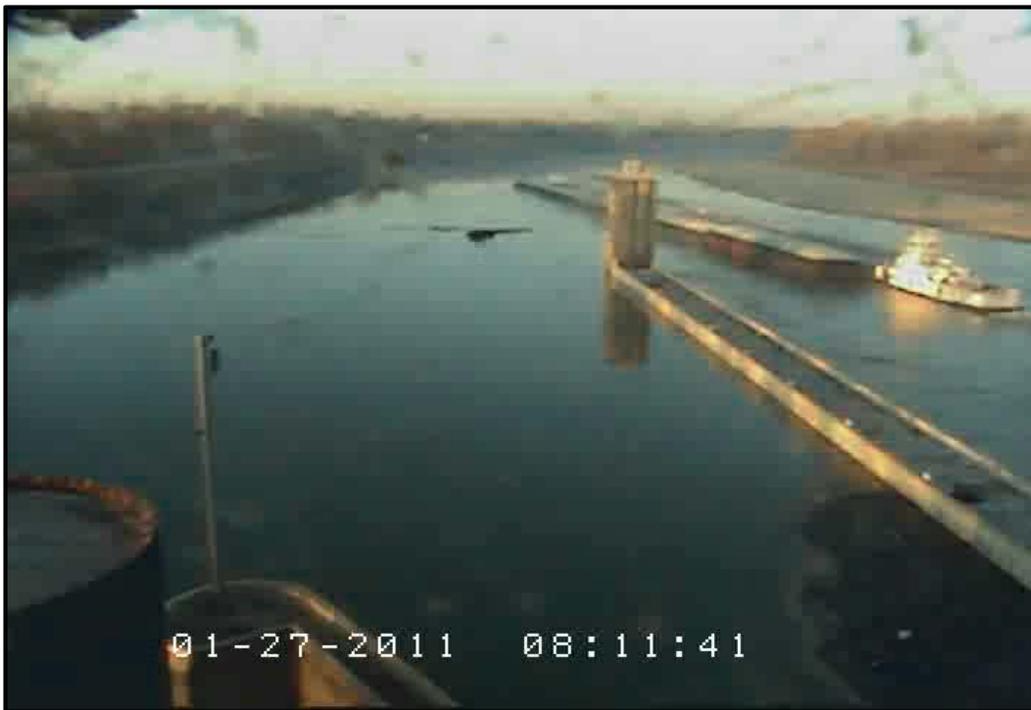
Figure 49. One of 10 MPLD navigation pass crest gates in raised position, looking upstream.

Ten 30 ft wide, bottom-hinged, torque-tube crest gates (Figures 49 and 50) are positioned across the navigation pass. Figure 51 shows the MPLD navigation pass crest gates in service. They are raised and lowered by hydraulic cylinders located in a concrete tunnel underneath the navigation pass (Figures 52 through 55).

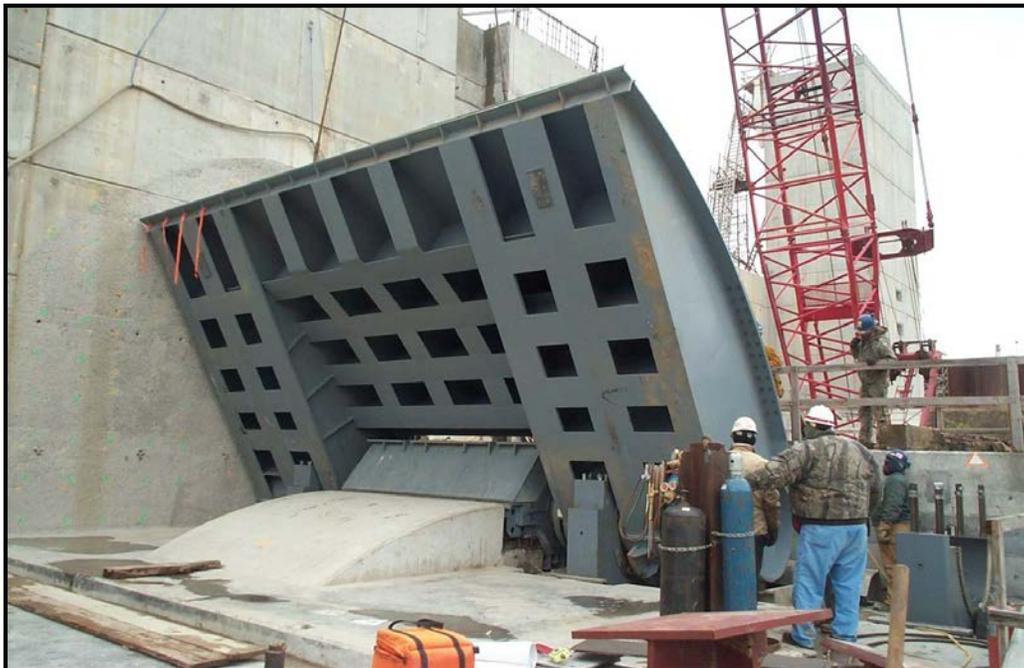
Figure 50. Four of 10 MPLD navigation pass crest gates in raised position, looking downstream.

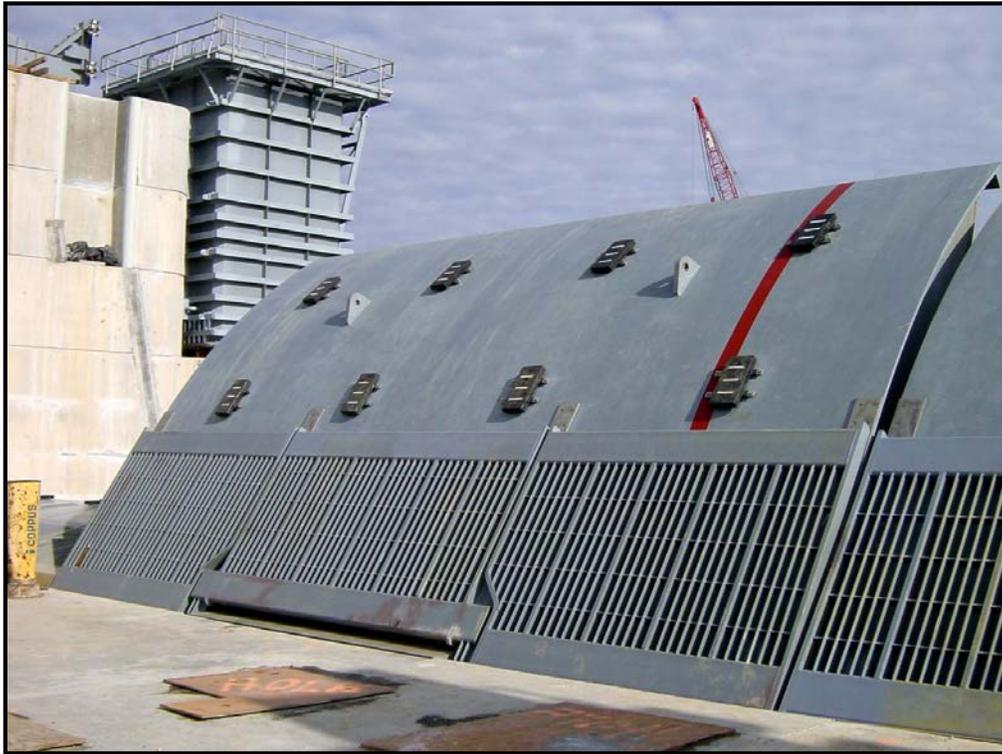
Figure 51. MPLD navigation pass crest gates in service.

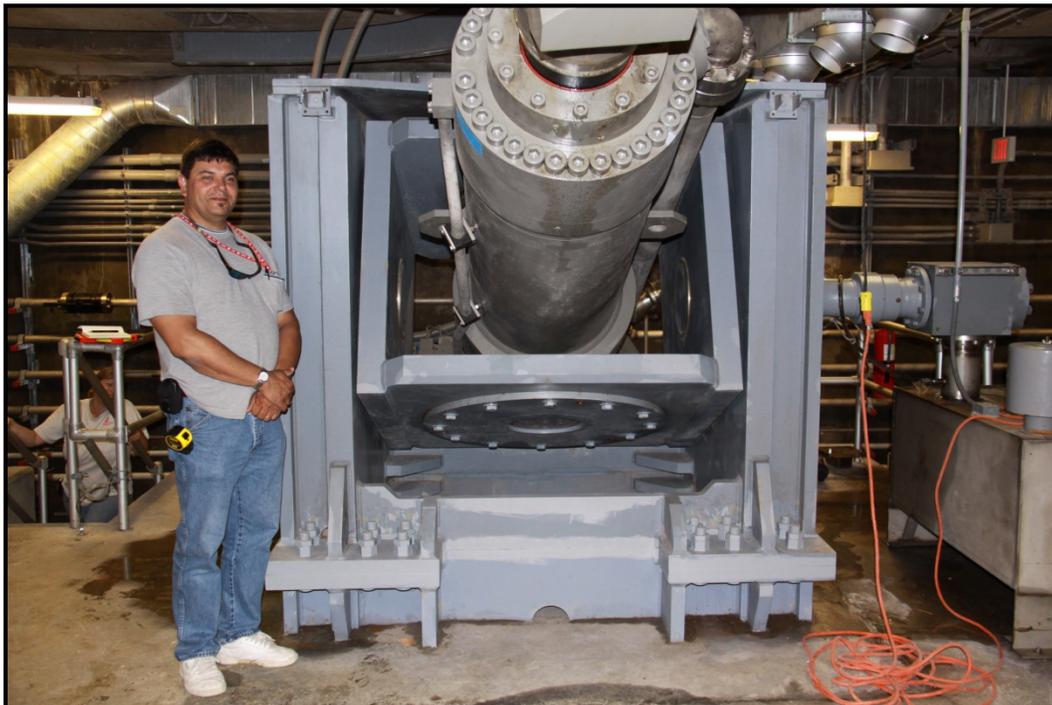
Figure 53. Hydraulic cylinder which raises and lowers one of the 30 crest gates under the navigation pass at MPLD.

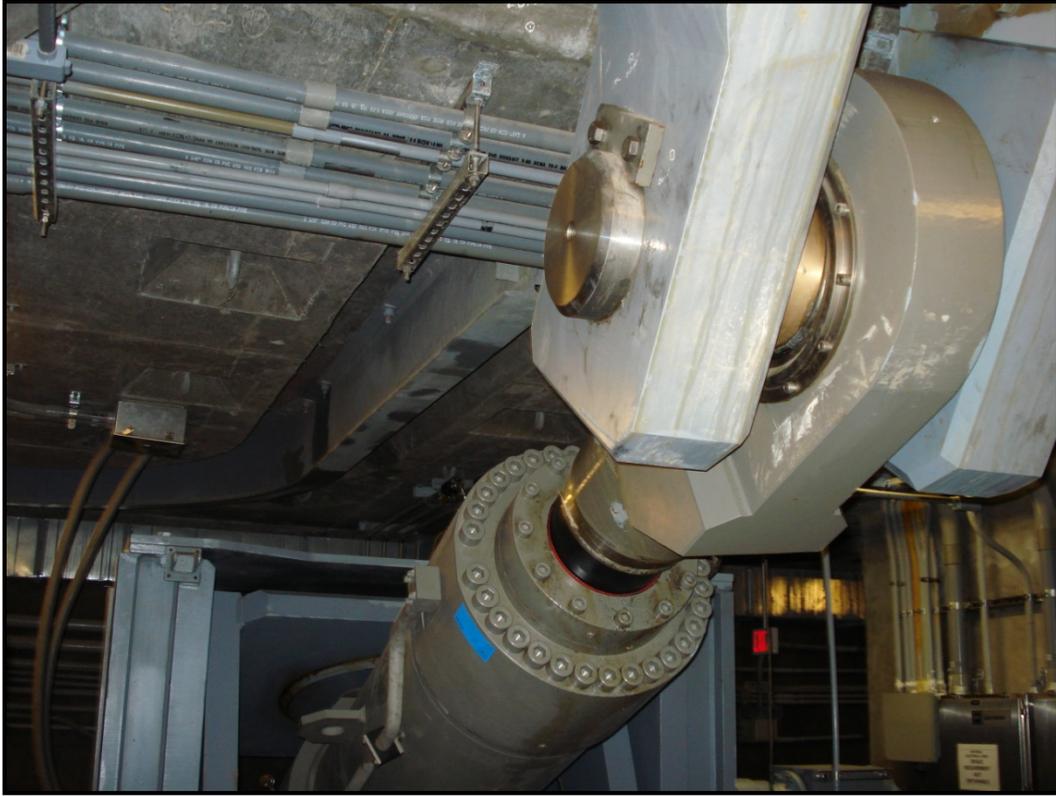
Figure 54. Hydraulic cylinder ram attached to gate strut mechanism.

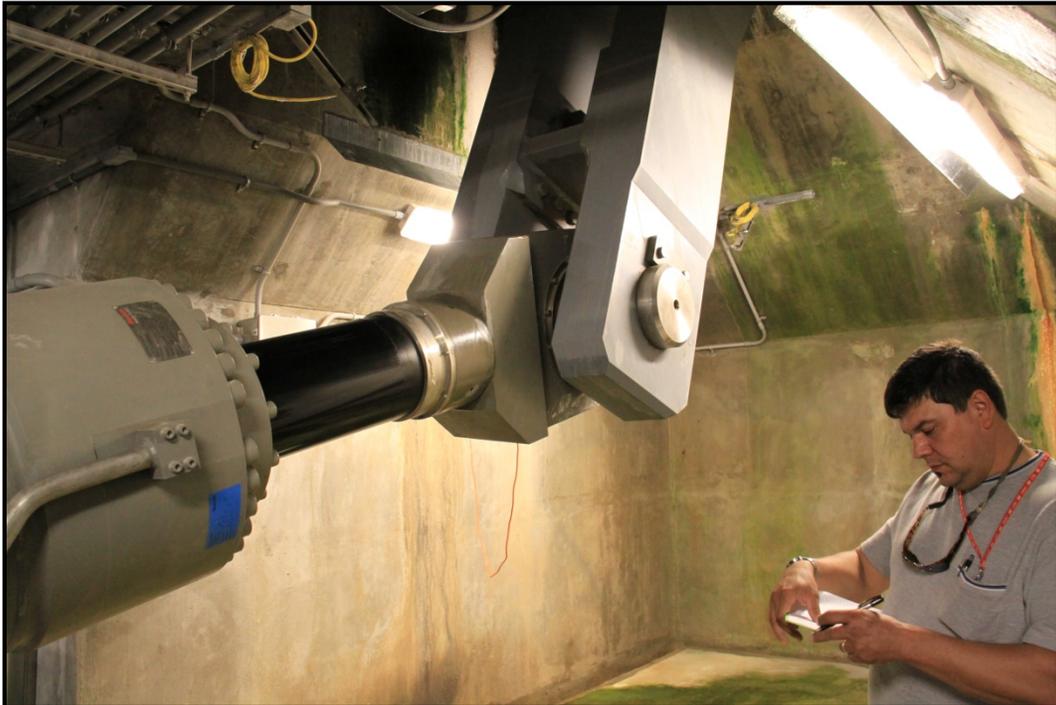
Figure 56. Installation of accelerometer.

Strain gages and accelerometers were placed on gate struts located in the galley of the dam to monitor the activity of the bottom-hinged, torque-tube crest gate during operation and while the gates were in the raised position. Figure 56 shows an accelerometer, and Figure 57 shows two strain gages attached to the gate mechanism. Figure 58 shows the location of both the accelerometer and the strain gages on the gate strut mechanism.

The strain gages and accelerometers that were used to monitor activity were connected to a Campbell Scientific CR1000 Data Logger that was installed in the dam galley. The CR1000 with a AM16/32B Multiplexer was used to extend the number of channels that the logger is capable of monitoring. Each strain gage required one data channel. Each tri-axial accelerometer required three data channels. The data logger was housed in a 16 in. × 18 in. enclosure.

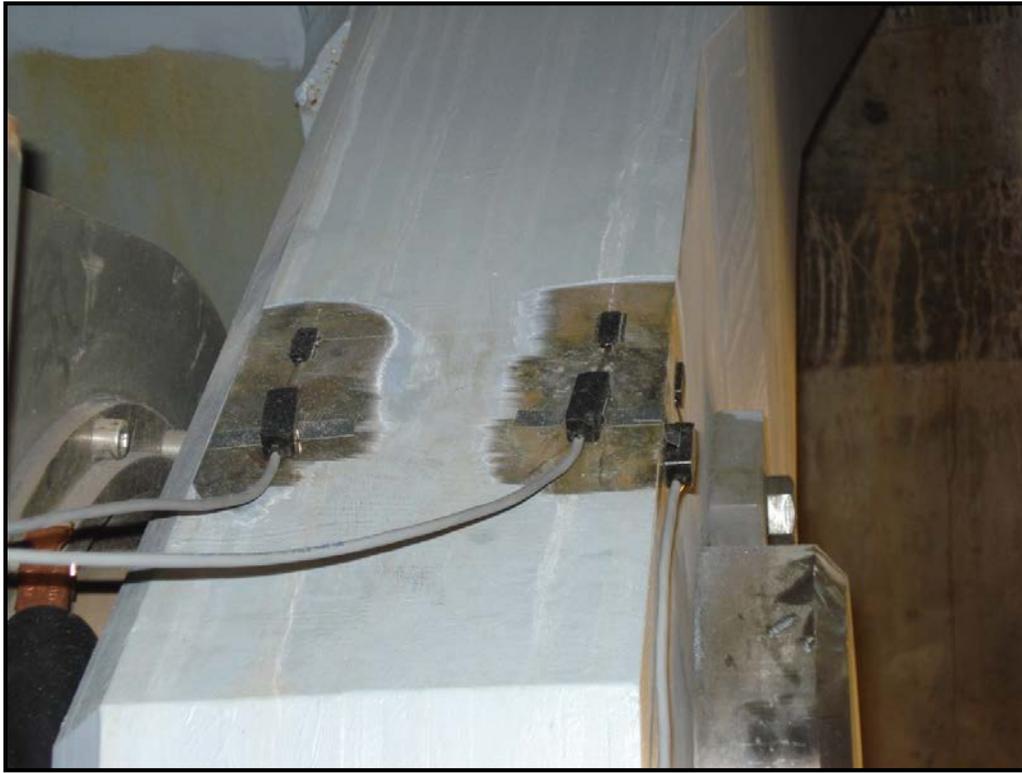
Figure 58. Accelerometer and strain gages installed on gate struts.

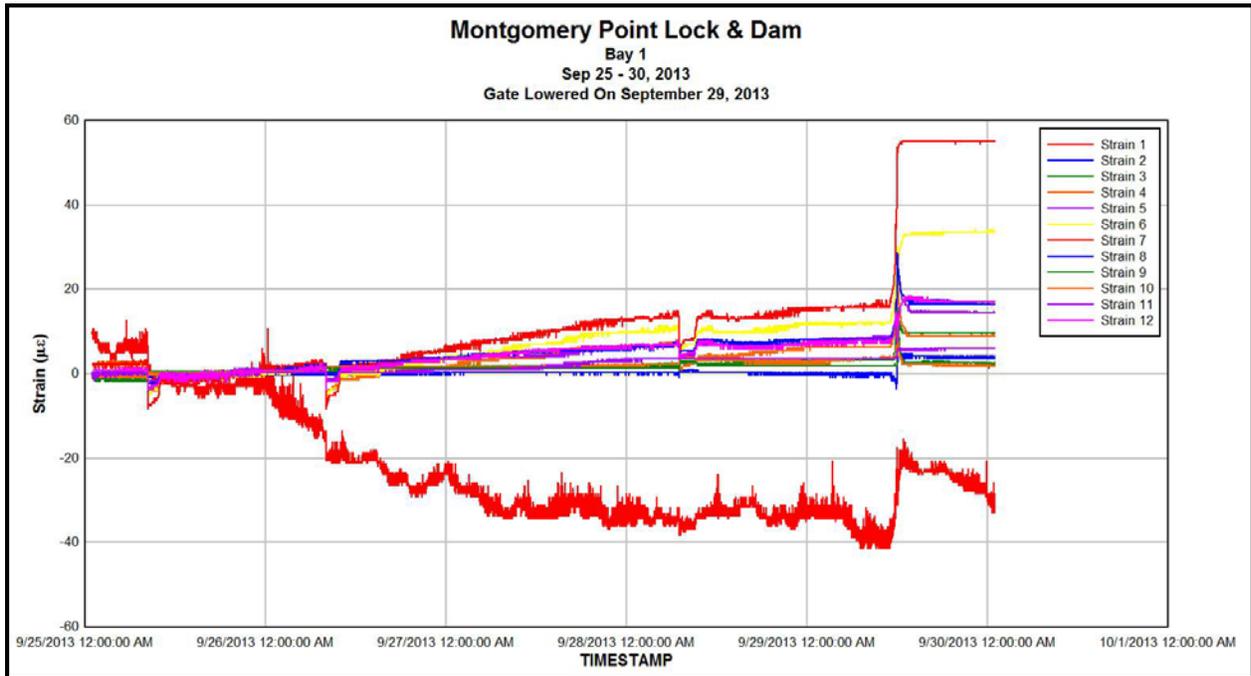
For the period of this gate load measurement investigation, the gates were (a) lowered on 29 September 2013, (b) raised on 1 October 2013, (c) lowered on 10 October 2013, (d) raised on 18 October 2013, and (e) lowered on 7 November 2013. Displays of the time histories of the strains (microstrain, $\mu\epsilon$) experienced by the gate strut mechanisms are shown in Figures 59 and 60 for Gate 1 (Bay 1) and Gate 4 (Bay 4), respectively, for gate lowering on 29 September 2013. Displays of the time histories of the strain, $\mu\epsilon$ (10^{-6} ft/ft), experienced by the gate strut mechanisms are shown in Figures 61 and 62 for Gate 1 (Bay 1) and Gate 4 (Bay 4), respectively, for gate raising on 1 October 2013. Here can be seen that the strains were exceedingly low for all conditions during lowering and raising of these gates (on the order of $\pm 50 \mu\epsilon$). No adverse situations occurred during any of these MCNP investigations. Strains in excess of $1000 \mu\epsilon$ would be required before serious concerns are raised.

Figure 59. Time history of strain experienced by Gate 1 (Bay 1), gate lowering on 29 September 2013.

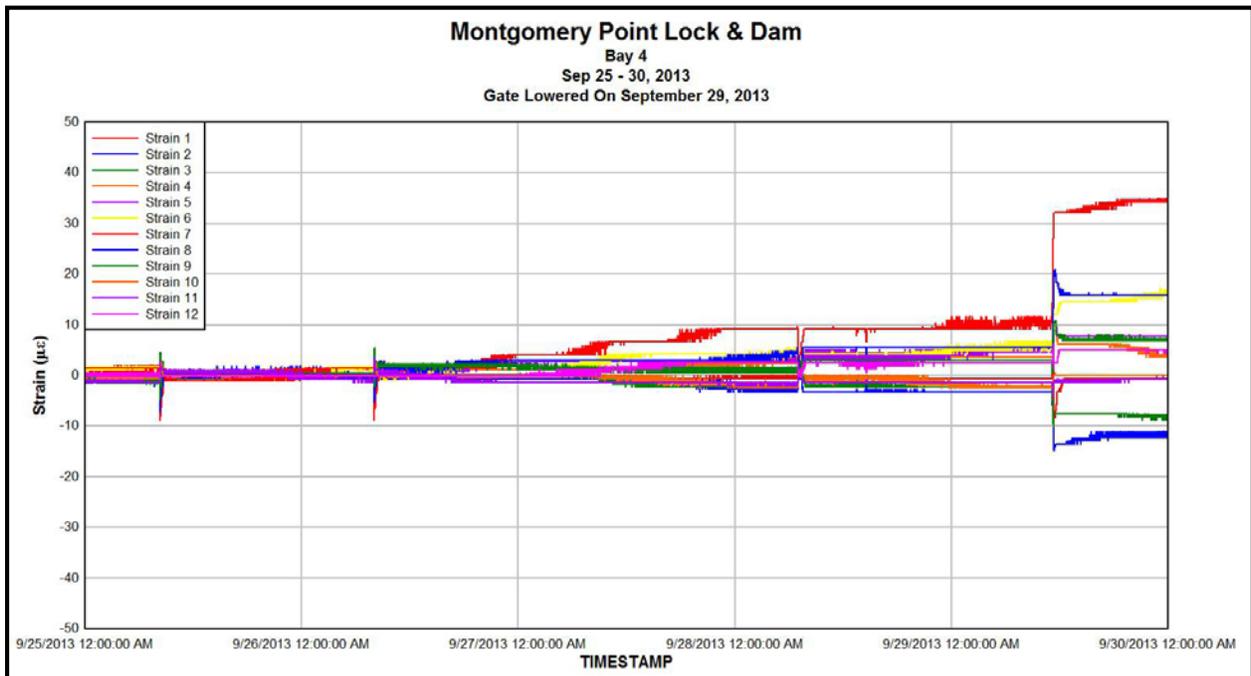
Figure 60. Time history of strain experienced by Gate 4 (Bay 4), gate lowering on 29 September 2013.

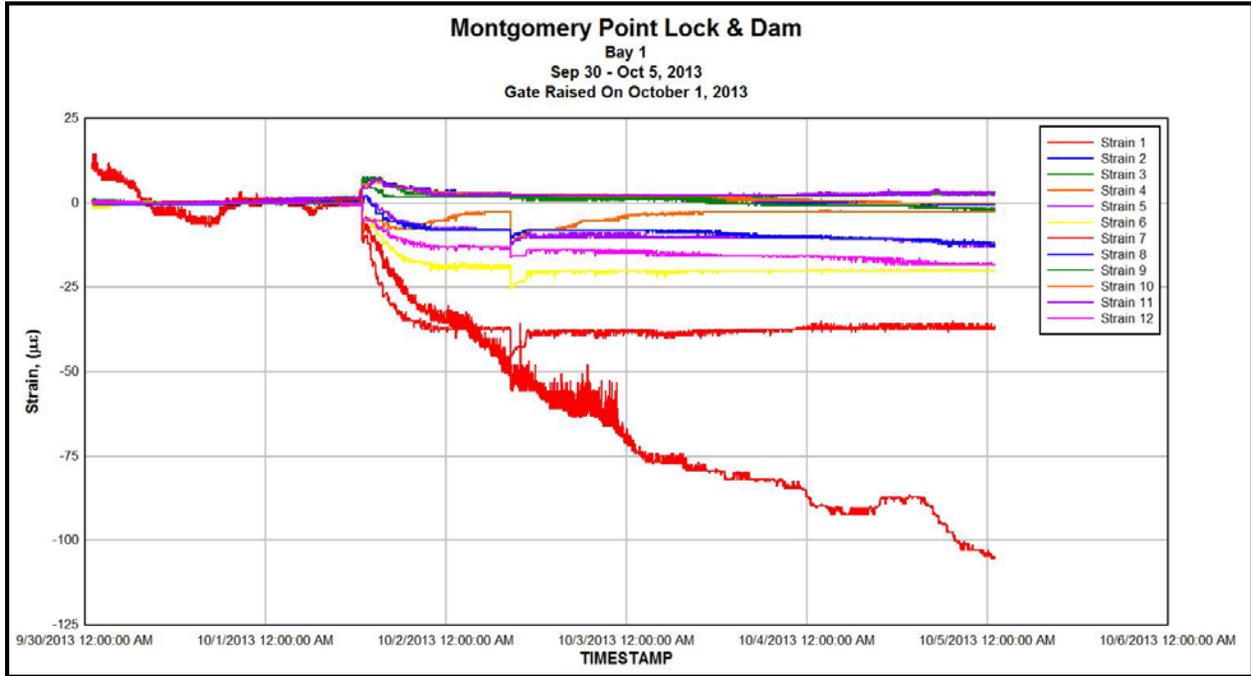
Figure 61. Time history of strain experienced by Gate 1 (Bay 1), gate raising on 1 October 2013.

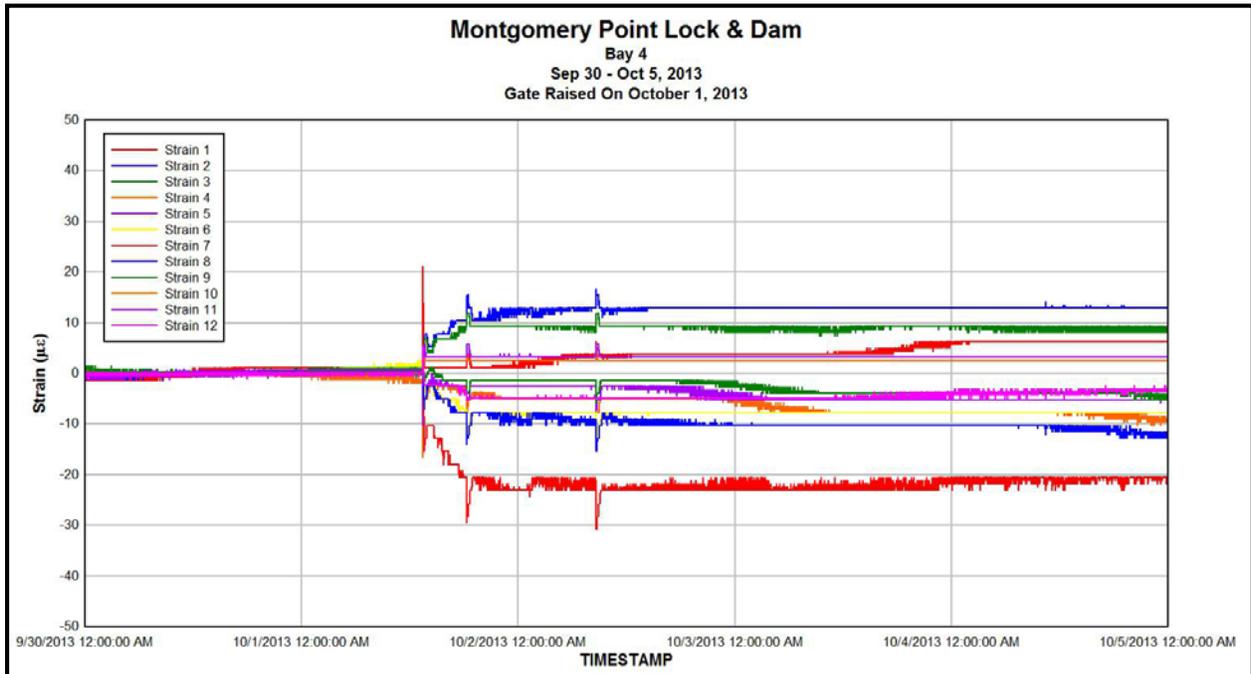
Figure 62. Time history of strain experienced by Gate 4 (Bay 4), gate raising on 1 October 2013.
