# Sludge Dewatering in a Freezing Bed A Pilot-Scale Study

C. James Martel and Carl J. Diener

April 1991

# CRREL Report 91-6

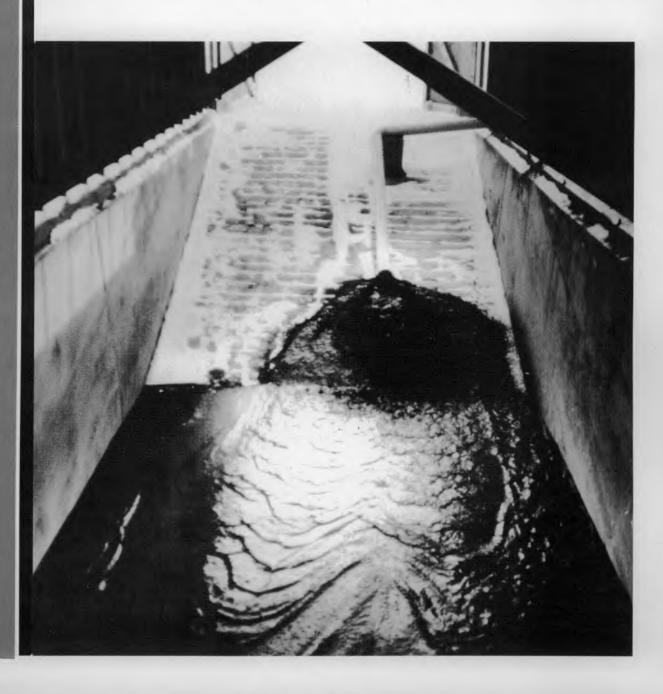
Cover: Freezing bed during application of anaerobically digested sludge.

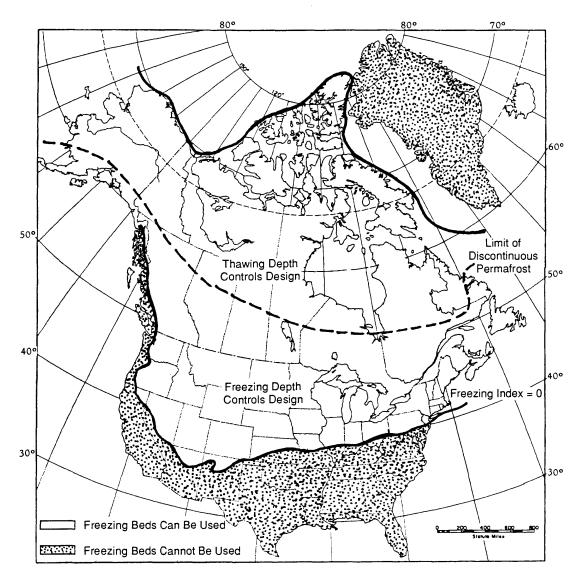
Figure 11. Areas in North America where sludge freezing beds can be used.

Based on this model the freezing design depth is zero when the freezing index is zero. A rough approximation as to where this occurs in North America can be determined from a freezing index map (Berg and Johnson 1983). As shown in Figure 11 the zero freezing index line runs through the central U.S. and along the Pacific Coast. Below this line a freezing bed would probably

not be feasible because freezing cannot be expected to occur on an annual basis. Freezing beds could be used in areas above this line, which includes most of the U.S. and Canada.

The freezing model will control the design wherever freezing occurs on an annual basis and the net gain of energy at the earth's surface is greater than the net energy loss. Generally this occurs in the more temperate regions where there is no permafrost. Based on maps showing the extent of discontinuous permafrost (Lunardini 1981), the approximate northern limit of this region is central Canada (Fig. 11). Above the permafrost line the net gain of energy can be expected to be less than the net energy loss, so not all of the sludge frozen during the freezing period will thaw during the thawing period. Therefore, the design depth in this region will be limited

by thaw. As shown in Figure 11, this region extends to the northernmost areas of the continent, except for icecovered areas such as Greenland.
