96-9

CRREL REPORT

Physical System Dynamics and White Phosphorus Fate and Transport, 1994, Eagle River Flats, Fort Richardson, Alaska

Daniel E. Lawson, Lewis E. Hunter, Susan R. Bigl,
Beth M. Nadeau, Patricia B. Weyrick and John H. Bodette

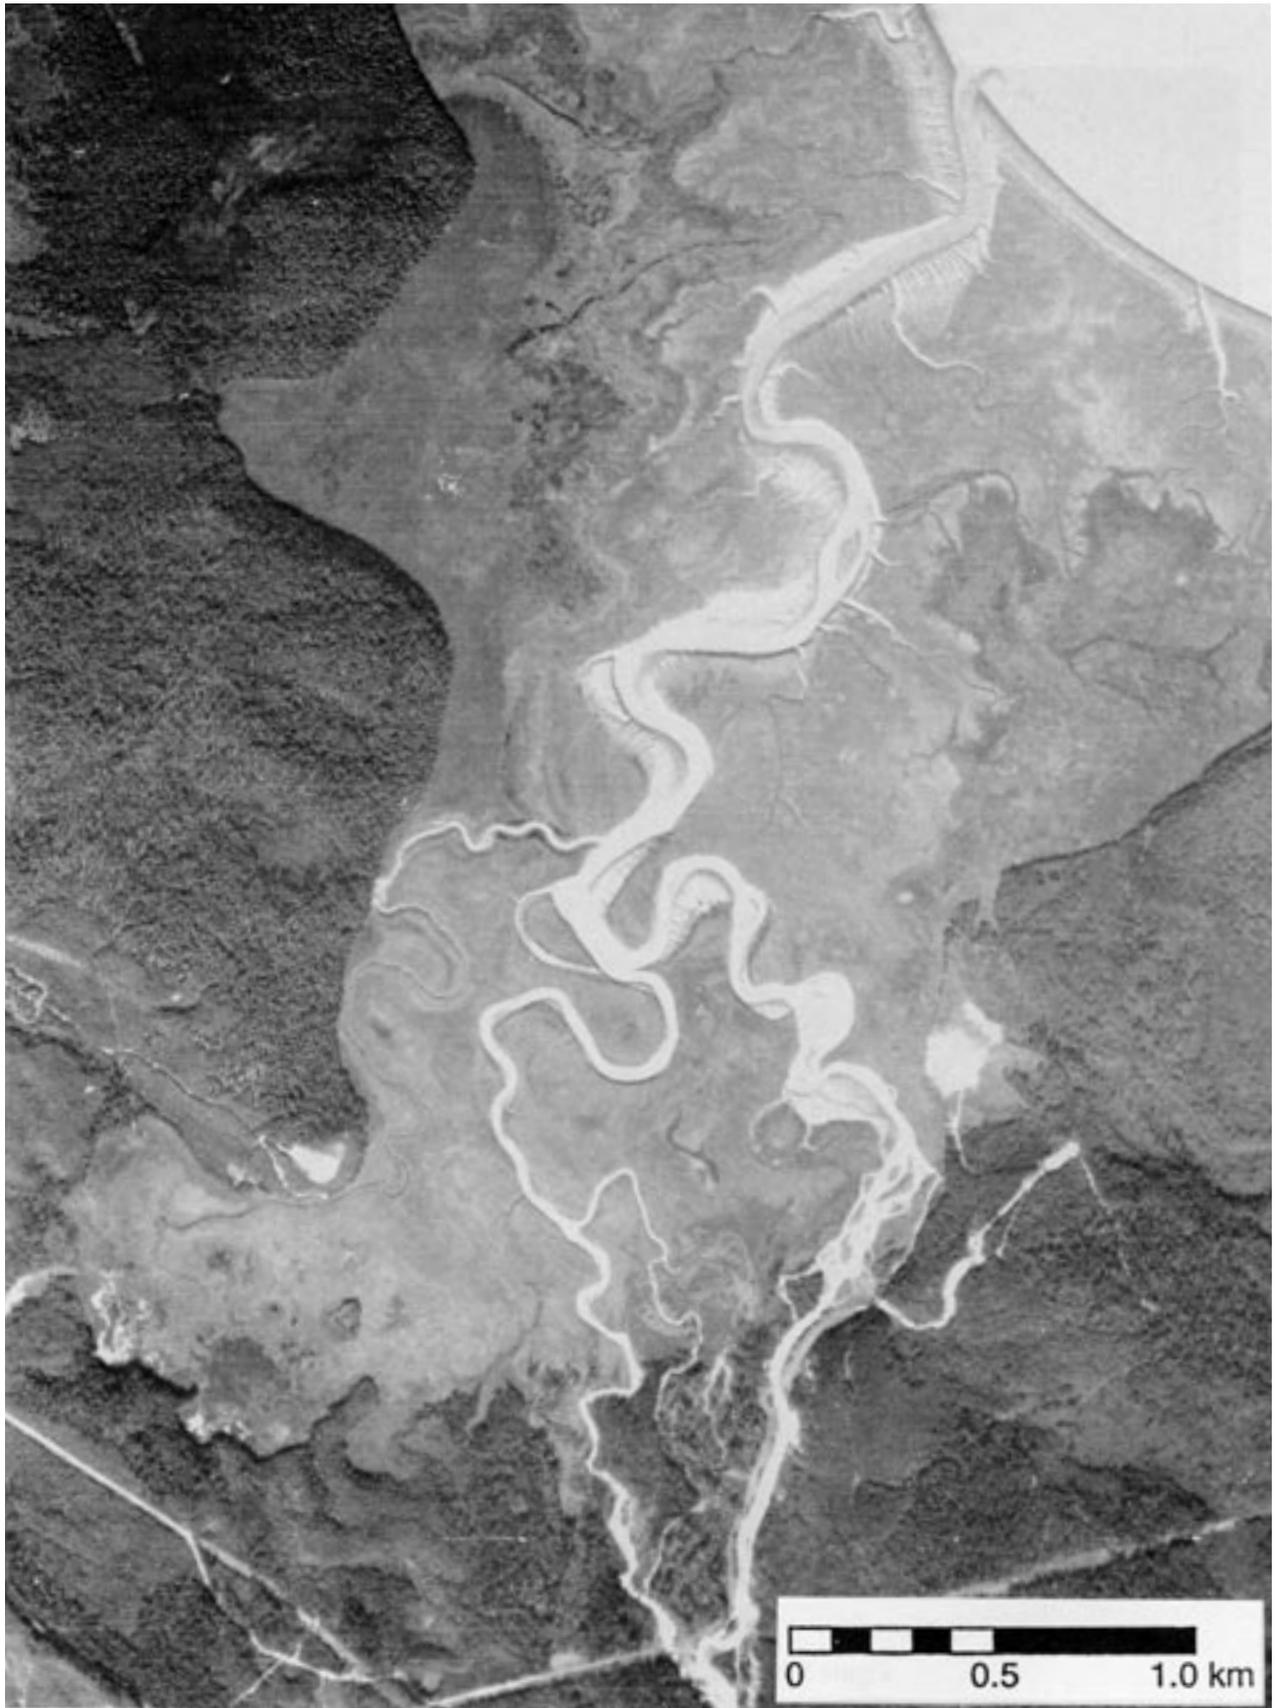
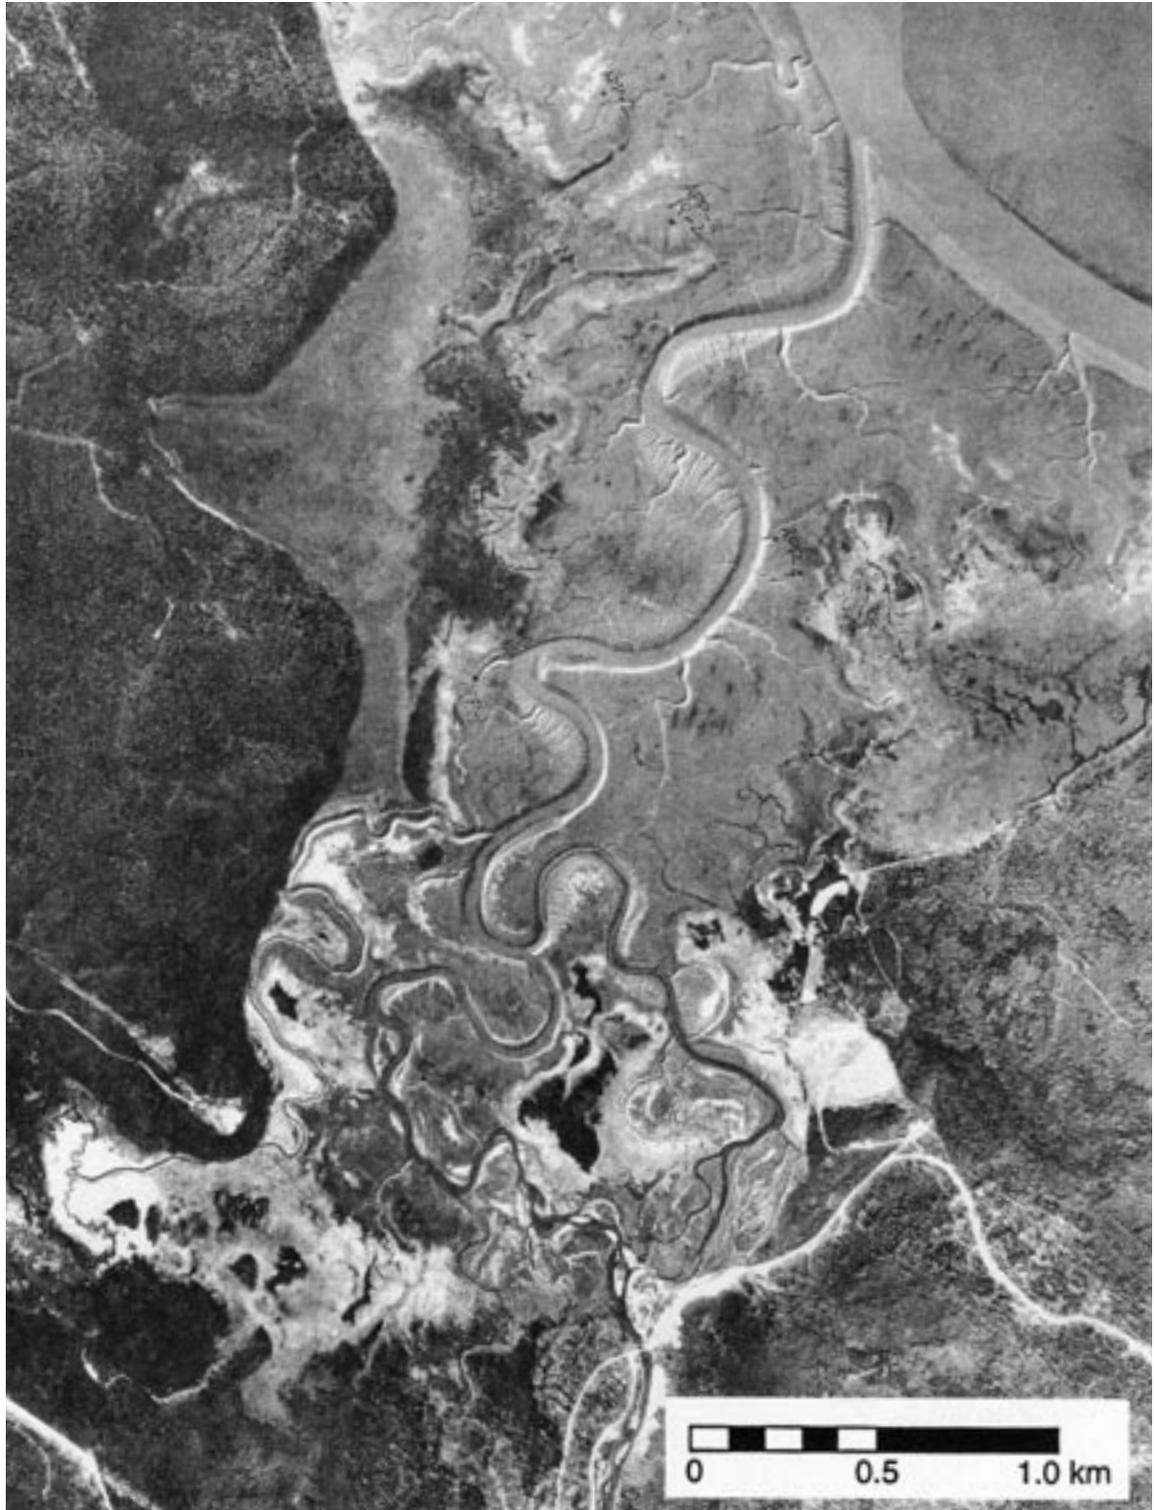
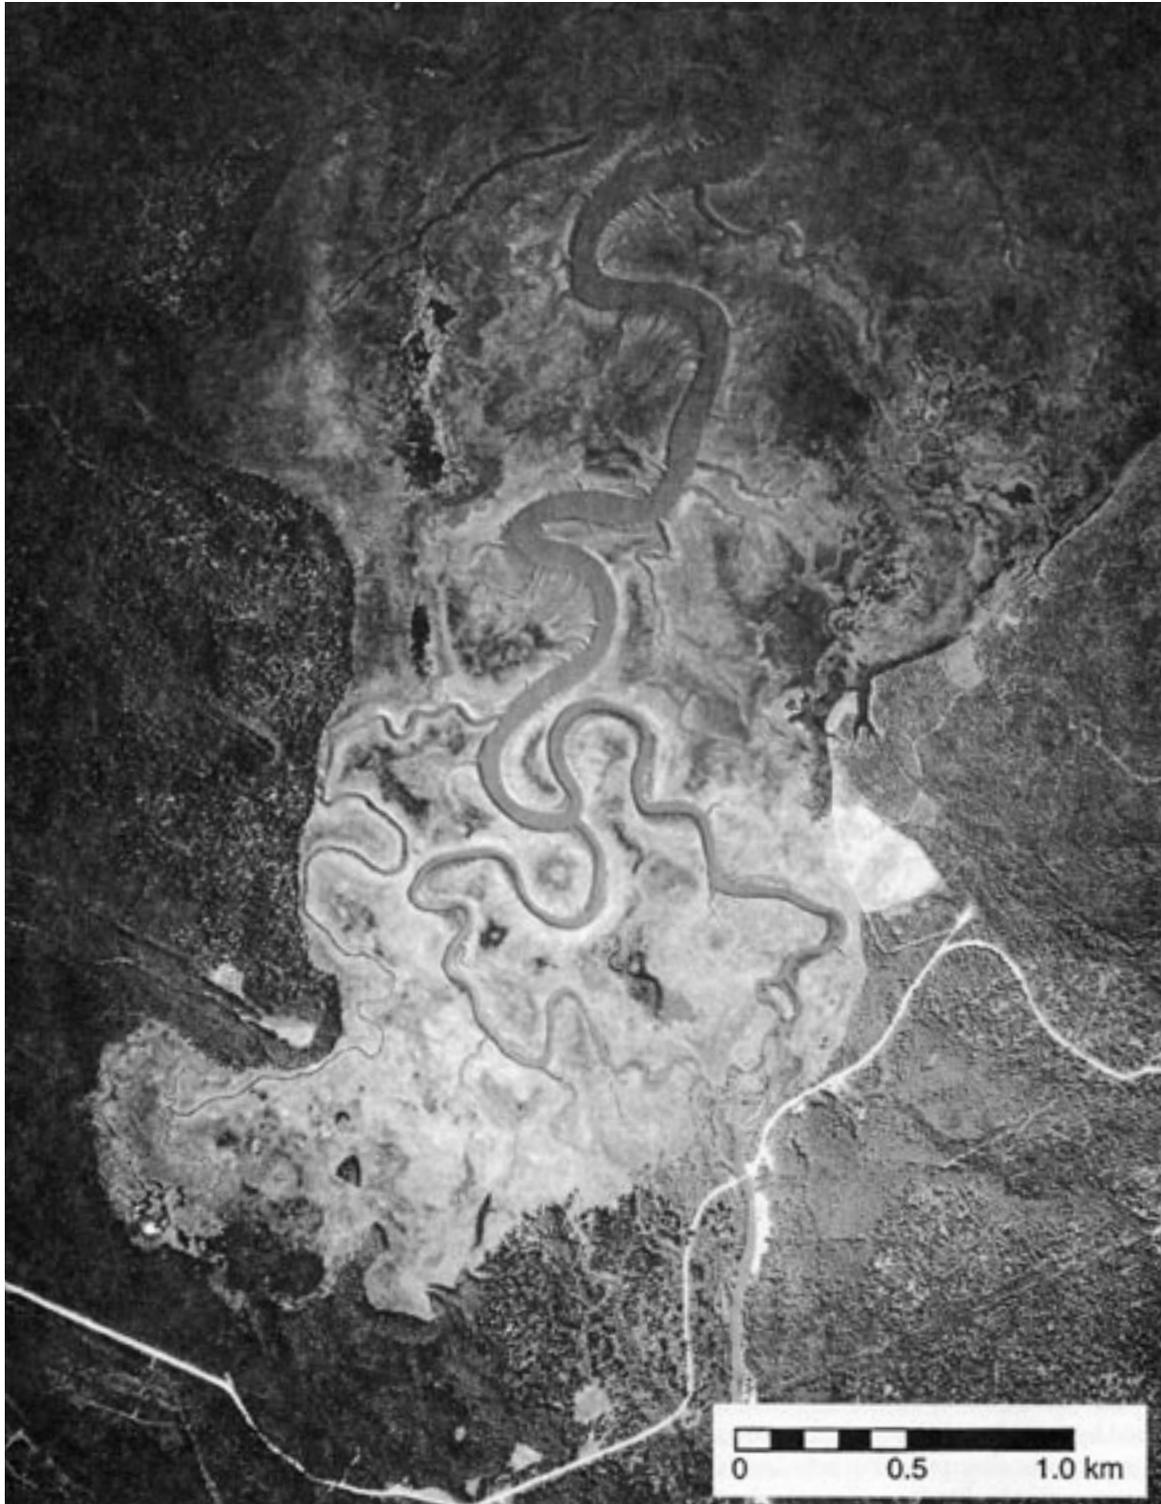
a. 1950.

Figure 5. Aerial photographs of ERF.

b. 1967.

c. 1993.
Figure 5 (cont'd).

doned point bars are common along the length of the active channel and are especially evident in photographs of the southern reaches of the Flats (Fig. 5c). Channel changes are a natural progression resulting from the erosion and recession of the outer banks of meander bends, deposition of sediments as point bars in the inner parts of each bend, and a general downstream migration of the channel (e.g., Allen 1982). At some locations, a breaching of tight meander loops causes their abandonment.

Gullies in the mudflats have also lengthened and deepened during the last 40 years, in some cases extending over 200 to 300 m. A significant extension of gullies toward the ponds and marshes is particularly evident in Figures 5b (1967) and 5c (1993). Headwalls recede during flood or ebb flow, as water is funneled into and out of the ponds and mudflats through the drainage system. The cause of gully expansion is not proven. But the tectonic activity during and following the 1964 Alaskan earthquake or large-scale river channel changes caused by flooding can cause the gully expansion. We must further quantitatively analyze historical aerial photographs and deposits in the alluvial landforms to find its cause.

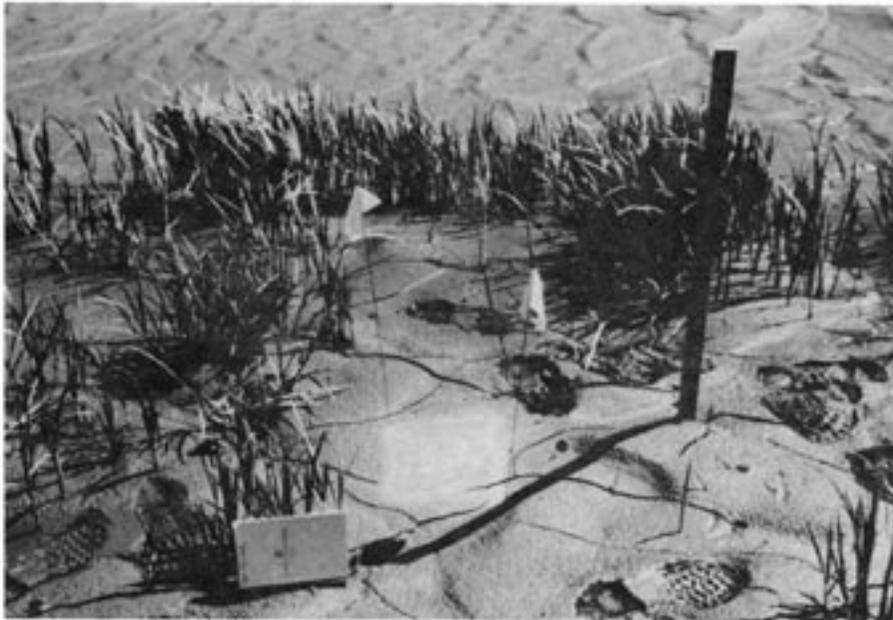
a. Sedimentation stake with plate that slides freely on the rod.

Figure 8. Sedimentation measurement techniques.

b. Wire flags mark an area of painted ground.

We used "sedimentation stakes" to measure erosion and deposition at transect points where the surface was wet or standing water was present (Fig. 8). These stakes consist of a rod and a square, rigid plate (about 7 cm²) that slides freely on the rod as used by Ovenshine et al. (1976a,b) in Turnagain Arm, Alaska. Erosion depth is defined by the increase in distance between the top of the rod and the top of the plate, as measured periodically.

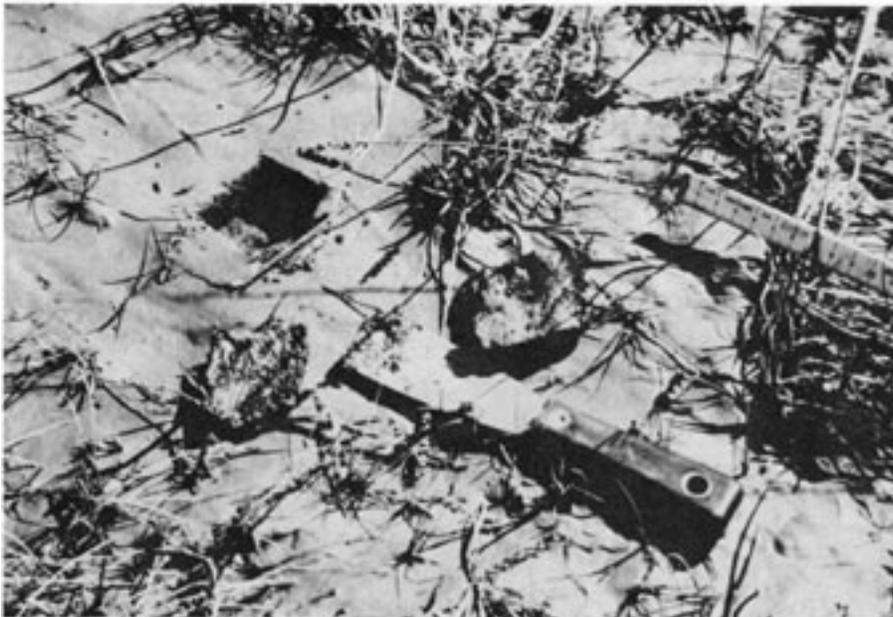
Figure 9. Paint layer depth within block of sediment is measured to define sedimentation rates.

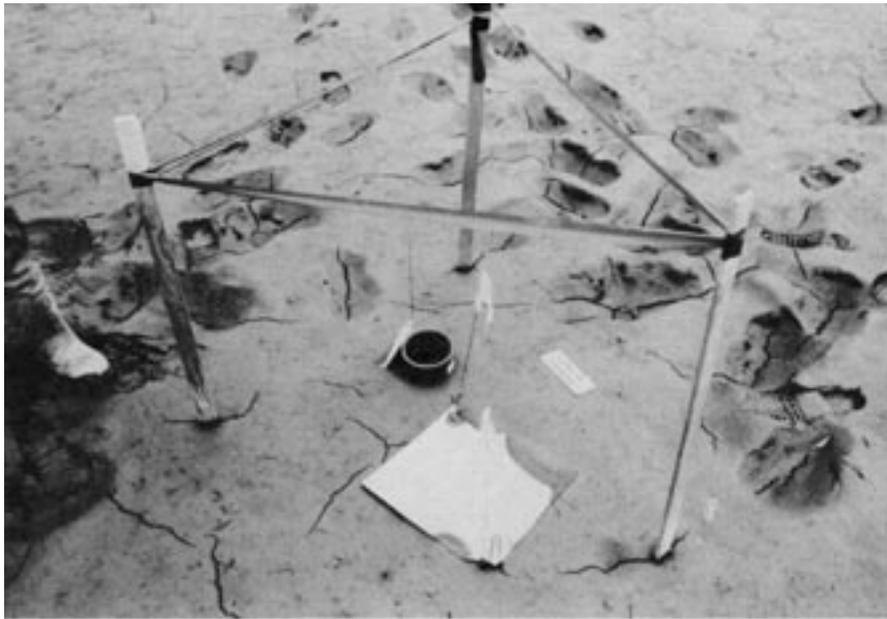
Figure 12. Example of sedimentation station at intermittent pond location showing layout of cup and plate sampler.

diam.) schedule-40 PVC pipe. The pipe was inserted into the pond until the bottom of the cup was in contact with the bed (Fig. 11b and 12). Sediment trapped in the cup includes new sediment brought into the ponds by tidal inundation and river currents, and materials resuspended by wind waves, dabbling ducks or other mechanisms.

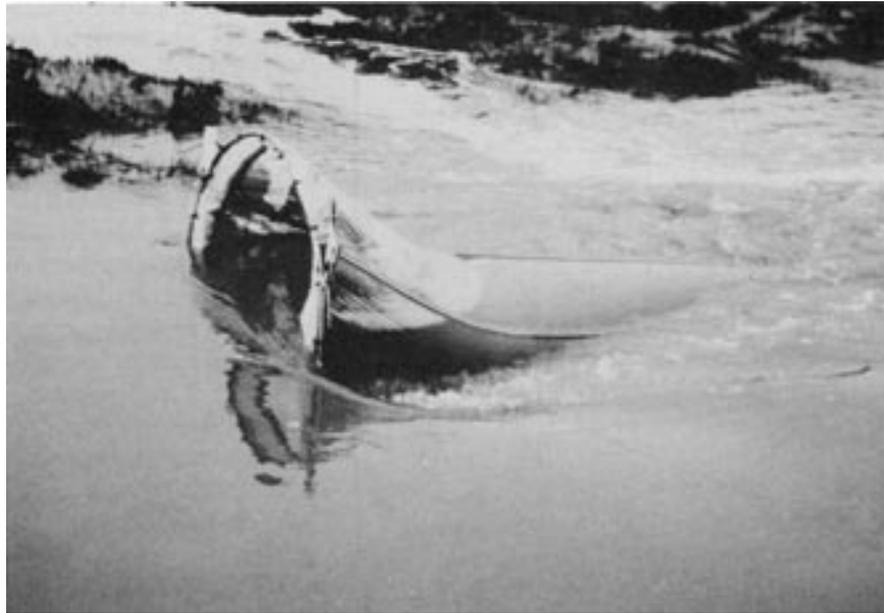
Figure 20. Plankton net used for collection of WP in transport through gullies.

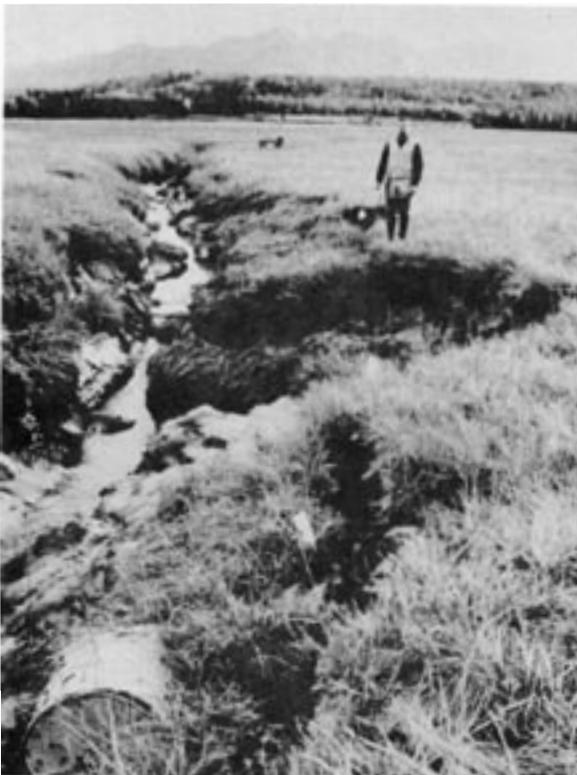
Figure 52. Eastward view of eroded cusped embayment at monitored section of B-Gully where white phosphorus was recorded in transport.

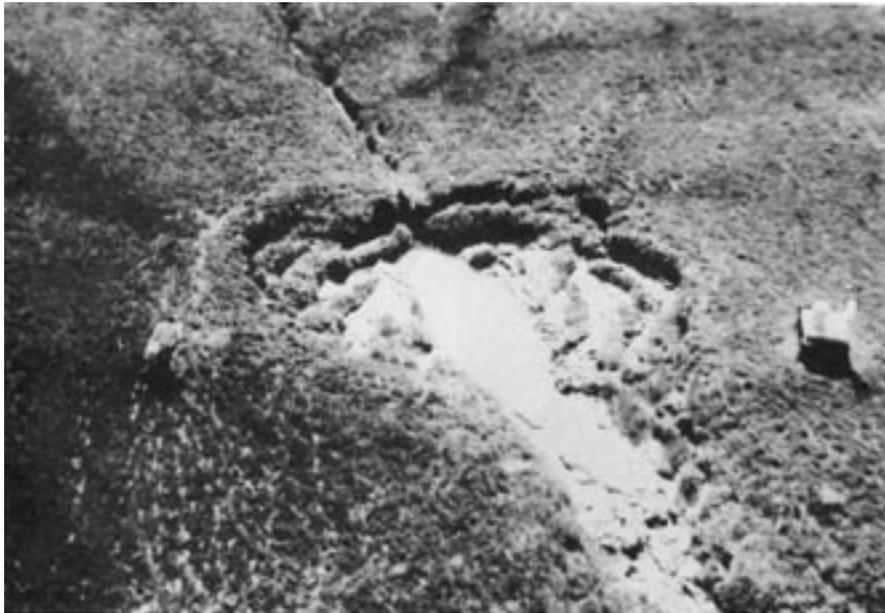
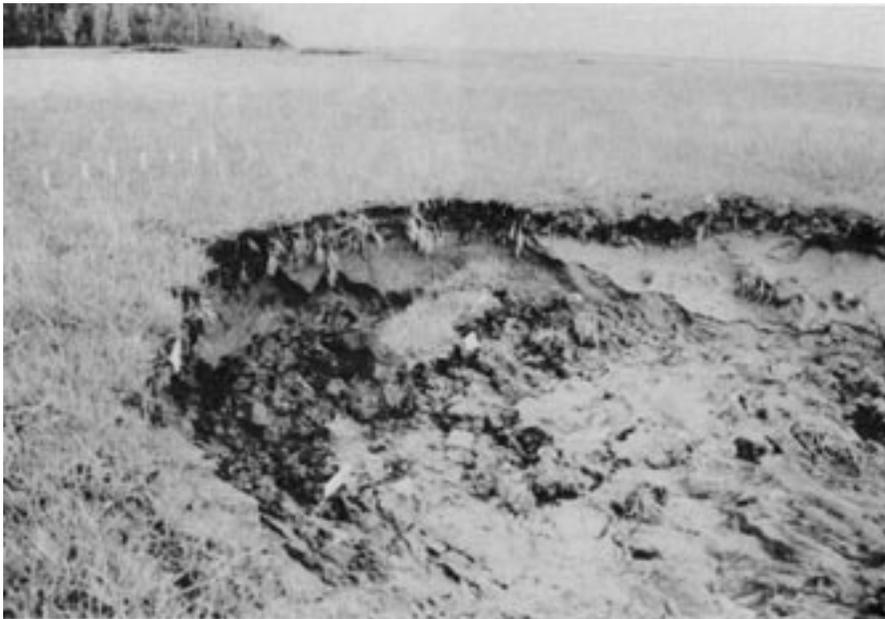
a. Plunge pool of Mortar Gully.

b. Gully scarp of Coastal 6 Gully.

Figure 53. Examples of slope failure.

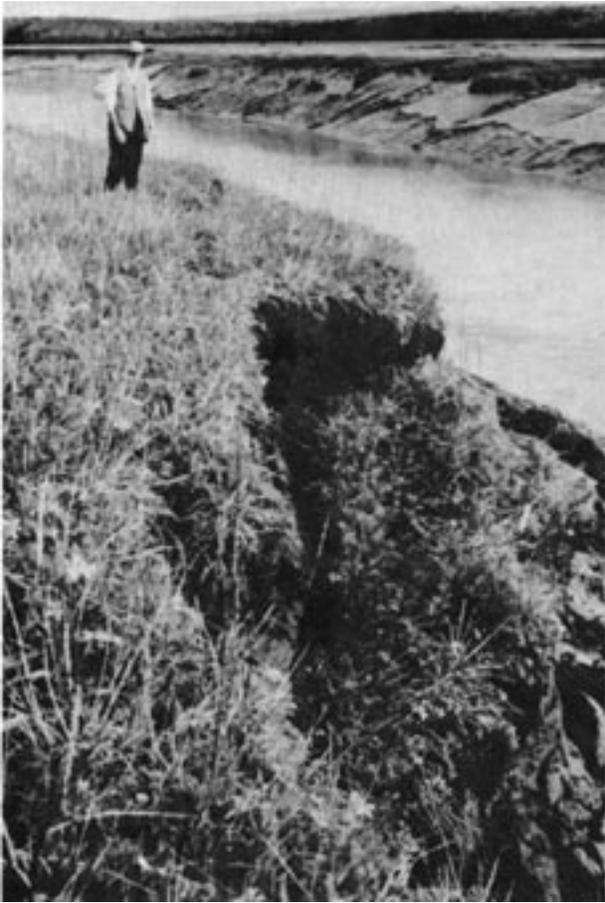
Figure 54. Rotational slump block failure at River Section-North.

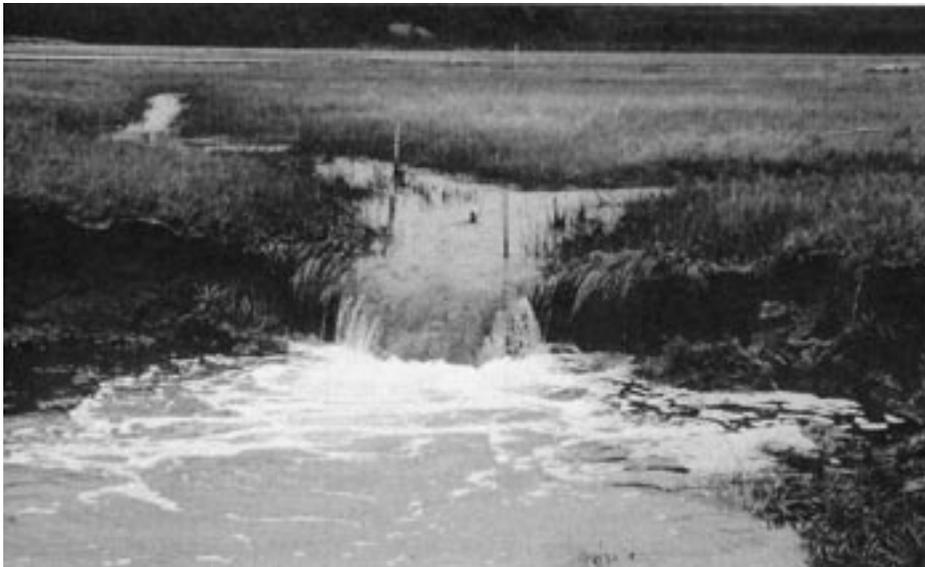
Figure 57. Water flowing over gully headwall at Parachute Gully plunge pool.

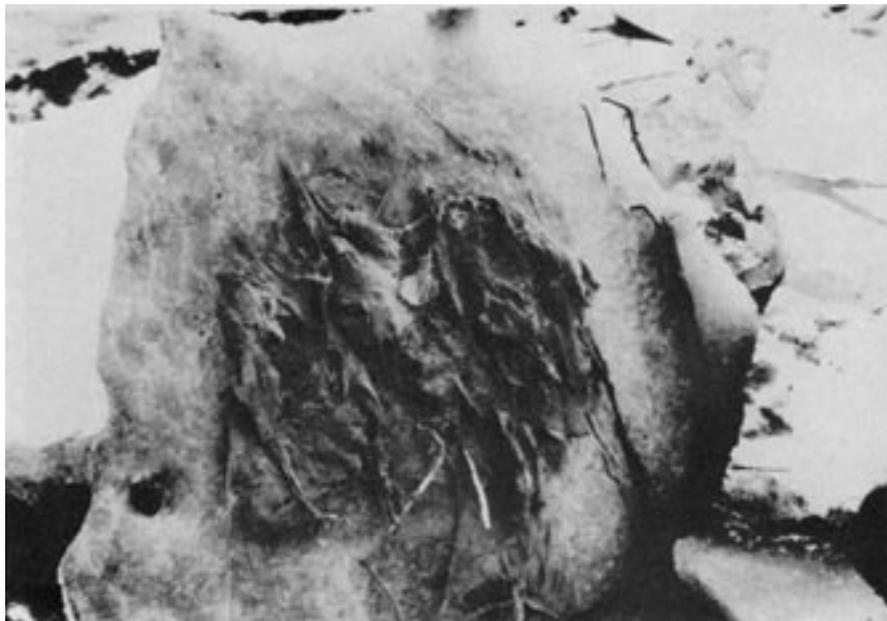
a. Vegetated pond bottom sediments frozen onto ice near the In-between Gully.

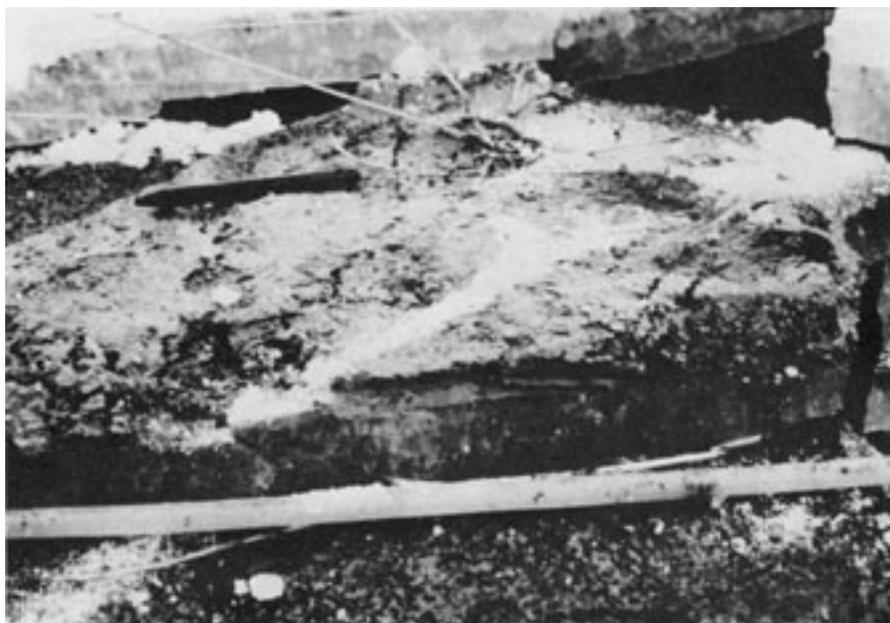
b. Sediment layer frozen onto an ice block at Otter Gully.

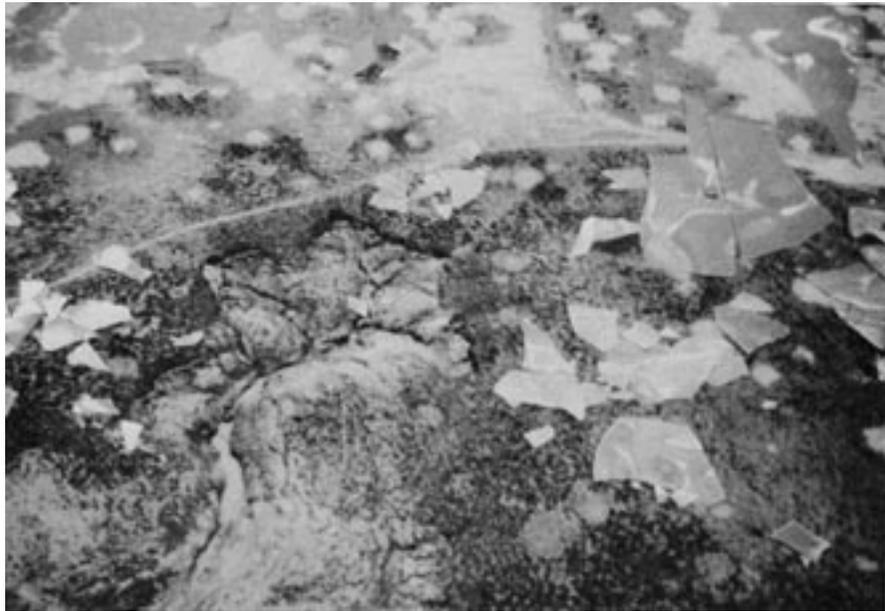
a. Aerial view showing distribution of ice blocks stranded during ebb tide.

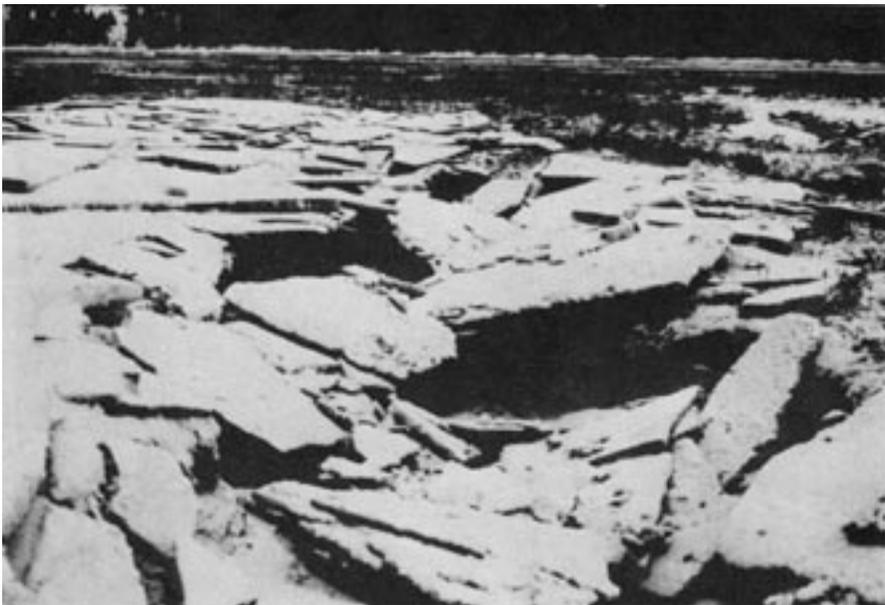
b. Ice block pile along high point near gully margin.
