## REPORT 81-16

*Cold regions testing of an air-transportable shelter*

Stephen N. Flanders

August 1981

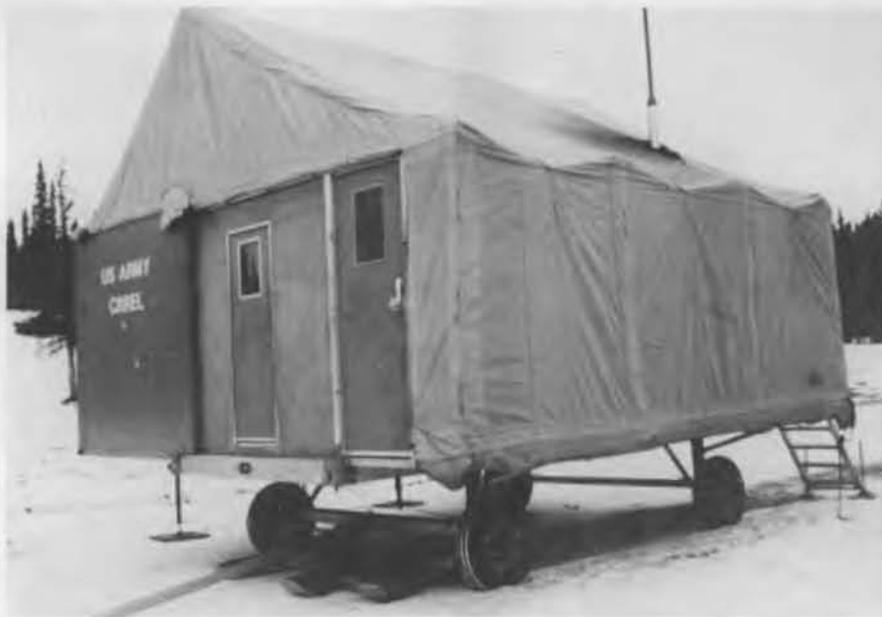
Figure 1. Fully erected shelter on site at Ft. Greely, Alaska.

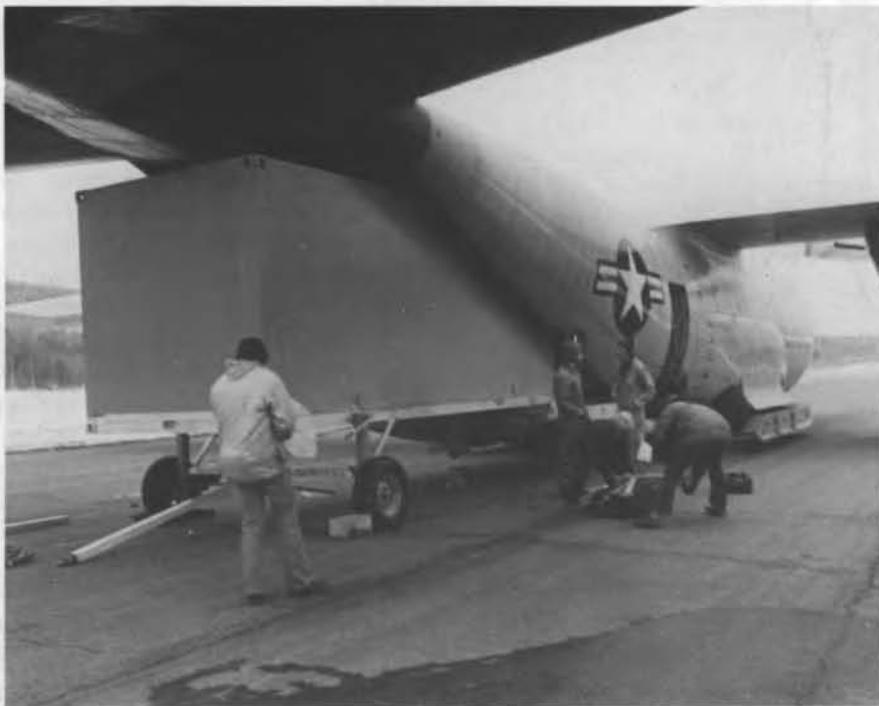
*Figure 3. Shelter loading on C-130—first set of legs removed.*

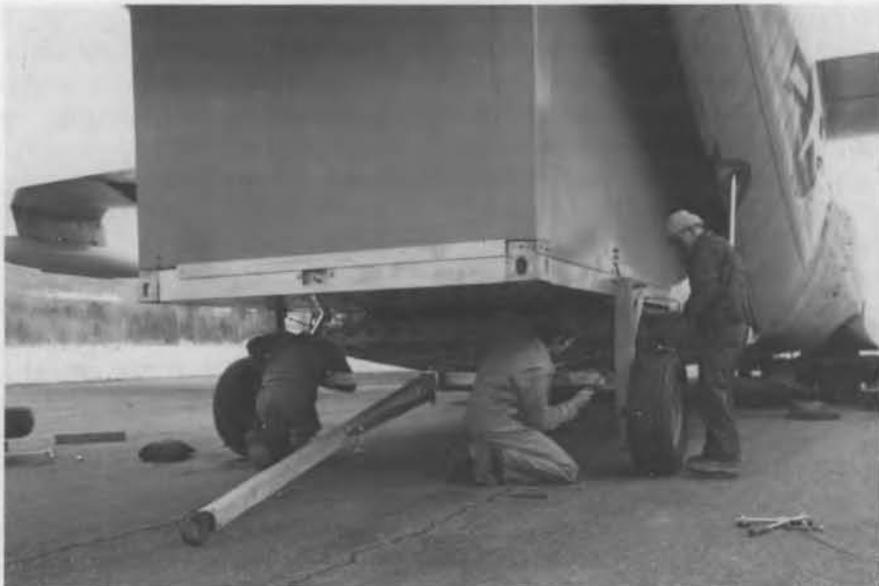
*Figure 4. Shelter on C-130—removing second set of legs.*

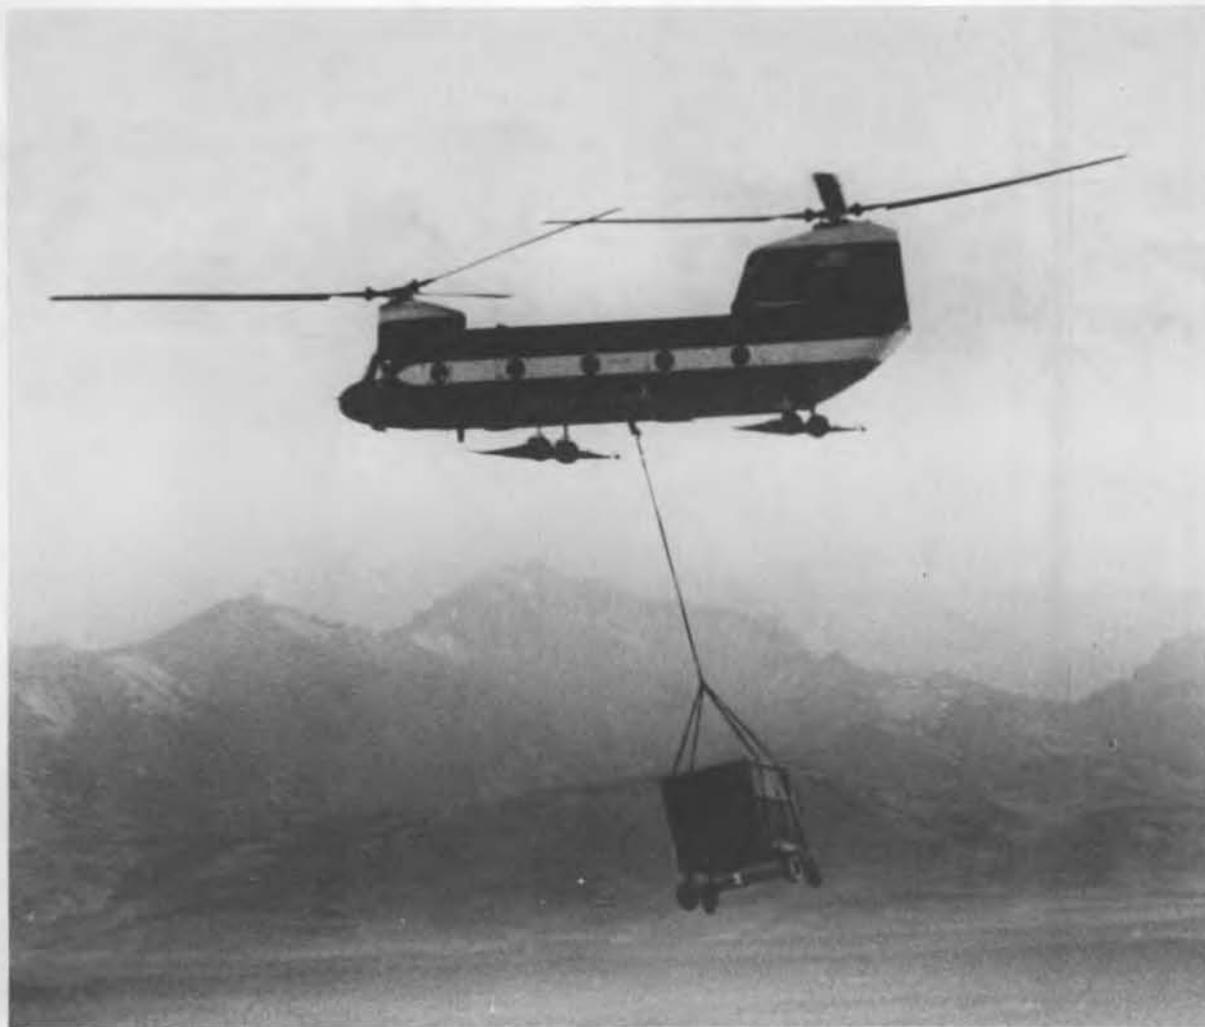
In hover, shown in Figure 6, the shelter rotated about its vertical axis. In forward flight the shelter flew fore-and-aft oriented until the helicopter executed a descending turn; thereafter it rotated and flew broadside to the direction of flight. The helicopter crew recommended a maximum airspeed of 80 knots for transporting the shelter. In sum, the flight crew considered the shelter to be very stable in straight and level flight and suitable for helicopter airlift (Dollahite 1978).

*Figure 6. Helicopter flight test of the CRREL shelter at Ft. Greely, Alaska.*

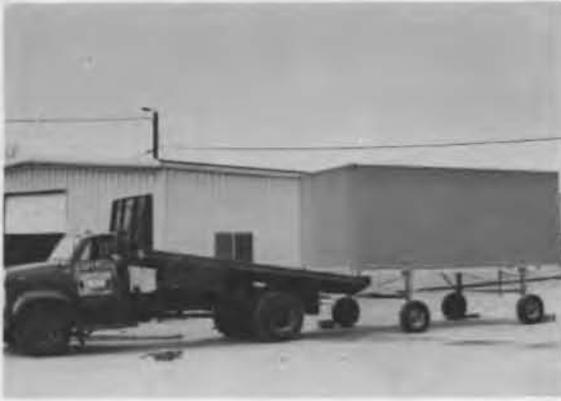
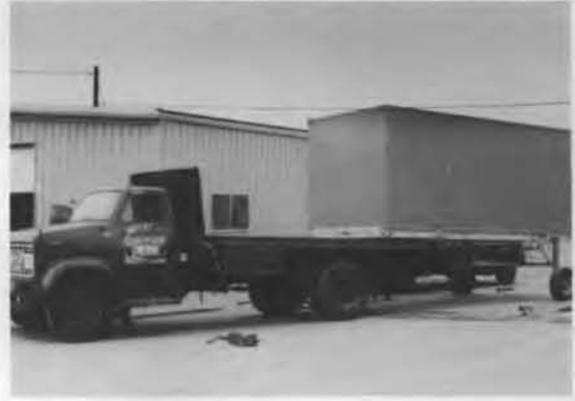
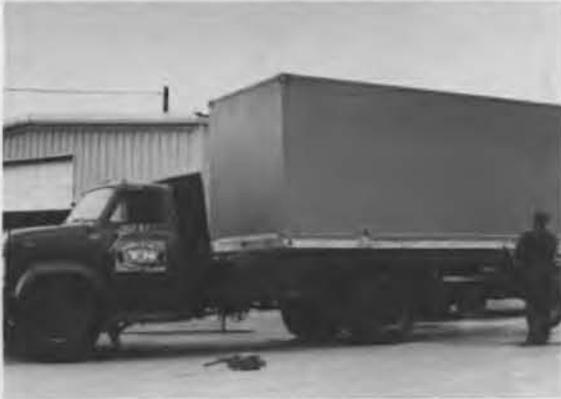
Figure 7. Loading the shelter onto a truck.

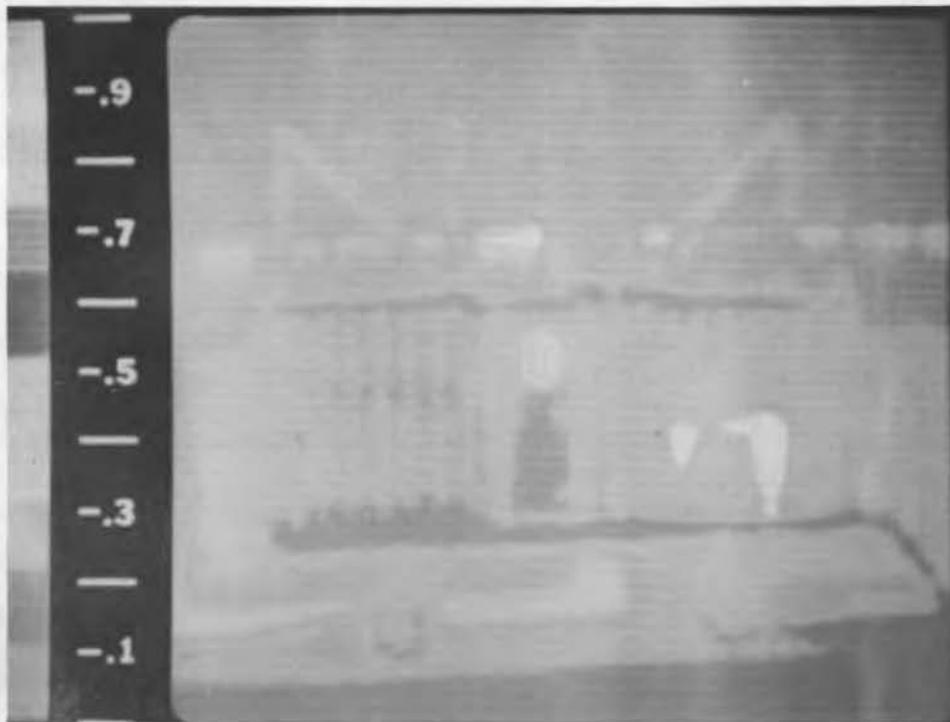
Thermograms of the shelter, such as in Figure 14, demonstrated that the surface temperatures do not vary by more than 1.8°F at a  $\Delta T$  of about 32°F. Inspection from all sides revealed no heat leaks except around the engine compartment door which was open for the operation of the generator and the snow melter which is a source of warm water vapor.

Figure 14. Thermogram of the shelter at  $\Delta T = 32^{\circ}\text{F}$ .

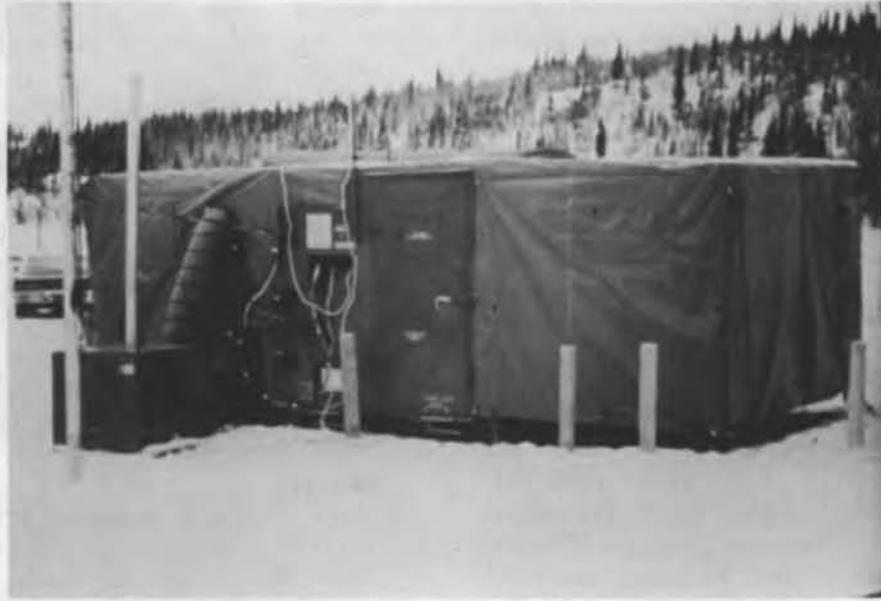
CRTC had tested two Air Force Bare Base 3-for-1 expandable shelters of about 265-ft<sup>2</sup> floor area during the 1973-74 winter test season. The Air Force shelters (similar to the one in Fig. 15) incorporated add-on features including an arctic cover, vestibule and carpet for use in extreme cold. These items impeded ease of erection without adding very much in thermal performance.

Figure 15. Three-for-one expandable hard wall shelter tested at CRTC 1973-1975.
