River channel characteristics at selected ice jam sites in Vermont

Lawrence W. Gatto

October 1978

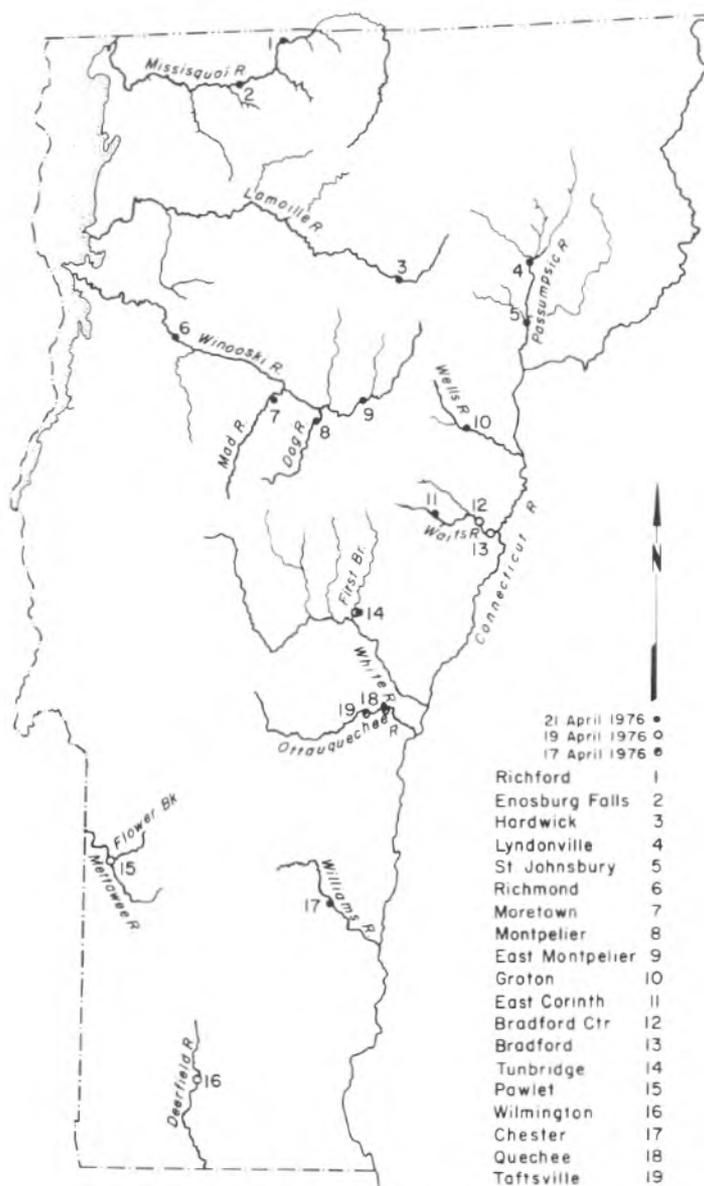
Figure 1. Ice jam sites.

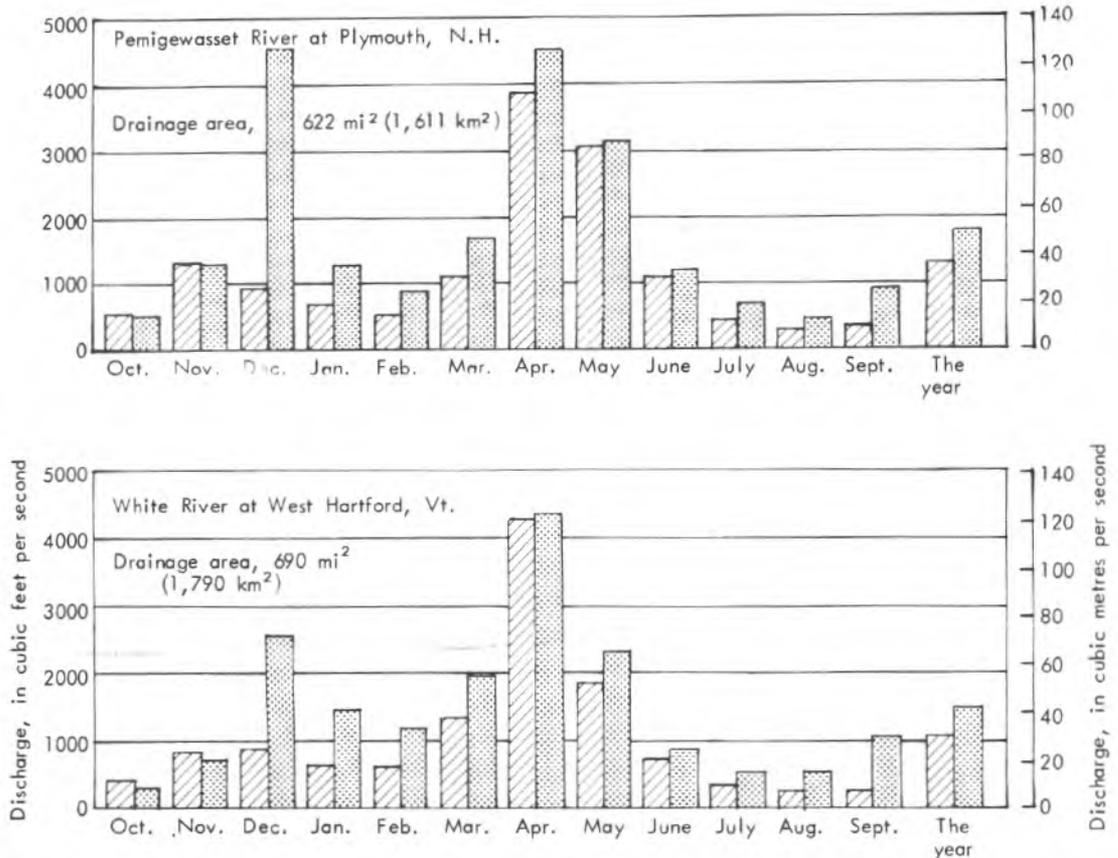
Figure 2. Median discharge at two long-term index gaging stations for period 1941-70 (U.S. Geological Survey 1974).

to February, then increases through March to April when it peaks and decreases to the August-September period. A stable ice cover generally forms during the decreasing discharge period from December through February; then this cover is broken and set in motion as discharge increases in March.

In retrospect, there are several reasons that the best time to acquire aerial photographs for this type of study would be in late October or early November. Based on the long-term flow data in Figure 2, flows at this time are comparable to those in February and March when jams usually begin to form. During the October-November period, the extents of riffles and pools could be easily observed and measured since water levels would be down. These features were apparent on the April photographs for only a few sites. In addition, most trees are bare at this time and would not obscure channel margins. Flying weather is usually good because atmospheric haze is low and cloud-free days are numerous. However, sun angle is decreasing during this period and shadows may mask portions of the channel margins that are bordered by trees. As DenHartog (1977) indicated, ideally aerial photographs should be taken twice: once when water levels are low and jams are absent to allow best observation of the channel so that possible obstructions to flow could be documented; and again, during increased flows after jams have formed to show where the ice was stopped and to suggest which obstruction may be the primary factor in initiating the jams.

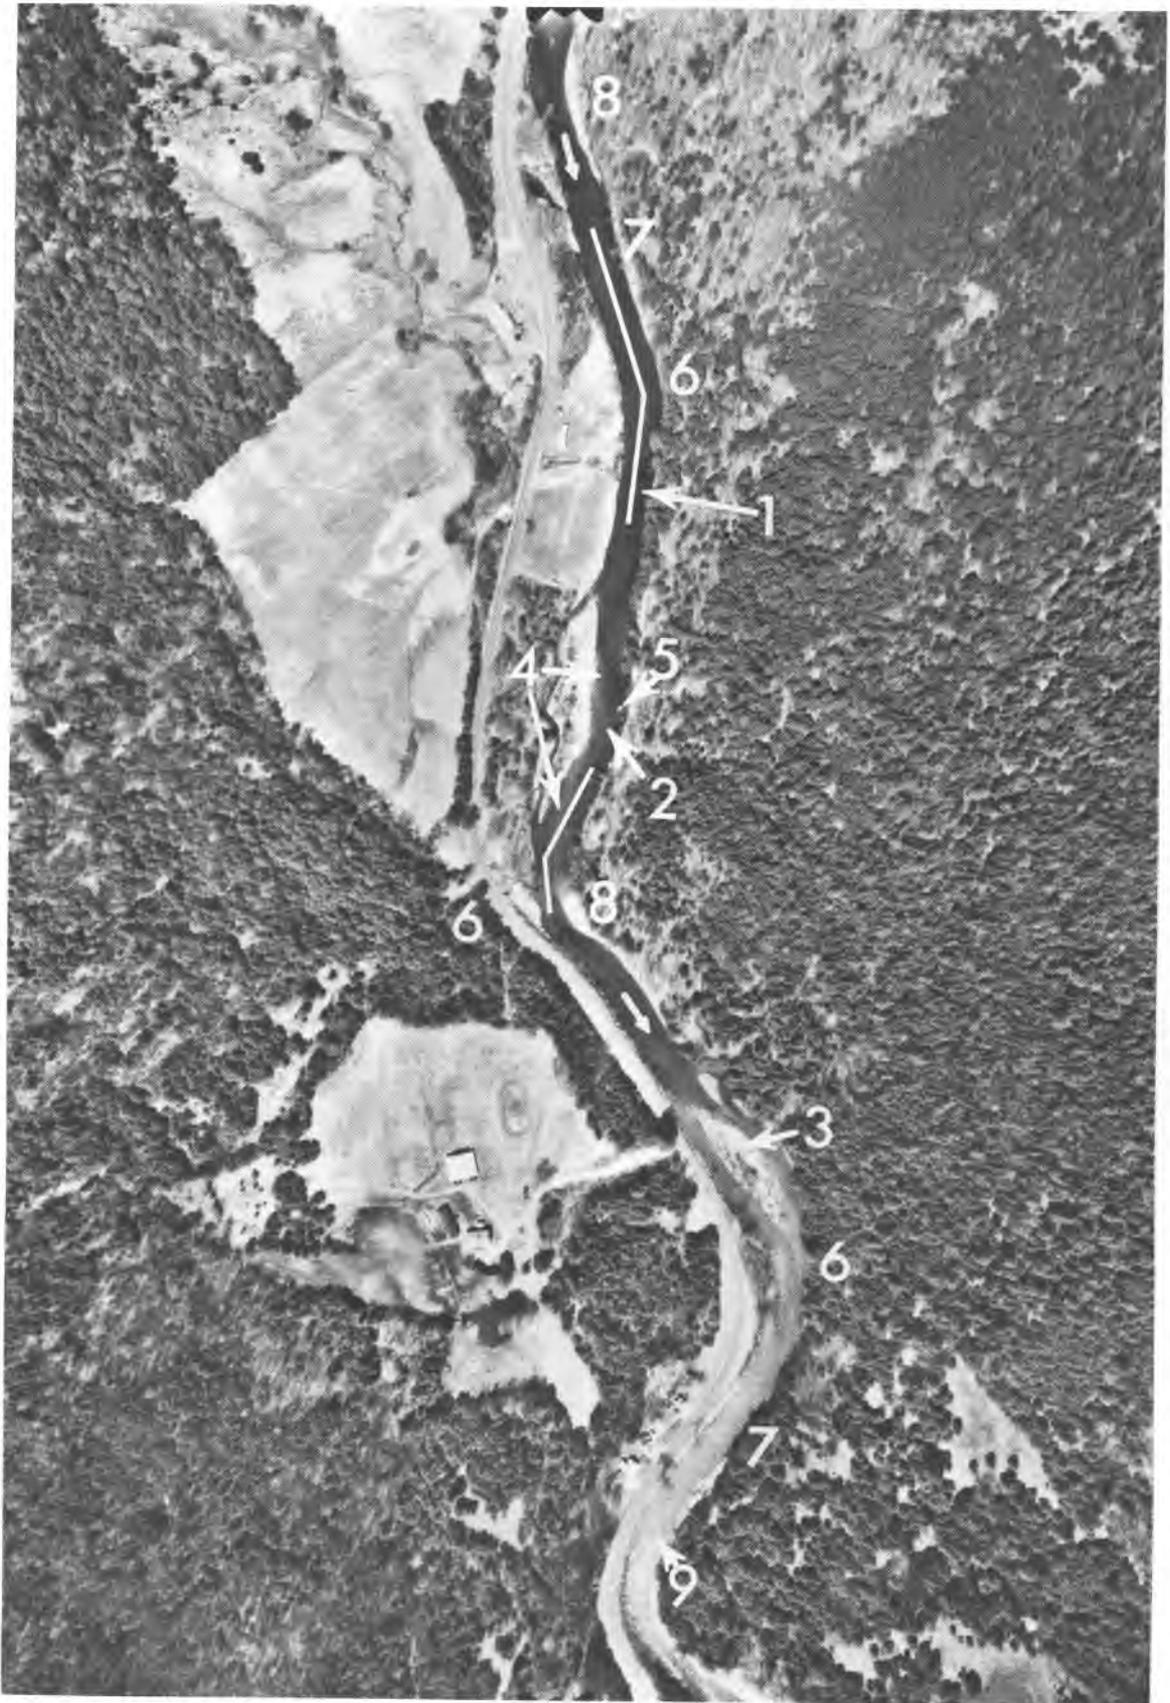
Figure 3. Waites River, upstream from Bradford site. Scale: 1 in. = 519 ft (north is upstream).

Figures 3-9 indicate how the features and conditions (Table III) observed at the various sites appeared on the original aerial photographs at full scale. Many of these features are shown in Figure 3. The other figures were selected to show the remaining features at different geographic settings. The dark, smooth appearance of the pool (1)† contrasts with the wavy lighter appearance of the riffle (2) (Fig. 3). Water depths are greater in the pools, but water velocities and surface roughness are generally less. The lighter appearance of the riffles results from a possible combination of increased bottom reflection and increased solar reflection due to water surface roughness. A large riffle (1 in Fig. 4) that extends across the Waits River is frequently the site of ice jams. Bed material here is coarse with exposed boulders (2) and cobbles (3). In Figure 3,

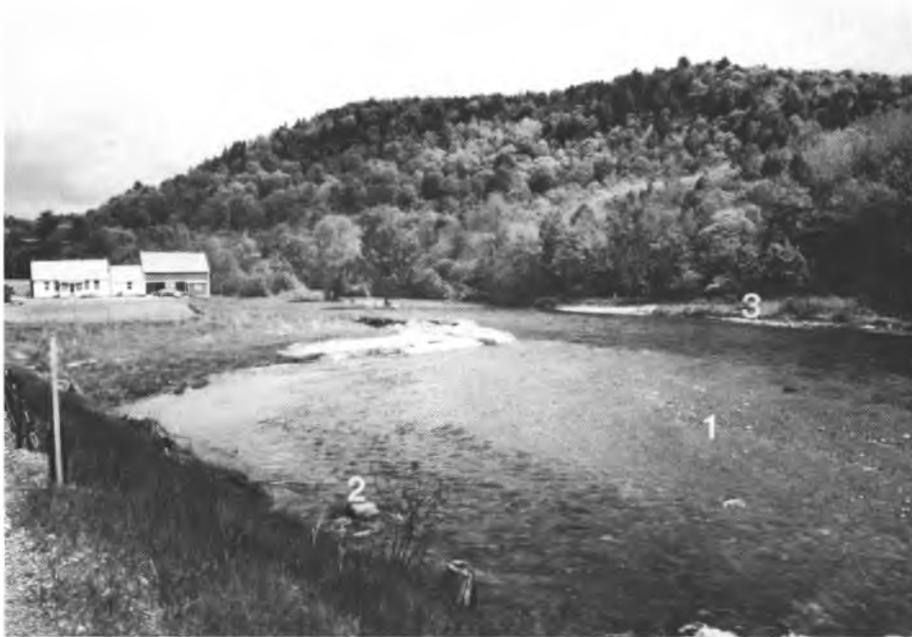
Figure 4. View upstream on Waits River from point 5 on photomosaic 12-13 (App. A). (Photo, courtesy of D. Calkins).

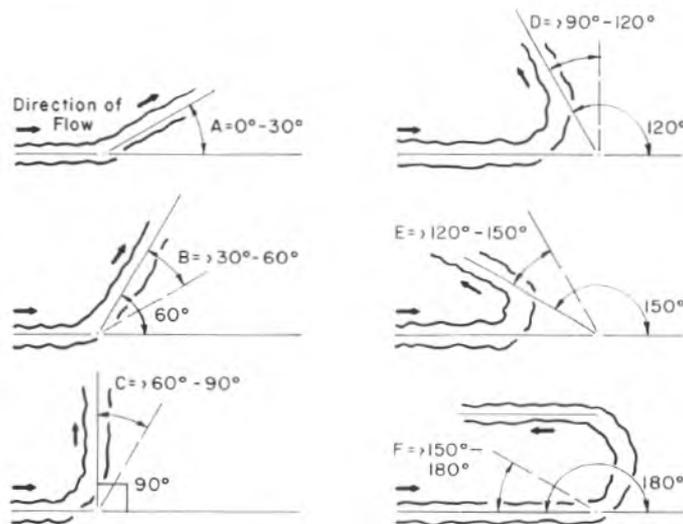
Figure 5. Meander classes.

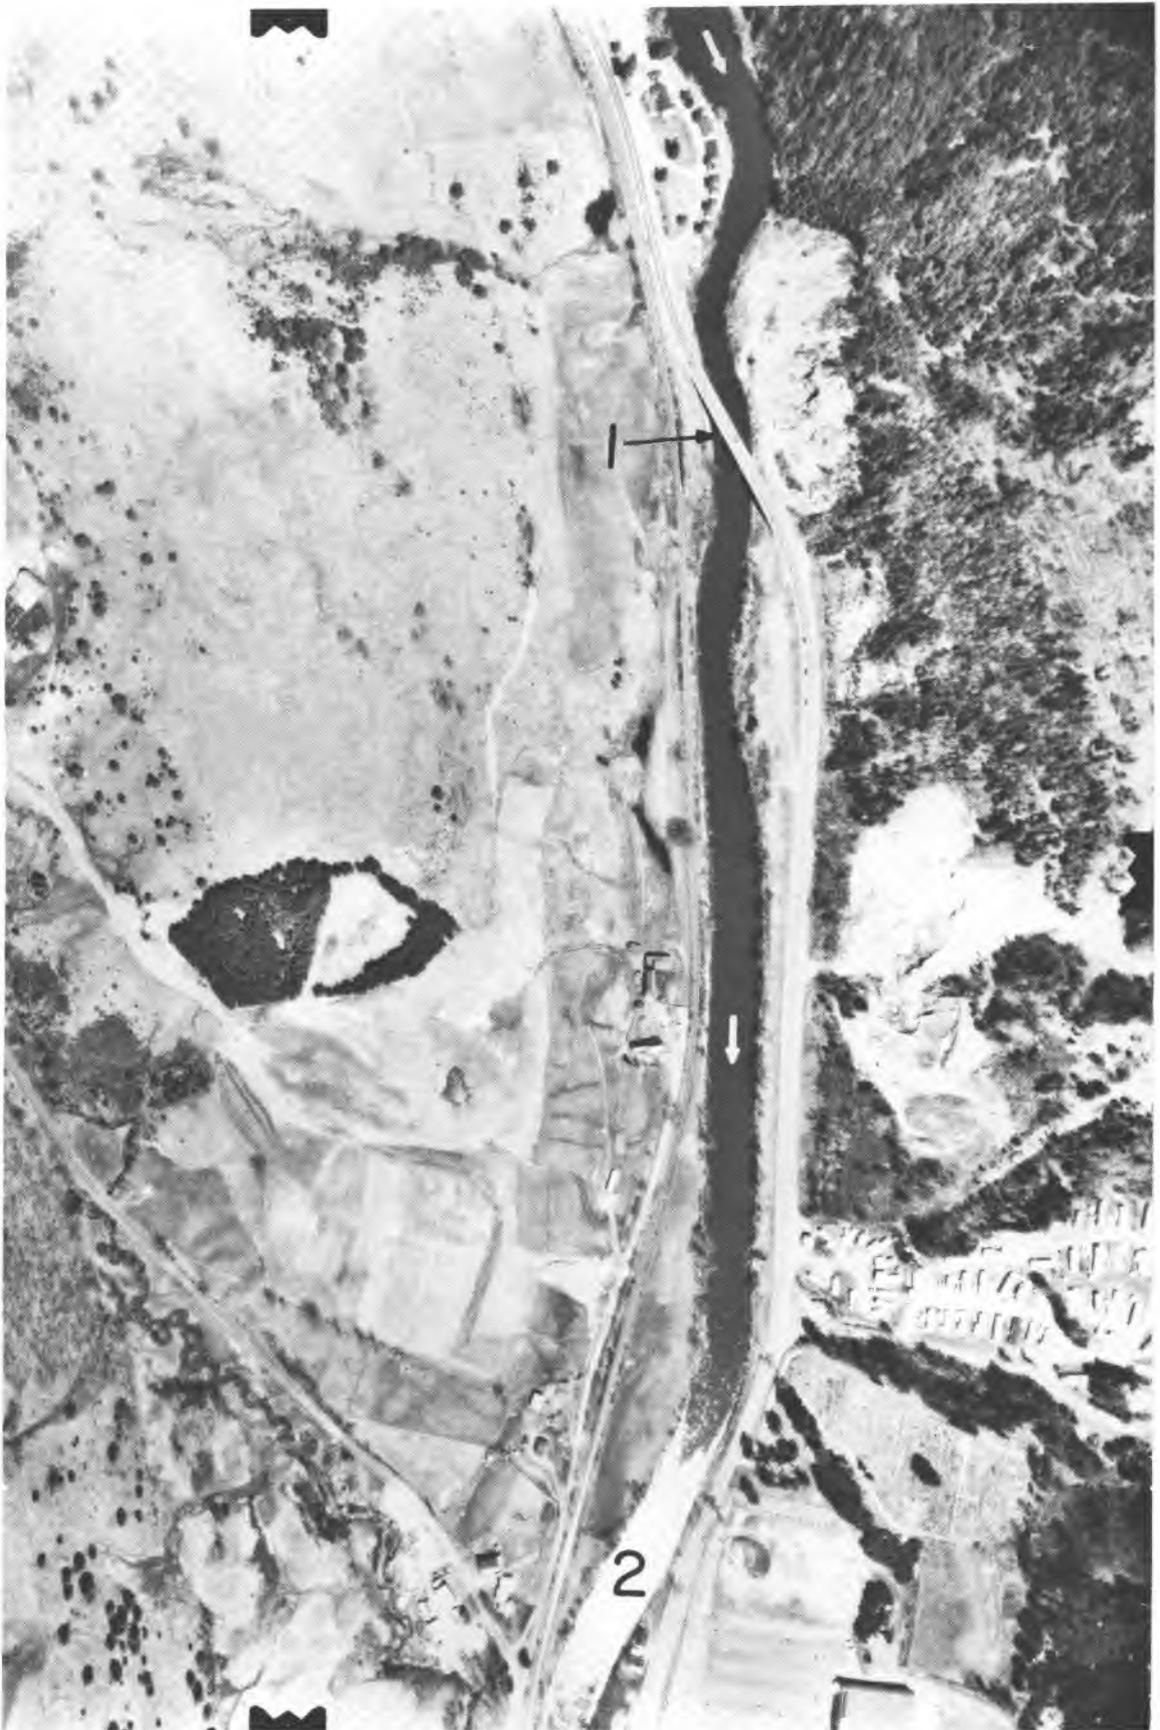
Figure 6. Northern end of St. Johnsbury site, Reach A. Scale: 1 in. = 483 ft.

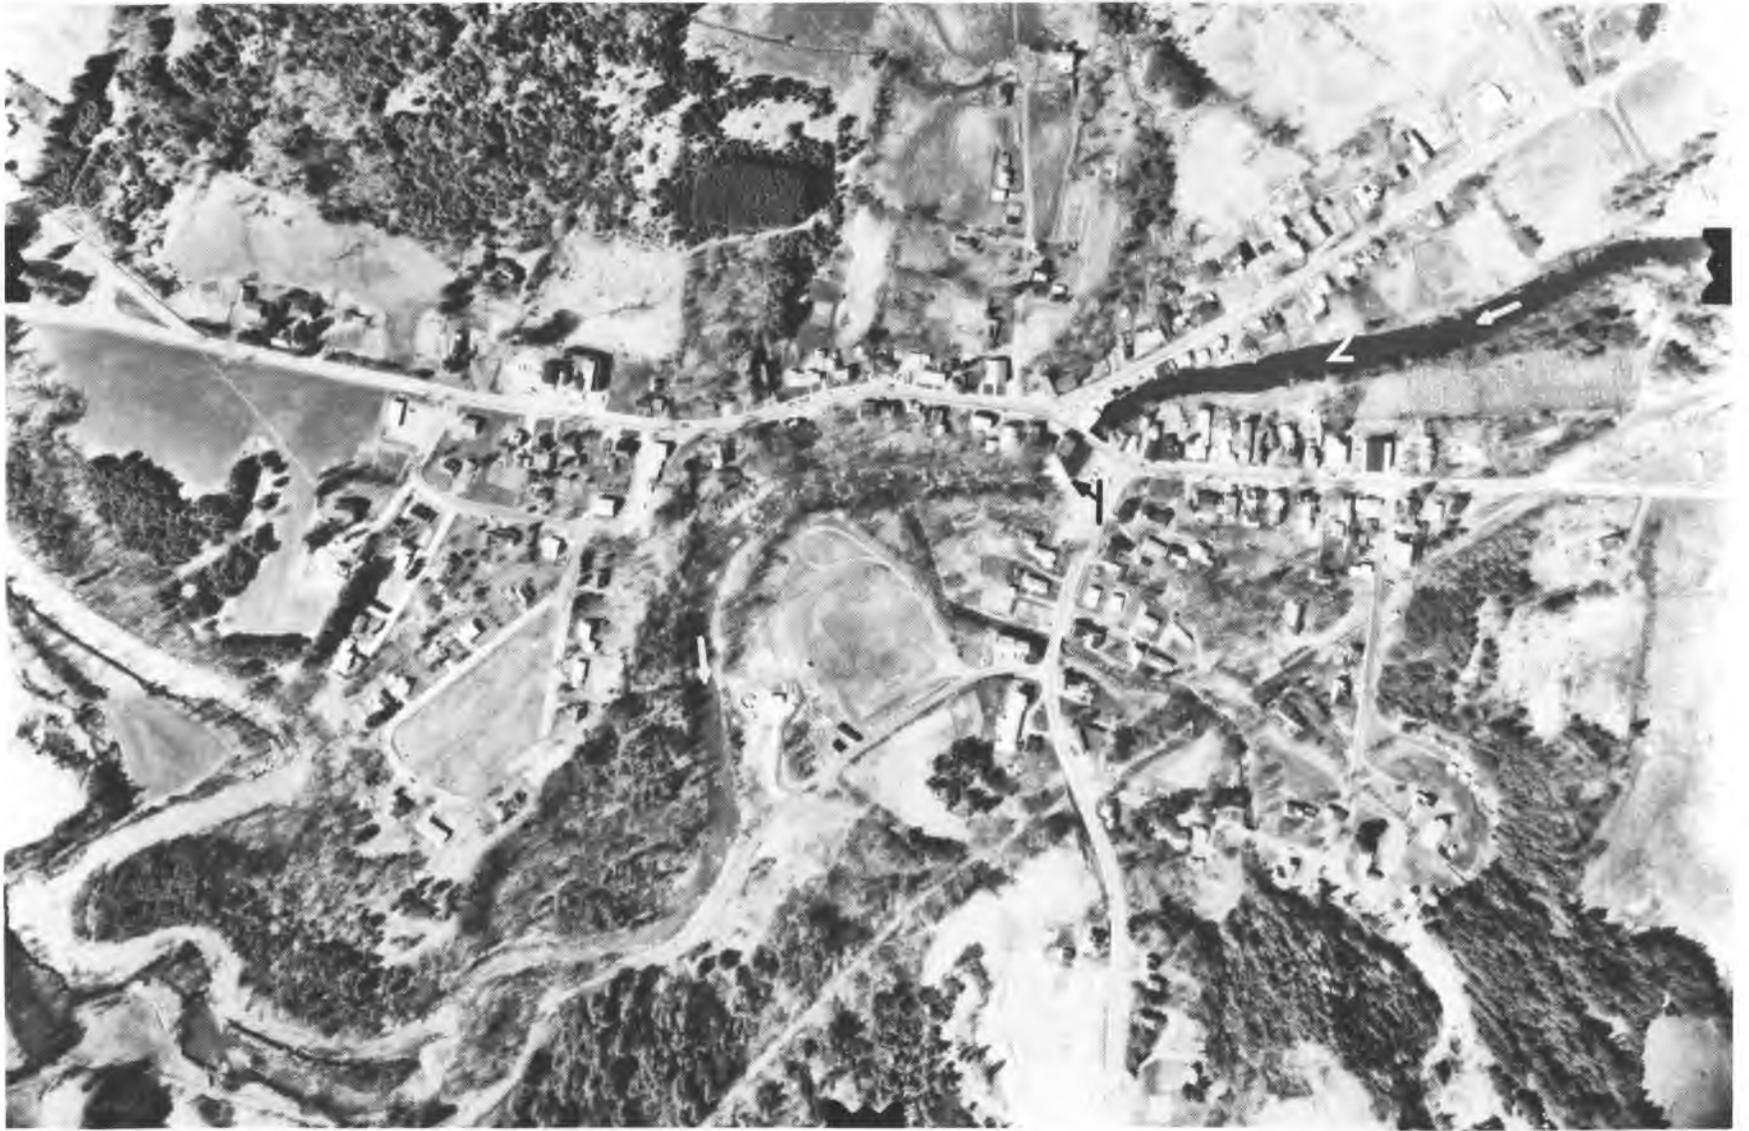
Figure 7. Winooski River, upstream from usual ice jam site shown on photomosaic 9. Features shown here are typical of those in the study site. Scale: 1 in. = 439 ft.

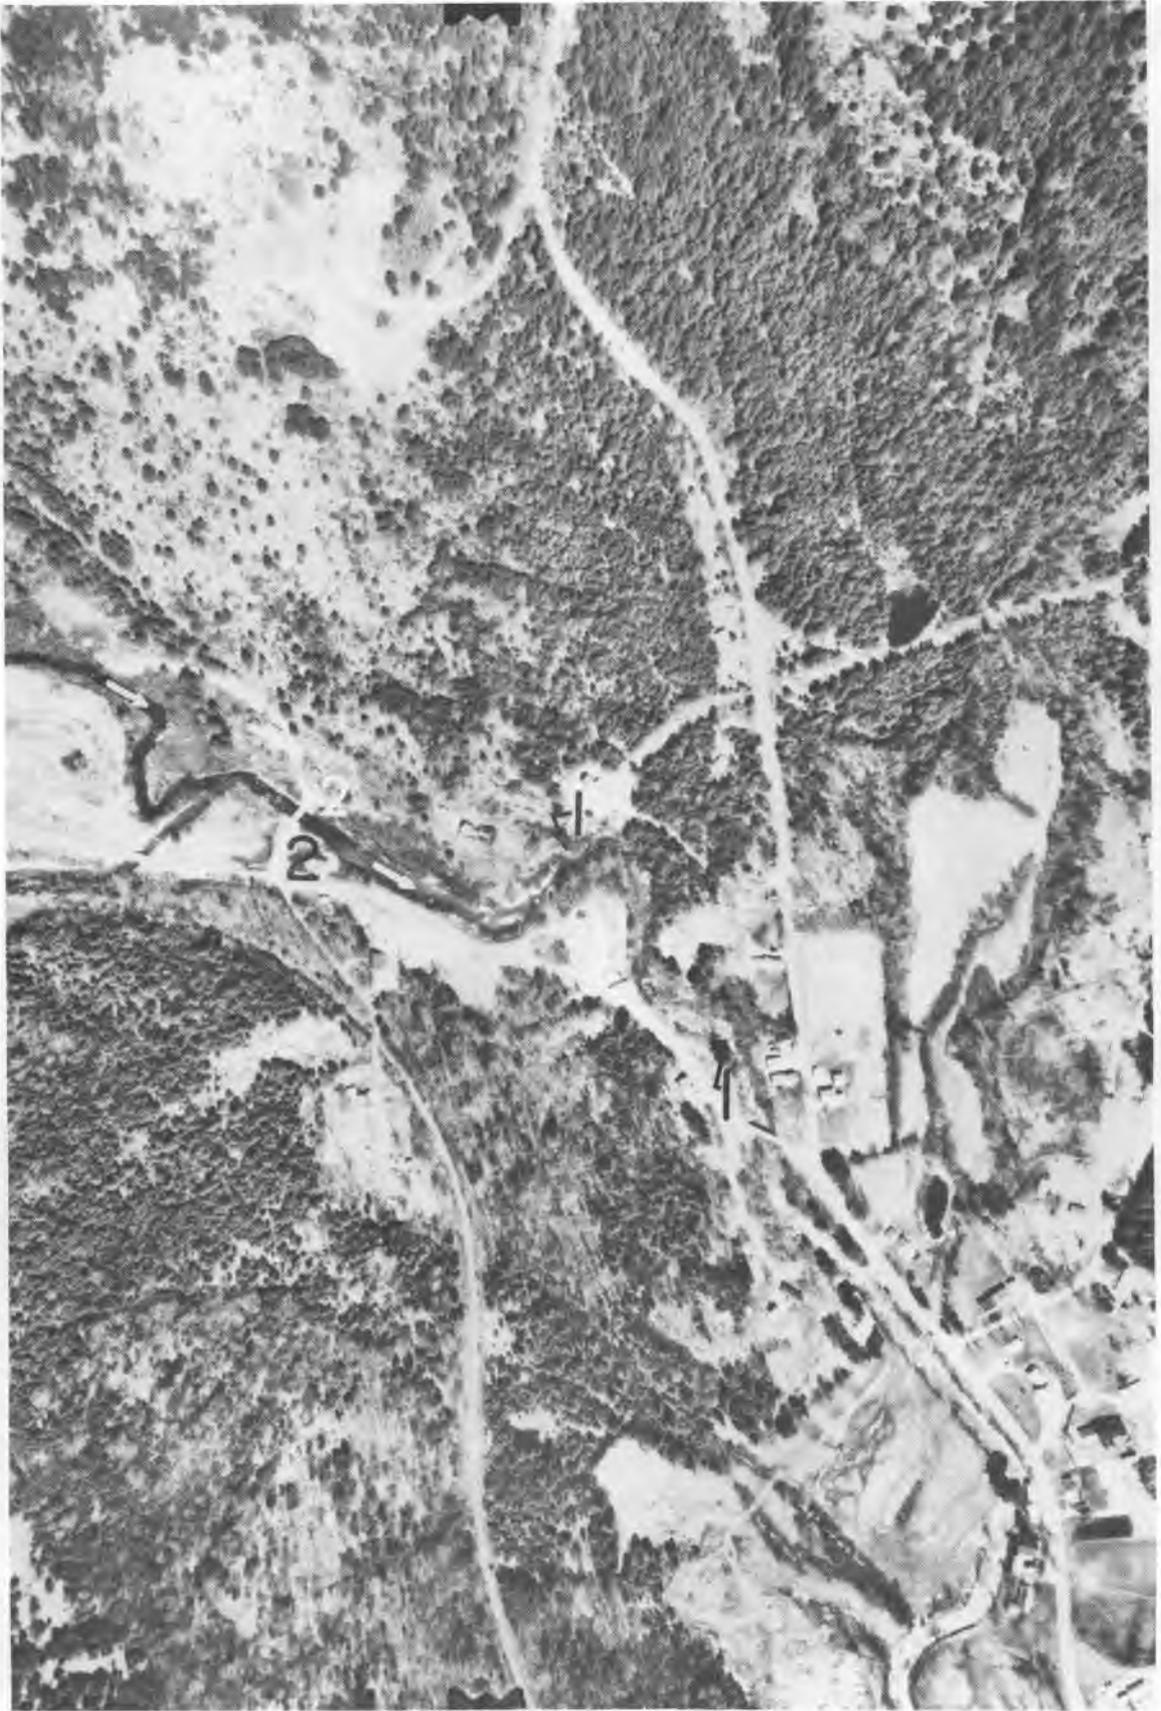
Figure 8. Groton site, photomosaic 10. Scale: 1 in. = 441 ft.

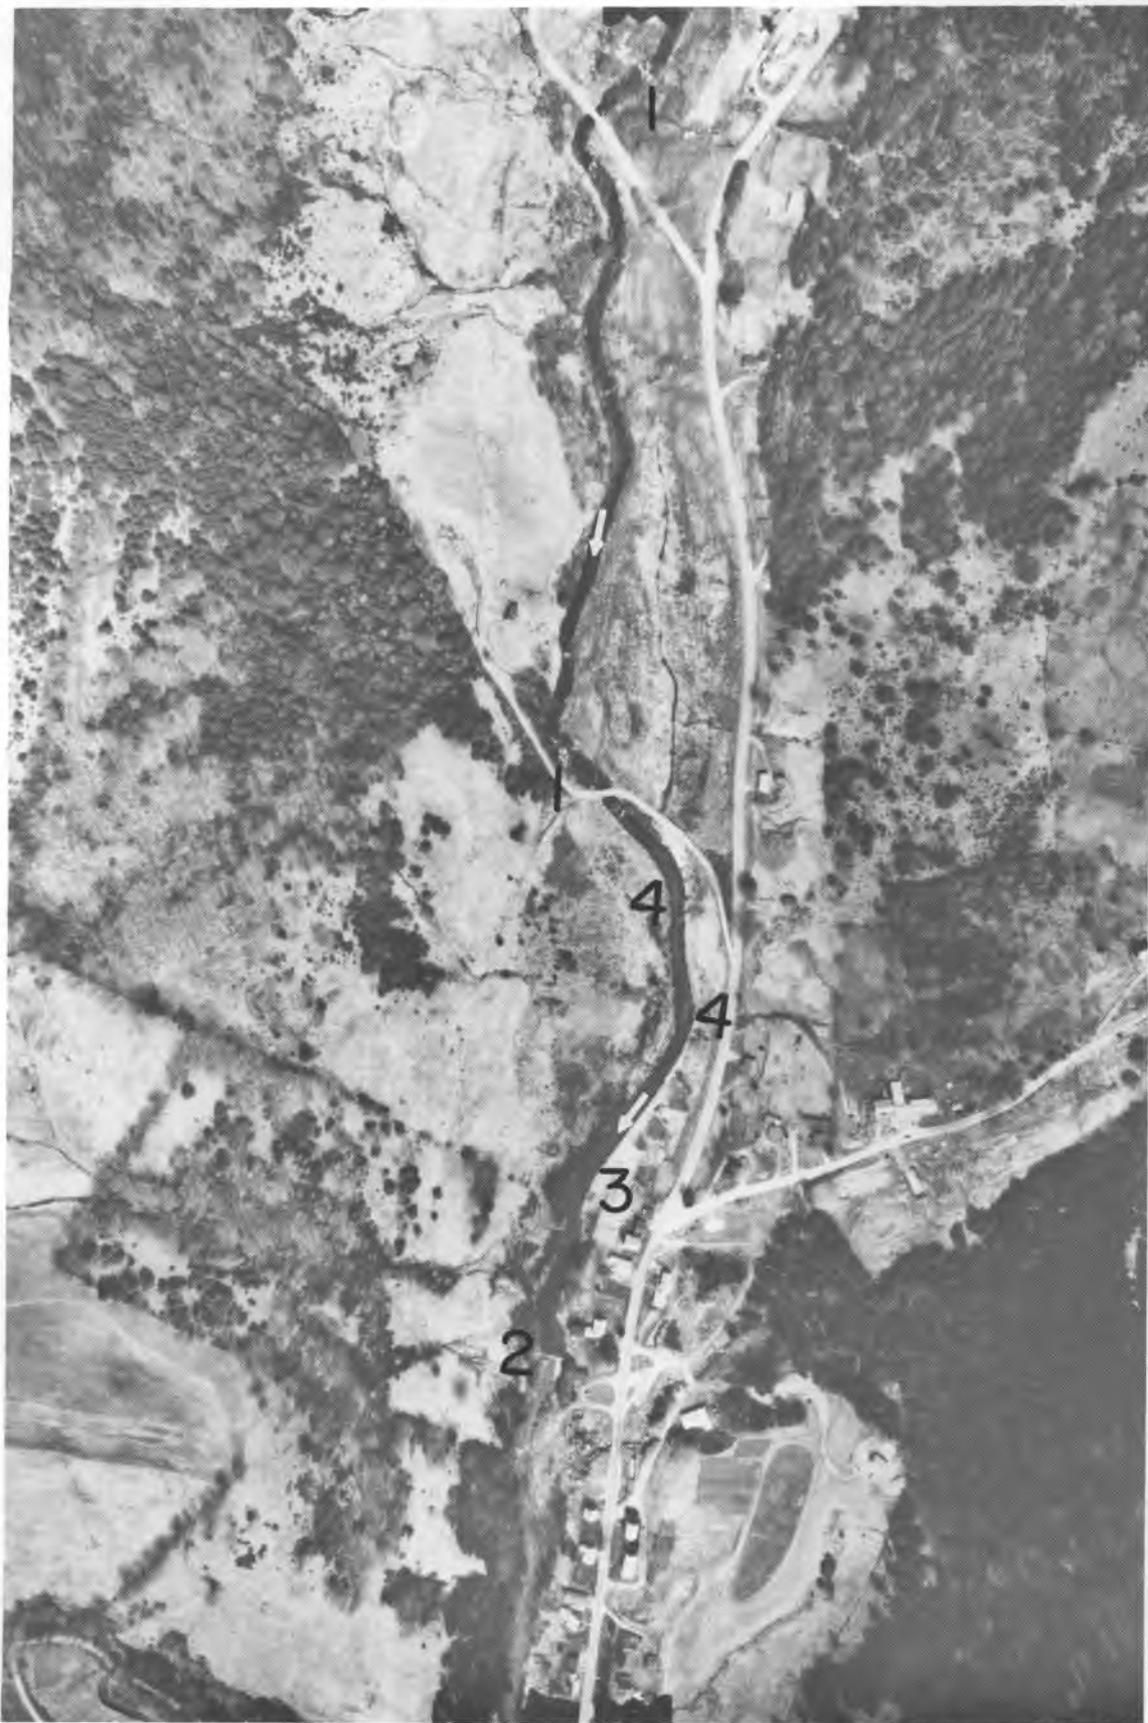
Figure 9. Tabor Branch of Waits River, upstream of the study site. Scale: 1 in. = 563 ft.

Rapids (1), a dam (2), and a dam pool (3) appear in Figure 9. The dam pool obscures much of the detail of channel roughness that is evident downstream from the dam, although shoals and riffles with surface waves are faintly observable at the light areas (4) in the water.

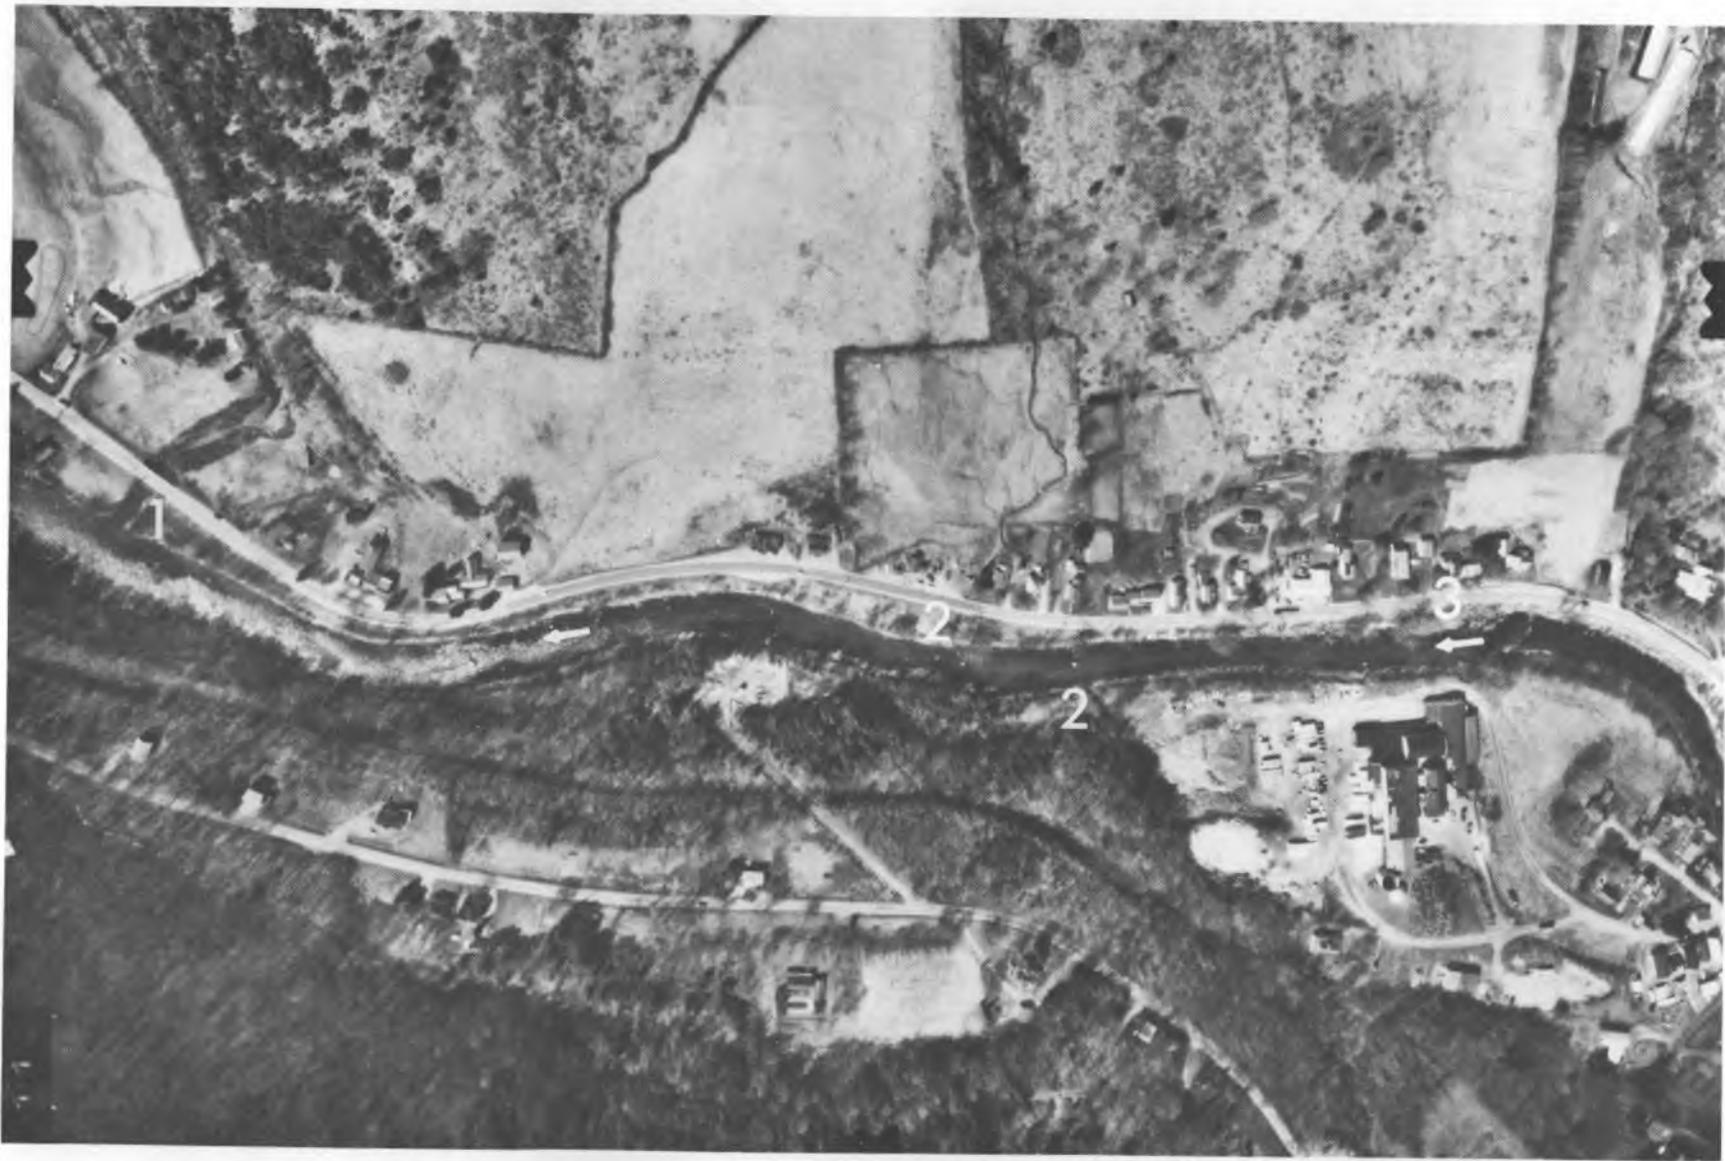
Figure 10. Downstream end of Wilmington site, photomosaic 16. Scale: 1 in. = 381 ft.

At the Wilmington site (Fig. 10) the appearance of a large confluence (1) is illustrated. Ice entering the main river from a tributary may add enough ice volume to the main channel to contribute to the formation of an ice jam. Within each site the number of major tributary confluences was counted (Table III). Small confluences (2) (Fig. 10) were not counted, since the amount of ice contributed to the main channel

was probably insignificant. The coarse texture of the bed material is apparent as shown by the many exposed rocks in the channel and by the boulders (3) along the shore. Sunlight obscures the surface water detail on the downstream side of the photograph (Fig. 10).

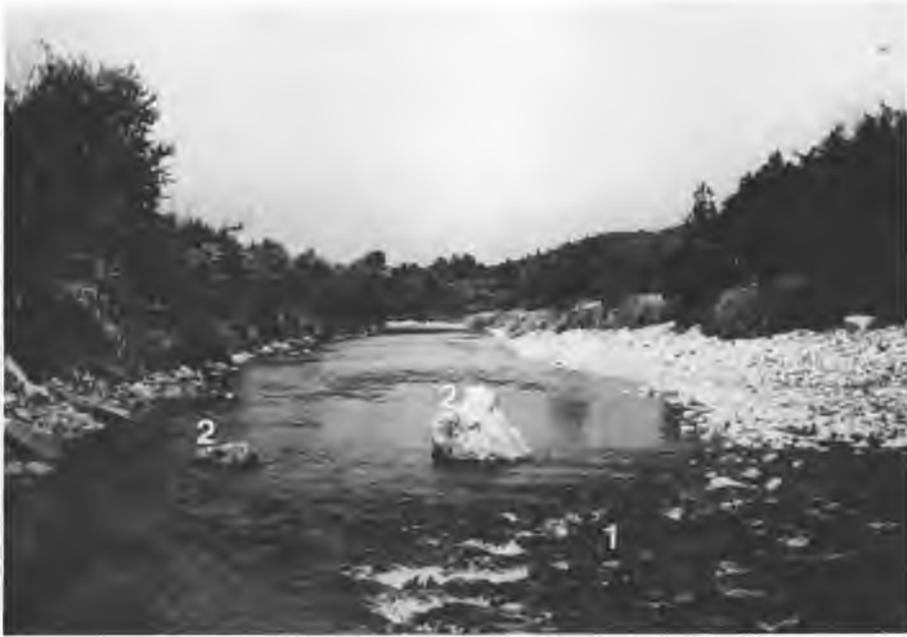
Figure 11. Channel at Hardwick site looking downstream. Riffle (1), channel rocks (2), coarse channel material (3). (Photo, courtesy of S. DenHartog).

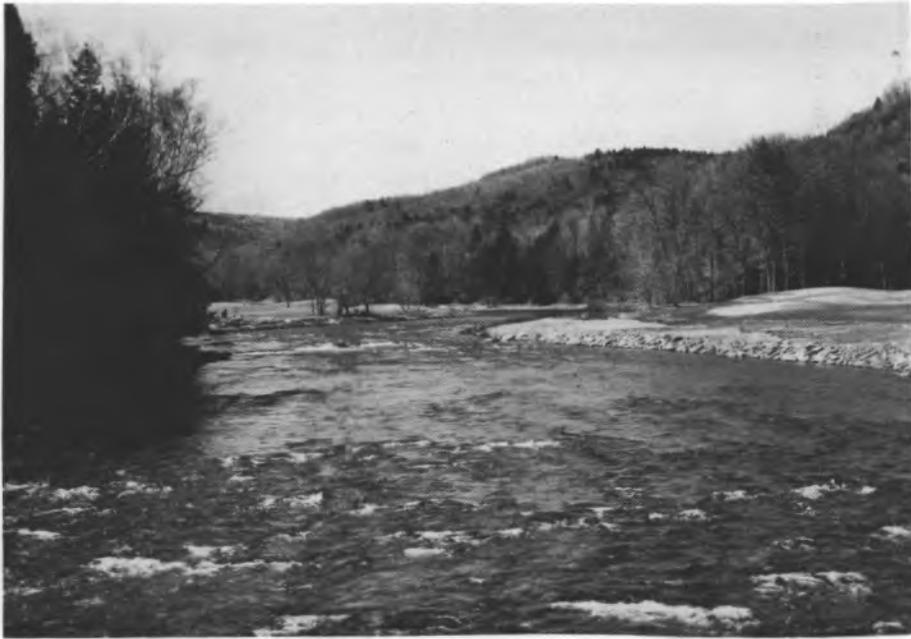
Figure 12. View upstream on the Ottawaquechee River from upstream point 3 on photomosaic 18. Rapids in foreground and center are shown on photomosaic. (Photo, courtesy of D. Calkins).

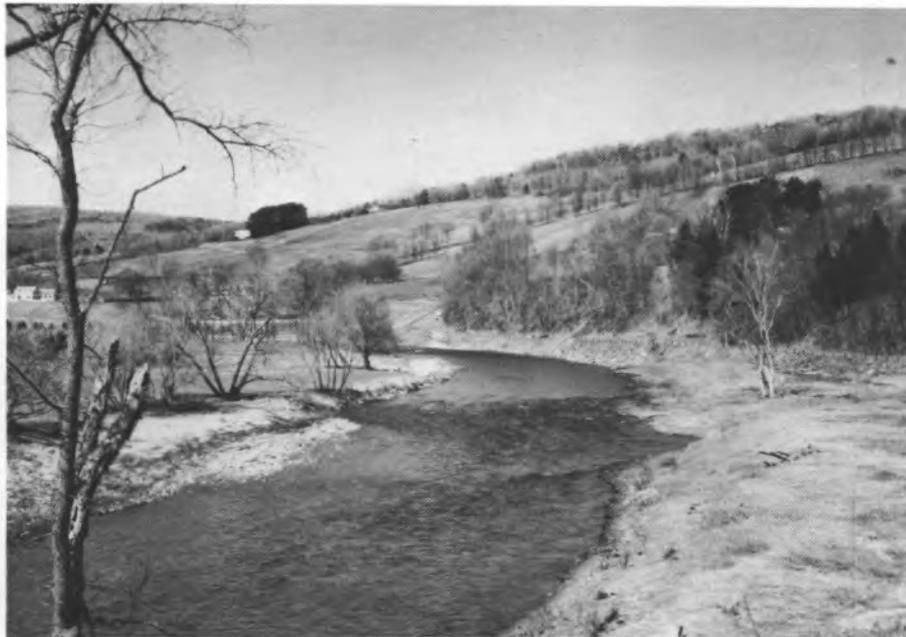
Figure 13. View upstream on the Ottawaquechee River from point 5 on photomosaic 18. Note riffle in center and coarse material on the bar. (Photo, courtesy of D. Calkins).

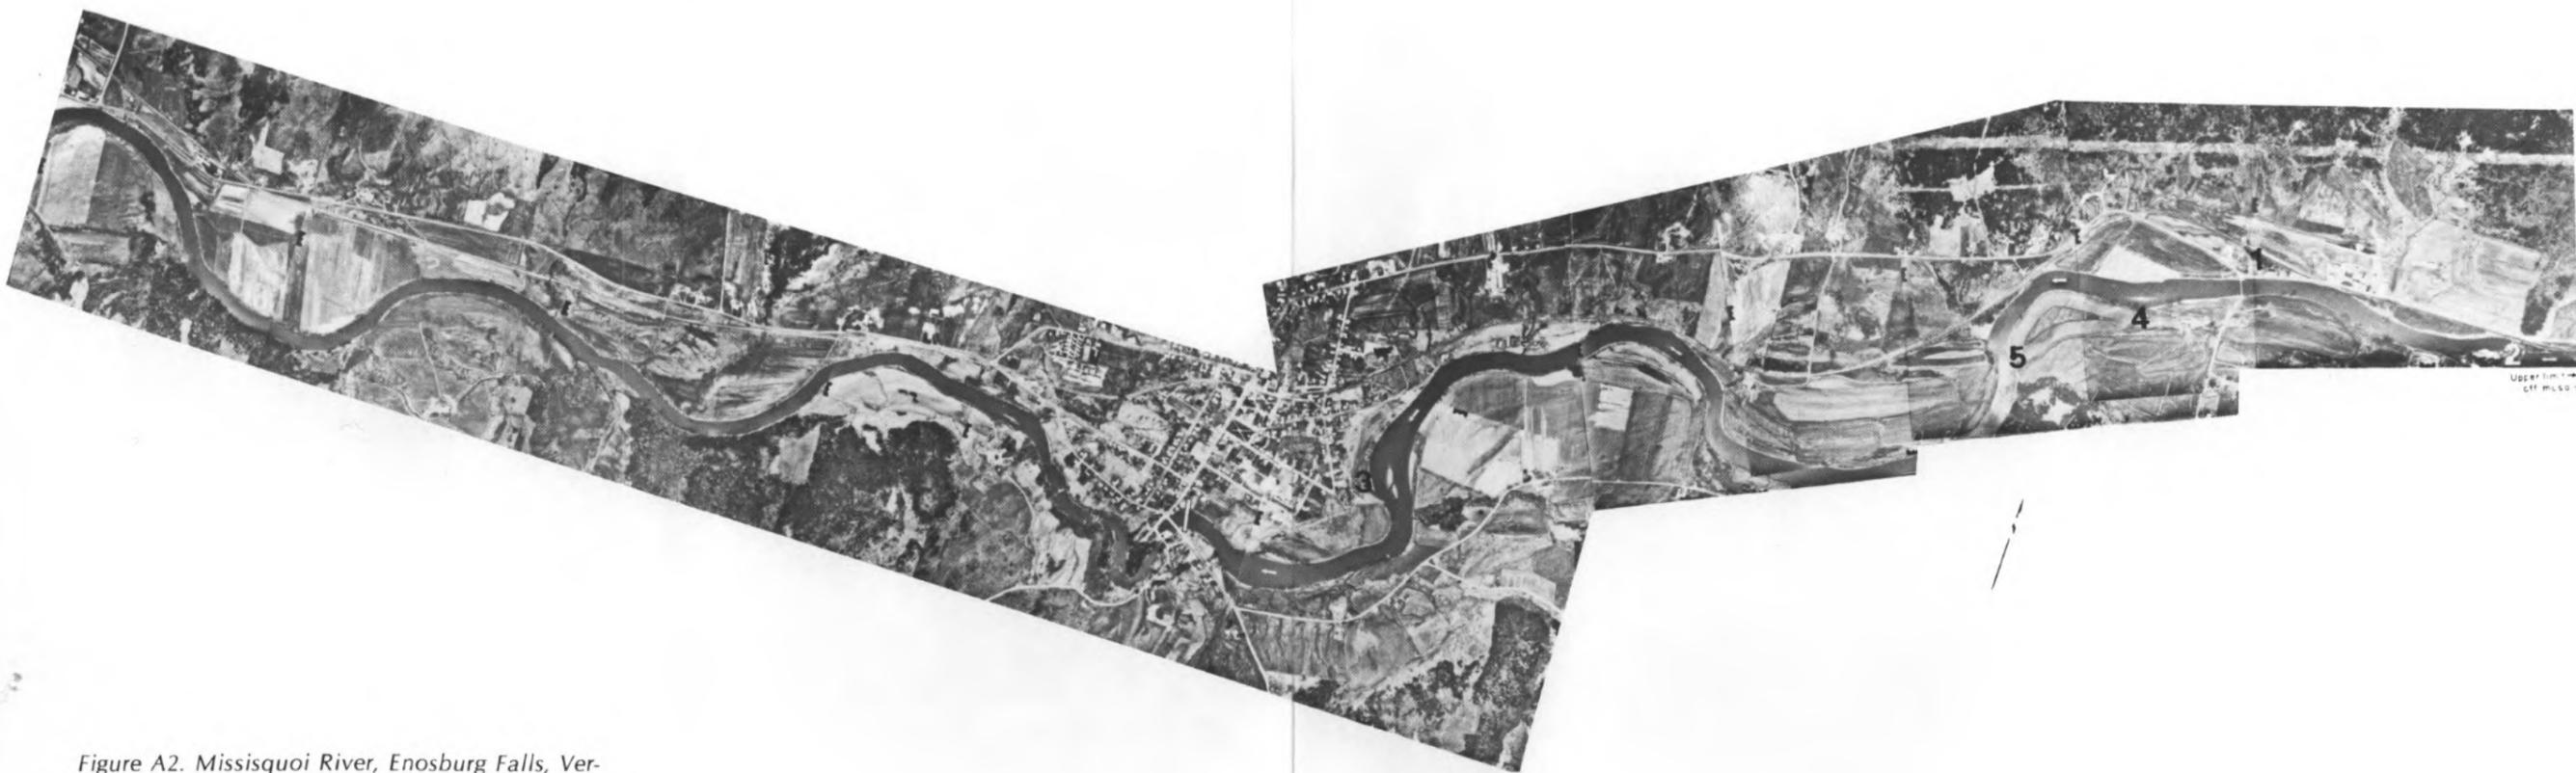
Figure A2. Missisquoi River, Enosburg Falls, Vermont, 21 April 1976. Original scale 1 in. = 511 ft; $\frac{1}{5}$ original size.

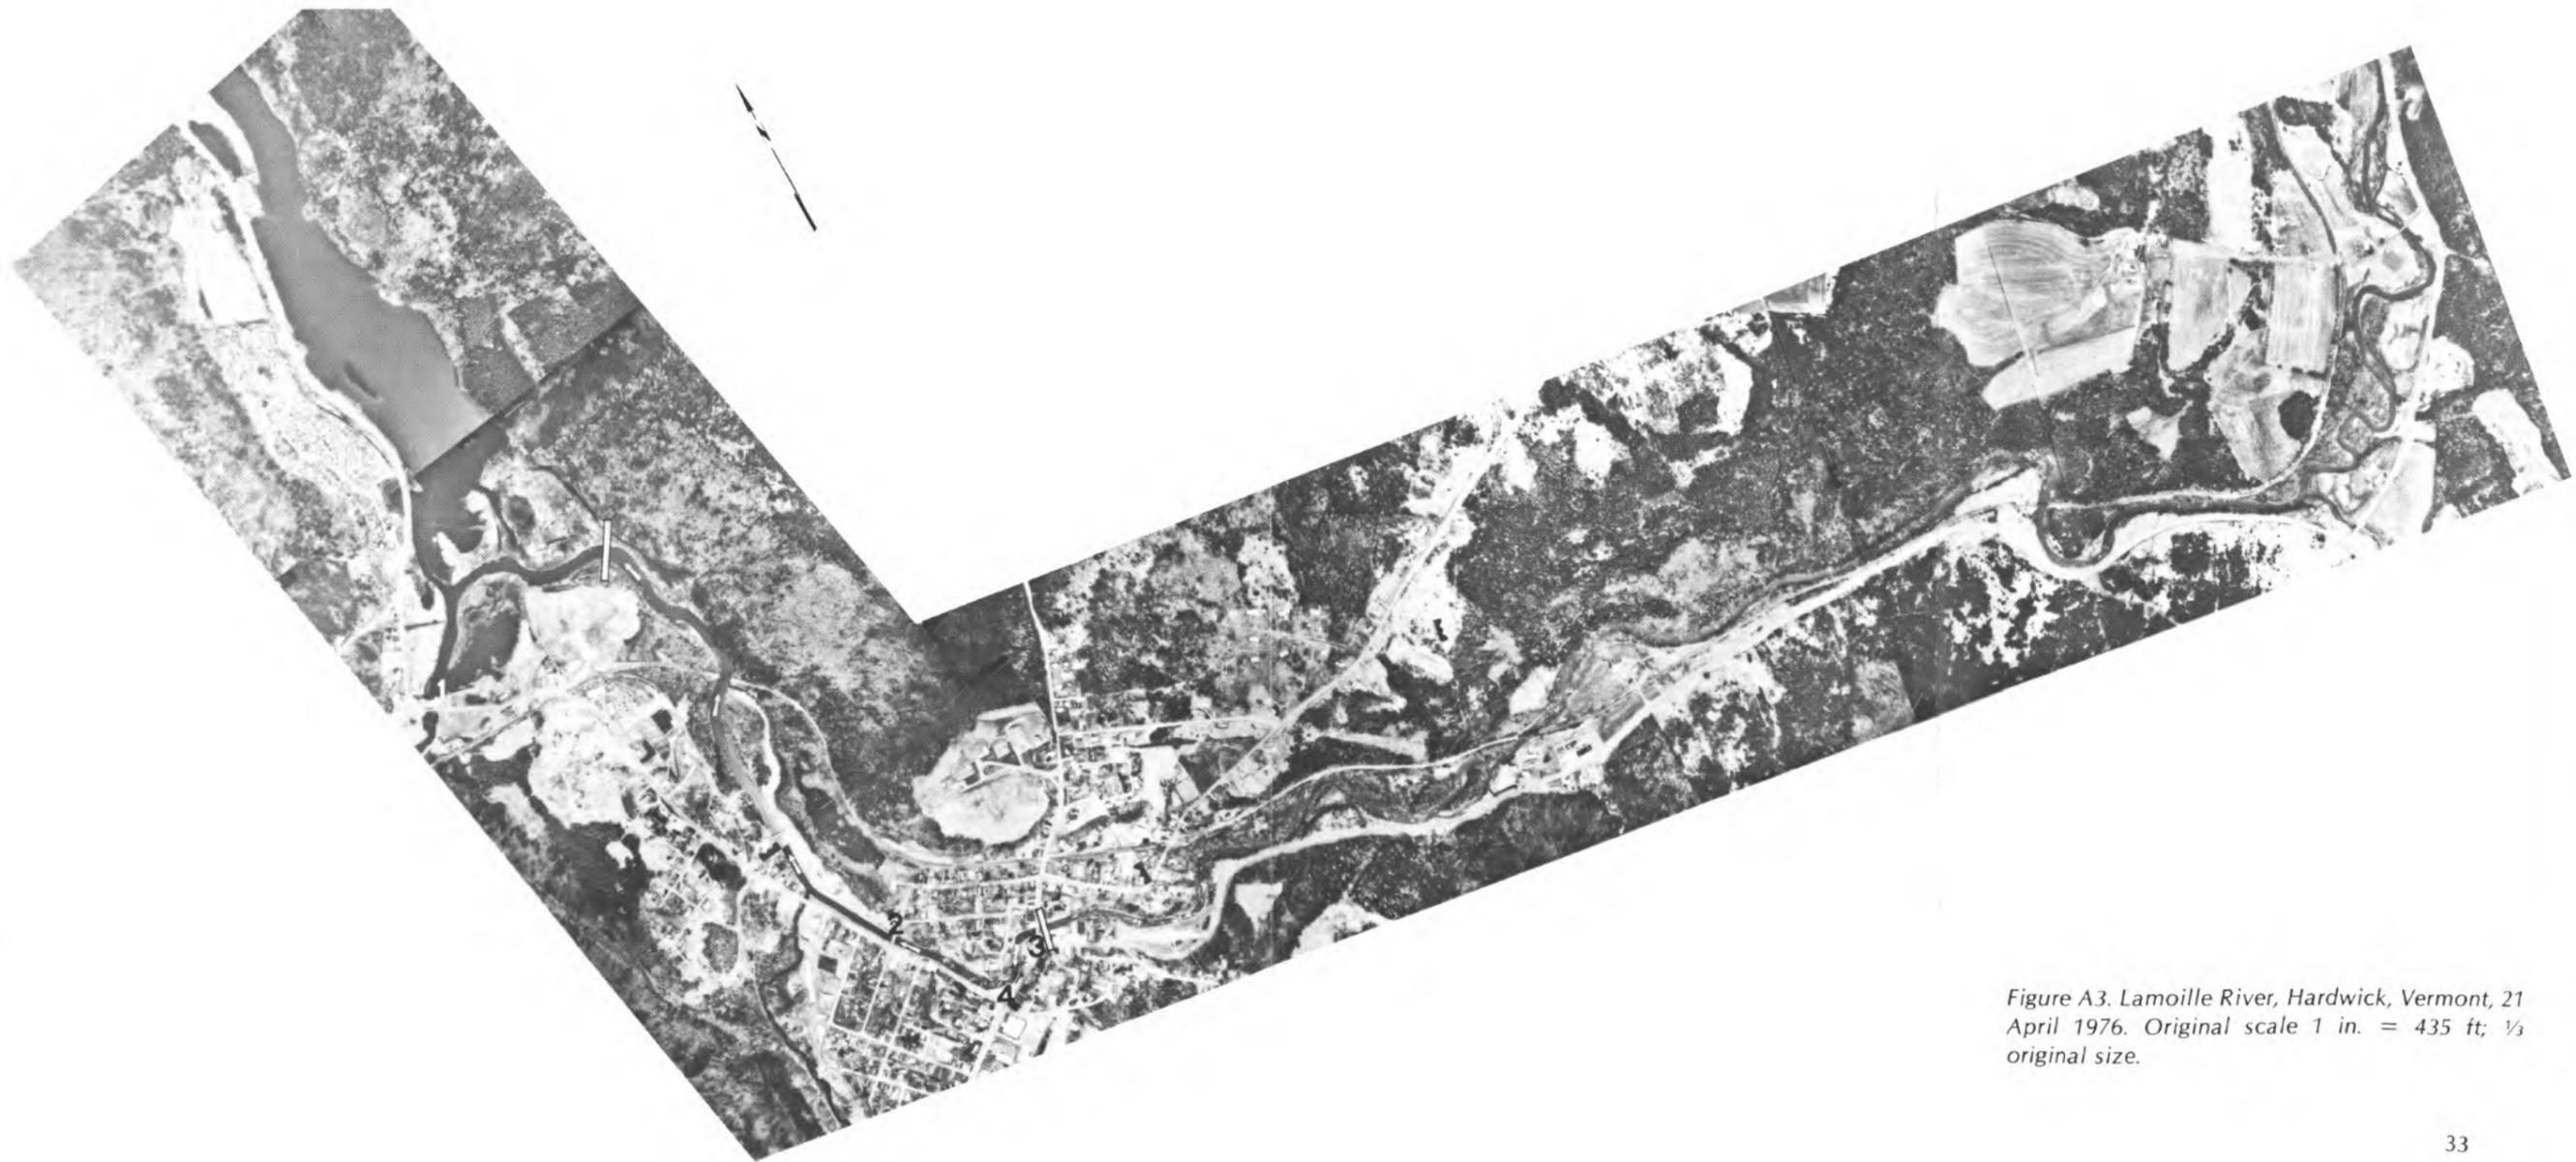
Figure A3. Lamoille River, Hardwick, Vermont, 21 April 1976. Original scale 1 in. = 435 ft; $\frac{1}{3}$ original size.
