River channel characteristics at selected ice jam sites in Vermont

Lawrence W. Gatto

October 1978

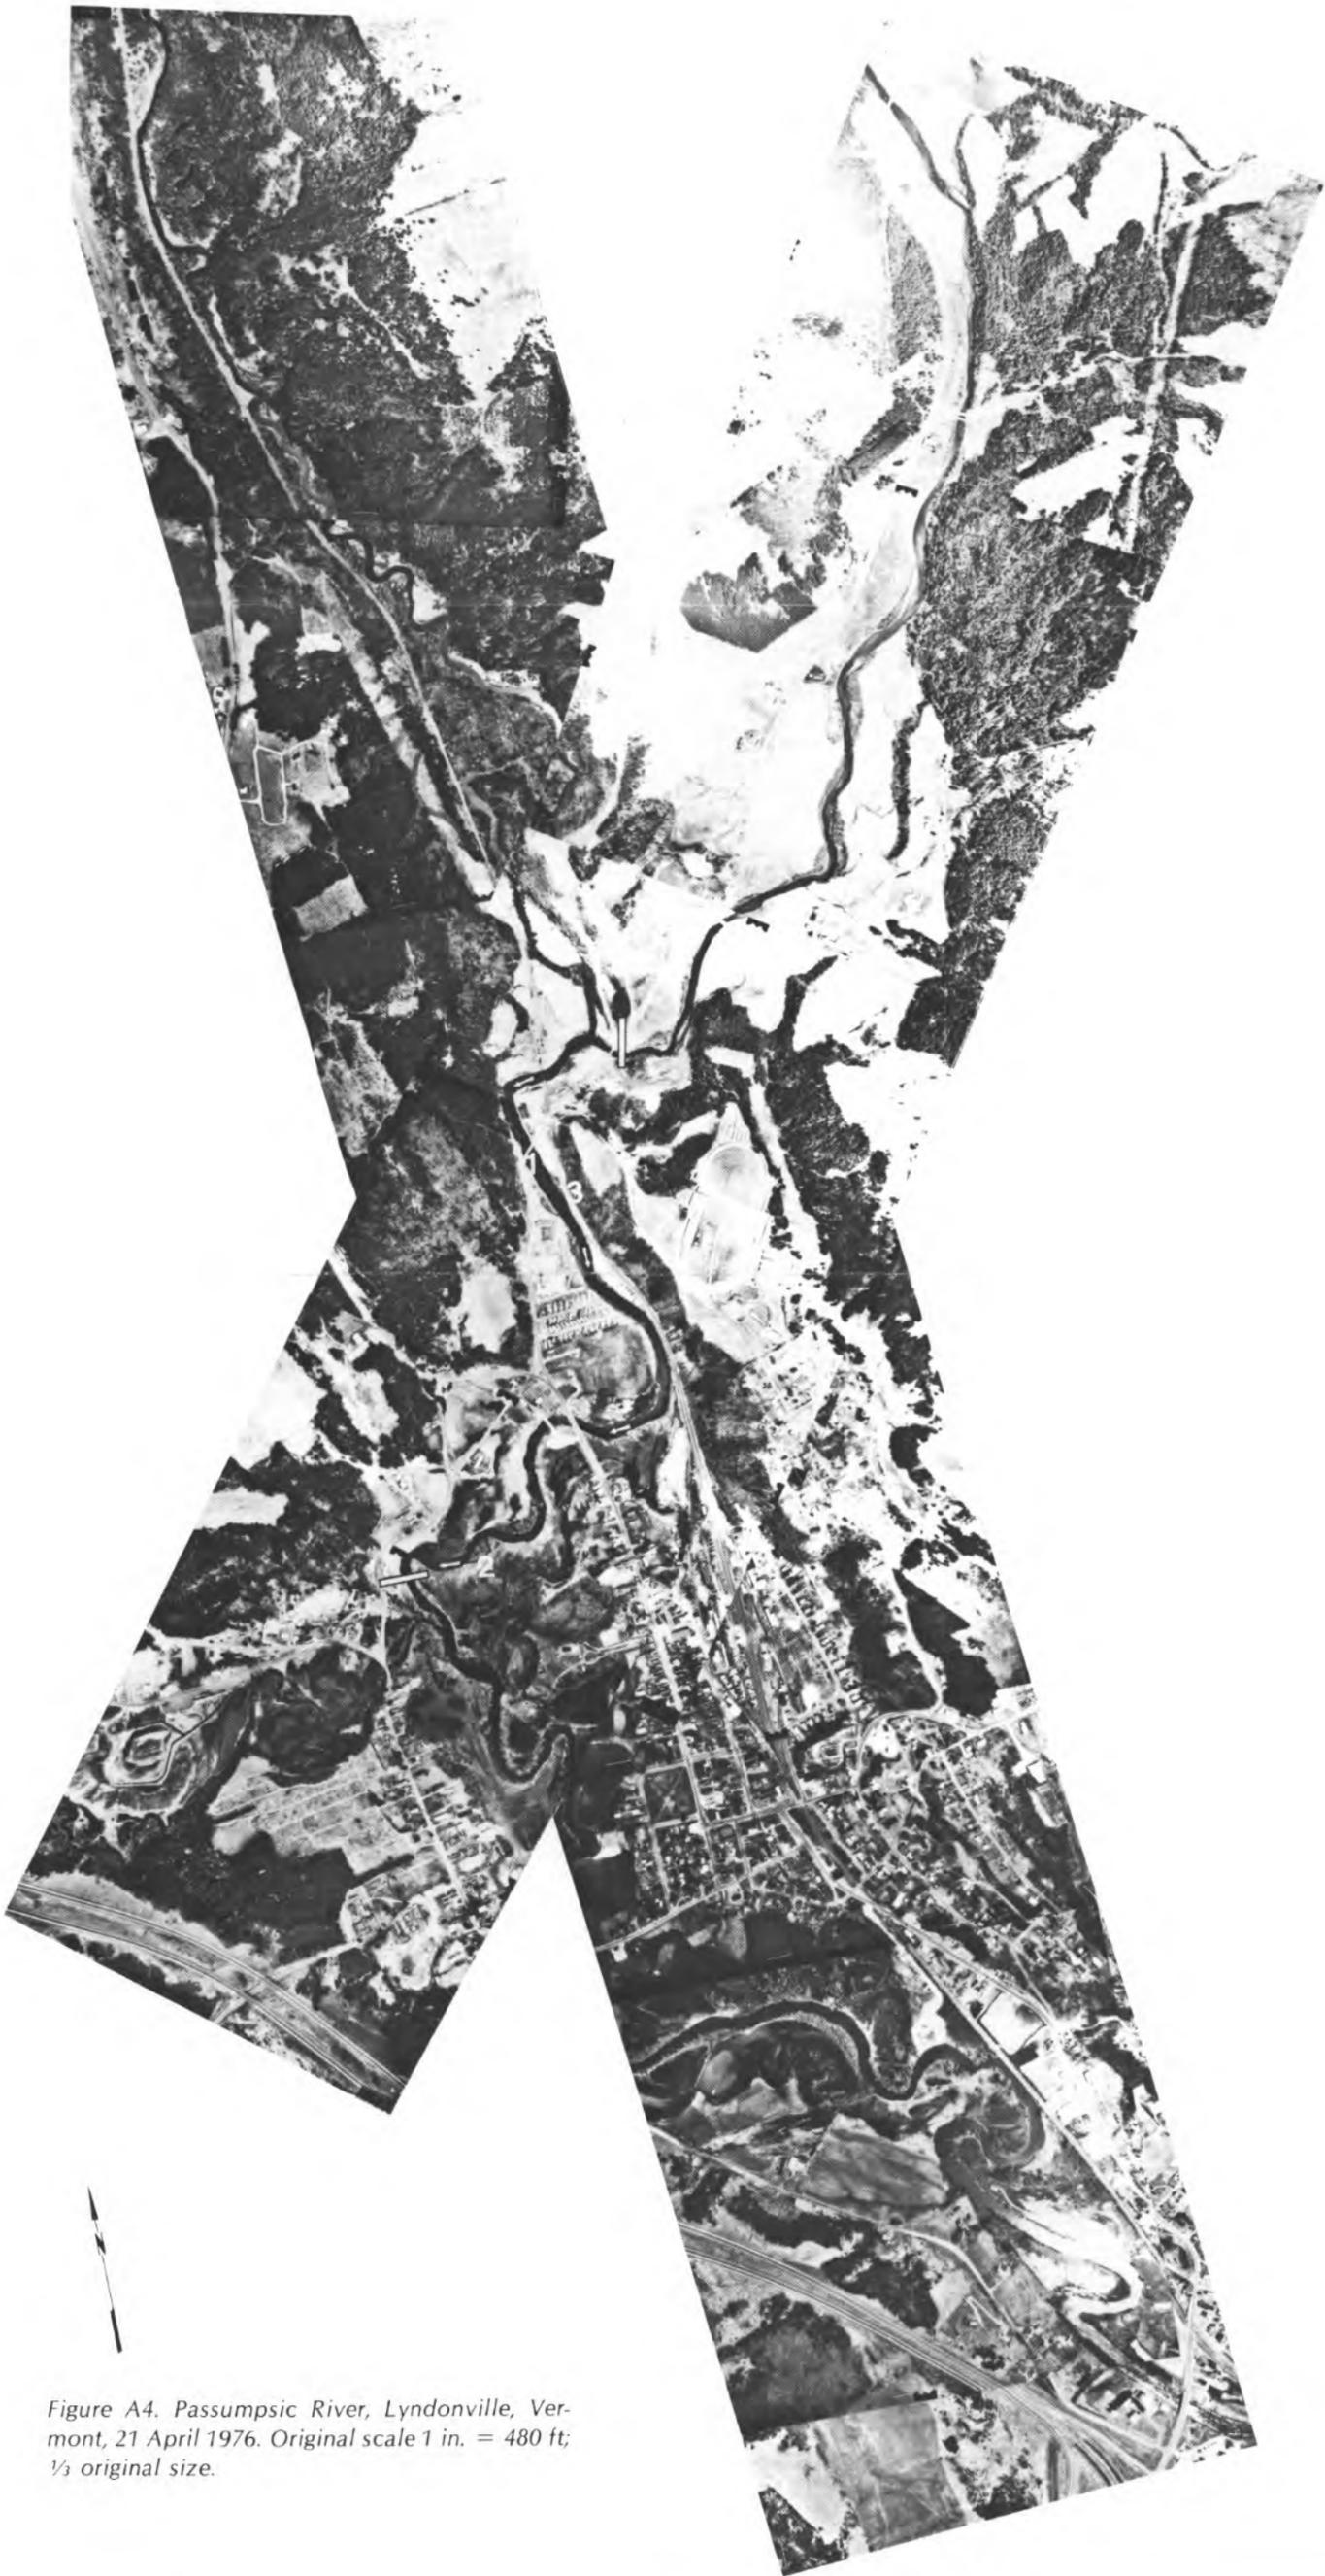
Figure A4. Passumpsic River, Lyndonville, Vermont, 21 April 1976. Original scale 1 in. = 480 ft; $\frac{1}{3}$ original size.

Ice jams usually occur along the Passumpsic River north of Lyndonville. The water surface appears smooth and the water appears deep throughout the reach. Small mid-channel bars are apparent and Frankenstein (personal communication, 1976) has observed a mid-channel bar in this reach. Meander bars are absent or small. Trees and brush occur in patches along the southern and northern portions, and border the entire central portion of the channel. The

floodplain width is variable, 400 ft near point (3) and nearly 4000 ft at the southern end across the north side of Lyndonville. Five bridges cross the river, three near meanders; bridge piers are visible at the middle bridge only. It is likely that the combined effects of a mild gradient and sharp meanders that restrict passage of flowing ice initiate local jamming. Calkins (personal communication, 1976) feels that the slope change along this reach is the major factor. However, indicators of this change are not apparent on the photomosaics; this points out the need for field verification and ground-truth data collection surveys as an integral part of further investigations using photointerpretation techniques.

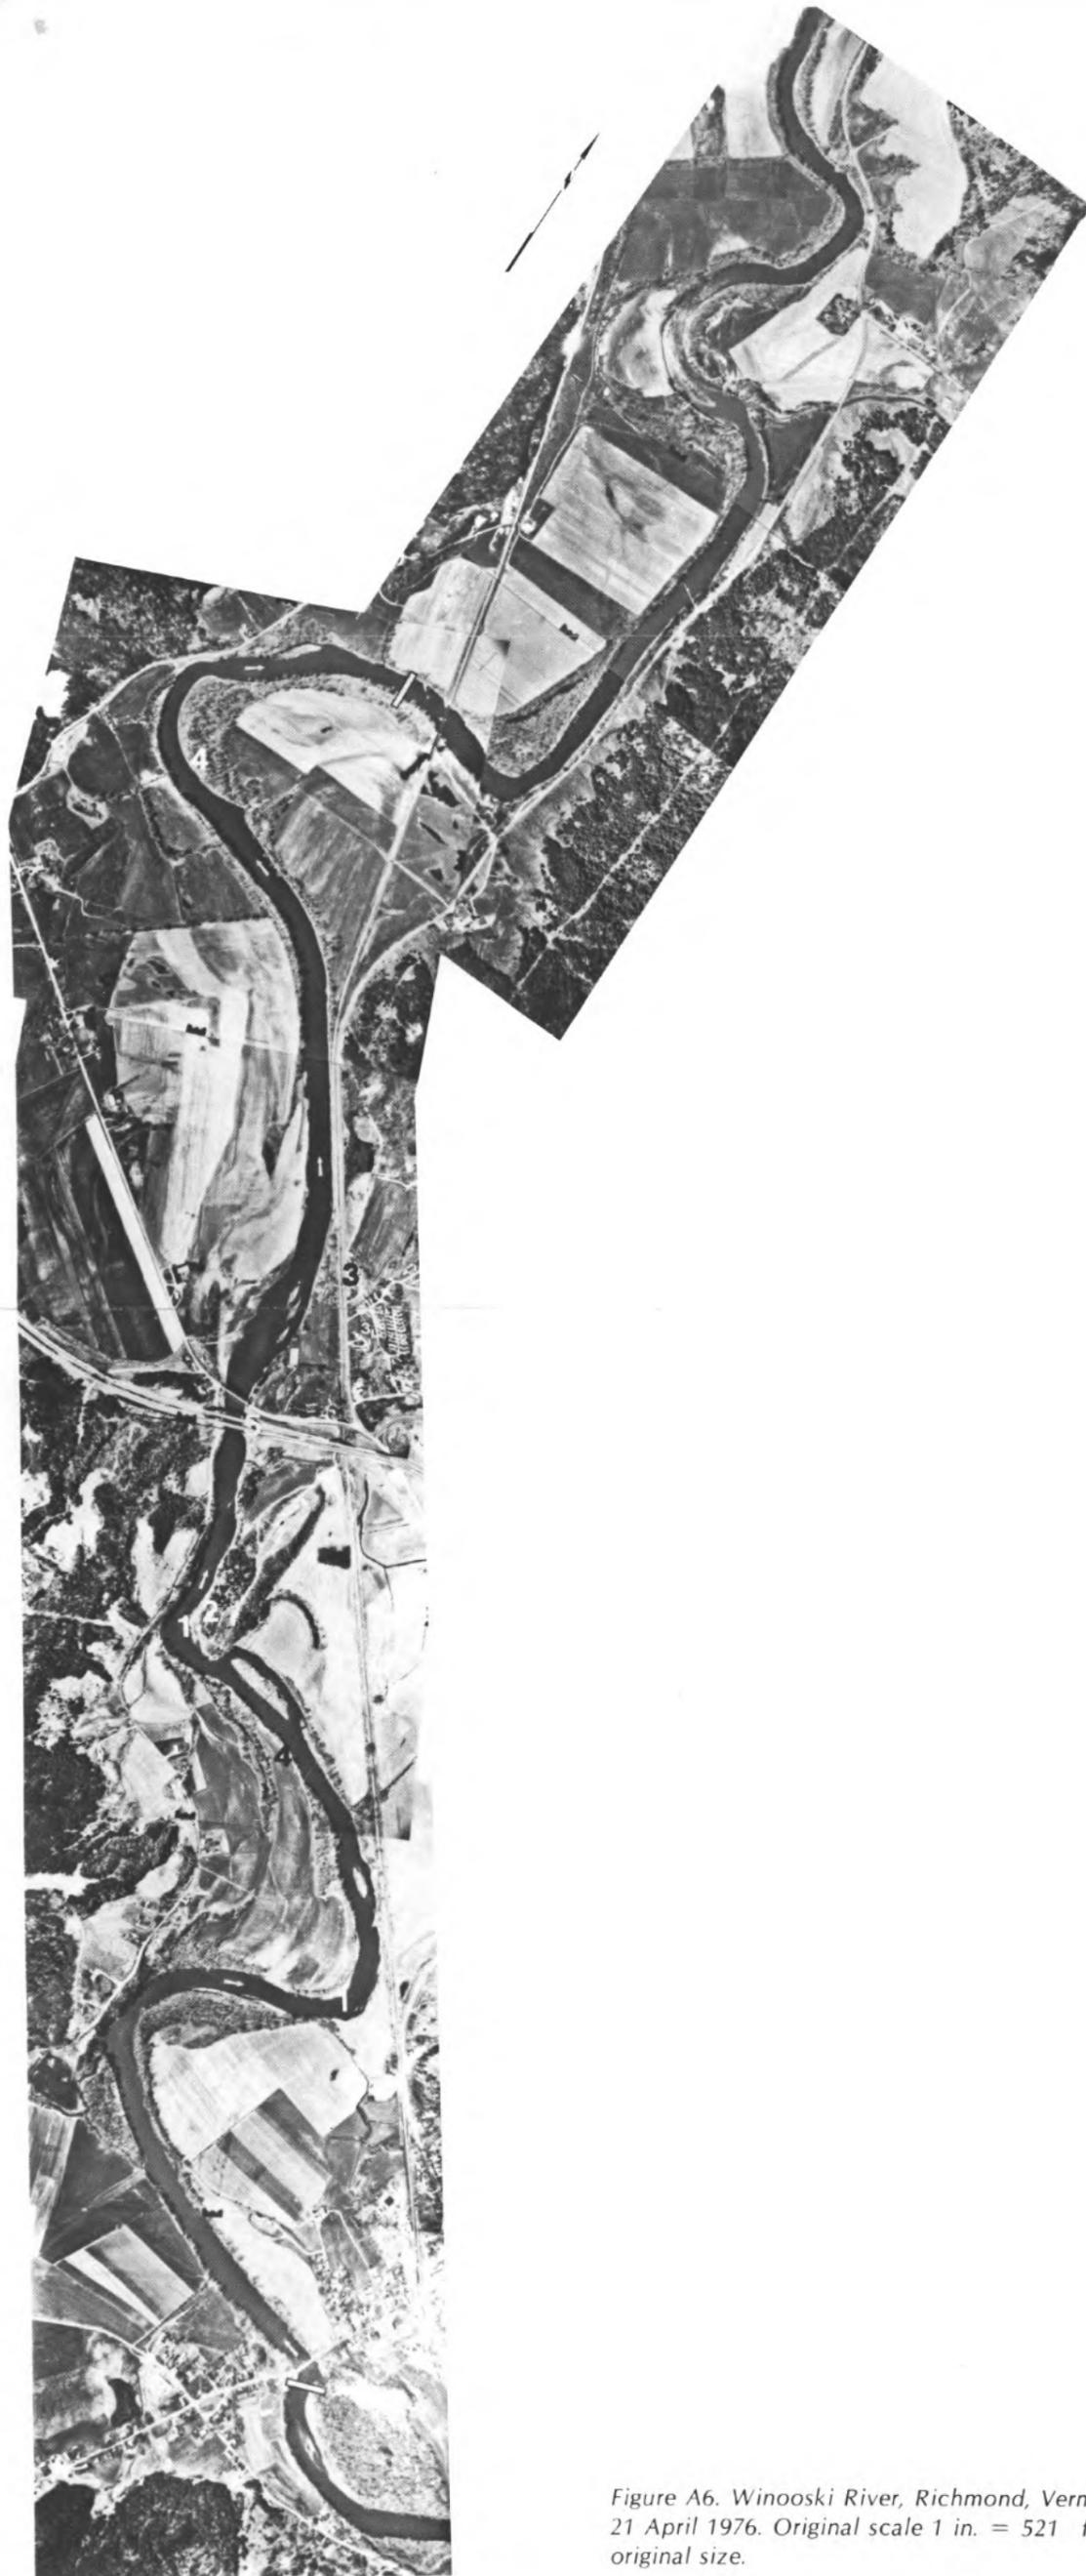
Figure A6. Winooski River, Richmond, Vermont, 21 April 1976. Original scale 1 in. = 521 ft; ¼ original size.

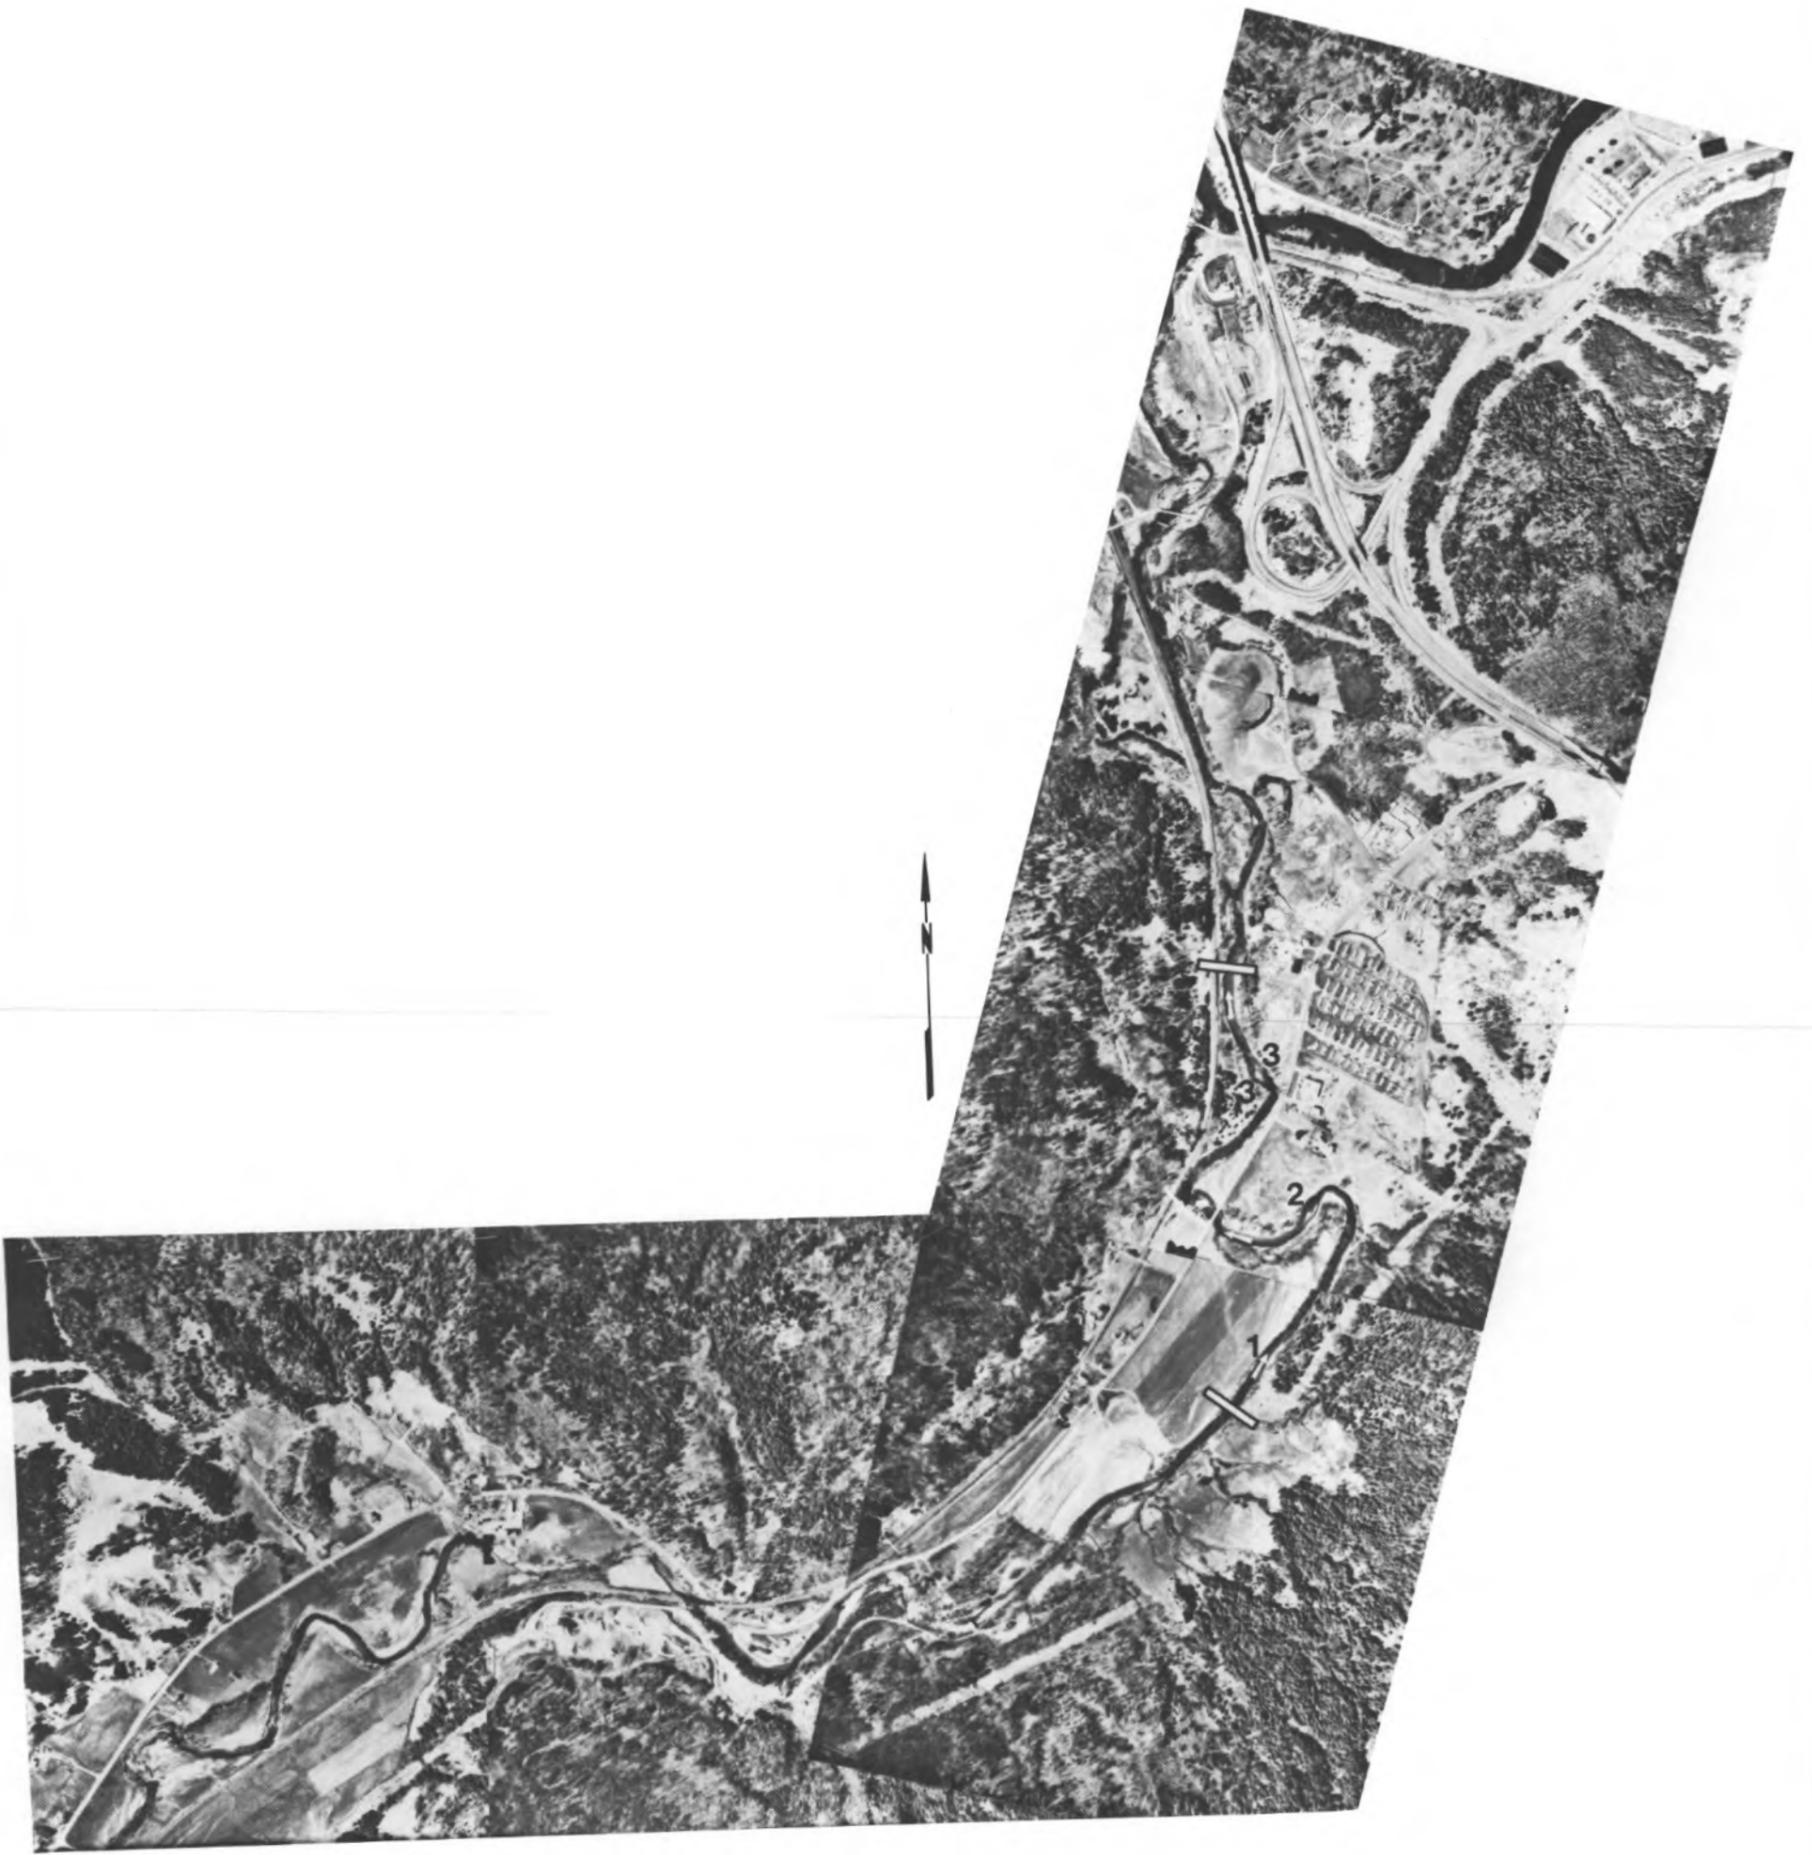
Figure A8. Dog River, Montpelier, Vermont, 21 April 1976. Original scale 1 in. = 556 ft; $\frac{2}{3}$, original size.

The site along the Dog River is approximately 1.5 miles southwest of Montpelier. The channel slope appears to be uniform, and riffles are more prominent than pools. There appears to be riprap just east of point 2 on the outside of the sharp meander. The channel widths are variable (70 ft at point 1, 100 ft at 2, 150 ft at 3); they are generally widest near mid-channel bars, and narrowest along meanders. The sharp meanders, mid-channel bars and associated shallows probably cause the ice jams. Calkins (personal communication, 1976) suggested that the local change in slope and the confluence with the Winooski River (north end of photomosaic) may also be important factors.

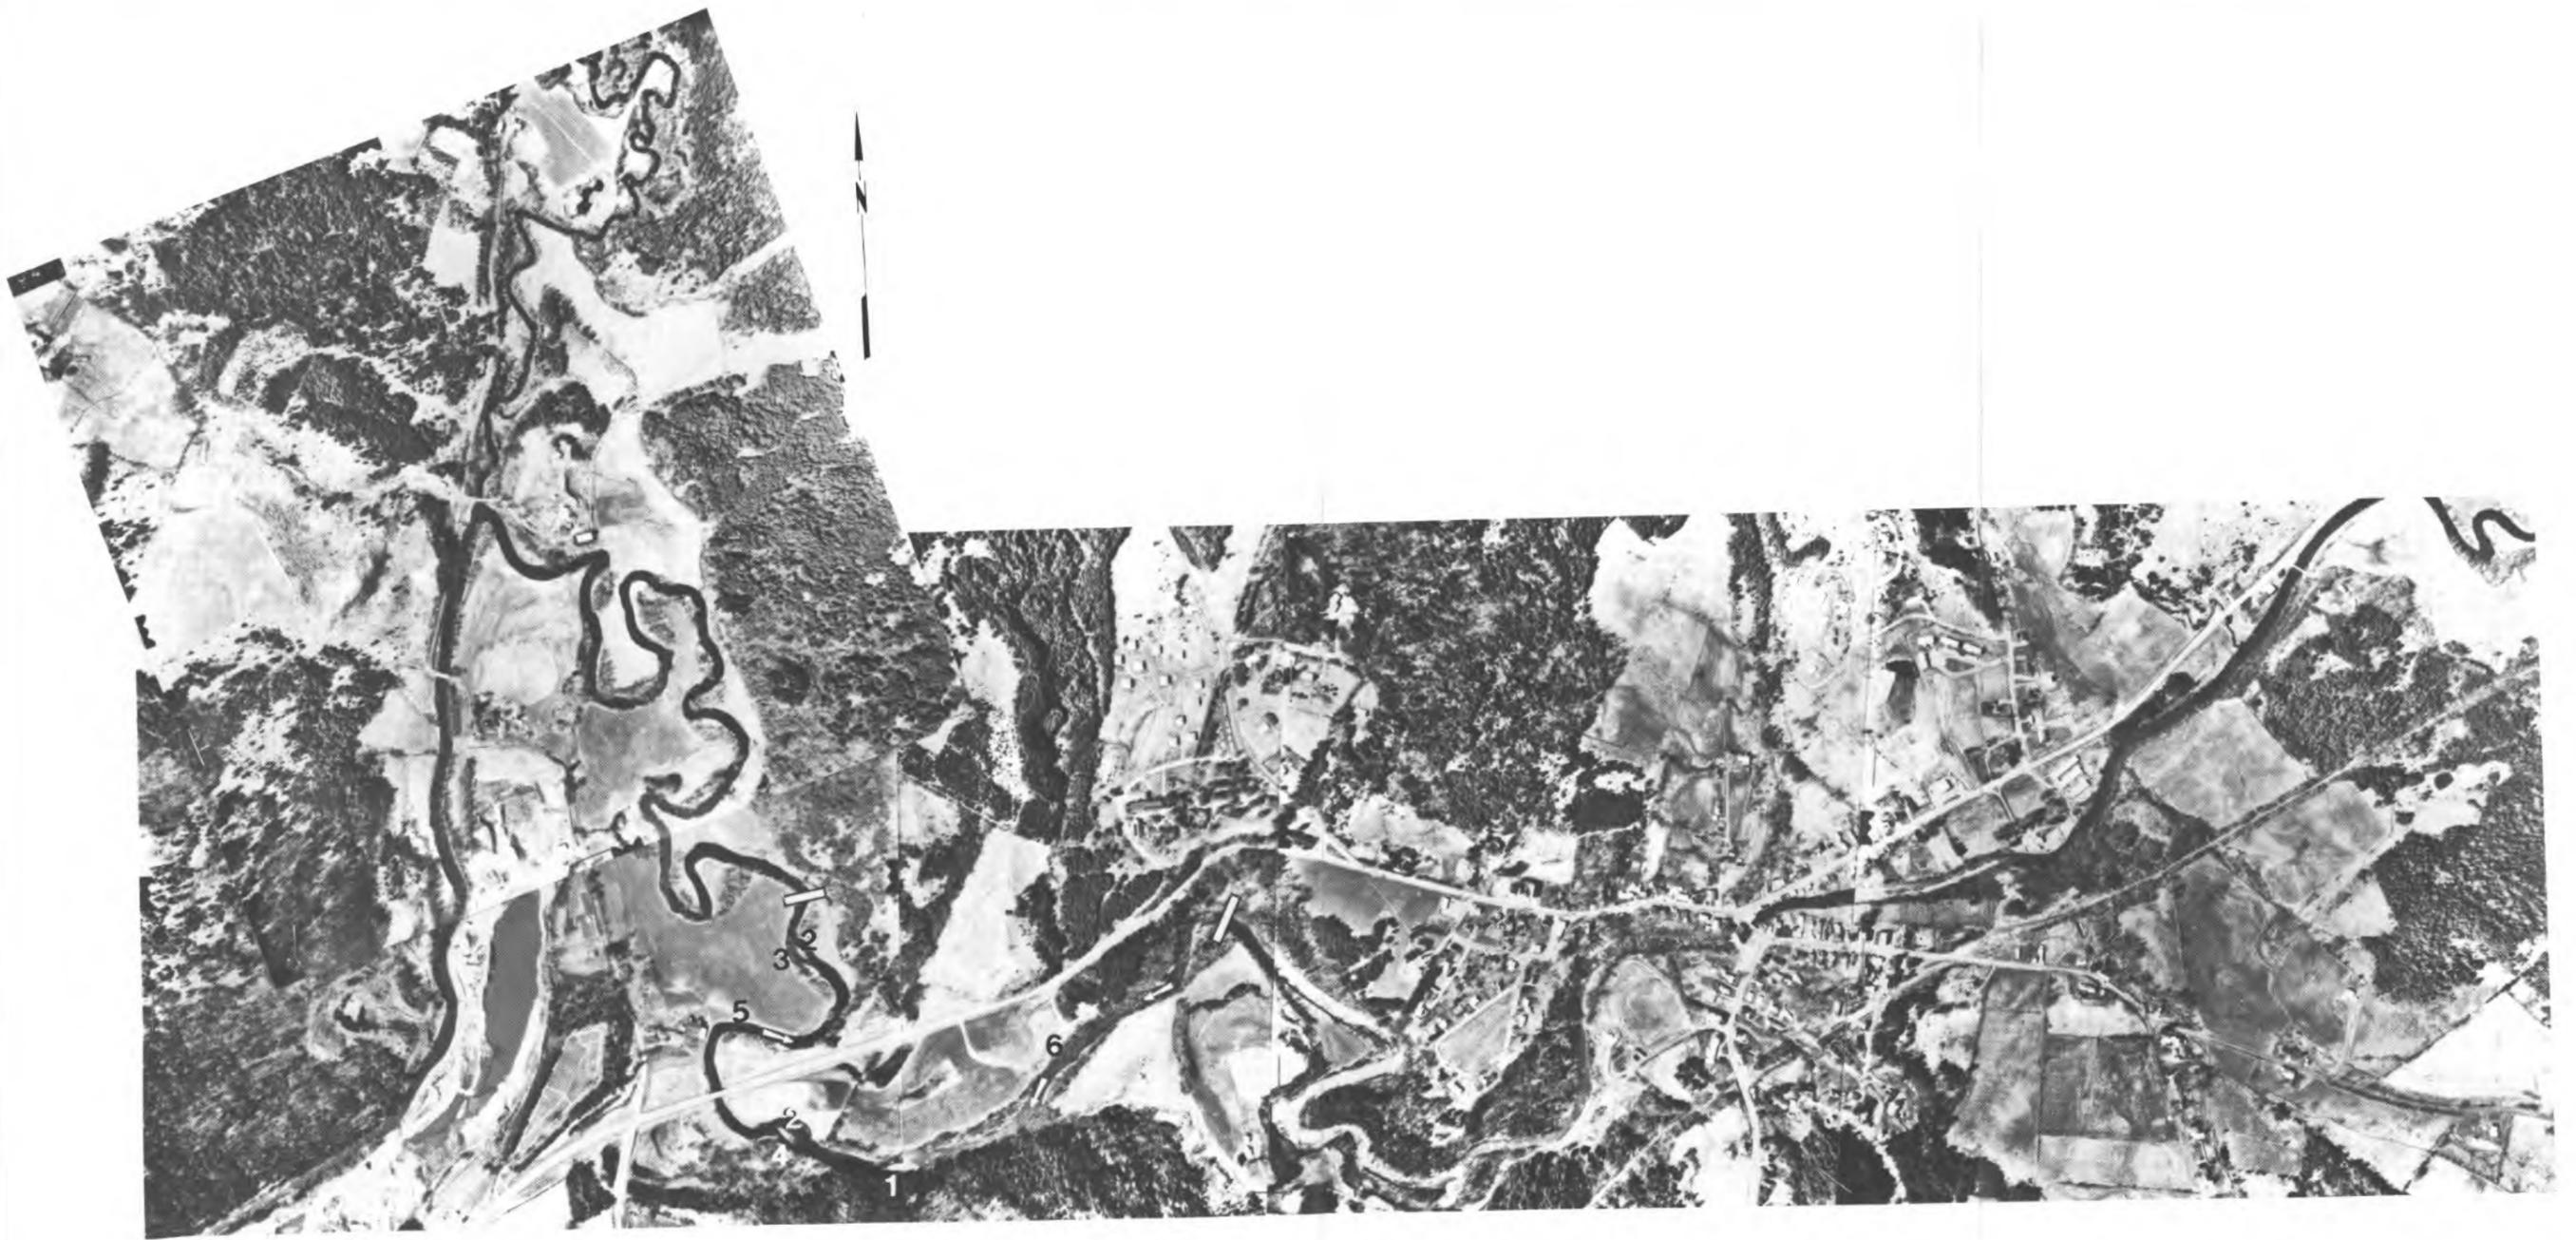
Figure A9. Winooski River, East Montpelier, Vermont, 21 April 1976. Original scale 1 in. = 439 ft; $\frac{1}{2}$ original size.

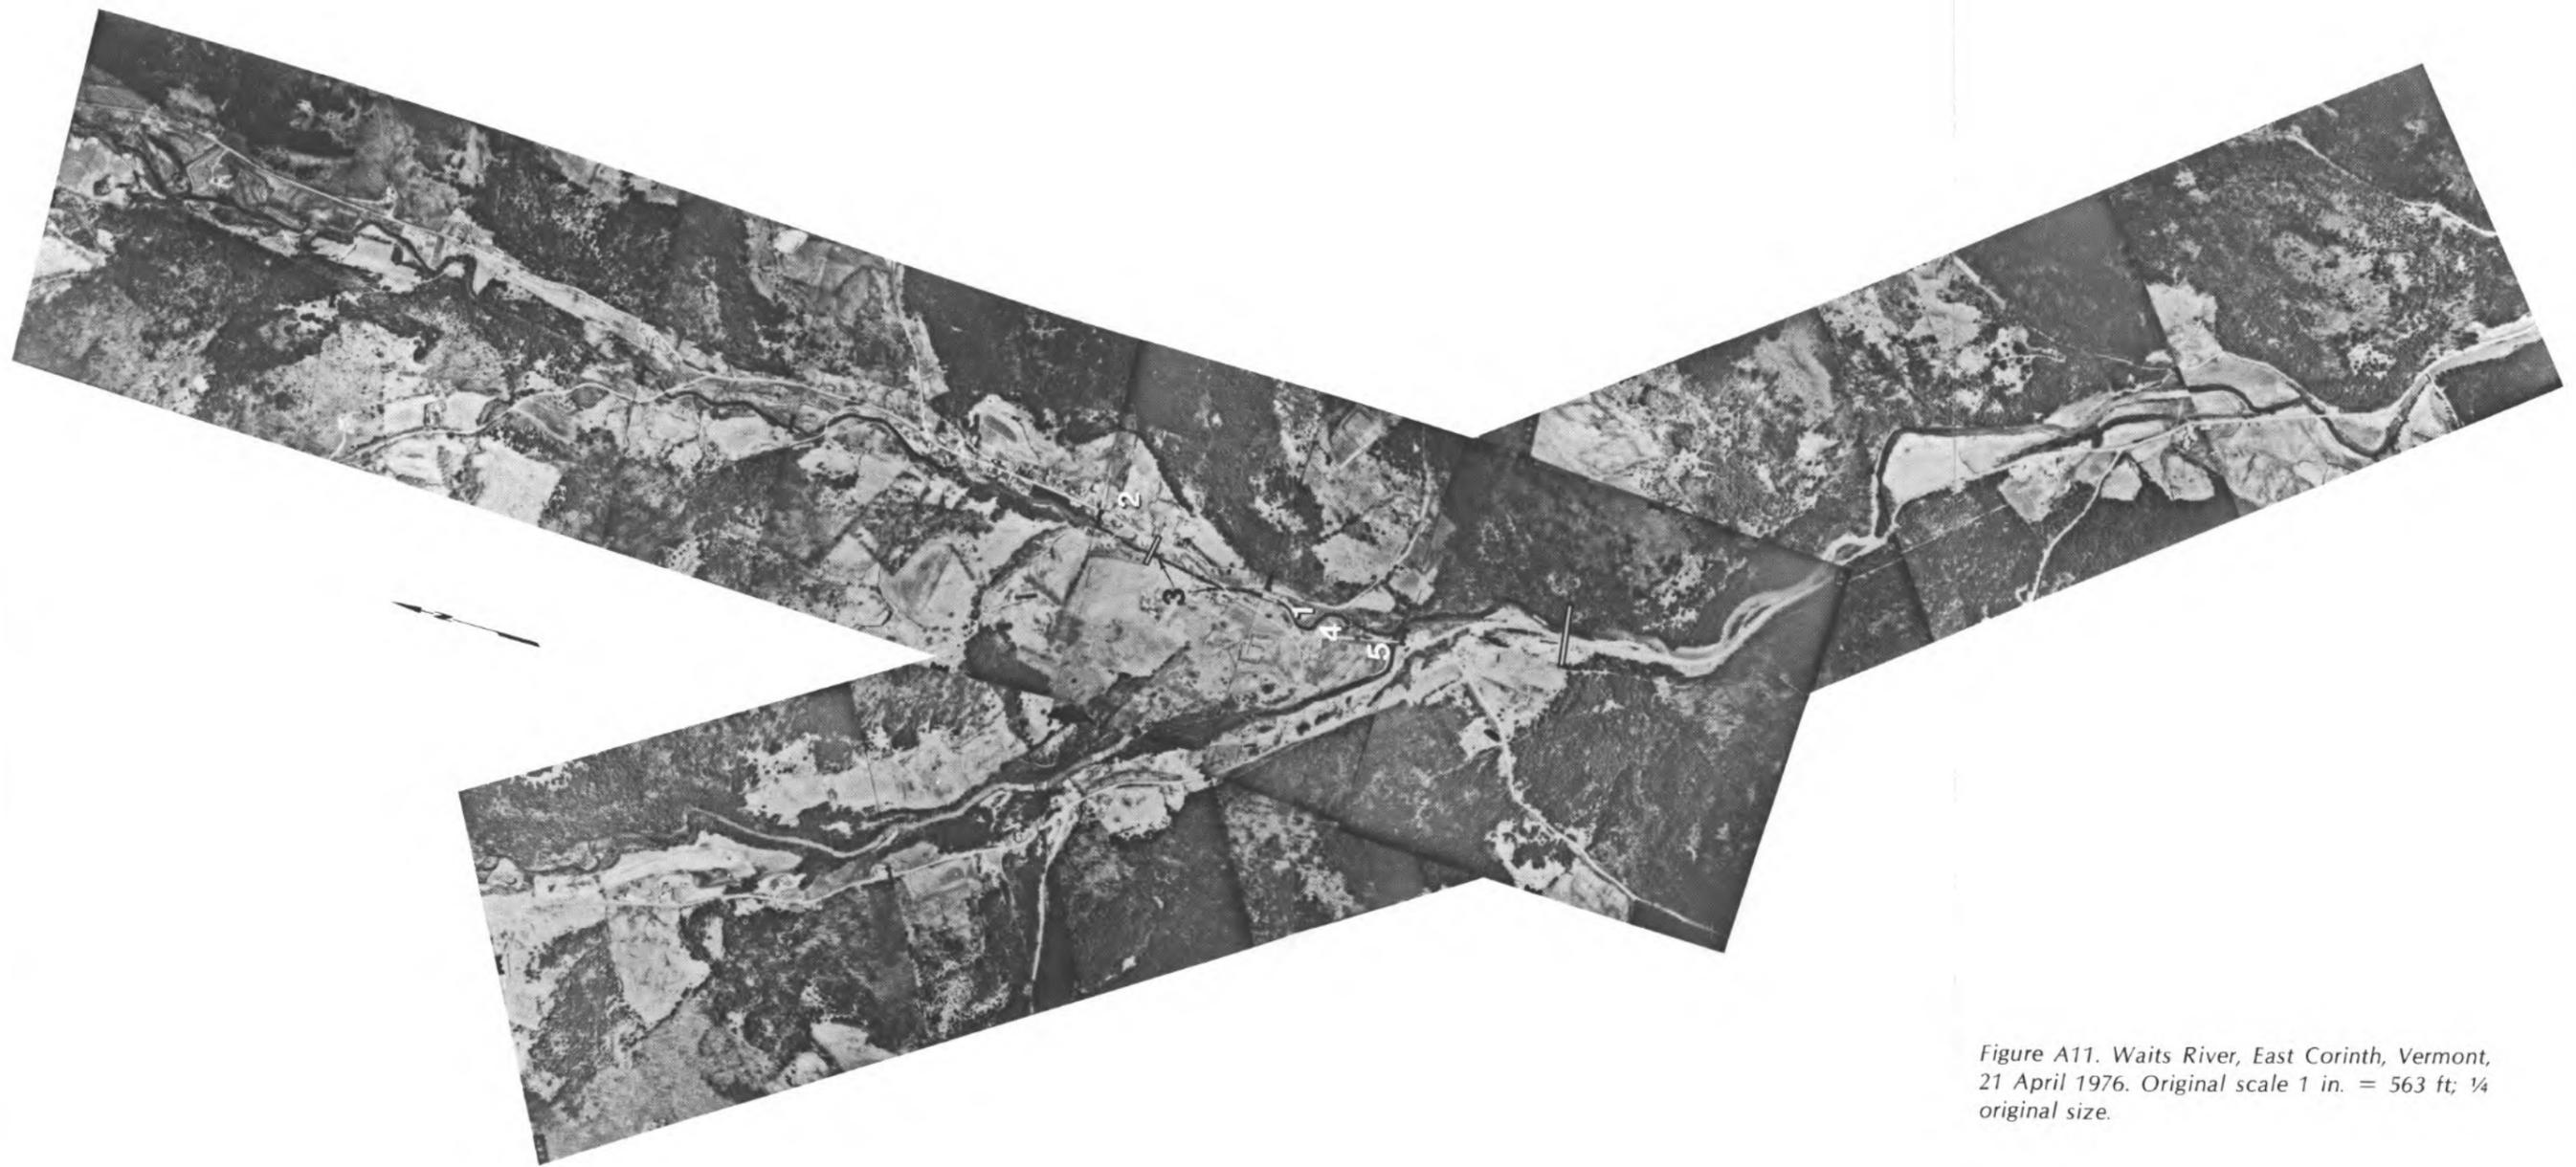
Figure A11. Waits River, East Corinth, Vermont, 21 April 1976. Original scale 1 in. = 563 ft; $\frac{1}{4}$ original size.

Ice jams typically occur at the confluence of the Waits River and Tabor Branch (1) near East Corinth (2). The channel is steepest along the Tabor Branch, and it is shallow. Pools along the Waits River portion are usually small and not too deep. The channel widths along the Tabor Branch vary from approximately 30 to 50 ft, and widths increase to 75 to 110 ft along the Waits River. Ice jams have formed along the Waits River at the bridge (5) near the confluence and have caused ice flowing down the Tabor Branch to stabilize and back up the Tabor.

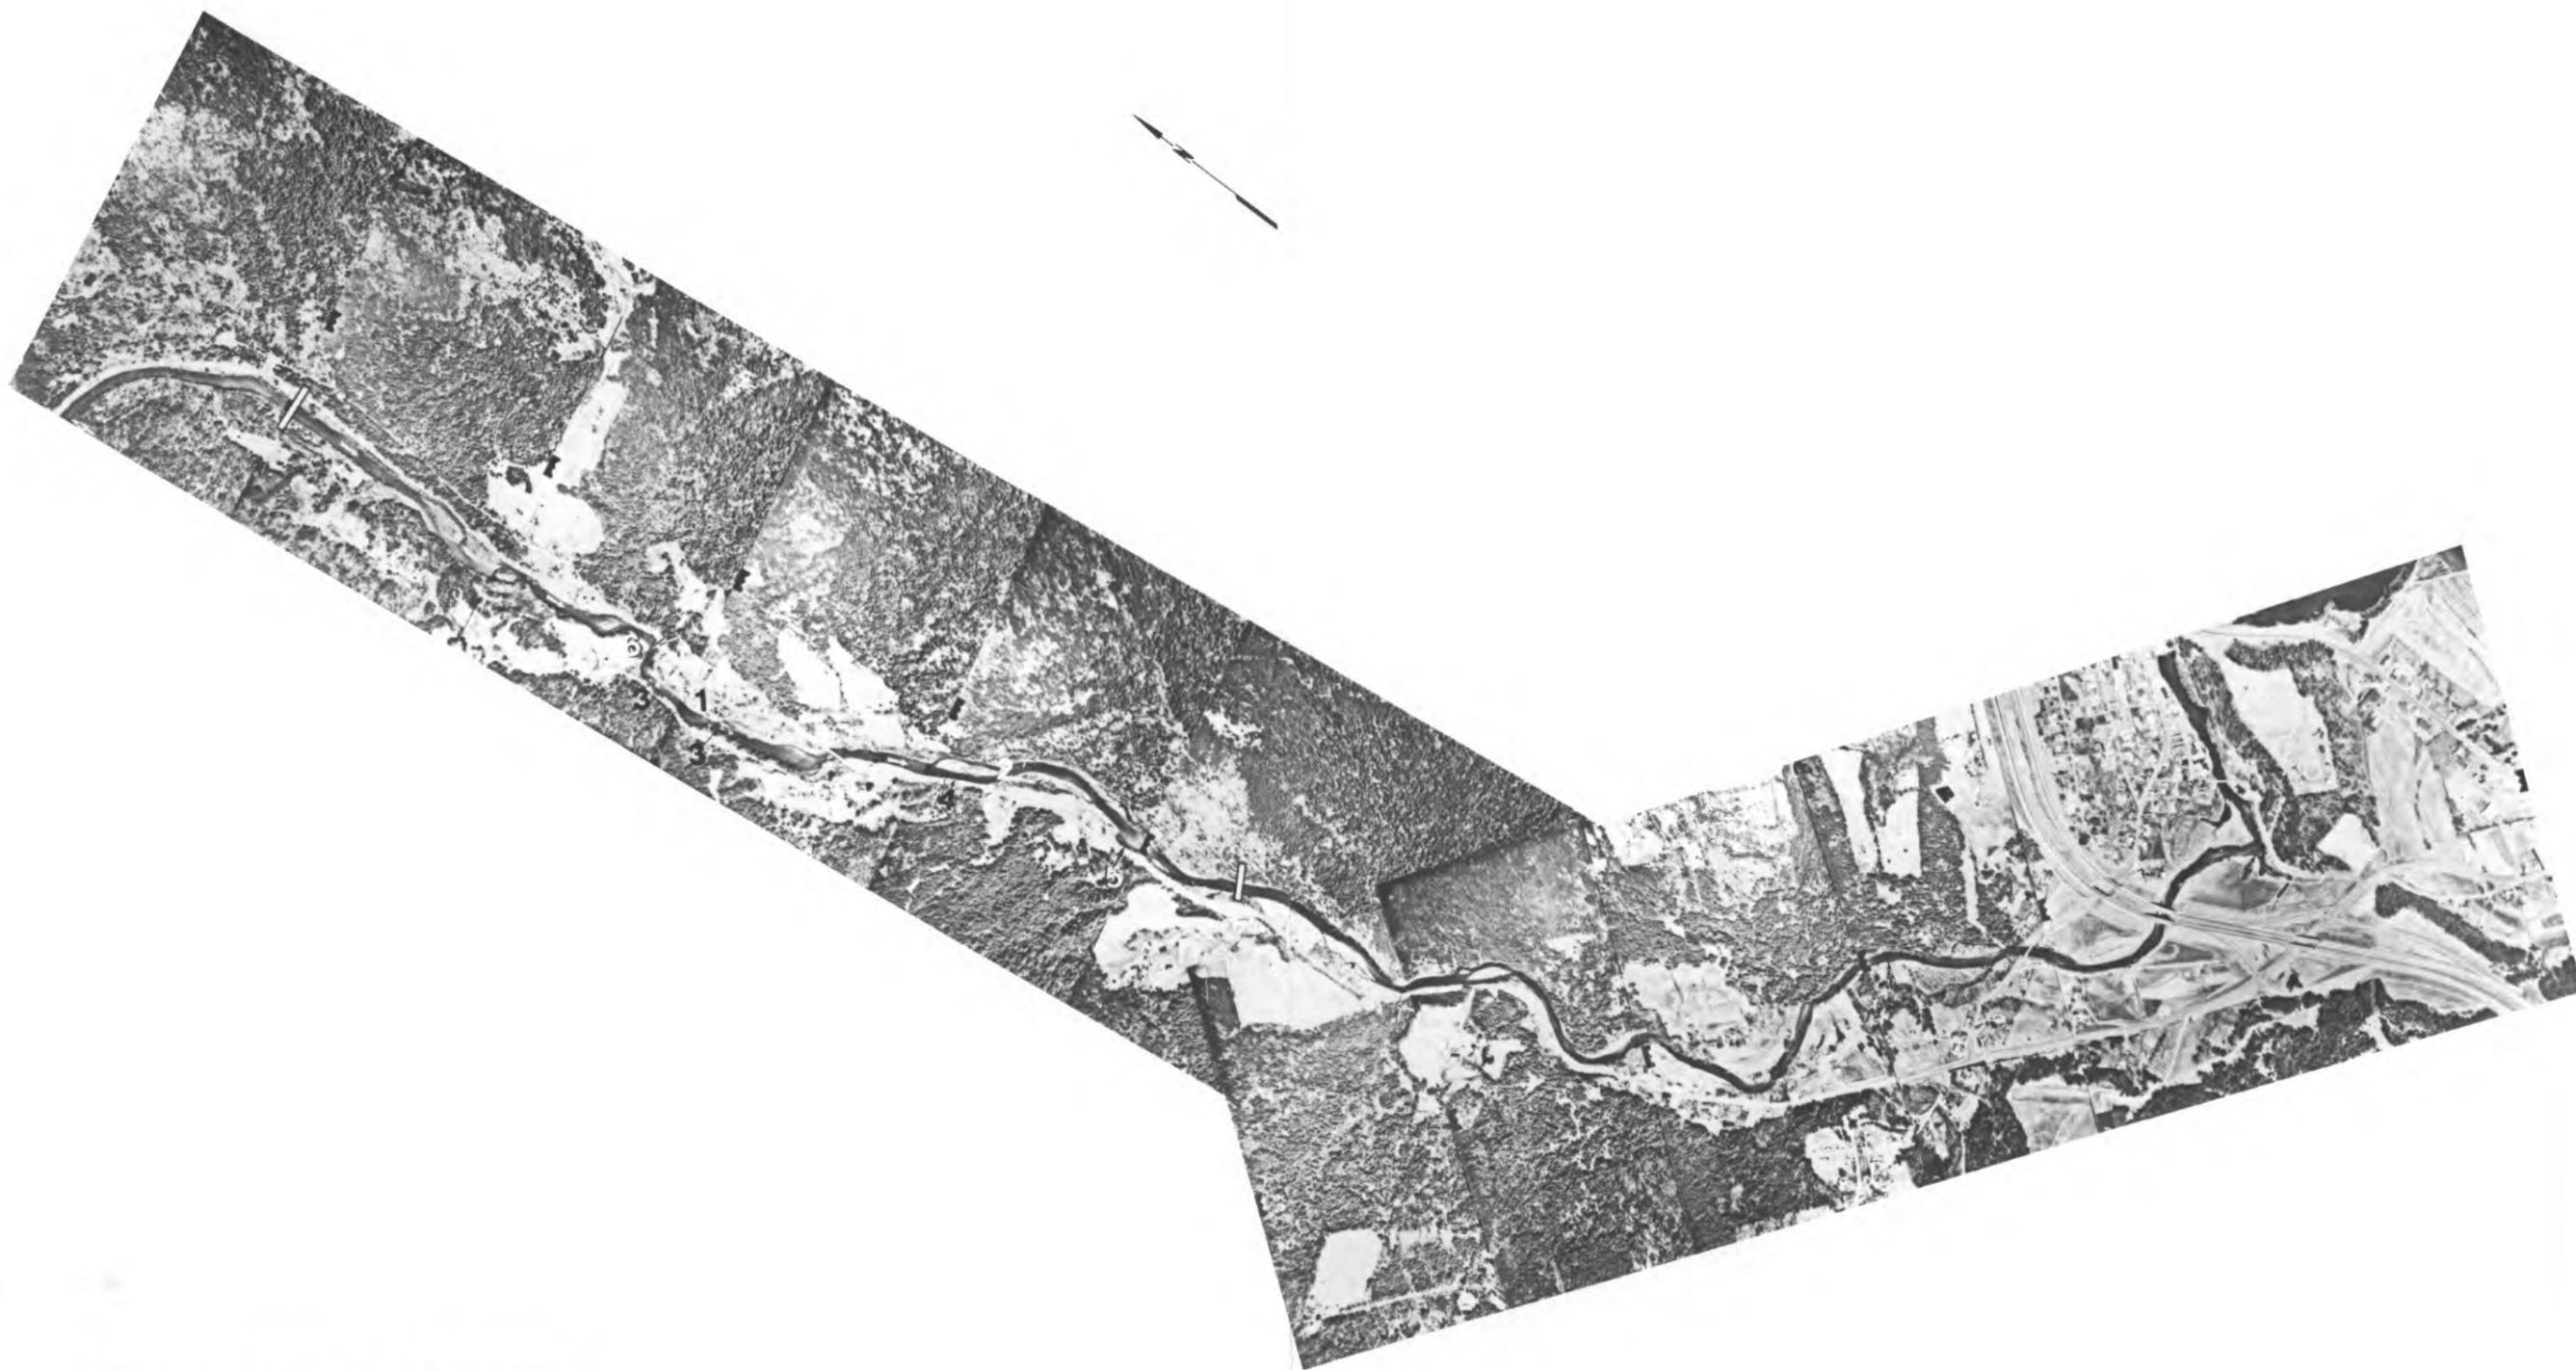
Figure A12-13. Waits River, Bradford, Vermont, 19 April 1976. Original scale 1 in. = 519 ft; $\frac{1}{3}$ original size.

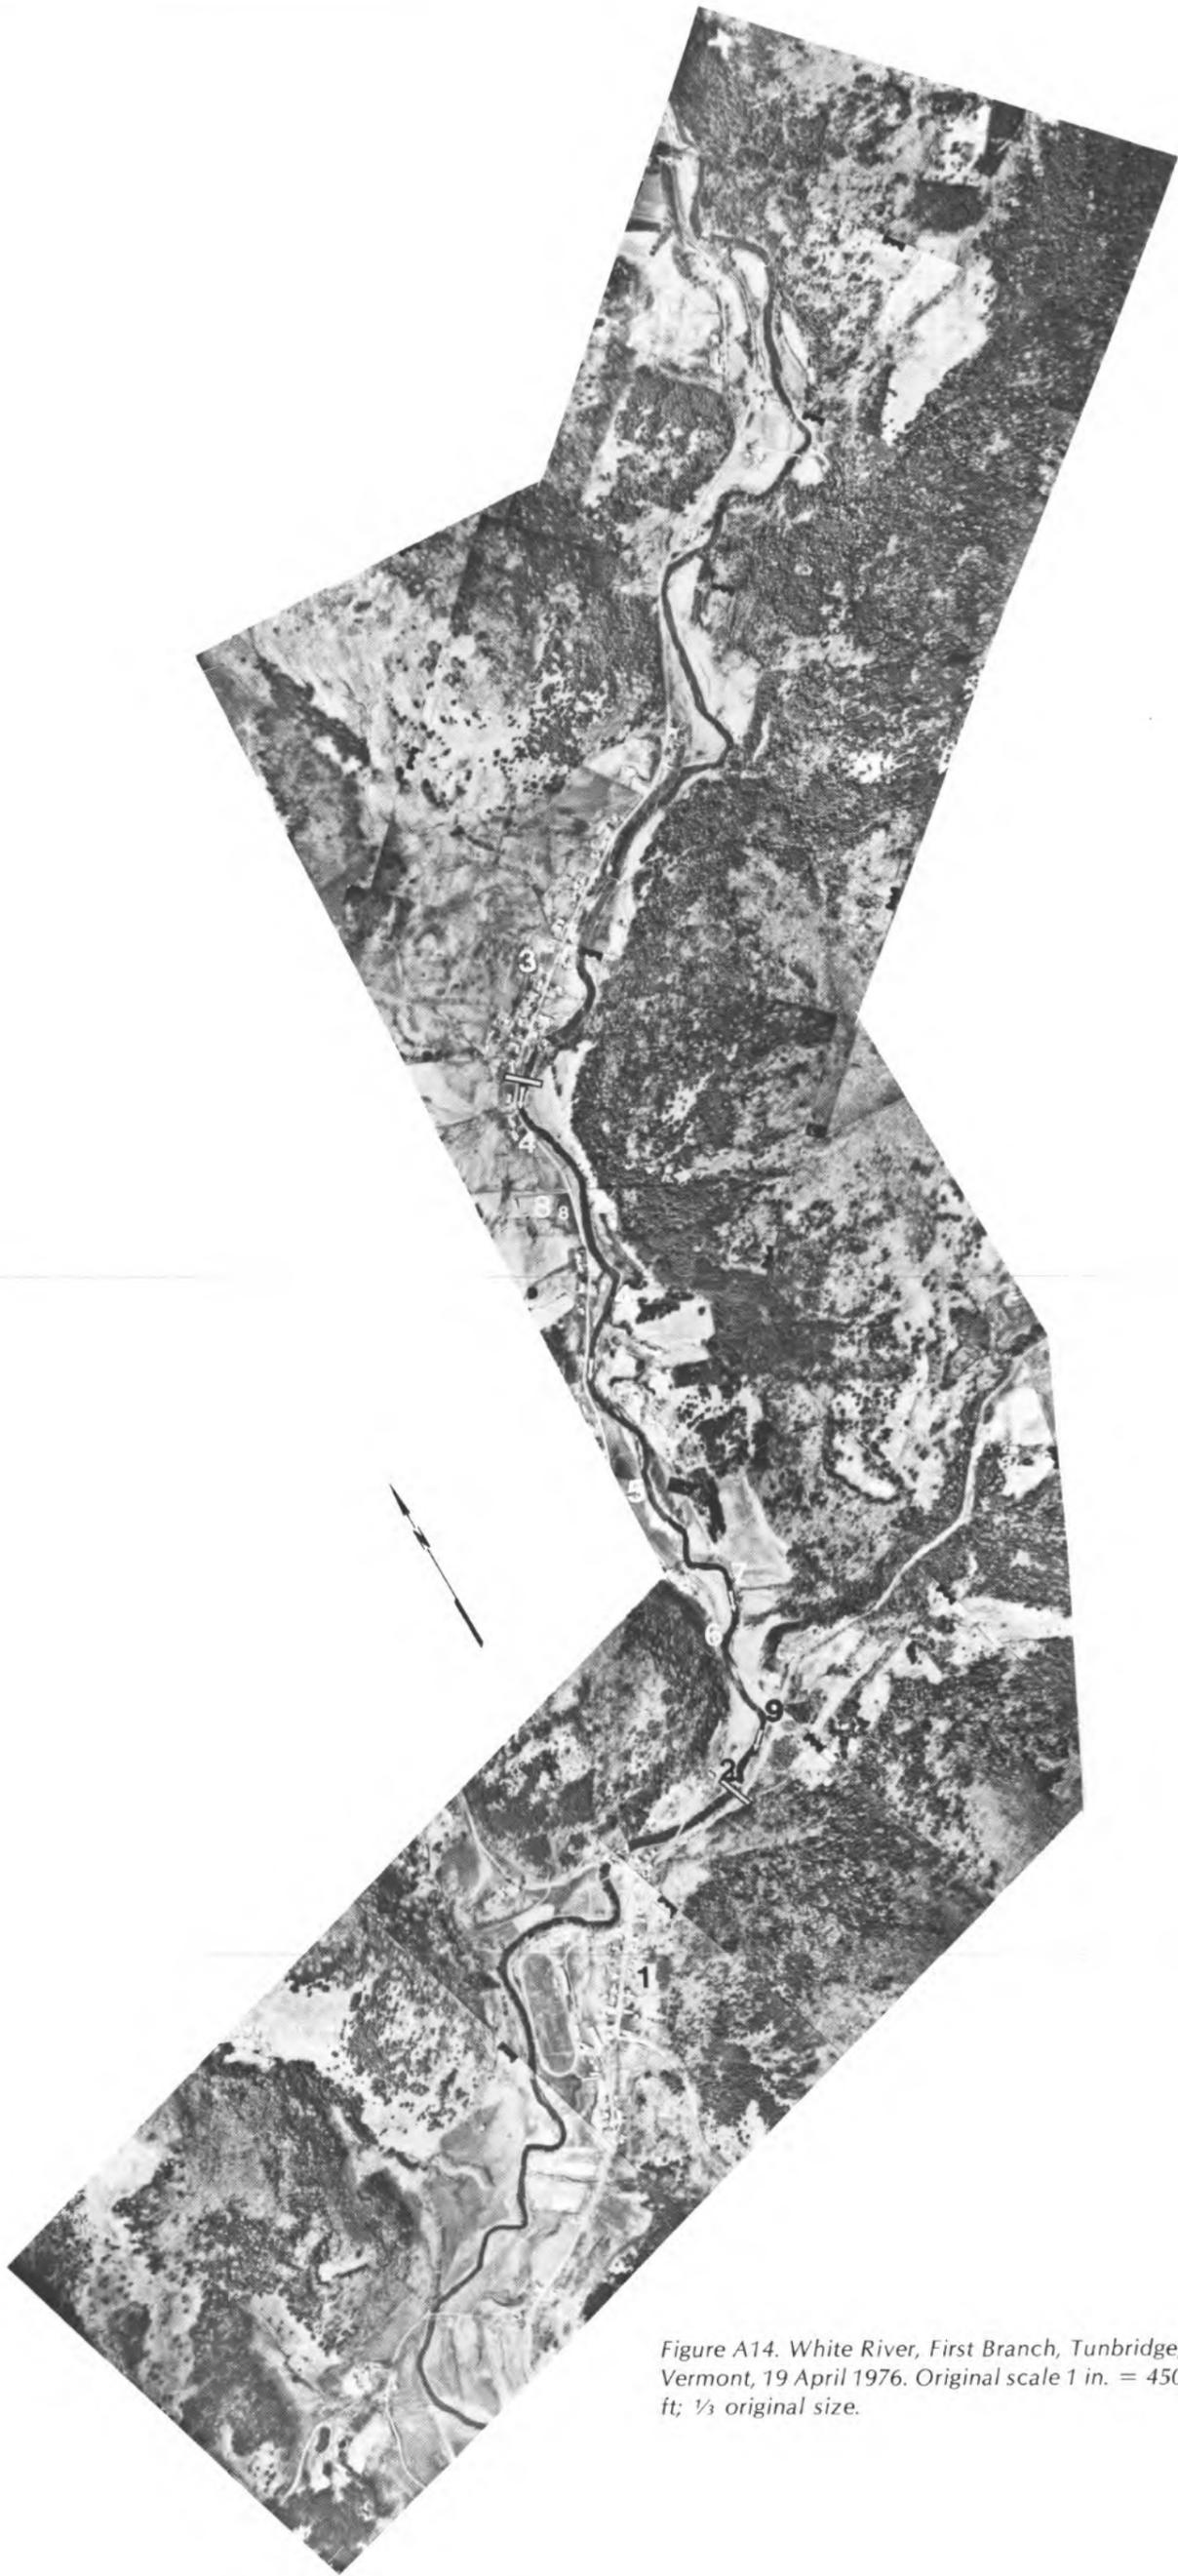
Figure A14. White River, First Branch, Tunbridge, Vermont, 19 April 1976. Original scale 1 in. = 450 ft; 1/3 original size.
