River channel characteristics at selected ice jam sites in Vermont

Lawrence W. Gatto

October 1978

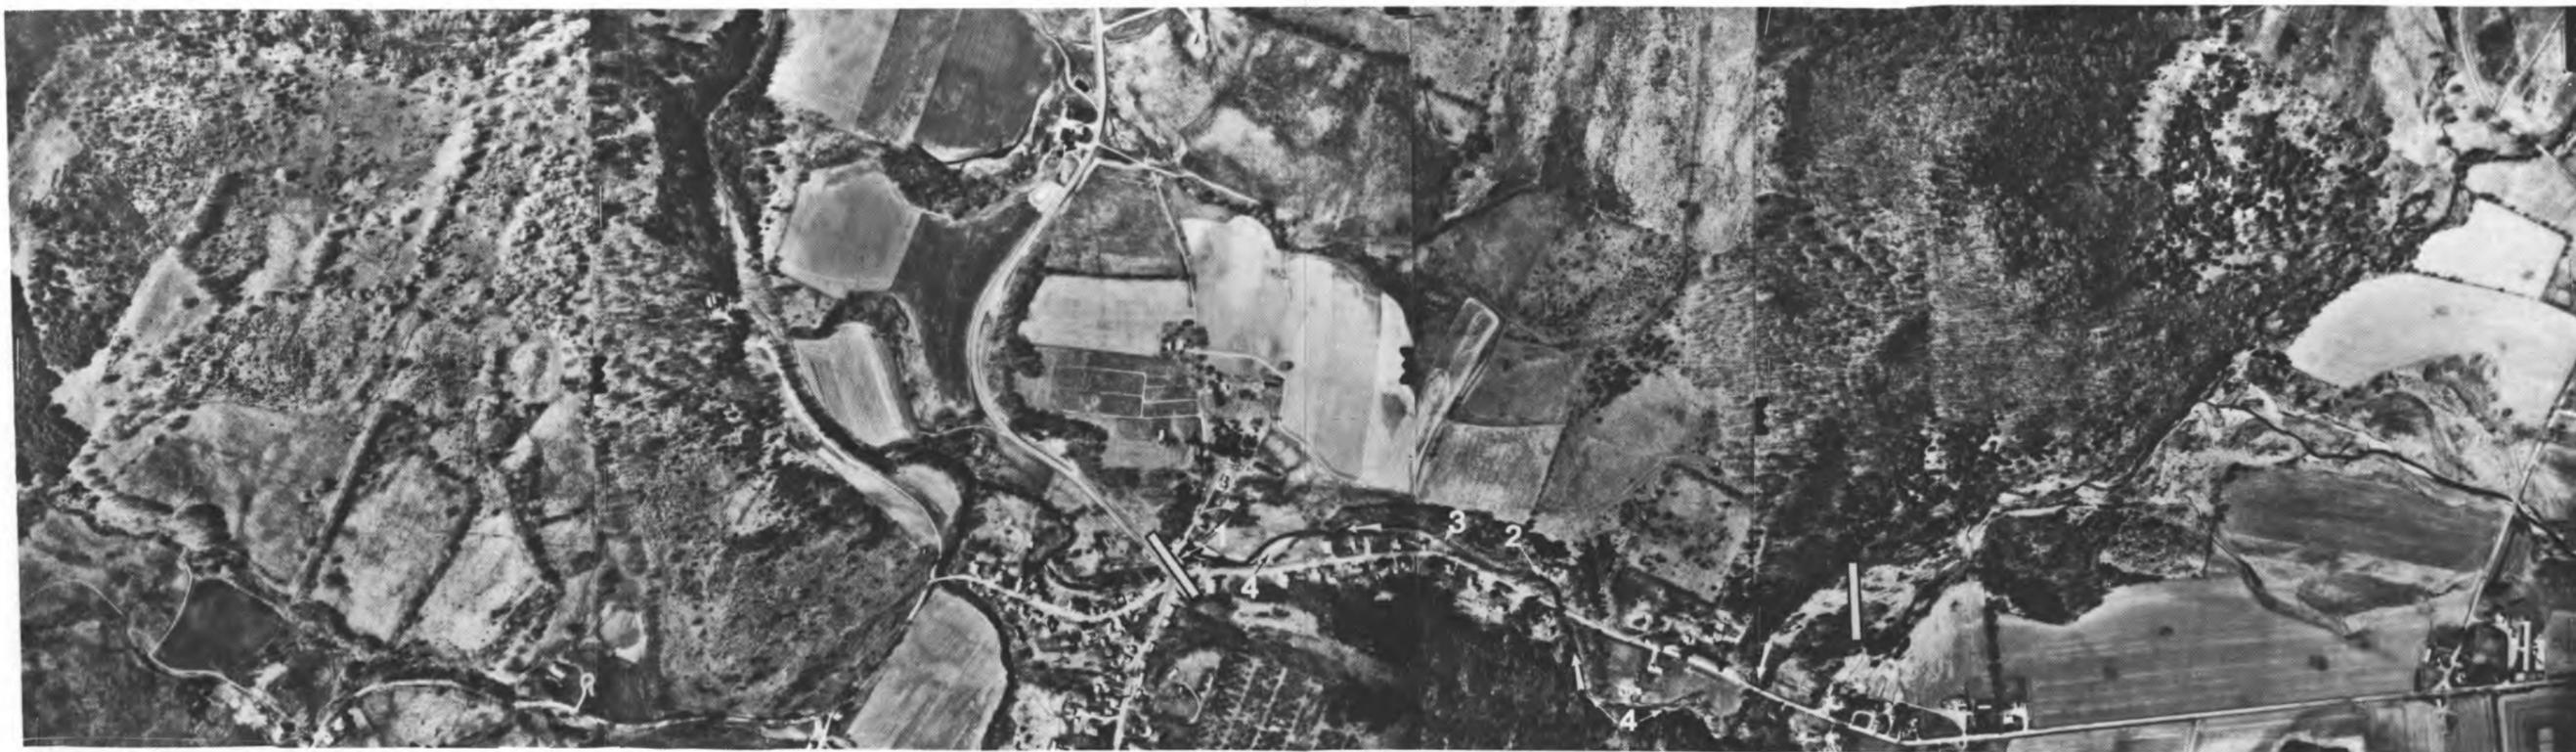
Figure A15. Flower Brook, Mettawee River, Pawlet, Vermont, 19 April 1976. Original scale 1 in. = 473 ft; 1/2 original size.

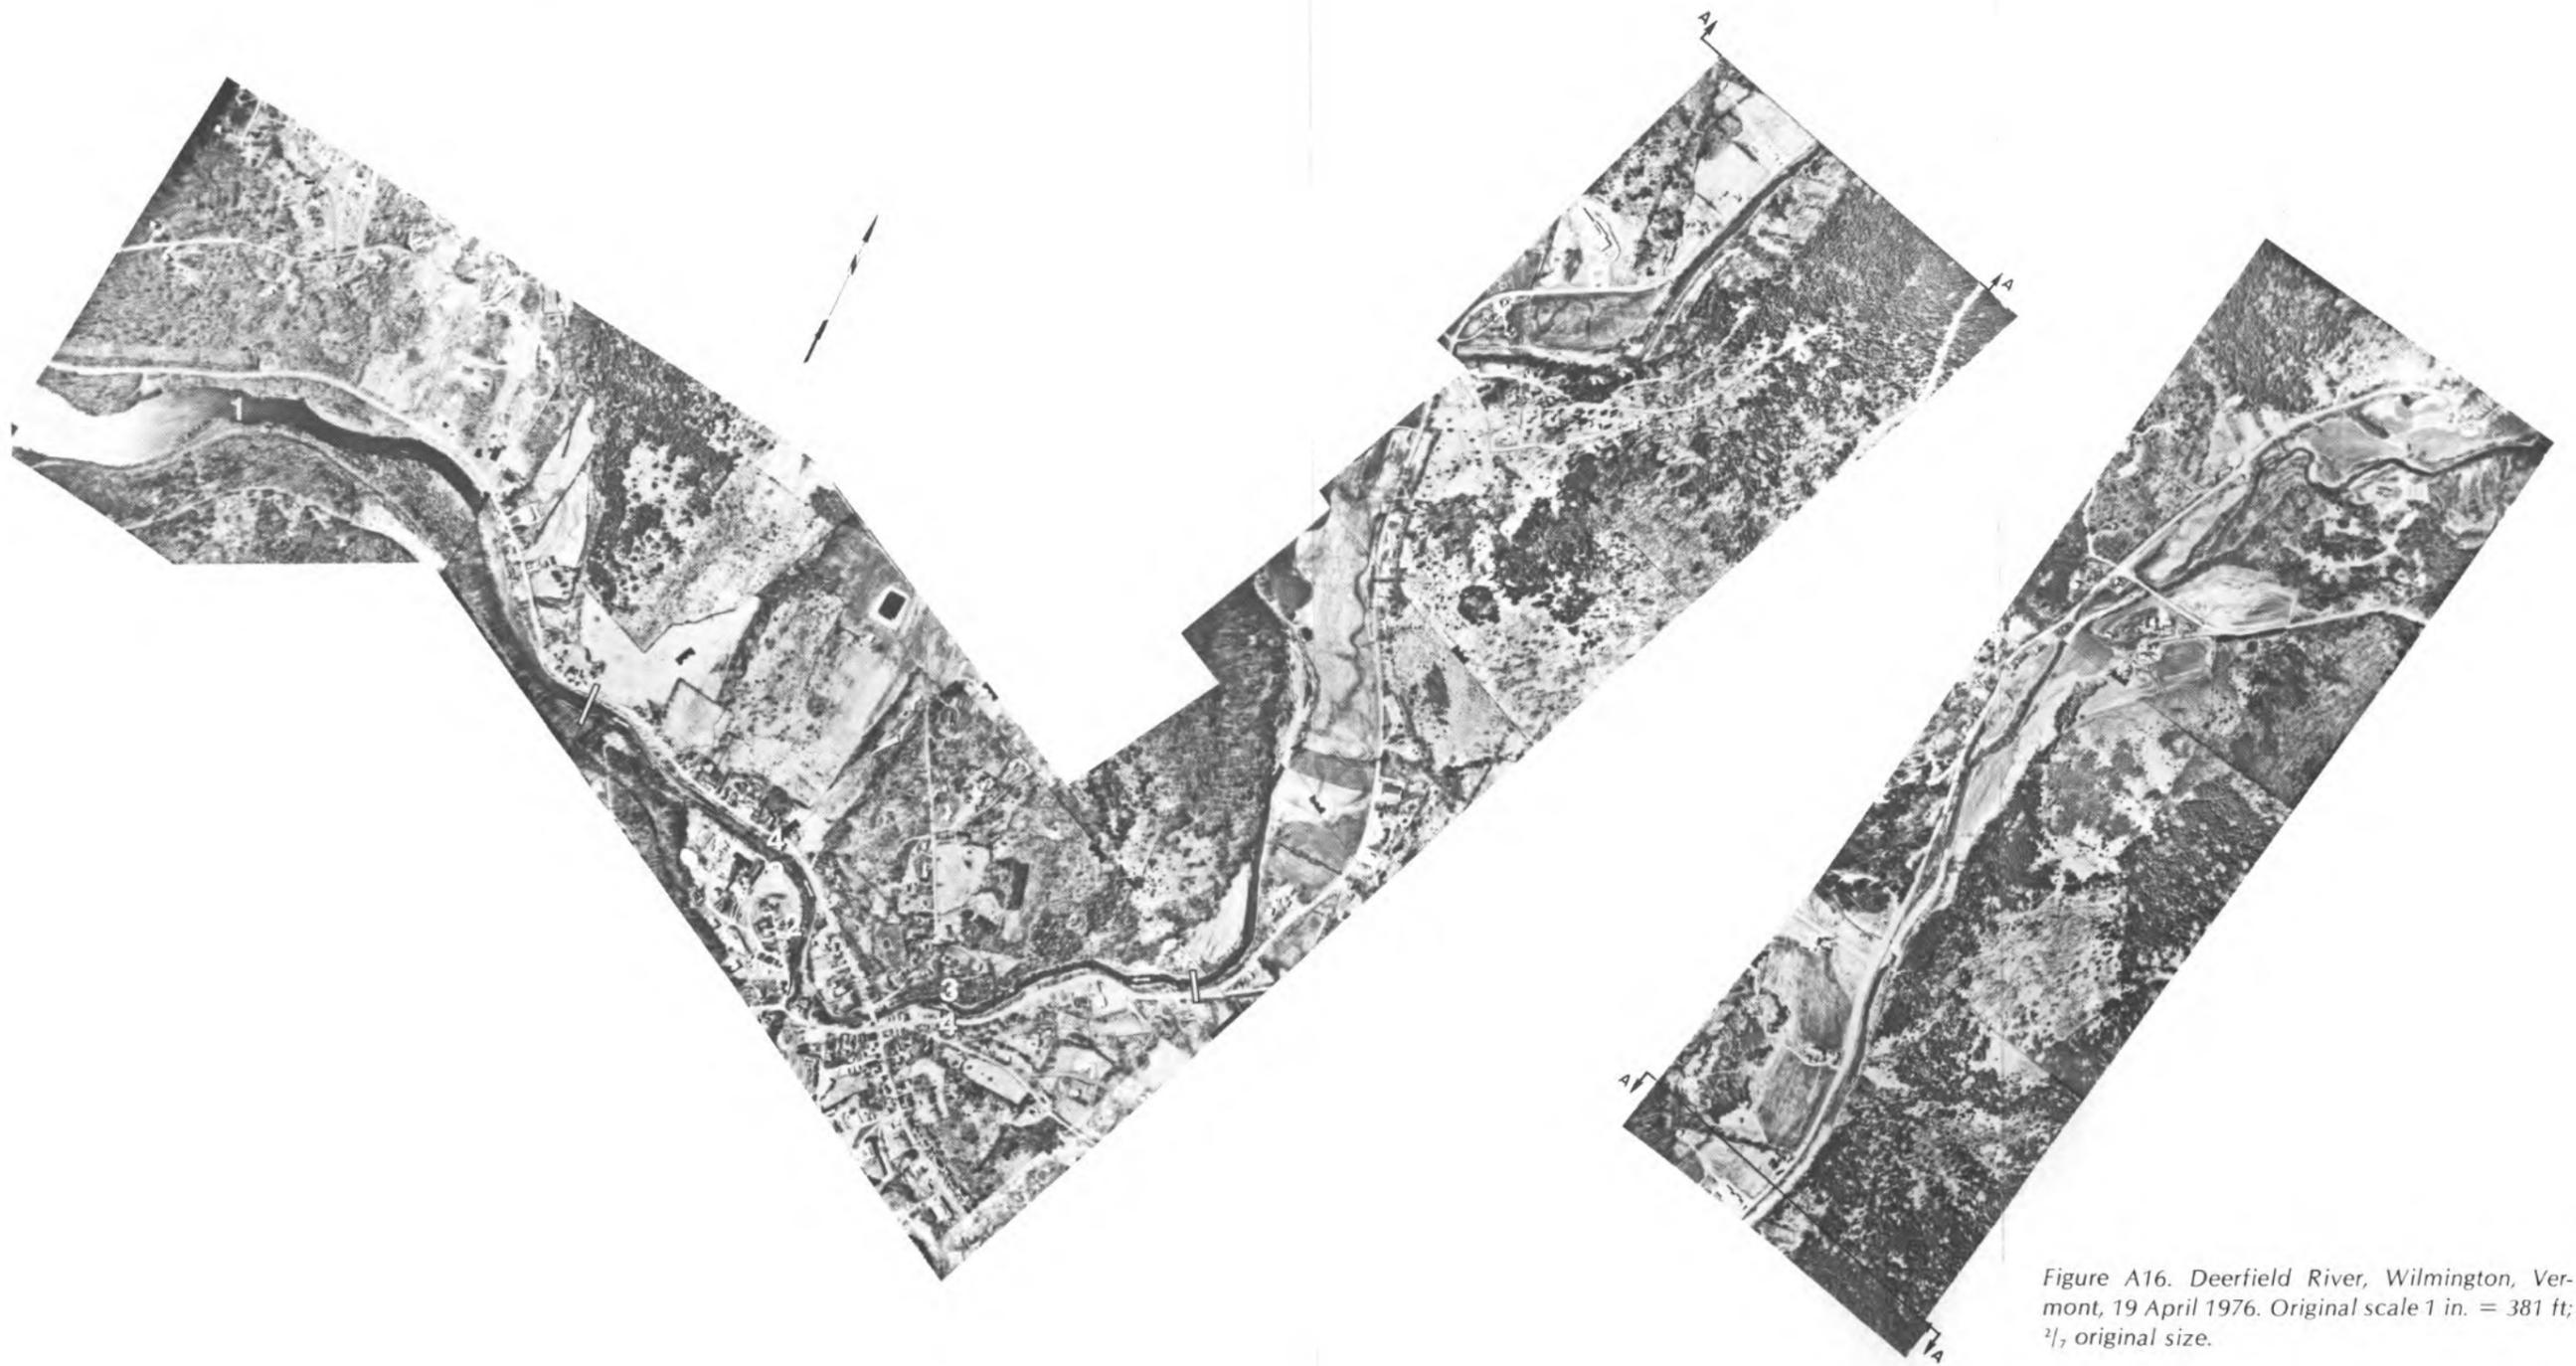
Figure A16. Deerfield River, Wilmington, Vermont, 19 April 1976. Original scale 1 in. = 381 ft; $\frac{1}{2}$, original size.

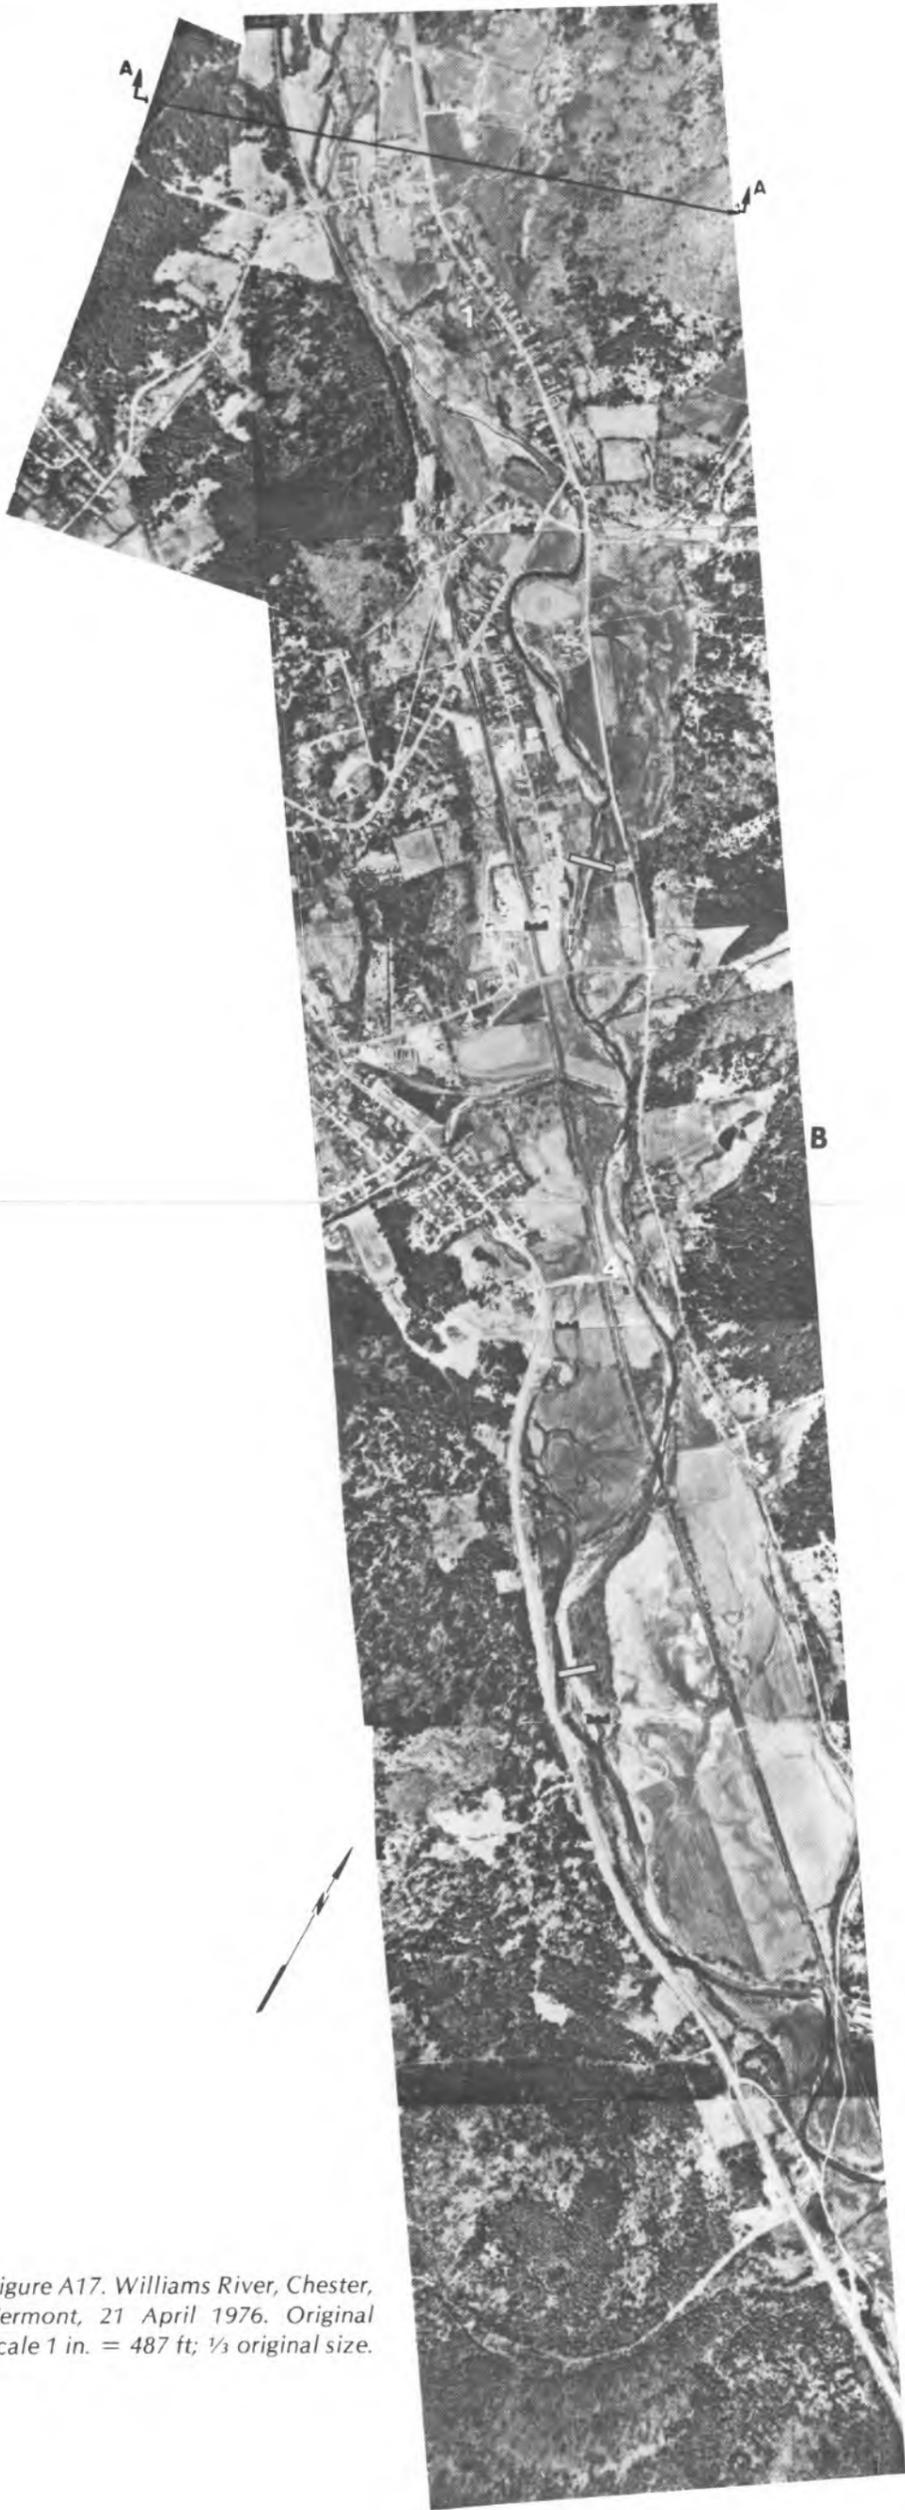
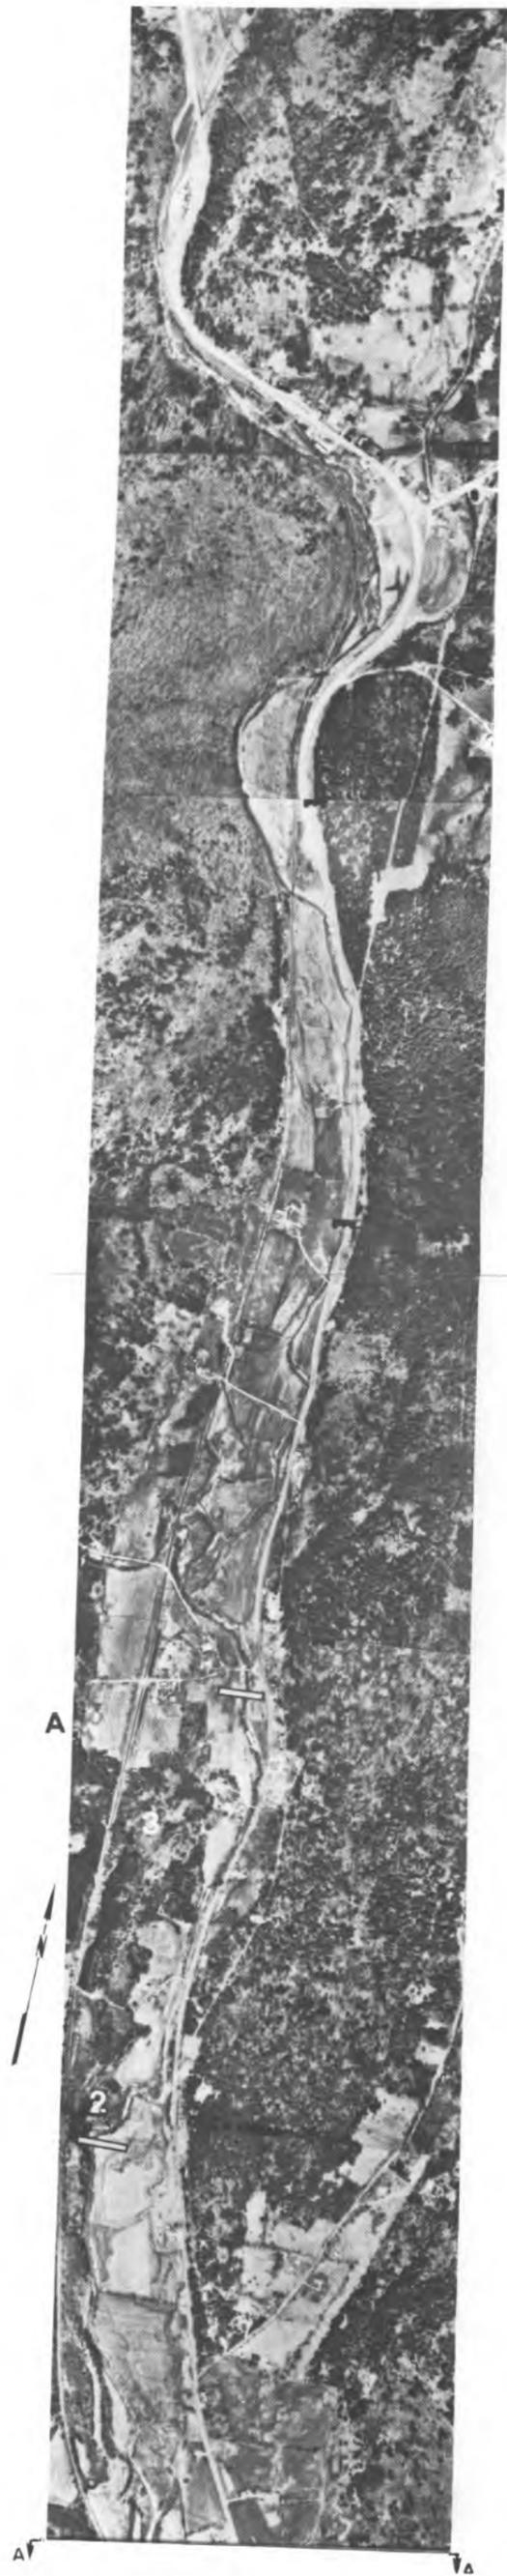
Figure A17. Williams River, Chester, Vermont, 21 April 1976. Original scale 1 in. = 487 ft; 1/3 original size.

There are two reaches along the Williams River near Chester where ice jams typically occur. Reach A is 1.5 miles north of North Chester (point 1 on Reach B), and Reach B extends from Chester 1.3 straight line miles downstream. Along Reach A, one pool (2) is apparent; the remainder of the reach is a riffle. Exposed rocks are common and rapids are small. Channel widths (Table BI, App. B) vary from 20 to 50 ft. The floodplain is wide (about 1100 ft) and marshy (3) on the west central side. The meanders and the meander bars at the southern end, and the shallow water, may be the primary factors that initiate the ice jams.

The channel along Reach B appears to be deeper than that along Reach A and has several mid-channel bars and large, well developed meander bars. Channel widths vary from 25 to 110 ft. Although riffles and shallow pools are apparent, most of the channel is shallow. Channel bottom material appears coarse [note the exposed boulders and the coarse appearance (4)]. The floodplain width varies from 2000 ft at the south end to 1000 ft in the middle. The mid-channel bars and bridge may be the controlling factors causing ice jamming.

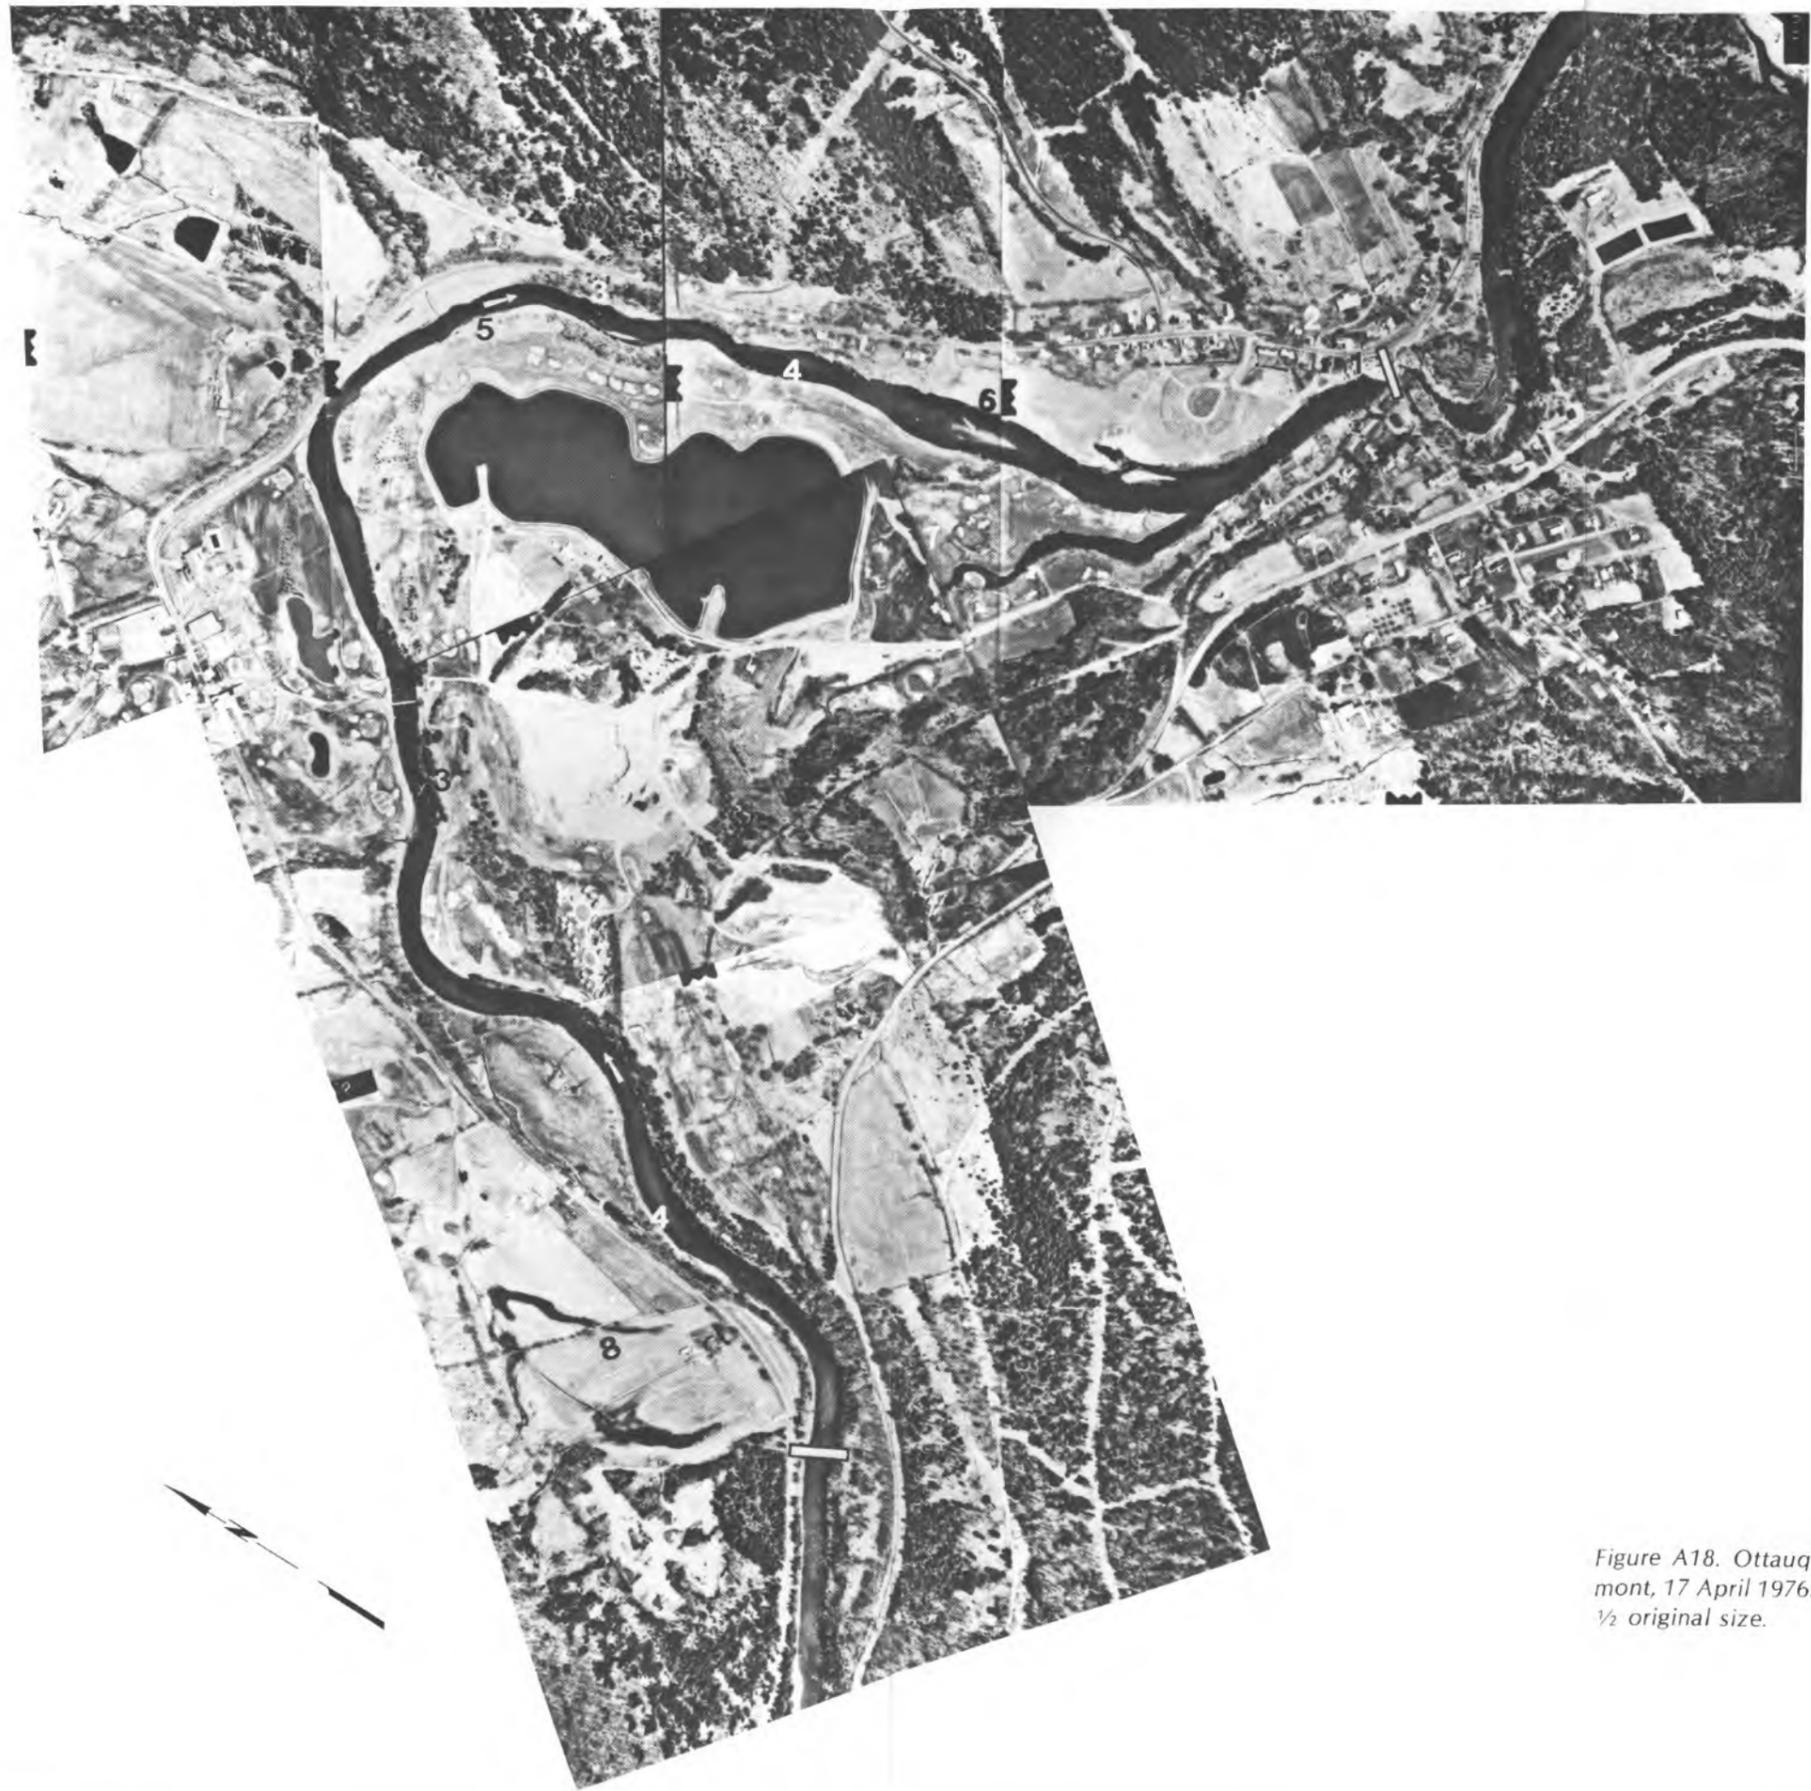
Figure A18. Ottauquechee River, Quechee, Vermont, 17 April 1976. Original scale 1 in. = 492 ft; 1/2 original size.

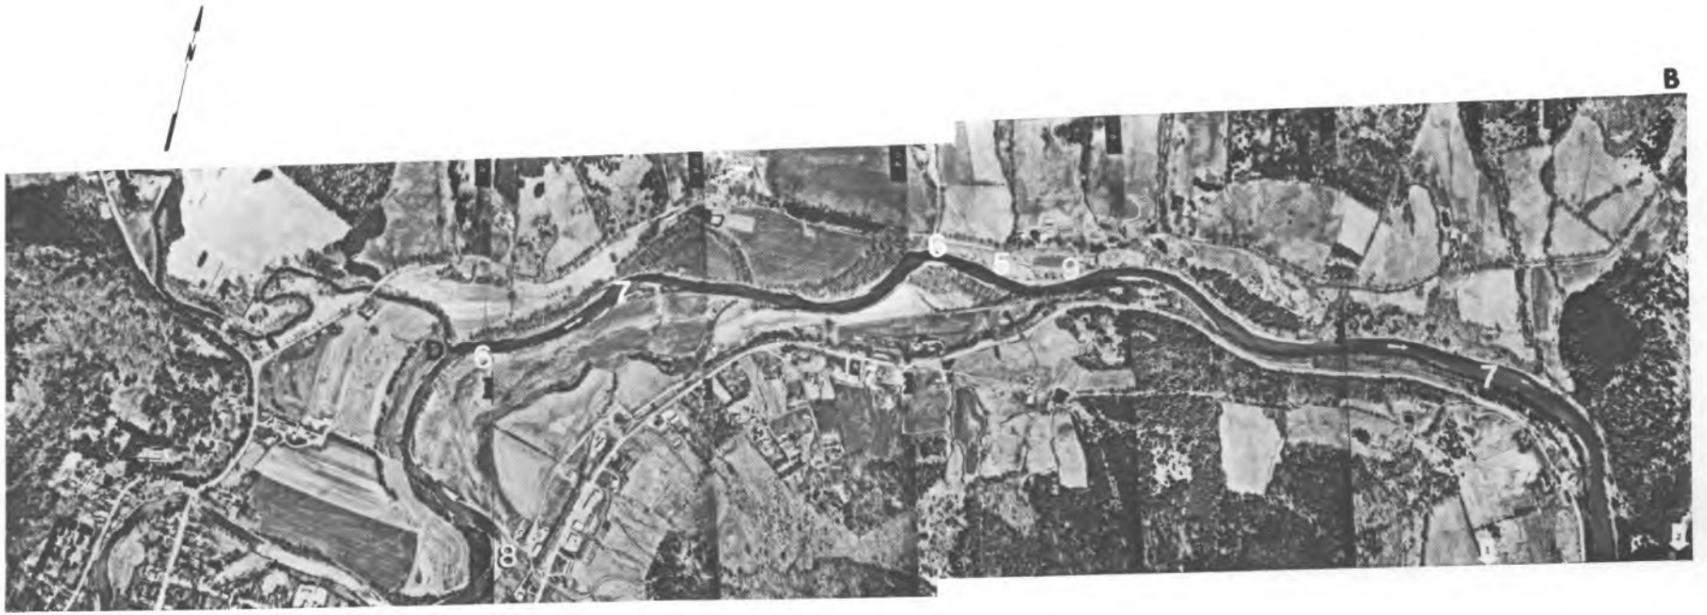
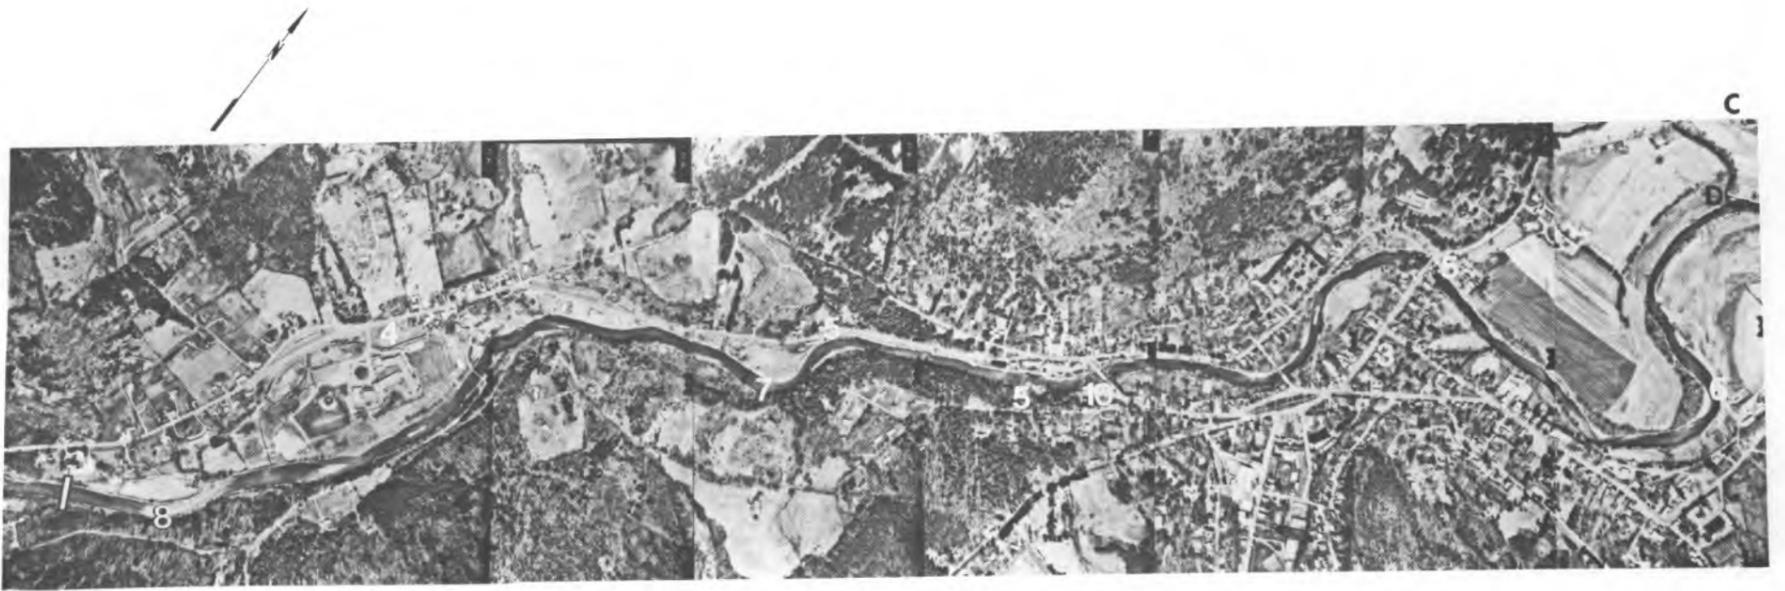
Figure A19. Ottauquechee River, Taftsville, Vermont, 17 April 1976. Original scale 1 in. = 492 ft; 1/3 original size.
