REPORT 76-33

Detecting structural heat losses with mobile infrared thermography

Part IV: Estimating quantitative heat loss at Dartmouth College, Hanover, New Hampshire

September 1976

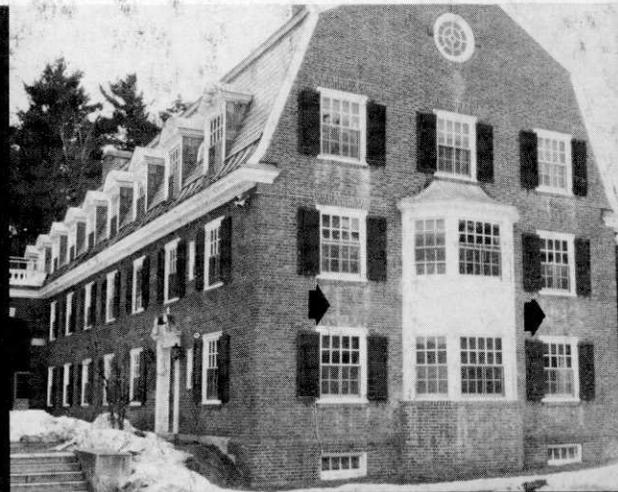
*Cover: Thermogram and photograph of Woodbury Hall,
taken on 28 March 1974. Arrows point to heat
loss from radiator conducted through brick wall.*

The inset on the cover of this report is a photograph of the south- and west-facing walls of Woodbury Hall dormitory on the Dartmouth College campus. The arrows point to the sections of the brick wall (between the first and second floors) where large cast-iron radiators are located on the insides of the rooms. Figure 4 shows one of these radiators.

The cover also shows a thermogram of the same south- and west-facing walls taken on 28 March 1974, at approximately 1930 hours. The ambient air temperature at this hour was -8°C , and the wind was north at approximately 8 miles per hour. The arrows point to two large white zones between the first and second-floor windows on either side of the bay window, which indicate the direct escape of heat from

the two cast-iron radiators located on the wall inside the room in which the bay window is located.

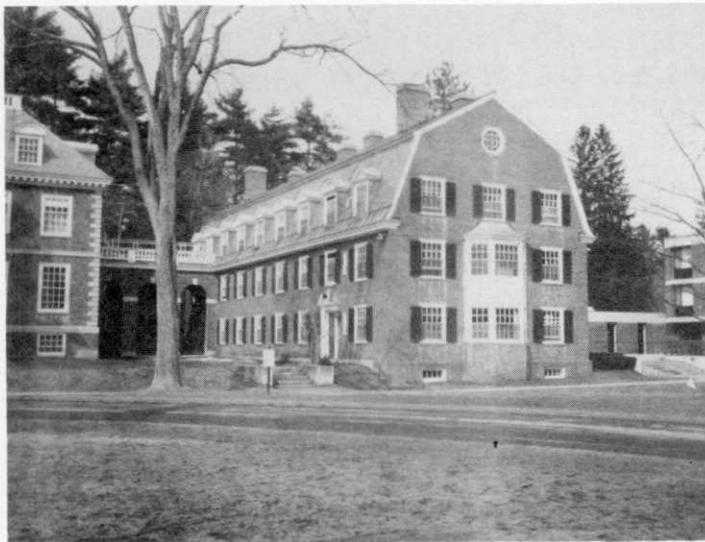
Figure 1. Woodbury Hall, Dartmouth College.

In the previous three reports we attempted to outline qualitative and some quantitative aspects of using infrared thermography to locate excessive heat losses in buildings. The increased usage of infrared scanners for inspecting buildings has led to wide-ranging discussions of whether or not thermography can be used effectively to obtain quantitative values of heat loss from buildings, and thereby to obtain cost savings by correcting locations of inadequate insulation. In order to provide some insight into this problem, we did a detailed study of one wall of a dormitory building (Woodbury Hall) on the campus of Dartmouth College at Hanover, New Hampshire (Fig. 1).

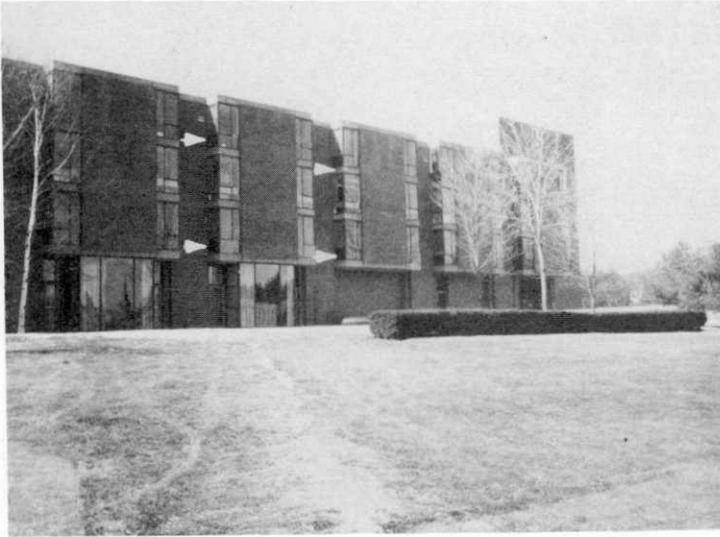
Figure 2a. Strassenburgh Hall on the Dartmouth College campus. White arrows point to construction joint between window frame and masonry.

Figures 2 and 3 show evidence of these heat losses. The thermogram of the building exterior shows a brighter shading in the locations where the construction defects occur than in the surrounding similar material. If obtained from the inside of the structure, the thermogram would show a darker shading in the locations where construction defects occur than in the surrounding similar material. However, any temperature information registered on a thermogram is a combination of the temperature of the surface material and the properties of the material. Therefore, all heat emanating from a surface is included in this temperature information.

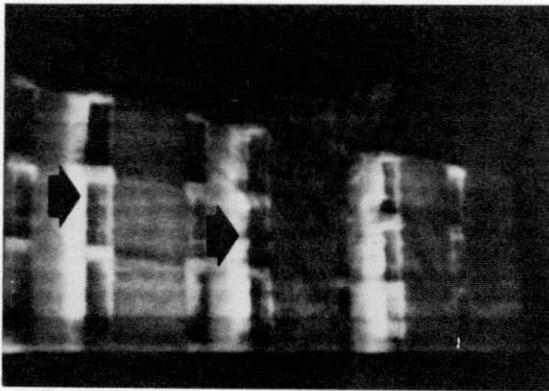
Figure 2b. Thermogram of Strassenburgh Hall. Black arrows point to infiltration loss through construction joints shown in Figure 2a.

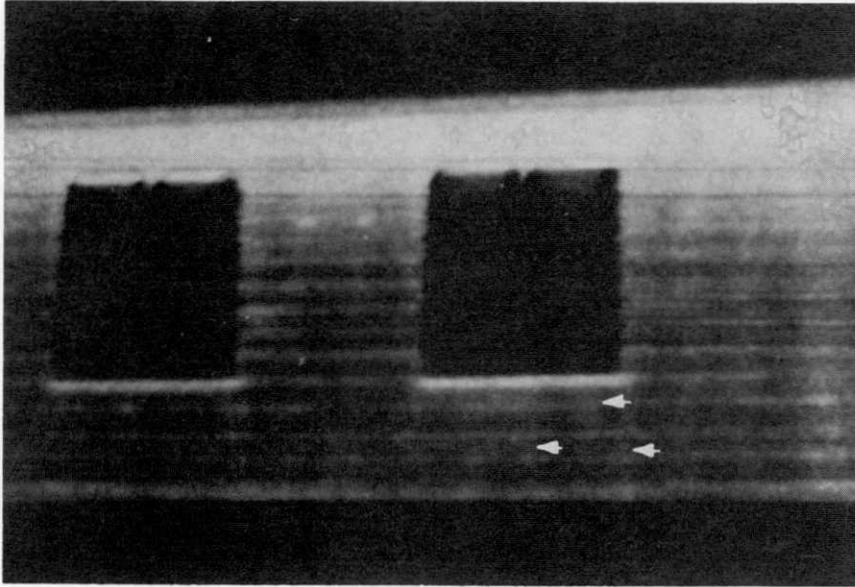
Figure 3. Arrows show heat escaping between insulation and 2-in. by 4-in. studs.

little or no heat escaping between the insulation and studs can be detected by the infrared scanner. However, as Figure 3 shows, the thermogram indicates an actual condition where heat *is* escaping.

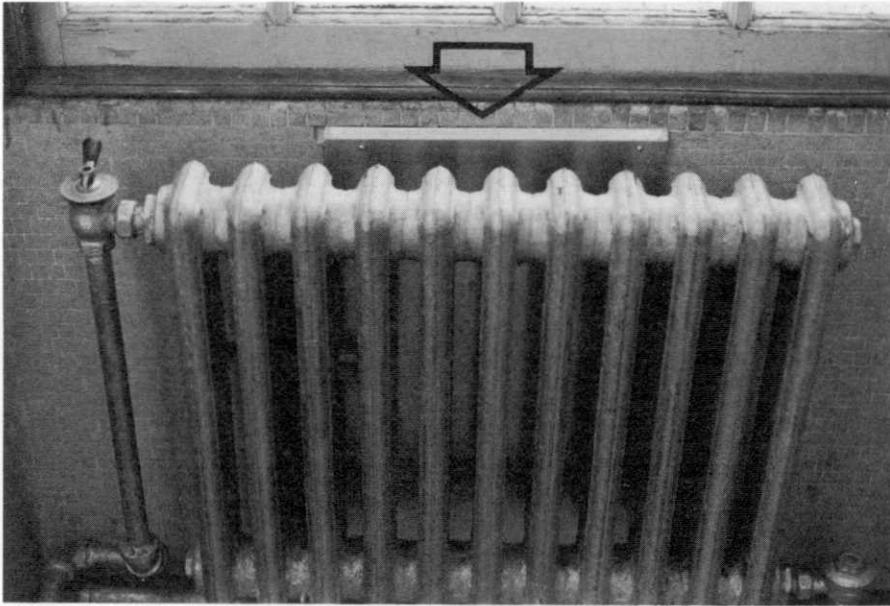
Figure 4. Typical radiator installation at Woodbury Hall. Arrow points to metallic reflector installed behind radiator.

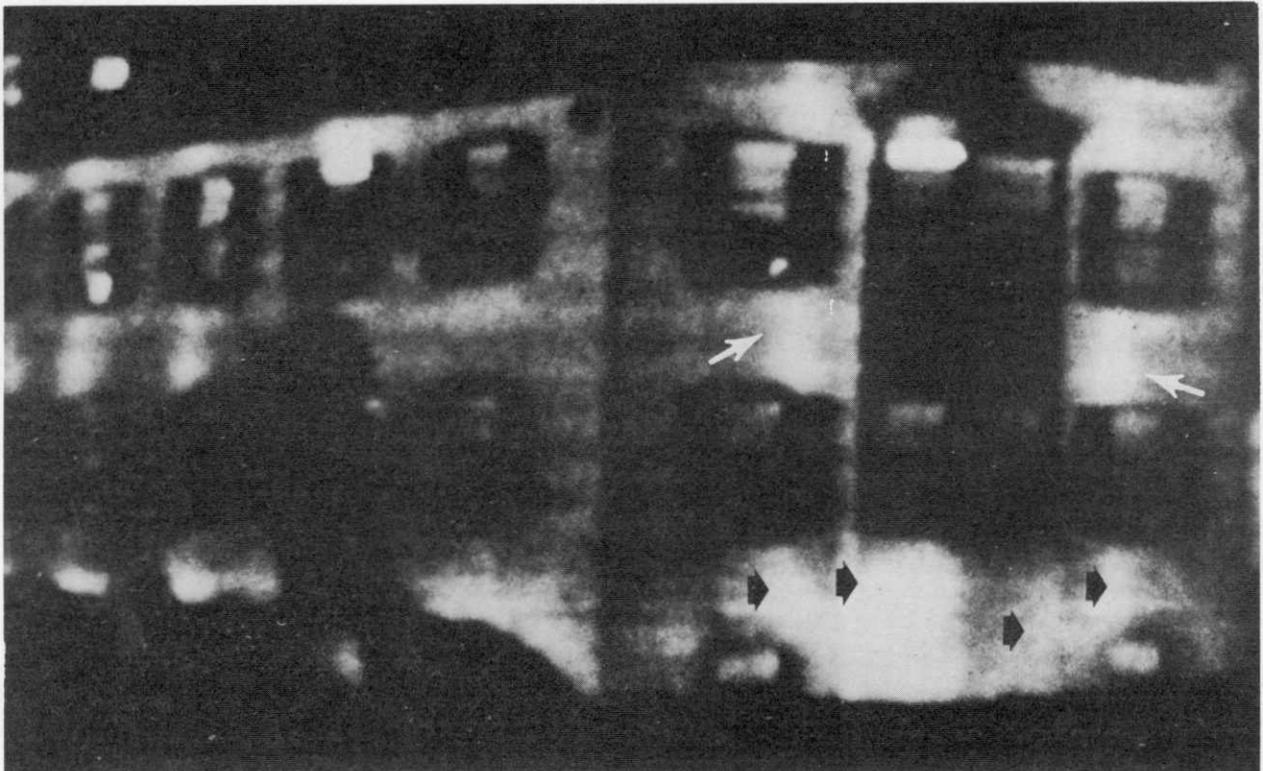
Figure 5a. Thermogram taken on 1 April 1974, after installation of reflectors. Note that the area of heat loss is reduced by about 50% (compare with photograph on cover).

Having been apprised of the escaping heat, Dartmouth personnel suggested that a simple experiment be attempted to determine if sheet metal reflectors placed between the radiators and the wall would retard the flow of heat through the wall. These reflectors were installed by the Dartmouth staff the next day, and we returned on 1 April to take thermograms of the modification. Figure 5a shows a thermogram taken on 1 April 1974, at approximately 2000 hours. The ambient air temperature at this time was 6°C and the wind was north at 4 mph. Again the arrows indicate the location of direct heat transfer through the wall. Notice, however, that the width of the area beneath the window now losing heat has been reduced by about 50%.

The remaining white area was attributed to heat escaping from the heat riser (pipe) located along the radiator and very close to the wall. Again, Dartmouth

Since it is impossible to repeat the exact setting of the black-white contrast level of the infrared scanner system from one day to the next, the black-white contrast is of necessity different for these thermograms. However, in order to provide a point of reference between Figures 5a and 5b, each thermogram includes the thermal profile of the radiators of the room immediately below the area indicated by the arrows (horizontal black arrows).

With reference to the discussion in the previous section, the thermograms taken of Woodbury Hall on 1 April (Fig. 5a and 5b) show the thermal profile of a section of the second floor exterior wall as it appeared with a reflector mounted between the radiator and wall and of the first floor immediately below which did not have a reflector inserted between the radiator and the wall. It is recognized that not all experimental parameters were identical in each room (e.g., temperature of both rooms and locations of heat loss). However, it was not possible to completely control the experimental conditions as, to some extent, was desirable because the quantitative results could be directly related to a real life situation.
