*Environmental engineering and ecological  
baseline investigations along the  
Yukon River-Prudhoe Bay Haul Road*

Jerry Brown and Richard L. Berg, Editors

September 1980

UNITED STATES ARMY  
CORPS OF ENGINEERS  
COLD REGIONS RESEARCH AND ENGINEERING LABORATORY  
HANOVER, NEW HAMPSHIRE, U.S.A.

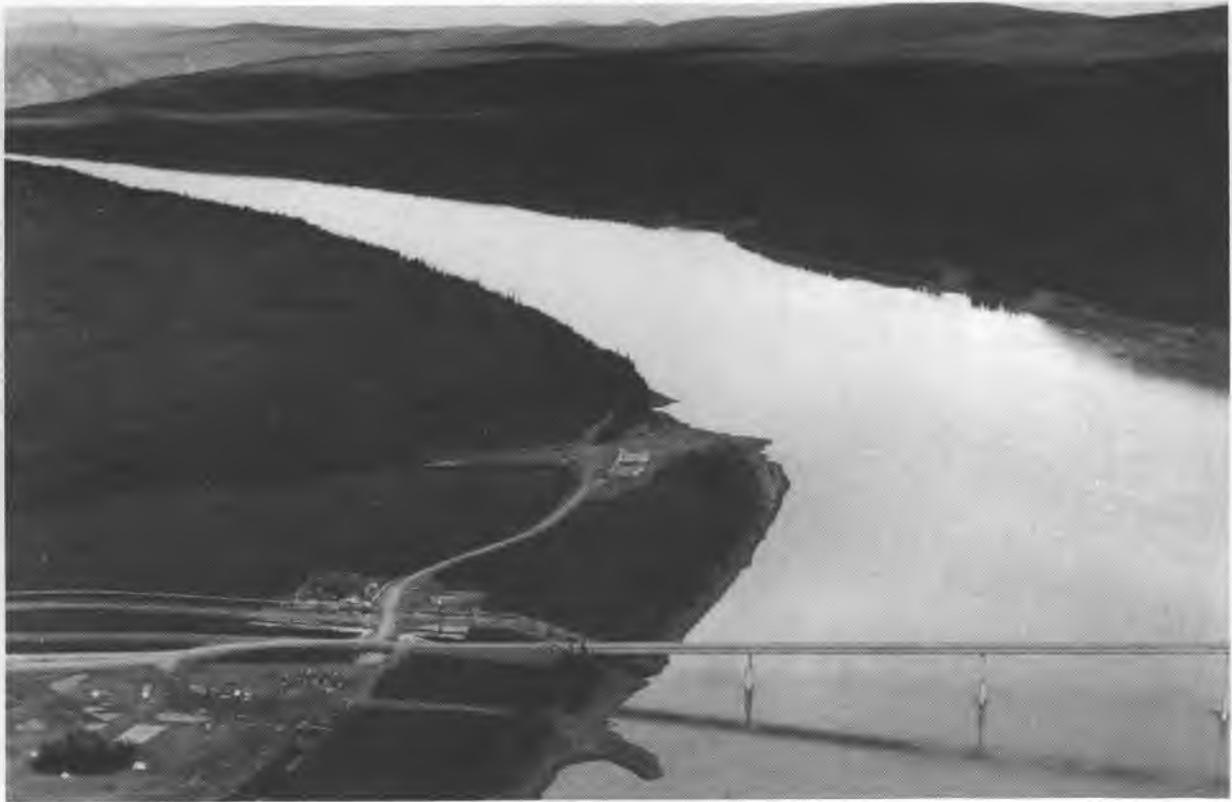
Figure 2. Beginning of the Haul Road on north bank of the Yukon River, 11 August 1976.

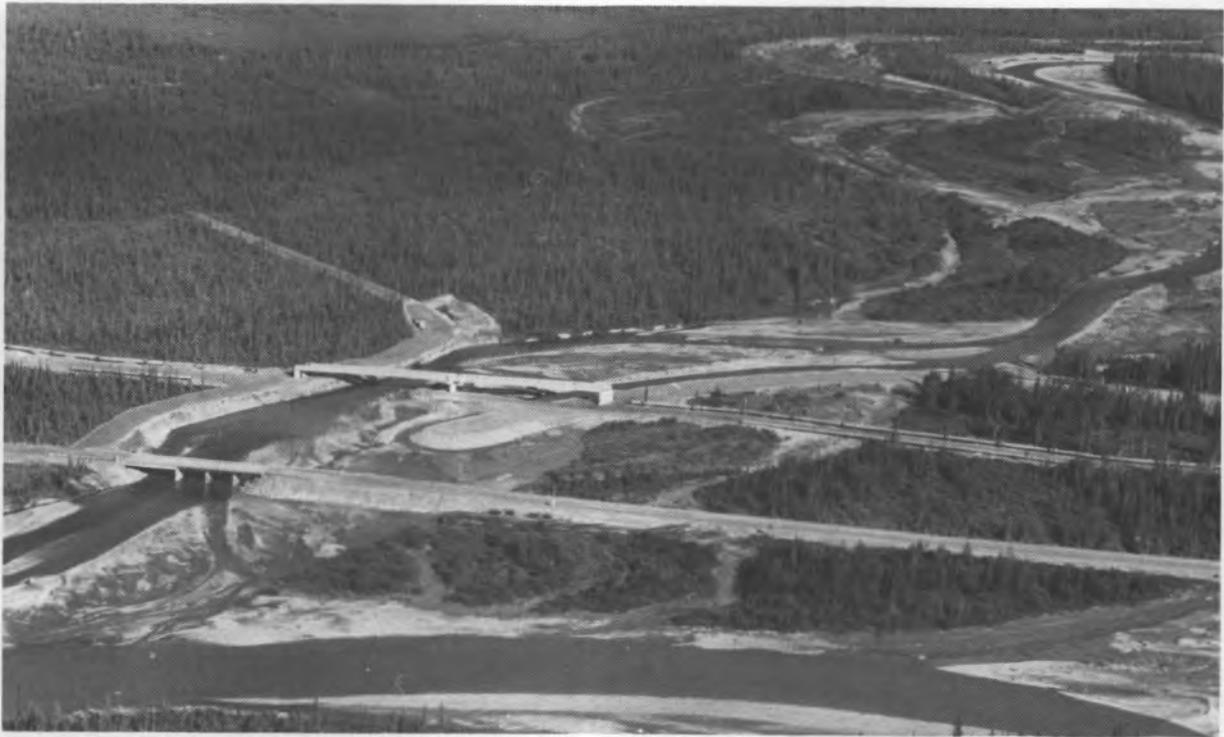
*Figure 3. Oil pipeline and Haul Road bridge crossings at the Middle Fork of the Koyukuk River, 11 August 1976.*

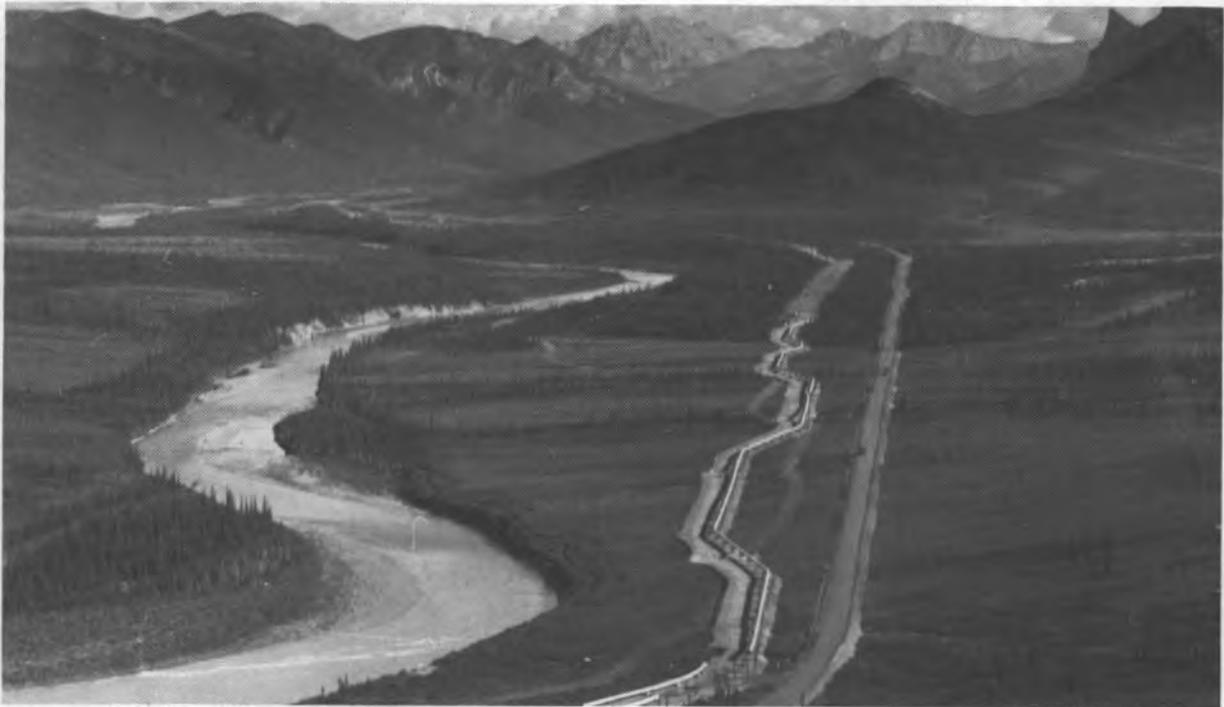
*Figure 4. Haul Road and elevated oil pipeline crossing an ice-rich treeless slope along Middle Fork, Koyukuk River, 11 August 1976. In background, road and buried oil pipeline cross a tree-covered low-ice content slope.*

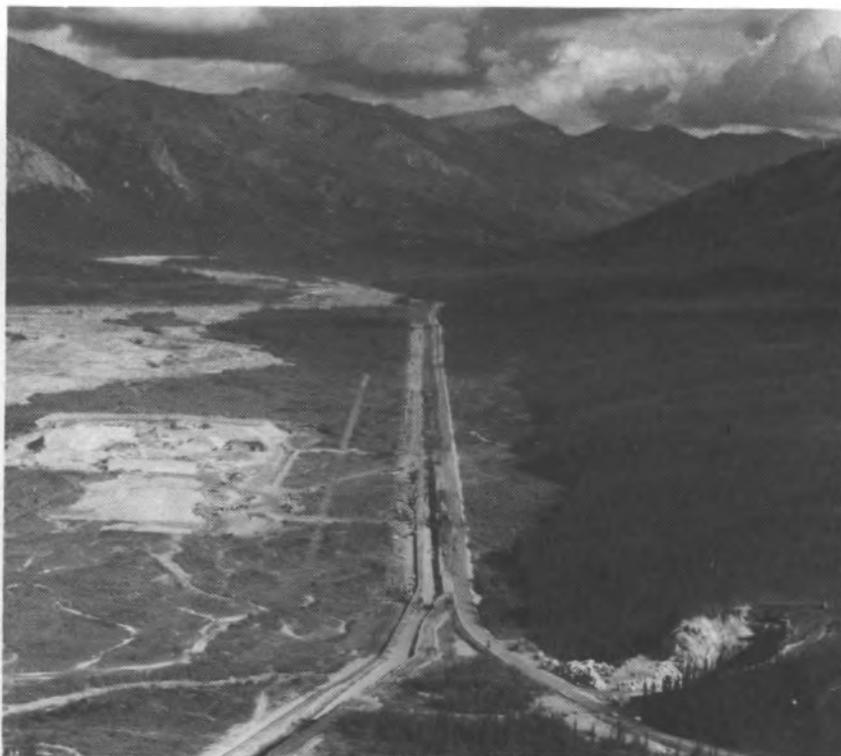
*Figure 5. Haul Road and buried oil pipeline 19 km north of Dietrich Camp on terrace of the Dietrich River, 11 August 1976. Bedrock material site in foreground.*

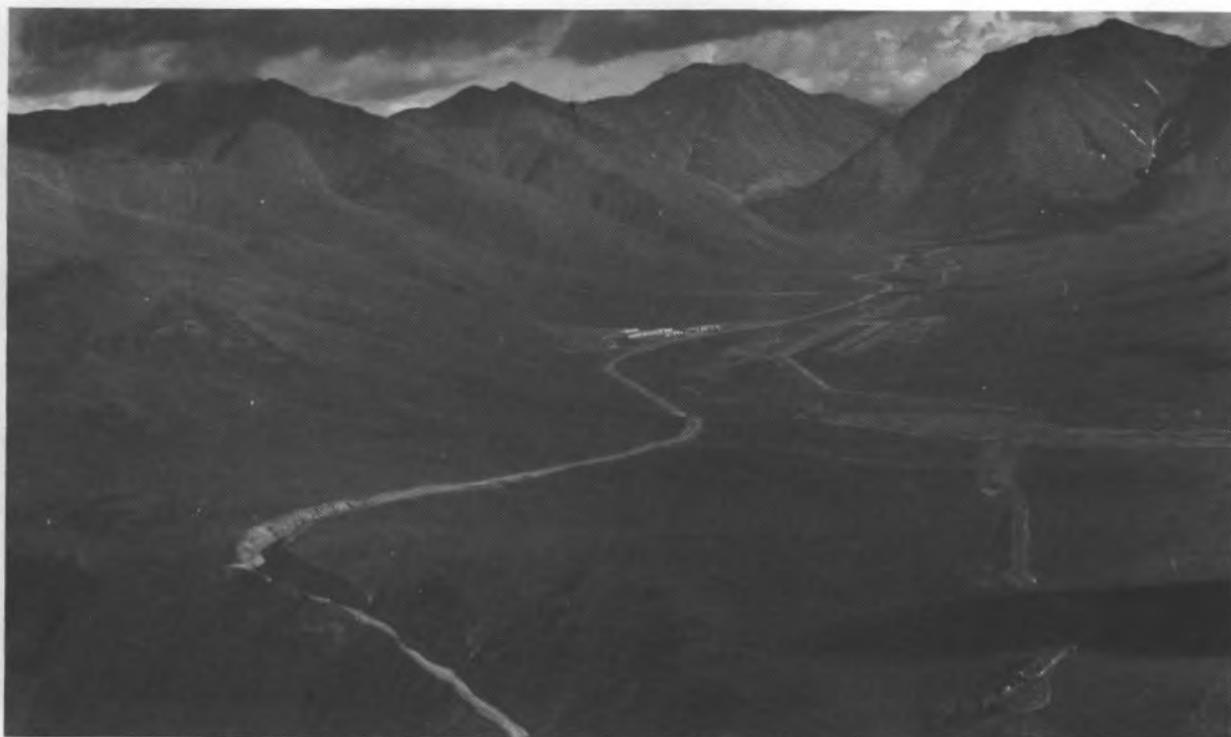
*Figure 6. Looking north onto Chandalar Shelf showing road ascending through steep cut, 11 August 1976. Atigun Pass is in background and Chandalar Camp in center of photograph.*

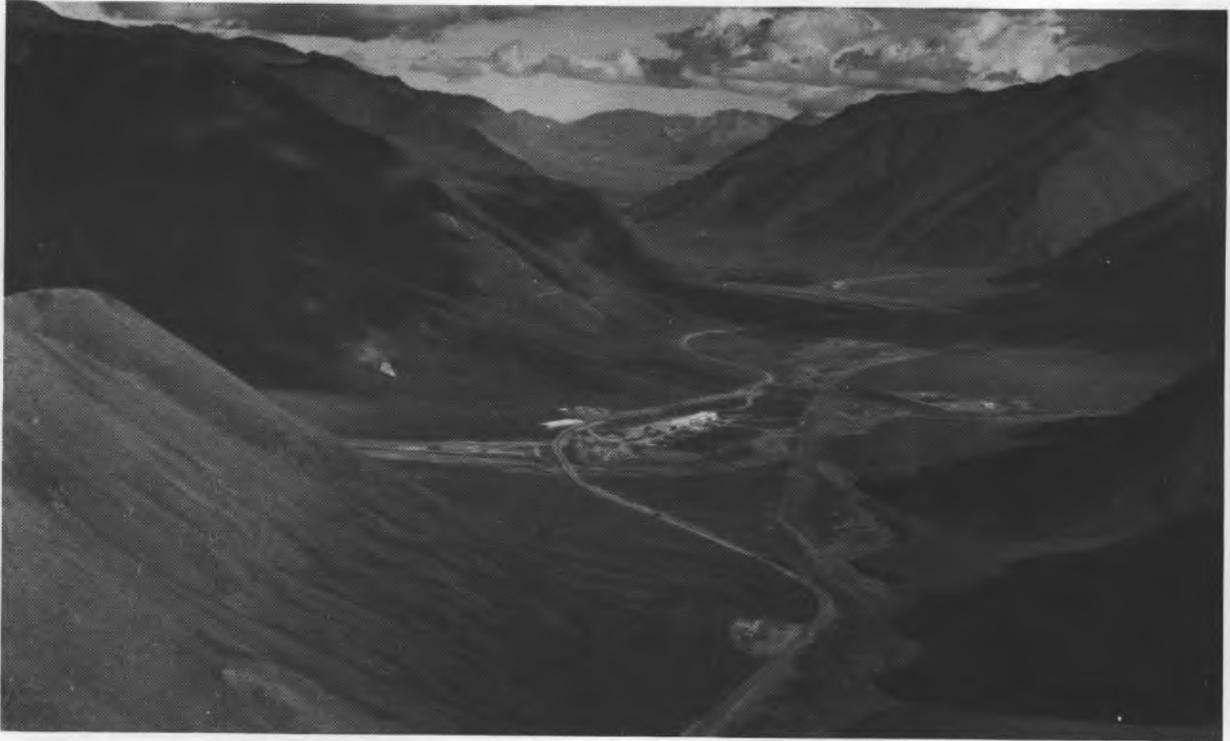
*Figure 7. Looking north down Atigun Valley with road crossing colluvial-alluvial slopes. Atigun Camp is in center of photograph, 11 August 1976.*

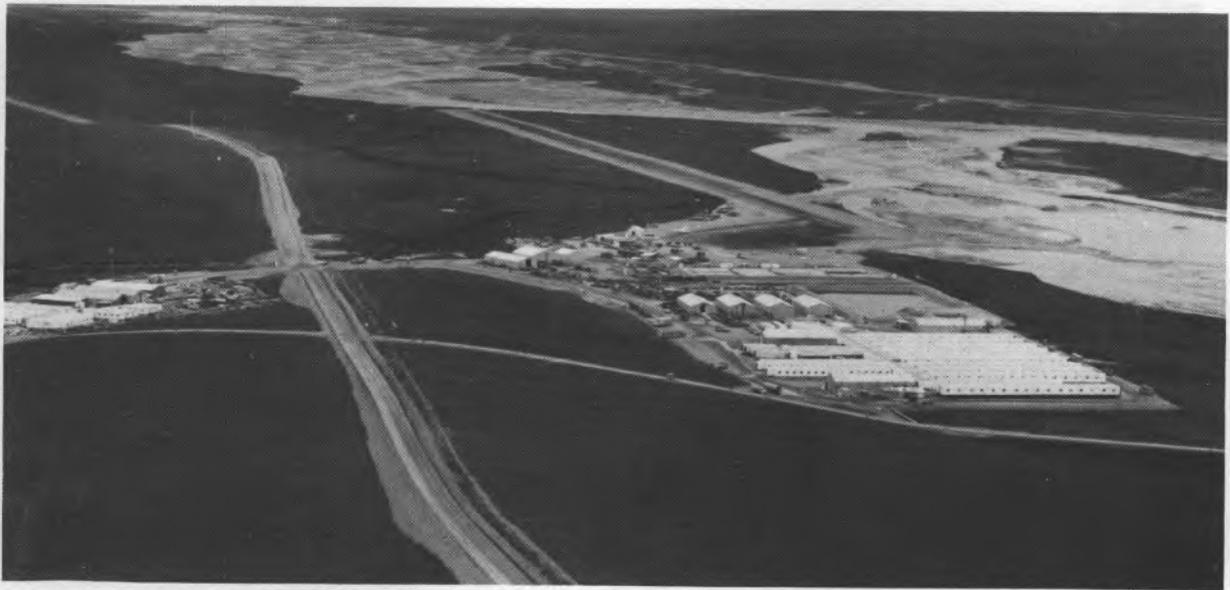
*Figure 8. Road crossing foothills between Happy Valley Camps, 11 August 1976. Sagavanirktok River is to the east. The gravel-filled fuel gas line trench is seen adjacent to the road on the right side of this ice-rich permafrost setting. The oil pipeline is across the river.*

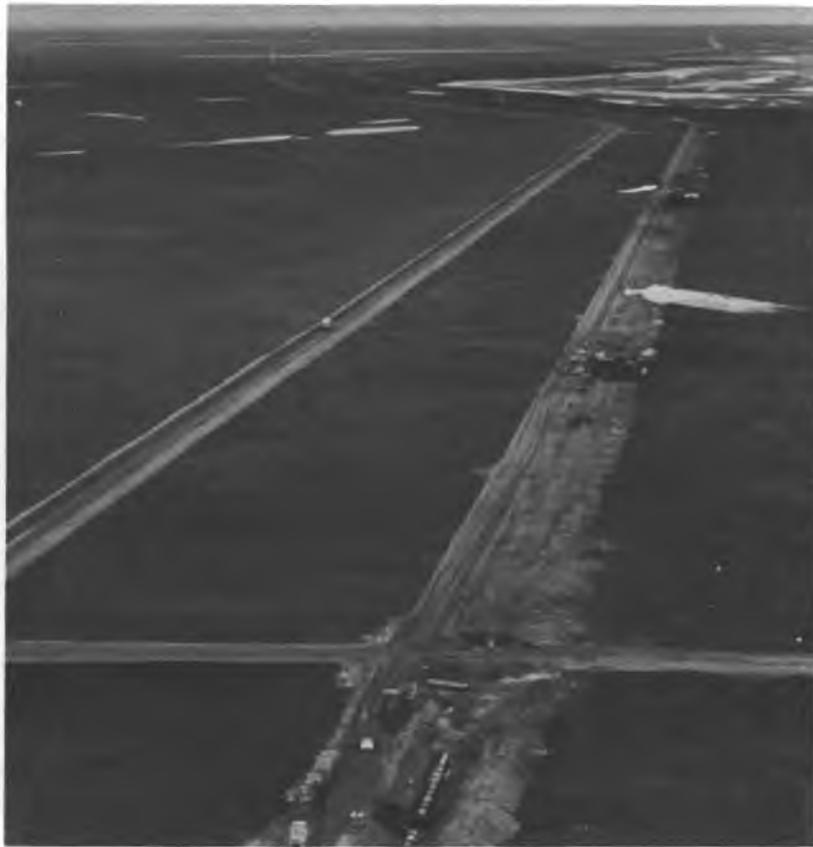
*Figure 9. View looking north across the Arctic Coastal Plain, 11 August 1976. The road and buried oil pipeline parallel each other and the Sagavanirktok River. Ice-wedge polygons are seen in the foreground.*

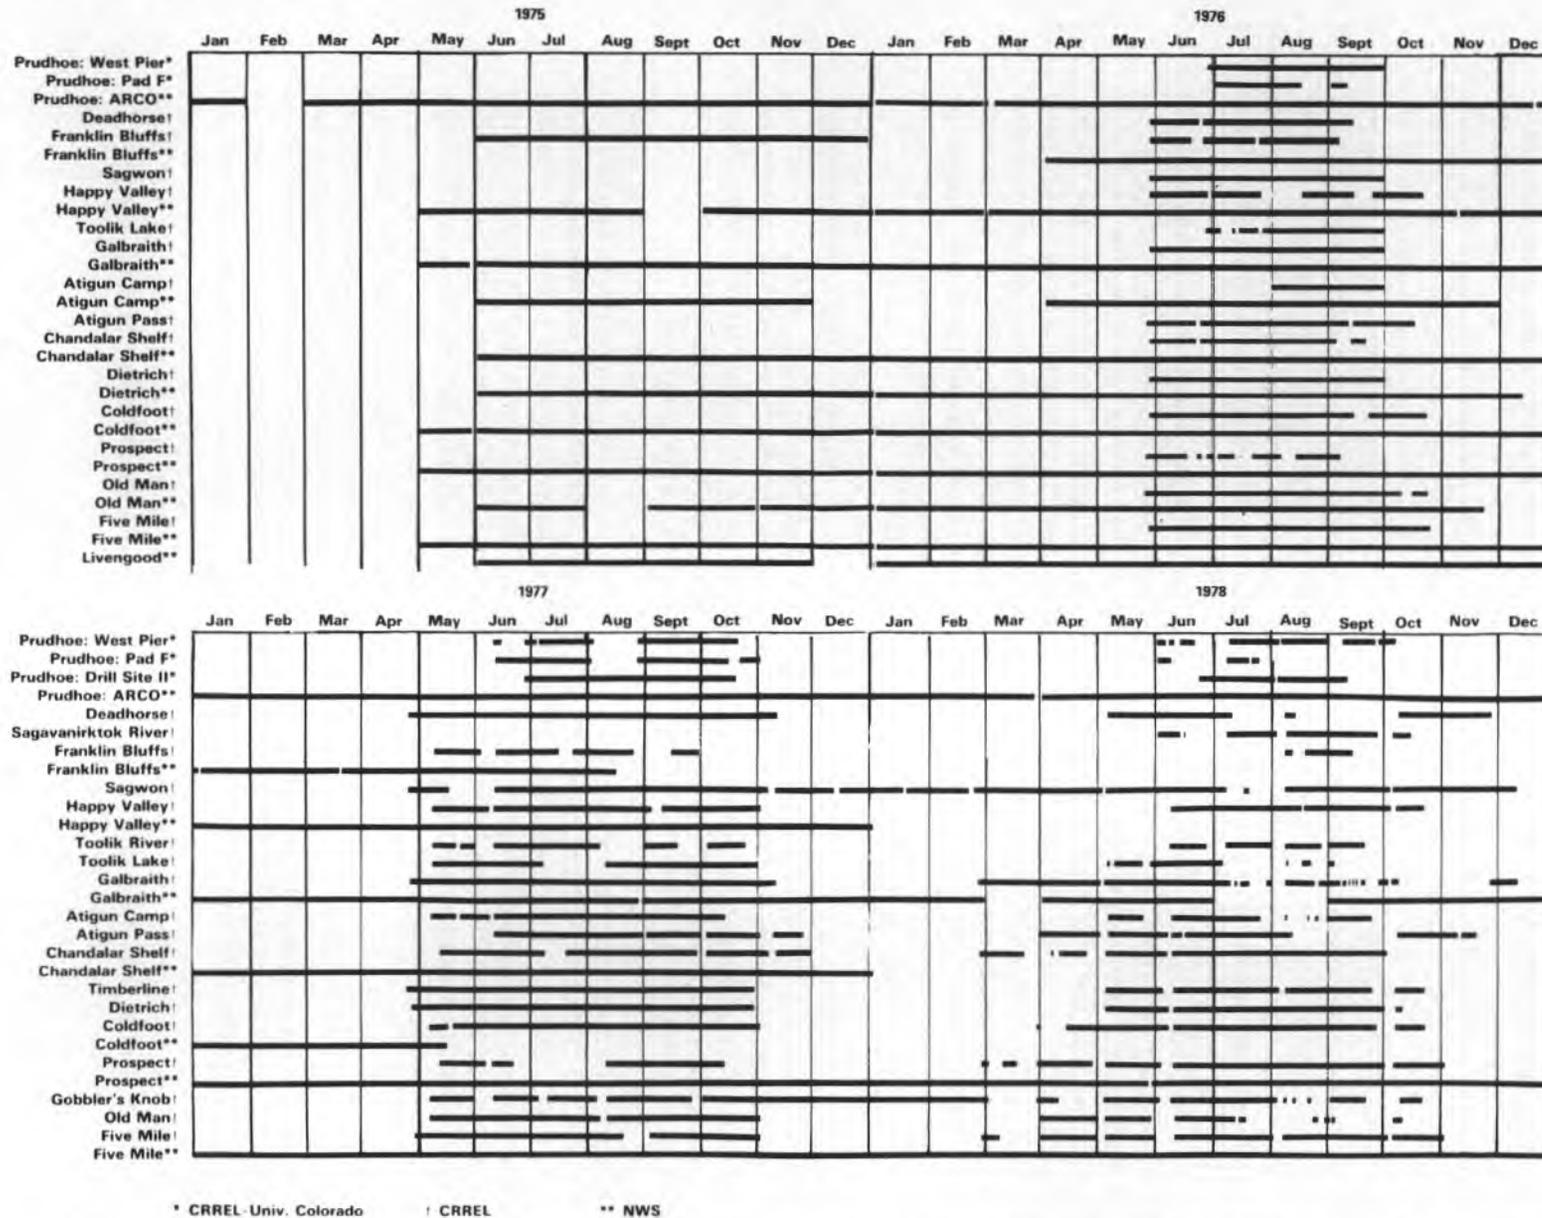
Figure 11. A graphic display of Haul Road climatic station records. CRREL, CRREL-University of Colorado and National Weather Service records are distinguished by symbols (see legend). Small breaks in the thaw season records were filled by regression analysis to permit the compilation of degree-days and monthly means. Regression was done on maximum and minimum temperatures separately. In the few cases where significant ( $P>0.05$ ) relationships were not found, simple differences between the means were used.

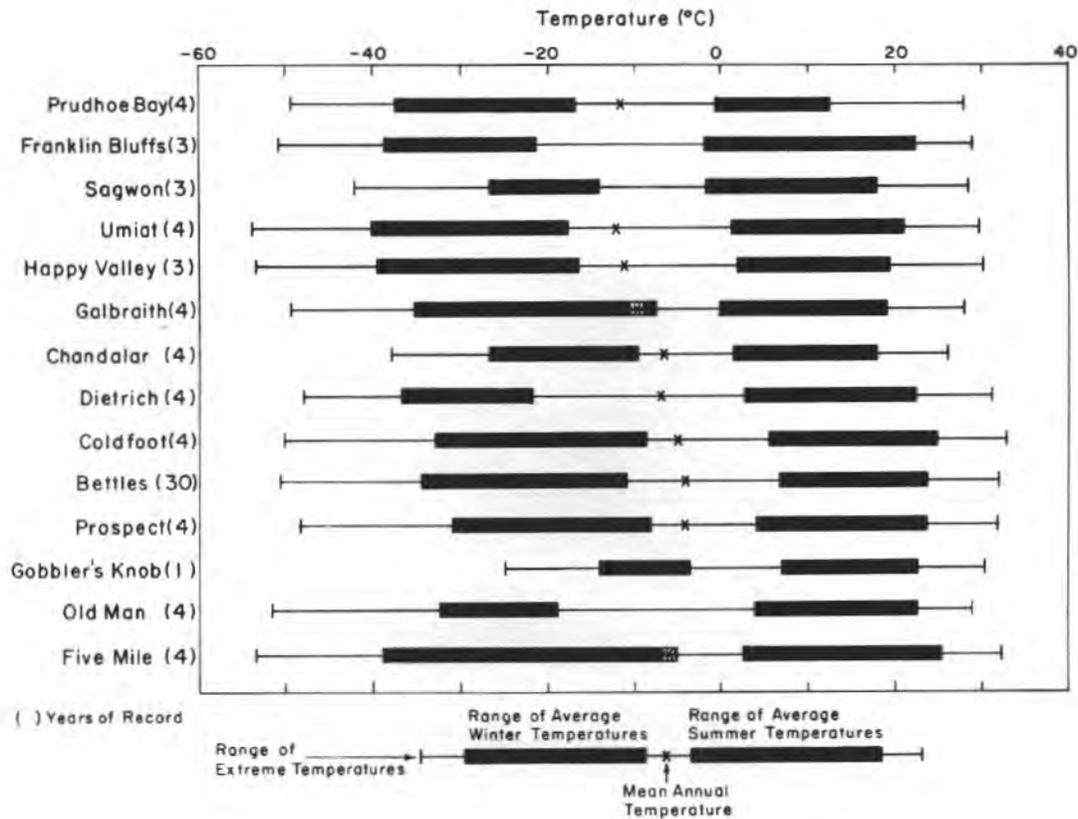
Figure 12. Annual temperature regimes for Haul Road stations. Mean annual temperatures are indicated by "X" on the extreme range line for stations with at least three years' continuous record. Umiat and Bettles are included for comparison. The range of the coldest and warmest monthly minimum and maximum temperatures are indicated by solid bars for winter (Dec-Feb) and summer (June-Aug) for each station.

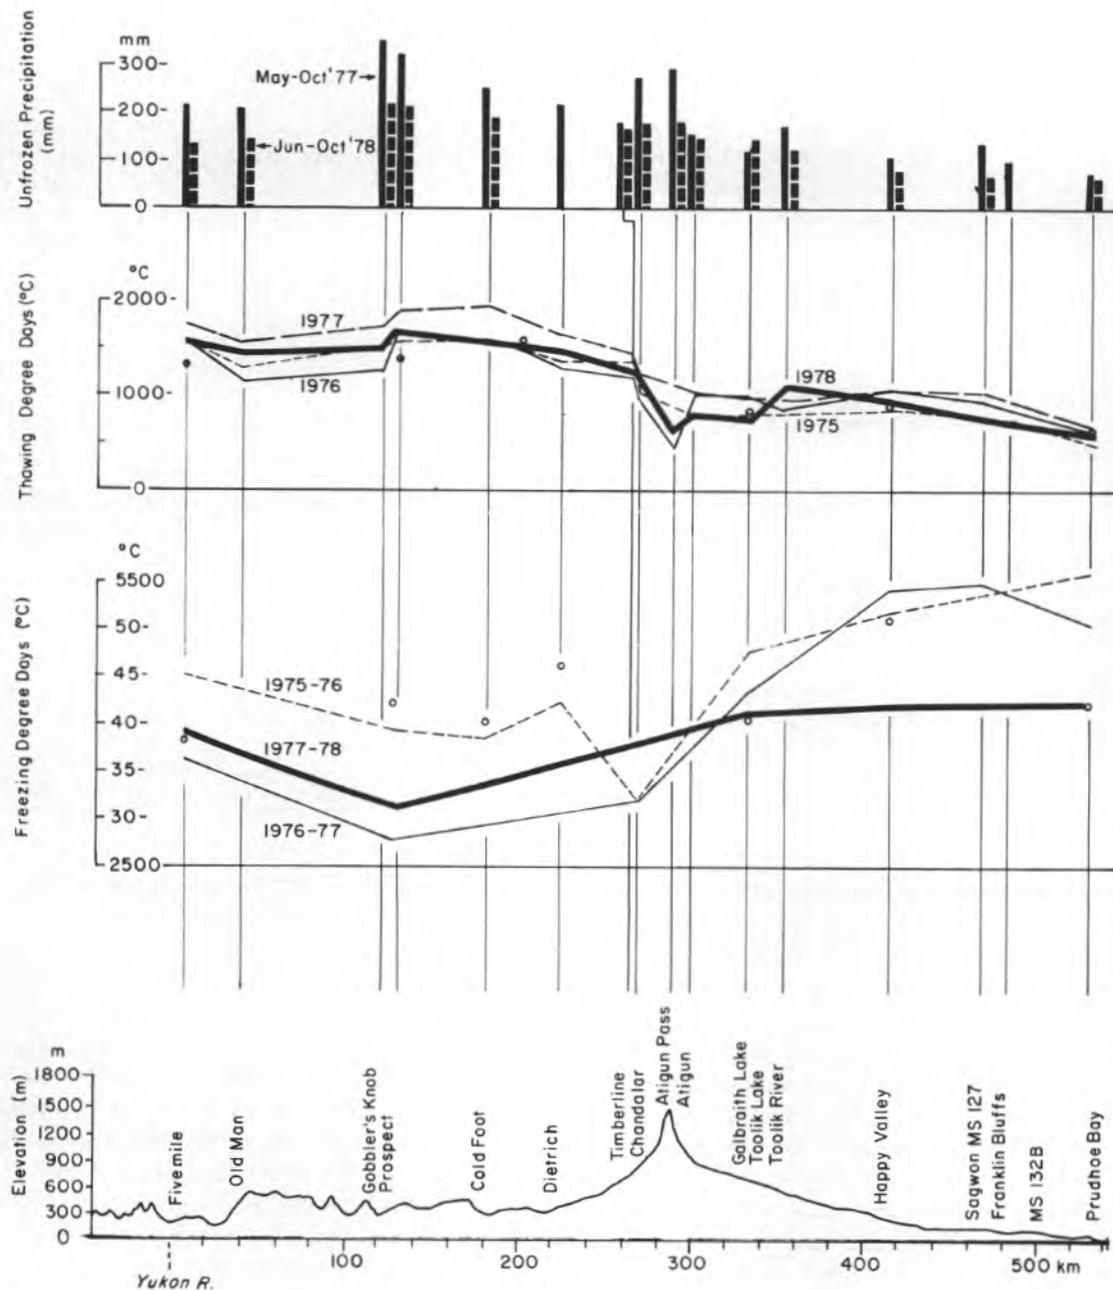
Figure 13. Climatic transects for the Haul Road, illustrating the variation of precipitation, thawing, and freezing degree-days ( $^{\circ}\text{C}$ ) over the transect. Small circles on the thawing and freezing degree-day cross sections indicate values obtained by averaging available data prior to 1975.

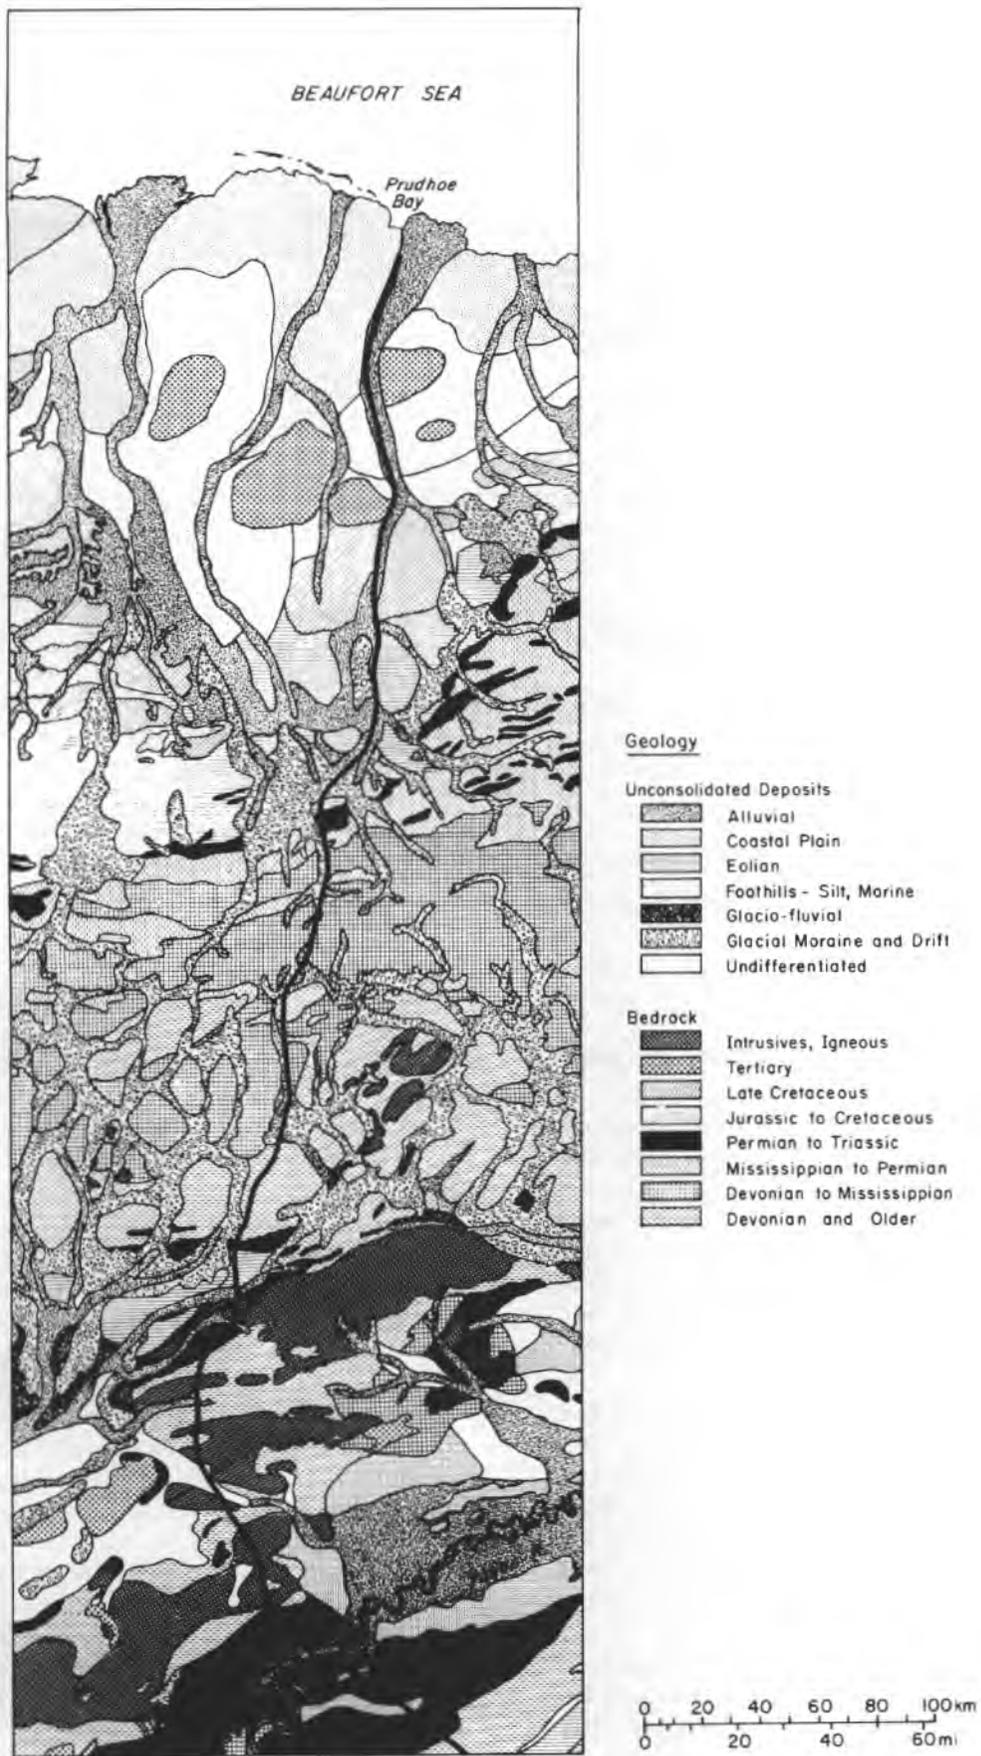
Figure 15. Bedrock and surficial geology of the Haul Road (map modified from University of Alaska 1975).

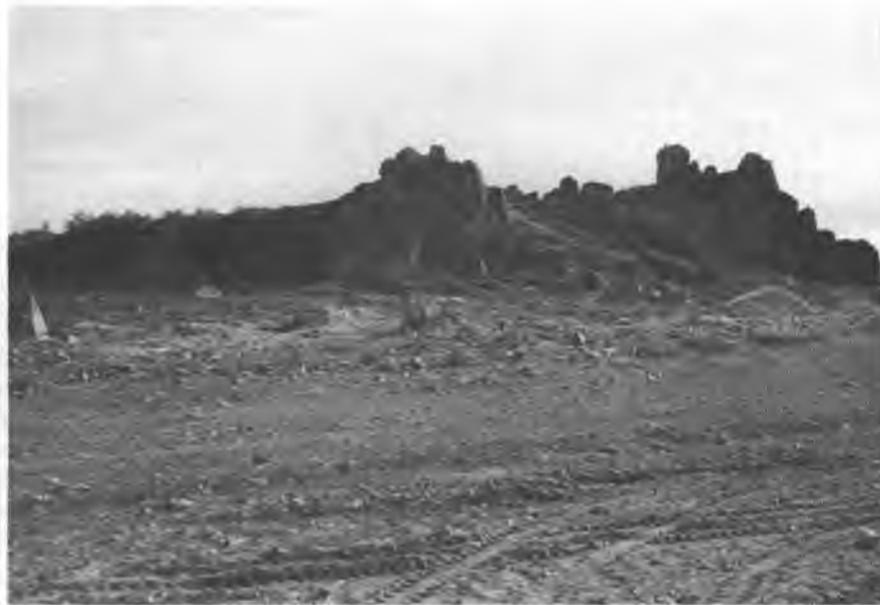
Figure 16. Bedrock remnant of tors in vicinity of Finger Mountain, south of Old Man Camp, 19 August 1976. Sorted stone nets surround the tors.

Tors are remnants of larger hills that were eroded under periglacial conditions. The bedrock undergoes intensive frost shattering and the resulting debris is moved downslope from its source by solifluction, slope wash and other mass-wasting processes (French 1976). Gently inclined slopes and benches, referred to as cryoplanation terraces, form adjacent to the tors as part of the erosional process (Reger and Péwé 1976). Once these processes reduce slope angles to the point where movement by solifluction is restricted, the frost action on the colluvial debris leads to local sorting and patterned ground development. Sorted polygons and nets with cobble and boulder margins, evidence of these processes, occur adjacent to the road (Fig. 16).

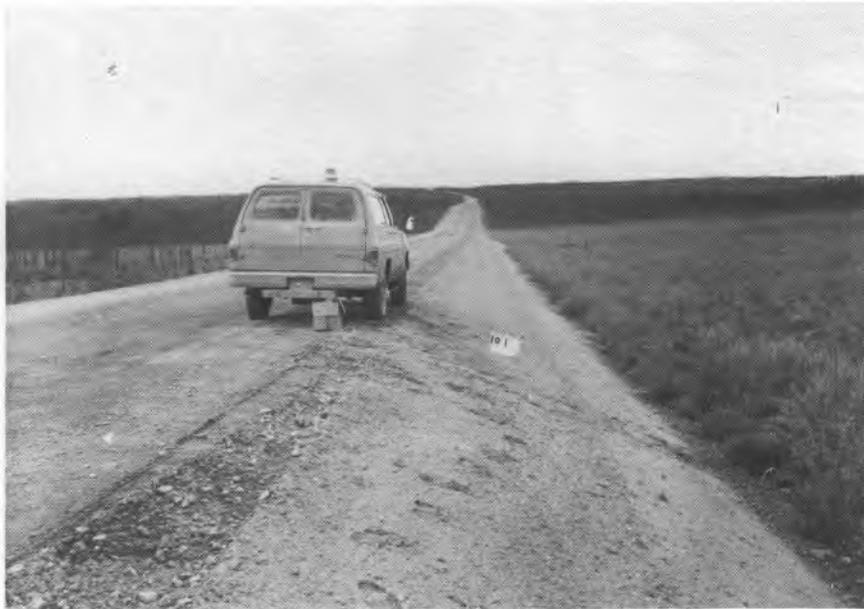
*Figure 18. No Name Creek site (CRREL site 82-1), 21 August 1976. In the foreground is the tussock-covered valley which contains ice wedge polygons and thermokarst ponds. In the background is the poorly drained black spruce forest.*

Examples of ice-rich permafrost occur at several locations on this portion of the road. At No-Name Creek (milepost 23), sediments beneath and adjacent to the road are mainly poorly drained, fine-grained deposits of eolian, colluvial and alluvial origins. The depth of thaw between the large tussocks that cover the valley bottom is less than 0.2 m (Fig. 18). The presence of massive ice in the form of wedges is indicated by the polygonal pattern visible on aerial photographs and by thermokarst ponds.

ground view of which is shown in Figure 18. The vegetation map (Fig. 35) is derived from the vegetation portion of the master map code. In forested areas the vegetation codes include dominant tree taxa, size and density of trees, and the understory communities. The vegetation communities portrayed on the master maps are considered unique to a particular map, so that no two maps have the same code, even though some communities may be very similar. In the vegetation map the names of the individual communities consist of three parts: 1) a site moisture category, 2) a series of representative

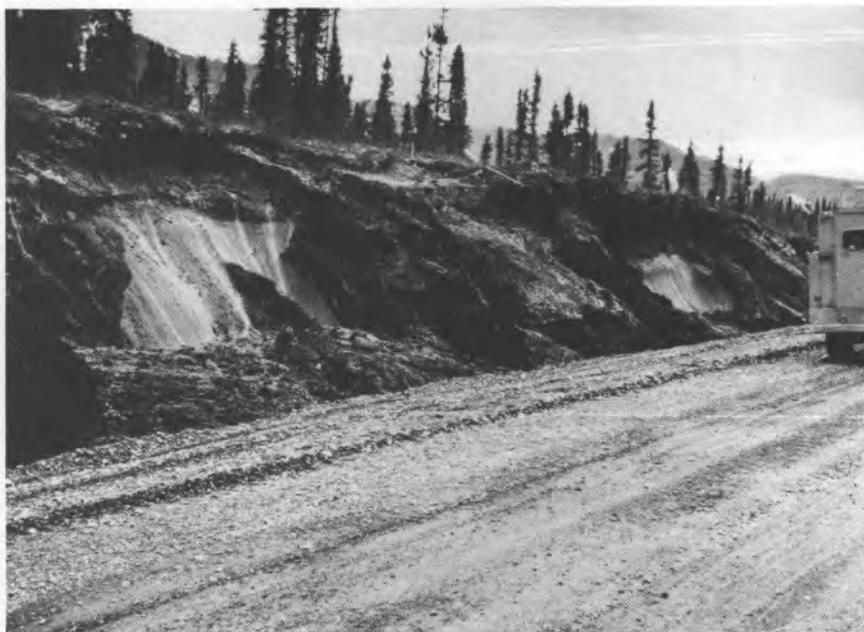
*Figure 19. Exposure of ice wedges on the south side of Rosie Creek, 30 May 1975.*

The excavation of the road cut on the south side of Rosie Creek exposed ice wedges in fine-grained solifluction deposits derived from glacial till (Fig. 19). These wedges began to melt almost immediately upon exposure and, although covered by slope materials, were still melting in August 1978. Downslope to the west of the road cut, the thermokarst pond and small

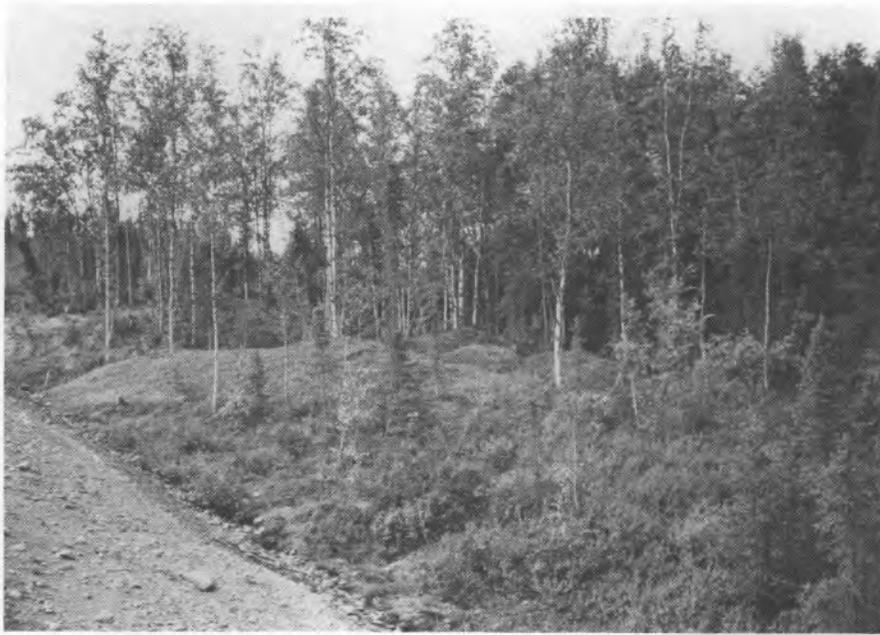
*Figure 20. Siberian cemetery mounds, or baydzherakh, downslope from the exposed ice wedge cut shown in Figure 19, 20 August 1976. Mounds are erosional remnants left after ice wedges have melted.*

hummocks, referred to as Siberian cemetery mounds or *baydzherakh*, indicate that these sediments are also ice-rich (Fig. 20 and 21).

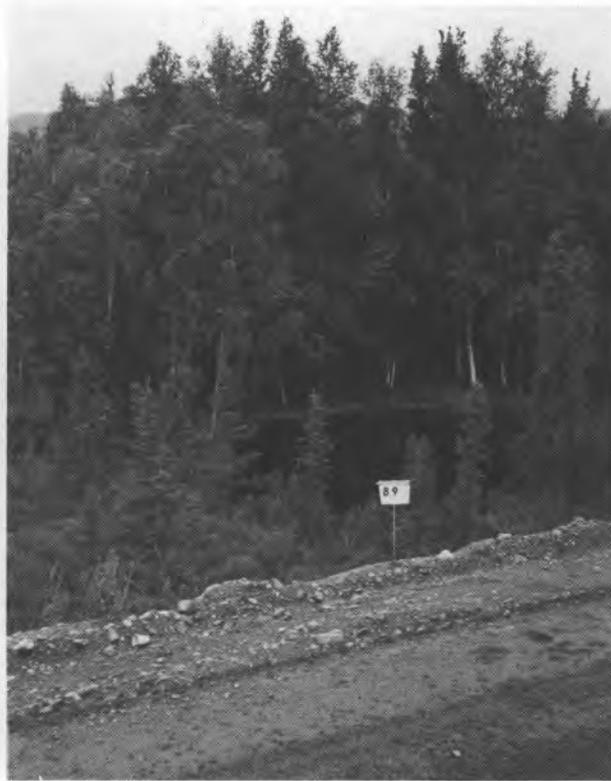
*Figure 21. Small thermokarst pond adjacent to moundy area shown in Figure 20, 20 August 1976. The mounds and pond indicate ice-rich permafrost.*

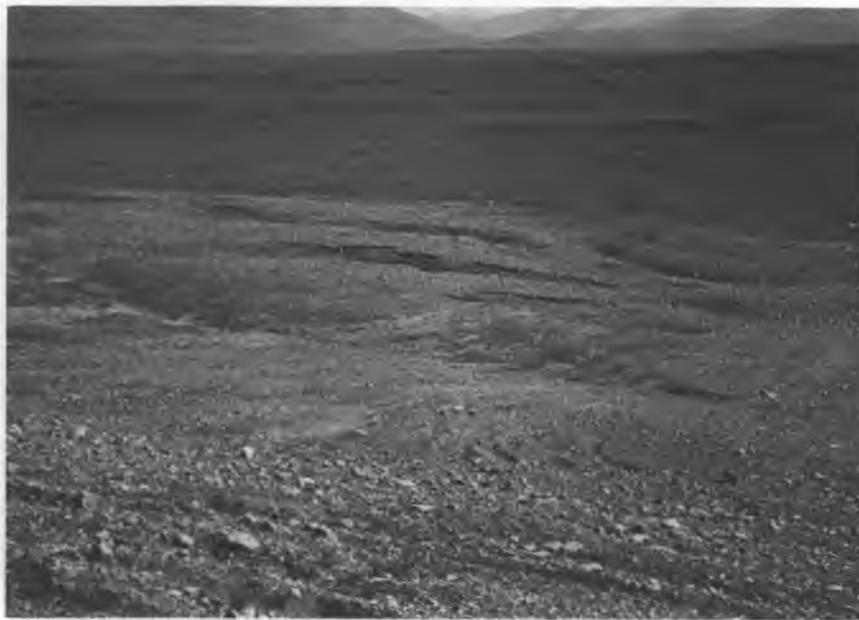
*Figure 23. Collapse features in material site 119-4 presumably the result of melting of large masses of ground ice, 19 July 1977.*

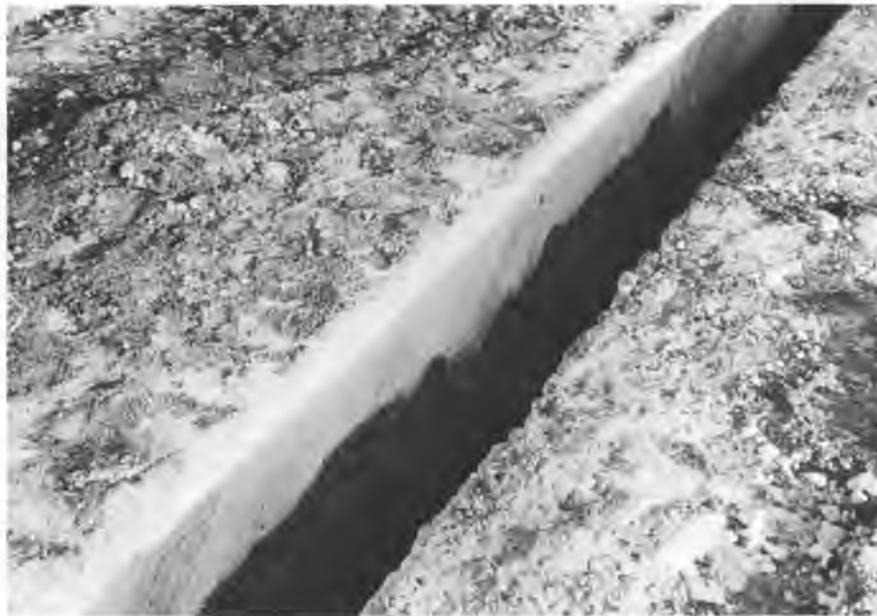
*Figure 24. Closeup of trench from which ice wedge distribution was logged.*

The road crosses numerous drainages that contain well-developed ice wedge polygons such as are observed both north and south of Happy Valley Camp. In a drained lake basin immediately south of the access road to MS 124-1, the fuel gas line trench exposed a 1-km-long section of ice wedges. Figure 24 is a ground view looking into the trench, and Figure 25 is an idealized cross section showing the spacing of these wedges. The irregular distribution of the tops of these wedges indicates that they were formed and modified by several cycles of development and degradation. VSM logs in this area often show large amounts of massive ice present.

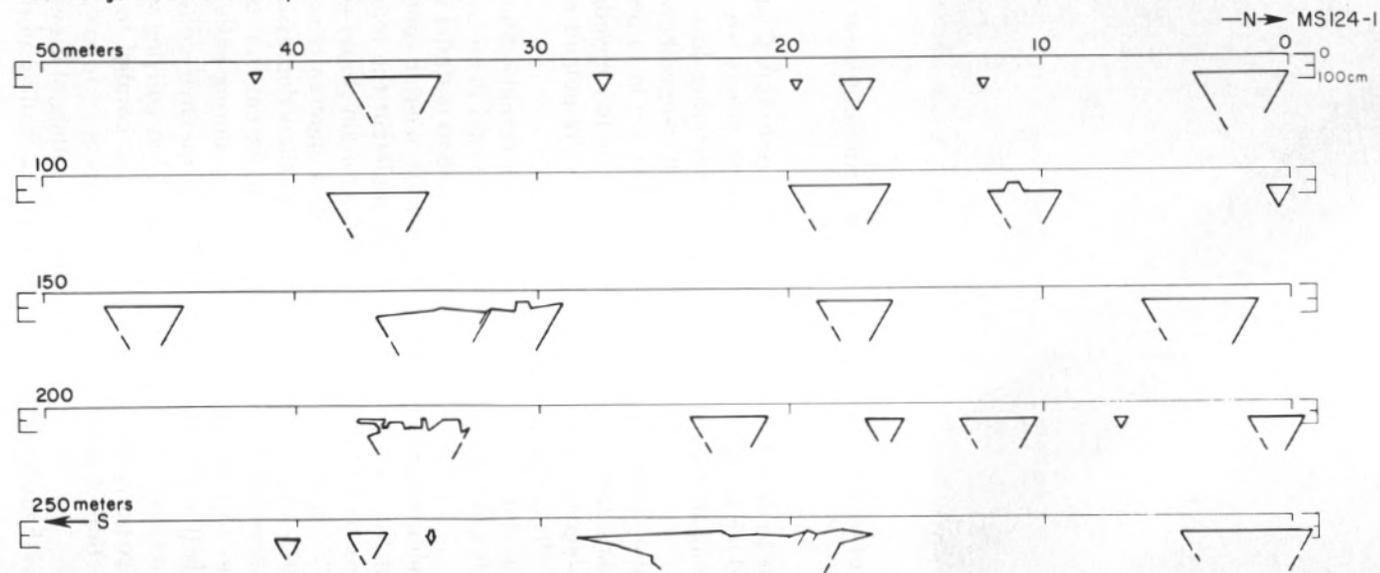
Figure 25. Idealized cross sections of fuel gas line trench immediately south of MS124-1 access road. Tops of wedges are to horizontal scale, but shapes are idealized and not to vertical scale (observed by J. Brown, 1976).

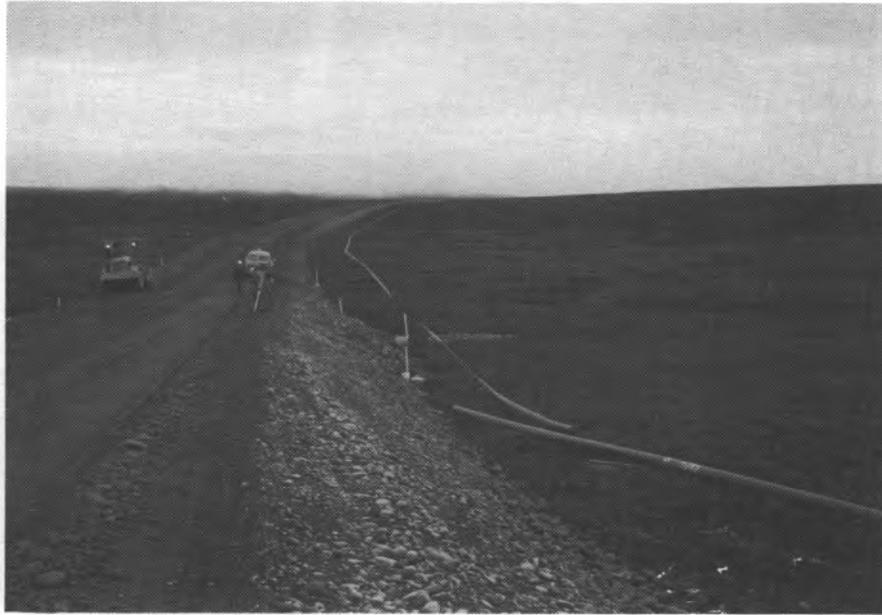
*Figure 26. Polygonized drainage north of Happy Valley Camp, CRREL site 124-1, on 18 August 1976 prior to burial of fuel gas line.*

Immediately north of Happy Valley Camp, the road cuts across several more basins and drainages that contain ice-wedge polygons. These basins are filled with organic-rich silts and sands that are locally coarse-grained (Fig. 26). A thaw lake adjacent to the road is actively eroding into an ice-rich, peaty bluff (Fig. 27).

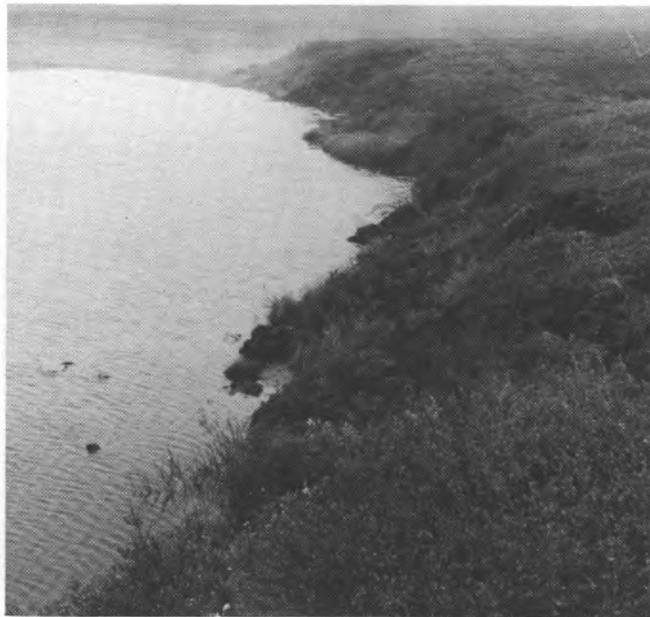
*Figure 27. Thaw lake actively eroding into organic- and ice-rich frozen sediments, 22 July 1977.*

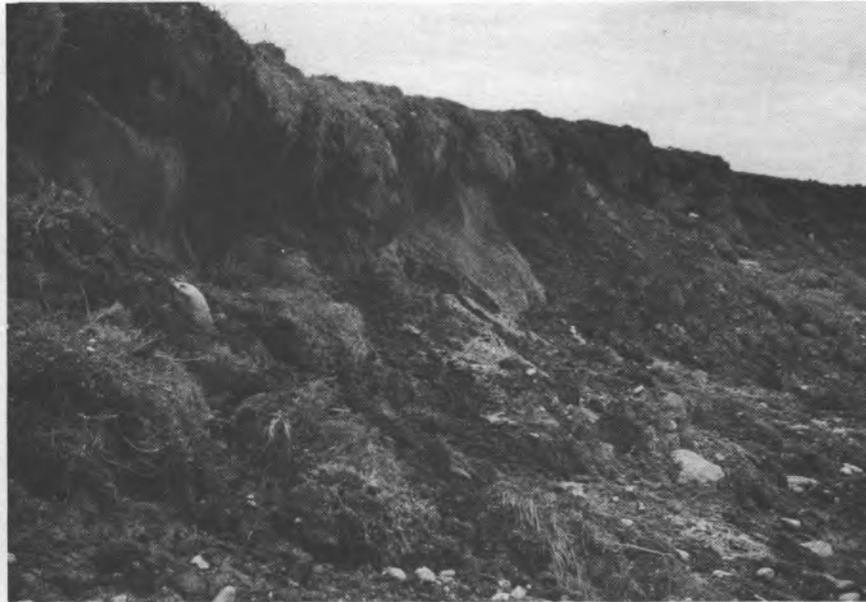
*Figure 28. Happy Valley road cut on 15 June 1975 showing exposed ice wedges and slumping tundra mat. See Hamilton (1979) and McPhail et al. (1976) for additional 1975 photographs and discussions.*

The Happy Valley road cut encountered ice wedges and ice-rich permafrost at the top of a slope composed of colluvial debris on bedrock (McPhail et al. 1976, Hamilton 1979). Figure 28 is a photograph obtained in early 1975 and shows several exposed ice wedges. The slope has gradually receded as the ice continues to melt. As can be seen in the 1977 photographs (Fig. 29), the lower portion of the road cut also shows subsidence. Ample evidence of ice wedge polygons in the area is seen upon close inspection of aerial photographs.

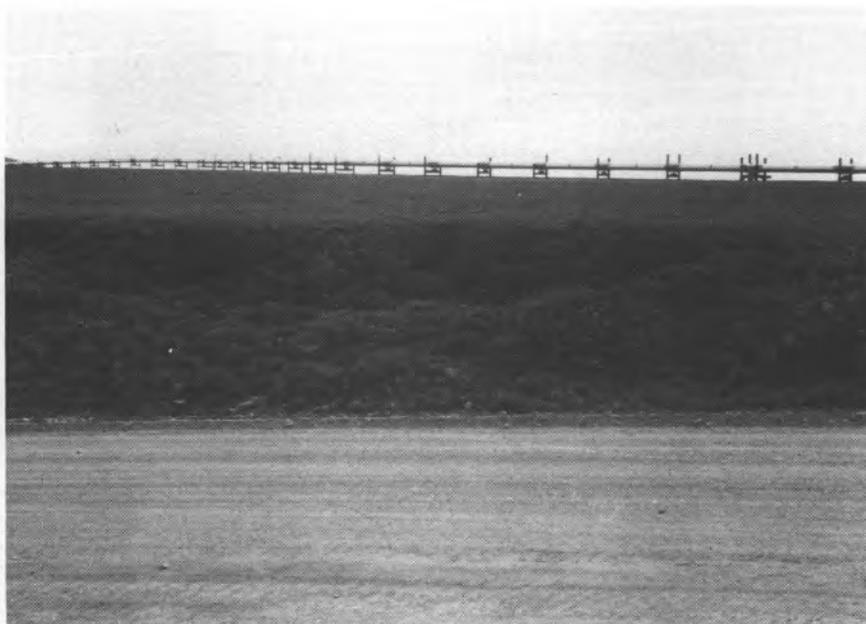
*Figure 29. Happy Valley road cut on 21 July 1977 showing slumped tundra mat and the thawed areas previously occupied by ice wedges. The elevated oil pipeline is seen in the background.*

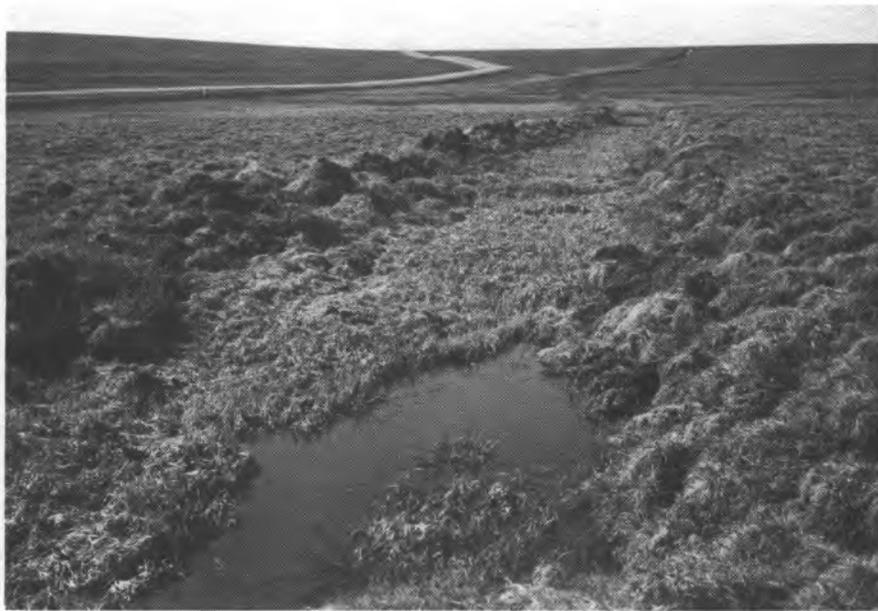
*Figure 30. Shallow thermokarst pond formed as ice wedges melted out following blading of tussock-covered tundra (CRREL site 127-2, 24 June 1976).*

site 127-2 (see App. C maps), a number of such thermokarst ponds are found (Fig. 30). Pond depths, indicating loss of volume due to ice wedge melt, ranged between 38 and 67 cm and averaged 50 cm in 13 ponds measured. Thermokarst pits due to ice wedge melt are also present in the gravelly upland material sites at MS127-2.1B.

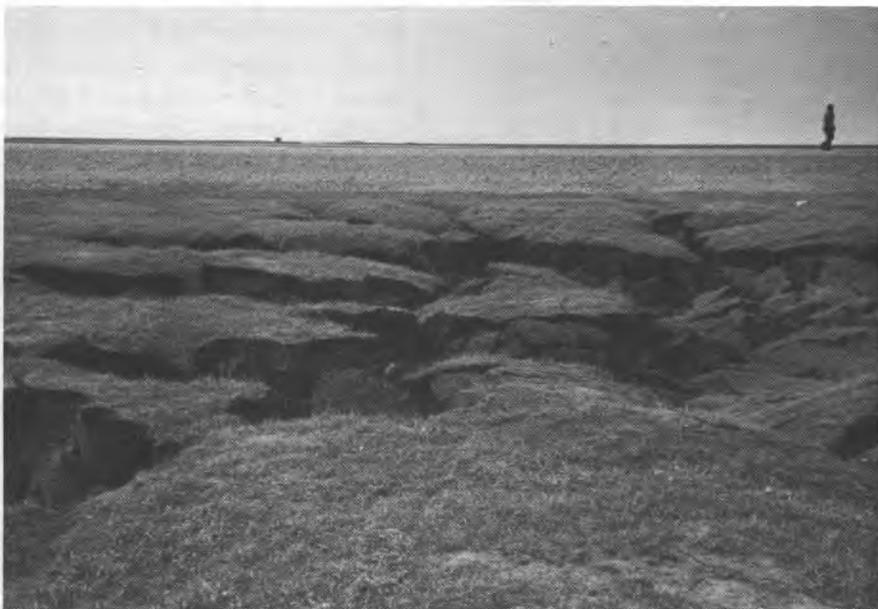
*Figure 31. Erosion channels adjacent to road at MS135-A, B, C caused by melting of ice-rich permafrost, 24 June 1976. Although the pattern resembles polygonal ground, some horizontally bedded massive ice was observed in the exposed cuts.*
