*Environmental engineering and ecological  
baseline investigations along the  
Yukon River-Prudhoe Bay Haul Road*

Jerry Brown and Richard L. Berg, Editors

September 1980

UNITED STATES ARMY  
CORPS OF ENGINEERS  
COLD REGIONS RESEARCH AND ENGINEERING LABORATORY  
HANOVER, NEW HAMPSHIRE, U.S.A.

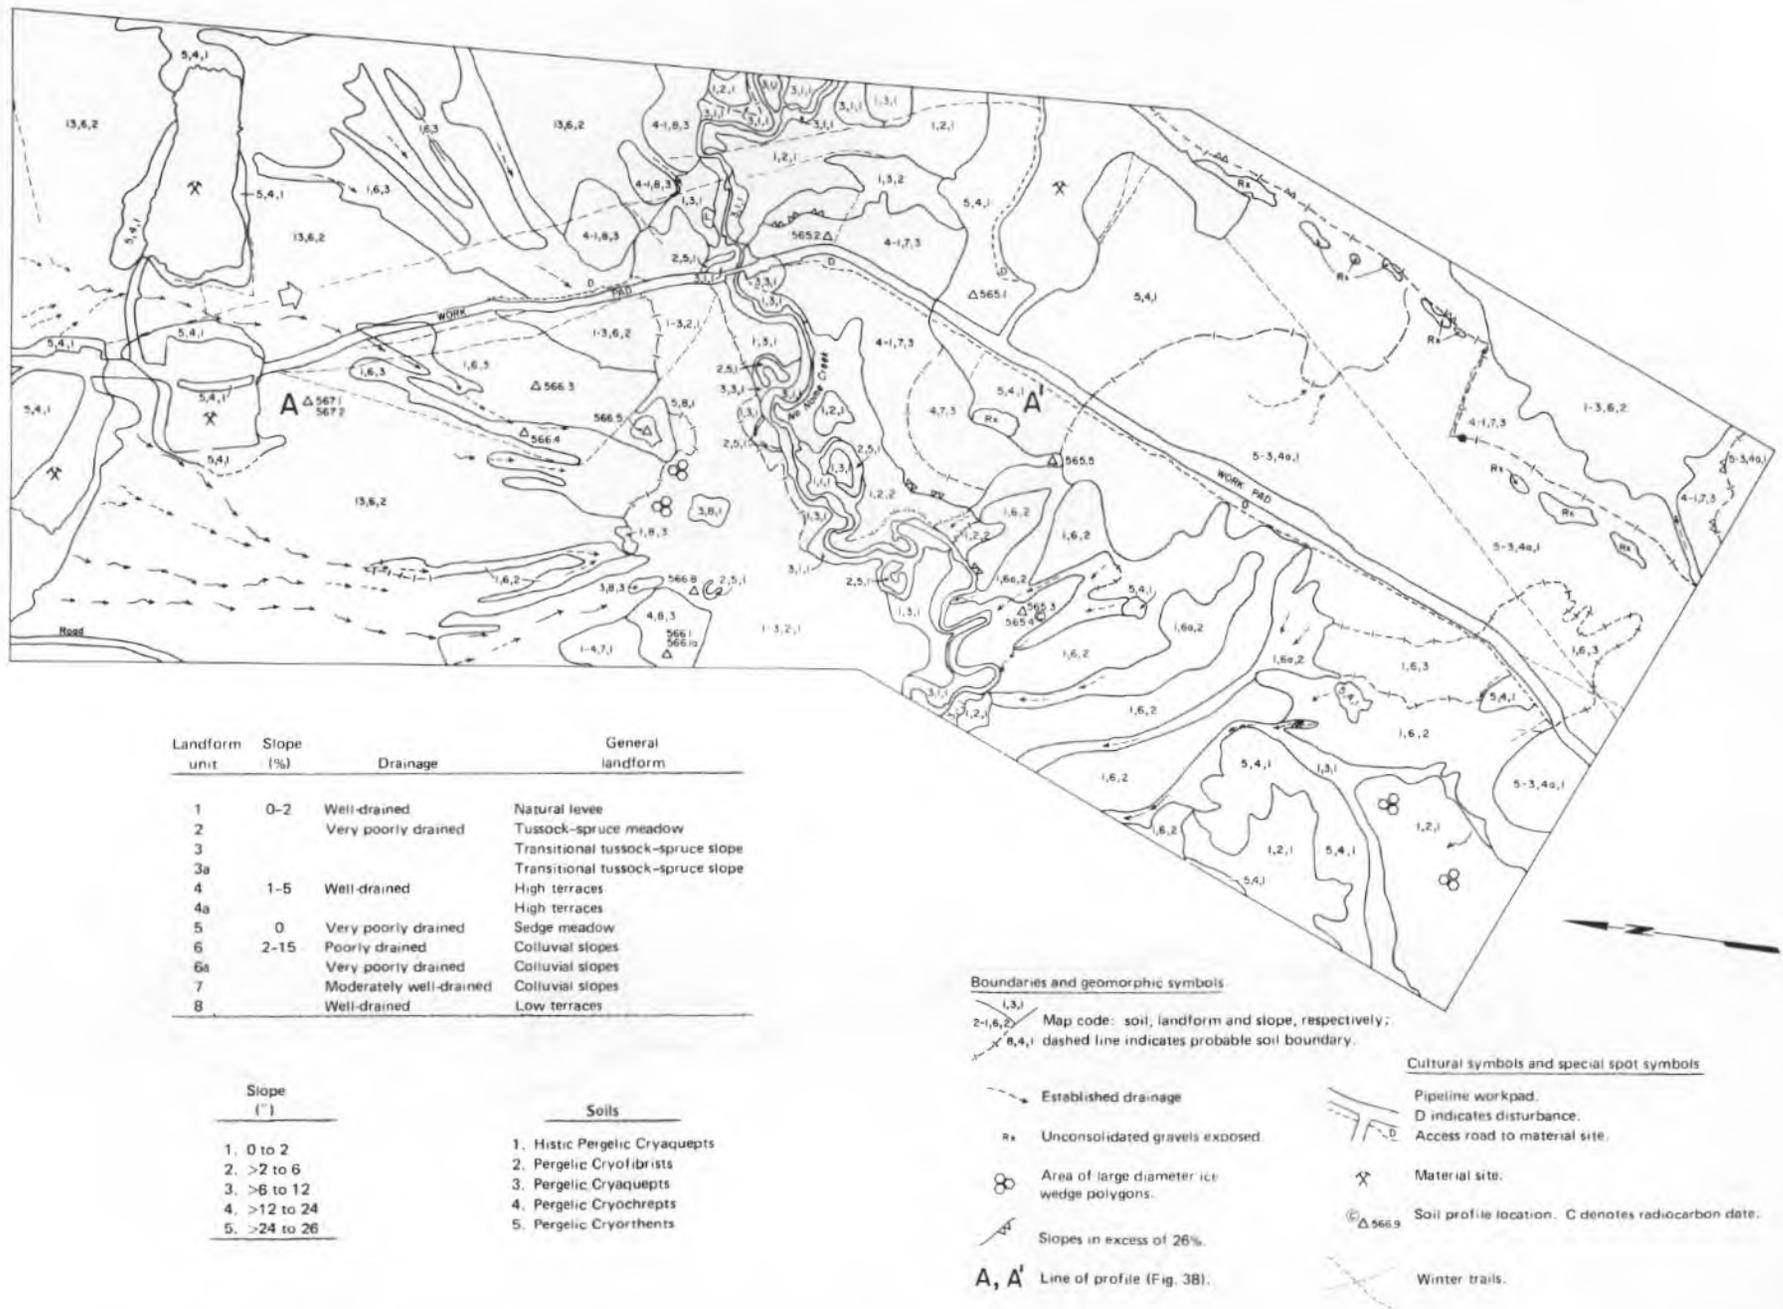
Figure 37. Soil-landform map of the No Name Creek site, mile 21.2-23.0, Haul Road, September 1978.

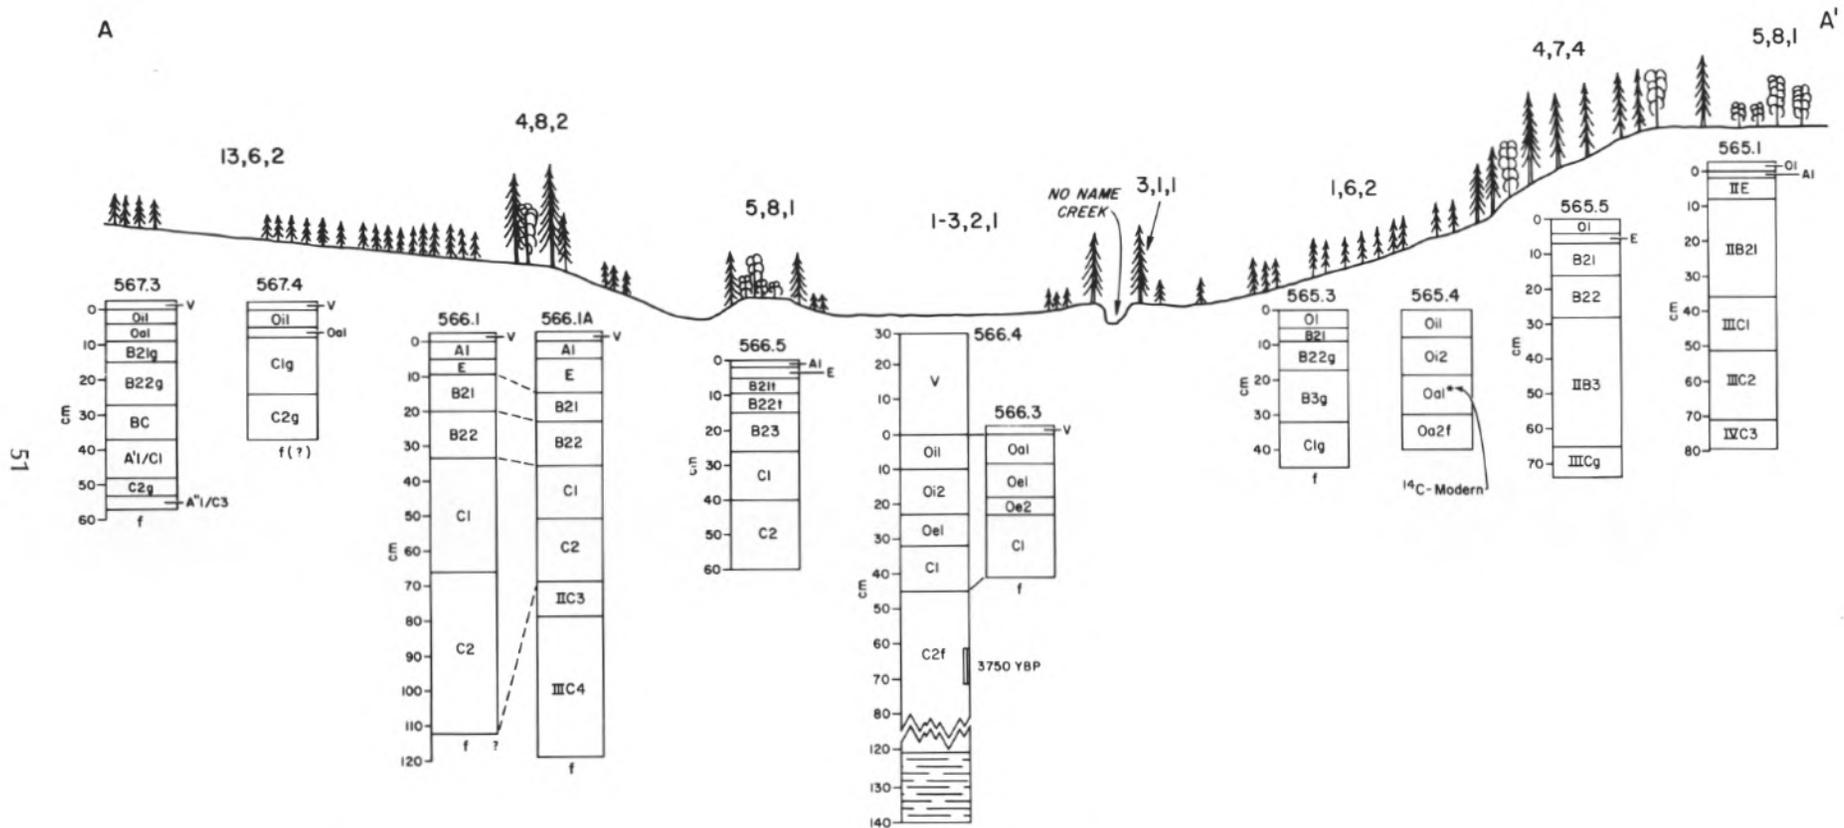
Figure 38. Idealized section projected along line A-A' in Figure 37 showing relationship among soils, vegetation and the principal landforms. Soil-landform unit designation (Fig. 37) appears above the section. Horizontal distance is approximately 2.7 km. Maximum relief is approximately 100 m.

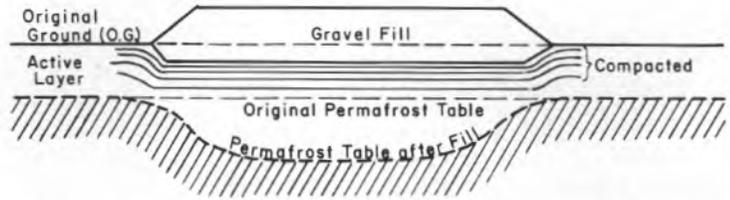
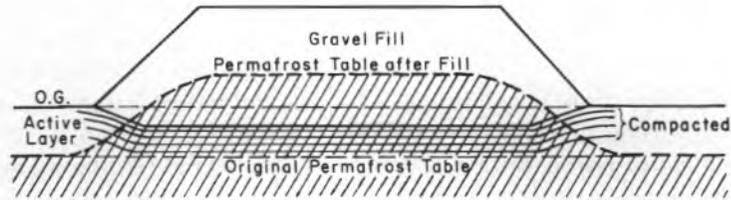
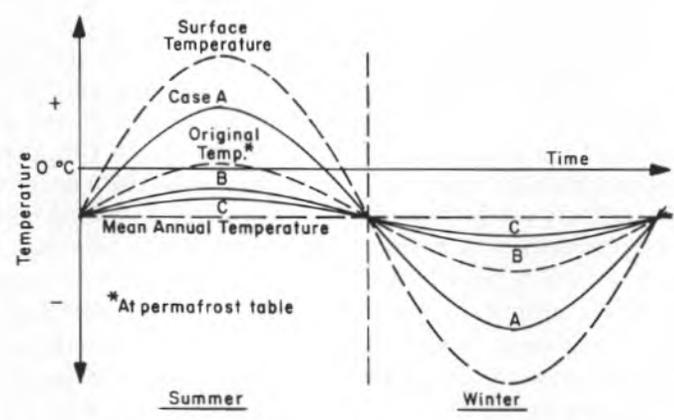
a. Effect on permafrost table if insulating effect of fill plus compacted active layer is less than the insulating effects of original active layer (from Ferrians et al. 1969), an example of design method 1.

b. Effect on permafrost table if insulating effect of fill and active layer is greater than the insulating effect of the original active layer (from Ferrians et al. 1969), an example of design method 3.

d. Effects of cases a, b, and c on amplitude of seasonal temperature variation at original permafrost table (modified from Ferrians et al. 1969).

Figure 39. Effect of gravel fill and insulating layers upon thermal regime.

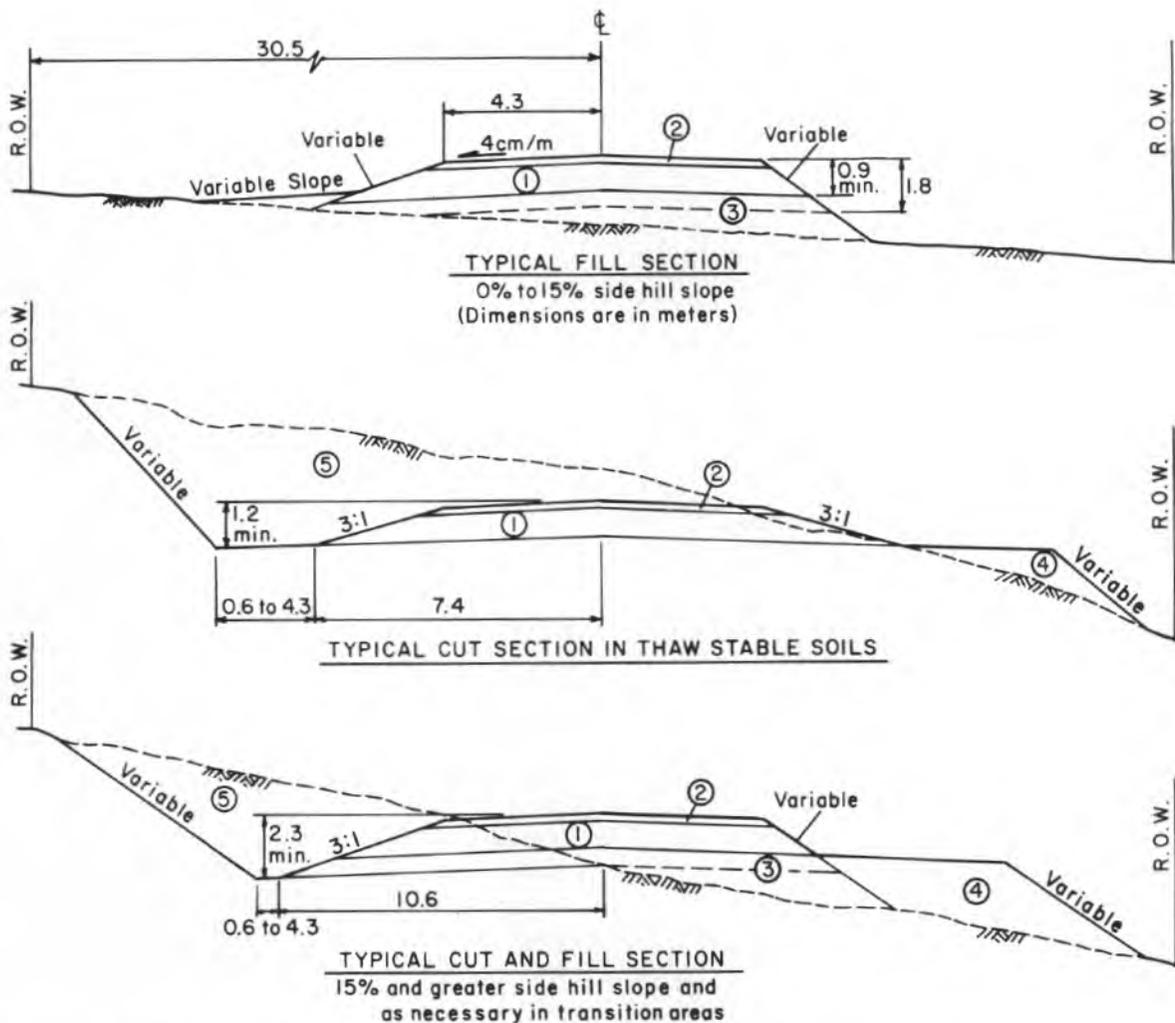
Figure 40. Typical Haul Road cross sections (Alyeska Pipeline Service Company 1971), with 1) select material (borrow excavation—common); 2) 15-cm surface course; 3) borrow excavation (common), borrow excavation (rock), suitable unclassified excavation or rock excavation; 4) available waste disposal area (maximum elevation not to exceed bottom of select material); 5) unclassified excavation and/or rock excavation.

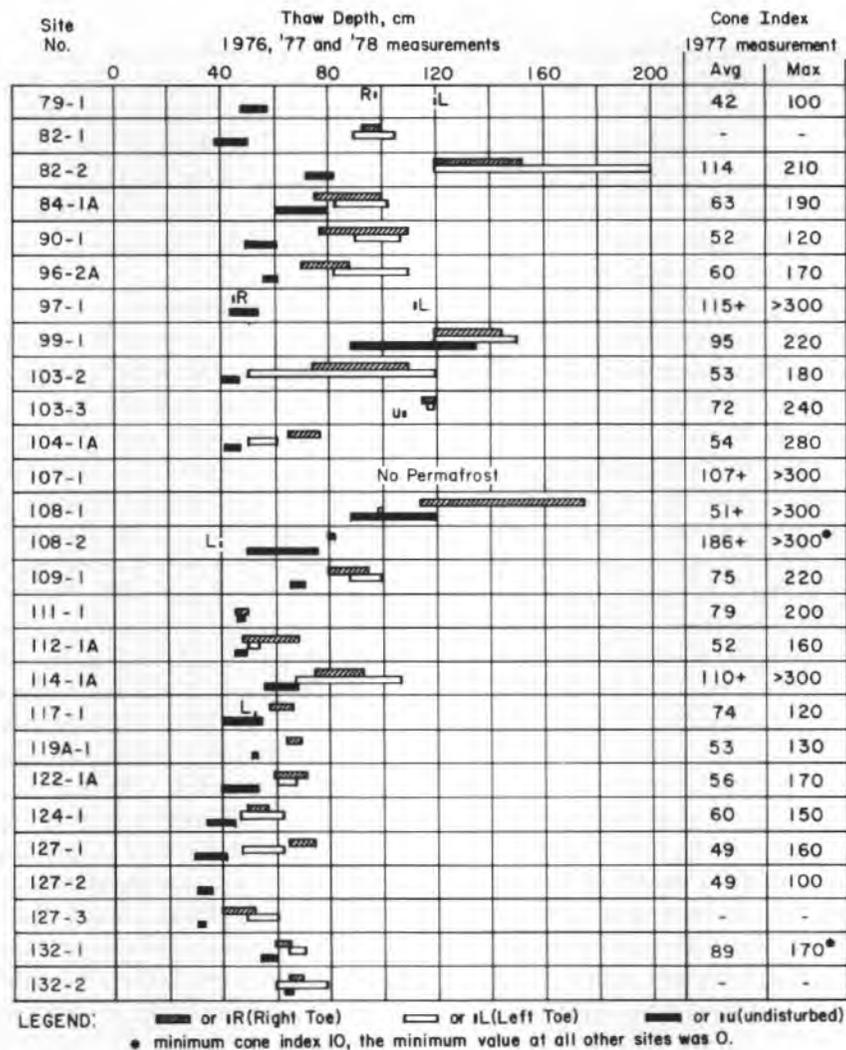
Figure 43. Thaw penetration and cone penetrometer index values of each test site.

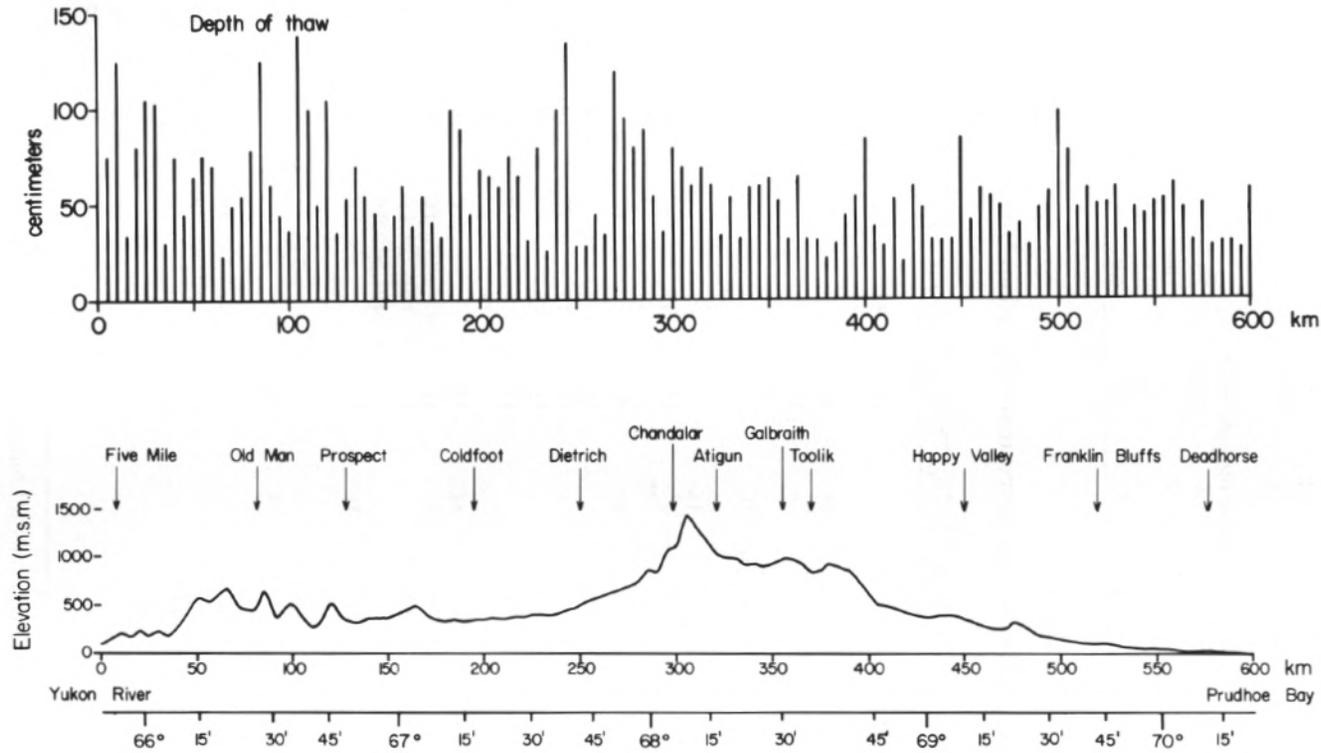
Figure 44. Distribution of thaw depths at 5-km intervals along the Haul Road during summer 1977. (Data from Komárková, unpublished).

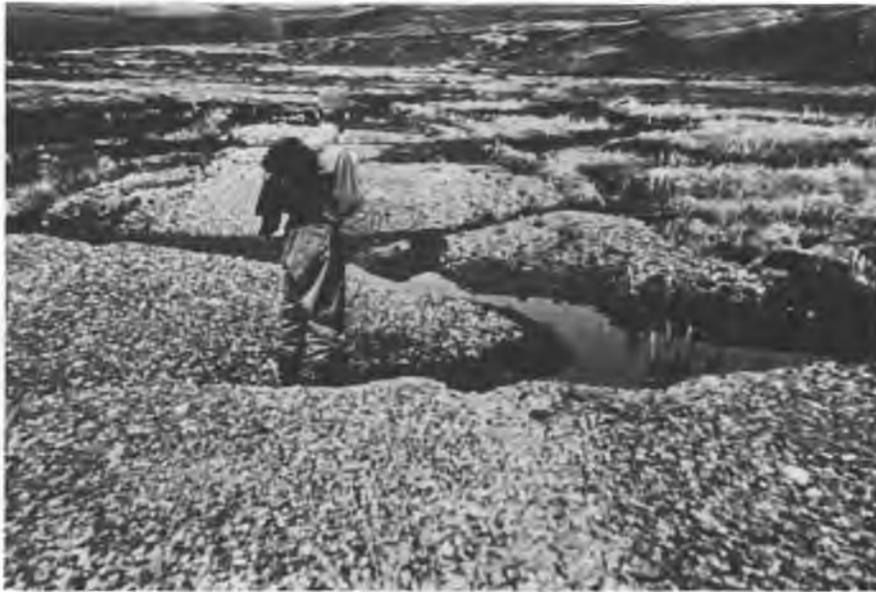
Figure 47. Gravel road showing severe differential subsidence caused by thawing of ice-wedge polygons in permafrost, Umiat, Alaska.

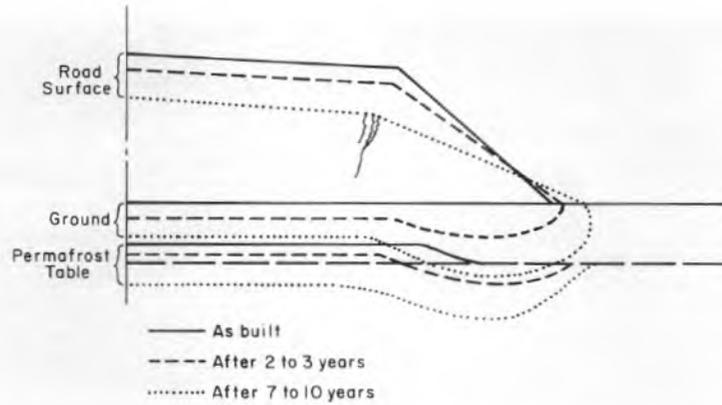
Figure 48. Idealized settlement of a roadway embankment due to thawing and consolidation of ice-rich permafrost.

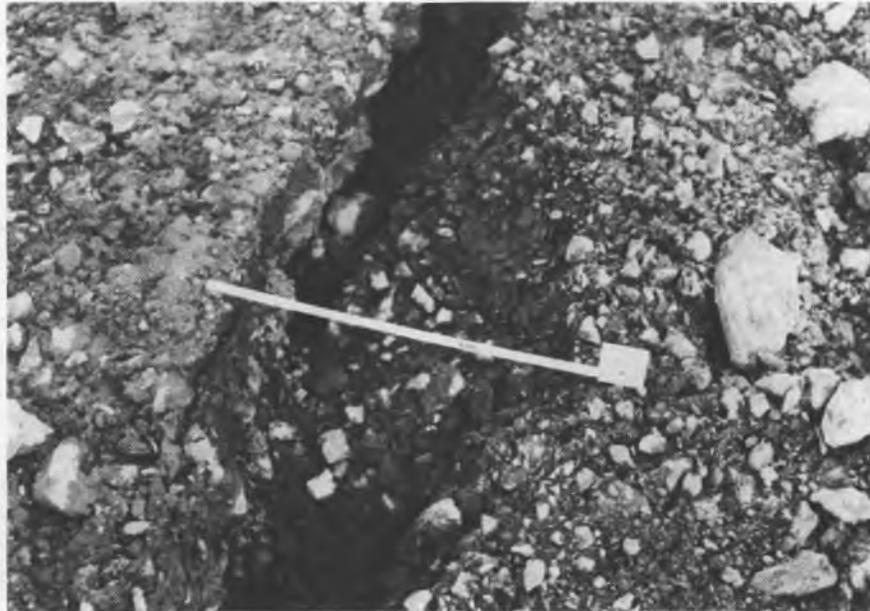
Figure 49. Longitudinal crack along roadway shoulder caused by settlement of embankment sideslope and toe (TAPS road, mile 54.9, from Clark and Simoni 1976).

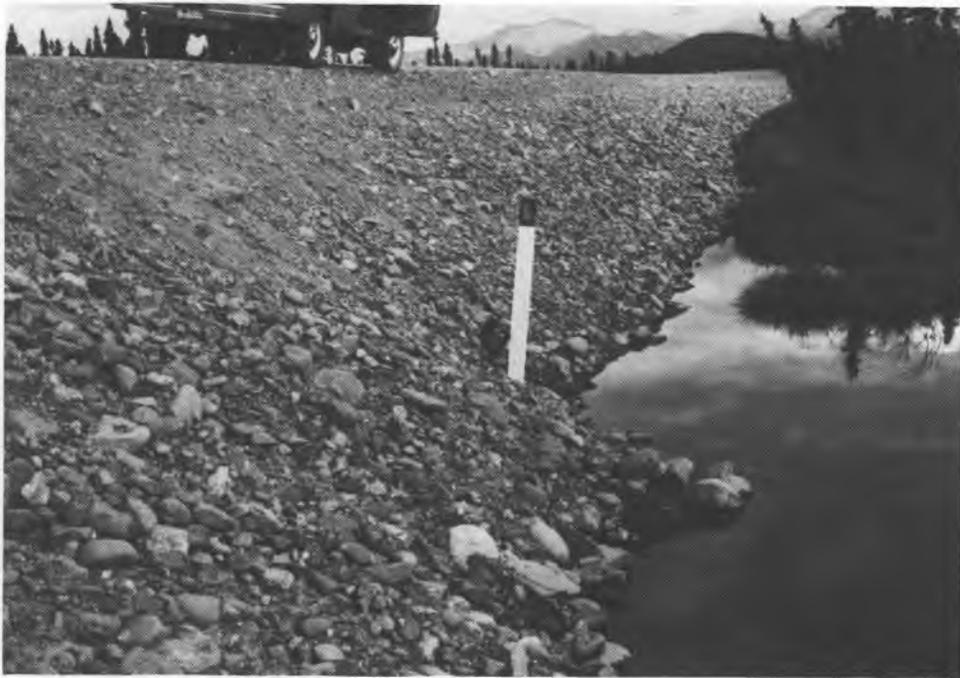
*Figure 55. Upstream ponding caused by shoulder thaw consolidation and bowing of the culvert, site 91-C1, August 1977.*

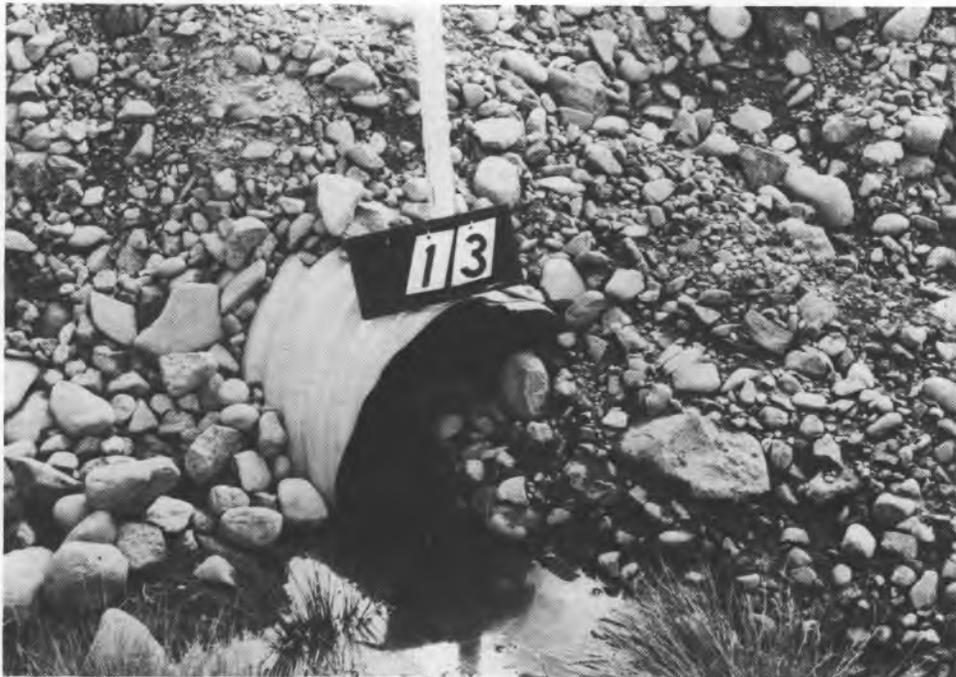
*Figure 56. "Maintenance clogging" problem caused by surface material graded down sideslope of road, site 91-C2, August 1977.*

4. The most frequent problem related to cross drainage was observed to be "maintenance clogging" of culverts. The problem is caused when short culverts are partially or entirely blocked by gravel pushed downslope from frequent grading, thereby preventing water movement through one or both ends of the culvert.

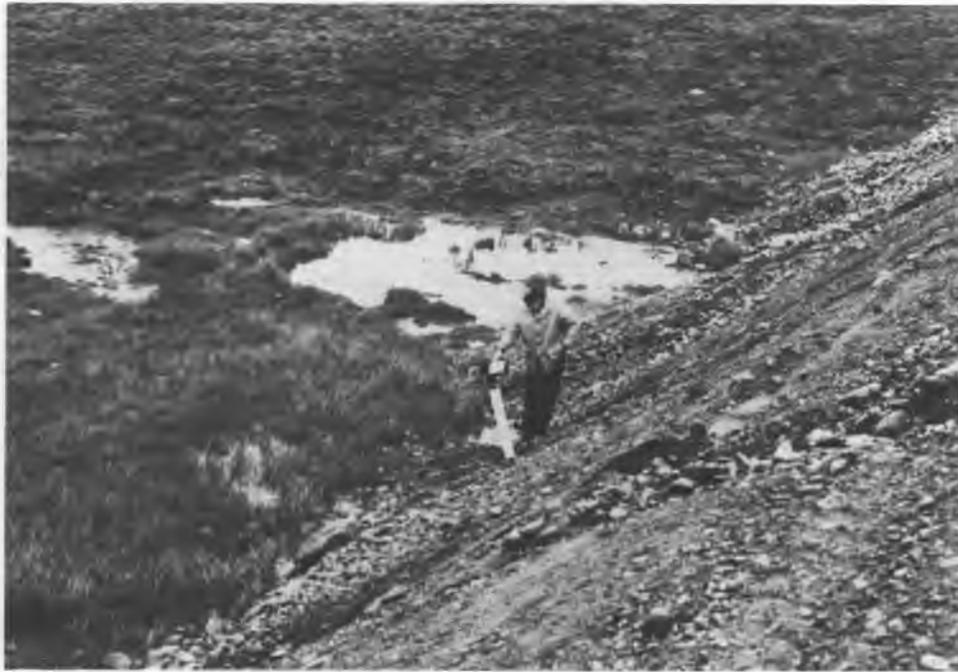
Figure 57. Maintenance clogging problem on a deep fill, site 121-C1, August 1977.

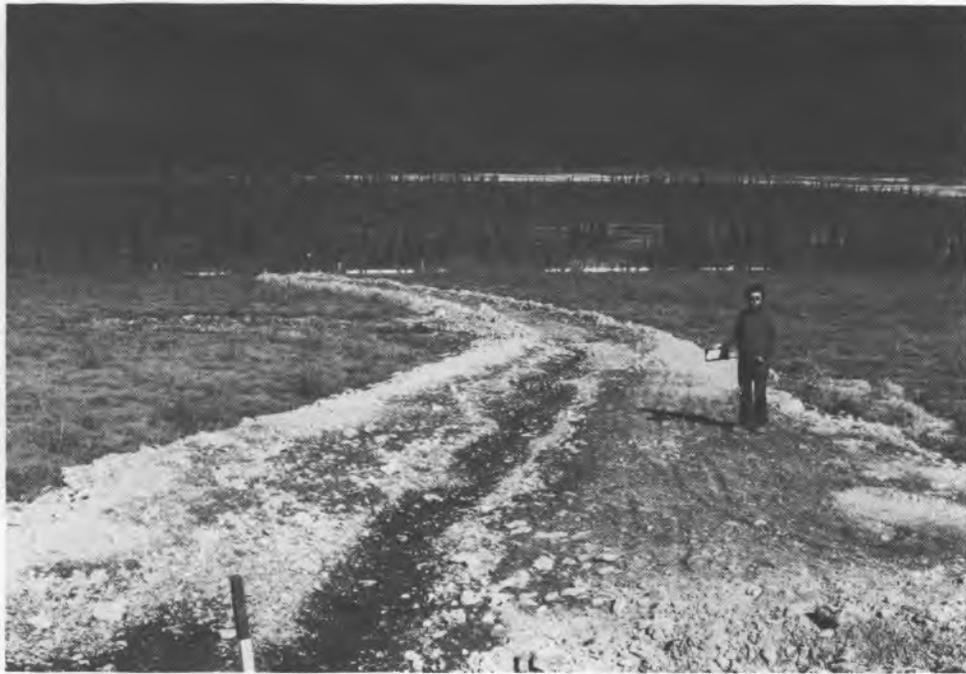
*Figure 58. Drainage channel constructed to minimize additional thermal erosion downslope from the road, site 102-C1, August 1977.*

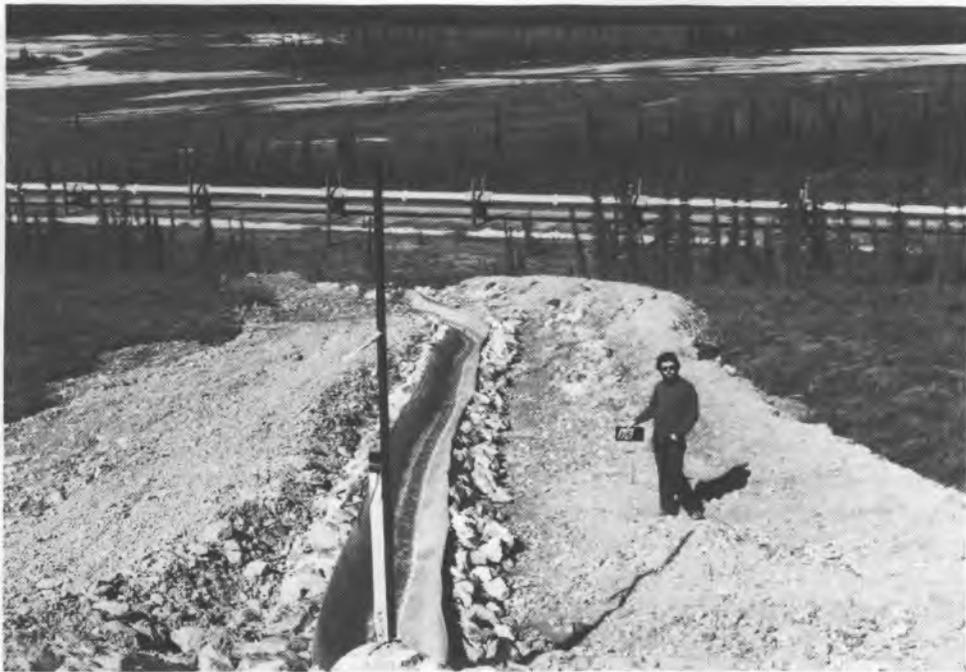
*Figure 59. Half sections of corrugated metal pipe (CMP) used to channel water downslope from culvert. The CMP sections were over a granular fill placed in a gully caused by thermal erosion, site 102-C6, August 1977.*

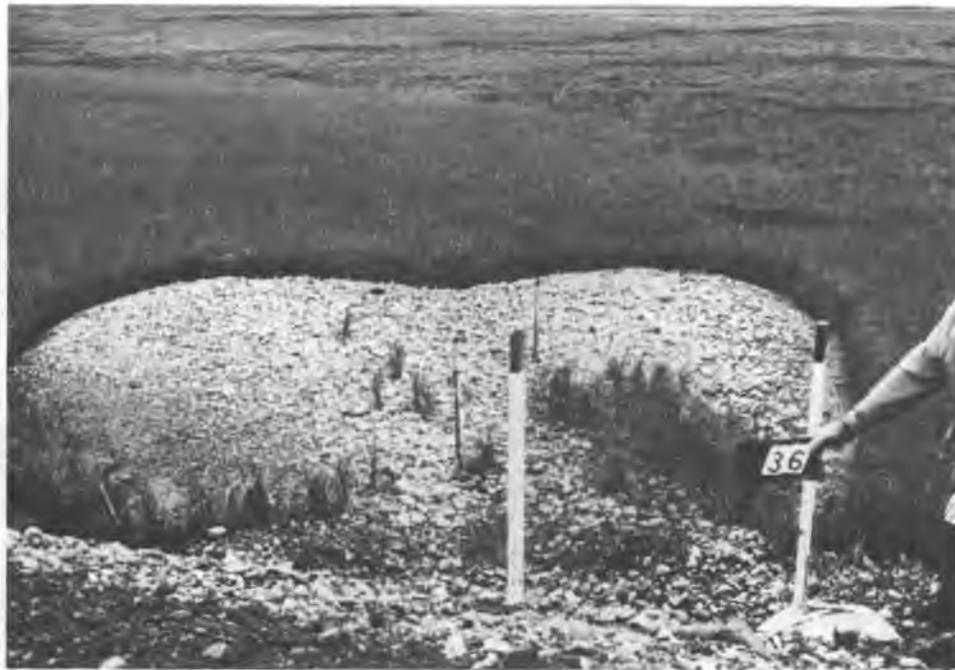
Figure 60. Debris deposit at outlet of culvert, site 132-C1, August 1977.

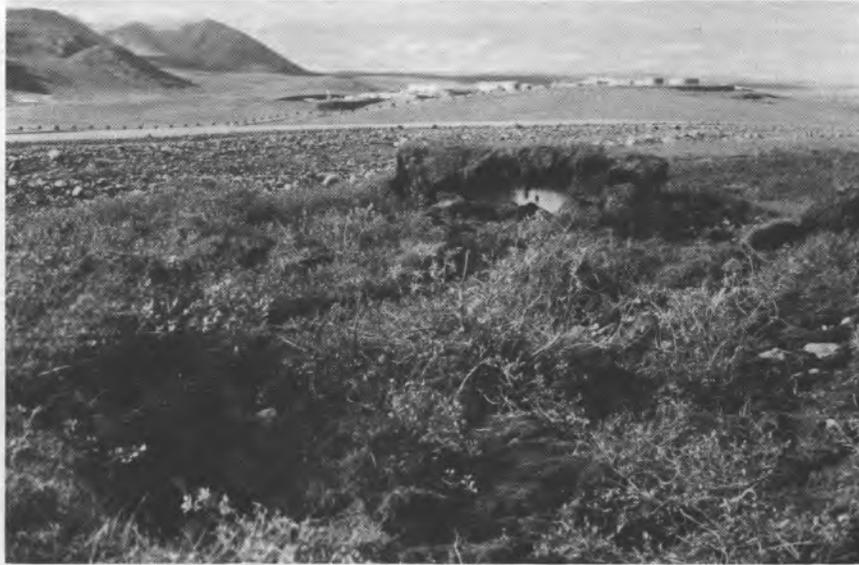
*Figure 61. Seasonal ground ice mounds upslope from the culvert at station 1198 + 50 on Haul Road segment 5 just south of Pump Station 4, August 1978.*

An example of seasonal ground ice formation induced by road construction is illustrated by the ice mounds that formed on the upslope side of the road a few kilometers south of Galbraith Lake (Fig. 61). They were observed in 1978 and appear to result from 1) downslope flow of water in the stream and/or through the active layer in the fall, 2) freezing of water and gradual blockage of the culvert, 3) freezing of accumulating groundwater at the interface of the permeable organic mat and impermeable frozen substrate, and 4) buildup of ice during the winter causing uplift and rupture of the vegetative mat. Melting

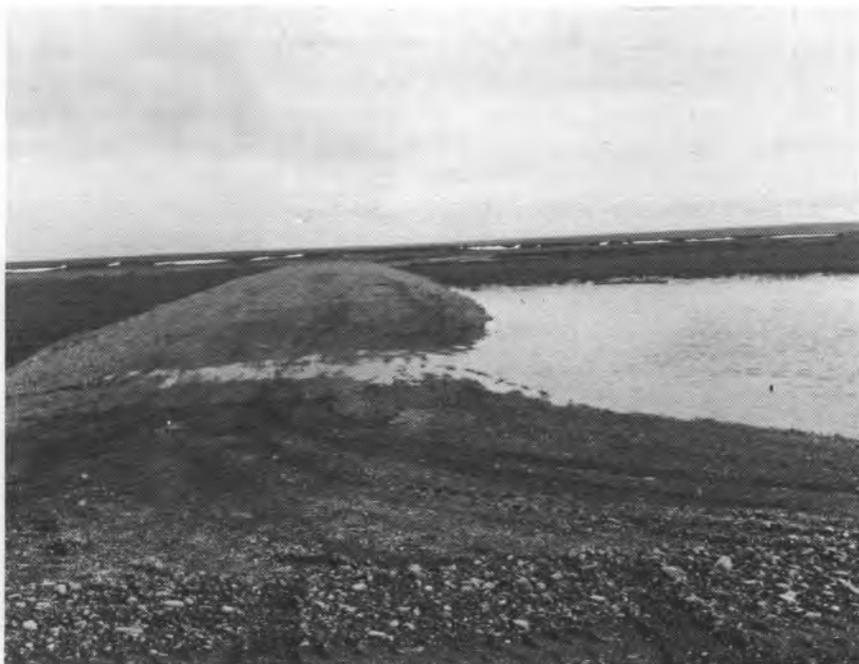
*Figure 62. Inundation adjacent to the Haul Road on the Coastal Plain was frequently observed on the southeast intersection of road and access road, 30 June 1976. In this case the ponding is overtopping the access road. Ponding generally persisted throughout the summer and eventually culverts or low water passes were installed.*

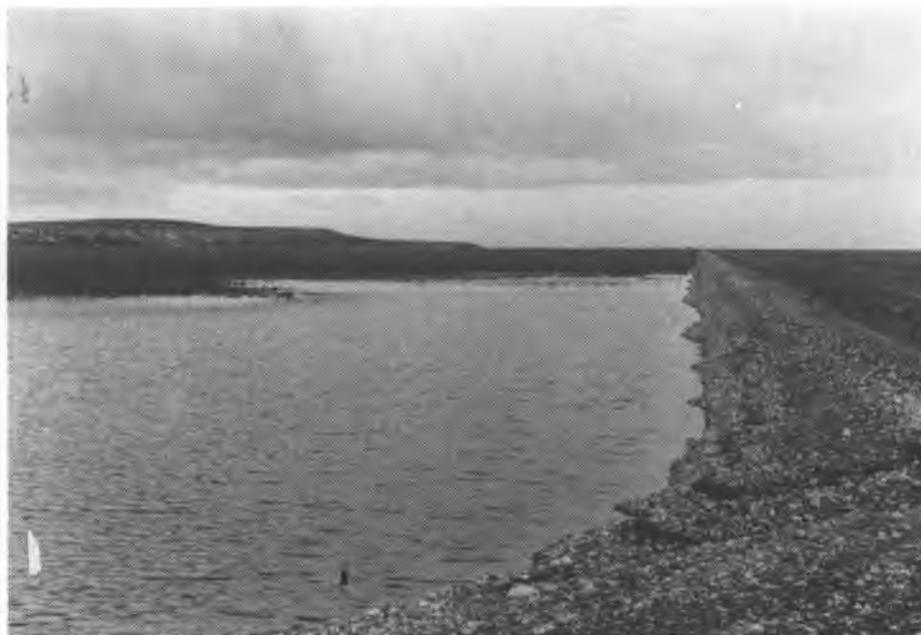
Figure 63. Inundation adjacent to the Haul Road looking upslope to the northeast by access road 133-2, 7 July 1976.

ponding water to 1 m in depth. Generally no culverts were placed under the access roads as they were used for temporary access to material sites. As a result, impoundments occurred at the upslope intersection of the Haul Road and access roads, and the water occasionally overflowed and breached the access roads (Fig. 62, 63 and 64). Some of these impoundments persisted for several summers until low water crossings through the road were constructed or culverts were installed. Thaw depths were measured in the inundated area and on the unflooded and opposite side of the access roads (Table 22). The shallow ponded areas generally show a greater depth of thaw than the undisturbed sites. If

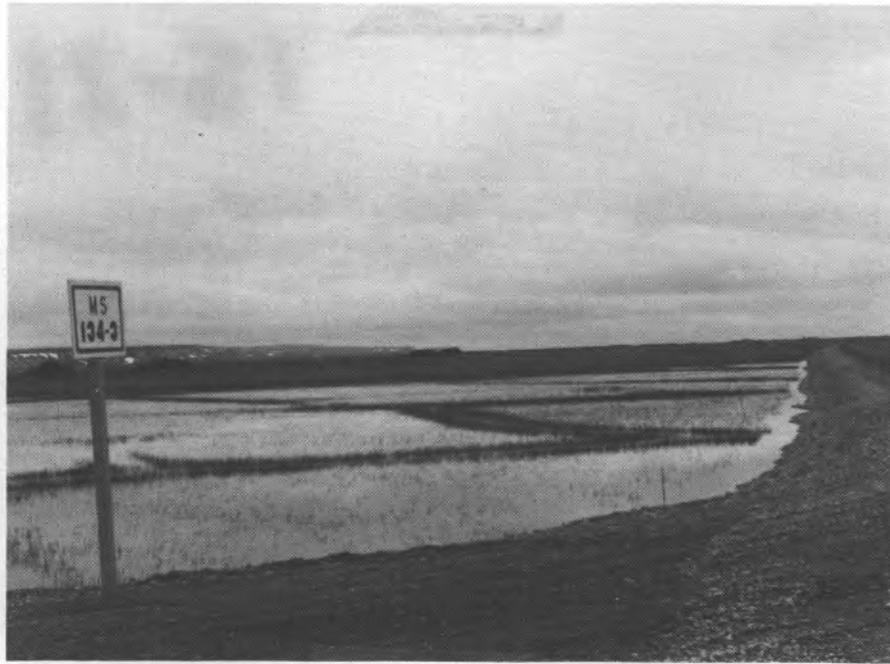
*Figure 64. Inundation adjacent to the access road for material site 134-3 showing raised edges of ice-wedge polygons, 30 June 1976.*

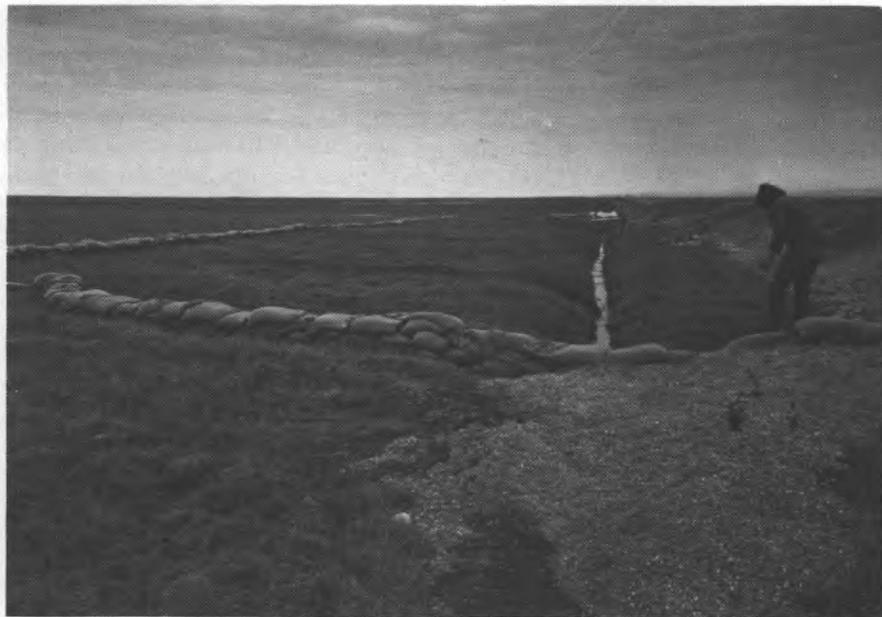
*Figure 65. Result of channelized flow over the buried fuel gas line on alignment sheet 133, 24 June 1976.*

An example of channelized flow along the Haul Road was observed about 30 km north of Franklin Bluffs Camp (Fig. 65 and 66). In this instance spring runoff became channeled in the small trench containing the buried fuel gas line, and some headward erosion of pre-existing polygons was initiated. The area was sand-bagged to control erosion and later the entire area was covered with gravel (Fig. 66).

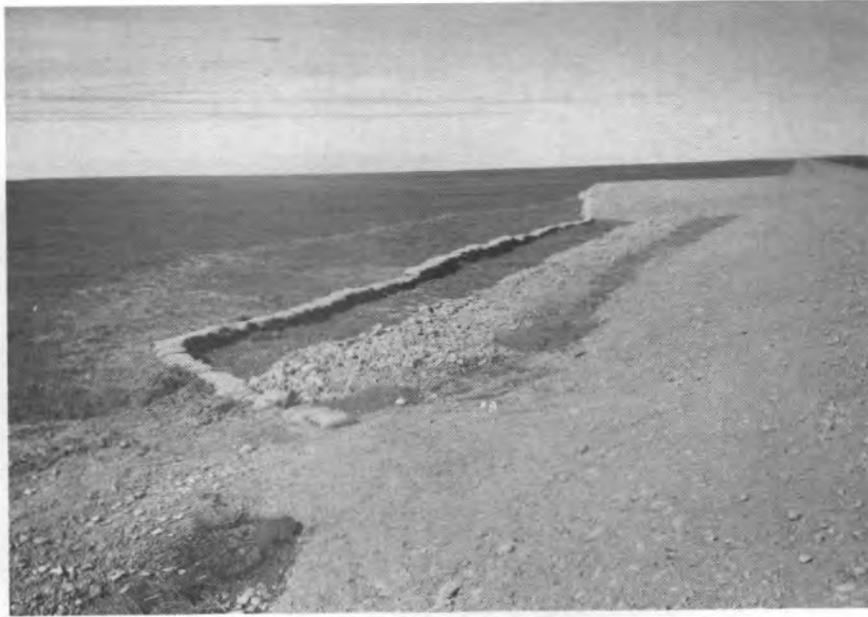
Figure 66. Area shown in Figure 65 was later covered with gravel, 17 August 1976.

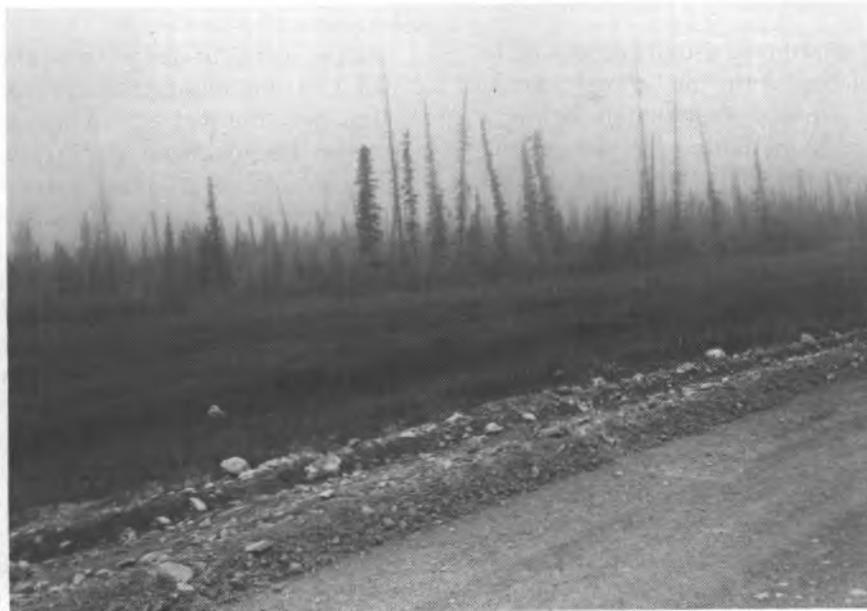
Figure 67. Gravel berms on roadway by site 107-1, 28 August 1977.

Because the gravel-surfaced roadway must be frequently regraded to maintain a relatively smooth surface, small berms of gravel are often created on one or both sides of the roadway (Fig. 67). When it rains the water cannot readily pass through the berms and must flow downslope until the berm is breached. The breach generally

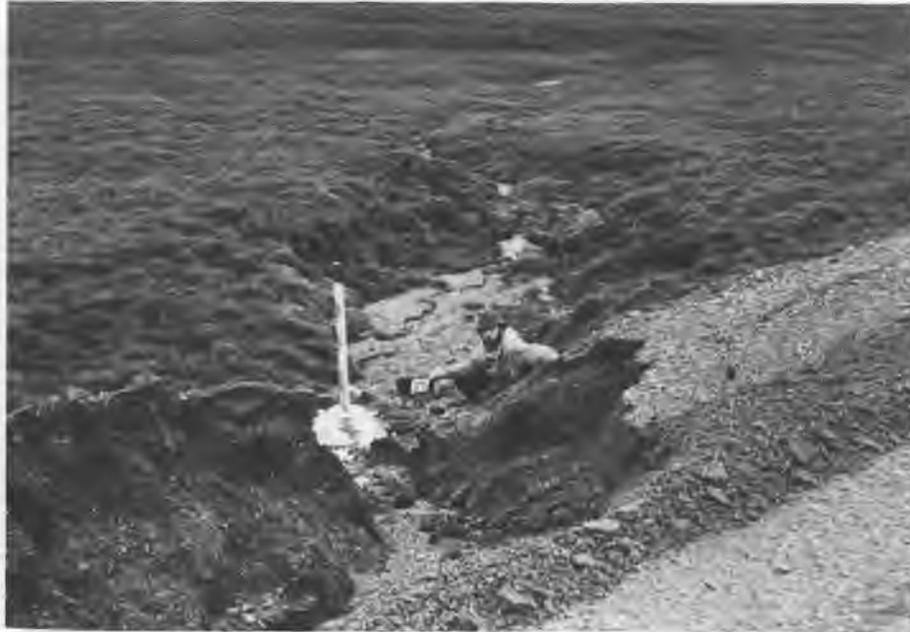
*Figure 68. Erosion of side slope due to drainage down the road, 28 August 1977. Also, note small berms which have been formed by most recent grading.*

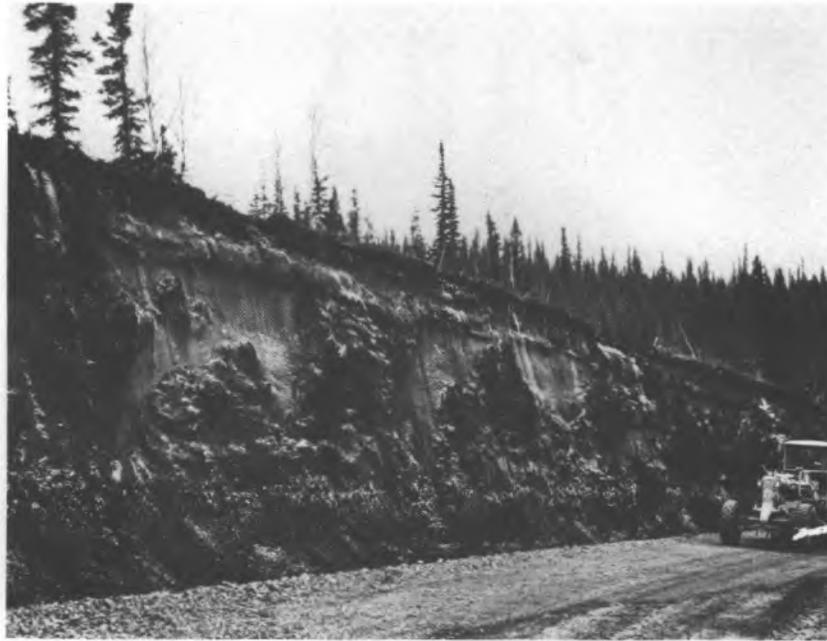
Figure 69. Frozen, nearly vertical backslope exposing large ice masses, left side of TAPS Road, mile 20.25 on 23 April 1970, (from Berg and Smith 1976).

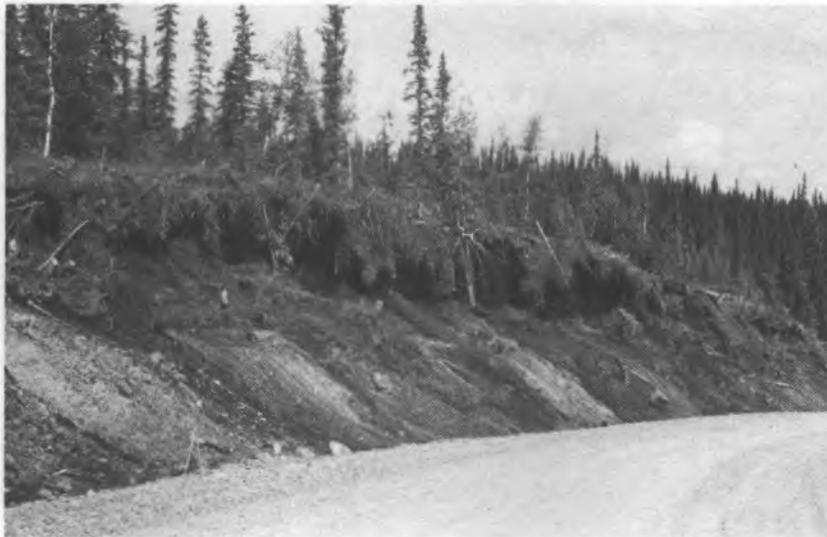
Figure 70. Ice face with overhanging mat and hydroseeded lower portion of slope, left side of TAPS Road, mile 20.25 August 1970 (from Berg and Smith 1976).

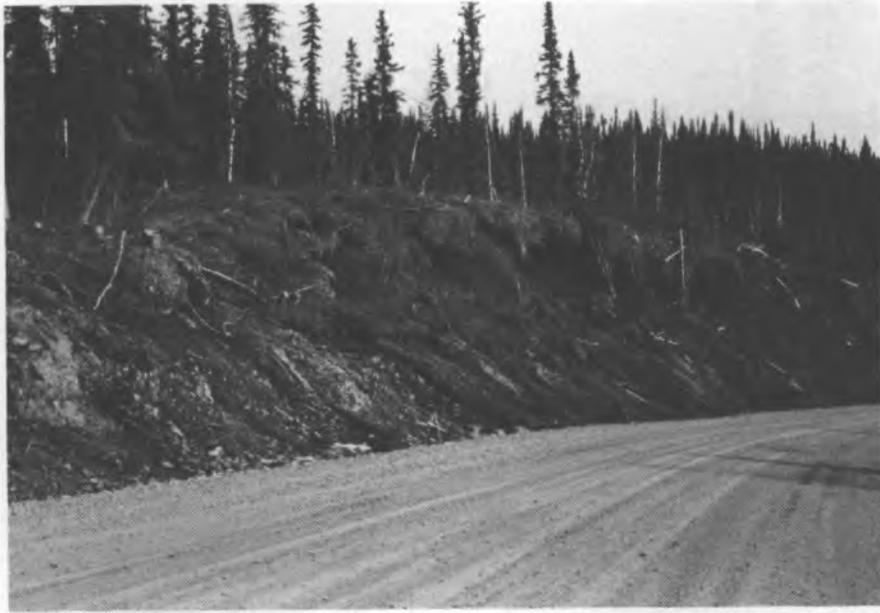
Figure 71. Overall view of slope, left side of TAPS Road, mile 20.25, 17 August 1971 (from Berg and Smith 1976).

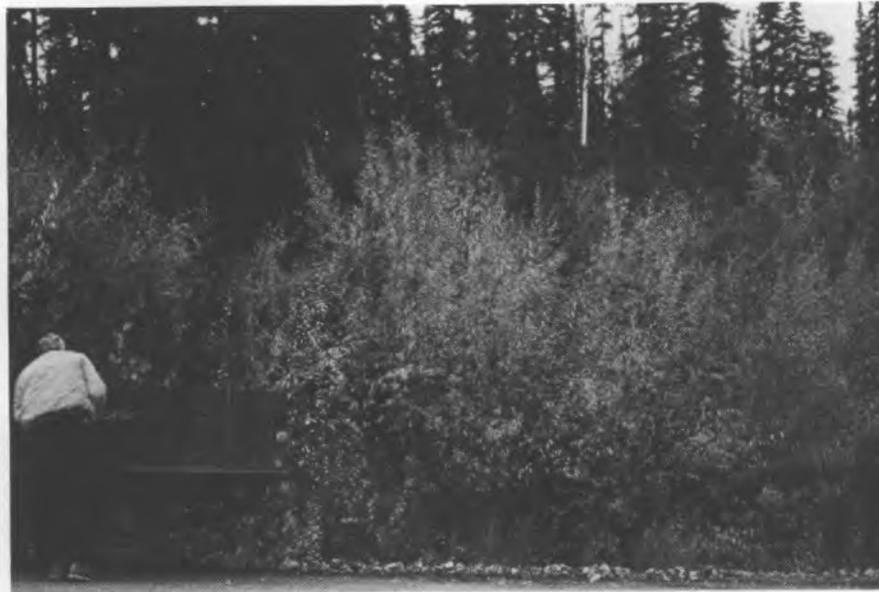
Figure 72. Tree growth near ditch line on portion of backslope, left side of TAPS Road, mile 20.25, 14 September 1975 (from Berg and Smith 1976).

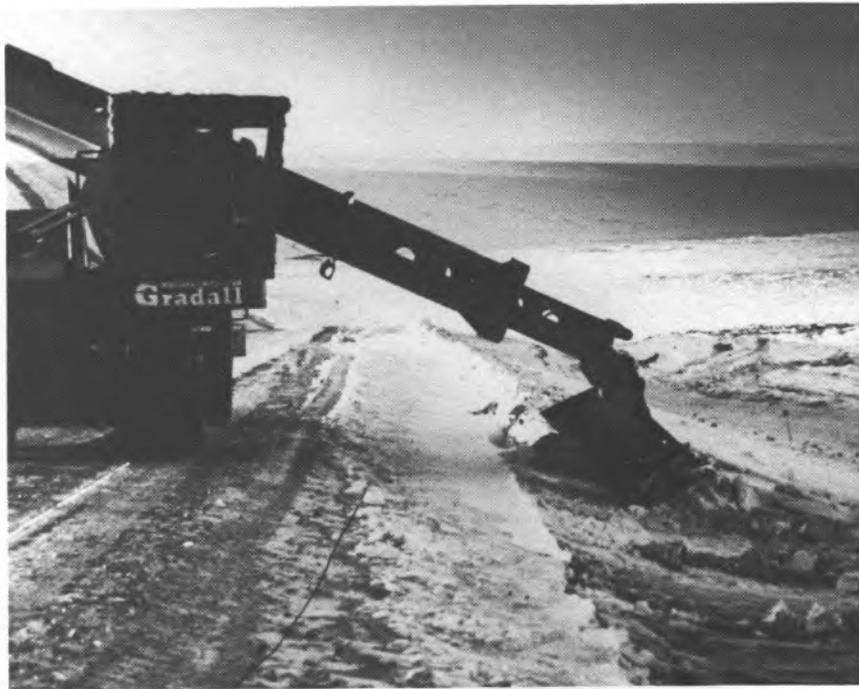
*Figure 77. Truck-mounted backhoe making berm beside road shoulders in order to catch additional snow used for snowpad construction.*

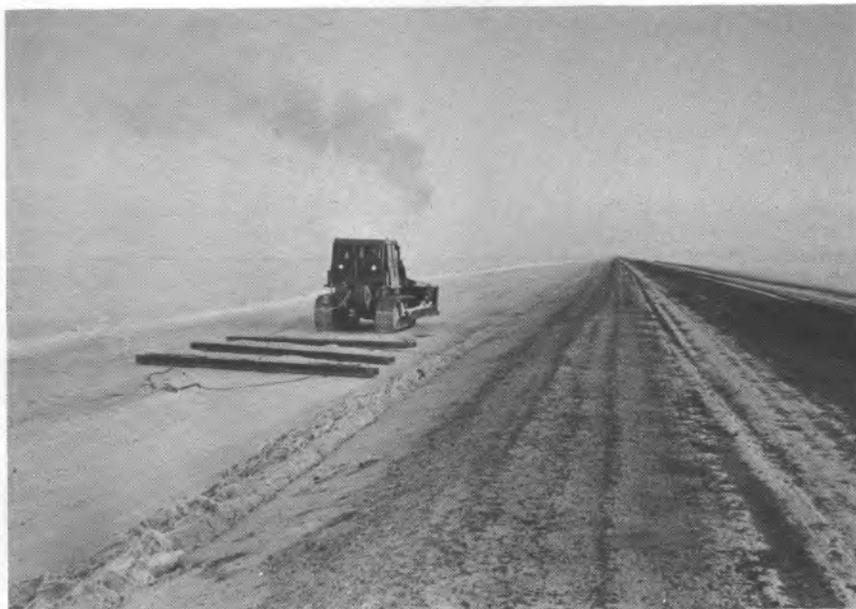
*Figure 78. Bulldozer packing snowpad by dragging steel beams.*
