*Environmental engineering and ecological  
baseline investigations along the  
Yukon River-Prudhoe Bay Haul Road*

Jerry Brown and Richard L. Berg, Editors

September 1980

UNITED STATES ARMY  
CORPS OF ENGINEERS  
COLD REGIONS RESEARCH AND ENGINEERING LABORATORY  
HANOVER, NEW HAMPSHIRE, U.S.A.

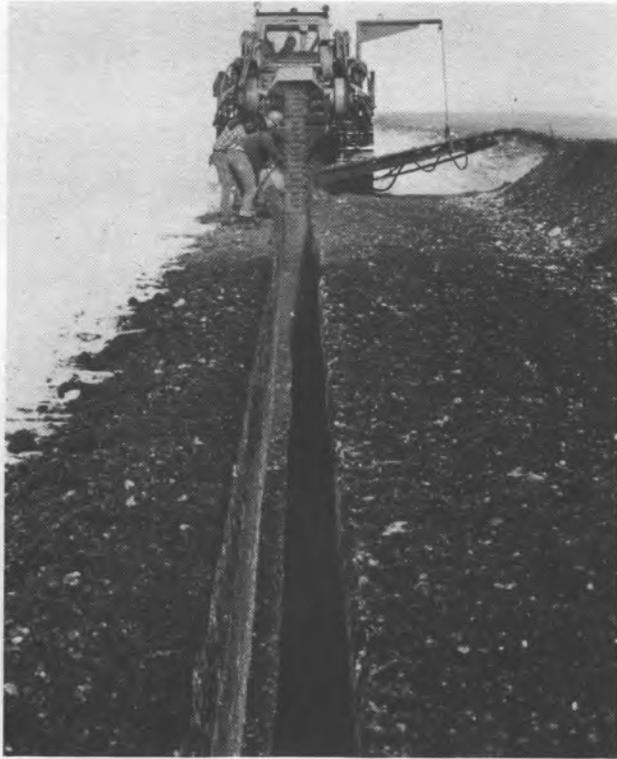
*Figure 79. Specially designed trenchers (Roc-Saw) excavating the fuel gas line trench through the snowpad. Spoil was deposited on the road shoulder.*

Trenching operations involved several different methods and types of equipment. Initially, a small snowblower removed most of the snowpad over the ditch locations. Then either a specially developed trencher (Roc-Saw) or a conventional type of trencher (Barber Greene) began trenching operations. In fine-grained soils, the special trenchers provided a 46-cm-wide  $\times$  approximately 1.8-m-deep trench in a single pass conveying the pulverized spoil to the edge of the road (Fig. 79). The conventional trencher (Fig. 80) cut a wider (60 cm) and shallower trench. The 8- to 15-cm-diam pieces of spoil were moved onto the snowpad or to the side of the road by a conveyor system. The two machines were occasionally used in tandem, in which case the conventional trencher made an initial pass to remove the surface sod and the upper 0.3 m or so of frozen soil, and the special trencher completed the trench on a second, deeper pass. In this case the spoil was either deposited on the road shoulder by the conveyor system or more frequently, deposited directly on the snowpad. The spoil was subsequently graded into piles and hauled away to disposal sites. This method, unfortunately, left some spoil on the snowpad which during the late spring induced melt and deterioration of the snowpad (Johnson and Collins 1980, Carson and Milke 1976).

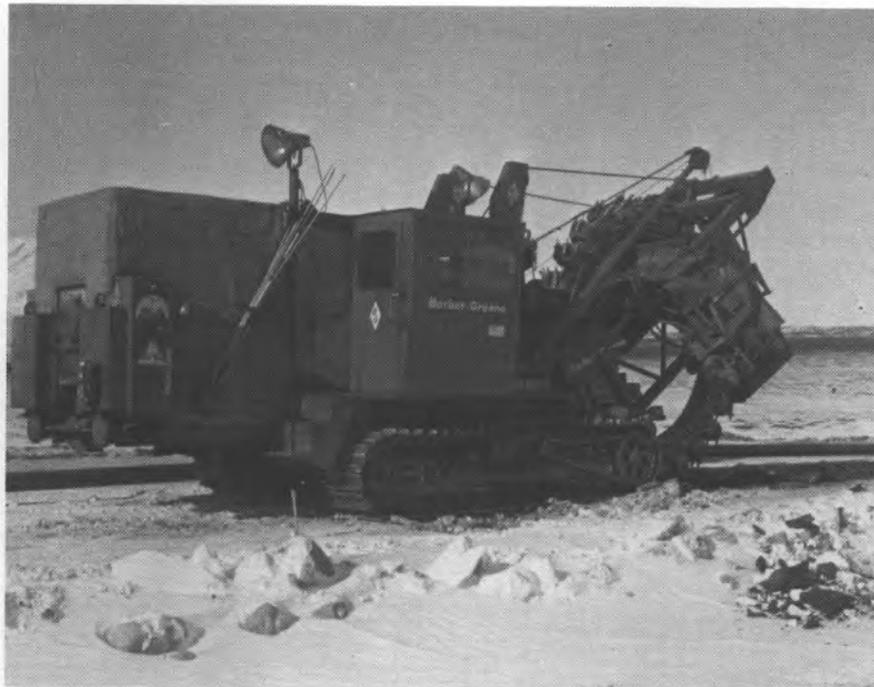
*Figure 80. Conventional type of trencher (Barber Greene) used for ditching fuel gas line.*

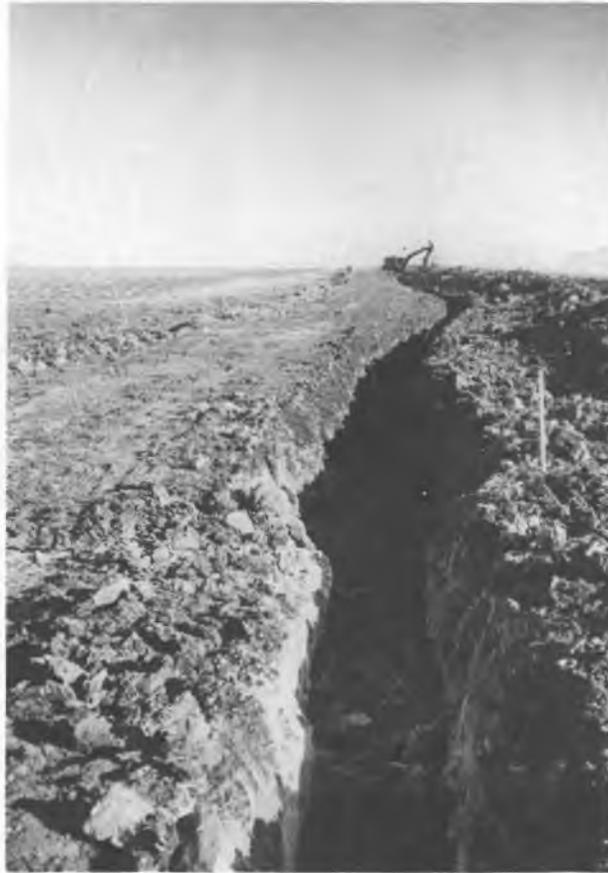
*Figure 81. View of blasted fuel gas line trench after excavation by a backhoe.*

The first winter's (1975-76) trenching began in the vicinity of Franklin Bluffs and between Galbraith and Toolik Camps. In the latter area the trenching quickly encountered problems, primarily due to glacial till containing boulders and also due to blowing snow which rapidly filled the open trench. In these bouldery sections between Galbraith Lake and Slope Mountain, it was necessary to blast most of the trench. After blasting, backhoes were used to clean out the trench which was frequently up to 1.8 m wide (Fig. 81). Between Galbraith and Toolik Lakes, large charges of explosives were also used as evidenced by the numerous pieces of debris, up to 25 cm or more in diameter, which were blown

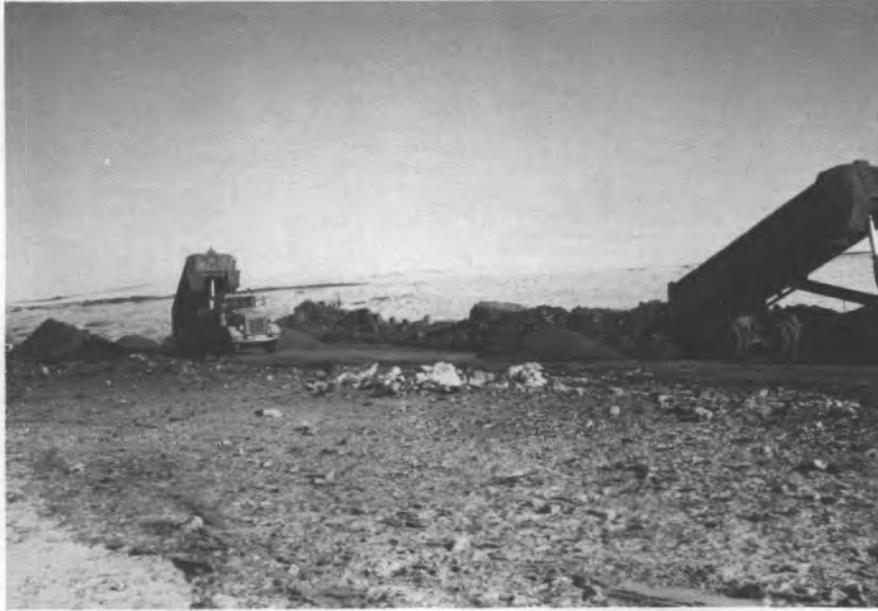
Figure 82. Gravel for backfilling the fuel gas line trench being dumped onto snowpad prior to fill operation.

After trenching was completed, gravel was placed in the trench for bedding, the pipe was placed in the trench, and the trench backfilled with additional gravel. Gravel for backfill initially was hauled by dumptruck or belly-dump trailer to the trench, dumped onto the snowpad, and then graded into the trench by a bulldozer (Fig. 82). This method left significant quantities of gravel on the snowpad.

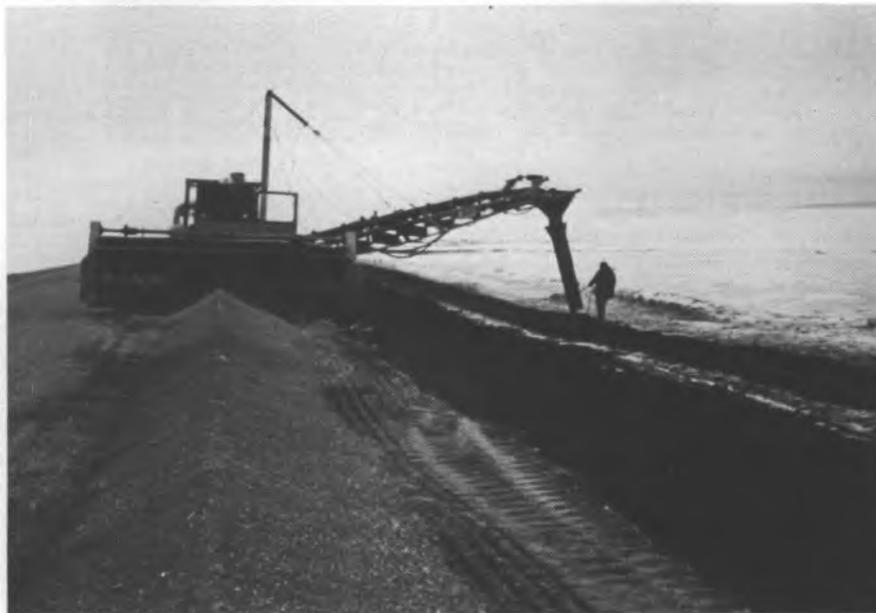
Figure 83. "Wooly worm" backfilling fuel gas line trench with gravel from road shoulder.

and a long chute for placement) was used to put the gravel directly into the ditch (Fig. 83). In order to prevent thaw over the pipe and maintain pipe and soil at the same temperatures, strips of rigid insulation were placed below ground level in the trench at a depth of approximately 30 cm. The insulation was covered by

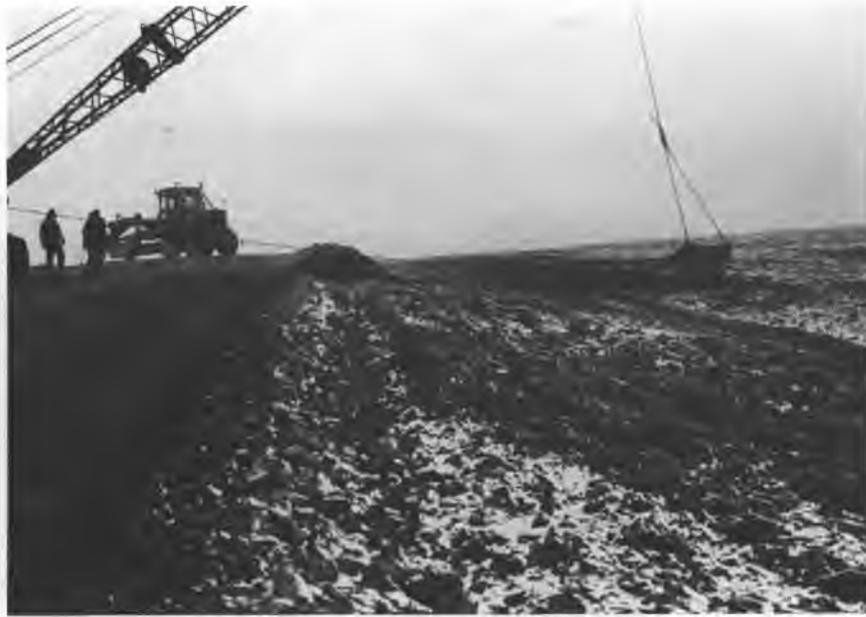
Figure 84. Crane with clam bucket scraping debris from snowpad. This equipment was also used to place backfill over the trench from the road during the summer.

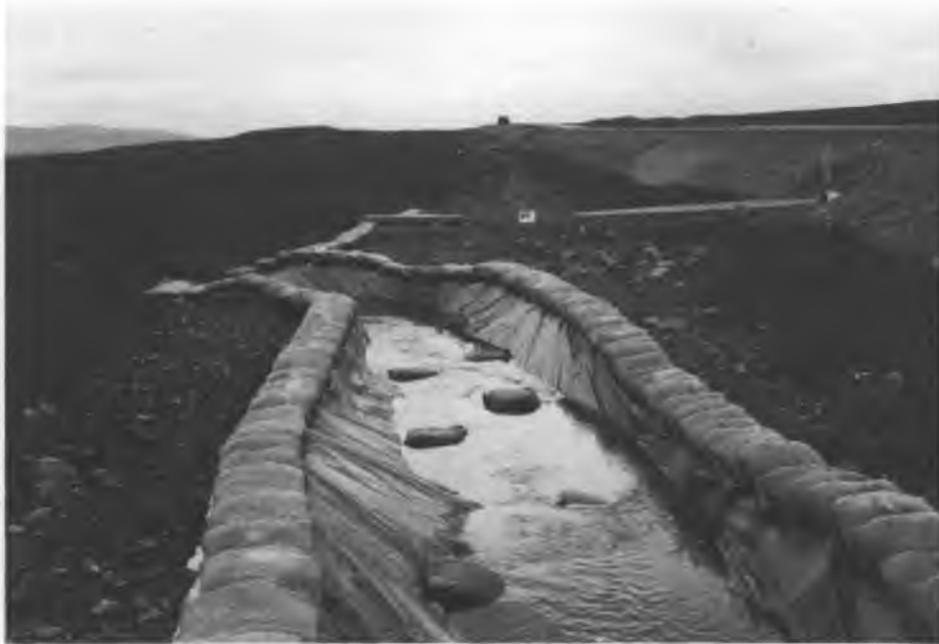
*Figure 85. Half culvert in background adjacent to road culvert and lined ditch channel downslope from the fuel gas line.*

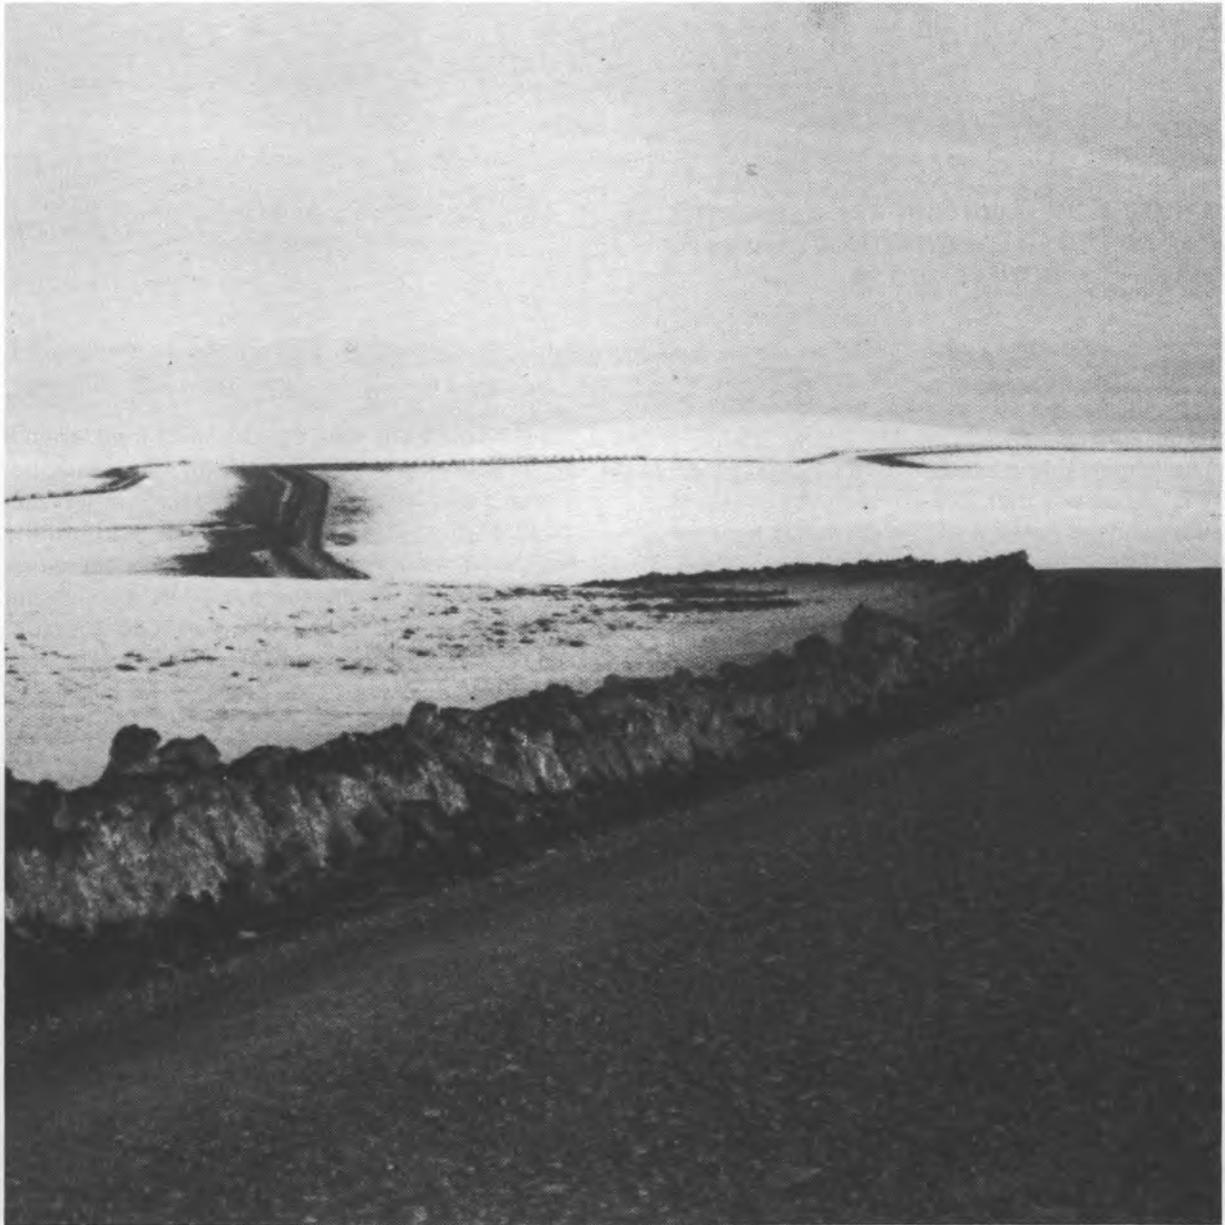
*Figure 86. Early melt of winter snow adjacent to Haul Road near the Toolik dust site as viewed to the north, 26 April 1977. Increased melt on west side is indicative of increased dust load and a probable winter dominance of northeast winds in this area.*

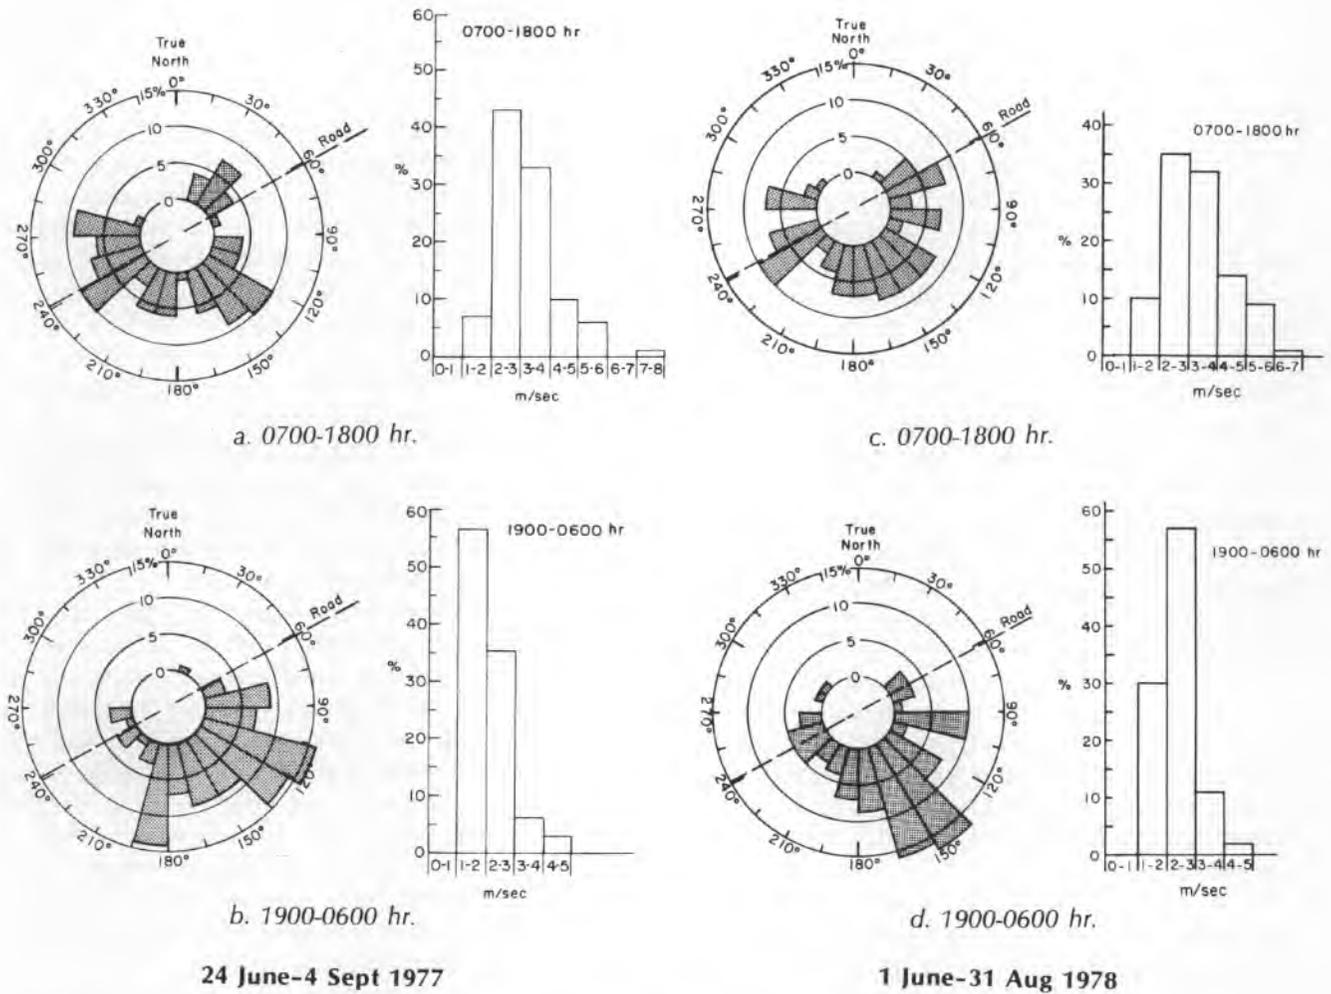
Figure 88. Diurnal wind direction and velocities for the summers of 1977 and 1978 at the Toolik site.

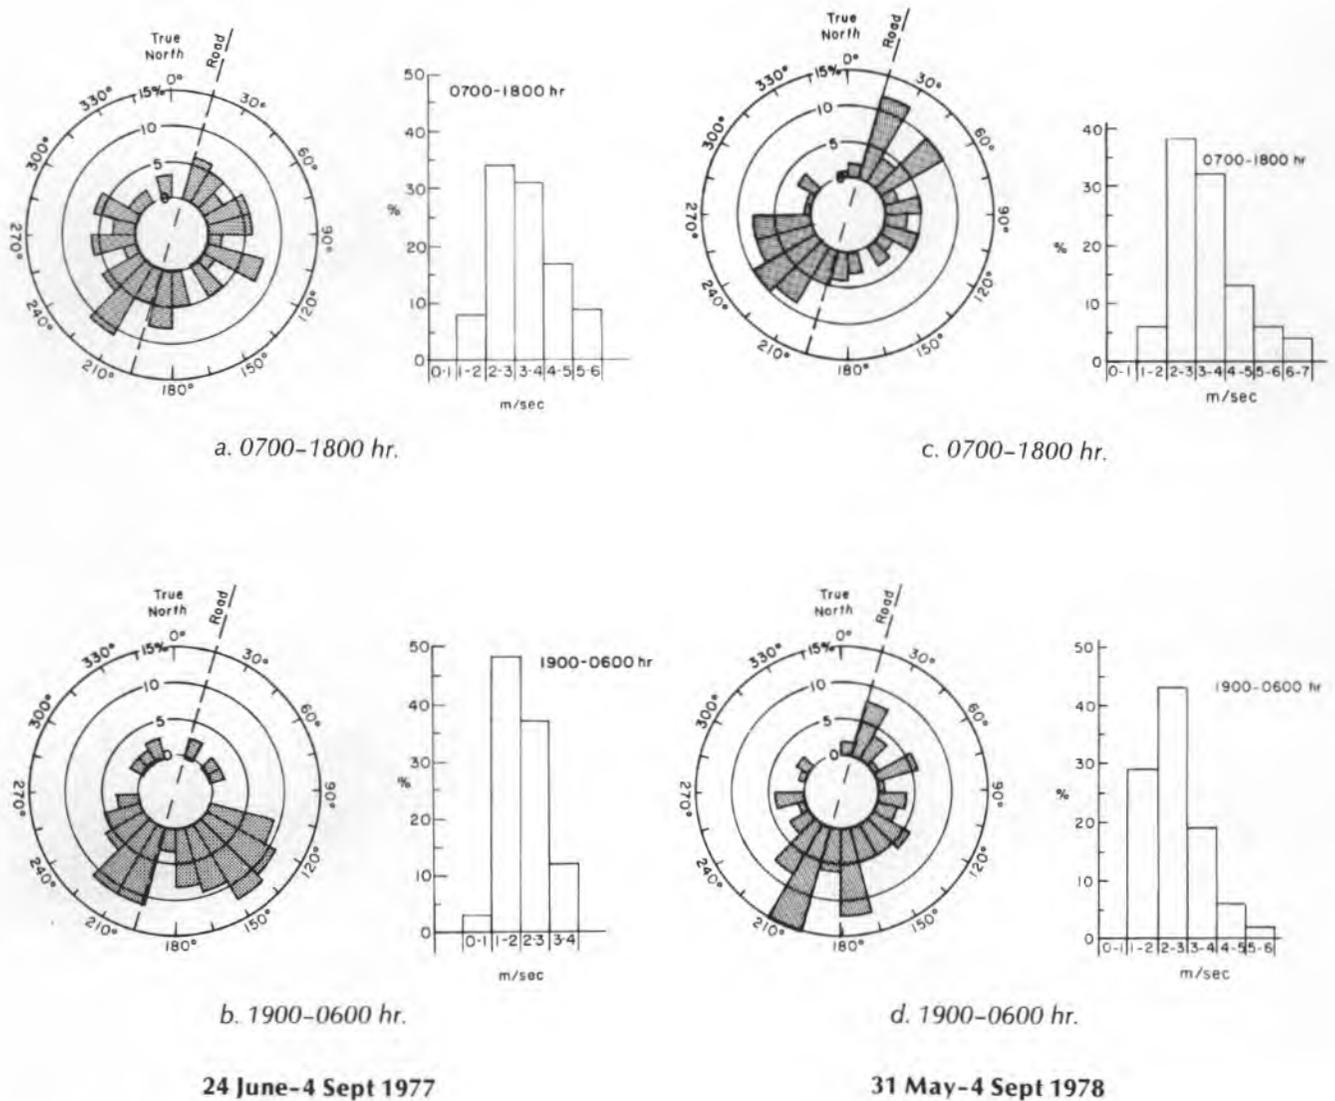
Figure 90. Diurnal wind direction and velocities for the summers 1977 and 1978 at the Sagwon site.

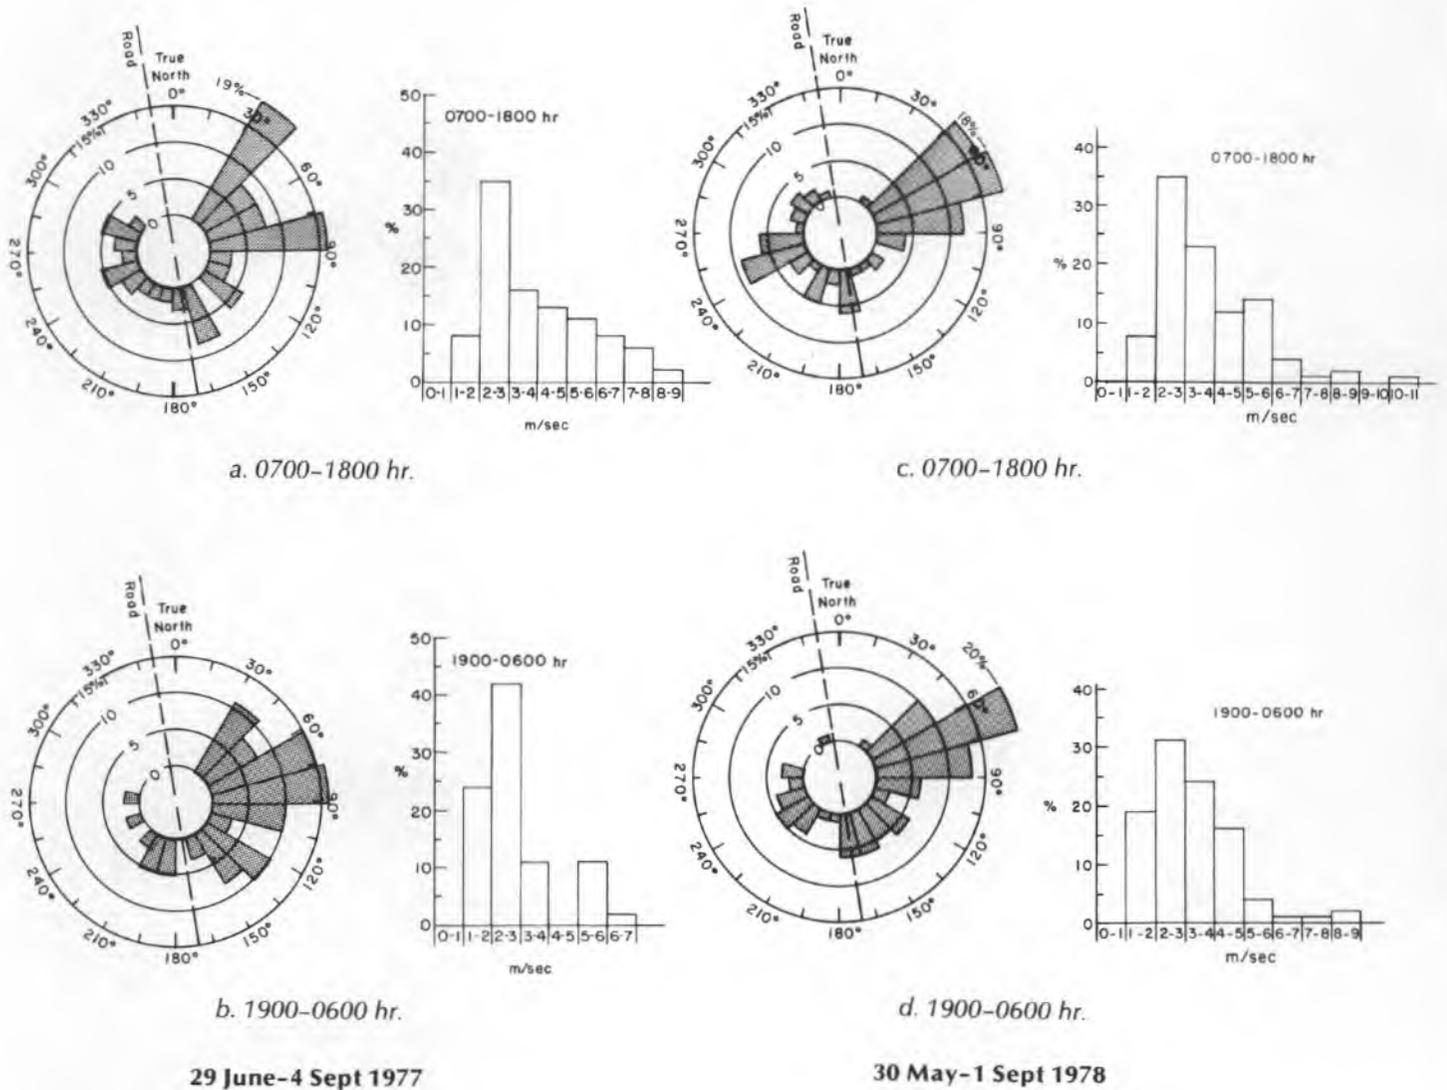
Figure 92. Diurnal wind direction and velocities for the summers 1977 and 1978 at the Franklin Bluffs site.

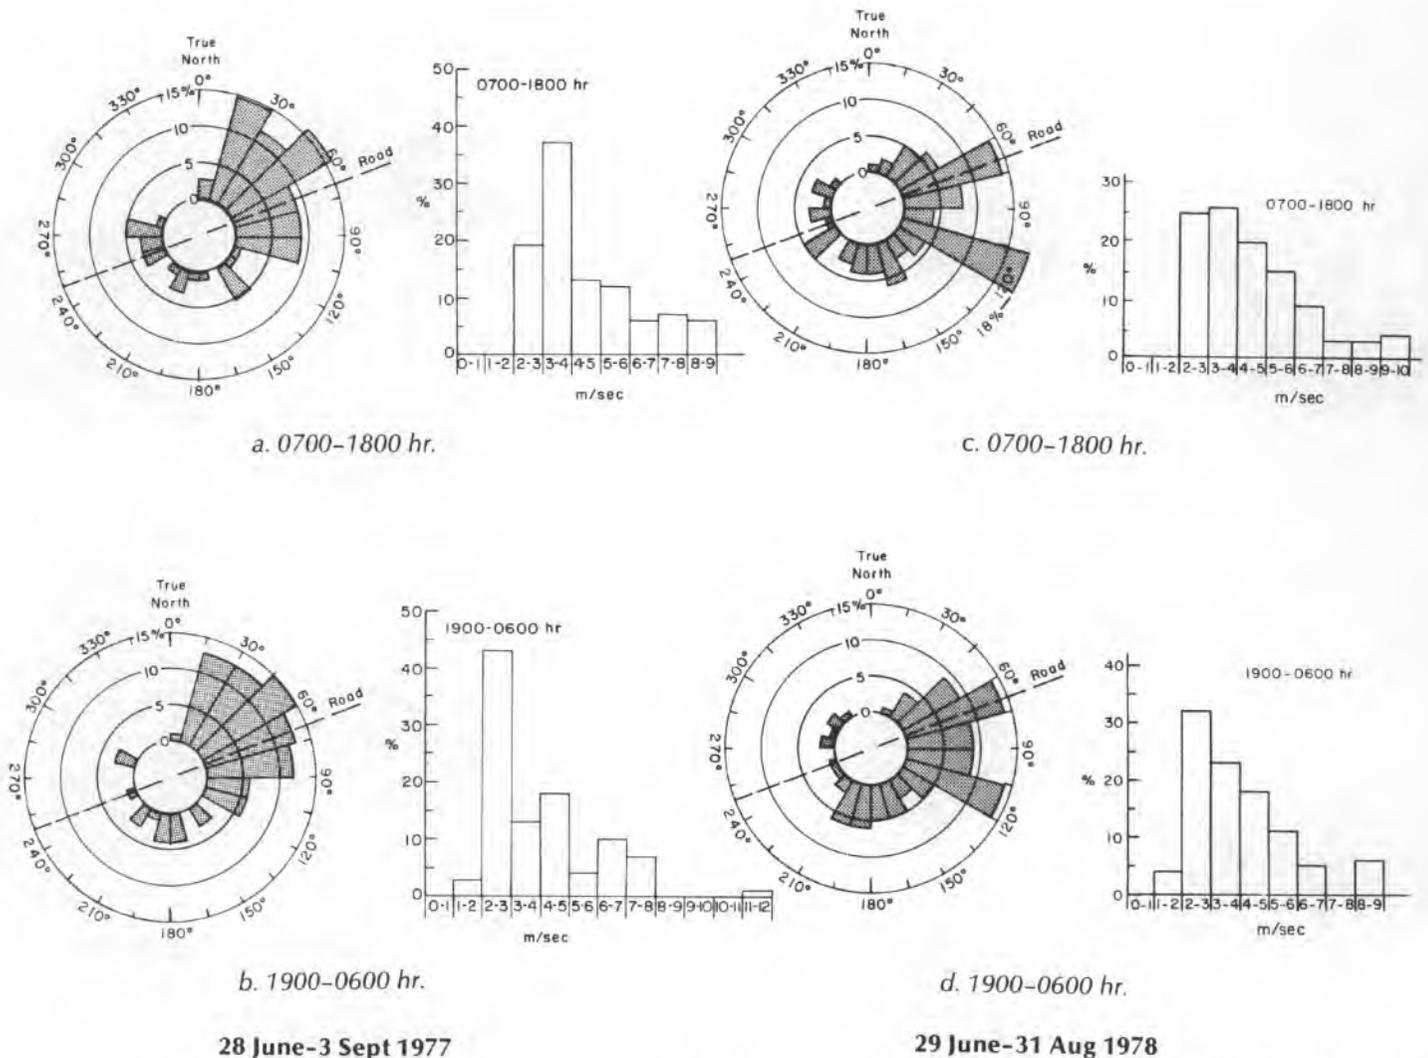
Figure 94. Diurnal wind direction and velocities for the summers 1977 and 1978 at the Prudhoe Bay site.

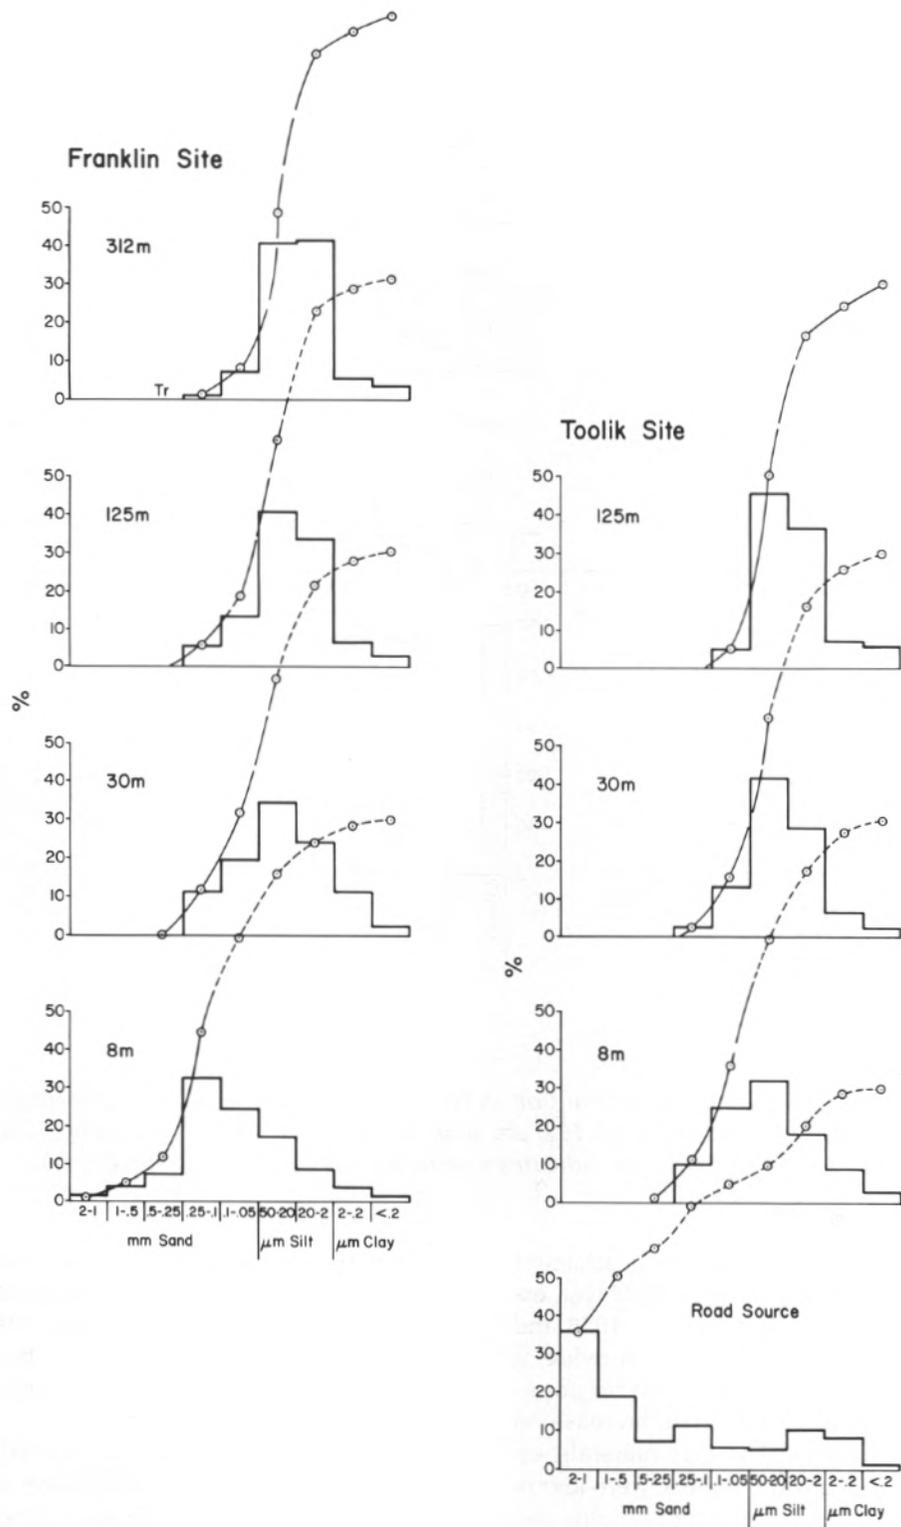
Figure 99. Particle size distribution of road material and road dust collected at 8, 30 and 125 m from the west side of the Haul Road (1978). Median particle diameters read from a cumulative curve.

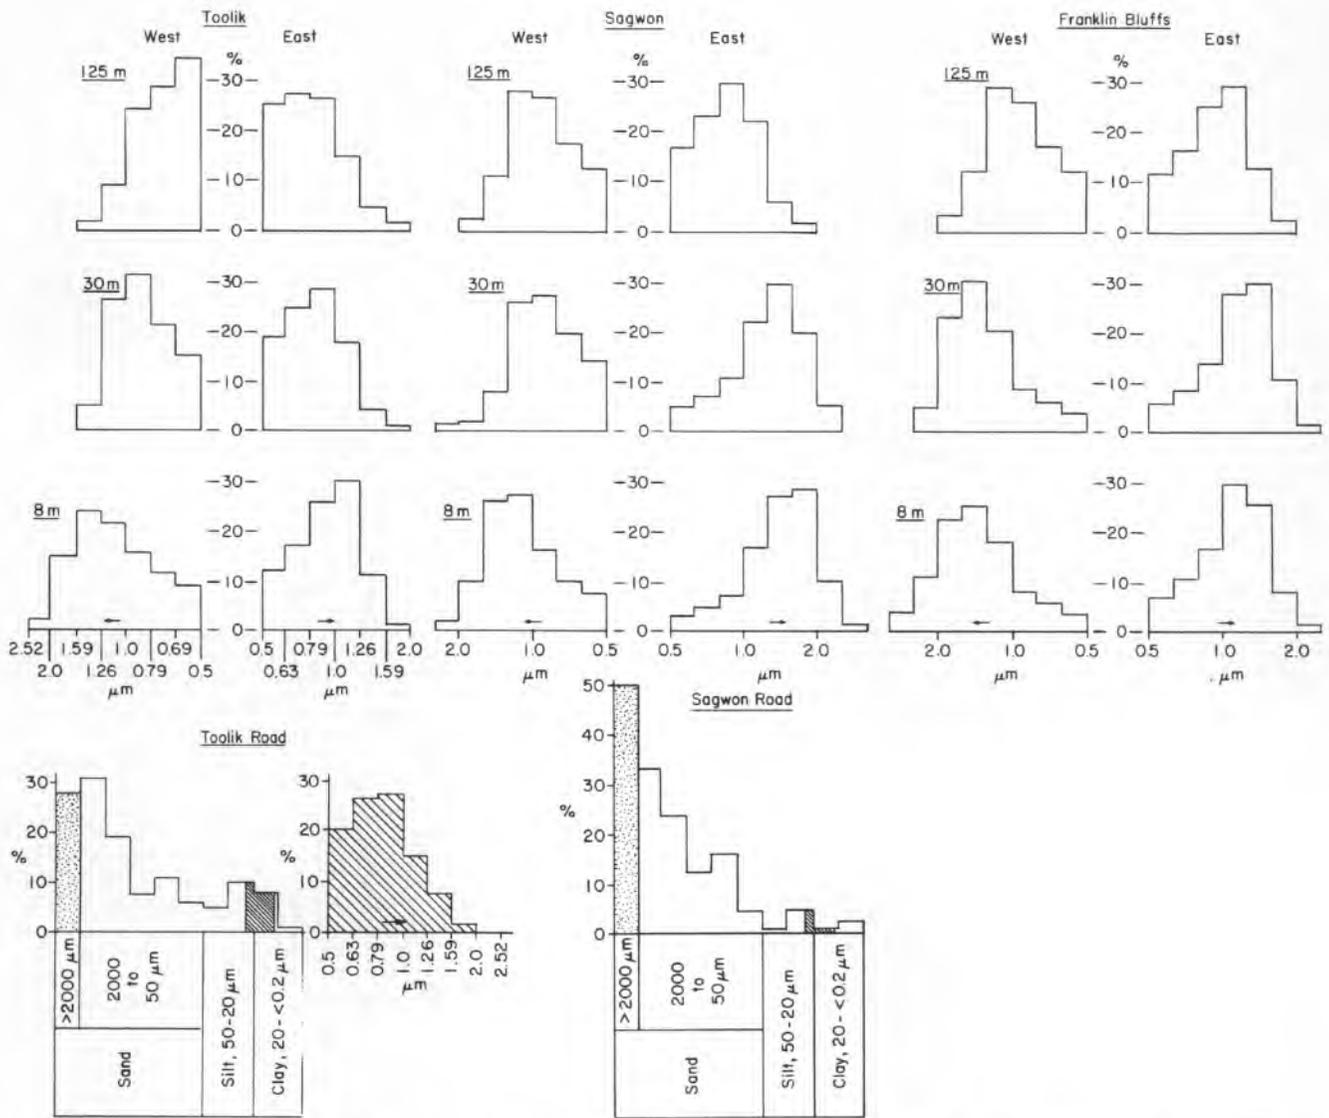
Figure 100. Microparticle (0.5-16.0  $\mu\text{m}$ ) distribution in Haul Road dust expressed as percentage of total count. Composite of road surface material in the 0.5-16.0  $\mu\text{m}$  range is shown for Toolik. Dust samples represent a collection period of 66 days. Cross-hatched area indicates size range analyzed for microparticles.

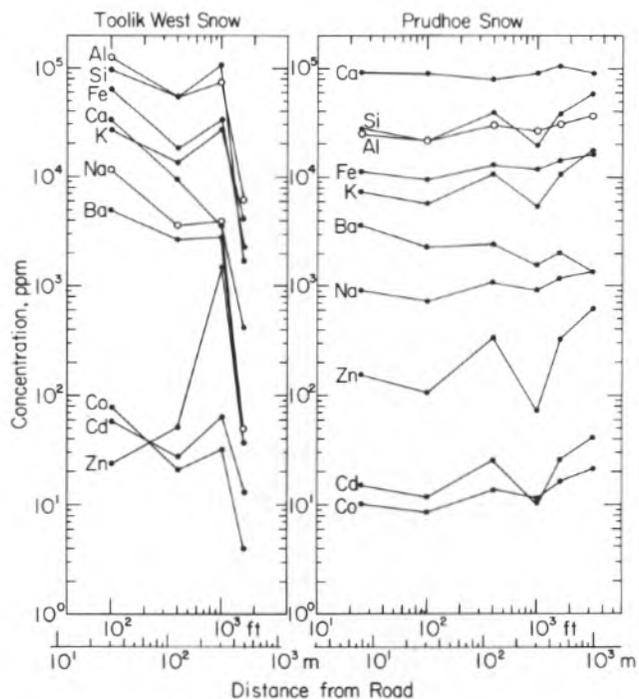
Figure 101. Concentrations of selected elements in the winter 1977 dust as determined by neutron activation analyses.

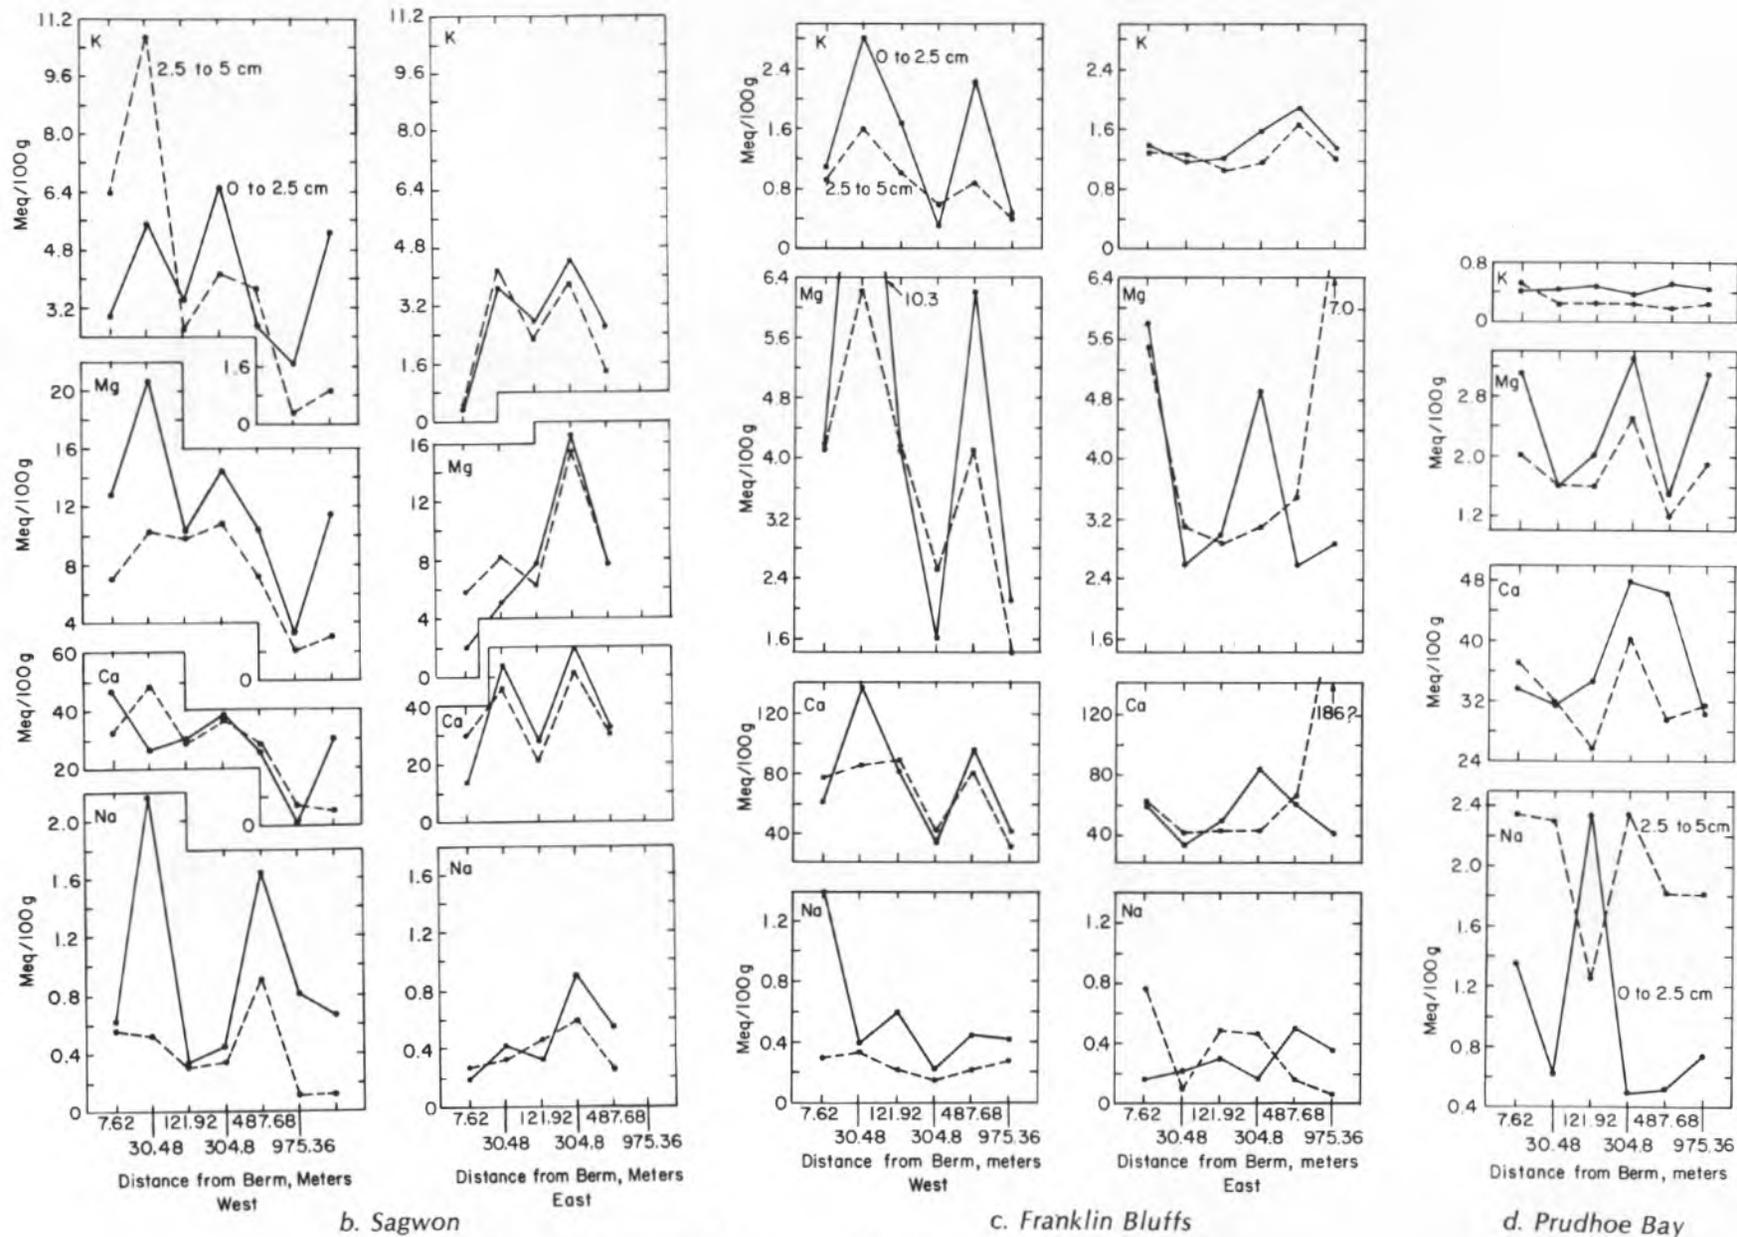
Figure 103 (cont'd). Exchangeable cations from surface samples.

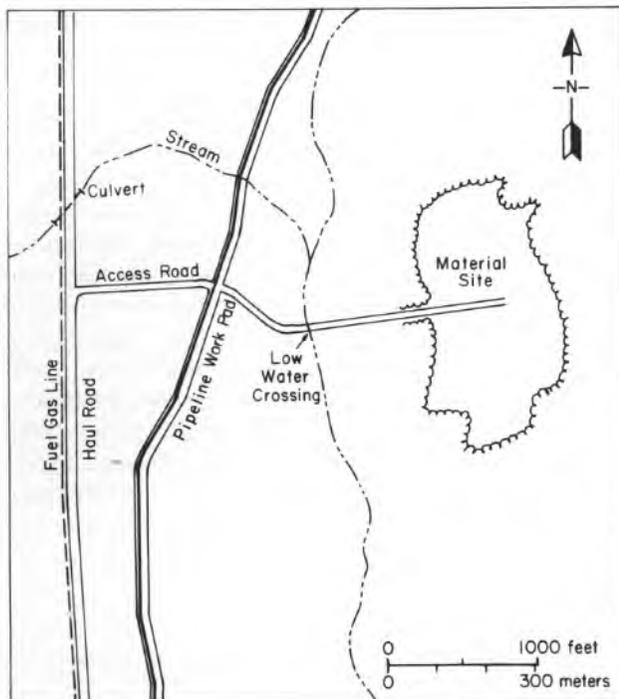
Figure 104. Idealized drawing showing major road and pipeline construction activities.

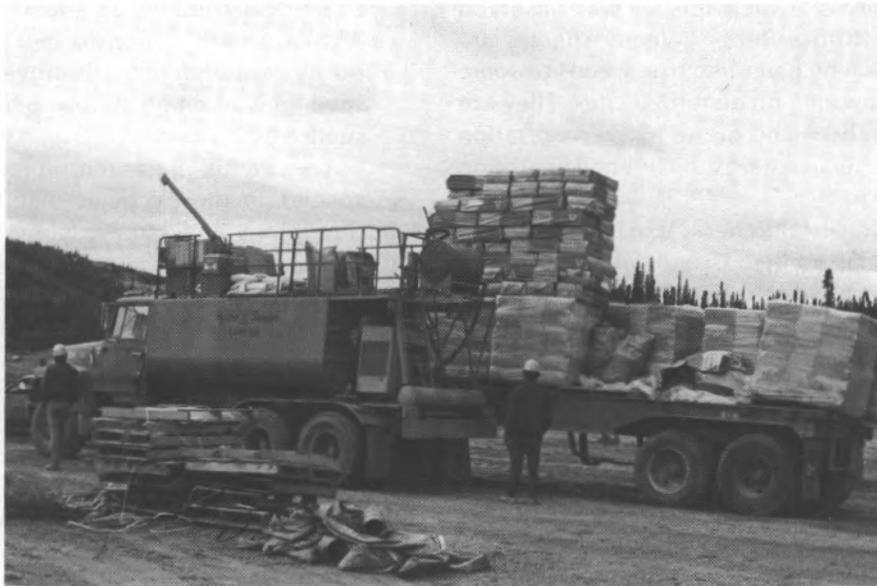
Figure 105. Hydroseeder, with bales of wood cellulose fiber on trailer.

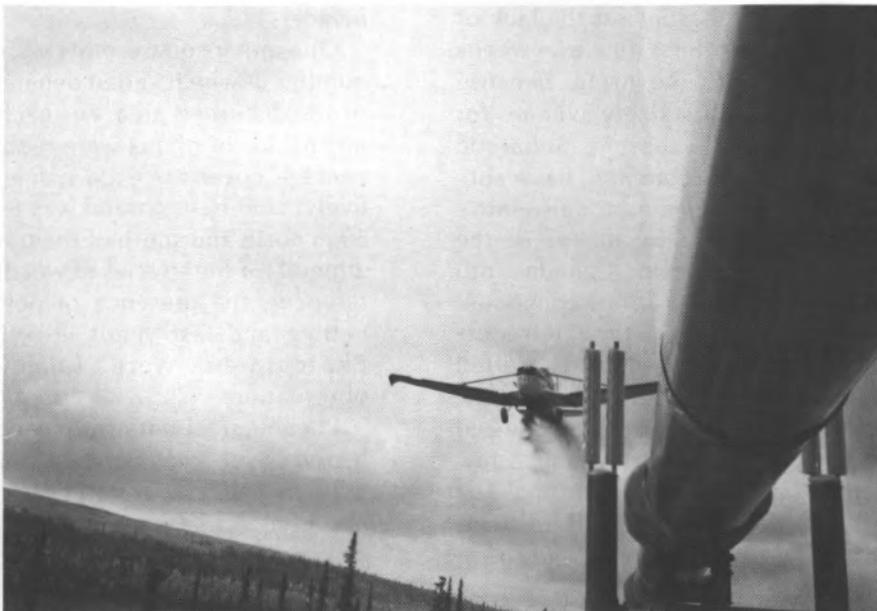
Figure 106. Aerial fertilizing of pipeline workpad in the vicinity of Old Man, September 1976.

Seeding methods varied, with hydroseeding being the most frequently used method (Fig. 105). Linear areas such as the pipeline workpad were often aeri ally seeded (Fig. 106), while hand seeding and seed spreaders were used on smaller areas. Fertilizer was applied by similar methods as well as with air injection applicators and specially modified sanding trucks. Fertilizer could be applied in combination with mulches but seeding was done separately from fertilizing. It was planned to check both seed and fertilizer application density and distribution in the field against Alyeska rate check boards for quality control; however, this procedure was probably never widely implemented.

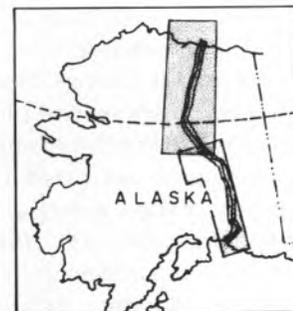
Figure 108. Location of CRREL permanent revegetation sites (C = fuel gas line, T = trails, J = other revegetation sites).

A number of revegetated sites were selected for observations of revegetation performance (Fig. 108). Sites included those established in 1975 (Johnson et al. 1977) and new areas revegetated during 1976, 1977 or 1978. Sites were selected to represent a variety of substrates, latitudinal and altitudinal locations, vegetation types, and categories of construction (e.g. pipeline workpad, road cuts, disposal sites, material sites). Sites are listed in order, from the Yukon River to the Prudhoe Bay, and are identified by the alignment sheet number and the number within that alignment sheet.

Two CRREL experimental restoration sites were established in northern Alaska along the Haul Road (MS 117-1,2 and MS 127-2.1B; Fig. 108.). The first objective of establishing these sites was to compare existing vegetation techniques (such as Alyeska's) with experimental techniques for promoting long-term tundra recovery. Questions to be examined included the rate of revegetation associated with each technique and the effect upon the re-establishment of native species of vegetation. A second objective was to provide sites for related research such as methods for increasing seed set from undisturbed tundra, an investigation which is being conducted by F.S. Chapin, III, University of Alaska.

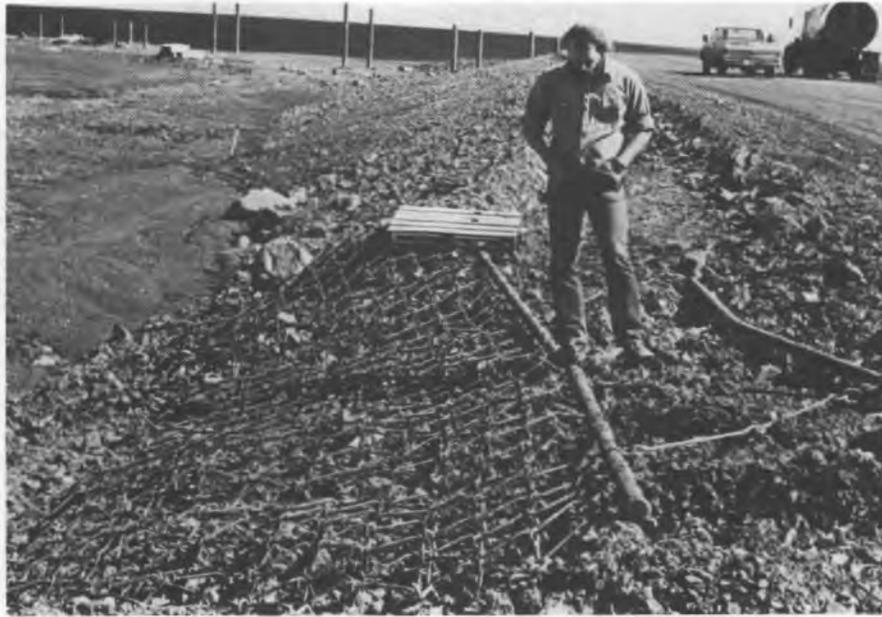
*Figure 109. Contour harrow used for seedbed preparation.*

(consisting of a large wire mesh with heavy wires protruding downward) was towed over the surface both before and after seeding (Fig. 109). Contour harrows were first used north of Toolik during 1976. By 1978 the practice was employed along the entire Haul Road. Harrowing appeared to result in greatly increased germination rates and a subsequent increase in vegetative cover,

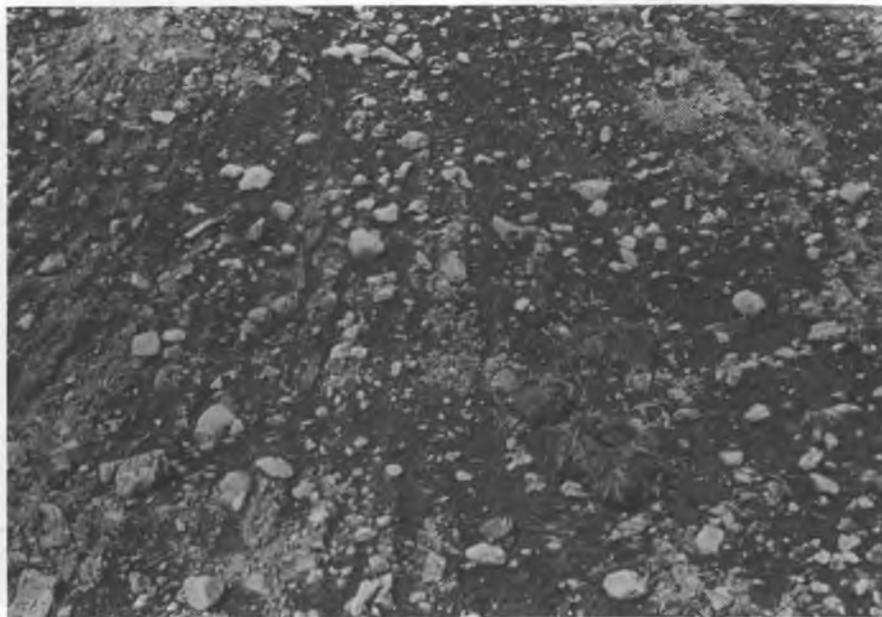
*Figure 110. Harrowed ground in which seeds are buried, resulting in increased germination.*

probably primarily due to burial of the seed which increased available moisture (Fig. 110).

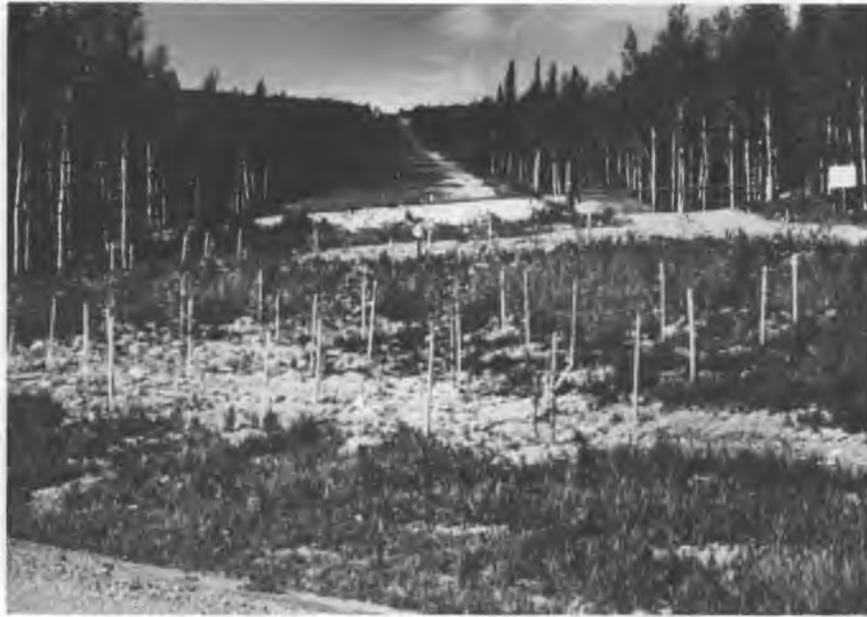
Figure 111. Birch transplants (VIE) near Old Man, 4 August 1977.

Species used varied depending upon the local vegetation. They included birch (*Betula papyrifera*, Fig. 111), white and black spruce (*Picea glauca* and *P. mariana* respectively, Fig. 112), willow (*Salix* spp.), aspen (*Populus tremuloides*), and alder (*Alnus crispa*). Plants were generally taken from nearby undisturbed areas. In most cases plants were removed and planted with a tree spade so that a ball of soil was taken along with the tree or shrub. A mulch such as hay or

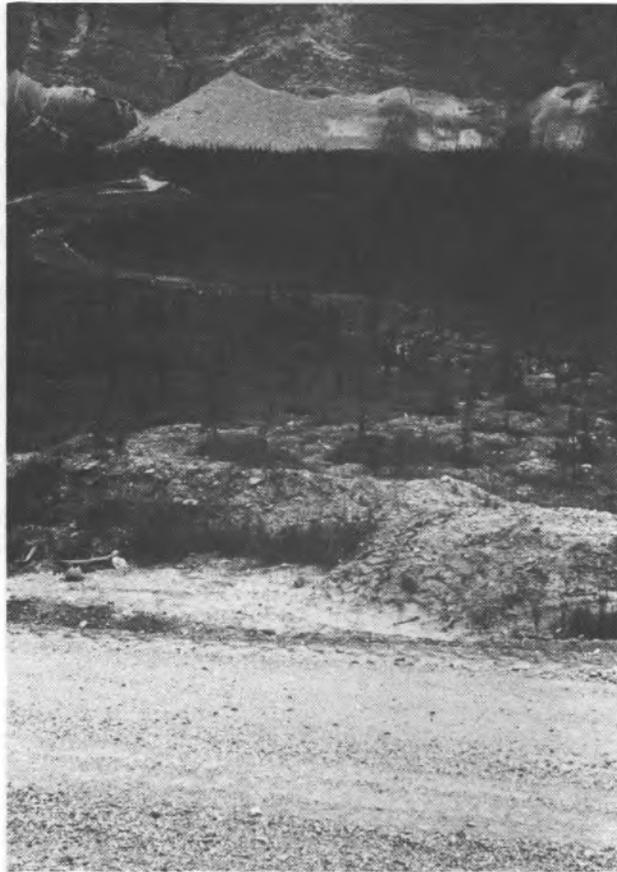
*Figure 113. View looking at Sukakpak Mountain material site (103-0.1) from the road, 15 August 1978.*

Visual and scenic considerations mandated that special measures be taken at the Sukakpak Mountain site which had been temporarily used for material borrow. This was the only site observed where large amounts of fine-grained soils and topsoils were transported to the location and spread over it to create an enhanced seedbed. Then, in addition to the normal seeding and fertilizing, transplants and nursery raised seedlings of white spruce were planted along the access road. The appearance of the area was markedly improved by August 1978, the end of the first full growing season (Fig. 113). Grass growth was noticeably better around the base of tree transplants, probably due to improved moisture conditions associated with the transplanted ball of fine-grained soils around the tree roots.
