*Environmental engineering and ecological  
baseline investigations along the  
Yukon River-Prudhoe Bay Haul Road*

Jerry Brown and Richard L. Berg, Editors

September 1980

UNITED STATES ARMY  
CORPS OF ENGINEERS  
COLD REGIONS RESEARCH AND ENGINEERING LABORATORY  
HANOVER, NEW HAMPSHIRE, U.S.A.

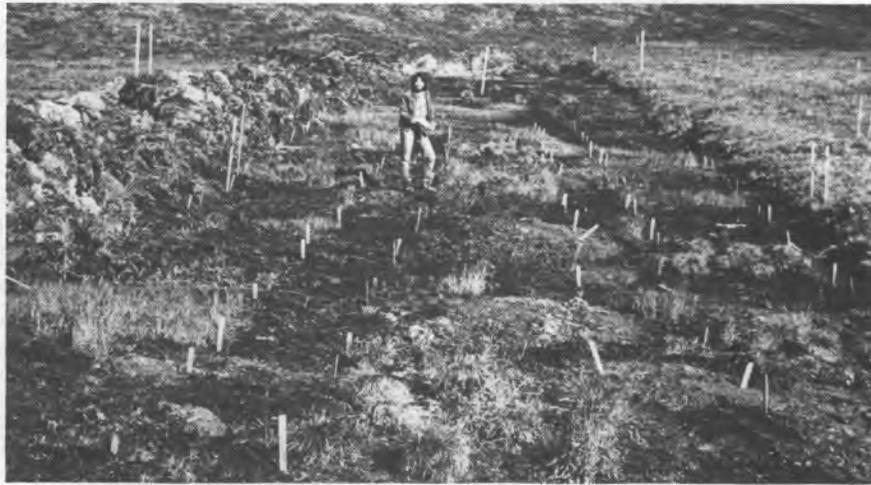
Figure 114. Experimental restoration site (MS 117-1, 2). Note growth of cottongrass tussocks (sod) and reseeded plots in foreground (13 August 1978).

The sites were observed in August 1977 and August 1978 (Fig. 114 and 115). Depth of thaw measurements, survival percentage, percentage cover, and maximum height data are given in Table 36. Although the data are still preliminary (since only 1.5 growing seasons have been evaluated), for most treatments the following tentative conclusions can be made.

Willow cuttings (*Salix pulchra*) and tussock sodding (*Eriophorum vaginatum*) offer feasible materials for re-establishing native vegetation in the Arctic. Survival is highest when planting is accomplished late in August as compared to early July. Birch (*Betula nana*) cuttings have low survival rates. As of August 1978 there was little

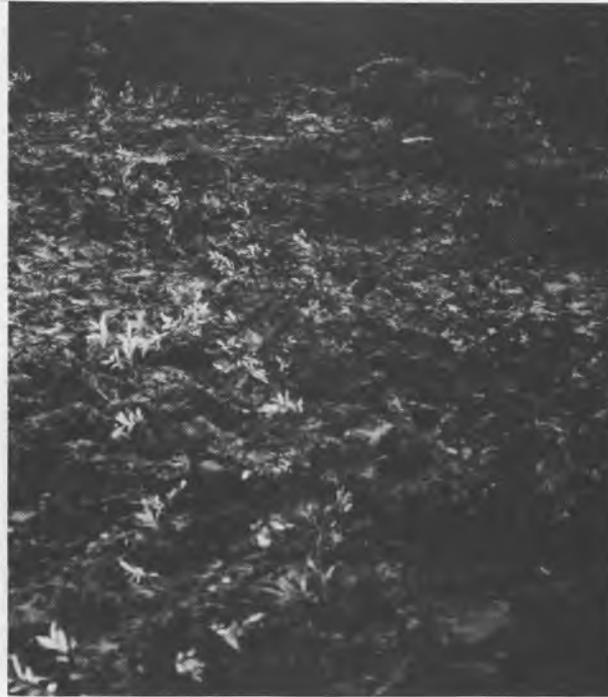
Figure 115. Willow (*Salix pulchra*) cuttings at Sagwon (MS 127-2. 1B) restoration site (August 1976).

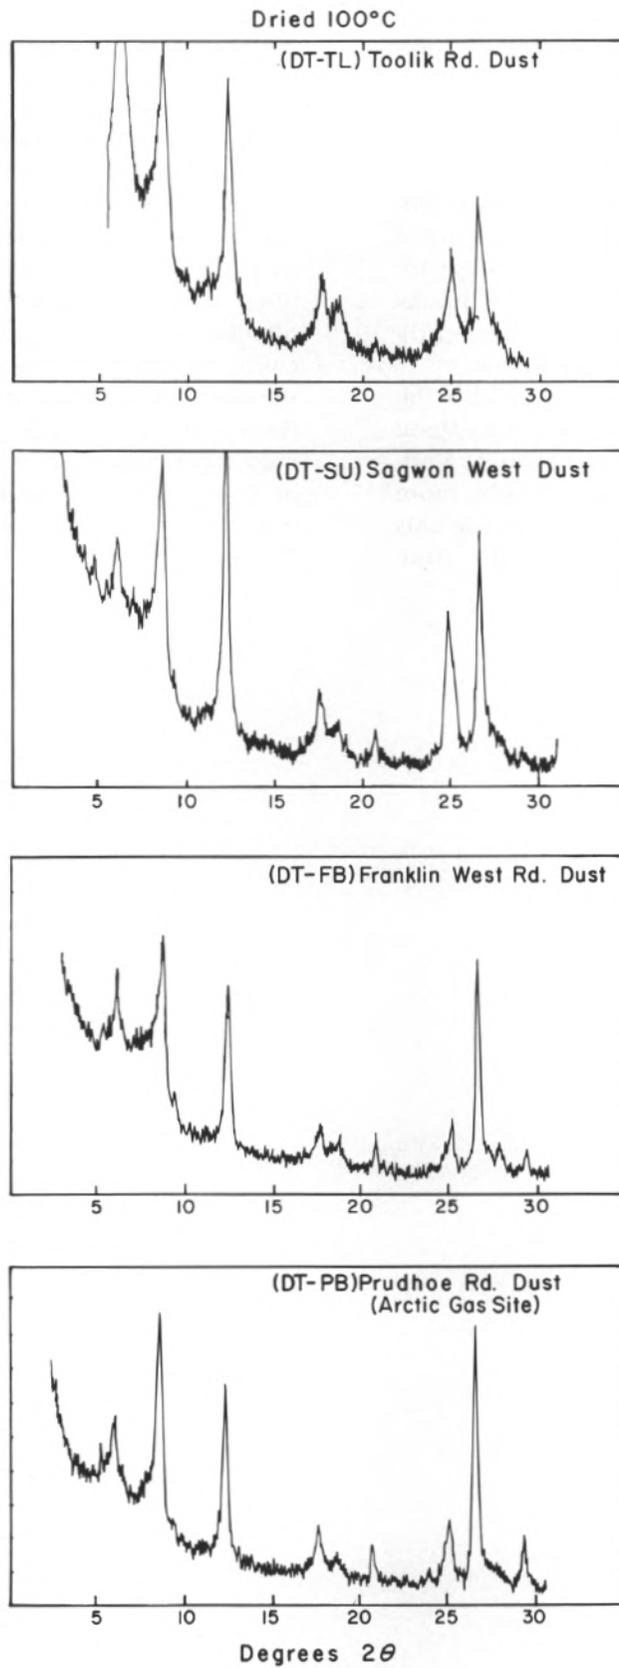
Figure E-1. X-ray diffractograms of road dust dried at 100°C.
