STUDY OF CHANNELIZED TRAFFIC

TECHNICAL MEMORANDUM NO. 3-426, FEBRUARY 1956

CORPS OF ENGINEERS, U. S. ARMY

WATERWAYS EXPERIMENT STATION

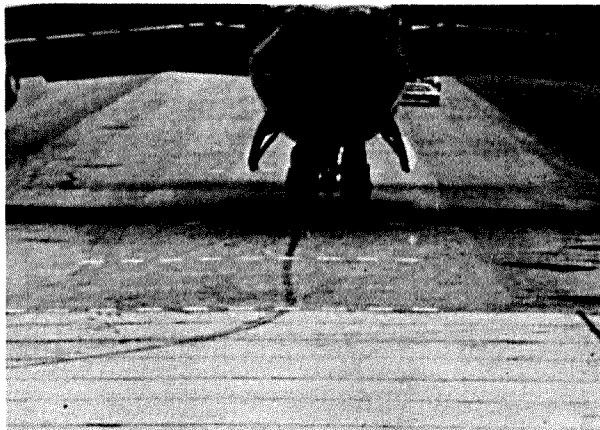
Photograph 1. Transverse reference lines used to determine position of wheels

5. Movie cameras were placed at strategic locations along straight-aways and curves as shown on plates 1, 2, and 3 and trained to photograph the relative position of the pavement stripes and the landing gear of the aircraft during taxiing operations. The cameras were placed on stands to provide sufficient elevation and were generally operated at 8 frames per sec while the plane was in the immediate vicinity. Transverse reference lines were painted across the taxi stripes at strategic locations (fig. 1). These lines were broken at 1-ft intervals so that lateral distribution could be determined. Subsequently, the movie film was projected by individual frames and the distribution of the landing gear at specific reference lines was scaled from the projected image.

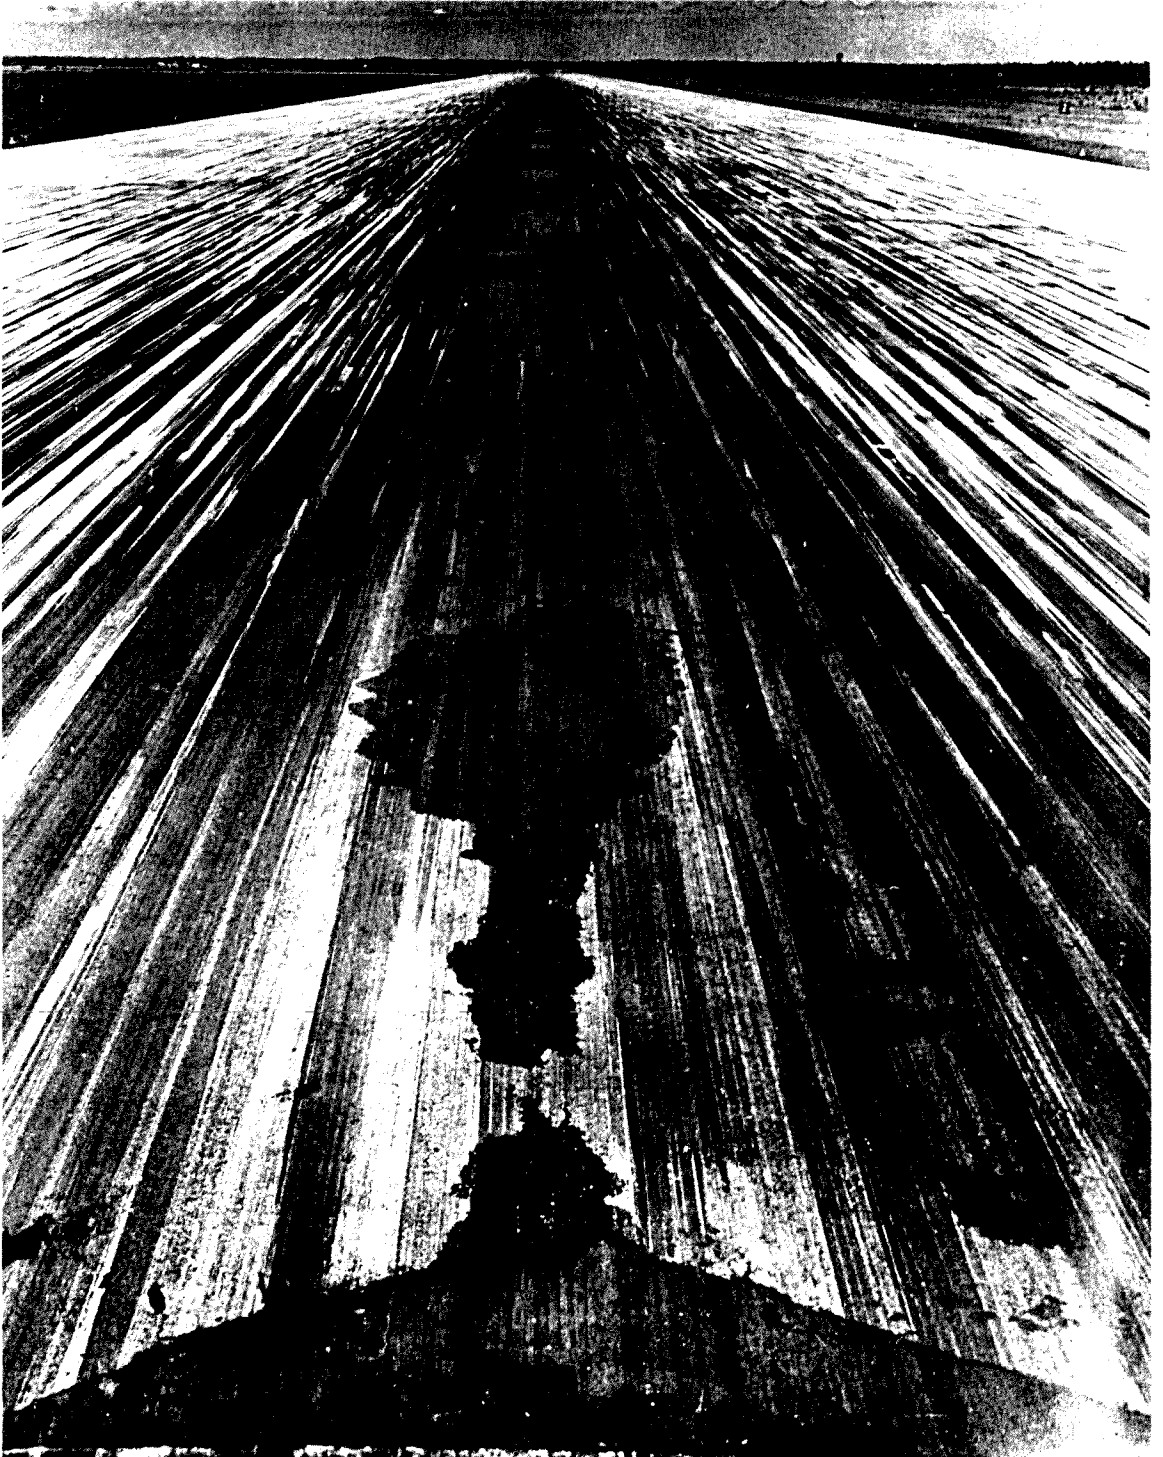
12. Fig. 2 is a photograph which was taken from the juncture between the rigid and flexible pavements on the runway at Pinecastle AFB. At the joint the flexible pavement was 1-2 in. lower than the rigid pavement causing "porpoising" of the B-47 aircraft on take-off. The "bird-baths" shown in the picture have been caused by bouncing of the planes. The depressions are restricted to an area about 20 ft wide in the center of the runway.

Fig. 2. Effects of concentration of traffic in the central 20 ft of runway at Pinecastle AFB

19. Runways. The photographic procedure of measuring lateral distribution of traffic could not be applied to runways because the cameras would have interfered with landing operations. However, visual observations of plane positions at the time of take-off, blast effects of B-47 motors, and pavement conditions provide information on the lateral position of B-47 planes at take-off. Longitudinal lines are painted on most runways at a distance of 15 ft on either side of the center line. It was observed at Lake Charles and Pinecastle that the take-offs were made from between these lines. The runway at MacDill was wider than the others and the distribution was found to be wider. Blast effects substantiated these observations. As discussed previously the Lockbourne data indicated that the most intensive loading was over a width of less than 50 ft. Fig. 2 (taken at Pinecastle) indicated a concentration of traffic in the central 20 ft. No such concentration was observed during taxiing after landing.
