MISCELLANEOUS PAPER GL-92-32

REANALYSIS OF MULTIPLE-WHEEL LANDING GEAR TRAFFIC TESTS

Richard G. Ahlvin, Jim W. Hall, Jr.

Geotechnical Laboratory

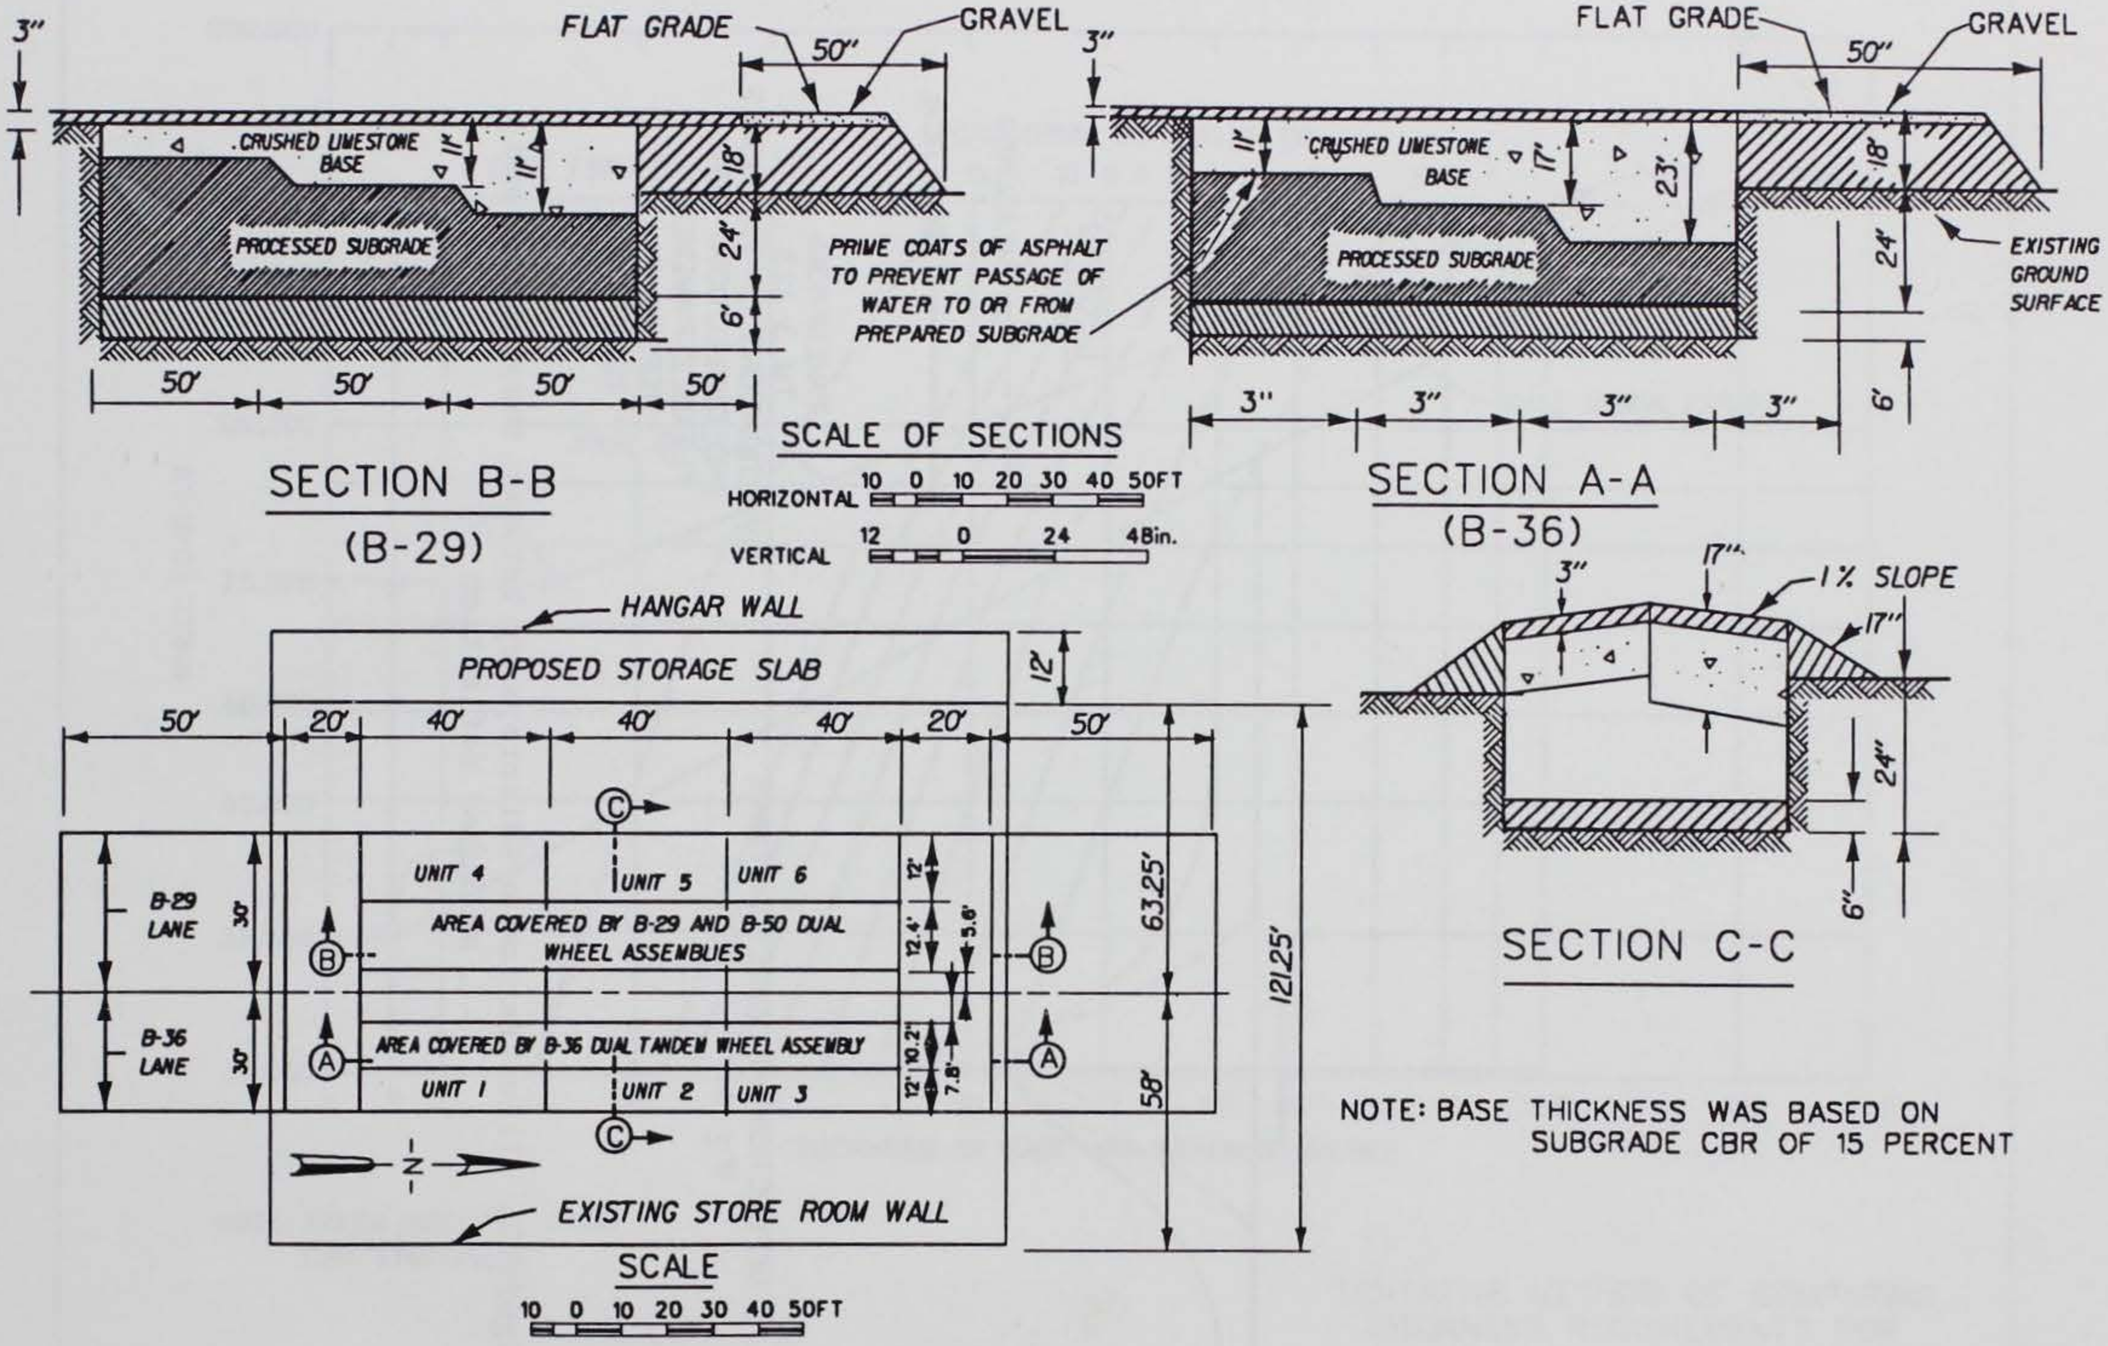
Figure 4. Layout and cross sections of test lanes

Figure 4* shows the layout and cross sections of the test lanes.

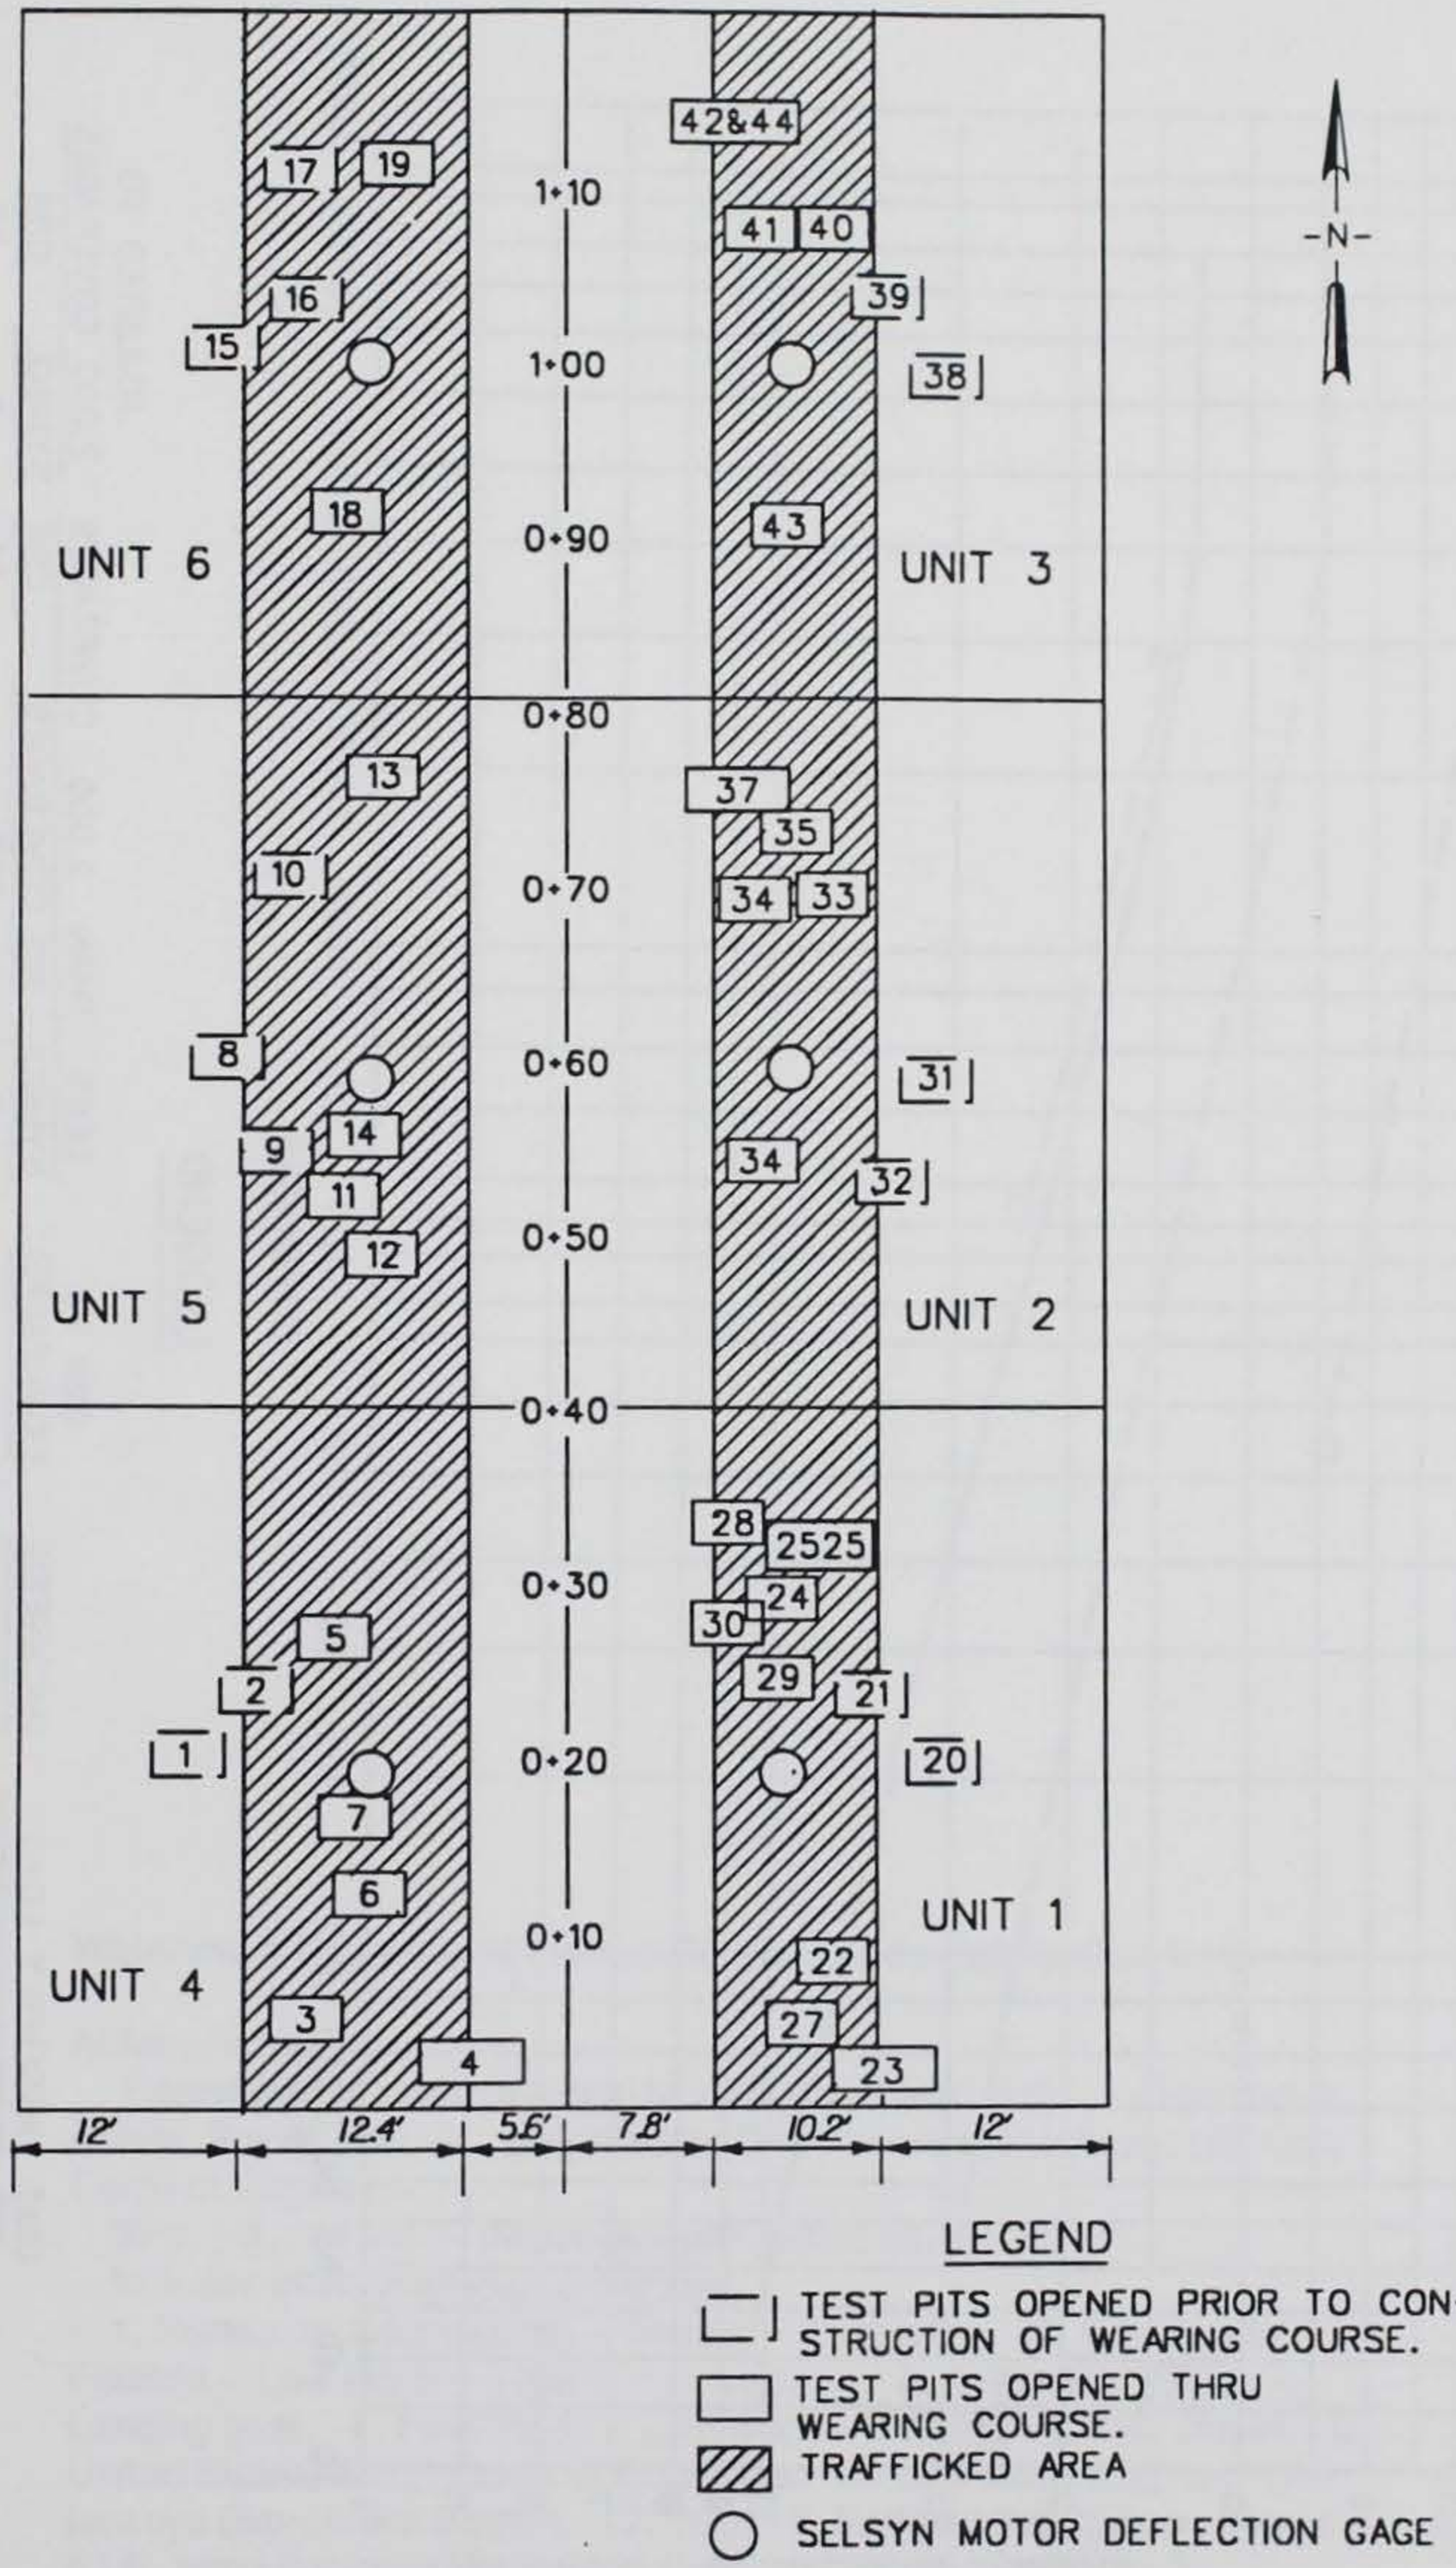
Figure 5. Location of test pits and deflection gages

Figure 5* shows the locations of deflection measurements and of test pits in the six test units.

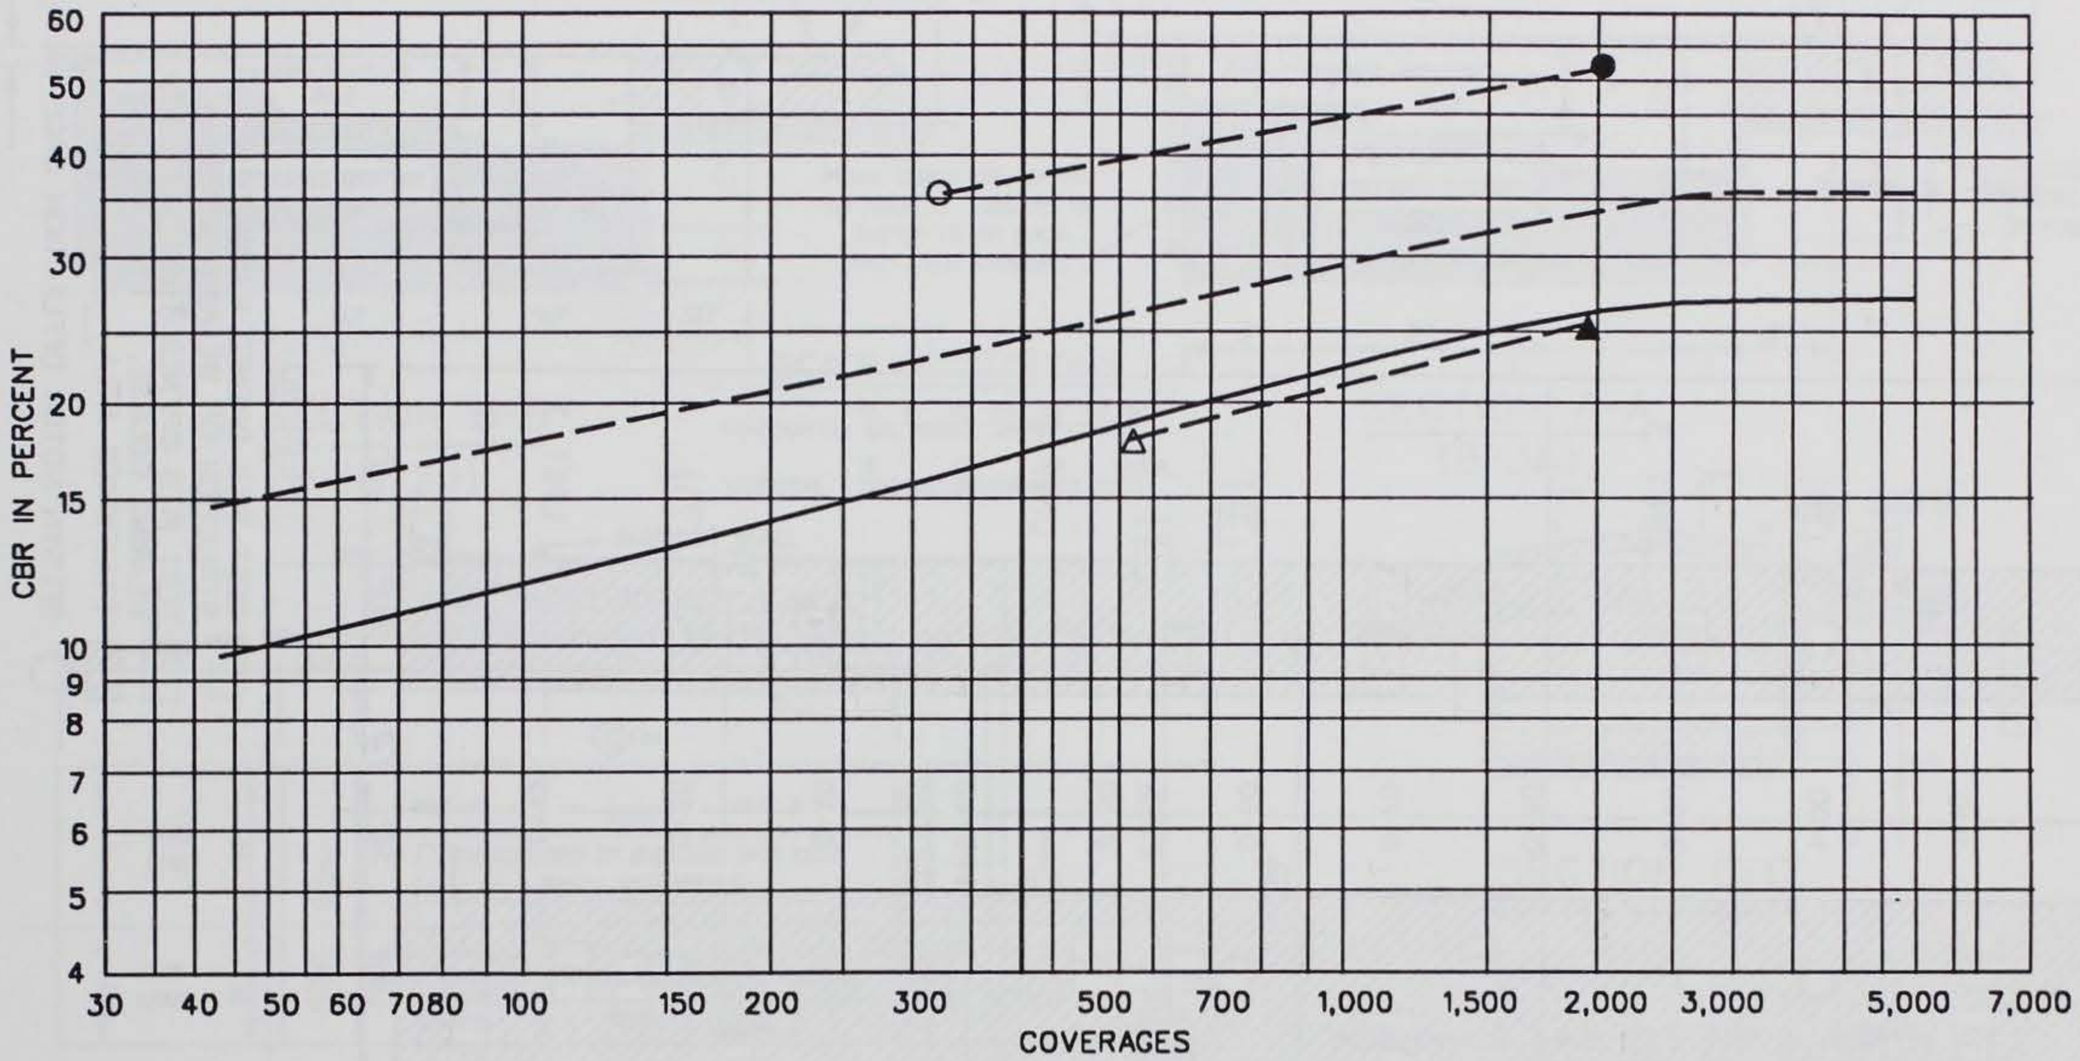
The strength (CBR) data in this table are the primary concern of this reassessment. The evaluation determinations are for traffic of 2,000 coverages. The determinations are for actual applied traffic in all but the two cases indicated. One of these, Unit 1 under 200,000 lb B-36 traffic, failed after 610 coverages. The CBR was rated 18 and was adjusted to 25 in., an attempt to represent a subgrade strength which would have led to failure at 2,000 coverages. Figure 6** shows the adjustment process. The second case of early failure, Unit 4 under 100,000 lb B-50 traffic, was considered failed at 328 coverages. The CBR was rated 35 and was adjusted to 50 to represent a 2,000 coverage inadequate behavior. Figure 6 also shows this adjustment.
