Contract Report CHL-97-1
March 1997

Interaction of Seawalls and Beaches: Eight Years of Field Monitoring, Monterey Bay, California

By *Gary B. Griggs, James F. Tait, Laura J. Moore, Katie Scott, Wendy Corona, Deborah Pembrook, University of California, Santa Cruz*

Final report

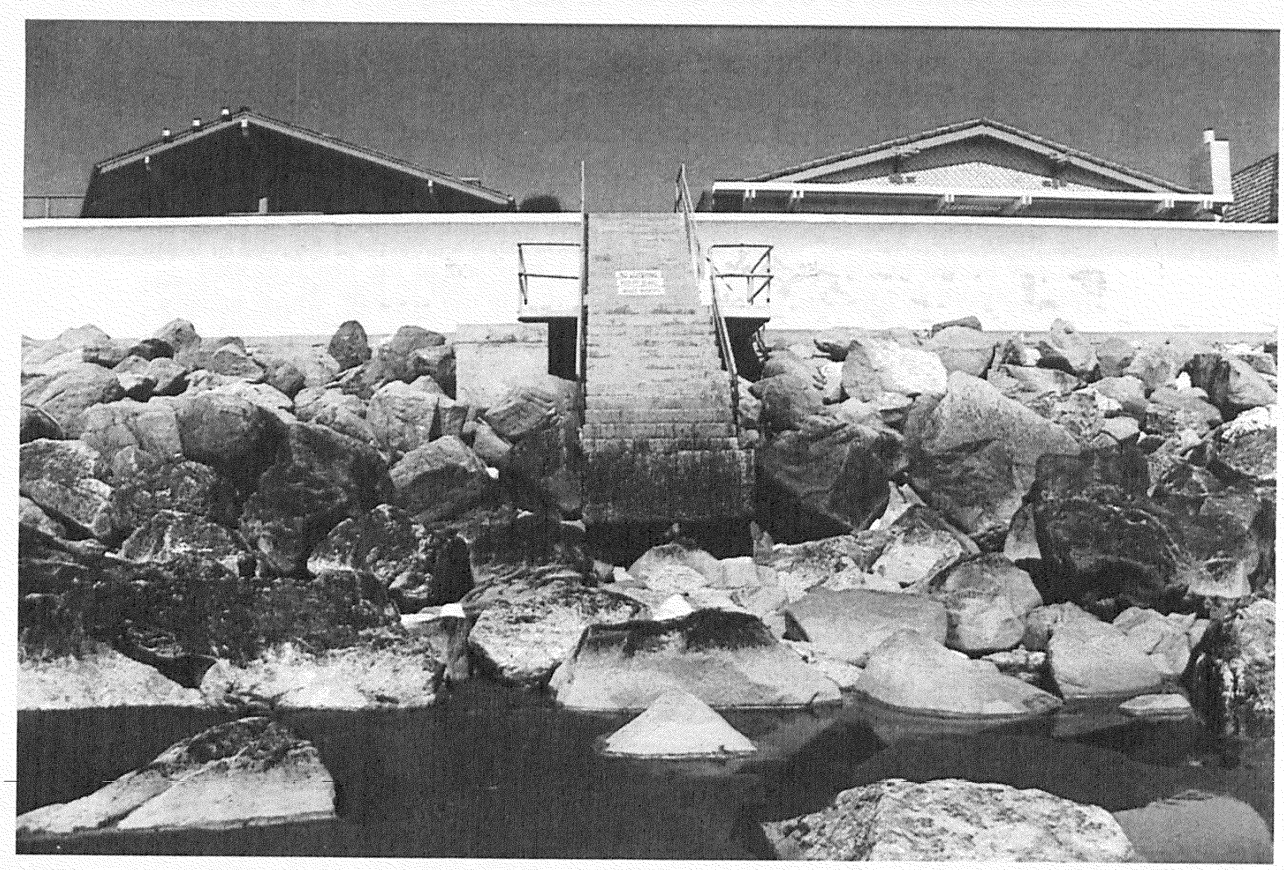
These extreme changes in beach level were reminiscent of the changes associated with the 1983 winter storms. However, despite obvious erosion, photographic comparison of the north control beach after the 1983 and 1995 events reveals that sand loss in 1995 (Figure 15b) was significantly less than it was in 1983 (Figure 15a).

Figure 14. Stairs fronting Aptos Seascape seawall after the storms of January 1995

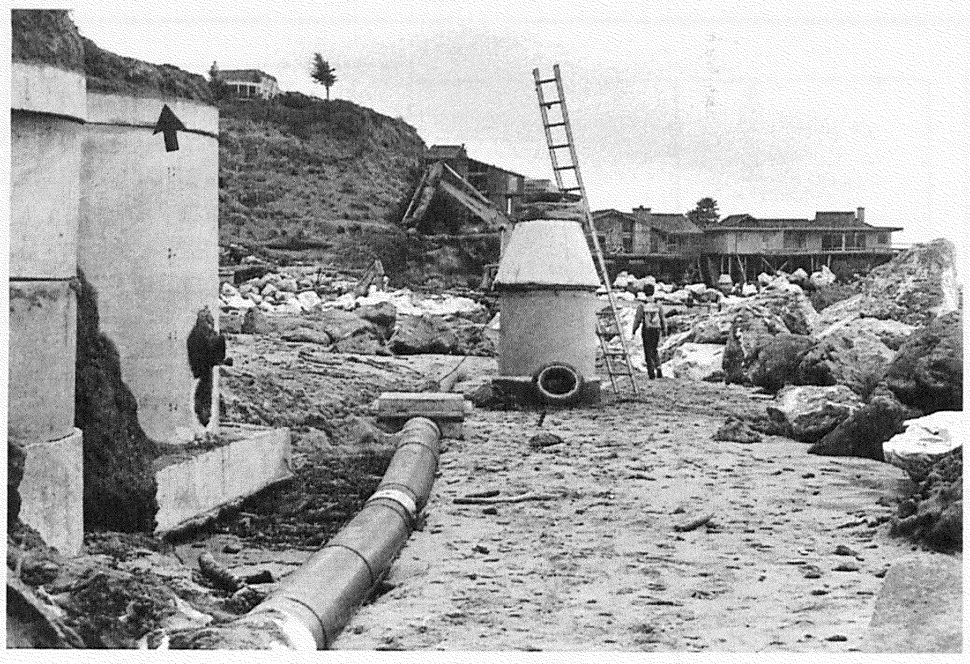
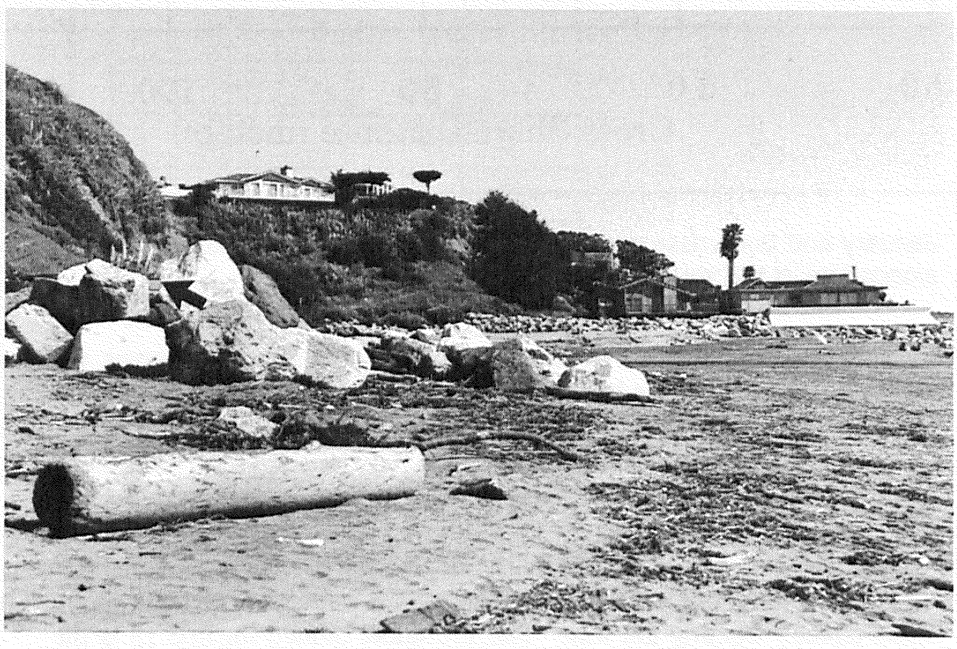
Figure 15. Comparisons of beach scour at north end of Aptos Seascape seawall. Photo scales differ; the seawall was under construction in 1983 and the sewage manholes (tops indicated by arrows) have been protected by riprap. Despite these differences, photos demonstrate that relative to the top of the manholes, the beach was significantly lower in elevation after the 1983 storms as opposed to the 1995 storms
