Opportune Landing Site Program

Suitability Measurement and Analysis for El Centro Naval Air Facility OLS

October 2008

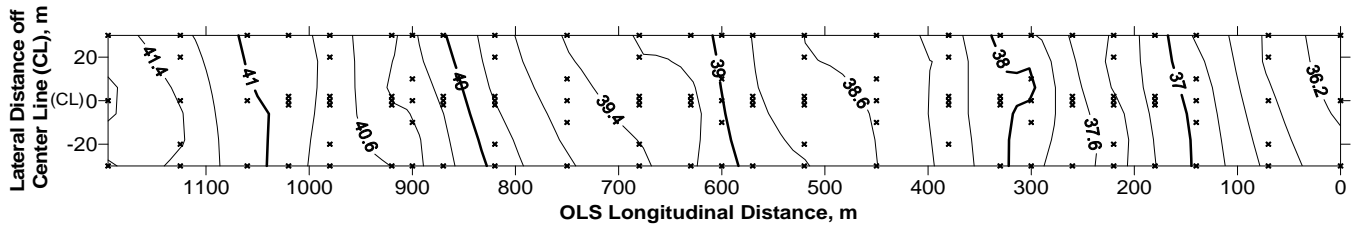
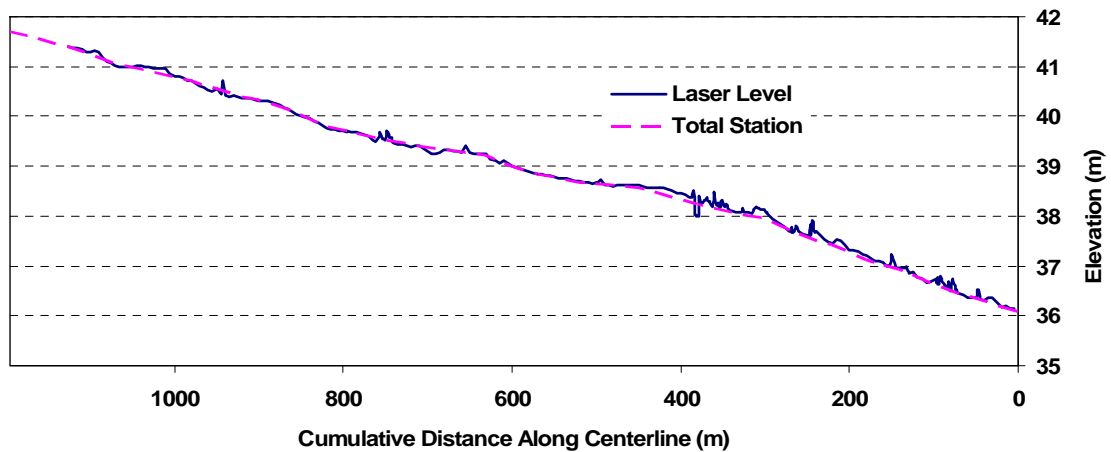
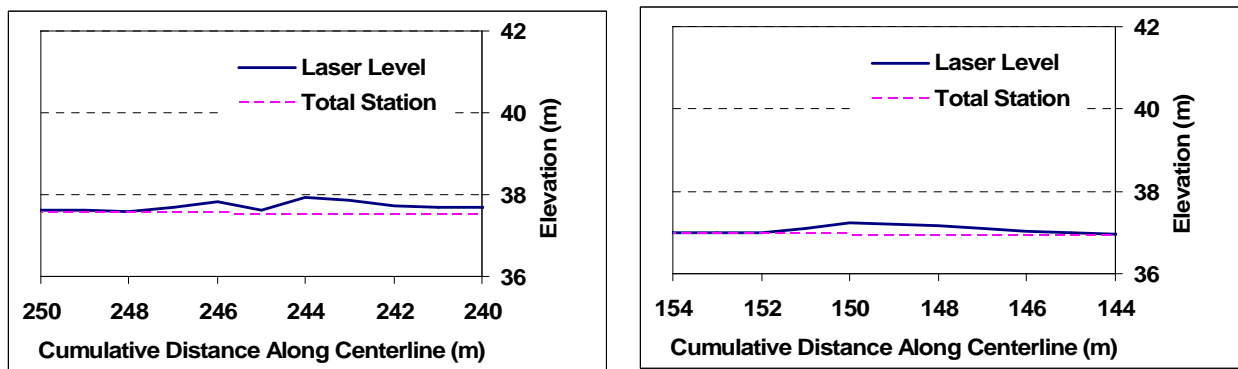
The topography of the OLS is very flat, but gently sloping to the east and northeast for the majority of the RAS (Fig. 13). The elevation of the RAS centerline based from the total station data showed a gradual increase of 5.6 m from the beginning (east) to the end (west), as shown in Figure 14a. The overall grade of the center of the RAS from the beginning to the end is 0.5%, which is relatively flat. A laser profile was collected every 1 m in areas with mounds and every 5 m in flat areas. The spikes in the laser data display the mounds along the center of the RAS (Fig. 14a and 14b). The mounds are quite pronounced in some areas on the RAS and range in height and width. However, these spikes do not represent the entire mound and the centerline measurements didn't always occur on the peak (top) of the mound, but may have captured the sides or the edges. Transitional areas of relatively smooth or flat sections were observed between areas with mounds. In general, the eastern third of the runway has a large number of mounds, and the remainder of the RAS is relatively smooth and flat. Figure 14c illustrates typical surface undulations of a natural ground

Figure 13. Contour map of the entire El Centro OLS. The x symbols show where elevations where taken (elevation in meters).

In some areas on the OLS, mounds are 0.3–0.6 m (1–2 ft) high and 1.2–3.0 m (4–10 ft) across and 1.5–6 m apart. If mounds are considered as changes in slope, the grade from the laser data at El Centro RAS ranges from 0 on the flat areas to a maximum of 40% over short distance. These mounds can be considered abrupt change of grades.

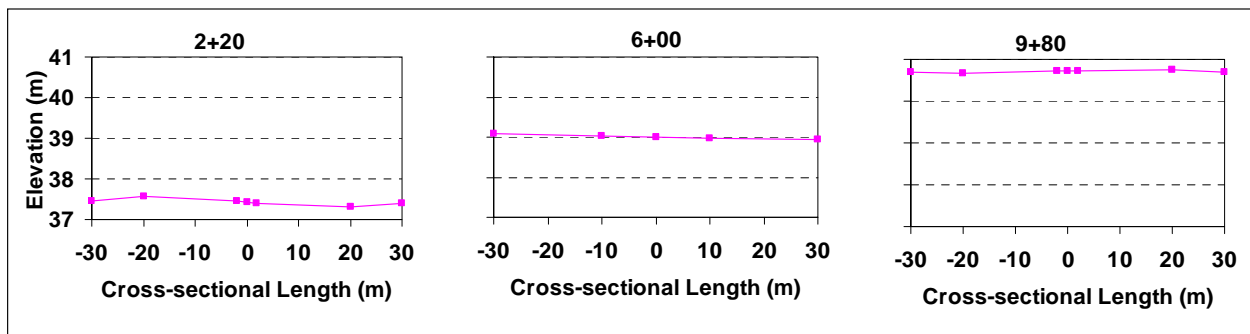
The average lateral cross-sectional grade of the OLS is approximately 0.2%. A couple of typical lateral profiles of the OLS are shown in Figure 15. Overall, the lateral cross section of the OLS is very flat.

Figure 15. Typical transverse profiles of the RAS at El Centro.

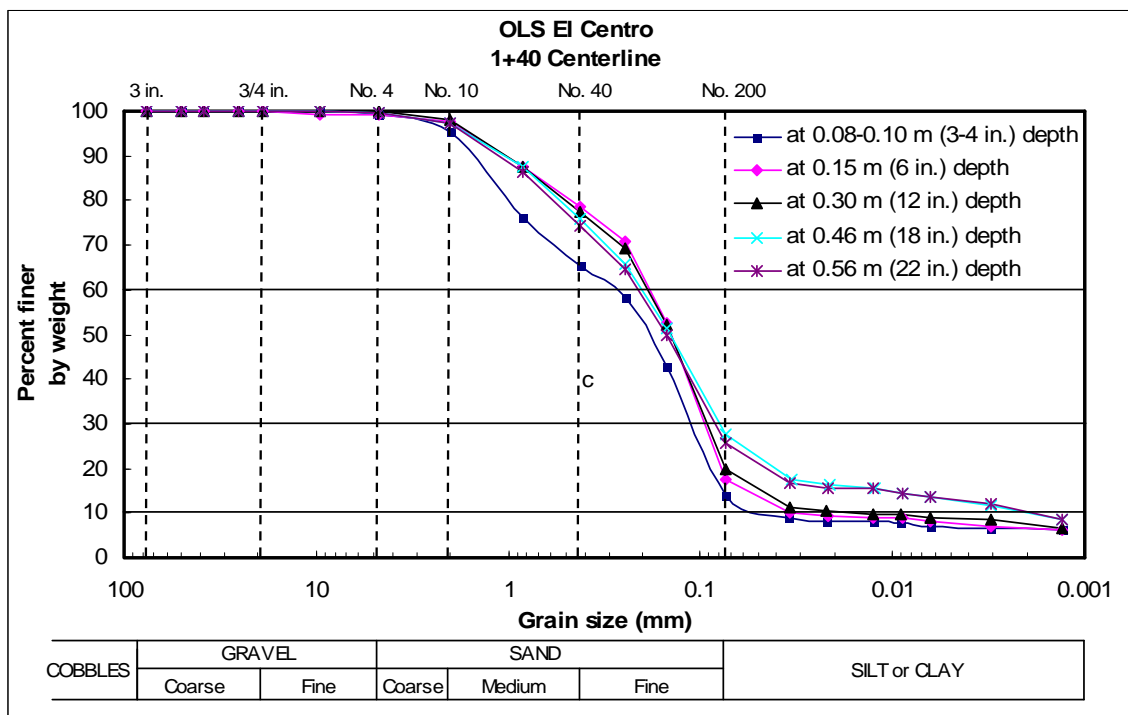
At sampling location 1+40 CL, the soil pit profile showed granular material embedded into fine sand near the surface (Fig. 17a). Below 0.30 m (12 in.) from the surface, the soil contained less coarse sand and more medium and fine-grained sand, as seen in Figure 17b. Soil samples were taken at depths of 0.08–0.10, 0.15, 0.30, 0.46, 0.56 m (3–4, 6, 12, 18, and 22 in.). The USCS soil type is classified as silty sand (SM) with a plasticity index of zero throughout the soil profile down to 22 inches. The gradation chart is shown in Figure 17c.

Figure 17. Soil profile at 1+40 CL. A hard layer was encountered at approximately 0.46 m (18 in.) where a pick was used to break the cemented soil.

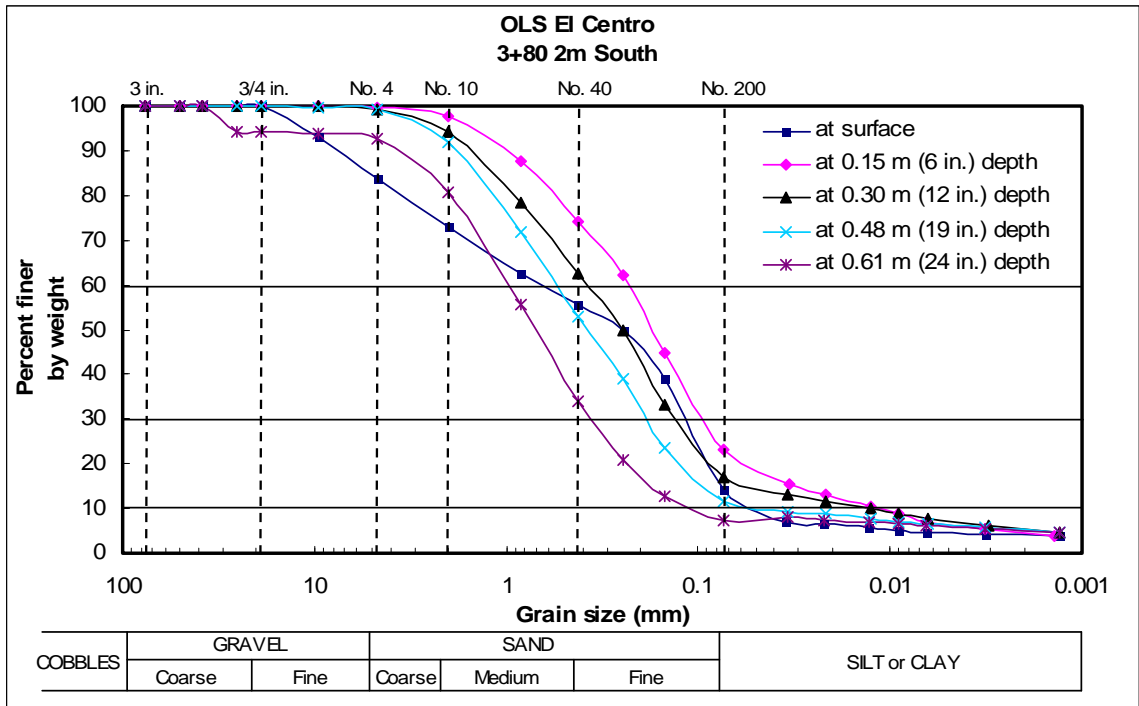
Cemented layers at various depths were found while digging the soil pit at 3+80 2S (Fig. 18a). The pit was dug down to 0.6-m (24-in.) depth (Fig. 18b). The results from the grain size analysis of the soils collected at station 3+80 2S are shown in Figure 18c. The gradation from the surface down to 0.30-m (12-in.) depth is classified as silty sand (SM). At 0.48- and 0.61-m (19- and 24-in.) depths, the soil samples are classified as well-graded sand with silt (SW-SM).

Figure 18. Soil profile at station 3+80 2S showing cemented layer at different depths. The bottom of the pit is at 0.6 m (24 in.) below the surface. (Note that the tape is not standing vertically.)

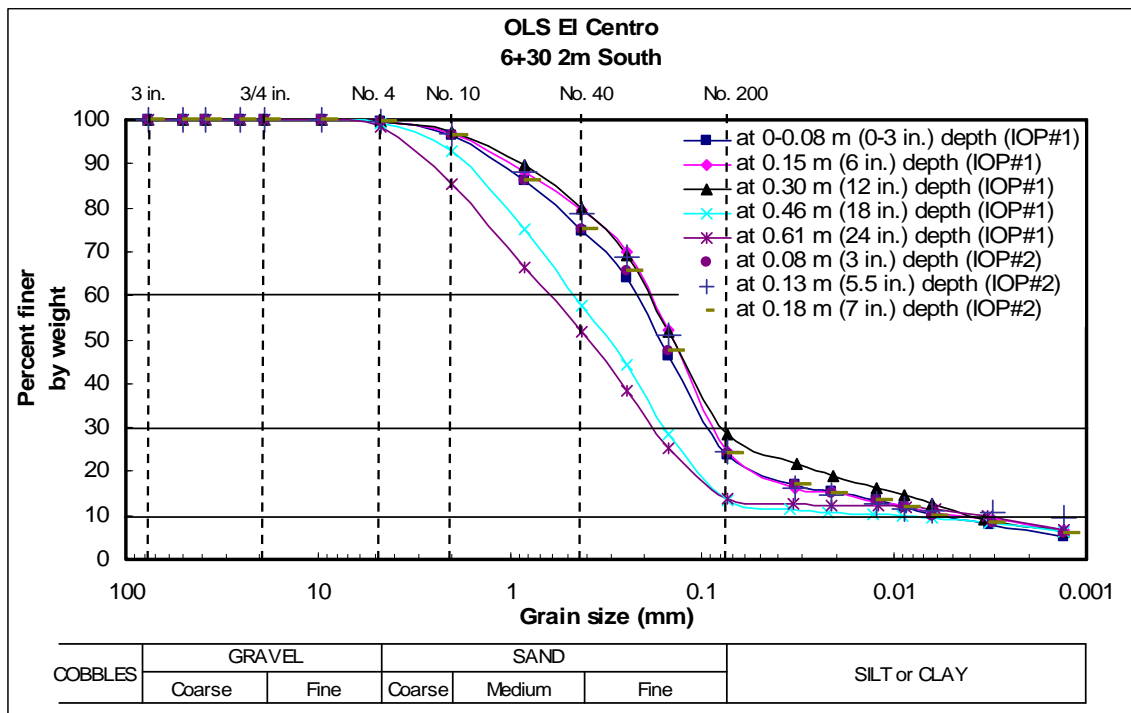
A photo of the soil profile taken at 6+30 2S during the first visit is shown in Figure 19a. The bottom of the pit was 0.6 m (24 in.) deep. Samples were collected for the gradation analysis during the first and second visits. A set from the soil pit during IOP #1 and another set from drive cylinder samples also were taken during IOP #2. The results of the grain size analyses of all the soils collected at 6+30 2S are shown in Figure 19b. The entire soil profile is classified as Silty Sand (SM) with higher percent fines passing the number 200 sieve in the top 0.3 m (12 in.) than in bottom.

Figure 19. Resulting soil profile at 6+30 2S.

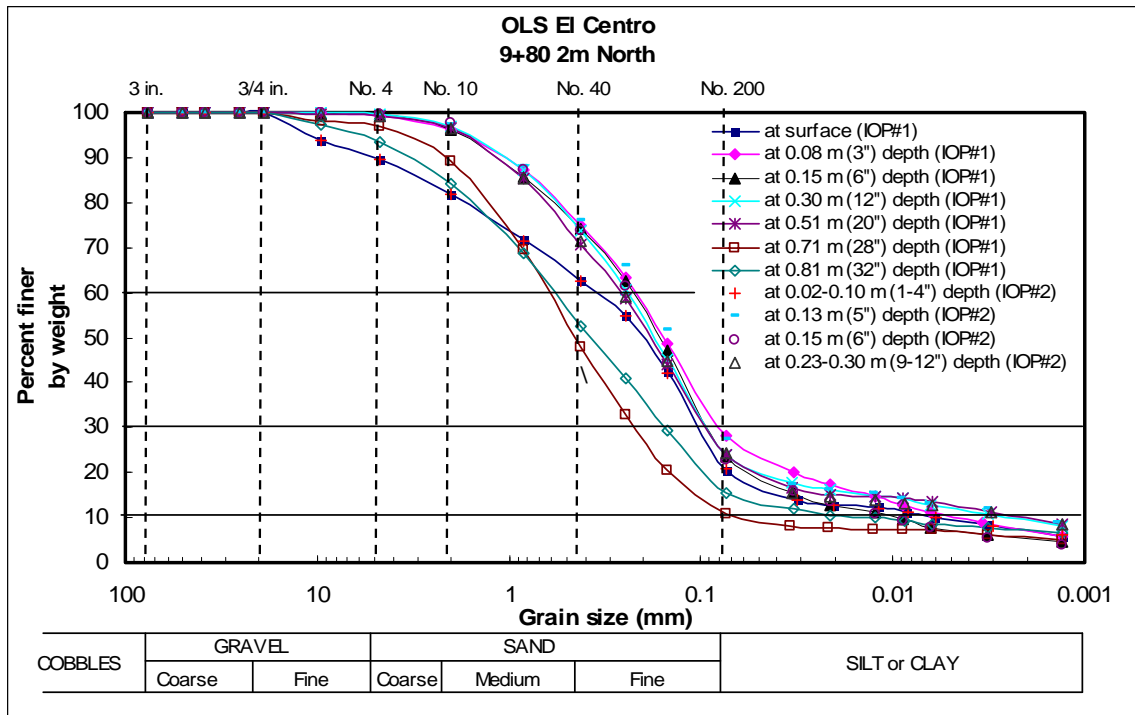
At sampling location 9+80 2N, the soil pit was dug to a depth of 0.81 m (32 in.). Thin cemented layering was observed throughout the soil profile (Fig. 20a). Similarly, soil samples were taken at both IOP #1 and IOP #2. The first set of soil samples was taken when a pit was dug during the first IOP on July 11–15, 2005. The second set of soil samples were collected October 17–21, 2005 and were taken on an undisturbed area approximately 1 m away from the edge of soil pit during IOP #1. The result from the grain size analysis for all samples is given in Figure 20b. The soil profile at this location indicates a silty sand (SM) from the surface down to 0.51 m (20 in.), then well-graded sand with silt (SW-SM) to a depth of 0.71 m (28 in.), and then the soil changes to silty sand (SM) at a depth of 0.81 m (32 in.).

Figure 20 (cont'd). Soil profile and grain size analysis at sampling location 9+80 2N.

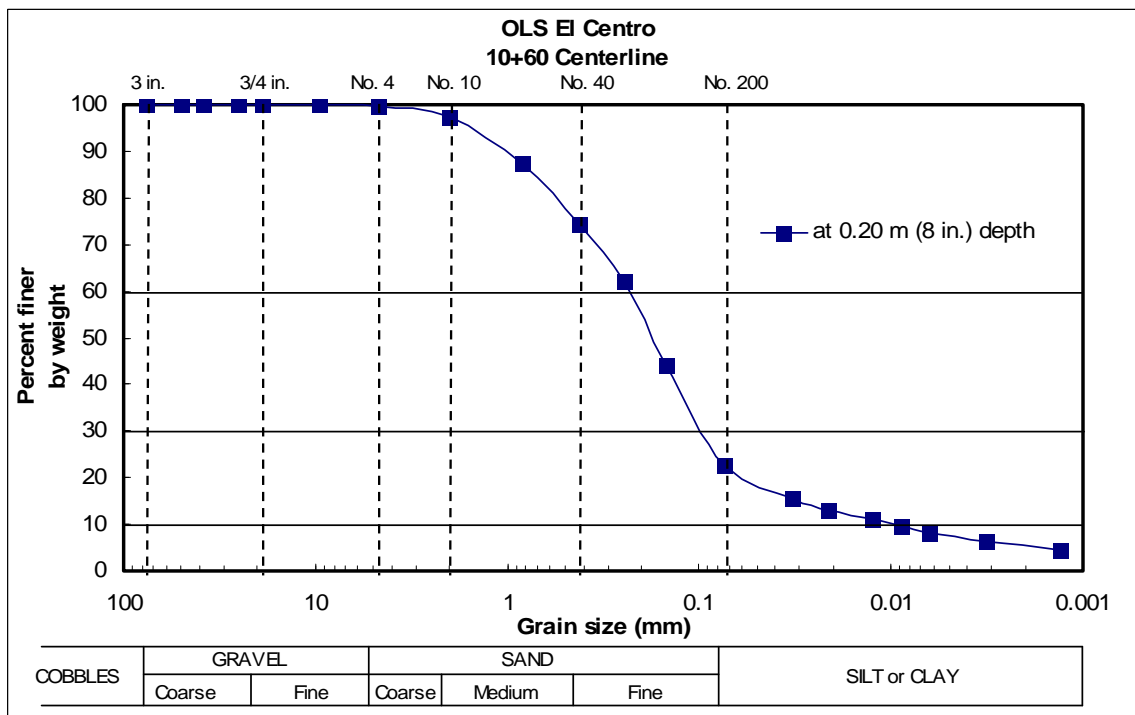
At sampling location 10+60 CL, soil was sampled using the drive cylinder at 0.20-m (8-in.) depth during IOP #2. The result from the grain size analysis can be seen in Figure 21. The soil type at that depth indicates a silty sand (SM) material.

Figure 21. Grain size analysis at 10+10 CL taken from a core sample at 0.2-m depth.

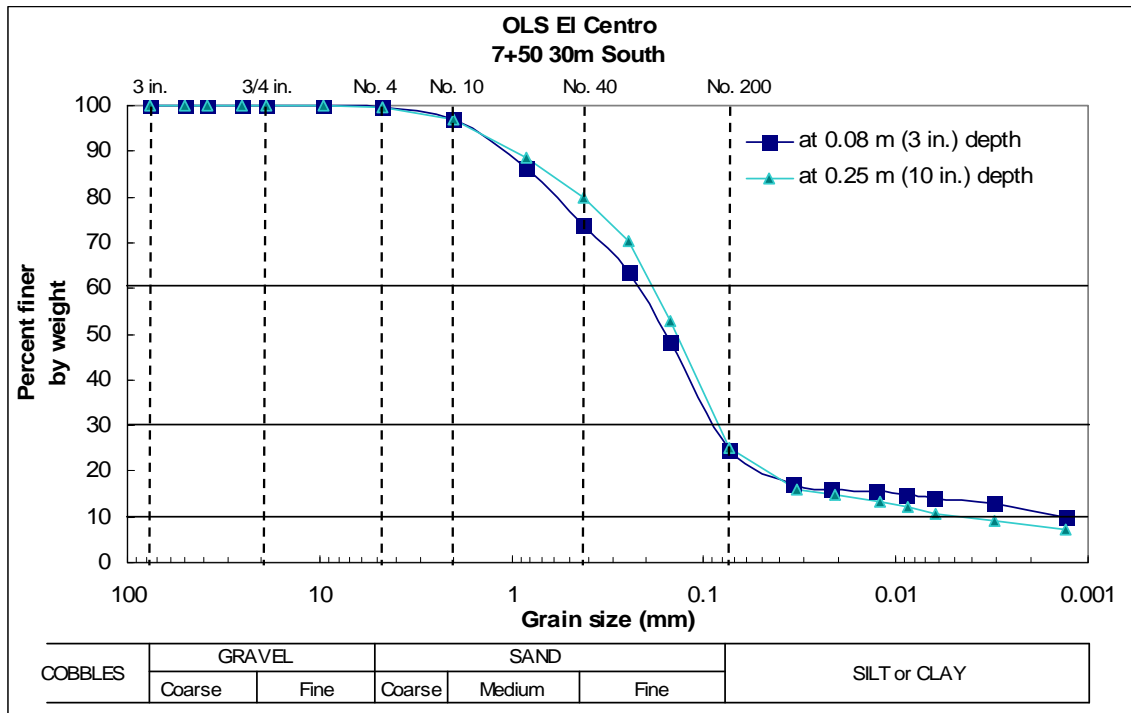
Figure 22. Soil profile and grain size analysis from drive cylinder samples at location 7+50 30S.

Soil samples at 0.08- and 0.25-m (3- and 10-in.) depth were extracted from the drive cylinder at sampling location 7+50 30S IOP #2. The results from the grain size analysis are given in Figure 22. The soil profile for this location indicates a silty sand (SM).

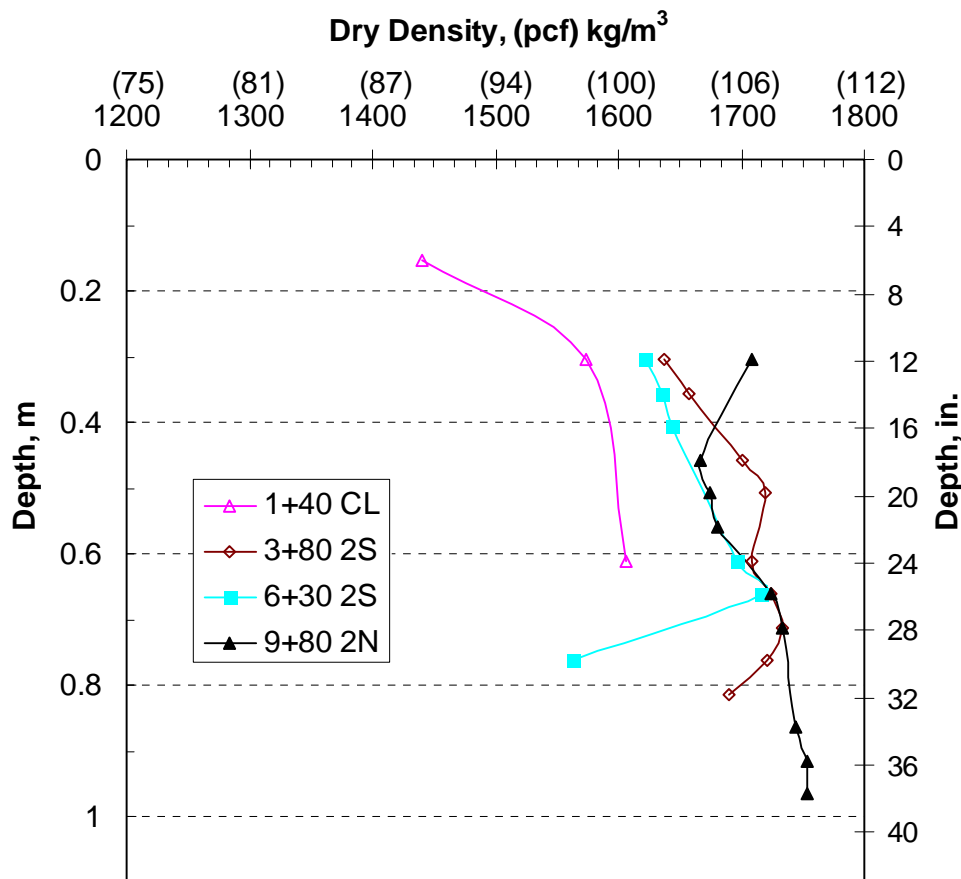
Soil density measurements were made with the Troxler nuclear gage at 1+40 CL, 3+80 2S, 6+30 2S, and 9+80 2N during IOP #1 and are summarized in Figure 23. Aside from the loose surface layer (1440 kg/m³), density ranged from 1573 to 1709 kg/m³ (98.2 to 106.7 lb/ft³) with an average 1664 kg/m³ (103.9 lb/ft³). The average specific gravity was 2.63. There is no significant density variation between 3+80 2S, 6+30 2S and 9+80 2N except for the density at 1+40 CL and at the 0.76-m (30-in.) depth at 6+30 2S (Fig. 23). Density generally increased slightly with depth. Although a low density was found just above a very hard layer at the bottom of the pit. This variation in soil density is typical for in-situ or natural deposited soils with non-homogenous layering and cemented layers. Instrument error, spatial variability, and mineralogy may also contribute to the variability and were not examined in this report.

Figure 23. Dry density measurements from the nuclear gage in four soil pits at El Centro RAS during IOP #1.

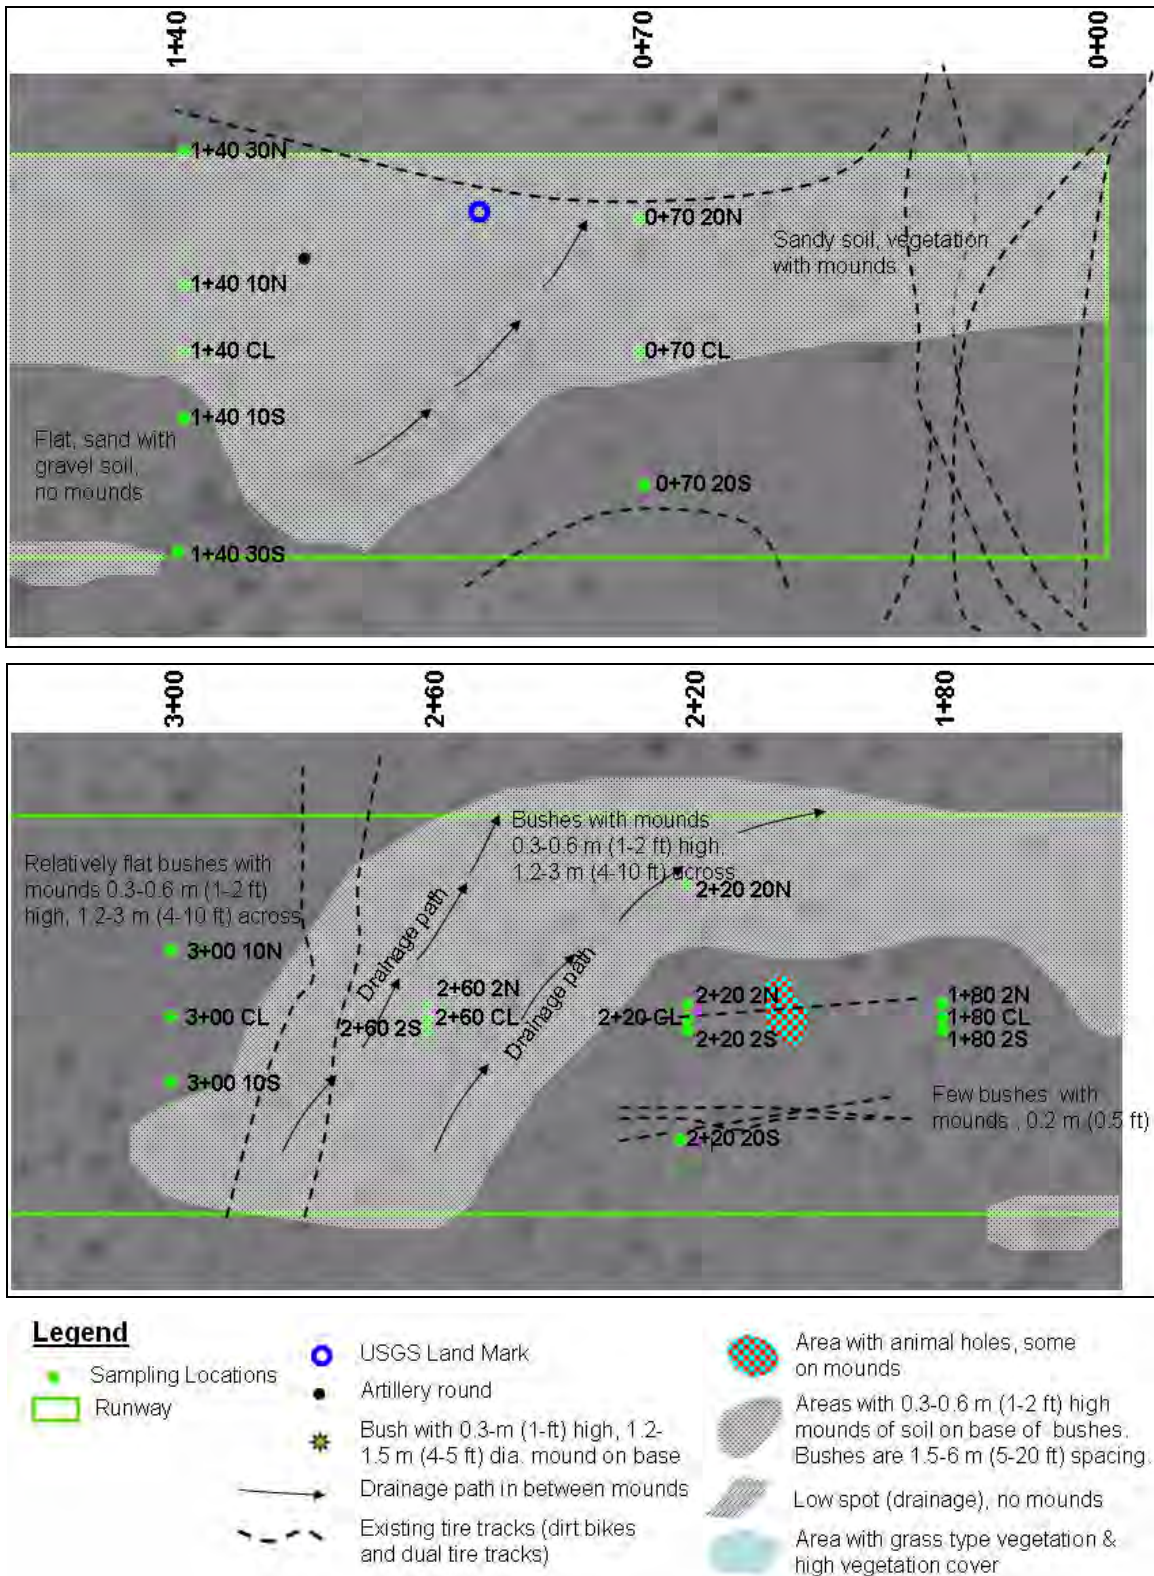
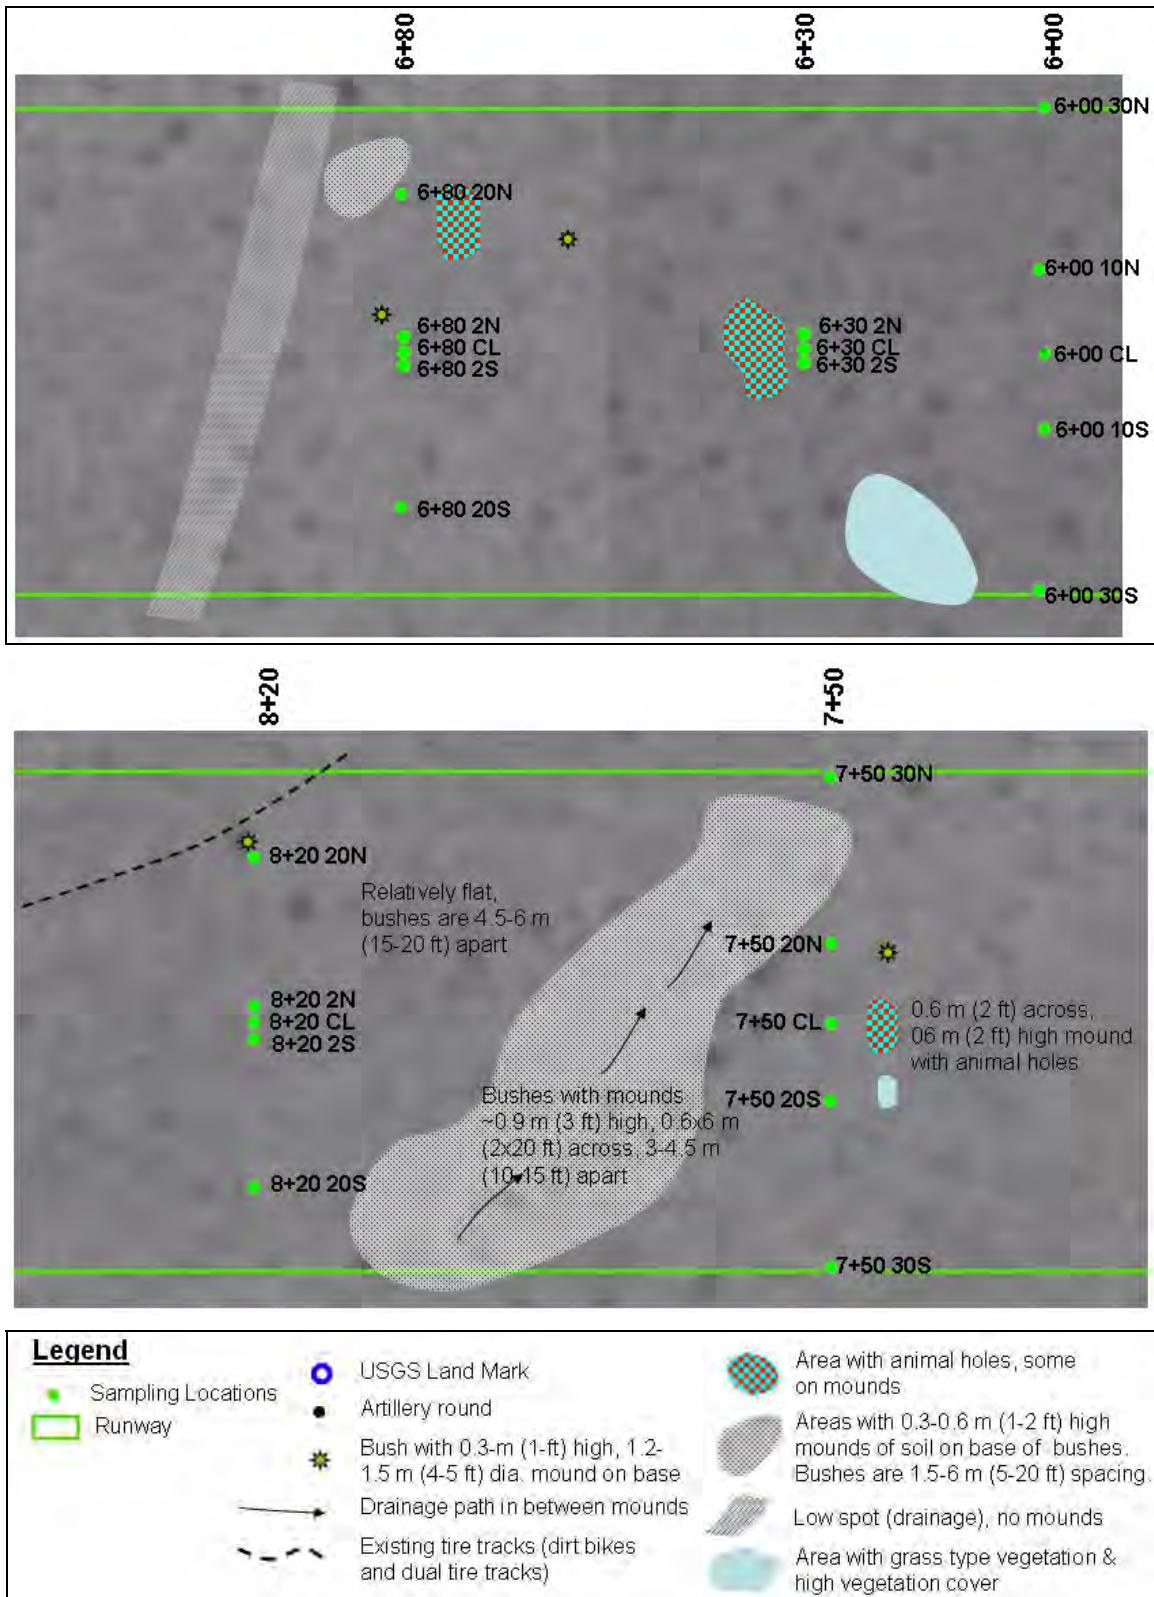
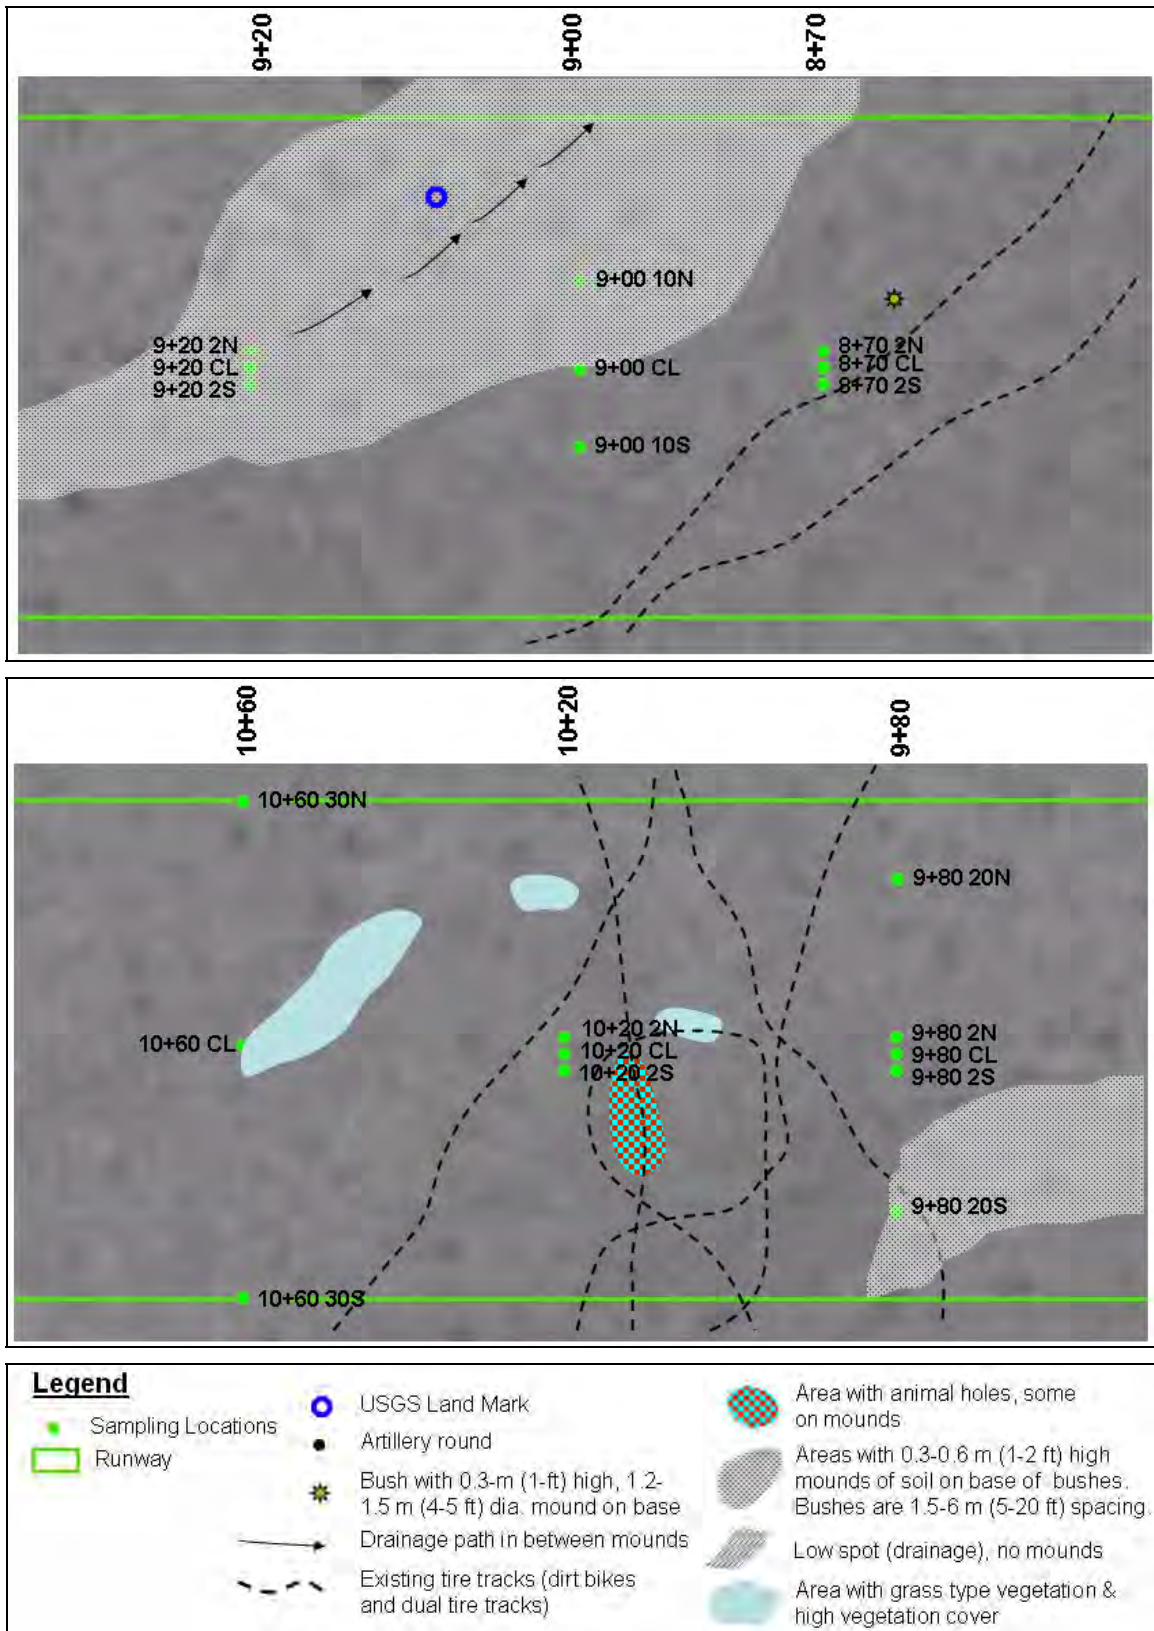
A walk-through visual survey along the RAS was conducted to determine the surface condition of the runway during IOP #1. From the visual survey, the observer noted vegetation type, vegetation cover, tire tracks or ruts, drainage, soil scouring from water or animals, landmarks, mounds, animal holes, artillery rounds, and anything else that could present a hazard to aircraft operations. A sketch was generated from the visual survey as shown in Figure 25 in approximately 150-m sections. Each sketch is a symbolic illustration of the surface features and is not drawn to precise scale. No additional visual surveys were conducted during subsequent visits because no significant changes were observed.

Figure 25. Symbolic representation of surface features from the visual survey along the RAS in sections.

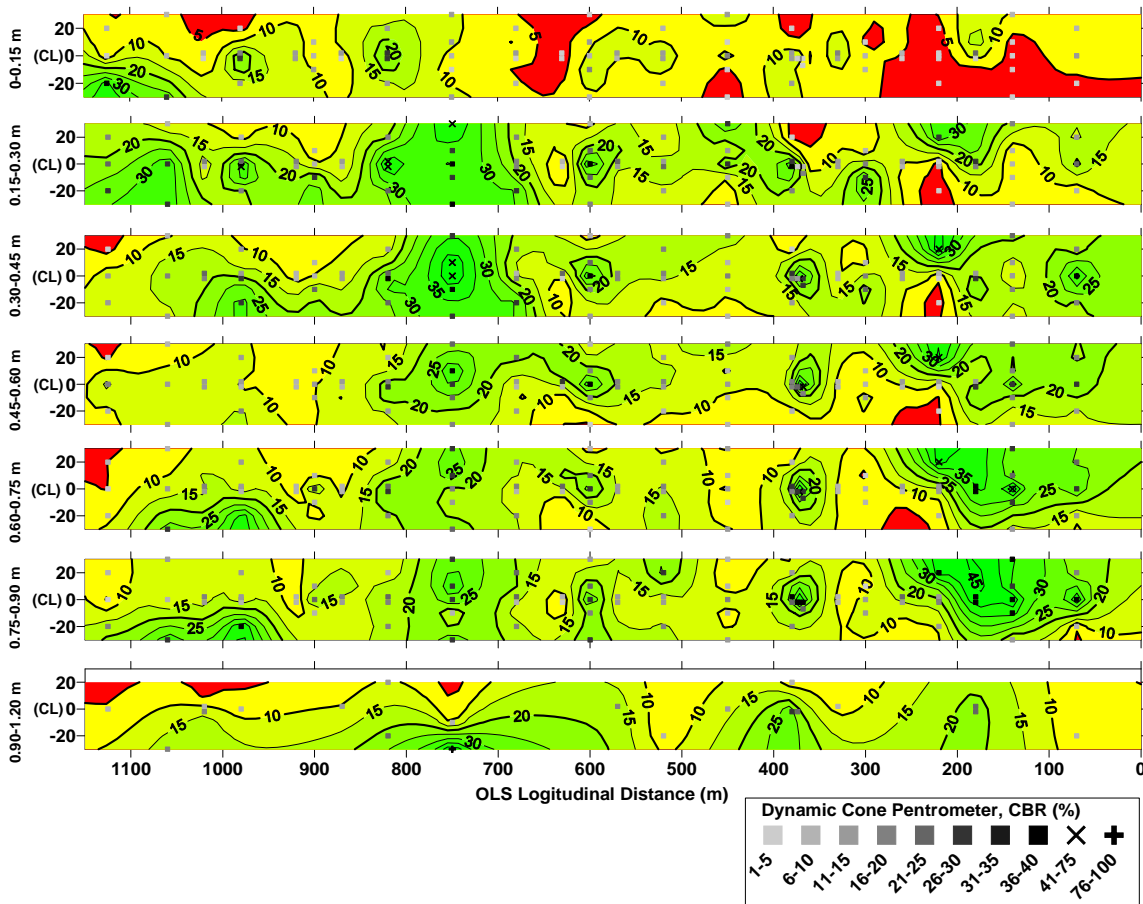
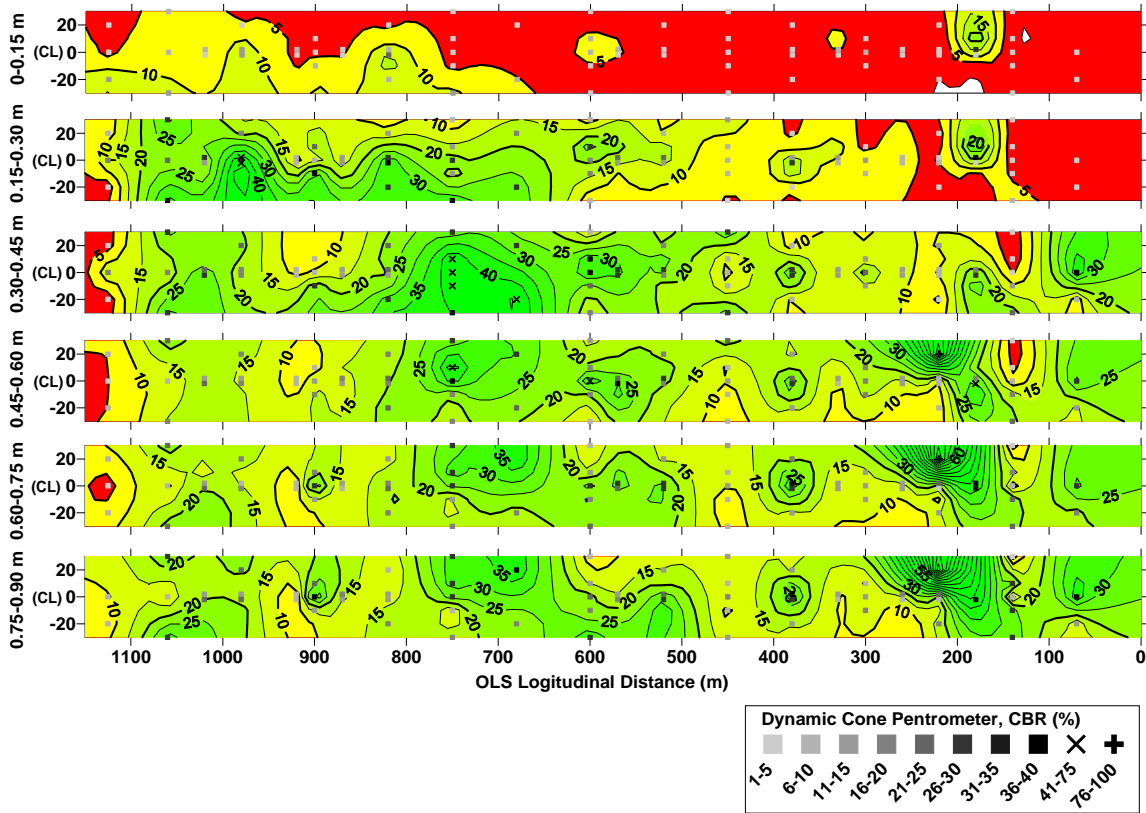
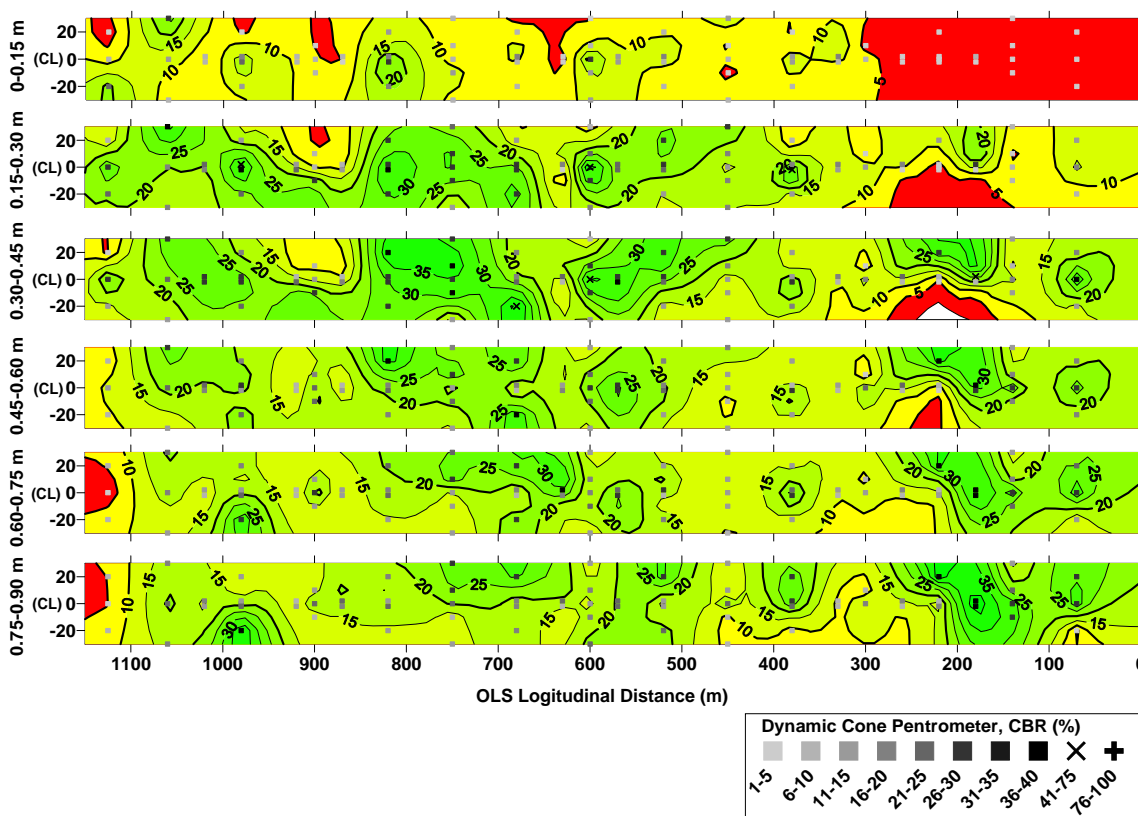
During IOP #1 (in July 2005), 81 DCP profiles were measured on the entire RAS (Table 6). CBR values of the top layer (0 to 0.15 m or 0 to 6 in.) were greater than 20 and up to 38 in a small area in the western corner and at a few other sample locations. For most of the RAS the surface layer CBR values are in the teens, with a few less than 10 and minimum of one (Fig. 41a). Of the 81 DCP profiles, at least 48 of those have CBR values of less than 10, and there are nine sampling locations with CBR strengths of less than or equal to two.

At depths of 0.15 to 0.30 m (6 to 12 in.), 25 of 81 locations have CBR values less than 10; four of these locations have CBR values less than or equal to two. In general, the soil strength increased below the surface layer and in some locations at deeper depths, such as areas surrounding stations 7+50 and 2+00, with relative high CBR values in the 30s and 40s (Fig. 41a). Based on our observations in the soil pits, the cemented layer is the main source of the soil strength increase at depth.

The soil strength for 0 to 0.15 m (0 to 6 in.) and 0.15 to 0.30 m (6 to 12 in.) during IOP #2 in October 2005 ranged from zero to 29, and one to 53 percent CBR, respectively (Fig. 41b). Of 70 DCP profiles, 63 of the sampling locations have surface layer CBR values less than or equal to 10, and two-thirds of these measurements have CBR values less than 2. Similarly, an

increase in soil strength is discerned from the CBR values at 0.15- to 0.30-m (6- to 12-in.) depth, with 50% of the locations having CBR values greater than 10, and at least 10% of the locations on the RAS having CBR values of two or less. The changes in soil strength with depth most likely are influenced by the cemented layer in certain parts of the RAS, as described earlier (Fig. 41b).

There were 77 DCP profiles taken during IOP #3 (April 2006). The CBR profiles for IOP #3 are shown in Figure 41c. The CBR for 0−0.15 m (0−6 in.) and 0.15−0.30 m (6−12 in.) ranged from 2 to 33, and 2 to 44, respectively. Soil strength profiles below 0.15 m (6 in.) are comparable to the strengths for IOPs #1 and #2 at these depths. The soil strength for 0−0.15 m to 0.30 m (6−12 in.) depth ranged between three and 32 (% CBR), and at 70% of the sampling locations the CBR is less than or equal to 10.

Figure 41. Soil strength contours measured using the Dynamic Cone Penetrometer for all IOPs on El Centro RAS.

In general, the surface layer CBR values are low and not reliable due to the lack of confinement in the soil. CBR values vary with depth, which are solely controlled by the irregular and discontinuous cemented soil layers. CBR values also differed with the topography of the RAS. In the upper depths (from the surface down to 0.3-m depth), the soil strength is lower elevation (the eastern part of the RAS) than in the higher elevation (the western part of the RAS). The area with lower soil strength is quite significant during IOP #2 (Fig. 41b), where the water from the rain event drained toward the lower elevation (Fig. 36), evident from the surface runoff patterns shown in Figure 31. The CBR can have variations within a soil type. The eastern part of the RAS consisted of fine coarsed-grained gravel and sand on the surface, with higher vegetation cover than the other section of the RAS.

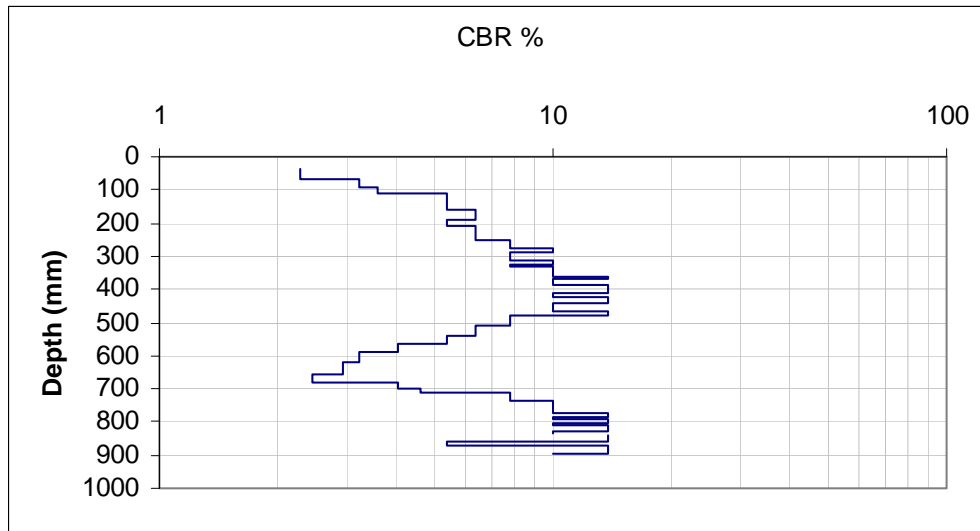
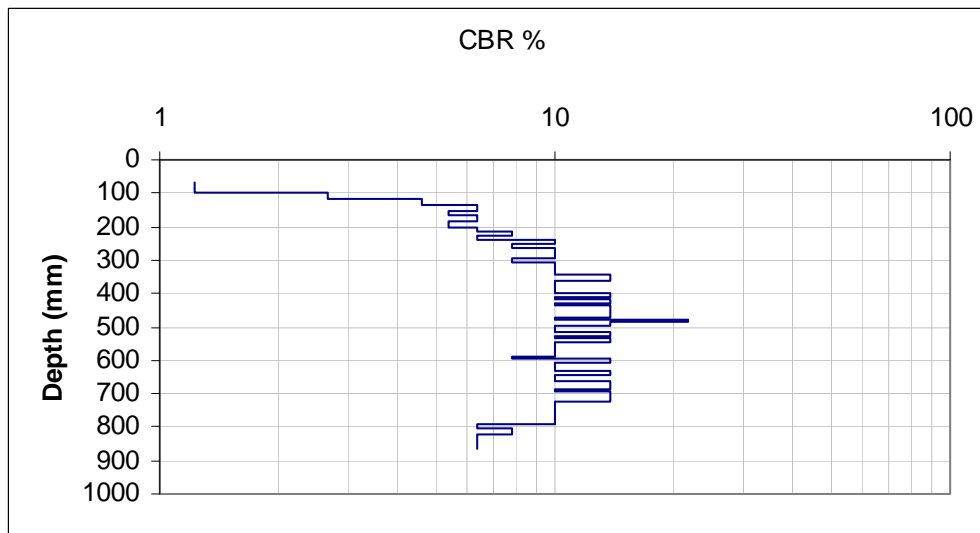
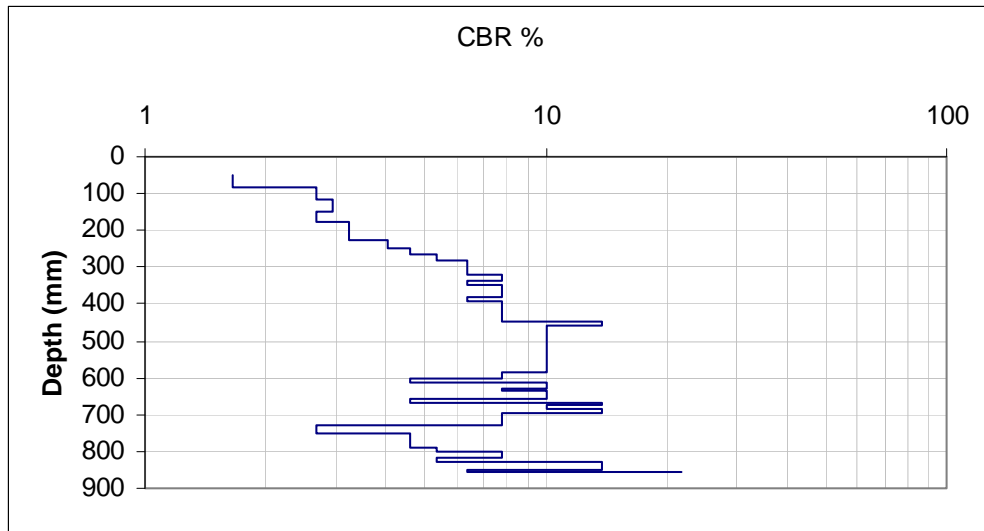
7+50 CL are shown in Figures 42 and 43, respectively. At sampling loca-
tions 2+60 2S, the soil displayed low strength profiles from the surface
down to 0.35 m, with CBR less than 10. Below it, the soil strength varied,
depending on where the DCP was taken at that specific location (Fig. 42).
While at 7+50 CL, the cemented layer can be easily detected from the DCP
profiles below 200 mm (Fig. 43). Despite changes in soil moisture for IOP
#2 in October, the soil strength profiles at the two locations vary little with
seasons.

Figure 42. CBR profiles at sampling location 2+60 2S taken during three IOPs at El Centro.

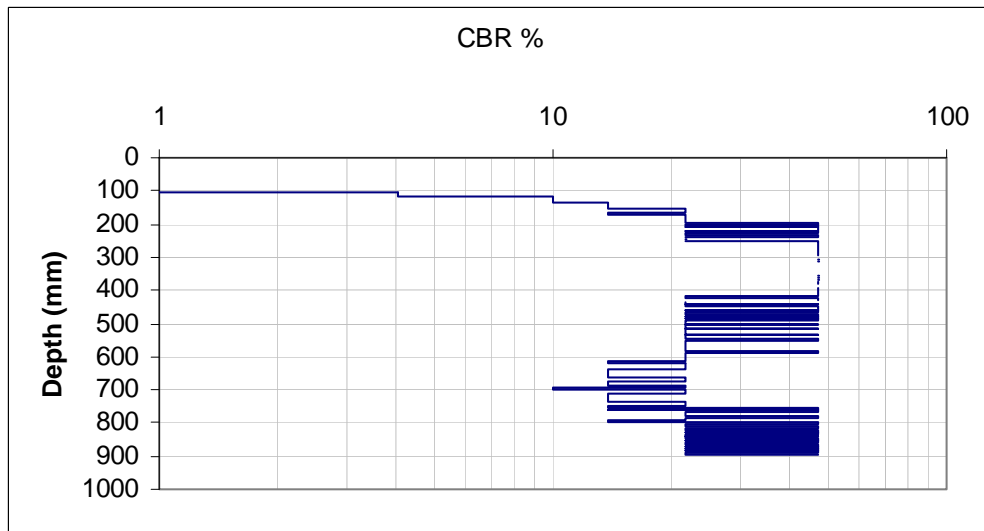
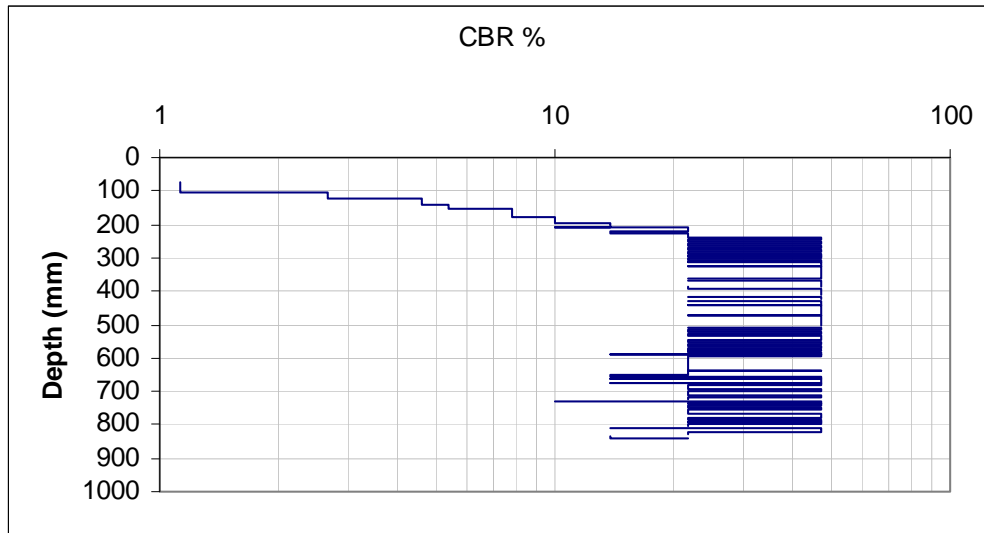
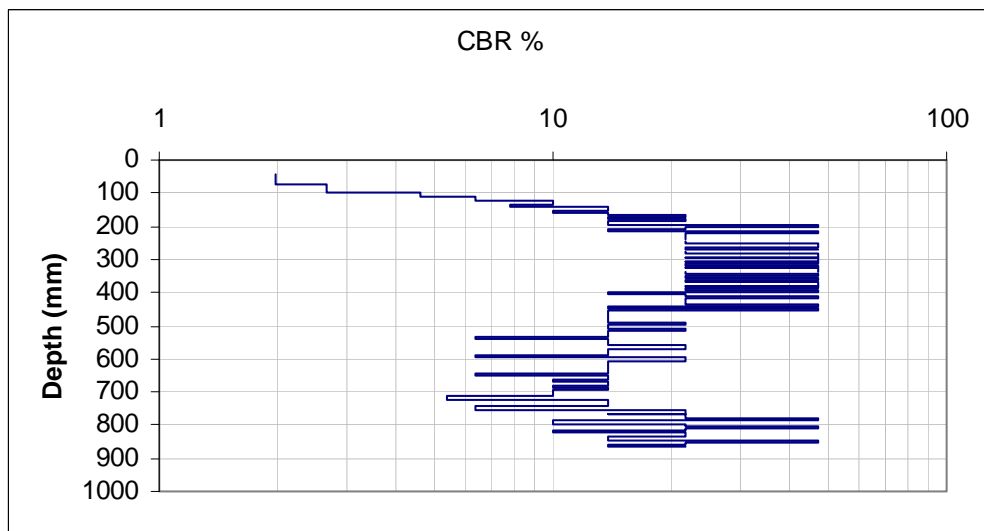
Figure 43. DCP profiles at sampling location 7+50 CL taken during three IOPs at El Centro.
