Opportune Landing Site Program

Suitability Measurement and Analysis for El Centro Naval Air Facility OLS

October 2008

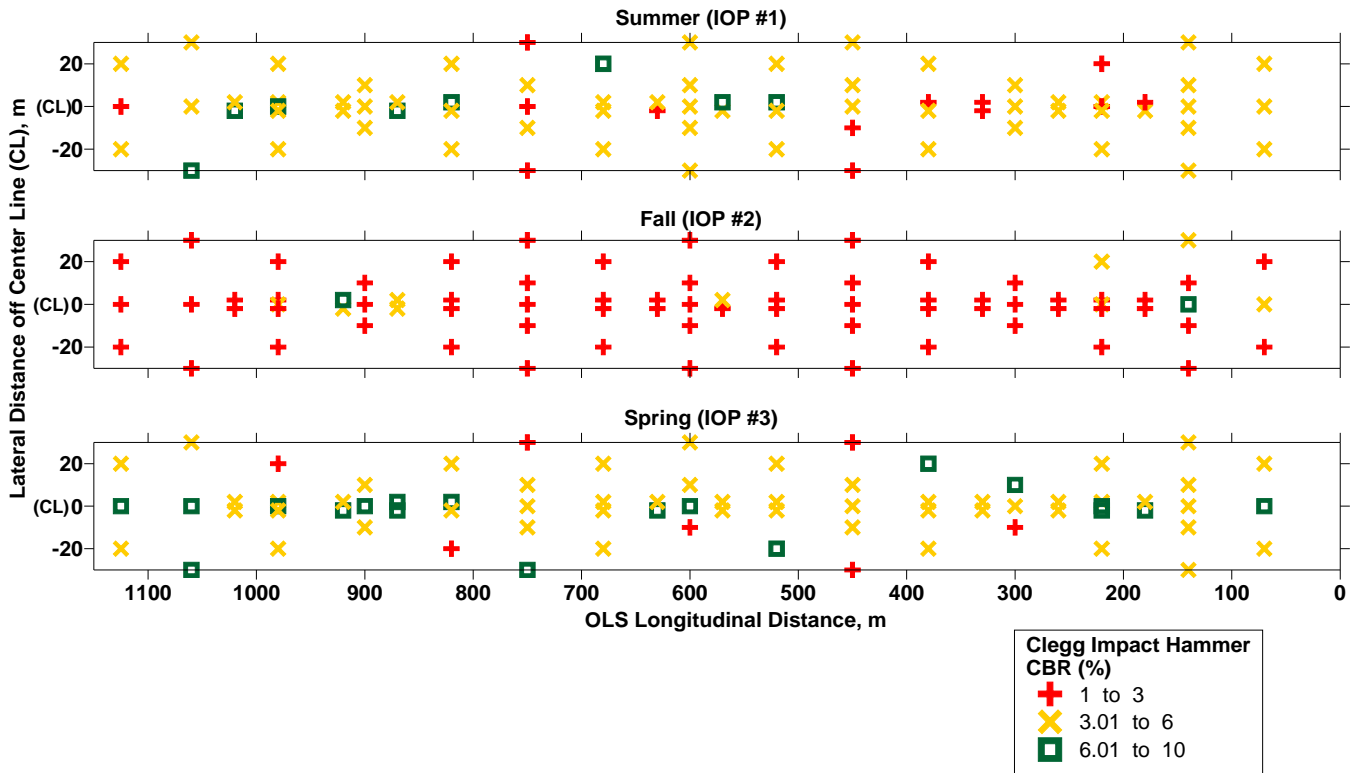
subsequent IOP. The higher soil moisture during IOP #2 seemed to cause a decrease in surface soil strength for the wet season, and we also noticed the disappearance of the near-surface cemented layer (shown in Fig. 24) when the soil was wet.

Figure 44. Soil strength for top 0.15 m (6 in.) measured using the light Clegg impact hammer expressed in CBR (%) for the El Centro RAS.

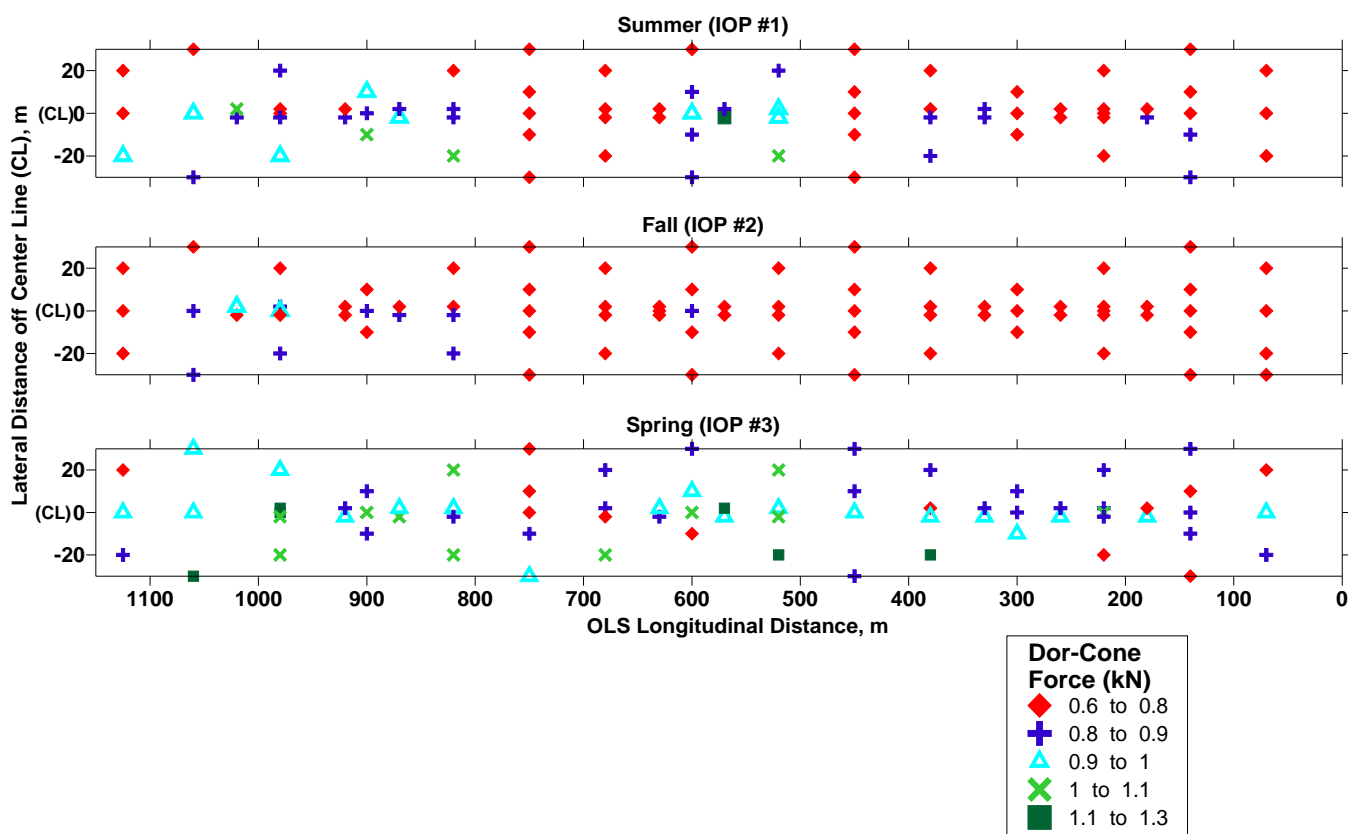
The force calculated using equation 5 from the Drop cone measurements for the entire RAS for three IOPs can be seen in Figure 45. Most of the areas presented very little resistance, resulting in force values of 0.6 to 0.8 kN (135 and 180 lb$_f$). Forces greater than 1 kN (225 lb$_f$) occurred primarily during IOP #3, with a few high strengths measured during IOP #1 and no high strength values during IOP #2. Some of the higher resistances are most likely attributed to the cemented materials on the surface from soil prior to summer and spring visits.

Figure 45. Calculated Drop cone force indicating the surface soil strength throughout the RAS during the three IOPs.

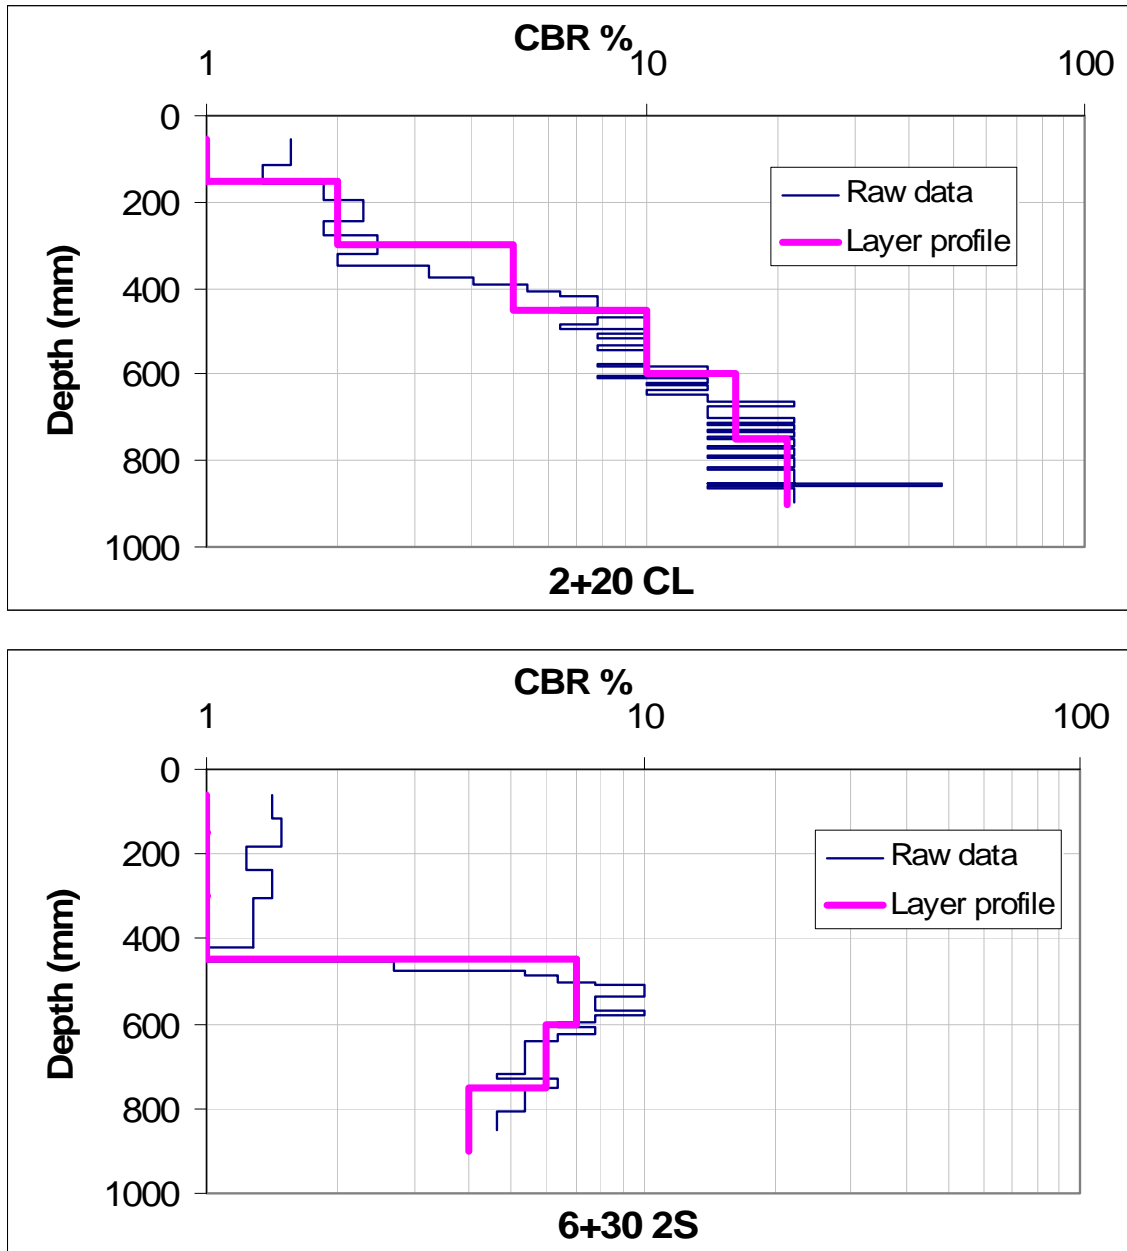
Figure 46. Selected CBR profiles showing layers with weak soil strength (IOP #1 at the El Centro RAS).

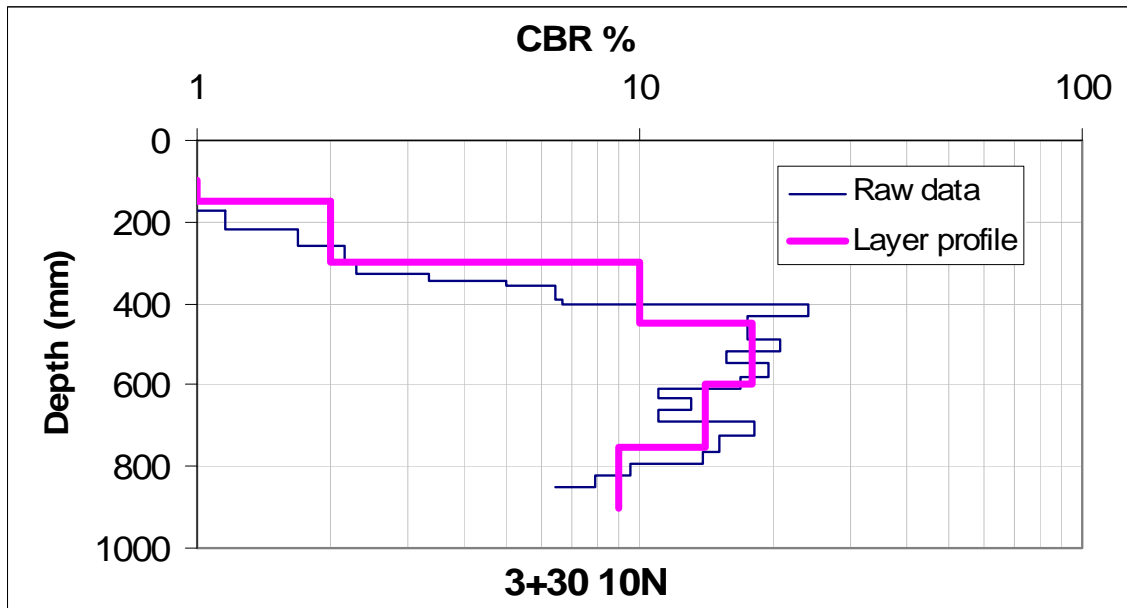
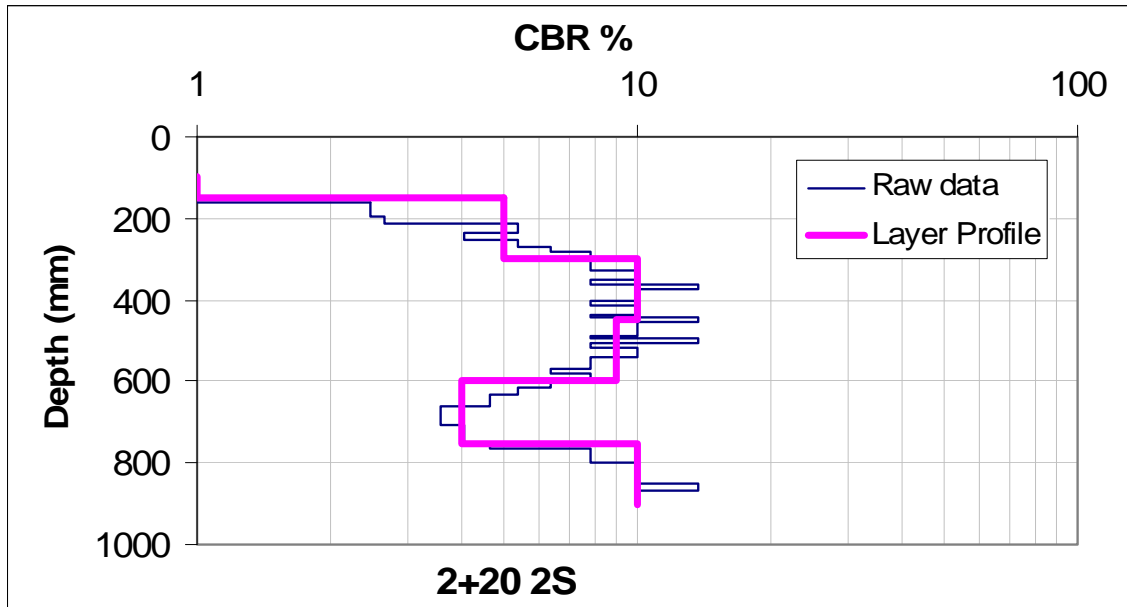
Figure 47. Selected CBR profiles showing layers with weak soil strength (IOP #2 at the El Centro RAS).

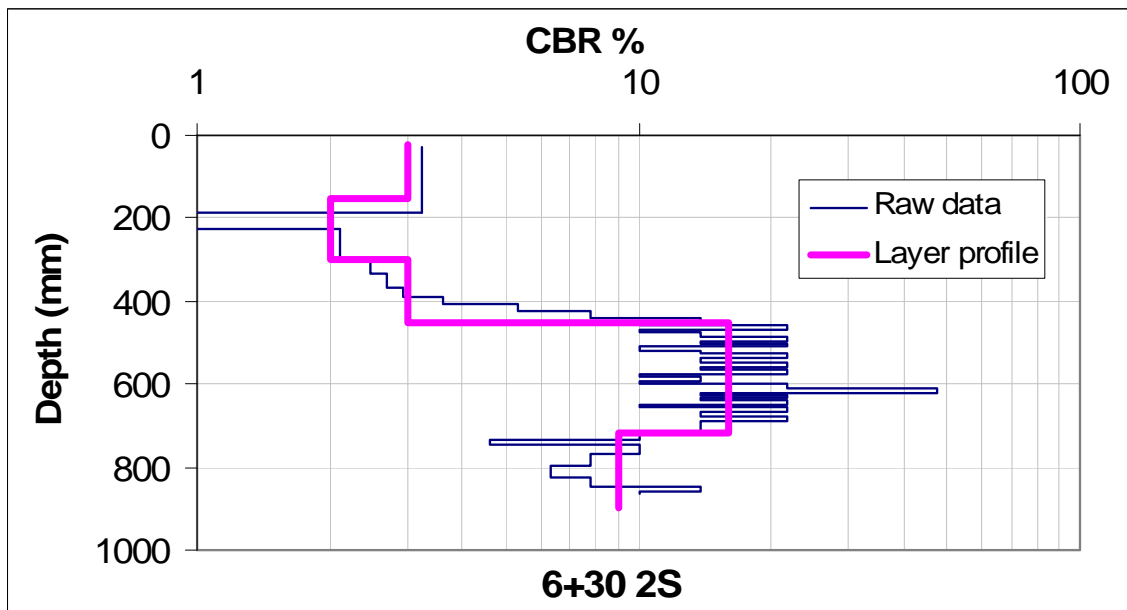
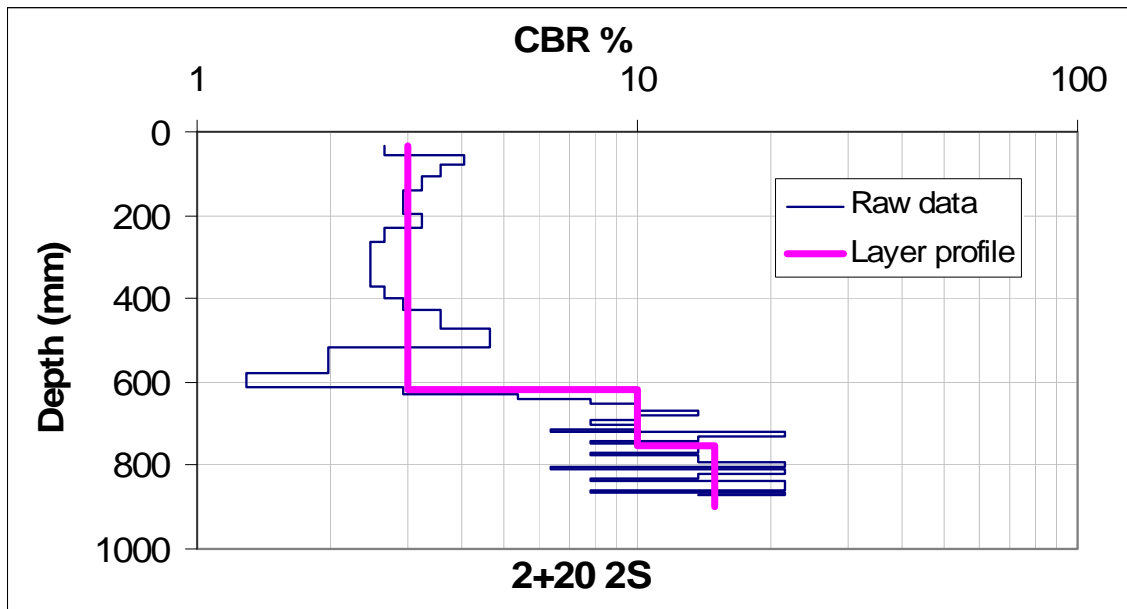
Figure 48. Selected CBR profiles showing layers with weak soil strength taken during IOP #3 at the El Centro RAS.

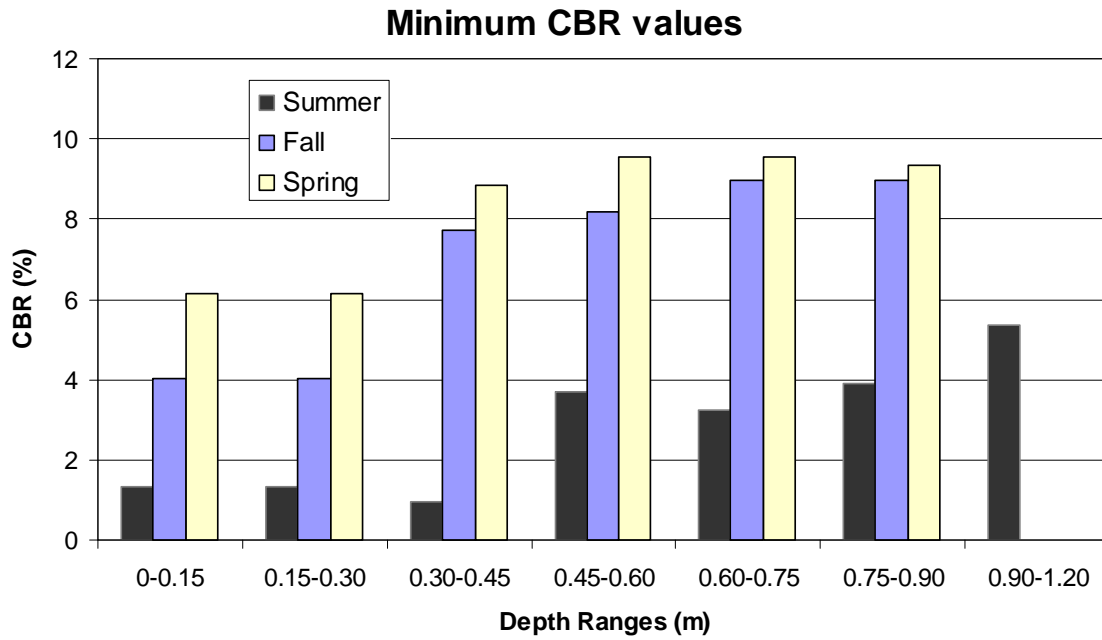
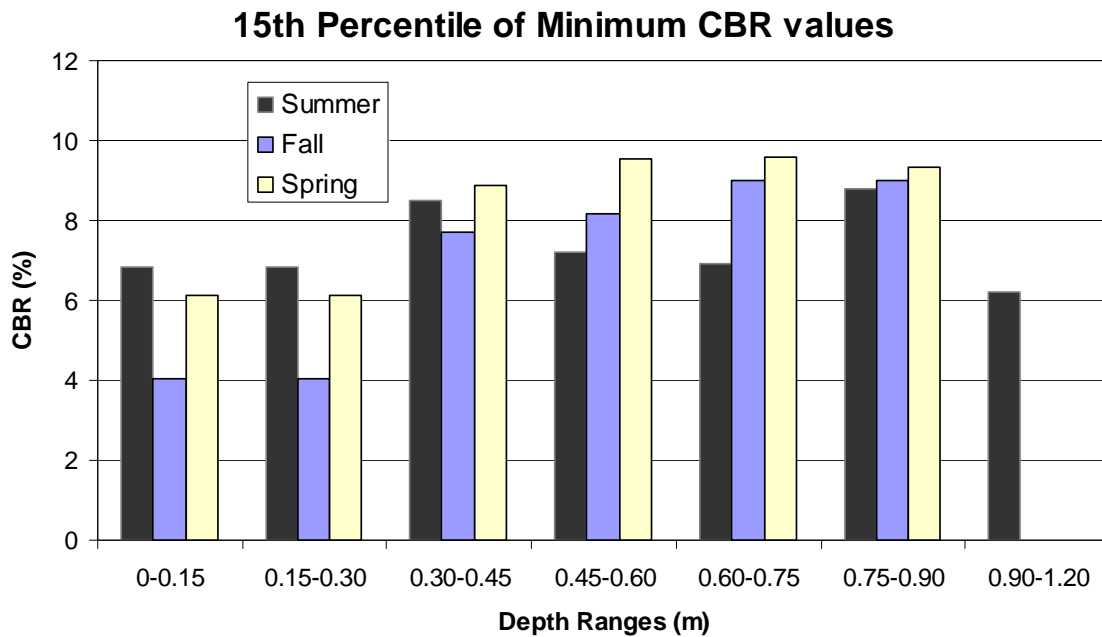
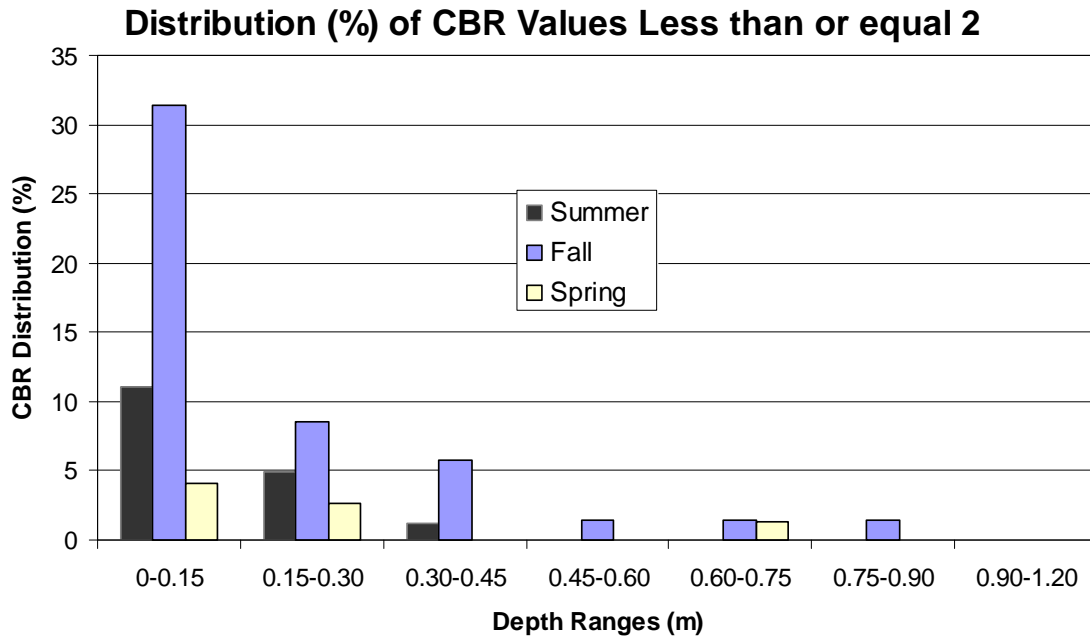
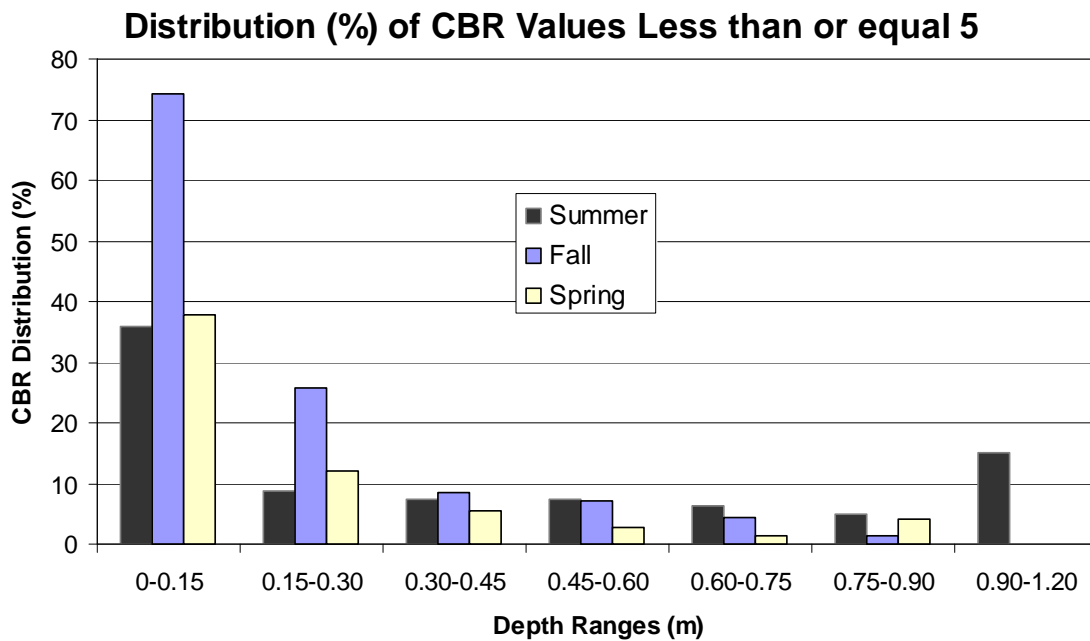
Table 13 summarizes the distribution of CBR values based on number of DCP profiles and 0.5-kg Clegg measurements for all IOPs. The CBR for 0- to 0.15-m (0- to 6-in.) depths was excluded in the analysis because of the lack of confinement at the top of the surface layer that affects the DCP measurements, and assumed that the CBR for the surface is equal to the CBR at 0.15- to 0.3-m depth. To evaluate the loading capacity of the RAS, the analysis was based on the DCP profiles of minimum (Fig. 49a) and 15[th] percentile of minimum CBR values (Fig. 49) for 0.15-m (6 in.) incremental layers. For design, it is common practice to take the representative CBR profile by obtaining the 15[th] percentile of the minimum CBR values from all the DCP data collected in the test area. The 15[th] percentile of the minimum CBR profiles at the SI-RAS shows low CBR on the surface, then slight increase in CBR with depth down to 0.45 m, and also uniform at deeper depths (Fig. 49b). The fall (IOP #2) CBR values for the surface down to 0.3 are lower than summer (IOP #1) and spring (IOP #3). Strength for the surface layer from the DCP showed that only 11%, 31%, and 4% of the DCP data on the SI-RAS have CBR values of 2 or less for the summer, fall, and spring seasons, respectively (Fig. 49c). Considerable amounts of DCP measurements on the SI-RAS have CBR values of 5 or less for the surface; however, the values significantly decrease with depth (Fig. 49d).

The influence of soil moisture in the fall season (October 2005) showed a significant decrease in surface soil strength as discerned from the DCP (Fig. 49), Clegg hammer, and Drop cone data. The DCP data show decreased strength of deeper layers during IOP #2. Total precipitation observed during the period was 29 mm, all immediately prior to IOP #2.

Applying the PCASE program (version 2.08) using the evaluation module for unsurfaced runway on subgrade soils, the results showed only one pass is allowed with varying allowable loads for C-17 using the 15th percentile of minimum CBR profiles. The C-130 is able to land on the RAS up to 48 passes with 62 ton (137 kips) of allowable gross load during summer, 42 tons (93 kips) of allowable gross load during fall, and up to 19 passes with 58 tons (127 kips) of gross load during spring using the 15th percentile of minimum CBR values (Table 14). This analysis was based on CBR profiles for 0.15-m (6-in.) incremental layers using profiles of minimum and 15th percentile of minimum CBR values from the DCP data during the three field visits as shown in Figures 49a and 49b.

Figure 49. CBR values at each depth range at SI-RAS.

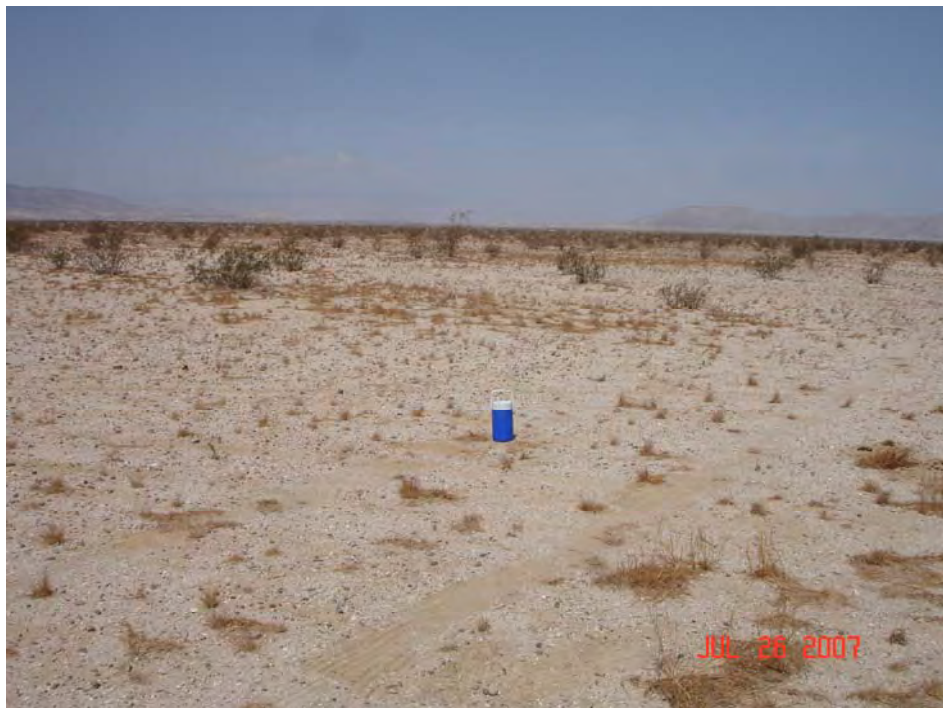
b. View looking west at 600 m west of the east end point of the PCI-RAS. Blue water jug is approximately 6 m (20 ft) away.

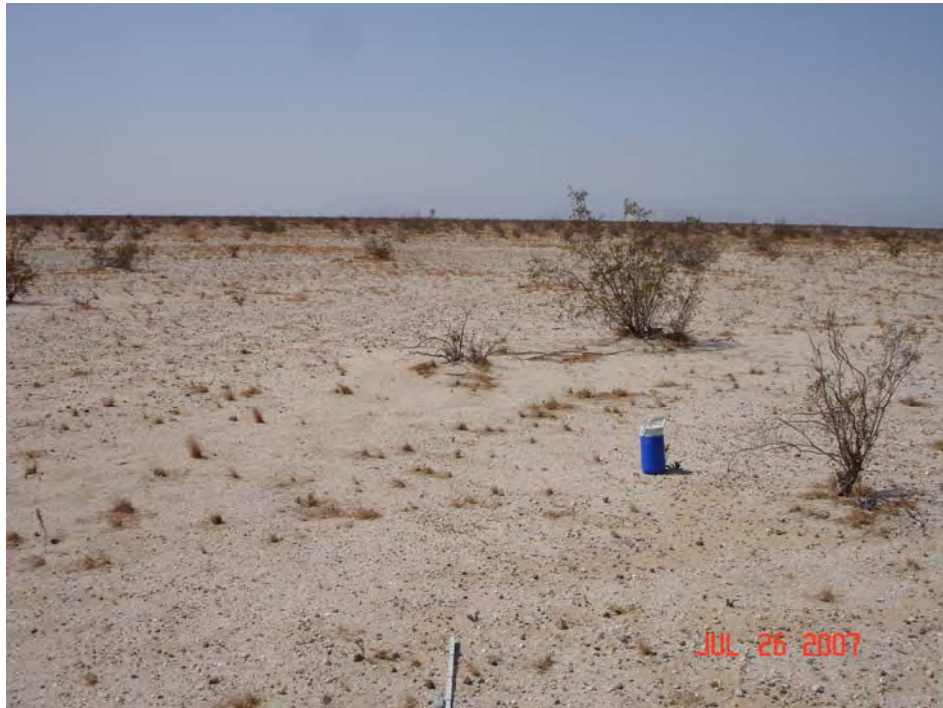
c. View looking south at 600 m west of the east end point of the PCI-RAS. Water jug is at approximate distance of 6 m.

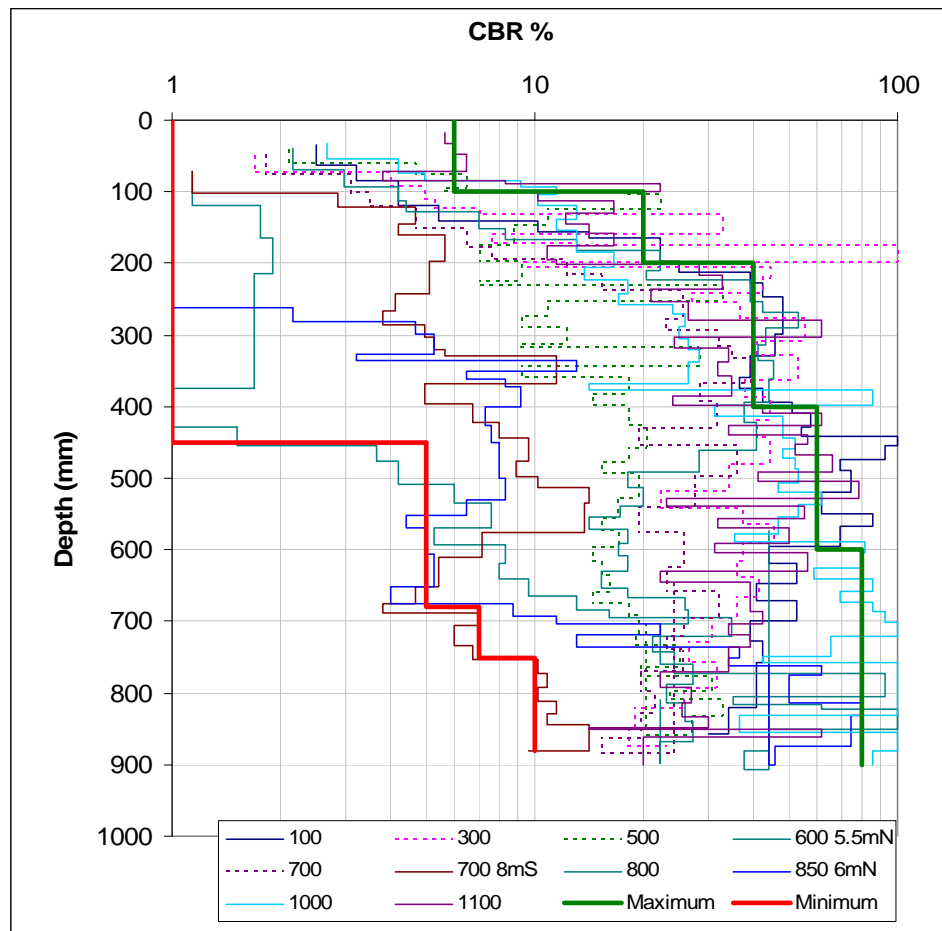
DCP is conducted at 10 locations along the PCI-RAS. The DCP are converted to CBR and are summarized in Table 15. A few of the measurements are taken in the middle of the animal burrow areas (i.e., 600, 5.5m N; 700, 8m S; 850, 6m N). The CBR profiles in the animal burrows are lower than in other areas in the RAS. Aside from having a low surface CBR value in the surface, the soil strength increased with depth in most areas of the RAS. Figure 57 represents the CBR profiles from 10 DCP measurements along the soil strength minimum and maximum layers.

Figure 57. CBR profiles from the raw data measured along the RAS with minimum and maximum ranges.

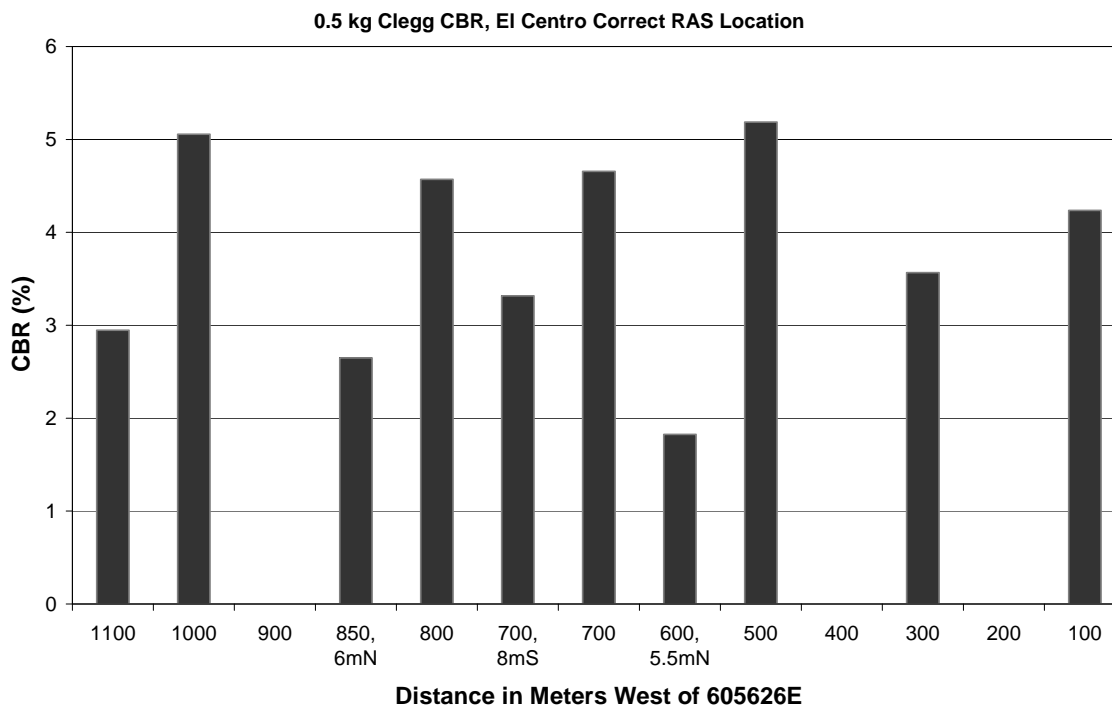
The 0.5-kg Clegg hammer is used to measure the surface soil strength at 10 locations along the RAS. The Clegg CBR values ranged from 2 to 5% as shown in Figure 58. These are similar to typical values measured on the SI-RAS during the dry season.

Figure 58. Clegg CBR values along the PCI-RAS.

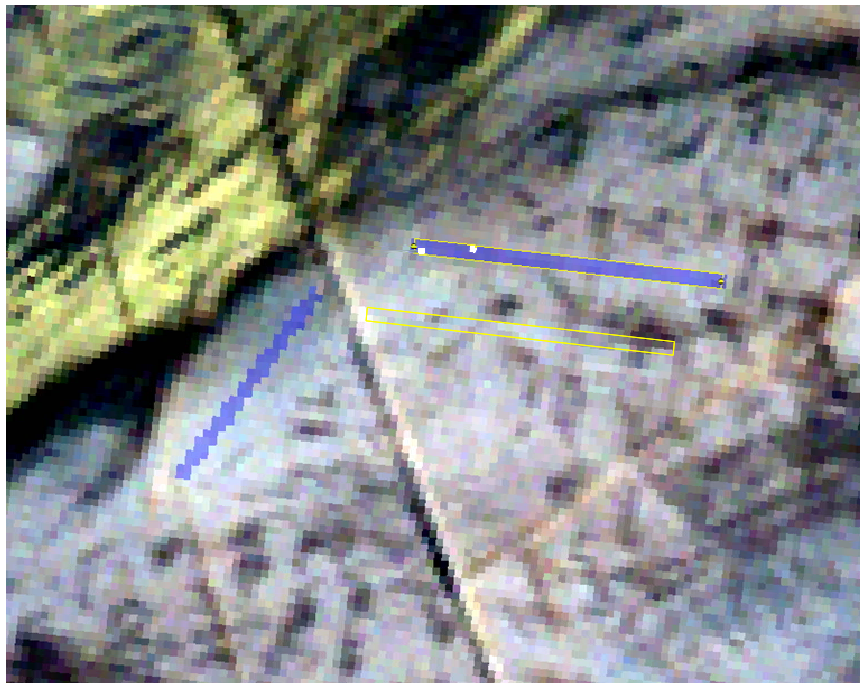
Figure 65. 1 November 2005 Landsat USGS Precision georeferenced image with Version 10 of the OLS software. Blue and red OLSs are in Precision georeferenced positions. The unfilled yellow outline OLS is the RAS field site from the Systematic georeferenced 9 May 2005 image. Filled yellow outline OLS is the field site as it should have been located from the Precision geoereferenced 9 May 2005 image.

Only the November 2005 Landsat image showed any OLSs with OLS software Version 10. The May 2005, July 2005, and April 2006 Landsat images recorded no OLSs within the immediate geographic area of the RAS field site shown in Figure 65. The November 2005 image shows several parallel OLSs oriented northeast to southwest, and crossing into the study area and possibly overlapping the Precision georeferenced RAS location. The April 2005 image used to locate the field site with software Version 7 showed no OLSs with software Version 10 within the image area of Figure 65. This suggests that Version 10 of the software is more strict, or conservative, in the selection of OLSs than was Version 7.
