MISCELLANEOUS PAPER GL-86-5

# FIELD EVALUATION OF THE WATER WEDGE FOR CUTTING PORTLAND CEMENT CONCRETE PAVEMENTS FOR REPAIR AND RESTORATION OF PAVED SURFACES (REREPS)

January 1986

Final Report

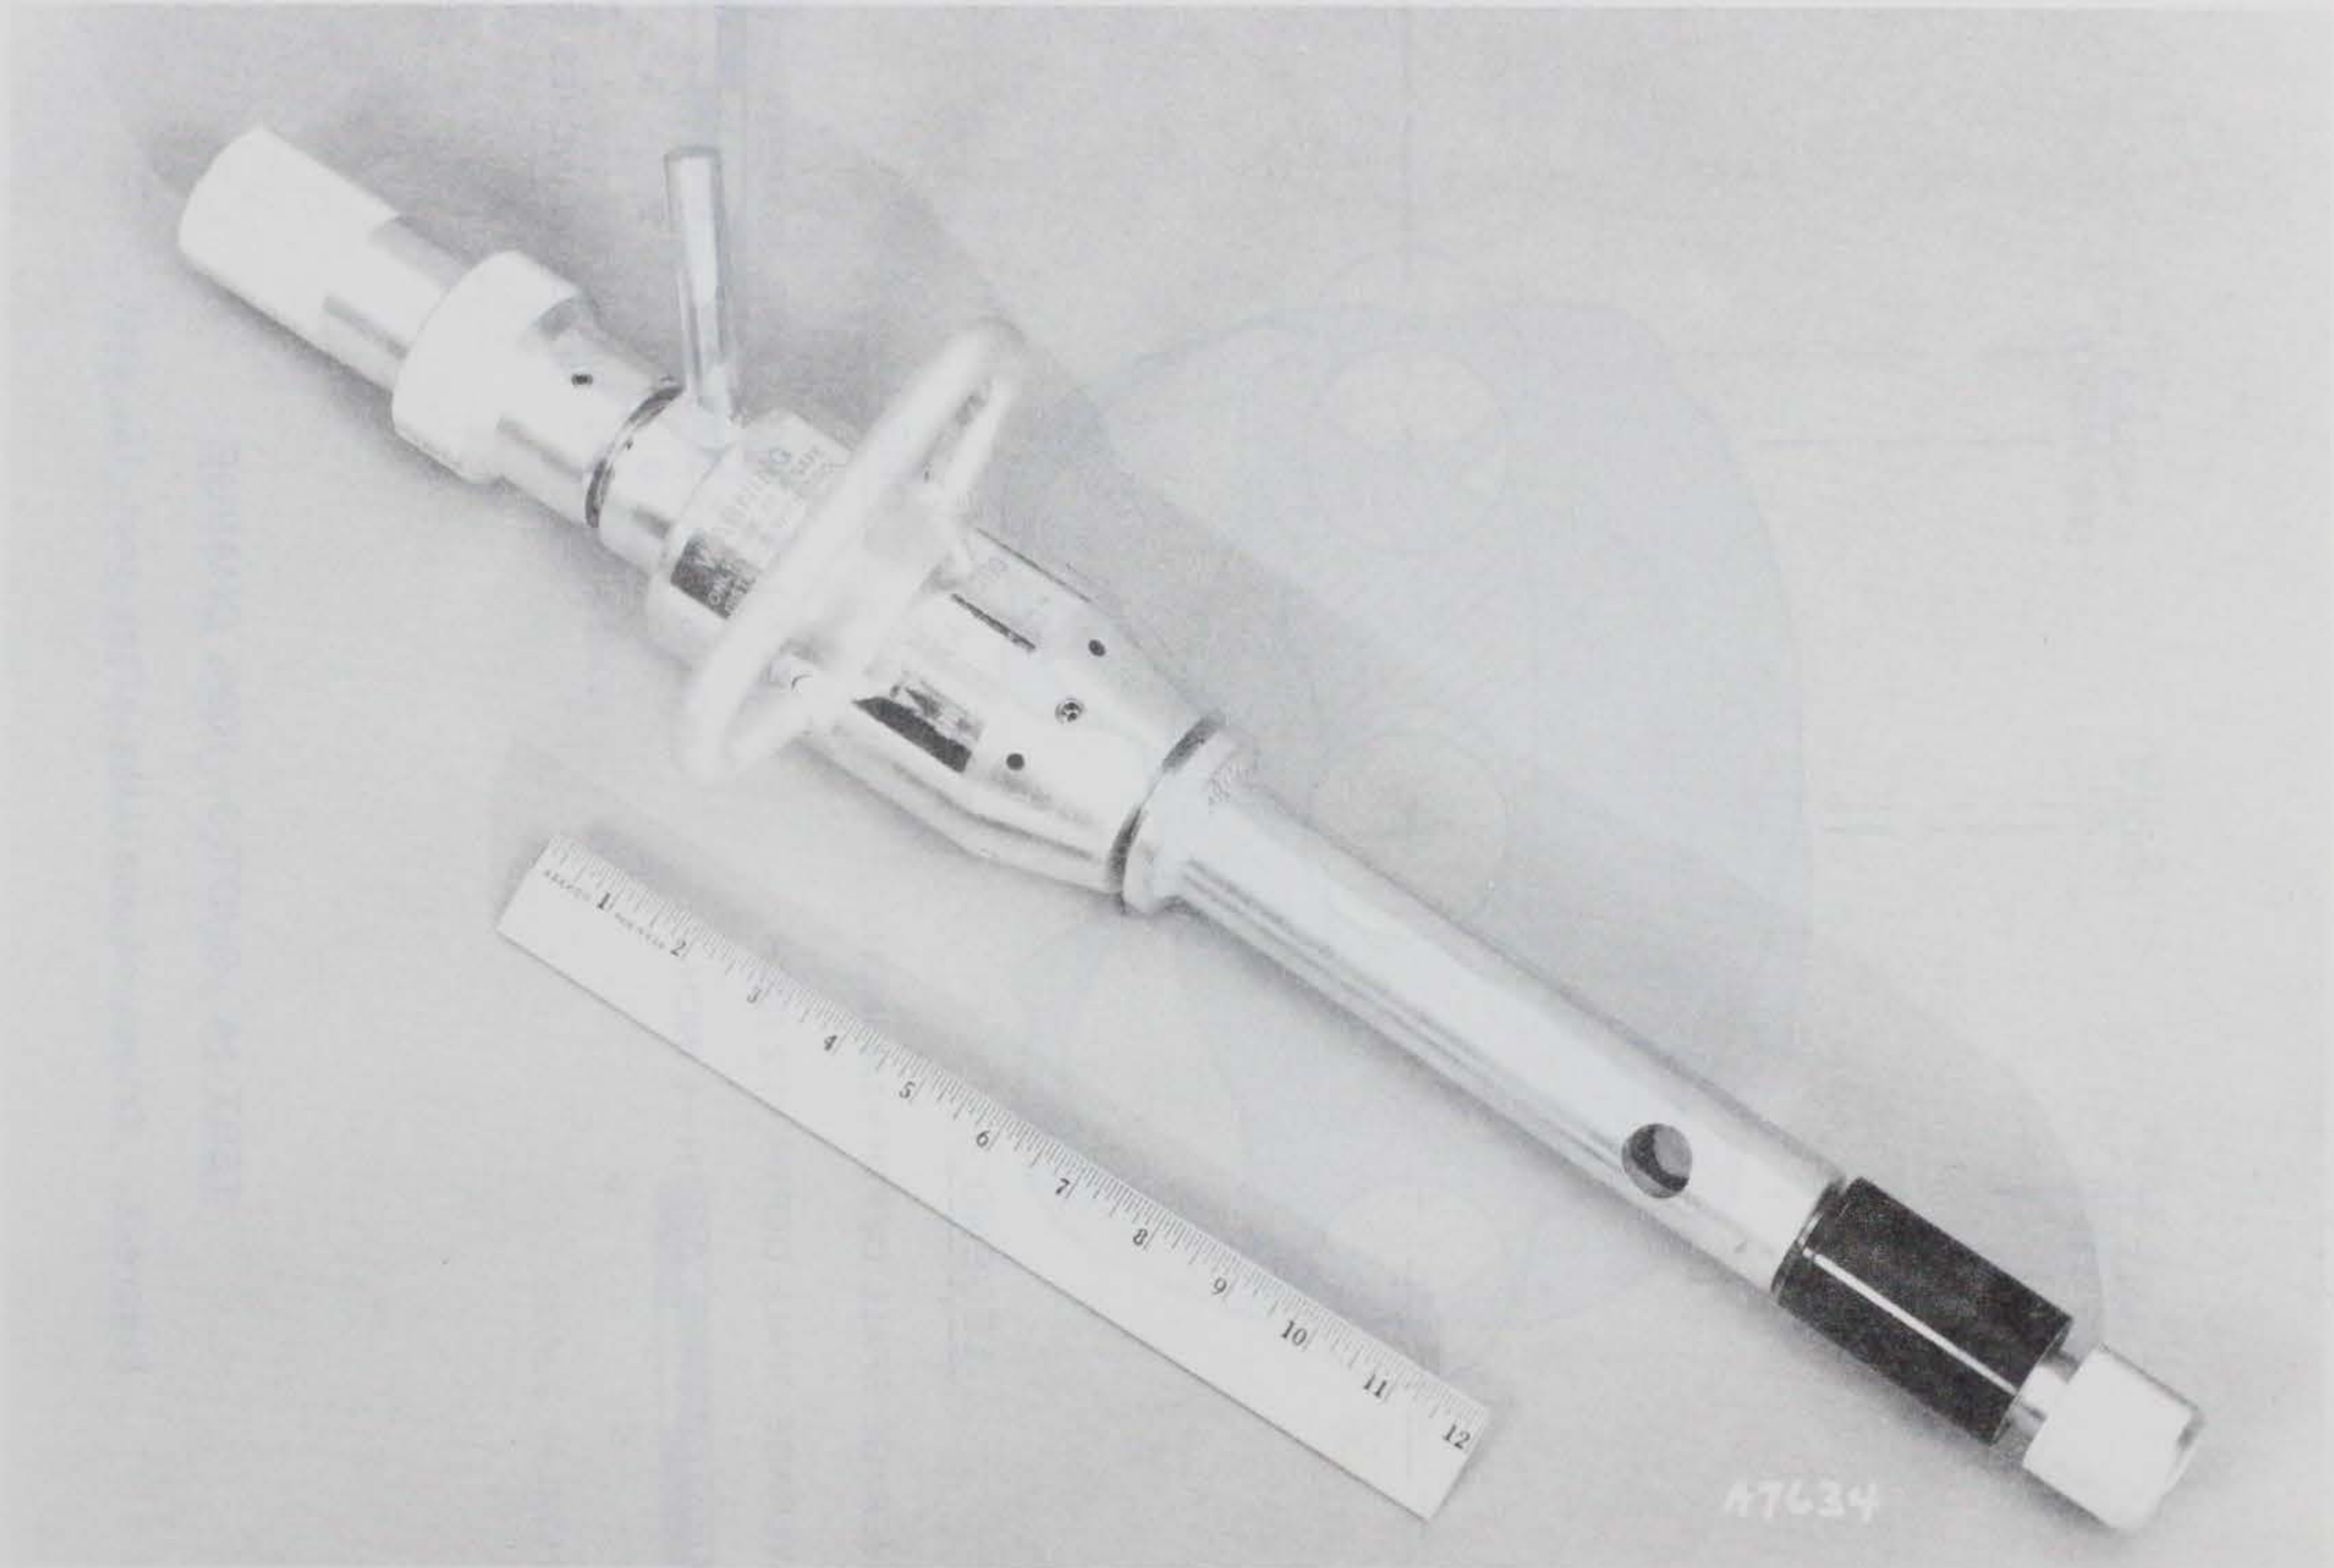
3. The Water Wedge 1200 device used in this study is shown in Photo 1. The device is 29 in. long, weighs 22 lb, and is manufactured from high strength steel. Photo 2 presents an exploded view of the device with each number keyed to a specific part.

Photo 1. Assembled Water Wedge device

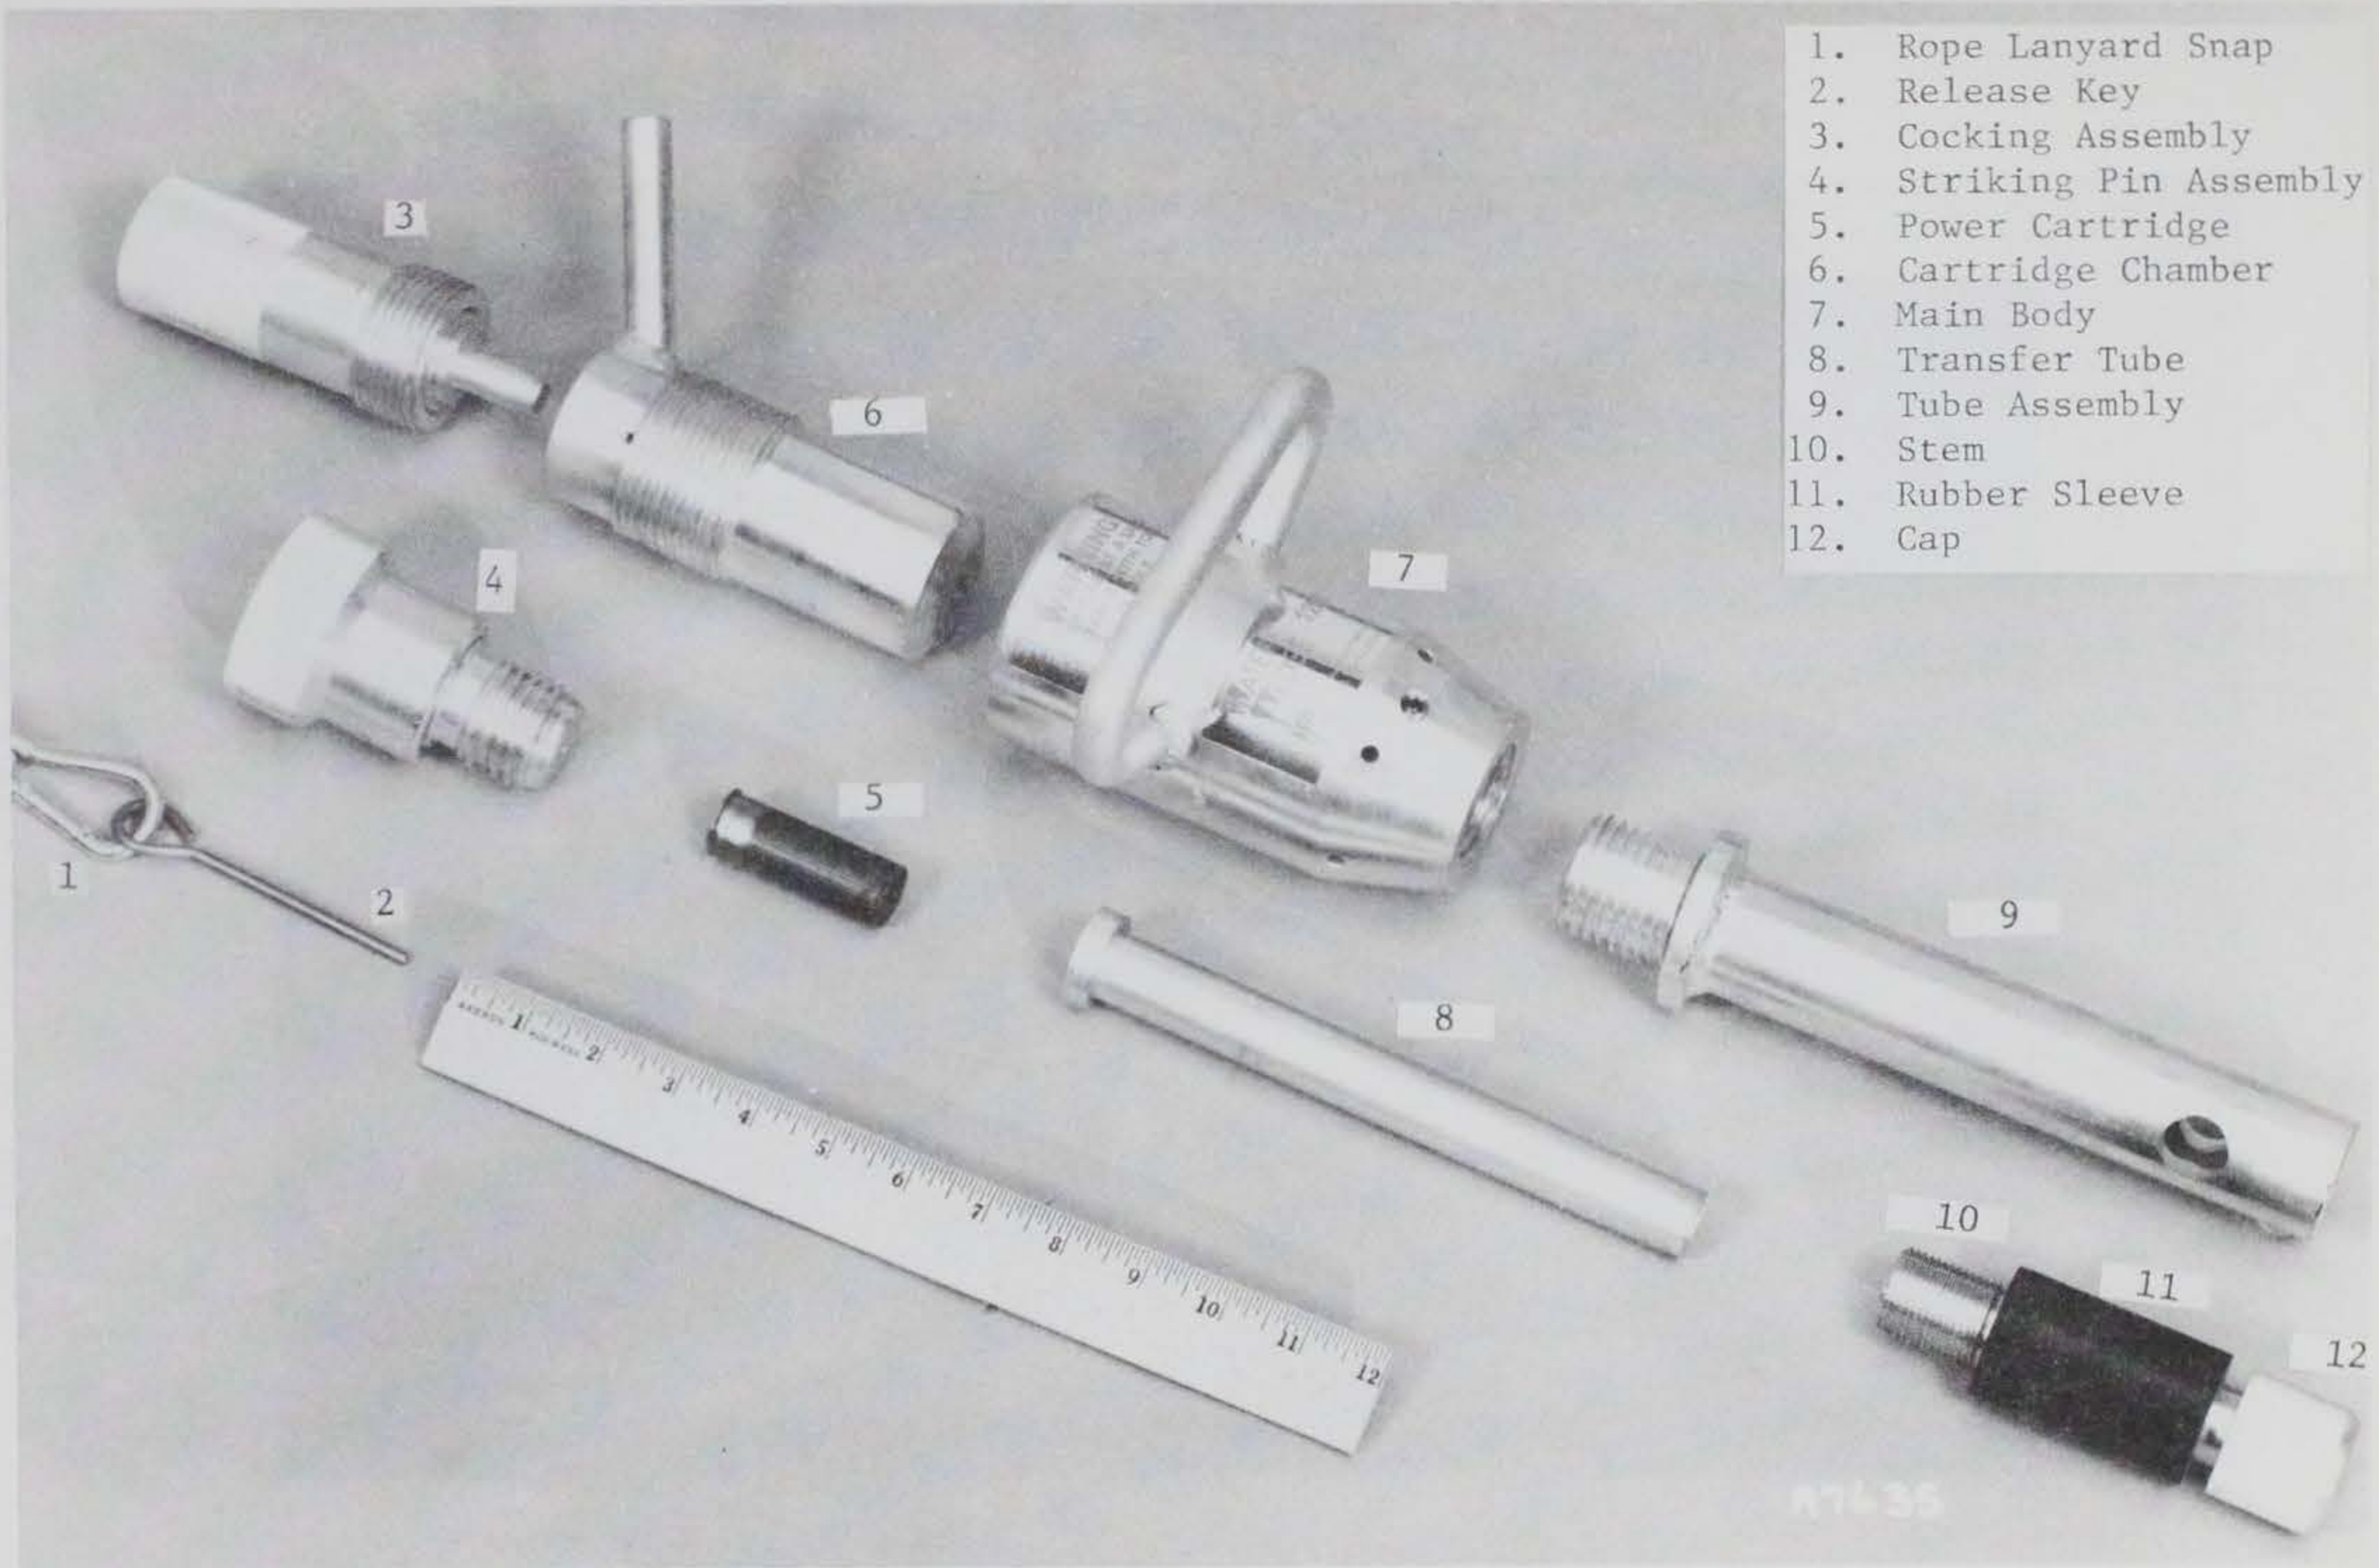
- 1. Rope Lanyard Snap
- 2. Release Key
- 3. Cocking Assembly
- 4. Striking Pin Assembly
- 5. Power Cartridge
- 6. Cartridge Chamber
- 7. Main Body
- 8. Transfer Tube
- 9. Tube Assembly
- 10. Stem
- 11. Rubber Sleeve
- 12. Cap

Photo 2. Exploded view of Water Wedge device

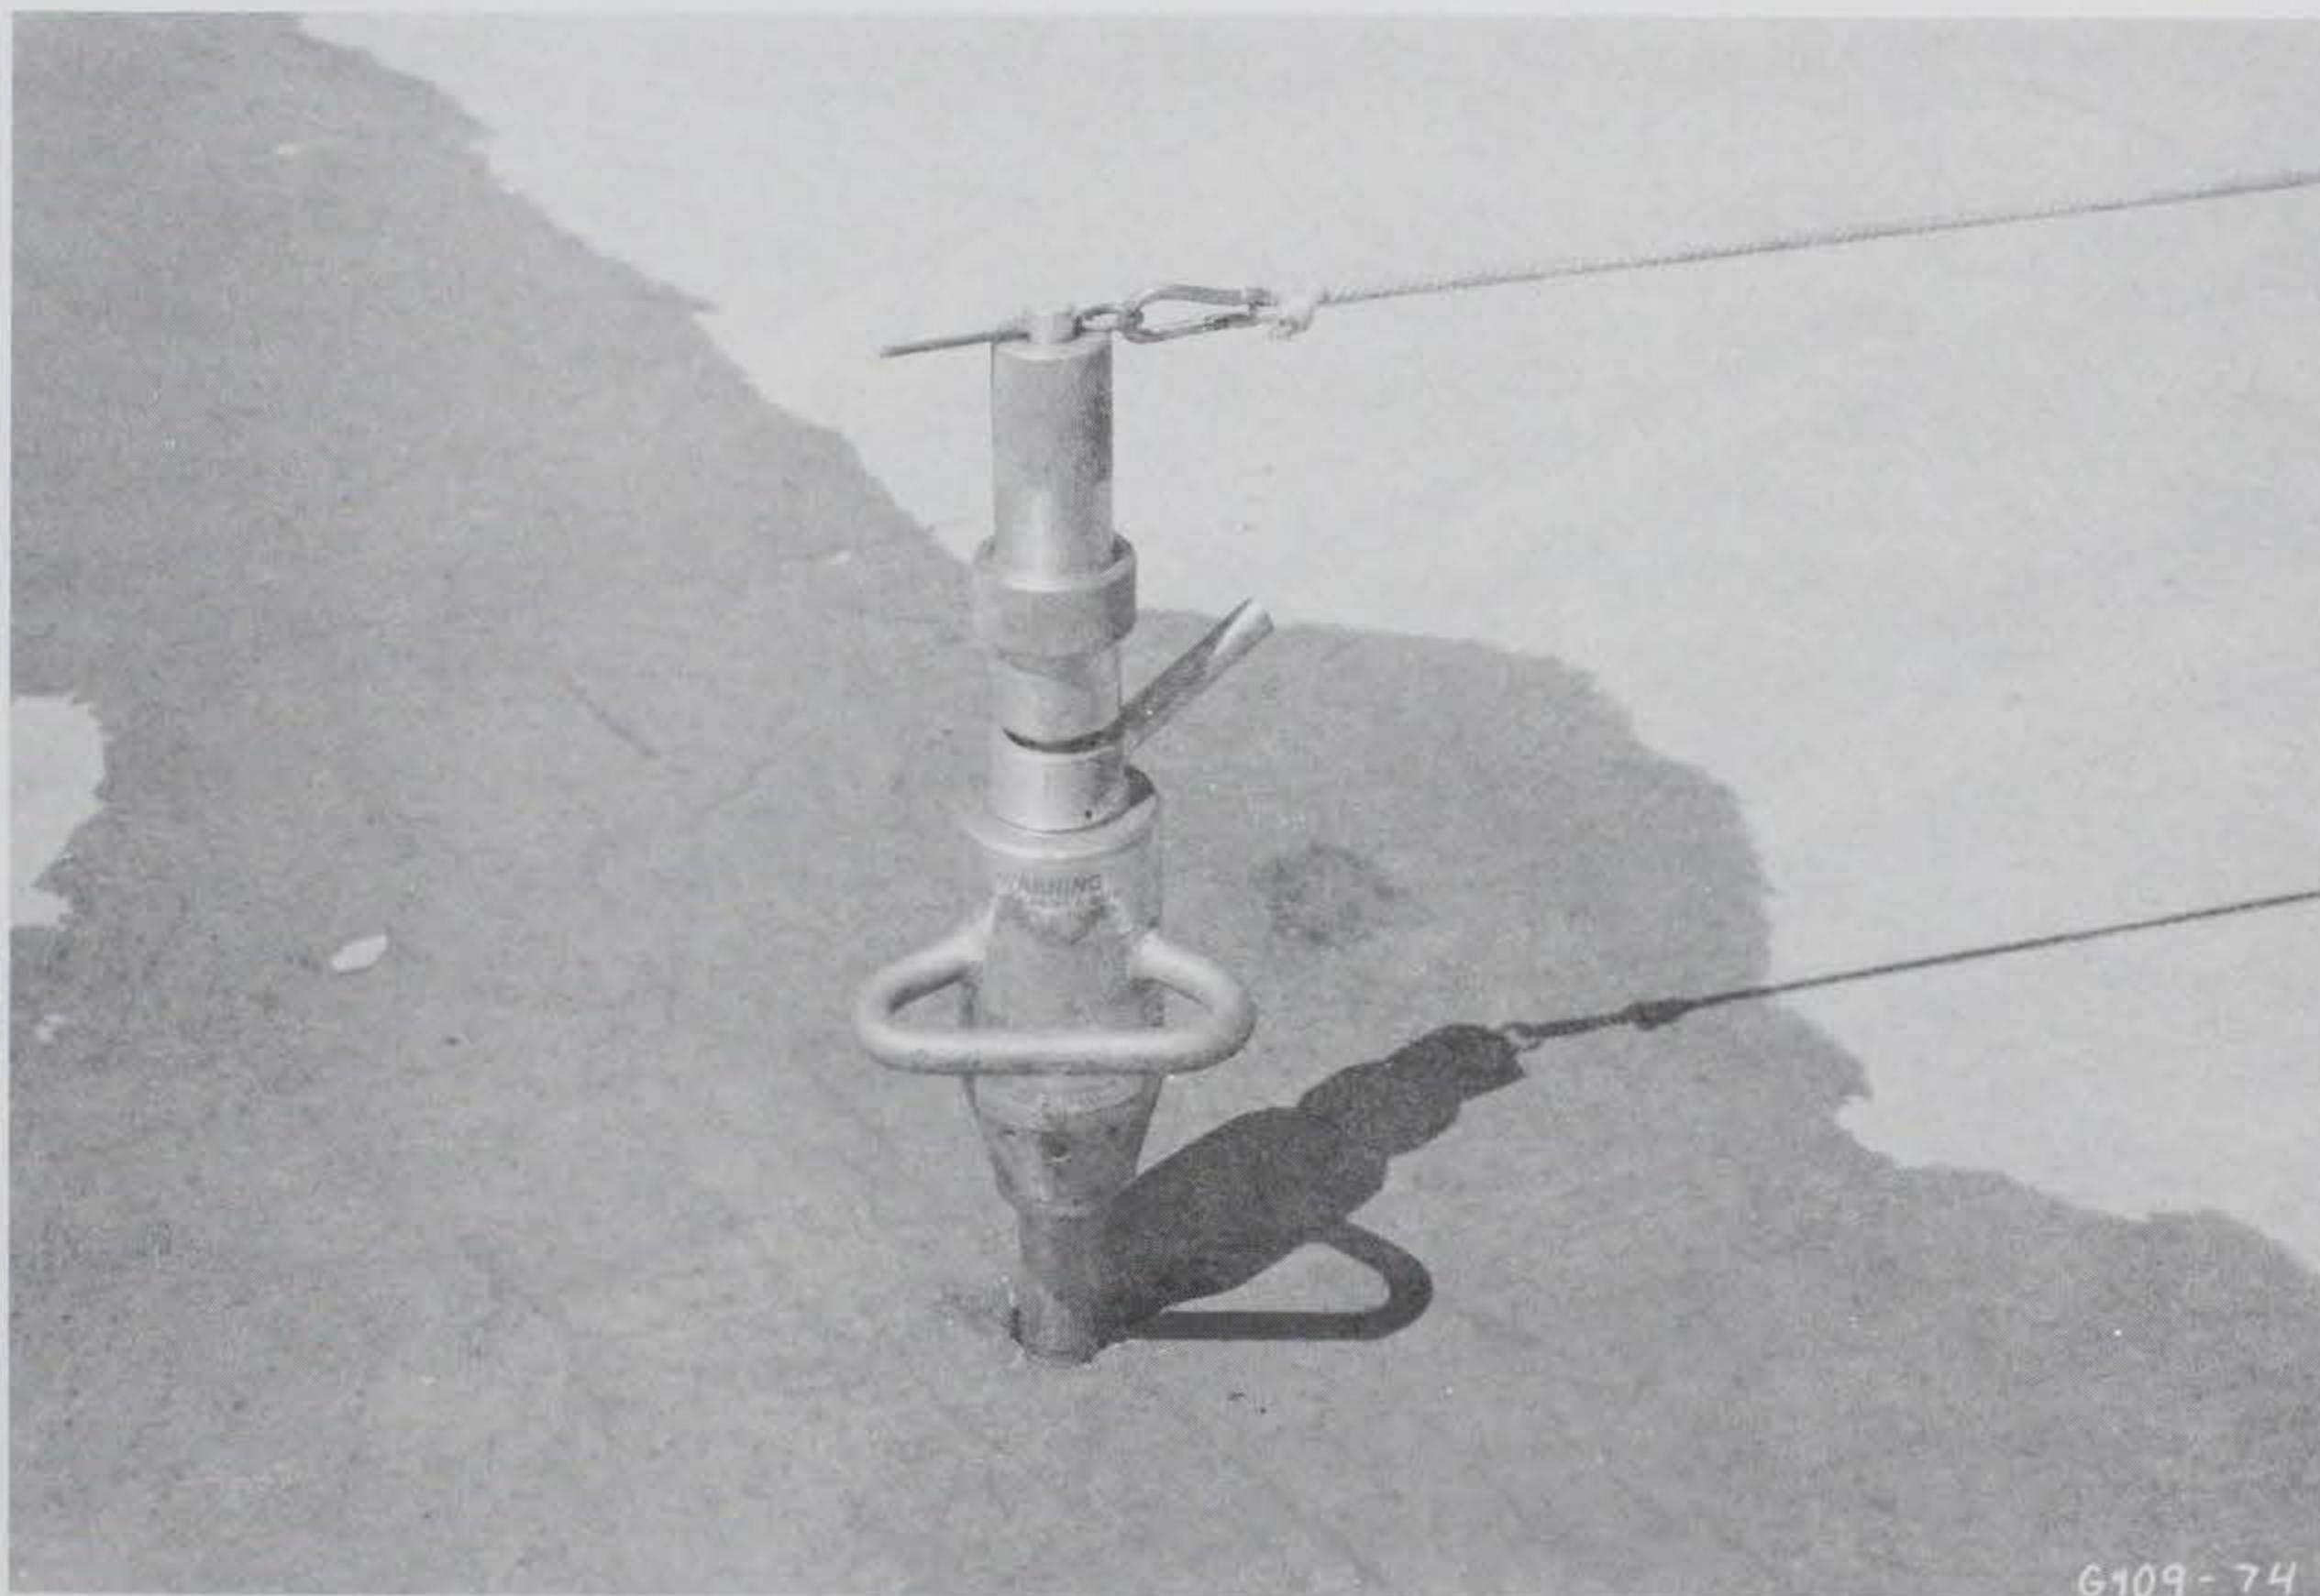
Photo 3. Device ready to fire

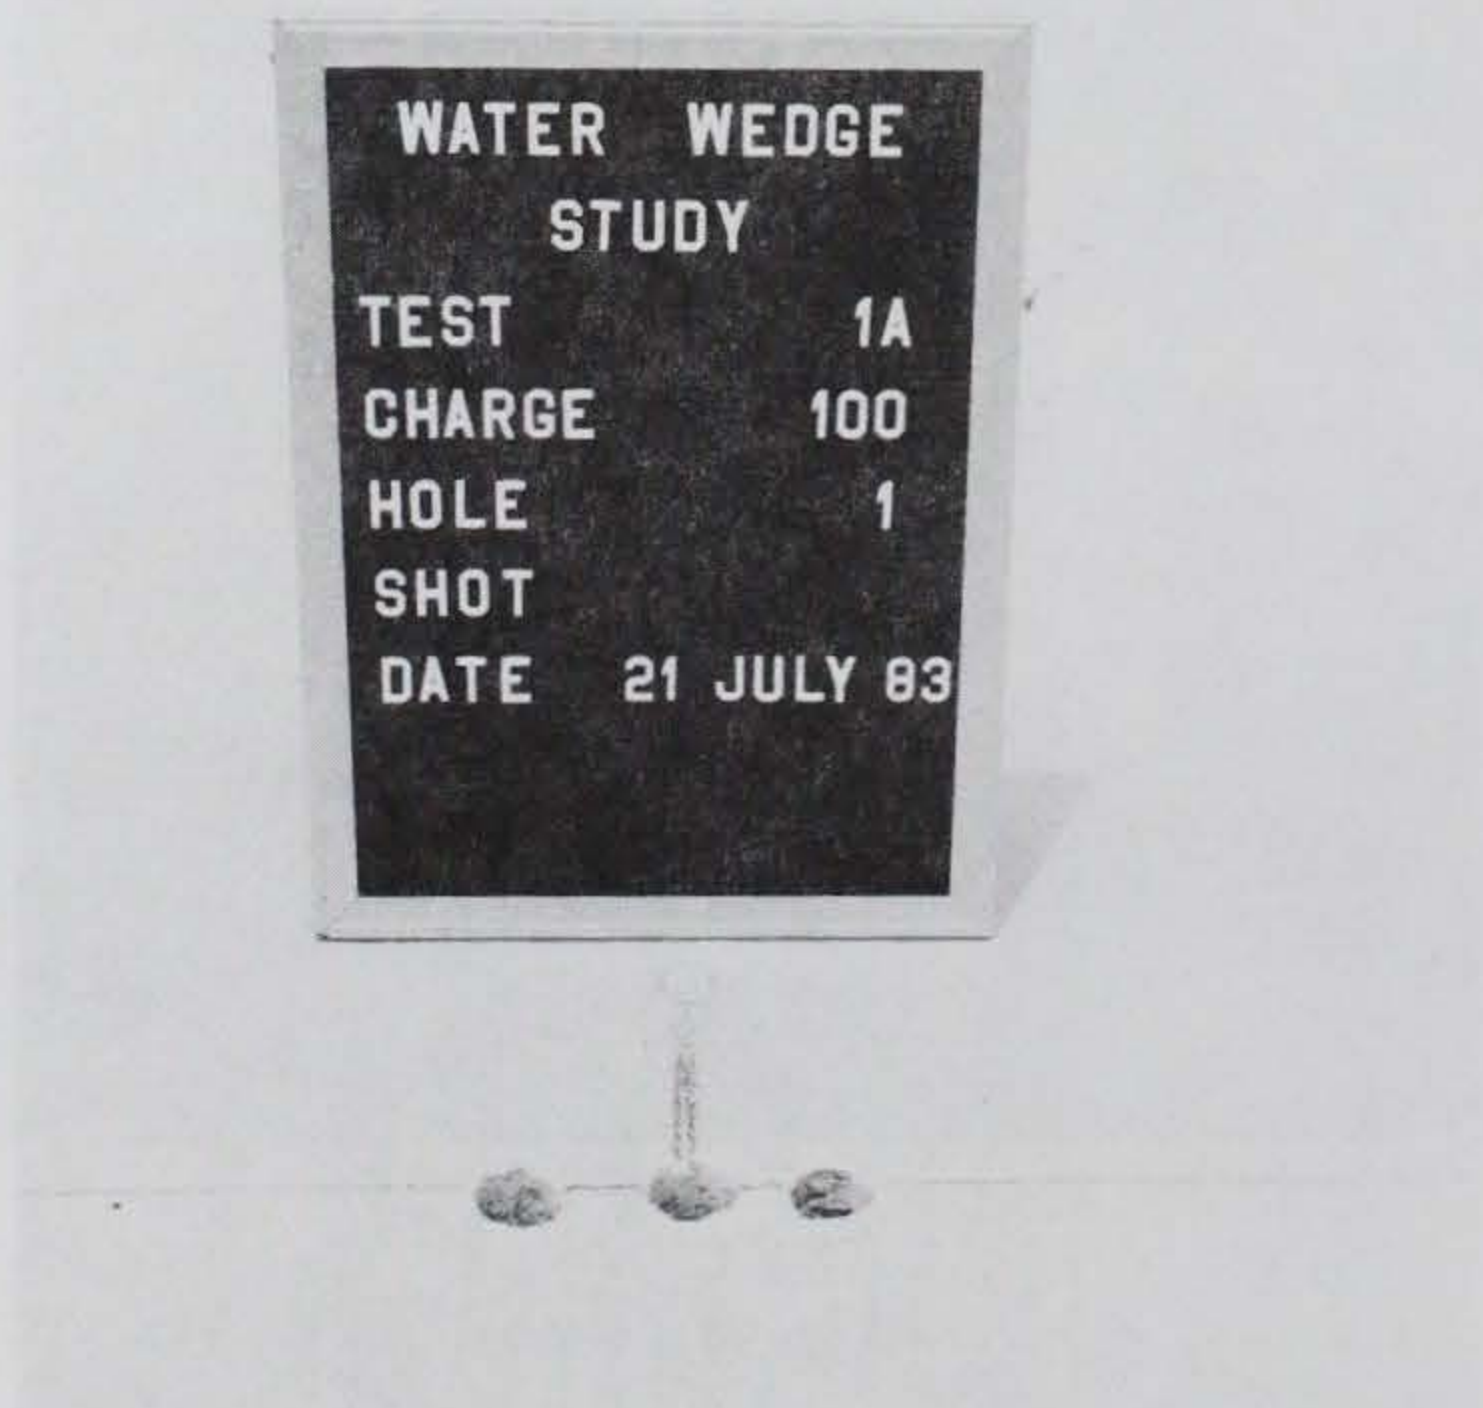
12. No cracks were generated in Tests 1 and 2; therefore, it was decided to change the approach. In Test 1A, three holes were drilled in the pavement spaced 3 in. apart as shown in Photo 7. The device was discharged in the center hole. The first 100 percent charge shot resulted in only spalling around the top of the holes as shown in Figure 1 and Photo 8. No cracking was observed on the pavement surface or the interior walls of the holes. After the second shot of a 100 percent charge in the center hole, some additional spalling was observed between holes 2 and 3 as shown in Figure 2 and Photo 9. Two hairline cracks were observed inside the center hole at the locations shown by the arrows in Figure 2. These cracks began approximately 1 in. below the pavement surface and extended downward into the pavement. The third shot of a 100 percent charge in the center hole resulted in little additional spalling and no observable change in the width of the cracks. Once again the device was wedged in the hole; however, it was easily removed by jacking it out as shown in Photo 10. Figure 3 shows the extent of spalling at this time.

Photo 7. Holes in pavement prior to test 1A

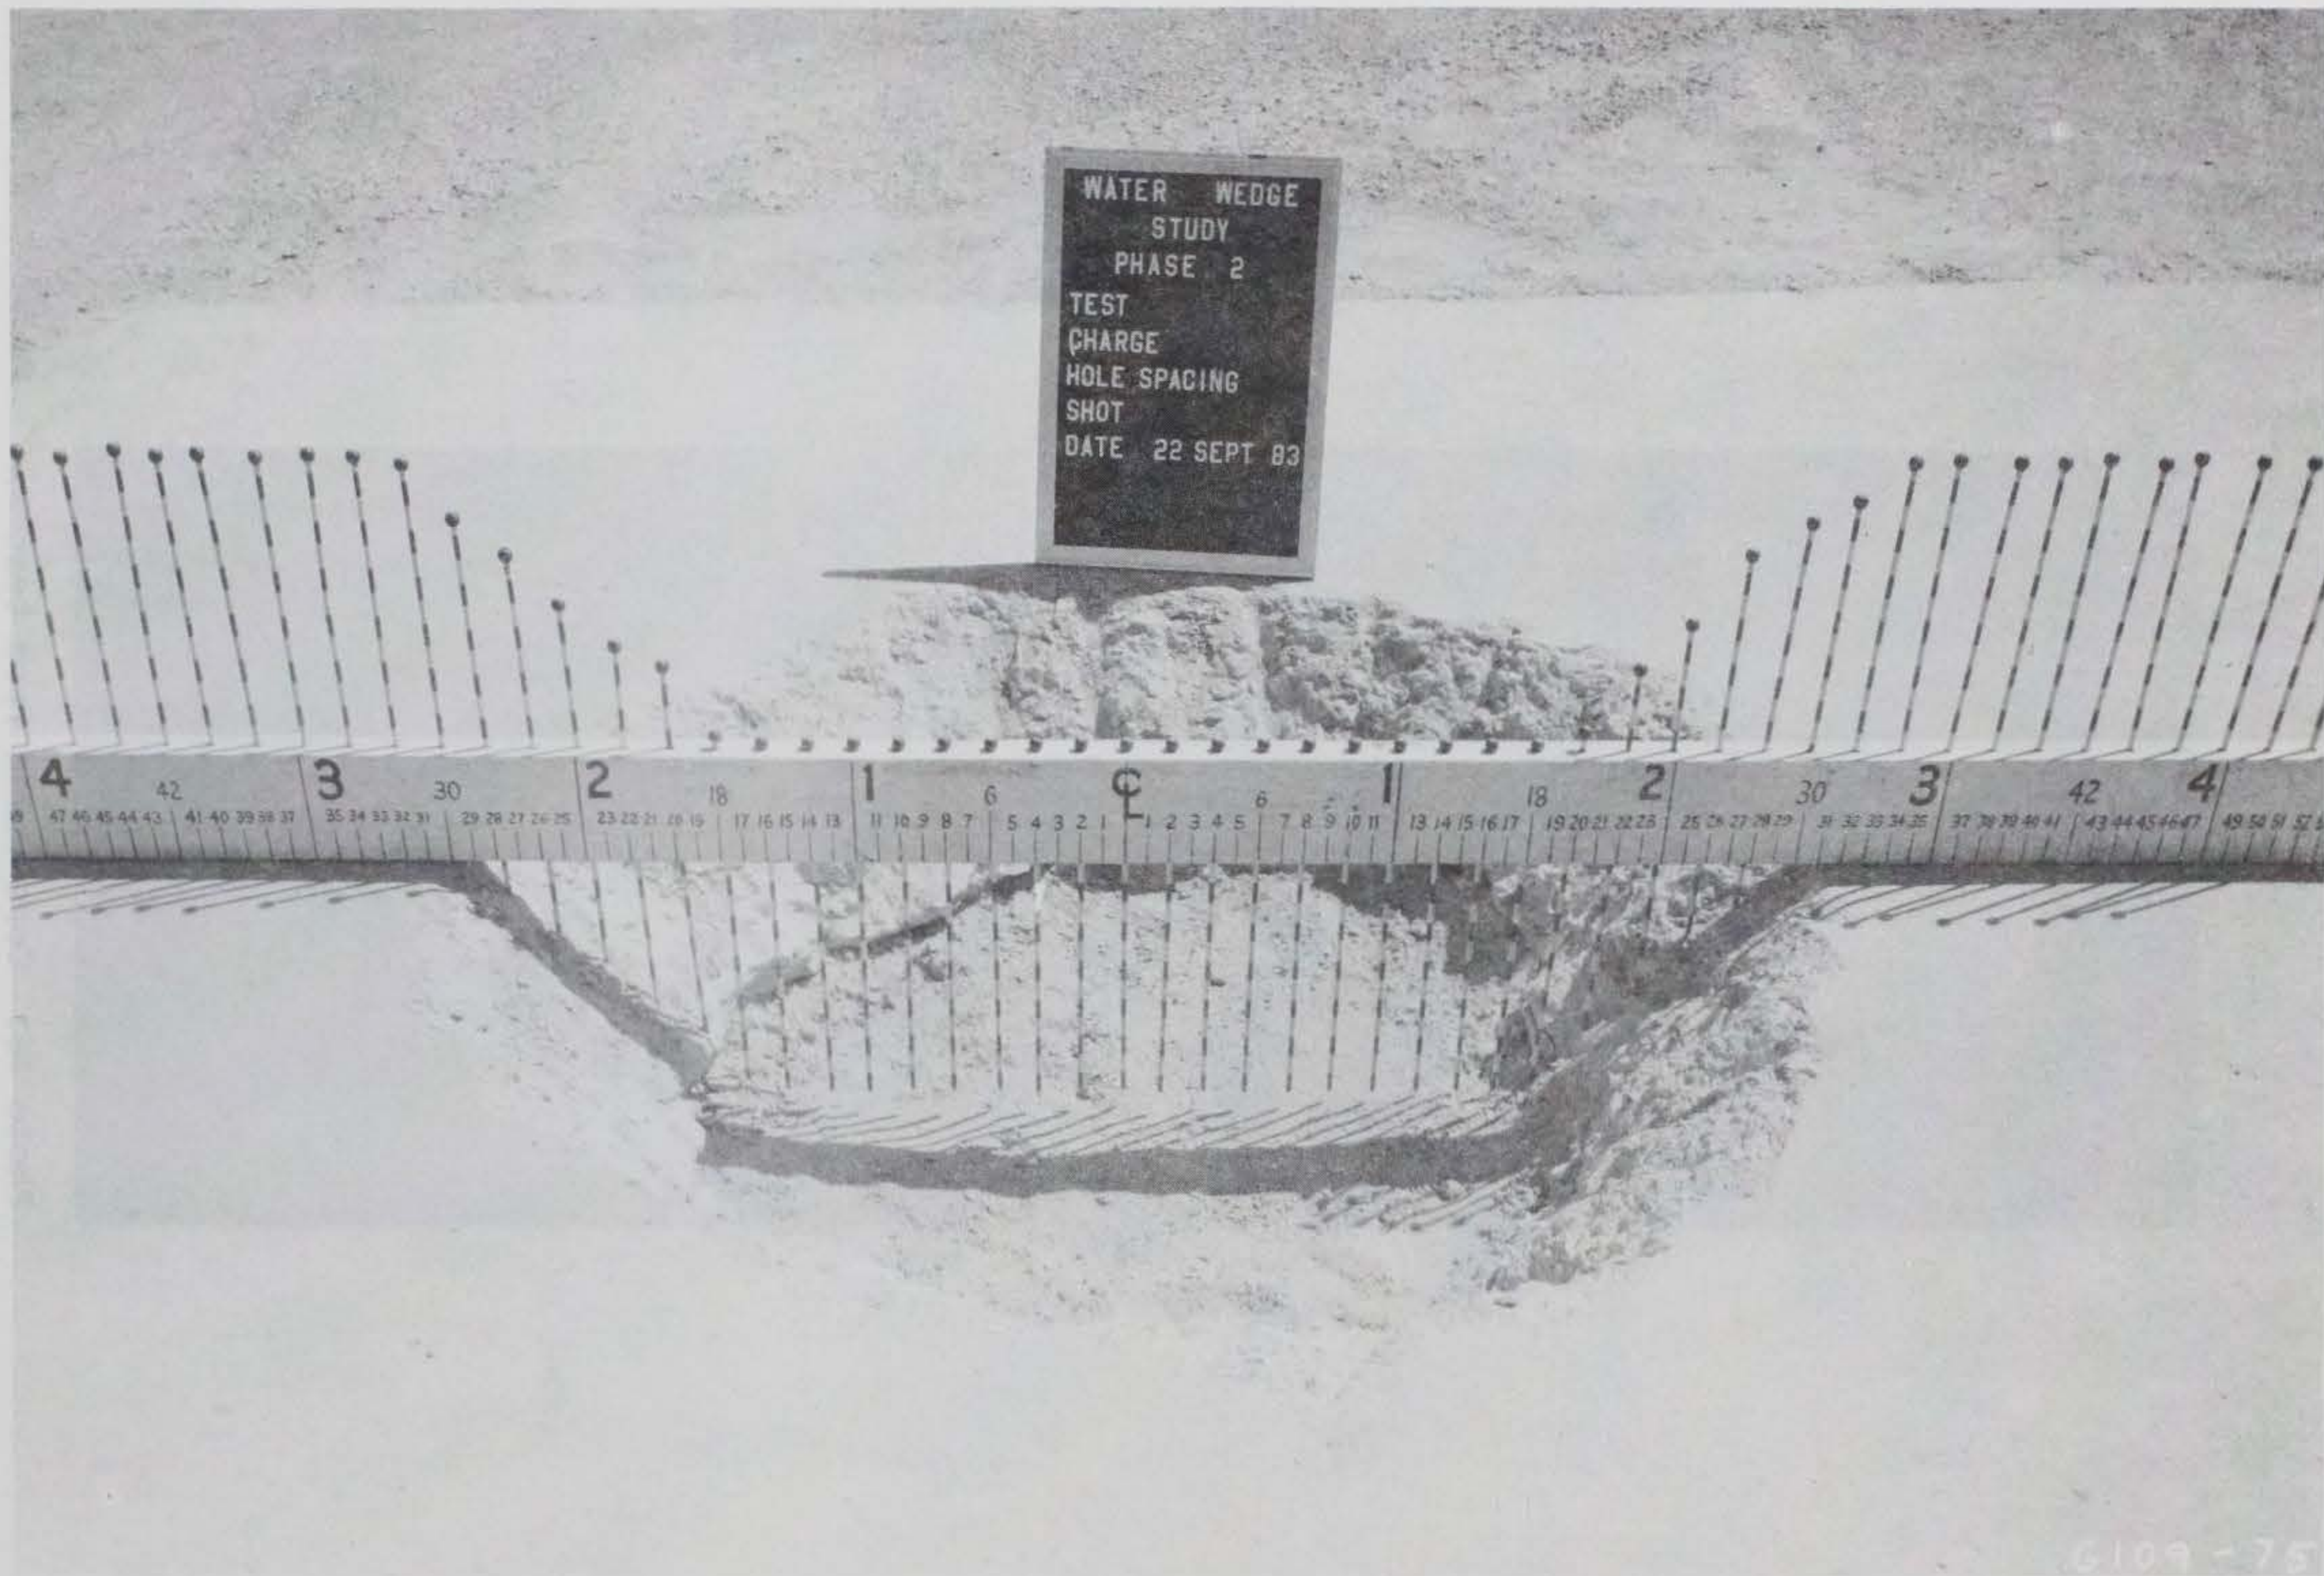
14. Phase II of this study was conducted to determine the best method for producing a straight crack in the PCC pavement. The Phase II testing was performed on a section of 12-in.-thick PCC built in April 1983 as part of a bomb damage repair test section. The pavement section consists of 12-in. non-reinforced PCC pavement over a sand subgrade. Laboratory test performed on the PCC at the time of construction indicated a 28-day compressive strength of 4,955 psi. Six-in.-diameter concrete cores taken in September 1983 indicate a split tensile strength of 549.5 psi which corresponds to 5,610 psi compressive strength and flexural strength of 771 psi. (See Table 1.) The tests of Phase II were conducted on the PCC slab adjacent to a 5-ft-diam crater cut in the slab. Photo 13 shows a typical crater used in these tests.

Photo 13. Typical crater

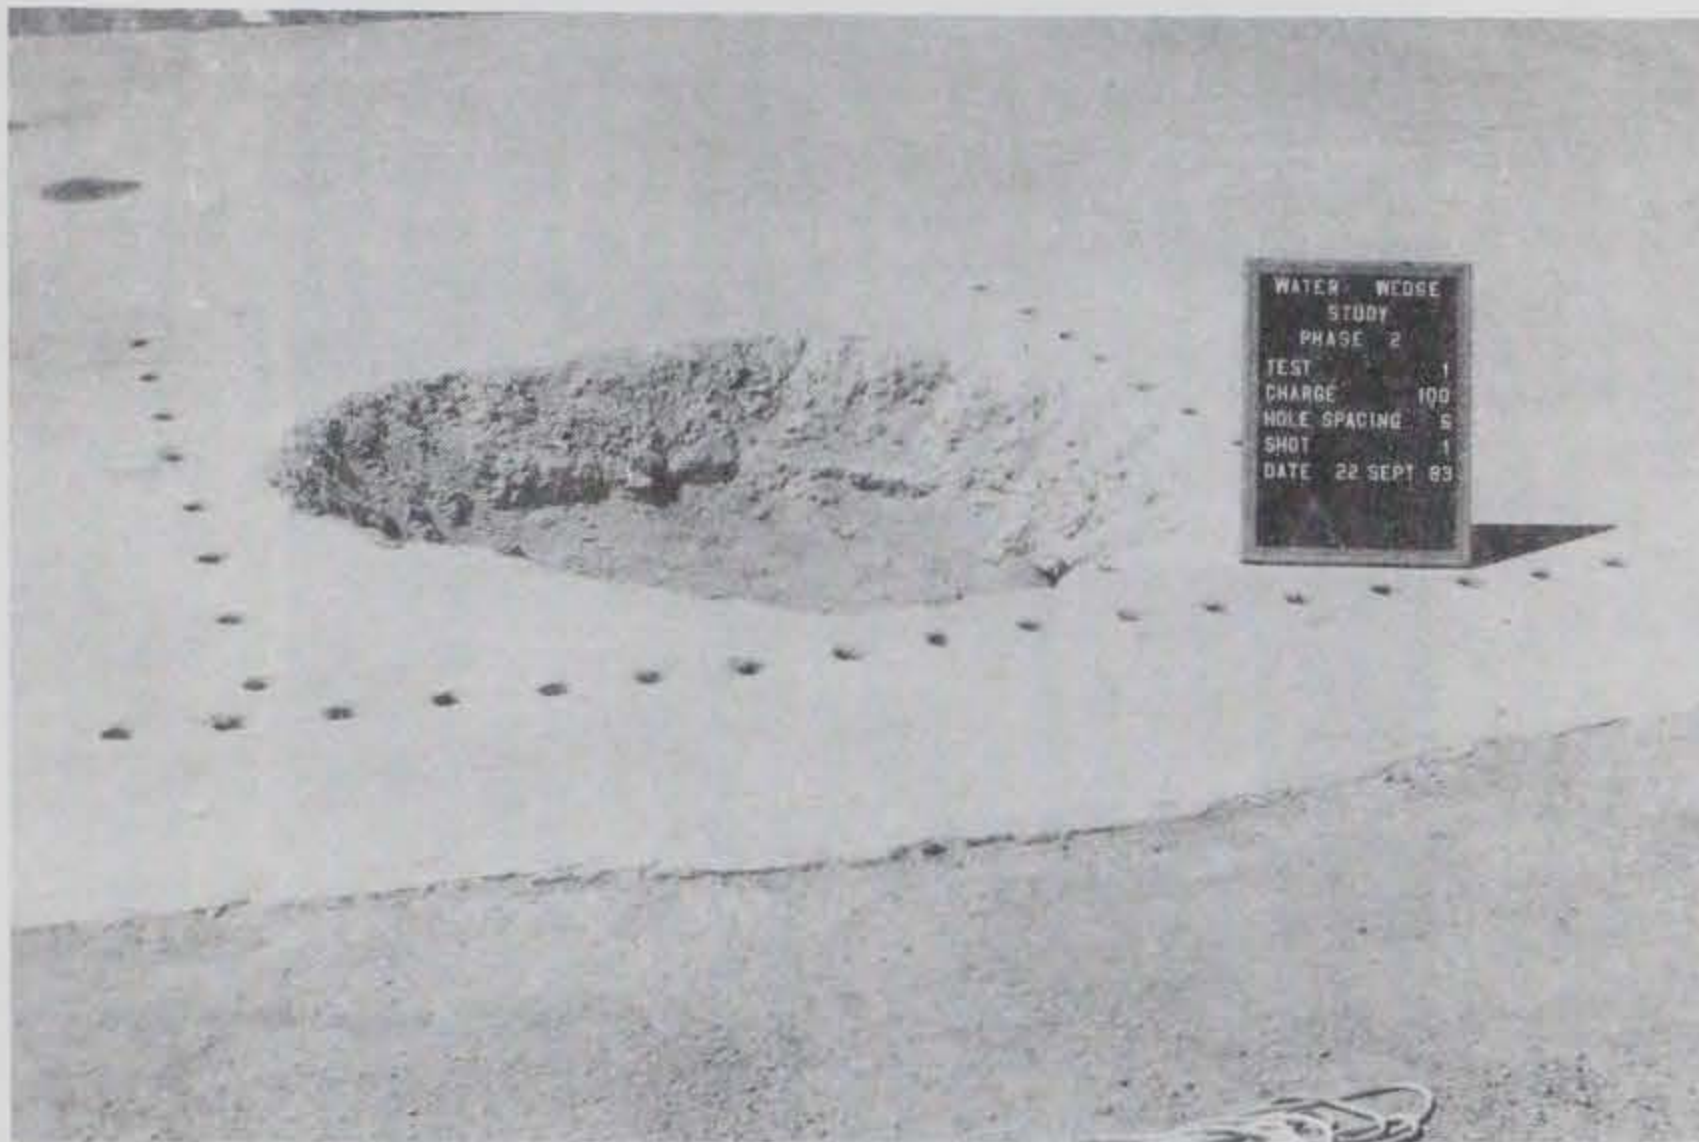
15. Test 1 of Phase II was designed to determine the amount of cracking produced by a 100 percent charge fired in a series of holes along the edge of a crater. The holes were spaced 6 in. center-to-center with hole 0 located 6 in. from the edge of the crater as shown in Photo 14. The first shot was discharged in hole 0, but no cracking or spalling occurred because the water had drained out of the hole. Shot 2 was discharged in hole 1L with no results; once again the water had run out. In Shot 3 hole 1L was then plugged with a heavy clay (CH) soil to prevent the water from escaping and the device fired again. The results of this firing were hairline cracks extending from hole 1L to hole 2L and approximately halfway to hole 0. In Shot 4 the device was once again fired in hole 1L with additional hairline cracks formed between holes 2L and 3L, 1L and 0, and 0 and 1R. No significant growth in the existing cracks was observed. Photo 15 shows the extent of cracking after Shot 4. Shot 5 was discharged in hole 2L causing hairline cracks to extend from hole 3L to 4L and approximately 4 in. toward hole 5L. Spalling, averaging 1/4 in. deep, extended out approximately 1 in. from the edge of hole 2L as seen in Photo 16. In Shot 6 the device was discharged in hole 0 resulting in spalling

Photo 14. Overall view of test 1 prior to shot

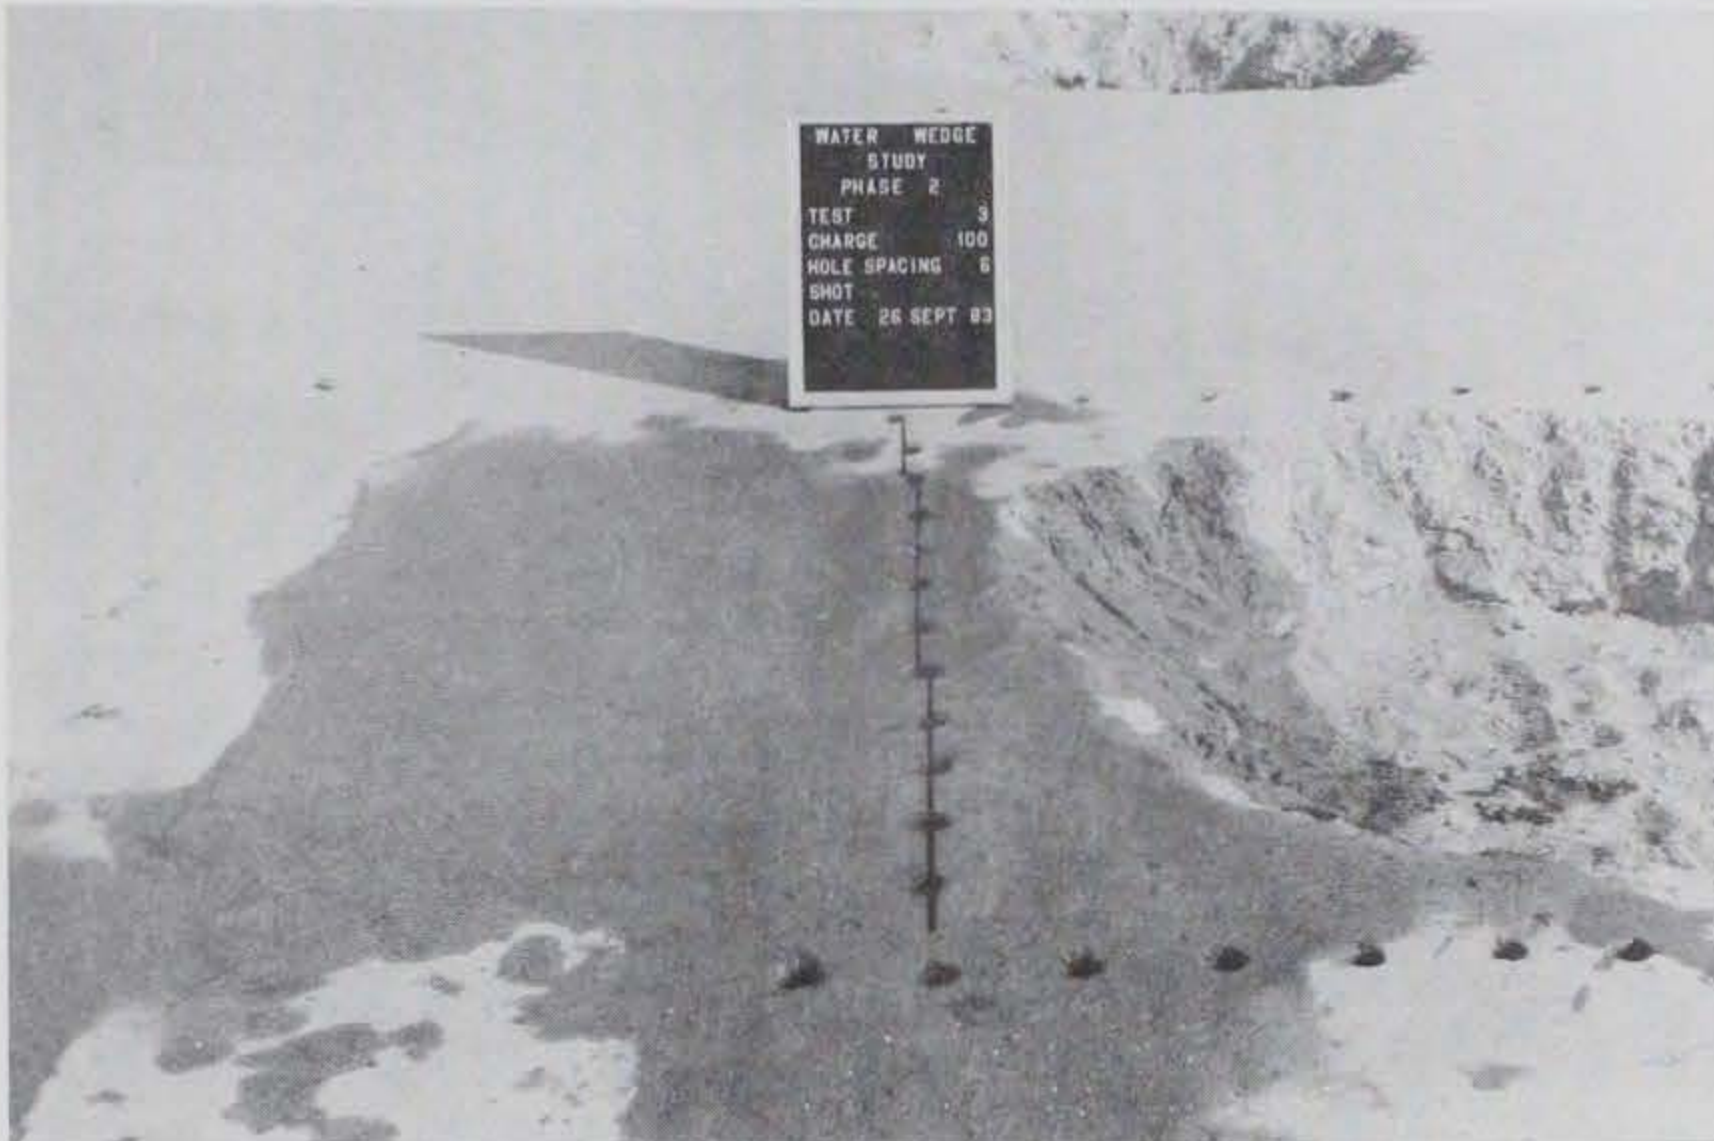
19. Test 3 was conducted to determine if a 2-in.-deep saw cut along the center line of the holes spaced 6 in. apart would increase the amount of crack growth. The holes were drilled in the PCC slab, and a saw cut was made along the center line of the holes as shown in Photo 22. Hole 0 was located 6 in. from the edge of the crater. The depth of the saw cut varied from 2.0 to 2.25 in. along the line of holes. Shot 1 consisted of a 100 percent charge discharged in hole 0. The resulting crack extended from hole 1L to hole 0 to hole 1R, and followed the saw cut. No spalling was observed around the top of the hole. A second 100 percent charge was discharged in hole 0 which resulted in hairline cracks extending along the saw cut from hole 5R to 3L (Shot 2). The third 100 percent charge discharged in hole 0 resulted in hairline cracks extending out to hole 5L and hole 6R along the saw cut (Shot 3). Some spalling occurred around the top of hole 1L. A core was taken from the area between hole 0 and hole 1L. When removed from the core barrel, the core broke into eight major pieces as shown in Photo 23. The top 2 in. of the core broke into two pieces along the saw cut. Two major pieces resulted from the vertical crack through the core, and four smaller pieces were broken from the side of the core adjacent to hole 0. The bottom 2 to 2-1/4 in. of the core was broken off and remained in the hole as rubble. Visual inspection of the cracks in the core hole indicated no significant difference in the size of the cracks produced in this test and the cracks produced in Test 1. A second core was removed from the area between 5R and 6R. The north side of the core hole has a small vertical crack through the slab, and the bottom 2 in. of the slab

Photo 22. Overall view of site 3 before test
