MISCELLANEOUS PAPER GL-86-5

# FIELD EVALUATION OF THE WATER WEDGE FOR CUTTING PORTLAND CEMENT CONCRETE PAVEMENTS FOR REPAIR AND RESTORATION OF PAVED SURFACES (REREPS)

January 1986

Final Report

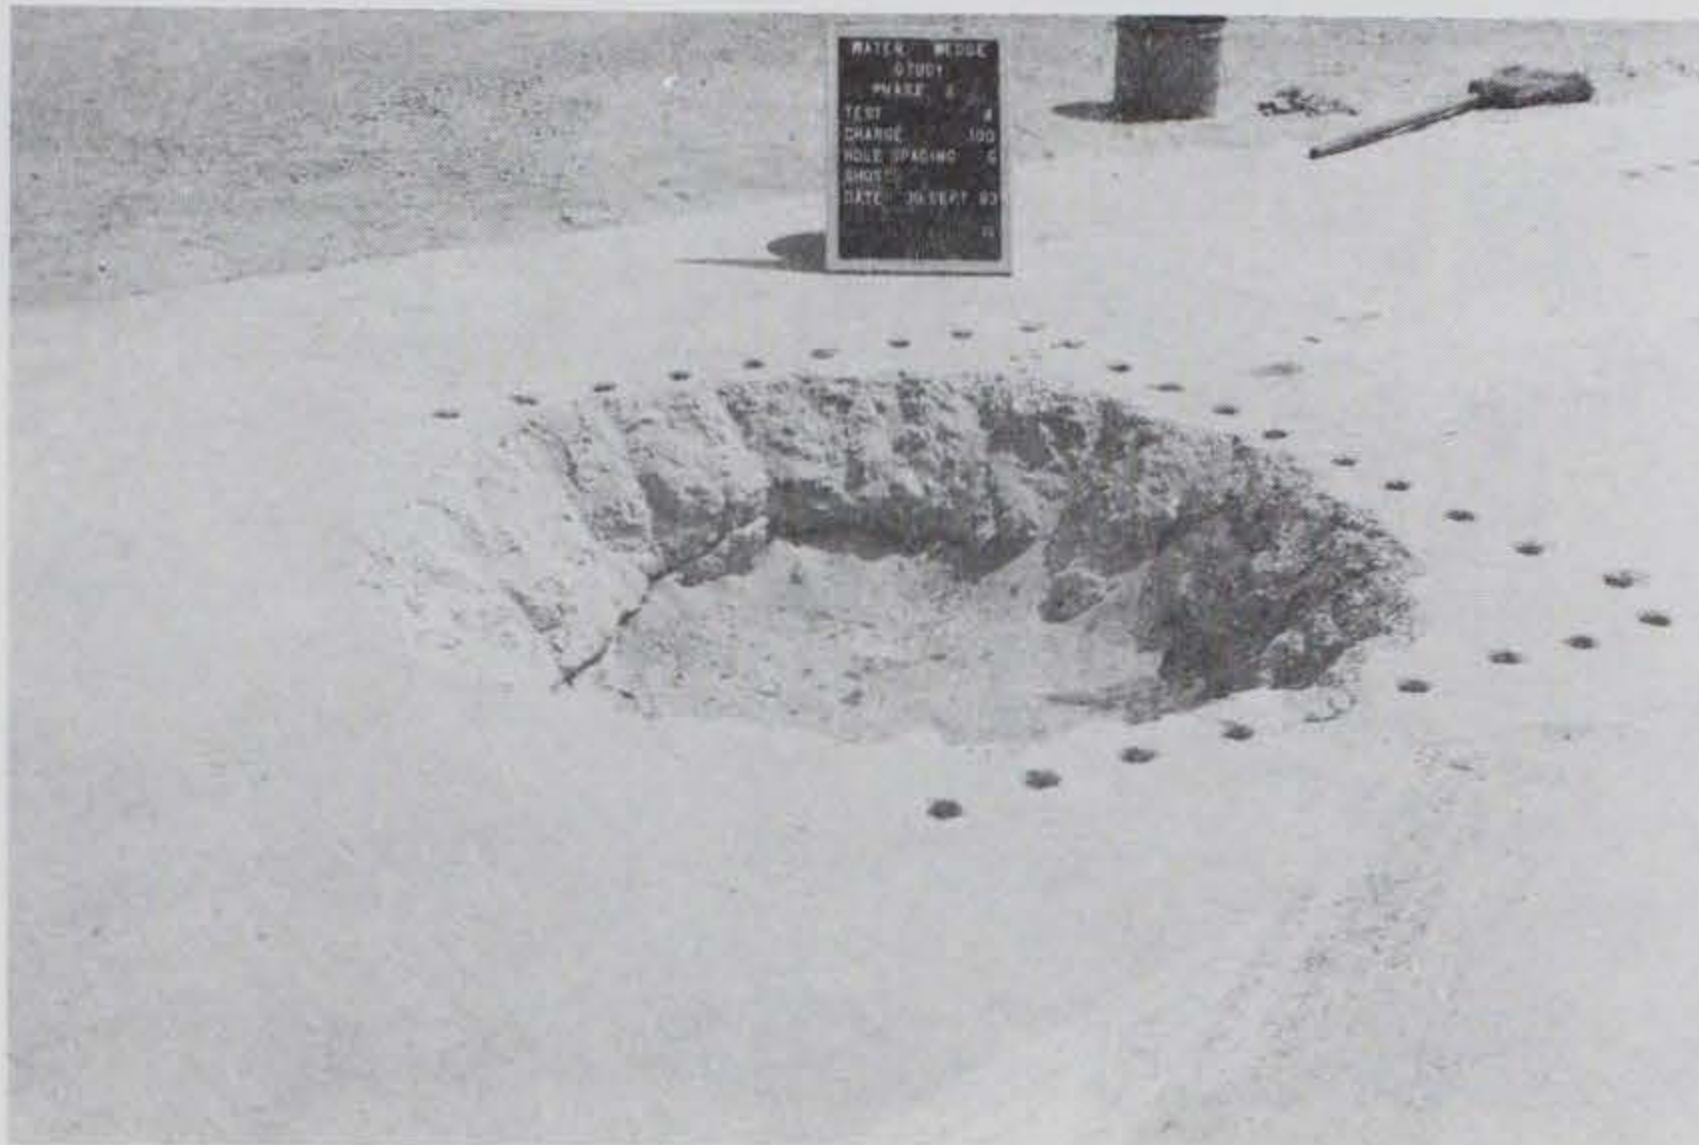
Photo 26. Crater 2, test 4 site
