US Army Corps
of Engineers

MISCELLANEOUS PAPER GL-92-17

A CASE STUDY: DAMAGE TO THE METROPOLITAN OAKLAND INTERNATIONAL AIRPORT CAUSED BY THE LOMA PRIETA EARTHQUAKE

July 1992

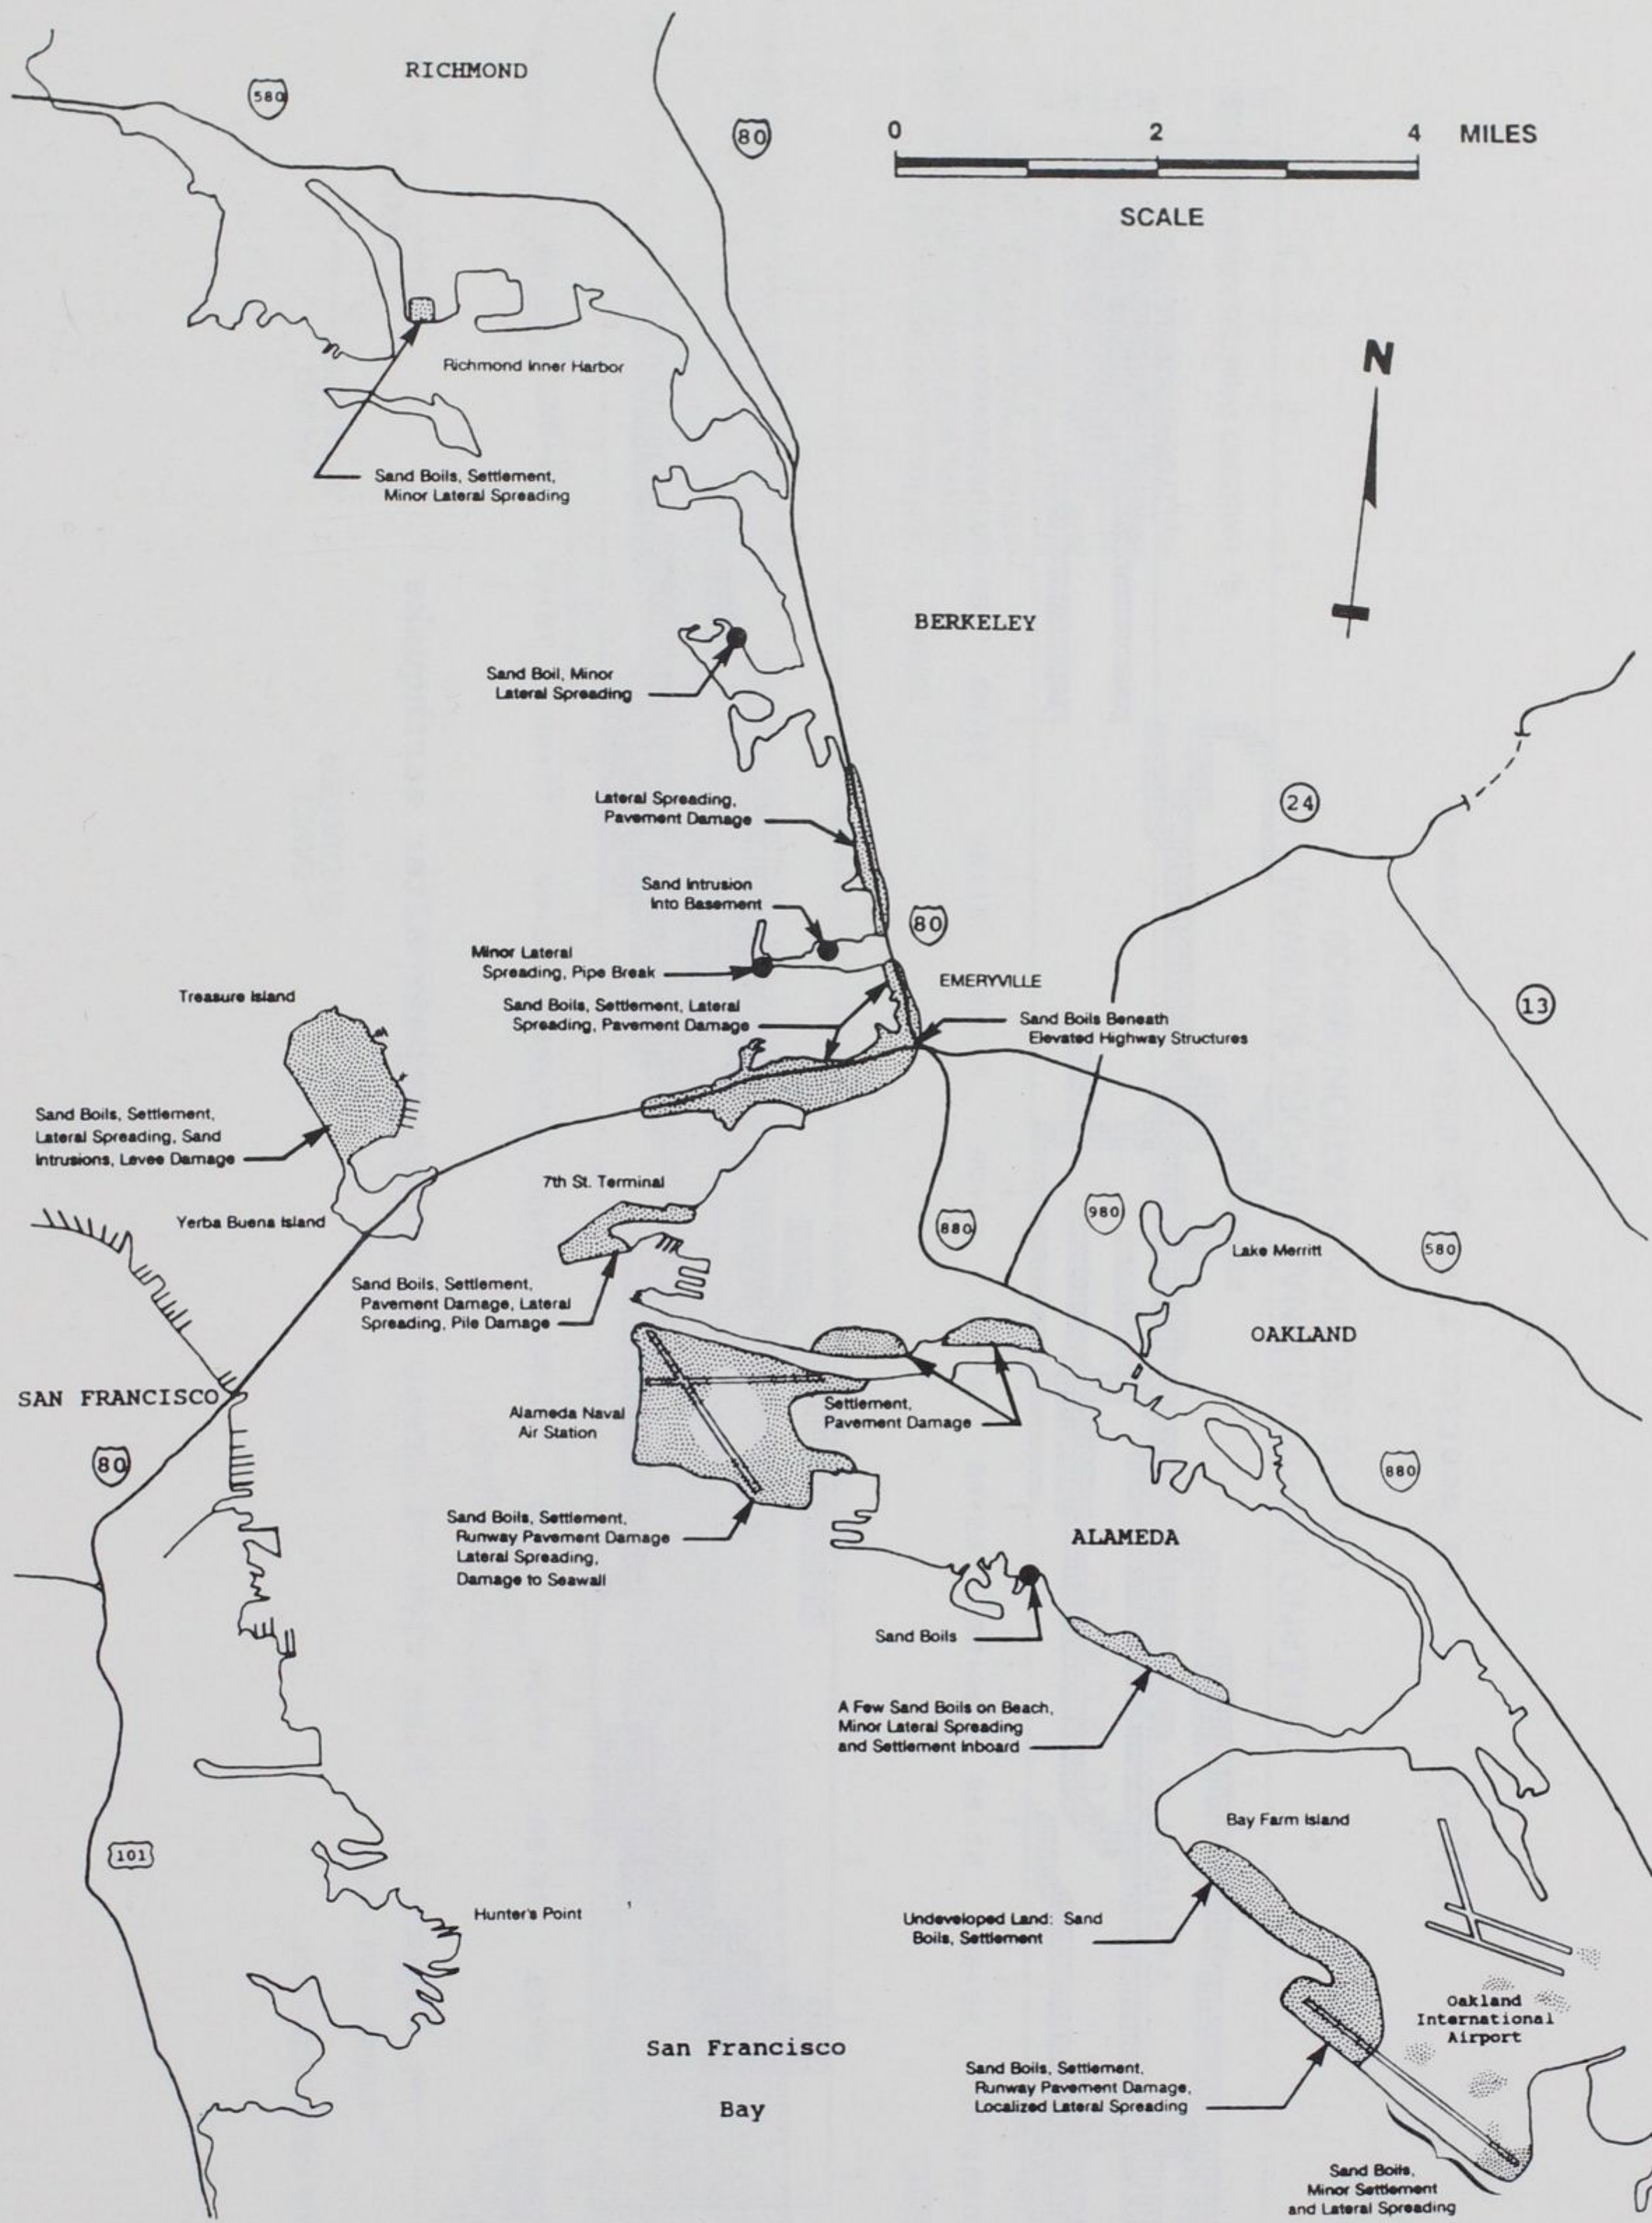
Figure 1. East bay areas suffering damage because of liquefaction

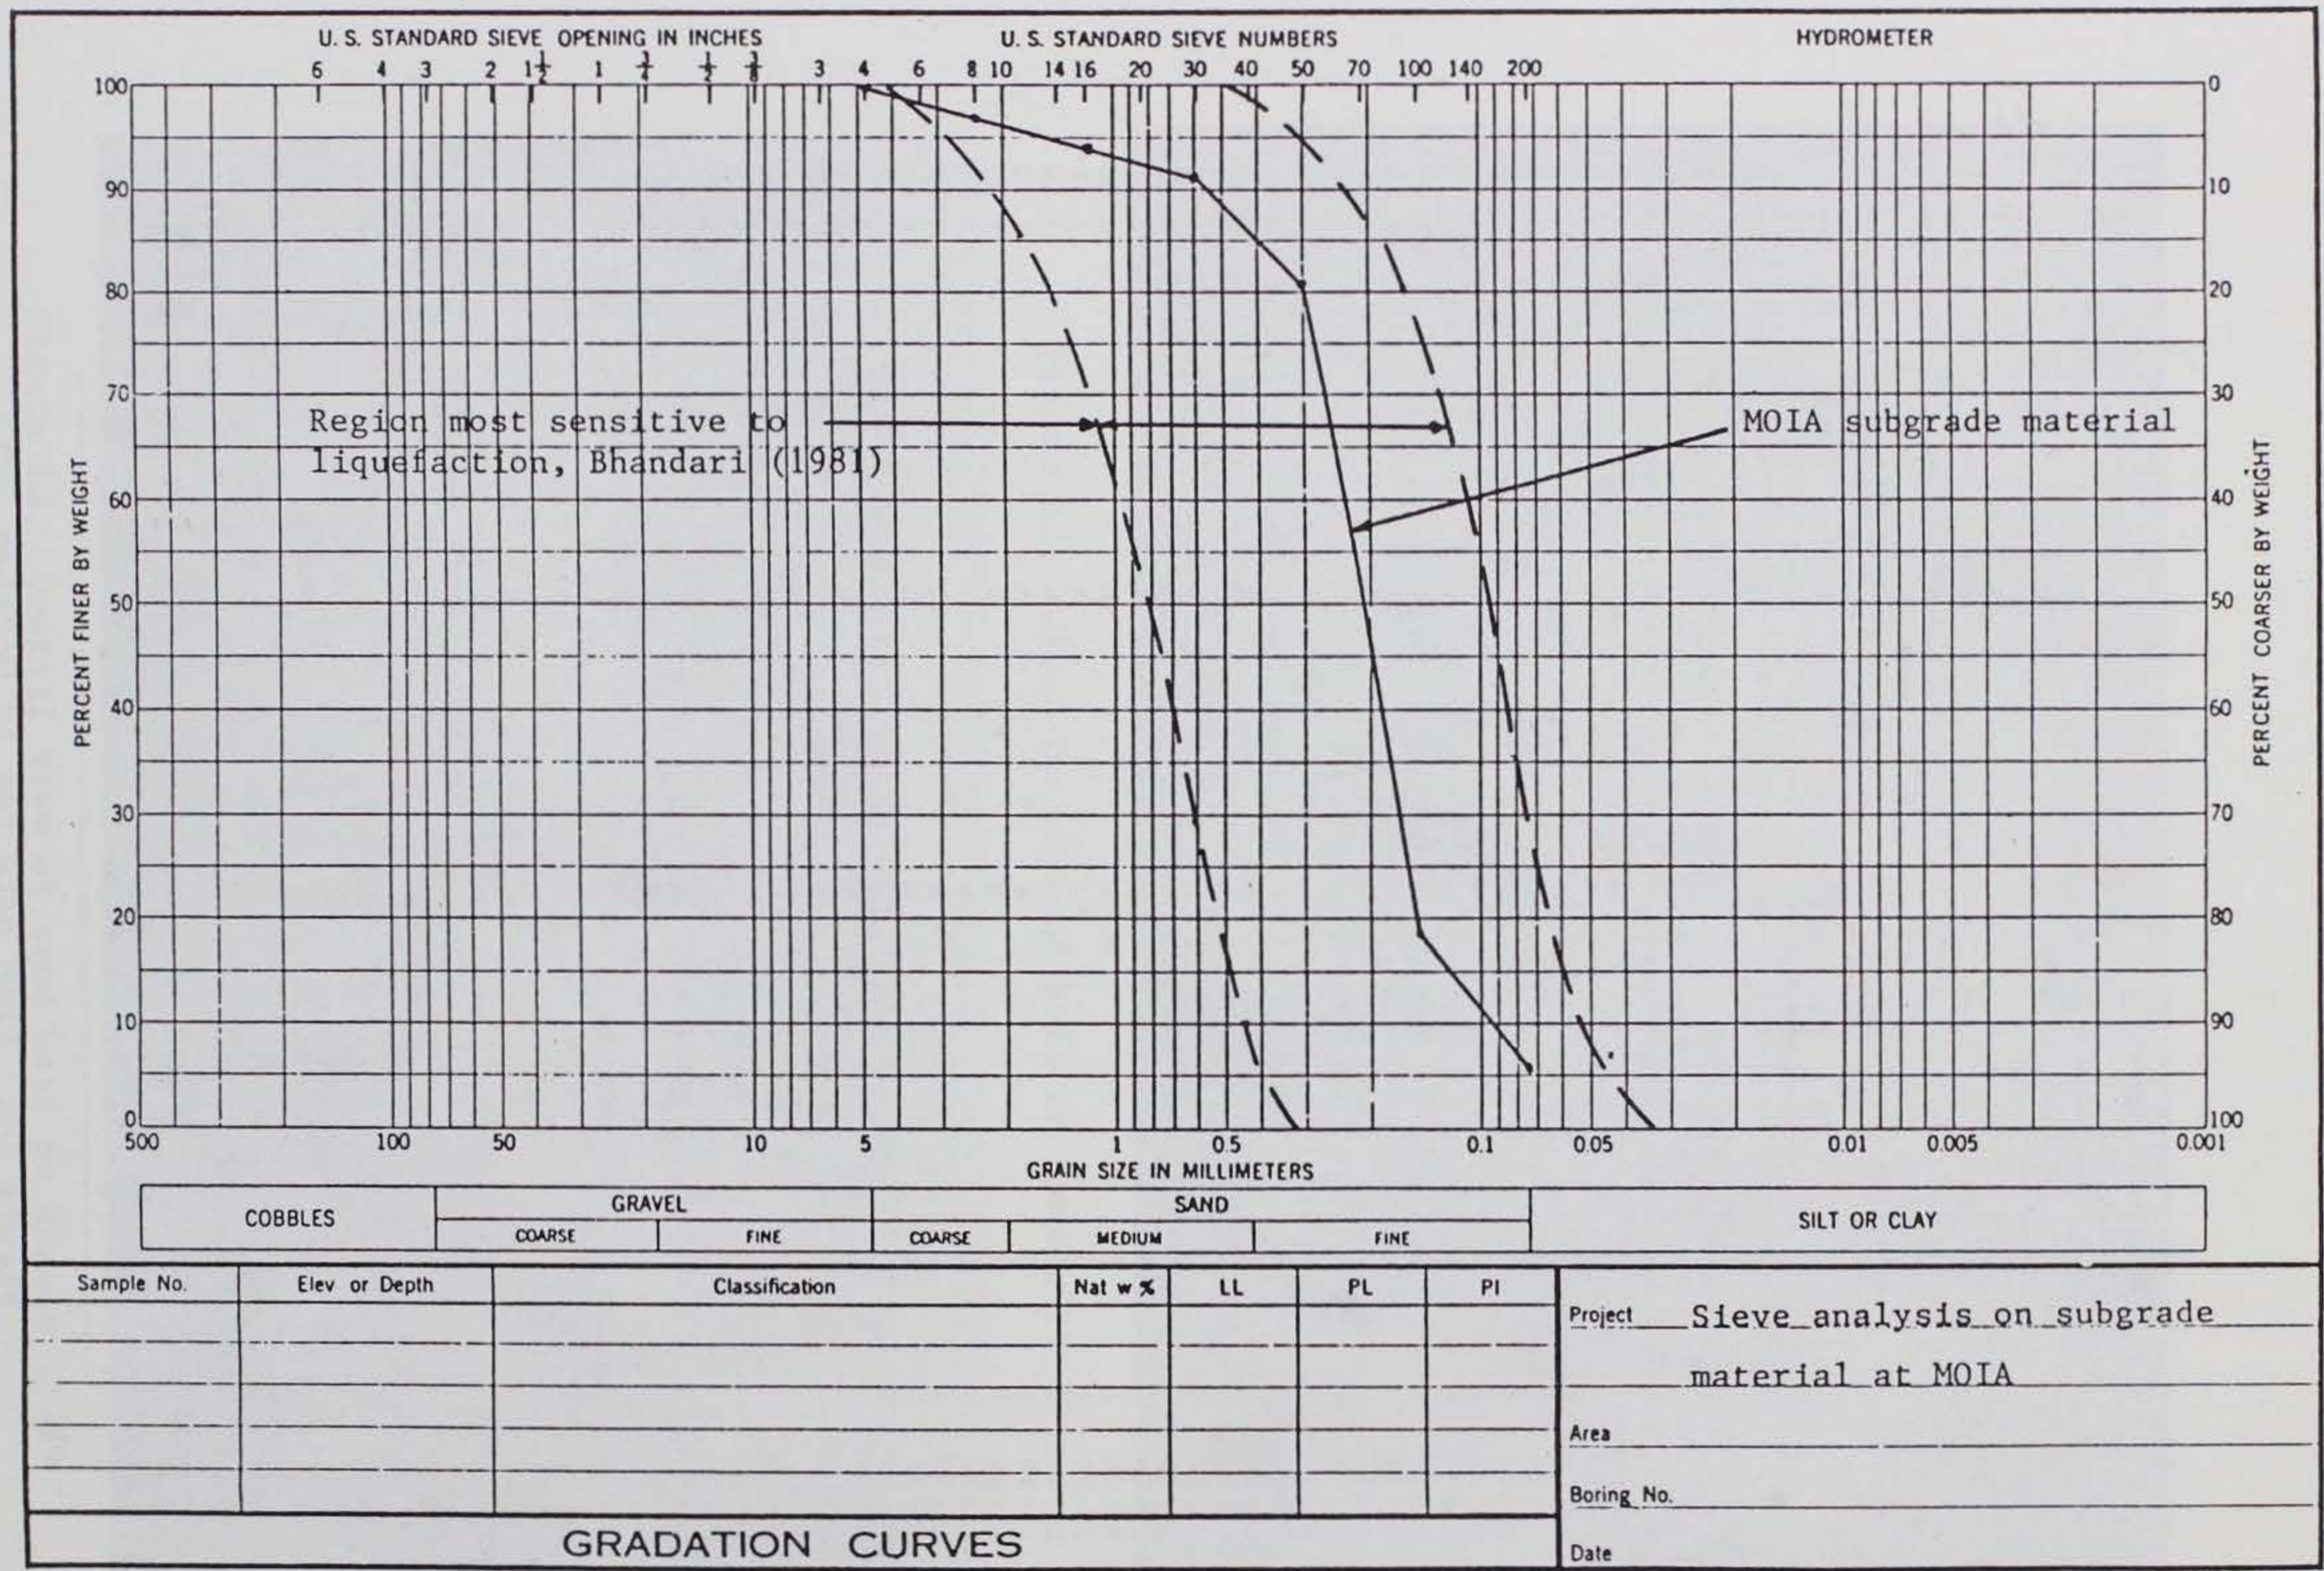
31. The material used as fill is a uniformly graded sand as shown in Figure 15. The uniformity of the gradation makes the material extremely vulnerable to the phenomena of liquefaction. The gradation of the fill material falls within the region of materials most sensitive to liquefaction (Bhandari 1981).

53. The soil type of a site in an earthquake zone should be investigated for vulnerability to strength loss and deformation because of earthquake activity. Different soil types behave differently when subjected to the loadings induced by an earthquake. Although many soil types may be susceptible to liquefaction, some soil types are more vulnerable than others. Soil characteristics such as age and fabric also affect the way a deposit will perform under an earthquake induced load. Any structure to be constructed in an earthquake prone region should be designed to withstand the expected behavior of the soil on which it is founded. The expected behavior of the soil should be evaluated based on the design earthquake and the soil type and characteristics at the site. At the MOIA, it is known that the soils are vulnerable to liquefaction because of the damage that occurred as a result of the Loma Prieta Earthquake. The site of the MOIA is also known to be vulnerable to liquefaction because the fill materials are relatively uniform, fine sands placed hydraulically. A hydraulically placed, uniformly graded sand soil type is particularly susceptible to liquefaction. Figure 15 (the results of a sieve analysis) shows that the dredged subgrade soil at MOIA is quite uniform in particle size.

Figure 15. Sieve analysis results on sandfill

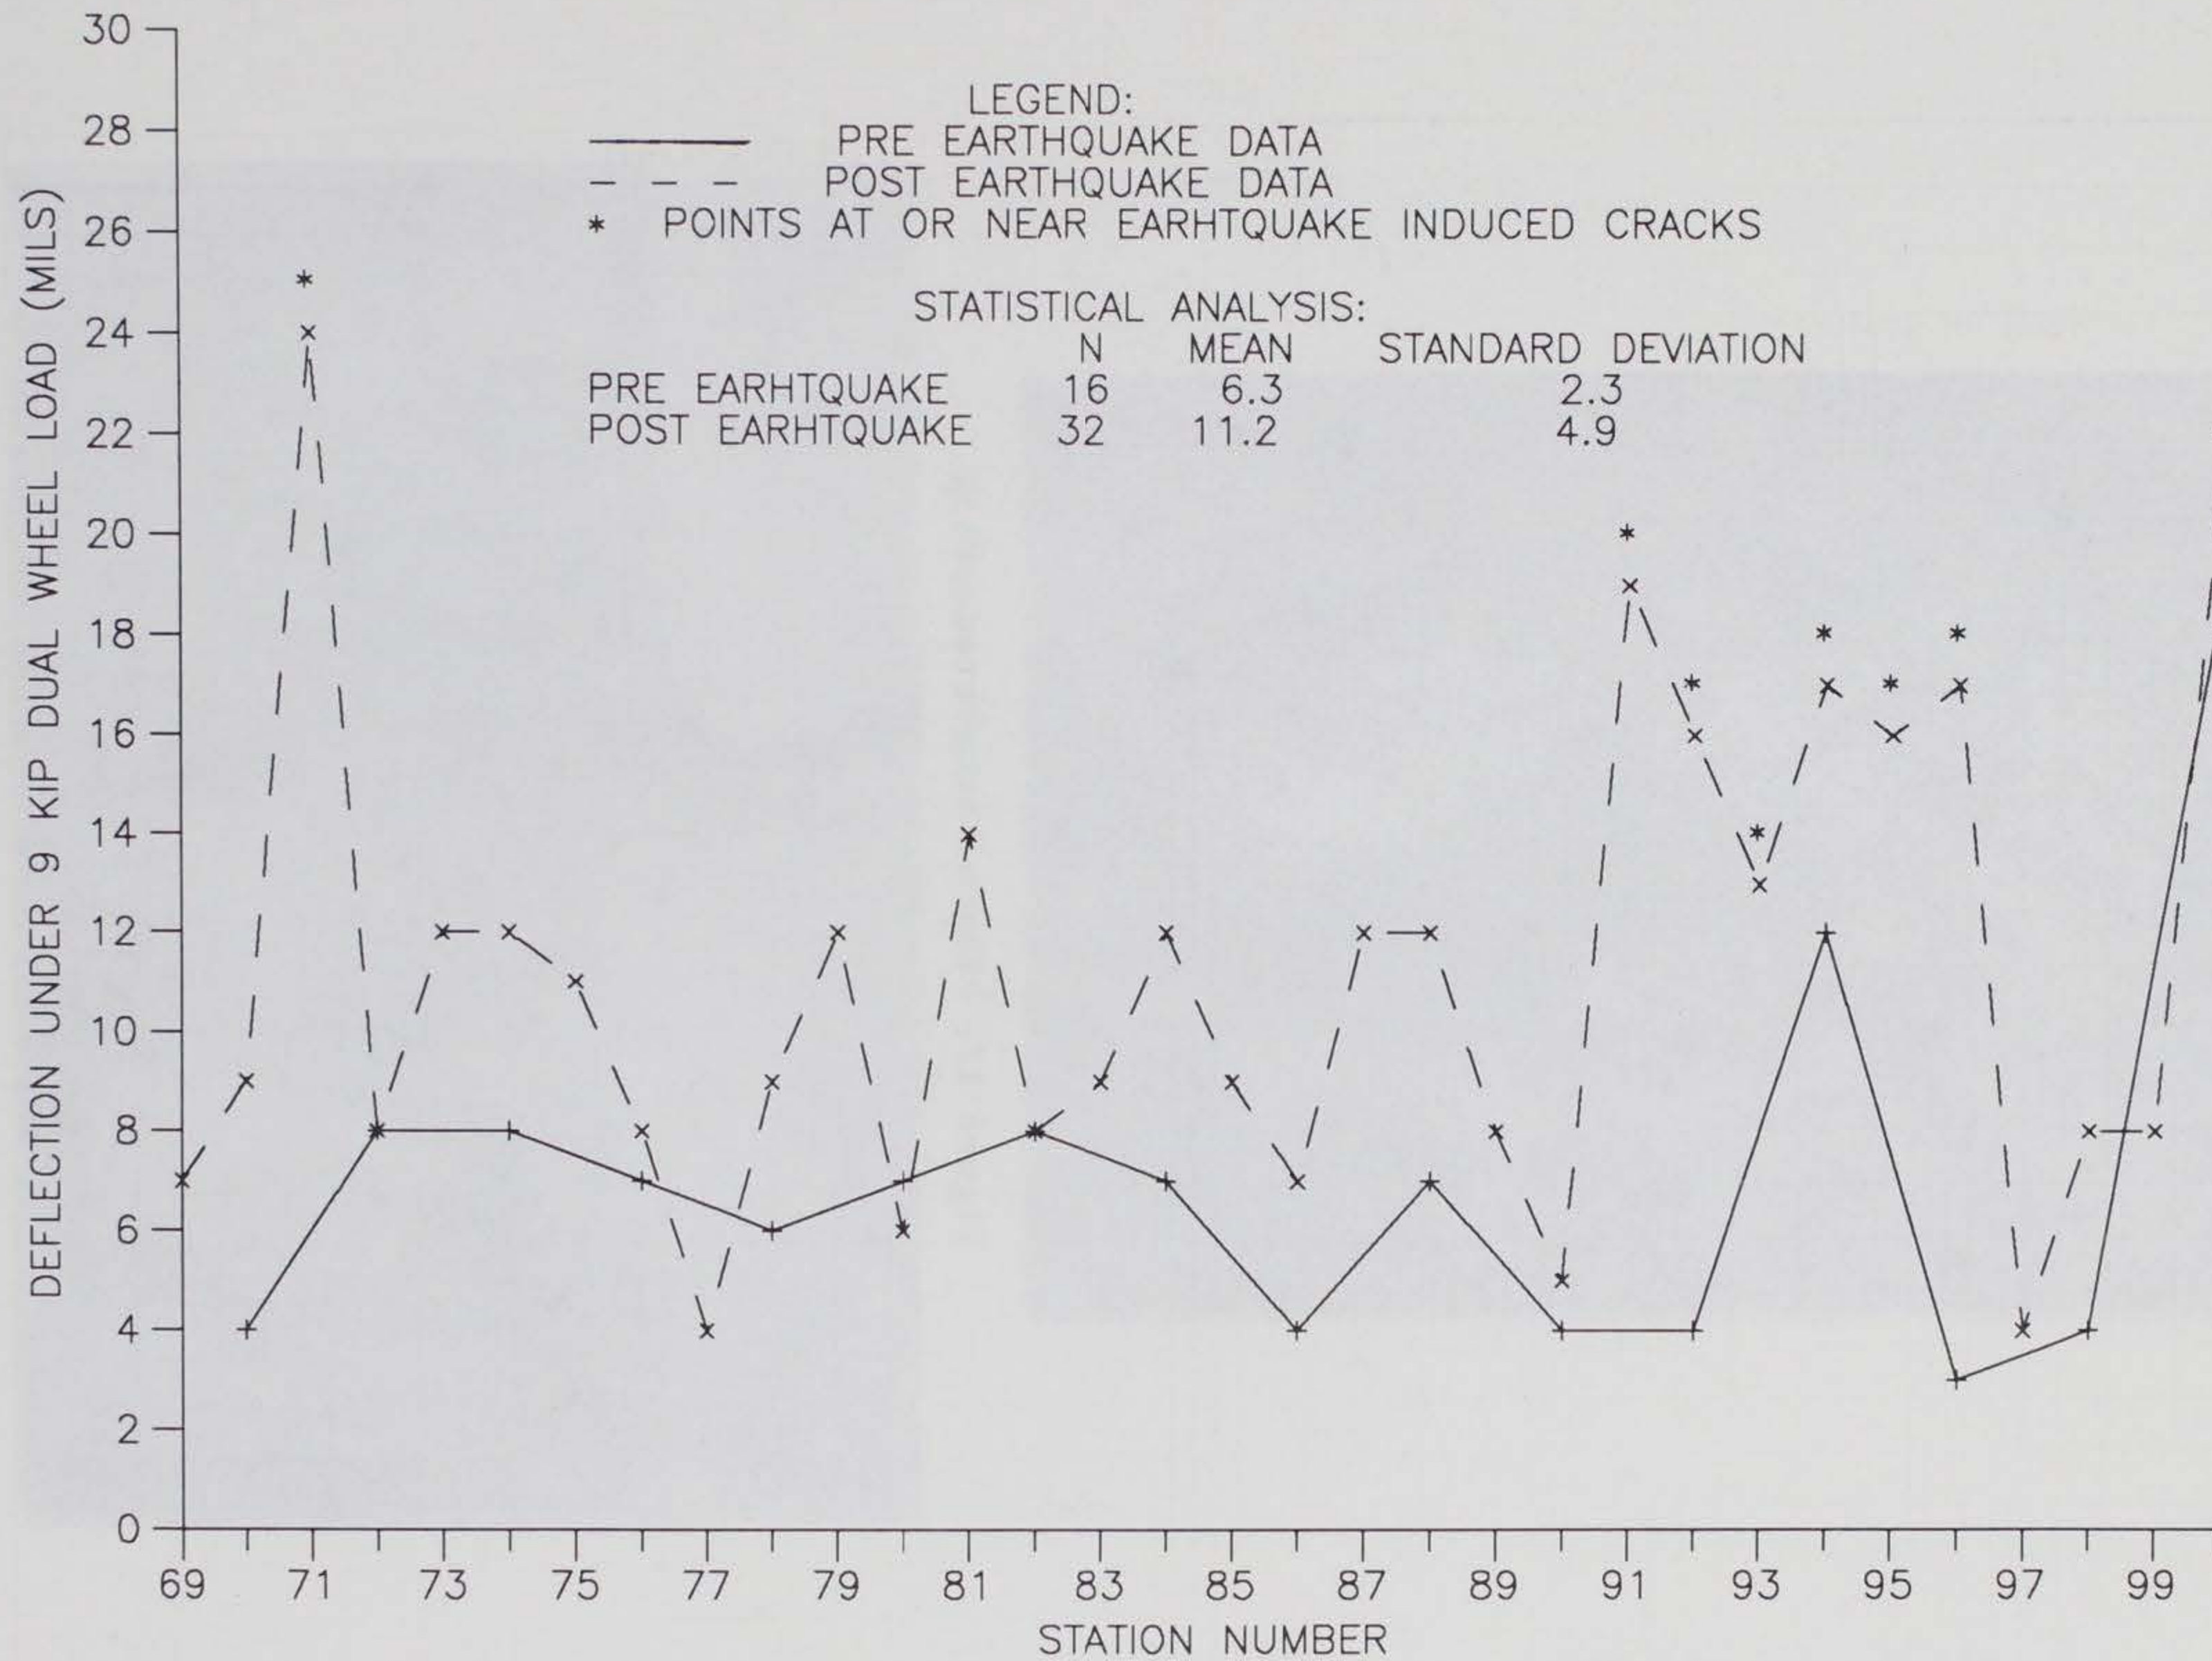
35. Following the visual ground survey, ground and aerial photos were taken to record the damage that occurred as a result of the earthquake. A topographic survey of the damaged area was run on a 25-ft grid to determine the extent of grade changes. Deflection data were taken with the Benkelman Beam to compare to data that were taken 3 years previously (1986). Results of the Benkelman Beam tests showed that the deflections were not significantly different than those from the 1986 results except for measurements directly adjacent to the cracks where the deflections were substantially larger. Figure 16 compares the deflection measurements before and after the earthquake and illustrates the increase in deflections immediately adjacent to the earthquake-induced cracks.

Figure 16. Benkelman beam deflection data
