E-Krete™ Polymer Composite Micro-Overlay for Airfields: Laboratory Results and Field Demonstrations

J. Kent Newman and James E. Shoenberger

November 2003

Final report

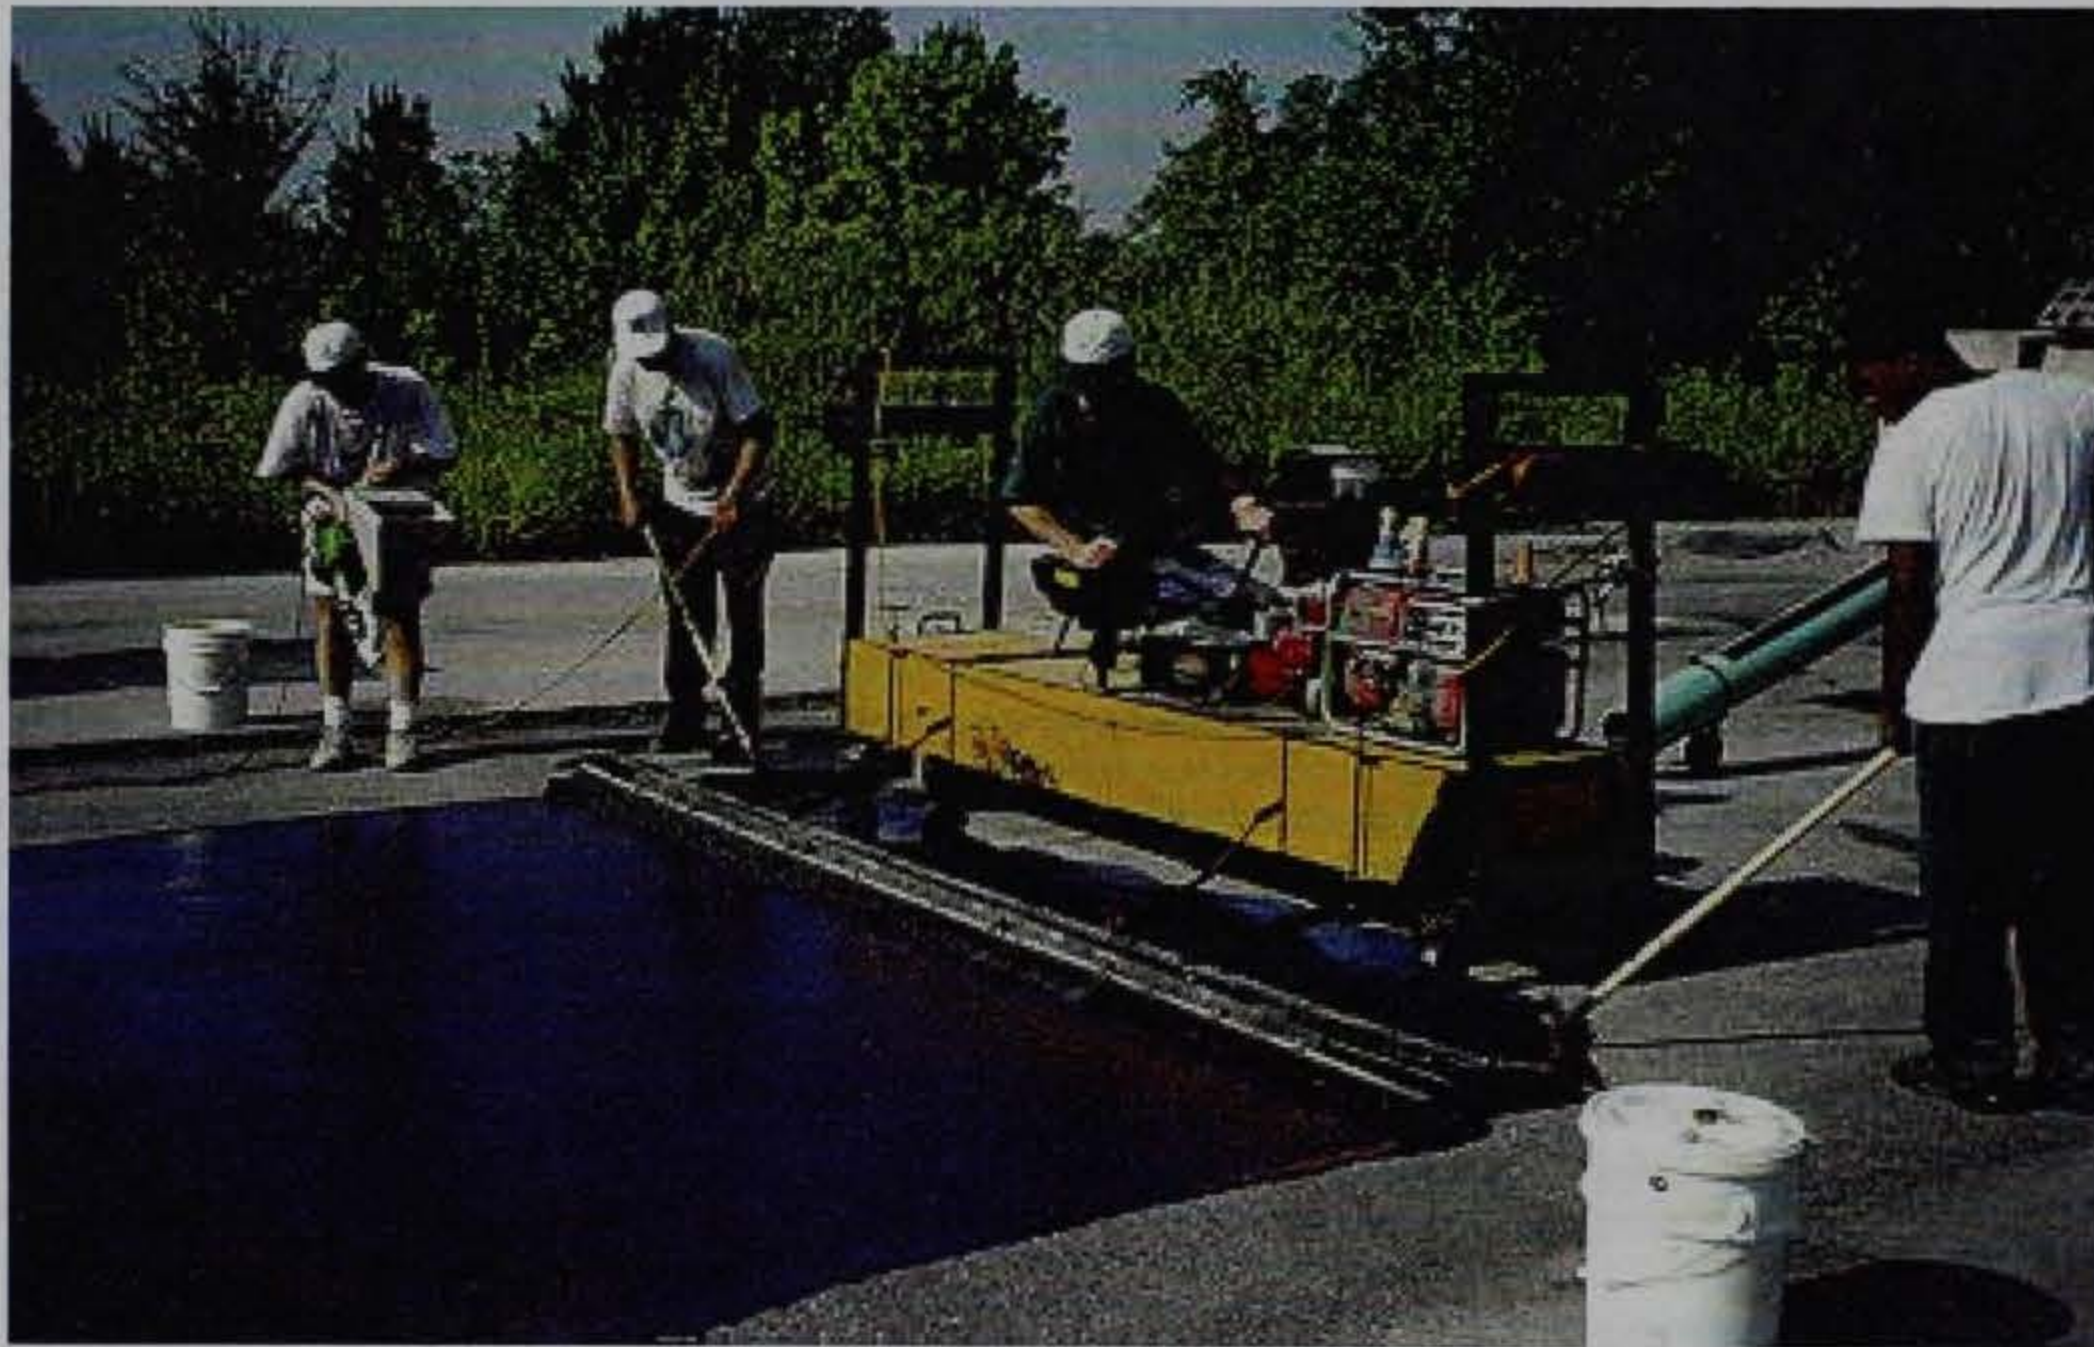
Figure 2. Application of E-Krete at ERDC, August 1998

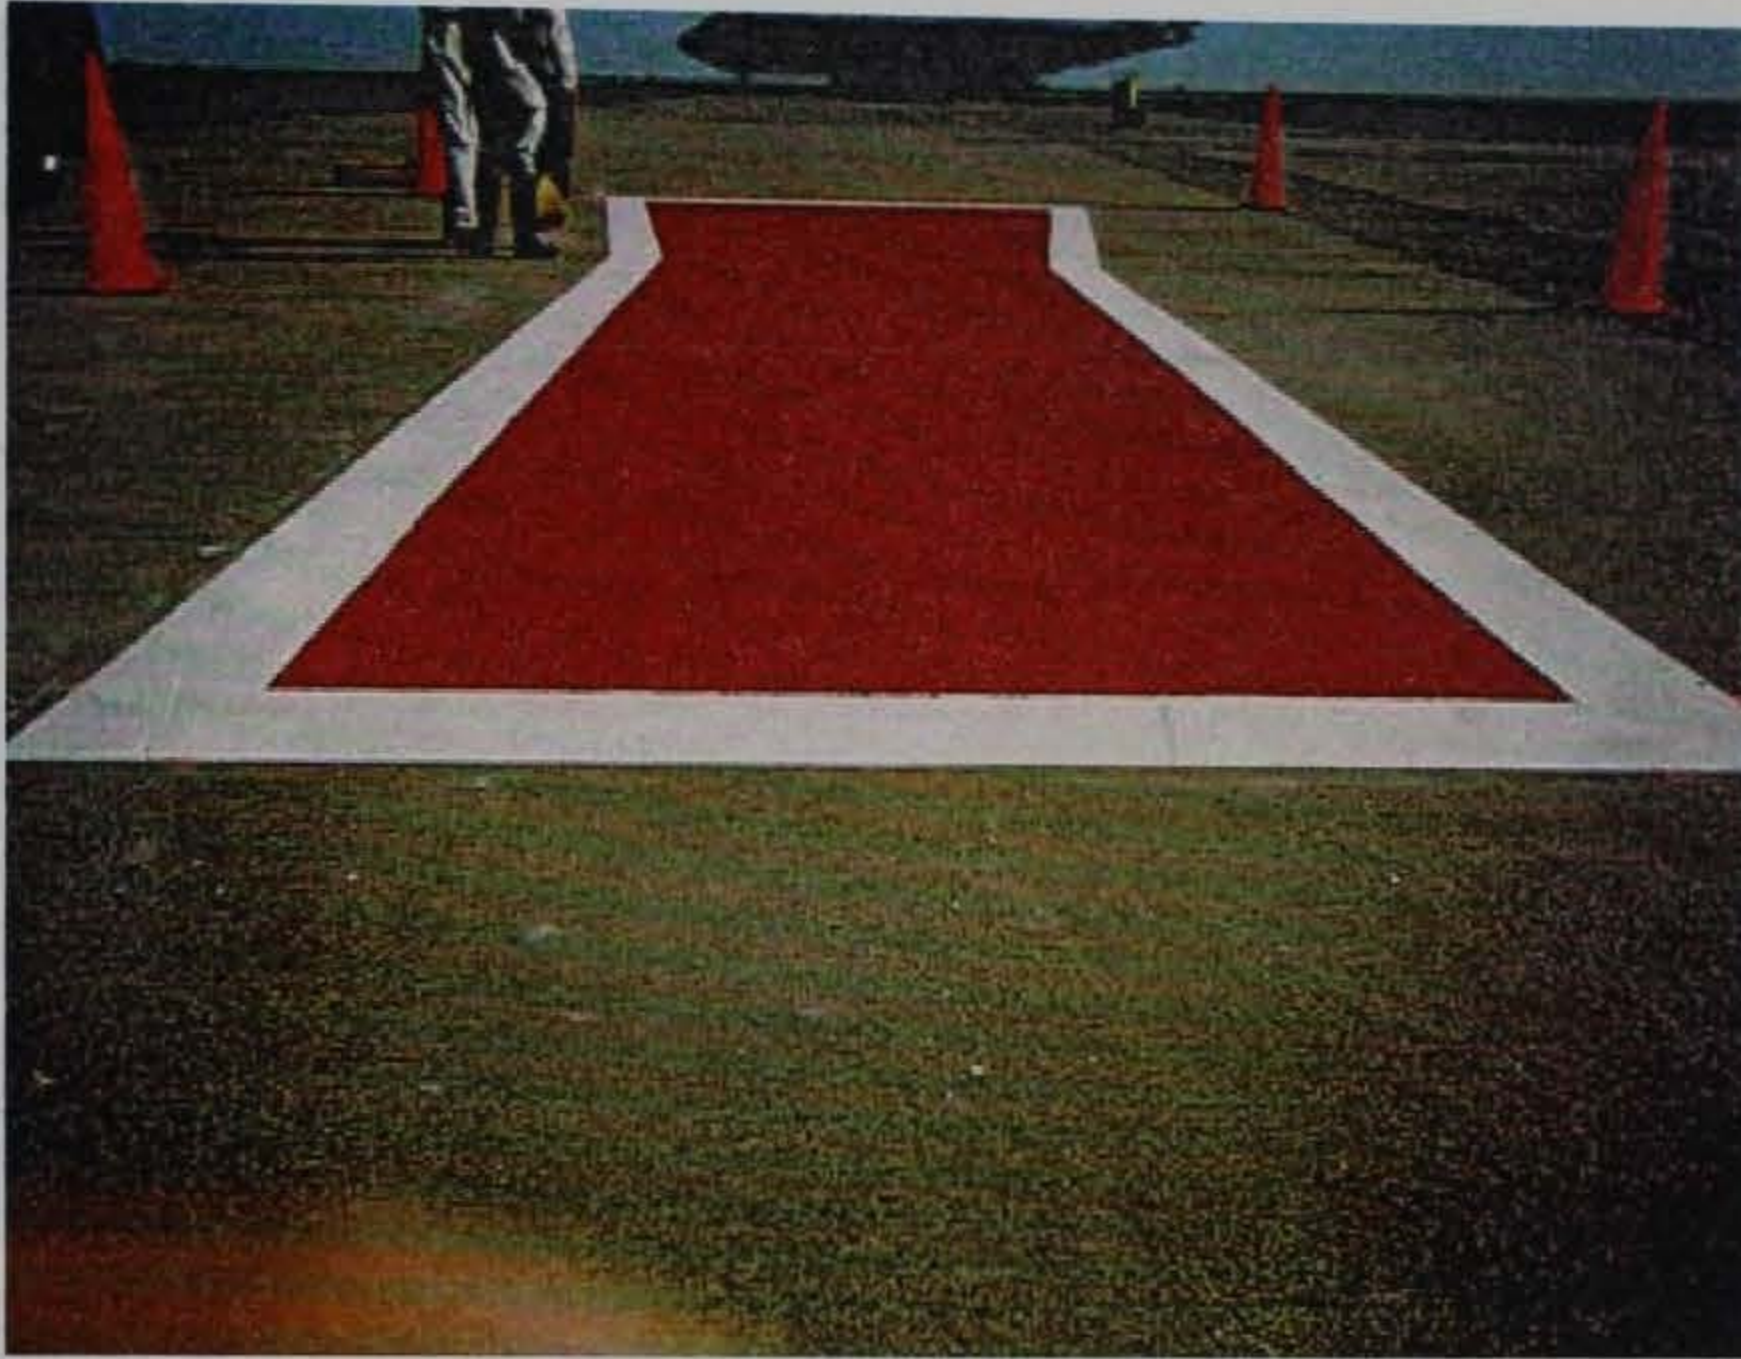
Figure 18. "Red Carpet" area at Forbes Field in November 1998. This E-Krete section was placed to provide a walkway for dignitaries exiting aircraft
