## **Fluvial Instability and Channel Degradation of Amite River and its Tributaries, Southwest Mississippi and Southeast Louisiana**

D. Ryan Hood, David M. Patrick, and Maureen K. Corcoran

September 2007

Final report

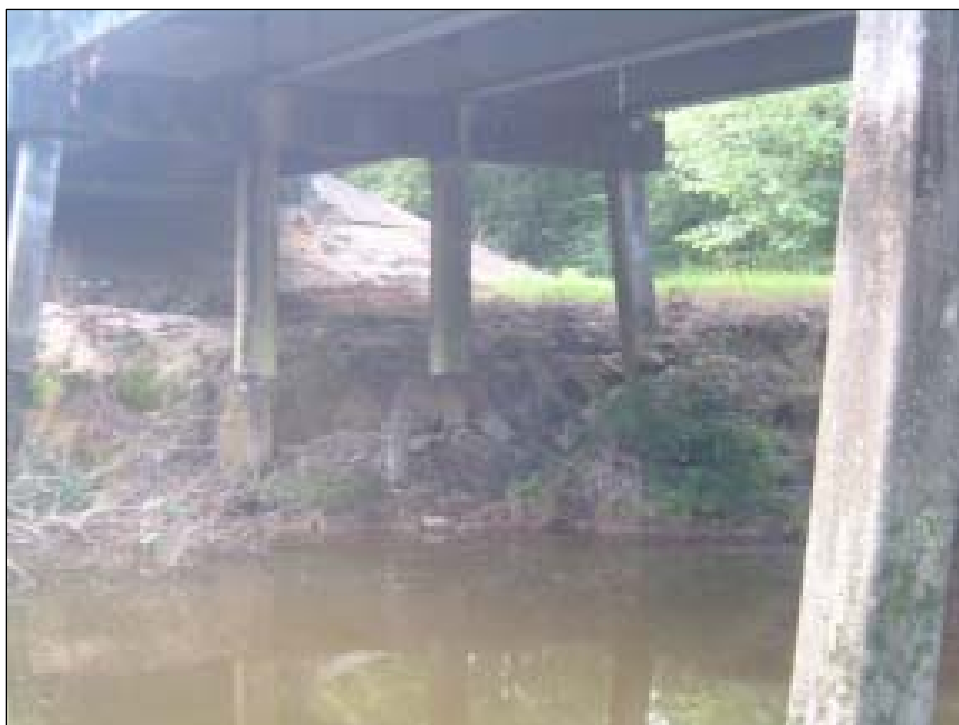
Figure 7. Scour of bridge piers at the Hwy 98 crossing of the East Fork near Smithdale, MS (July 2003).

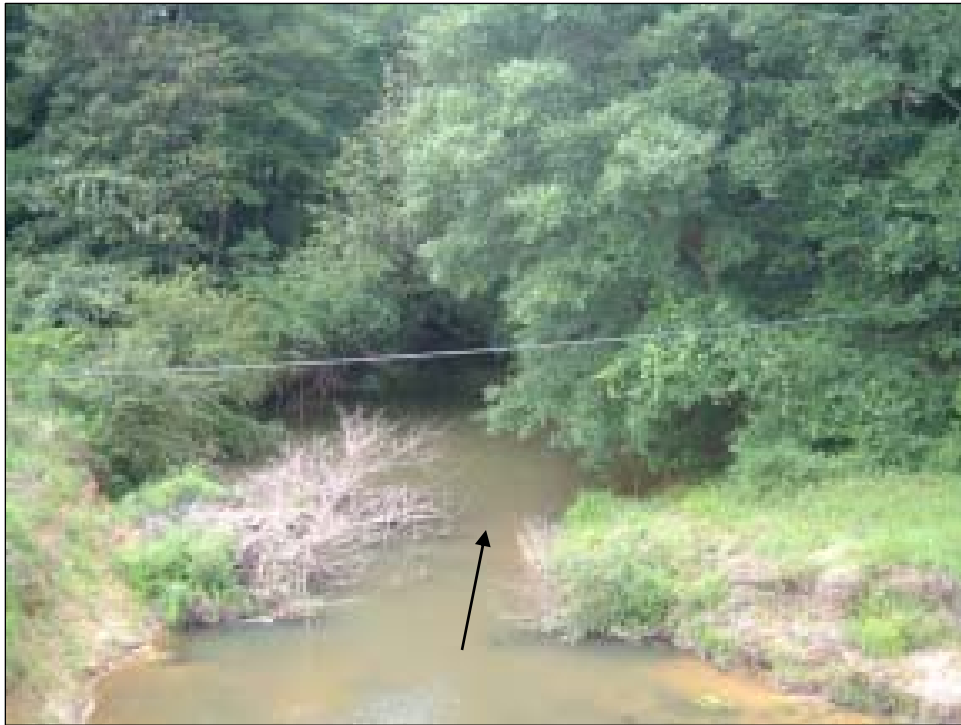
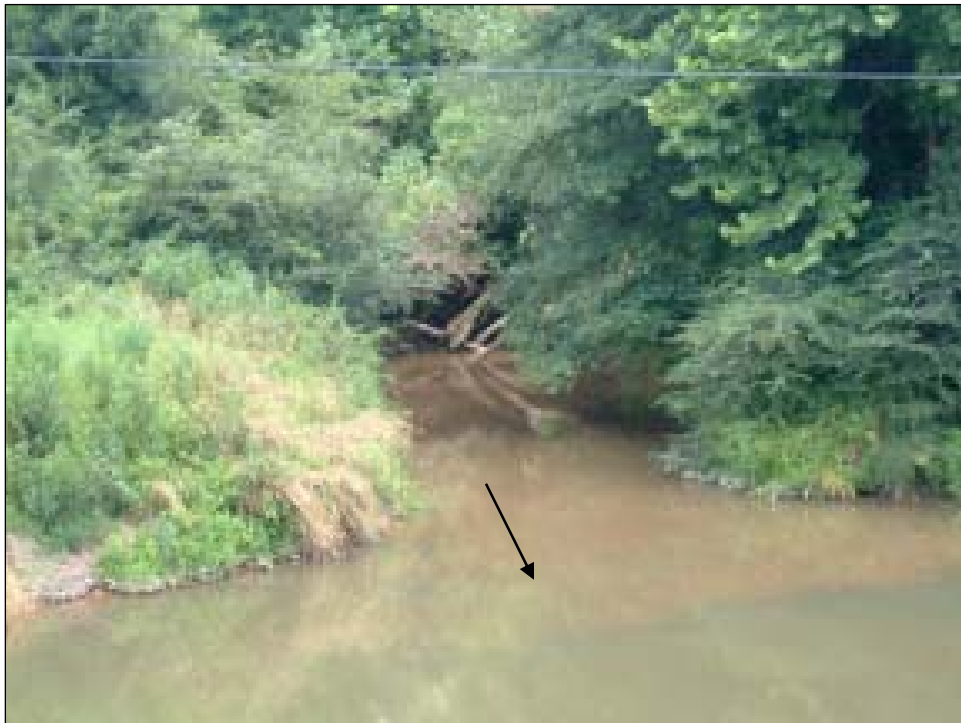
The East Fork Amite River exhibited additional channel instability at the Mississippi Highway 570 crossing near Mars Hill, MS (Figures 8 through 11). At this site, which is approximately 6.4 km downstream of the Mississippi Highway 98 crossing, the channel is still narrow and well vegetated, but there is more leaning vegetation present as well as some dead vegetation in the channel. Both sides of the channel have been over-steepened and excessive, local erosion has occurred.

Figure 8. Downstream view of the East Fork at the Hwy 570 crossing near Mars Hill, MS (July 2003) (arrow notes flow direction).

Figure 9. Upstream view of the East Fork at the Hwy 570 crossing near Mars Hill, MS (July 2003) (arrow notes flow direction).

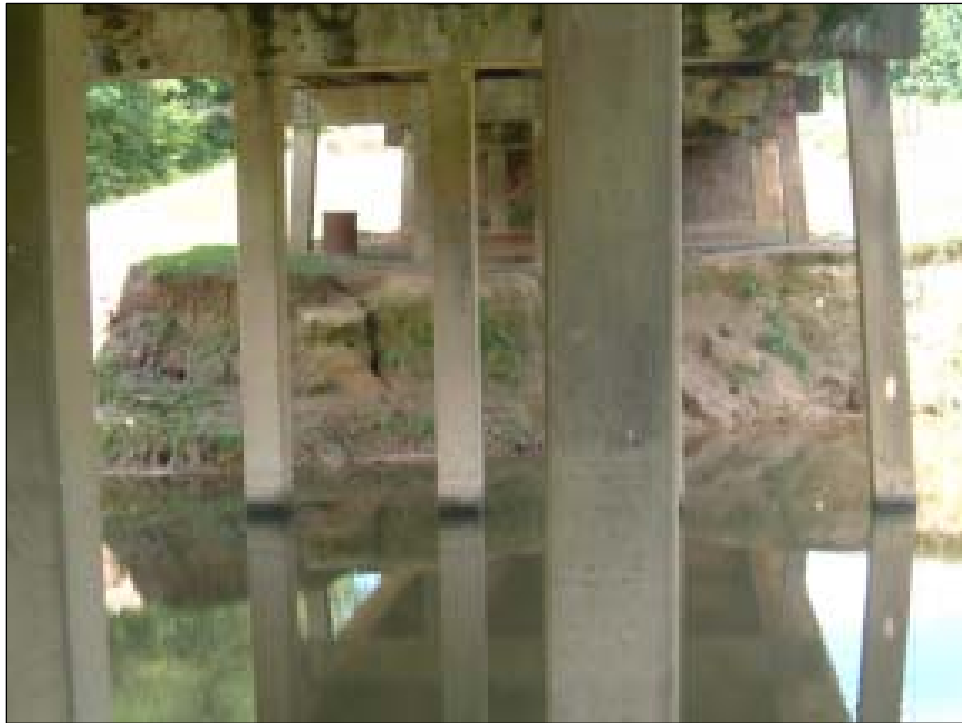
Figure 10. Steep, eroded bank of the East Fork at the Hwy 570 crossing near Mars Hill, MS (July 2003).

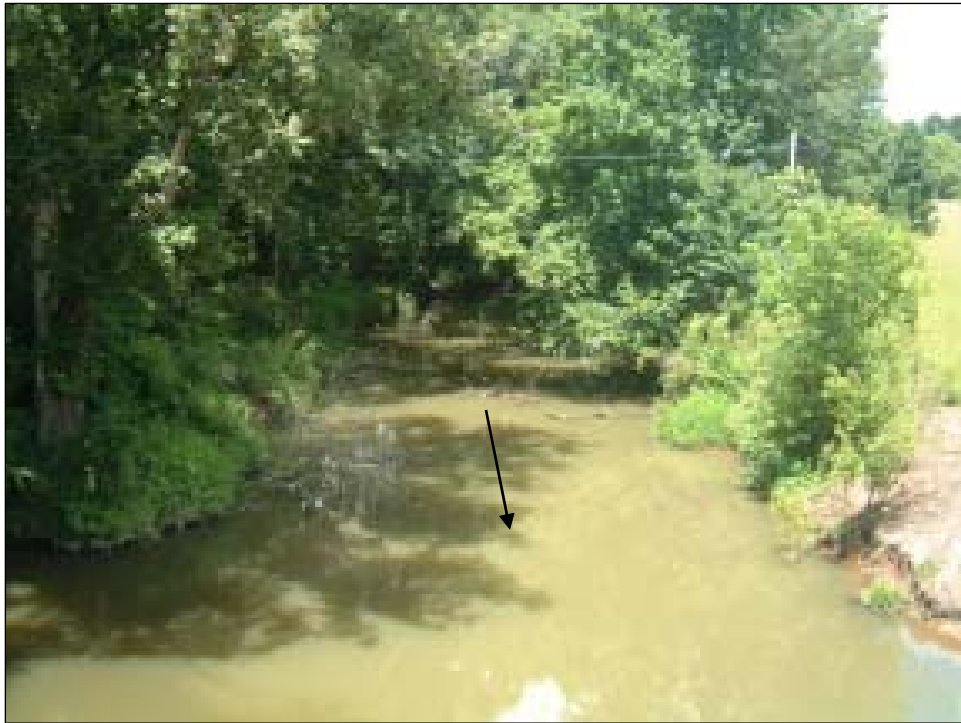
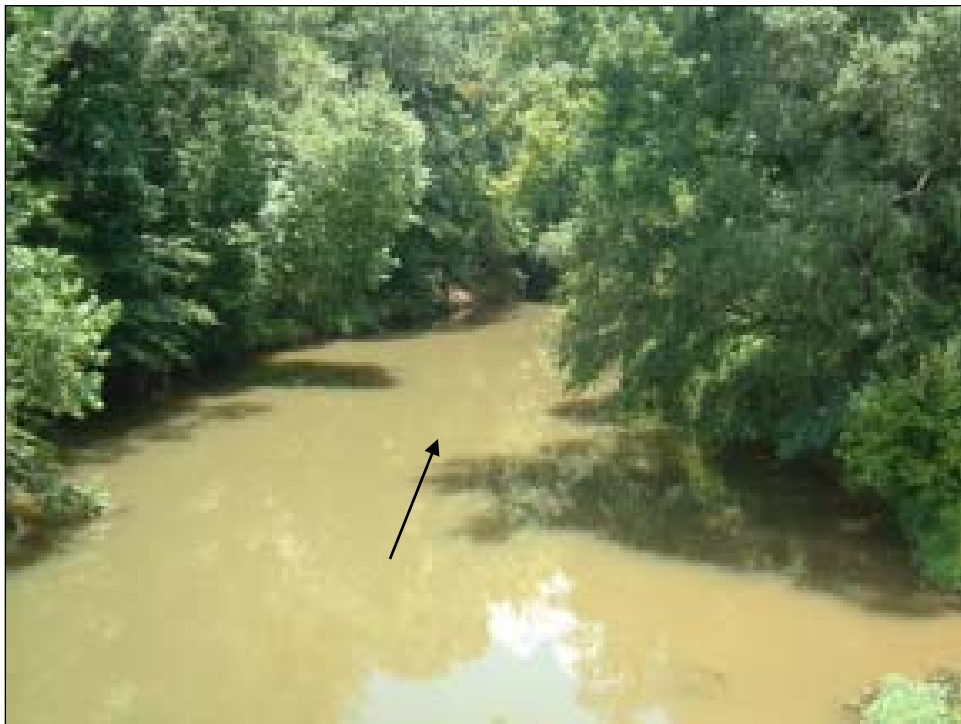
The Mississippi Highway 24 Bridge Crossing near Peoria, MS, is a good example of the East Fork's middle reaches (Figures 12 through 15). The channel has widened, as opposed to the upper reaches, but the banks are still well vegetated. The left (east) and right (west) banks are steep and eroded with the right bank erosion threatening the piers of the Mississippi Highway 24 bridge (Figure 15). Leaning vegetation and vegetation in the channel are present here as well. The channel and bed materials for each of the sites were predominately sand with some silt.

Figure 12. Upstream view of the East Fork at the Hwy 24 crossing near Peoria, MS (July 2003) (arrow notes flow direction).

Figure 13. Downstream view of the East Fork at the Hwy 24 crossing near Peoria, MS (July 2003) (arrow notes flow direction).

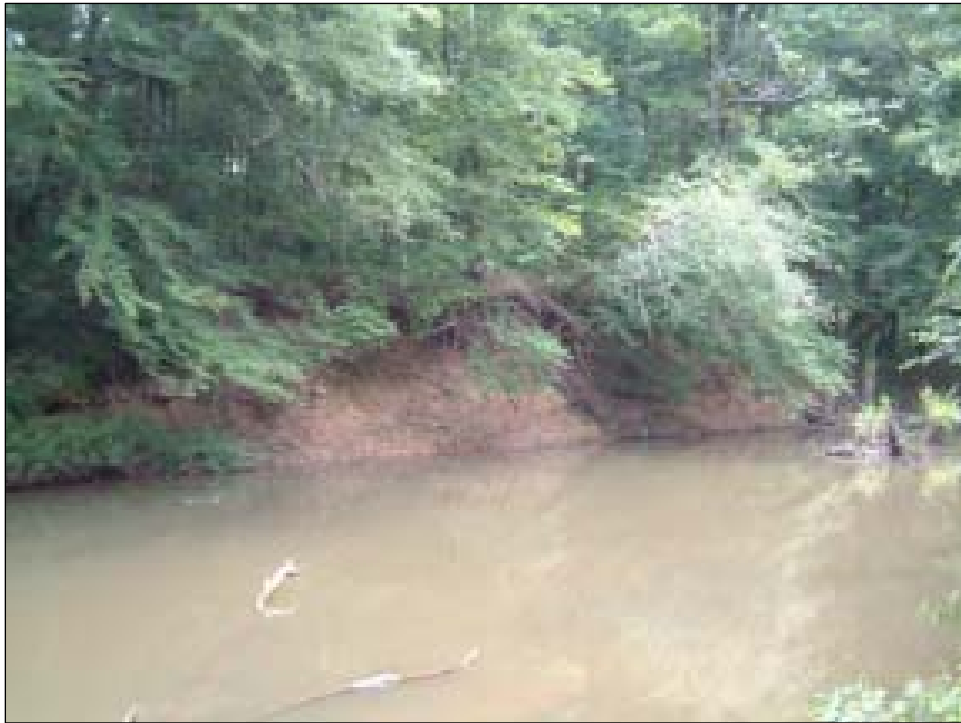
Figure 14. Steep, eroded left bank of the East Fork at the Hwy 24 crossing near Peoria, MS (July 2003).

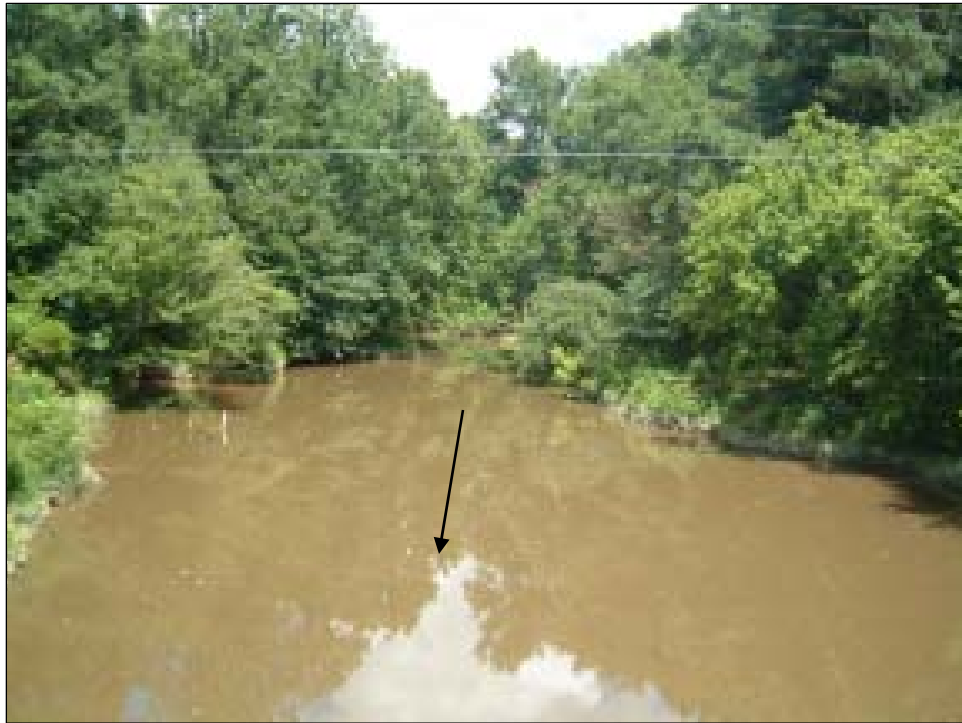
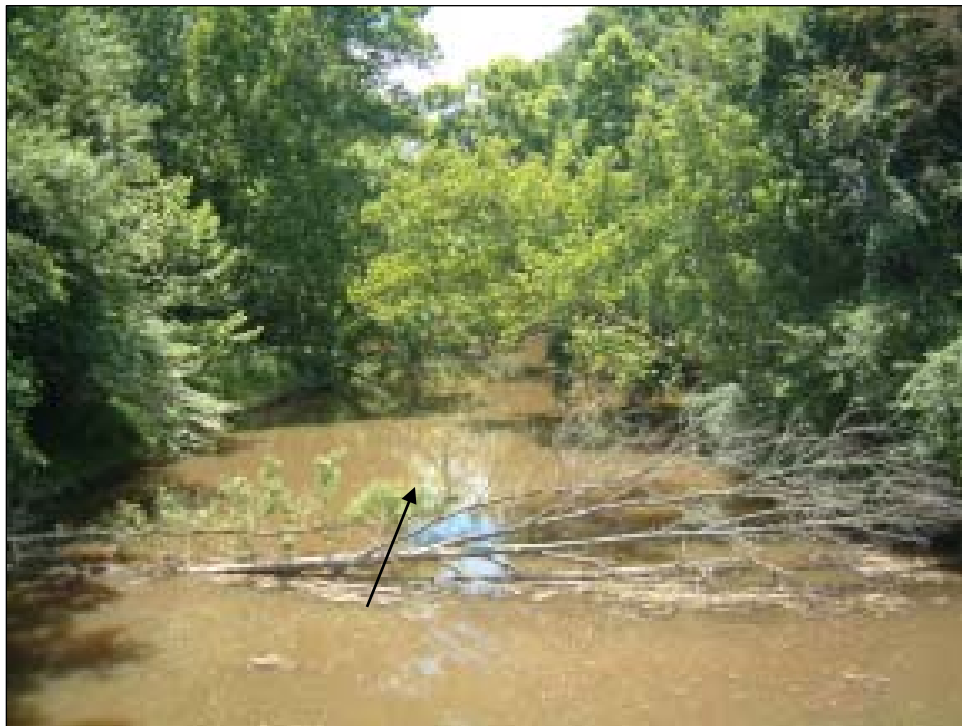
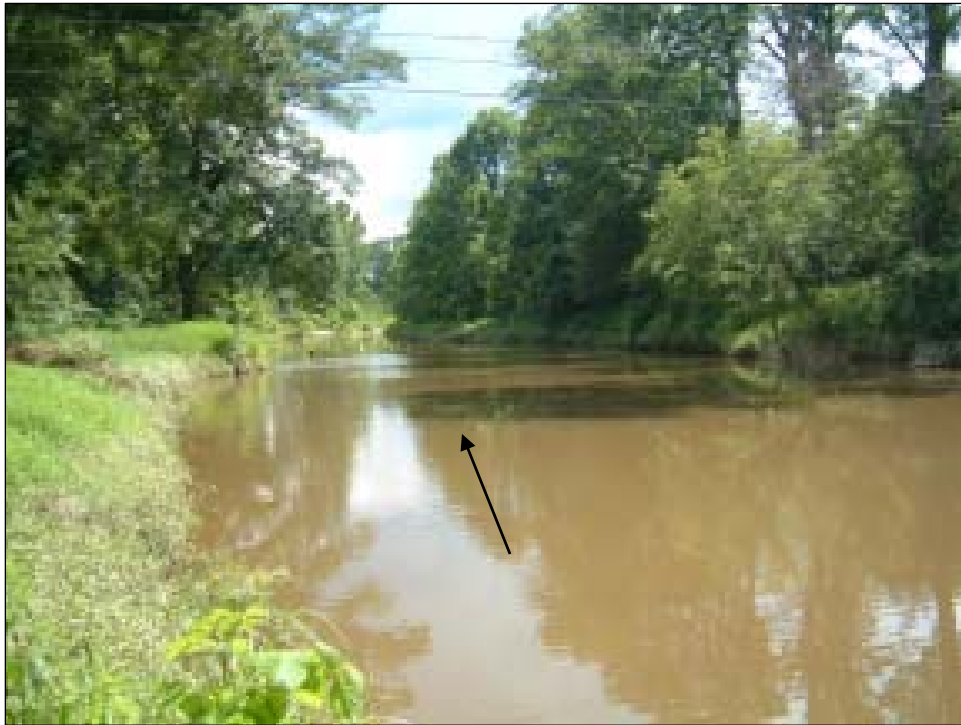
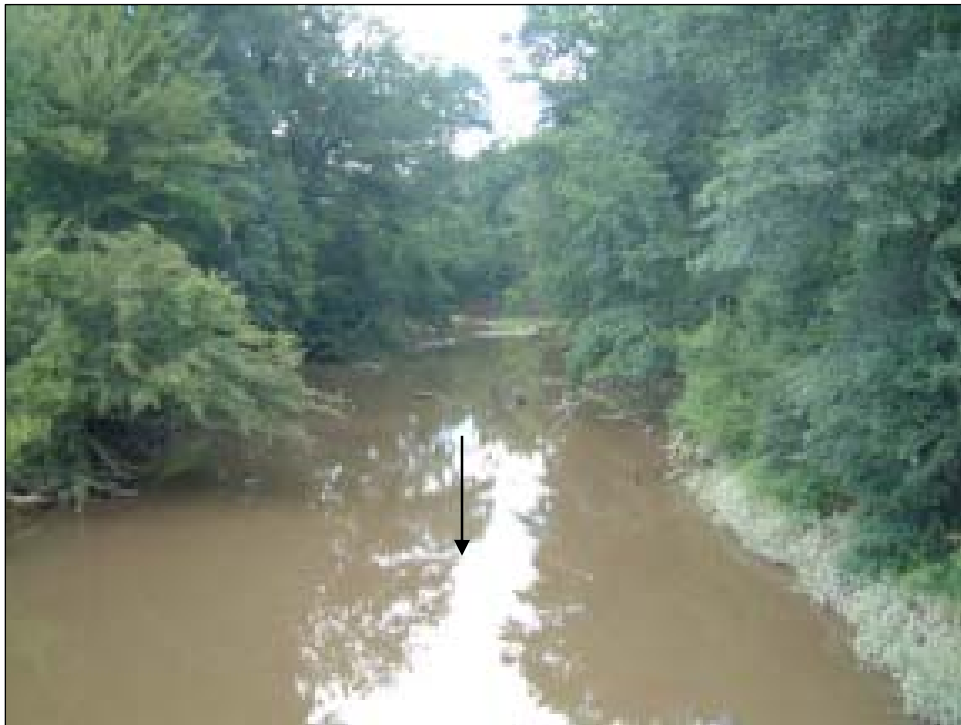
Field observations in the middle and upper reaches of the West Fork Amite, Mississippi Highway 567 (Figures 17 and 18) and Mississippi Highway 24 (Figures 19 and 20) crossings, revealed relatively stable bank and channel conditions. Bank-line vegetation was well established and erosion was minor along these reaches. There was, however, leaning vegetation and a minor amount of vegetative debris in the channel.

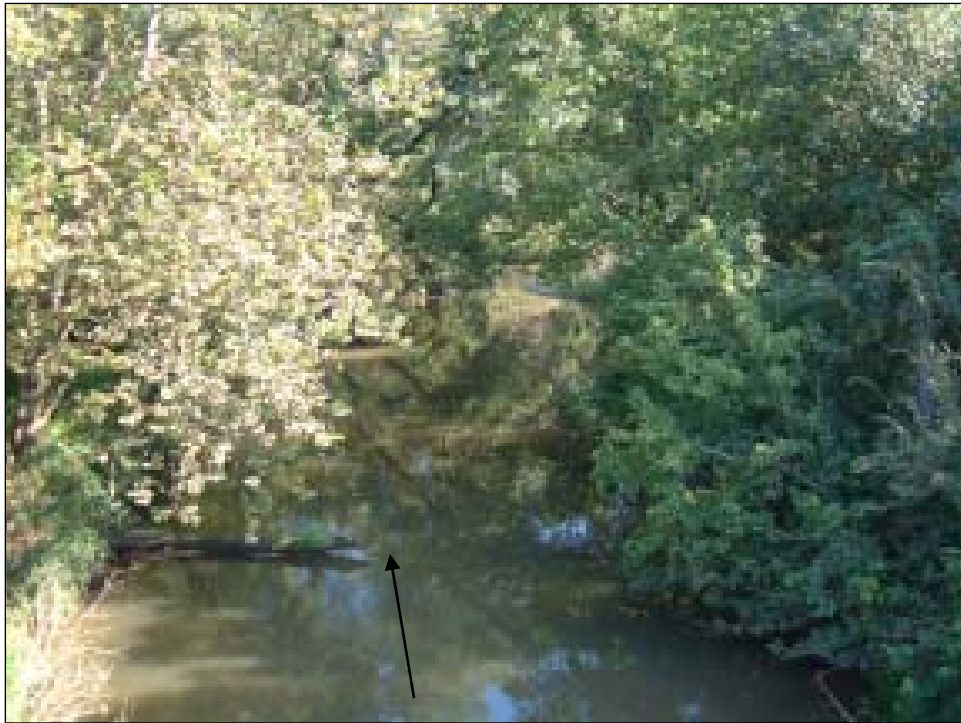
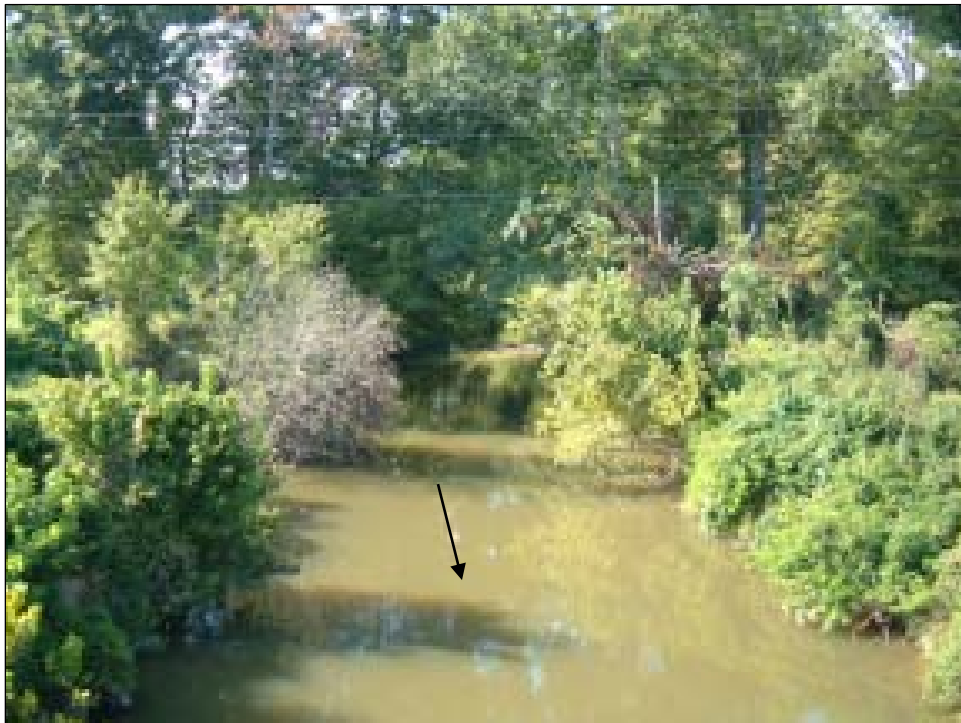
At the uppermost portion of the lower reach of the West Fork (Mississippi Highway 48 crossing), slightly more unstable conditions were observed (Figures 21 through 24). At this crossing near Liberty, MS, the banks are well vegetated but they have become much steeper, especially on both sides of the channel, than the banks of the upper reaches. It is obvious that bed incision occurred along the West Fork although none of the bridges

Figure 21. Downstream view of the West Fork at the Hwy 48 crossing near Liberty, MS (July 2003) (arrow notes flow direction).

Figure 22. Upstream view of the West Fork at the Hwy 48 crossing near Liberty, MS (July 2003) (arrow notes flow direction).

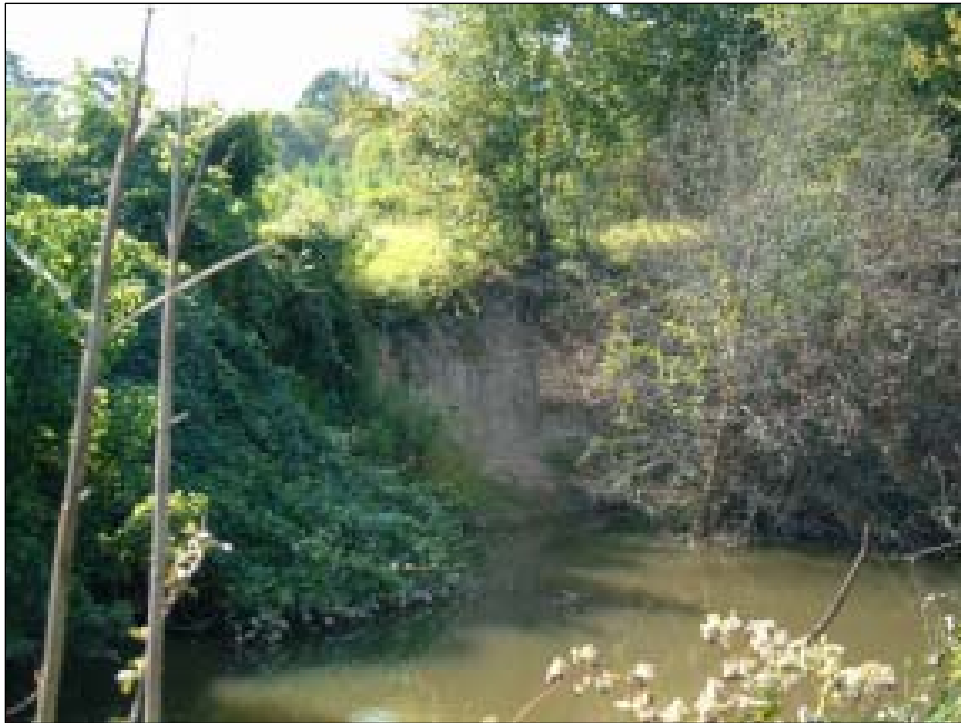
Figure 23. Steep, eroded right bank of the West Fork at the Hwy 48 crossing near Liberty, MS (July 2003).

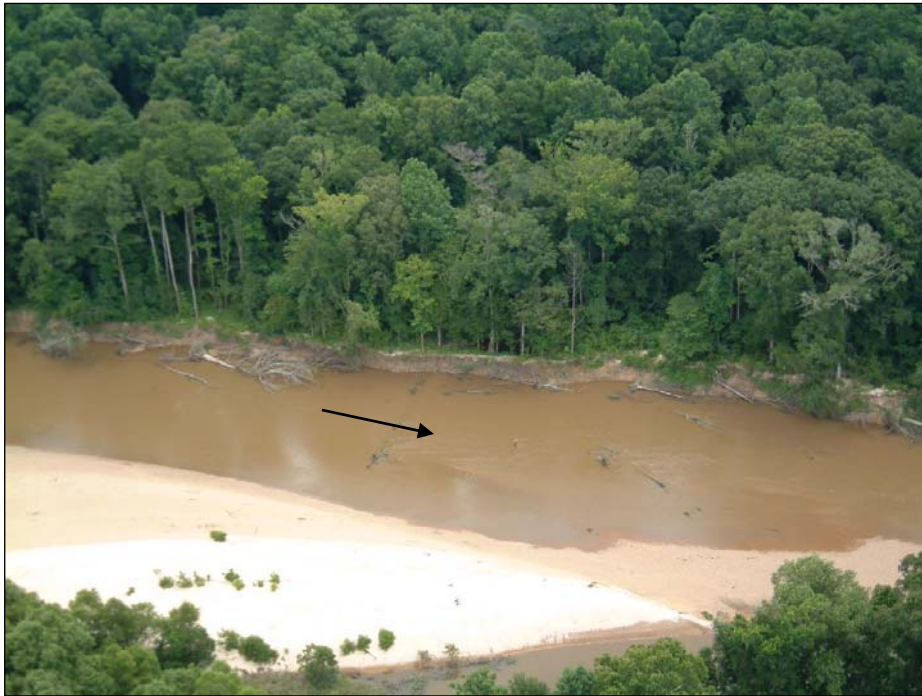
Figure 27. Steep eroding left bank of the Amite River in southeast Louisiana just north of the Louisiana Hwy 432 crossing near Felixville, LA (arrow notes flow direction—July 2004).

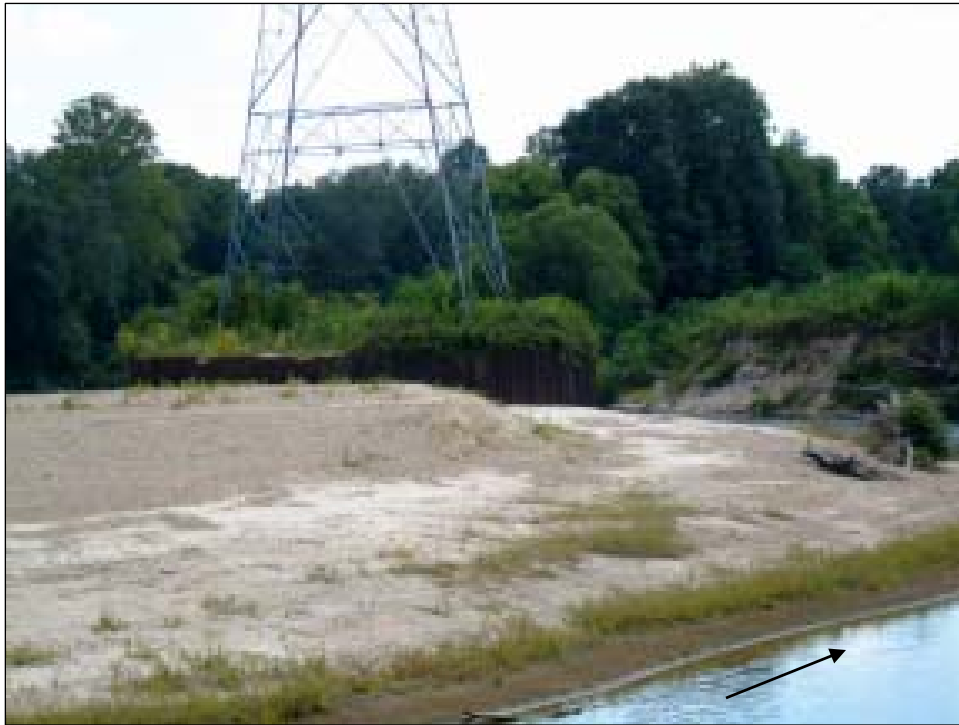
Approximately 100 m downstream of the Highway 43 bridge, a power transmission pylon in the channel has been placed on pilings to help protect it from undermining effects of erosion (Meadows and Patrick 1999) (Figure 31). Erosion has worked its way around the structure and appears to be downcutting the pilings. The right (west) bank of the channel, directly across from the power company structure, has undergone severe erosion that has left it steep and bare (Figure 32). Erosion still seems to be relatively active on this bank and the channel appears to be, at least locally, migrating from east to west.

Figure 31. Power transmission pylon at the Louisiana Hwy 432 crossing of the Amite River near Felixville, LA (view downstream—September 2003) (arrow notes flow direction). Note the terrace effect on the point bar.

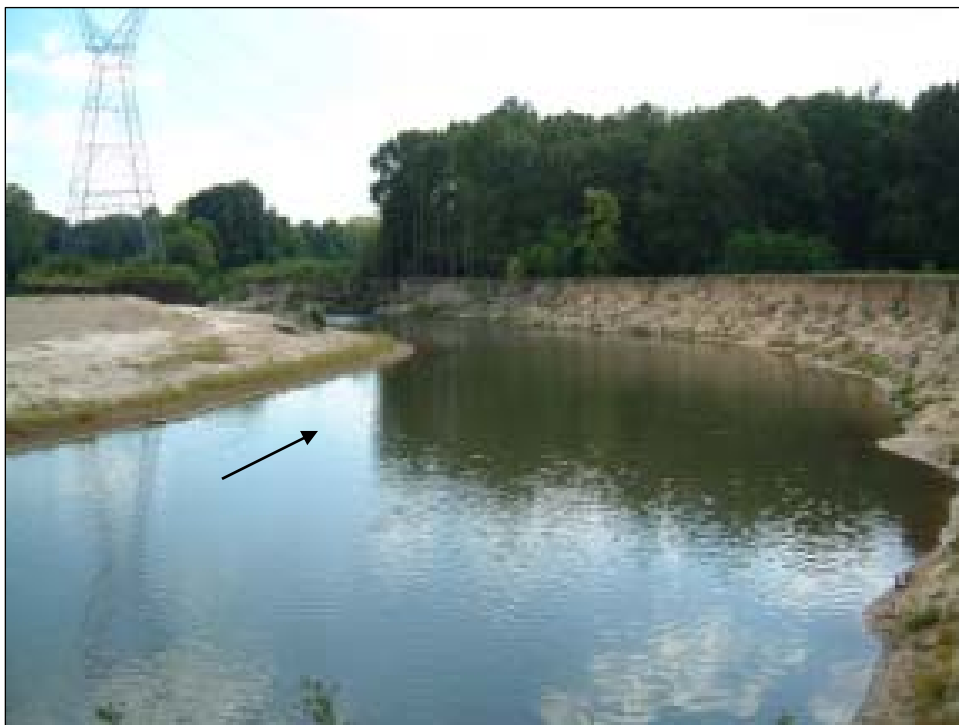
Figure 32. Steep, eroding right bank of the Amite River downstream from the Louisiana Hwy 432 crossing near Felixville, LA (view downstream—September 2003) (arrow notes flow direction).

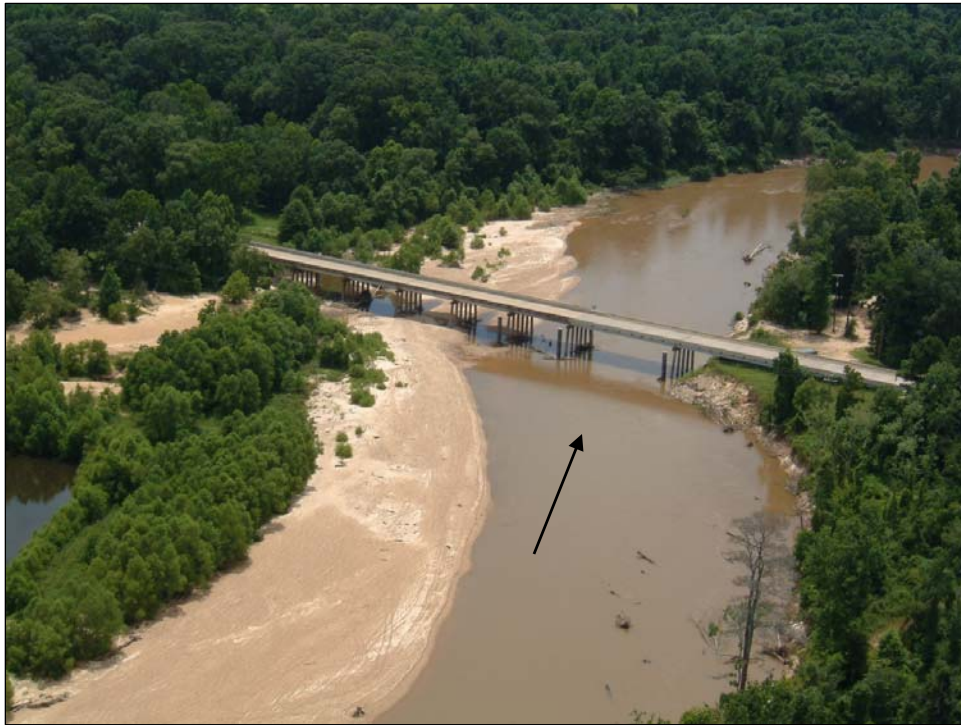
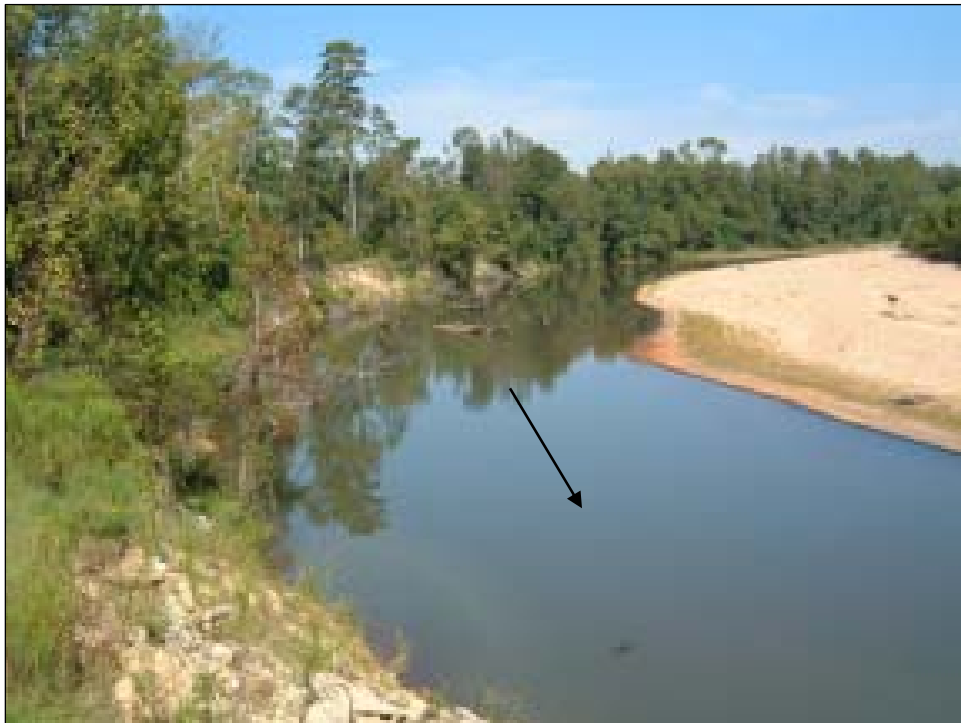
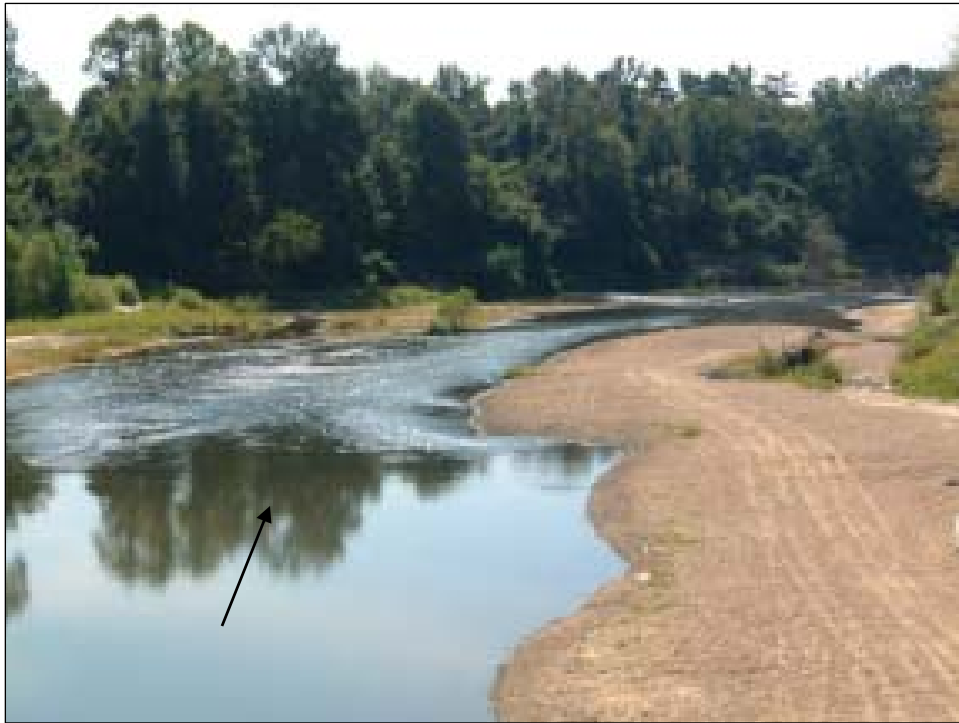
The Louisiana Highway 10 crossing near Darlington, LA, is approximately 9.6 km upstream of the main mined reach. Figure 33 is an aerial view of the bridge. Figure 34 is a ground view upstream and Figures 35 and 36 are downstream ground views. Steep, eroding banks; leaning vegetation; loss of bank-line vegetation; a wide, shallow channel; and divided flow conditions were prominent at this site.

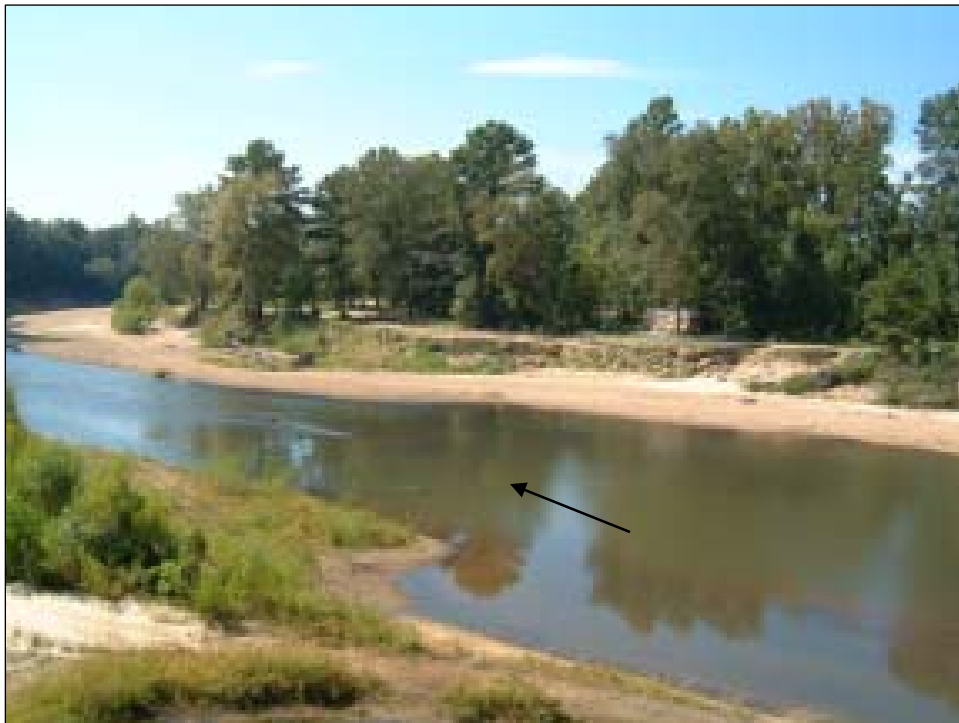
Figure 36. Downstream view of the Amite River at the Louisiana Hwy 10 crossing near Darlington, LA (notice steep, eroding bank behind bar—September 2003) (arrow notes flow direction).

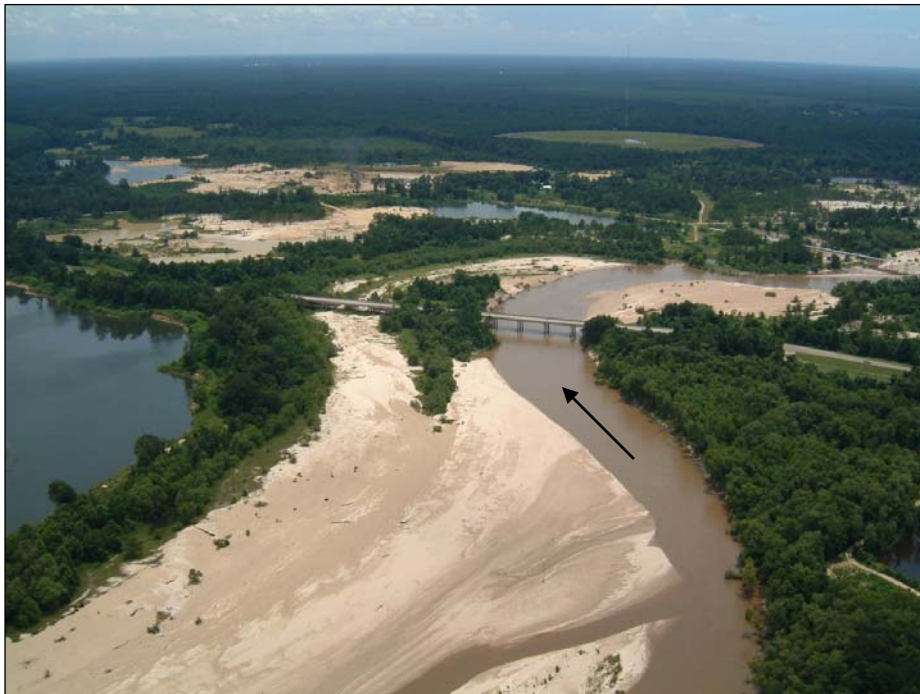
The reach of the Amite River most seriously affected by accelerated erosion is centered at Grangeville, LA. Figures 37 and 38 illustrate the extent of mining upstream of Grangeville and Figures 39 and 40 are 2004 and 1995, respectively, downstream aerial views of the Louisiana Highway 37 crossing southwest of Grangeville. Since 1995, there has been significant mining on the left bank upstream of the bridge. Both views show two bridge sections, a dry span on the left bank and a water crossing on the right bank. Prior to active mining the currently dry, left bank section was the only crossing of the river (see Analysis of Aerial Photography). The main channel contains virtually all of the streamflow during most of the year with the secondary channels holding standing water during normal rainfall conditions as well as excess flow during times of significant flooding (Mossa 1995). The presence of this abandoned channel is evidence that along this reach, the river has become less sinuous and the channel has migrated to the west. This change in course required the Louisiana Highway 37 bridge to be extended.

Figure 39. Downstream view of the Amite River at the Louisiana Hwy 37 crossing near Grangeville, LA (note large, dry abandoned channel at left bank—July 2004) (arrow notes flow direction).

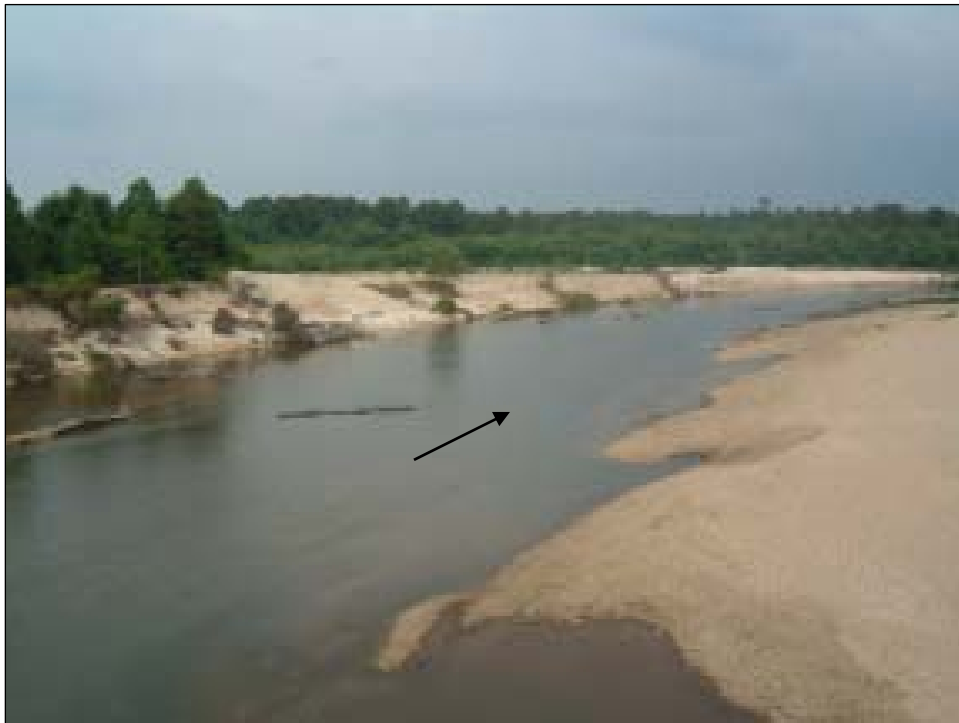
Figure 42. Downstream (left bank) view of the Amite River at the Louisiana Hwy 37 crossing near Grangeville, LA (September 2003) (arrow notes flow direction).

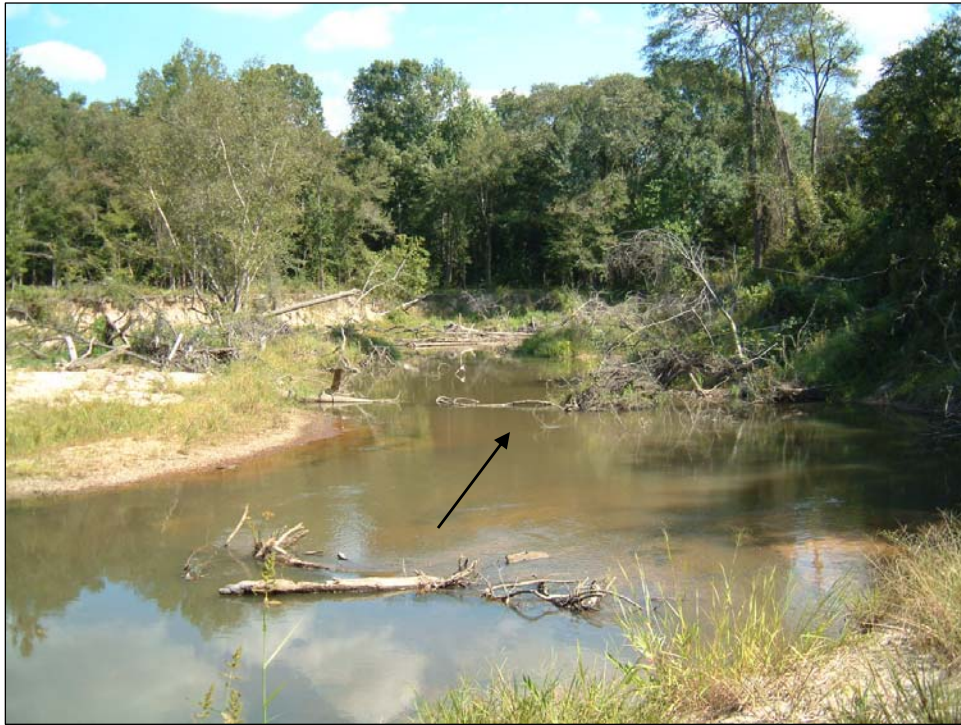
Beaver Creek enters the Amite River from the west in the vicinity of Felixville. At the Perkins Road crossing (Figures 44 through 47), there were signs of channel degradation manifested by steep, eroding banks, leaning vegetation, and dead vegetation in the channel (Figures 44 and 45). A large debris jam formed beneath the Perkins Road bridge (Figure 46) and extends the width of the channel. Erosion protection at the left abutment is apparent in Figure 47.

Figure 45. Downstream view of Beaver Creek at the Perkins Road crossing near the Mississippi/Louisiana state line (September 2003) (arrow notes flow direction).

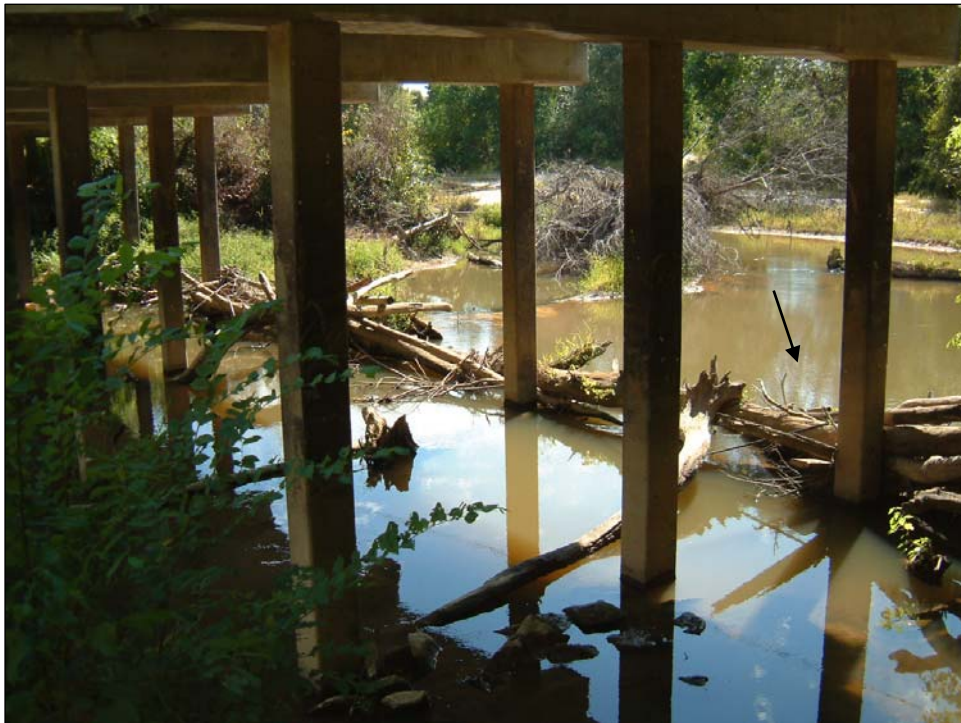
Figure 46. Debris jam on Beaver Creek at the Perkins Road crossing near the Mississippi/Louisiana state line (view upstream—September 2003) (arrow notes flow direction).

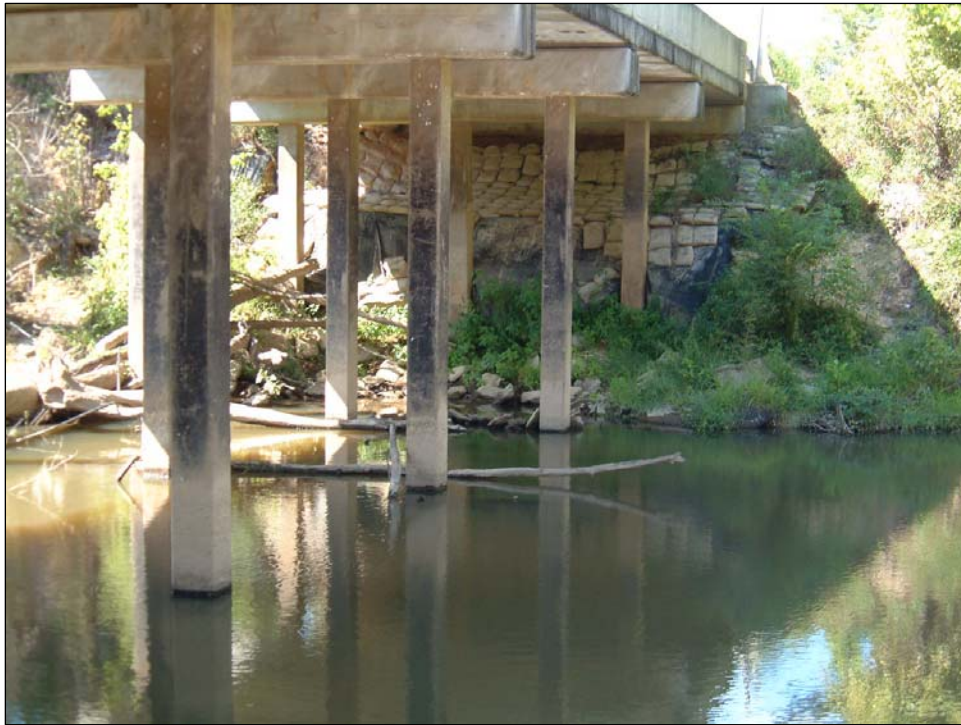
Figure 47. Left bank bridge abutment of Beaver Creek at the Perkins Road crossing near the Mississippi/Louisiana state line (note erosion control feature—September 2003).

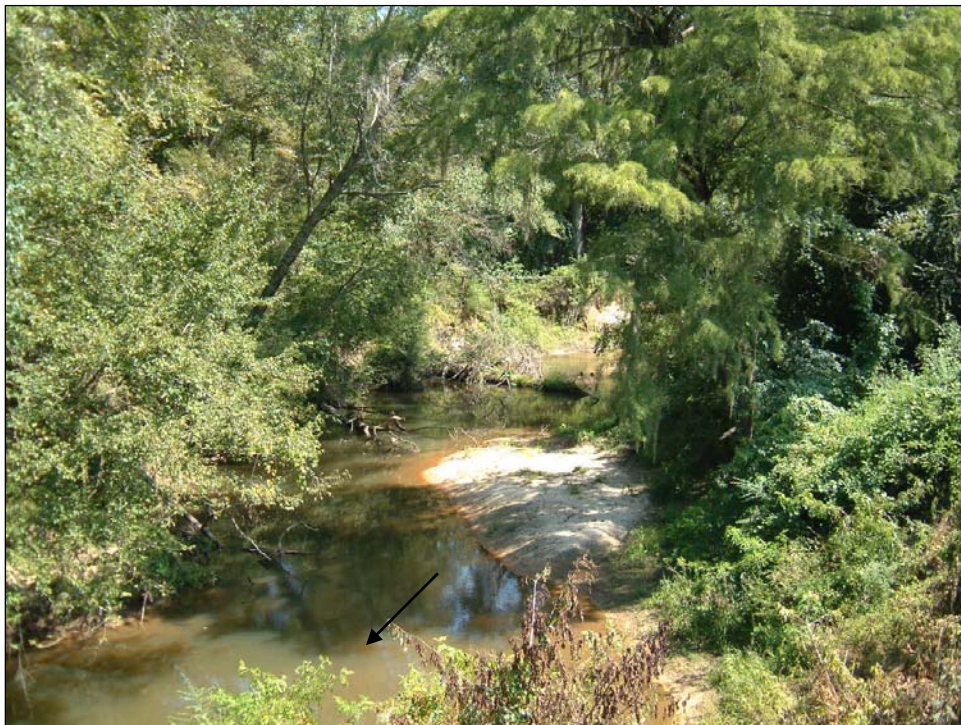
Darling Creek enters the Amite River from the east near Darlington, LA. The Louisiana Highway 10 crossing showed signs of channel instability evident from leaning vegetation, bridge pier damage, debris in the channel, and steep, eroded banks (Figures 48 through 51). Remains of a wooden bridge and undermined banks were also observed. Undermining can cause the bank to become unstable by removing the toe of the bank. At the Louisiana Highway 38 crossing (Figures 52 through 57), bridge piers were scoured and threatened by bed erosion. Undercutting of the right bank was observed and a debris jam was present underneath the bridge.

Figure 48. Upstream view of Darling Creek at the Louisiana Hwy 10 crossing near Darlington, LA (September 2003) (arrow notes flow direction).

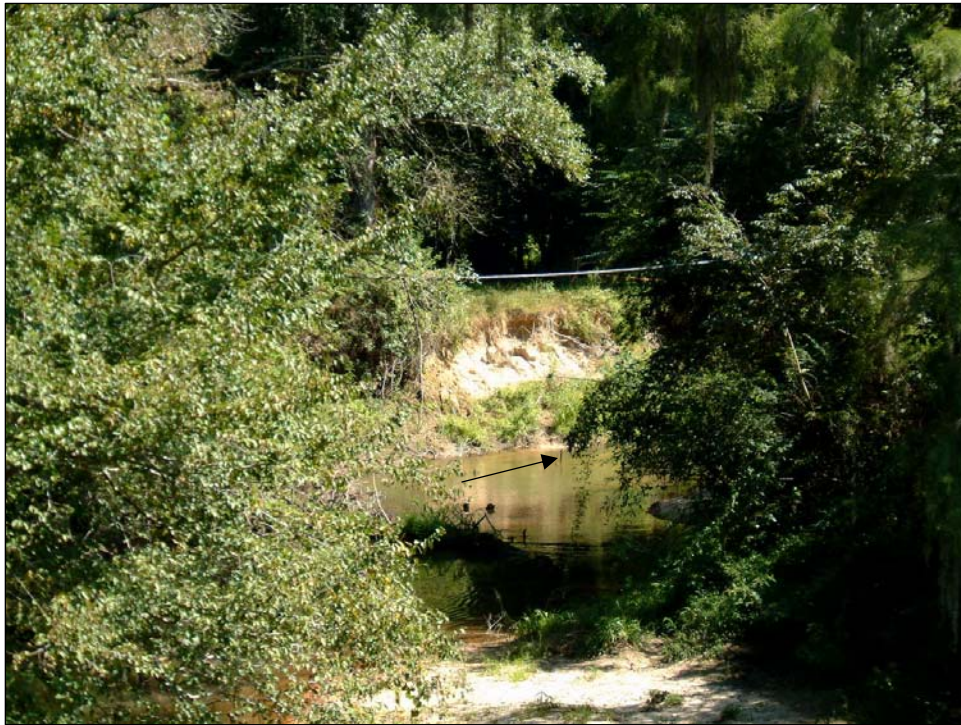
Figure 49. Downstream view of Darling Creek at the Louisiana Hwy 10 crossing near Darlington, LA (September 2003) (arrow notes flow direction).

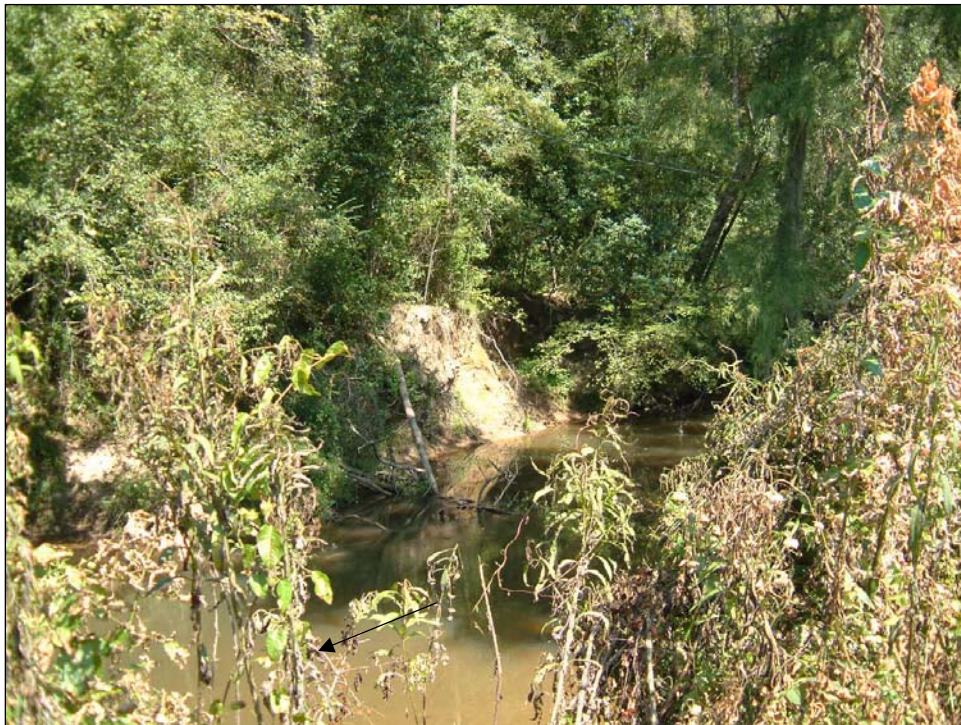
Figure 50. Steep, eroded right bank of Darling Creek at the Louisiana Hwy 10 crossing near Darlington, LA (view upstream—September 2003) (arrow notes flow direction).
