## **Fluvial Instability and Channel Degradation of Amite River and its Tributaries, Southwest Mississippi and Southeast Louisiana**

D. Ryan Hood, David M. Patrick, and Maureen K. Corcoran

September 2007

Final report

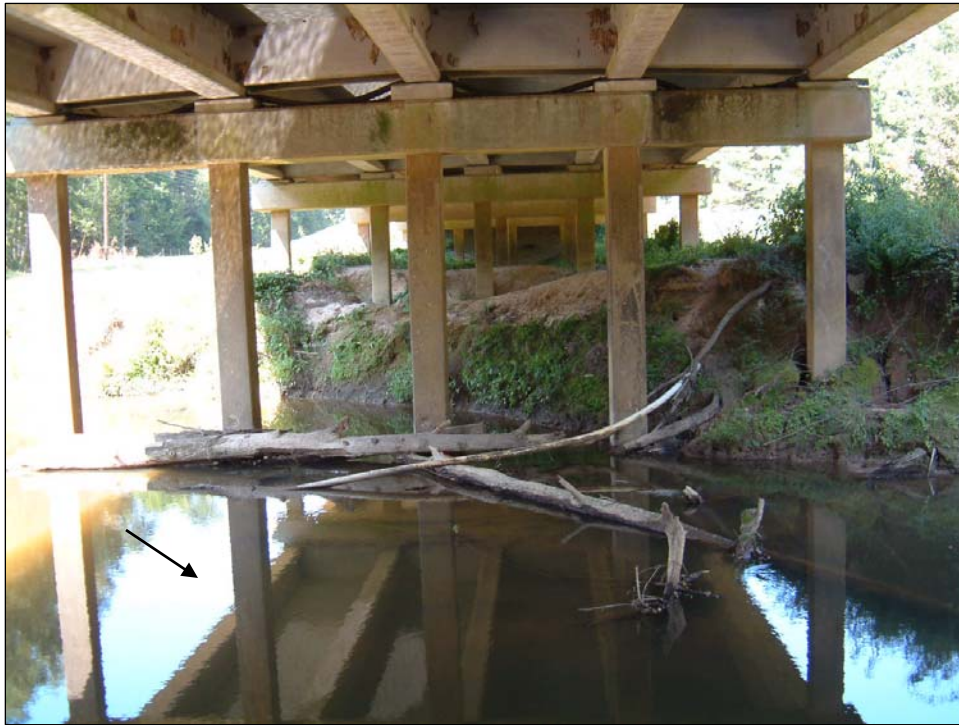
Darling Creek enters the Amite River from the east near Darlington, LA. The Louisiana Highway 10 crossing showed signs of channel instability evident from leaning vegetation, bridge pier damage, debris in the channel, and steep, eroded banks (Figures 48 through 51). Remains of a wooden bridge and undermined banks were also observed. Undermining can cause the bank to become unstable by removing the toe of the bank. At the Louisiana Highway 38 crossing (Figures 52 through 57), bridge piers were scoured and threatened by bed erosion. Undercutting of the right bank was observed and a debris jam was present underneath the bridge.

Figure 51. Steep, eroded left bank of Darling Creek at the Louisiana Hwy 10 crossing near Darlington, LA (arrow notes flow direction—September 2003).

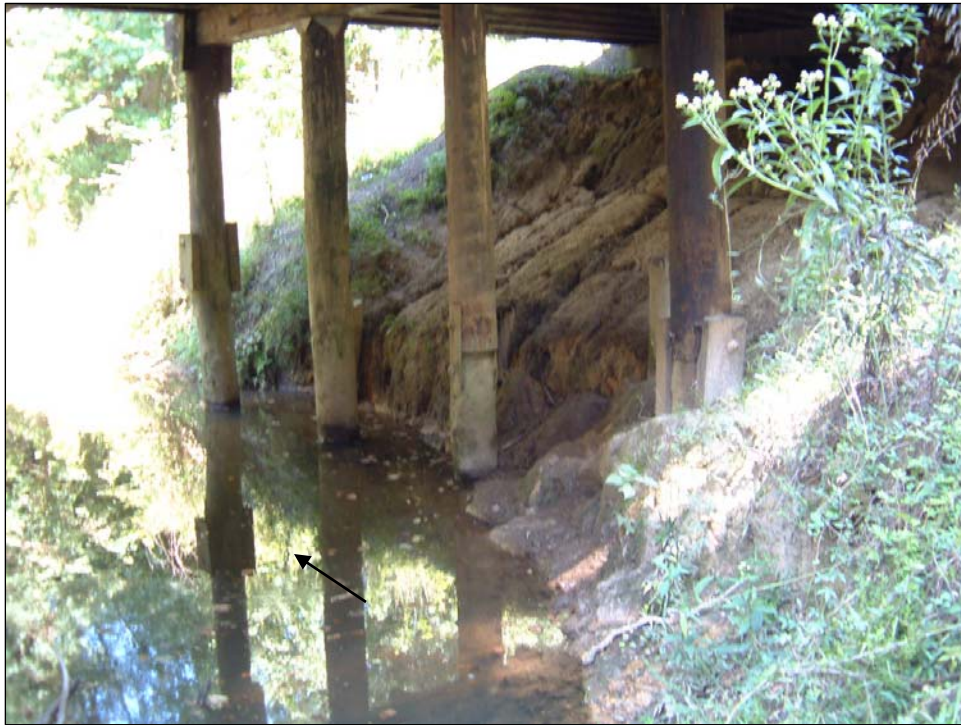
Figure 55. Bridge pier scour at the Louisiana Hwy 38 crossing of Darling Creek near Darlington, LA (arrow notes flow direction—September 2003).

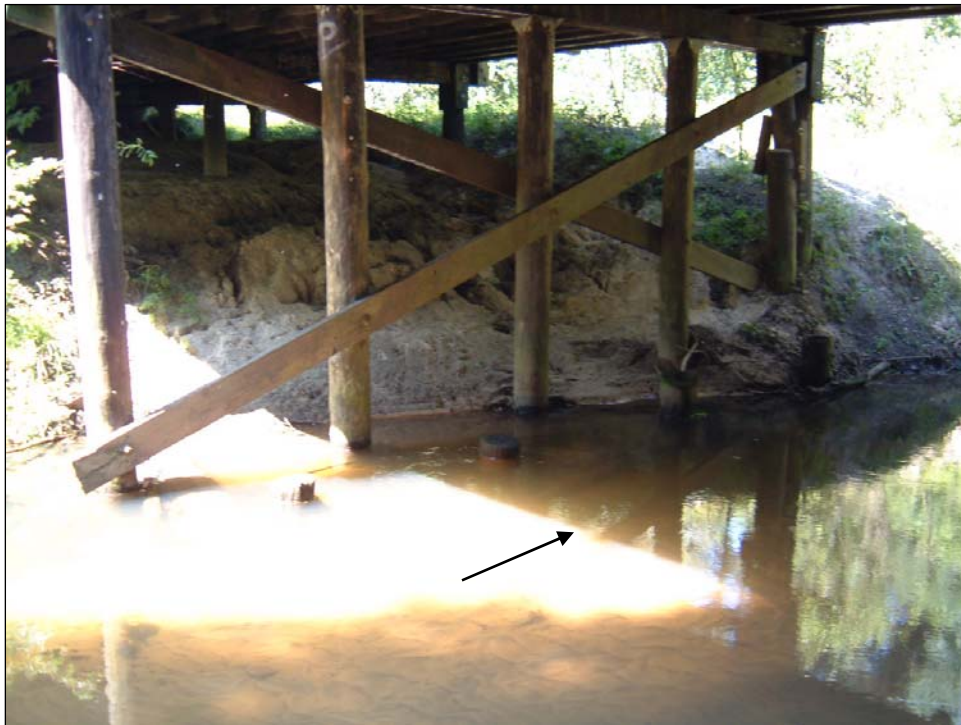
Figure 56. Right bank of Darling Creek at the Louisiana Hwy 38 crossing near Darlington, LA (arrow notes flow direction—September 2003)

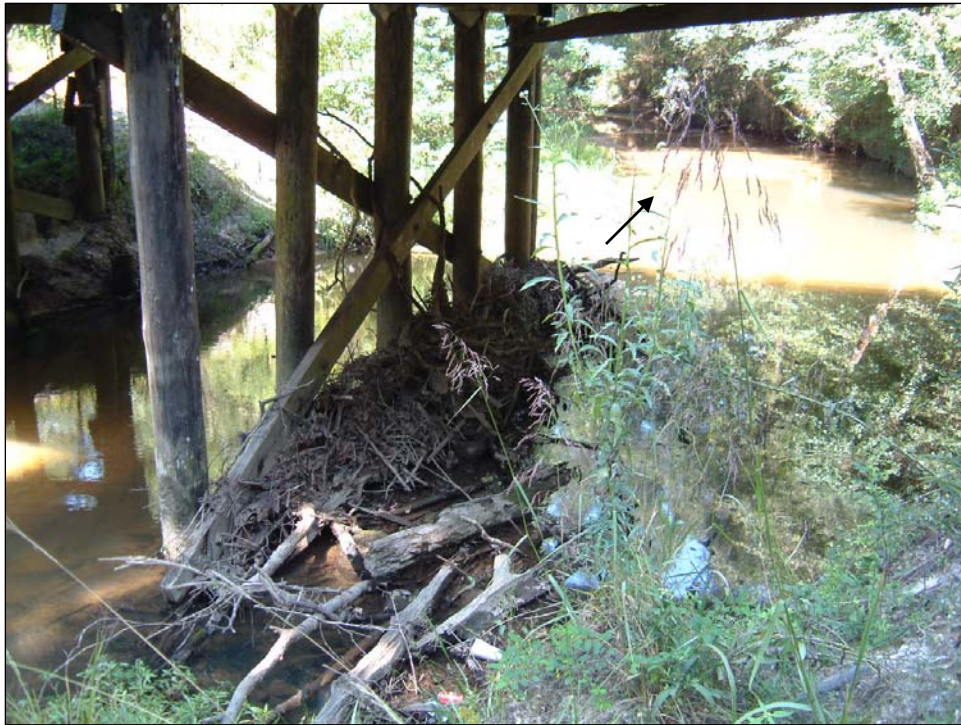
Figure 57. Debris jam at the Louisiana Hwy 38 crossing of Darling Creek near Darlington, LA (arrow notes flow direction—September 2003).

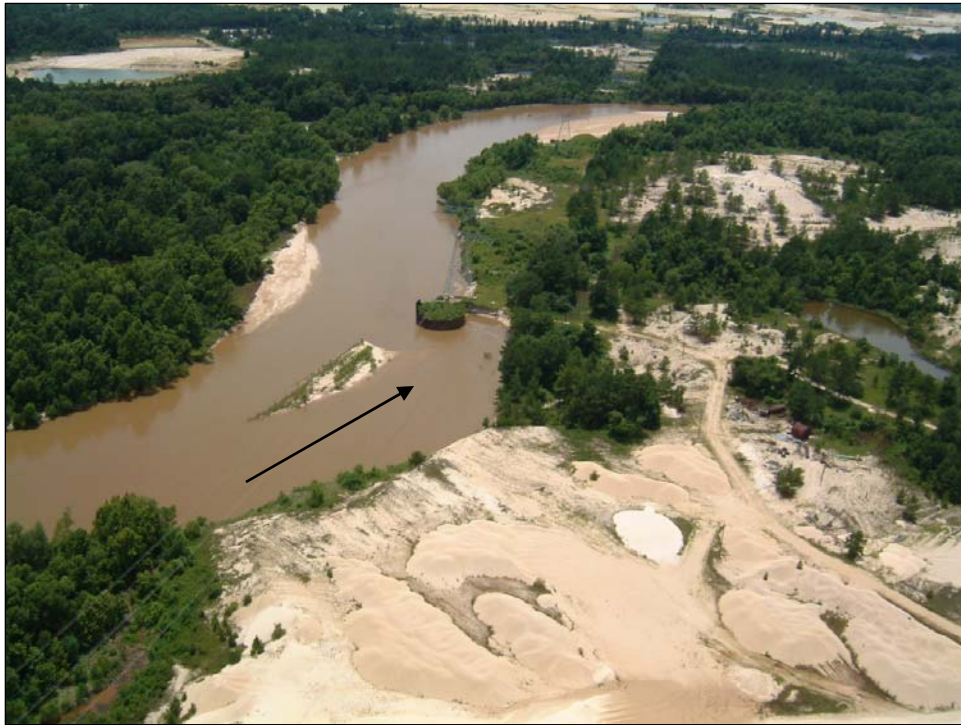
This reach near Magnolia, LA, is actively mined as shown in the 2004 aerial over-flight views (Figures 58 through 61). Figure 58 shows a right-bank mine, which is buffered from the river whereas the right-bank mine shown in Figure 59 does not appear to be buffered, and the buffer of the right-bank mine shown in Figure 60 has been breached. A power transmission pylon surrounded by water is shown in Figure 61. This structure was most likely not constructed in the channel but on the floodplain and the subsequent erosional widening of the channel resulted in the pylon's current location.

Figure 59. Downstream view of the Amite River near Magnolia, LA (note power company pylon in the channel—July 2004) (arrow notes flow direction).

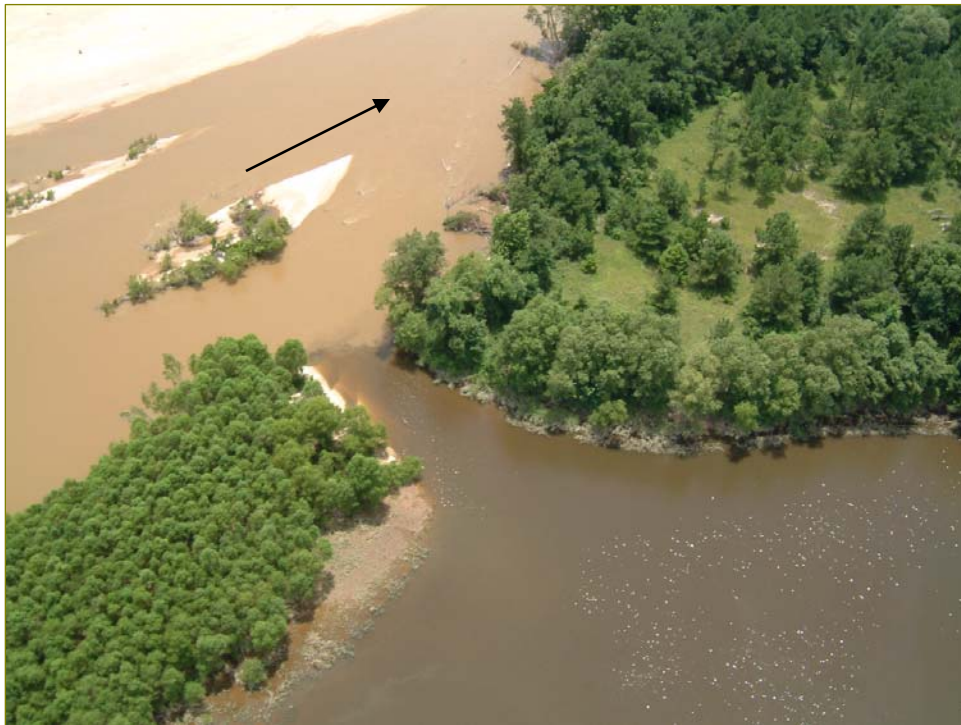
Figure 60. Downstream view of breached right bank of the Amite River near Magnolia, LA (July 2004) (arrow notes flow direction).

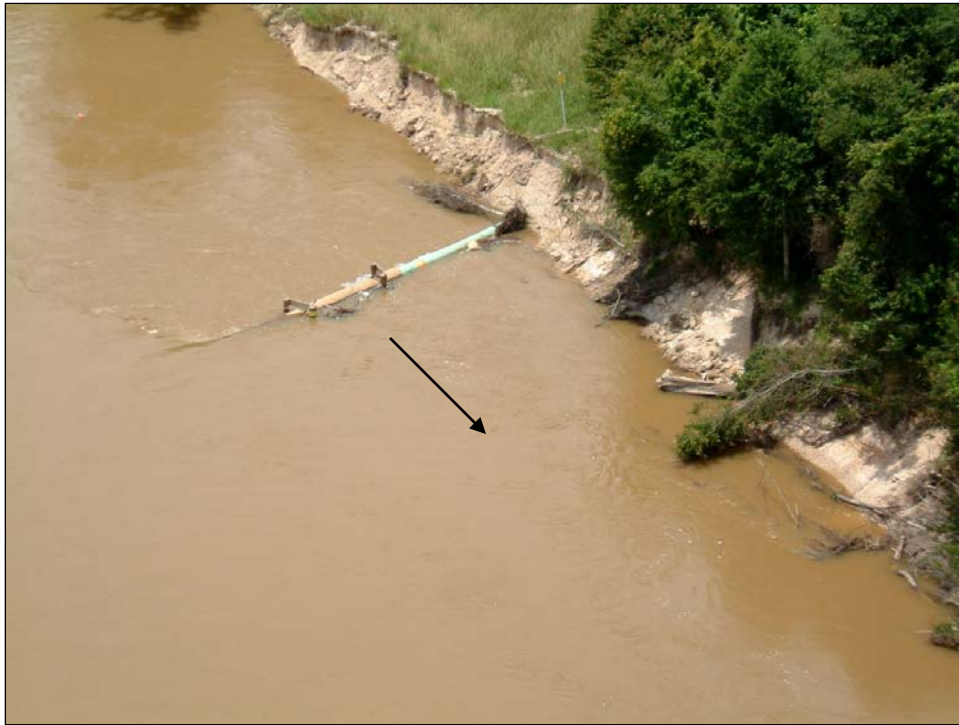
Figure 61. Exposed pipeline and steep, eroding right bank of the Amite River near Magnolia, LA (arrow notes flow direction—July 2004).

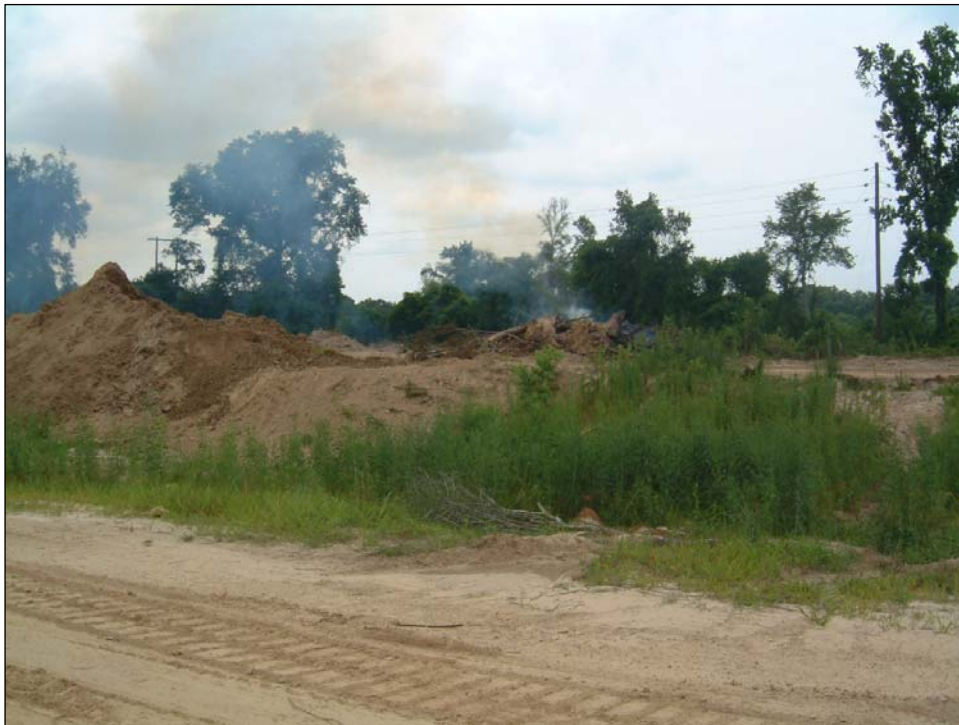
Figure 64. Clearcutting (deforestation) of the riparian buffer between the Amite River and adjacent gravel mine near Magnolia, LA (note the channel runs beneath the power line in background—June 2003).

separated from the channel by a riparian buffer, the mine was separated by a terraced sand and gravel bar. The riparian buffer was being cleared for access to the channel so the bar could be mined. A large lake with several sand piles lining its shoreline formed as a result of the mine pit filling with water.

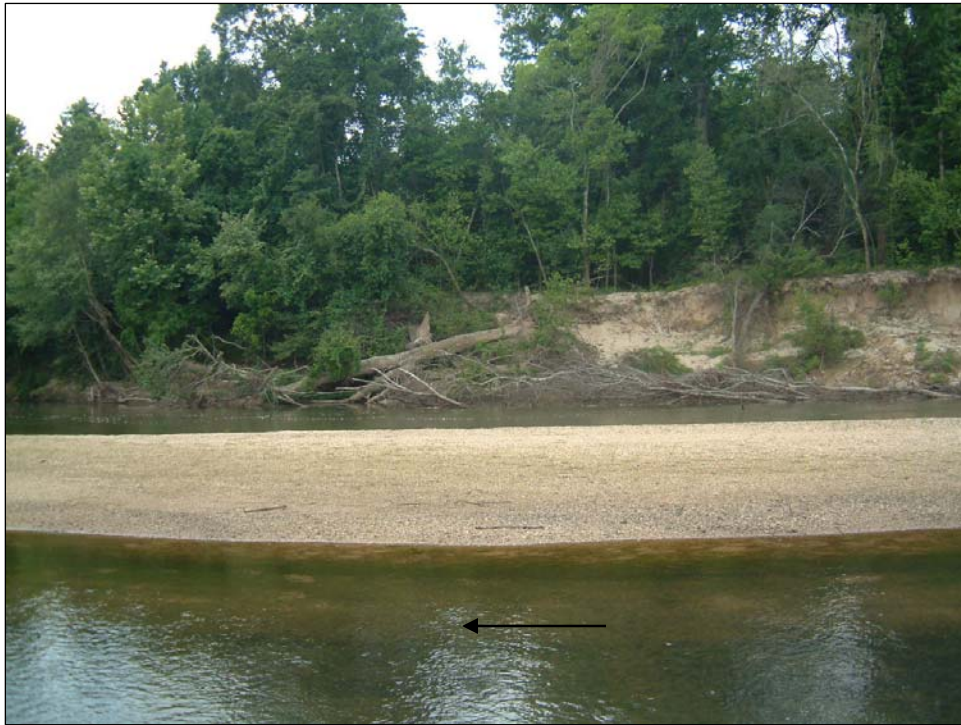
The Amite River channel along this short mined stretch exhibited sand and gravel bars, divided flow, steep eroded banks and loss of bank-line vegetation (Figures 66 through 71). Streambank material consisted of predominately fine-grained sediments, suggesting that the Amite River incised its channel into the Prairie Formation (Figure 69). This fine-grained bank section also exhibited a reddish-brown, approximately 10-cm-thick zone near the waterline (Figure 69). This zone may represent a paleosol within the Prairie Complex. The channel bed material was predominantly sand and gravel.

Figure 66. Large midchannel sand and gravel bar of the Amite River adjacent to gravel mine near Magnolia, LA (arrow notes flow direction—June 2003).

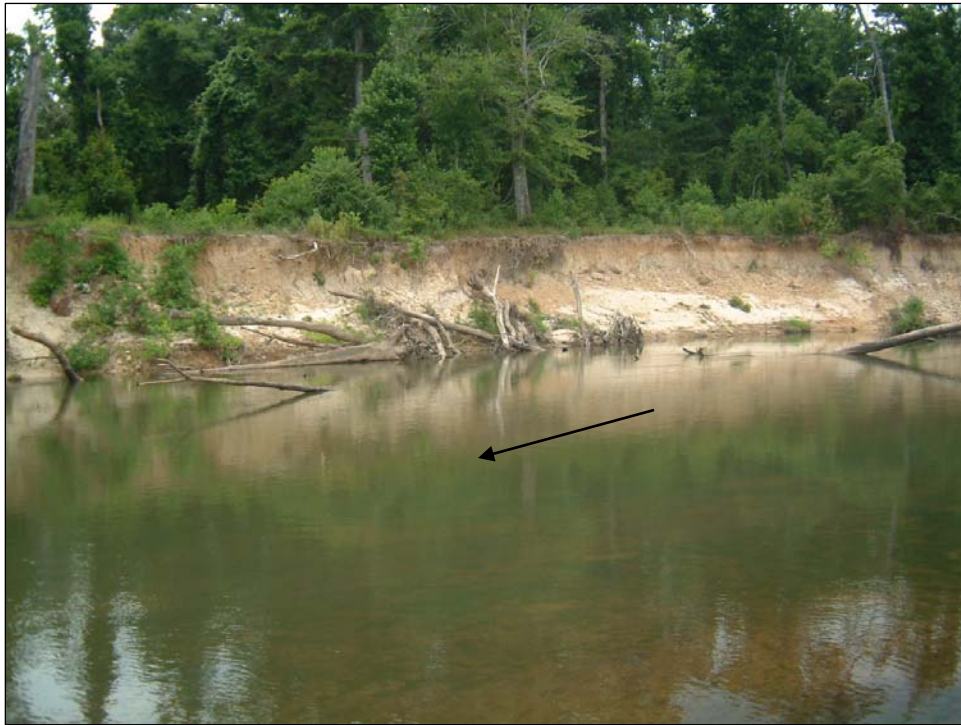
Figure 70. Steep, eroding right bank of the Amite River adjacent to gravel mine near Magnolia, LA (arrow notes flow direction—June 2003).

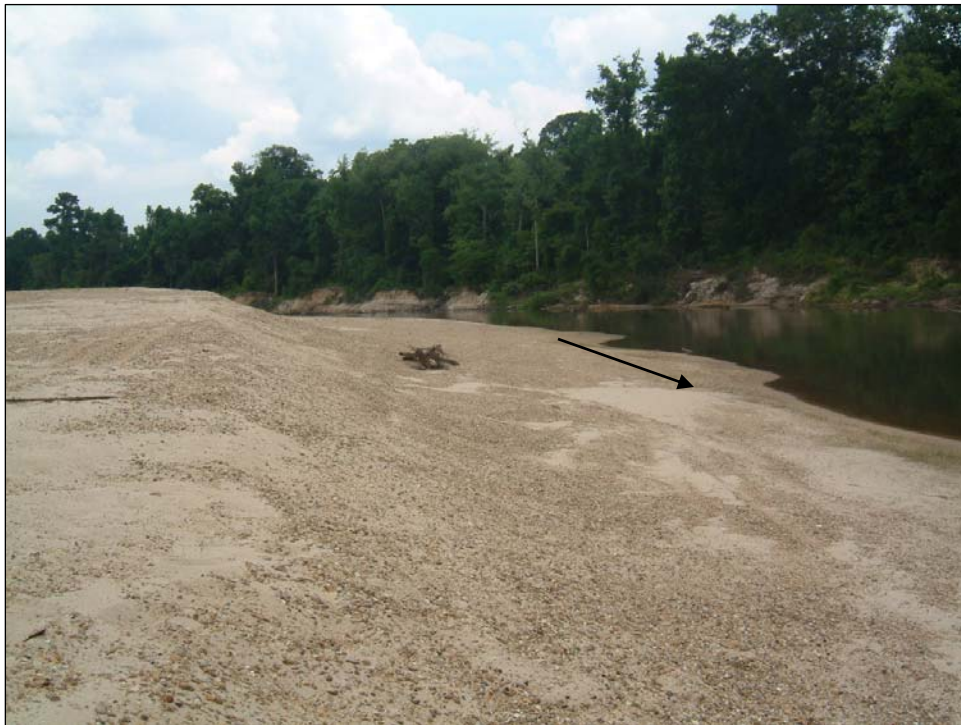
Figure 71. Terraced point bar of the Amite River adjacent to active gravel mine near Magnolia, LA (arrow notes flow direction—June 2003).

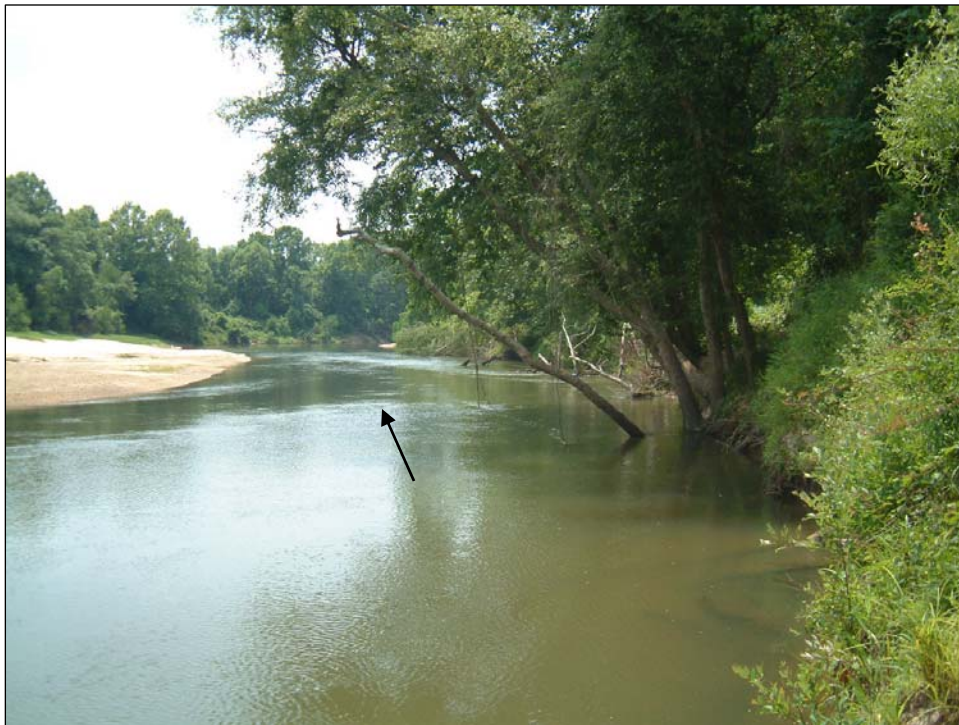
Louisiana Highway 64 crosses the Amite River approximately 4.8 km south of Magnolia, LA, and is within the lowermost part of the main mined reach with gravel mining both upstream and downstream of the site. Locally, the channel was wide and shallow (Figure 72) and exhibited bank erosion, leaning, fallen and uprooted vegetation (Figures 73 through 76), sand and gravel bars, and divided flow (Figures 77 and 78).

Figure 73. Downstream view of the Amite River at the Louisiana Hwy 64 crossing near Magnolia, LA (June 2003) (arrow notes flow direction).

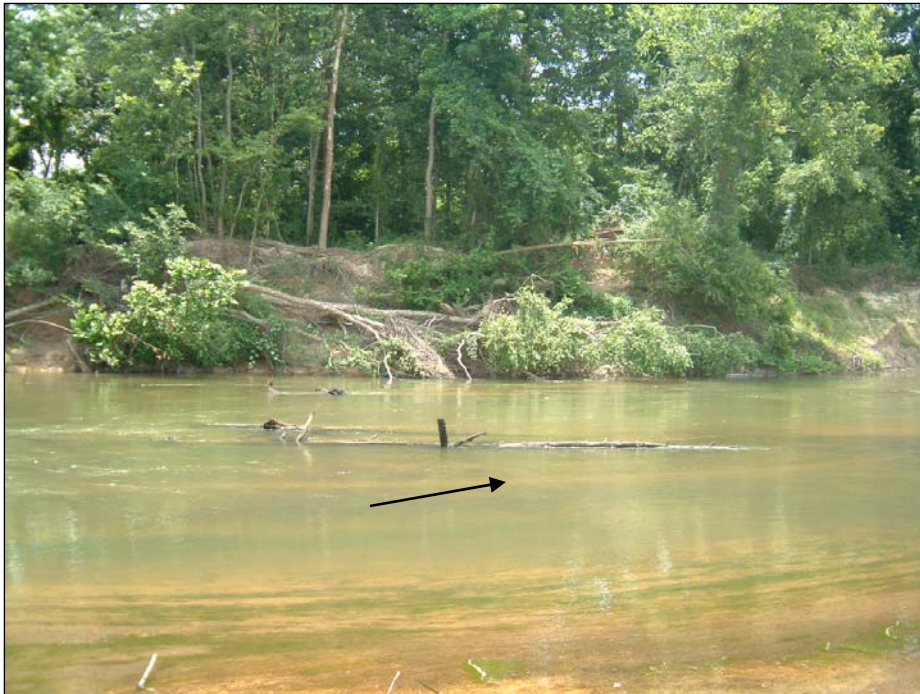
Figure 74. Steep, eroding left bank of the Amite River approximately 100 m downstream of the Louisiana Hwy 64 crossing near Magnolia, LA (note flow is from left to right—June 2003).

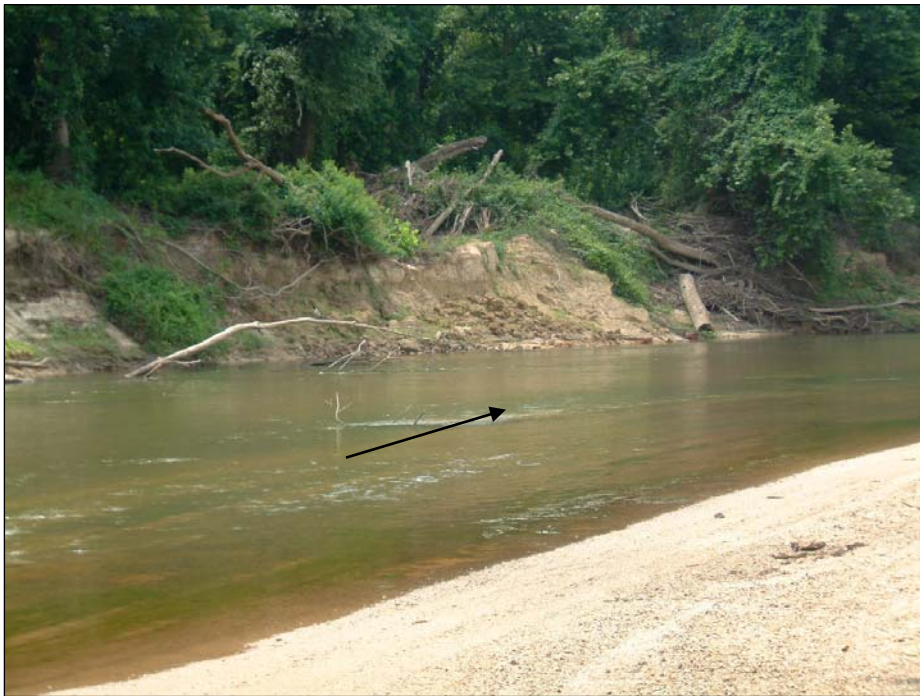
Figure 75. Fallen vegetation and bank erosion on left bank of the Amite River at the Louisiana Hwy 64 crossing near Magnolia, LA (arrow notes flow direction—June 2003).

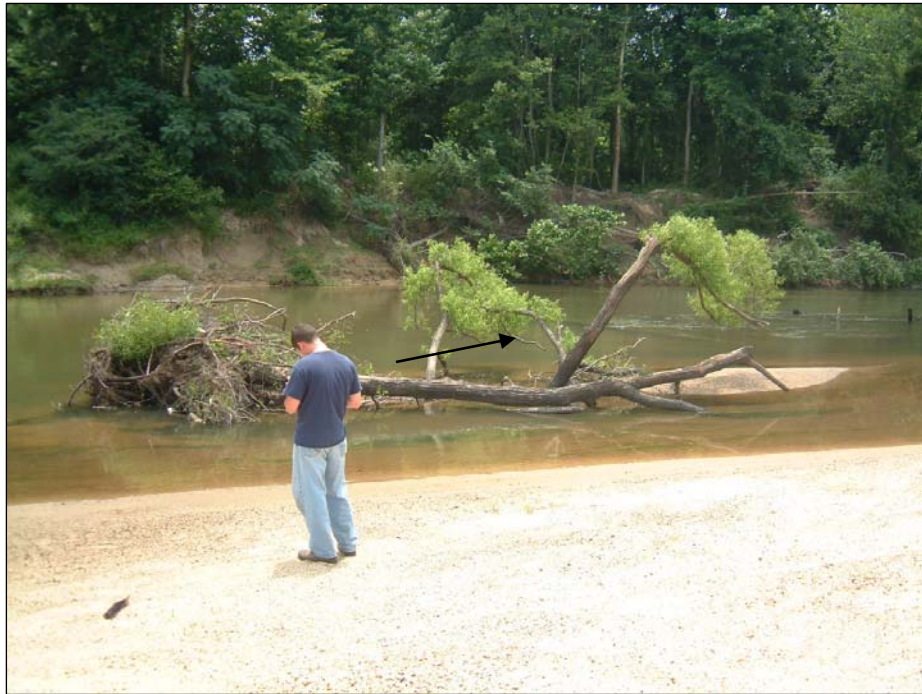
Figure 76. Uprooted tree in the channel of the Amite River just downstream of the Louisiana Hwy 64 crossing near Magnolia, LA (arrow notes flow direction—June 2003).

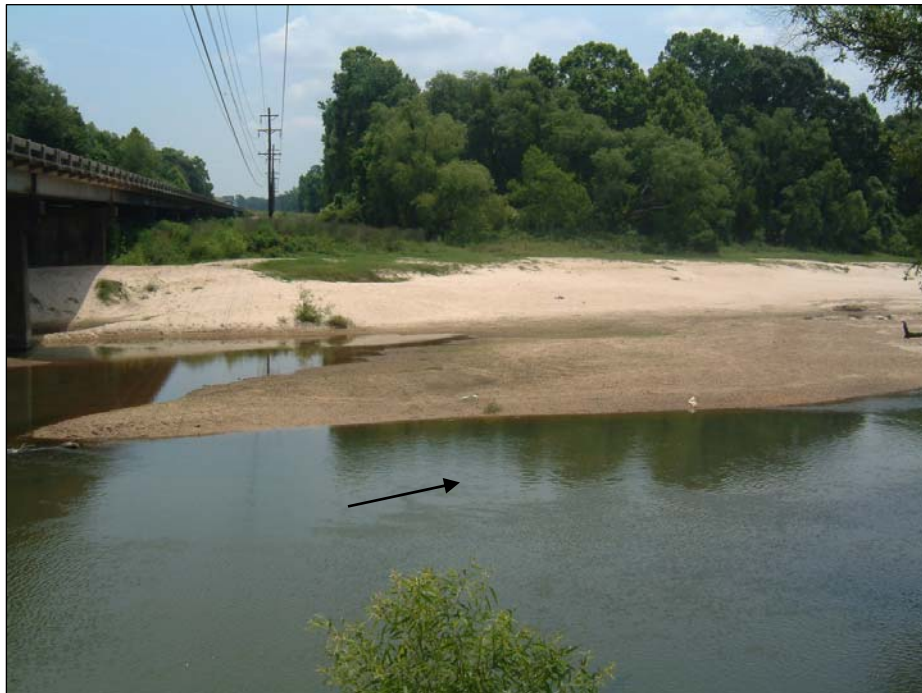
Figure 77. Eroding sand and gravel bar at the Louisiana Hwy 64 crossing of the Amite River near Magnolia, LA (arrow notes flow direction—June 2003).

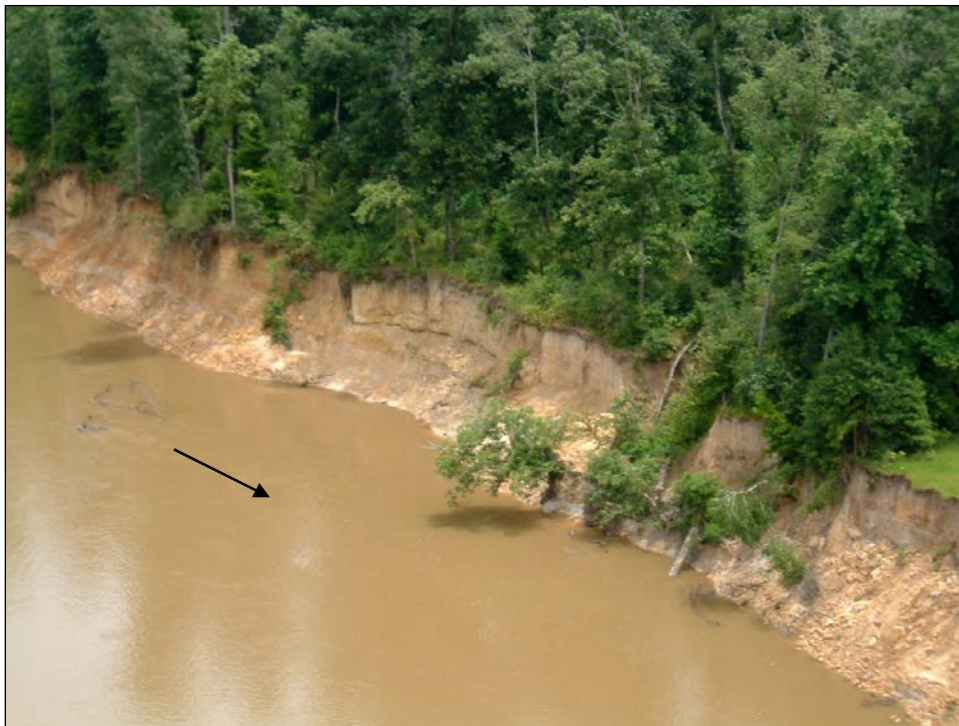
Aerially, channel conditions south of Magnolia and upstream of the Louisiana Highway 190 crossing near Denham Springs (Figure 79) exhibited fewer and more localized indications of instability than in the close vicinity of Magnolia. Bank erosion (Figure 80), divided flow (Figure 81), and point bar development (Figure 82) are apparent in the 2004 aerial views. This decreased level of instability is most likely due to fewer mining operations along this reach. Figure 83 is a 2004 downstream aerial view of the Louisiana Highway 190 crossing showing the confluence of the Amite River and the Comite River.

Figure 80. Steep, eroding left bank of the Amite River just north of Denham Springs, LA (arrow notes flow direction—July 2004).

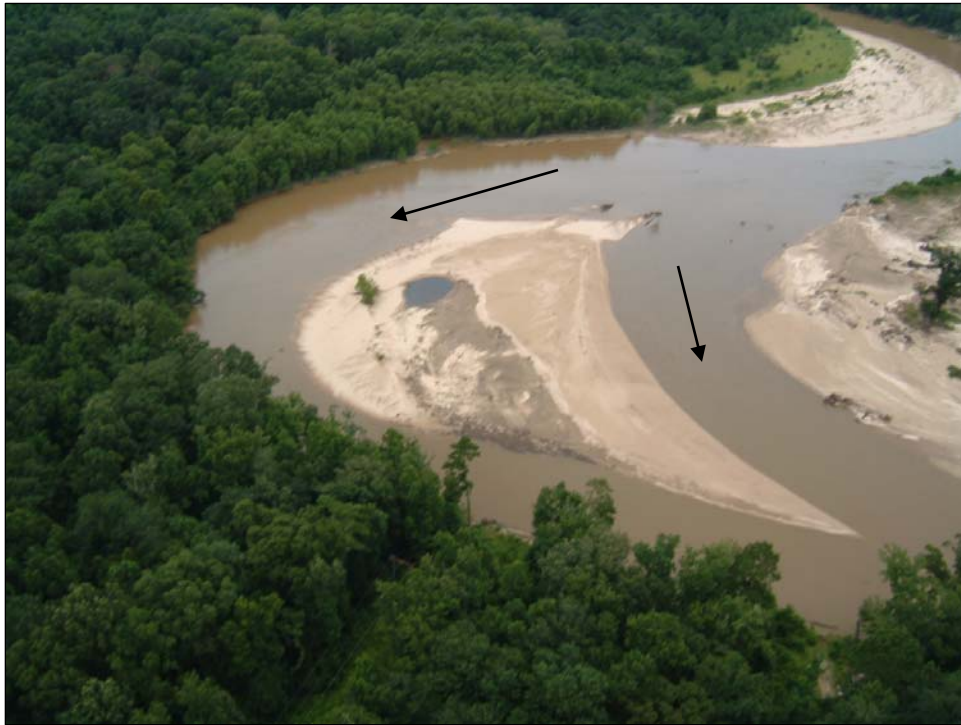
Figure 81. Upstream view of the Amite River north of Denham Springs, LA (note large midchannel sand and gravel bar—July 2004) (arrow notes flow direction).

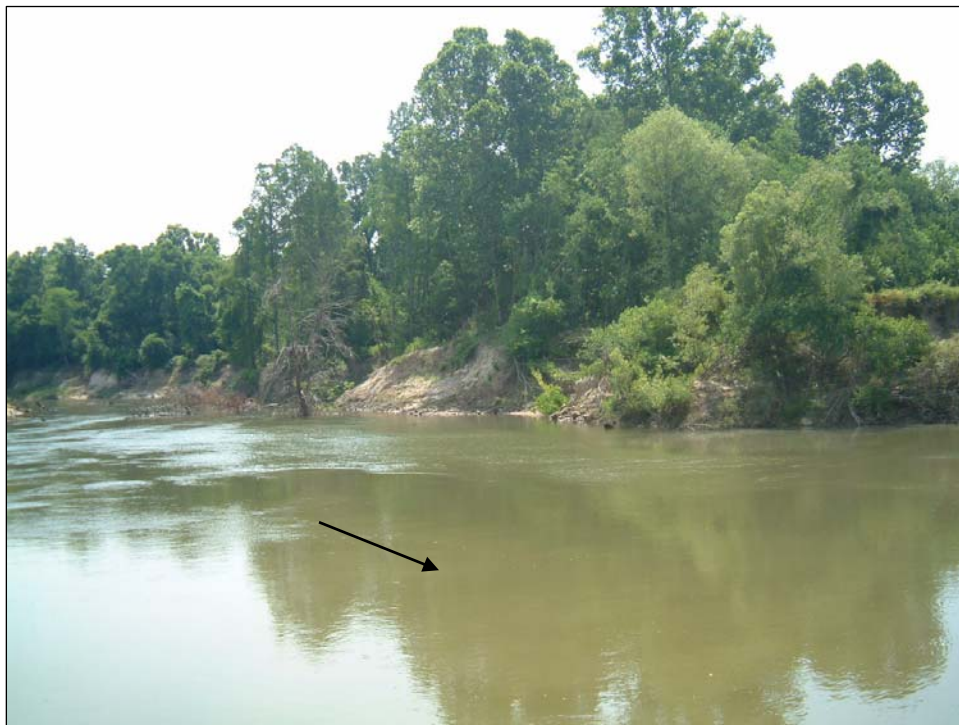
Similarly, channel conditions seen on the ground at the Louisiana Highway 190 crossing near Denham Springs, LA, exhibited fewer indications of instability than in upstream reaches. However, leaning vegetation and bank erosion were evident (Figures 84 and 85).

Figure 84. Steep, eroding left bank of the Amite River at the Louisiana Hwy 190 crossing near Denham Springs, LA (view upstream—June 2003) (arrow notes flow direction).

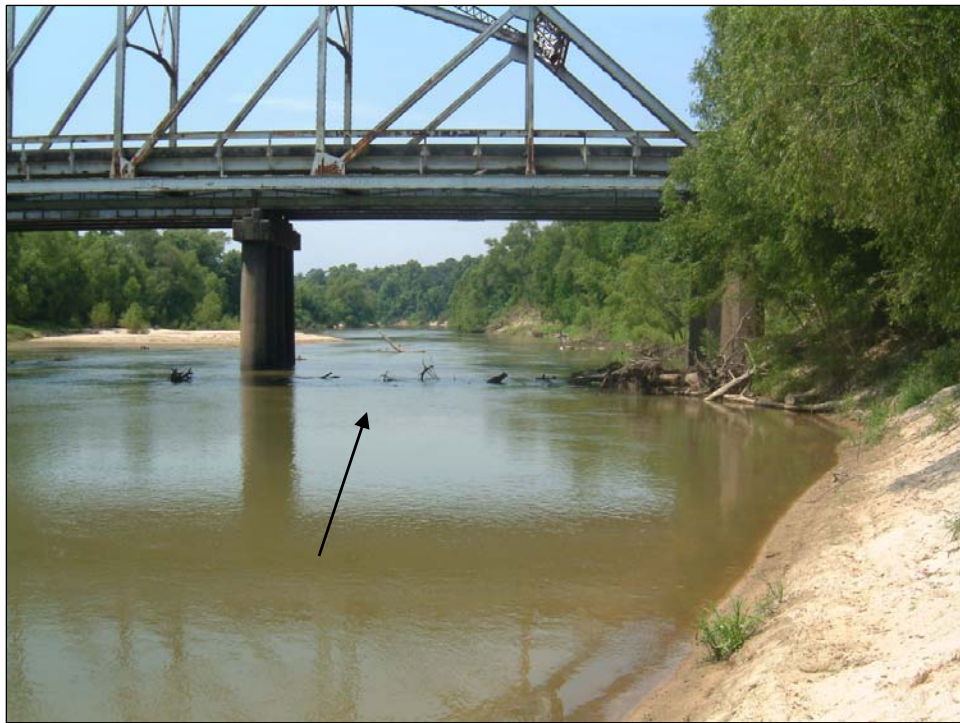
Figure 85. Downstream view of the Amite River at the Louisiana Hwy 190 crossing near Denham Springs, LA (note debris in the channel—June 2003) (arrow notes flow direction).

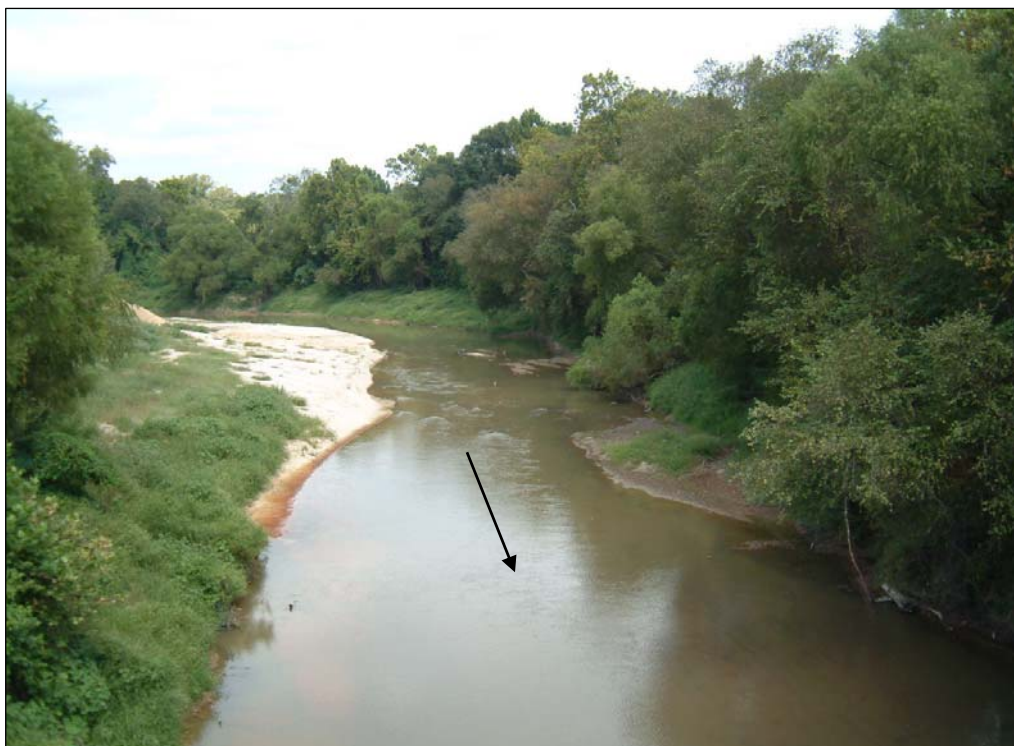
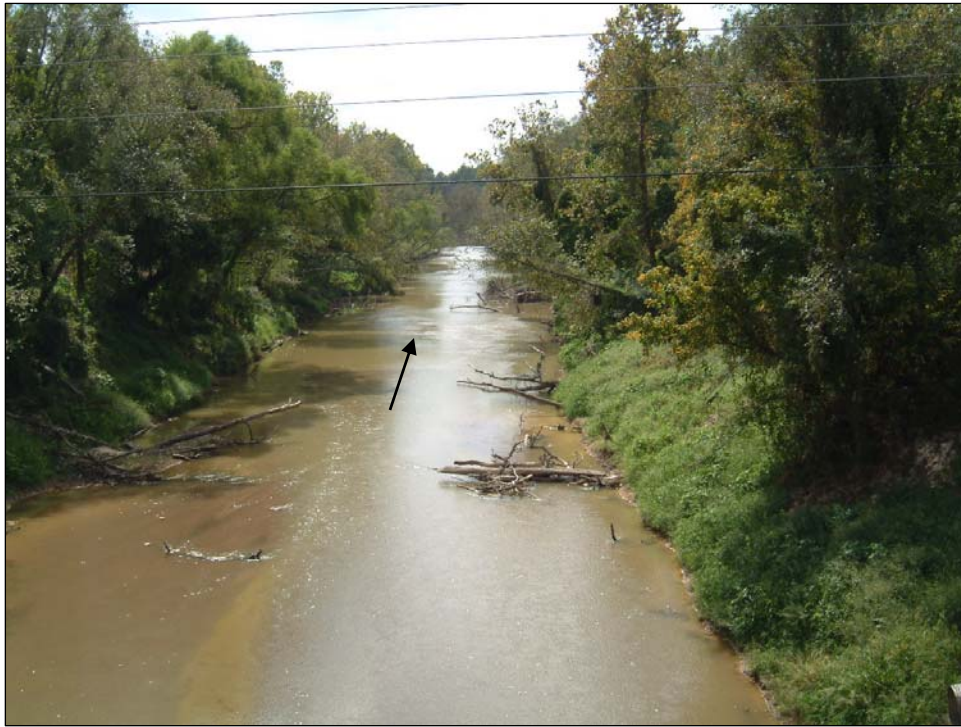
The Louisiana Highway 37 crossing near Comite, LA, is approximately 8 km upstream of the Amite-Comite River confluence. At this lower-reach crossing, banks appeared relatively stable. However, vegetation was leaning and there was vegetation in the water as shown in Figures 87 and 88.

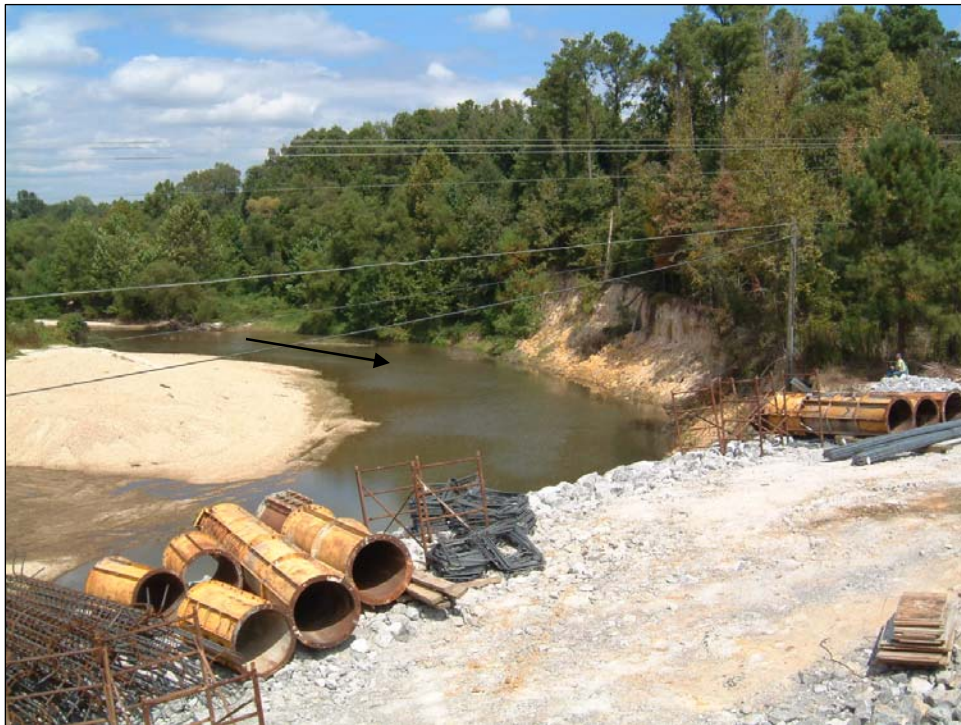
At the Louisiana Highway 67 crossing near Olive Branch, LA, the left bank upstream of the bridge was steep and eroding (Figure 91), and there were several moderately sized midchannel sand and gravel bars (Figure 92). Riprap had recently been placed on the left bank upstream of the bridge

Figure 91. Upstream view of the Comite River at the Louisiana Hwy 67 crossing near Olive Branch, LA (note steep, eroding left bank—July 2004) (arrow notes flow direction).

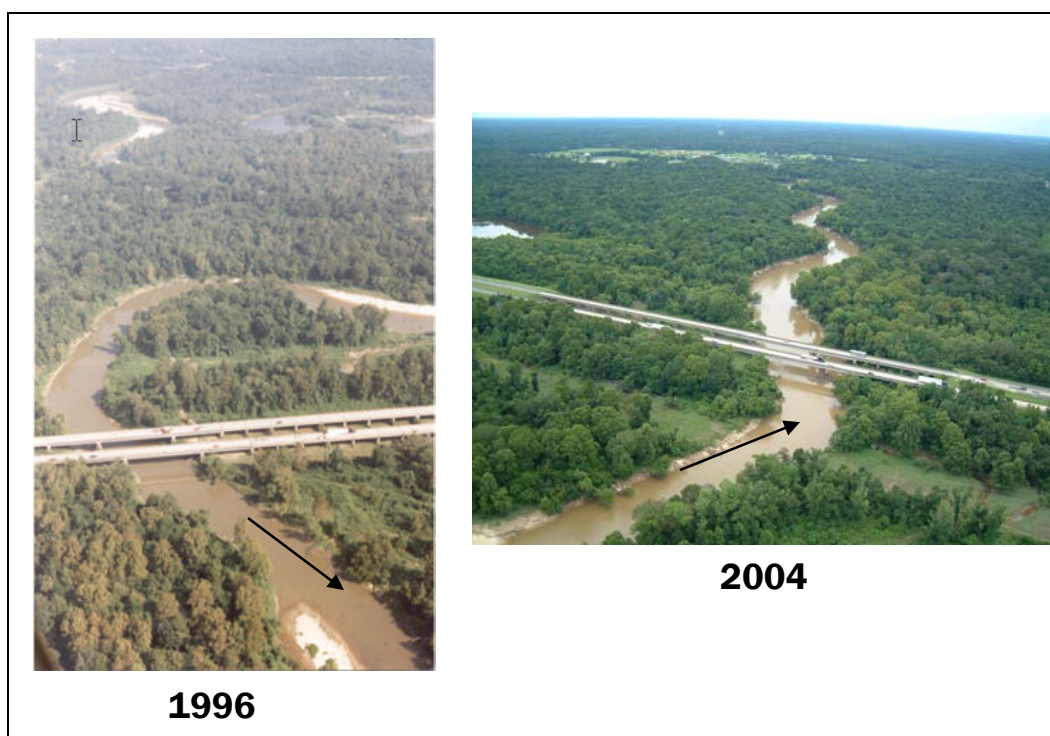
In the vicinity of the Interstate 12 crossing, the general nature and condition in the lower reach of the channel are shown in the 1995 and 2004 aerial views in Figure 95. It is apparent that the channel appearance is significantly different from upstream reaches, such as those at Grangeville or

Figure 95. 1995 upstream and 2004 downstream aerial views of the Interstate 12 crossing of the Amite River between Baton Rouge and Denham Springs. (arrow notes flow direction).

Magnolia, and there are no indications of significant bar construction in this downstream area.

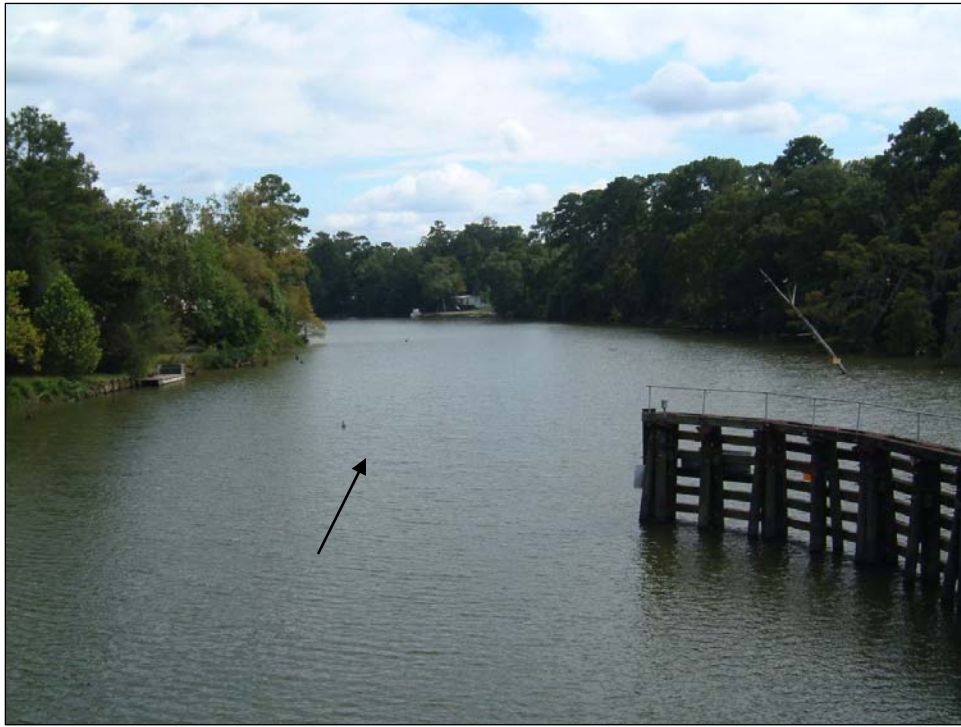
The lower reach of the Amite River was observed from the Louisiana Highway 42 crossing near Port Vincent, LA (Figures 96 and 97). Channel conditions indicated a strong state of stability and reflect the beauty that the Amite River once possessed in its upper and middle reaches prior to gravel mining. Banks are sloping and support thick, mature, healthy stands of mixed deciduous and conifer forests. The basin in this area is virtually flat and composed of poorly drained soils and sediments. As a result, increased flooding is a major problem. This increased flooding may also result from increased water and sediment discharge in the upstream reaches of the river due to urbanization and gravel mining.

Figure 96. Downstream view of the Amite River at the Louisiana Hwy 42 crossing near Port Vincent, LA (July 2004) (arrow notes flow direction).

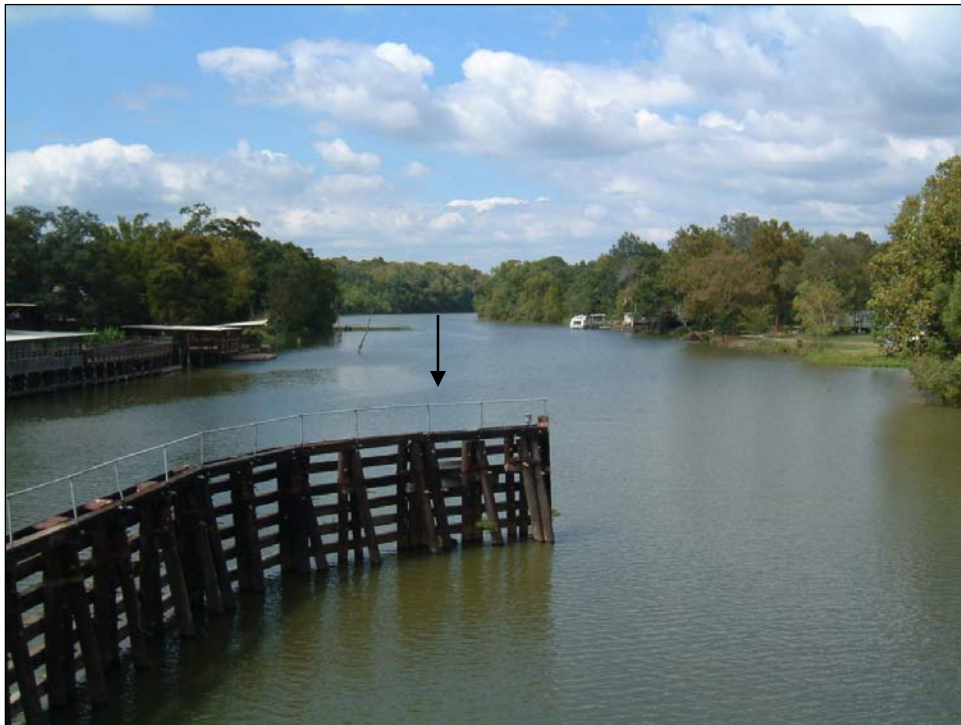
Figure 97. Upstream view of the Amite River at the Louisiana Hwy 42 crossing near Port Vincent, LA (July 2004) (arrow notes flow direction).

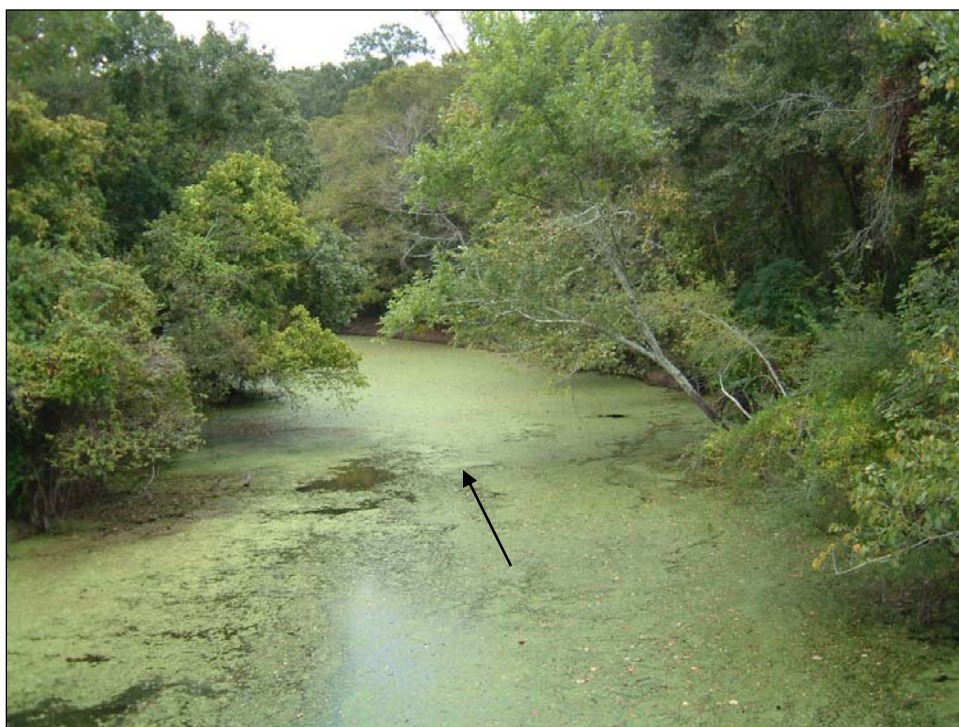
the confluence of Bayou Manchac and the Amite River. Two major crossings were visited on this stream and both revealed relatively stable channel conditions. The I-10 crossing (Figures 98 and 99) and the Louisiana Highway 61 crossing (Figures 100 and 101) cross Bayou Manchac just south of Baton Rouge, LA. Moderately sloping, well vegetated banks were observed at both locations although there were some minor signs of leaning vegetation present. The channel appeared to be rather straight with no bar development at either site. If instability is occurring or has occurred along this stream, then it is minor.

Figure 98. Downstream view of Bayou Manchac at the I-10 crossing near Baton Rouge, LA (July 2004) (arrow notes flow direction).

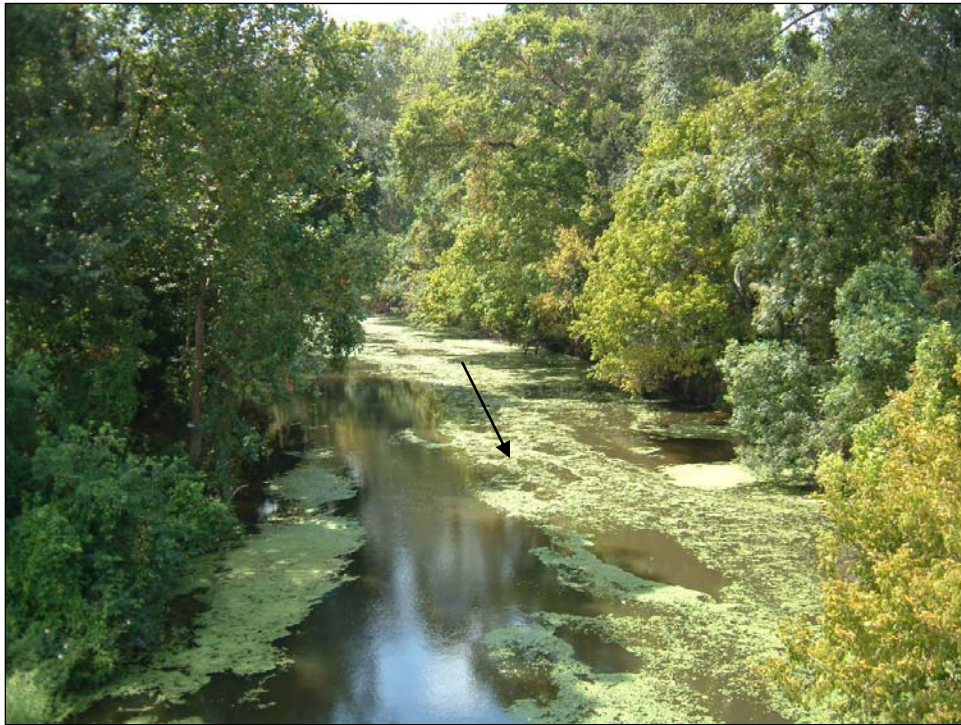
Figure 99. Upstream view of Bayou Manchac at the I-10 crossing near Baton Rouge, LA (July 2004) (arrow notes flow direction).

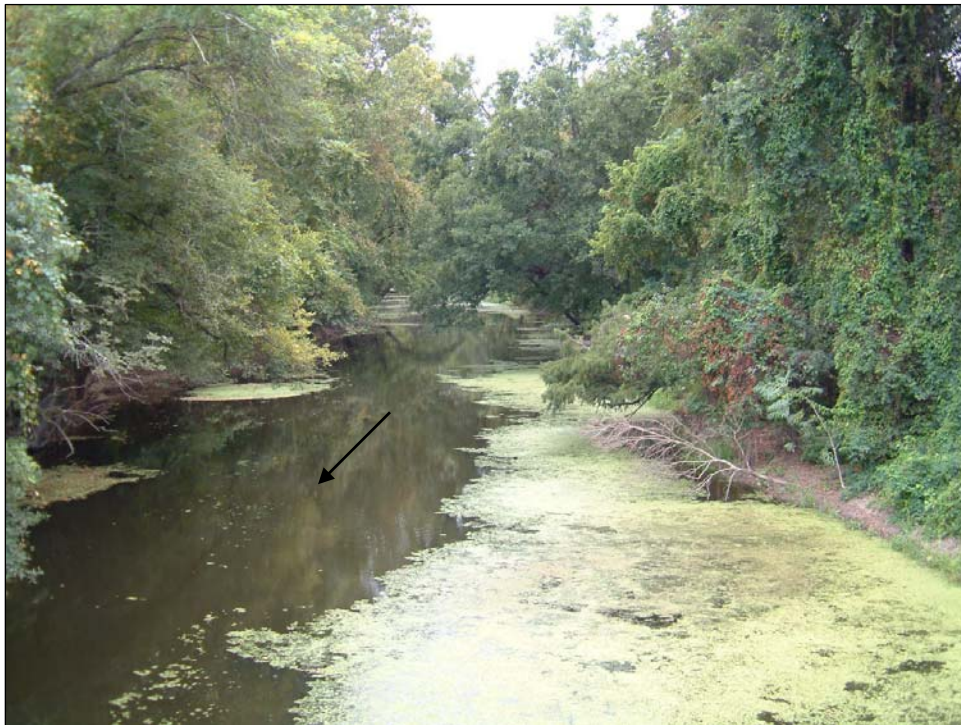
Figure 100. Upstream view of Bayou Manchac at the Louisiana Hwy 61 crossing near Baton Rouge, LA (July 2004) (arrow notes flow direction).
