## **Fluvial Instability and Channel Degradation of Amite River and its Tributaries, Southwest Mississippi and Southeast Louisiana**

D. Ryan Hood, David M. Patrick, and Maureen K. Corcoran

September 2007

Final report

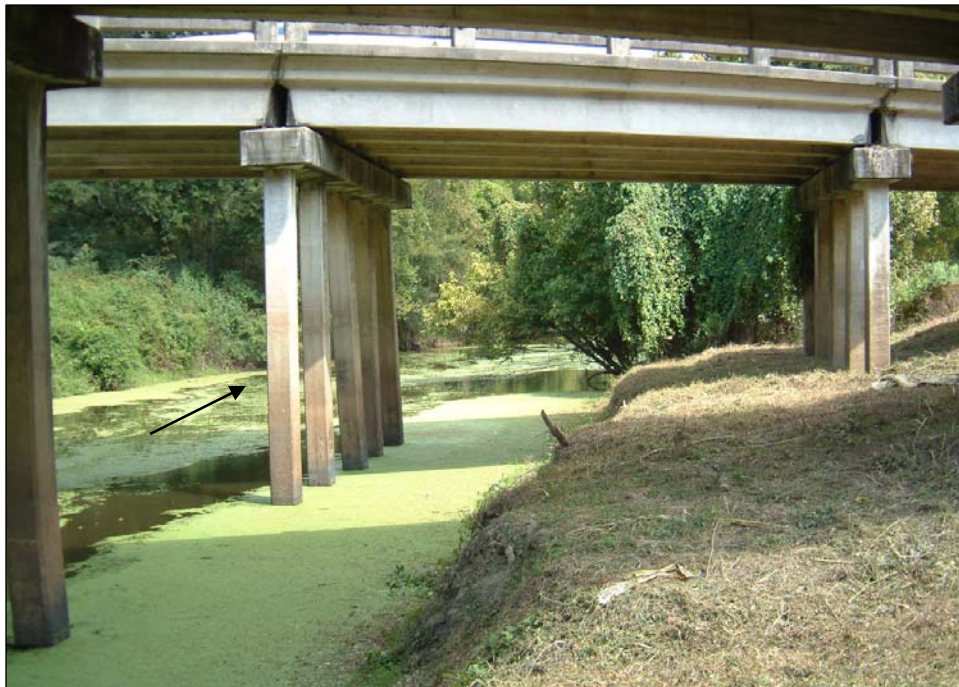
the confluence of Bayou Manchac and the Amite River. Two major crossings were visited on this stream and both revealed relatively stable channel conditions. The I-10 crossing (Figures 98 and 99) and the Louisiana Highway 61 crossing (Figures 100 and 101) cross Bayou Manchac just south of Baton Rouge, LA. Moderately sloping, well vegetated banks were observed at both locations although there were some minor signs of leaning vegetation present. The channel appeared to be rather straight with no bar development at either site. If instability is occurring or has occurred along this stream, then it is minor.

Figure 101. Downstream view of Bayou Manchac at the Louisiana Hwy 61 crossing near Baton Rouge, LA (July 2004) (arrow notes flow direction).

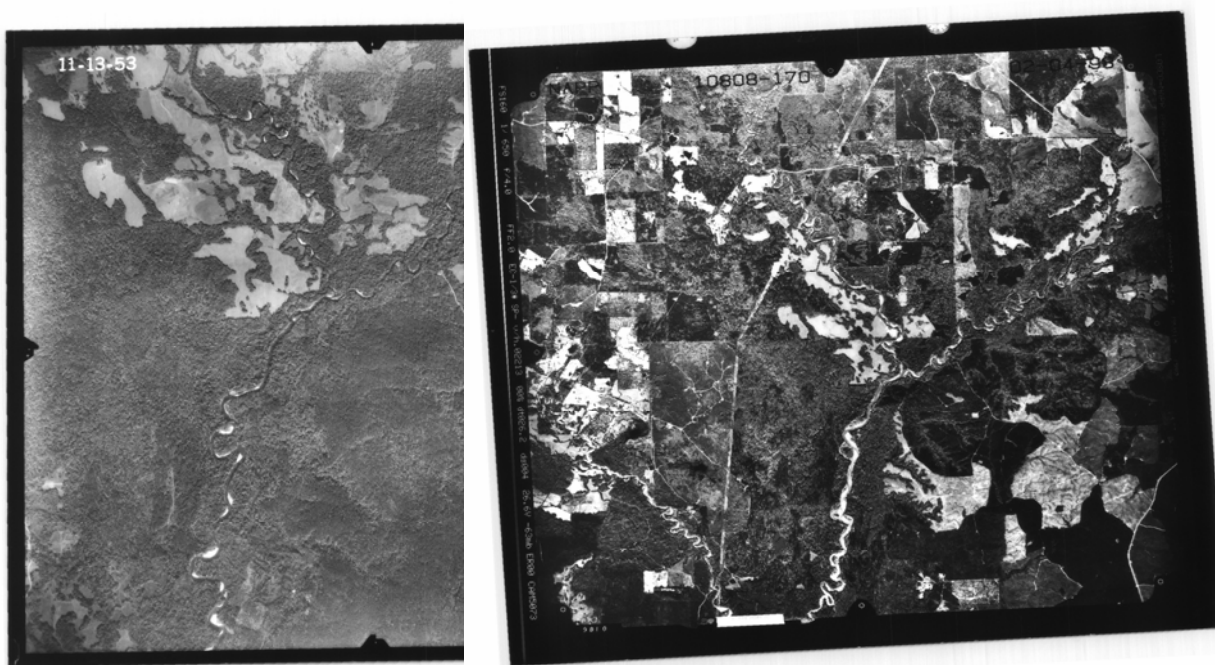
Figure 107 shows the 1953 (a) and 1998 (b) photos of the headwater reach upstream of the mined reach and Figure 108 is the digitized planform for all four periods of time. In 1953, the channels of the West and East Forks appear narrow and sinuous with well-vegetated banks, an indication of stability. The reach downstream of the West Fork and East Fork confluence appears stable. By 1998, a significant amount of channel straightening had occurred on the West Fork Amite and the main stem of the

channel. Although the stream channel was locally straightened, the bankline still appears to be well-vegetated in the 1998 photo. By 1998, there is less forest cover as indicated by the areas of lighter phototone. The changes in stream plan form along this reach is shown in Figure 108.

Figure 107. 1953 and 1998 aerial photographs of the Amite River headwaters in Mississippi and Louisiana.

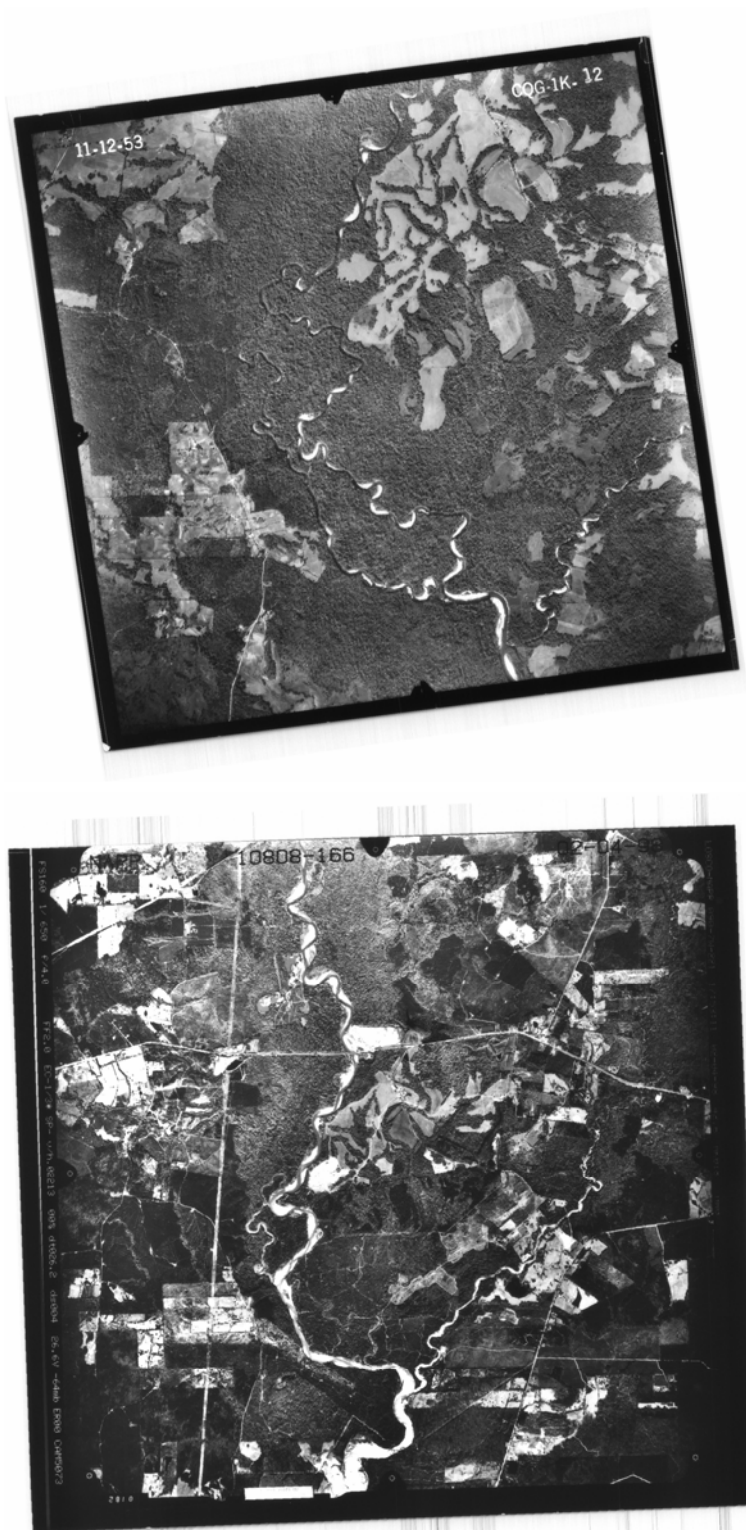
Darling Creek is a main upper reach tributary to the Amite River. It converges with the Amite River near Darlington, LA, approximately 4.8 km downstream of the Louisiana Highway 10 crossing of the Amite River. This confluence lies well upstream of the main mined reach of the Amite River. Figure 109 depicts 1953 (a) and 1998 (b) photography of the reach upstream of this confluence shown in the lower center of each photograph. The 1953 image showed that the Amite River channel, approximately 4.5 km upstream of the confluence, was bifurcated. The bifurcation

extended downstream approximately 0.8 km upstream of the confluence. The two channels are the West Prong and East Prong of the Amite River. The 1998 photograph showed that bifurcation was present; however, most of the East Prong had been abandoned. The 1998 photograph also indicated larger and more extensive point bar development and less forest/more cleared areas. Planform changes are shown in Figure 110.

Figure 109. 1953 (upper) and 1998 (lower) views of the Amite River near the confluence with Darling Creek downstream of the Louisiana Highway 10 crossing. Darling Creek enters the Amite River from the east and the confluence is shown at the bottom center of the photographs.

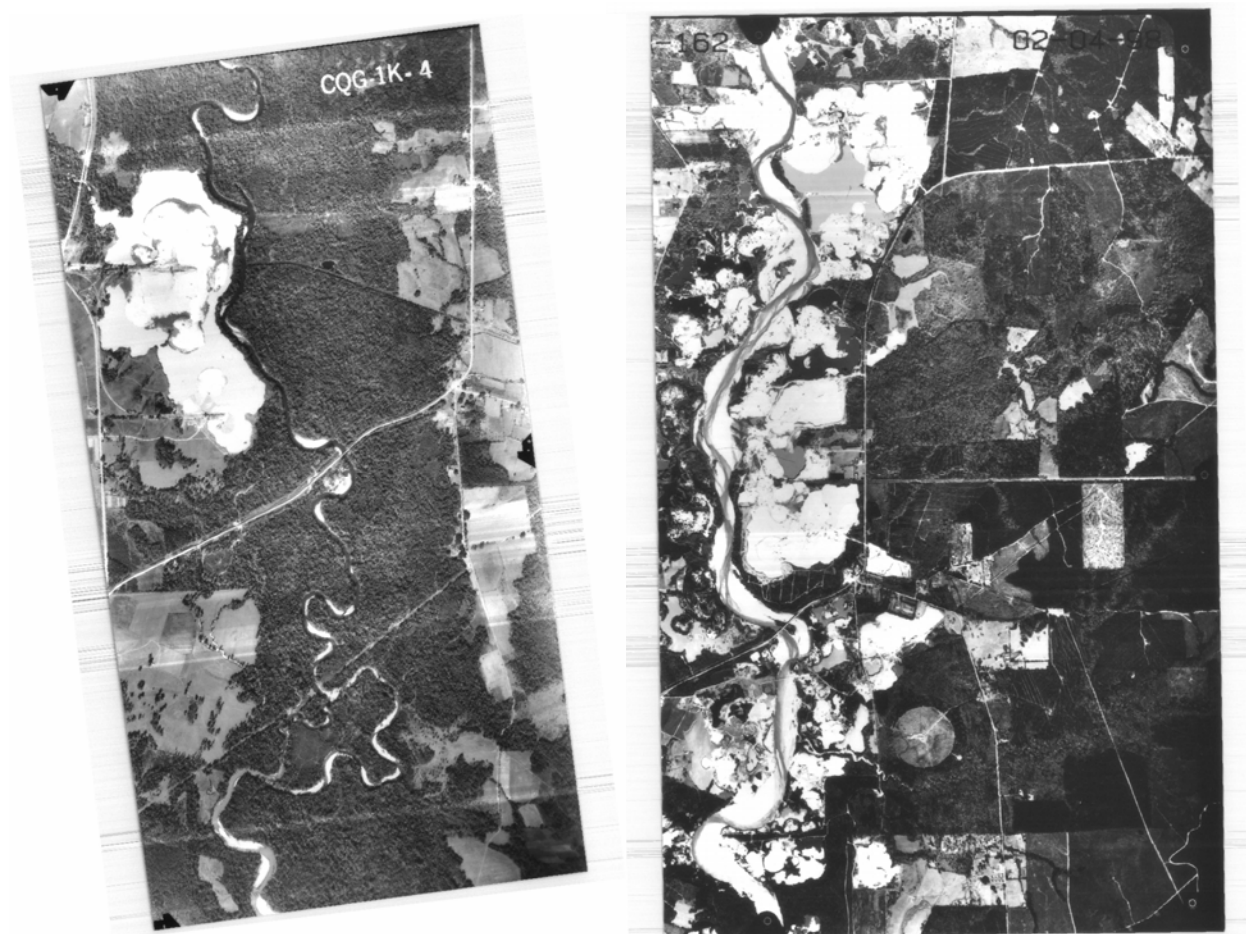
The 1953 and 1998 aerial photographs of the Louisiana Highway 37 crossing of the Amite River near Grangeville, LA, are shown in Figure 111. The Louisiana Highway 37 crossing is represented by “a” in the photos. In the 1953 photograph, the stream appears to be sinuous with good bar development and well vegetated banks. On the right bank, a large floodplain gravel mine is apparent in the 1953 photo, upstream of the Louisiana Highway 37 crossing. There appears to be a riparian buffer zone between this mine and the Amite River channel. No mines are present in this view downstream of the crossing. The 1953 photograph shows bank-line vegetation, absence of divided flow, and point bar development. The 1953 photograph shows a pipeline crossing the river approximately 1.7 km downstream of the crossing. The 1953 photograph shows bank-line

Figure 111. 1953 and 1998 aerial photography of the Louisiana Hwy 37 crossing of the Amite River near Grangeville, LA.

vegetation, absence of divided flow, and point bar development. The 1953 photograph shows a pipeline crossing the river approximately 1.7 km downstream of the bridge. Near the pipeline crossing, there is evidence of bifurcation and a short reach of divided flow. The 1998 photograph exhibits extensive mining on both sides of the river, channel widening and straightening, loss of bank-line vegetation and divided flow. The bridge appears to cross a dry area of the channel as noted in the previous section on the field studies. Planform changes along this reach are shown in Figure 112.

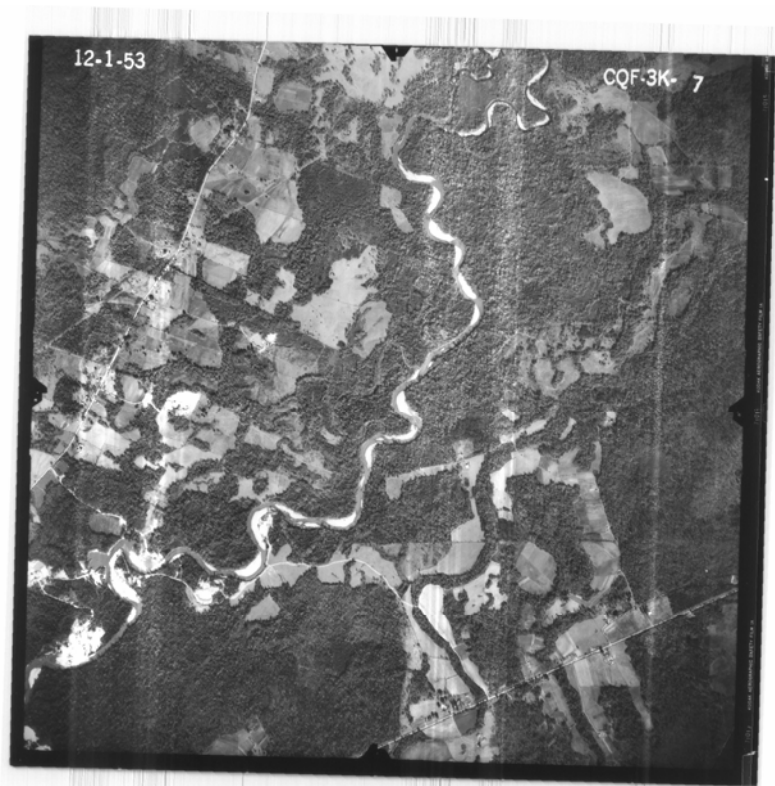
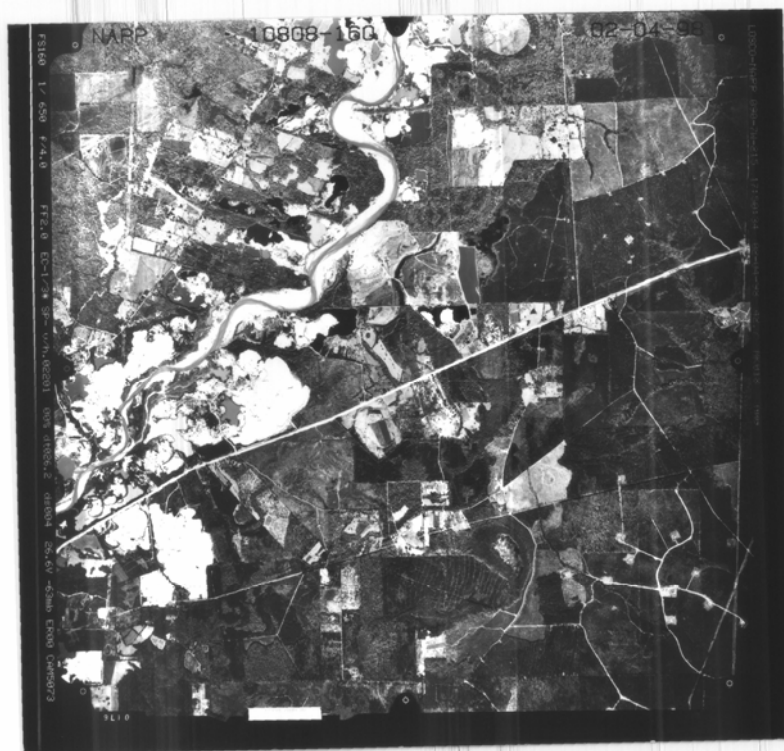
Figure 113 is the 1953 and 1998 photographs of the Amite River further downstream of the Louisiana Highway 37 crossing near Grangeville, LA. The roughly east-west highway in the lower right corner of the 1998 photograph is Louisiana Highway 16. In the 1953 photograph, there are several small mined areas along the lower reaches and the channel appears

stable with a meandering configuration, good bar development, and well-established bank-line vegetation. In the 1998 photograph, numerous large mines are evident on both sides of the channel. It is apparent that severe channel widening and straightening has occurred along with divided flow and loss of bank-line vegetation. Planform changes are shown in Figure 114.

Figure 113. 1953 (a) and 1998 (b) photographs of the Amite River downstream of the views presented in Figure 111.

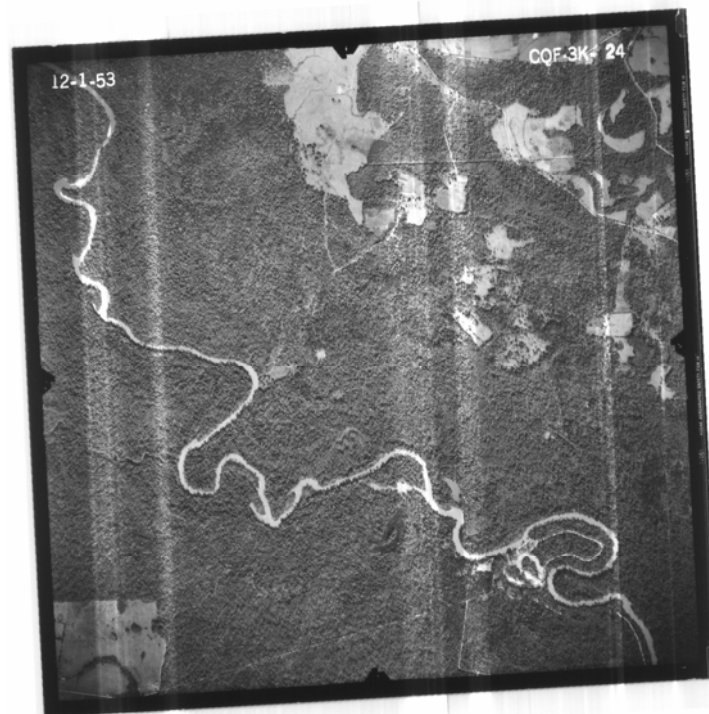
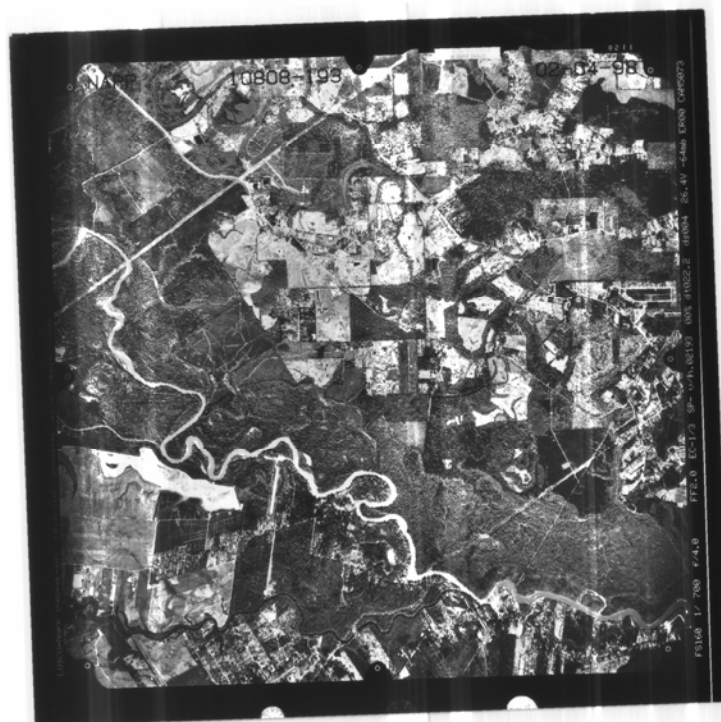
Figure 117 is 1953 (a) and 1998 (b) aerial photographs of a portion of the lower reaches of the Amite River, including the confluence of the Amite River with Bayou Manchac. This particular portion of the Lower Amite River is located approximately 7 km upstream of Port Vincent, LA. Horseshoe Bend, a well known natural landmark in this area, is found at the lower right corner of the 1953 photograph and it is the major reference feature on both the 1953 and 1998 views. The additional linear reference features seen in the 1998 view are the power transmission line in the north and the pipeline crossing downstream of Horseshoe Bend. Bayou Manchac enters the Amite River from the west downstream of the pipeline crossing. The Amite River in the 1953 view appears stable with well vegetated banks and minor point bar development. The channel in the 1998 view also appears stable; however, the reach is more urbanized. Planform changes are shown in Figure 118.

Figure 117. 1953 (a) and 1998 (b) aerial photographs of the Amite River reach approximately 7 km upstream of Port Vincent, LA. The prominent meander bend (Horseshoe Bend) is apparent in both views. Two crossings are shown in the 1998 view, a power transmission line to the north and a pipeline to the south of Horseshoe Bend. Bayou Manchac enters the Amite River from the west a short distance downstream of the pipeline crossing.

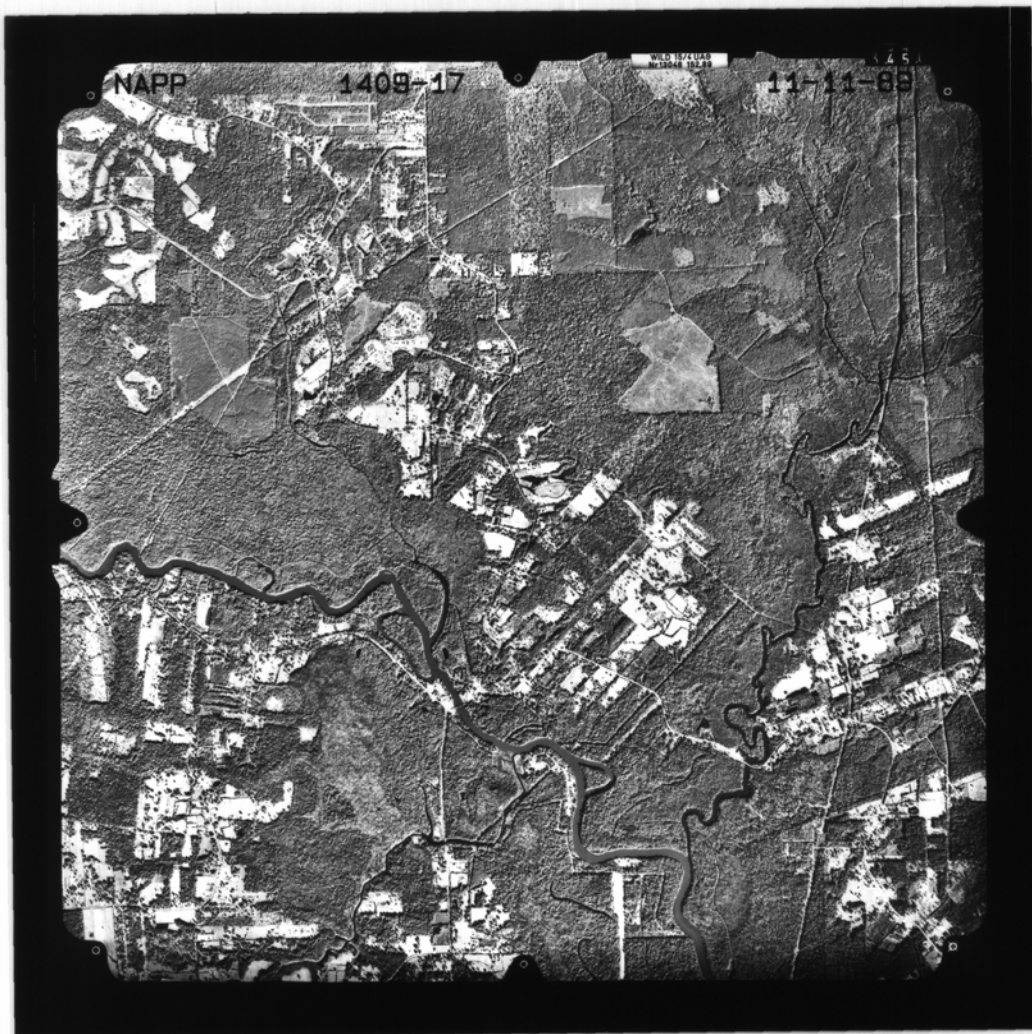
Figure 119 shows the 1989 aerial photo of the Lower Amite River reach in the vicinity of Port Vincent, LA, located in the urbanized area on the left bank near the center of the view. No photography was available prior to 1989. The tributary entering from the east in the lower center of the view is Colyell Bay. The Amite River channel in this photograph appears to be somewhat less sinuous than that seen upstream. There are three meander cut-offs present but otherwise, there are no indications of instability.

Figure 119. 1989 aerial photograph of the Amite River in the vicinity of Port Vincent, LA.

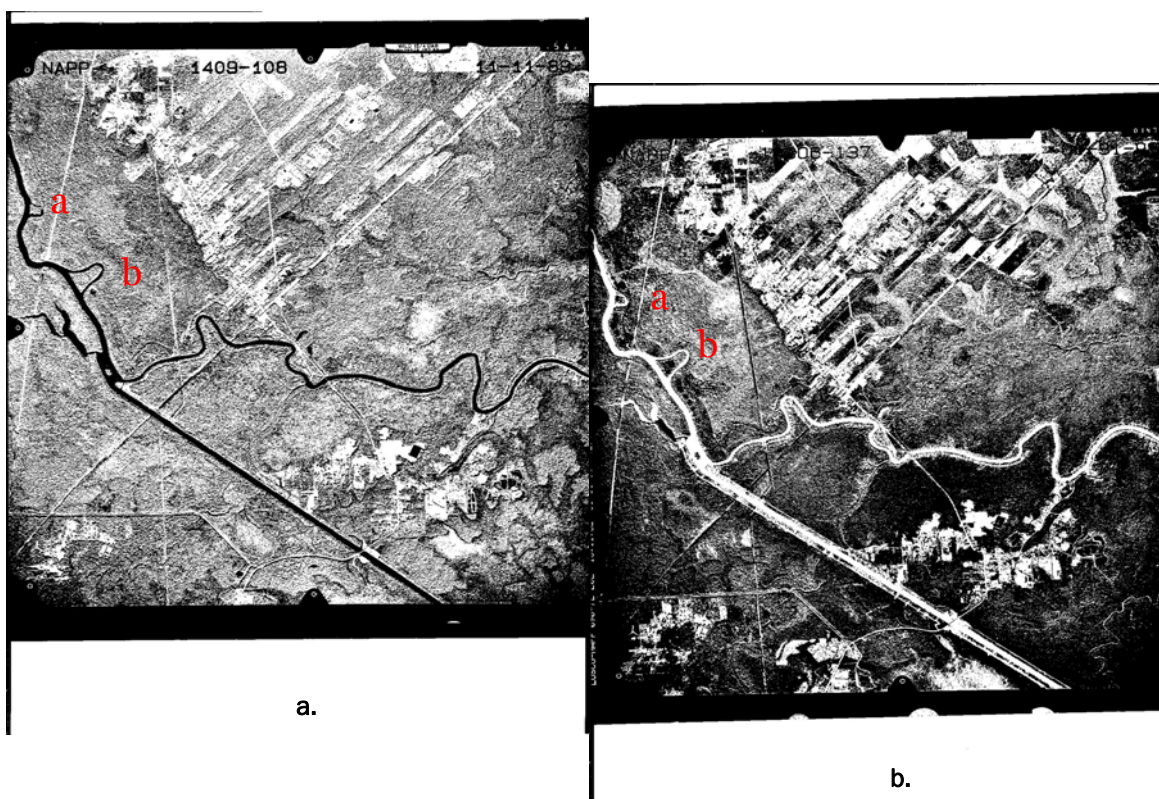
Figure 120 depicts 1989 (a) and 1998 (b) aerial photographs of the Amite River Diversion Canal where it bisects the Amite River a few kilometers south of Port Vincent, LA. No aerial photography was available prior to 1989. The canal was built between 1957 and 1964 for the purpose of flood-control by diversion of floodwaters from the Amite River directly to Lake Maurepas. The aerial photographs show two meander cutoffs, which were probably constructed as a part of the diversion project. There does not appear to be significant change in channel planform nor land-use between 1989 and 1998 as indicated in Figures 120 and 121.

Figure 120. 1989 (a) and 1998 (b) aerial photographs of the Amite River Diversion Canal downstream of Port Vincent, LA (note points “a” and “b” are common points and major meander cutoffs).

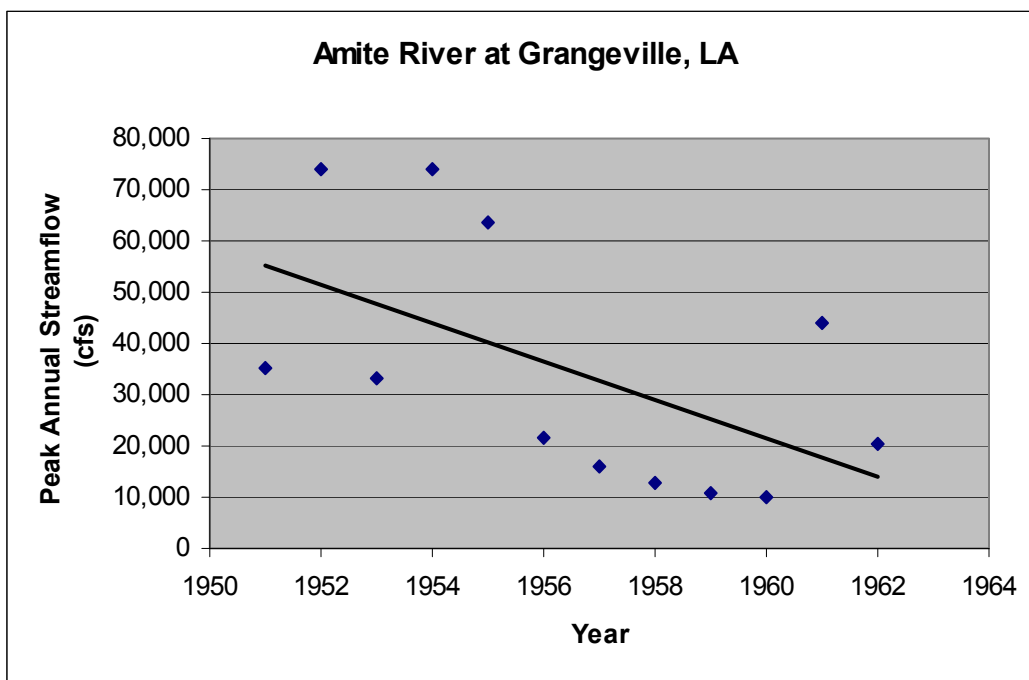
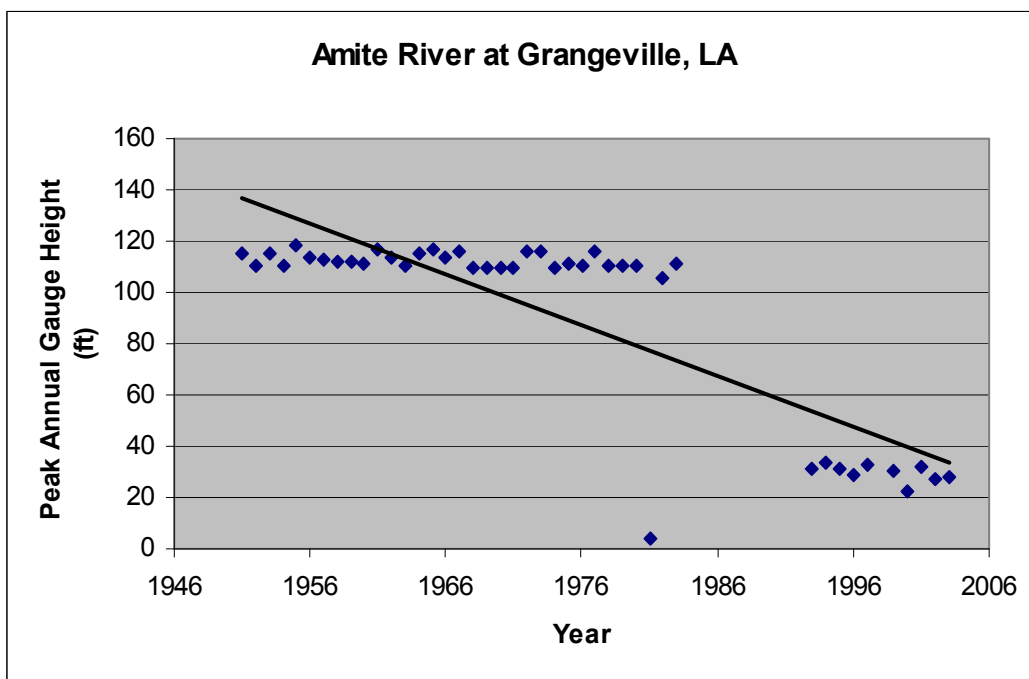
This gauge station is located near the center of the principal mined reach. Peak annual streamflow and peak annual gauge height are shown in Figure 124. Peak annual streamflow was recorded from the early 1950s

through the early 1960s (Figure 124a) and exhibits a significant decrease in streamflow. Peak annual gauge height also decreased after the mid-1980s. Both decreases may be attributable to the widening of the channel by mining.

Figure 124. Peak annual streamflow (a) and peak annual gauge height (b) for the Amite River at the Louisiana Highway 37 Bridge Crossing near Grangeville, LA. The flood stage at this station is approximately 35 ft.

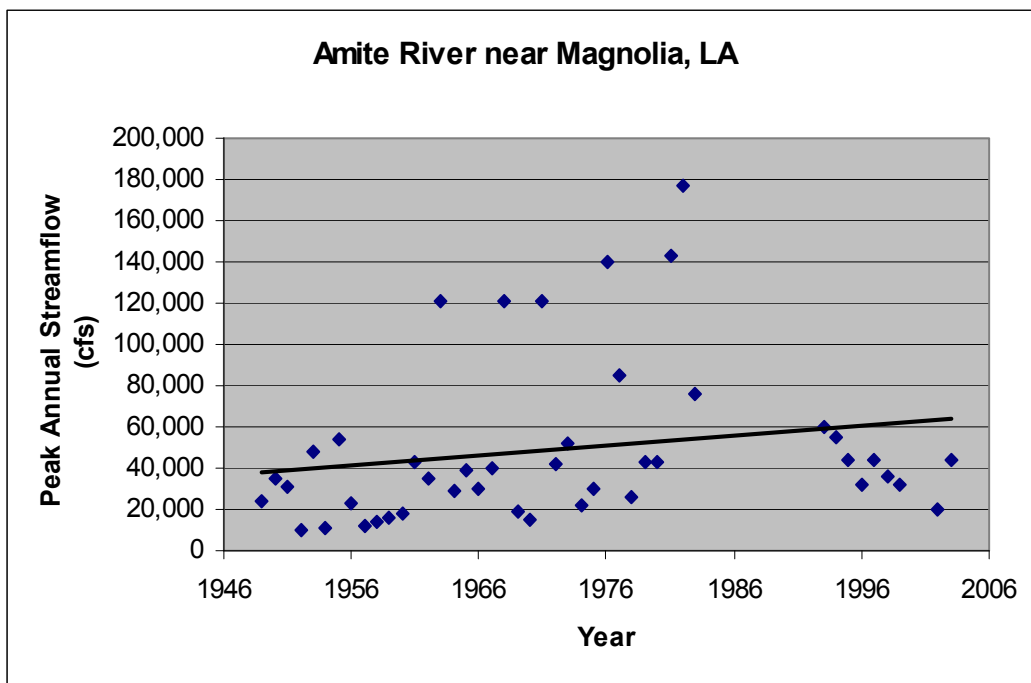
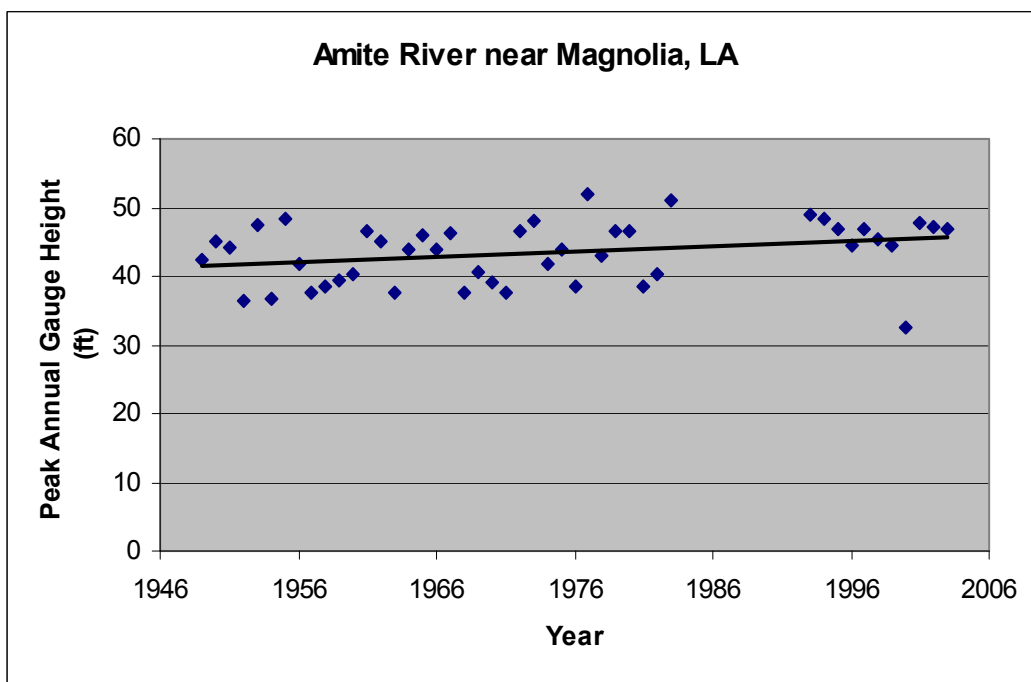
This gauge is located downstream of the principal mined reach, but there are scattered mines both upstream and downstream of this gauge station. Peak annual streamflow and peak annual gauge height trends (Figure 125) both exhibit increases with time. This trend is particularly apparent for peak annual gauge height.

Figure 125. Peak annual streamflow (a) and peak annual gauge height (b) for the Amite River at the Louisiana Highway 64 Bridge Crossing near Magnolia, LA. The flood stage at this station is 34.66 ft (NGVD).

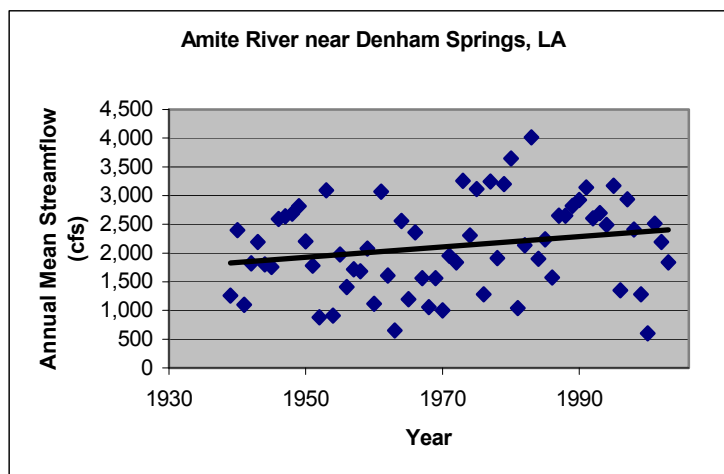
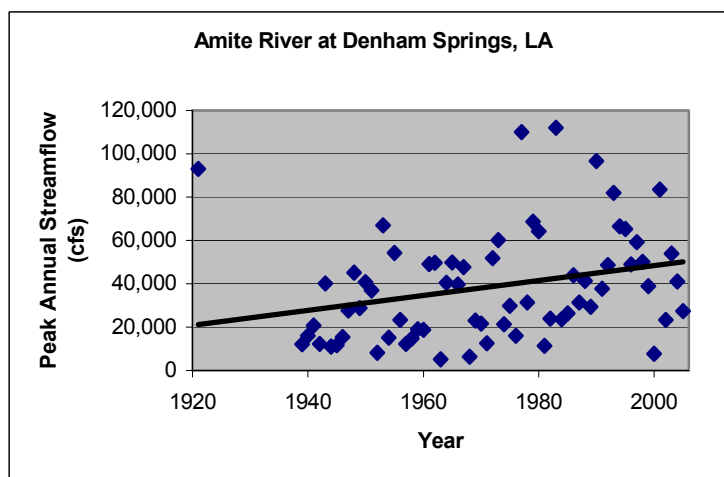
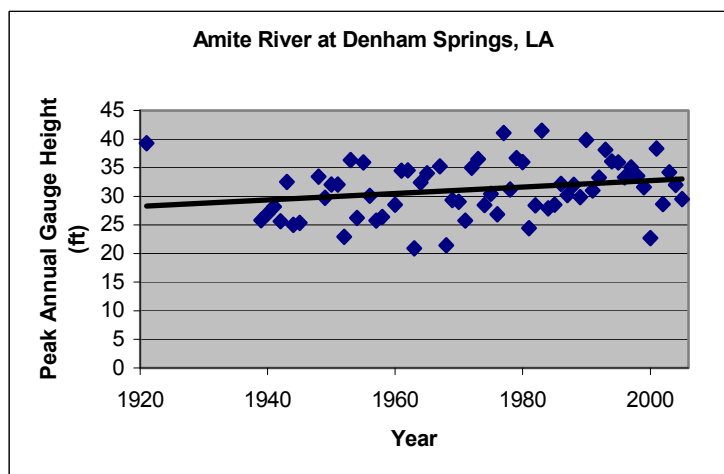
Figure 126 shows the annual mean streamflow (a), peak annual streamflow (b), and peak annual gauge height (c) all of which, particularly peak gauge height, exhibit trends, which increase with time. This site is located in an urbanized area, which includes Denham Springs to the east and Baton Rouge to the west.

Figure 126. Annual mean streamflow (a), peak annual streamflow (b), and peak annual gauge height (c) for the Amite River at the Louisiana Highway 190 Bridge crossing near Denham Springs, LA. The flood stage at this station is 20.81 ft (NGVD).

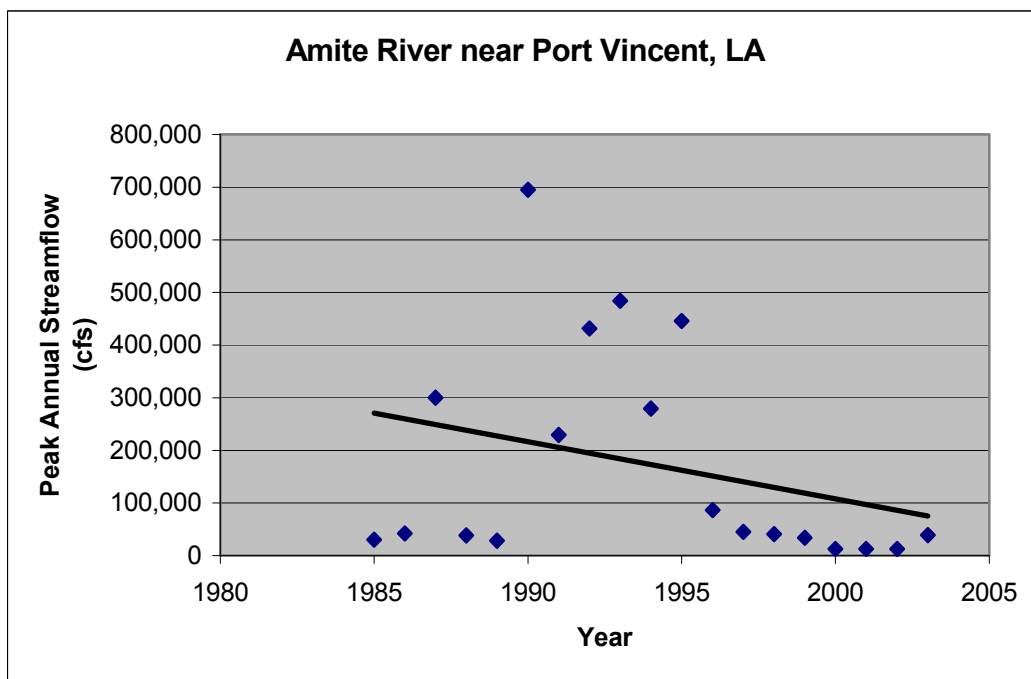
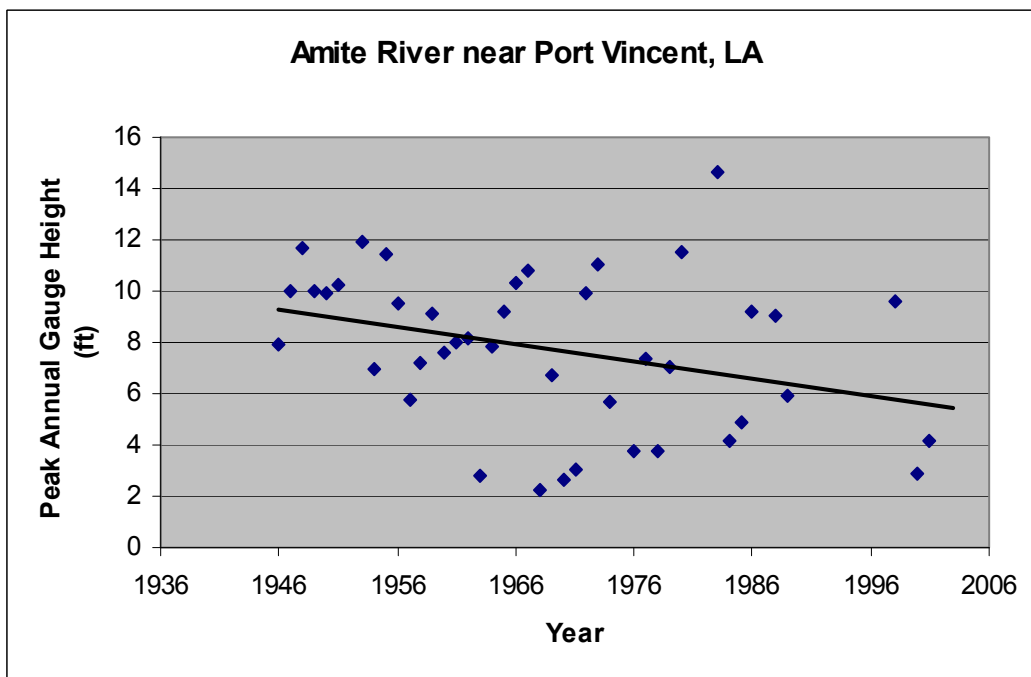
This site is located upstream of the Amite River Diversion Canal and available gauge data are shown in Figure 127. Trend data for both peak annual streamflow (Figure 127a) and peak annual gauge height (Figure 127b) decrease with time. These decreases are probably due to the diversion canal.

Figure 127. Peak annual streamflow (a) and peak annual gauge height (b) of the Amite River at the Louisiana Highway 42 Bridge crossing at Port Vincent, LA. The flood stage at this station is 3.54 ft (NGVD).

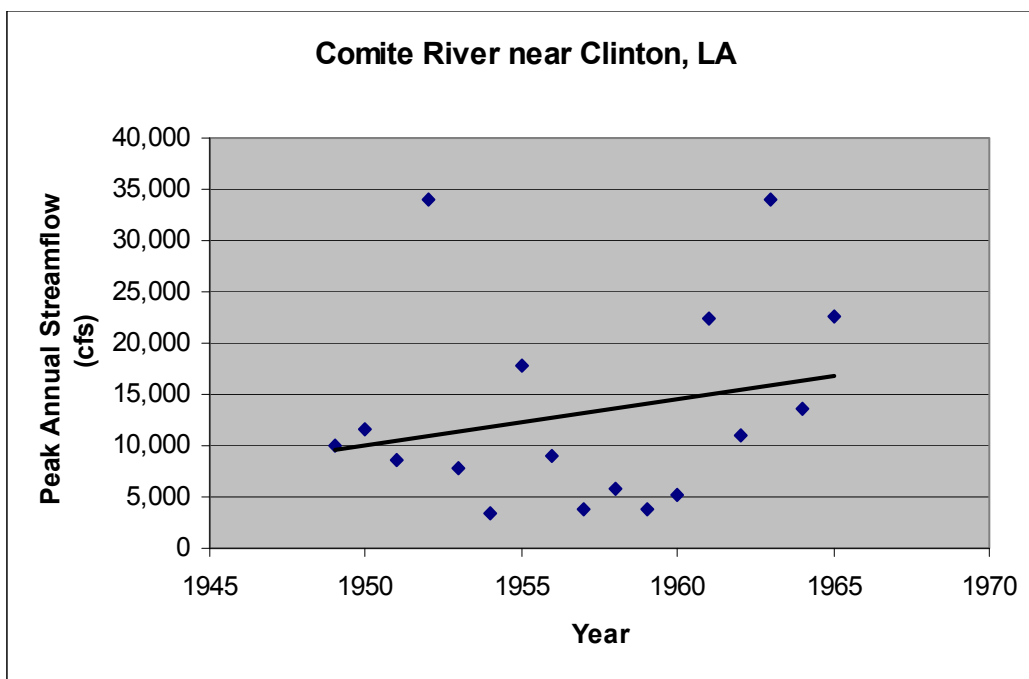
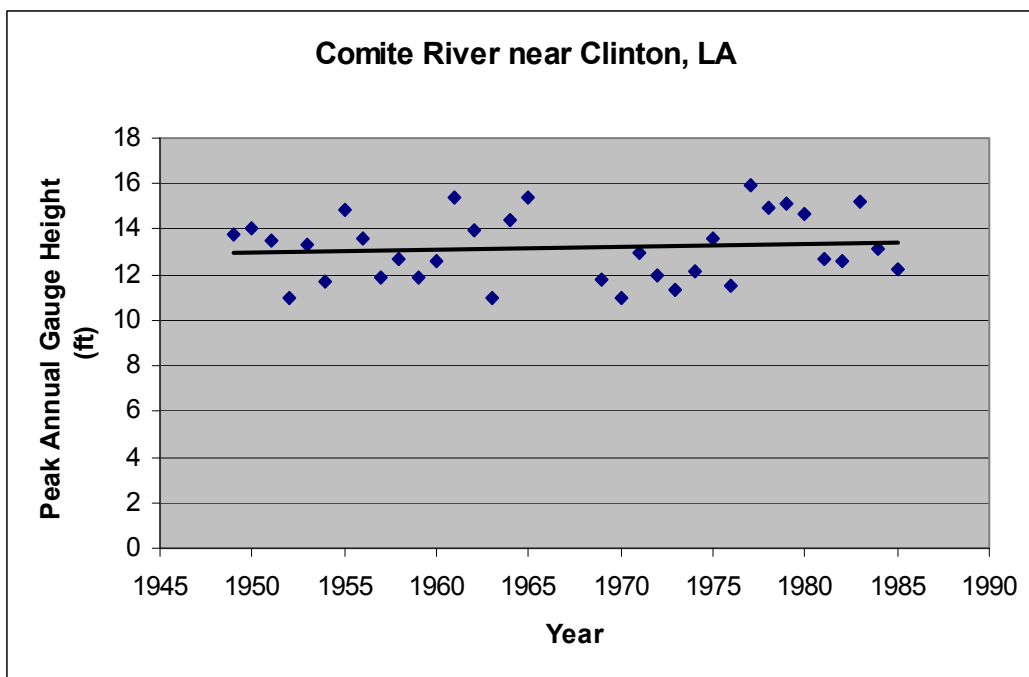
This station is located in a mainly rural area and is furthest upstream station in the Comite River Basin. Peak annual streamflow data (Figure 128a) are incomplete so the trend line is not significant. However, peak annual gauge height data (Figure 128b) are complete and indicate virtually no change over time.

discharge seen on the Olive Branch gauge may indicate that there may be some significance to the peak annual streamflow trend line shown in Figure 128a at the Clinton gauge upstream.

Figure 128. Peak annual streamflow (a) and peak annual gauge height (b) for the Comite River and Louisiana Highway 10 Bridge crossing near Clinton, LA.

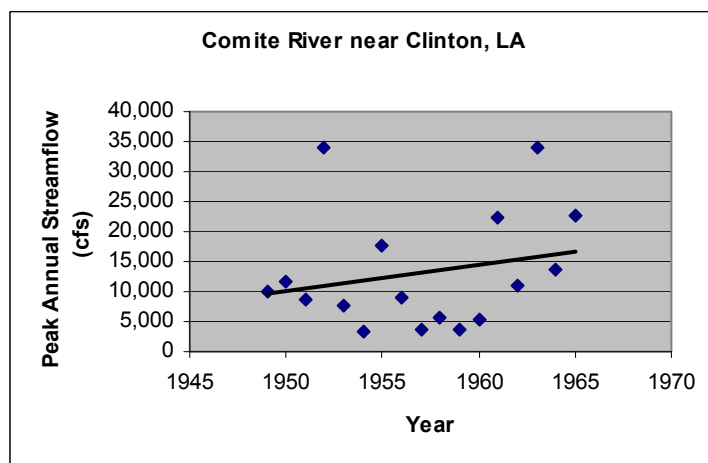
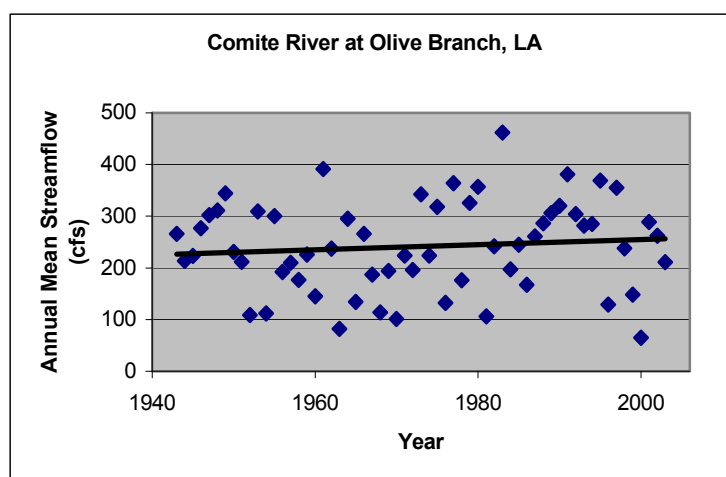
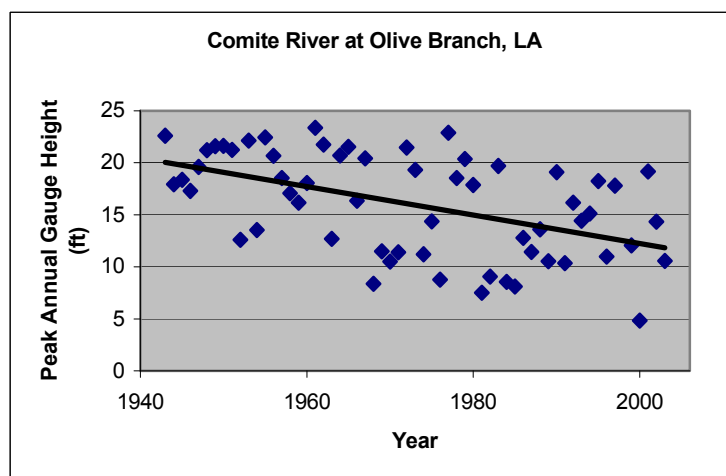
This station is located in a predominantly rural area. Gauge data are given in Figure 129. Both annual mean (Figure 129a) and peak annual streamflow (Figure 129b) have increased over time, whereas peak annual gauge height (Figure 129c) has decreased over time. A temporal increase in stream discharge accompanied by decreased gauge height is most likely an indication of channel erosion. Furthermore, an increase in stream

Figure 129. Annual mean streamflow (a), peak annual streamflow (b), and peak annual gauge height (c) of the Comite River at the Louisiana Highway 67 Bridge crossing near Olive Branch, LA.

Erosion occurring on the Comite River is not considered to be related to mining activities because the confluence of the Comite River and the Amite River lies downstream of the mined reach and headward erosion has progressed upstream on the Amite River. Even so, field studies did indicate some erosion occurring on the downstream reach of the Comite River. However, the most significant erosion occurred further upstream in the vicinity of Clinton, Olive Branch, and Zachary, LA. In these reaches, the channel exhibits eroded banks, divided flow, and bank vegetation lying in the water. The cause of the erosion may be explained by the USGS stage and discharge data for the sites previously named. The USGS data for the Olive Branch station are particularly meaningful in that a historical

increase in stream discharge is accompanied by a historical decrease in stream stage (gauge height). The increase in stream discharge is believed to be due to increased run-off caused, in turn, by land-use/land-cover changes within the drainage basin, namely urbanization. The increased discharge has deepened the channel resulting in lower stages. The erosional process is gulying, which results in headward erosion. Headward erosion on the Amite River has been triggered by activities downstream, whereas the erosion on the Comite River has been triggered by activities (urbanization) occurring upstream.

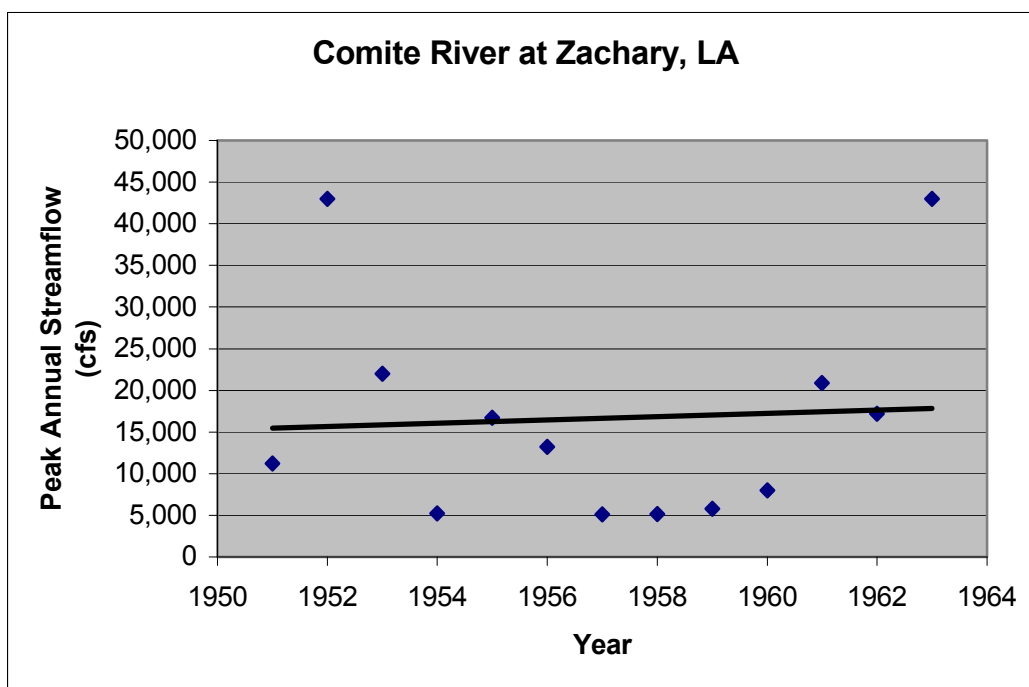
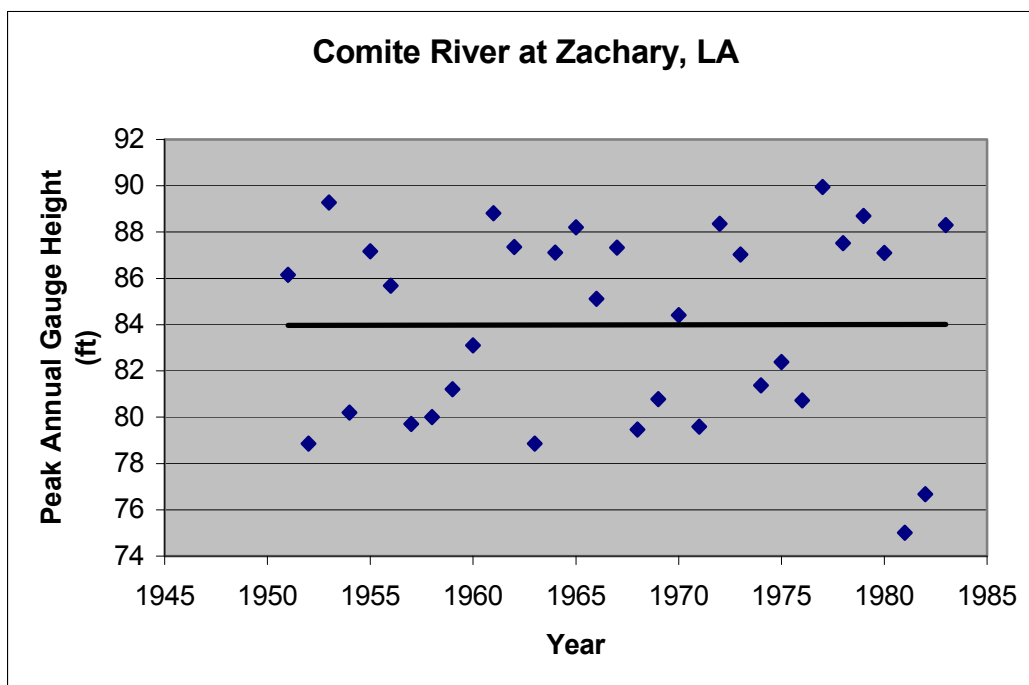
This gauge station is also located in a rural area. Gauge data shown in Figure 130a are incomplete but there is an indication of an increase in peak annual streamflow over time; however, the peak annual gauge height (Figure 130b) has remain relatively constant.

Figure 130. Peak annual streamflow (a) and peak annual gauge height (b) for the Comite River at the Louisiana Highway 64 Bridge crossing near Zachary, LA.

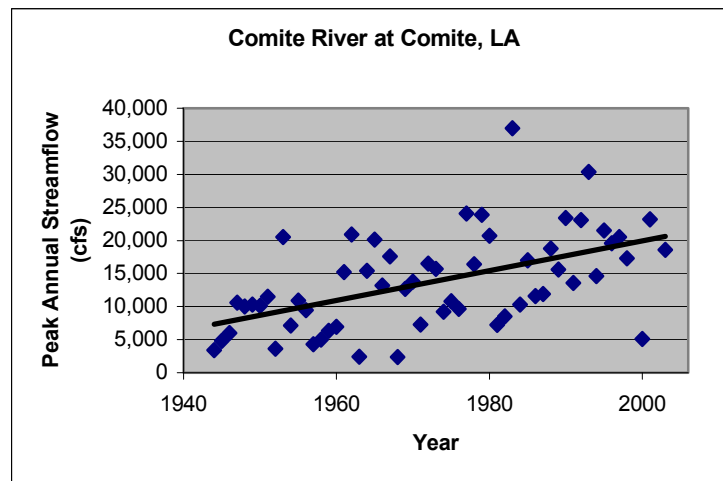
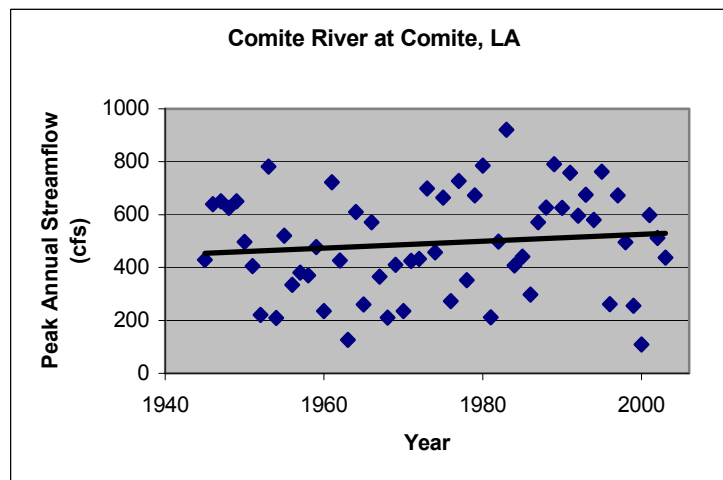
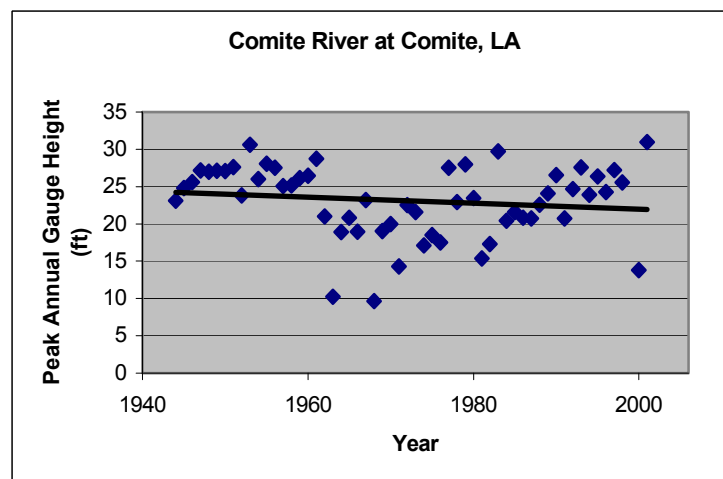
This gauge station is located in a highly urbanized area with the town of Comite on the left bank and Baton Rouge suburbs on the right. Both annual mean and peak annual streamflow shown in Figures 131a and 131b, respectively, increase with time. However, there is a decrease in peak annual gauge height (Figure 131c). An increase in discharge accompanied by a decrease in stage is an indication of channel erosion.

Figure 131. Annual mean streamflow (a), peak annual streamflow (b), and peak annual gauge height (c) for the Comite River at the Louisiana Highway 37 Bridge crossing near Comite, LA.
