## **Fluvial Instability and Channel Degradation of Amite River and its Tributaries, Southwest Mississippi and Southeast Louisiana**

D. Ryan Hood, David M. Patrick, and Maureen K. Corcoran

September 2007

Final report

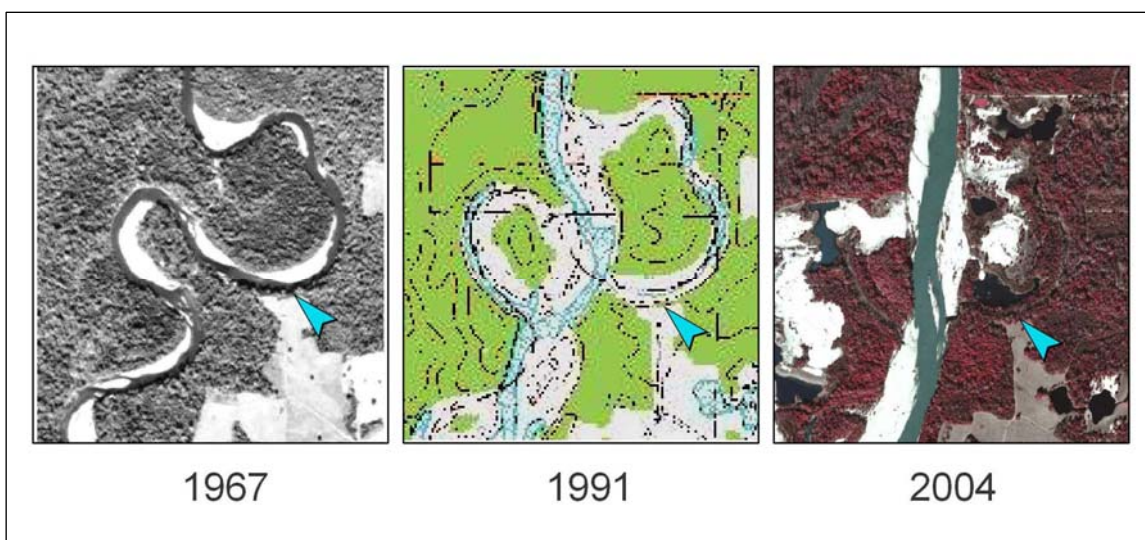
Data from field studies, imagery and bridge surveys indicate significant erosion and changes in stream planform. These changes may be summarized by direct comparison of the planform of the river pre-mining versus successive periods of time as shown in Figure 132. The illustrated area is along a mined reach upstream of Grangeville, LA, and due east of Gilead, LA. The pre-mining image (1967) illustrates well-developed point bars and well-vegetated cut banks. The post-1967 views reveal an increase in point bar size and by 1991, significant cutoffs on the meander bends. By 2004, the river had changed from meandering to nearly straight having been reduced in length by approximately 27 to 29 percent. Imagery and bridge survey data, as well as field data, indicate that the channel has become wider by as much as 233 percent. Bridge survey data, however, do not indicate significant change in channel bed elevation at the crossing sites. Another result, derived from these data, is that the gradient of the channel has increased due to decreased sinuosity. The bank erosion has, thus, been caused by increased water velocity due to the increased gradient.

Figure 132. Planform changes exhibited by the Amite River since the pre-mining period in 1967 (aerial photo), after mining commenced during 1991 (topographic map) and 2004 (Atlas satellite image). Arrows indicate matchpoints on the maps and imagery.

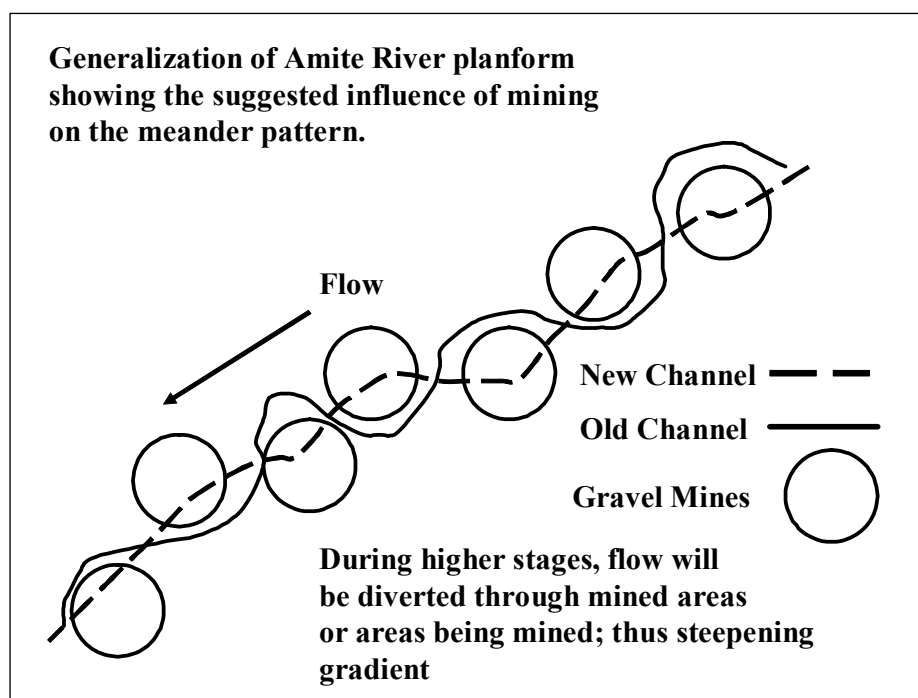
Field studies and imagery have shown that reaches of the river occupy mined areas, divided flow exists in the channel, and bank erosion occurs on both sides of the channel. These data suggest that changes in planform may be explained by breaching of the mined areas during high river stages as shown in Figure 133. The former thalweg of the river is shown as a solid line and the former or current mined areas shown as circles. During high stages the river shifts into the mined areas (dashed line) similar to a natural meander cutoff. The channel shift results in straightening of the river, higher water velocity, and increased erosion on both sides of the channel. The changes in planform and gradient exhibited on the Amite River appear similar to those described by Smith and Winkley (1996) on the Lower Mississippi River and attributed to artificial cutoffs.

Figure 133. Proposed explanation of planform changes due to mining.

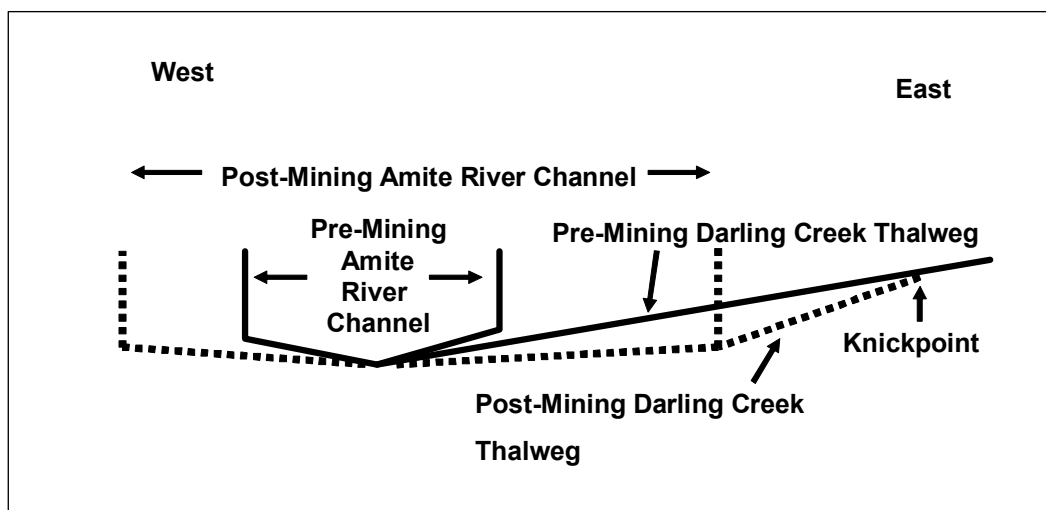
Field studies have shown that bank erosion occurred on Darling Creek, which enters the Amite River within the mined reach north of Grangeville (Figure 1). The erosional processes that explain the erosion on the Amite River main stem may not be applicable to erosion on Darling Creek. Even so, the Amite River erosion has certainly affected the mouth of Darling Creek. As the Amite River became wider, erosion occurred at the mouth of

the tributary as shown in Figure 134. The widening of the Amite River caused the gradient of the tributary to increase forming a knickpoint and the upstream progression of erosion (headcutting).

Figure 134. Generalized west-east cross-section of the Amite River and tributary along the mined reach.

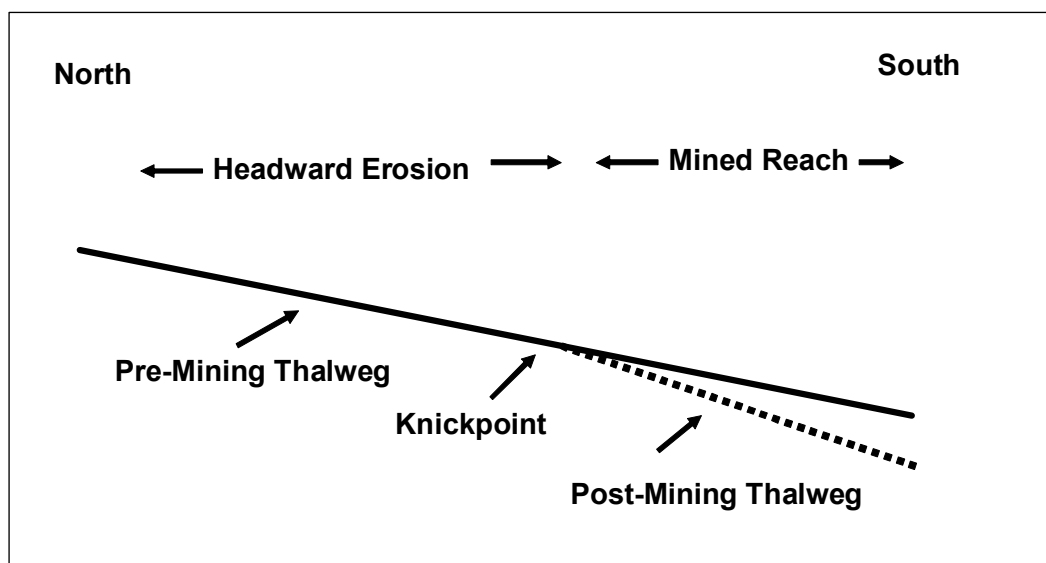
Field studies and imagery have shown that erosion occurred on the main stem of the Amite River upstream of the mined reach and on the tributaries as well. Imagery demonstrated that the stream length decreased by approximately 5 percent in the vicinity of the East Fork and West Fork confluence and at Felixville, the channel width has increased by 25 percent. These data indicate that there has been an increase in channel gradient along this upstream reach. As in the case of the tributaries along the mined reach, a knickpoint was formed and headward erosion progressed upstream as shown in Figure 135.

Figure 135. Generalized north-south cross-section of the Amite River showing the knickpoint resulting from the steepened gradient on the mined reach.
