TECHNICAL REPORT SL-83-6

AN EVALUATION OF THE SEPARATED BAY CONCEPT FOR A MUNITION ASSEMBLY COMPLEX; AN EXPERIMENTAL INVESTIGATION OF THE DEPARTMENT OF ENERGY BUILDING 12-64 COMPLEX

Robert D. Volz, Sam A. Kiger

September 1983

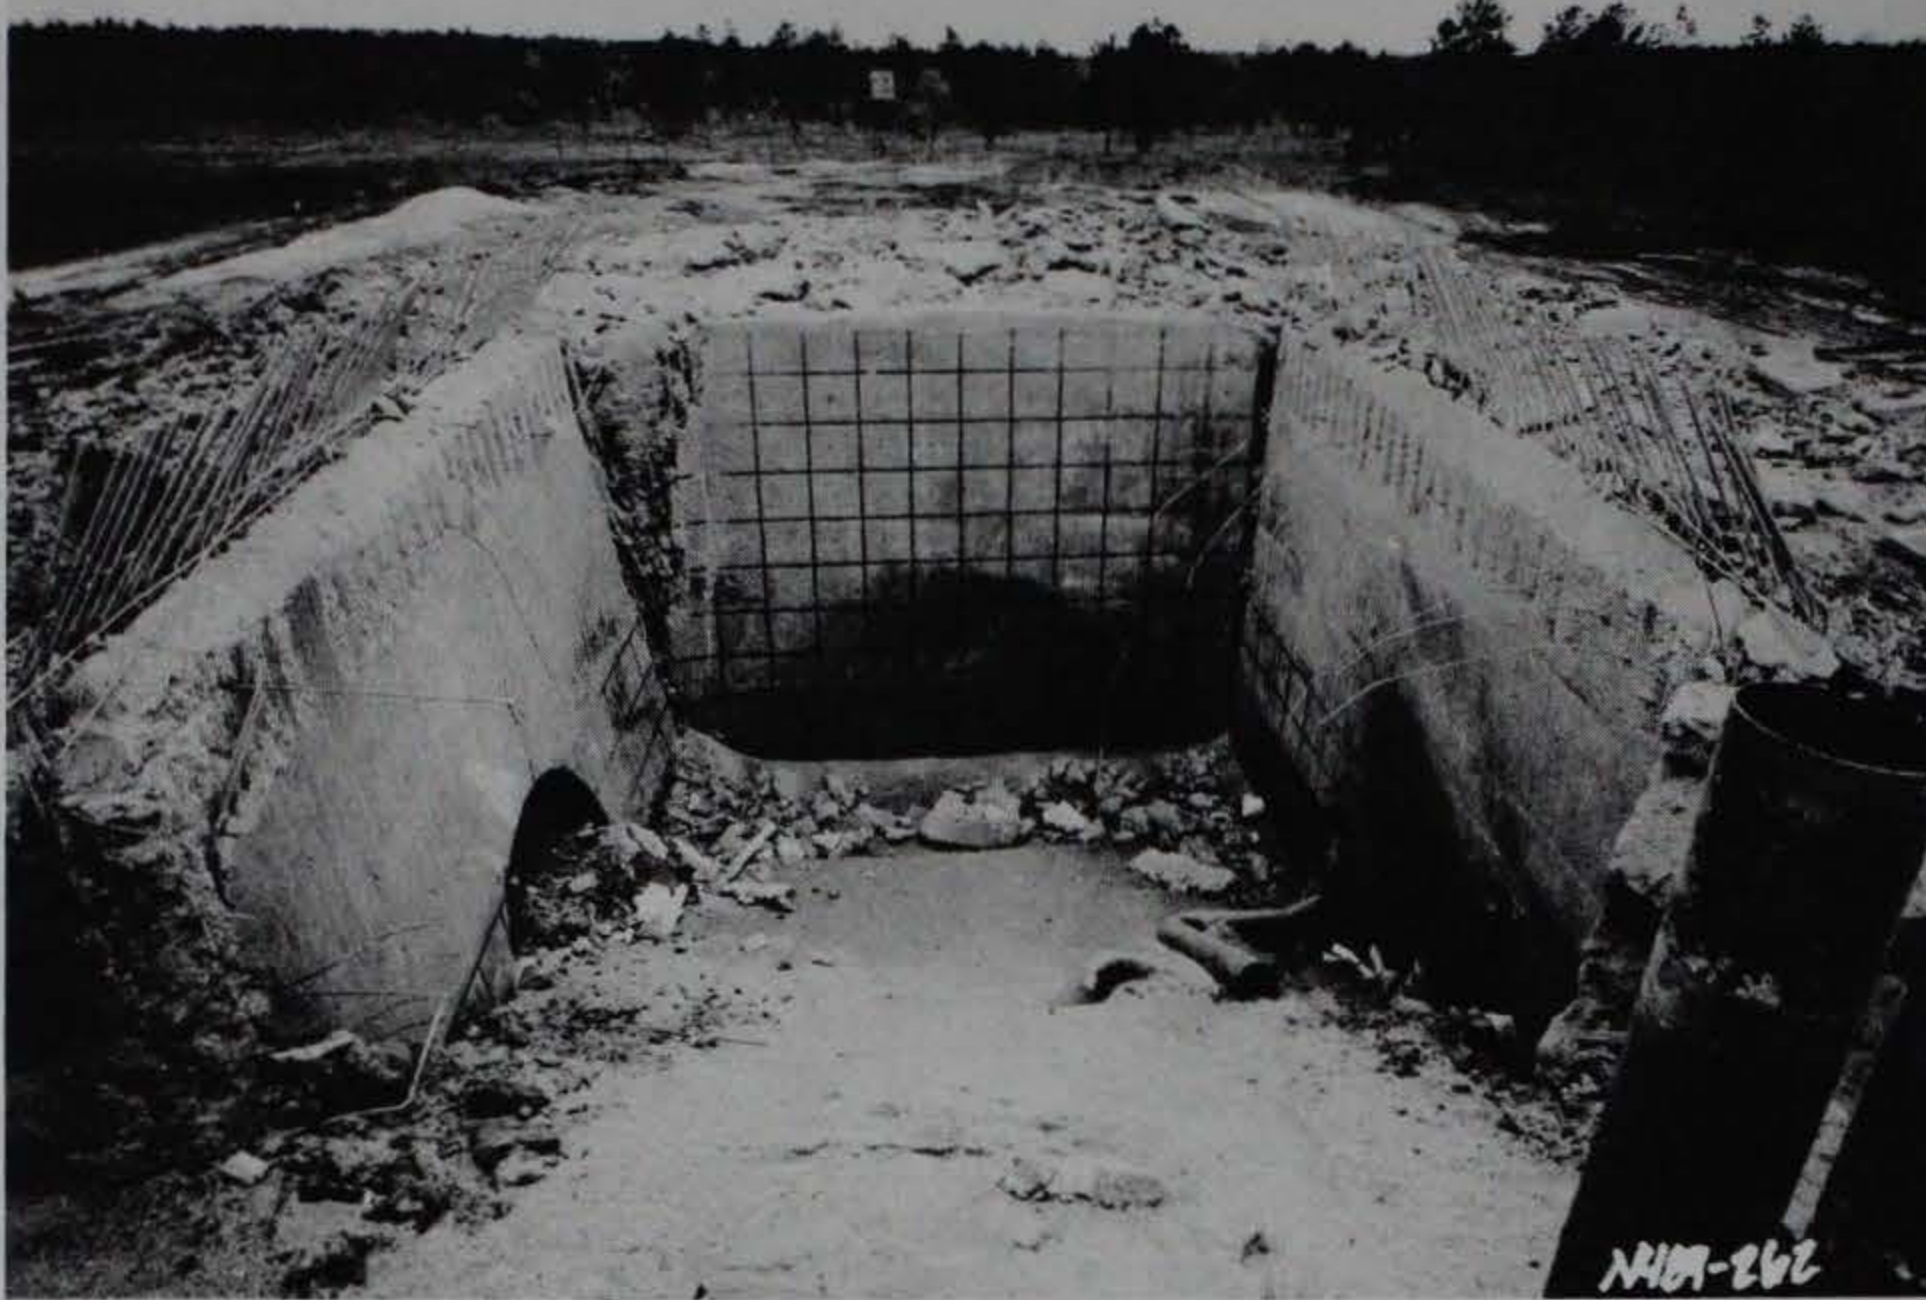
Figure 4.2. Posttest view of donor bay.

An overall view of the donor bay immediately after the test is shown in Figure 4.2. The roof disengaged and completely separated from the bay leaving only a few No. 5 bars which had pulled out of the roof slab. The roof slab broke into two major fragments which impacted to the east and west of the donor bay. The north wall completely separated from the floor and the east and west walls and fell back onto the bay floor. The east wall was displaced and rotated away from the center of the bay, and the corrugated entrance pipe was destroyed. The south and west walls suffered much less severe damage. Post-test donor bay relative displacements were measured between the east and west walls and are listed in Table 4.3.

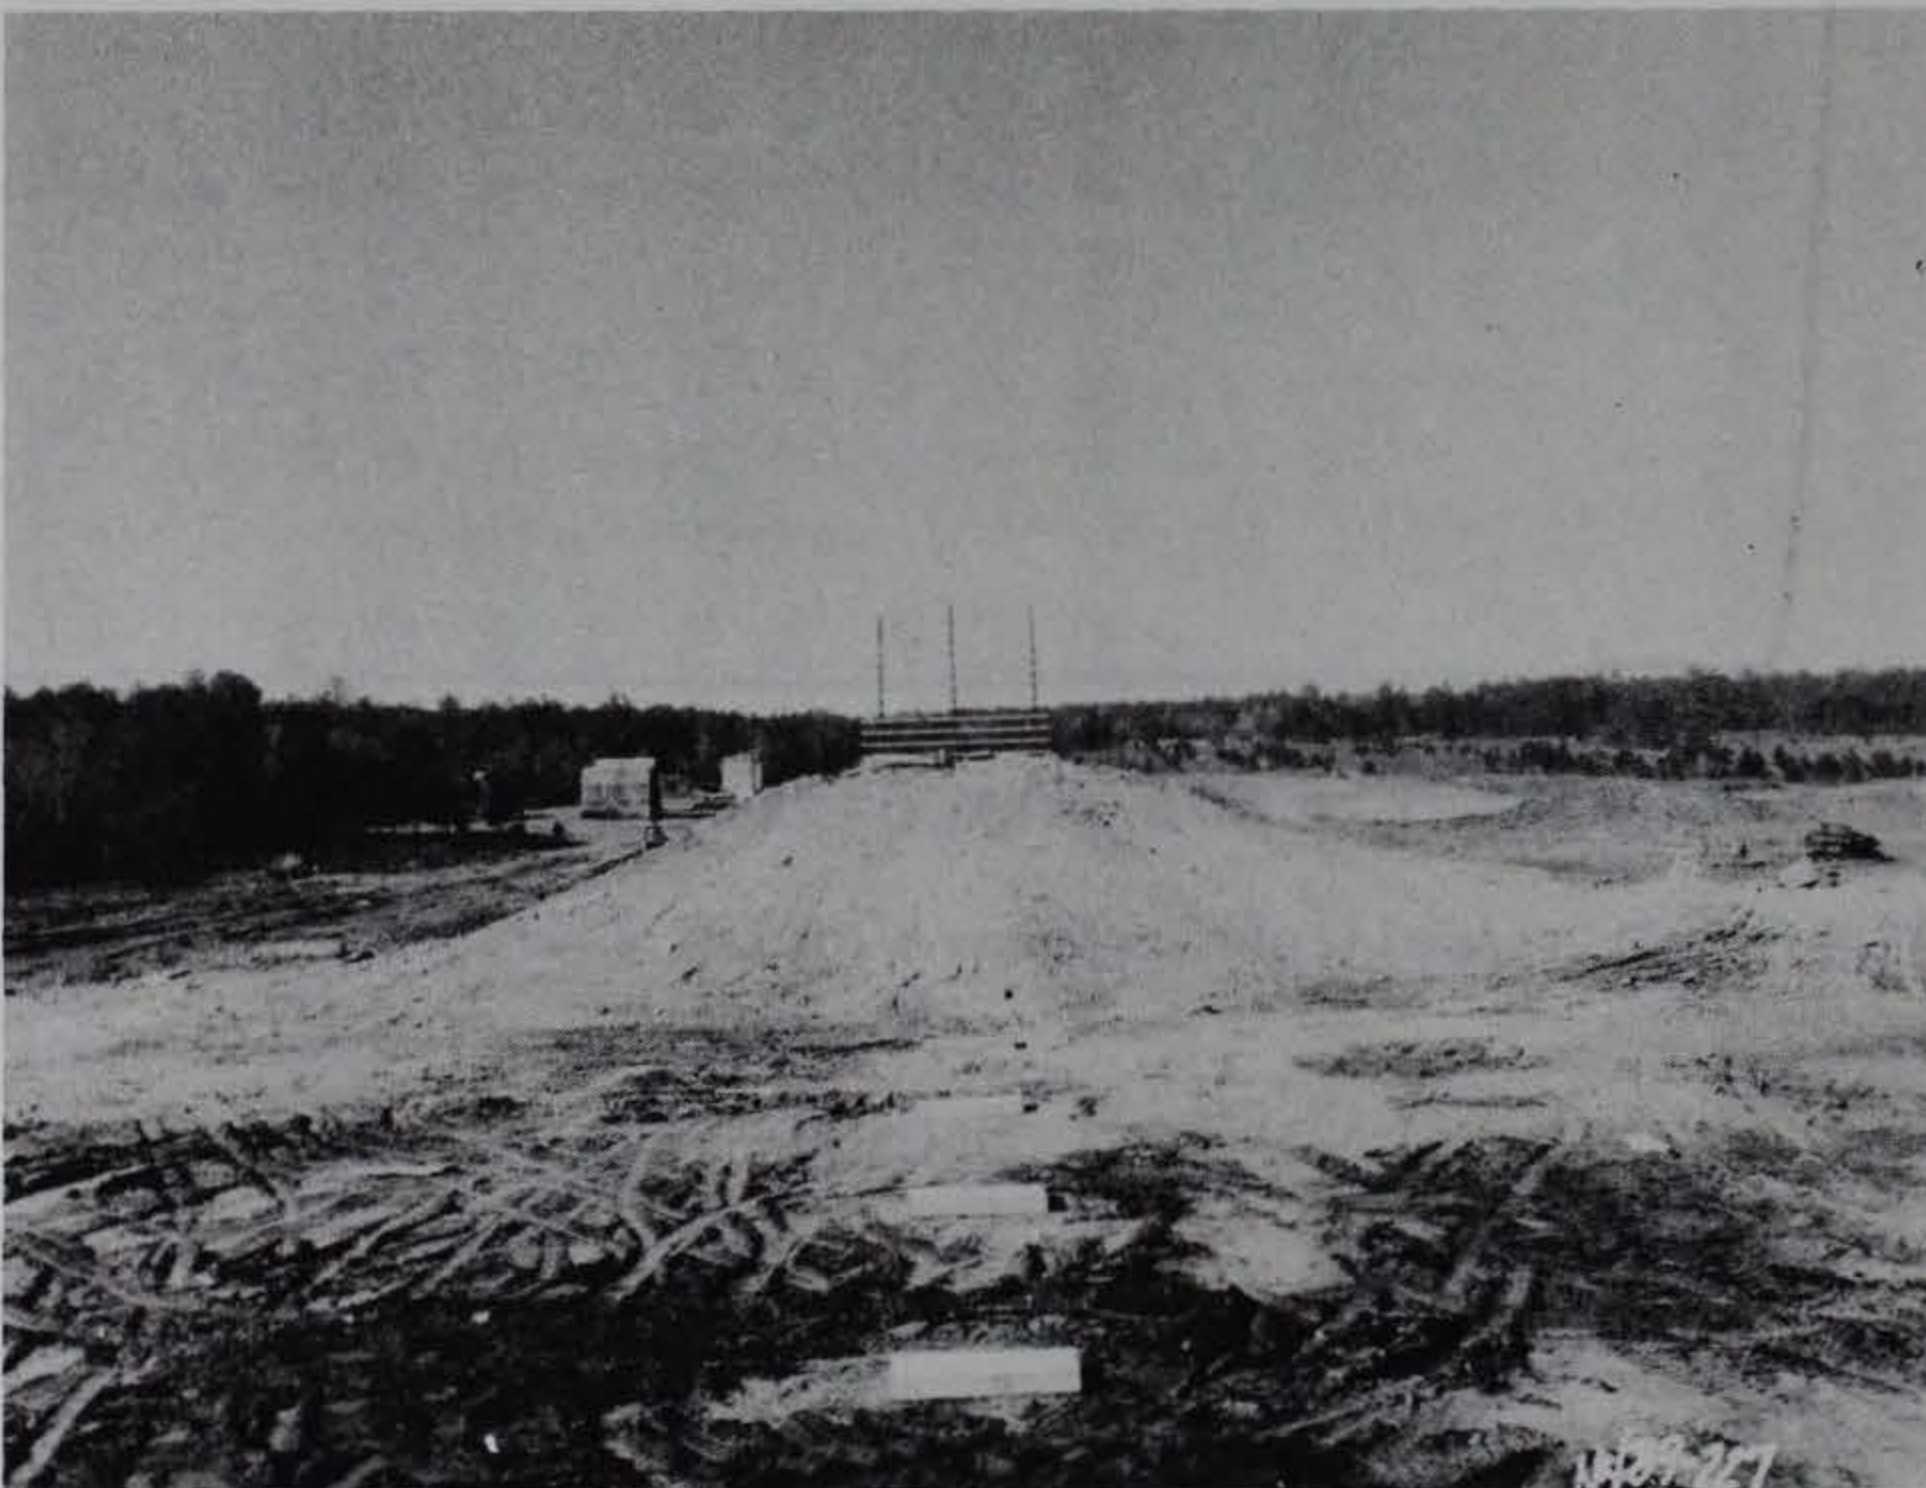
Figure 4.3. Posttest view of Phase I test site.

The roof slab broke into two major fragments, approximately 9 by 31 ft in plan, which impacted 104 ft to the east and 102 ft to the west of the bay (Figure 4.3). Analysis of high-speed photography from camera station 1 revealed that the major roof fragment on the west side of the bay achieved a terminal velocity of 52 fps. The two major roof slab fragments are shown in Figures 4.4 and 4.5. The concrete covering the rebar splices at the east and west edges was spalled away from the bars. These secondary fragments were primarily distributed on the east and west backfill slopes, as shown in Figure 4.6.

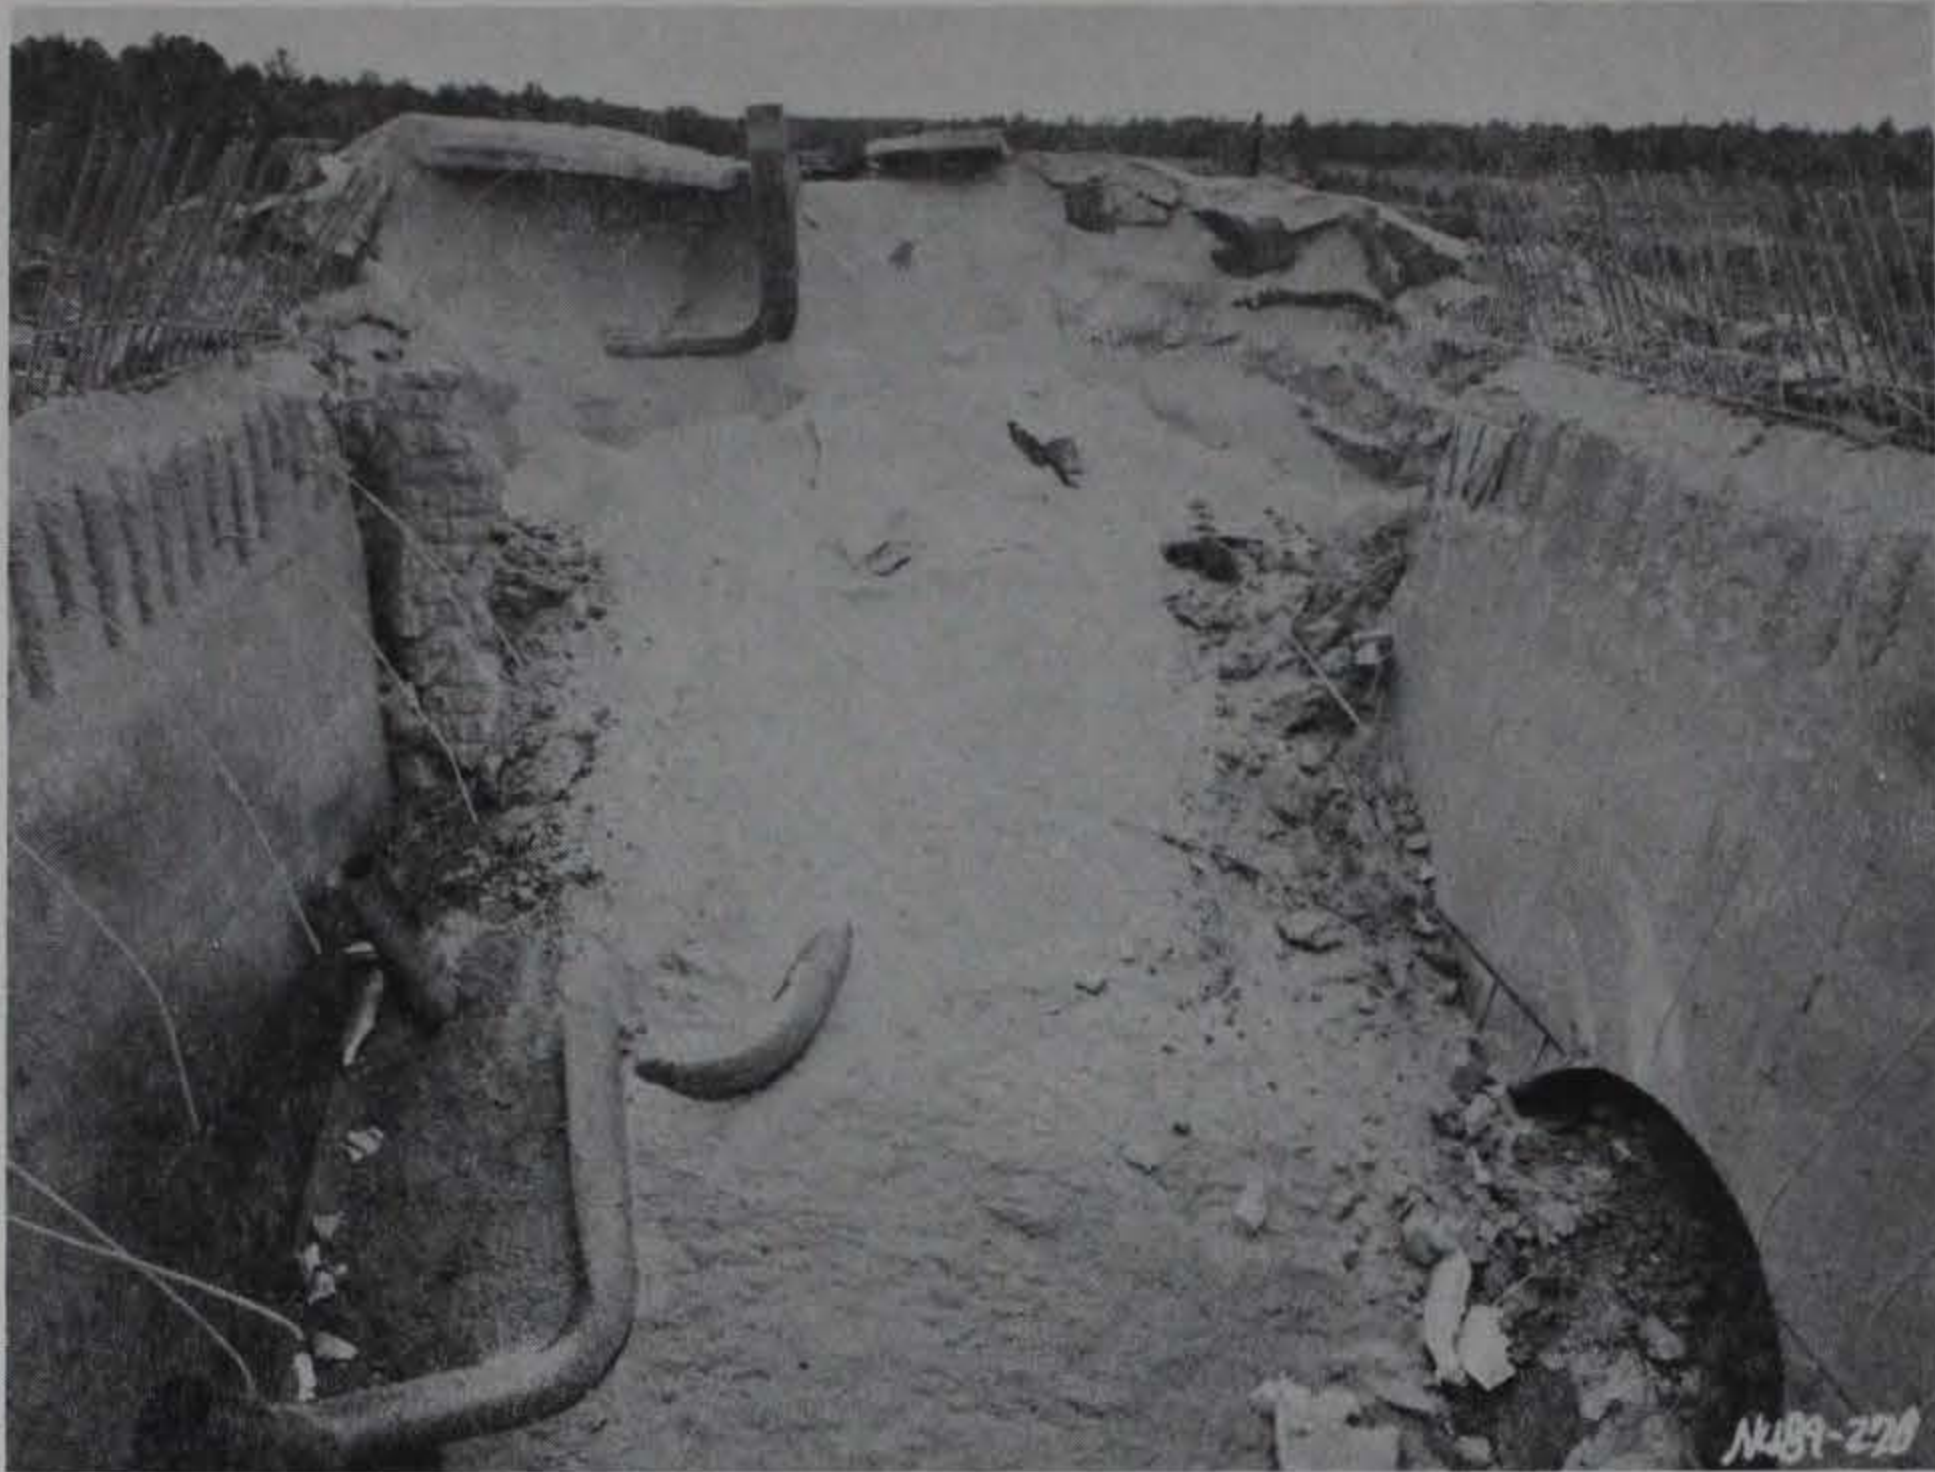
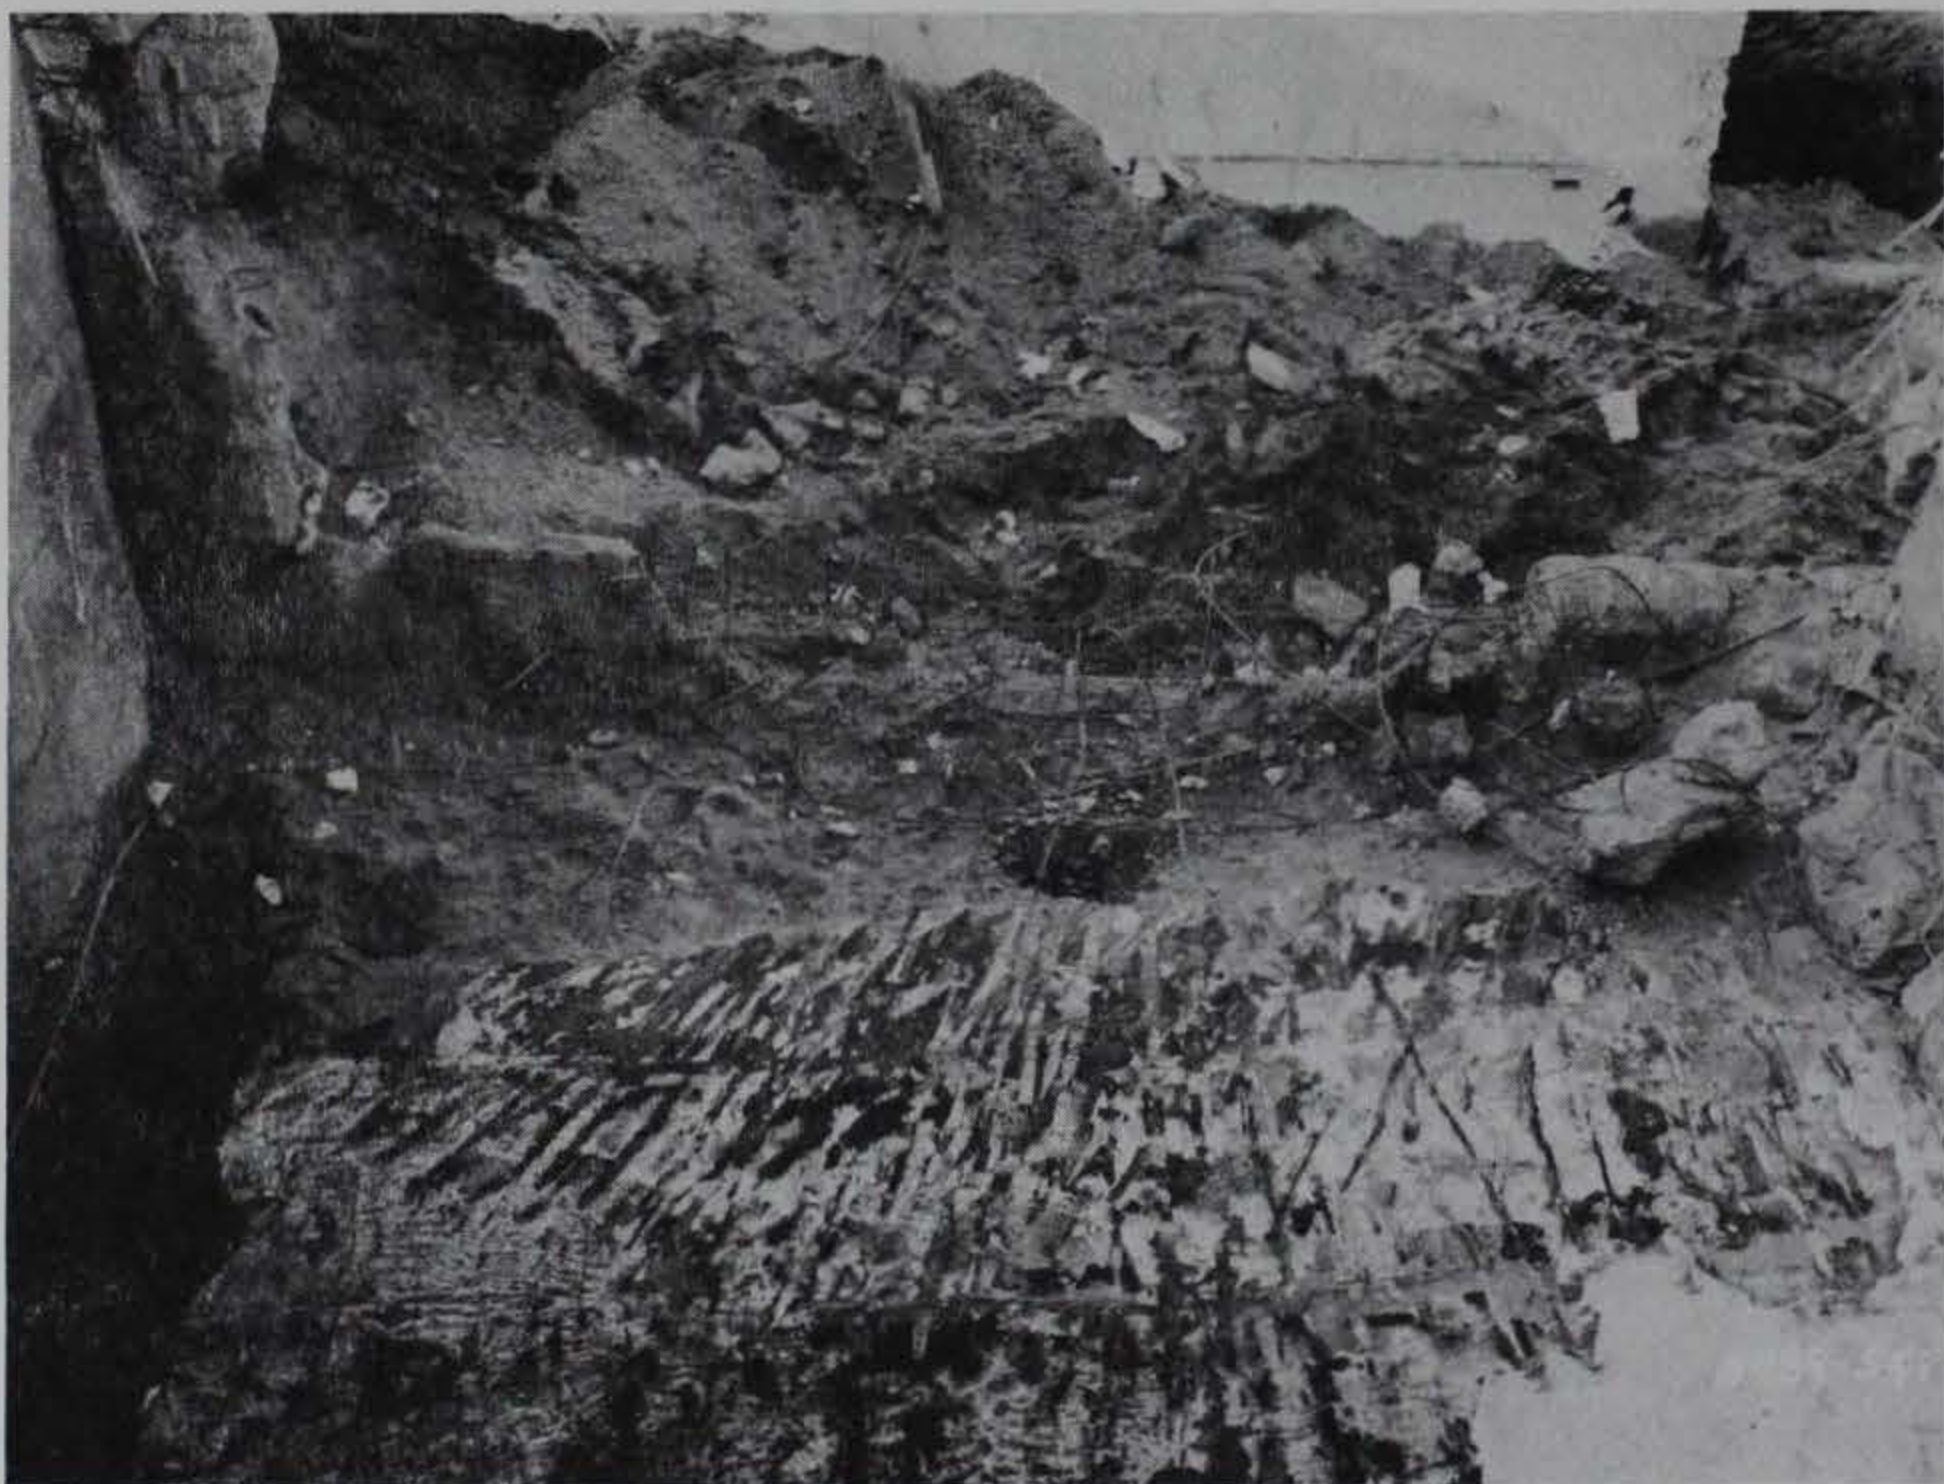
Figure 4.11. Posttest view of north donor bay wall
(Sheet 1 of 3).

Figure 4.11a shows the north wall shortly after the test event. The wall was excavated to remove the sand backfill which fell back into the bay. Figure 4.11b shows the exterior face of the north wall. The collapse of the wall left all No. 8 dowel bars joining the floor to the wall intact. The wall broke away from the floor slab as shown in Figure 4.11c. The portion of the wall left standing on either side of the center of the wall was 36 in. high and was broken flush with the top of the floor dowels. The wall's inside face vertical No. 8 rebar merely pulled away from the dowels without apparent deformation. Of the outside face vertical No. 4 rebar, 9 bars pulled out and 11 were broken. The center of the wall adjacent to the charge location was crushed and spalled. The distance from the top of the wall to the spalled and crushed area was 14 ft 10 in.

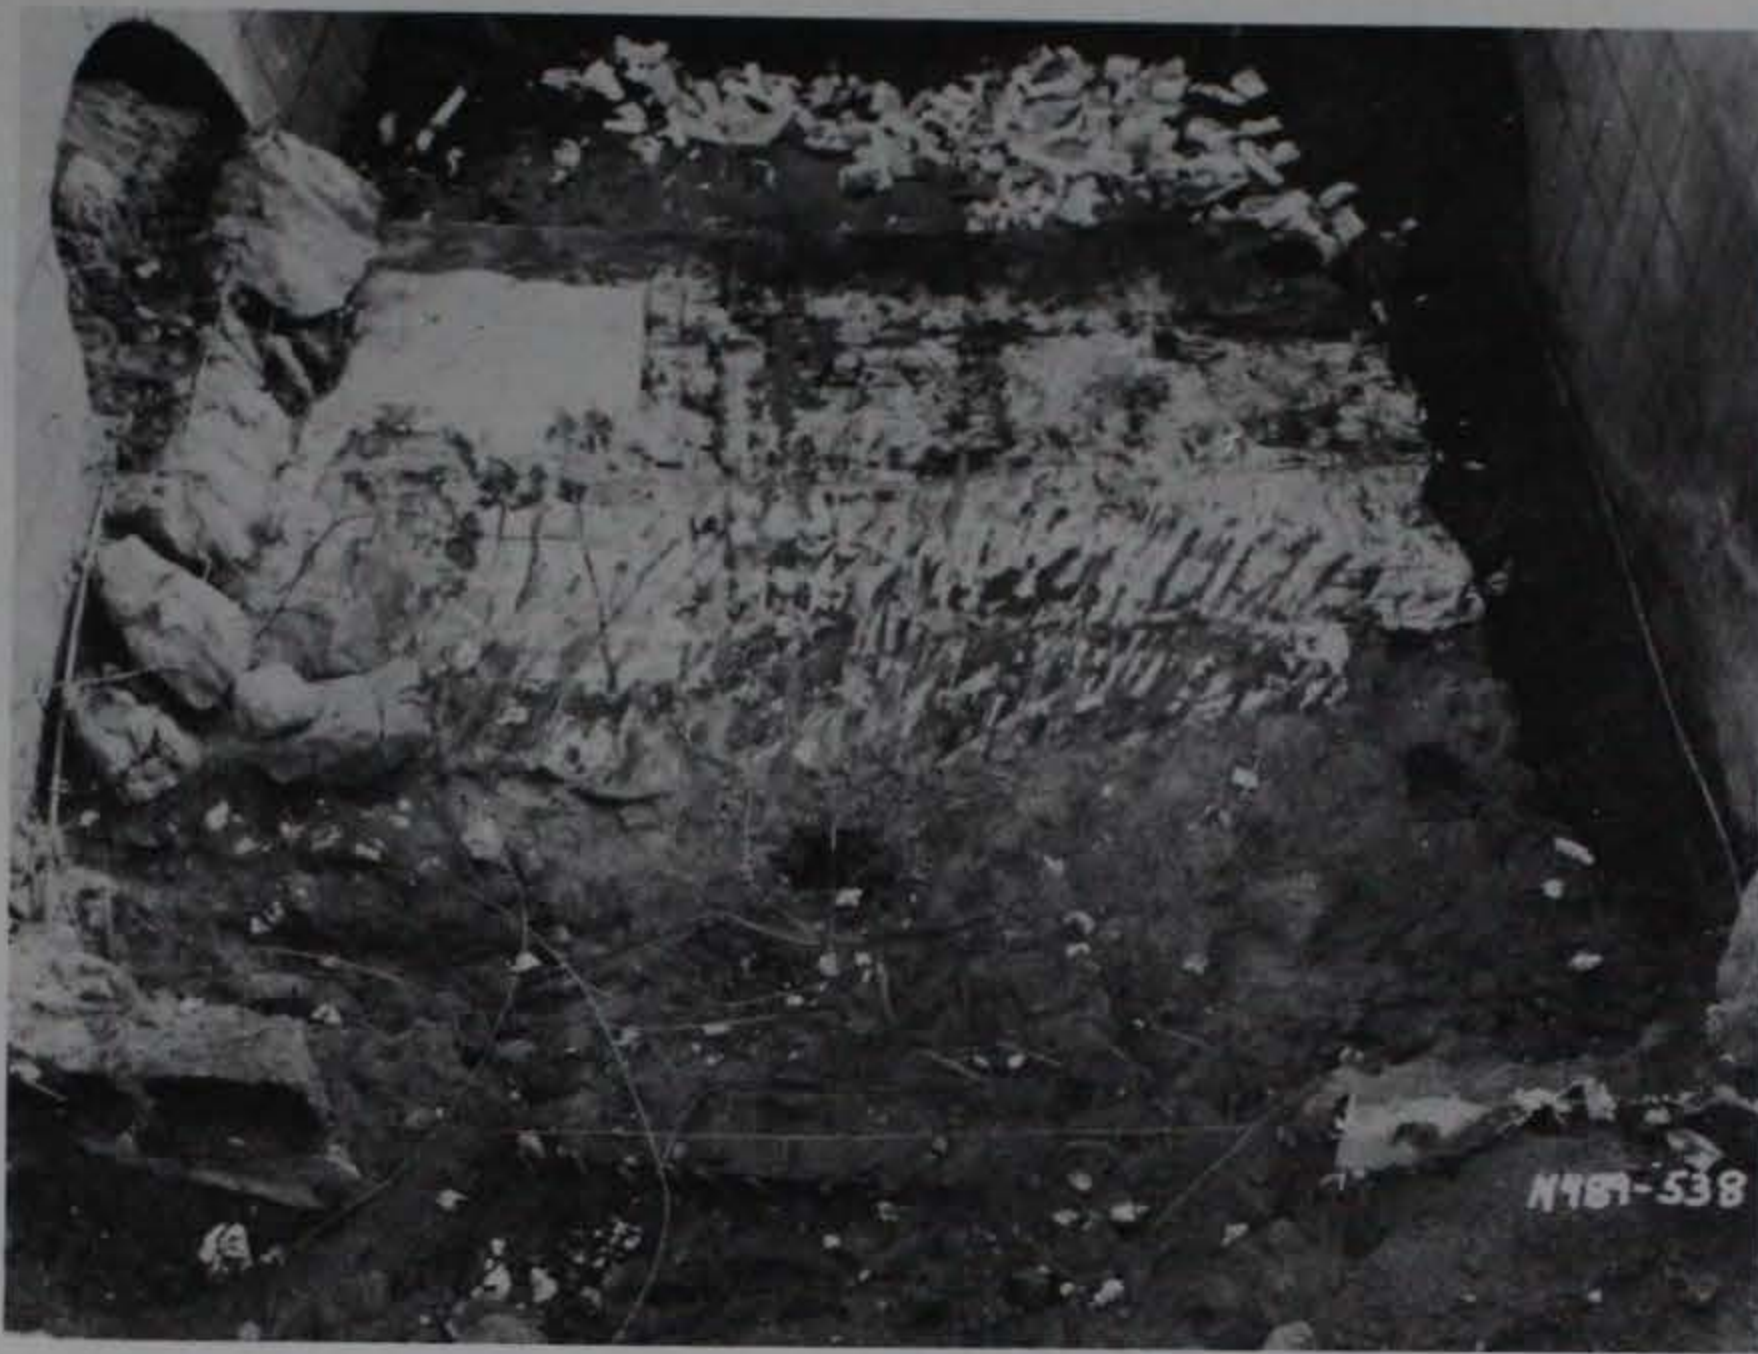
c. South view after excavation.

Damage to the north walls of the two bays can be compared using Figures 4.11 and 5.6. Both walls experienced cracking at the corners and the development of hinge mechanisms a small distance from each corner. But the large displacements of the walls in the Phase I structure produced much more severe damage and resulted in the collapse of the wall.

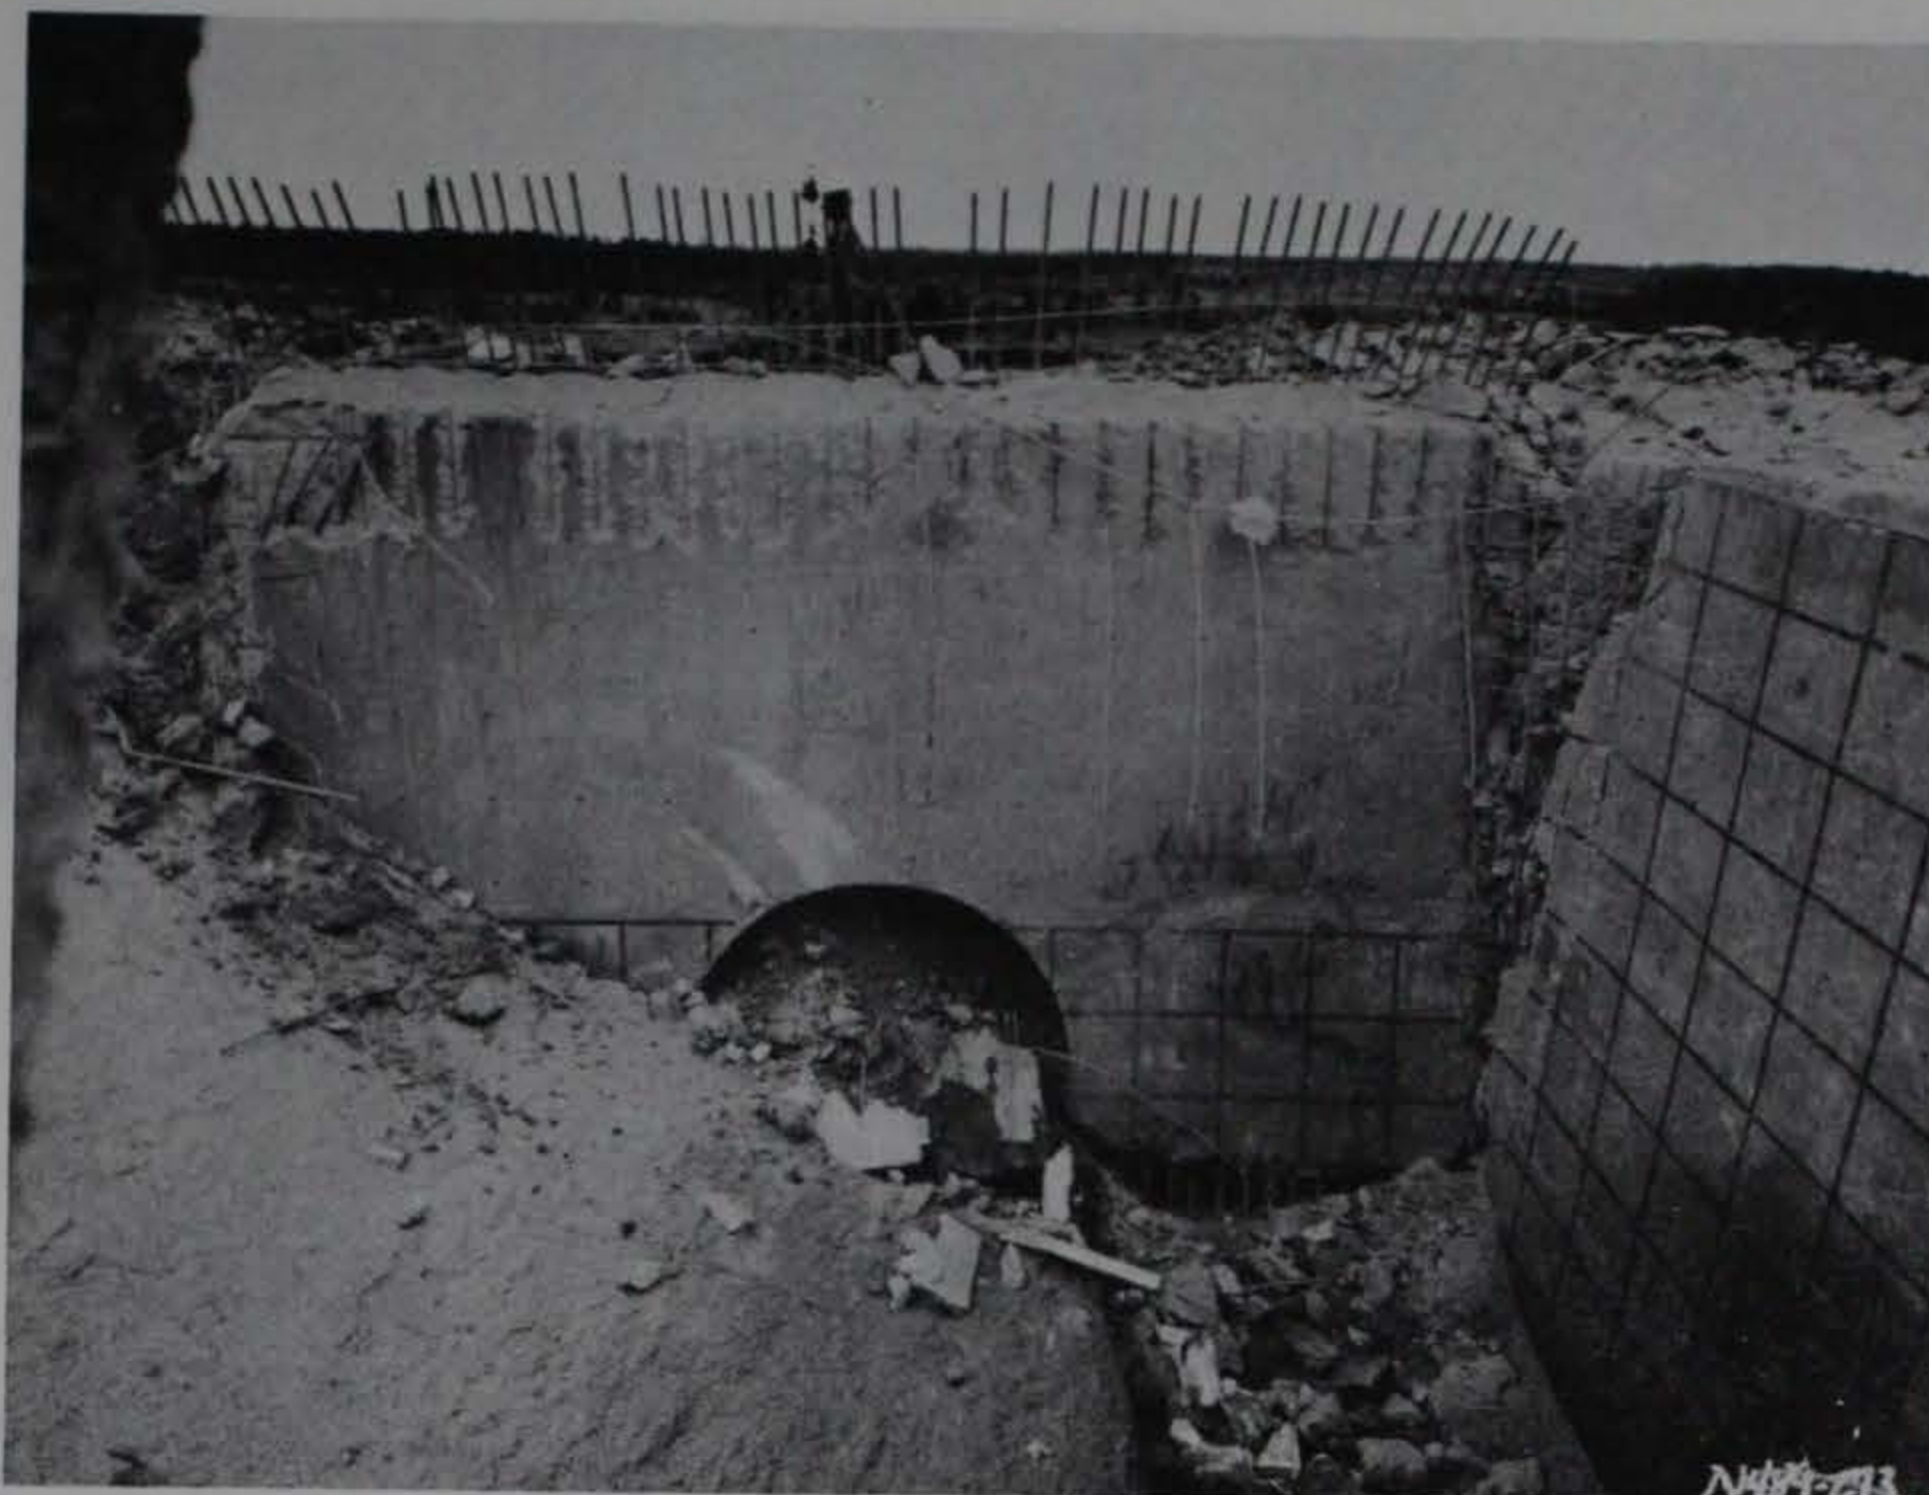
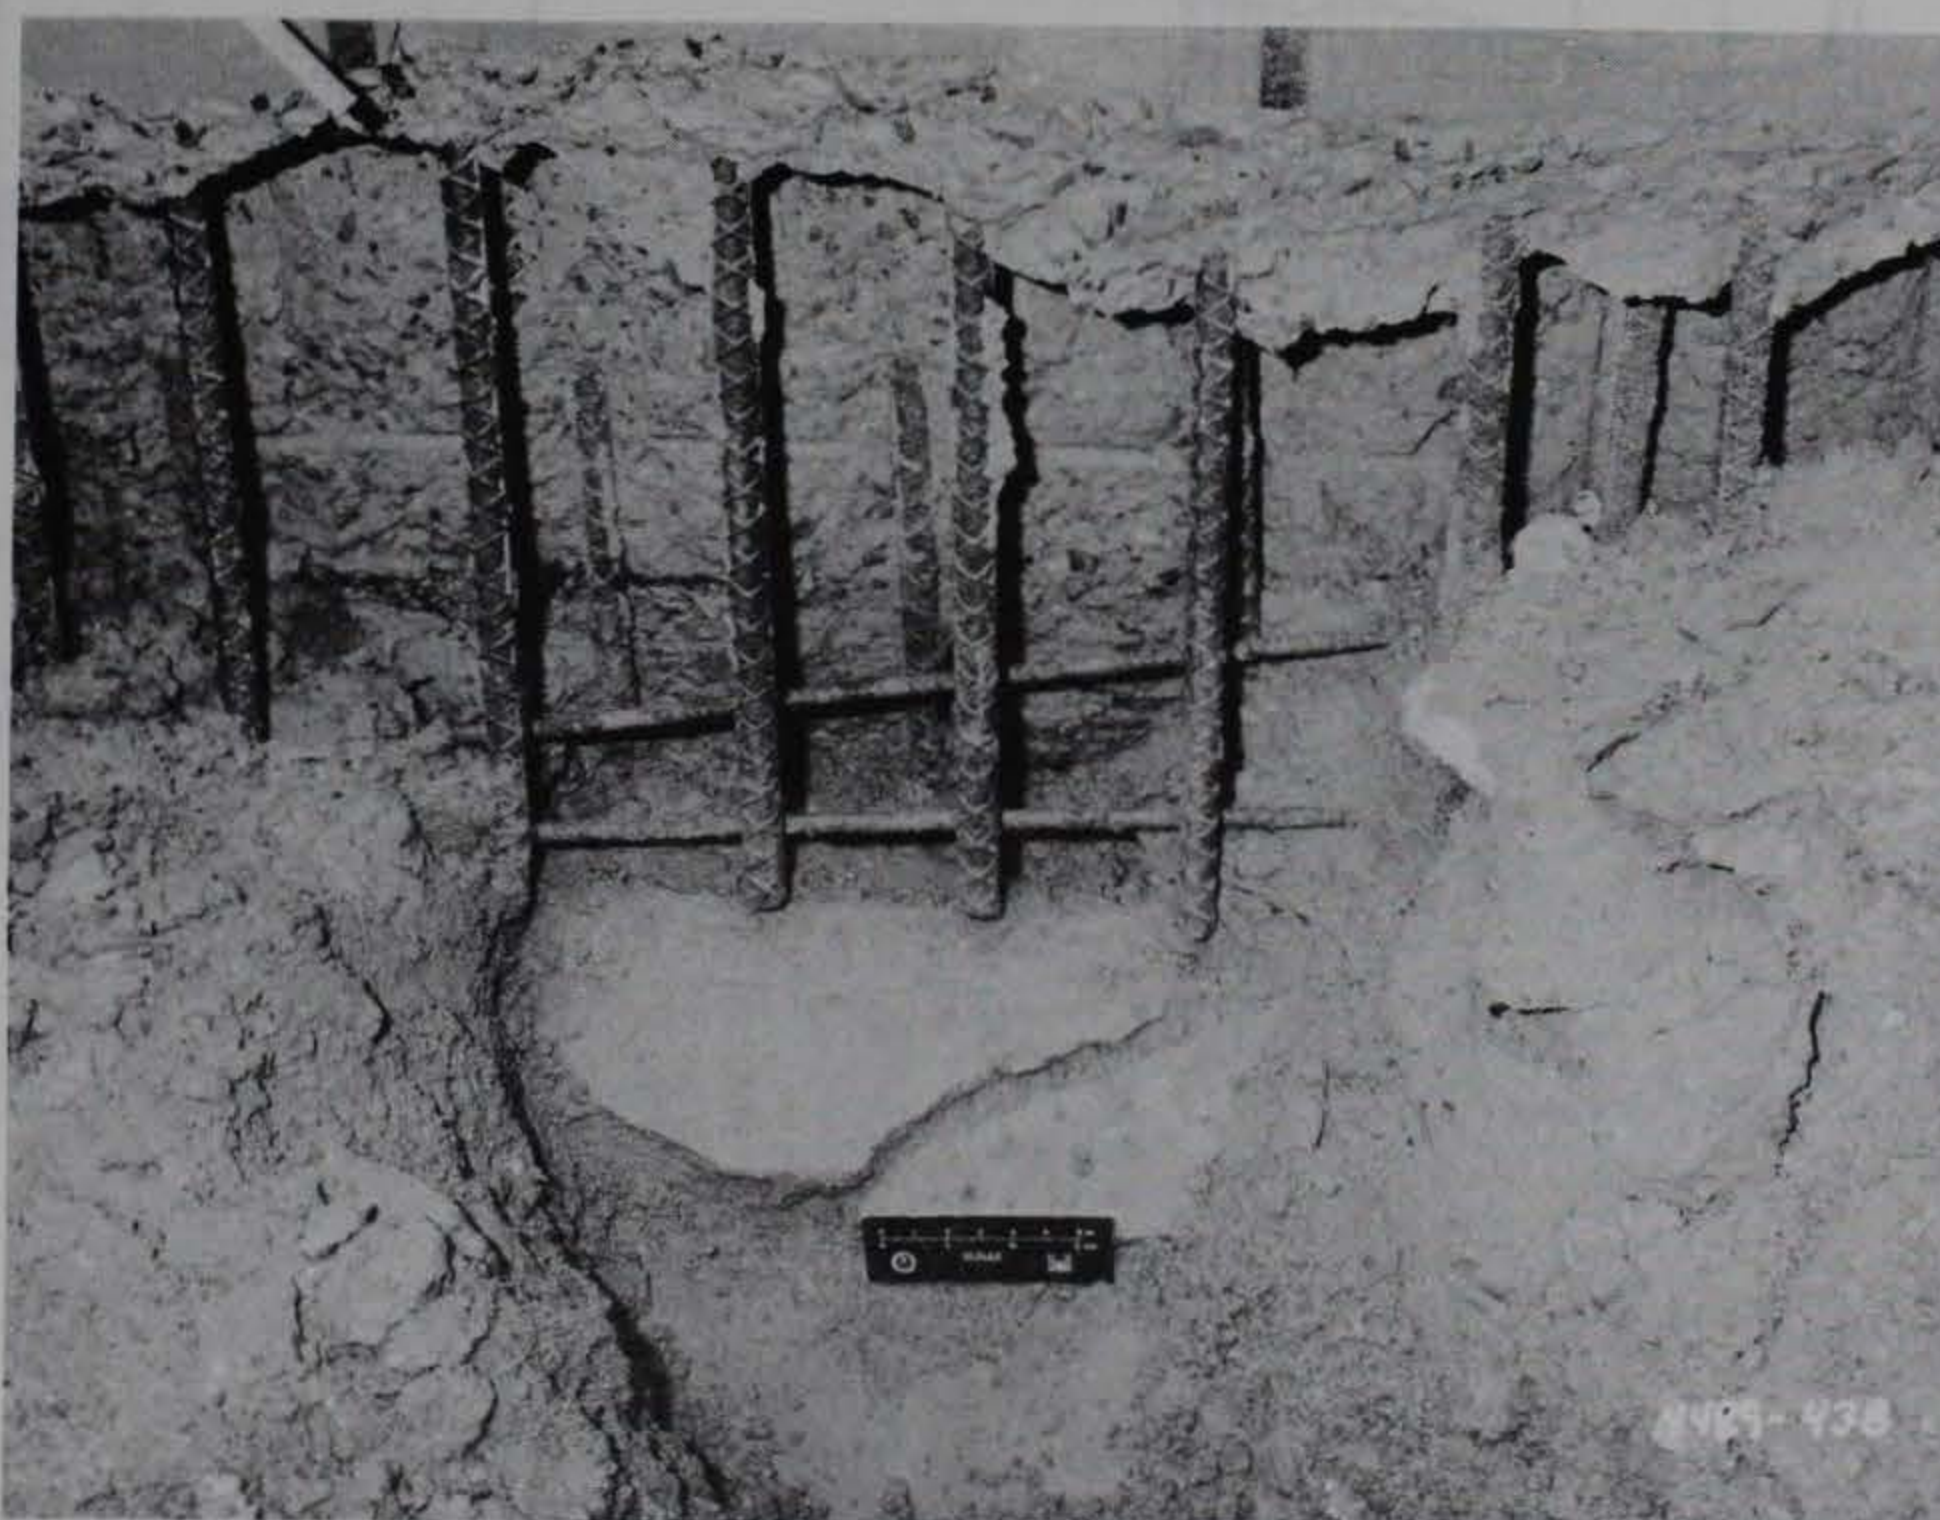
Figure 4.12. Posttest view of east donor bay wall.

a. Overall view.

b. Reinforcement separation at base of wall.
