TECHNICAL REPORT SL-83-6

AN EVALUATION OF THE SEPARATED BAY CONCEPT FOR A MUNITION ASSEMBLY COMPLEX; AN EXPERIMENTAL INVESTIGATION OF THE DEPARTMENT OF ENERGY BUILDING 12-64 COMPLEX

Robert D. Volz, Sam A. Kiger

September 1983

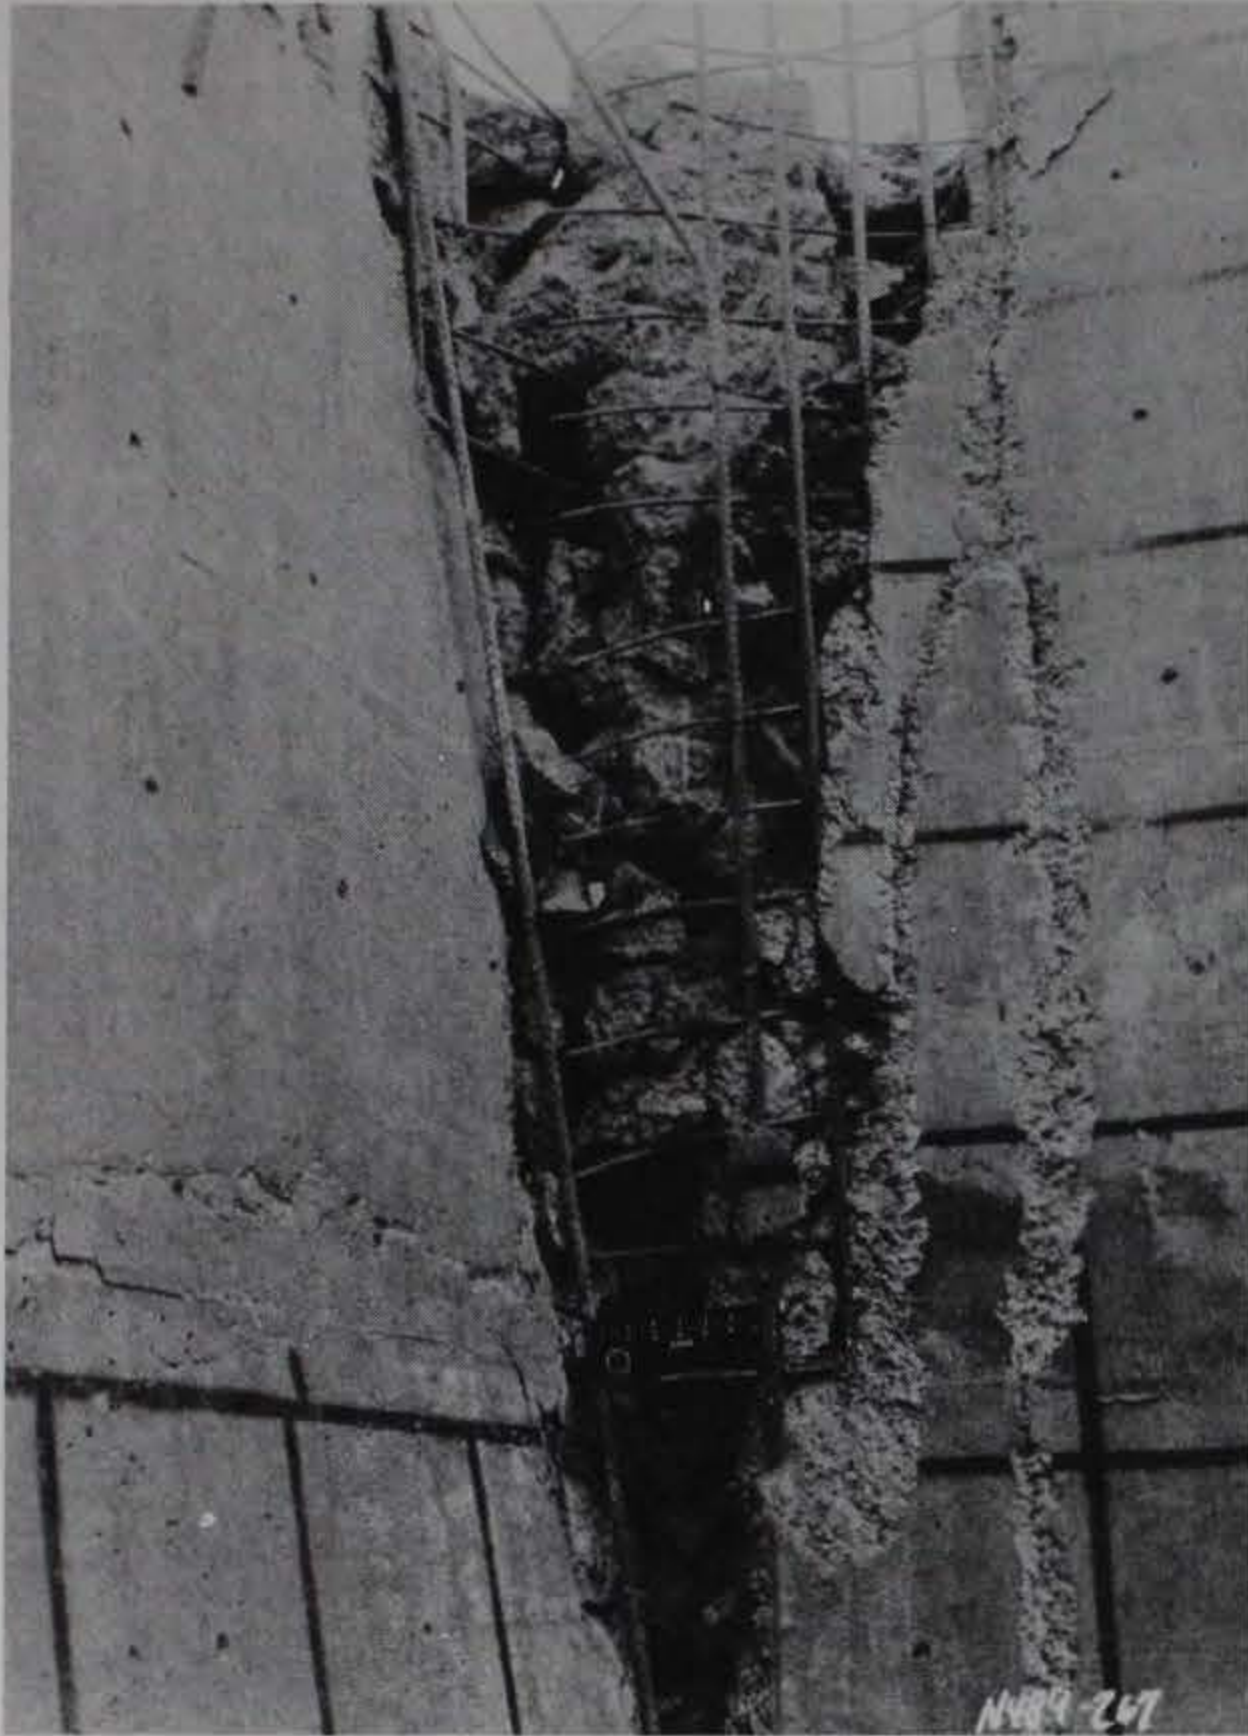
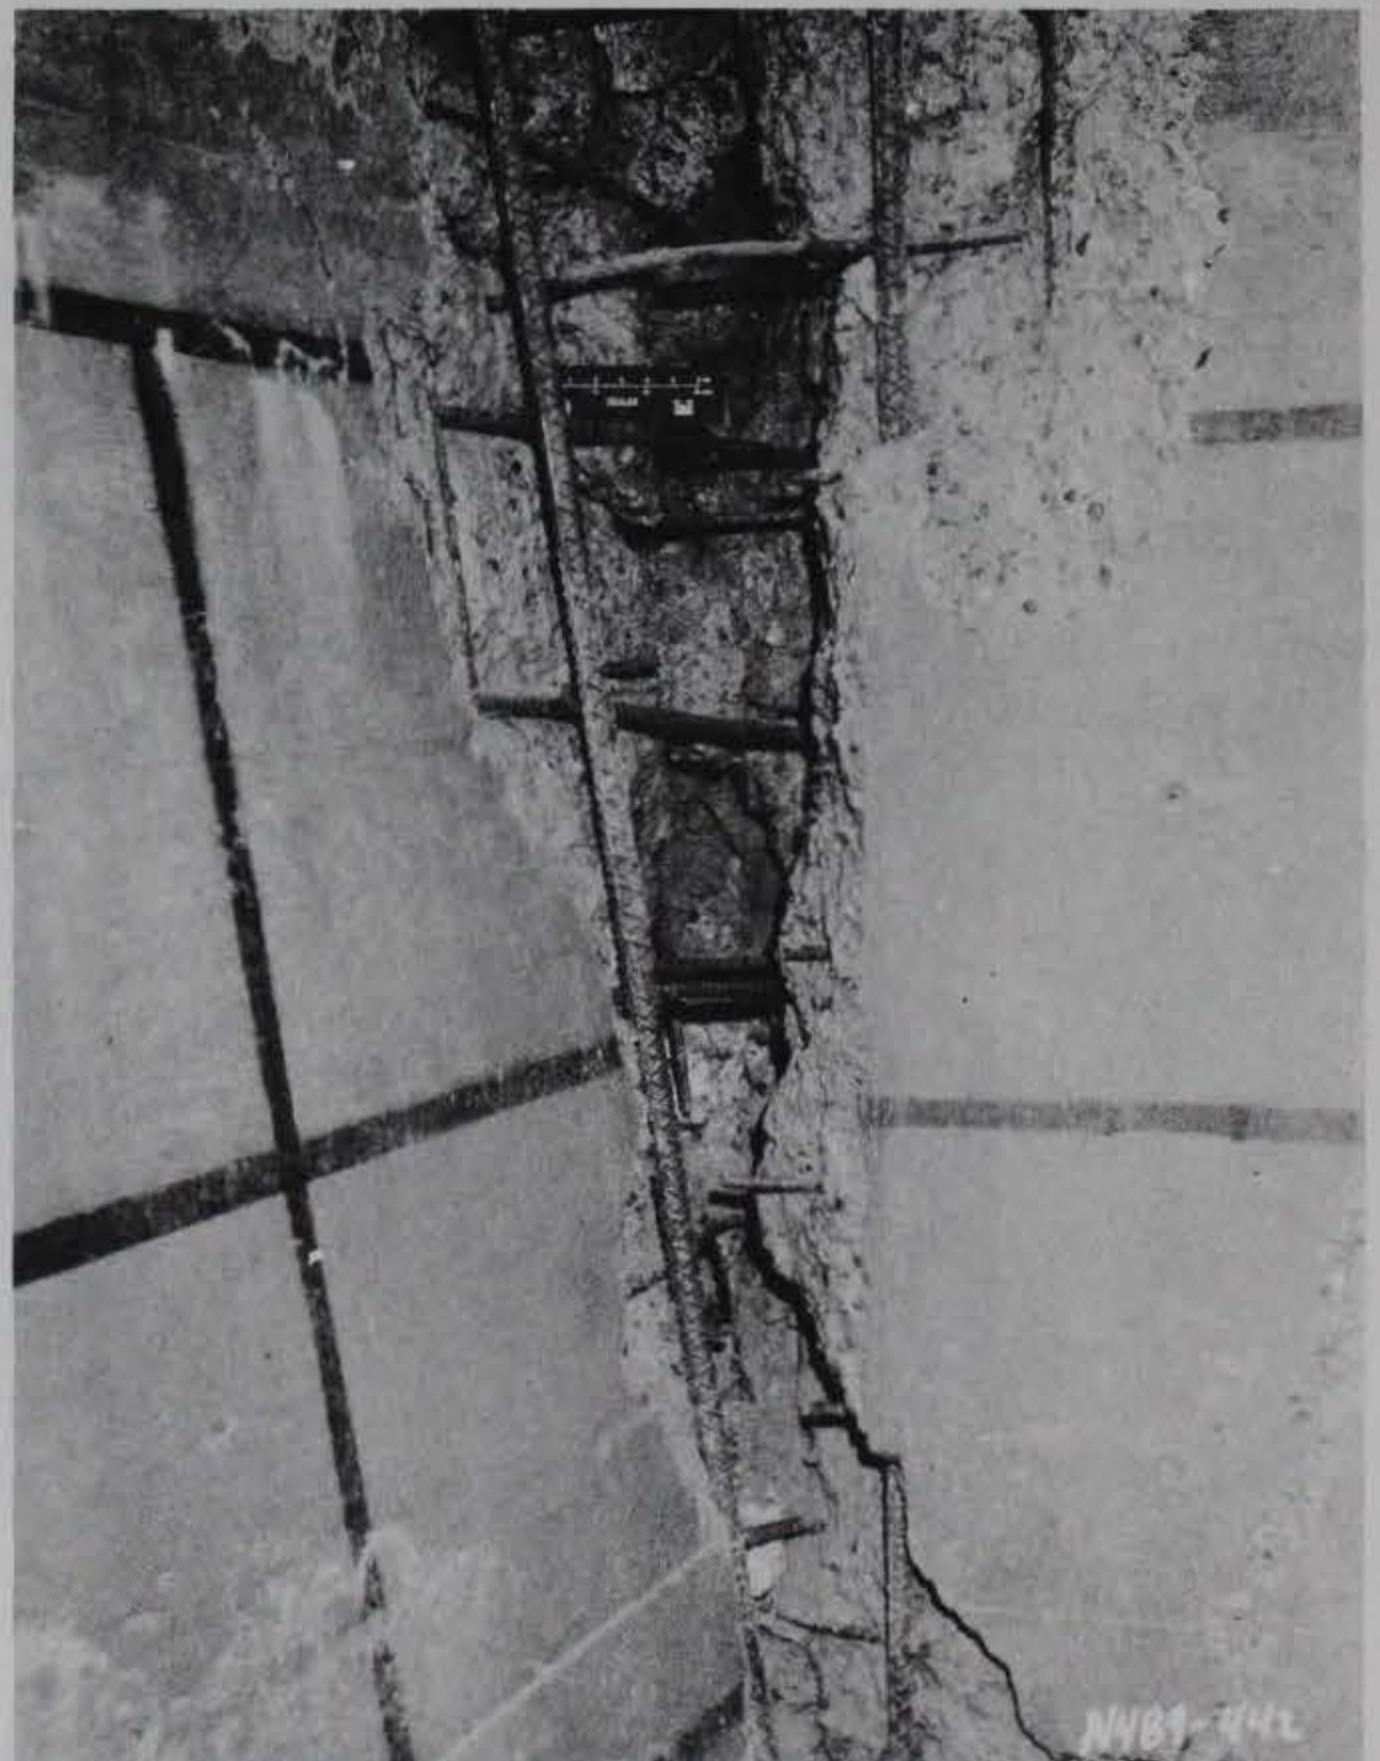
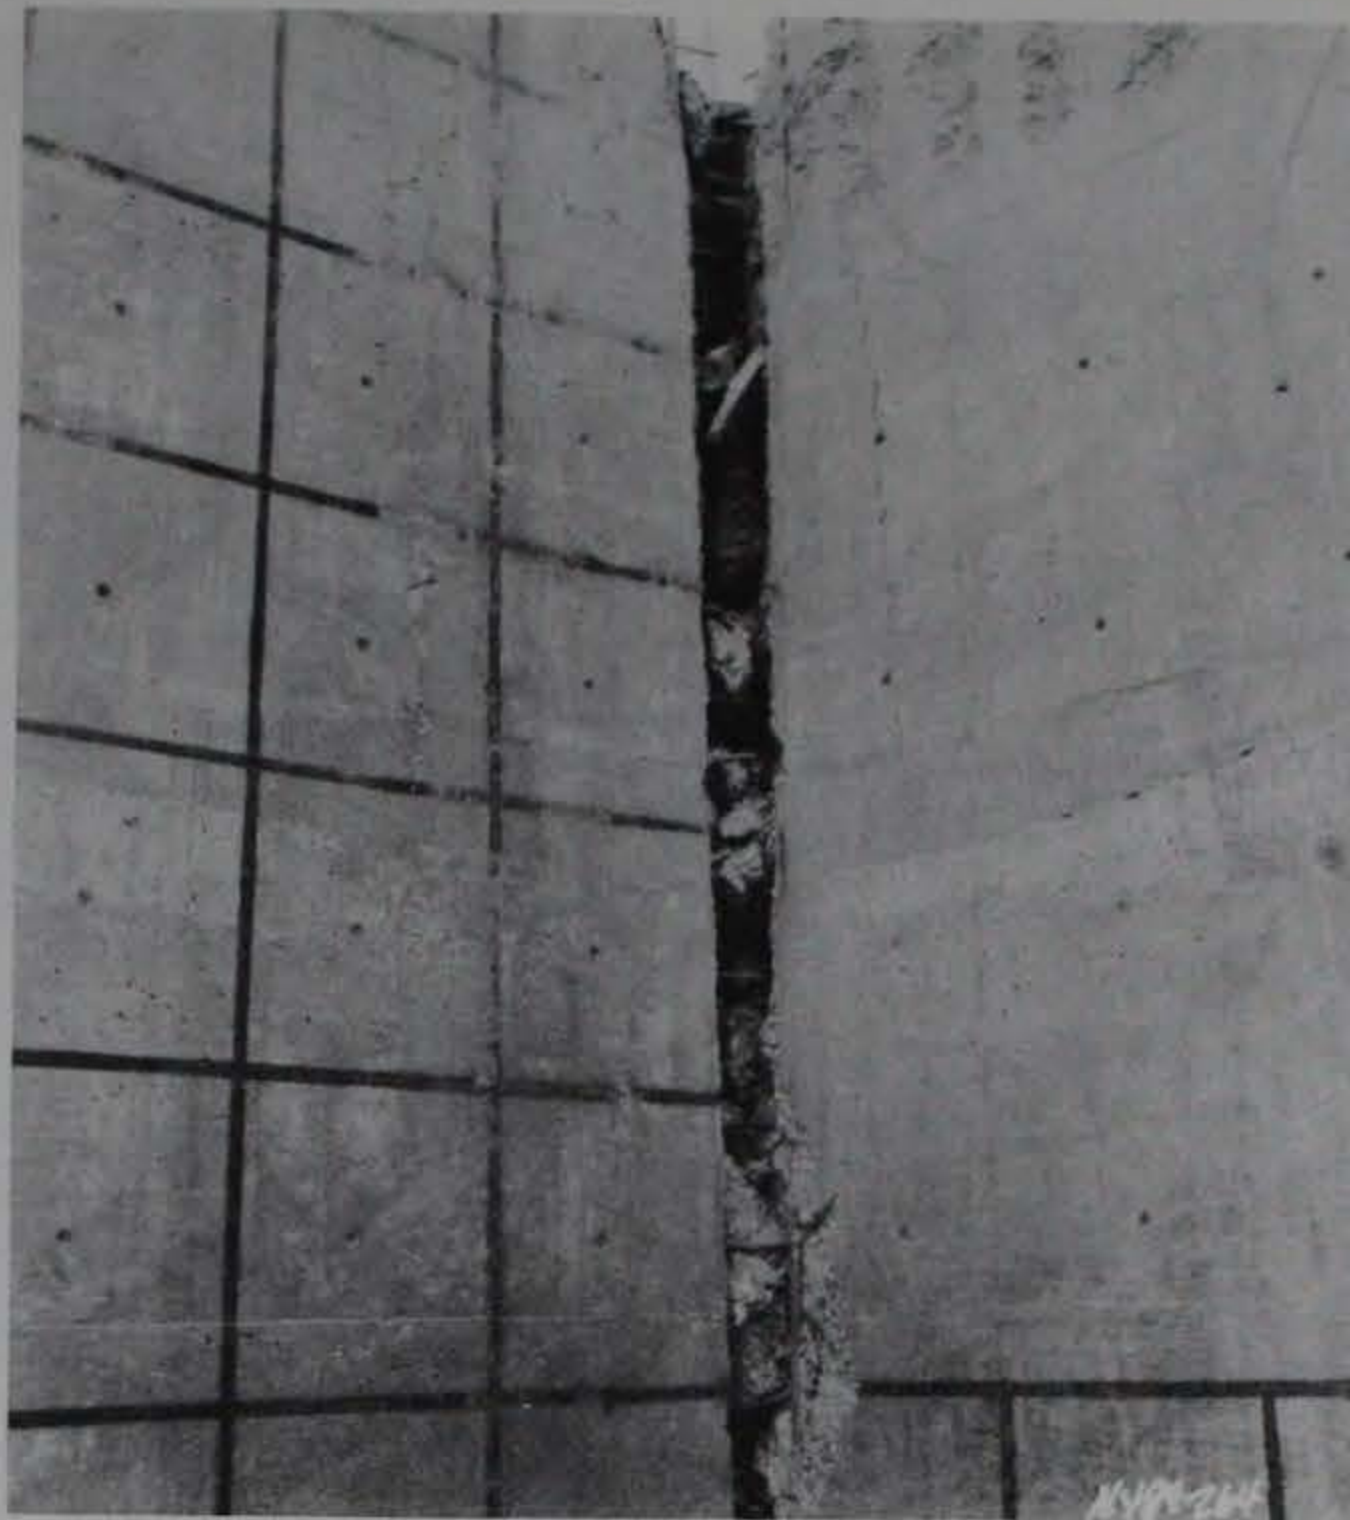
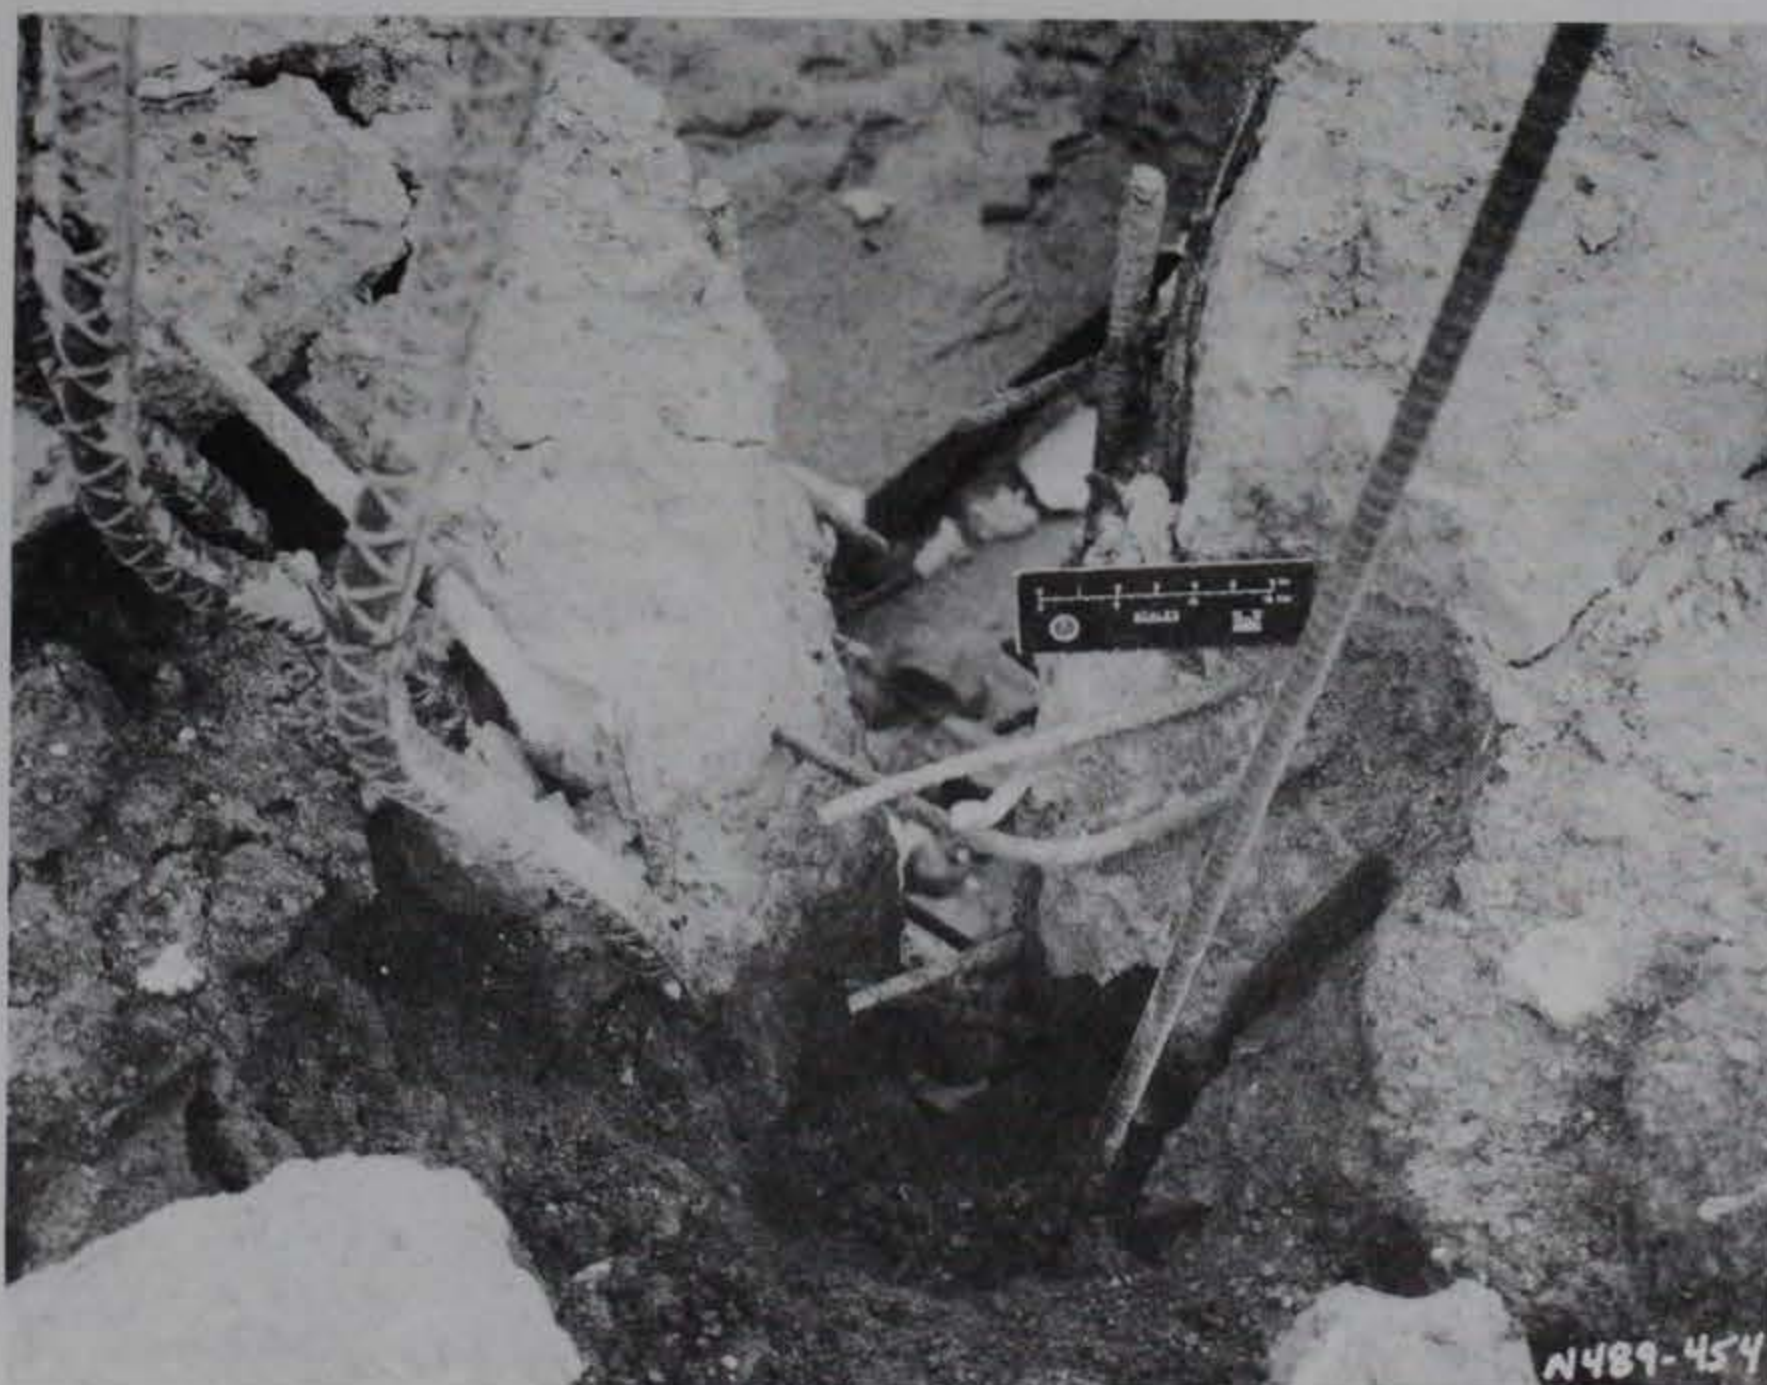
Figure 4.14. (Sheet 2 of 3).

Figure 4.14. Posttest damage to donor bay south wall (Sheet 1 of 3).

c. Upper interior view of southeast corner.

d. Lower interior view of southeast corner.

e. Interior view of southwest corner.

f. Exterior view of southwest corner.

Damage to the south and west walls of the Phase I donor bay is very similar to the damage to the Phase II south and east bay walls. South wall damage can be compared using Figures 4.14 and 4.15 for Phase I and Figures 5.10 and 5.11 for Phase II. The formation of hinge mechanisms and cracking at the corners are very similar. The southeast corner of the Phase I wall was more heavily damaged in the Phase I bay due to large rotation of the east wall. The posttest condition of the west Phase I wall and the east Phase II wall can be compared using Figures 4.16 and 4.17 versus Figures 5.8 and 5.9. The crack and damage patterns are similar.

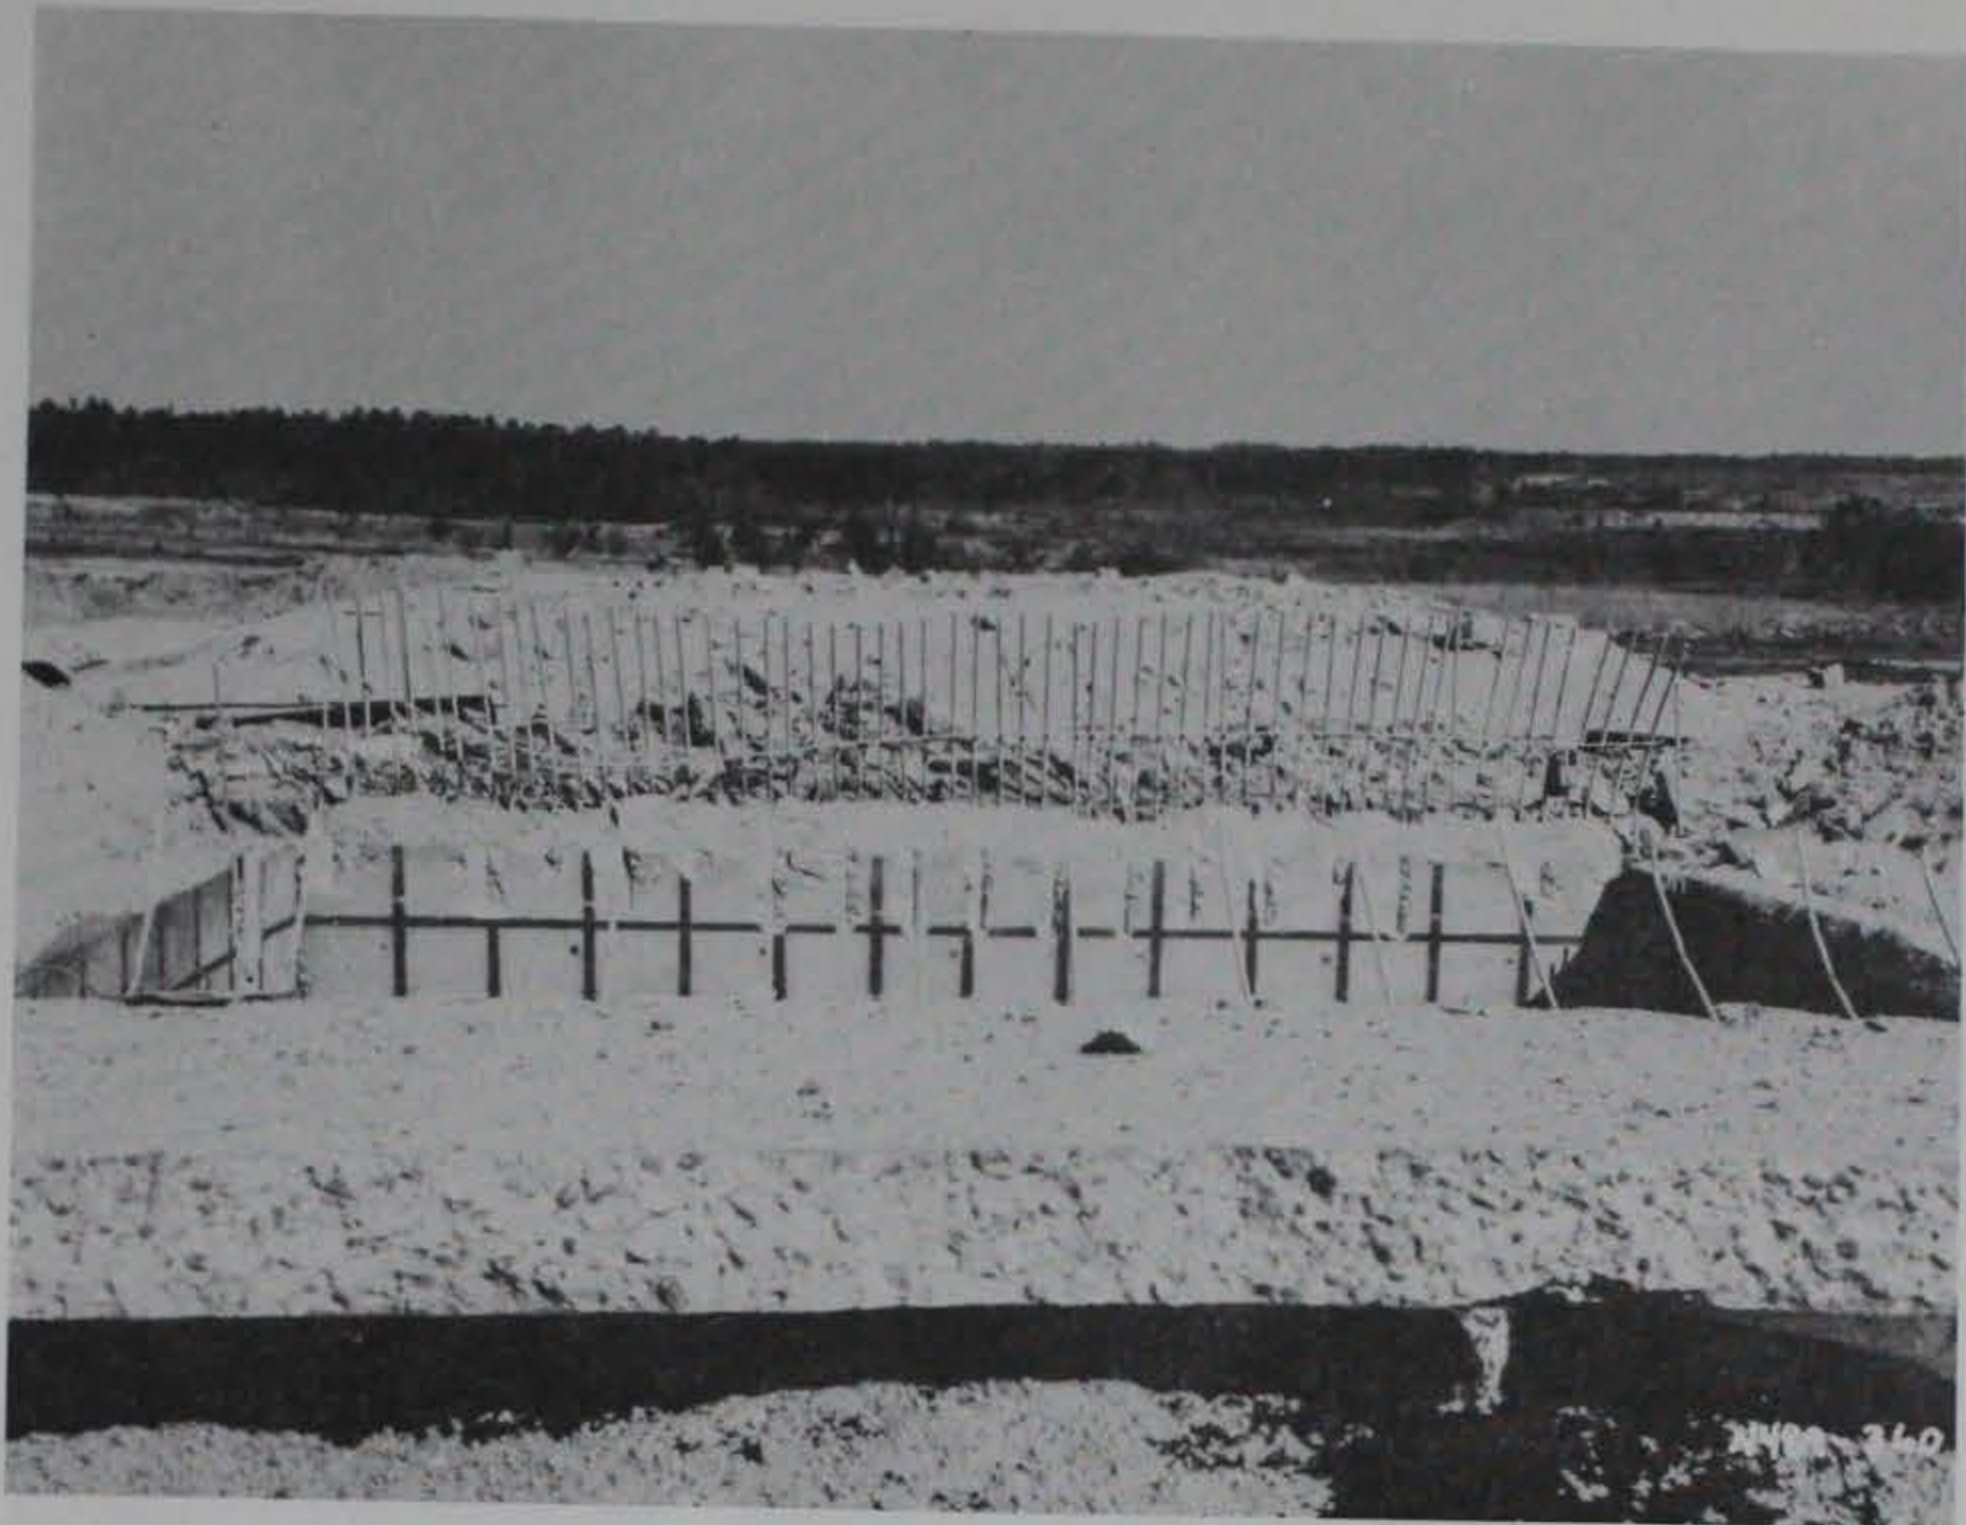
a. View facing east.

Figure 5.2. Damage to donor bay roof (Sheet 1 of 2).

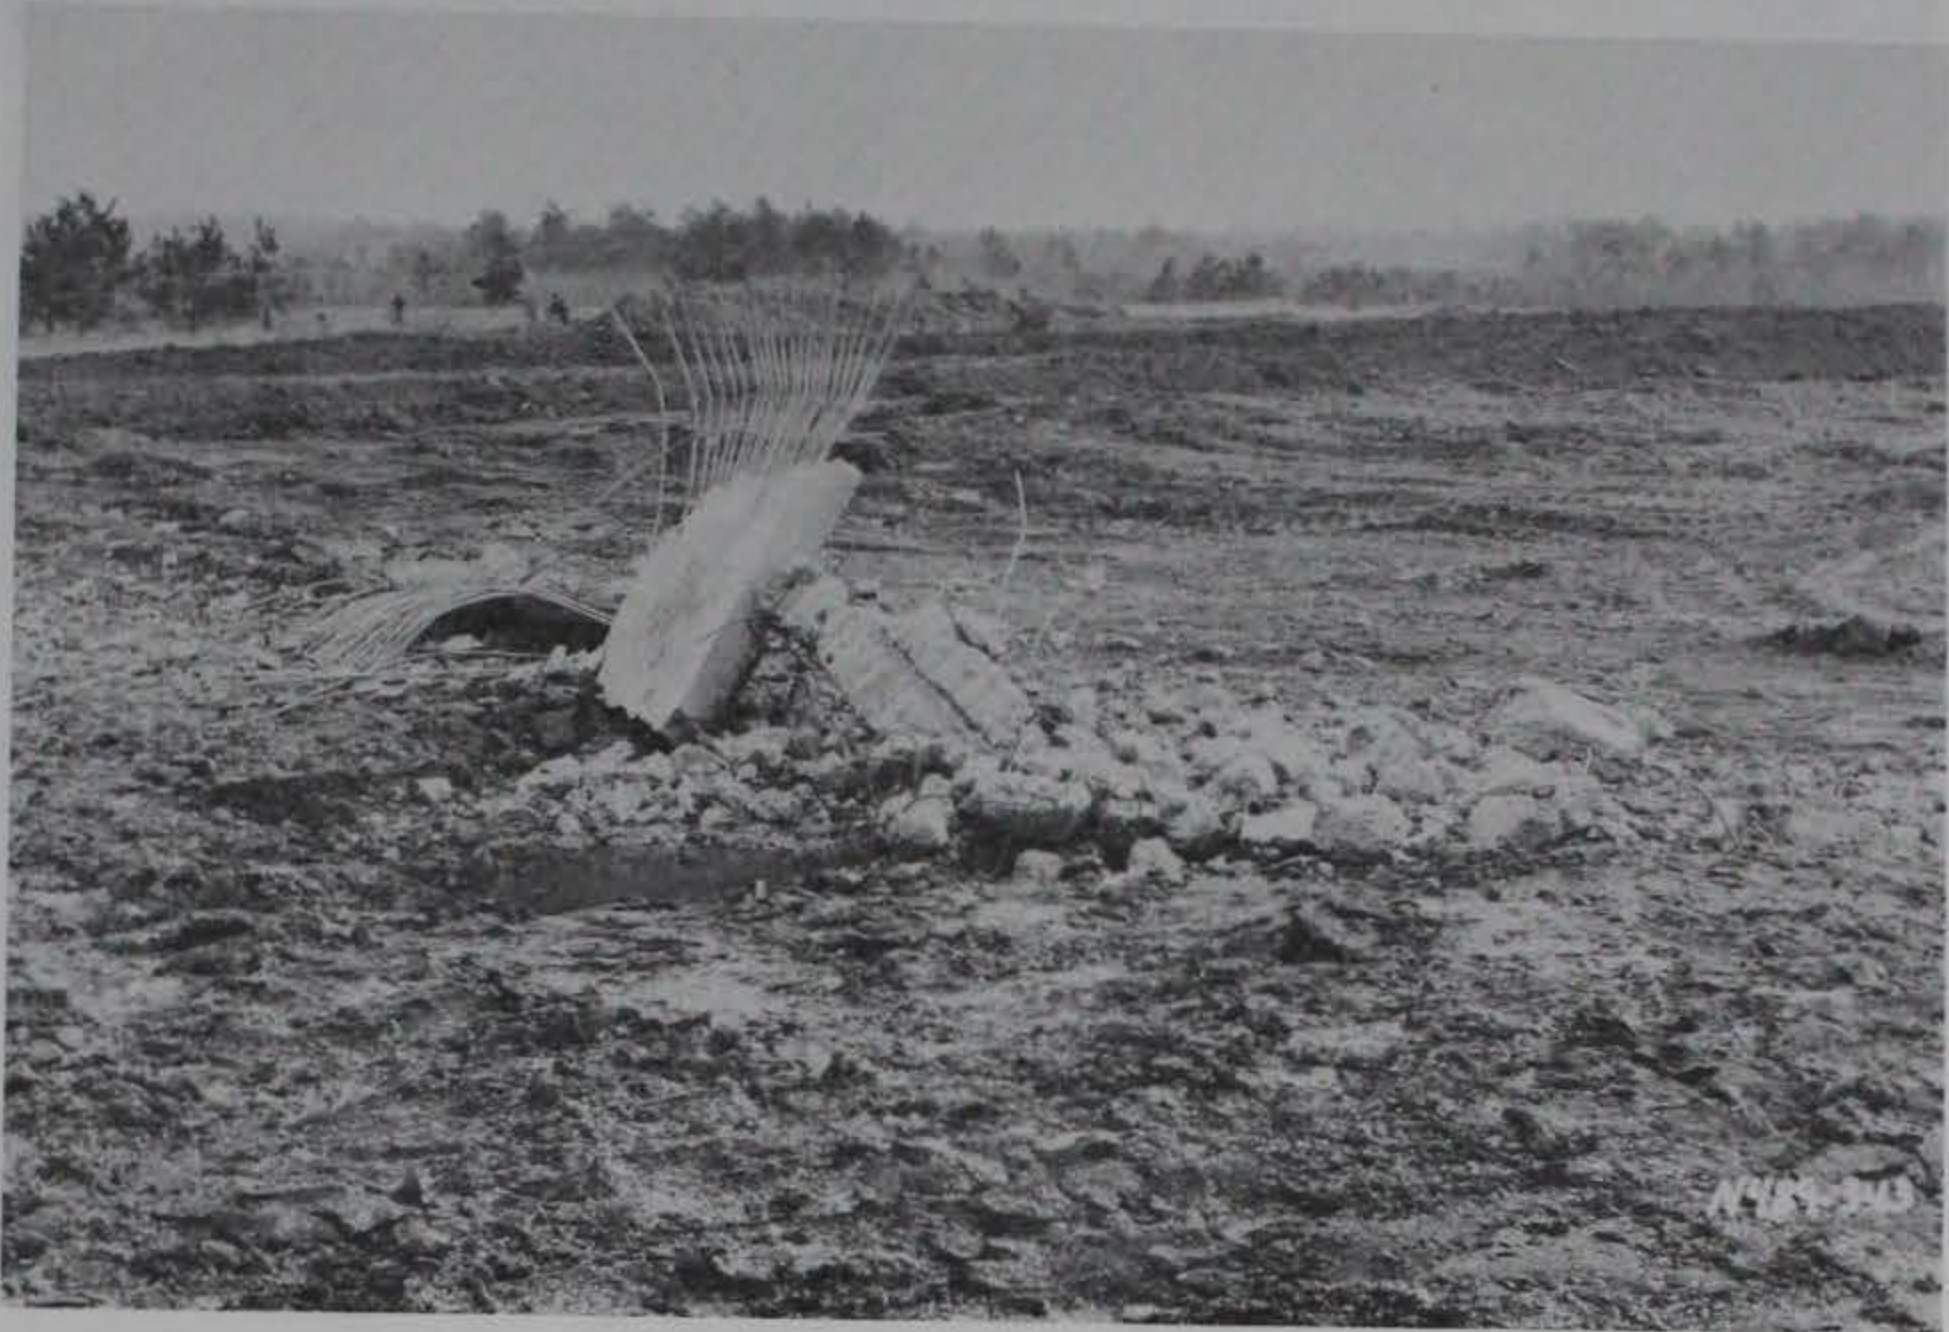
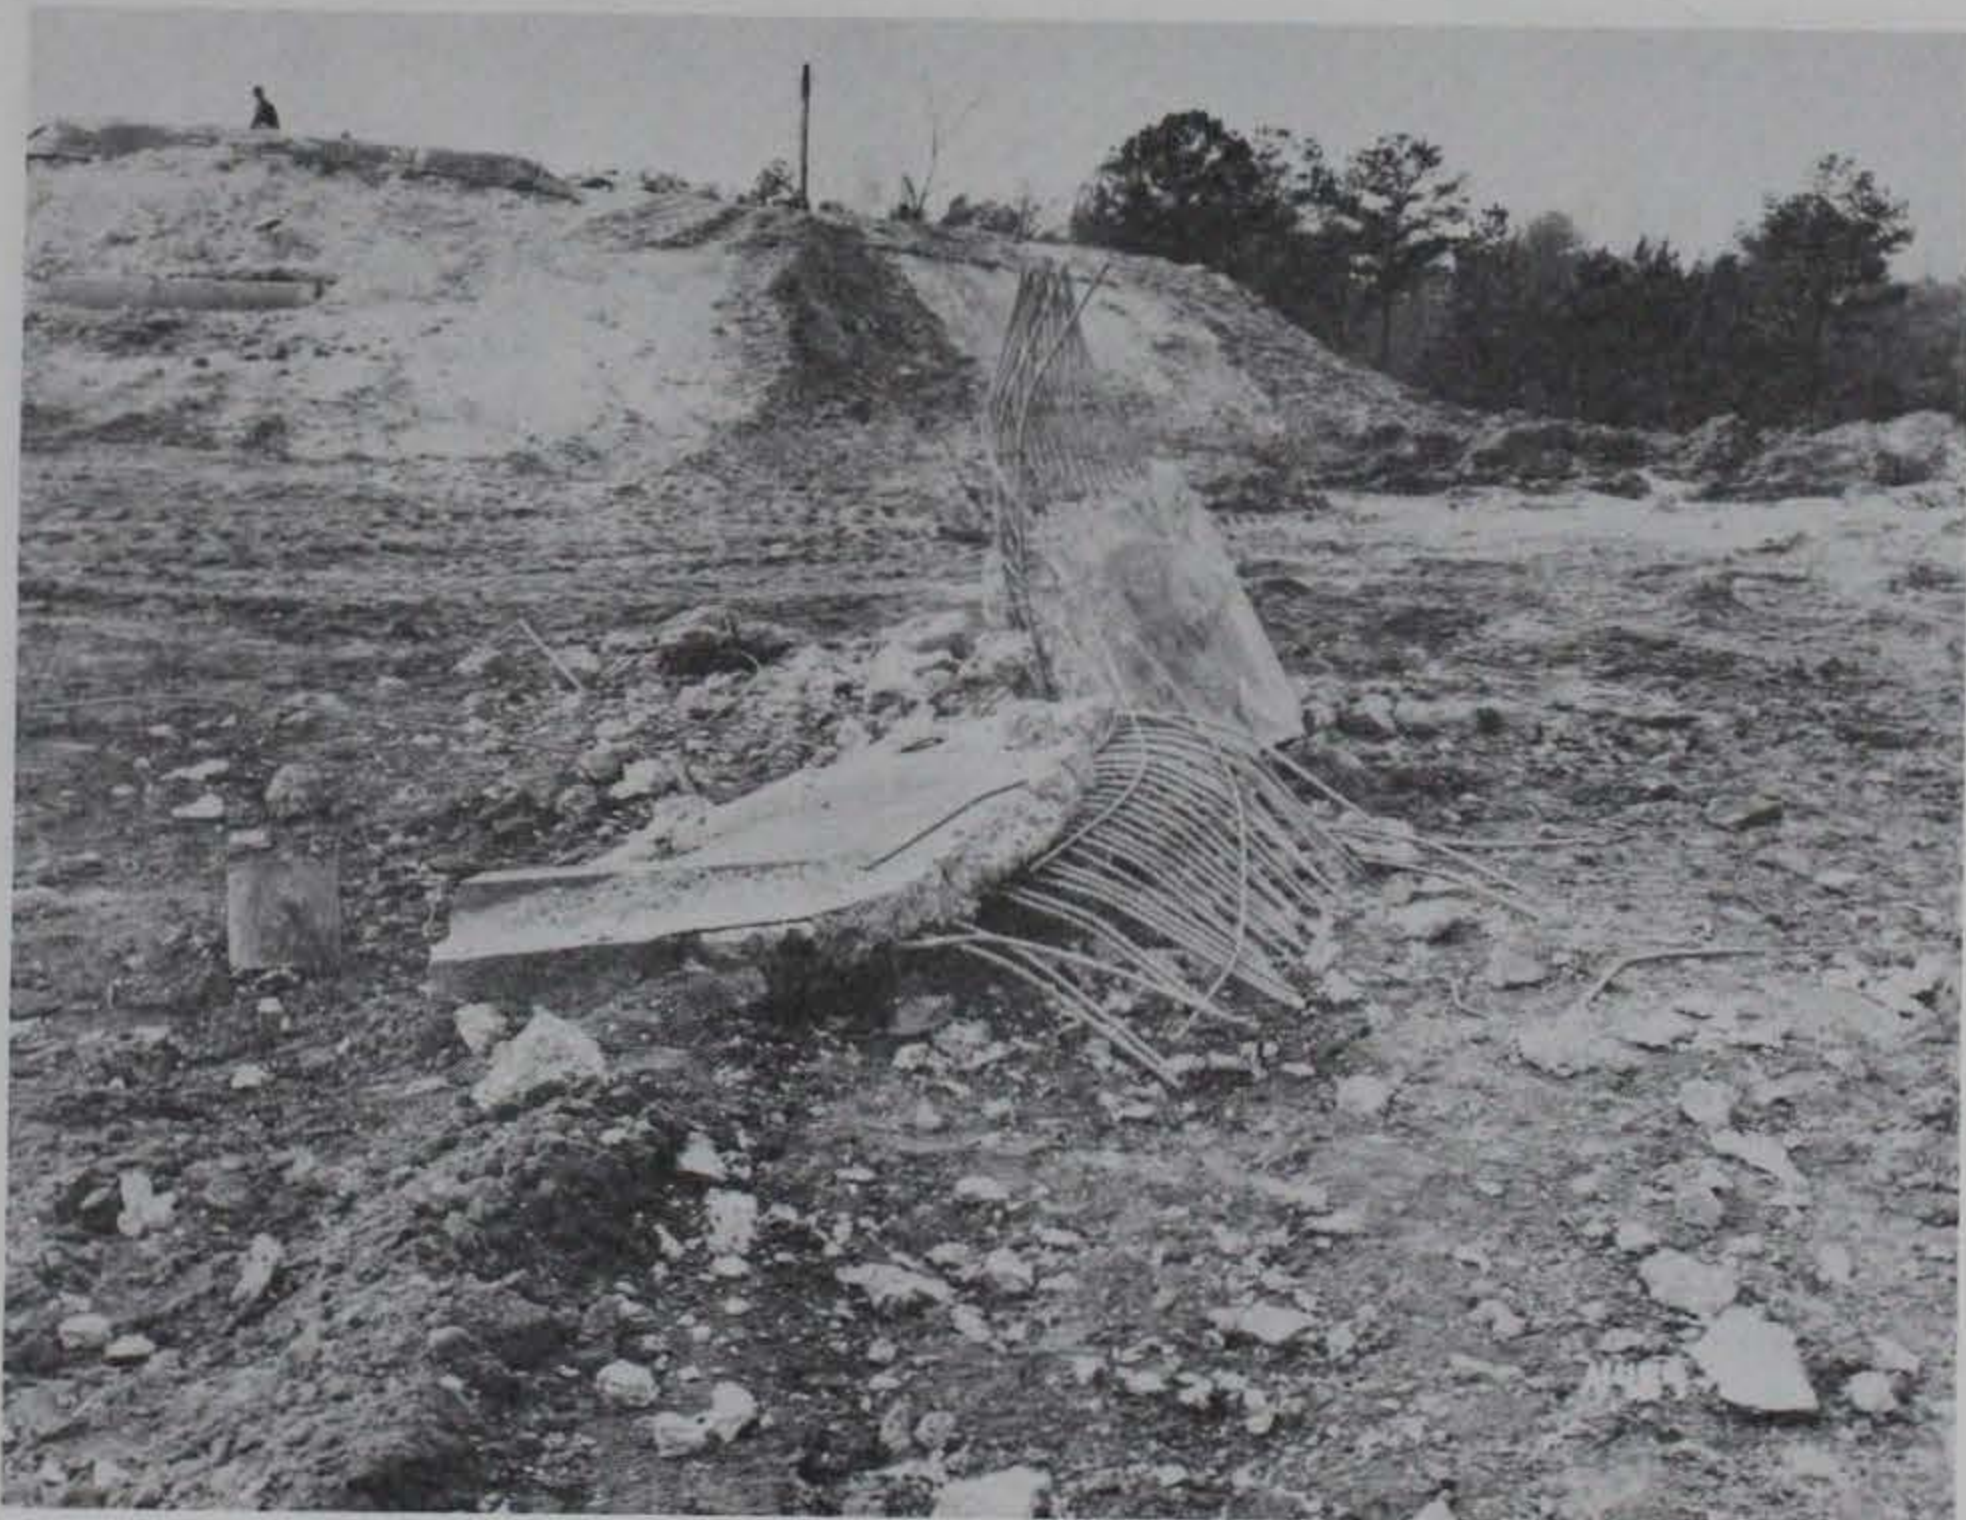
Figure 5.3. Major donor bay roof fragment.

a. View facing east.

b. View facing west.
