TECHNICAL REPORT SL-83-6

AN EVALUATION OF THE SEPARATED BAY CONCEPT FOR A MUNITION ASSEMBLY COMPLEX; AN EXPERIMENTAL INVESTIGATION OF THE DEPARTMENT OF ENERGY BUILDING 12-64 COMPLEX

Robert D. Volz, Sam A. Kiger

September 1983

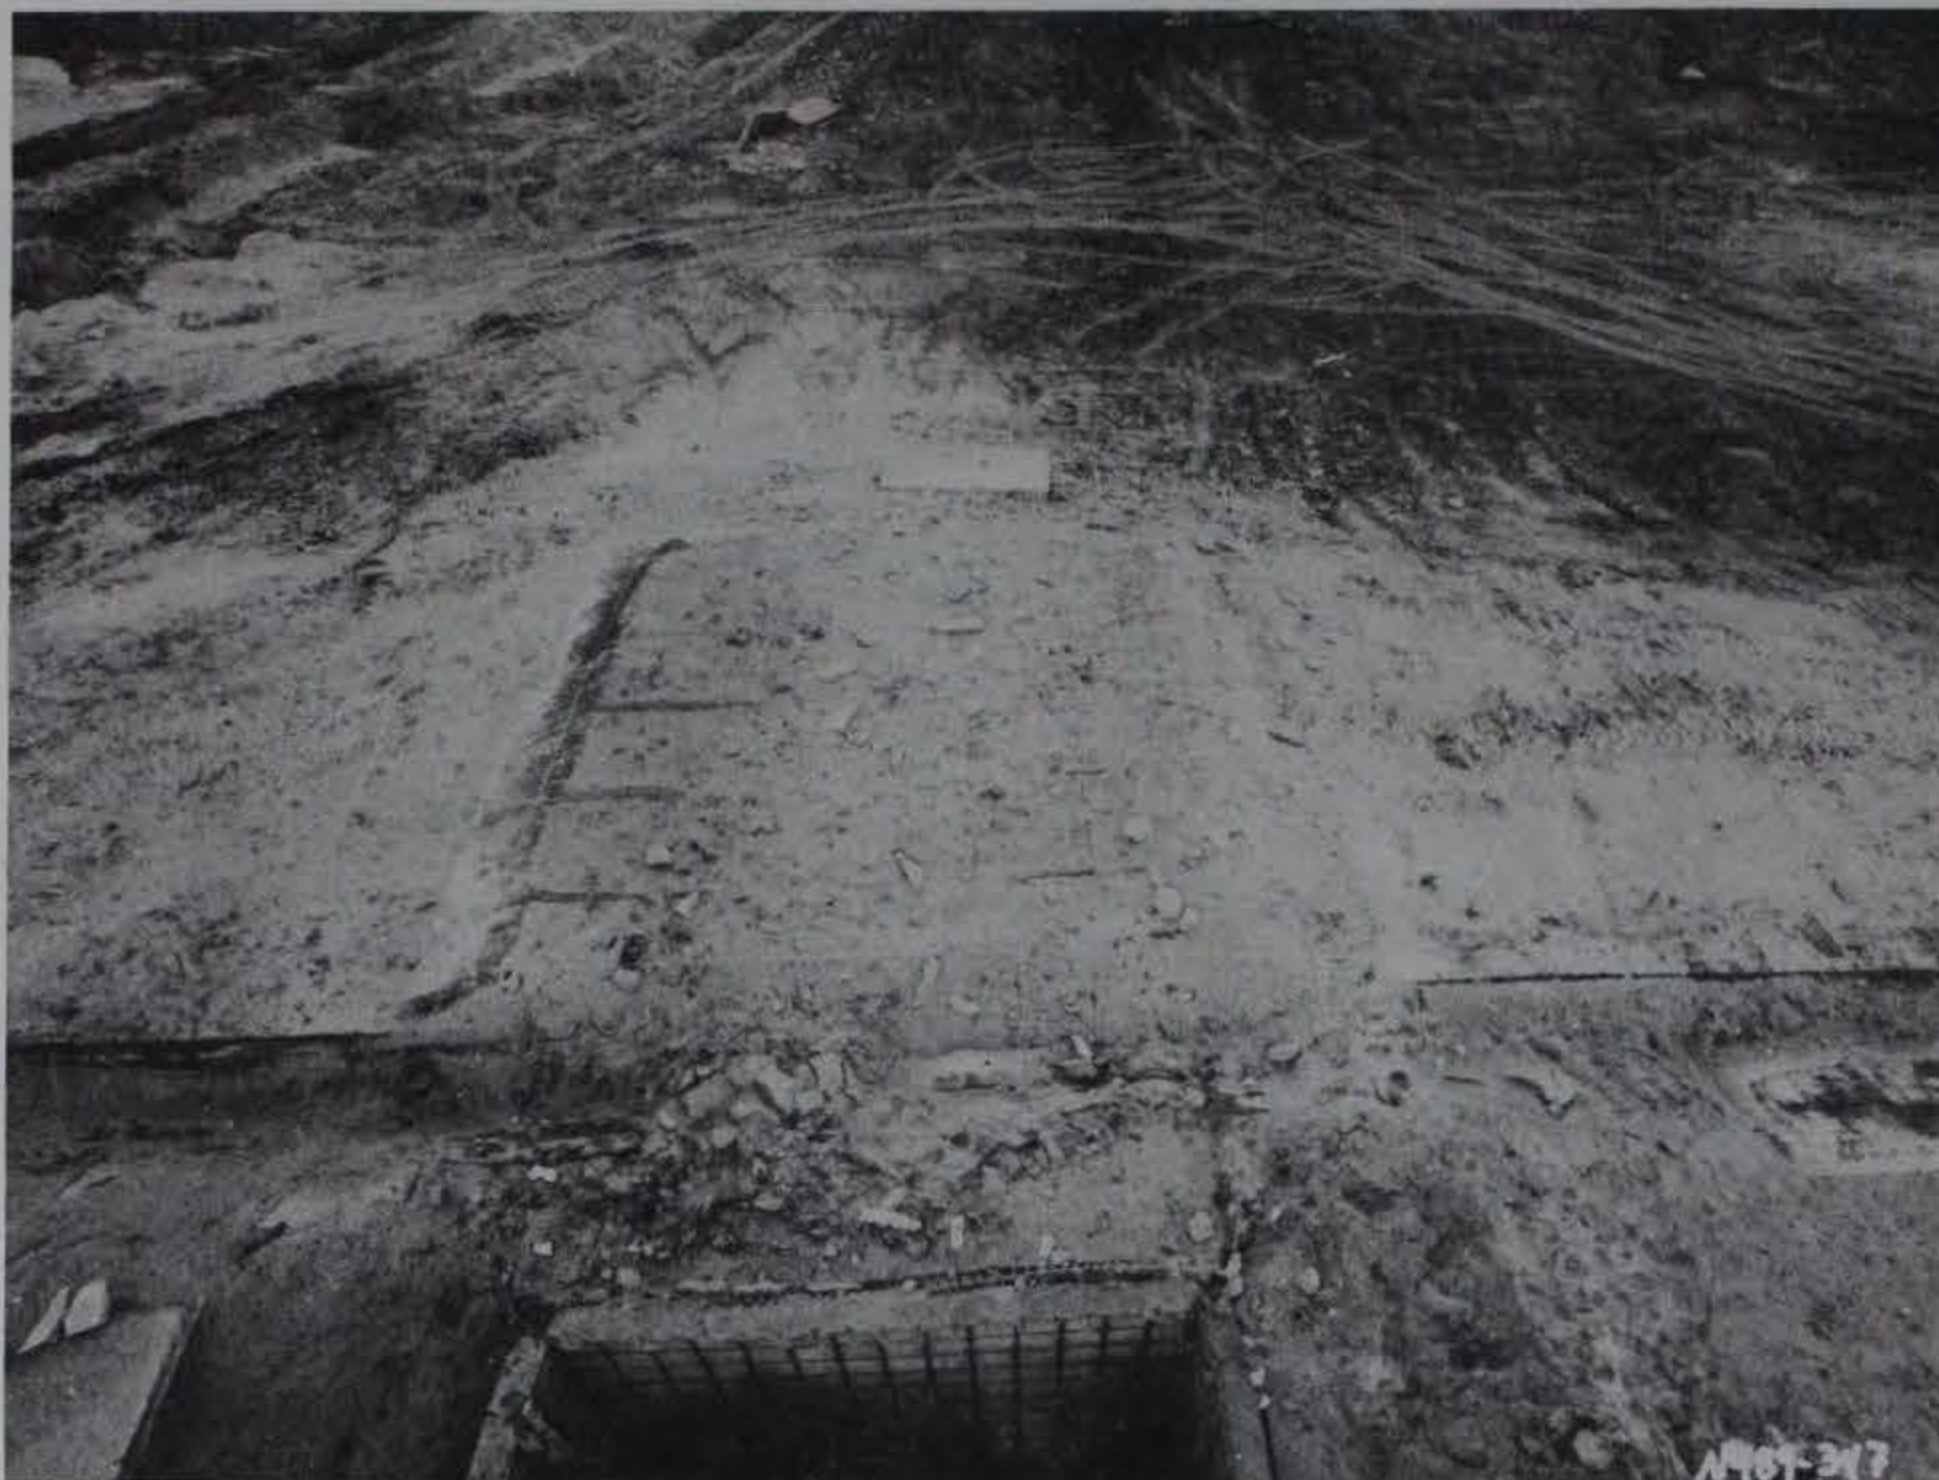
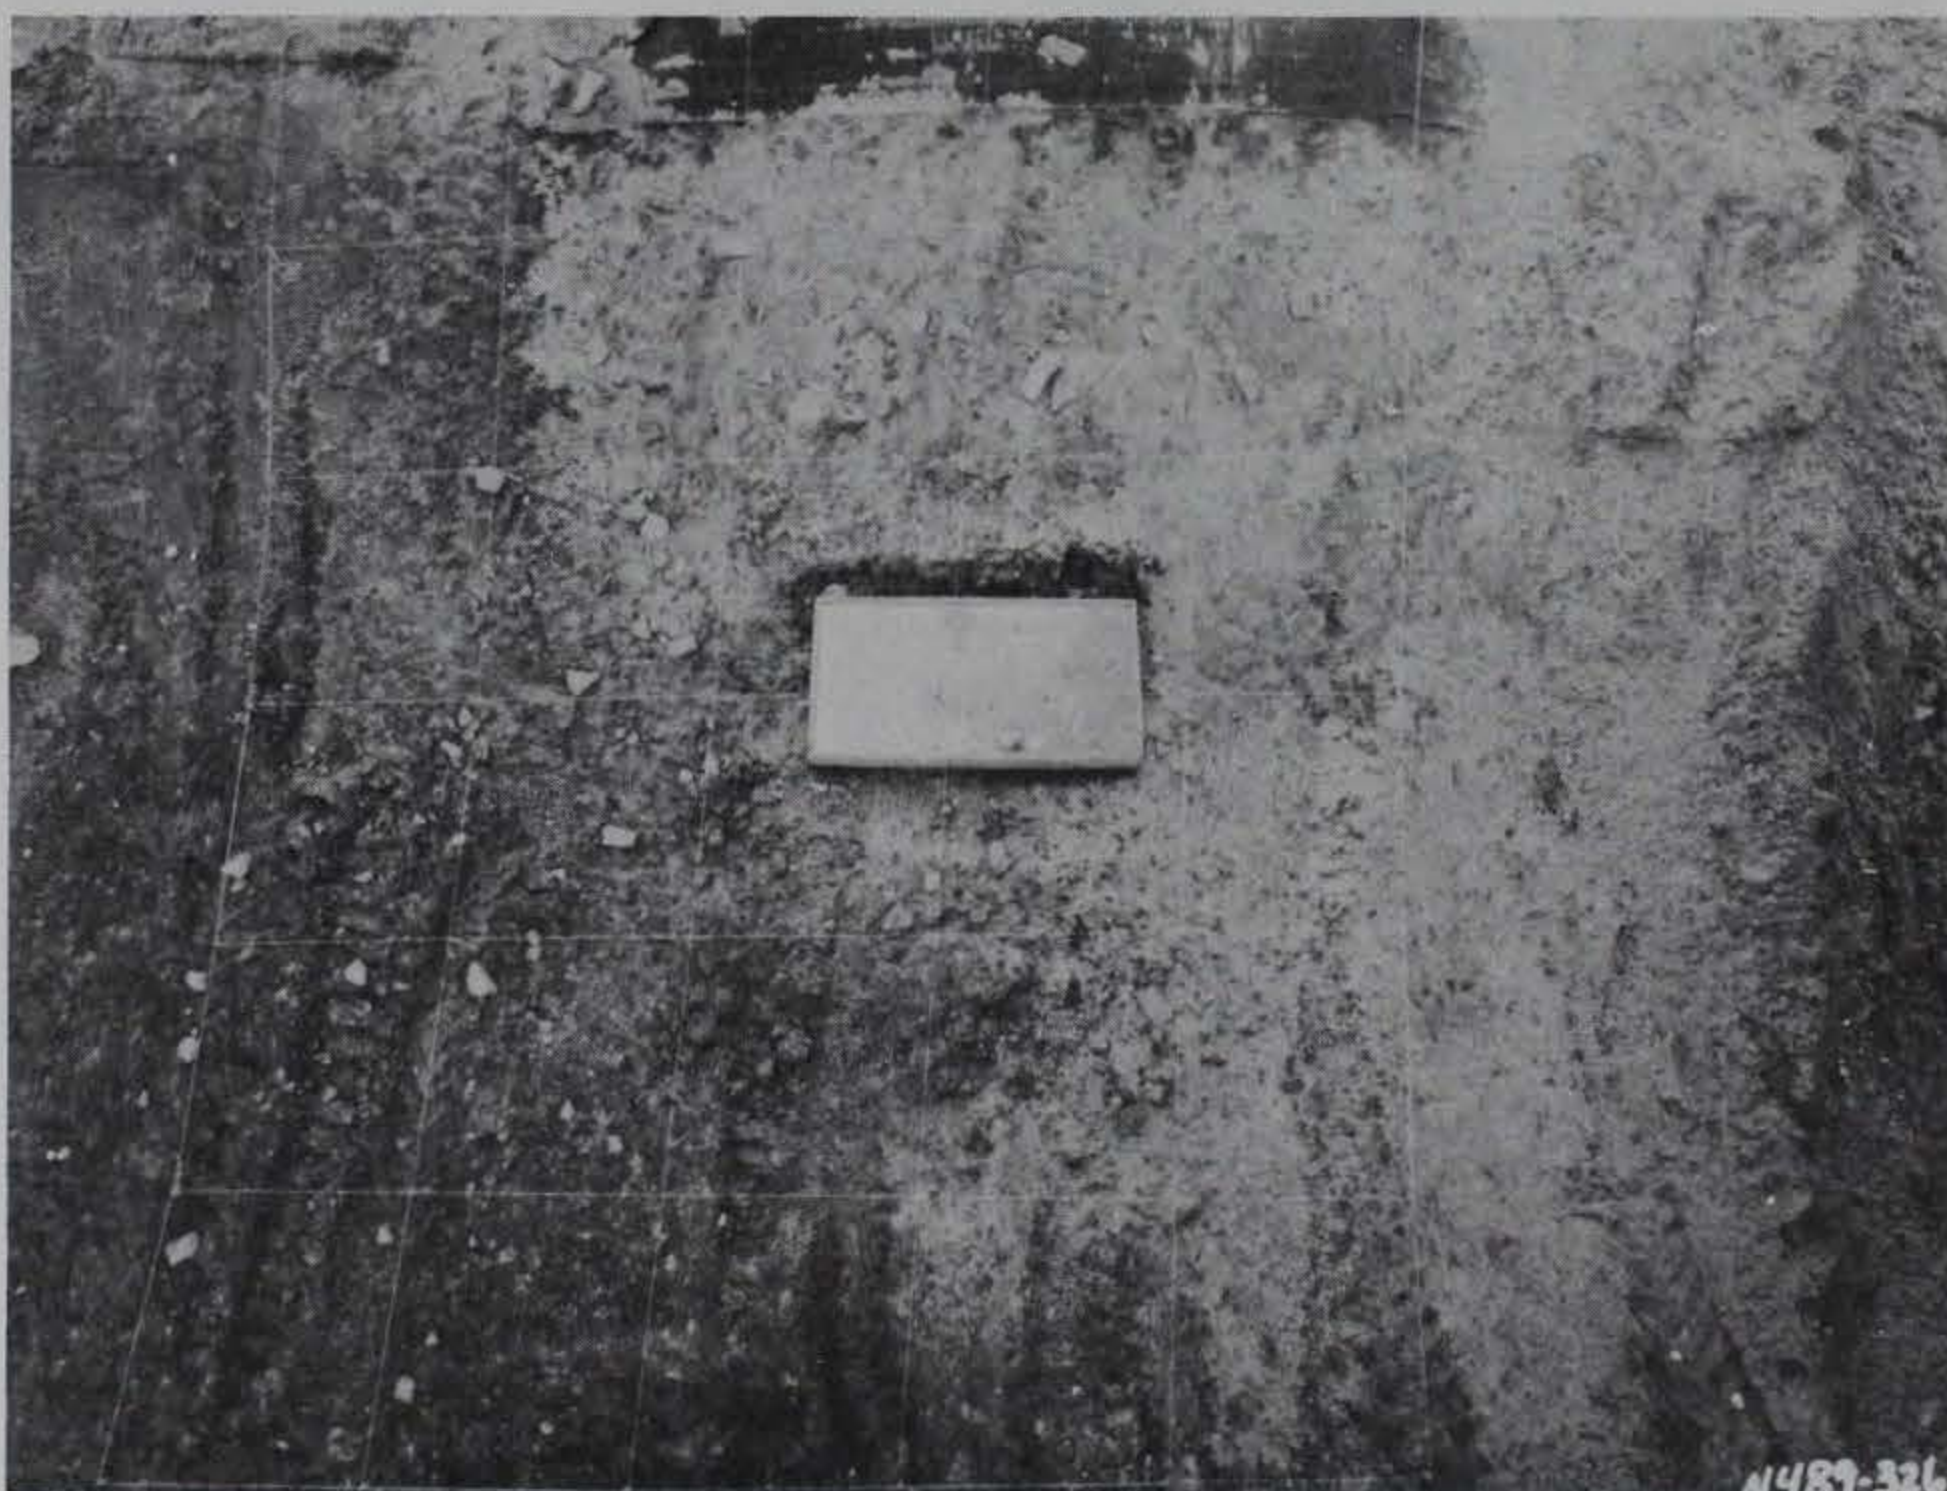
Figure 5.4. Donor bay roof fragments.

a. Grid over east simulated acceptor roof slab.

b. Grid over east backfill slope.

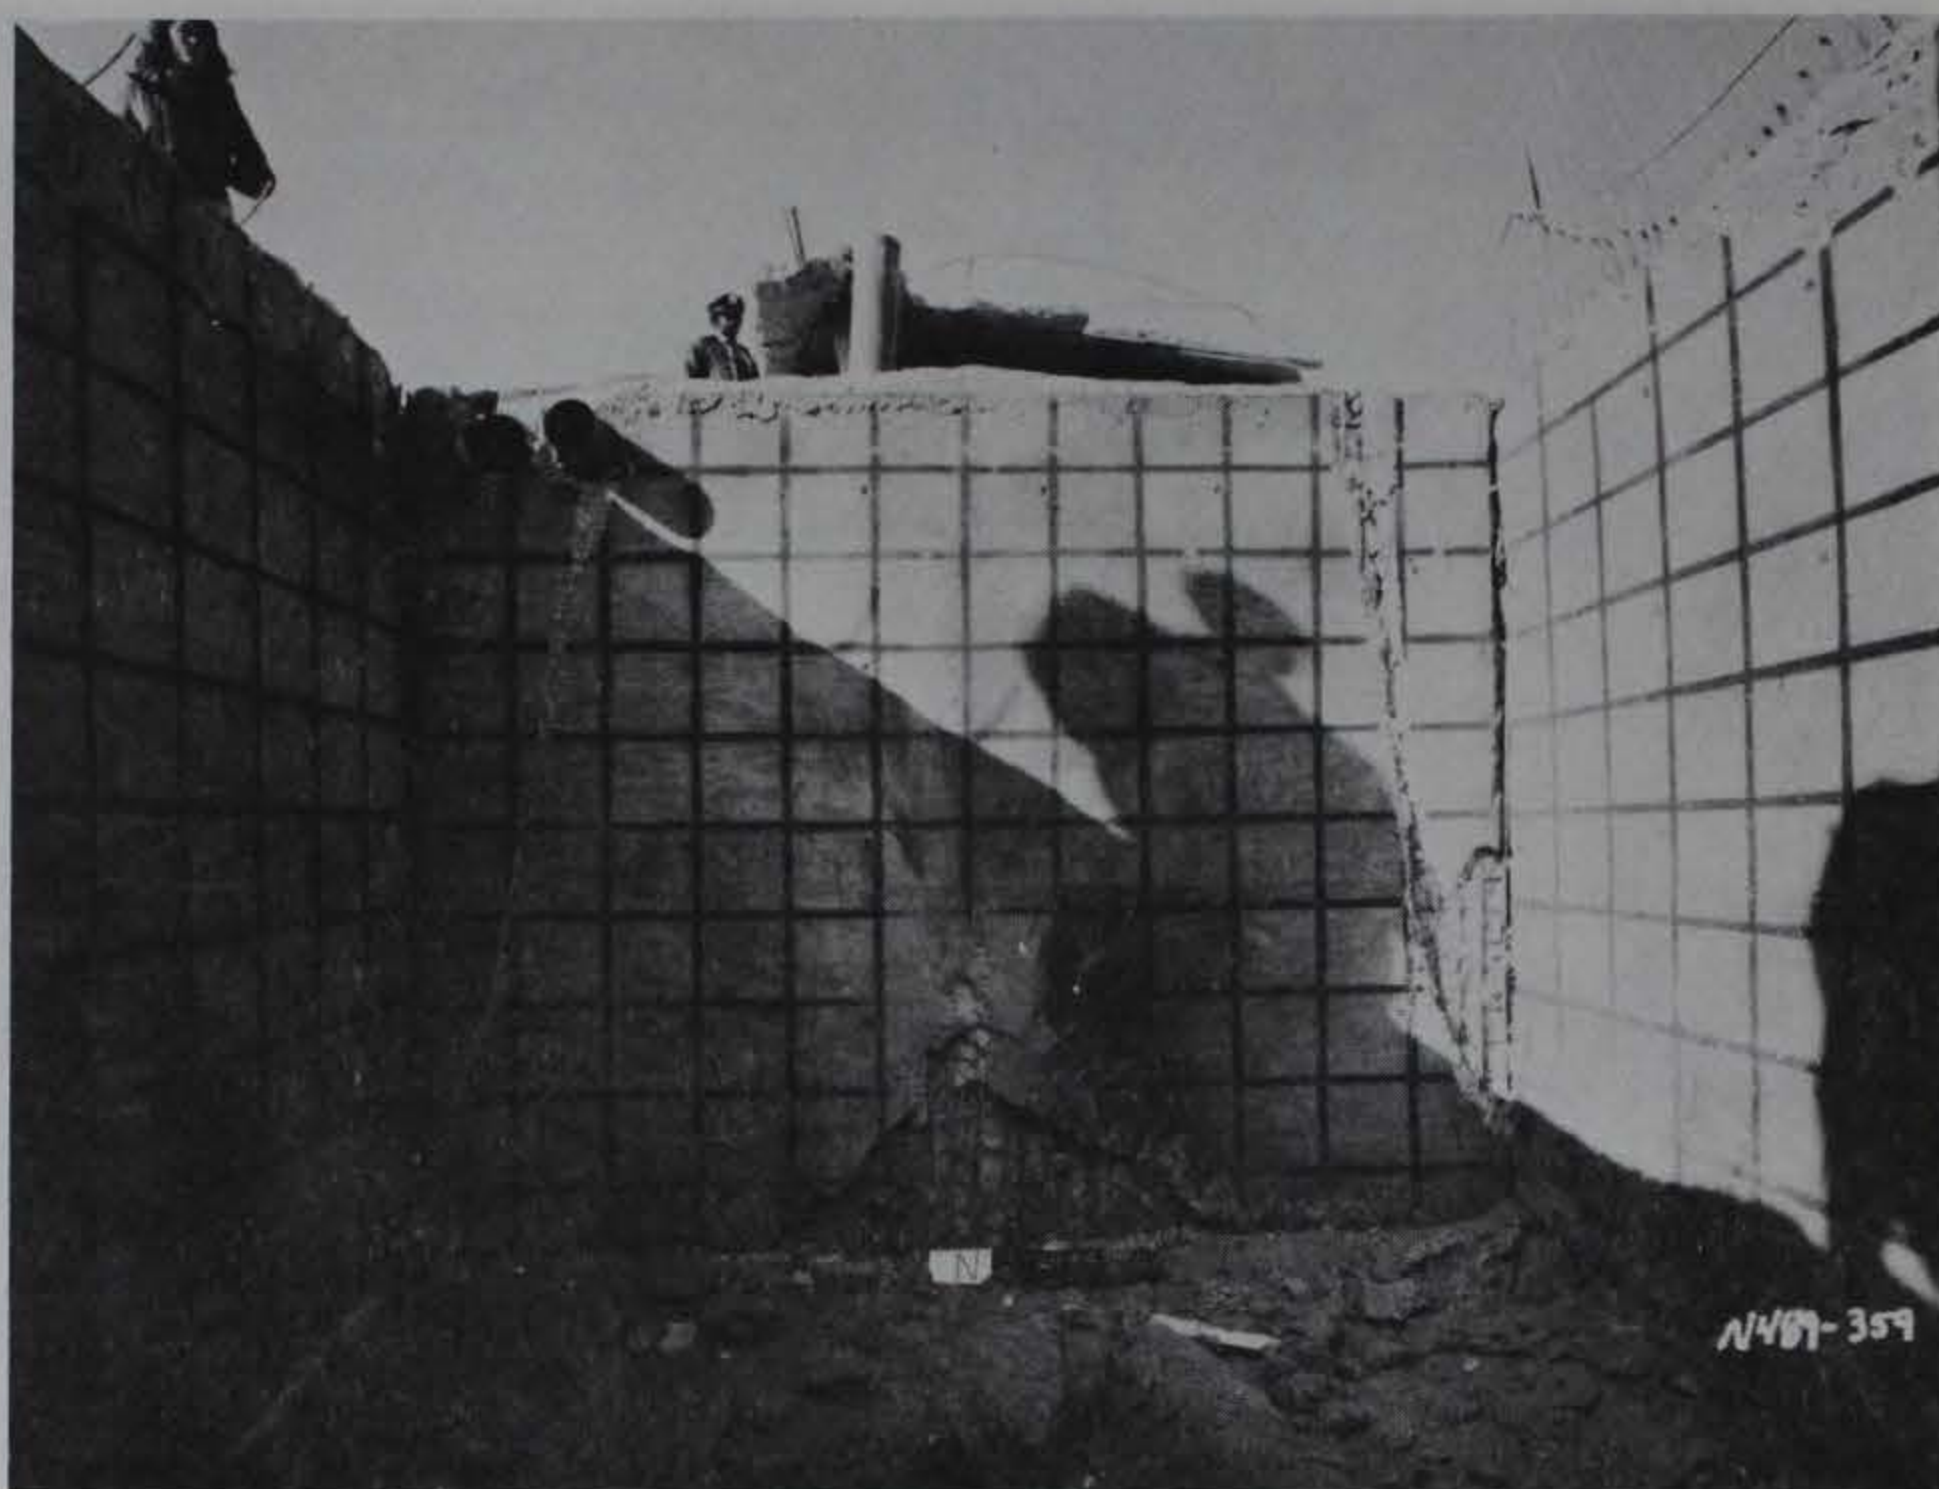
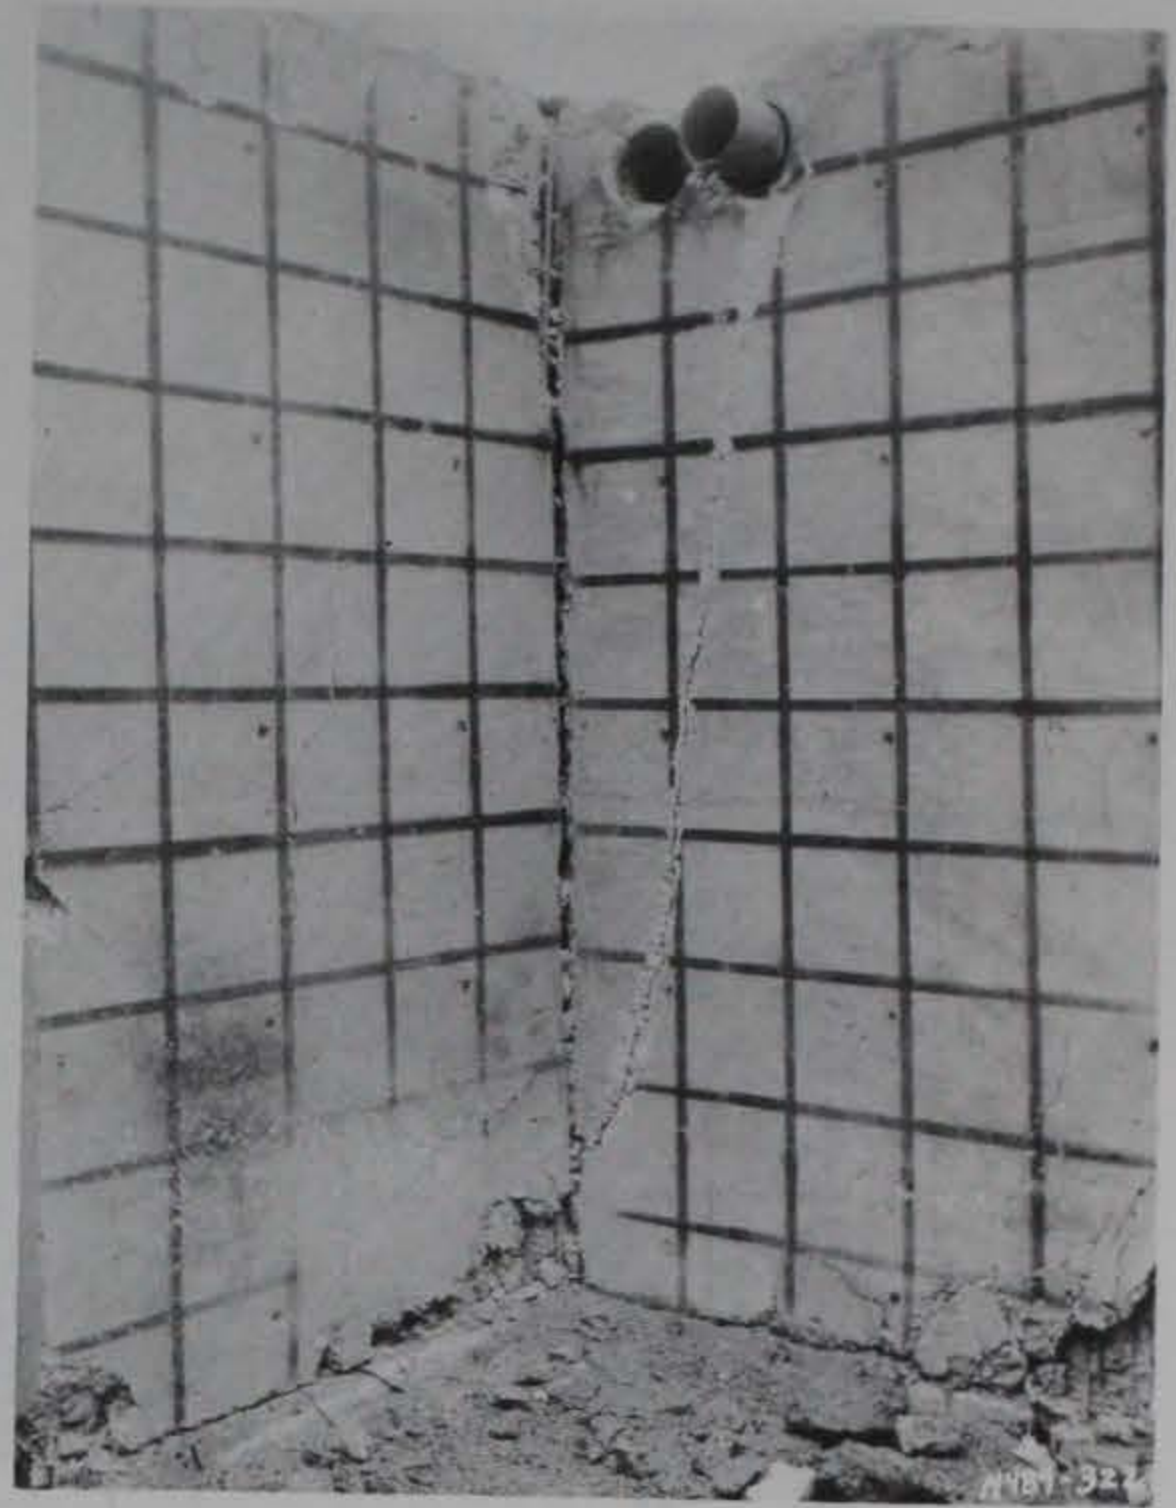
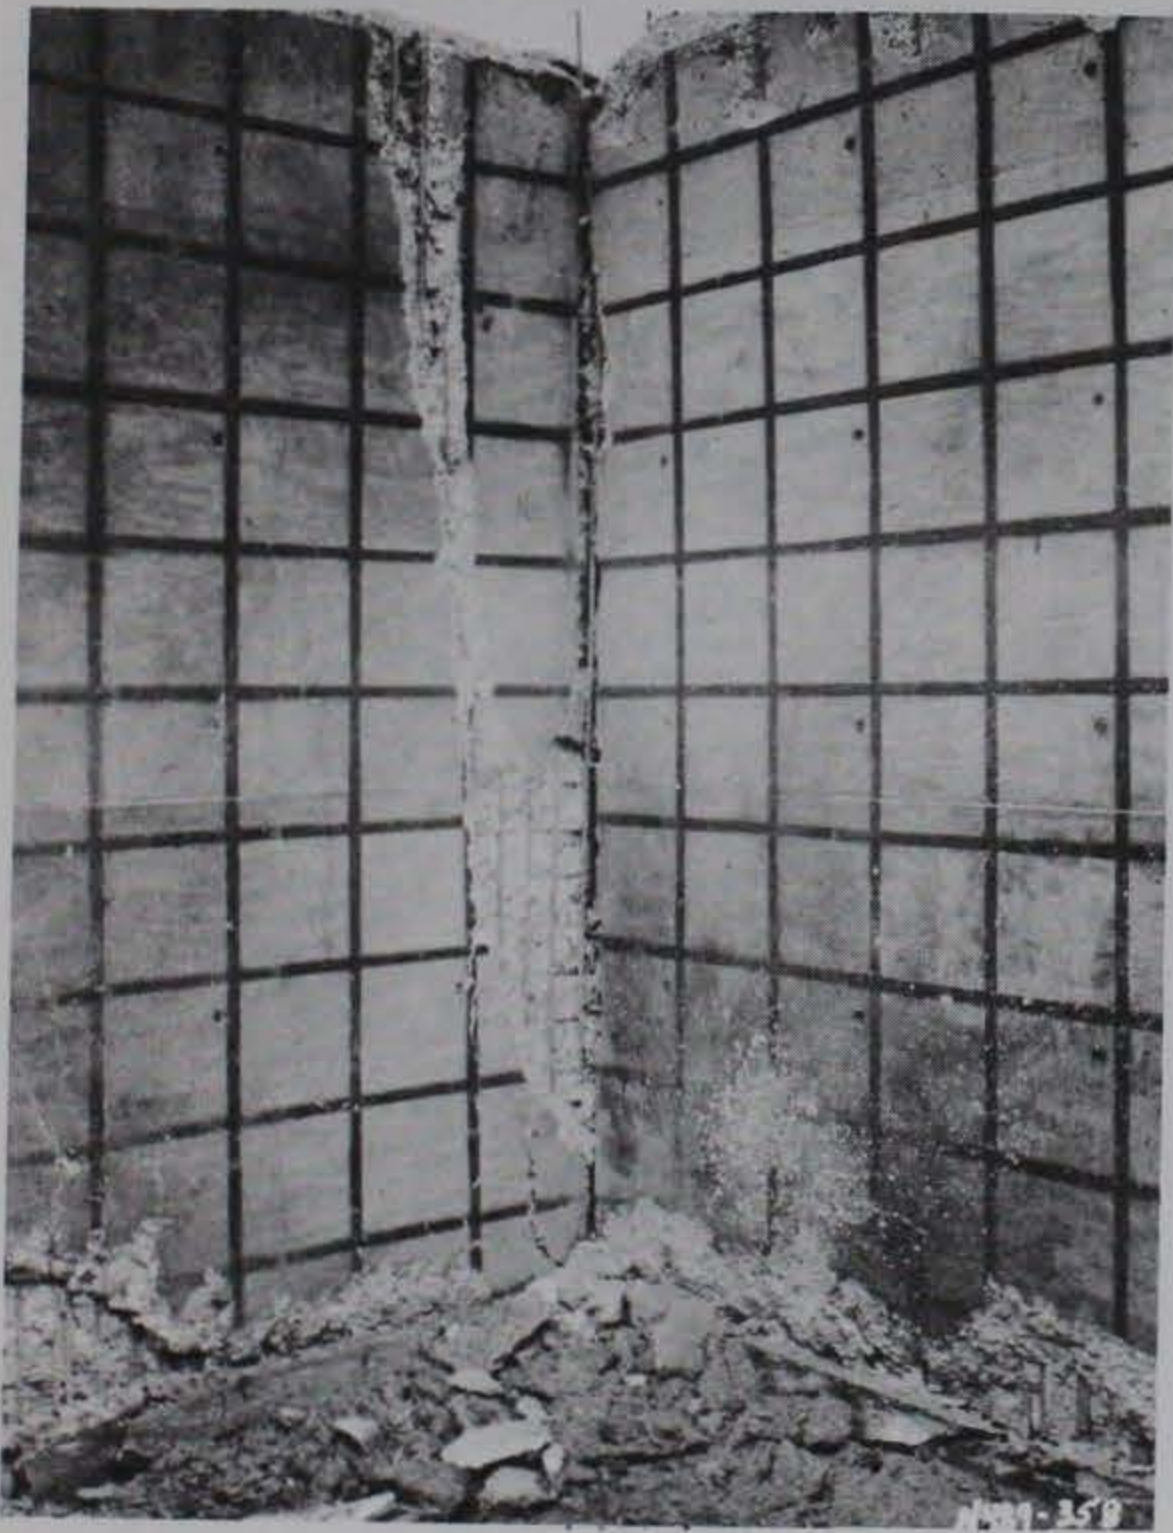
Figure 5.6. (Sheet 2 of 2).

a. Overall view.

Figure 5.6. Posttest view of north donor bay wall
(Sheet 1 of 2).

c. Northwest corner.

d. Northeast corner.

Damage to the north walls of the two bays can be compared using Figures 4.11 and 5.6. Both walls experienced cracking at the corners and the development of hinge mechanisms a small distance from each corner. But the large displacements of the walls in the Phase I structure produced much more severe damage and resulted in the collapse of the wall.

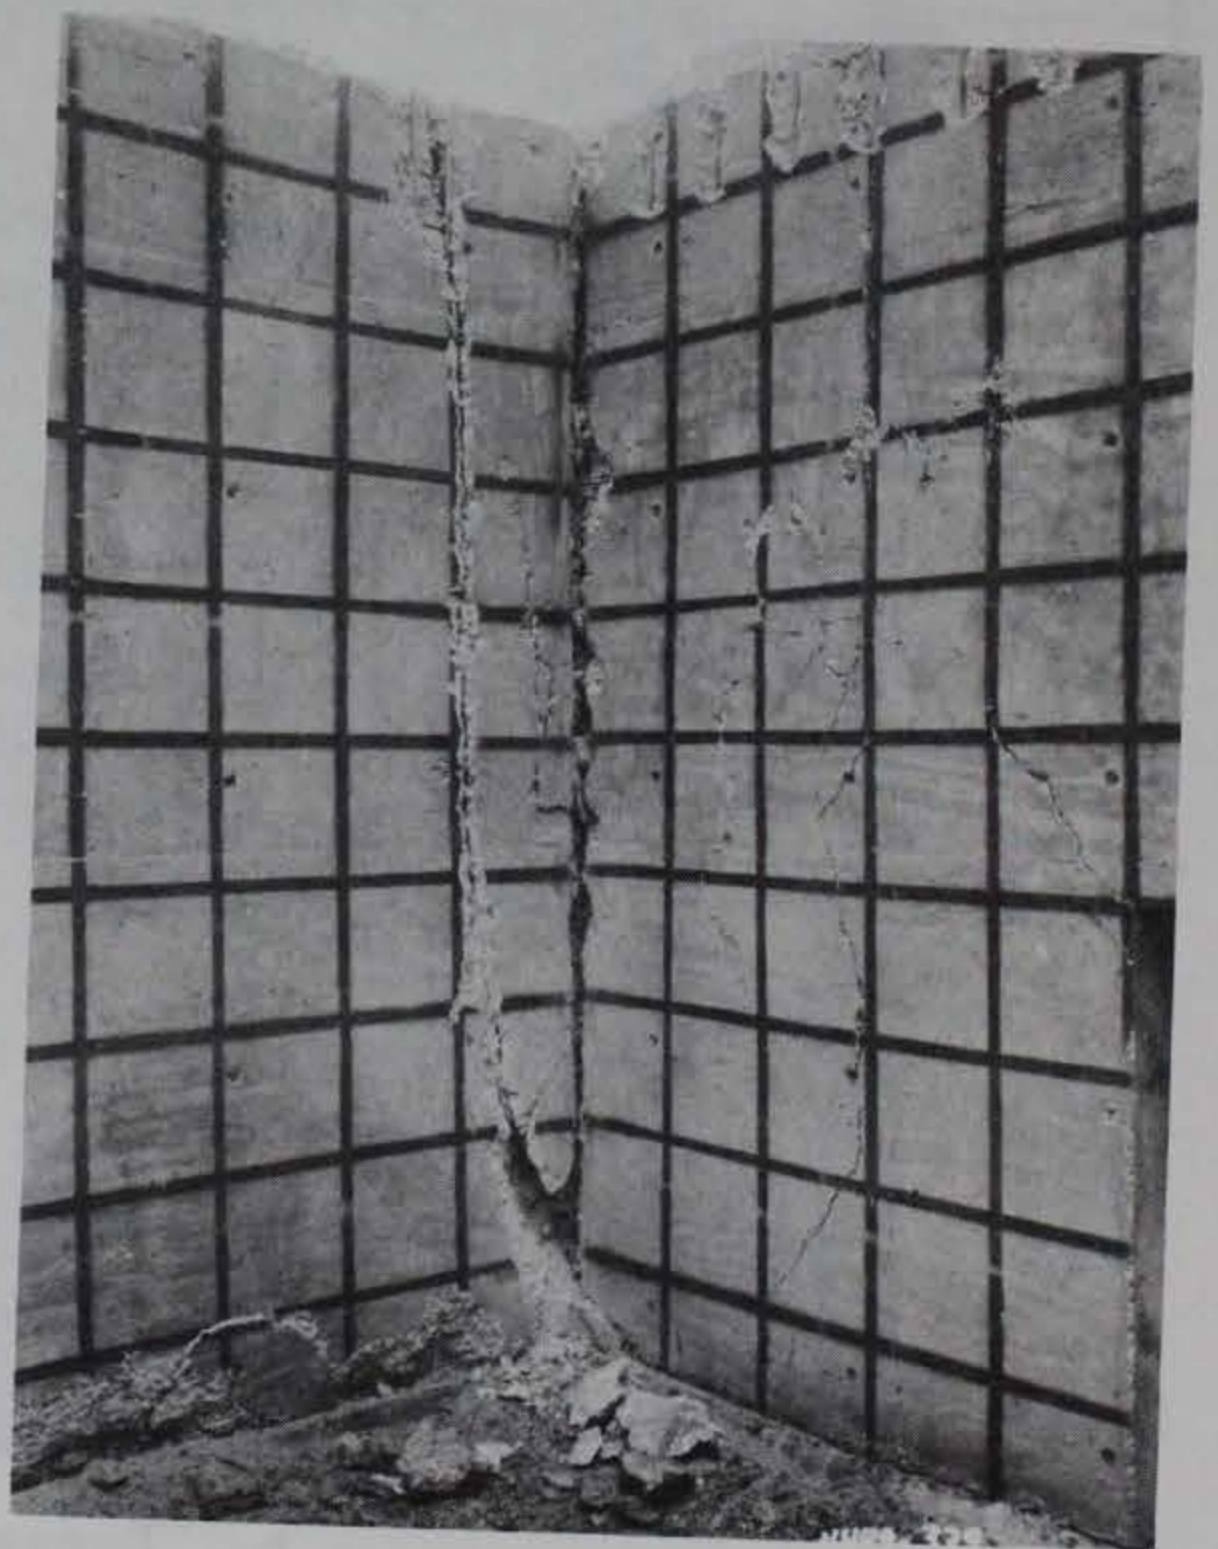
Figure 5.10. (Sheet 2 of 2).

Damage to the south wall was very similar to that of the north wall except there was no local spalling at the center since the charge was detonated near the north wall. The wall is shown in Figure 5.10, and posttest damage is shown in Figure 5.11. Although the corners were seriously damaged, the damage to the remainder of the wall was limited to spalling at the base of the wall and two small vertical cracks which terminated 4 ft from the floor.

d. Southwest corner.

Damage to the south and west walls of the Phase I donor bay is very similar to the damage to the Phase II south and east bay walls. South wall damage can be compared using Figures 4.14 and 4.15 for Phase I and Figures 5.10 and 5.11 for Phase II. The formation of hinge mechanisms and cracking at the corners are very similar. The southeast corner of the Phase I wall was more heavily damaged in the Phase I bay due to large rotation of the east wall. The posttest condition of the west Phase I wall and the east Phase II wall can be compared using Figures 4.16 and 4.17 versus Figures 5.8 and 5.9. The crack and damage patterns are similar.

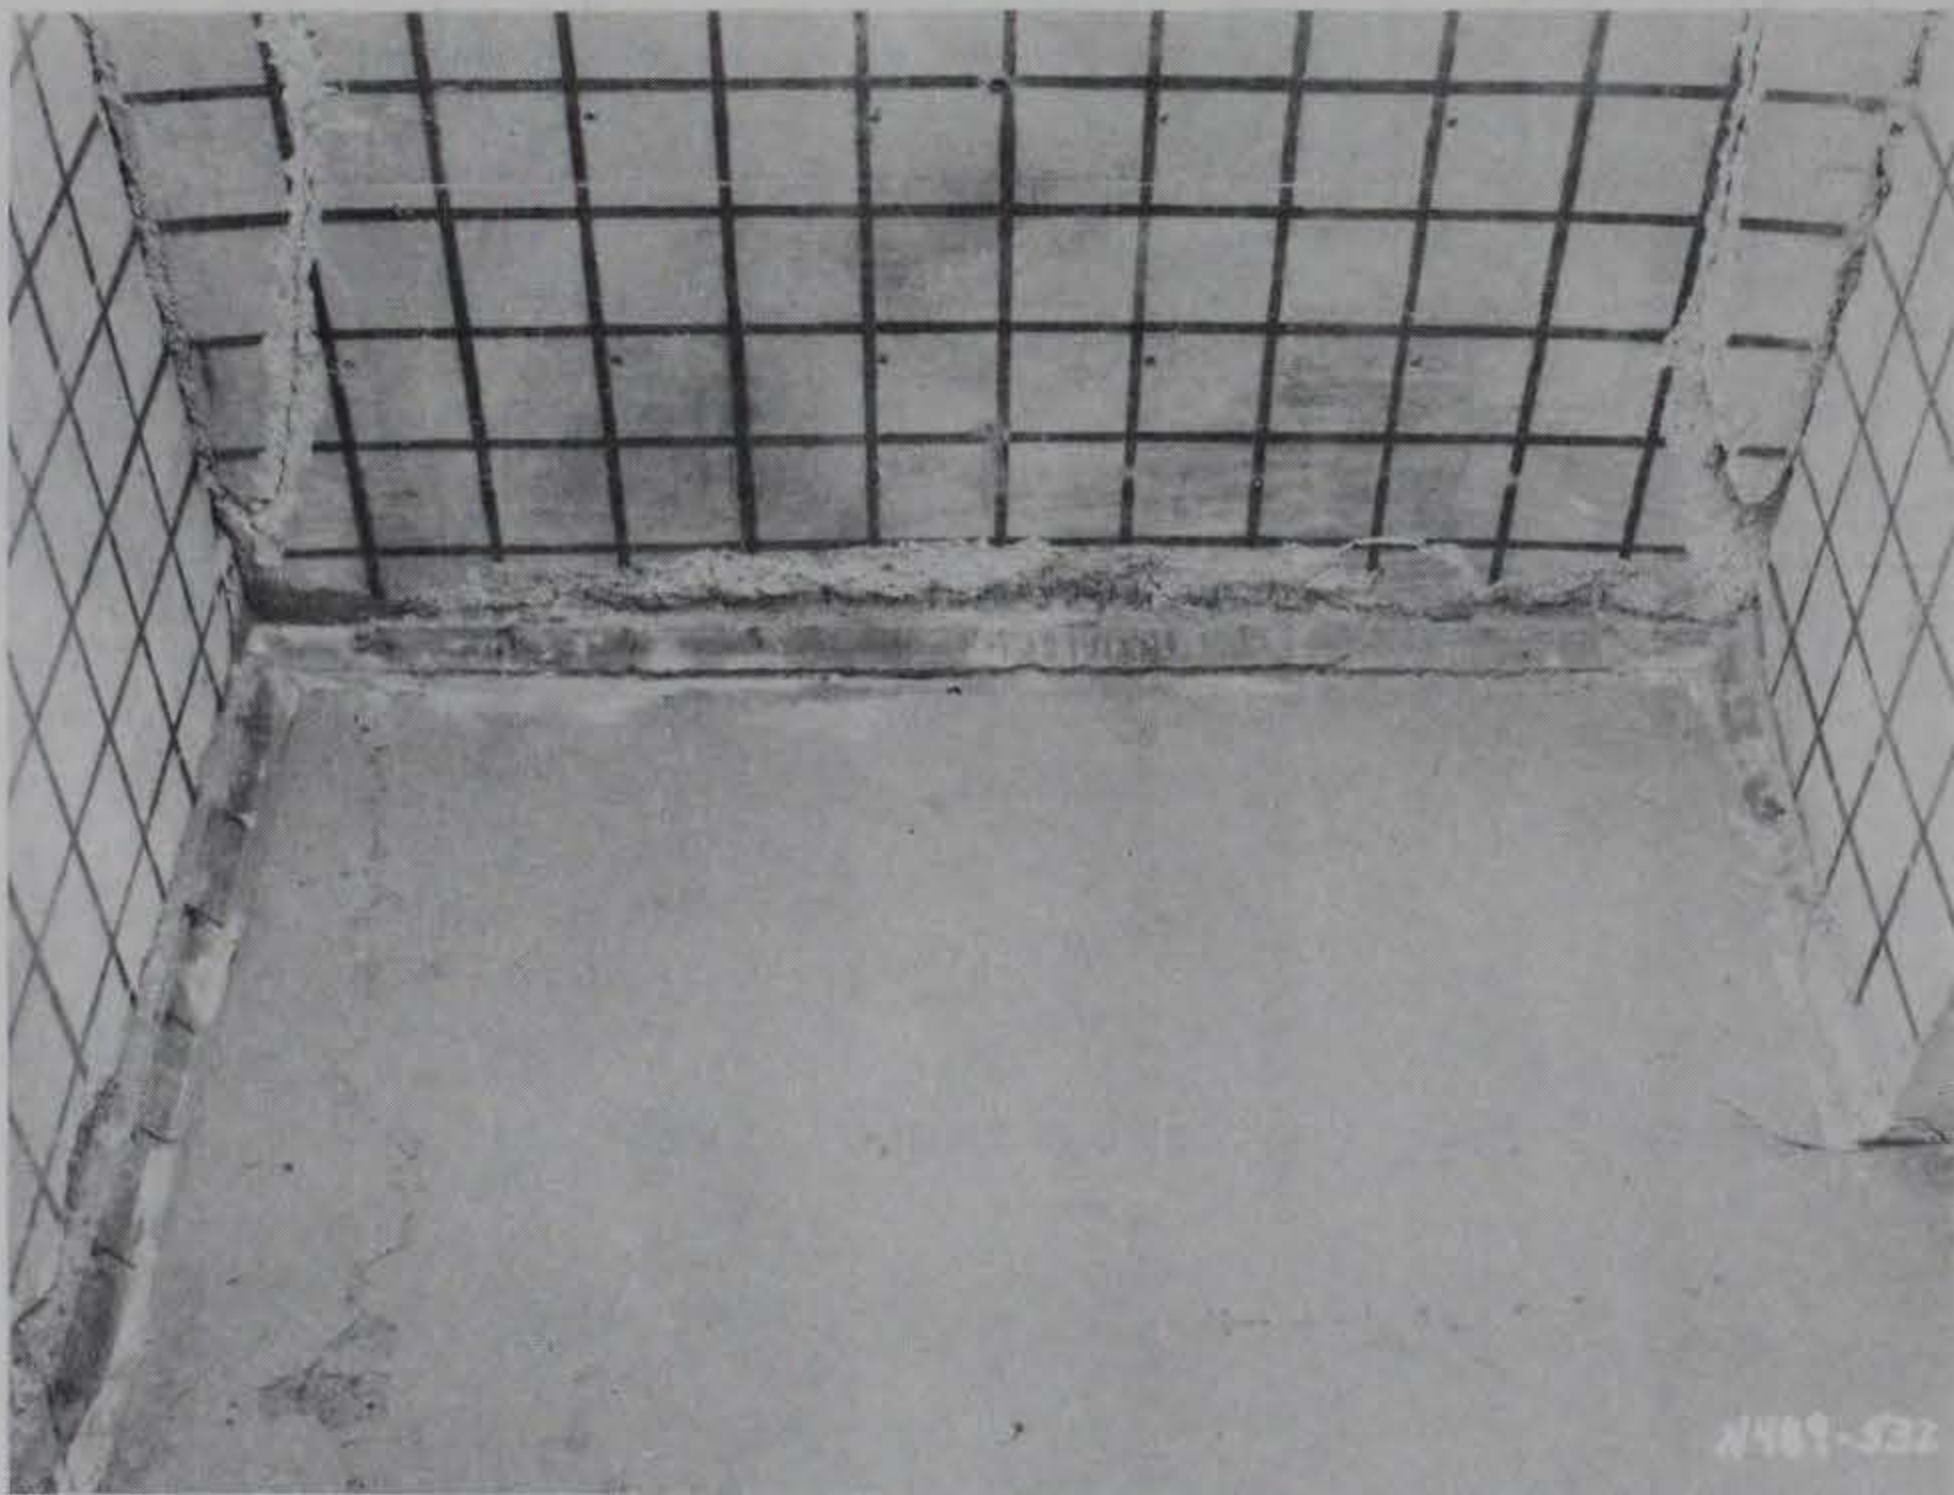
Figure 5.14. Posttest view of donor bay floor after removal of debris.

Damage to the floor slab included hairline cracks near the location of the explosive charge and cracks adjacent to the east and west walls. Spalling was limited to an area near the northwest corner of the slab. A pictorial view of the slab is shown in Figure 5.14 and the damage is mapped in Figure 5.15.

b. South end.

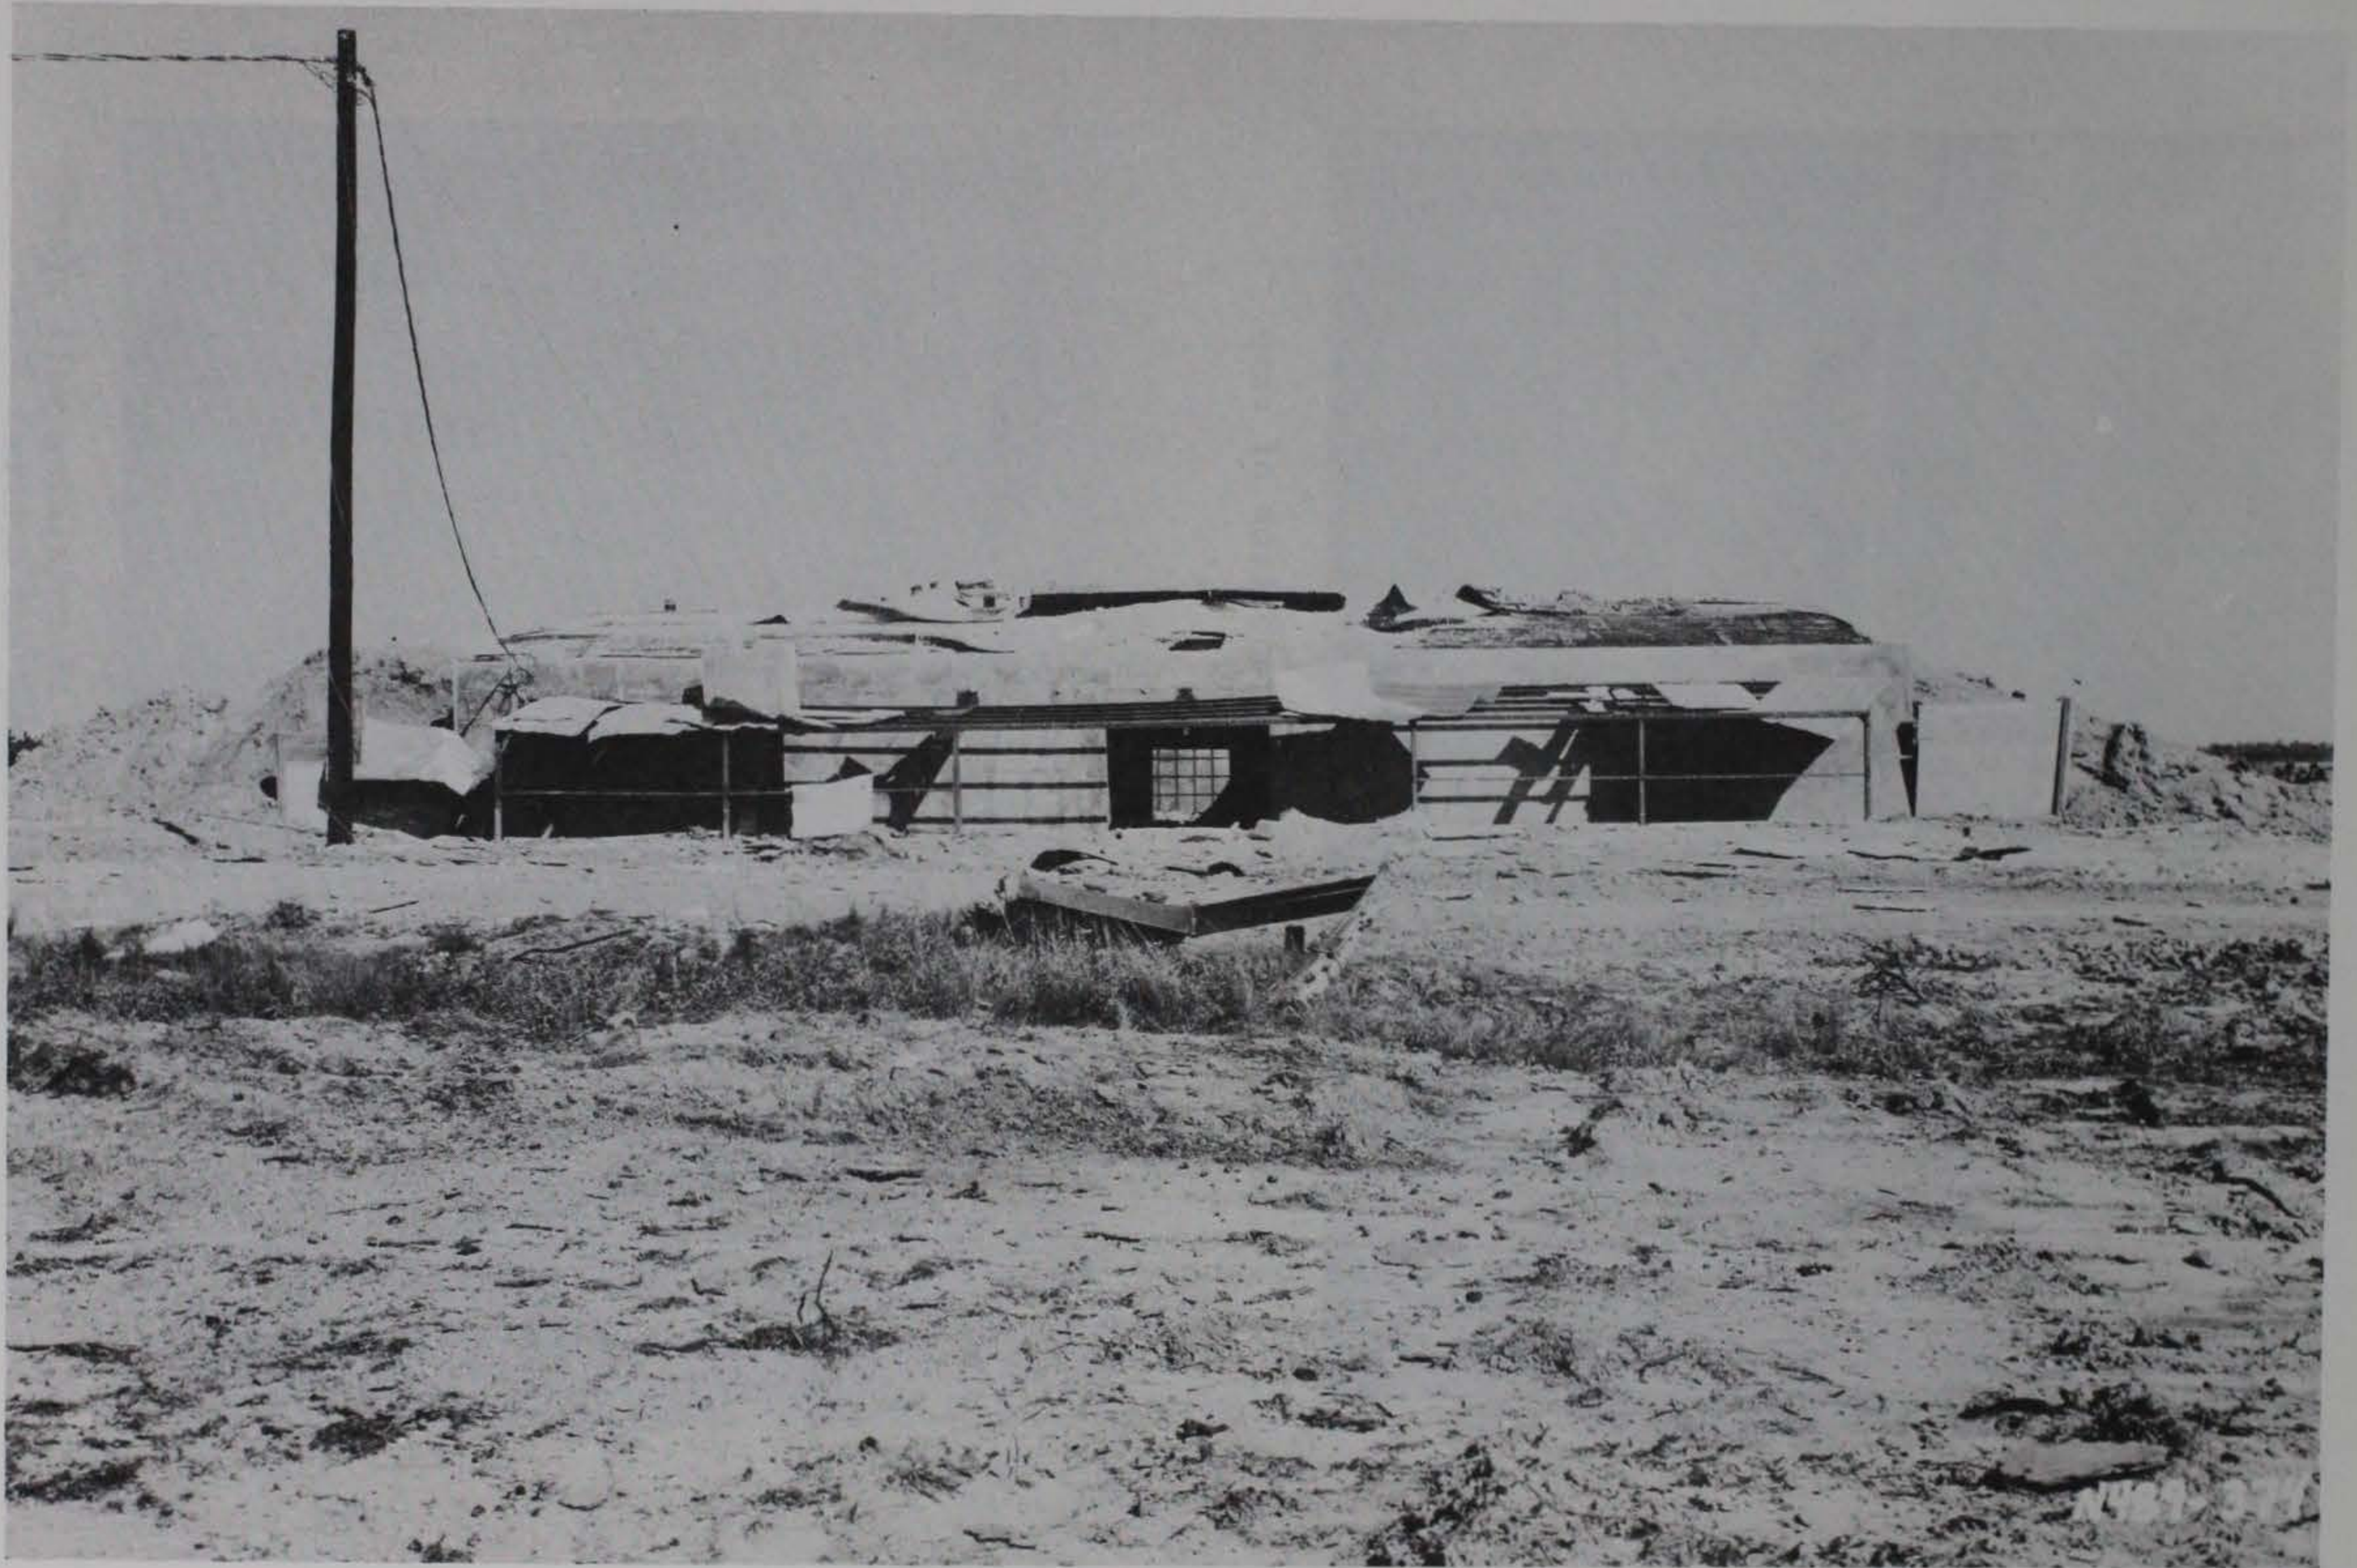
Figure 5.20. Posttest view of Phase II structure.

An overall posttest view of the ramp and Phase II structure is shown in Figure 5.20. All of the cemesto board on the walls and virtually all of it on the roof were destroyed during the test. All aluminum roofing material was removed. The aluminum sheets seen on the ramp in Figure 5.20 fell back to that position after the test. Figure 5.21 shows a more detailed view of the ramp damage. All of the self-tapping screws remained in place as the cemesto board fractured around them. The column in front of the donor bay was struck by debris from the air lock and broke away from the roof beam. It came to rest 417 ft east of the ramp. The girt attached to the column also broke away from the ramp and impacted several feet from the ramp. The impact load transmitted to the ramp also caused the beam and column immediately north of the donor bay air lock to break away from the retaining wall and to shear column baseplate bolts. The displacement of this member can be seen in Figure 5.21.
