TECHNICAL REPORT SL-83-6

AN EVALUATION OF THE SEPARATED BAY CONCEPT FOR A MUNITION ASSEMBLY COMPLEX; AN EXPERIMENTAL INVESTIGATION OF THE DEPARTMENT OF ENERGY BUILDING 12-64 COMPLEX

Robert D. Volz, Sam A. Kiger

September 1983

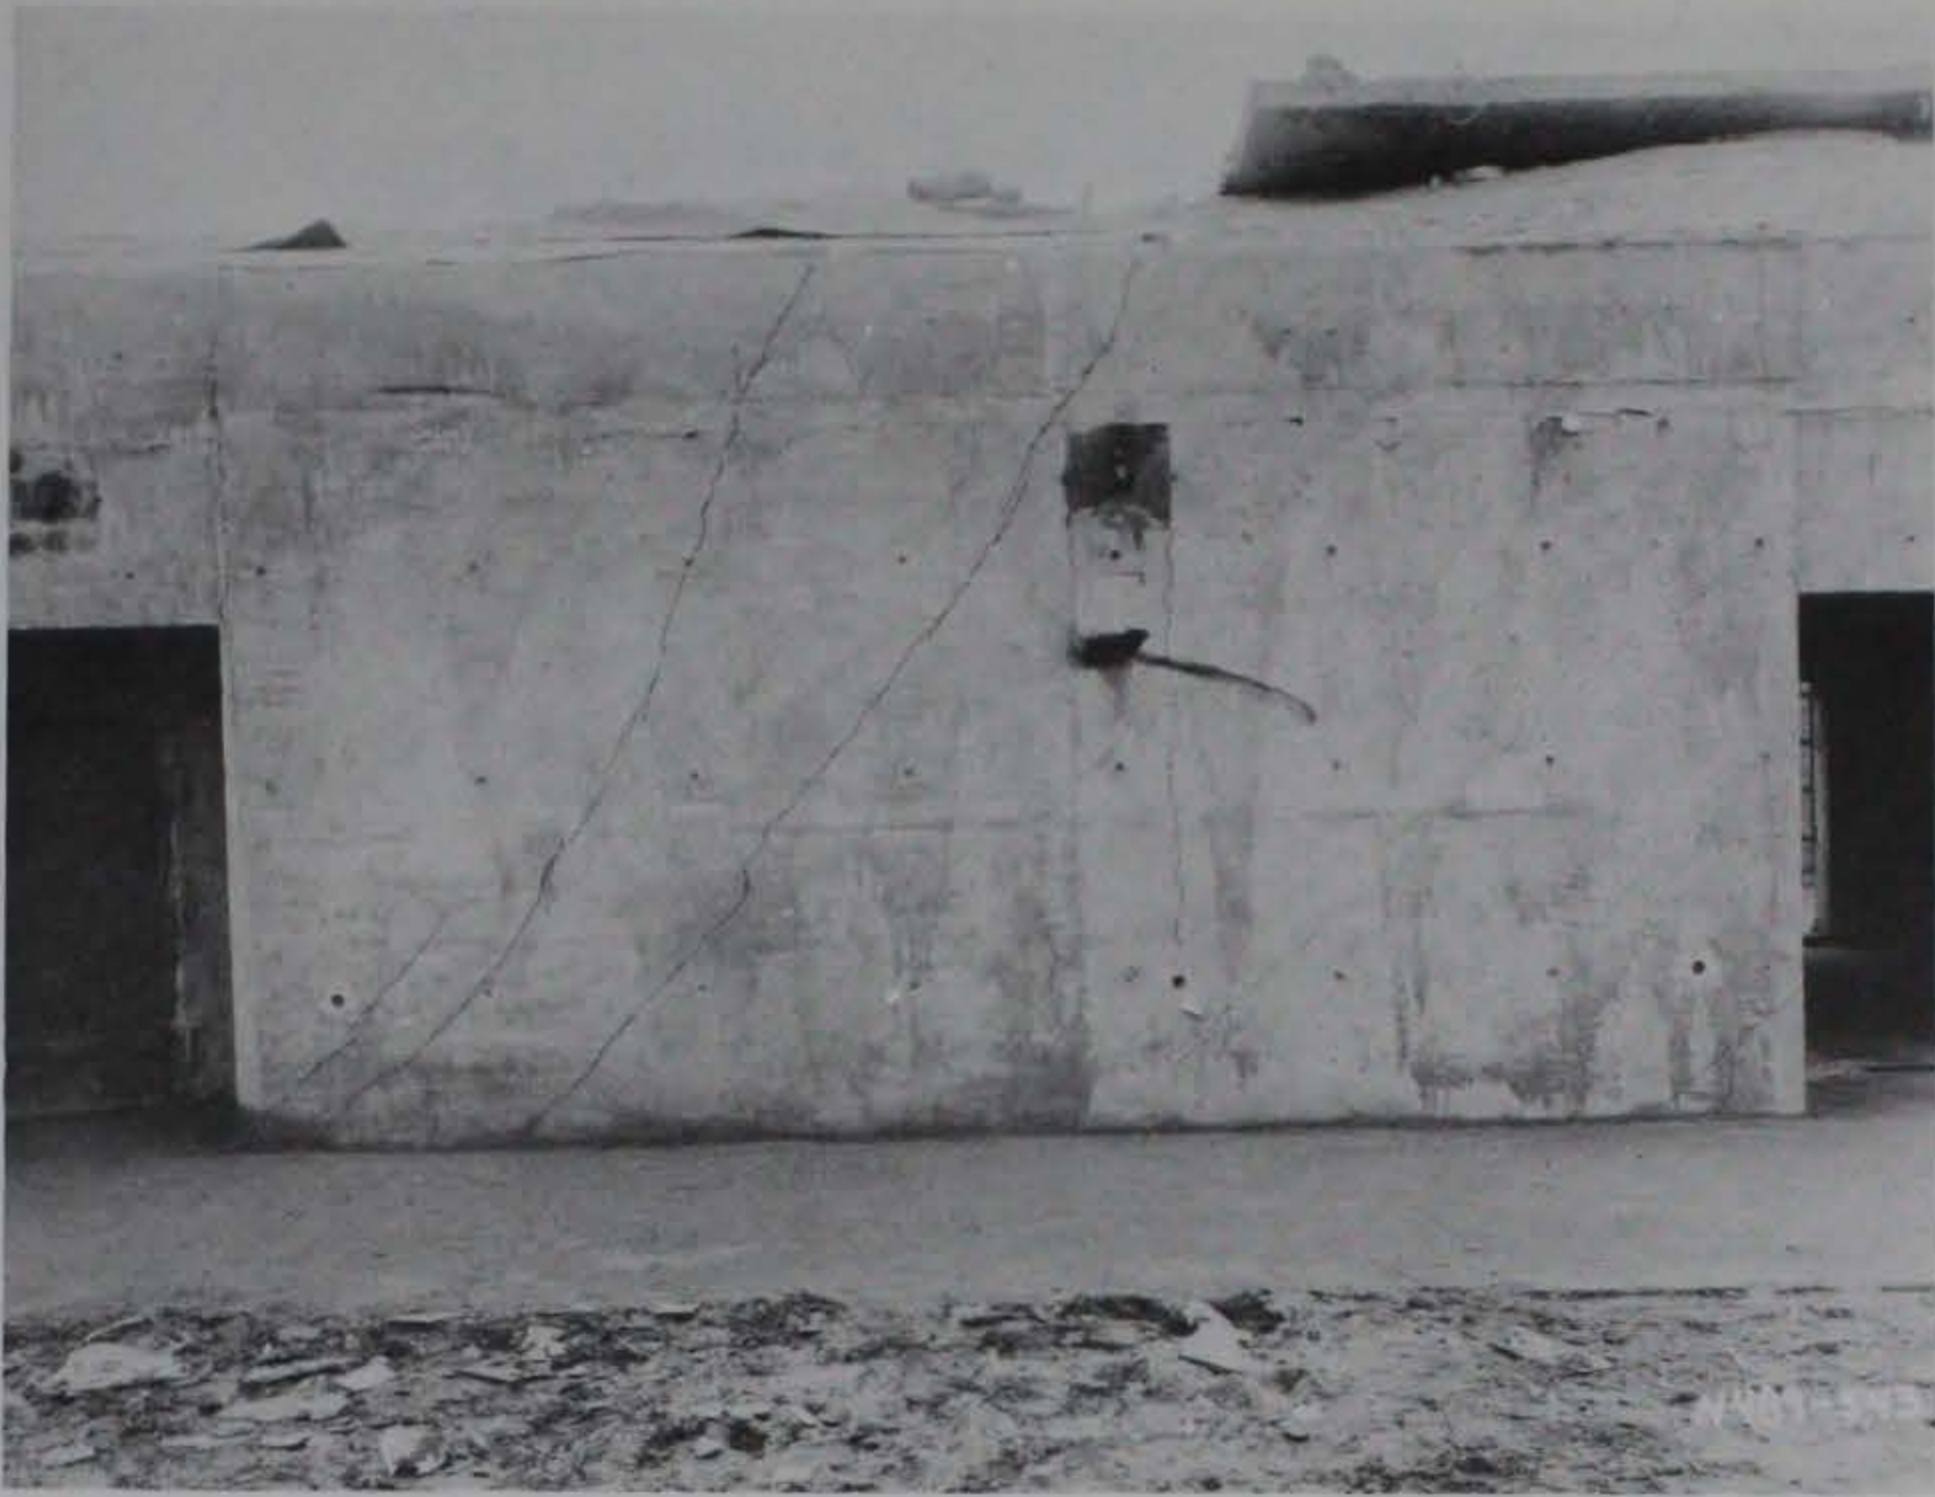
a. North of donor air lock.

The retaining wall experienced minor cracking. Figure 5.22 shows a post-test view of the wall after the ramp structure and debris were removed. More detailed views of the crack patterns are given in Figure 5.23. All cracks in the photographs were less than 0.1 in. wide and were enhanced with felt-tip pens for the photographs.

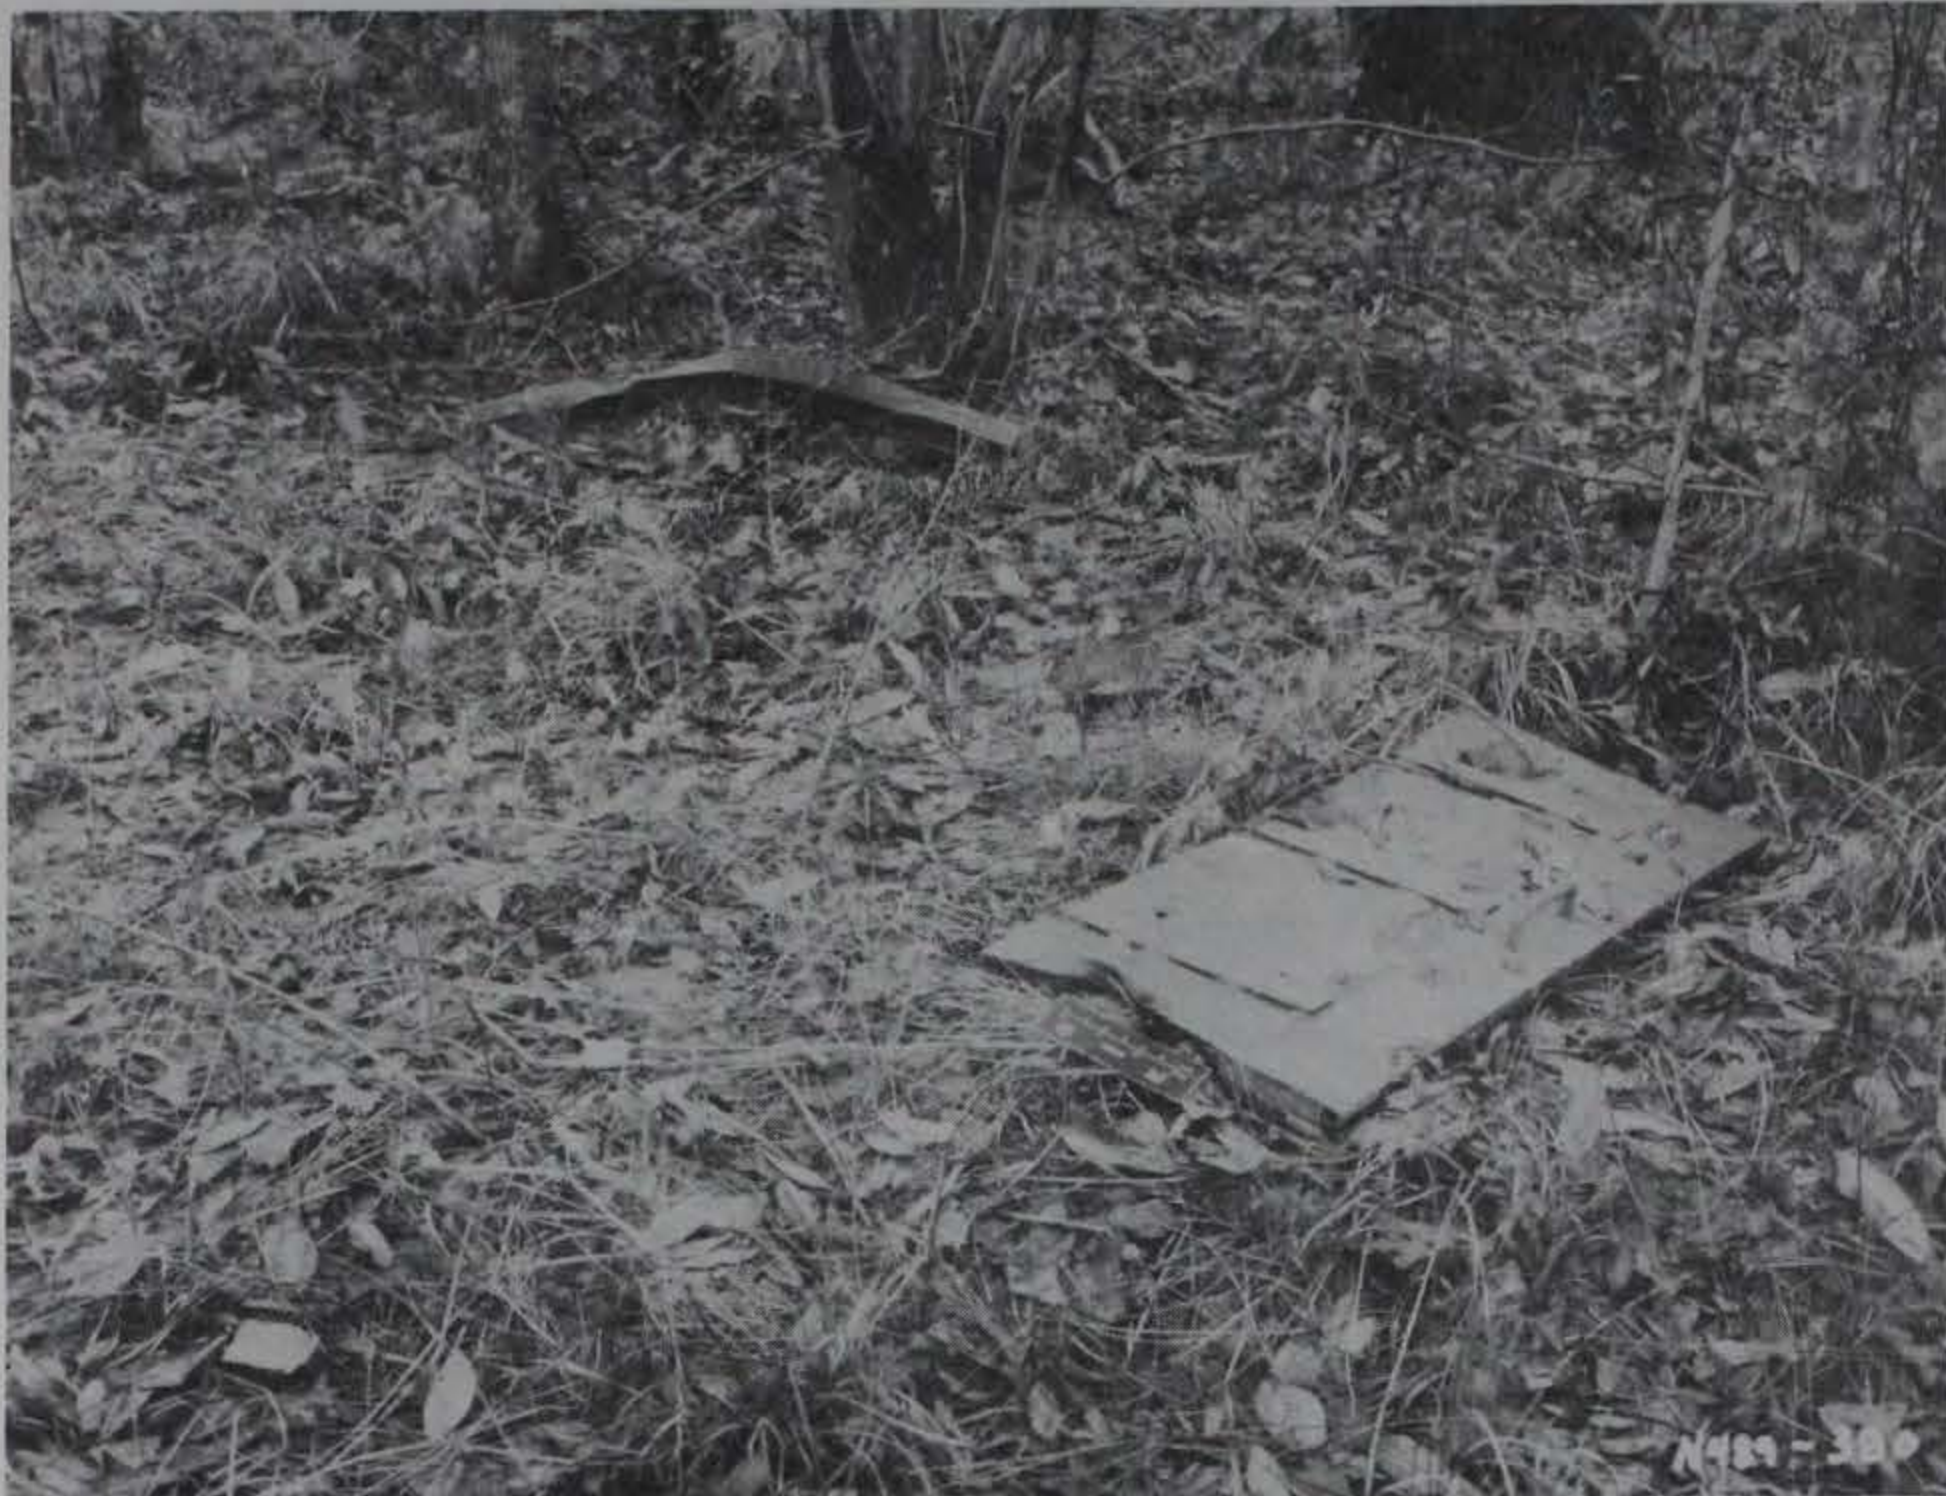
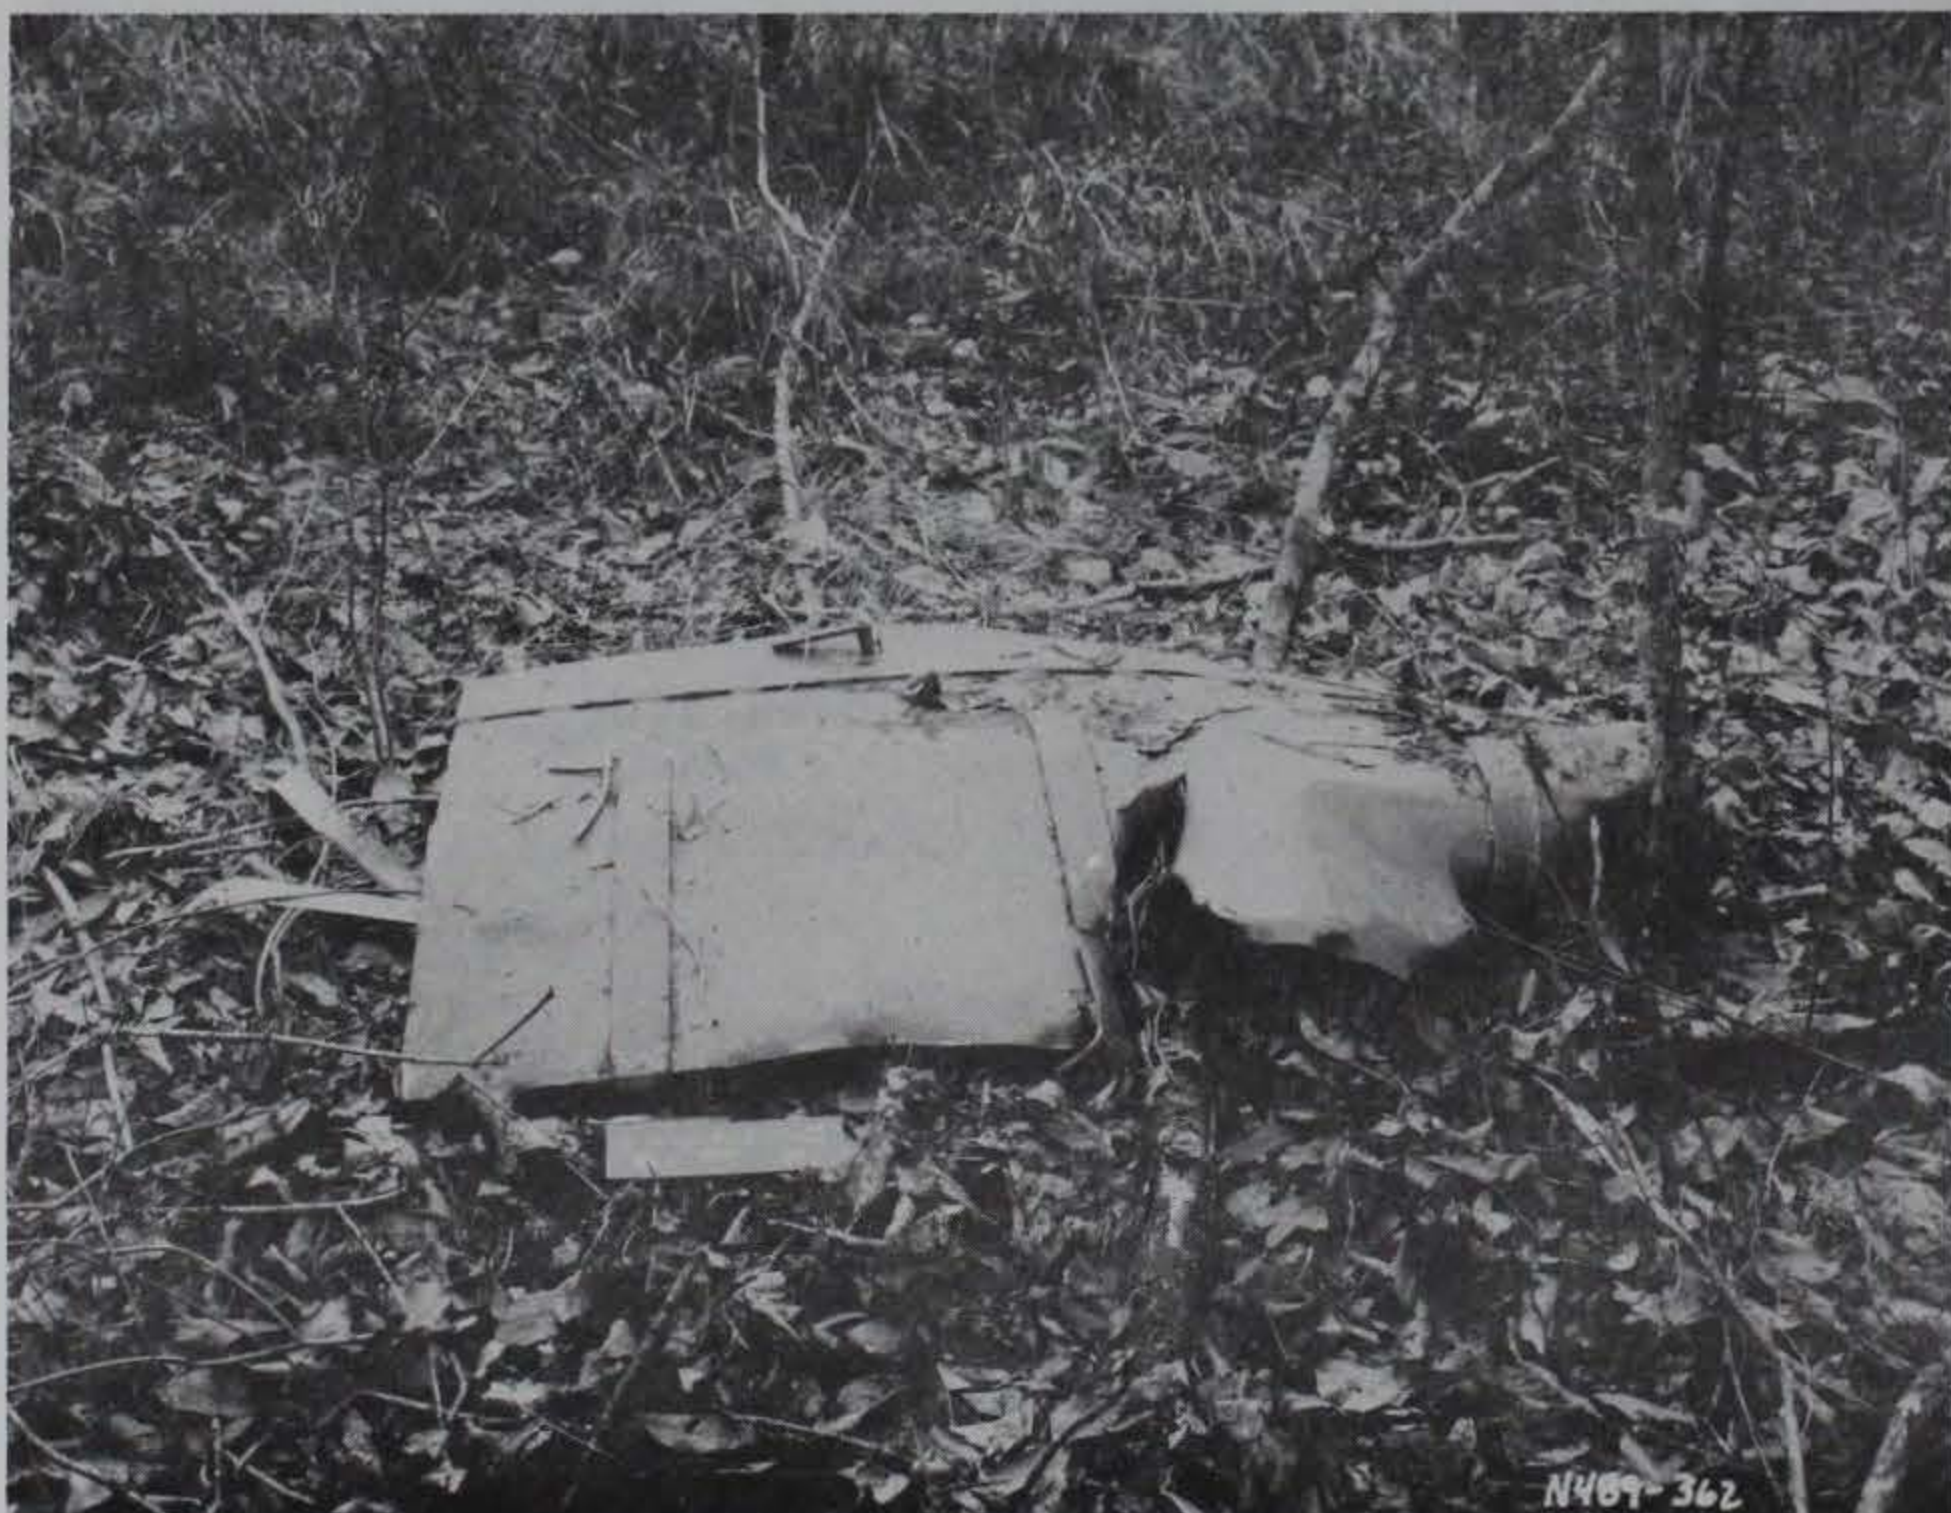
Figure 5.28. Posttest view of donor bay blast doors.

The blast doors broke away from the doorframe after breaking their hinge straps at the hinge pins. The lower locking bolt in the inactive (locked) leaf did not fail, but it rotated within the door and elongated the bolt holes in both the door and the embedded floor plate. The upper locking bolt was found undamaged and in the fully extended position. The interior skin plate on the inactive leaf was badly buckled and the entire door was severely damaged. The interior skin on the active leaf was also buckled, but the only other damage to the door was dents at the upper and lower edges. The active and inactive leafs came to rest 412.5 and 507.6 ft, respectively, from their initial position. The column broken from the ramp was found next to the active leaf as shown in Figure 5.28a.

a. Active leaf and ramp column.

b. Inactive leaf.
