MISCELLANEOUS PAPER C-78-12

CONCRETE AND ROCK CORE TESTS MAJOR REHABILITATION OF STARVED ROCK LOCK AND DAM, ILLINOIS WATERWAY CHICAGO DISTRICT, PHASE I, REHABILITATION

Richard L. Stowe, Barbara A. Pavlov, Ging S. Wong

September 1978

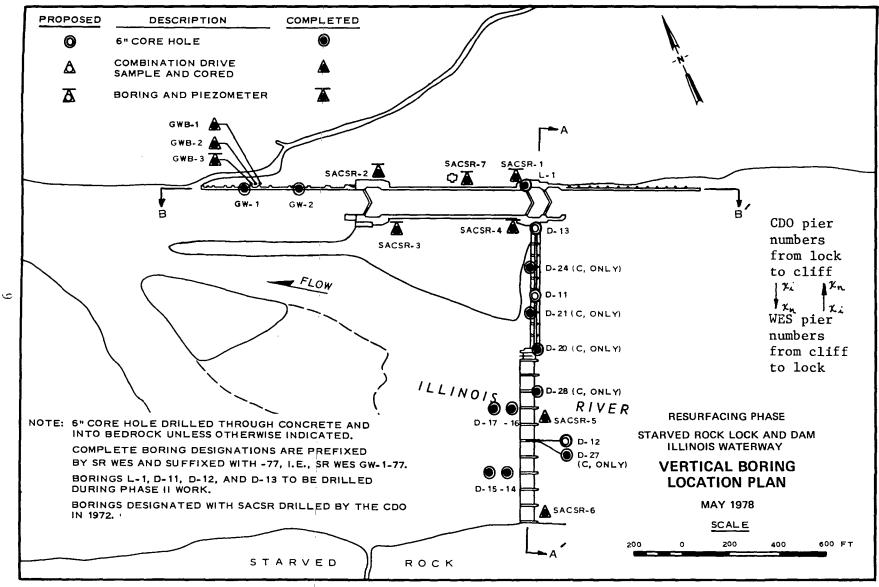
Figure 1. General boring location plans

a. Vertical boring location plan

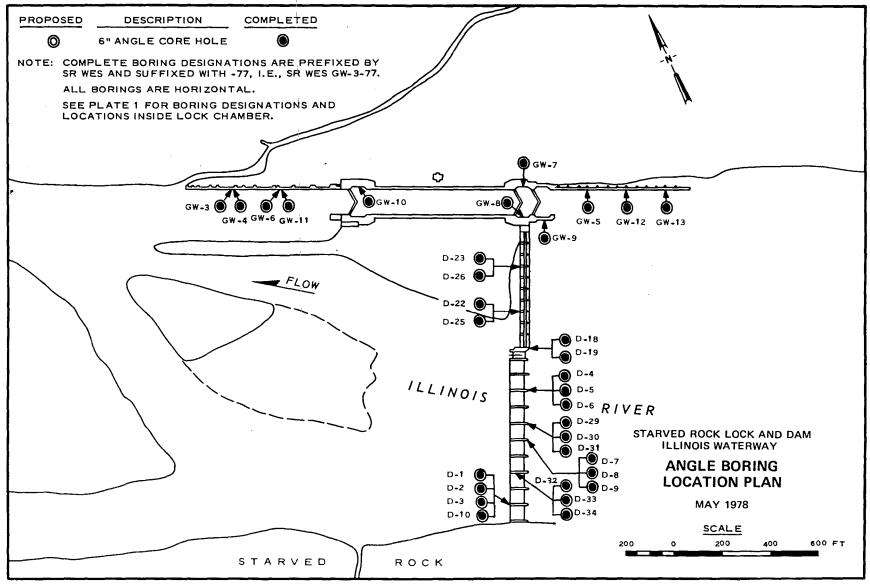
Figure 1. General boring location plans

b. Angle boring location plan

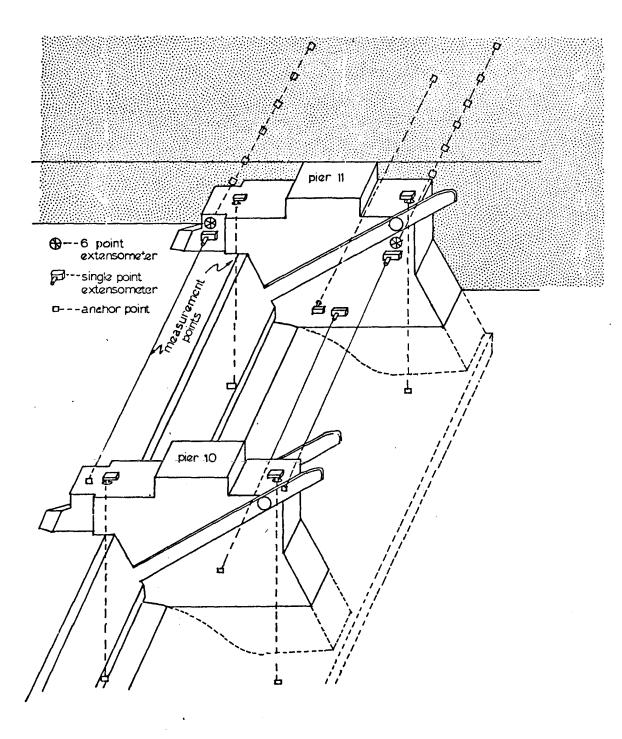
FIGURE 7. Gage location

- In order to determine the appropriate remedial actions a. for the above-mentioned problem, the movements of piers 10 and 11 should be described as a function of time. To detect the pier movements, 10 extensometers are recommended. Two multiple-point borehole extensometers (MPBX) should be placed through the abutment pier and extended into the abutment to a depth beyond any possible movement. One MPBX should be located upstream of the tainter gate as far as practical and the other downstream of the gate (Figure 7). The third extensometer to be placed in the abutment should be a single-point extensometer placed through the lower center of the abutment pier. Three single-point extensometers should be used for spanning the tainter gate which has opening difficulties. The remaining four extensometers should be single-point, placed vertically through the piers and anchored to competent foundation rock.

- b. Precise location of the MPBX should be determined from visual inspection of the abutment adjacent to the pier. The depth of the deepest anchor should be determined from visual inspection of the top of the abutment for surface expressions of stress relief joints, conjugate joint sets, etc., and from the core obtained from the MPBX borings. Intermediate anchor points for the MPBX will be located from the borehole cores in an effort to

avoid multiple anchorage within the same rock block, anchorage within joints, etc. Location of the singlepoint extensometers between piers 10 and 11 should be adjacent to the abutment extensometers. The remaining extensometers are to be located toward each end of the two piers and the depth of anchor point should be determined from core logs of the respective borings.
