MISCELLANEOUS PAPER C-76-9

ENGINEERING CONDITION SURVEY AND STRUCTURAL INVESTIGATION OF LOCKS AND DAM 3, MONONGAHELA RIVER

August 1976

Prepared for U. S. Army Engineer District, Pittsburgh
Pittsburgh, Pennsylvania 15222

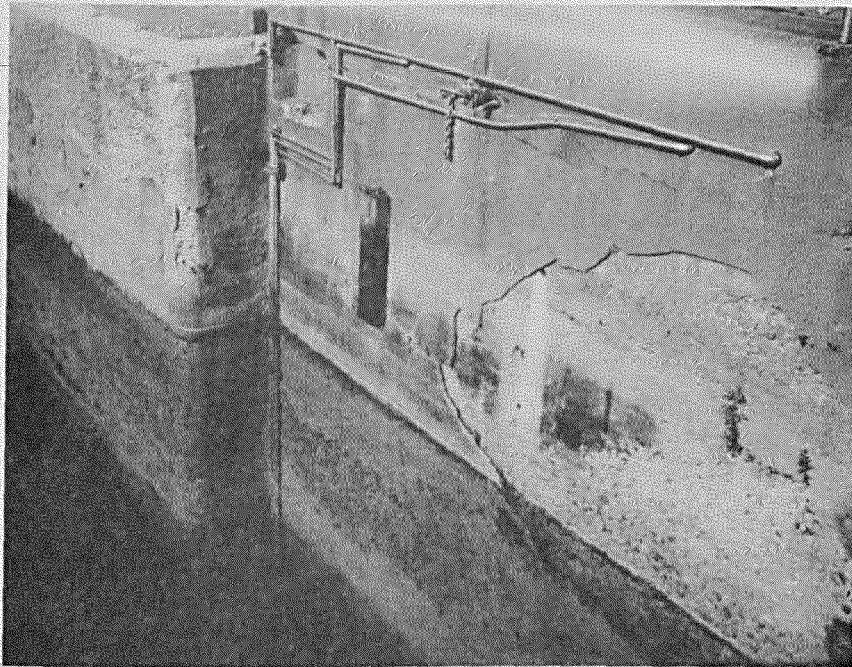
Figure 2.1 shows the downstream areas of the chamber face of the river wall. They illustrate the appearance of the gunite, the areas of old concrete where the gunite cover has come off, and some opening between the gunite and the underlying concrete in the gate recess. Figure 2.2 shows an area on the top of the river wall near the chamber face where the overlying concrete repair has spalled off exposing the old concrete beneath it. The aggregate particles in the old concrete are loose in their sockets and pieces of mortar can be removed by hand; this area of loose aggregate and fragmented mortar looks like and probably represents damage due to long-time frost action. Figure 2.3 illustrates the damaged surface of the guard wall just above the upper gate of the large chamber. This type of damage is common in the guard wall surfaces, and is caused by continued impact and scraping by boats and barges upon

b. Downstream Gate Recess of River Wall
Showing Loss of Gunite Cover

Figure 2.1. River Wall Showing Loss of Gunite Cover.

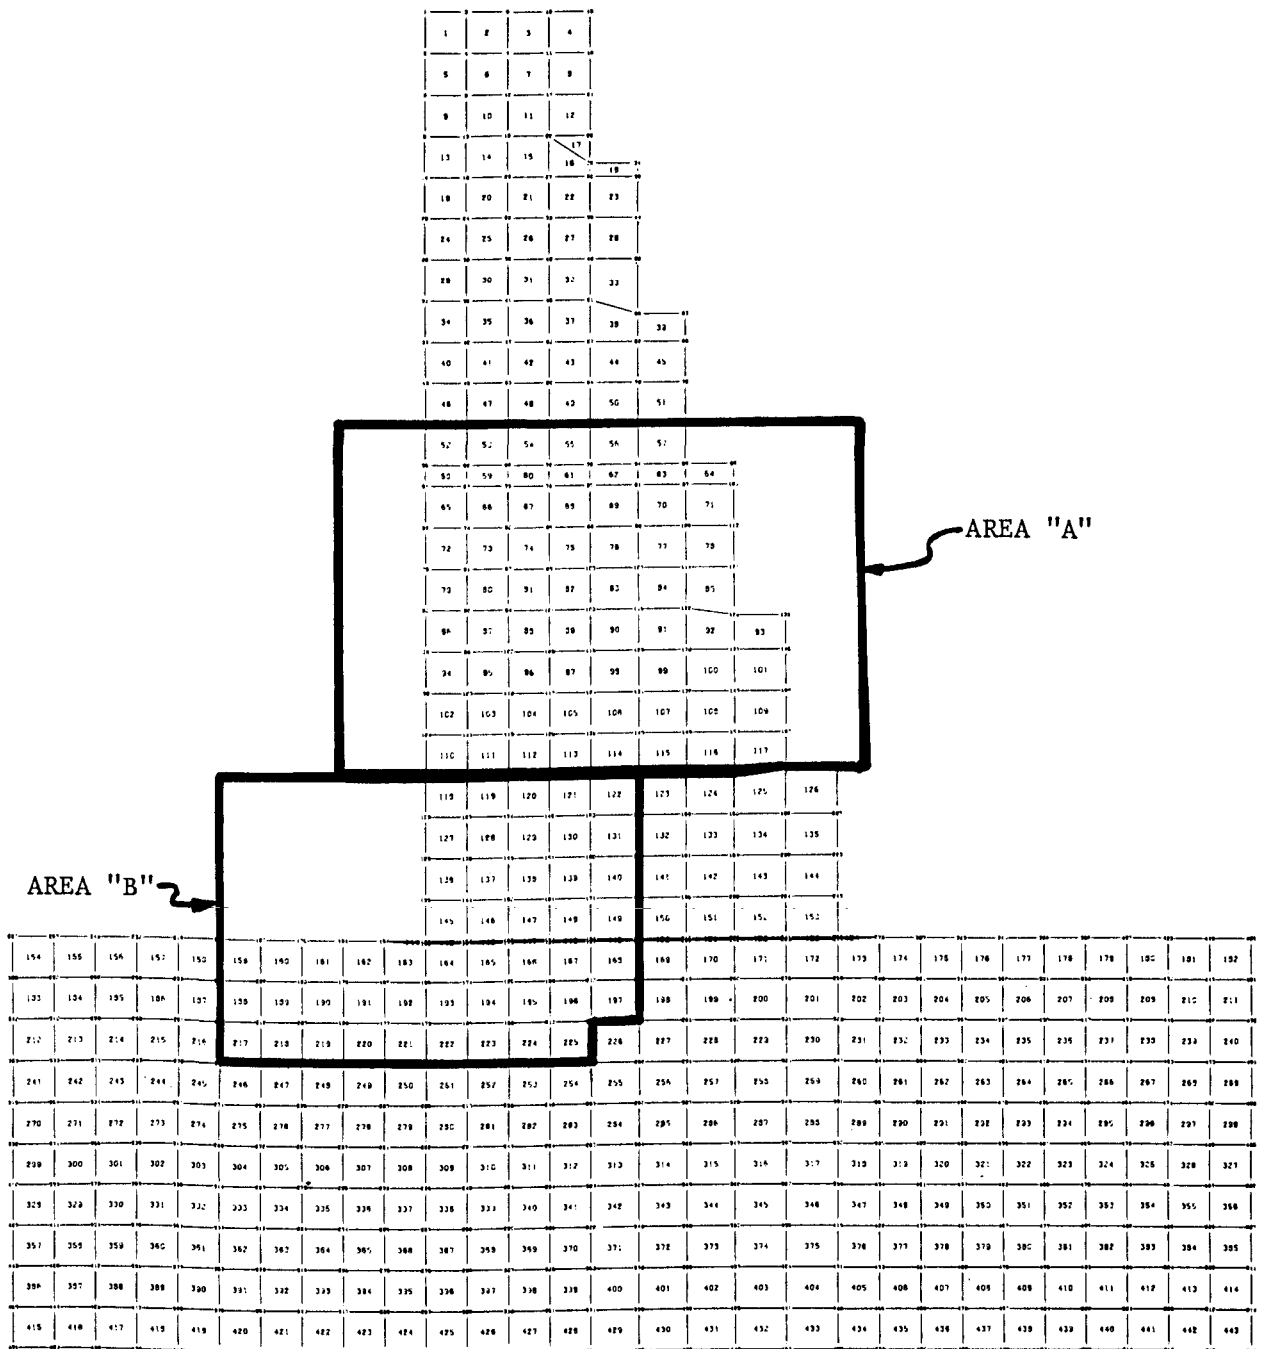
The grid depicting the areas of maximum stress for monolith L-18 is presented in Figure 7.10. These areas of stress concentration are then shown in Figures 7.11 and 7.12. Several important concepts become clear when the stresses in L-18 were studied. One concept is that the normal conventional design does not give maximum stress values. The S22 component is usually obtained, and it is generally not maximum or minimum principal stress. For example, when considering tensile stress in elements 64, 71, 78, 85, 92, 93, and 101, the maximum stresses are from 7 to 86 percent more than the S22 value. This shows that conventional computations can be misleading when obtaining stresses for design. This could cause the gouge depths necessary for failure in this upper guide wall (Table 7.1) to be reduced.

The location of the compressive stress concentrations are indicated in Figure 7.10 and is given in Figure 7.12. The maximum compressive stresses in L-18 are low (≈ 550 psi) when considering good quality concrete but the maximum tensile stresses are higher than the allowable even for good concrete. The allowable tensile stress for 4000-psi concrete is about 102 psi where L-18 has tensile values over 300 psi.

Figure 7.10. Grid - Upper Guide Wall Monolith, L-18, Depicting Stress Concentration Areas for Presentation

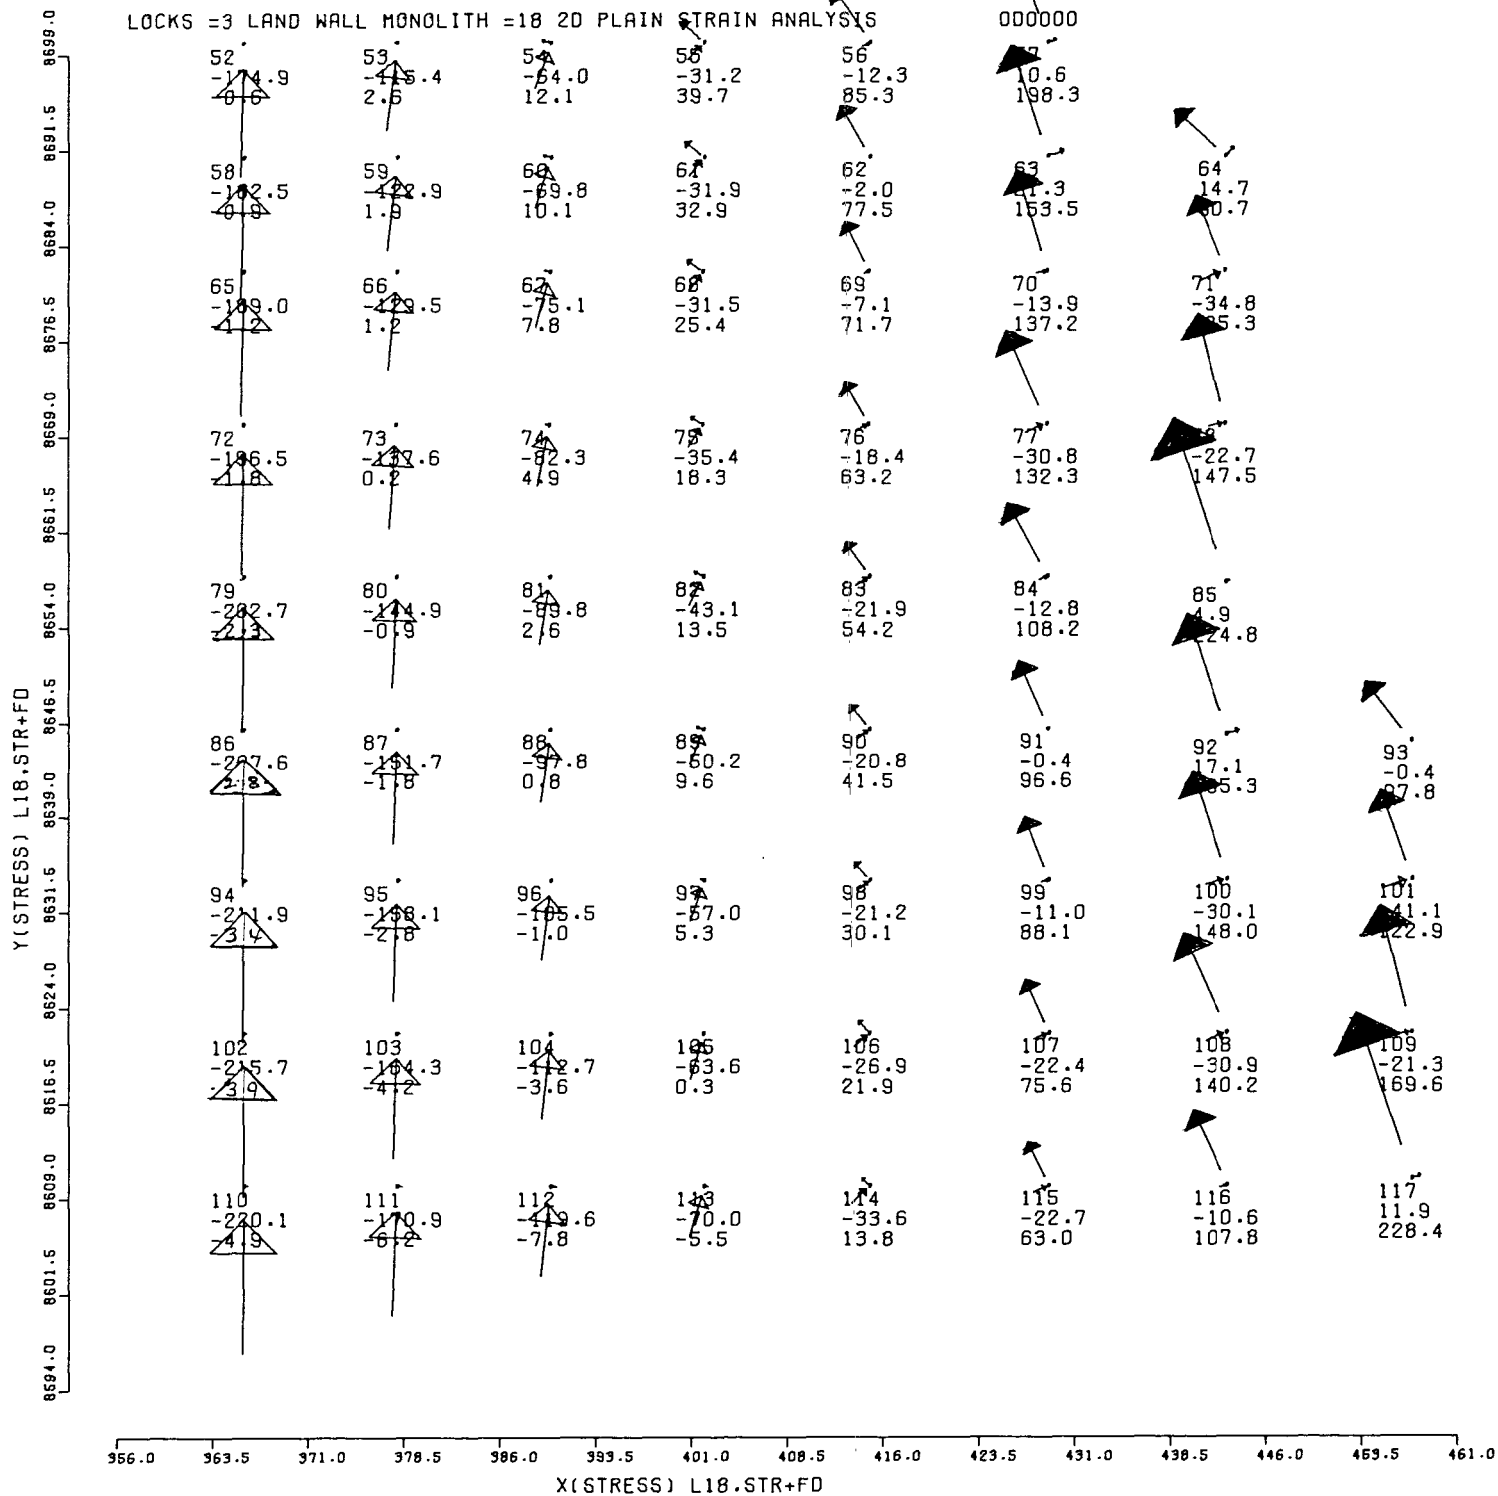
Figure 7.11. Stress vector plot of area "A" as depicted in Figure 7.10.
Monolith L-18

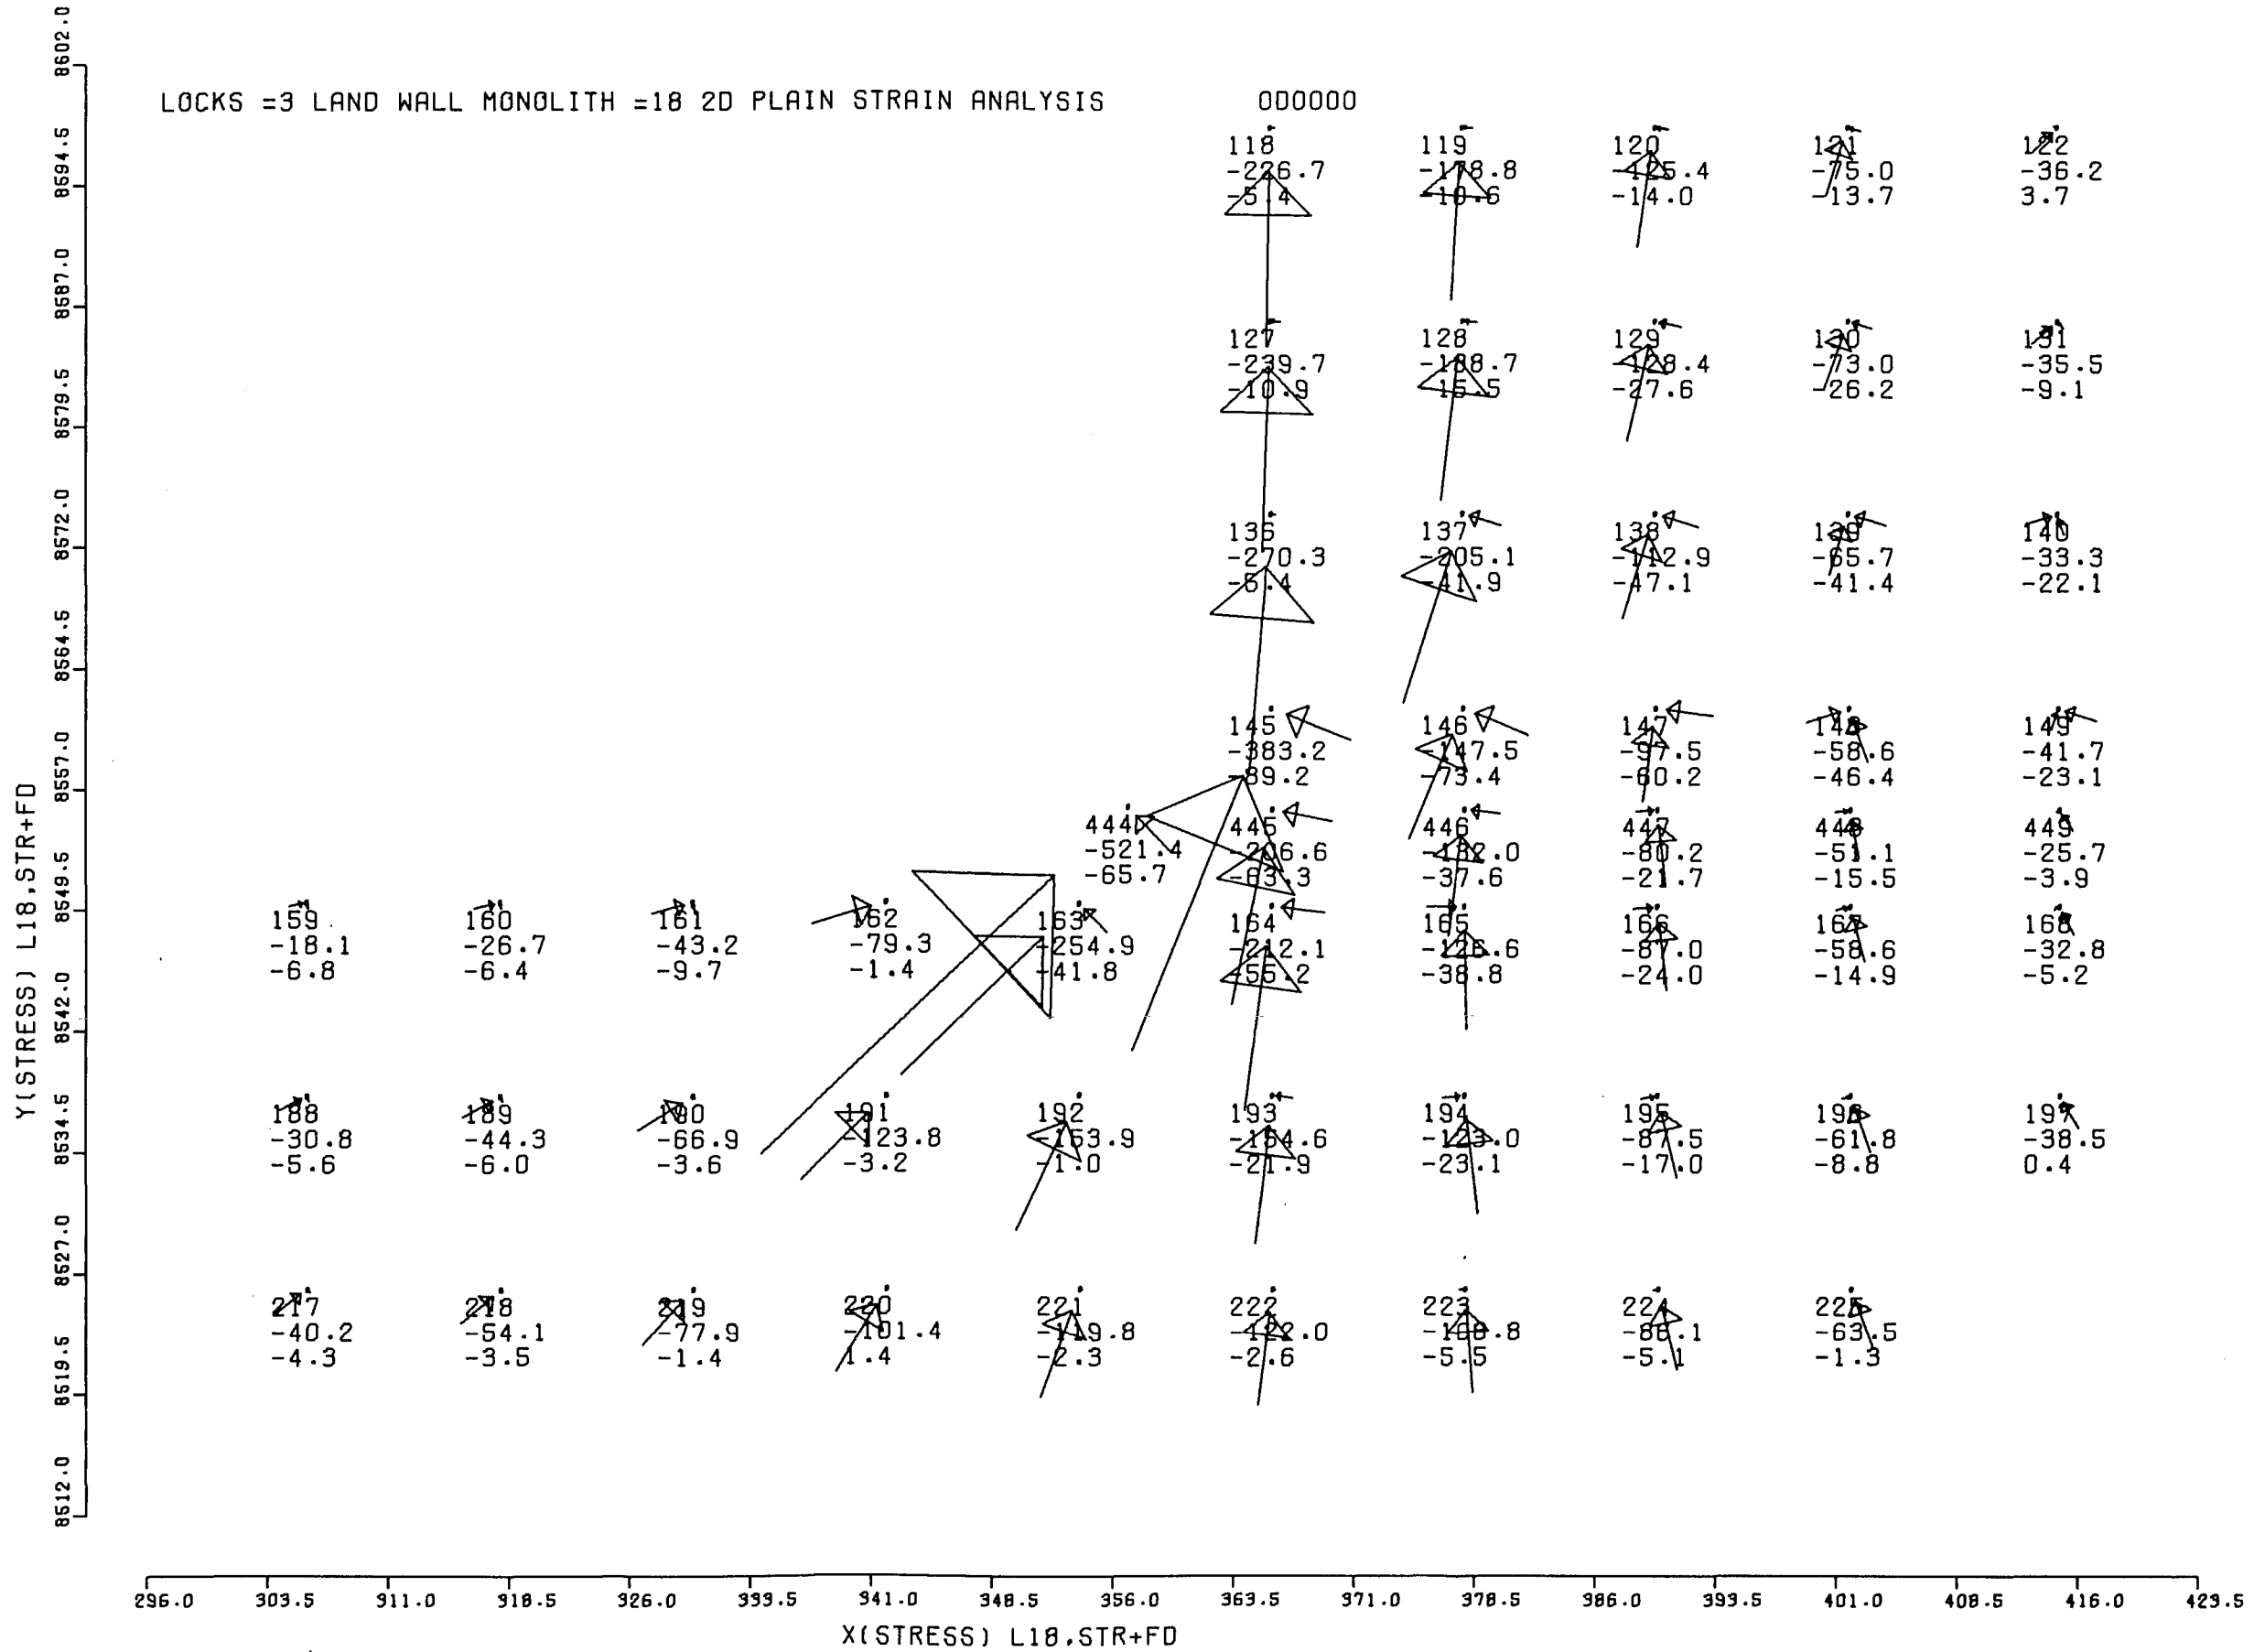
Figure 7.12. Stress vector plot of area "B" as depicted in Figure 7.10.
Monolith L-18

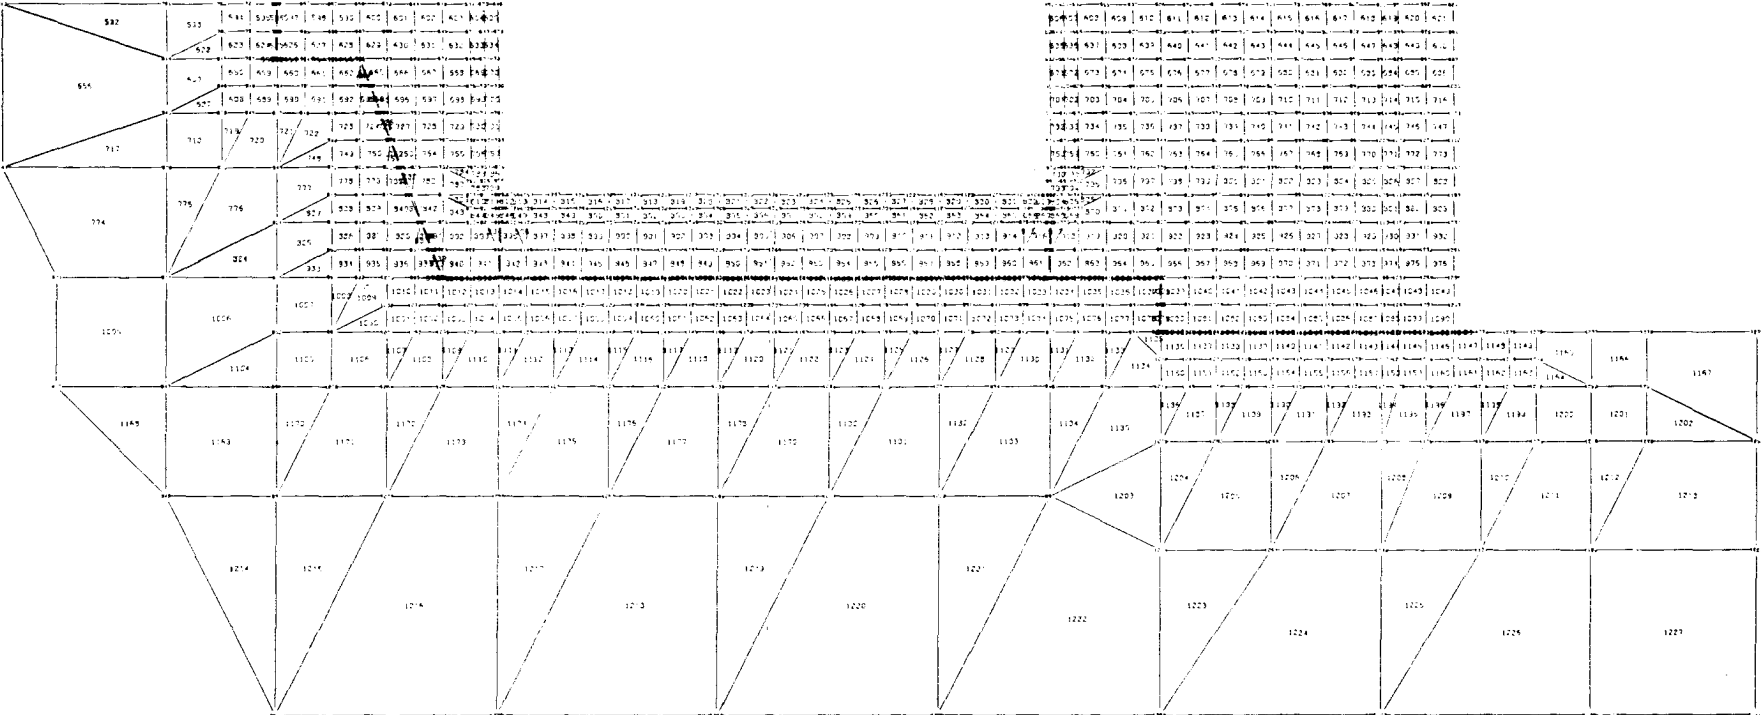
The grid for L-23 (Figure 7.13) shows the region of critical stress in the structural slab over the filling and emptying flume. This stress presentation is given in Figure 7.14. The large grid for L-23 is given in Appendix VII by Figure VII.9. The displacement plot is given in Figure VII.10 of Appendix VII. The stress plot for only the case of normal operation is given. The reason for this is that the stresses for the dewatered or maintenance condition are about the same as those for normal operation.

Figure 7.13. Grid - Land Wall, Upper Gate Bay Monolith, L-23, Depicting Stress Concentration Area for Presentation

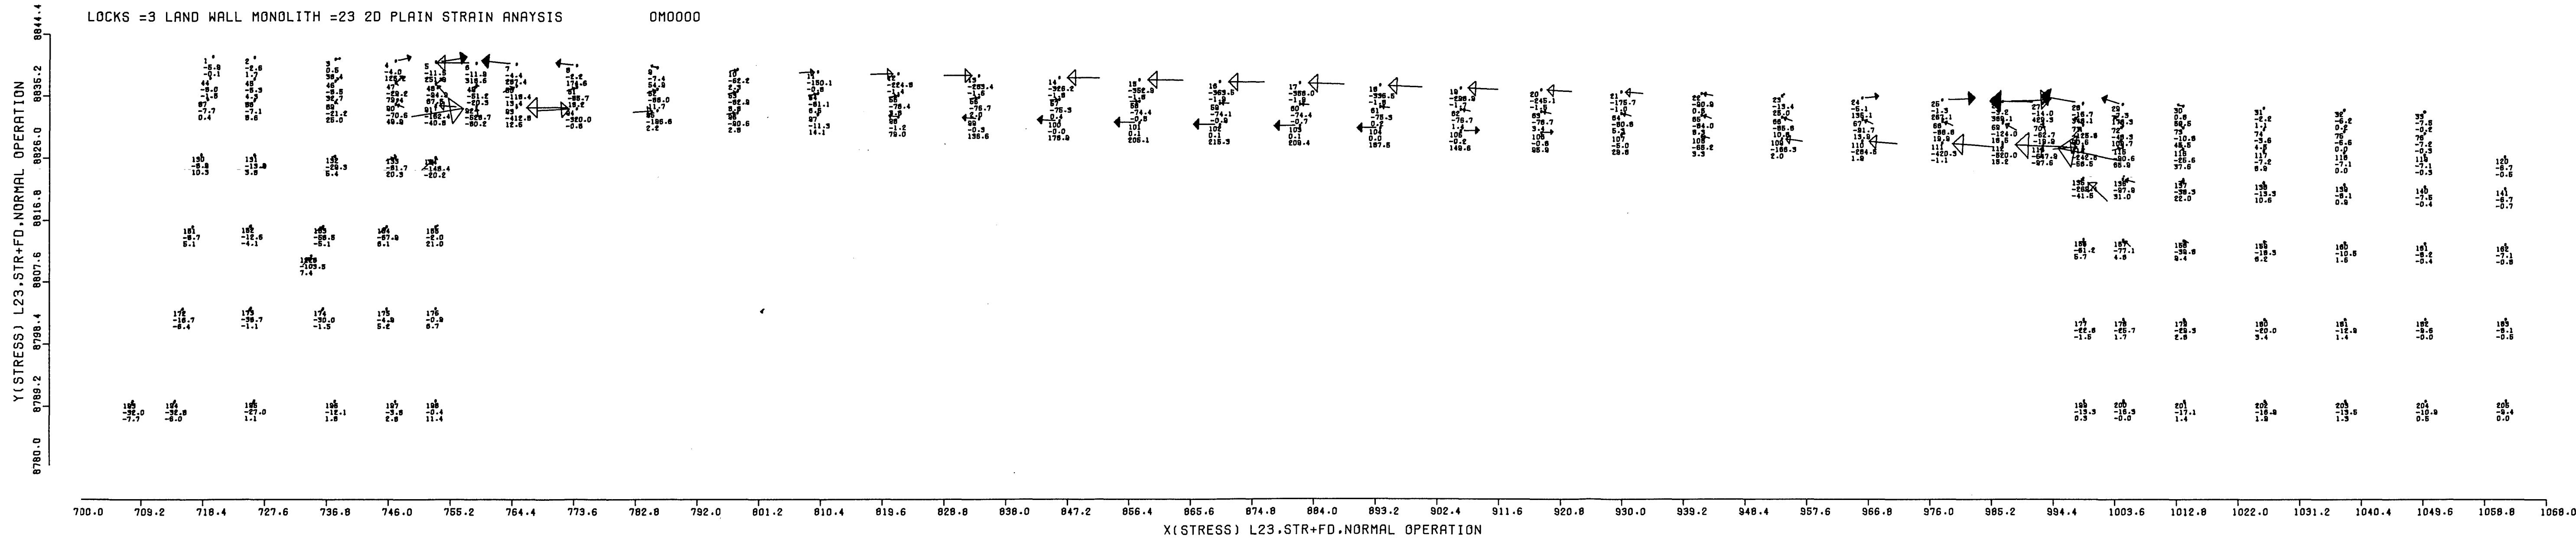
Figure 7.14. Stress vector plot of area "C" as depicted in Figure 7.13.
Monolith L-23

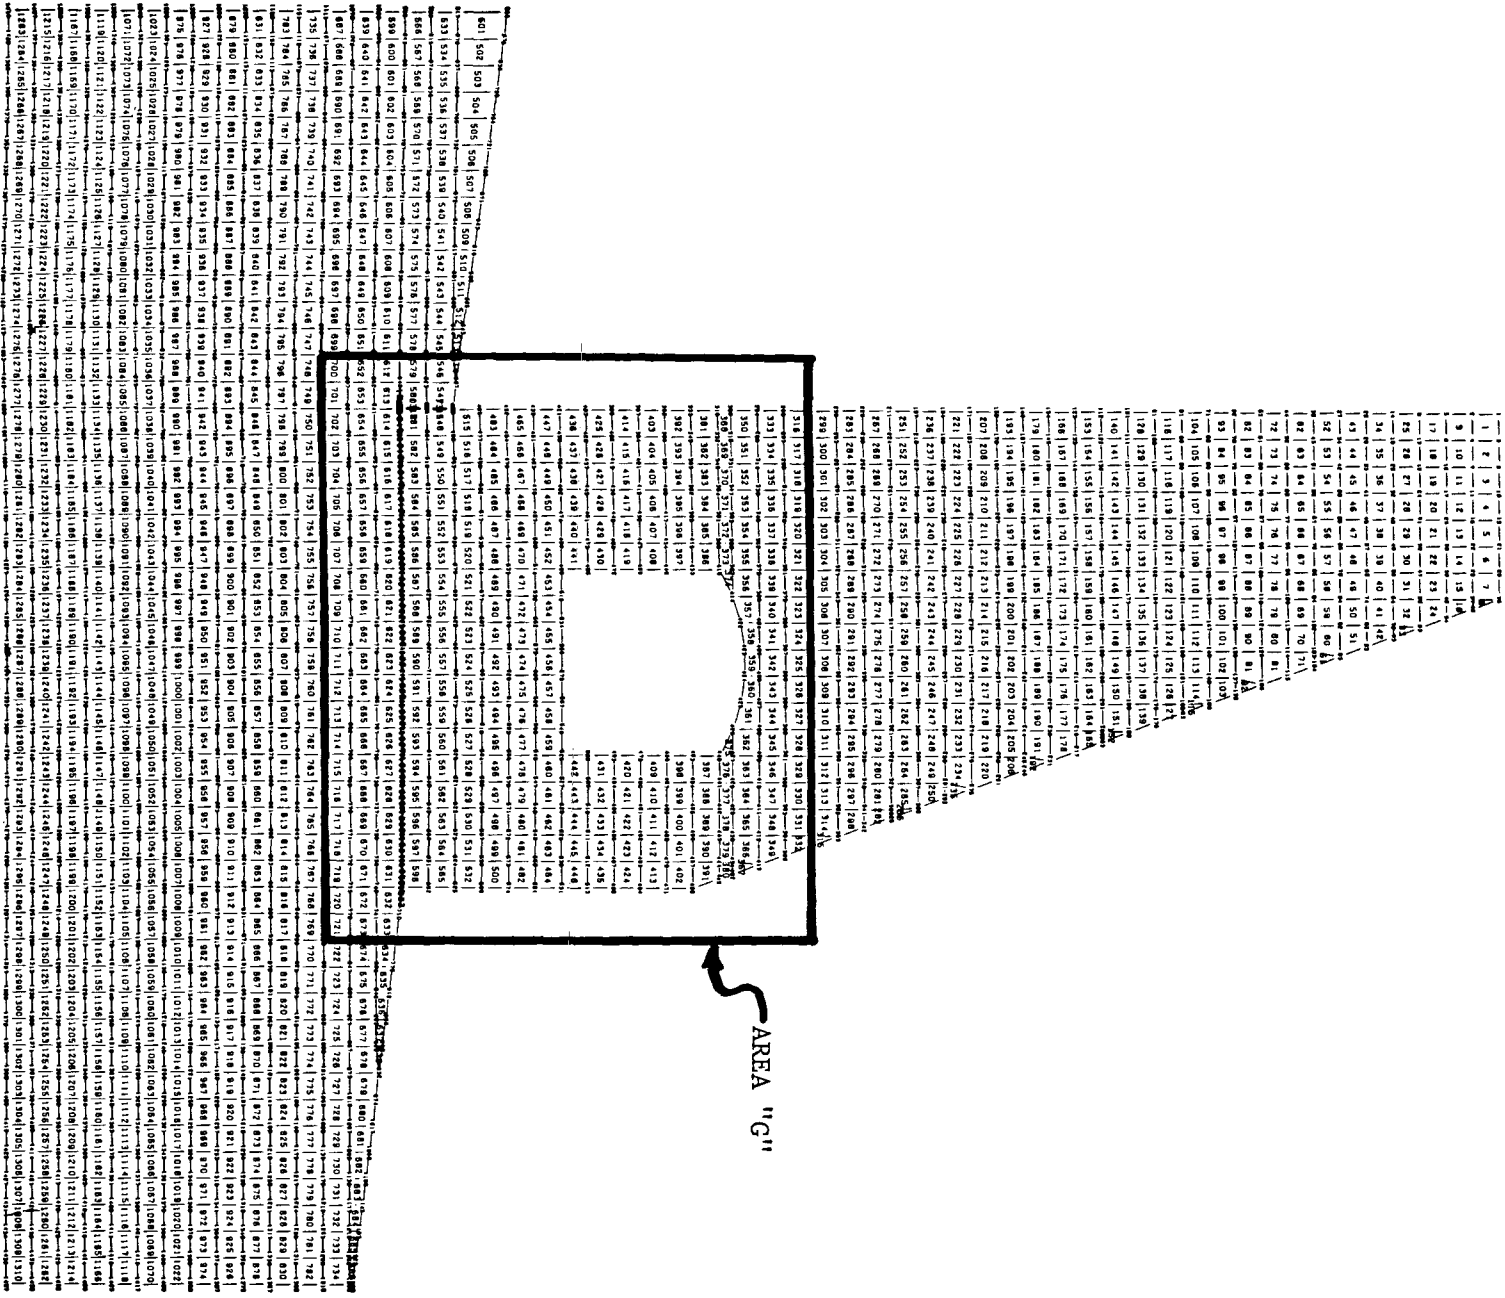
The grid of R-15 depicting the critical stress area is shown in Figure 7.20. The stress plot for this area is presented in Figure 7.21. The larger grid is given in Figure VII.17. The largest tensile stresses of approximately 120 psi occur at the top and to the sides of the lower culvert. It is common that locks have cracks in these upper corners.

Figure 7.20. Grid - River Wall Monolith, R-15, Depicting Stress Concentration Area for Presentation

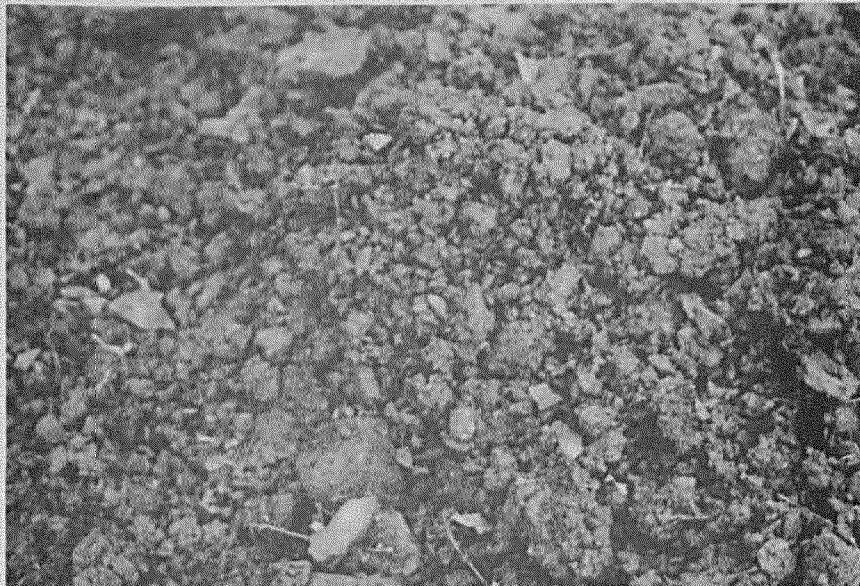
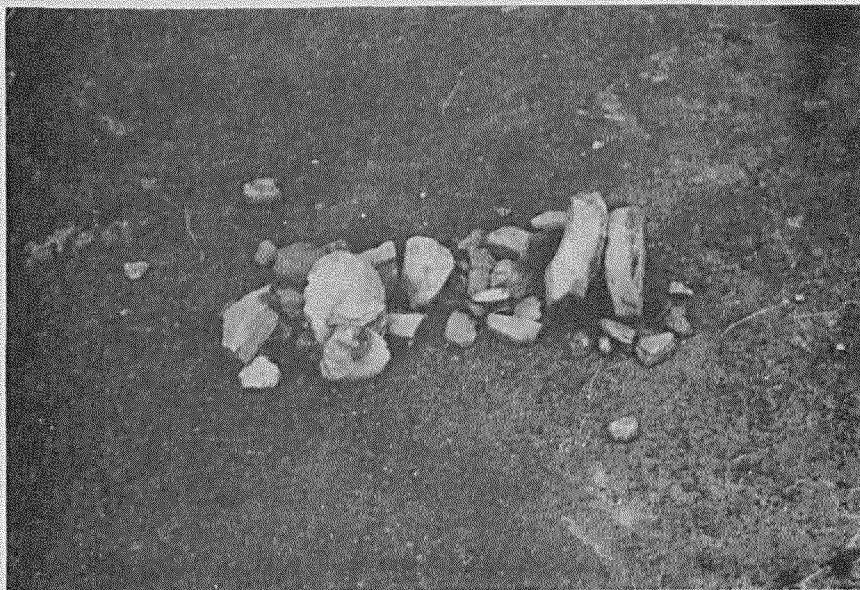
Figure III.1. Photographs Showing Backfill (M-8).

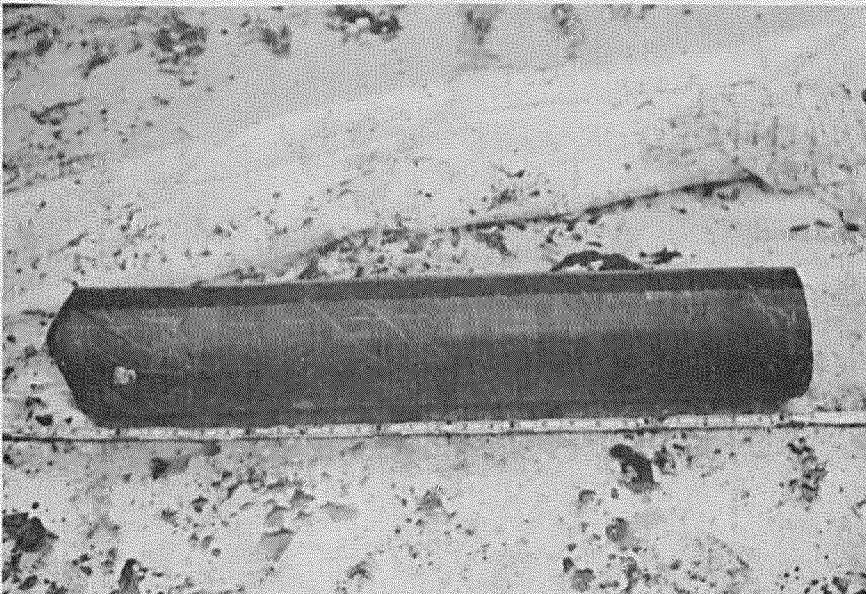
b. Blue-Green Shale

Figure III.2. Core Recovered with 6-in.-Diameter
Core Barrel (M-8).

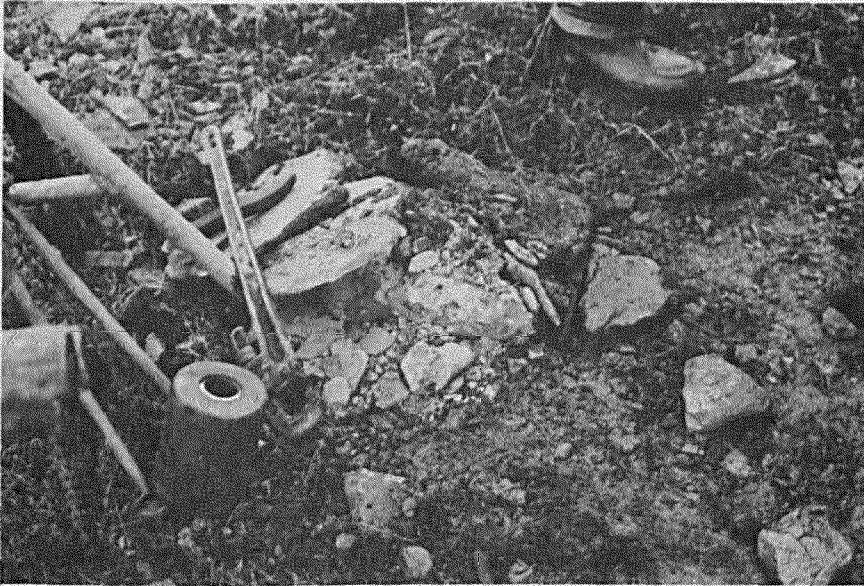
Figure III.3. Backfill Removed with 6-in.-Diameter Core Barrel (M-7).

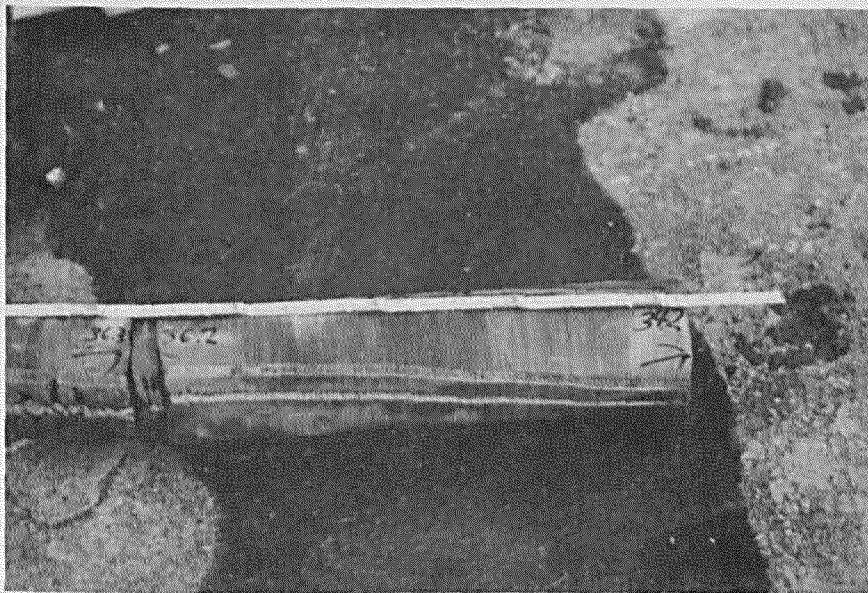
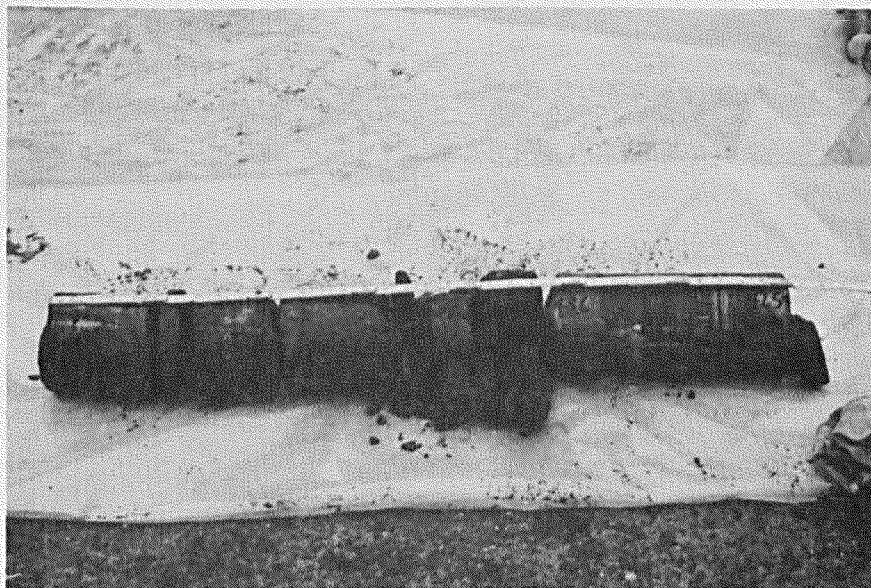
a. Blue-Green Shale

b. Black Shale

Figure III.4. Core Recovered with 6-in.-Diameter Core Barrel (M-7).

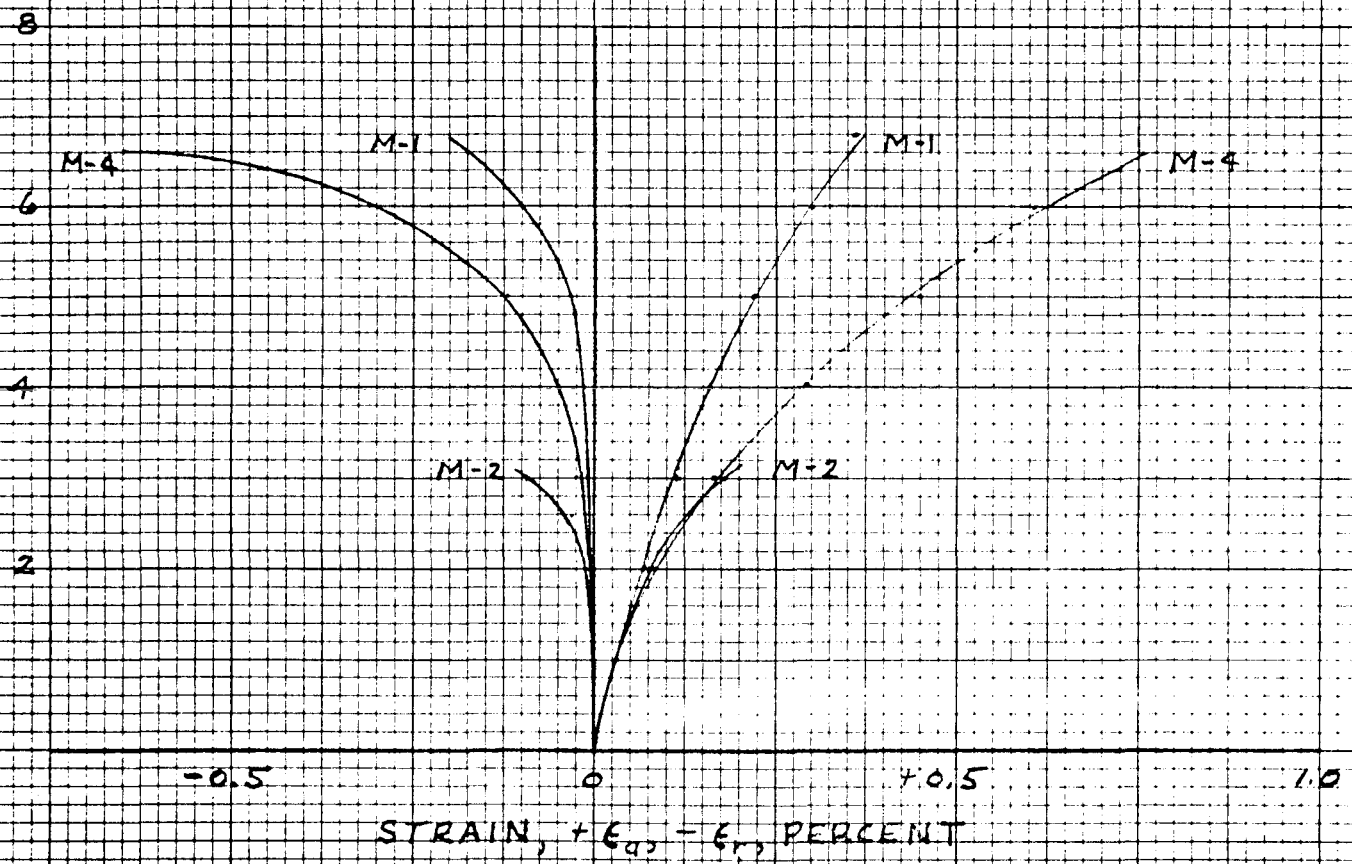
Figure V.1 TRIAXIAL TEST RESULTS OF CONCRETE CORES, ($\sigma_1 - \sigma_3$) vs ($\epsilon_{\sigma_1} - \epsilon_r$), LOCK & DAM NO. 3

The stress-strain relations for the two specimens tested under triaxial conditions are presented in Figure V.1. An E and ν were calculated for the specimen tested with a confining pressure of 500 psi and found to be 4.00×10^6 psi and 0.20, respectively. Figure V.2 presents the principal stress difference ($\sigma_1 - \sigma_3$) versus principal strain difference ($\epsilon_a - \epsilon_d$) from which an initial tangent shear modulus was computed. The shear modulus is 1.18×10^6 psi and compares reasonably with the shear modulus calculated using:

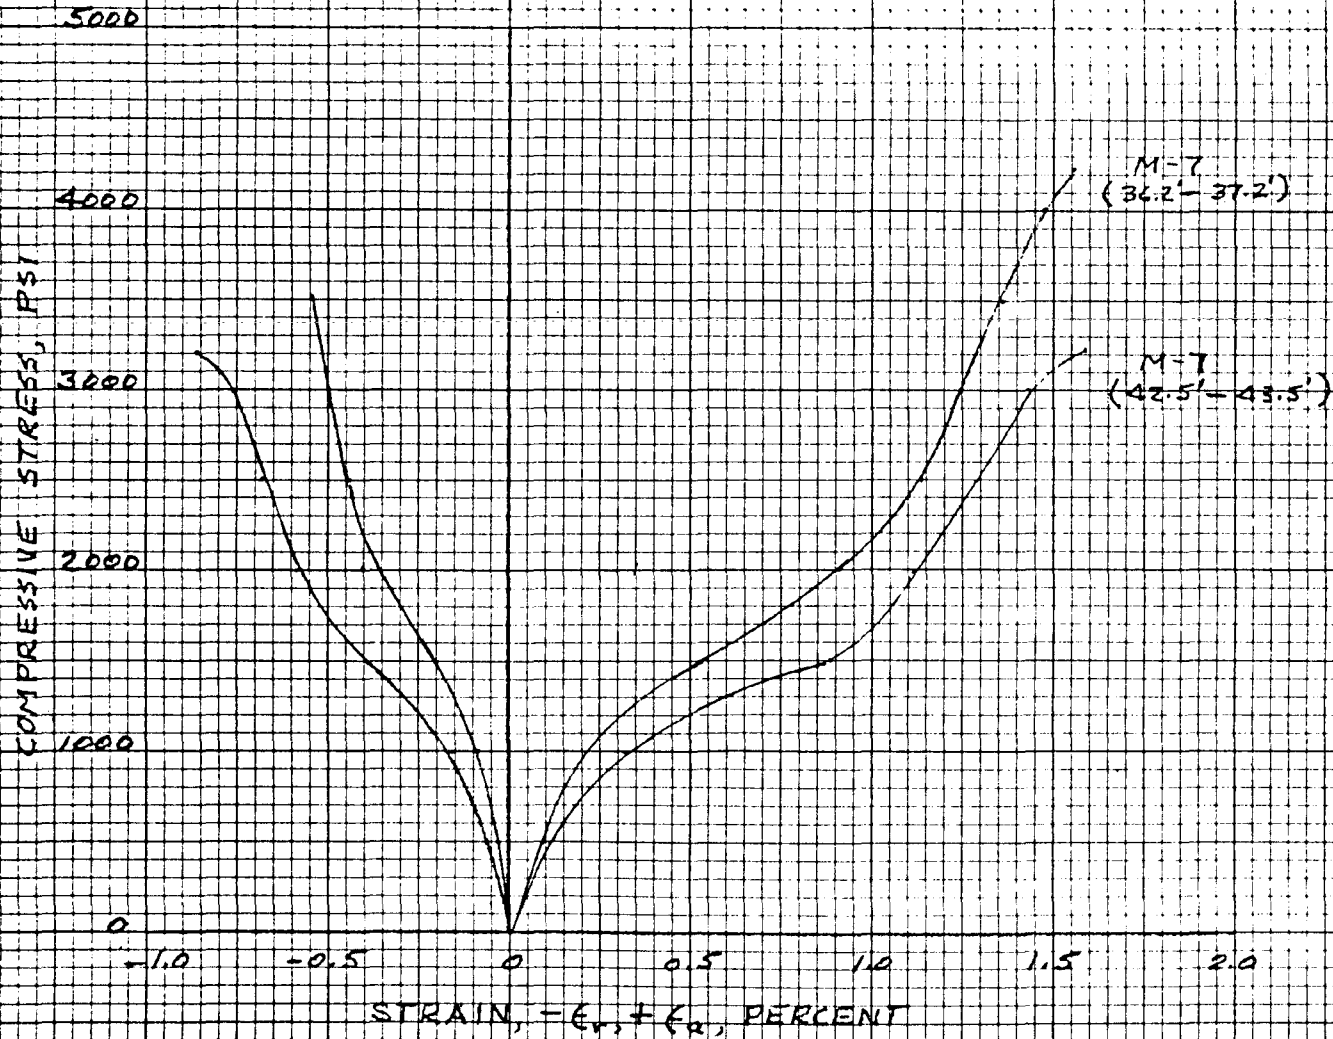
Figure T.3 STRESS-STRAIN RELATION FROM UNCONFINED TEST ON SHALE

Three unconfined compression tests were conducted with the stress-strain relation being recorded for two specimens. The σ - ϵ results are presented in Figure V.3. The average strength is 3960 psi. During testing, water was observed coming out of the specimen from bedding planes and small vertical cracks at a stress level of about 800 psi. This stress level corresponded to the point on the σ - ϵ curve where the curve started to become concave downward. Water continued to be extruded from the specimens

until a stress level corresponding to the second linear portion of the σ - ϵ curve. The initial portion of the curve was linear to about 800 psi. This is a typical response for rock core representing none or little stress relieving upon being removed from its in-situ position. The middle portion of the curve reflects increased strain as free water was extruded from the core. The final portion of the curve is very nearly the same as the initial portion; the slopes are almost identical. The moduli were taken as initial tangent values due to the relatively low stress states assumed for the foundation; the average $E = 0.59 \times 10^6$ psi, which appears reasonable for this type of shale. Poisson's ratios were calculated for the initial portions of the curves; the average $\nu = 0.17$. Presented in Figure V.4 the σ - ϵ relation for the test check specimen; the shale shows hysteresis upon unloading. The test check specimen was run to verify the ϵ response obtained under triaxial testing.
