MISCELLANEOUS PAPER C-76-9

ENGINEERING CONDITION SURVEY AND STRUCTURAL INVESTIGATION OF LOCKS AND DAM 3, MONONGAHELA RIVER

August 1976

Prepared for U. S. Army Engineer District, Pittsburgh
Pittsburgh, Pennsylvania 15222

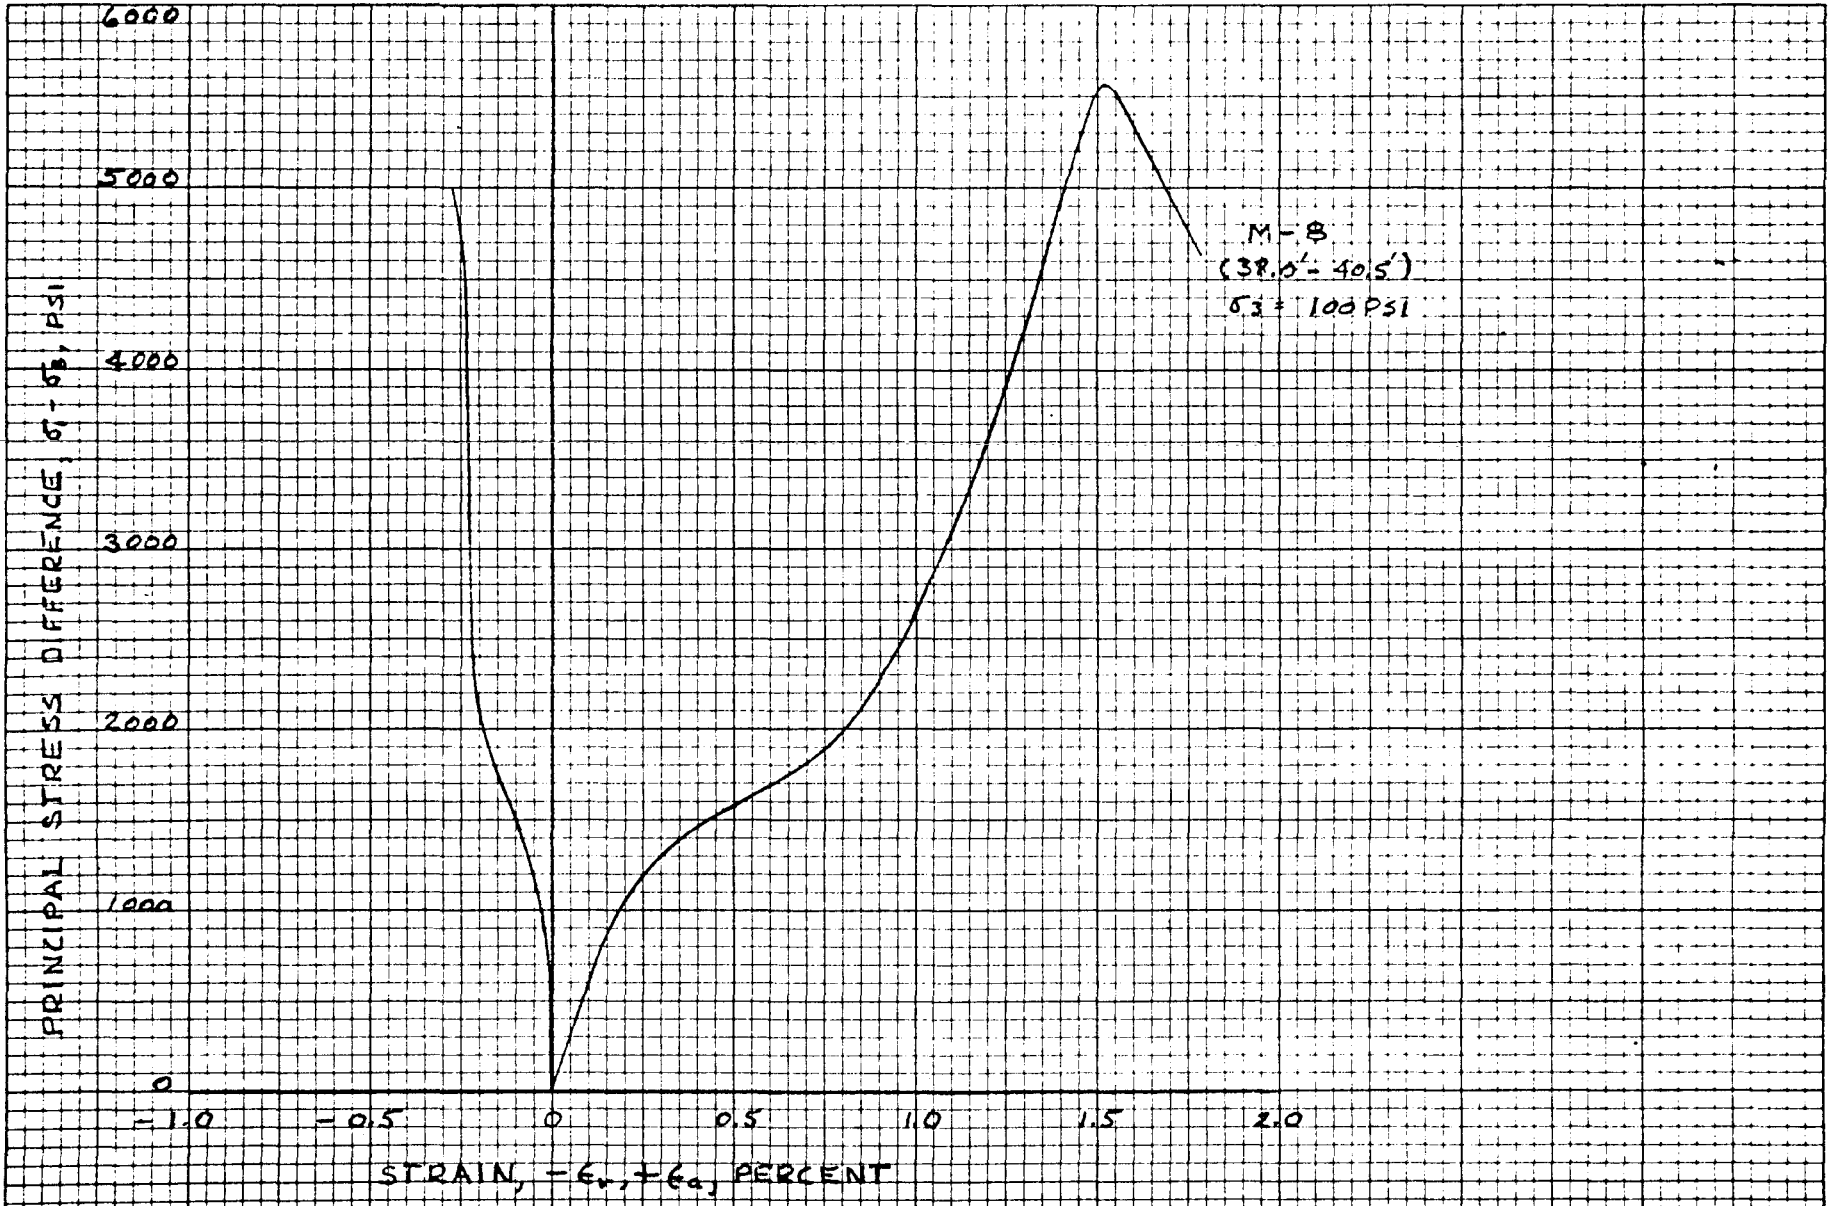
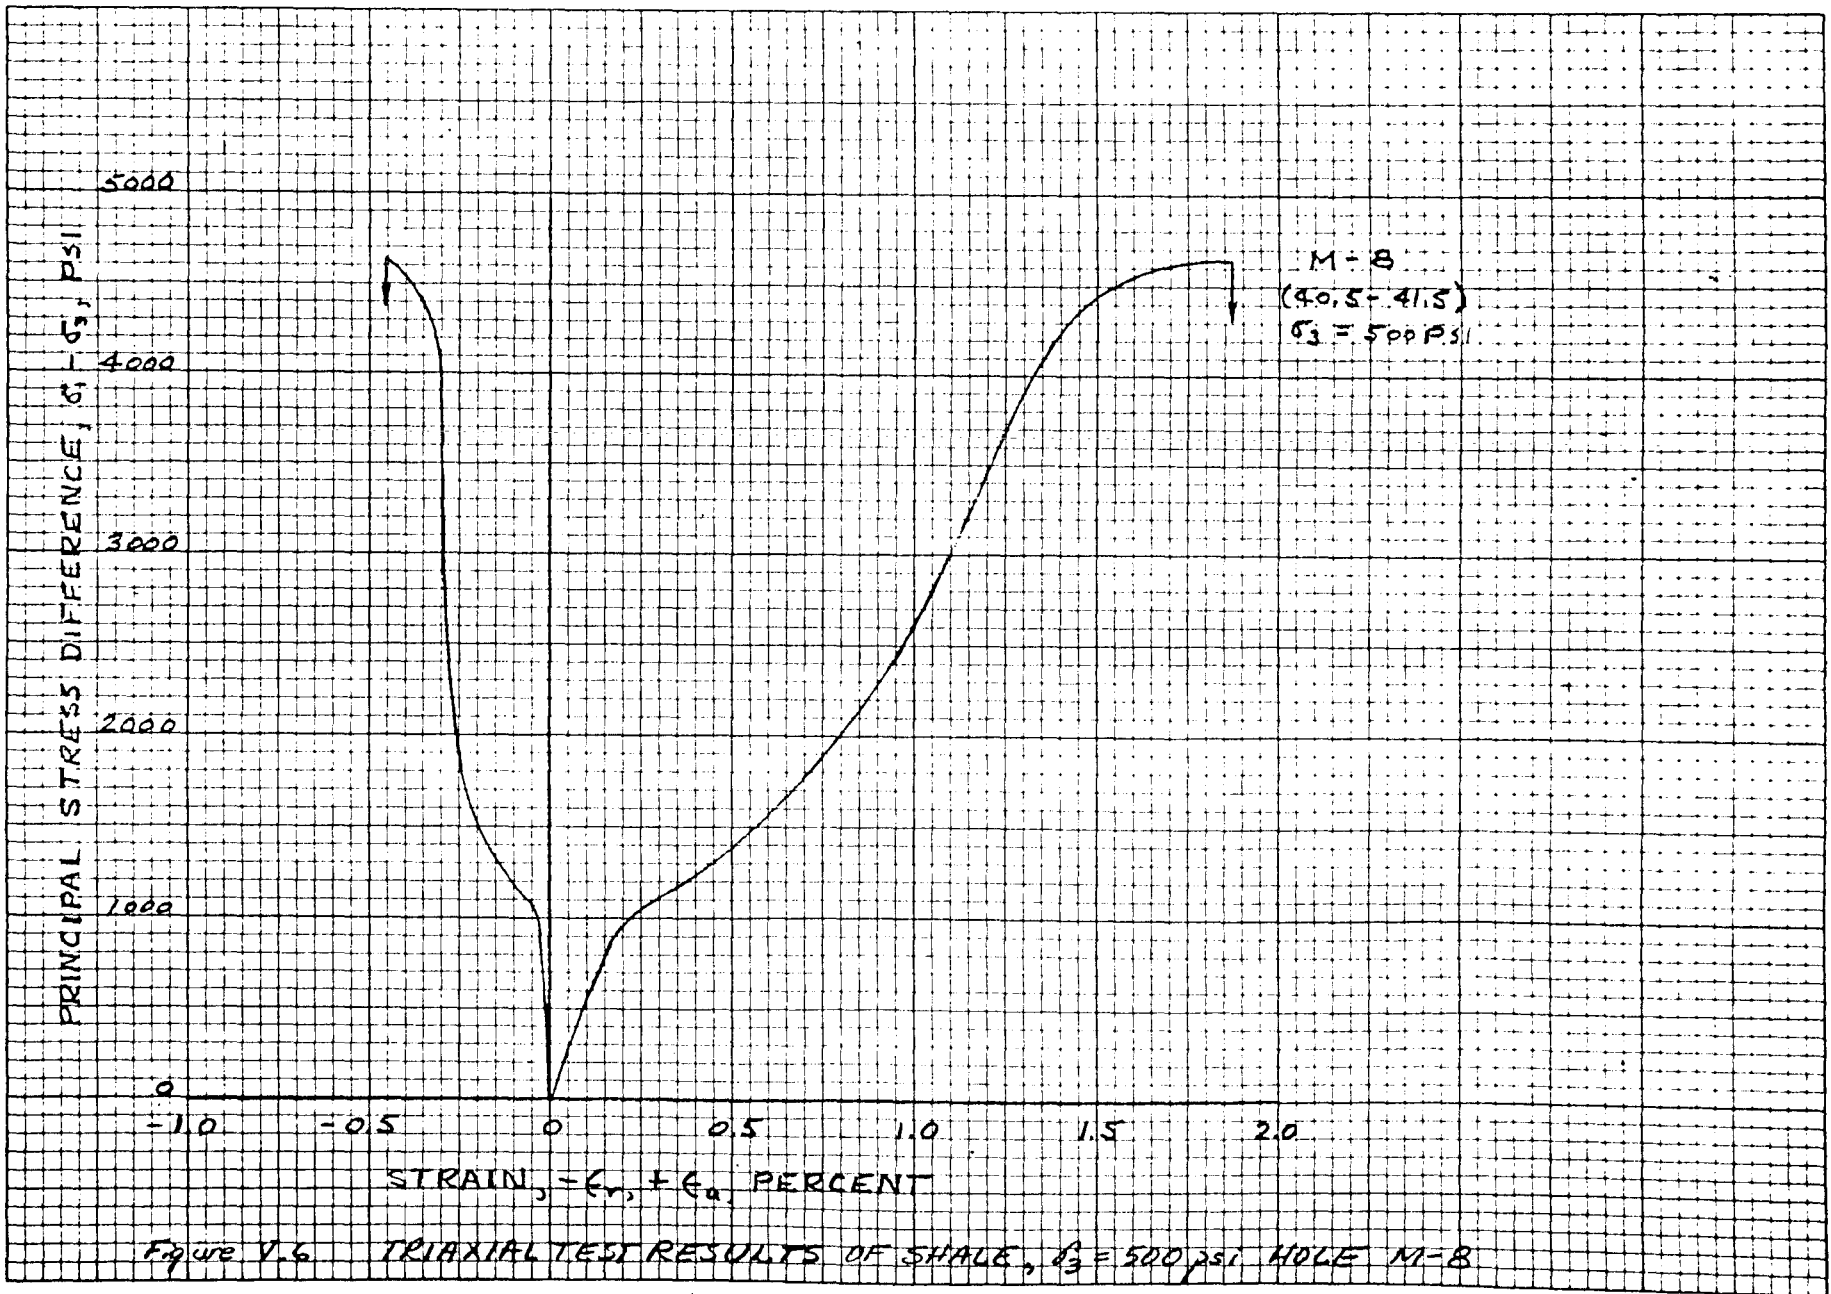
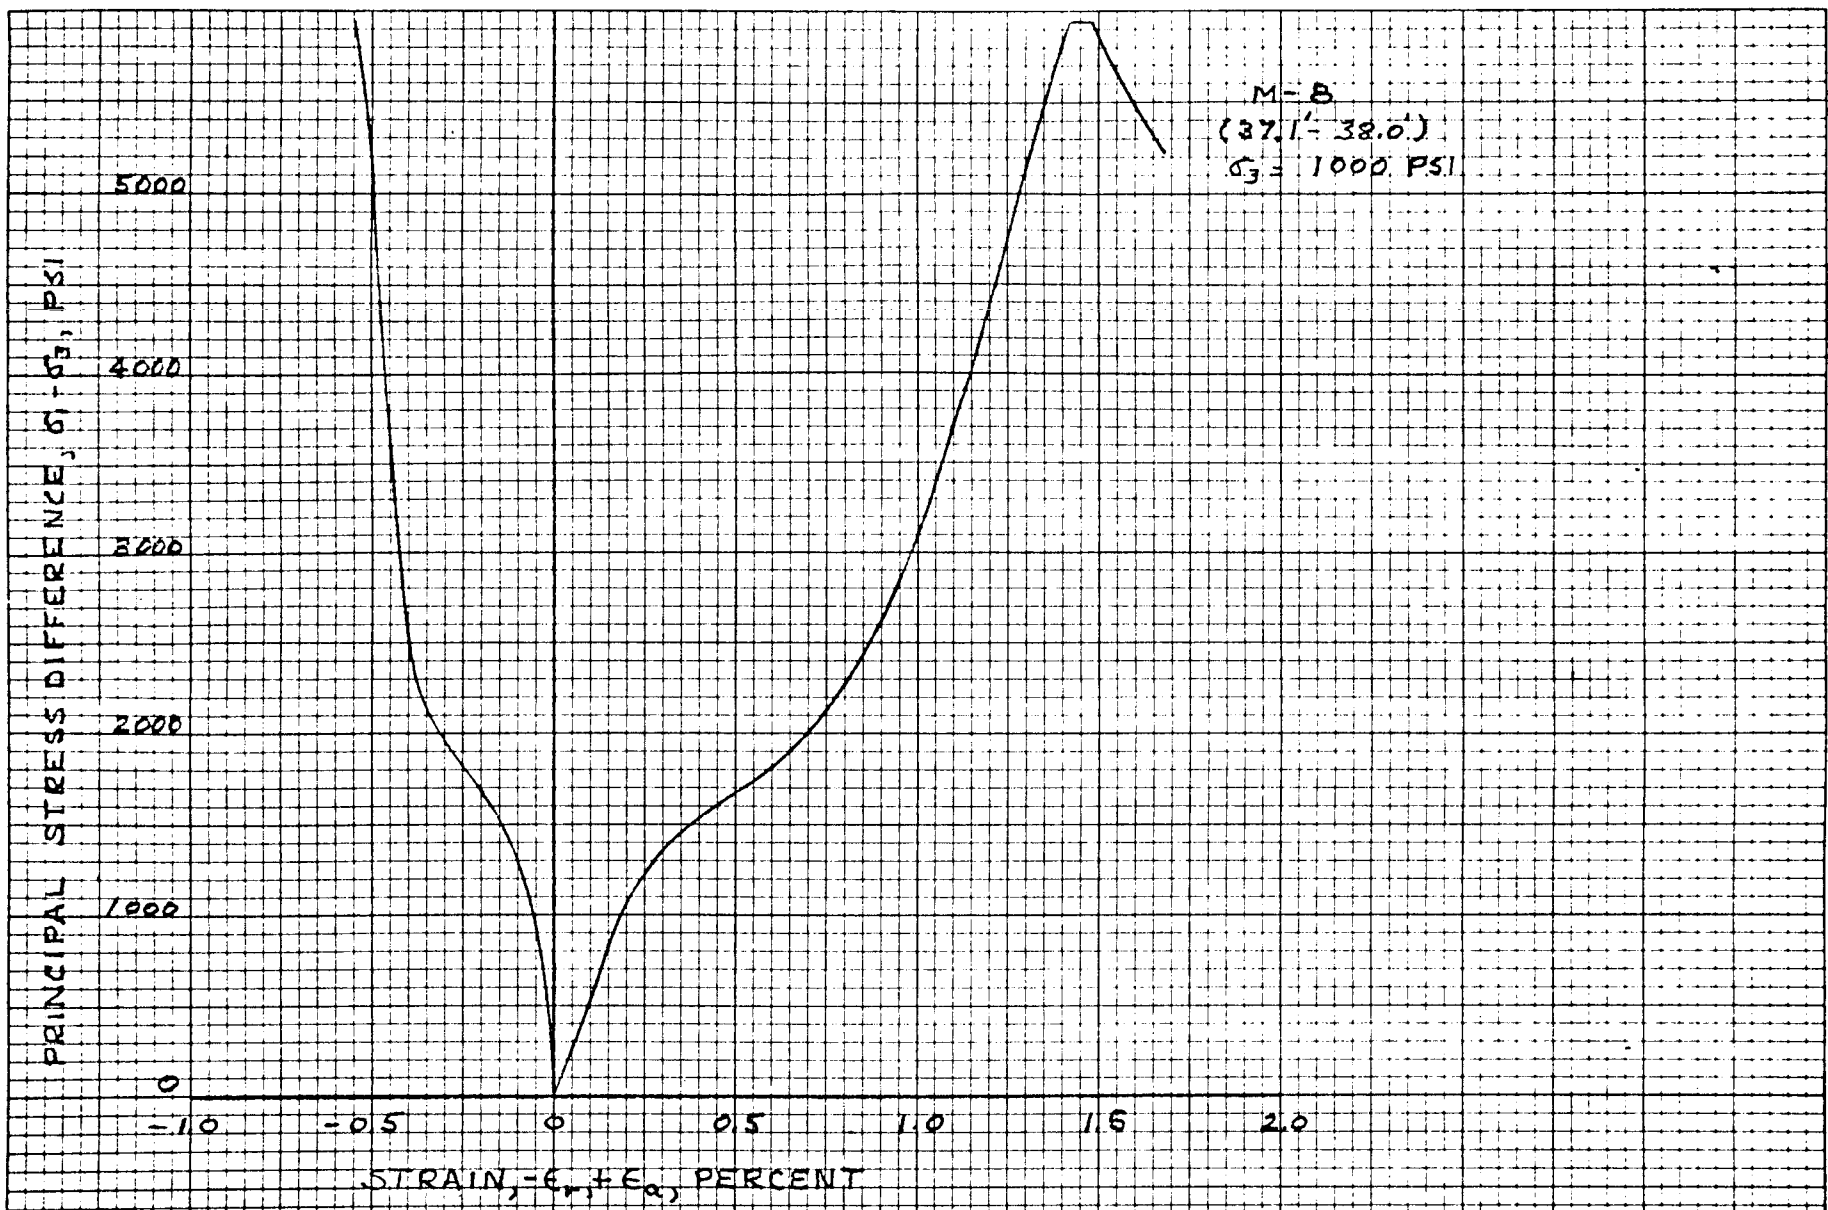
Three standard undrained triaxial tests were conducted on the shale from hole M-8 using σ_3 's of 100, 500, and 1000 psi. The σ - ϵ data for the triaxial tests are presented in Figures V.5-V.7. The σ - ϵ relationship is the same as that observed for the specimens tested in unconfined compression. The initial E and ν are similar to the E and ν as were calculated for the specimens tested in unconfined compression. Shear moduli were calculated from principal stress difference ($\sigma_1 - \sigma_3$) and principal strain difference ($\epsilon_a - \epsilon_d$) data. The average shear modulus is 0.24×10^6 psi.

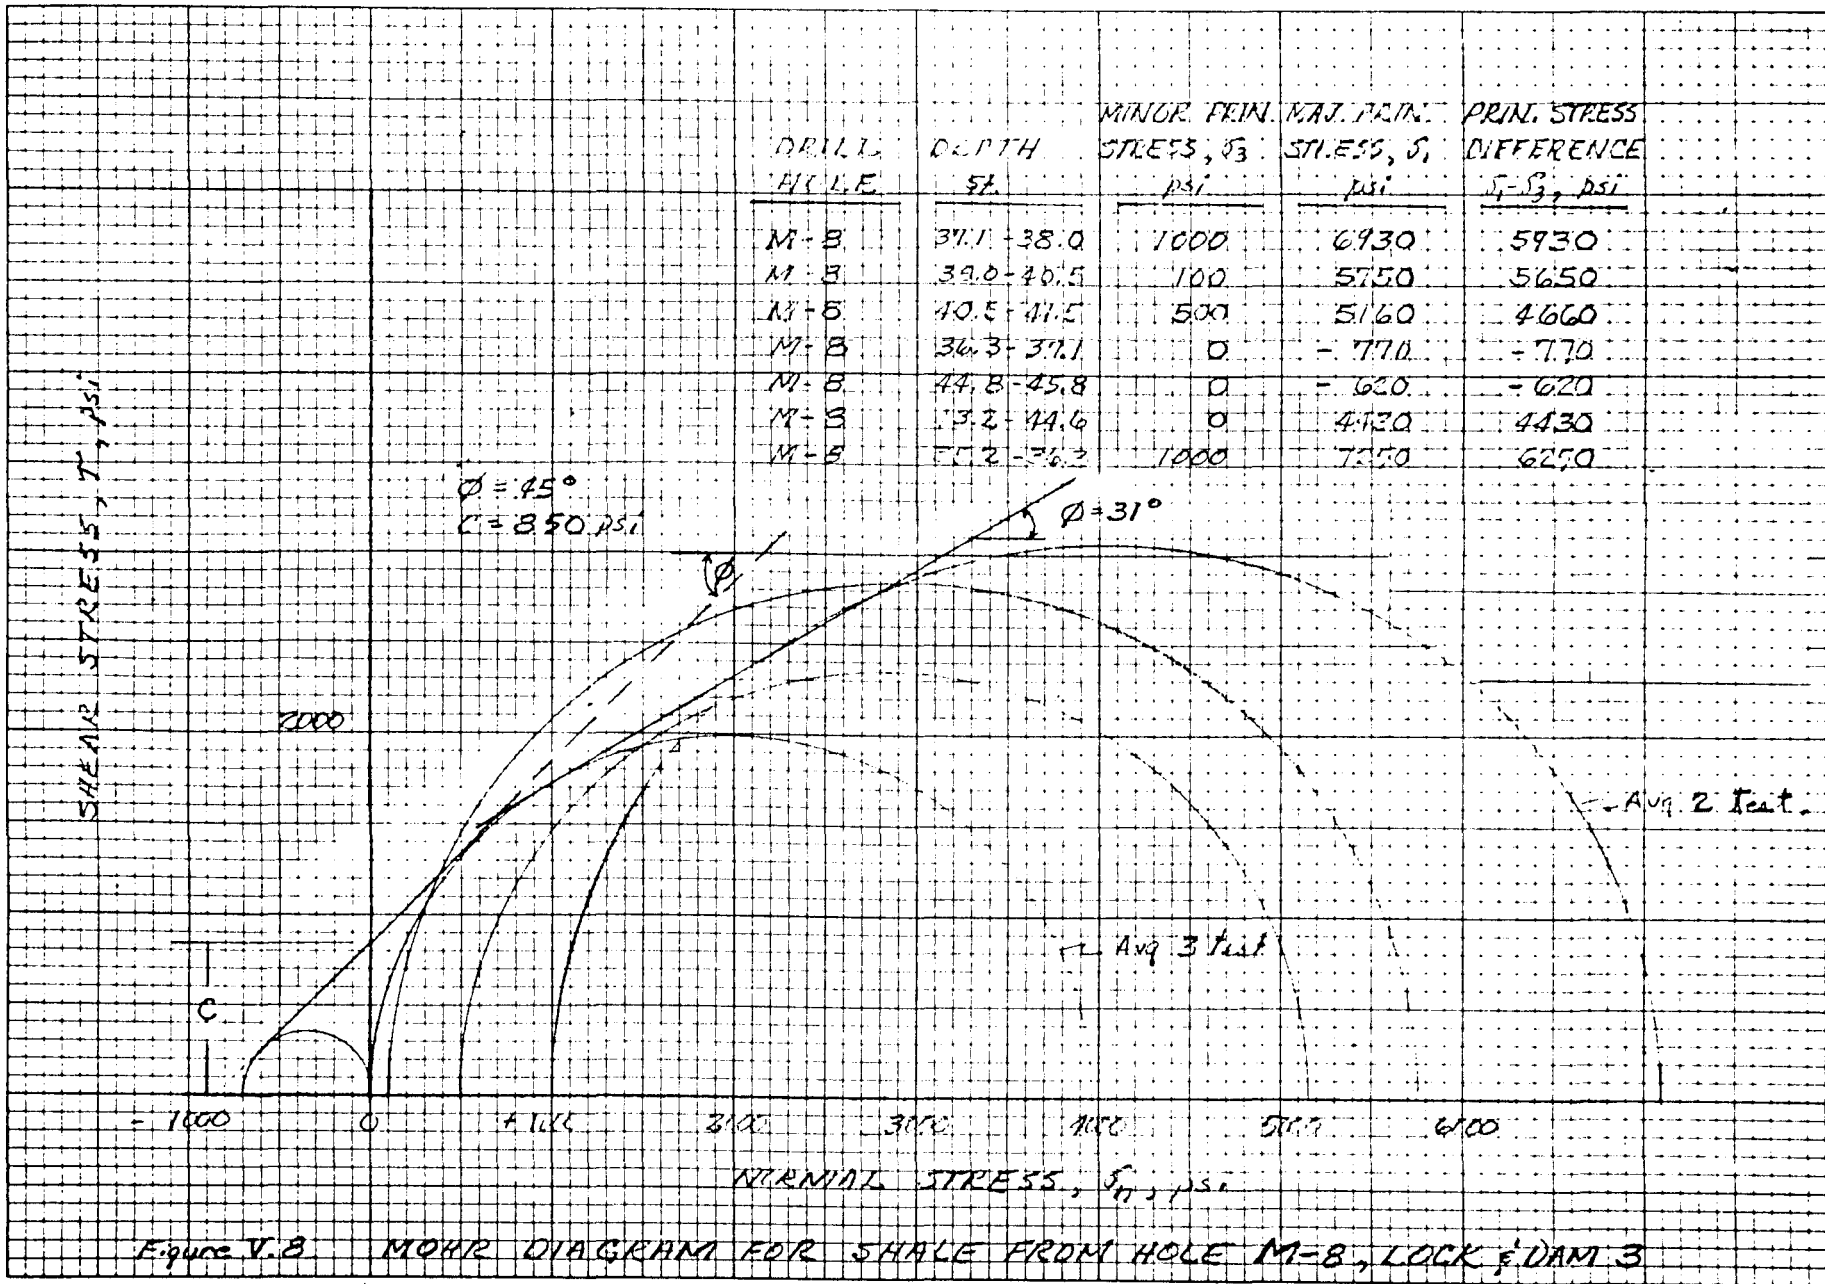
Figure V.8 MOHR DIAGRAM FOR SHALE FROM HOLE M-B, LOCK # DAM 3

Figure V.8 presents the Mohr's diagram for the results obtained from the strength tests. The angle of internal friction (ϕ) for the initial portion of the failure envelope, defined as being tangent to the tensile stress circle and the average circle of three unconfined stress circles, is 45 deg. The cohesion (c) is 850 psi. At a $\sigma_n \approx 700$ psi, the failure envelope has an angle of 31 deg. The initial ϕ and the c are reasonable for the competent shale.

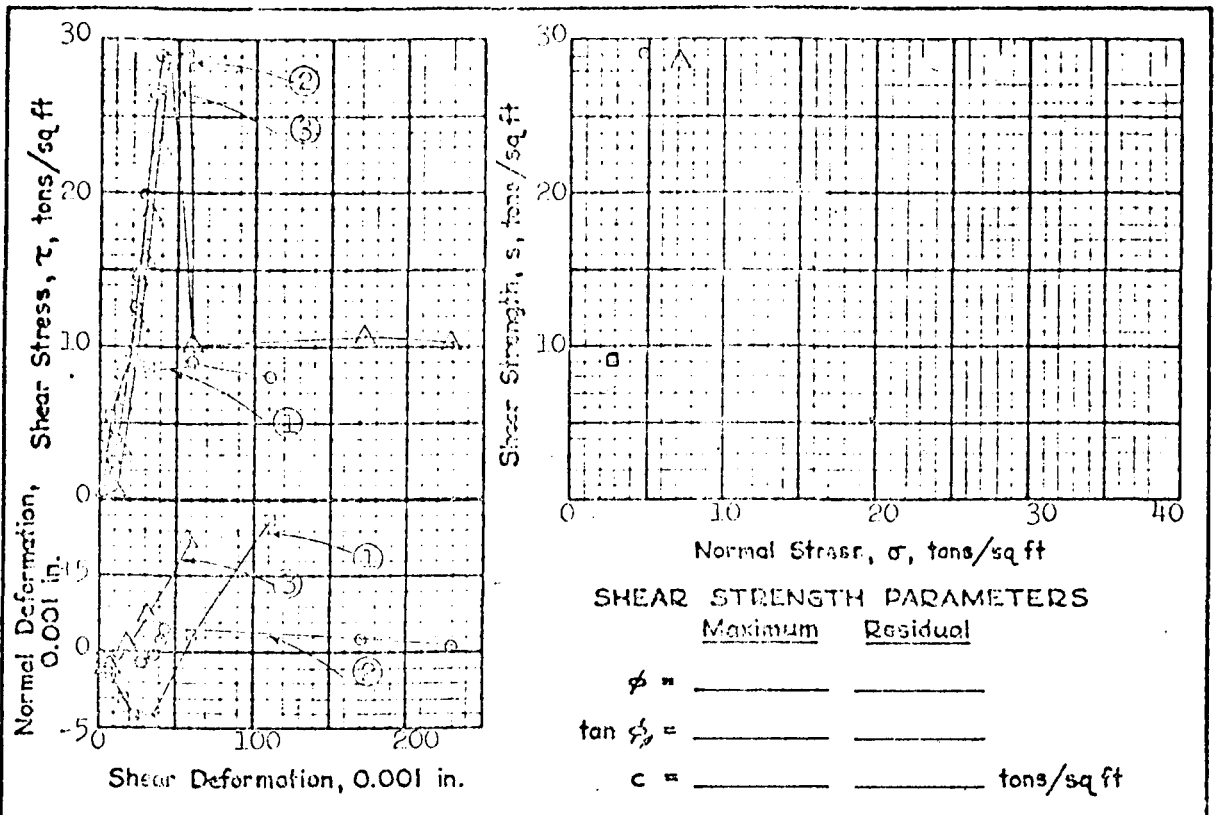
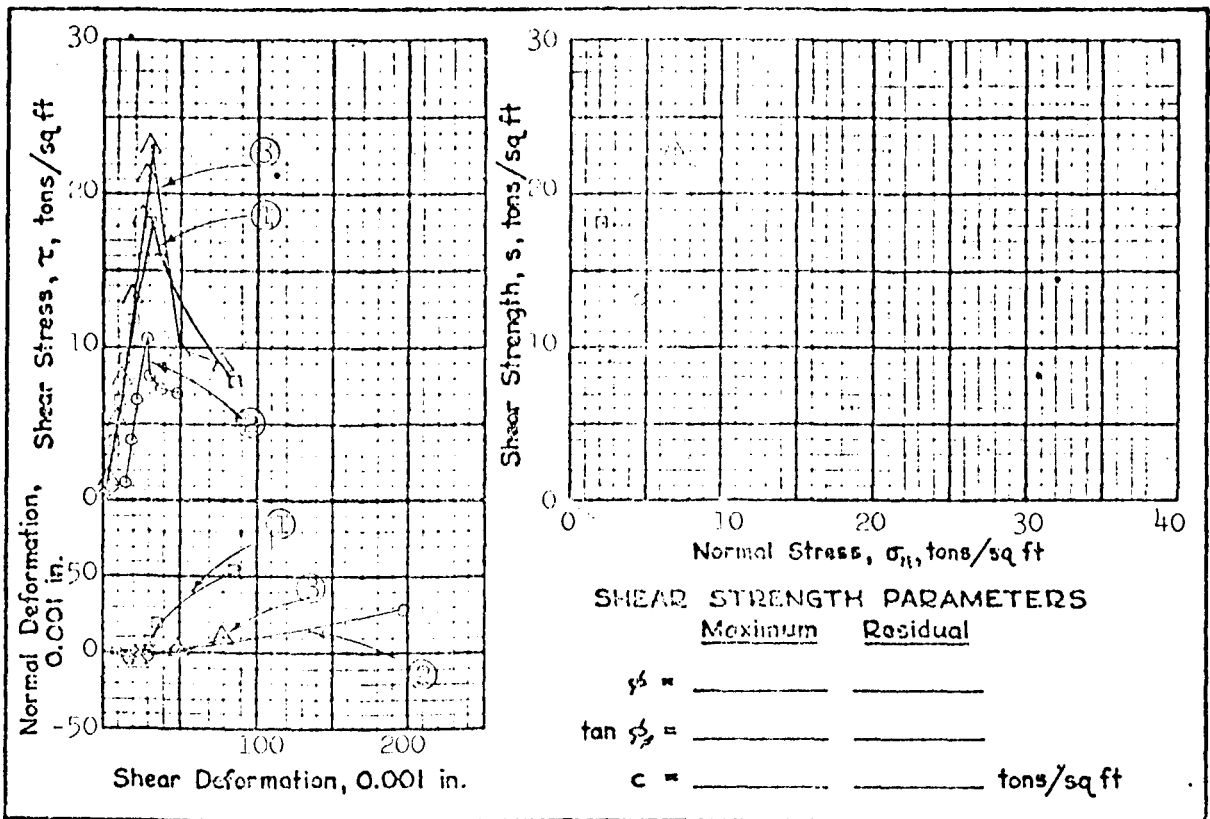
Six direct shear tests were conducted for peak strengths on intact shale recovered from near the contact between the concrete and the foundation material in Hole No. M-7. Specimens were selected from a depth interval of 9.4 to 10.7 ft below the concrete-rock contact. Most of the pieces of core closer to the contact were of an inadequate length for testing. Two series of three specimens each were tested using normal stresses, σ_n , of 33, 66, and 100 psi (2.37, 4.75, and 7.20 tons/ft²). The range of σ_n is well within the range of σ_n 's anticipated at Locks and Dam 3.

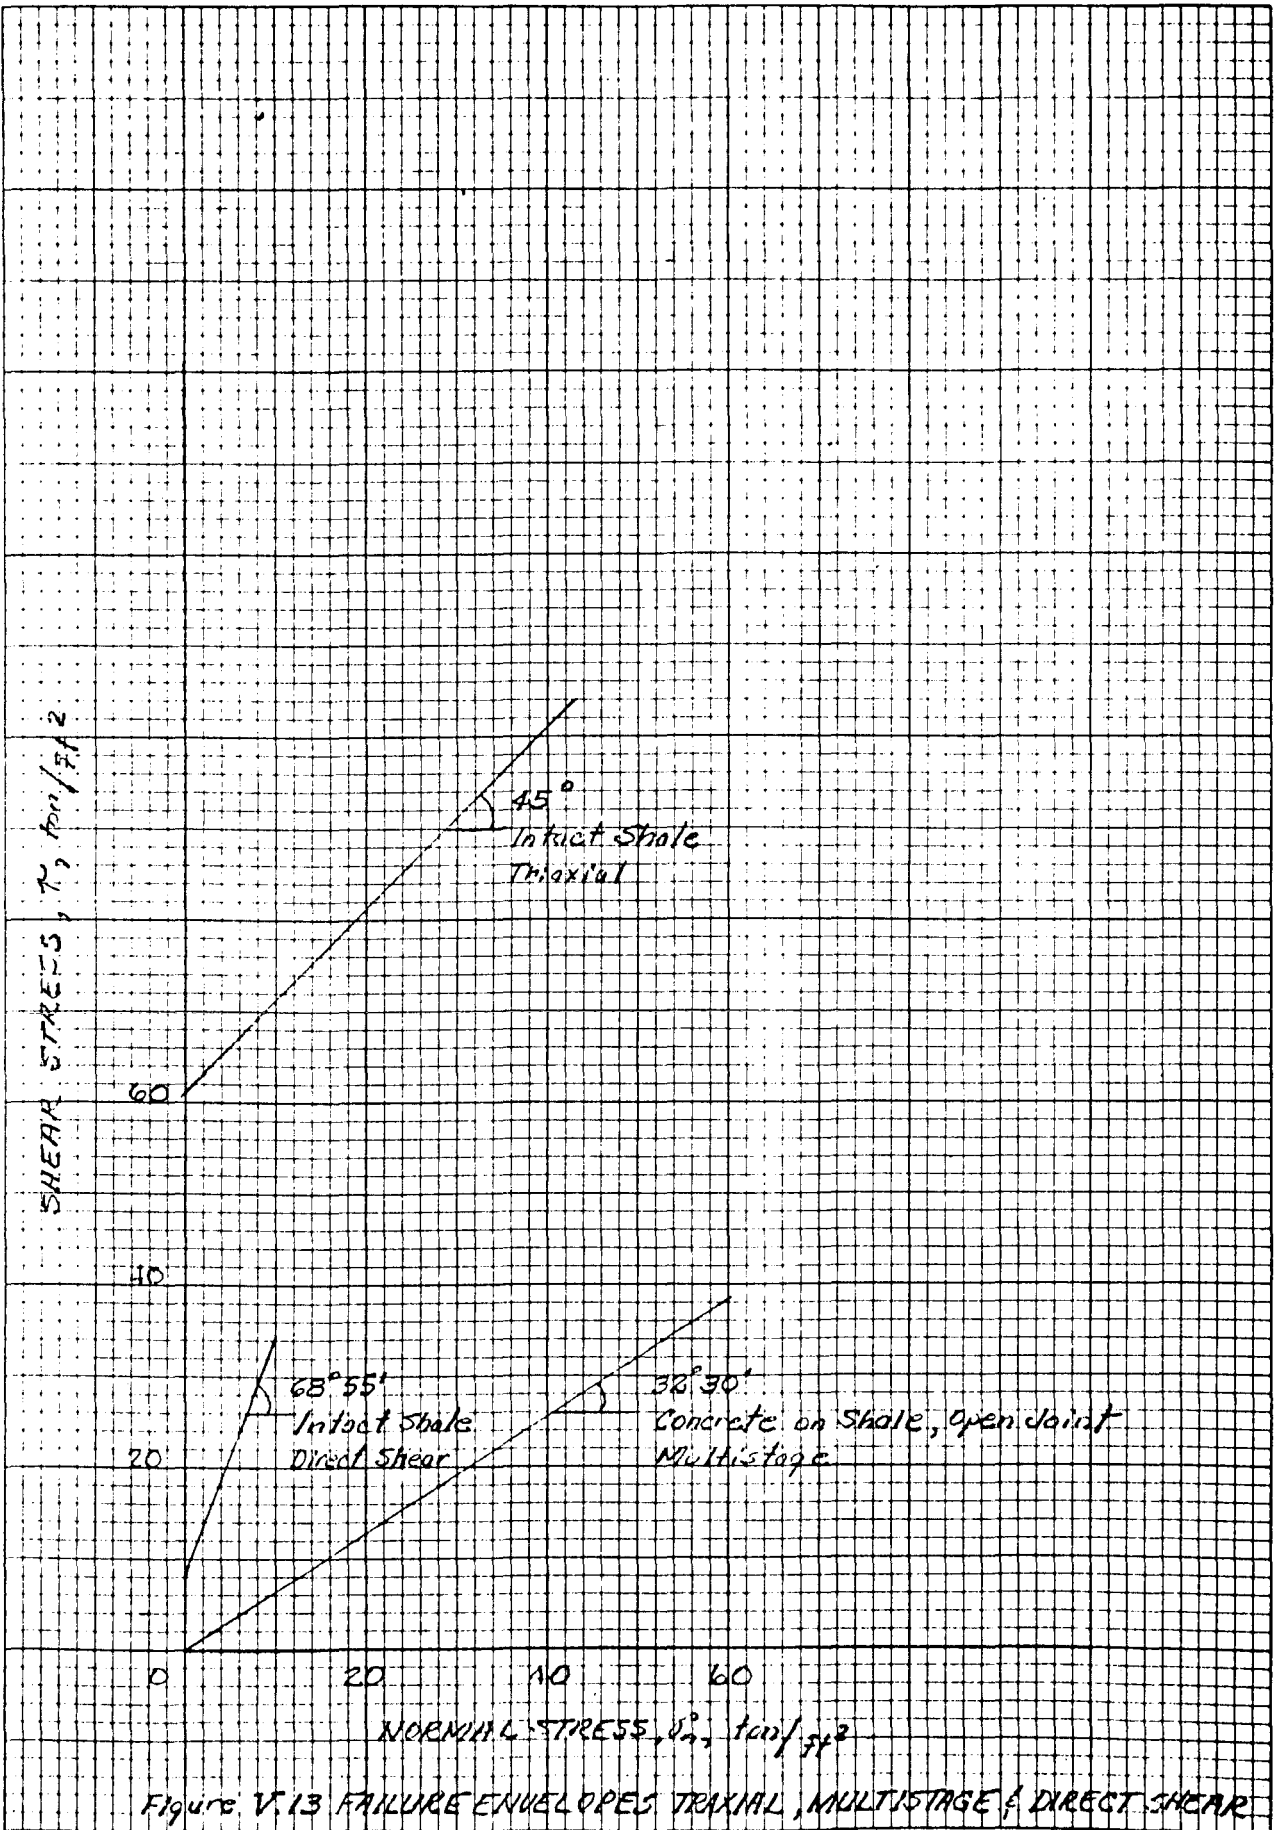
Figure V.13 FAILURE ENVELOPES TRIAXIAL, MULTISTAGE & DIRECT SHEAR

Presented in Figure V.13 are the failure envelopes representing the shale tested in triaxial and direct shear and the concrete on rock tested using the multistage triaxial test.
