A SURVEY OF ROAD CONSTRUCTION AND MAINTENANCE PROBLEMS IN CENTRAL ALASKA

E.F. Clark and O.W. Simoni

October 1976

CORPS OF ENGINEERS, U.S. ARMY
COLD REGIONS RESEARCH AND ENGINEERING LABORATORY
HANOVER, NEW HAMPSHIRE

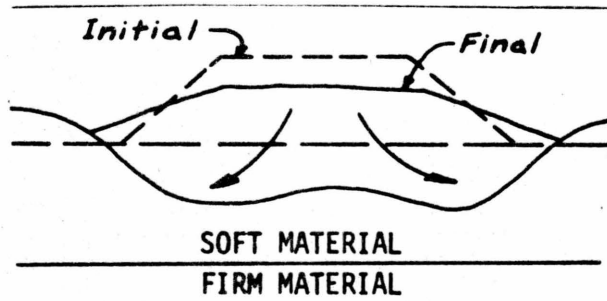
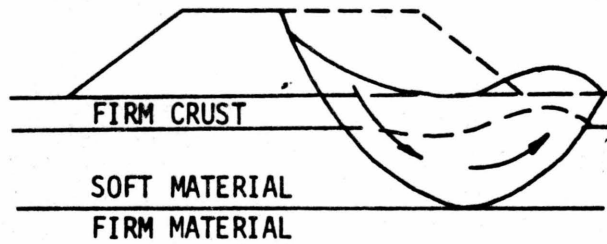
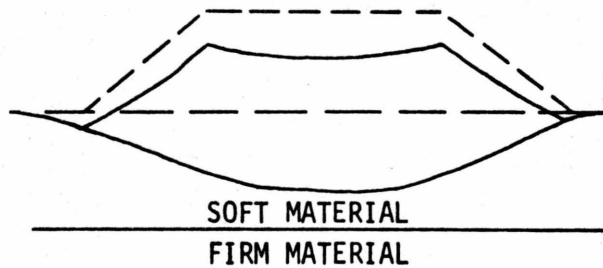
A few roads have been built over soft organic materials (such as peat or muskeg), but these soils tend to flow laterally from under the embankment to one or both sides (as shown in Fig. 2) during trafficking. Current knowledge of peat and muskeg classification and properties, and current practices in testing and engineering construction are reported in Robison and Dodd (1962) and Philainen (1965). The prevalence of peat and muskeg throughout the Subarctic seems to justify an increase in research aimed at development of better design and construction criteria for its use.

a) Embankment Failure Over Soft Foundation

b) Embankment Failure - Soft Material Overlain by Firm Crust

c) Settlement of Embankment Over Soft Foundation

Figure 2. Typical embankment problems over soft foundations (Highway Research Board 1971).

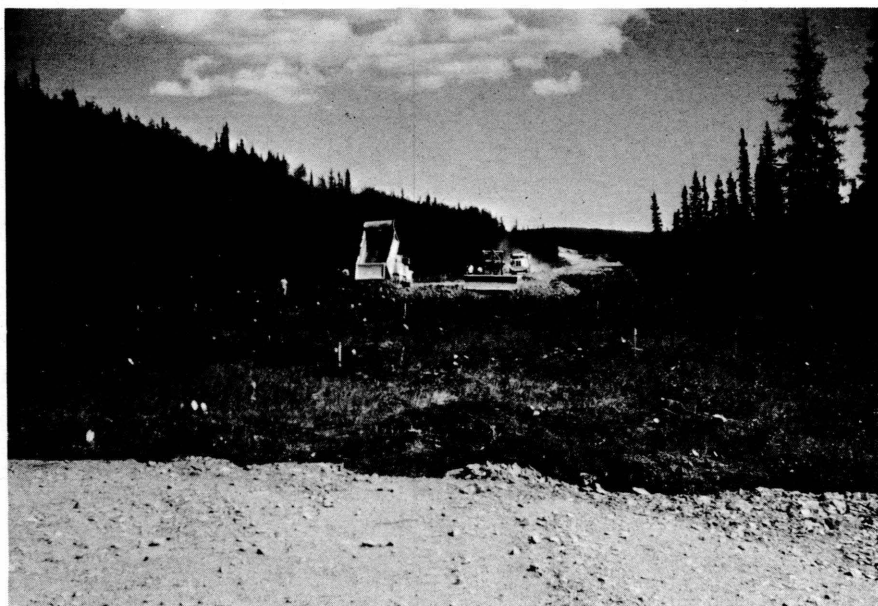
Figure 4. End dumping on Goldstream Road.

End dumping is recommended over permafrost. The surface vegetation is left undisturbed but the trees are cut and laid in the right of way, and embankment material is dumped over the organic matter (Fig. 4). The organic matter provides insulation so as to slow the rate of permafrost degradation and it also acts as a filter material between the fine soils and the embankment fill.

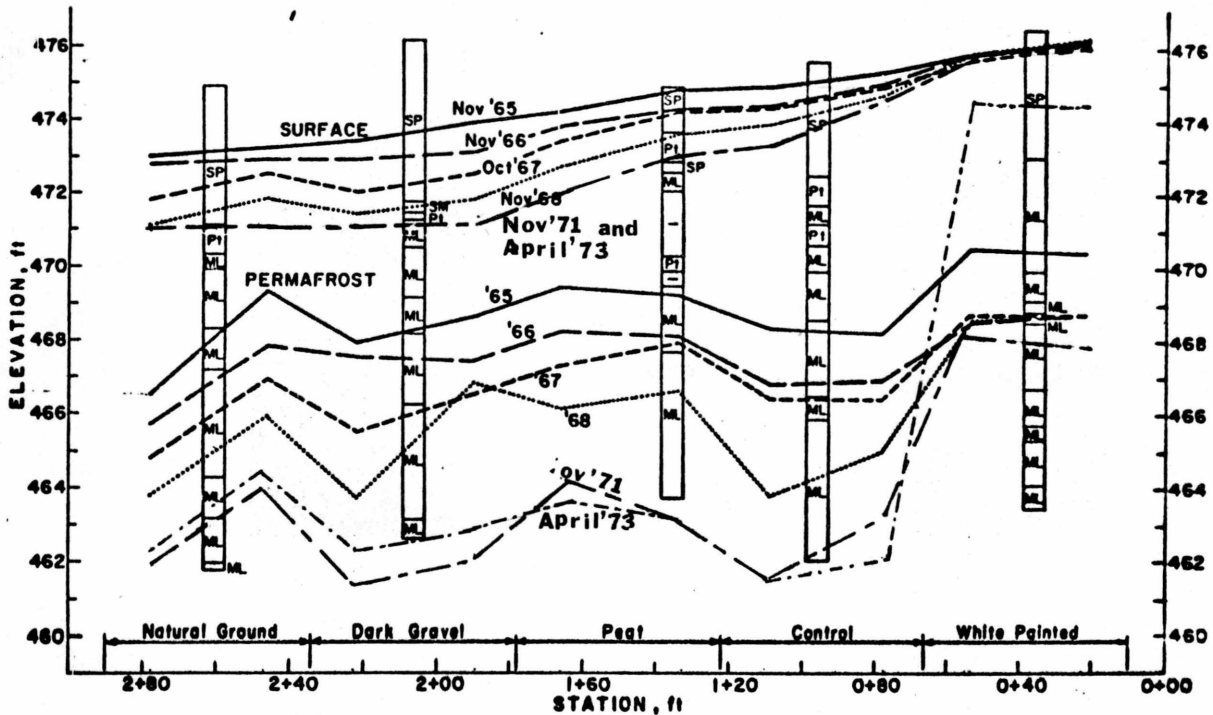
Figure 14. Highway test sections, permafrost degradation and surface subsidence.

As shown in Figure 14, embankments constructed under unfavorable permafrost conditions may not stabilize for approximately 8 to 10 years. In some instances settling may continue for as much as 20 years, because the thickness of most highway gravel embankments in central Alaska, excluding deep fills, is not great enough to insulate the permafrost. The high ice content of permanently frozen silt is widespread in central Alaska, and highways are sometimes unavoidably founded upon such permafrost. The amount of ice, which may vary from interstitial to massive, is responsible for differential settlement as thawing progresses. The normal staged construction practice of the Alaska Department of Highways is to continue regrading the gravel road and filling in low spots for about five years before even considering paving. Paving a highway, even after it has stabilized under a gravel surface, will cause more thawing and subsidence through the increased thermal absorption of the asphalt surface.

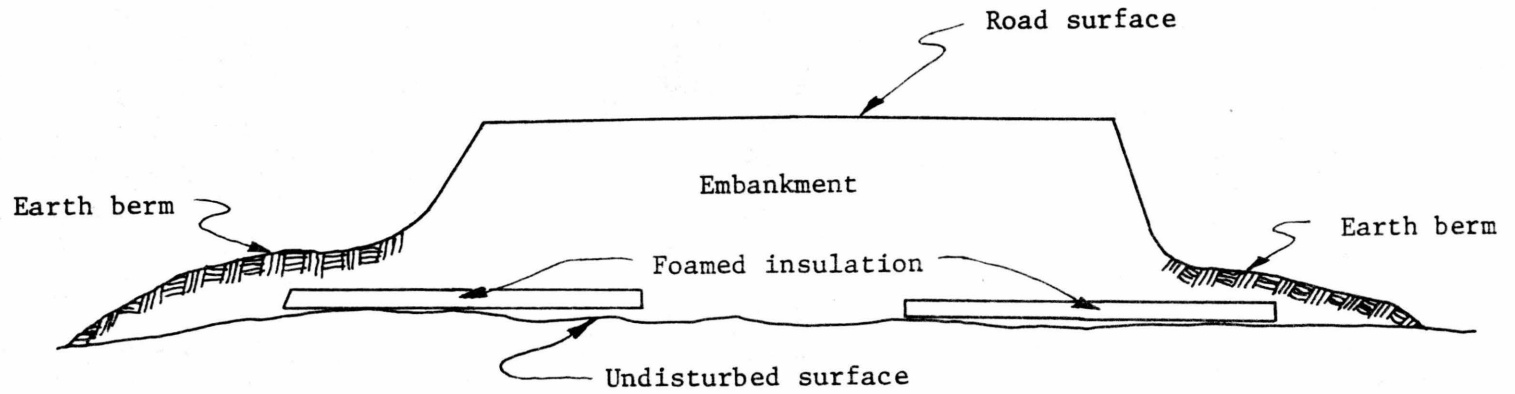
Figure 25. Use of foamed insulation to prevent shoulder failure.

The above photographs illustrate but a few of many such failures observed. In cases in which failures are caused by permafrost degradation at or under the toe of the embankment, use of insulation such as polyurethane or polystyrene in and extending out from the shoulder might provide a solution (Fig. 25). Earth berms extending several yards from the embankment might also serve a useful purpose in preventing this type of failure.

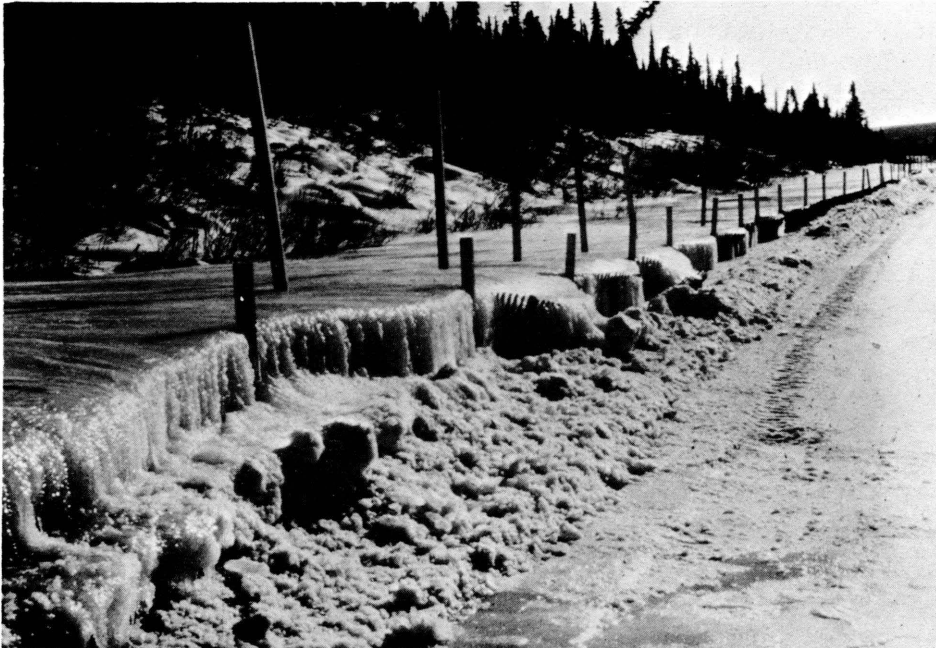
Figure 32. Fence to control icing on the Richardson Highway near Paxson, Alaska.

Another way of minimizing culvert icing is shown in Figure 31. The culverts may be placed at several elevations so that drainage may continue as the lower culvert freezes over. Icing over roadways occurs not only at the streams and culverts but also at side hills. Water seeps out of the upper slope and into the roadway where it freezes. Figure 32 shows a fence erected by the side of the road for control and containment of the freezing water. The Alaska Department of Highways prepared frostbelt areas at suitable sites to control icing. A frost belt area allows deep frost and icing to develop away from the road surface (Carey et al. 1975).

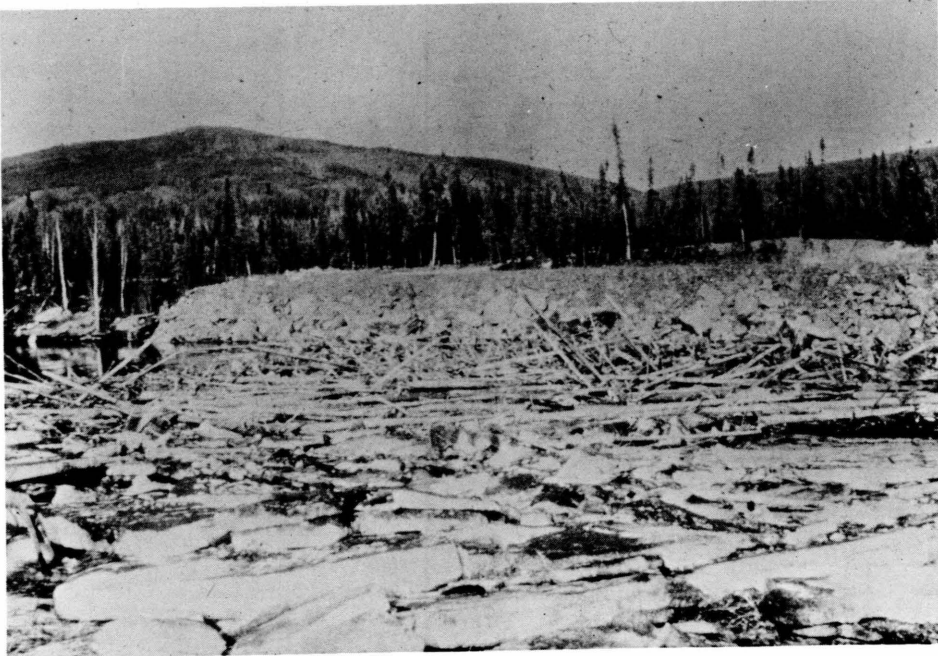
those that occur during high water and ice breakup. During breakup the streams carry not only ice floes but also logs, brush, and other floating objects. Figure 34 (a photograph of Hess Creek, 1973) shows a typical assortment of ice floes and debris during the spring breakup.

Figure 34. Ice breakup at Hess Creek.

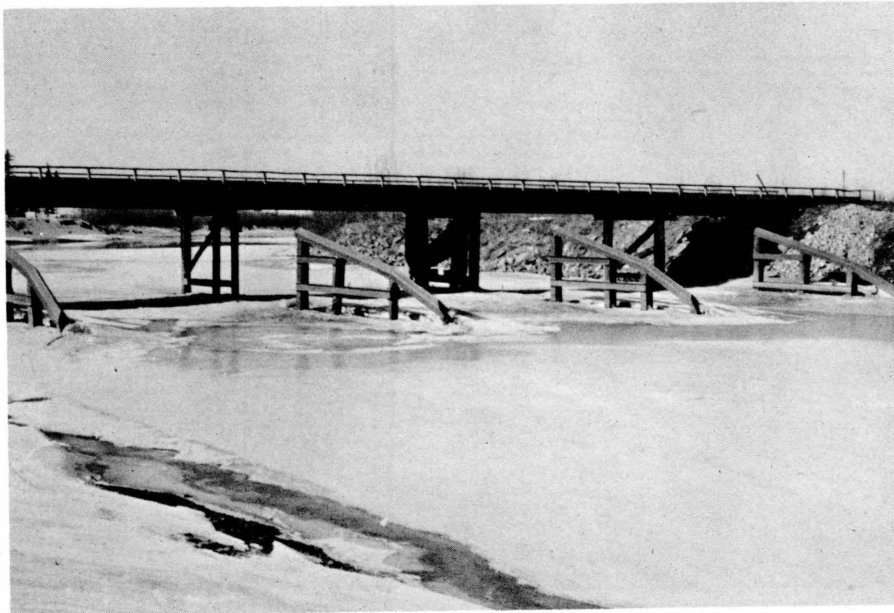
Figure 38. Ice and debris deflectors to protect bridge bents, Engineer Bridge, Fort Wainwright.

deflection devices such as those used for a pile bent bridge across the Chena River on Fort Wainwright (Fig. 38) have been found useful for some bridges. These deflectors are constructed of "H" beams and placed approximately 15 ft upstream from the bents. A crane is used to clear debris from the deflectors.
