Special Report 77-8

REVEGETATION AND
EROSION CONTROL OBSERVATIONS
ALONG THE TRANS-ALASKA PIPELINE

1975 Summer Construction Season

March 1977

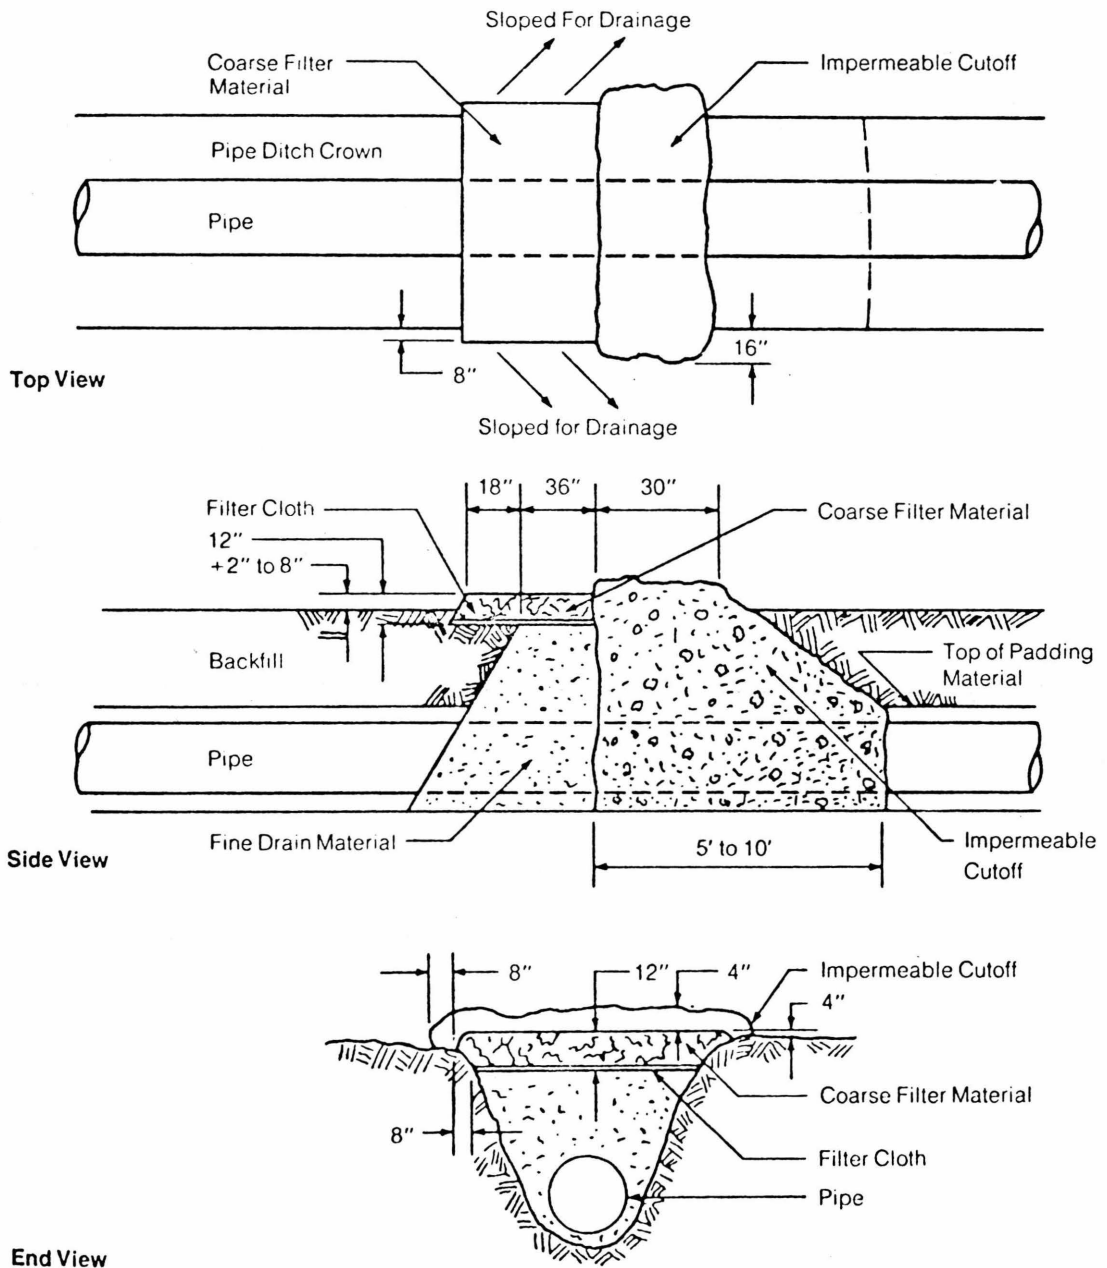
To protect buried sections of the pipeline from possible erosional damage caused by subsurface water seepage along the pipe trench, about 500 special ditch plugs are planned for use on selected slopes greater than three percent. The plugs consist of an impermeable material which is covered on the uphill side with a granular filter material which permits passage of groundwater to the surface (Fig. 2).

Figure 2. Drawings of pipe ditch plug and typical installation used to protect buried sections of pipeline from subsurface water seepage. (Source: Alyeska Pipeline Data Sheet: Pipe Ditch Plugs, January 1976.)
