Special Report 82-7

May 1982

Moisture detection in roofs with cellular plastic insulation — West Point, New York, and Manchester, New Hampshire

Charles J. Korhonen and Barry A. Coutermarsh

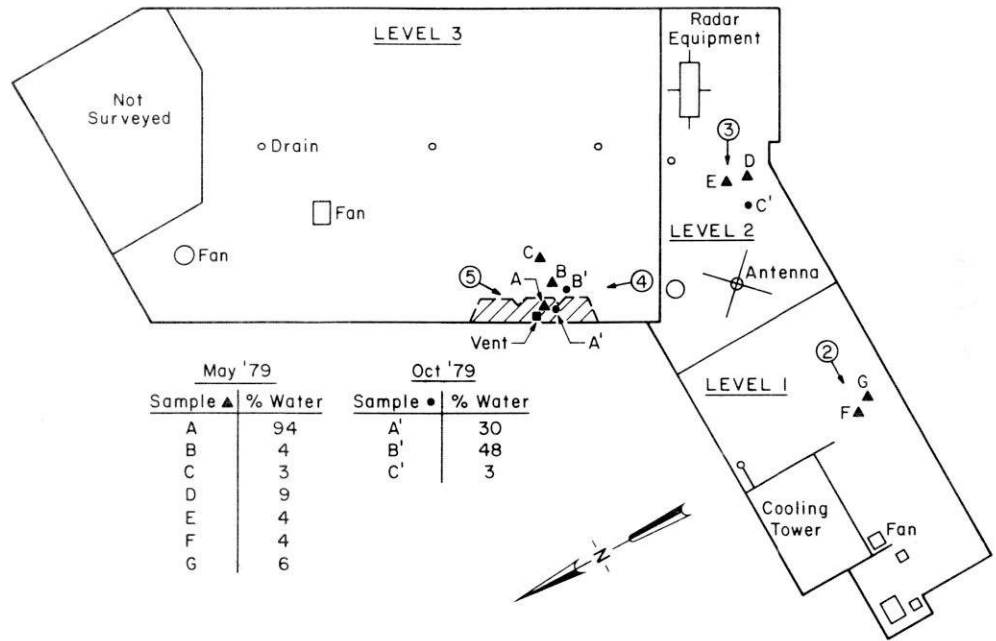
Figure 1. Plan view sketch of Building 753, West Point. For this and all other building sketches in this report, a circled number with an arrow indicates the location and viewing direction of a particular figure.

During the May and October surveys the thermal image of each level of the roof of Building 753 (Fig. 1) was mottled (i.e. with thermally light and dark areas blending into one another). By scraping the gravel cover and taking samples F and G (Fig. 2) in May we determined that the mottling was caused by varying gravel thicknesses and not wet insulation. Thick layers of gravel store more solar heat and remain warmer longer than thin gravel layers. Figure 2c, although mottled, does not have as pronounced mottling as Figure 2a, indicating less solar effect in October. The two black areas in Figure 2c were caused by patches at F and G.

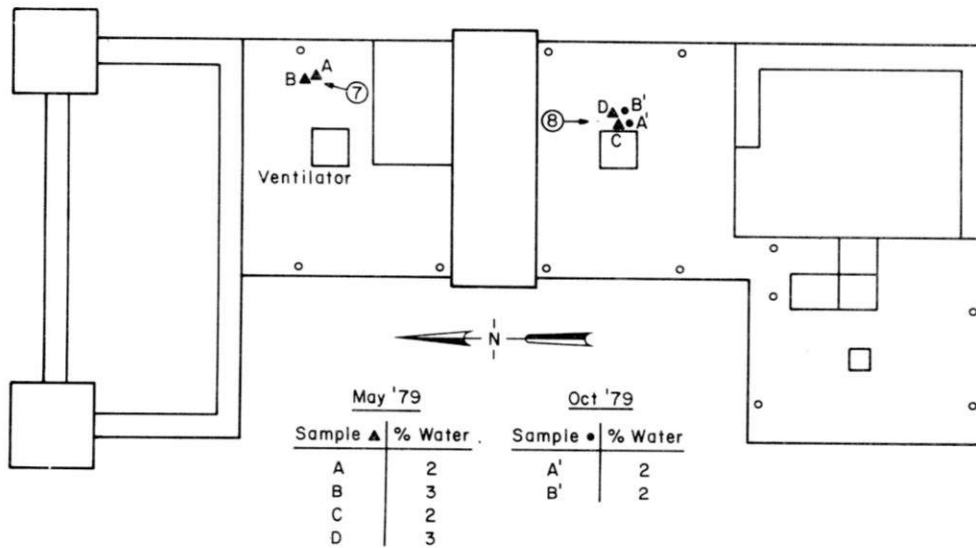
Figure 6. Plan view of Building 751.

thermal mottling on most of this roof was related to varying gravel thickness, but mottling was also observed in a few areas where the gravel thickness was uniform. Representative samples A and B (Fig. 7) contained only 2 and 3% water, respectively; therefore the thermal mottling was not considered moisture-related. Since both A and B had identical membrane thicknesses (3/8 in.), we expect that slight differences in the bitumen flood coat thickness caused the slight thermal mottling. Since the gravel and a portion of the flood coat are normally spudded off before coring, no measurements were obtained to verify this contention.

Figure 8 shows a bright thermal anomaly that appeared to be caused by

hot air blown onto the roof from the neighboring ventilator. But since we could not feel any movement of air from the ventilator, core samples C and D were taken; they contained only 2 and 3% water, respectively. A similar situation occurred in October except that the hot spot seemed to be somewhat larger and samples A' and B' again proved the hot spot to be dry.

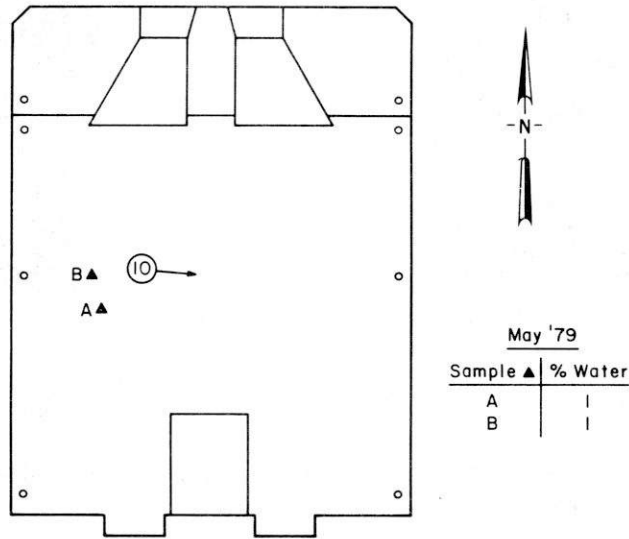
Figure 9. Plan view of Building 745A.

A plan view of the roof of Building 745A is shown in Figure 9. The thermal mottling, to which we had by now become accustomed, was present on this roof and could be attributed to varying gravel (or bitumen) thicknesses and not moisture. We did note that the mottling was somewhat fainter by the time we surveyed this roof. Figure 10 shows that the northern half of this roof was thermally brighter than the southern half, but that samples A and B taken from the southern and northern half, respectively, were dry. We were unable to gain access to the space below the roof but speculate that this thermal pattern was caused by room to room temperature differences.

No wet insulation was found in this roof.

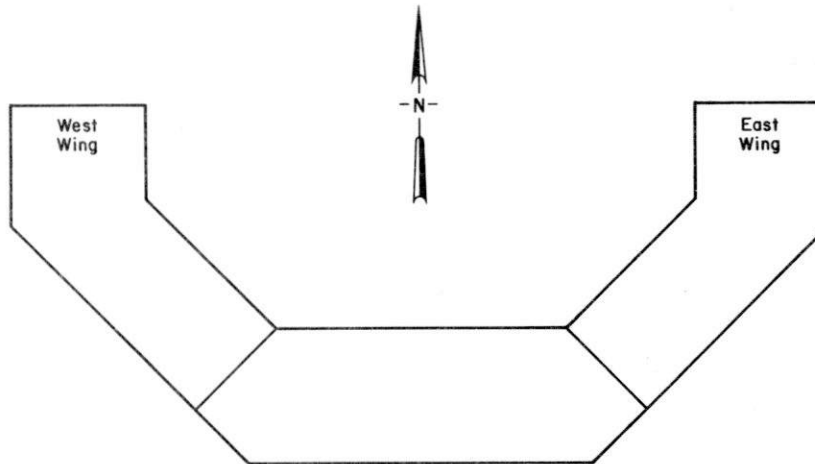
Figure 11. Section A, Building 667.

of the west and east wings of section A, which are shown in plan view in Figure 11. The west wing roof membrane was installed prior to December 1977 and the east wing membrane was installed prior to May 1978. Due to some unfinished work, the warranty for the roofs of these wings did not commence until December 1978.

Several thermally bright areas were found on each wing. Core samples showed that they were areas of wet insulation. Most of this moisture can probably be traced to flashing problems. The counter-flashing shown in Figure 12 was not installed until six months after the roof membrane was finished. When the flashing was finally installed, the sealant and bond-breaker rod between the flashing and the wall began to fall out and had to

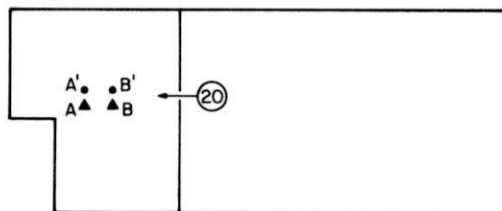
Figure 19. Plan view of the Motor Pool Garage at Grenier Field.

A plan view of the roof of the Motor Pool Garage is shown in Figure 19. Thermally this roof was mottled during both the May and November surveys (Fig. 20). Samples A and B taken in May and samples A' and B' taken in November were dry, which convinced us that this mottling was not moisture-related. The bright areas in the Figure 20 thermograms correspond to areas of thicker gravel. Since all core samples were dry and no other thermal anomalies were detected, we feel that this roof contains no wet insulation.

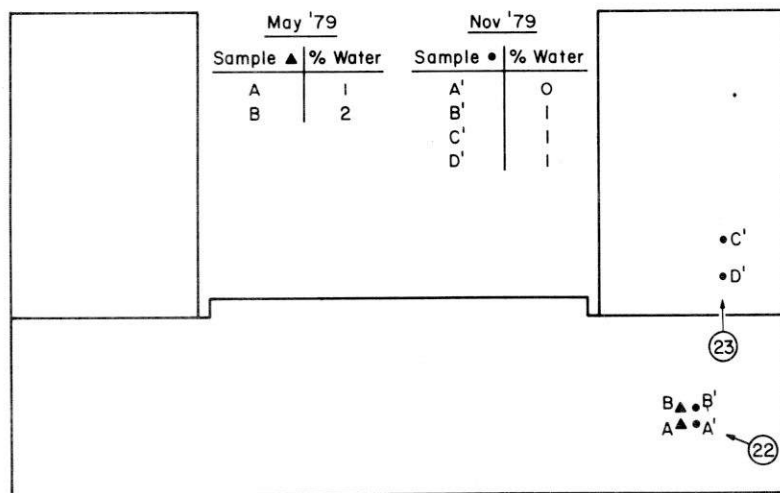
Figure 21. Plan view of the Main Building at Grenier Field.

A plan view of the Main Building's roof is shown in Figure 21. Varying gravel thicknesses created the thermal mottling detected on this
