Effects of Variable Tire Pressure on Road Surfacing

Volume I: Design, Construction, Behavior Under Traffic, and Test Results

by *Robert W. Grau*
Geotechnical Laboratory

Technical Report GL-93-20
August 1993

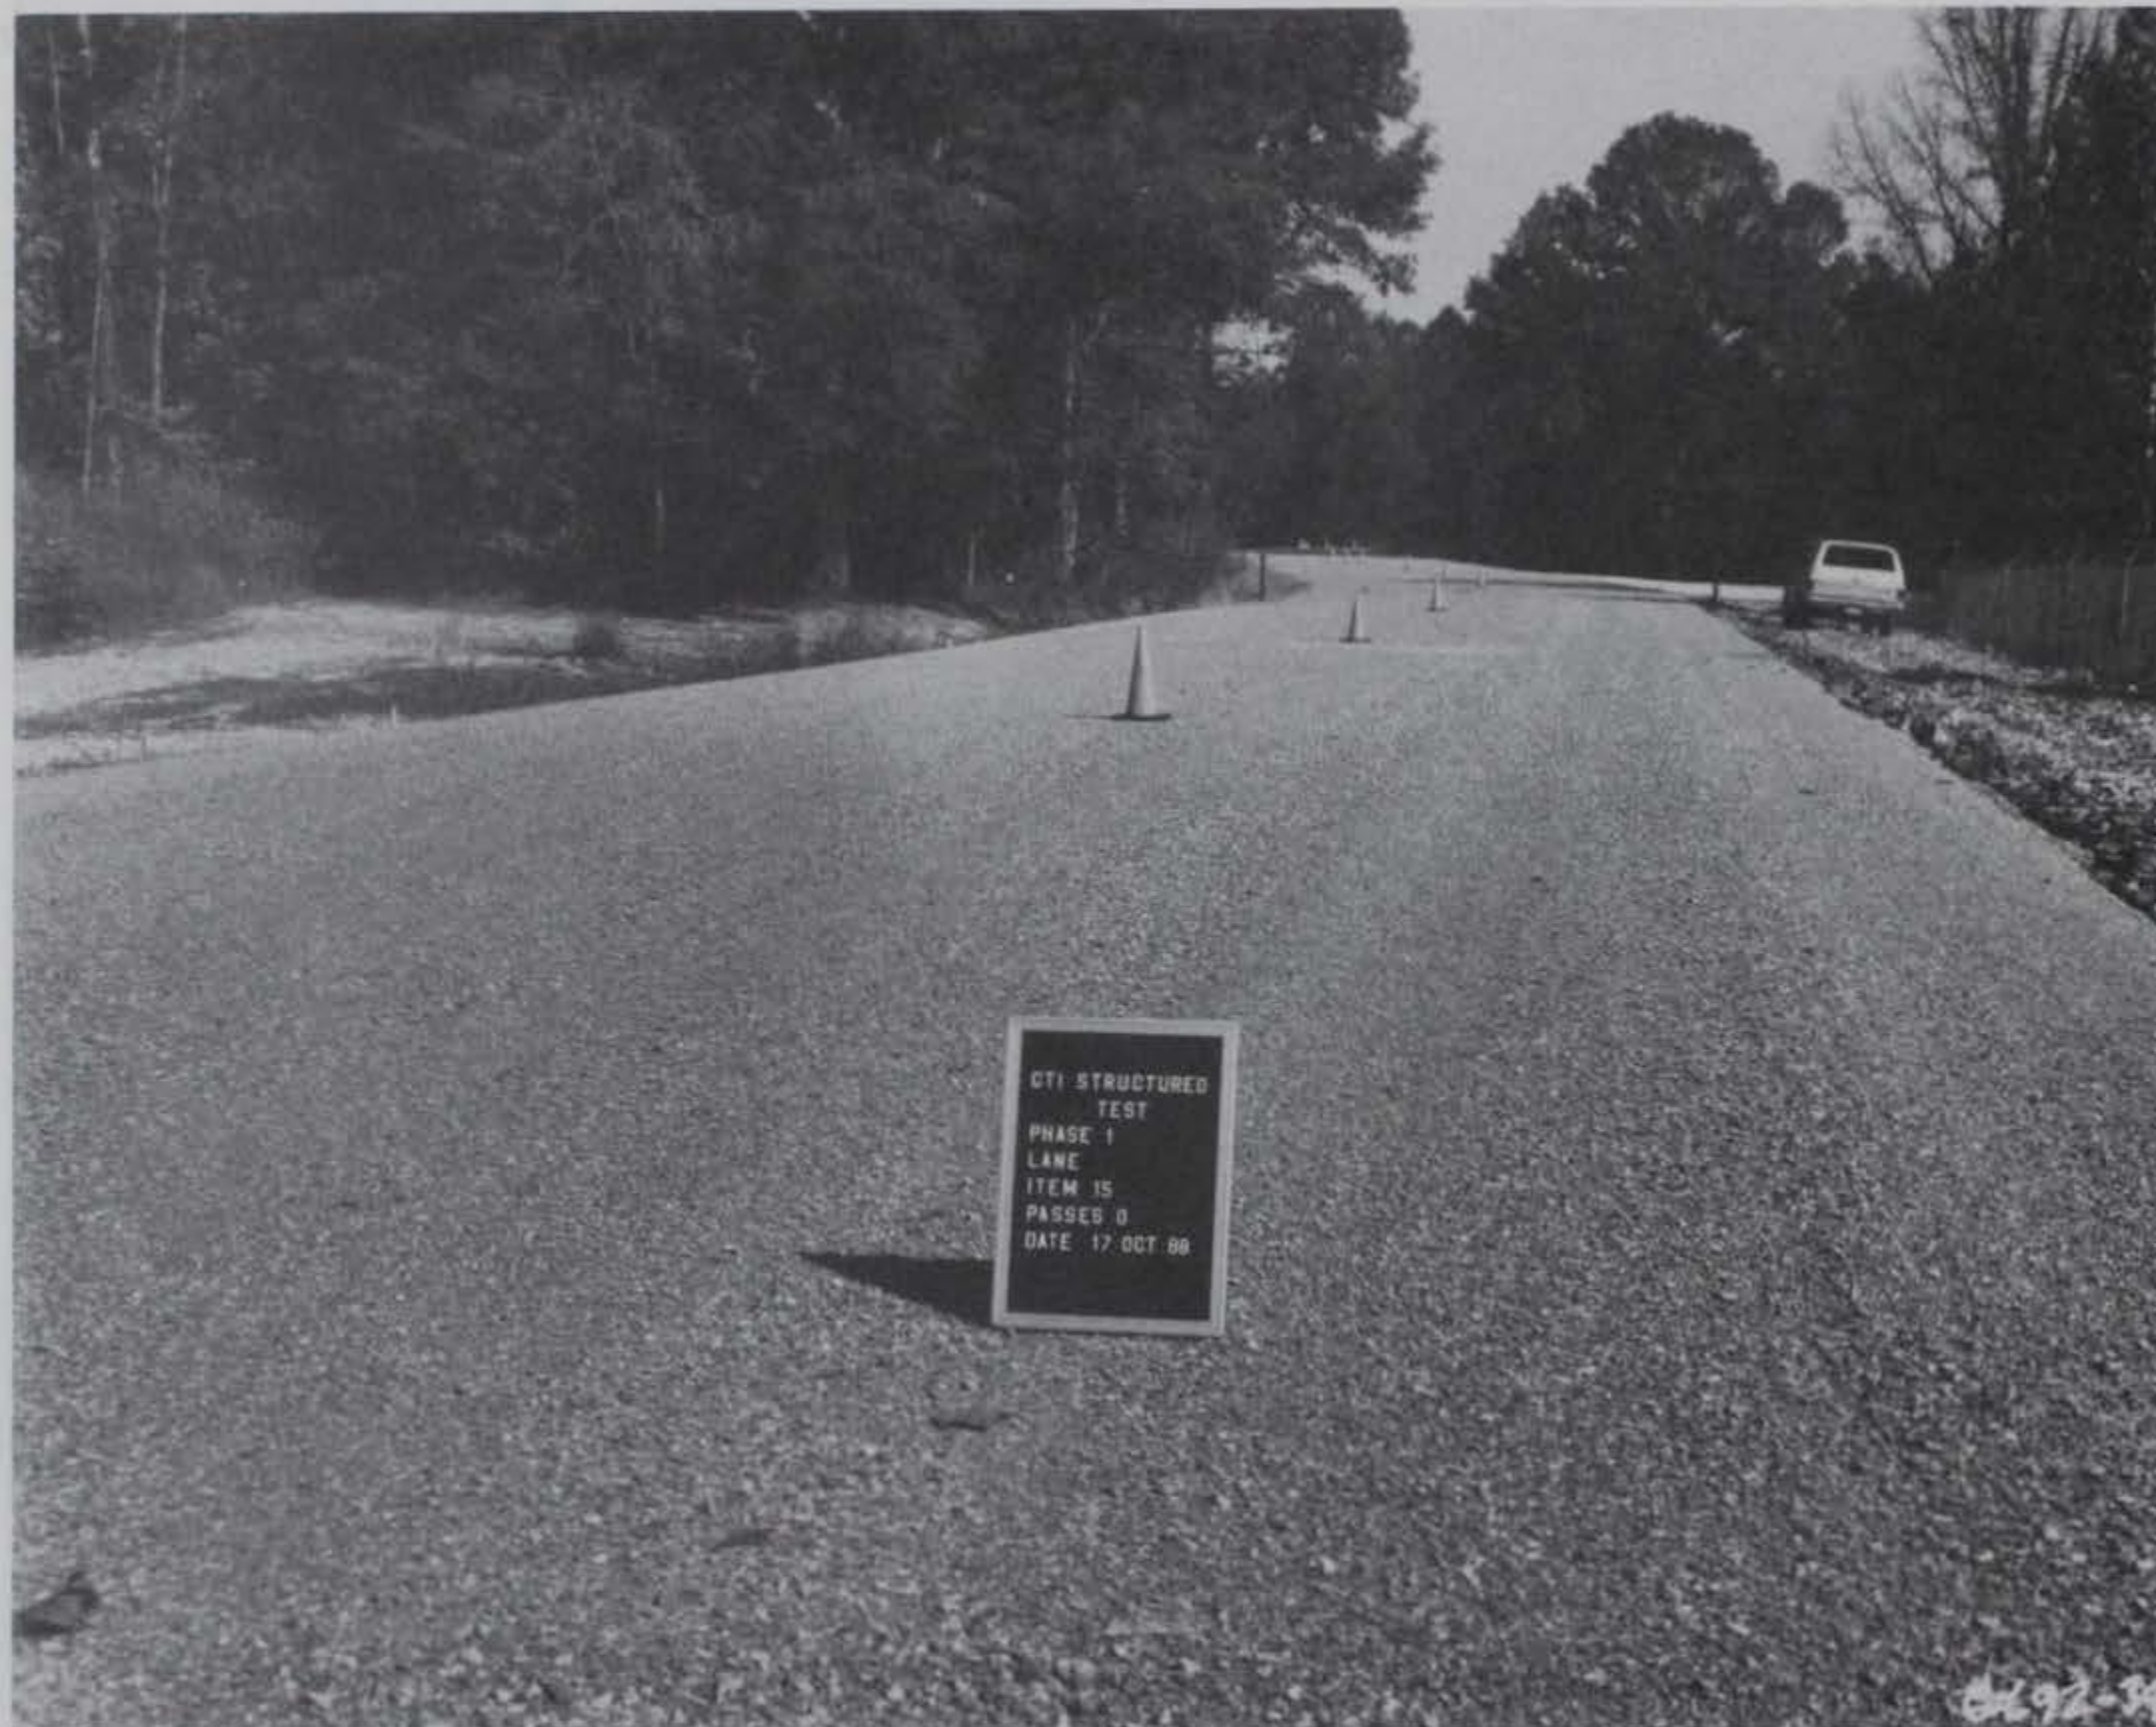
Photo 40. Item 15, general view before traffic

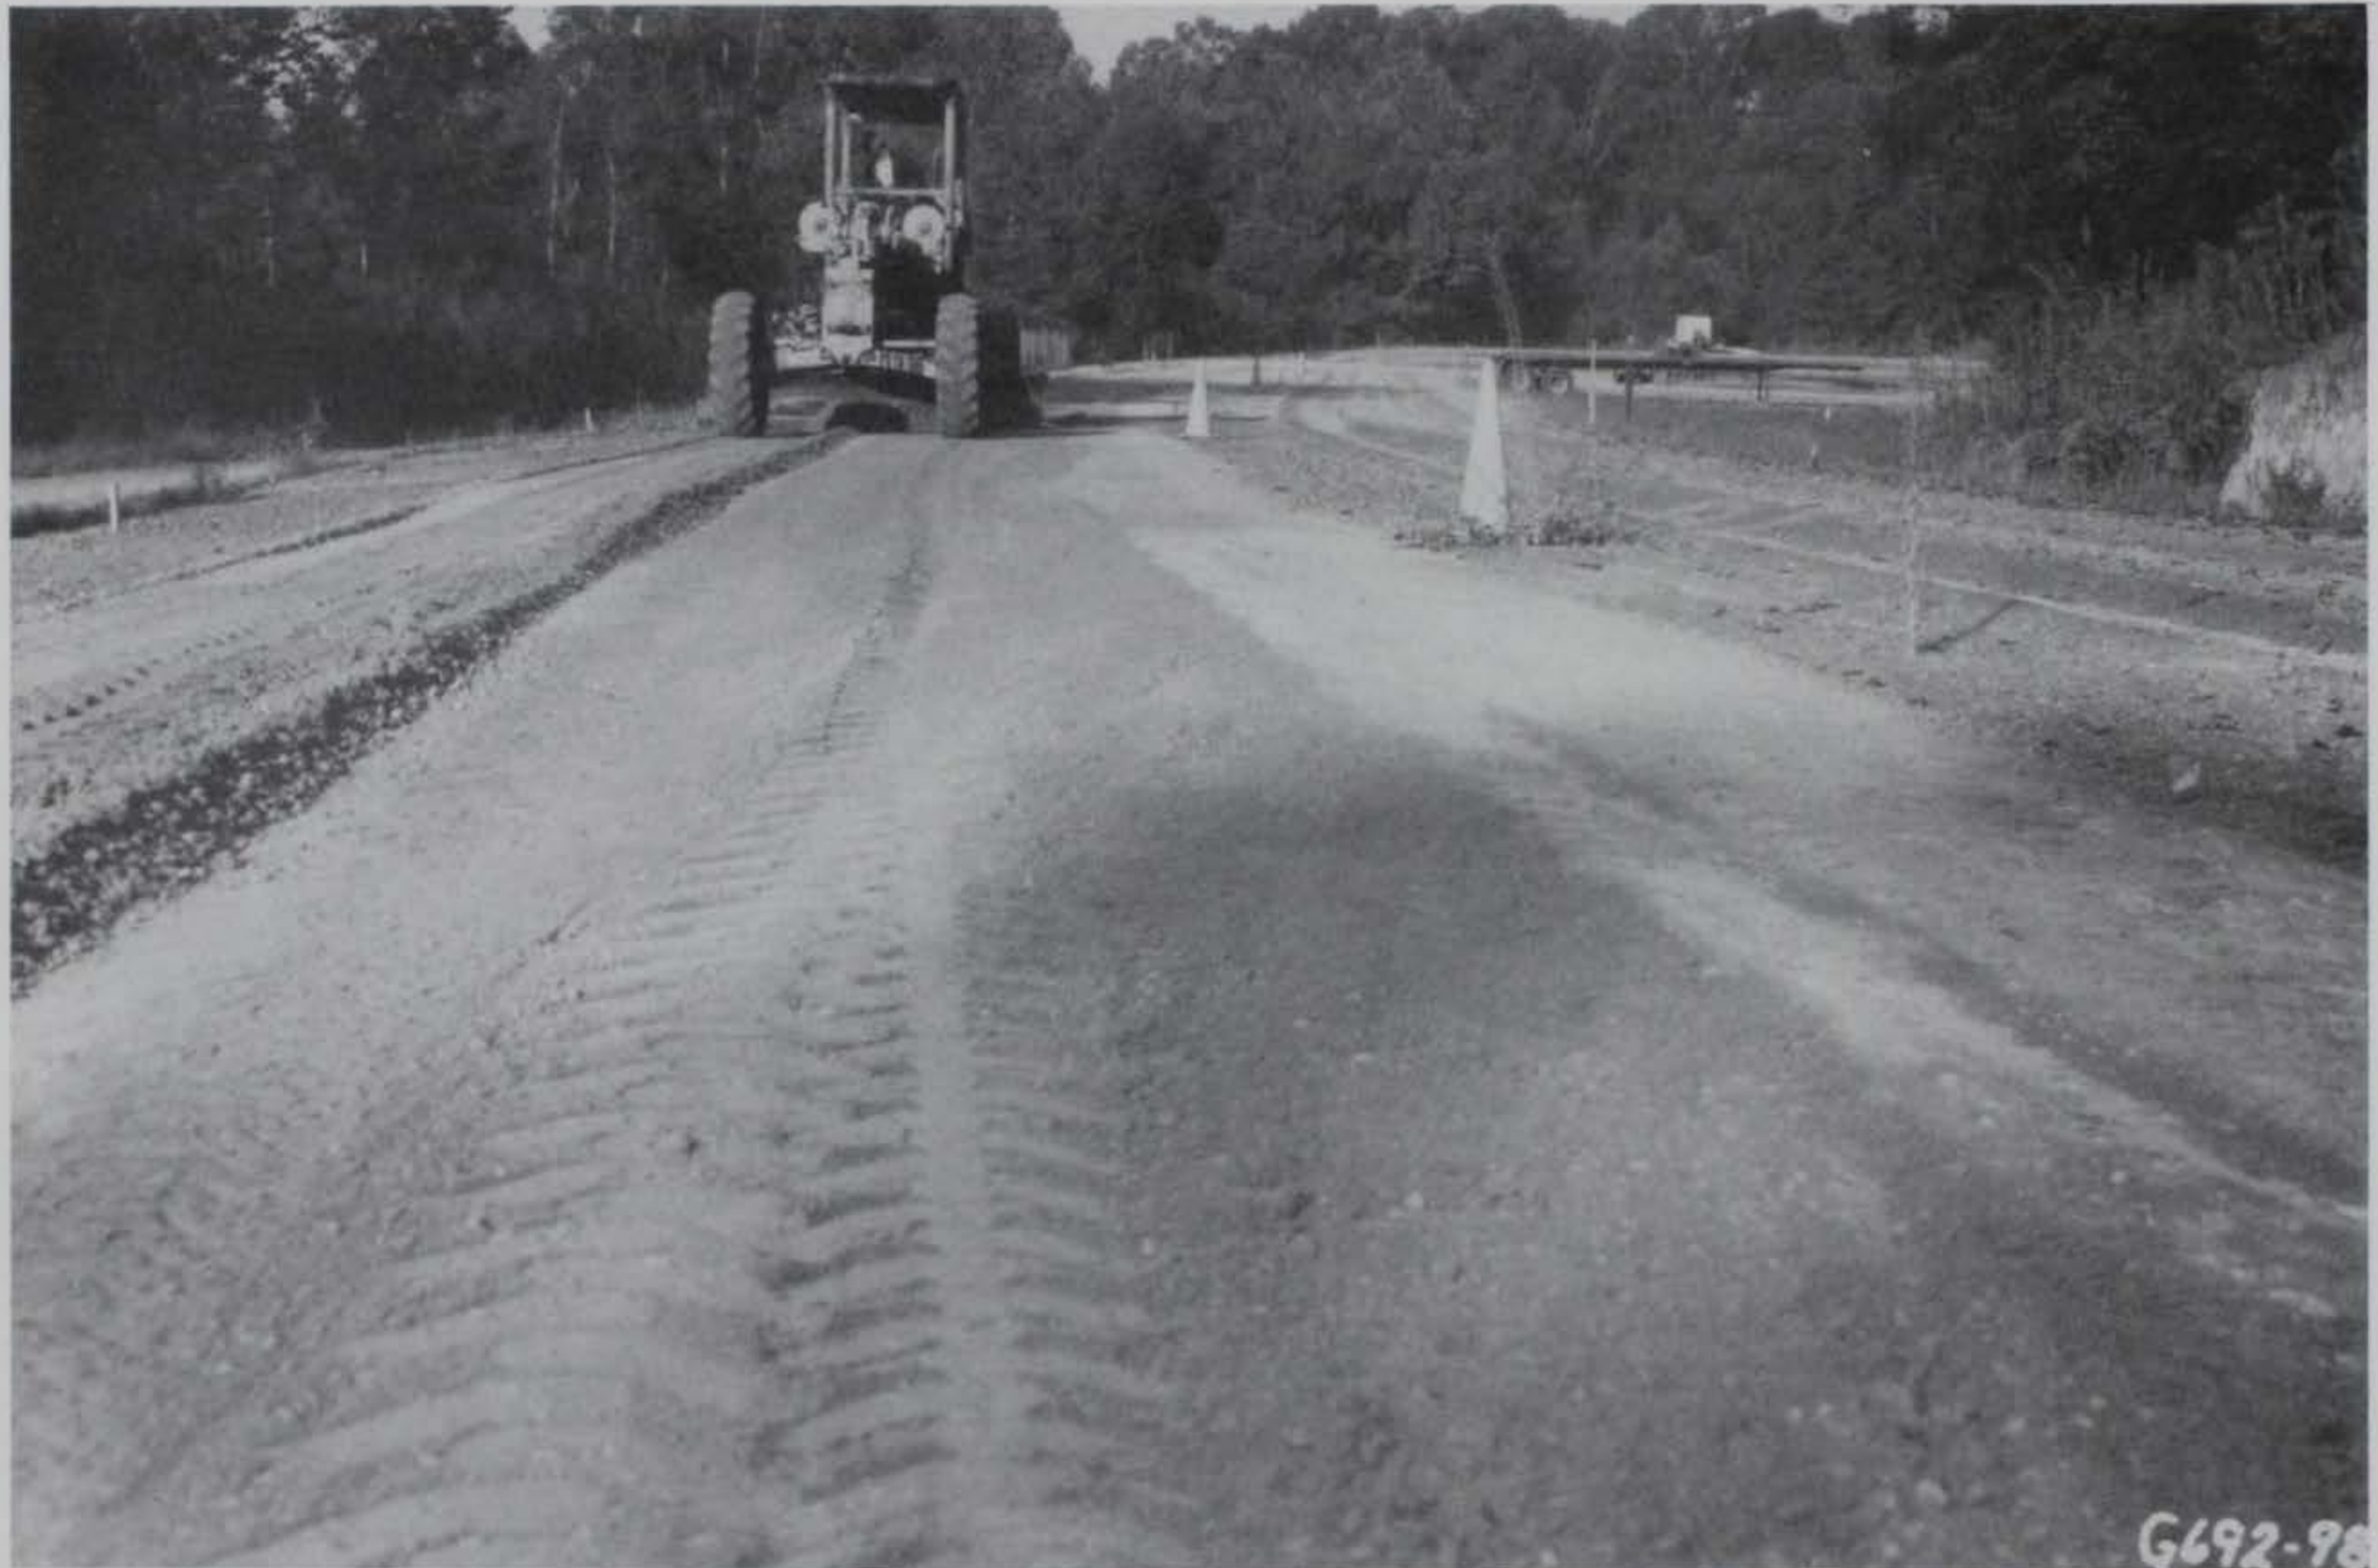
Due to the higher subgrade strengths and no vertical or horizontal curves, items 13 to 15 performed quite a bit better during traffic than did items 1 to 3. Very little distress was detected in items 13 to 15 until about 90 passes of loaded traffic was applied to both lanes during a light drizzle on 29 September 1989. Traffic had not been applied the previous day due to a heavy (1.22-in.) rain. A considerable increase in rutting of all wheel paths of each test item resulted from the 90 passes applied after this rain. The maximum rutting in item 13 increased from 1.5-in. to 4.75-in. In items 14 and 15 the rutting increased from 3.0-in. and 1.75-in. to 4.25- and 5.75-in., respectively. General views of the high- and low-tire-pressure lanes of item 14 at this time are shown in Photos 52 and 53. A total of 883 loaded and 672 unloaded passes had been applied in the high-tire-pressure lane and 1,077 loaded and 838 unloaded passes in the low-tire-pressure lane of these items. Each item was rated as failed due to severe rutting and required grading. It should be noted that these failures were attributed to a wet subgrade, and there was no notable differences between the performance of the various items or test lanes. The aggregate thicknesses of 3, 6, and 9 in. were not sufficient to protect the weak wet subgrade. Grading as shown in Photo 54 removed the ruts in all items. After grading, unloaded traffic was first applied to compact

Photo 54. Grading both lanes of Items 13, 14, and 15
