**US Army Corps
of Engineers**
Waterways Experiment
Station

Coastal Engineering Research Program

Scour Hole Problems Experienced by the Corps of Engineers; Data Presentation and Summary

Final report

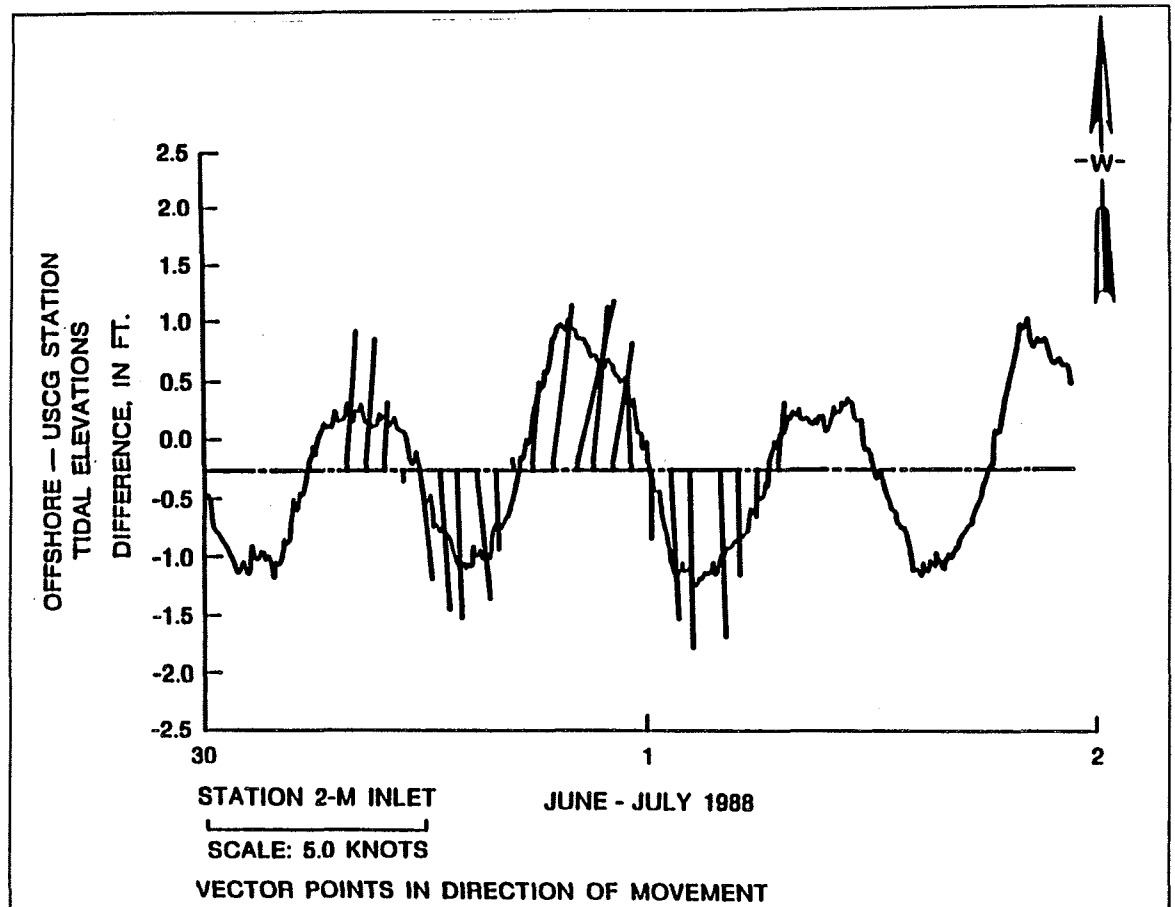
Figure 6. Residual tide signal at Indian River Inlet

The hydraulics of Indian River Bay and Rehoboth Bay have changed dramatically since the inlet was created in the late 1930's. The ebb tidal prism has increased from approximately 27.5 by 10^6 cu ft in 1931 to 3.7 by 10^8 cu ft in 1948 to 1.5 by 10^9 cu ft in 1986. The tide range inside the inlet went from near zero in 1931 to 2.5 ft in 1948 to 2.7 ft in 1986. Inlet velocities increased from 2.4 ft/sec in 1948 to 6.6 ft/sec in 1986, and during field measurements made in 1988, maximum recorded velocities exceeded 8 ft/sec during spring ebb tidal flows. Ocean tides are substantially greater than tides immediately inside the inlet at the US Coast Guard station, as illustrated in Figure 6, which shows the difference in elevation between the two locations.

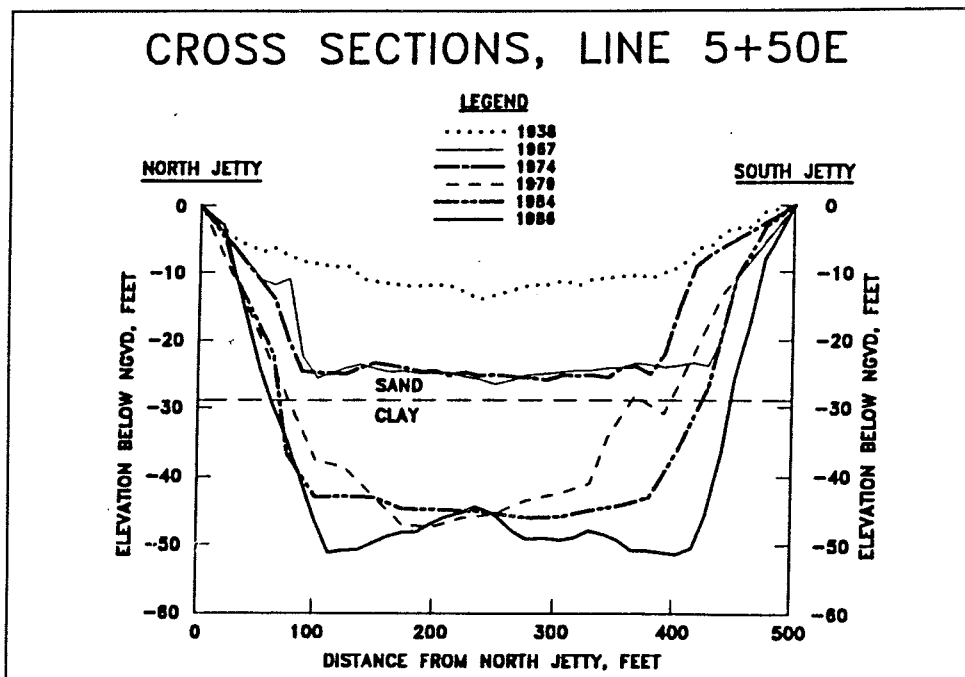
Figure 9. Inlet cross-sectional changes, Indian River Inlet

- c. Due to "a" and "b," the inlet has the potential to continue to deepen, possibly eventually eroding to the Pleistocene layer that is much more compacted than the Holocene layer. The extreme scour holes are already approaching the Pleistocene layer (located at approximately -100 ft, NGVD). Both inlet stability theory and the numerical model show it is quite probable that even then erosion will continue.

This could occur either through horizontal enlargement of the extreme scour holes, through overall deepening of the entire inlet, or through a combination of both. Eventually, both jetties could be seriously damaged or even lost as a result of scour hole enlargement and inlet deepening.

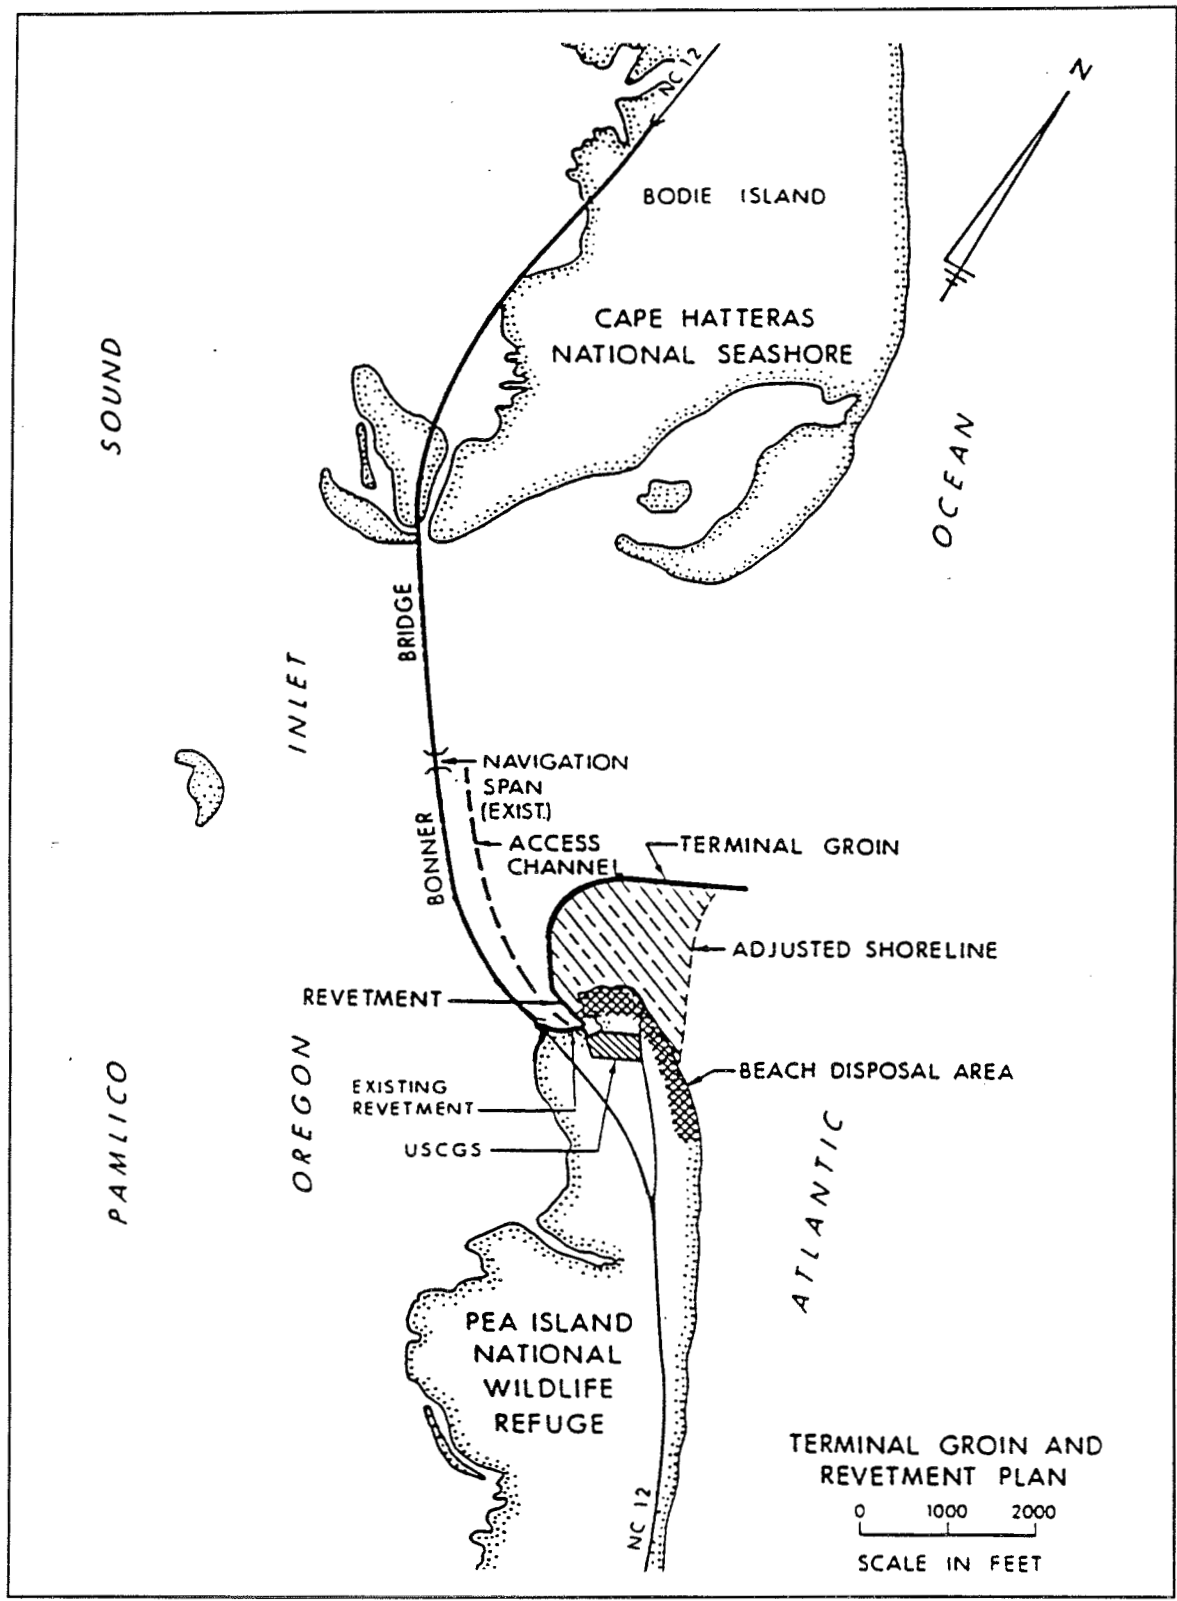
Figure 12. Oregon Inlet and terminal groin

The migration of Oregon Inlet to the south has caused erosion of Pea Island to the extent that, by 1989, the abutment of the state-owned Bonner Bridge was being threatened. This prompted the State of North Carolina Department of Transportation (DOT) to contract for the construction of a terminal groin on the south side of the inlet to stabilize the shoreline and protect the bridge abutment. A plan view of the terminal groin is shown in Figure 12. The winning bid for groin construction was \$9.4 million, and the 19-month-long project was managed by the Corps of Engineers under contract to the North Carolina DOT.

It was speculated during the May 1991 workshop that the primary cause of scour at Oregon Inlet was the ebb-flow tidal current because the deepest scour was observed on the channel side of the groin. Waves were discounted as a process contributing to the scour because most waves break on the ebb shoal, thus decreasing their effect. However, there is a possibility that nearshore currents generated by waves during storm conditions could have contributed to the scour. Aerial photographs of the groin showed currents being trained along the structure.

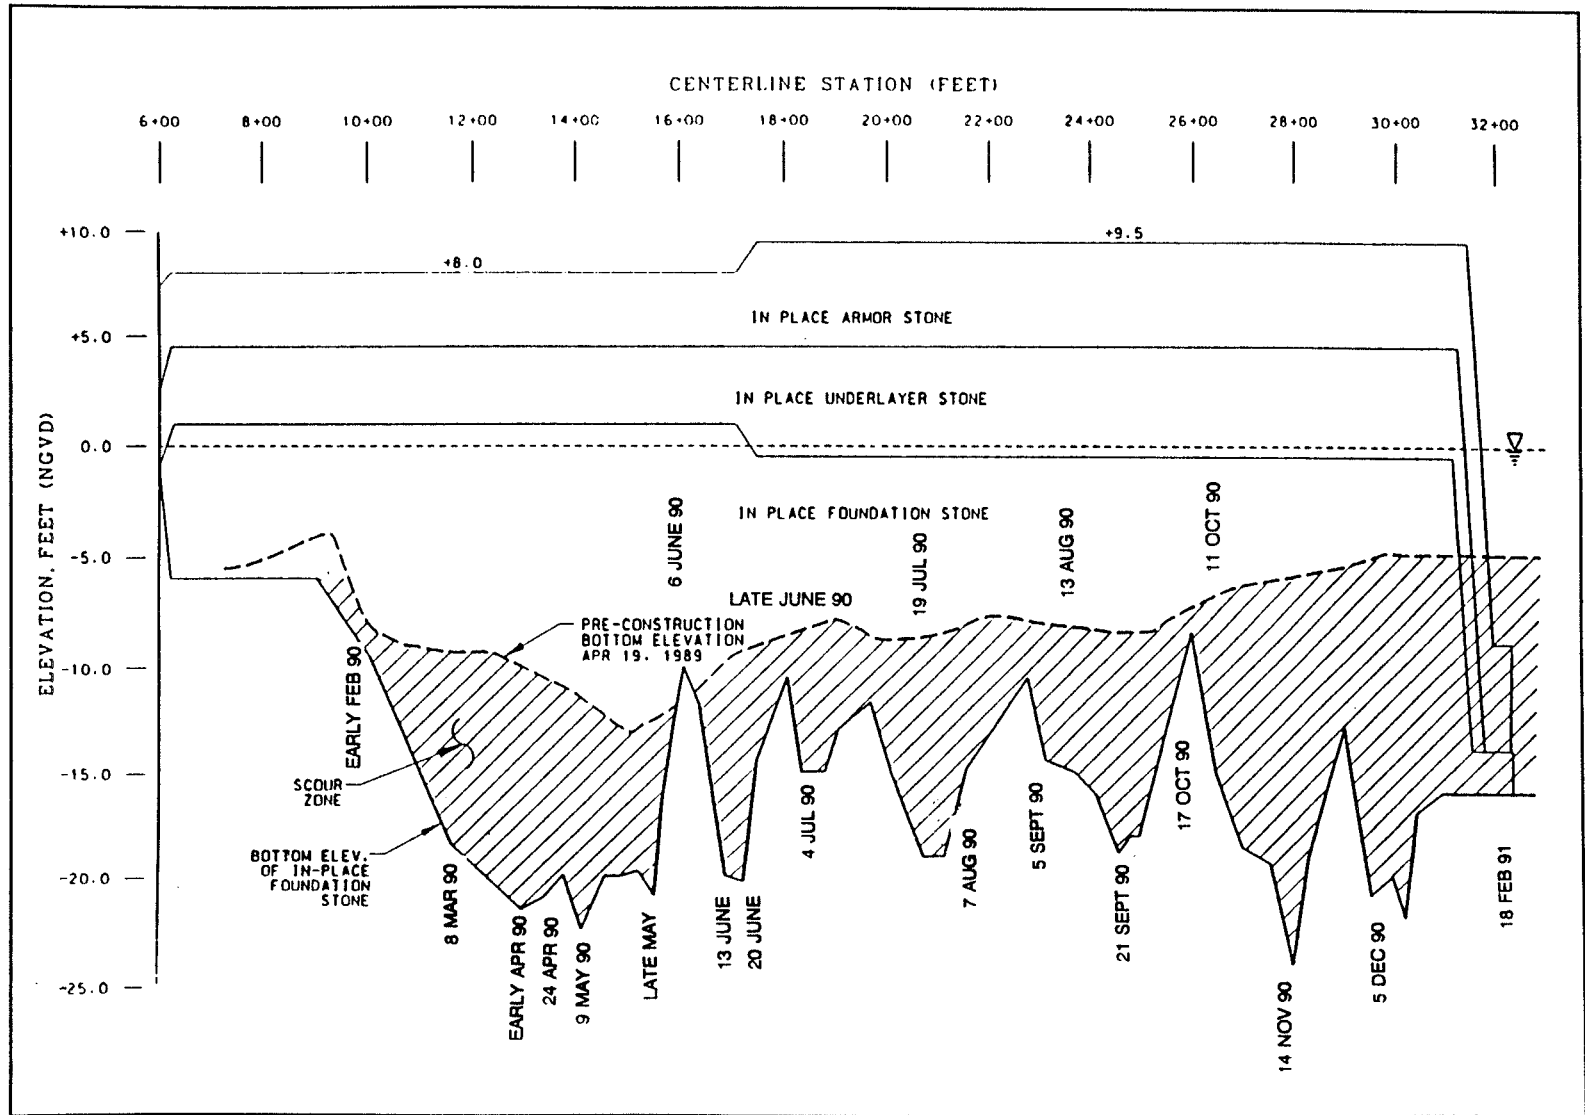
Figure 13. Scour during construction, Oregon Inlet, pre- and post-construction

The extent of scour that occurred during construction is shown in Figure 13. Center-line stations on this figure refer to the positions indicated on the terminal groin plan view given in Figure 12.

As the groin was constructed, there were periods of scour and no scour (even accretion) as shown in Figure 13. An attempt was made by the monitors to correlate wave height, period, and direction with scour depth. Figures 14, 15, and 16 show that, based on preliminary results from Miller (1992), none of the aforementioned wave parameters correlated with scour depth.

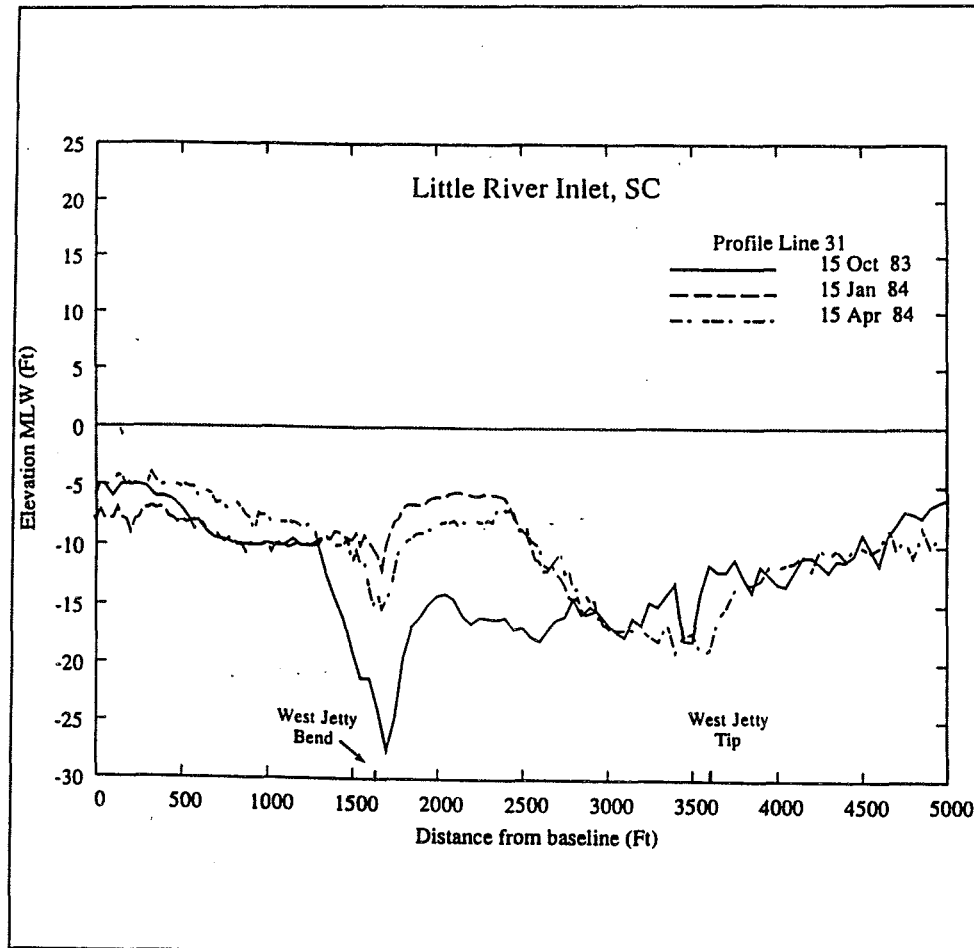
Figure 19. Little River Inlet bathymetry profile

Scour is also occurring along the west jetty adjacent to the inlet channel, and the cause appears to be different from that at the tips. Along this section, natural thalweg migration appears to be shifting the channel toward the jetty, scouring to a depth of about 20 to 25 ft mlw. Prior to construction of the navigation project, the natural channel shifted frequently; and at the time of construction of the west jetty, the natural channel was toward the southwest and Waties Island (Chasten and Seabergh, in preparation). This flow route was closed off as the west jetty was constructed and the ebb tidal flow began channelizing along the west jetty. In December 1983, dredged material from the inlet was placed in the scour hole but has since eroded away, and the hole continues to enlarge. Figure 19 shows a survey taken along the west jetty prior to dredged material placement and following placement. Note that the deepening trend continued immediately following fill placement.

The channel migration and jetty scour began following construction of the Federal navigation project and continued through 1989. Since 1989, the inlet continued to evolve with some changes, probably as a result of Hurricane Hugo. Chasten and Seabergh (in preparation) predicted that, with deepening of a natural feature near the east jetty, the inlet may adjust to a more centralized location for the natural thalweg thus relieving some of the scour potential at the west jetty.

However, scour at the tip of the jetties is continuing, which may eventually result in damage. Chasten and Seabergh (in preparation) stated that collapse of either jetty head section would not immediately affect the functionality of the jetties to stabilize the inlet, and reported that the rate of scour at the west jetty has slowed.

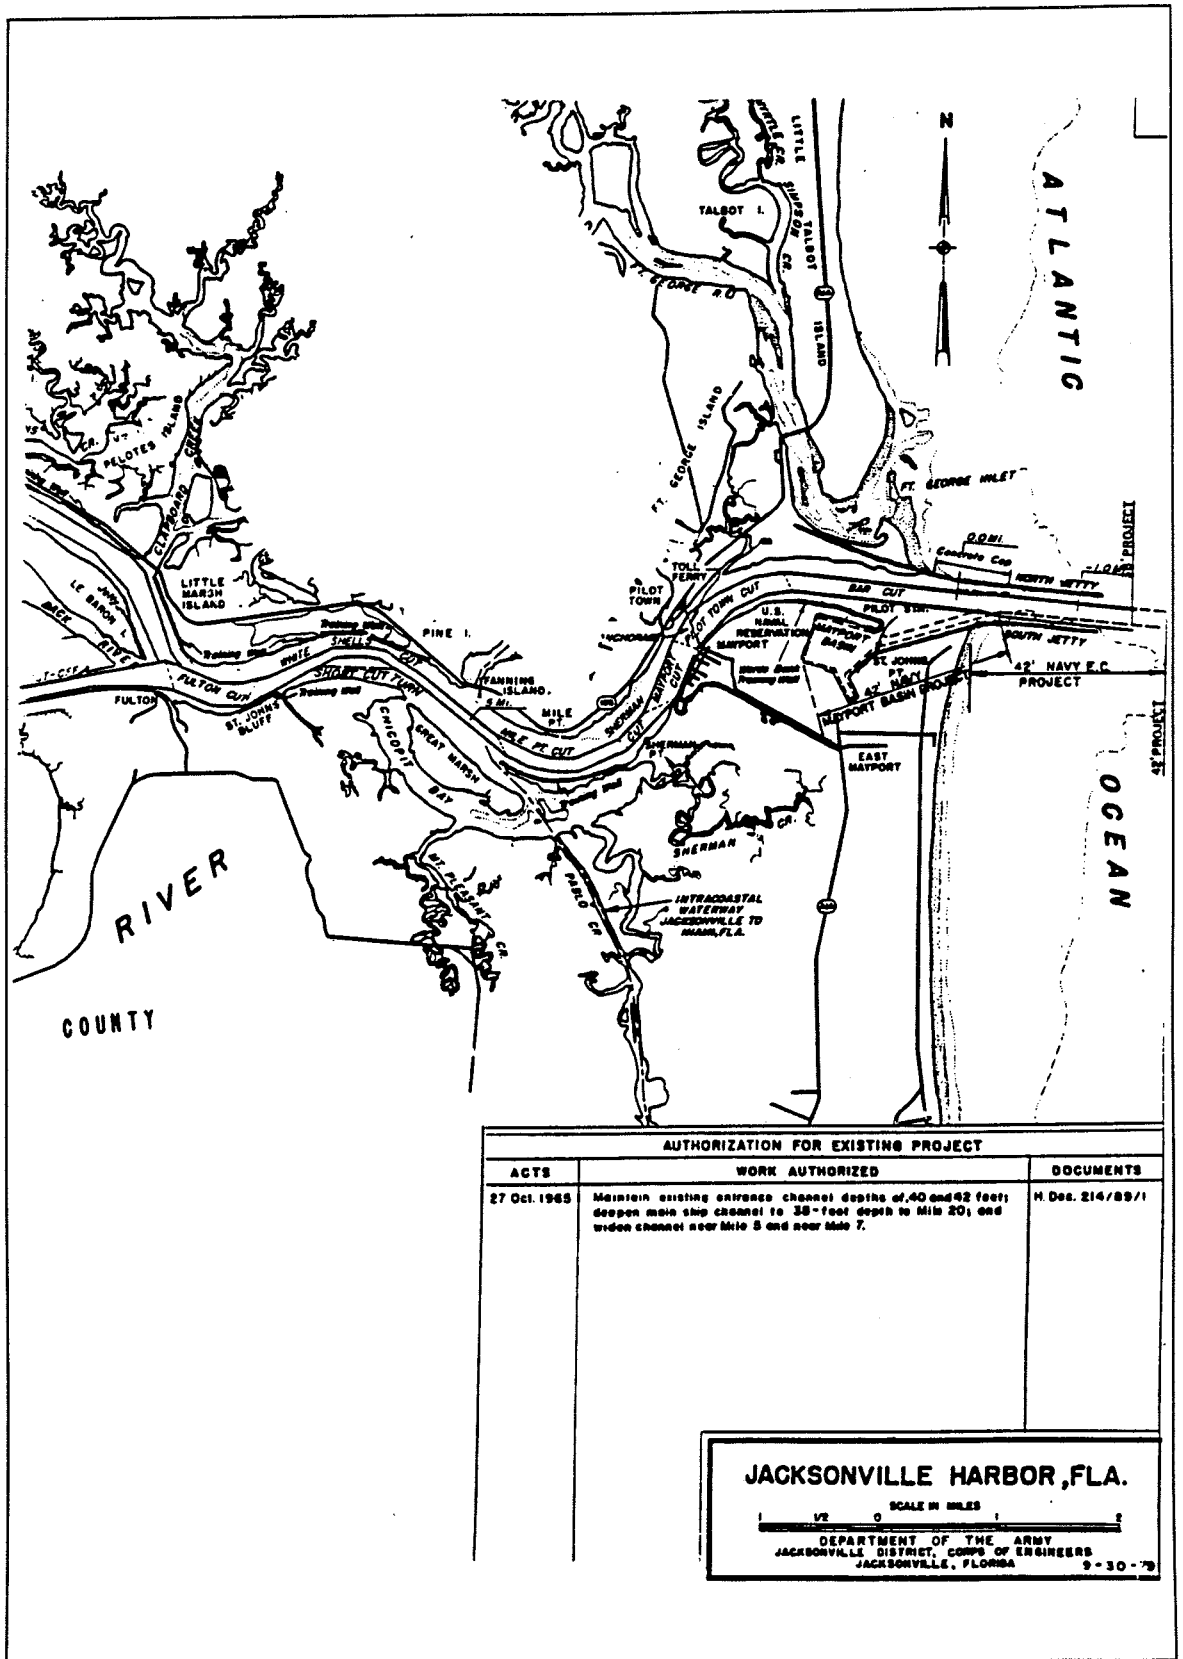
Figure 20. St. Johns River, Florida, site location map

The entrance to Jacksonville Harbor from the Atlantic Ocean traverses approximately 20 nautical miles of the St. Johns River. Approximately 3 nautical miles from the Atlantic Ocean, at a bend in the channel, is Mile Point, located on the north side of the channel (Figure 20). Significant scour is occurring along this reach, causing bank erosion. Two scour holes have formed, one small hole about 65 ft deep and a second scour trench approximately 45 ft deep and 1,500 ft long running east/west. Surrounding bottom depths are in the 10- to 20-ft range. As the scour holes have increased in size, significant shoreline erosion has resulted. Riverine mechanics predict that scour should occur on the outside of a channel bend and deposition along the inside of the bend. Unlike more typical river settings, scour at Mile Point is located on the inside of the bend.

The Jacksonville District reports that, recently, property along the bend has eroded from 35 to 100 ft. A cause of scour has yet to be identified. The Federal navigation channel is located over 900 ft south of the scour holes. The navigation channel has been dredged for over 100 years, and this scour problem is a recent occurrence.

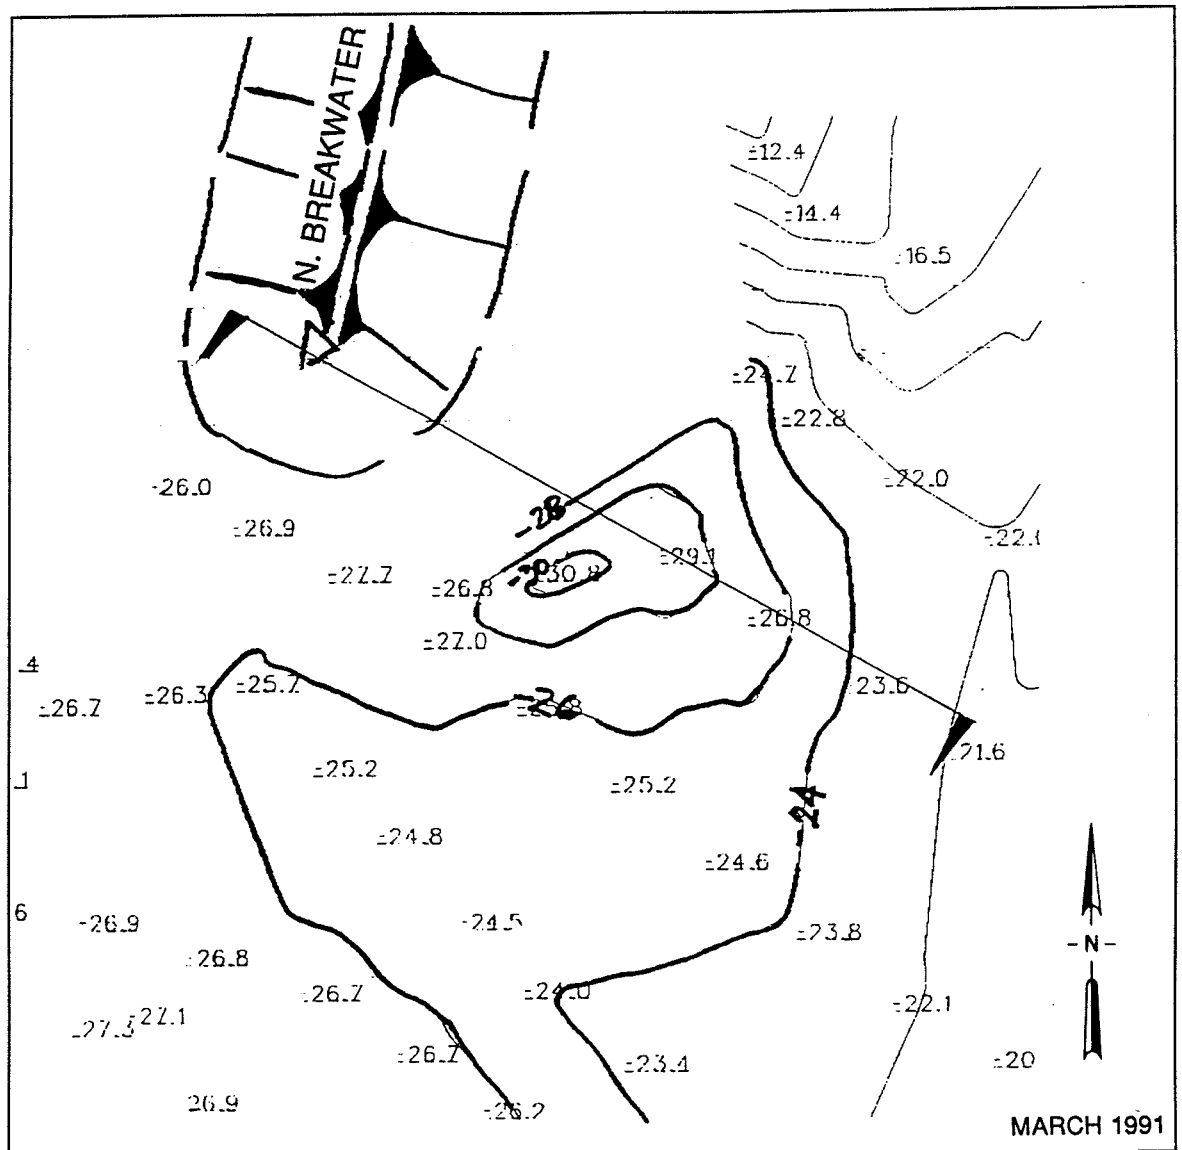
Figure 30. Morro Bay scour hole, plan view

A scour hole was discovered off the tip of the north jetty after the January - March 1991 winter storm season. This particular winter was characterized by several intense storm sequences, including a storm in early March 1991 in which the significant wave height reached 17.5 ft.

Figure 30 is a plan view of the scour hole as it existed during the survey of March 11, 1991. The maximum depth is 30 ft below mean lower low water (mllw), and it was pointed out that the survey was performed 8 days after the storm, and, thus, there could have been some infilling of the hole in the meantime.

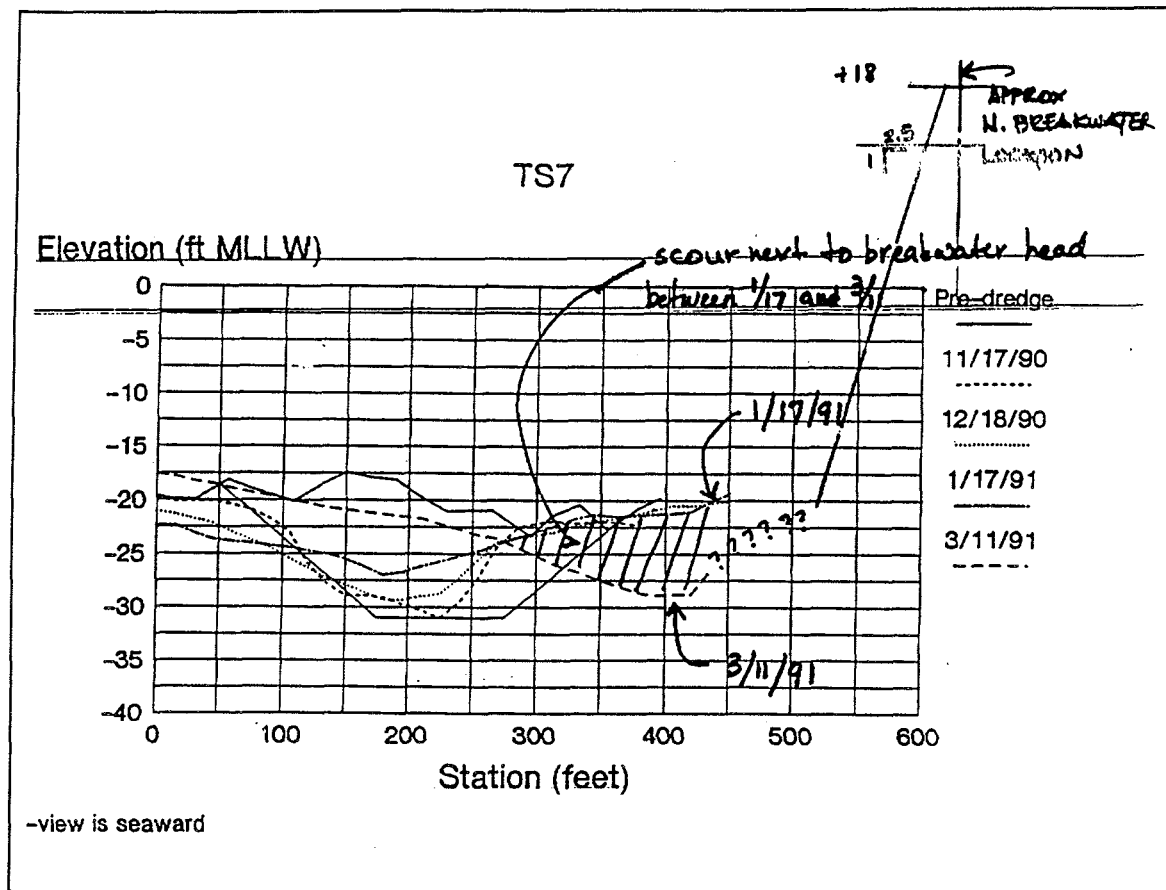
Figure 31. Morro Bay scour hole cross section

The cross section indicated on Figure 30 is shown on Figure 31. Survey data did not extend up to the toe of the jetty, so there is some question as to whether the structure's toe might be in jeopardy.

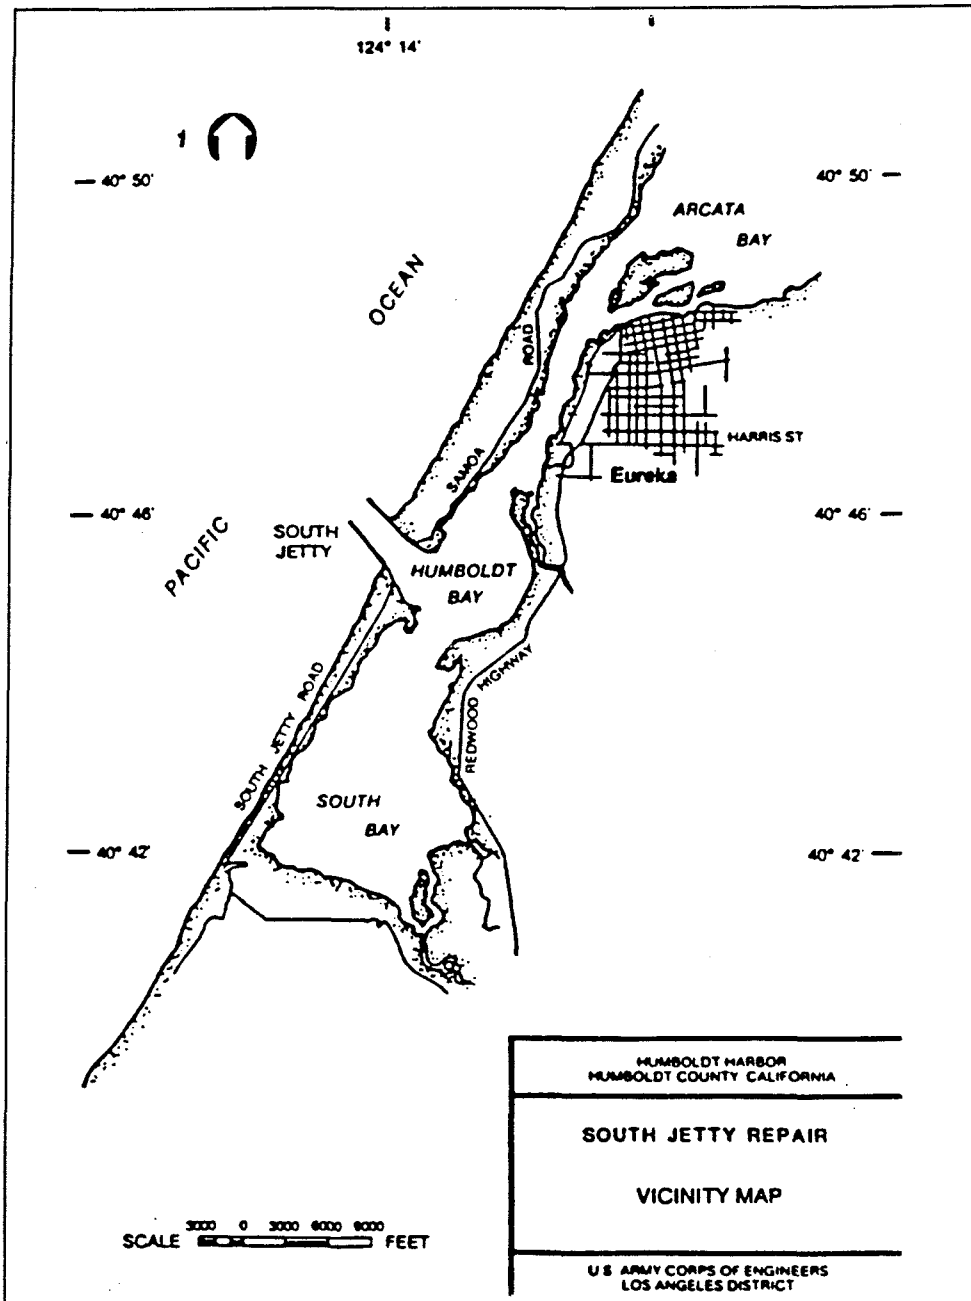
Figure 32. Humboldt Bay entrance channel

Bathymetric data show three areas with significant active seasonal changes. Two are off the southwest side of the two jetty heads, and the third is along the channel side of the south jetty. The large holes tend to scour in the summer and fill in the winter. Off the south jetty head, soundings indicated depths almost to -70 ft mllw in August 1983 at station 85+50 and 350 ft off the center line. Surveys in 1984 showed this area had shoaled to -40 ft mllw in April,

which was the most extreme shoaling between the two survey periods. The two scour holes adjacent to the jetty tips are slightly linear in shape, parallel with the jetties and deepest close to the toe. The hole at the north jetty is considerably larger ranging from 200 to 300 yd wide. Historic soundings do not show the scour holes so they are believed to be a modern feature. The third scour hole lies adjacent to the south jetty trunk between stations 47 and 62. It is approximately 100 yd wide, reaching depths greater than -60 ft mllw. Comparison with historic bathymetry show that, unlike the first two scour holes, this one has been present since construction of the jetties. Diver

The structures at Humboldt Bay experience three types of scour, each apparently governed by different hydrodynamic processes. The first type of scour is caused primarily by the ebb-flow jet exiting the northerly interior channel, flowing diagonally across the entrance channel and impinging on the rubble-mound revetment on the south side of the entrance channel. This has resulted in scouring of the bottom near the toe of the south jetty along part of its length. Depth of scour was reported to be 60 - 70 ft.

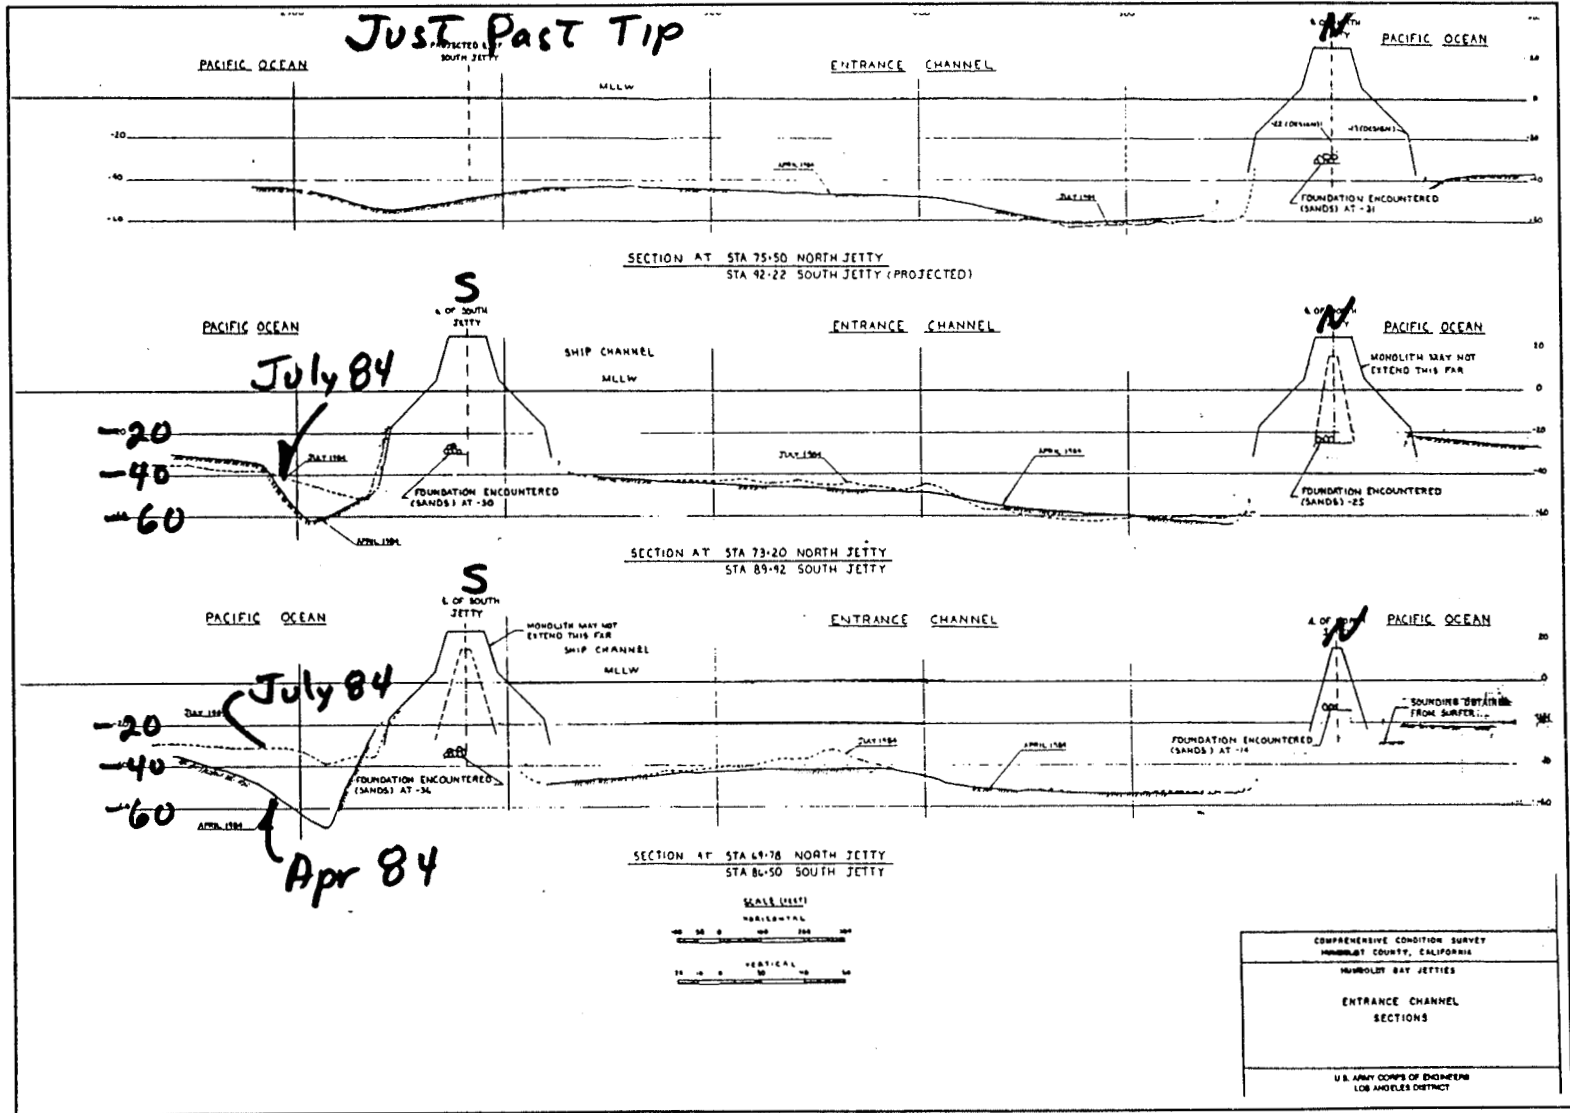
Figure 33. Humboldt Bay south jetty rip channel scour

The second type of scour occurs along the jetties on the side opposite to the channel. Longshore-moving currents and wave setup contribute to "rip-channels" that flow from the shore along the updrift jetty in a seaward direction. Floats have been used to estimate current speeds of about 5 knots (8 ft/sec) as the flow moves around the tips of the structures. This rapid flow scours a trench along the toe of the structures, and repeated dumping of stone to protect the structure has resulted in a flattening of the structure slope to about 1:5. Figure 33 shows a typical scour trench near the tip of the south jetty at Humboldt.

During the winter, when the rip currents scour a channel on the outside of the south jetty and the ebb currents scour near the toe on the inside of the jetty, the combined effect puts the structure in considerable danger of liquefaction-related failure.

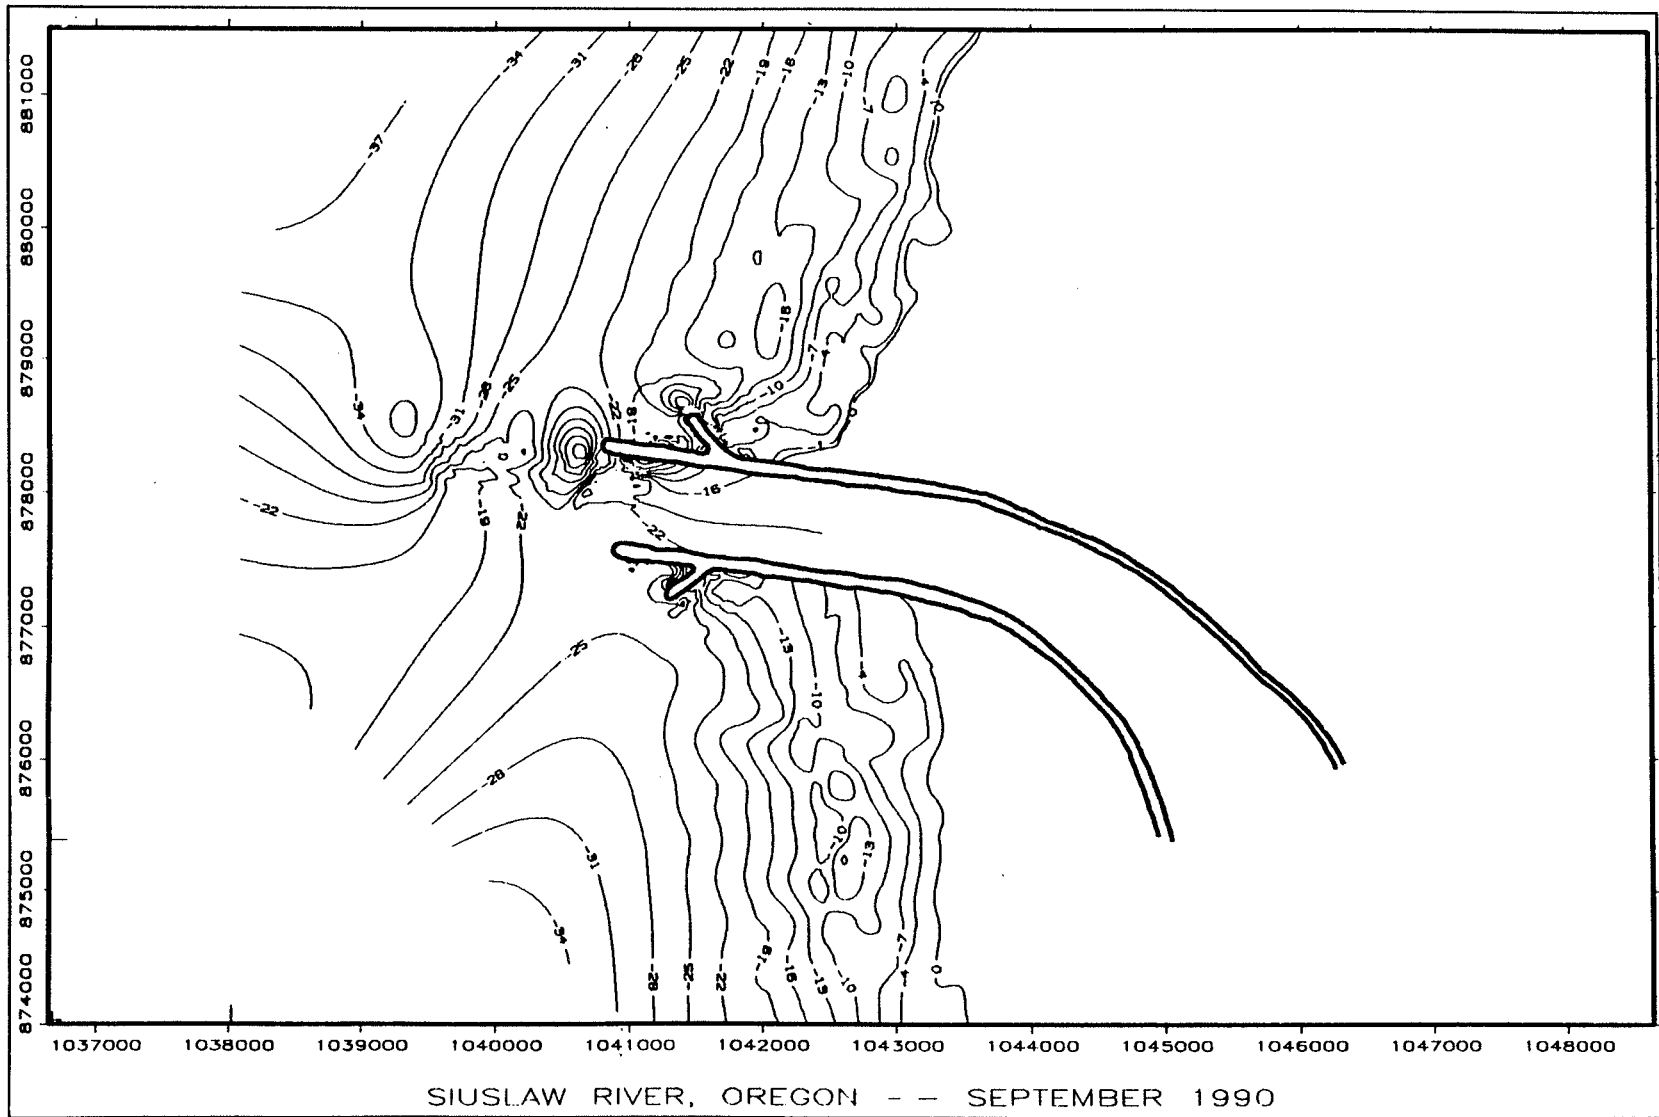
Figure 34. Jetties and bathymetry at Suislaw River Entrance

Two scour problems are occurring at Suislaw. The first problem, seen in Figure 34, is caused by longshore currents flowing from the north to south. The currents reach the north jetty and are deflected seaward along the jetty as a rip current. The current velocities are sufficient to scour a trench along the toe of the structure, thus giving concern for the integrity of the rubble mound. The scour trench extends along the spur jetty as well.

The types of scour observed at Suislaw are similar to the problems occurring at Humboldt Bay. The scour trench caused by the longshore currents meeting the north jetty is most likely seasonal, with the trench filling in during calmer periods. The effectiveness of the spur jetties is being evaluated in the MCCP Program.

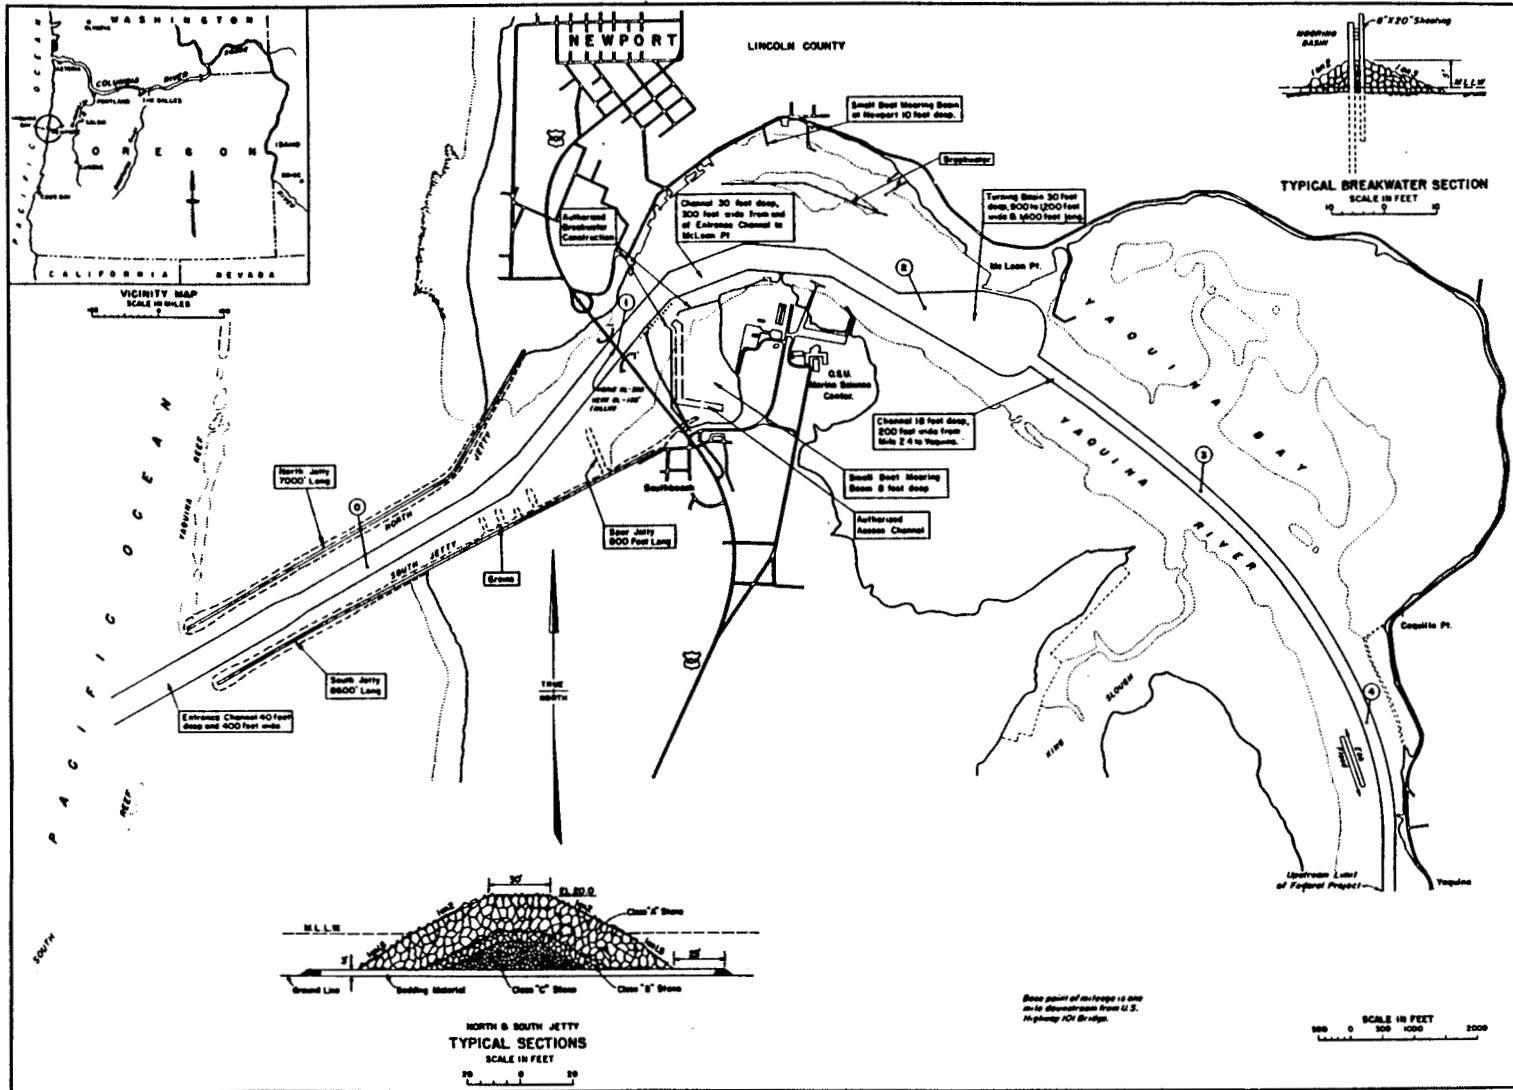
Figure 35. Yaquina Bay and Harbor, Oregon, site location map

The tip of the north Yaquina jetty intersects an offshore reef as indicated in Figure 35.

Very recent geophysical evidence indicates that the bottom material immediately landward of the reef is a fairly deep deposit of littoral sand. It is hypothesized that waves in severe storm conditions cross over the hard bottom of the reef and scour sediment from the bottom just landward of the reef and right at the toe of the "notch" area. This causes toe failure and slumping of the structure's armor layer into the hole. After the storm, milder wave conditions move littoral material into the scour hole and cover up some of the missing armor units.

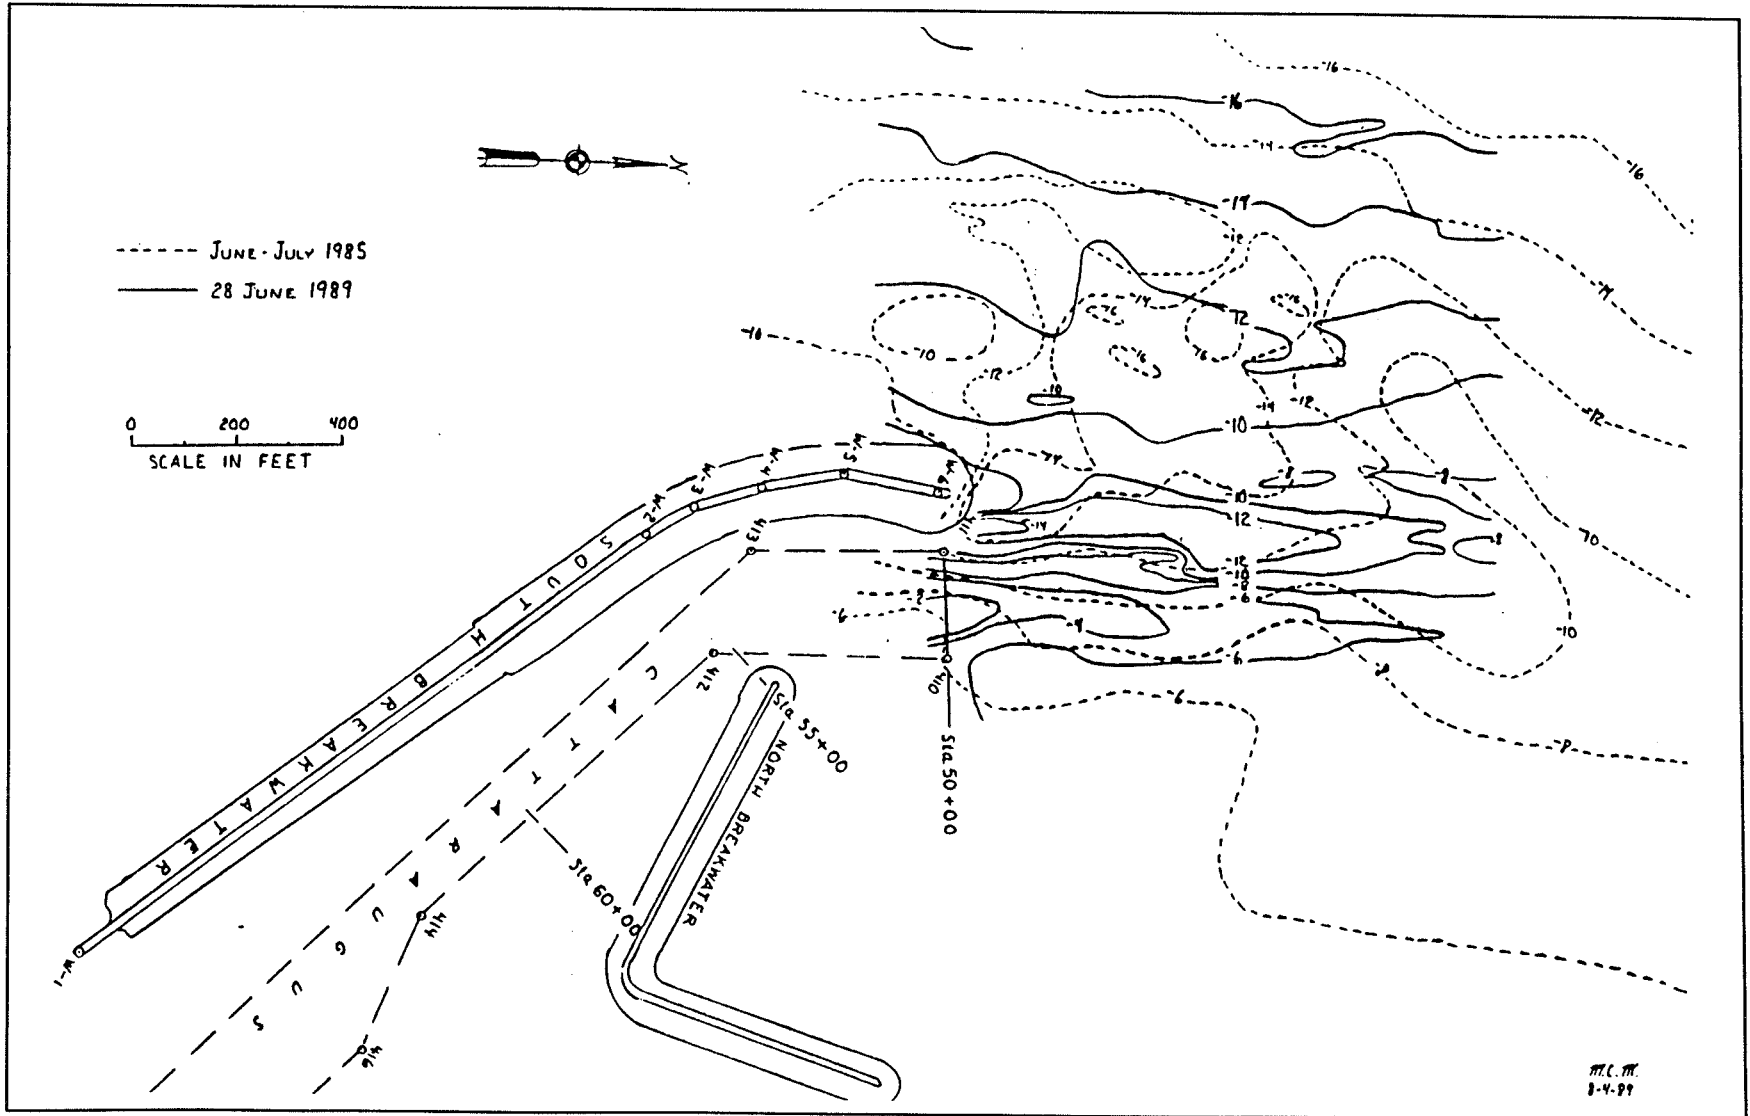
Figure 42. Cattaraugus Harbor, New York, site location map

The MCCP survey data indicated the development of a scour hole that apparently formed shortly after construction (Figure 42). This scour was located off the head of the breakwater structure with approximate dimensions of 800 ft in diameter and a depth of 4 ft below the usual bottom depth in the surrounding area. The scour contours are shown in Figure 42. Subsequently, natural littoral processes have filled in the scour hole to the point that by 1989 the hole was nearly filled in and the depth contours have been straightened. Presently there is no scour hole problem at Cattaraugus Harbor.

During the scour hole episode at Cattaraugus Harbor, the lake was about 1.5 ft above average. It is thought that the scour was a temporary feature resulting from construction of the breakwater, possibly caused by wave reflection from the structure. The high lake levels may have allowed more wave energy closer to shore, also contributing to the scour. The scour was not thought to be related to storm activity.
