**US Army Corps
of Engineers**
Waterways Experiment
Station

Coastal Engineering Research Program

Scour Hole Problems Experienced by the Corps of Engineers; Data Presentation and Summary

Final report

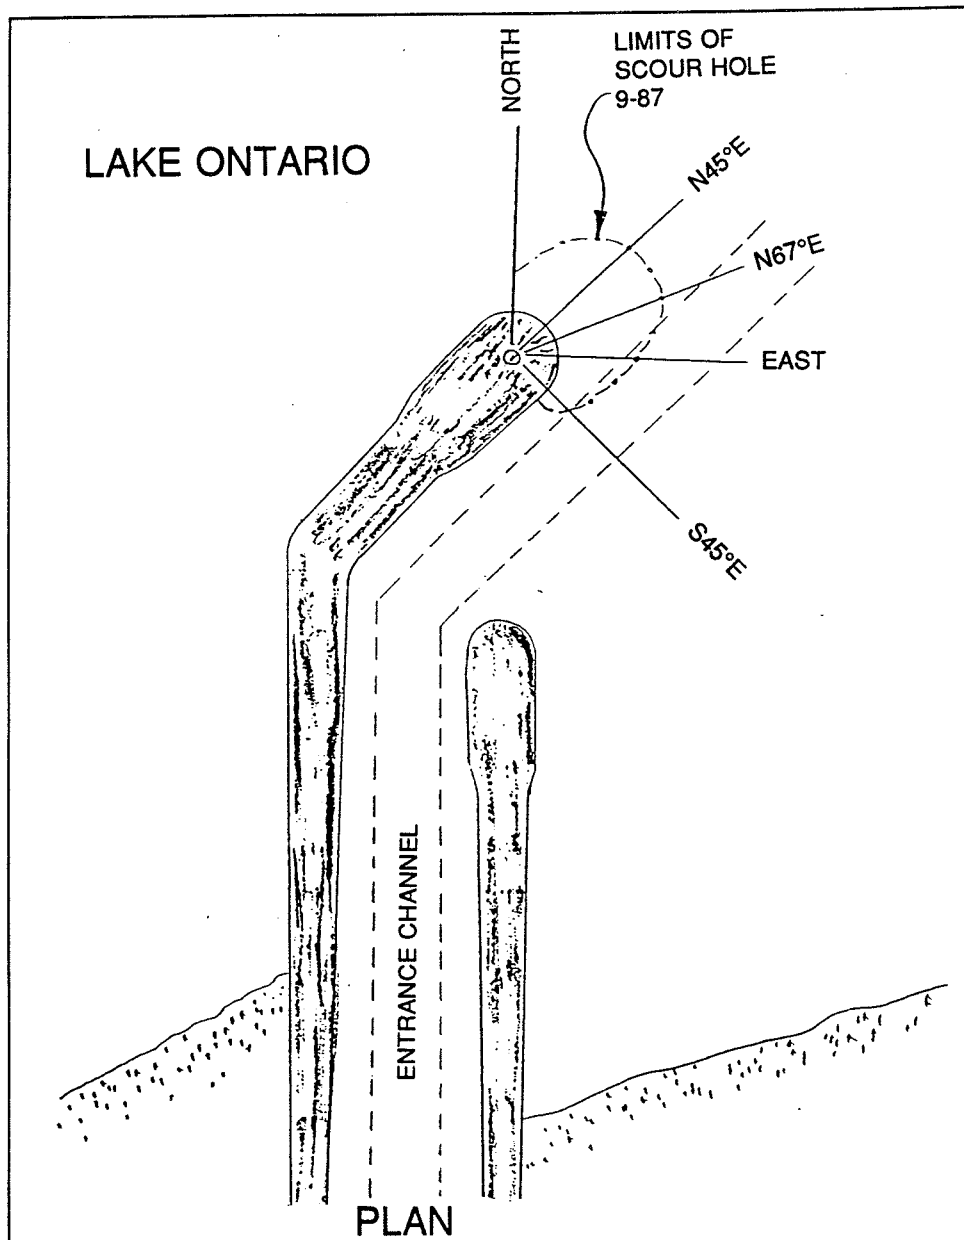
Figure 43. Irondequoit Bay, New York, site location map

Post-construction scour, similar to what occurred at Cattaraugus Harbor, developed at the tip of the west breakwater as shown on Figure 43, only it was more severe, with maximum depths 19 ft below the bottom level of the surrounding area.

The scour hole caused sufficient concern that it was filled in December 1987, prior to the winter storm season. The rock material used to fill the hole was quarry scrap with sizes up to 1,500 lb. Subsequent to the rock filling, the rest of the scour hole filled naturally with sand from the littoral system to the point that the scour hole can be considered negligible. As with Cattaraugus Harbor's scour hole, the scour at Irondequoit was most likely a transient effect resulting from construction of the breakwater. Over time, these holes seem to heal themselves with sand available from the littoral drift. The scour holes do not appear to be storm-related, but scour may be linked to the higher water levels present at the time of construction.

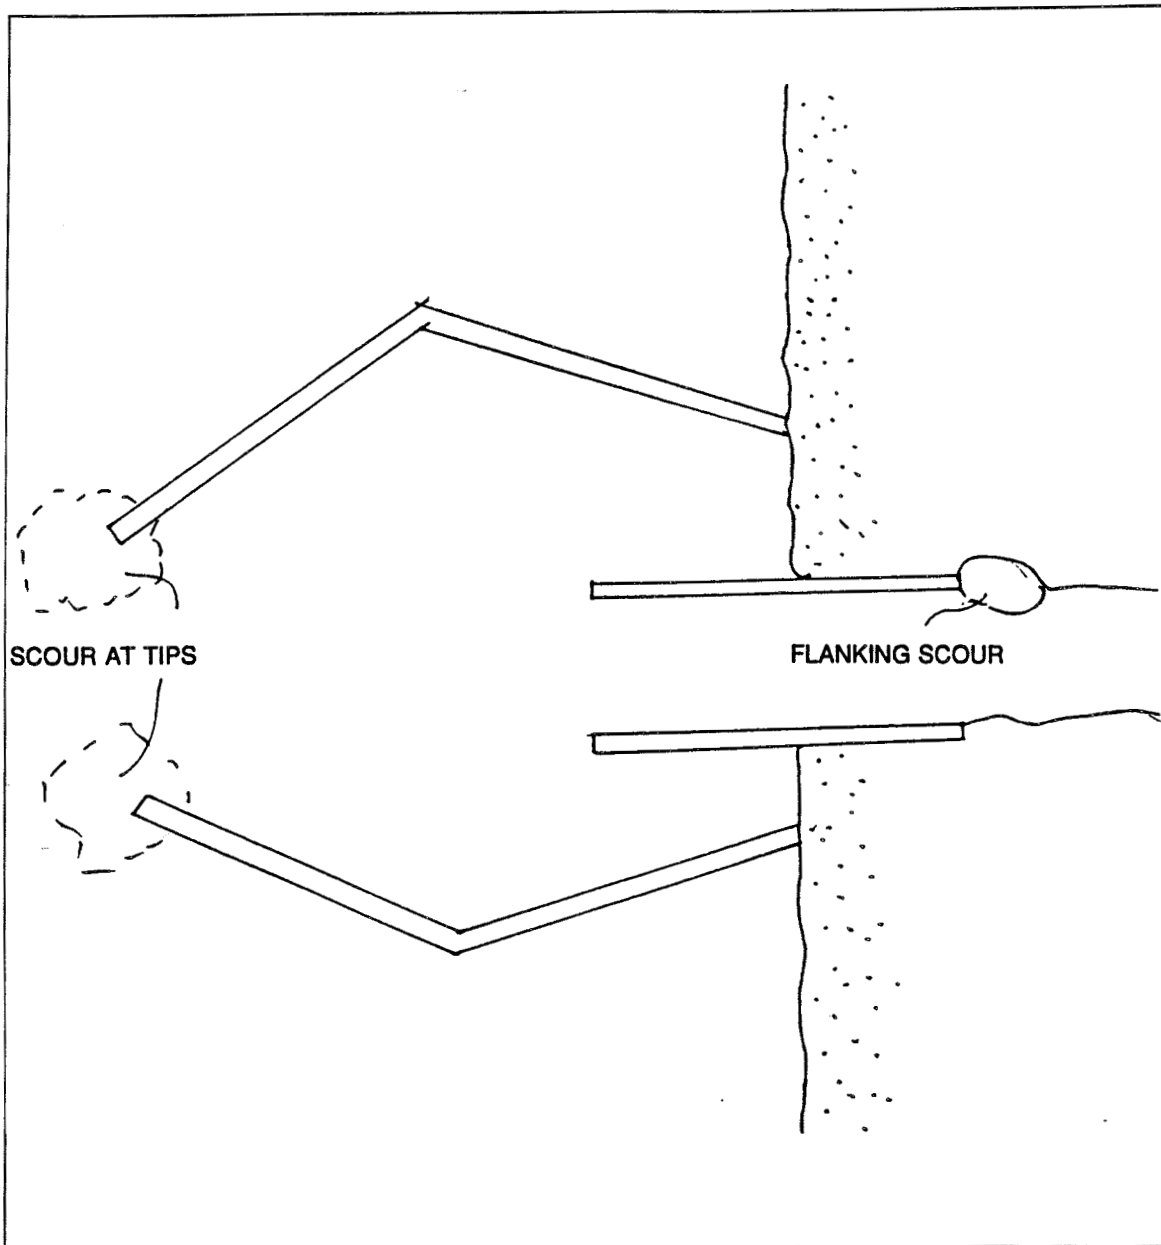
Figure 44. Scour problems at Lake Michigan harbors

Scour problems occur at Lake Michigan harbor structures, generally around the area of the breakwater head. Figure 44 is a sketch showing a harbor layout with areas susceptible to scour.

Depth of these scour holes usually ranges between 3 and 6 ft below the normal bottom. However, it is possible to have scour holes form that are as

much as 30 ft deep, and the Muskegon Harbor, Michigan jetty was cited during the 1991 workshop as having such a scour hole formation.

Scour holes also form on the upstream ends of pile-driven structures due to flow separation as the water moves past the pile structure. These types of problems are solved by adding stone toe protection where scour is likely to occur.
