MISCELLANEOUS PAPER CERC-86-3

# FLOATING BREAKWATER PROTOTYPE TEST PROGRAM: SEATTLE, WASHINGTON

March 1986

Final Report

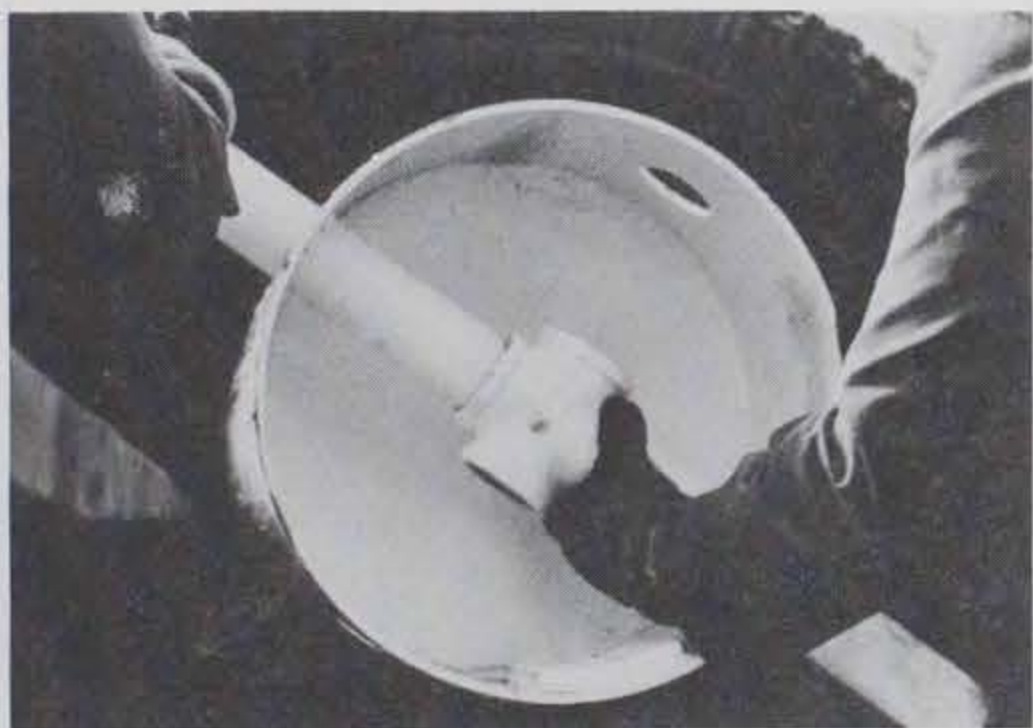
Photo 11. Keeper pipes being secured (welding of keepers required to prevent loosening).

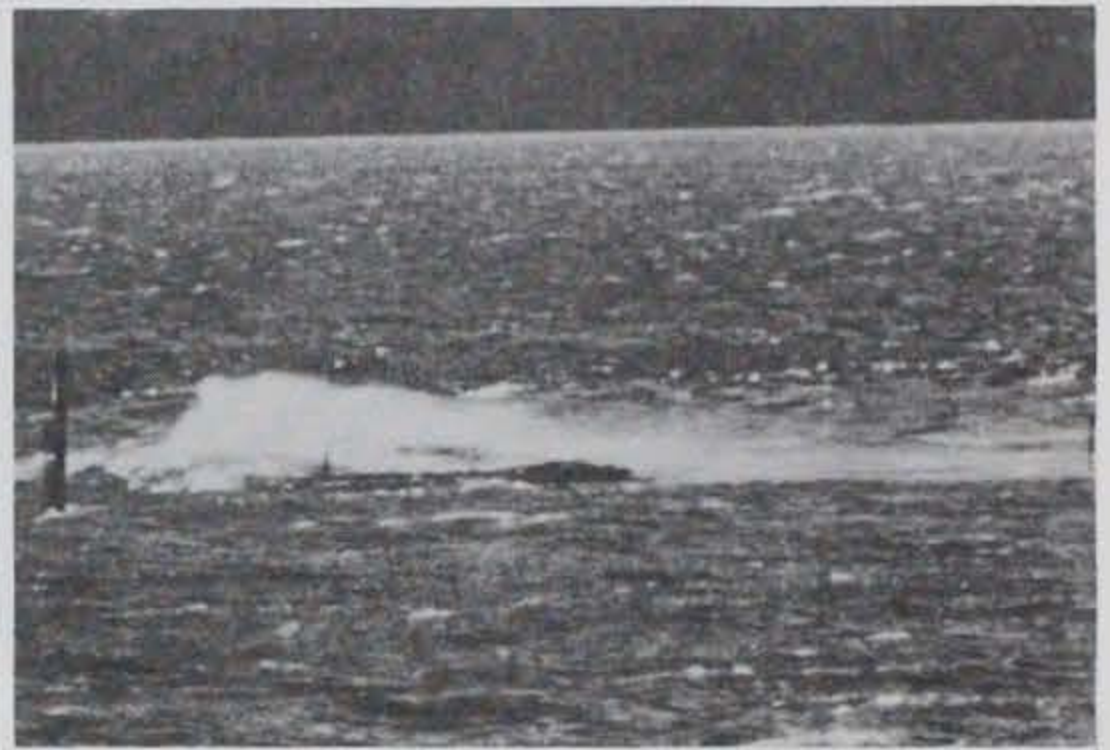
Photo 16. Waves reflecting from the concrete breakwater sending spray 20 ft into the air.

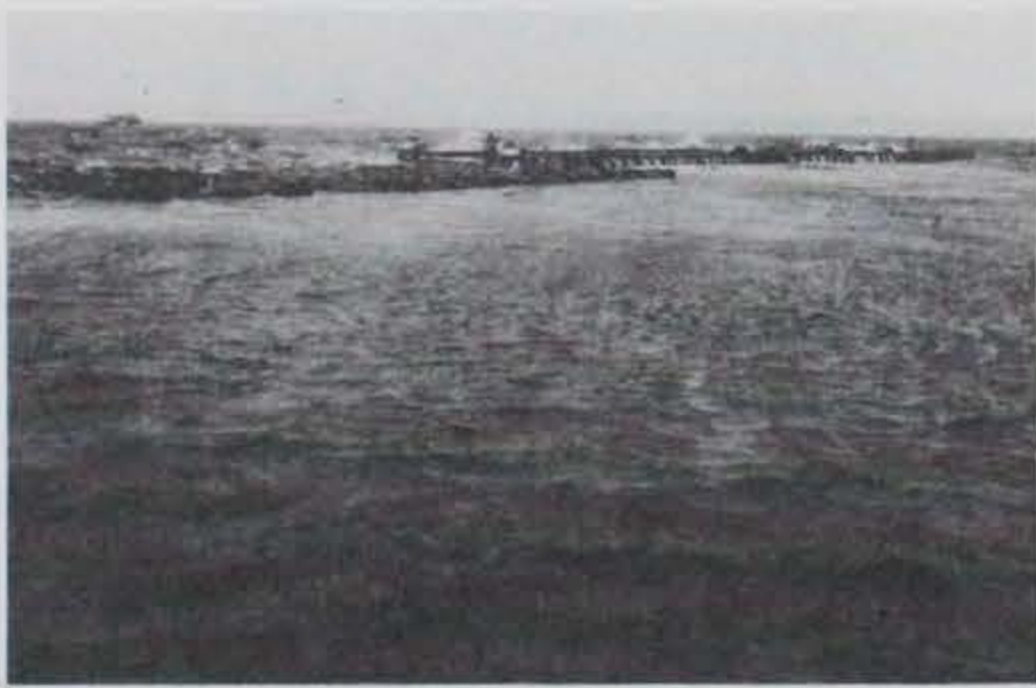
Visual comparisons of incident and transmitted wave heights indicated that, under all observed wave conditions, the pipe-tire and the concrete breakwaters provided an adequate and very similar degree of wave protection for both wind waves and boat wakes (photograph 17). Moreover, the concrete breakwater reflected the wave energy, but the pipe-tire breakwater dissipated it through viscous damping. As a result of wave reflection, the windward side of the concrete breakwater was always noticeably rougher than the windward side of the pipe-tire breakwater (photograph 18).

Photo 17. Example of both breakwaters providing good protection from storm waves.

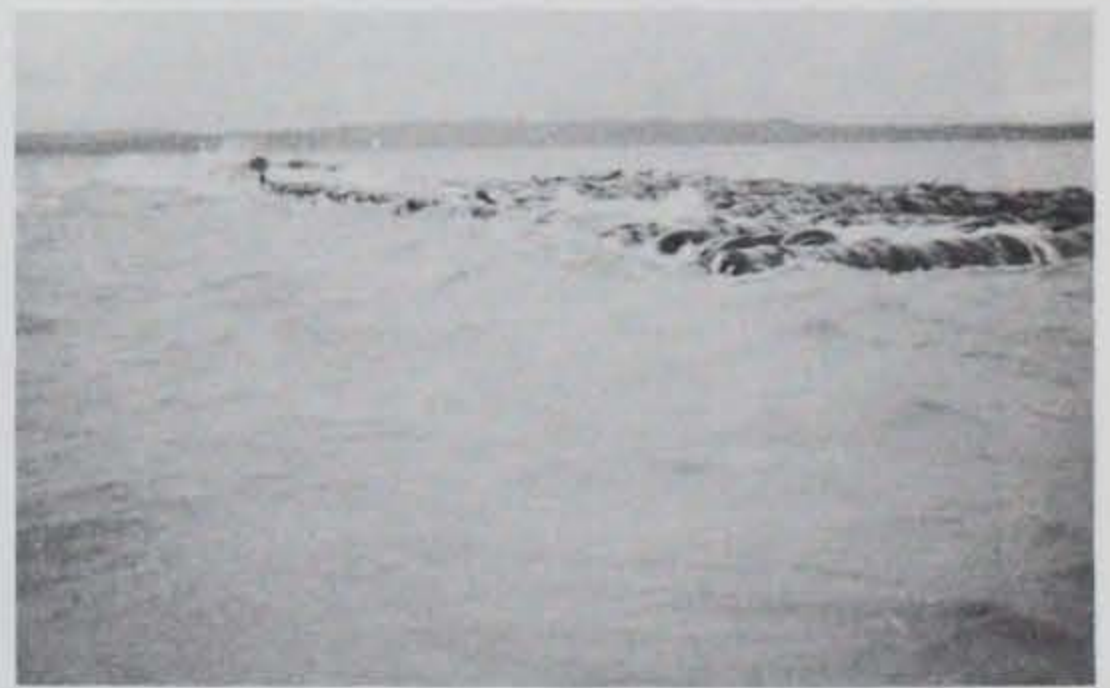
Photo 18. Waves reflecting from windward side of concrete float.

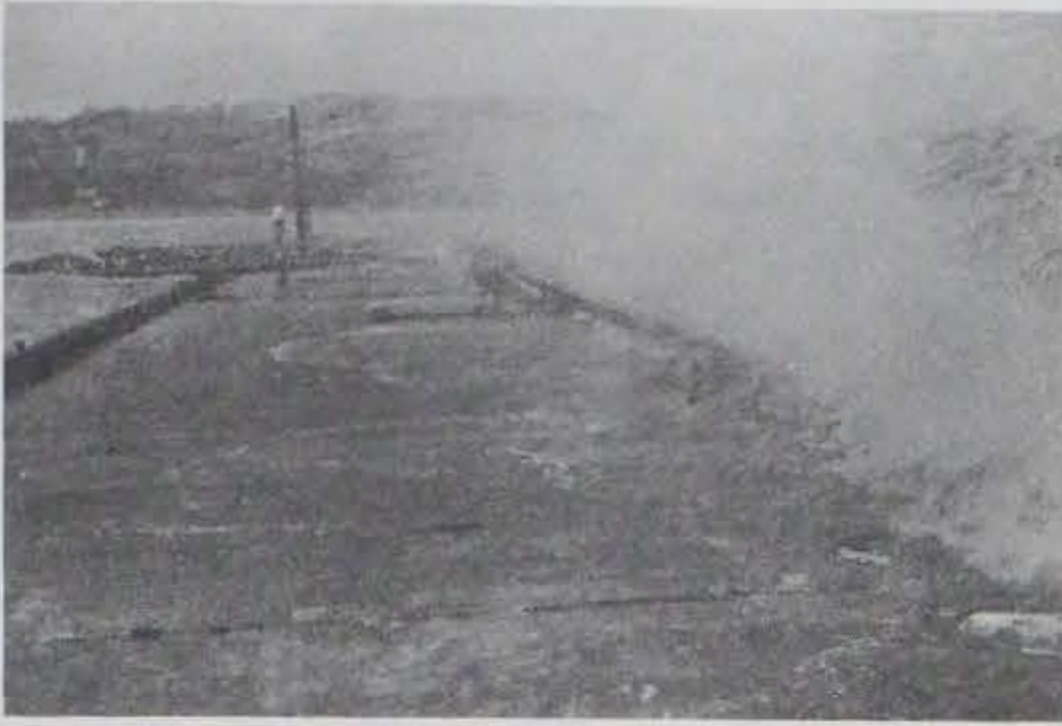
Overtopping of the concrete breakwater by ship wakes and wind waves was quite pronounced (photograph 19). Sheet flow 6 in. deep was common. As a result, a lush crop of algae thrived on the deck of the structure, making the surface

Photo 19. 1.5-ft waves overtopping the concrete breakwaters.

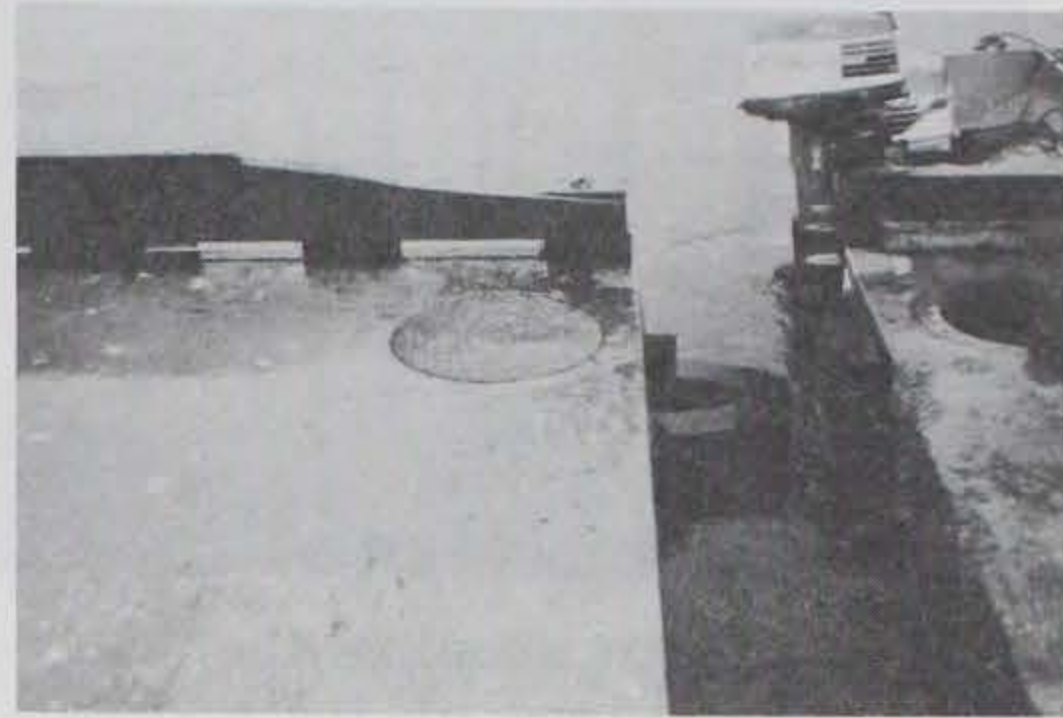
One of the major goals of the test program was to investigate various methods of connecting (or fendering) the two 140-ton floats. Four different connection methods were tested: flexible connectors (two types), complete disconnection (with fendering), and rigid bolting of the units. Both the fendering (photograph 20) and the rigid connection were successful. None of the flexible connector designs survived their test period undamaged, although considerable progress was made toward a viable flexible connection design. Details of the connector testing are given in Appendix D.

Photo 20. Concrete units in disconnected and fendered configuration.

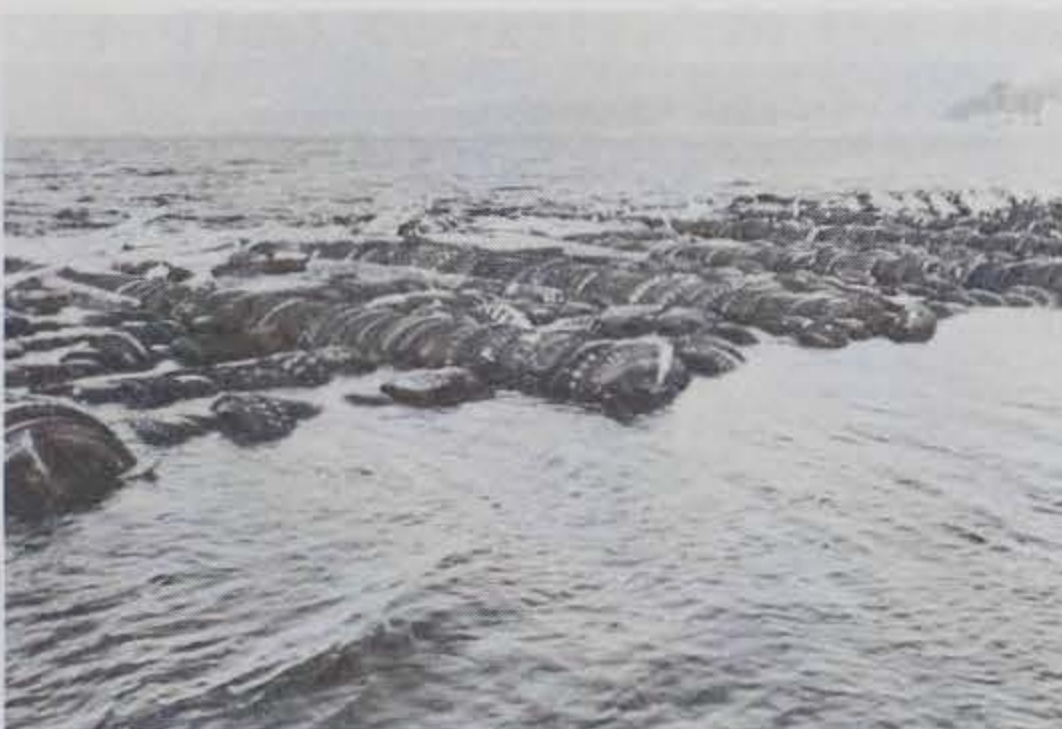
For nearly a year, the pipe-tire breakwater proved to be remarkably durable. Except for minor repairs to the keeper pipes, it withstood the winter storms of 1982 without any maintenance (photograph 23). But in June 1983, almost a year to the day after the pipe-tire breakwater was installed, the first problem of any consequence developed. After a minor storm, routine inspection revealed that one of the longitudinal pipes had broken (photograph 24). A closer inspection revealed that the 45-ft pipe had been fabricated from a 40-ft section and a 5-ft section. A poor weld between the two sections had finally failed because of a combination of corrosion and fatigue, allowing the two pipe sections to pull out of the tires. One month later, when a second pipe failed in exactly the same manner, a decision was made to terminate testing of the pipe-tire breakwater. During the removal process, the anchor lines were inspected, and no major problems were found in the nylon anchor lines or connecting hardware. After the breakwater was removed, it was surplused and eventually reinstalled at a private marina in southern Puget Sound. Monitoring of the long-term durability of this unit is planned.

Photo 23. Pipe-tire breakwater after having weathered numerous storms.

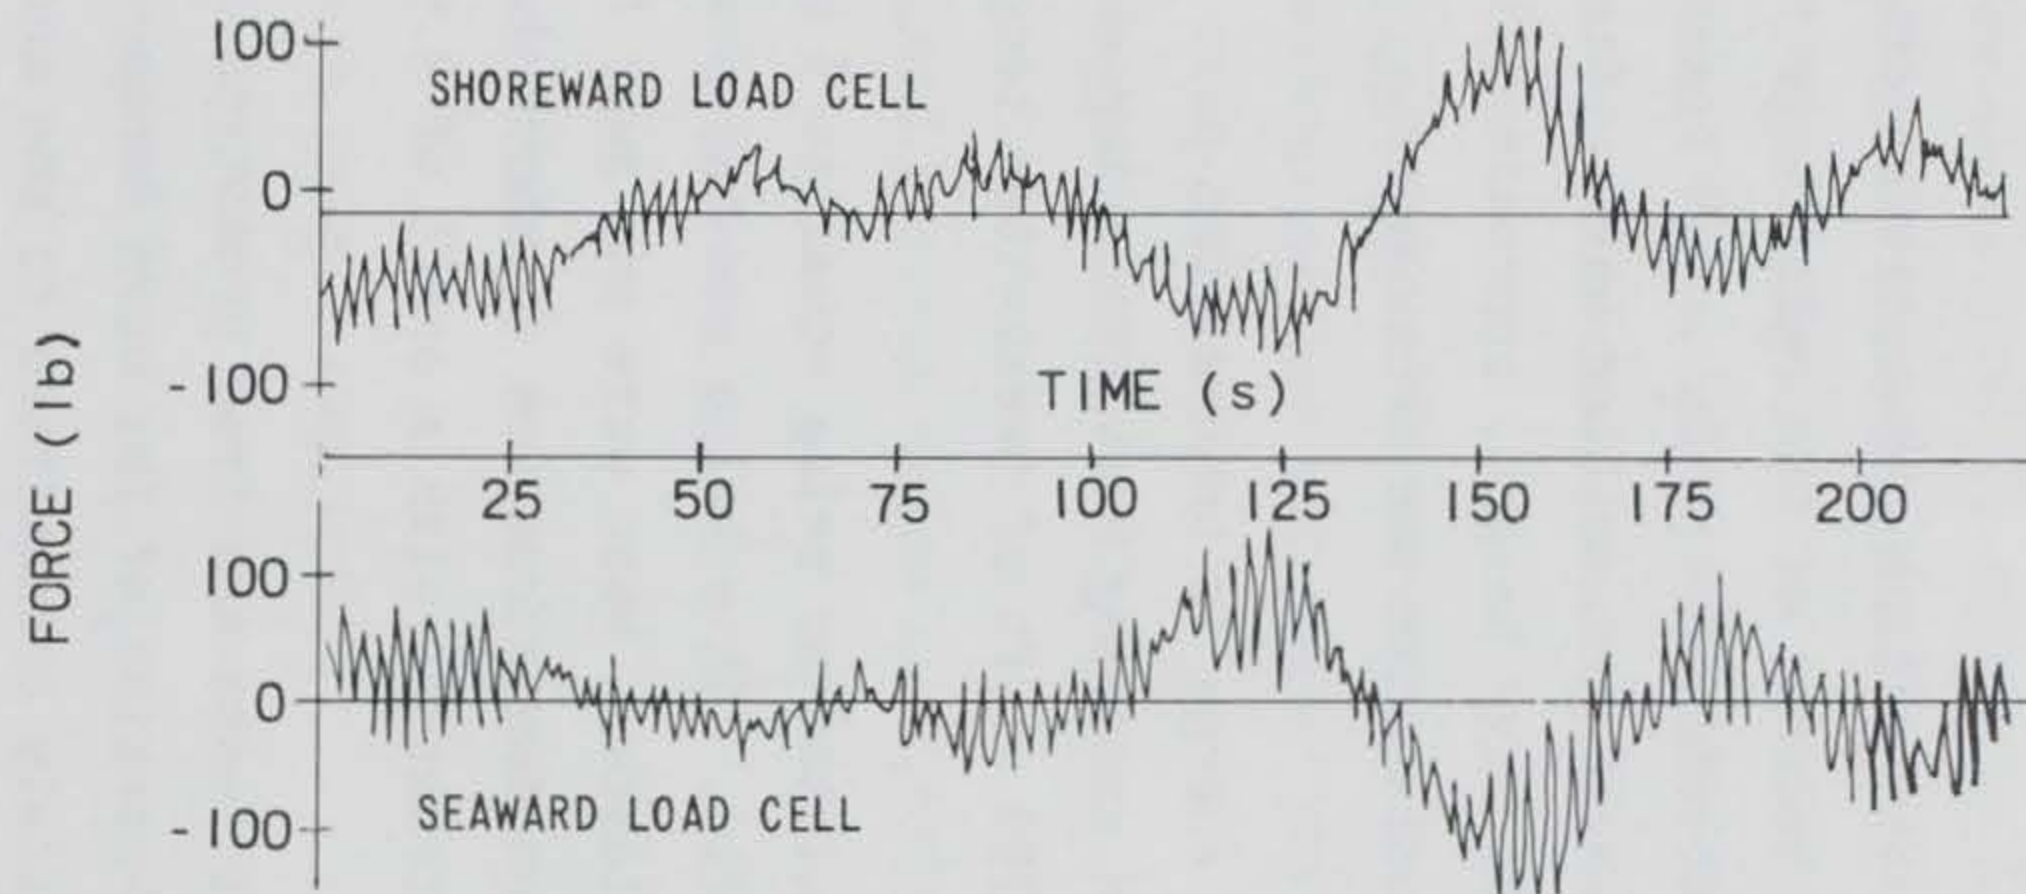
FIGURE A-7. Typical Anchor Force Record from Friday Harbor Floating Breakwater - 1976

1.06 Estimated Wave and Anchor Loads. Loads on the concrete breakwater were calculated in such a manner that they retained the same features observed in previous field measurements (figure A-7). These forces are a combination of short period wave forces superimposed on a long period sway force. Wave forces were calculated using the Miche-Rundgren method for non-breaking waves on a vertical wall with a design wave height of 6.0 ft and a period of 5.0 sec.

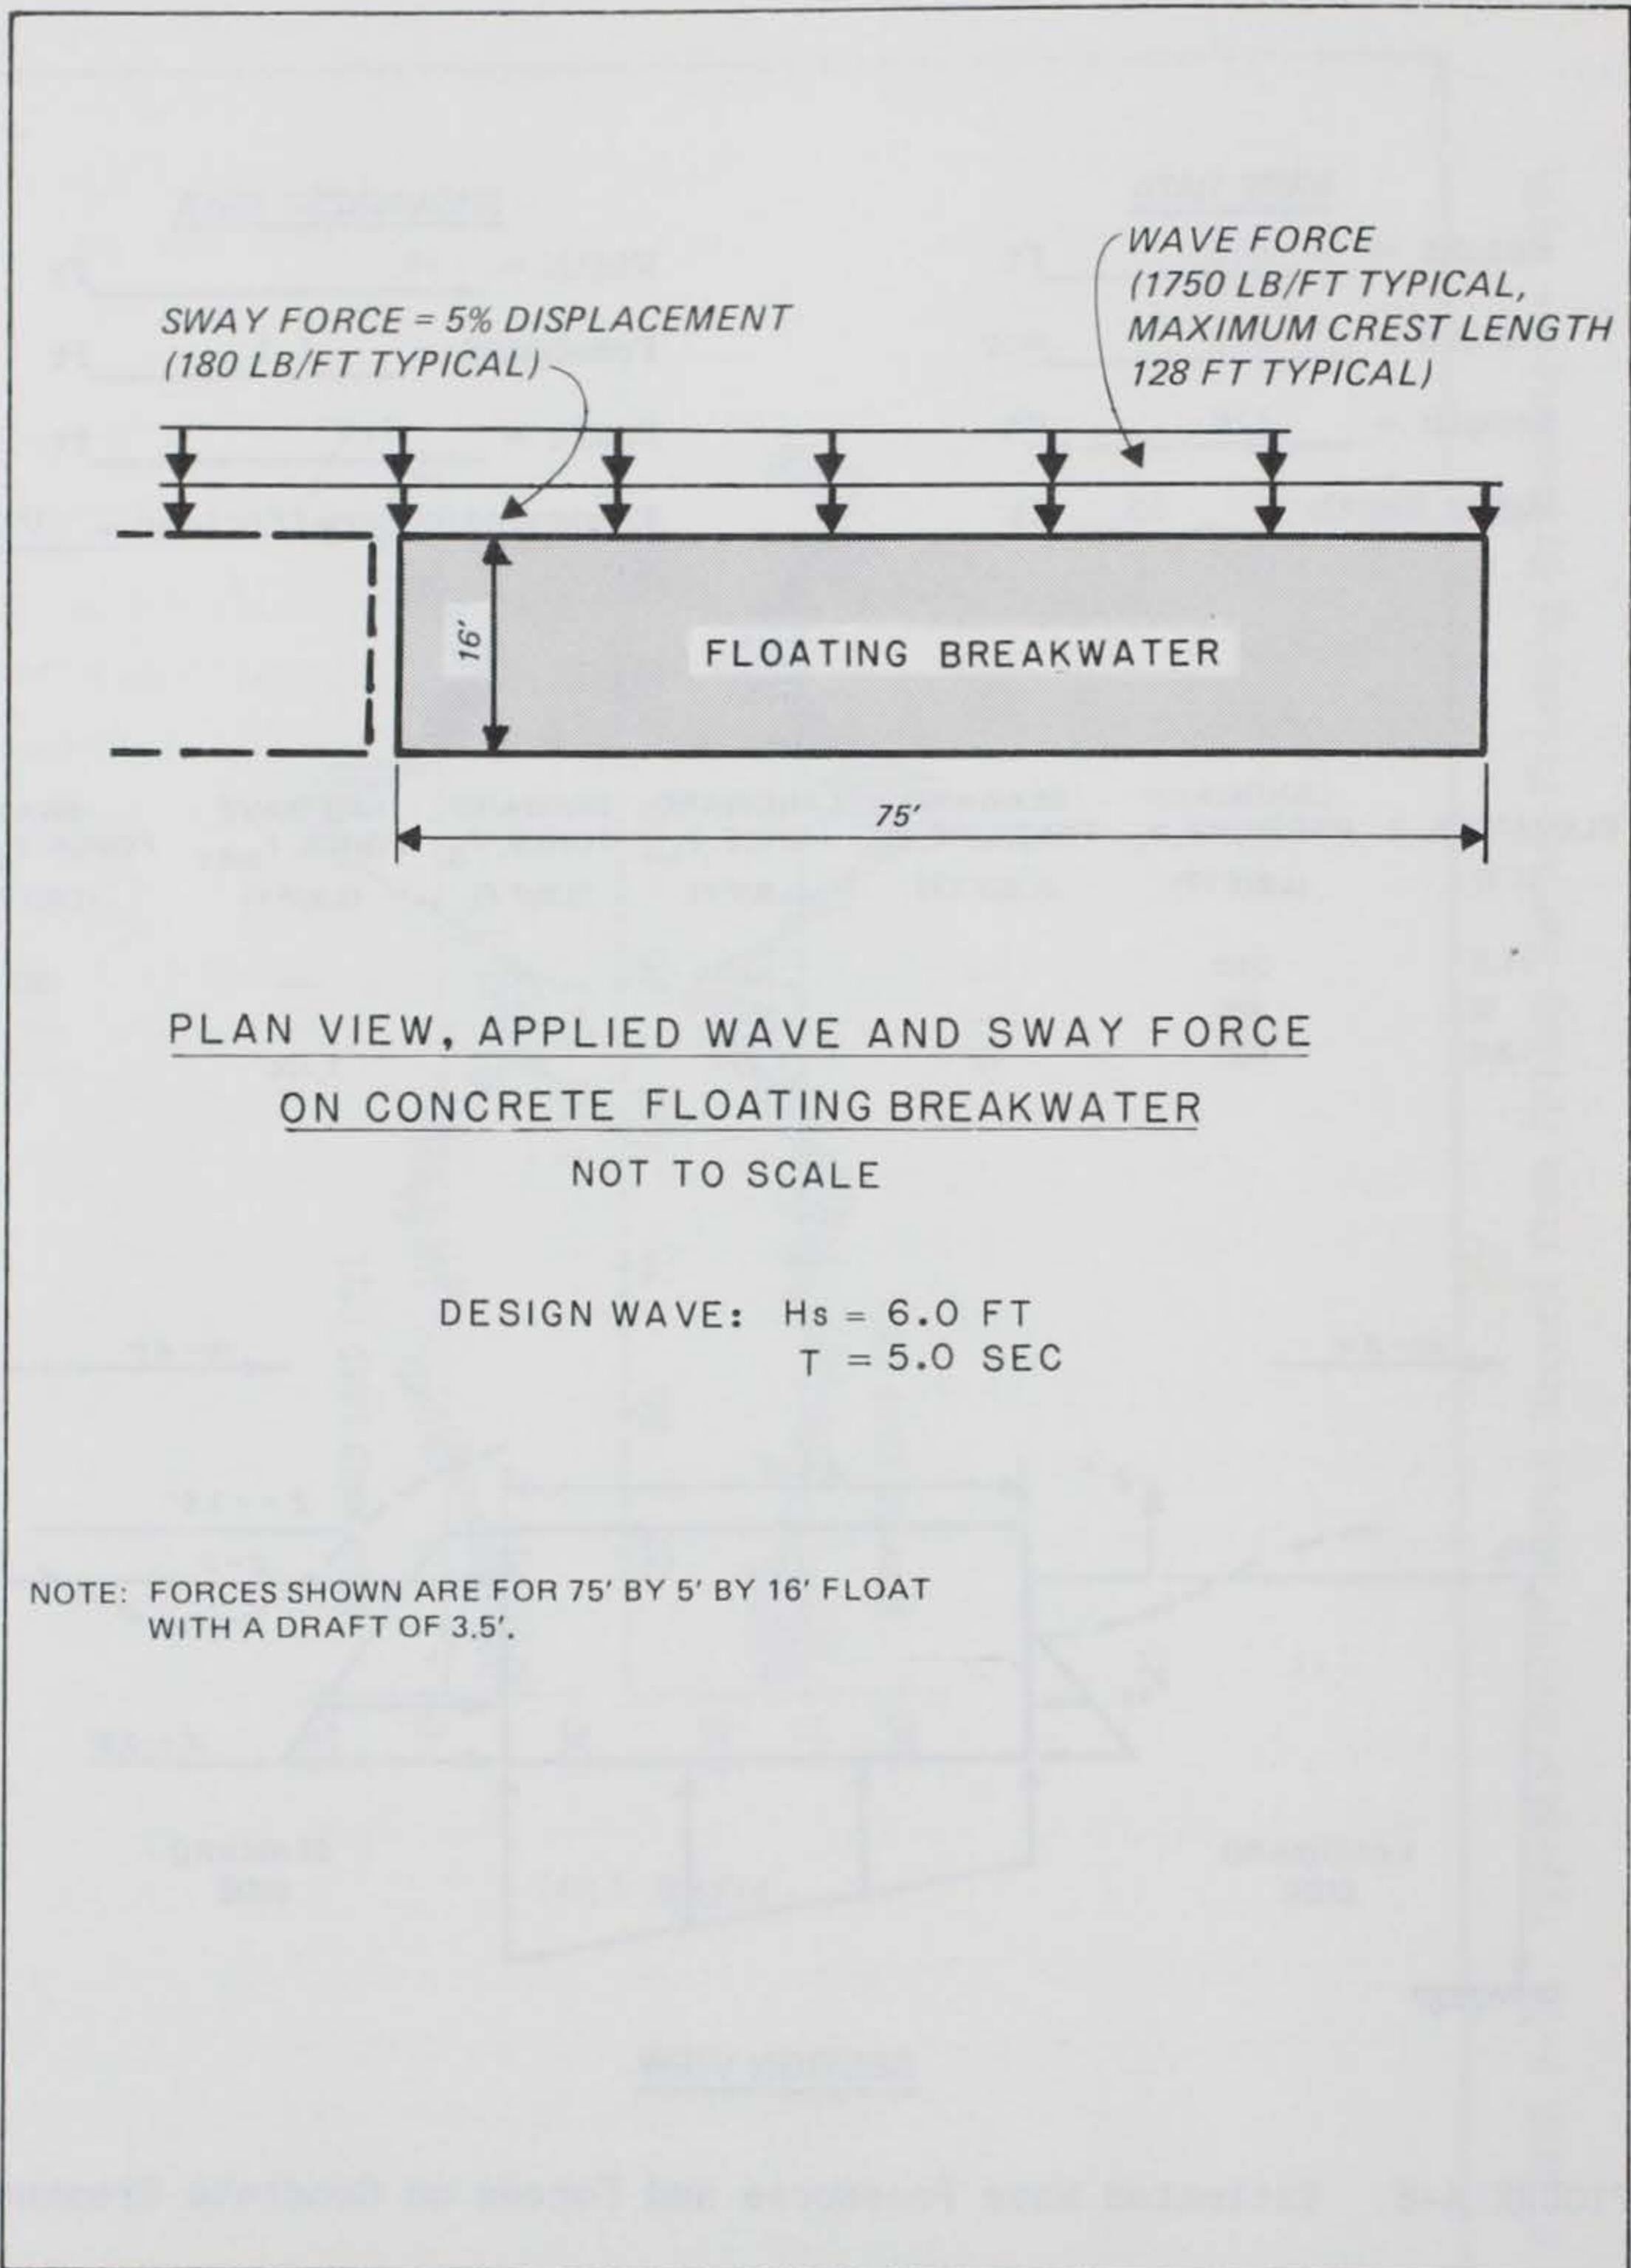
FIGURE A-9. Estimated Wave and Sway Force on Concrete Floating Breakwater

The maximum sway force was calculated as being equal to 5 percent of the structure displacement (180 lb/ft). This value was based on forces measured on the breakwater at Tenakee, Alaska. When wave and sway forces combine, they produce a total estimated load on the structure of about 1,930 lb/ft of breakwater length for a 16-ft-wide structure with a draft of 3.5 ft (figure A-9).

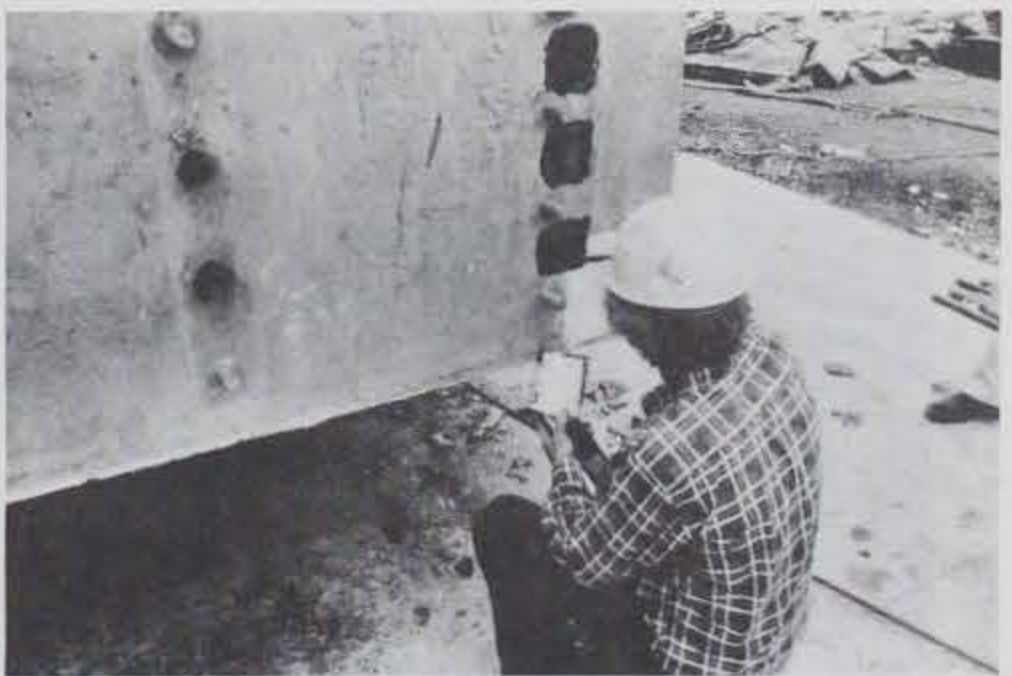
Photo A-18. Rubber patches being glued over the bolt holes (later covered by steel angles).

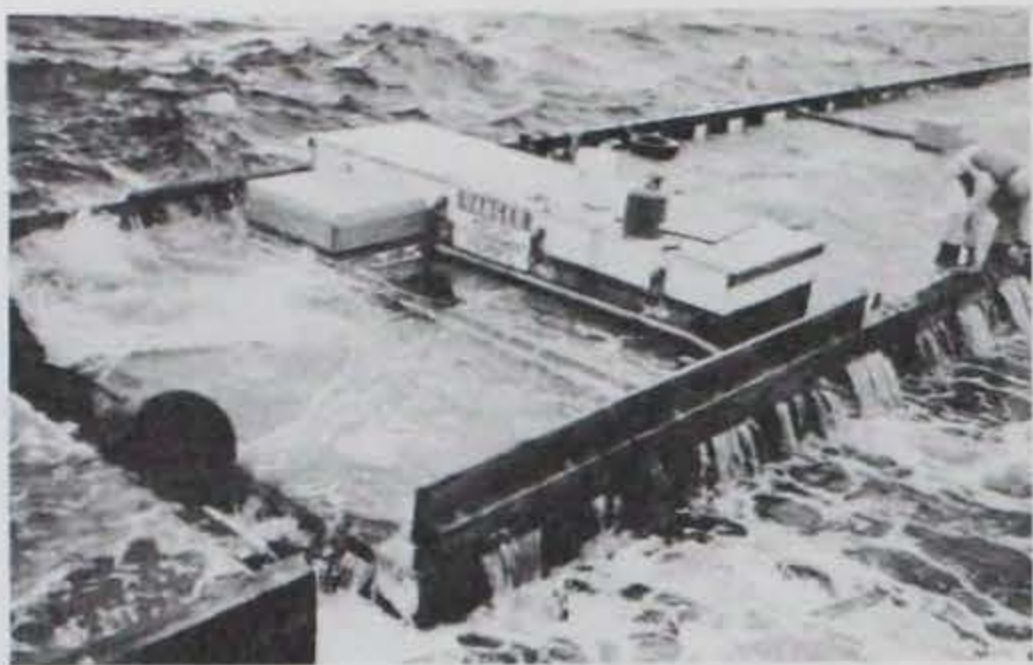
be 2 ft high caused 6-in.-deep water to flow across the deck (photo A-19). This made moving about on the rolling, slippery deck an extremely precarious proposition (photo A-20). On more than one occasion, tools and equipment were swept overboard, and life vests were a standard dress item. In addition, care had to be exercised in mooring the work boat to avoid swamping it with the water which ran off the leeward side of the breakwater (photo A-21).

Photo A-19. Waves overtopping the low deck (13-in.) freeboard allowing considerable wave overtopping.

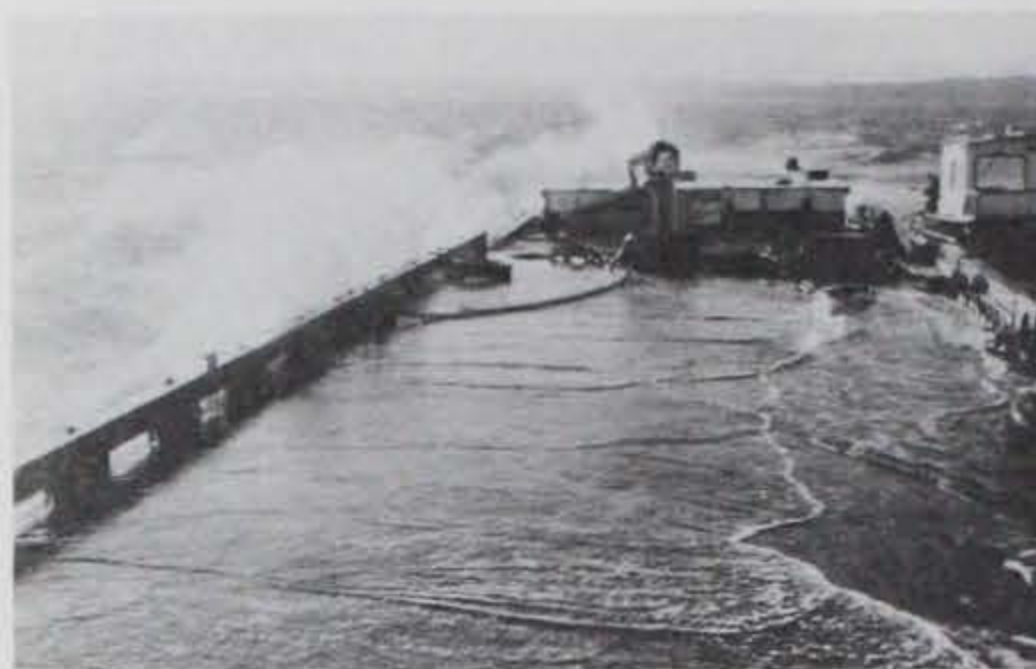
Photo A-20. Work continuing cautiously on the slippery, rolling deck.

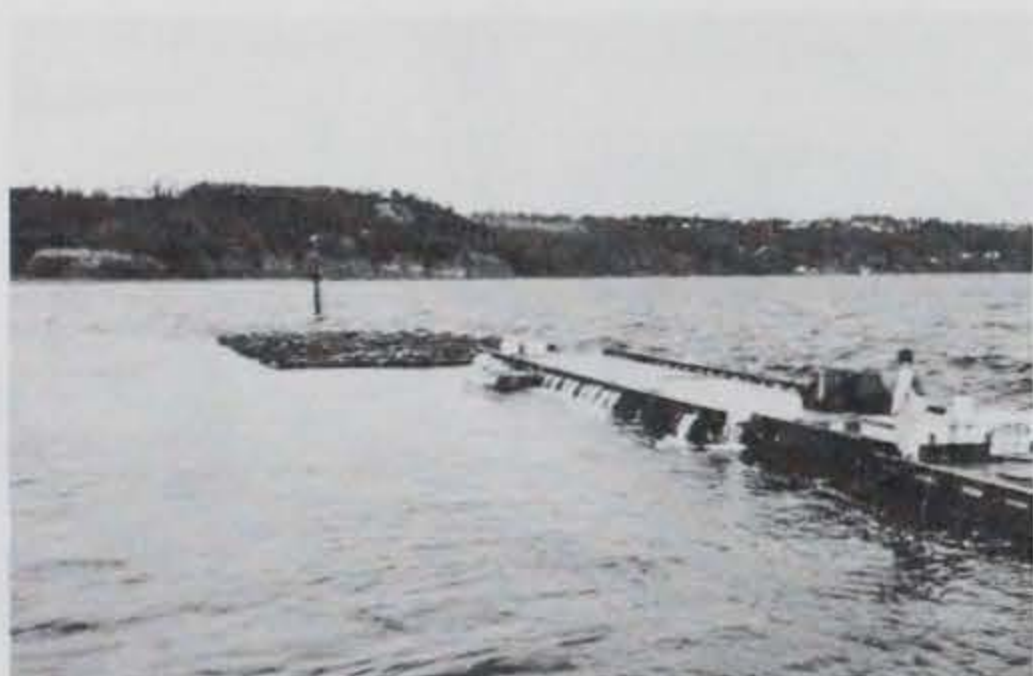
Photo A-21. Overtopping waves swamping a work skiff.

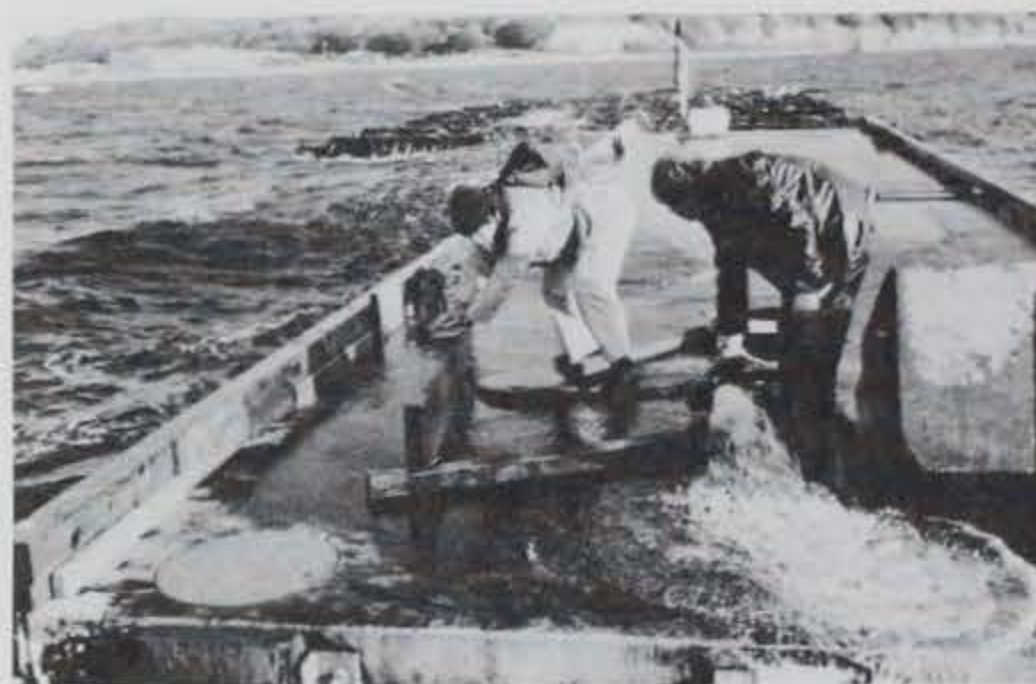
Photo A-22. About 3,000 gallons being pumped from an end compartment after a storm.

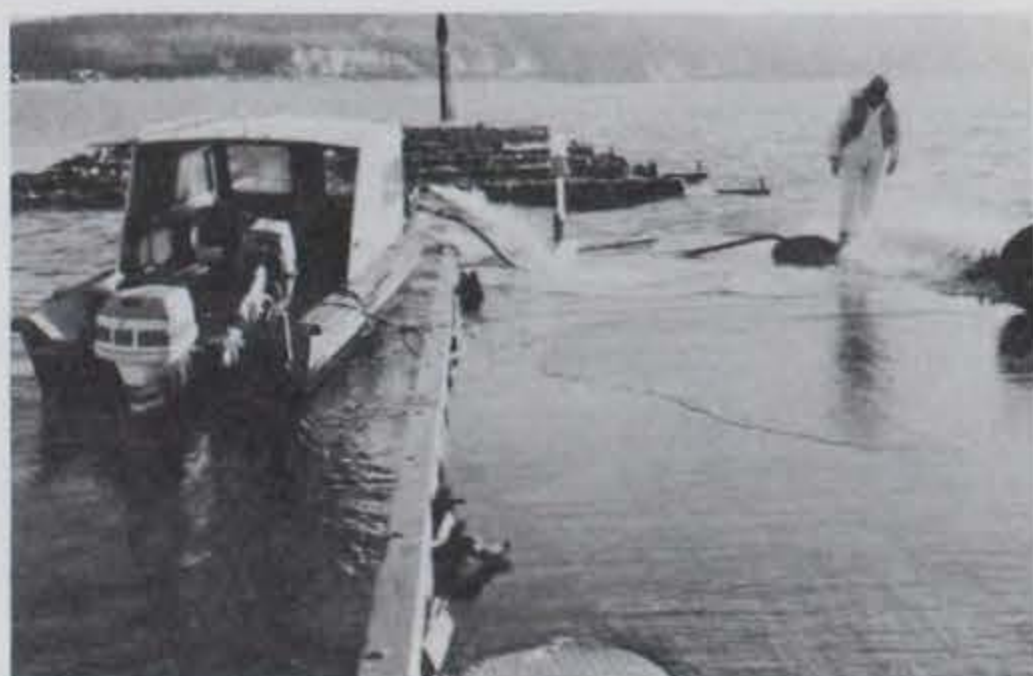
Photo A-23. Pumping out another end compartment (the deck is nearly awash).

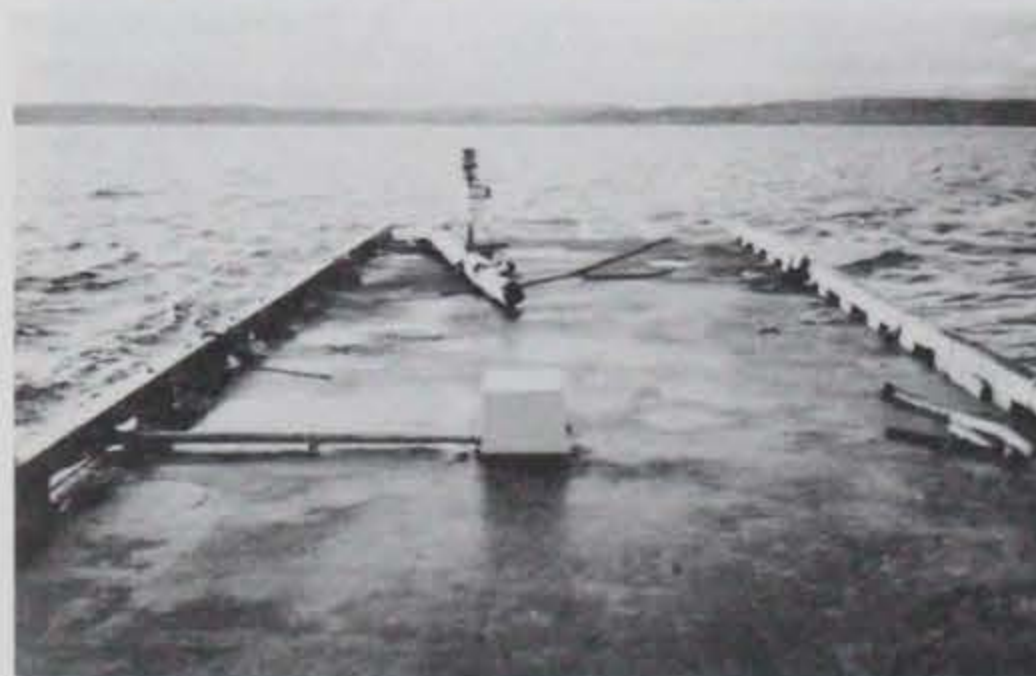
Photo A-24. Photo showing type of debris which washed across the deck.

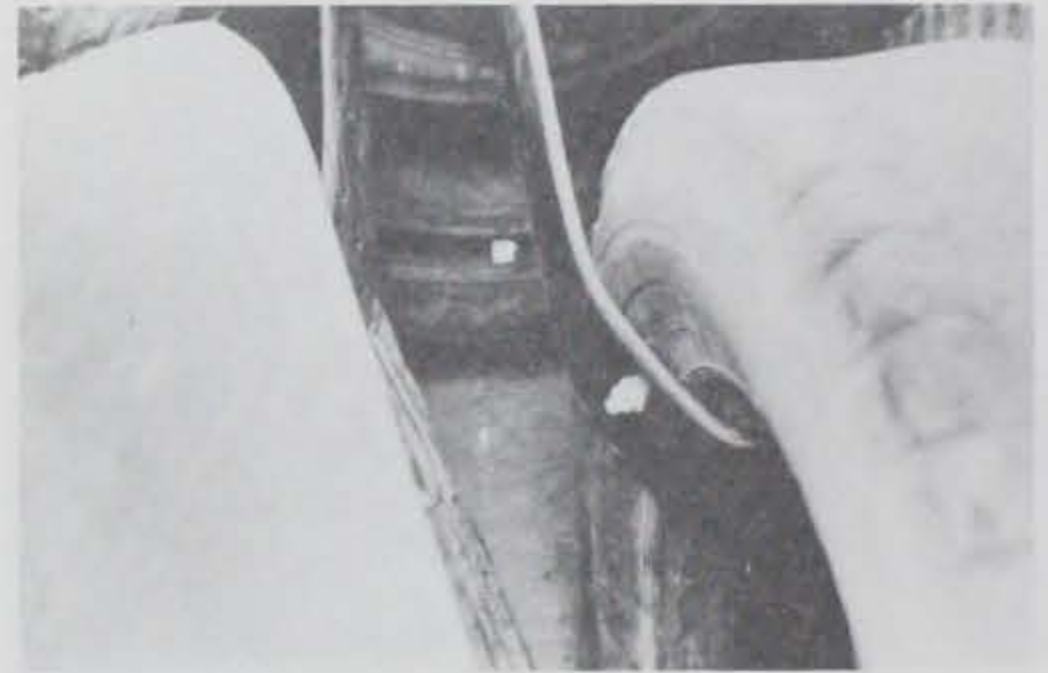
Ten conveyor belt connections were inspected. Eight of the connections, which use five 1/2- by 2-in. nylon bolts, had one or more broken bolts. Only those connections on the perimeter of the breakwater were accessible for inspection. Two bolt patterns were used in fastening the belting together, but no conclusions regarding their relative performance could be drawn (photos B-14 and B-15).

Photo B-16. Closeup showing bolt which fastened the belting to the tires (all such bolts broke, with no adverse consequences).

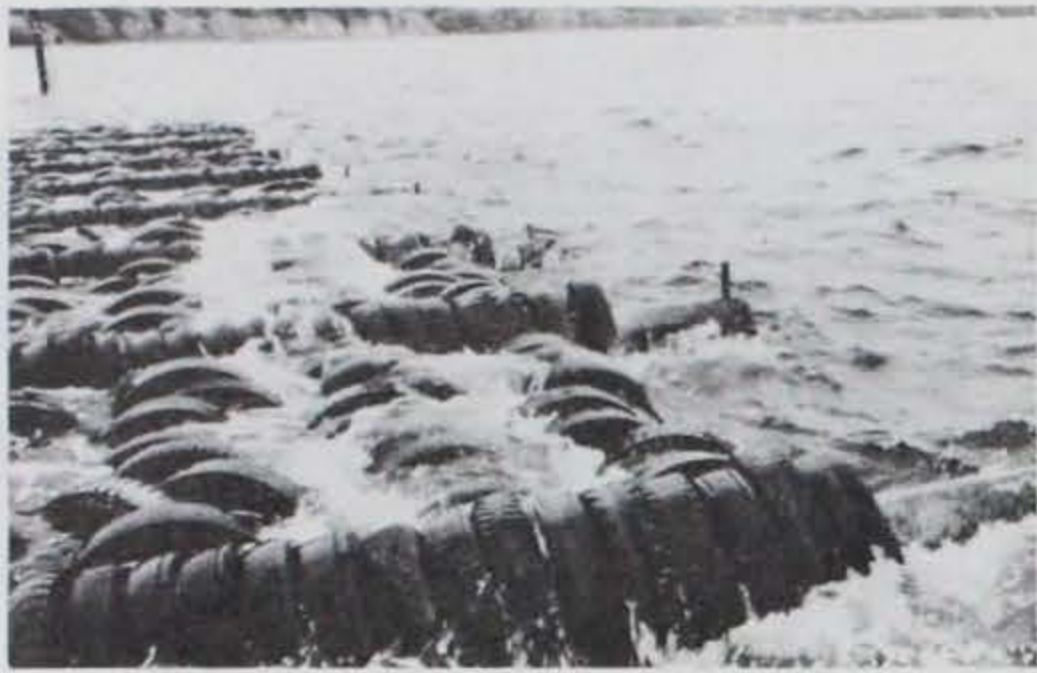
The beads of many of the tires that encircled the pipes had worn down to the wire reinforcing. The loose wire was found wrapped tightly around the 16-in. pipes. The wear on the beads did not appear to weaken the tires significantly. The surface of the 16-in. pipe was pitted, but corrosion was not severe enough to compromise the structural integrity. The reinforced portion of the pipe where the anchor line connection was made showed very little wear.

Photo B-25. Wave action compressing the tires on the pipes.

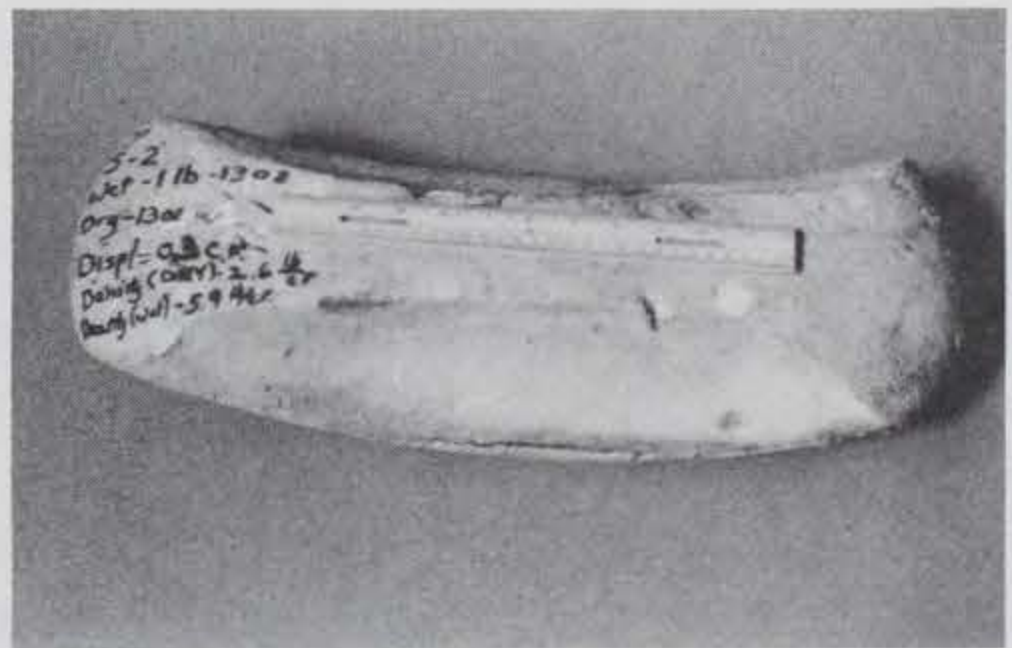
Photo B-36. Urethane foam flotation after being removed from a tire.

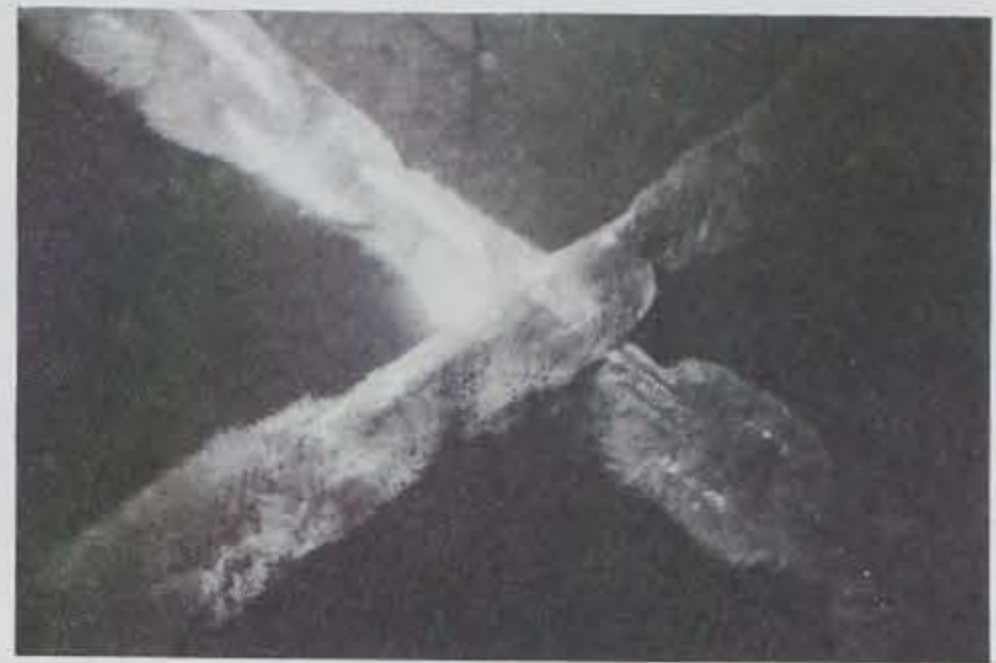
discovered the problem 3 months later, several tenths-of-an-inch of the steel anchor chain had been worn away (photo C-14). Anchor line No. 6 was replaced with the aid of commercial hard-hat divers and US Army Corps of Engineers (Corps) equipment and personnel (photo C-15).

Photo C-14. Underwater photo of anchor lines rubbing against each other.

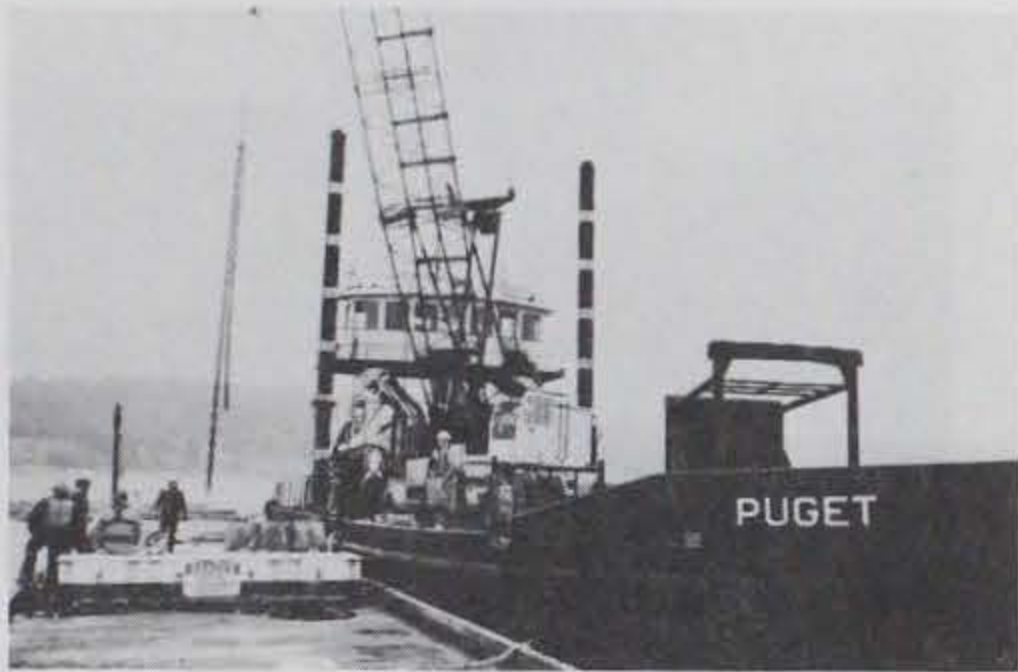
Photo C-15. A new anchor chain being readied for installation.

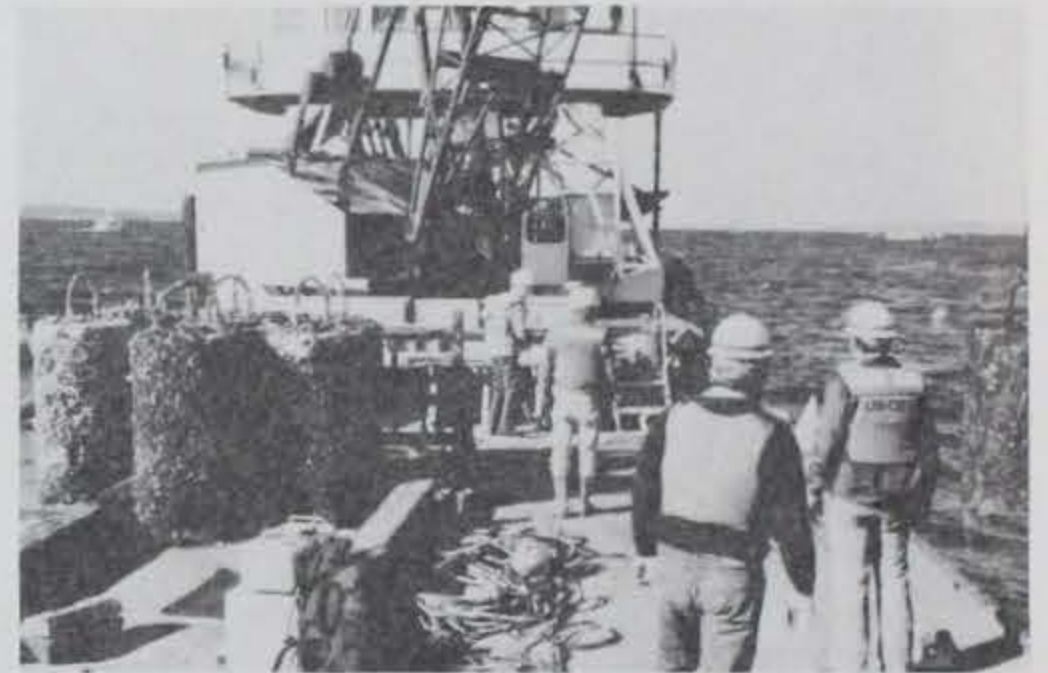
breakwater anchor line hardware did not appear to be significant; however, the galvanizing was completely gone from the steel bridge rope, and all the individual strands of the bridge rope that were examined were noticeably rusted (photo C-21). Several strands in the vicinity of the clump weight attachment clamp had broken. Some algae attached to the upper chains of the concrete breakwater anchor lines. Virtually no marine growth took hold on the galvanized anchor lines, but mussels, tunicates, and anemones had begun to attach to the clump weights by the time these weights were removed in October 1983 (photo C-22).

Photo C-22. Removing clump weights (note numerous marine organisms attached to the weights).

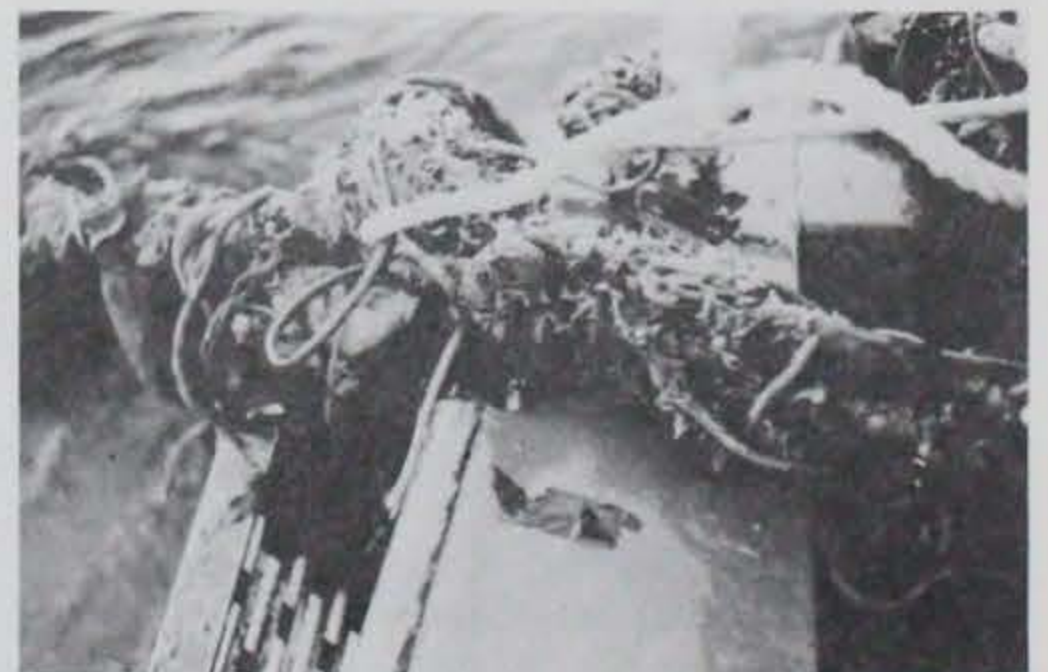
The pipe-tire breakwater anchor line showed only minor wear at the attachment points. The eye splices, shackles, and chain were in excellent condition after 1 yr of hard use. However, the cotter keys that secured the shackle nuts were obviously not made of corrosion resistant material and were nearly destroyed by the time testing of the pipe-tire breakwater was complete (photo C-23). (All cotter keys on the concrete breakwater were stainless steel and were not corroded.) The pipe-tire breakwater anchor lines proved to be an excellent substrate for marine growth (photo C-24). Because the anchor lines descended at a shallow angle, kelp attached to them and grew to the water surface in an area 50 ft to either side of the breakwater. The kelp was an additional attraction for the artificial reef community that was establishing itself in, on, and around the breakwater.

Photo C-24. Photo of marine growth covering the nylon anchor line.
