MISCELLANEOUS PAPER CERC-86-3

# FLOATING BREAKWATER PROTOTYPE TEST PROGRAM: SEATTLE, WASHINGTON

March 1986

Final Report

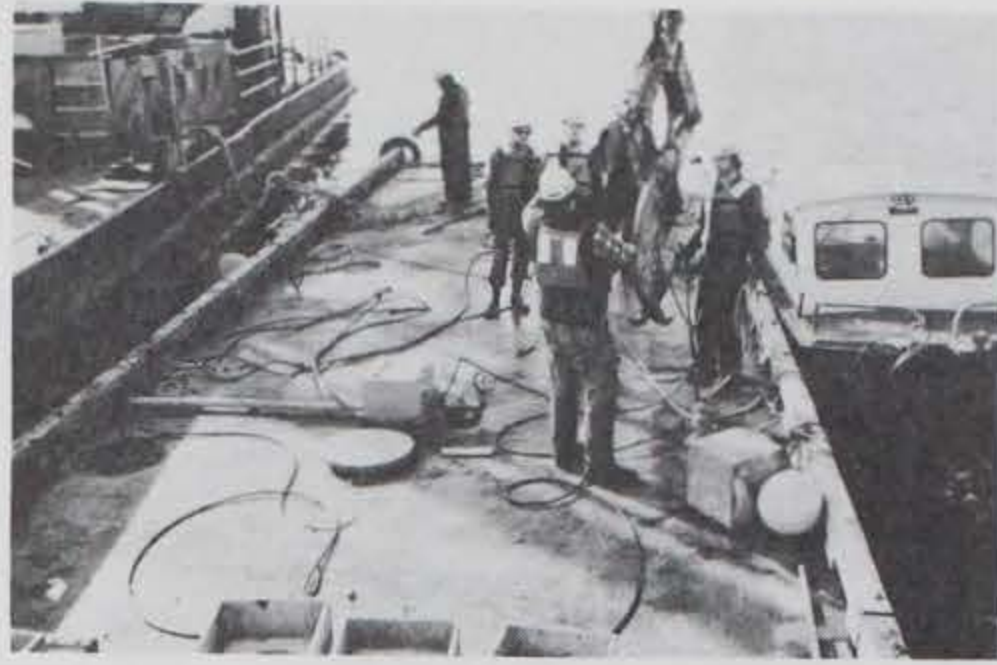
Photo C-26. Encountering some difficulties during the first reanchoring operation.

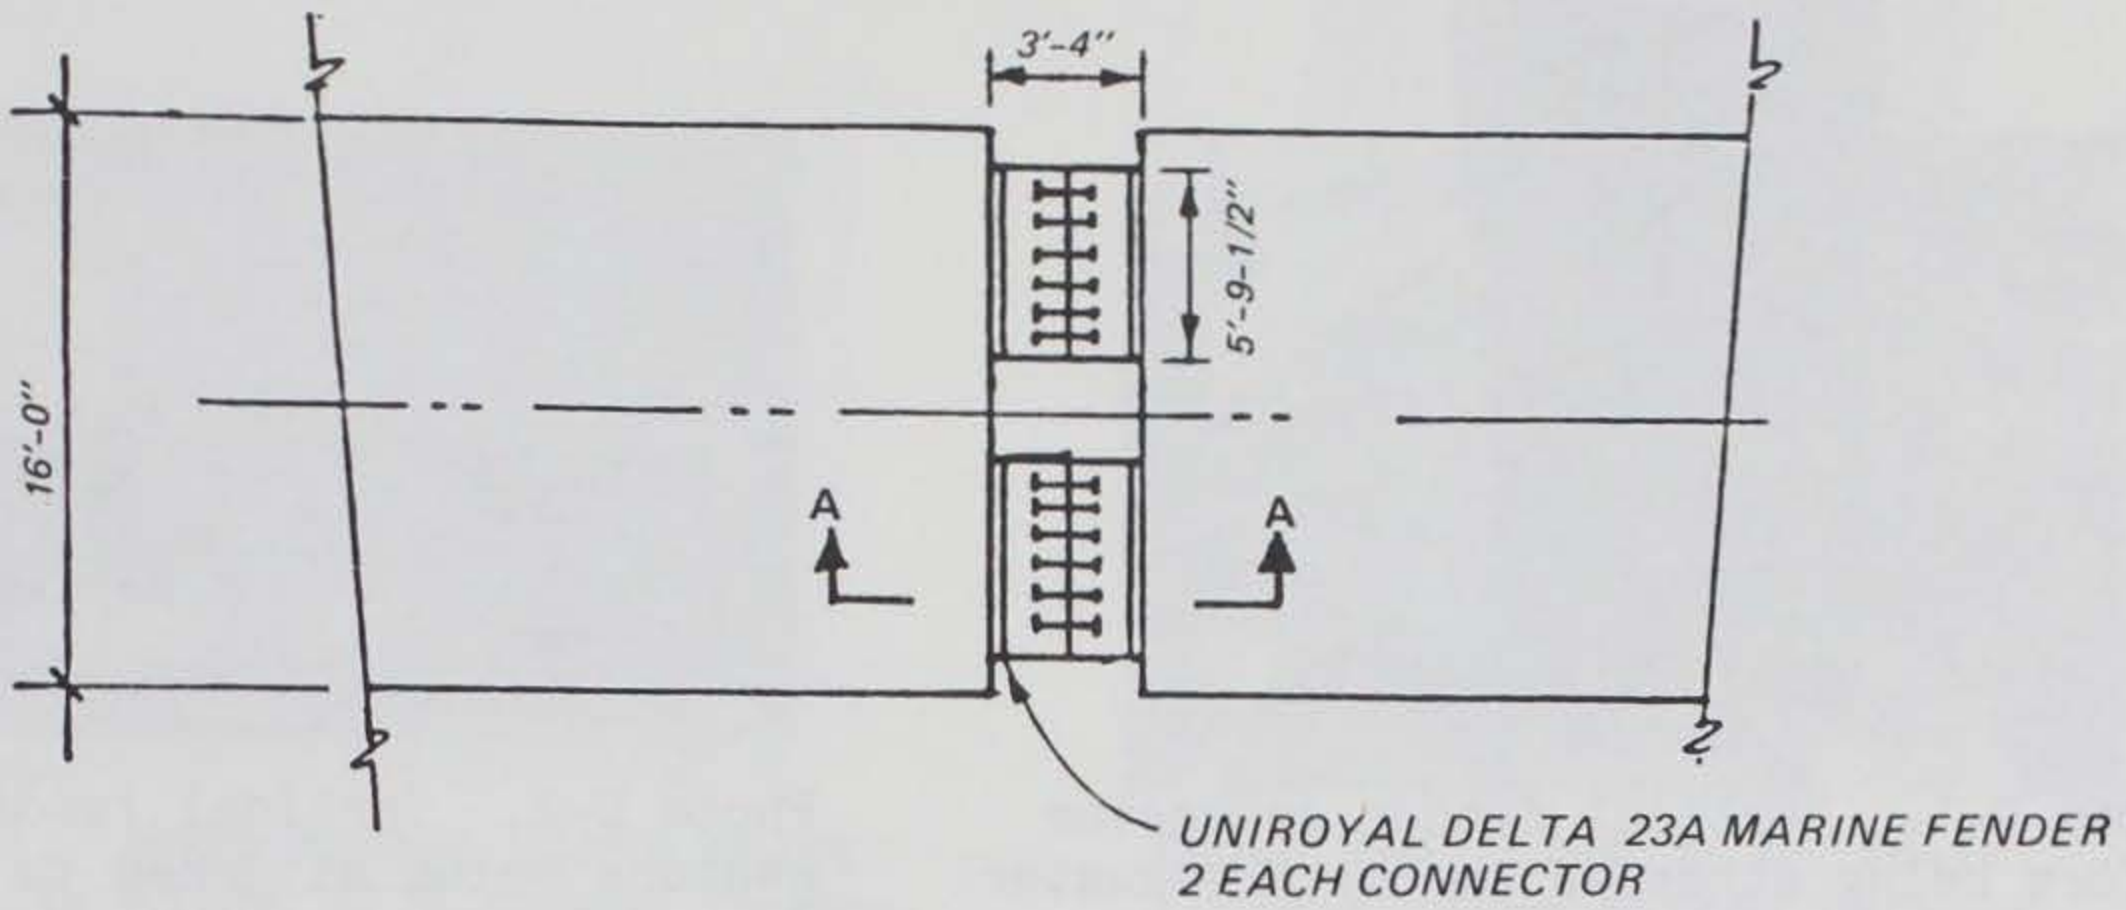
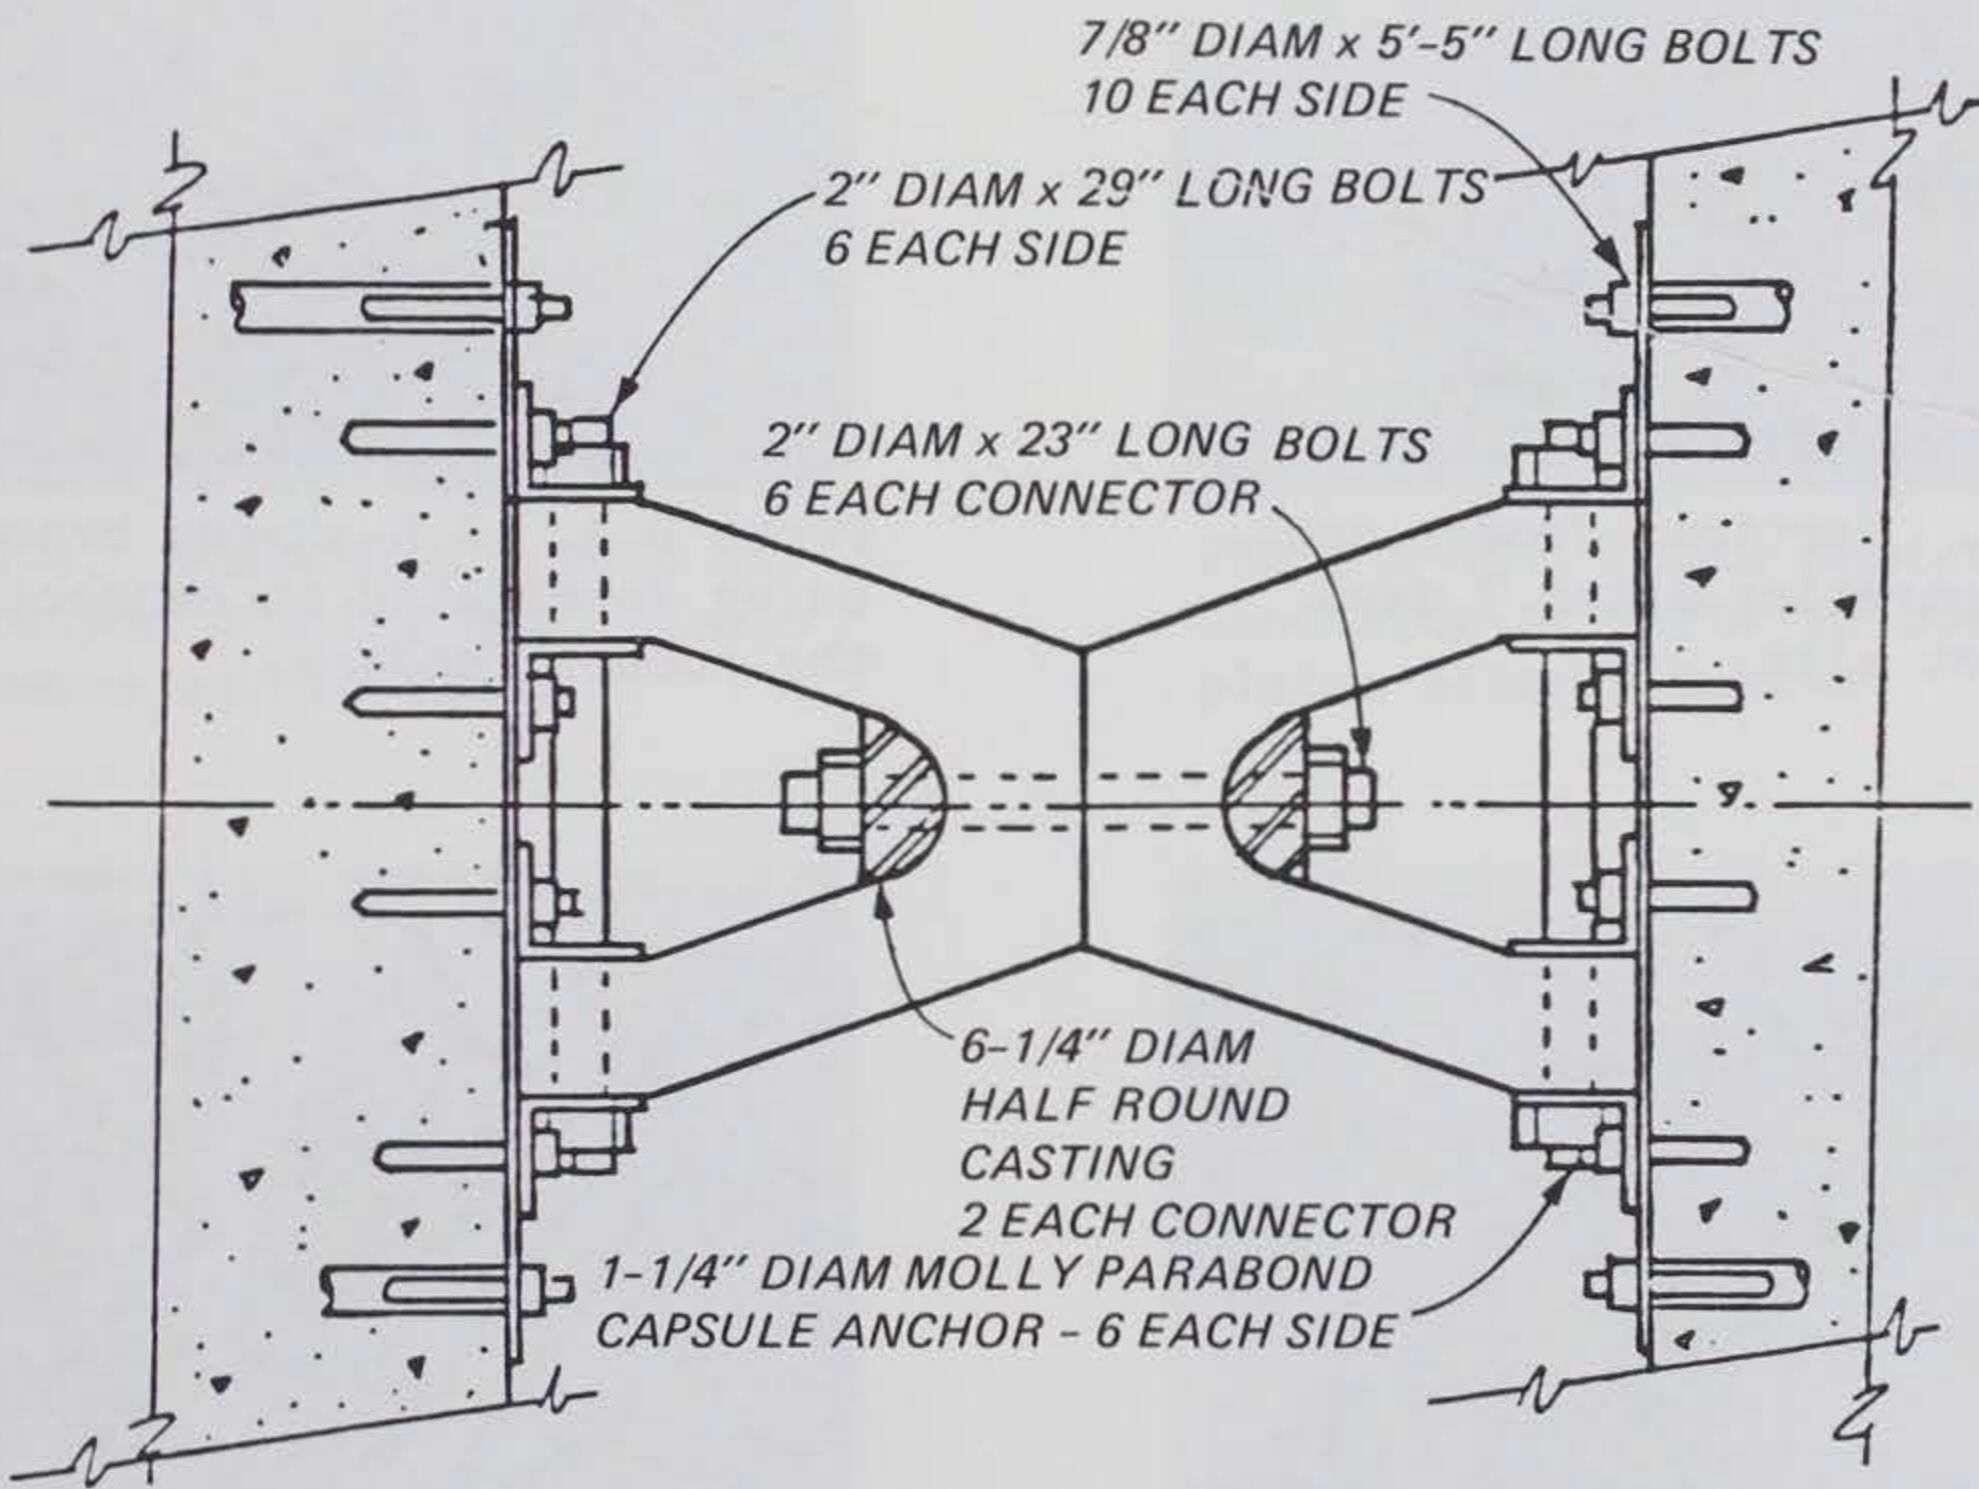
FIGURE D-1. Horizontal Fender Connector

This connector proved to be much more durable than the first (vertical fender) configuration. Until a posttest inspection, the connector appeared to be undamaged after 2 months (December and January), but a close inspection found that three of the vertical bolts had been pulled through the rubber fender on the north side of the breakwater (photo D-36). This damage appeared to be progressive, and continued testing probably would have resulted in additional damage.

Additional bolt holes were drilled in the concrete for fastening the new connector brackets to the floats, and sixteen 1-in.-diam bolts were cemented into place with epoxy grout. Each bracket was bolted in place with sixteen 3/4-in.-diam bolts (in addition to eight grouted bolts). Finally, the rubber fenders were lowered into place and fastened to the brackets with 2-in.-diam by 2-ft-long bolts (figure D-1). The cofferdam was flooded and removed, and on 1 December 1983 the breakwater was reanchored at the test site (photos D-25 through D-35). The concrete clump weights were not reattached to the anchor lines for the test of the horizontal fender connector.

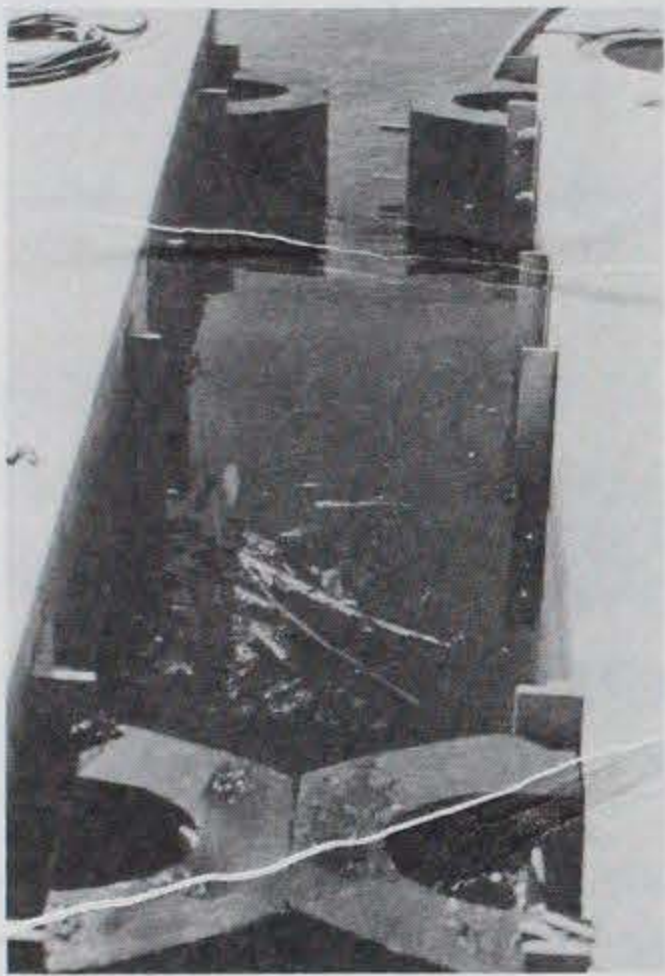
Within 5 days after the breakwater arrived at West Point, wave action had loosened the nuts from the 1-in. bolts which held the butyl rubber fenders together (photo D-3). With considerable difficulty, the nuts were reinstalled. The bolts were then double nutted, and an attempt was made to deform the exposed threads. This repair transferred the problem to the 3/4-in. bolts which fastened the fenders onto each float. A number of these bolts sheared, and eventually all were replaced with 3/4-in., high-strength steel pins. The nuts continued to slip off the 1-in. bolts, and eventually only four bolts were holding the two units together. A means of holding the fenders together was required, but the difficult working conditions and a reluctance to expose the floats to possible damage by removing the fenders at the

Photo D-3. Vertical fender connector separating after 3 days at the test site.

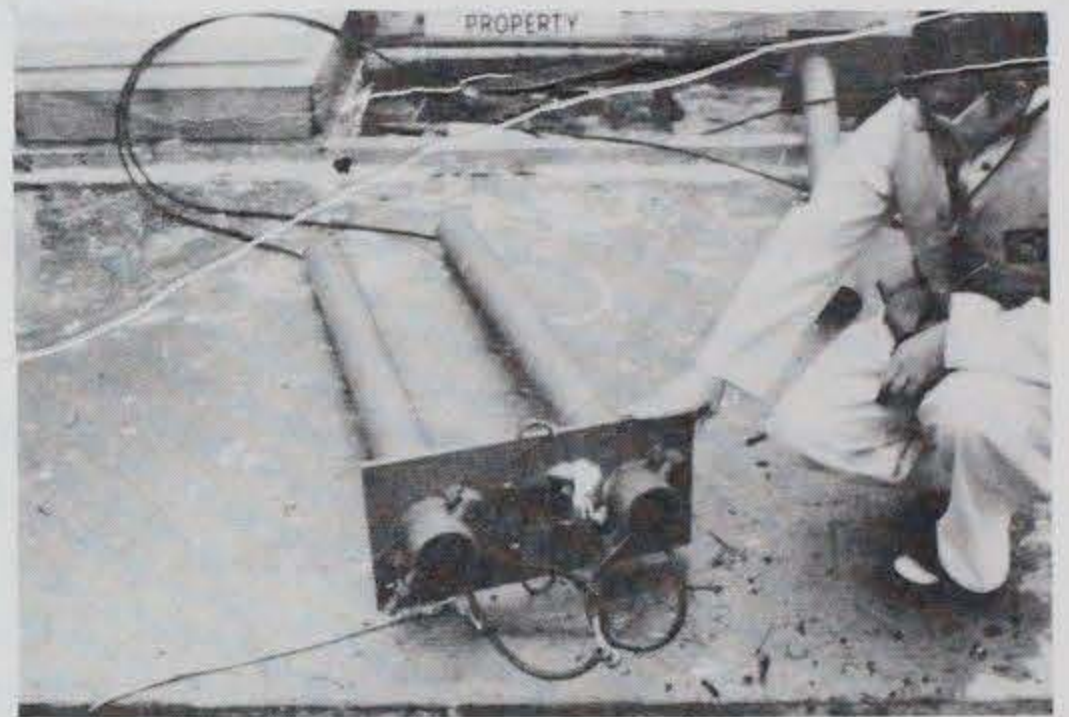
Photo D-4. A U-shaped bracket being fabricated to connect the rubber fenders.

test site limited the options available. Connecting each pair of fenders with a U-shaped bracket was the eventual choice. The bracket was fabricated from 5-ft-long by 4-in.-diam extra strong pipes welded to a 24- by 12-in. plate of 3/4-in.-thick steel (photo D-4). It was installed by lowering the bracket below the fenders and raising the pipes through the large vertical opening in each fender. A second plate was then placed over the pipes and pinned in place (photo D-5). This connection method lasted for 7 weeks, from late August to mid-October. By mid-October 1982, wave action caused by two storms had deformed the pipes and broken one of the 3/4-in. steel plates (photo D-6). To prevent further damage, the fenders were disconnected from each other, and testing of the fendering alternative was begun.

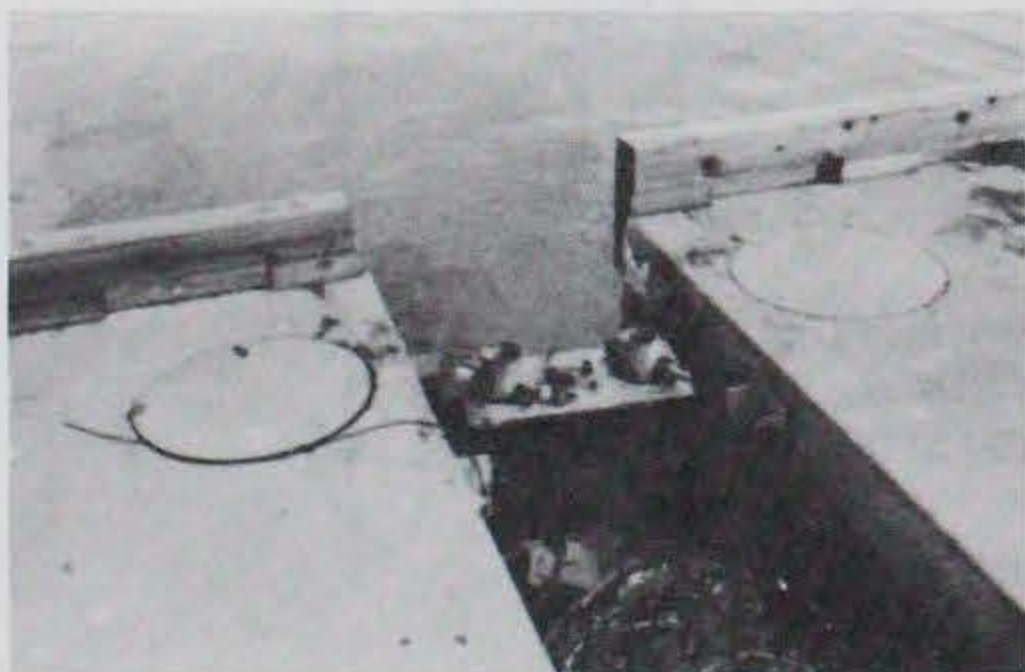
Photo D-5. Photo depicting U-shaped bracket in place.

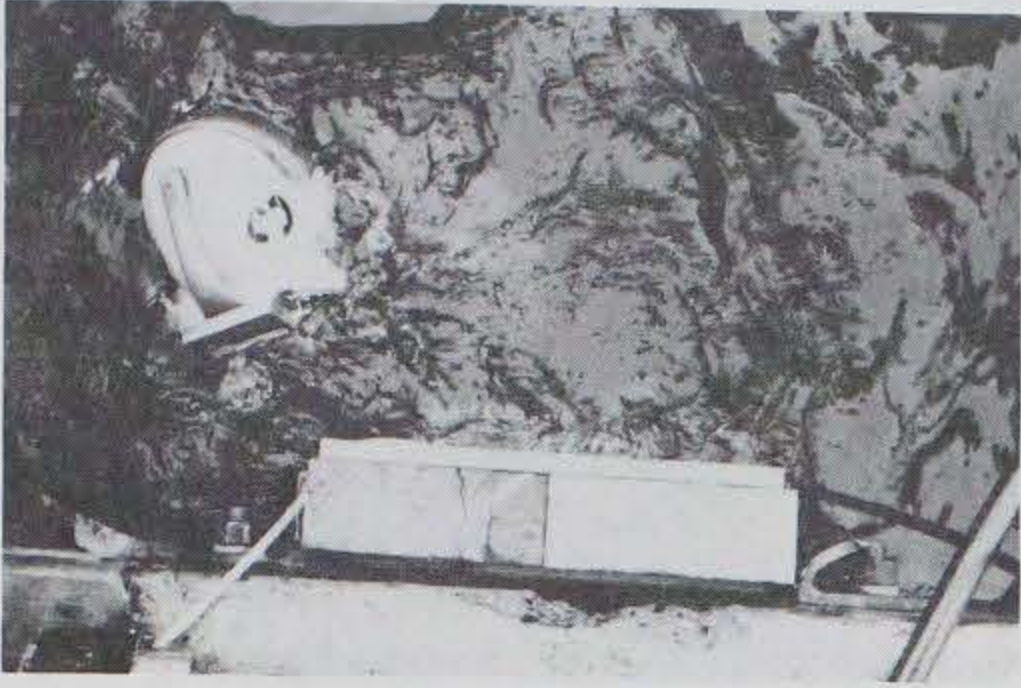
Photo D-7. Wood bumper plate being fastened in place of a rubber fender.

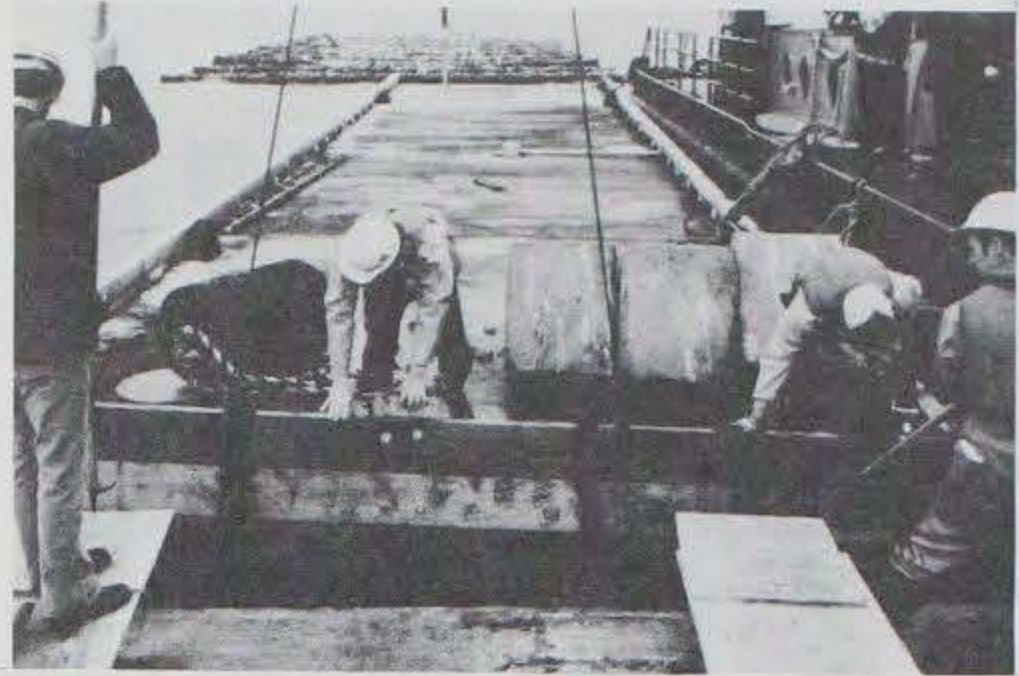
The two horizontal timbers were torn off during the next storm, leaving only the wood bumper plates. Signs of wear on both the bumper plates and the

Photo D-8. Two 3- by 12-in. timbers being bolted between the bumper plates.

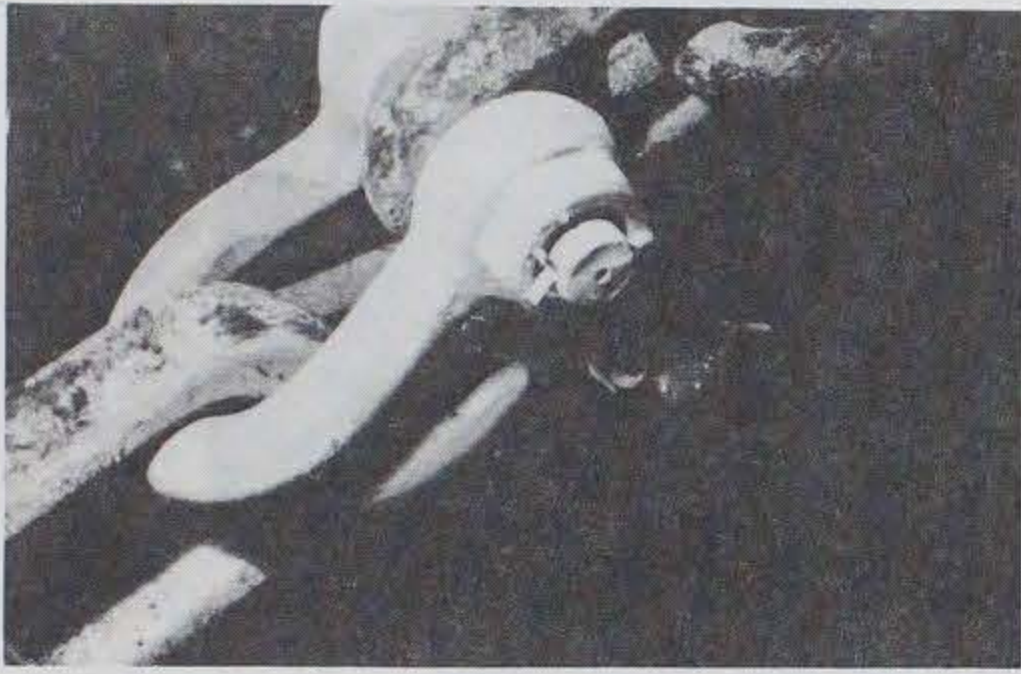
Photo D-9. Underwater photo of Y-connection joining both floats to a common anchor line.

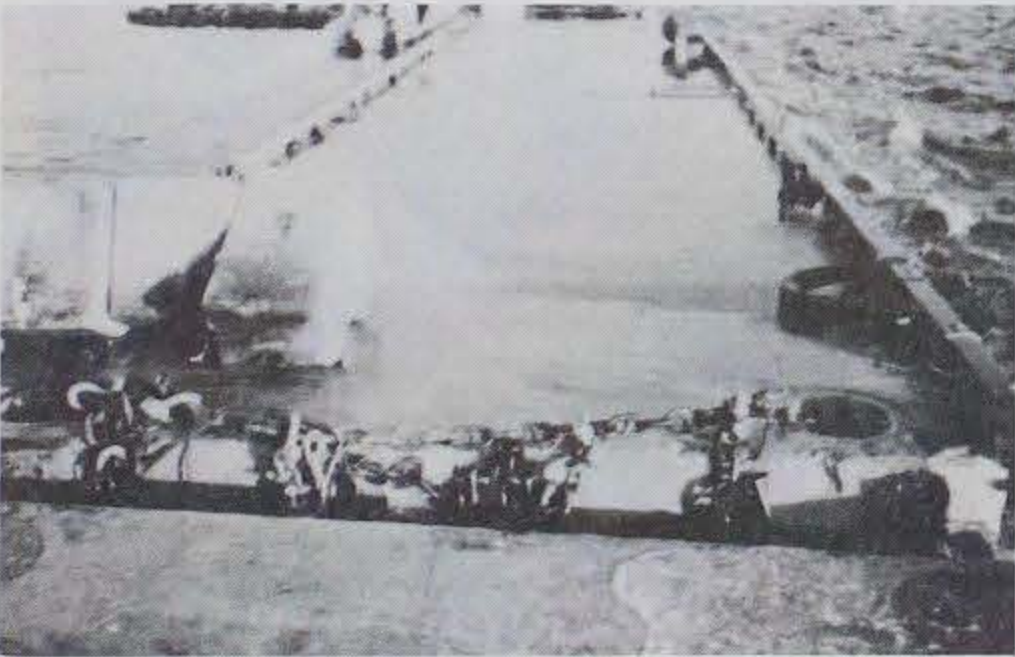
rubber fenders began to appear. Within 2 months the bumper plates had been worn enough to expose the lag bolts. The next storm dislodged it completely (photos D-10 and D-11). Just before the arrival of yet another storm system, emergency repairs were carried out to fasten new rubber fenders and new bumper plates made of iron bark (photo D-12). This combination survived the next month (4 storms) with no sign of wear, and 7 months of modification and testing had finally yielded a viable connection method. On 8 February 1983, the concrete breakwater was unanchored and towed 3 miles to the protected waters of the Seattle District (NPS) work yard at the Hiram M. Chittenden Locks to make the rigid connection between the two floats.

Photo D-11. Ship fenders being hung between the floats after dislodging of damaged plate.

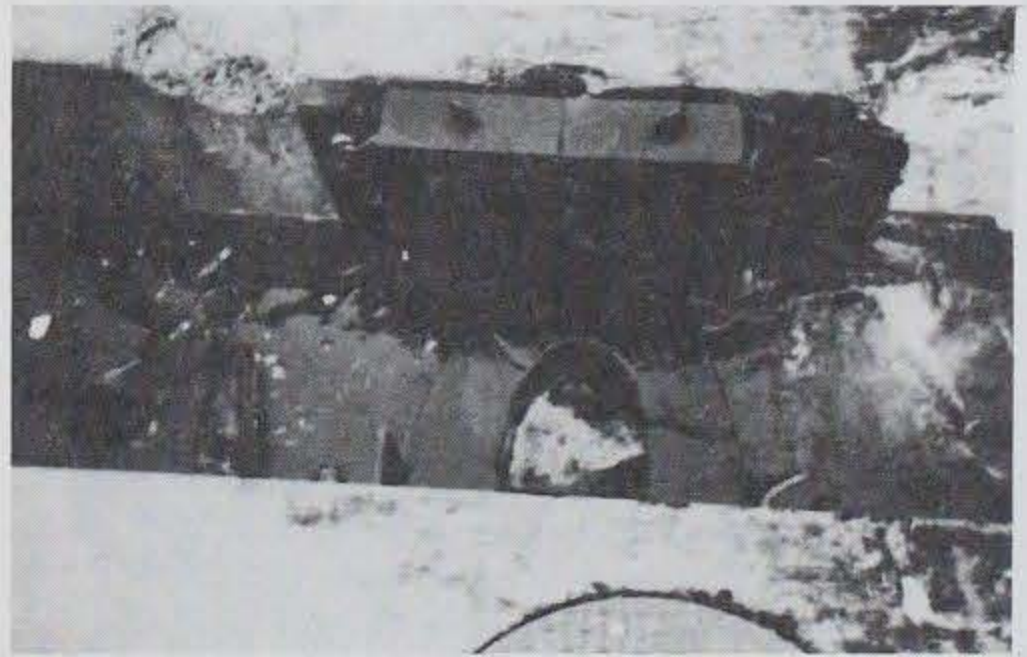
Photo D-12. Photo depicting the new ironwood bumper plate which proved to be more durable.

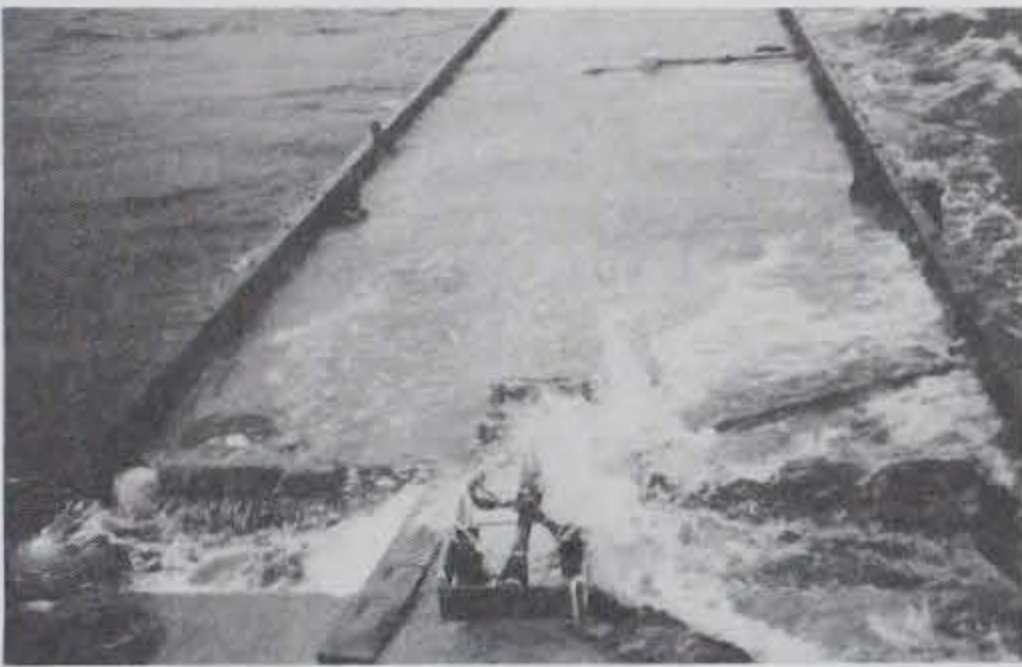
Photo D-35. Waves washing over new flexible connection.

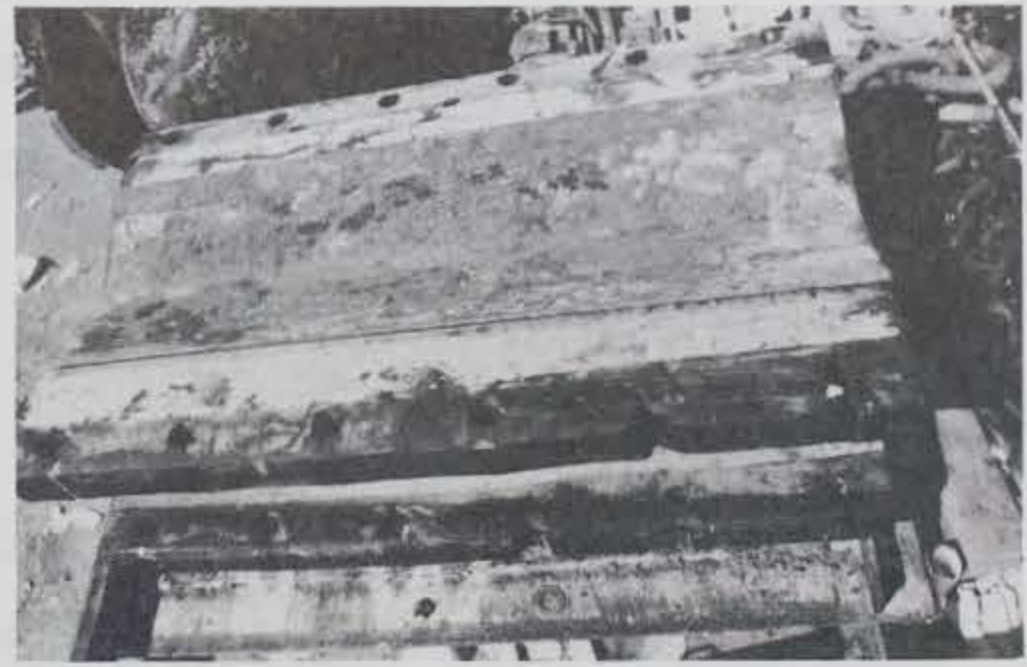
Photo D-36. Photo depicting the area where the 2-in.-diam bolts tore out of the three outermost holes of the north connector.

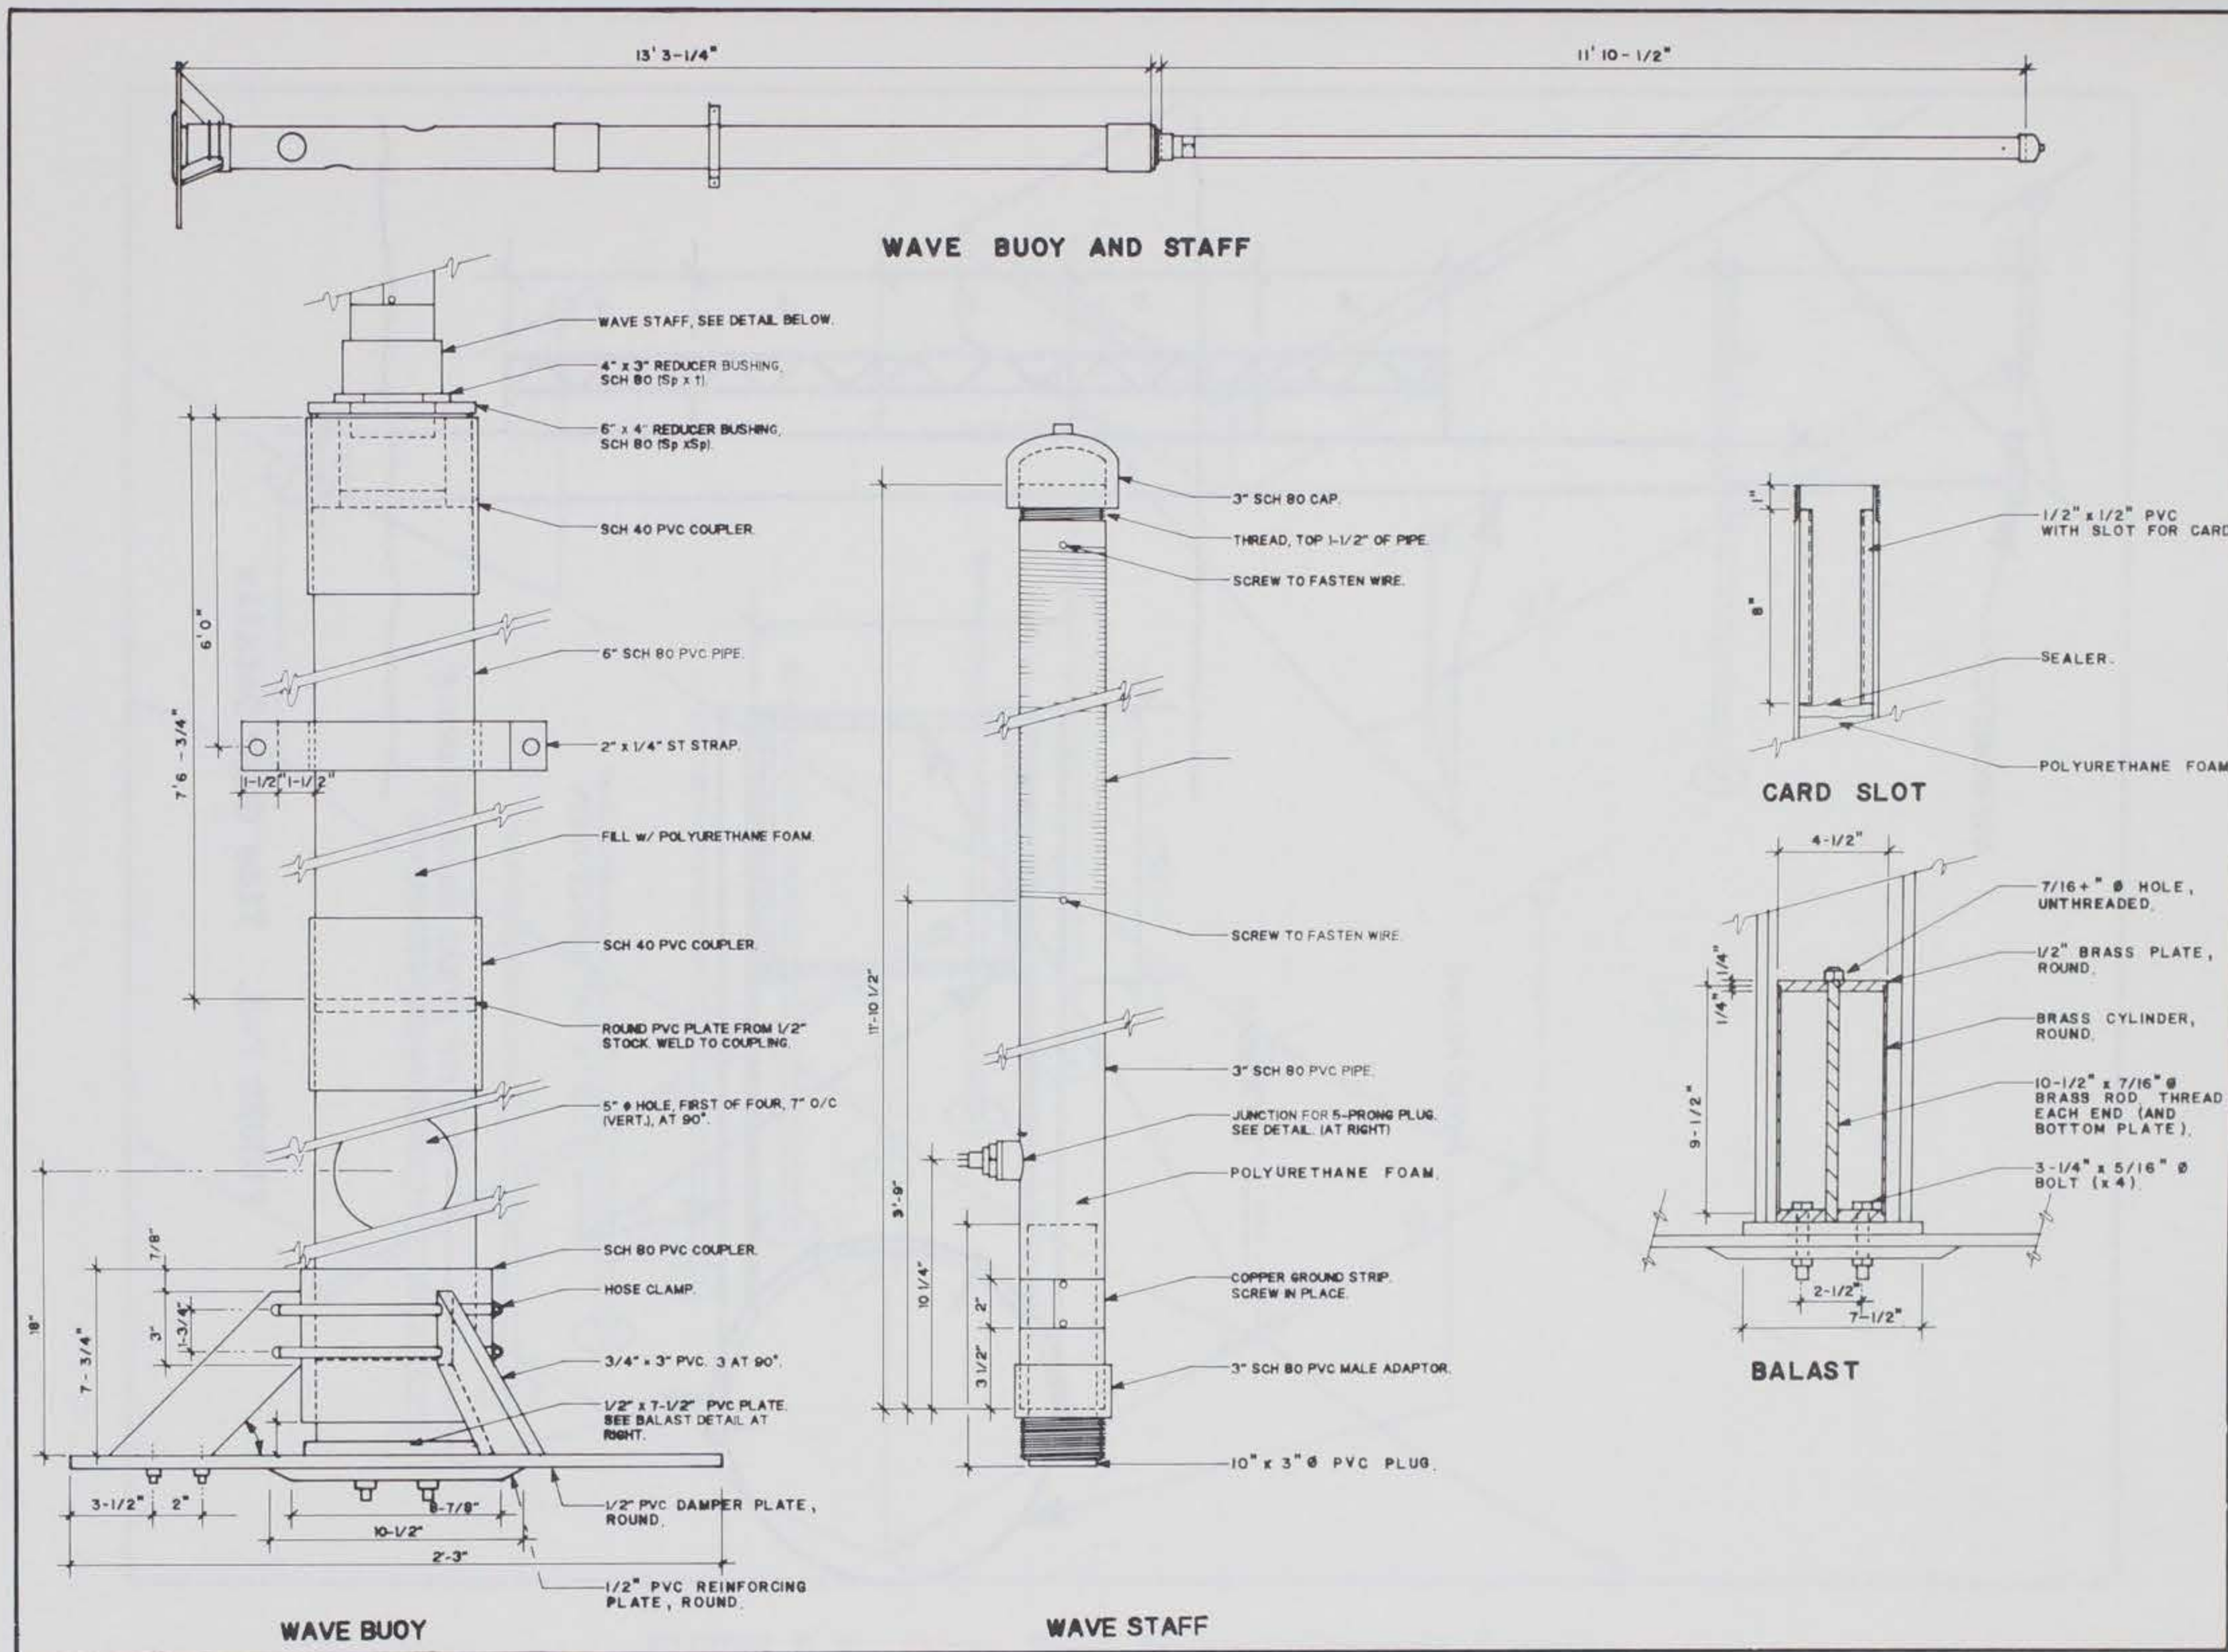
FIGURE F-7. Wave Buoy and Staff Schematic

A number of other problems with the wave gages were encountered, but they were considered routine maintenance. The electrical leads running from the buoys to the data acquisition system were damaged and had to be replaced several times. Also, after several months of use, the stainless steel resistance wire on the staffs tended to break, either because of corrosion or debris impact damage; and on one occasion a small brass screw retaining the upper end of the resistance wire corroded and caused electrical problems. Although not a common problem, some of the circuit boards inside the wave staffs did fail and had to be replaced. Finally, some of the buoys slowly lost buoyancy, and empty Clorox bottles were tied on to raise them to the proper height.

Even though the unusually stormy weather showed no sign of easing, success in the collection of data improved as the winter wore on. After the replacement of seven wave buoy staffs, reinforced staffs and modified buoy moorings nearly eliminated the breakage problem. With the frequent use of divers, a majority

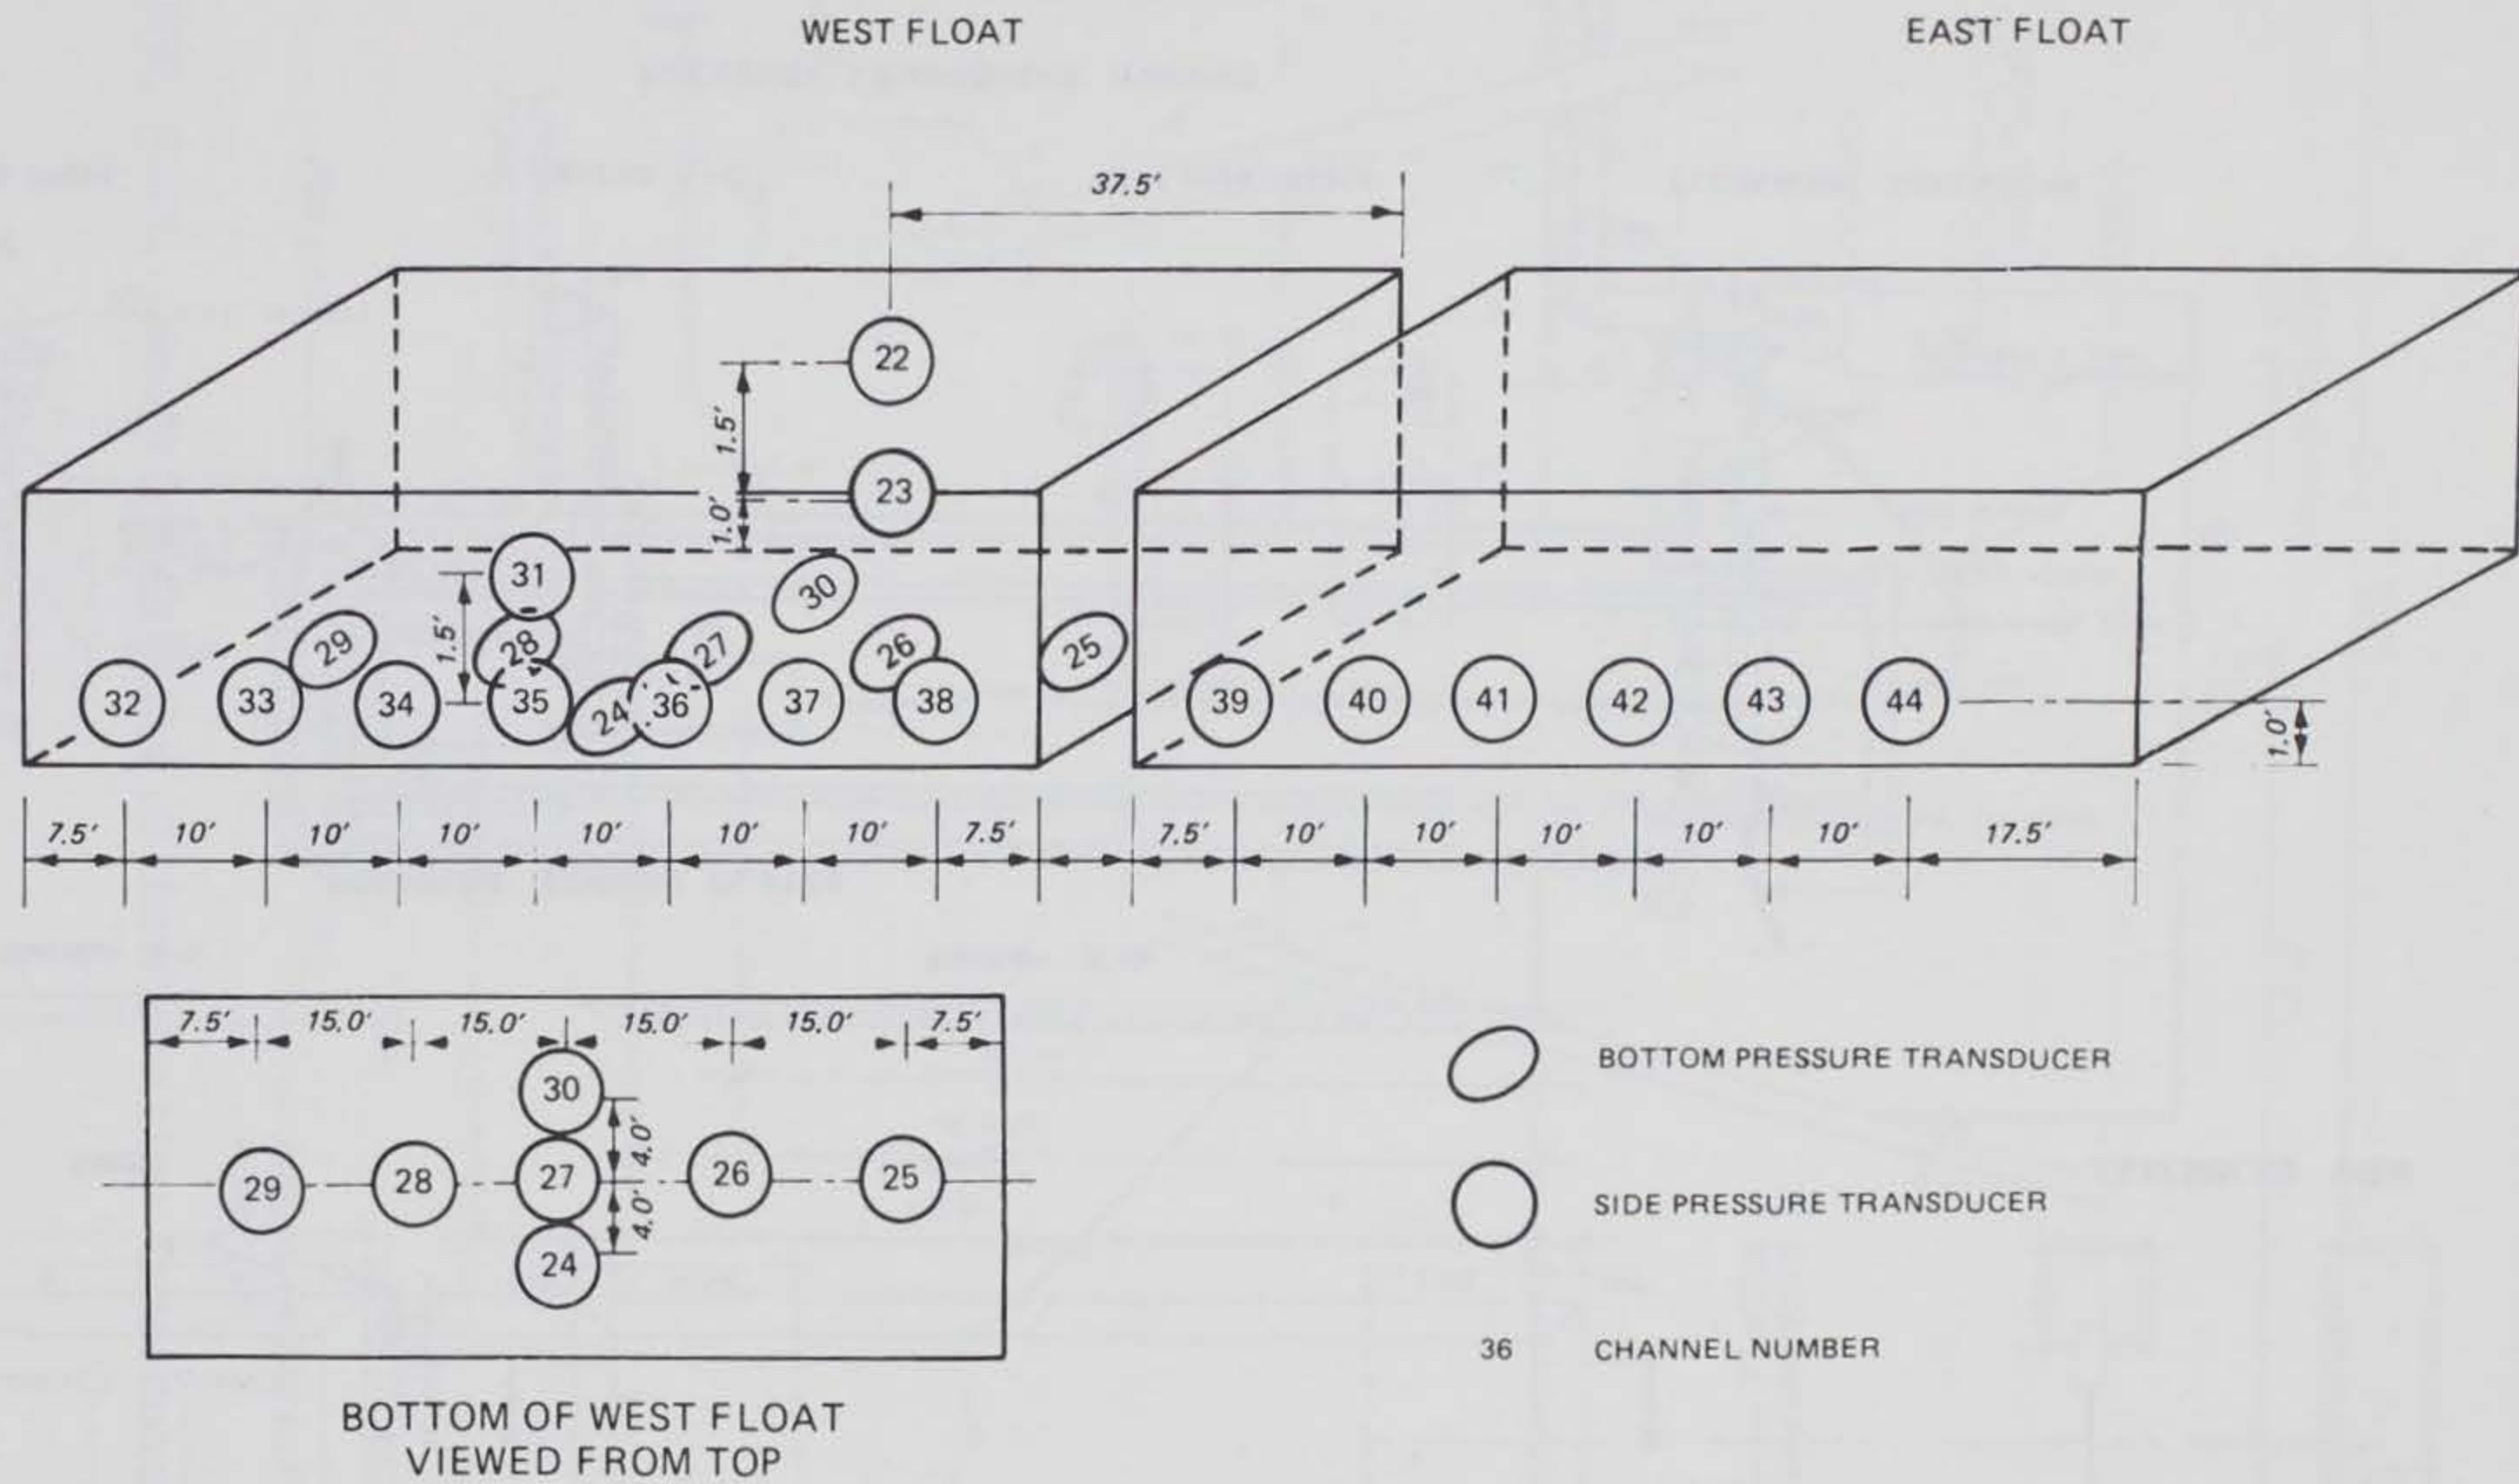
FIGURE F-11. Pressure Transducer Layout

2.05 Pressure Sensors. Sixteen pressure sensors were mounted on the sides of the concrete pontoons, and seven were mounted on the bottom of the west pontoon only (figure F-11 and photo F-6). All of the side-mounted units were damaged early in the project and were not replaced until late summer 1983. The mounting details for the improved method for attaching the side-mounted gages are shown in figure F-12.
