MISCELLANEOUS PAPER CERC-86-3

# FLOATING BREAKWATER PROTOTYPE TEST PROGRAM: SEATTLE, WASHINGTON

March 1986

Final Report

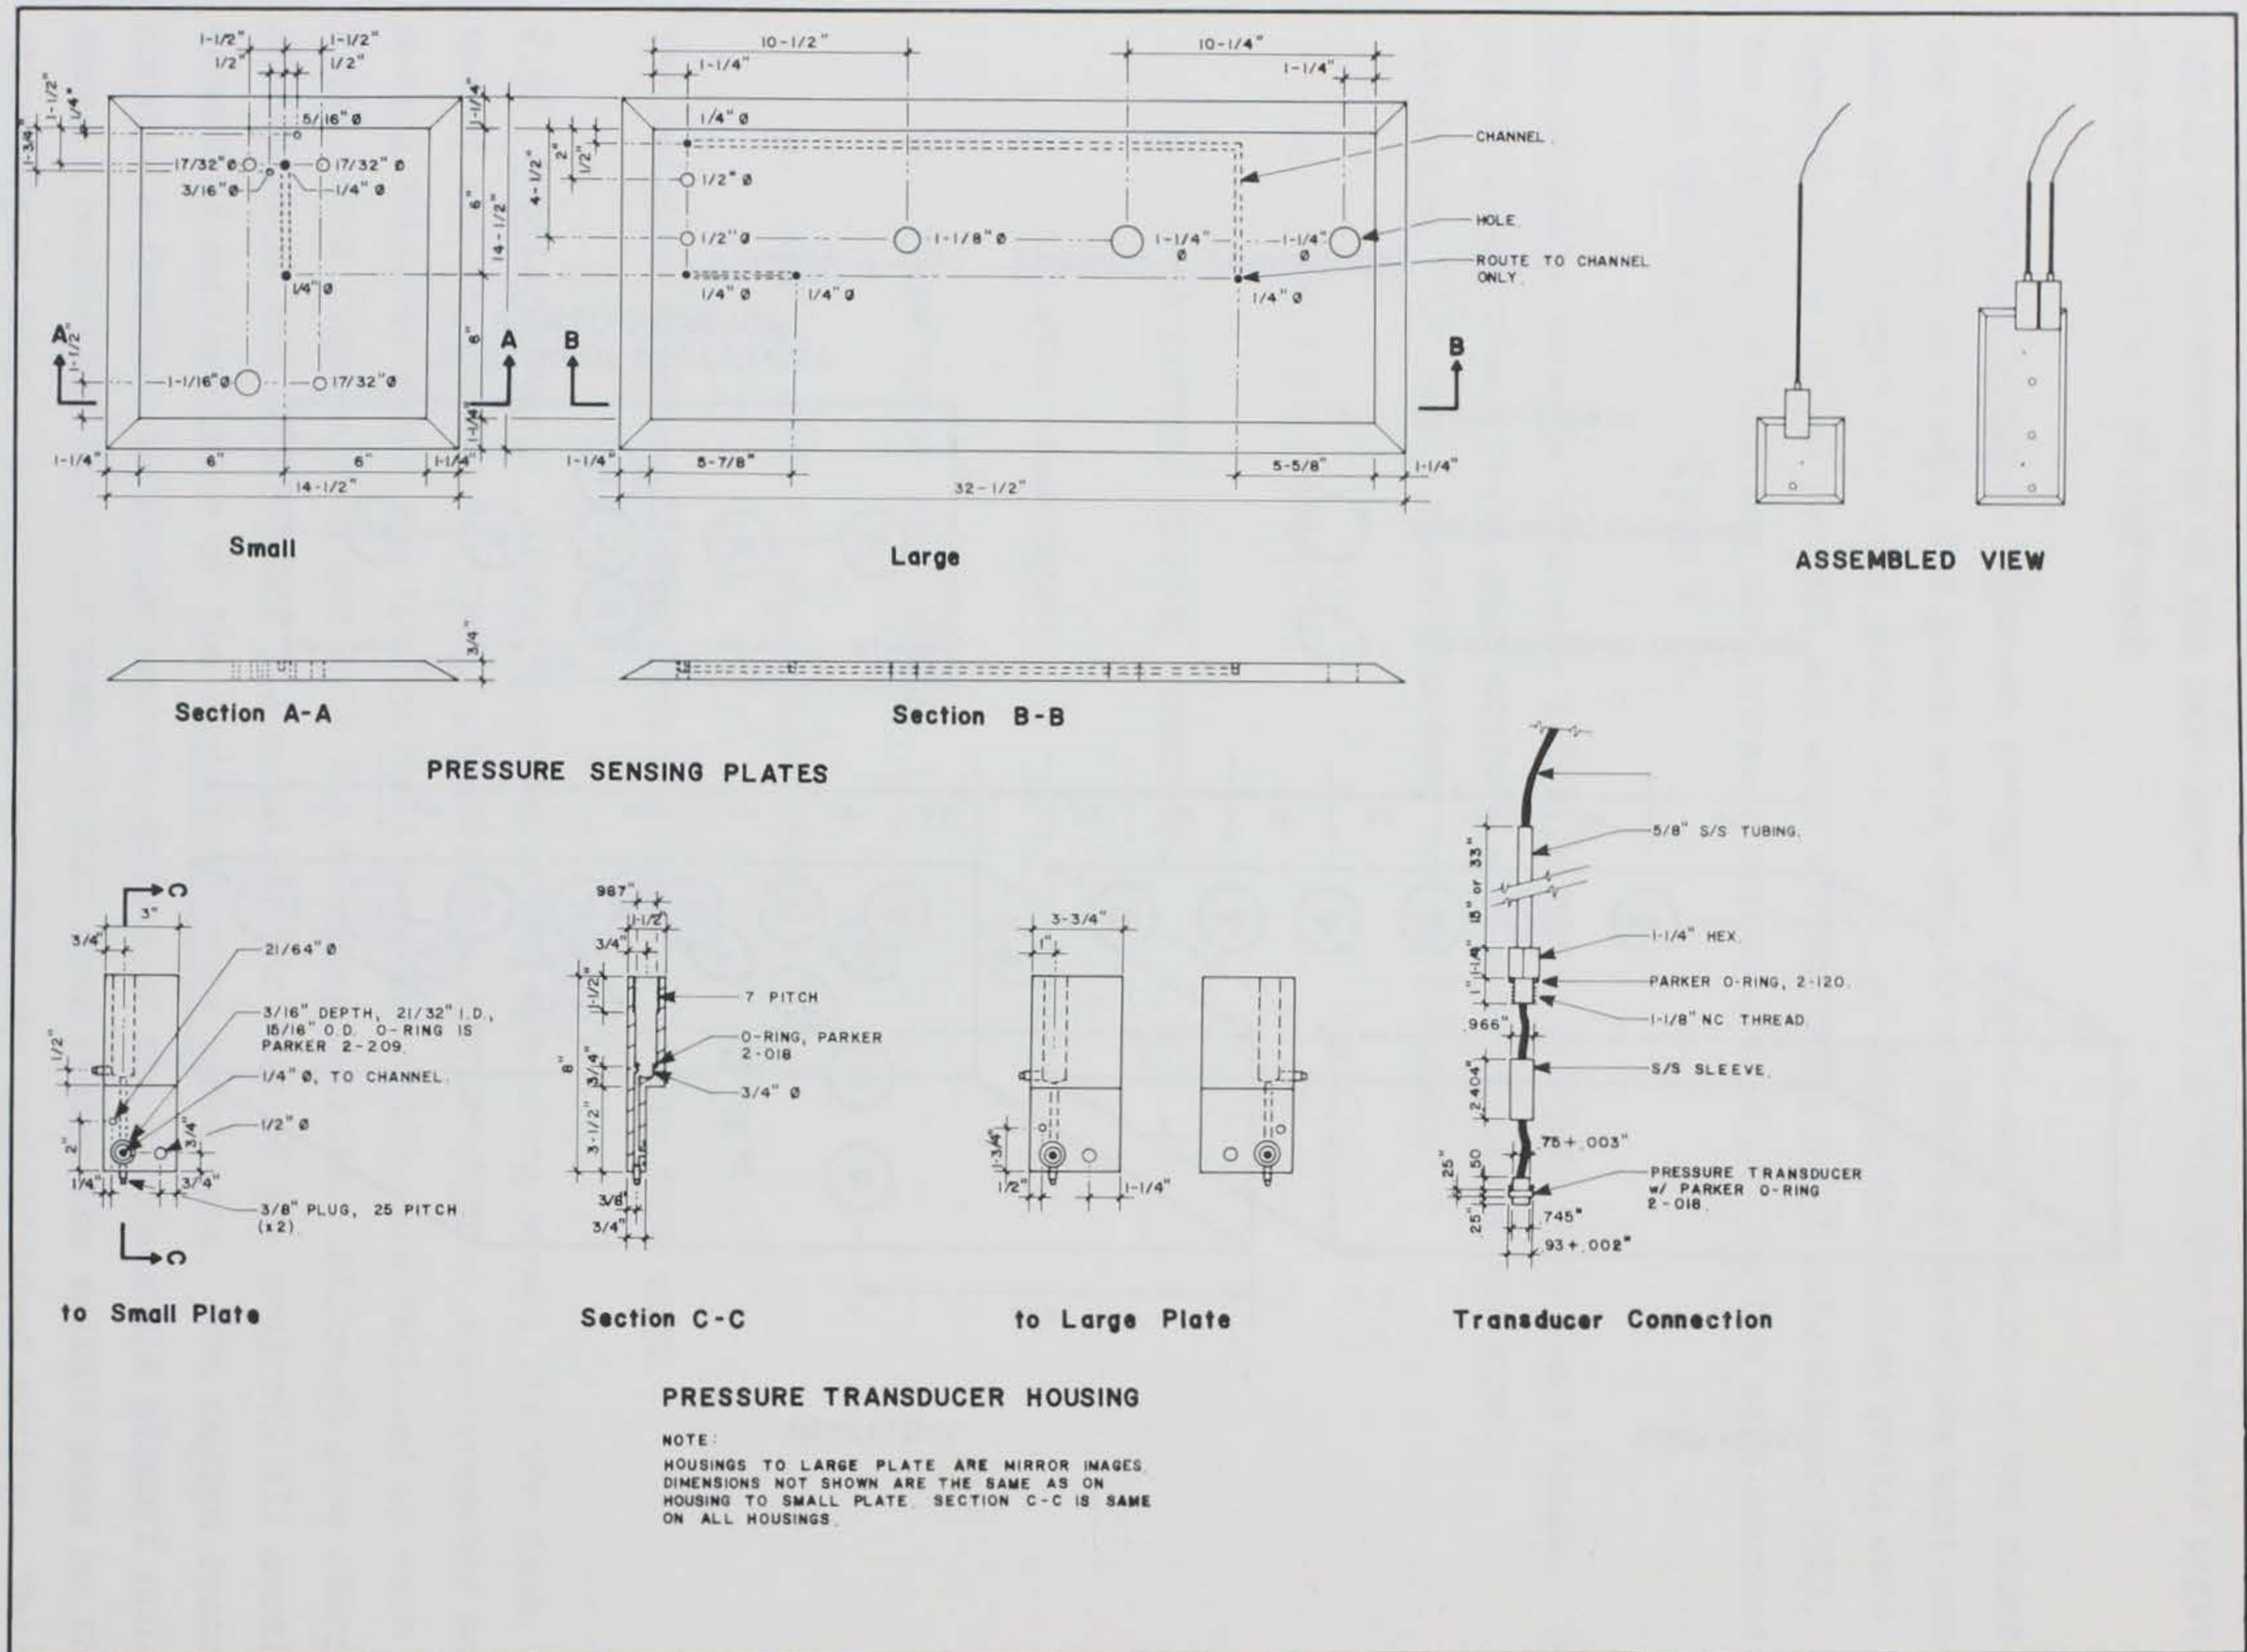
Figure F-12. Mounting Details of Side Pressure Transducers

2.05 Pressure Sensors. Sixteen pressure sensors were mounted on the sides of the concrete pontoons, and seven were mounted on the bottom of the west pontoon only (figure F-11 and photo F-6). All of the side-mounted units were damaged early in the project and were not replaced until late summer 1983. The mounting details for the improved method for attaching the side-mounted gages are shown in figure F-12.

mounted on the south side of the breakwater were lost in the first 3 months of testing. An electrical conduit attached to the side of the floats was the main support for the transducers. The conduit, installed as part of the breakwater construction contract, was not able to resist wave forces and debris impacts. As each section of conduit was torn off, the attached transducers went with it. Transducers mounted on the bottom of the float fared somewhat better. All survived physically, but electrical leads to four of them were damaged during the test period. Three of the gages operated continuously. Parts of the side-mounted transducers were recovered by divers, new housings were made, and they were reattached in August 1983. The new attachment method, designed by the University, worked very well; and all of the transducers provided data throughout the rest of the test.

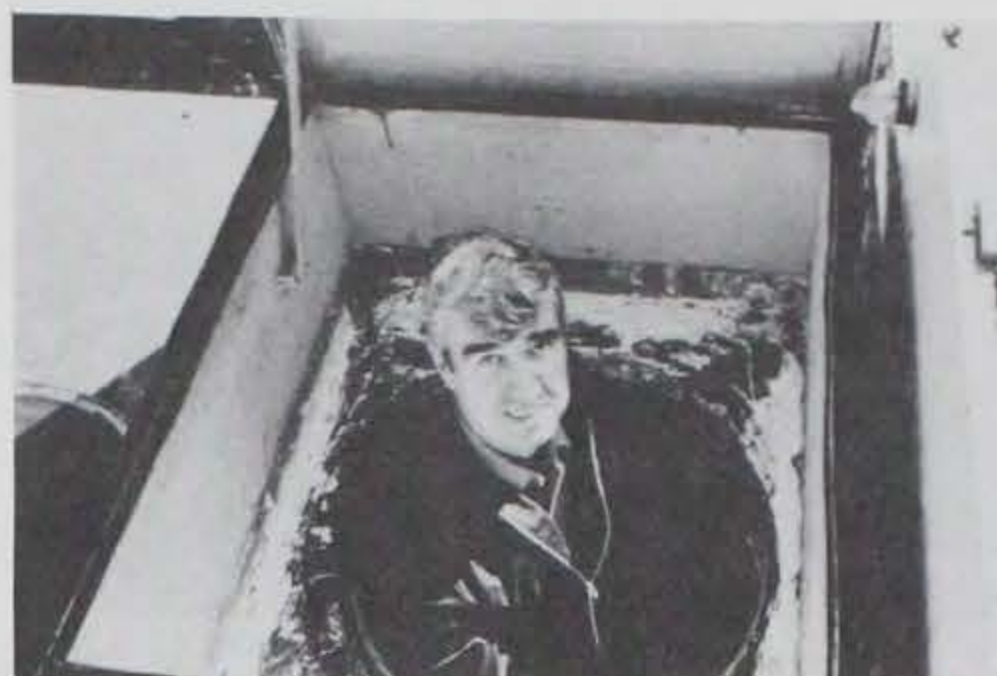
Photo F-14. Photo showing secondary hatch to keep waves from washing into the equipment compartment.

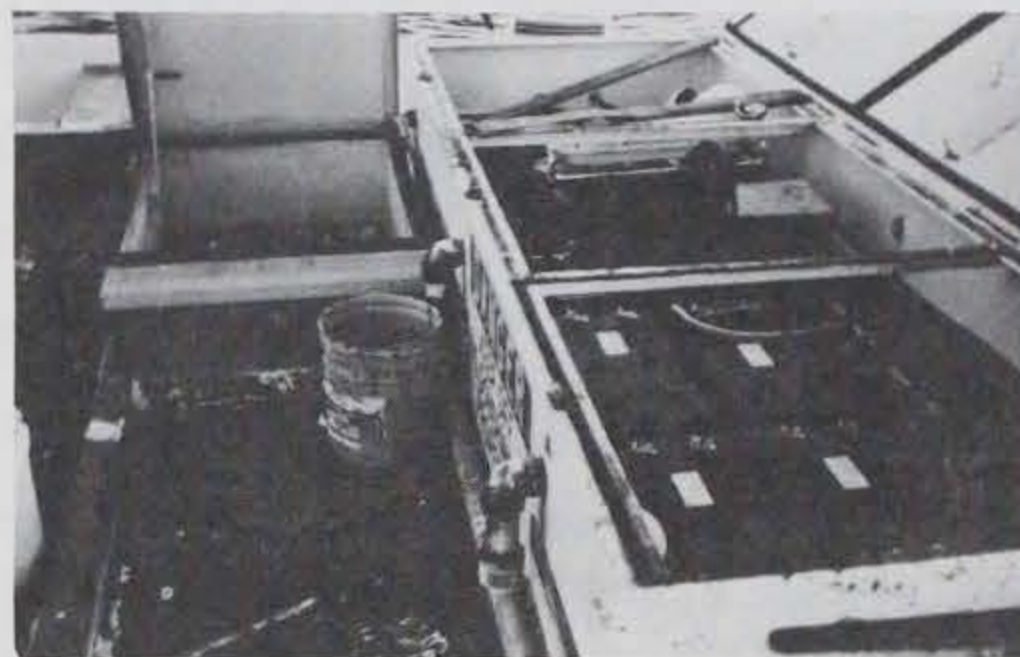
Photo F-16. Photo showing original storage box for the generator and batteries.

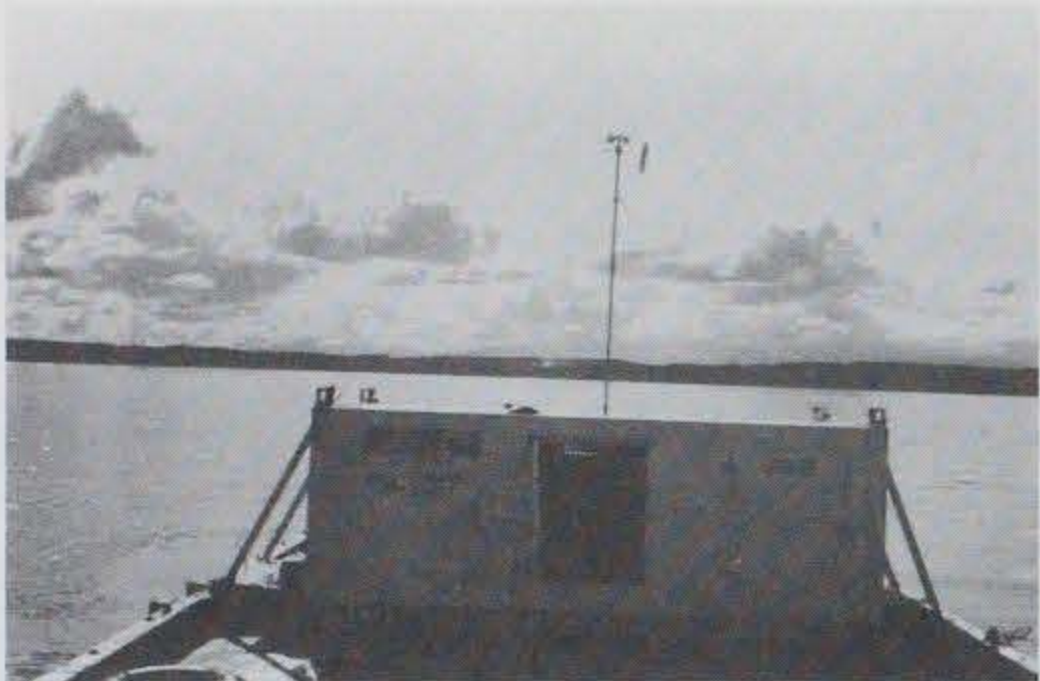
Photo F-20. A diver installing a new electrical lead to an anchor force load cell.

Addition of the steel deckhouse during the rigid connection work was a major improvement (photo F-21). The deckhouse provided a dry storage area for the electronic components, two complete sets of lead acid batteries, and the generator. At the test site, work on the system could continue even during relatively rough conditions, dramatically increasing the amount of time that the breakwater data acquisition system was accessible for making repairs and adjustments.

Photo F-21. Photo depicting deckhouse which greatly improved working conditions.
