MISCELLANEOUS PAPER CERC-86-2

GENERALIZED MONITORING OF SEASCAPE® INSTALLATION AT CAPE HATTERAS LIGHTHOUSE, NORTH CAROLINA

February 1986

The National Park Service
Cape Hatteras Seashore
North Carolina

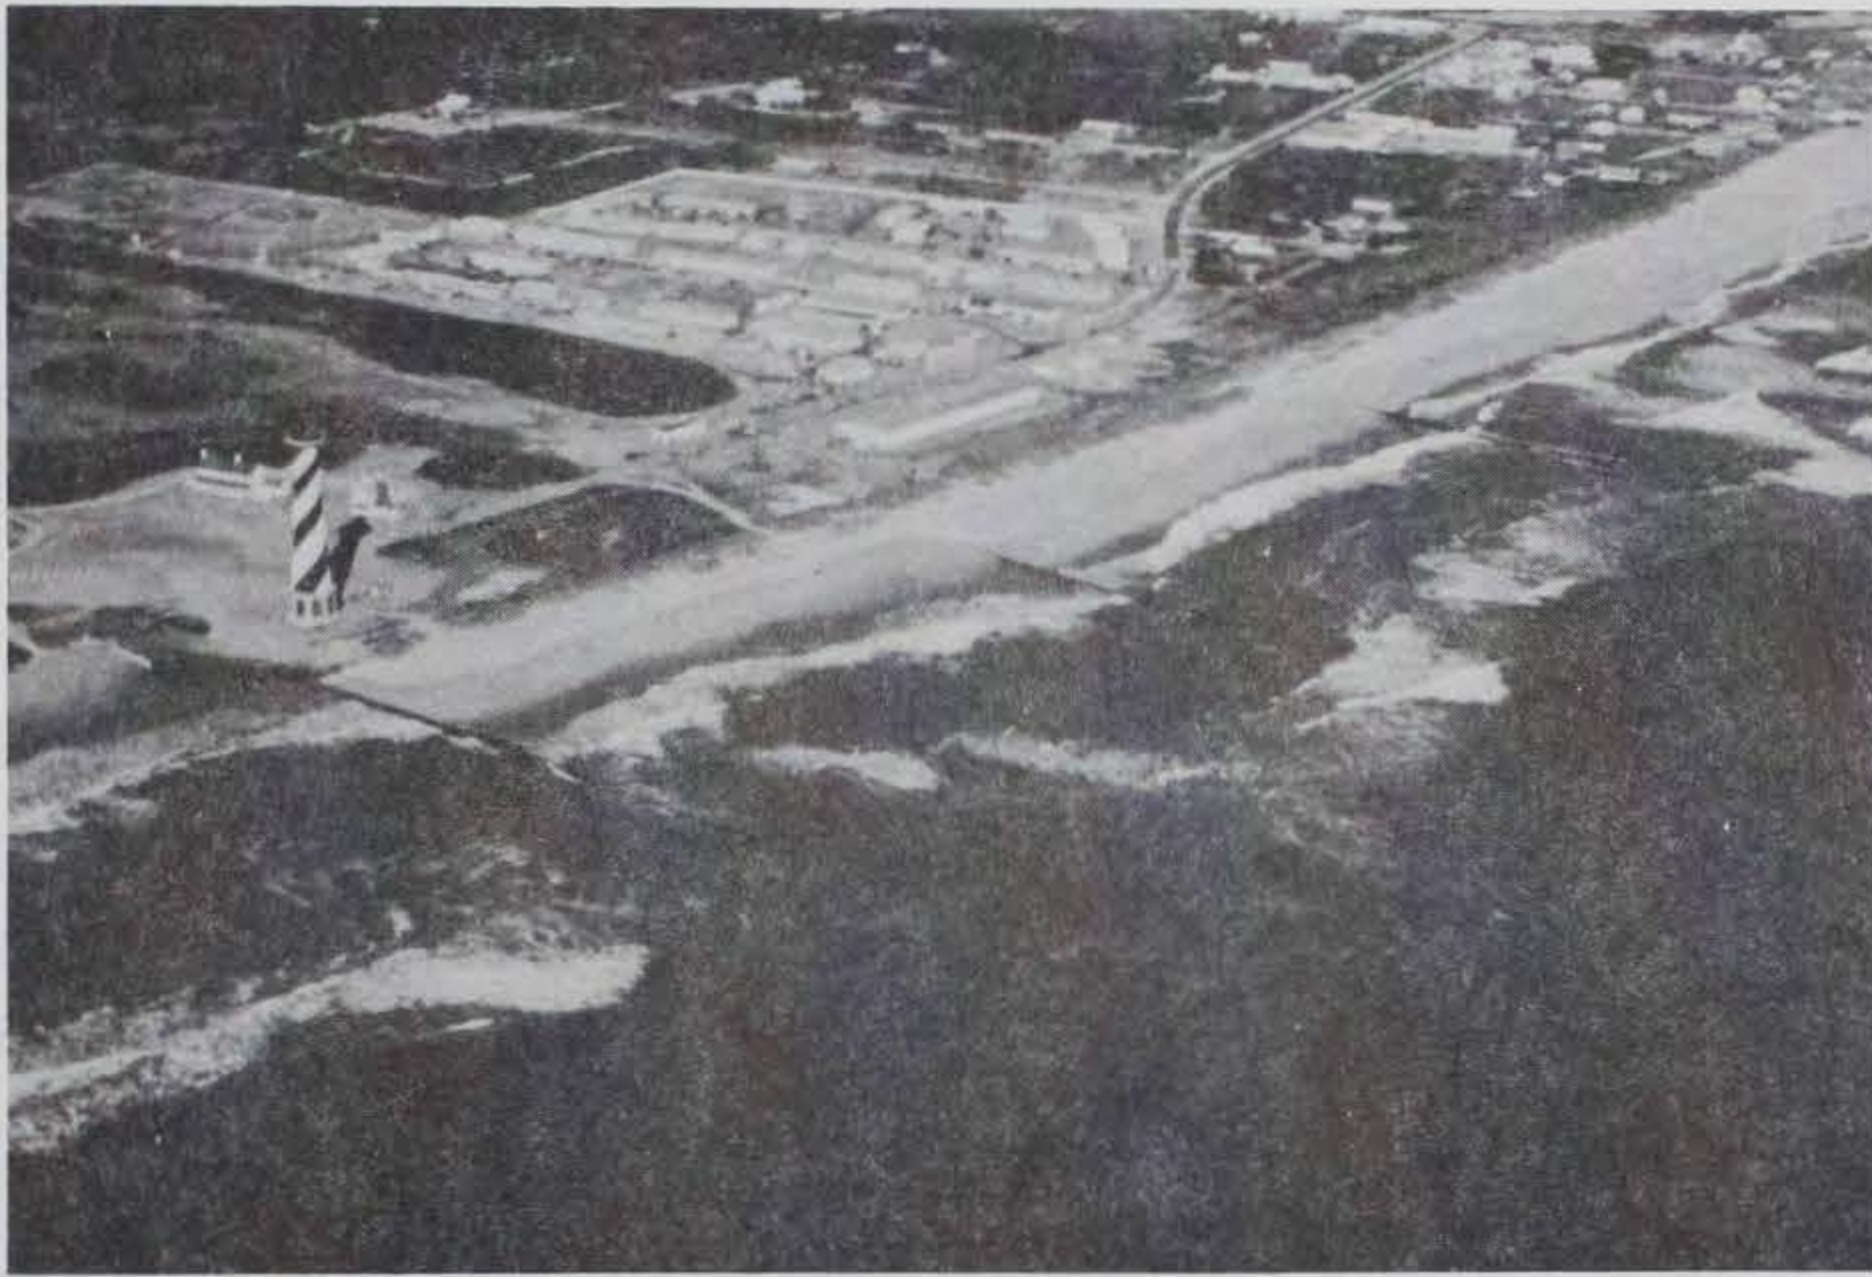
Photo 1 Groins at Cape Hatteras Lighthouse

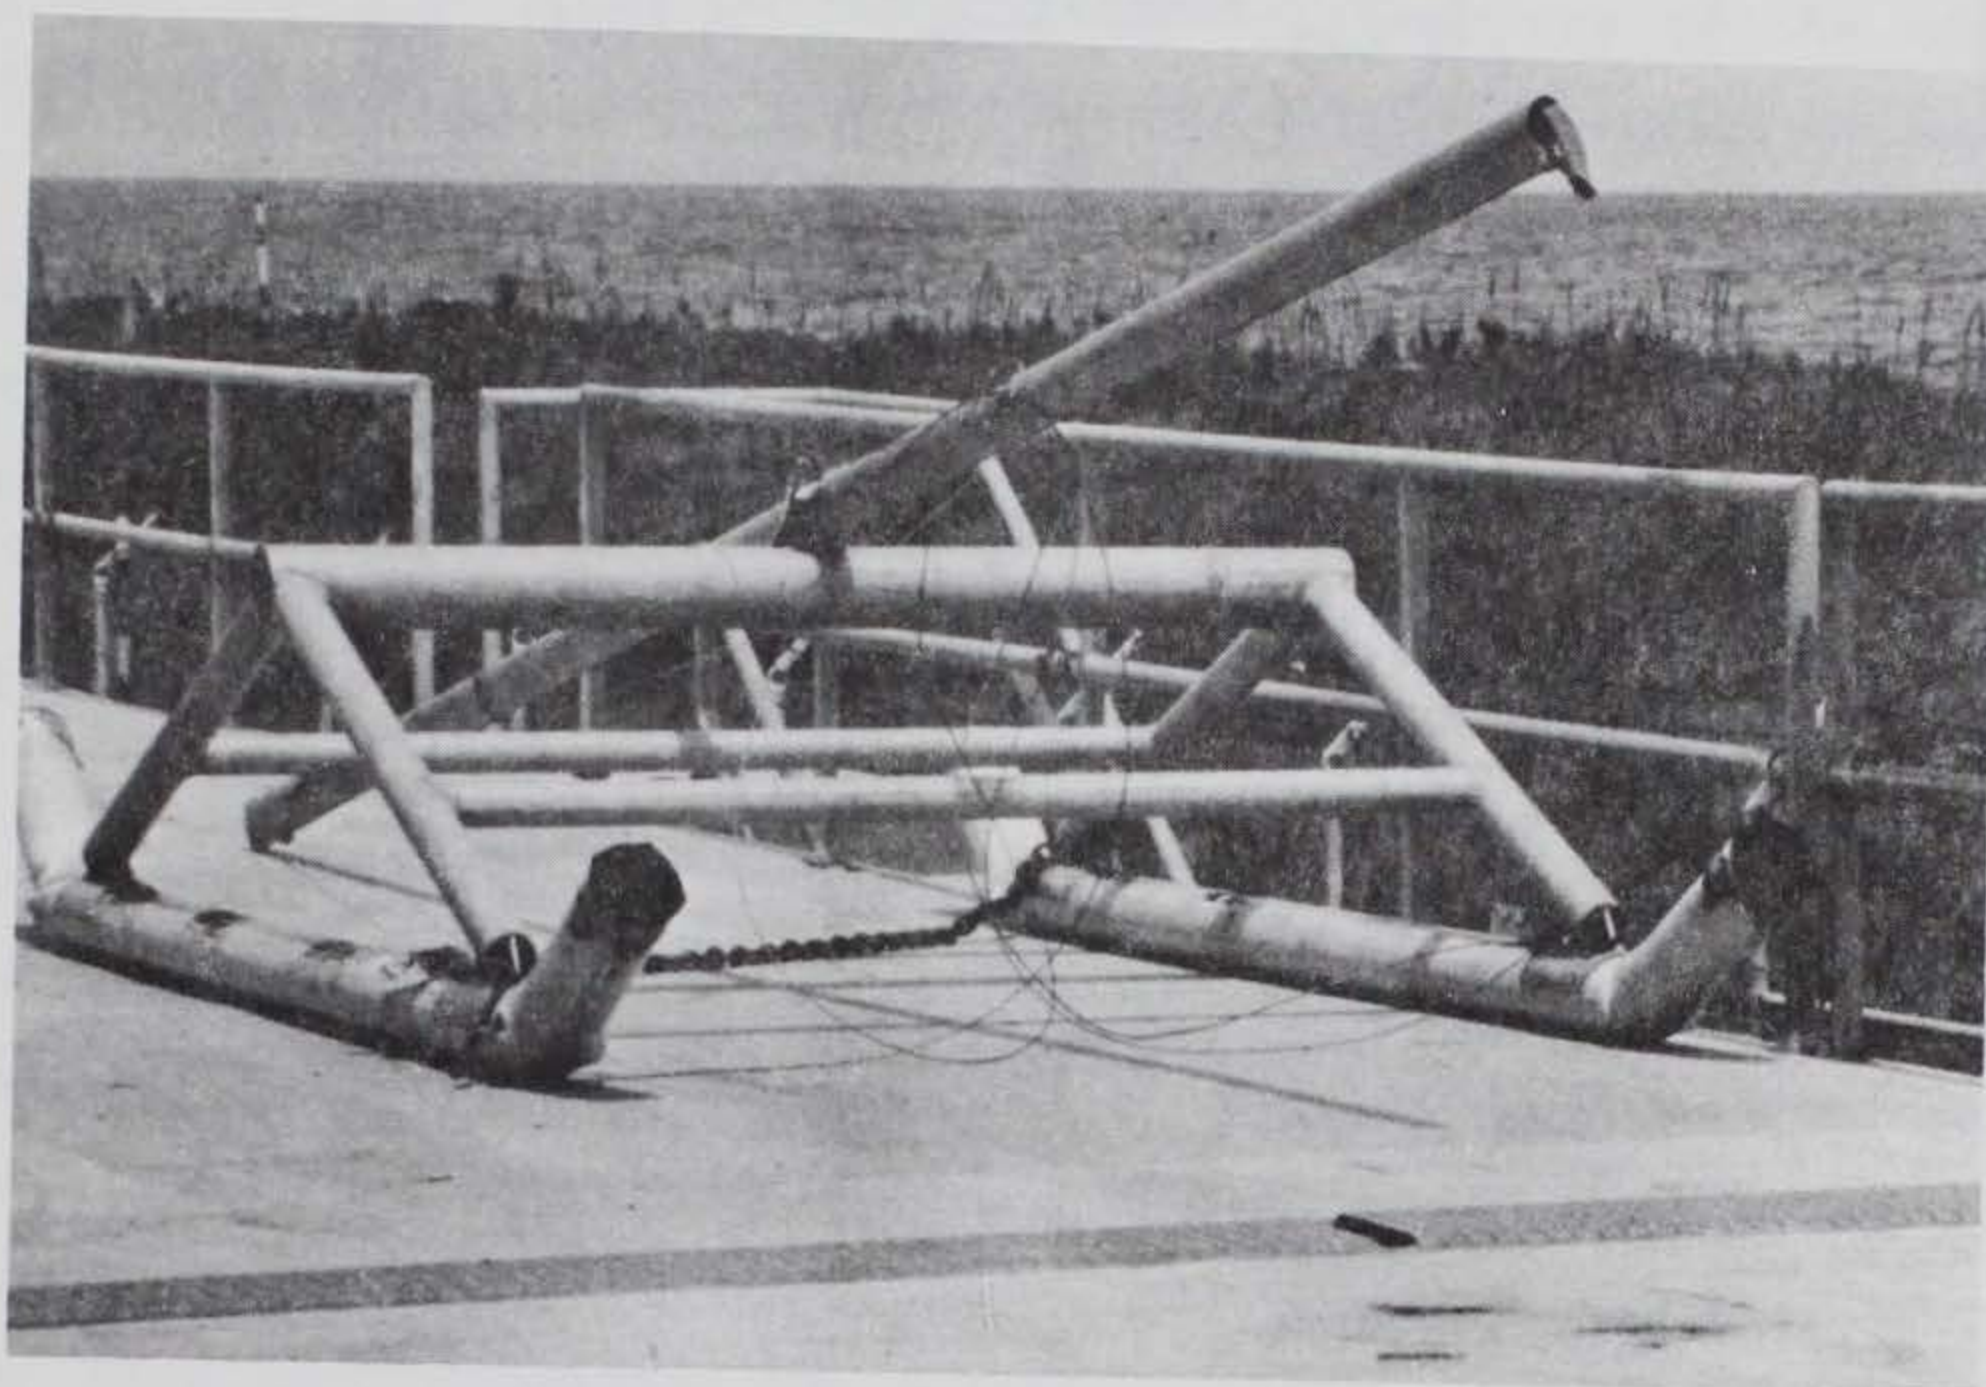
Photo 7 Sea Sled - Disassembled

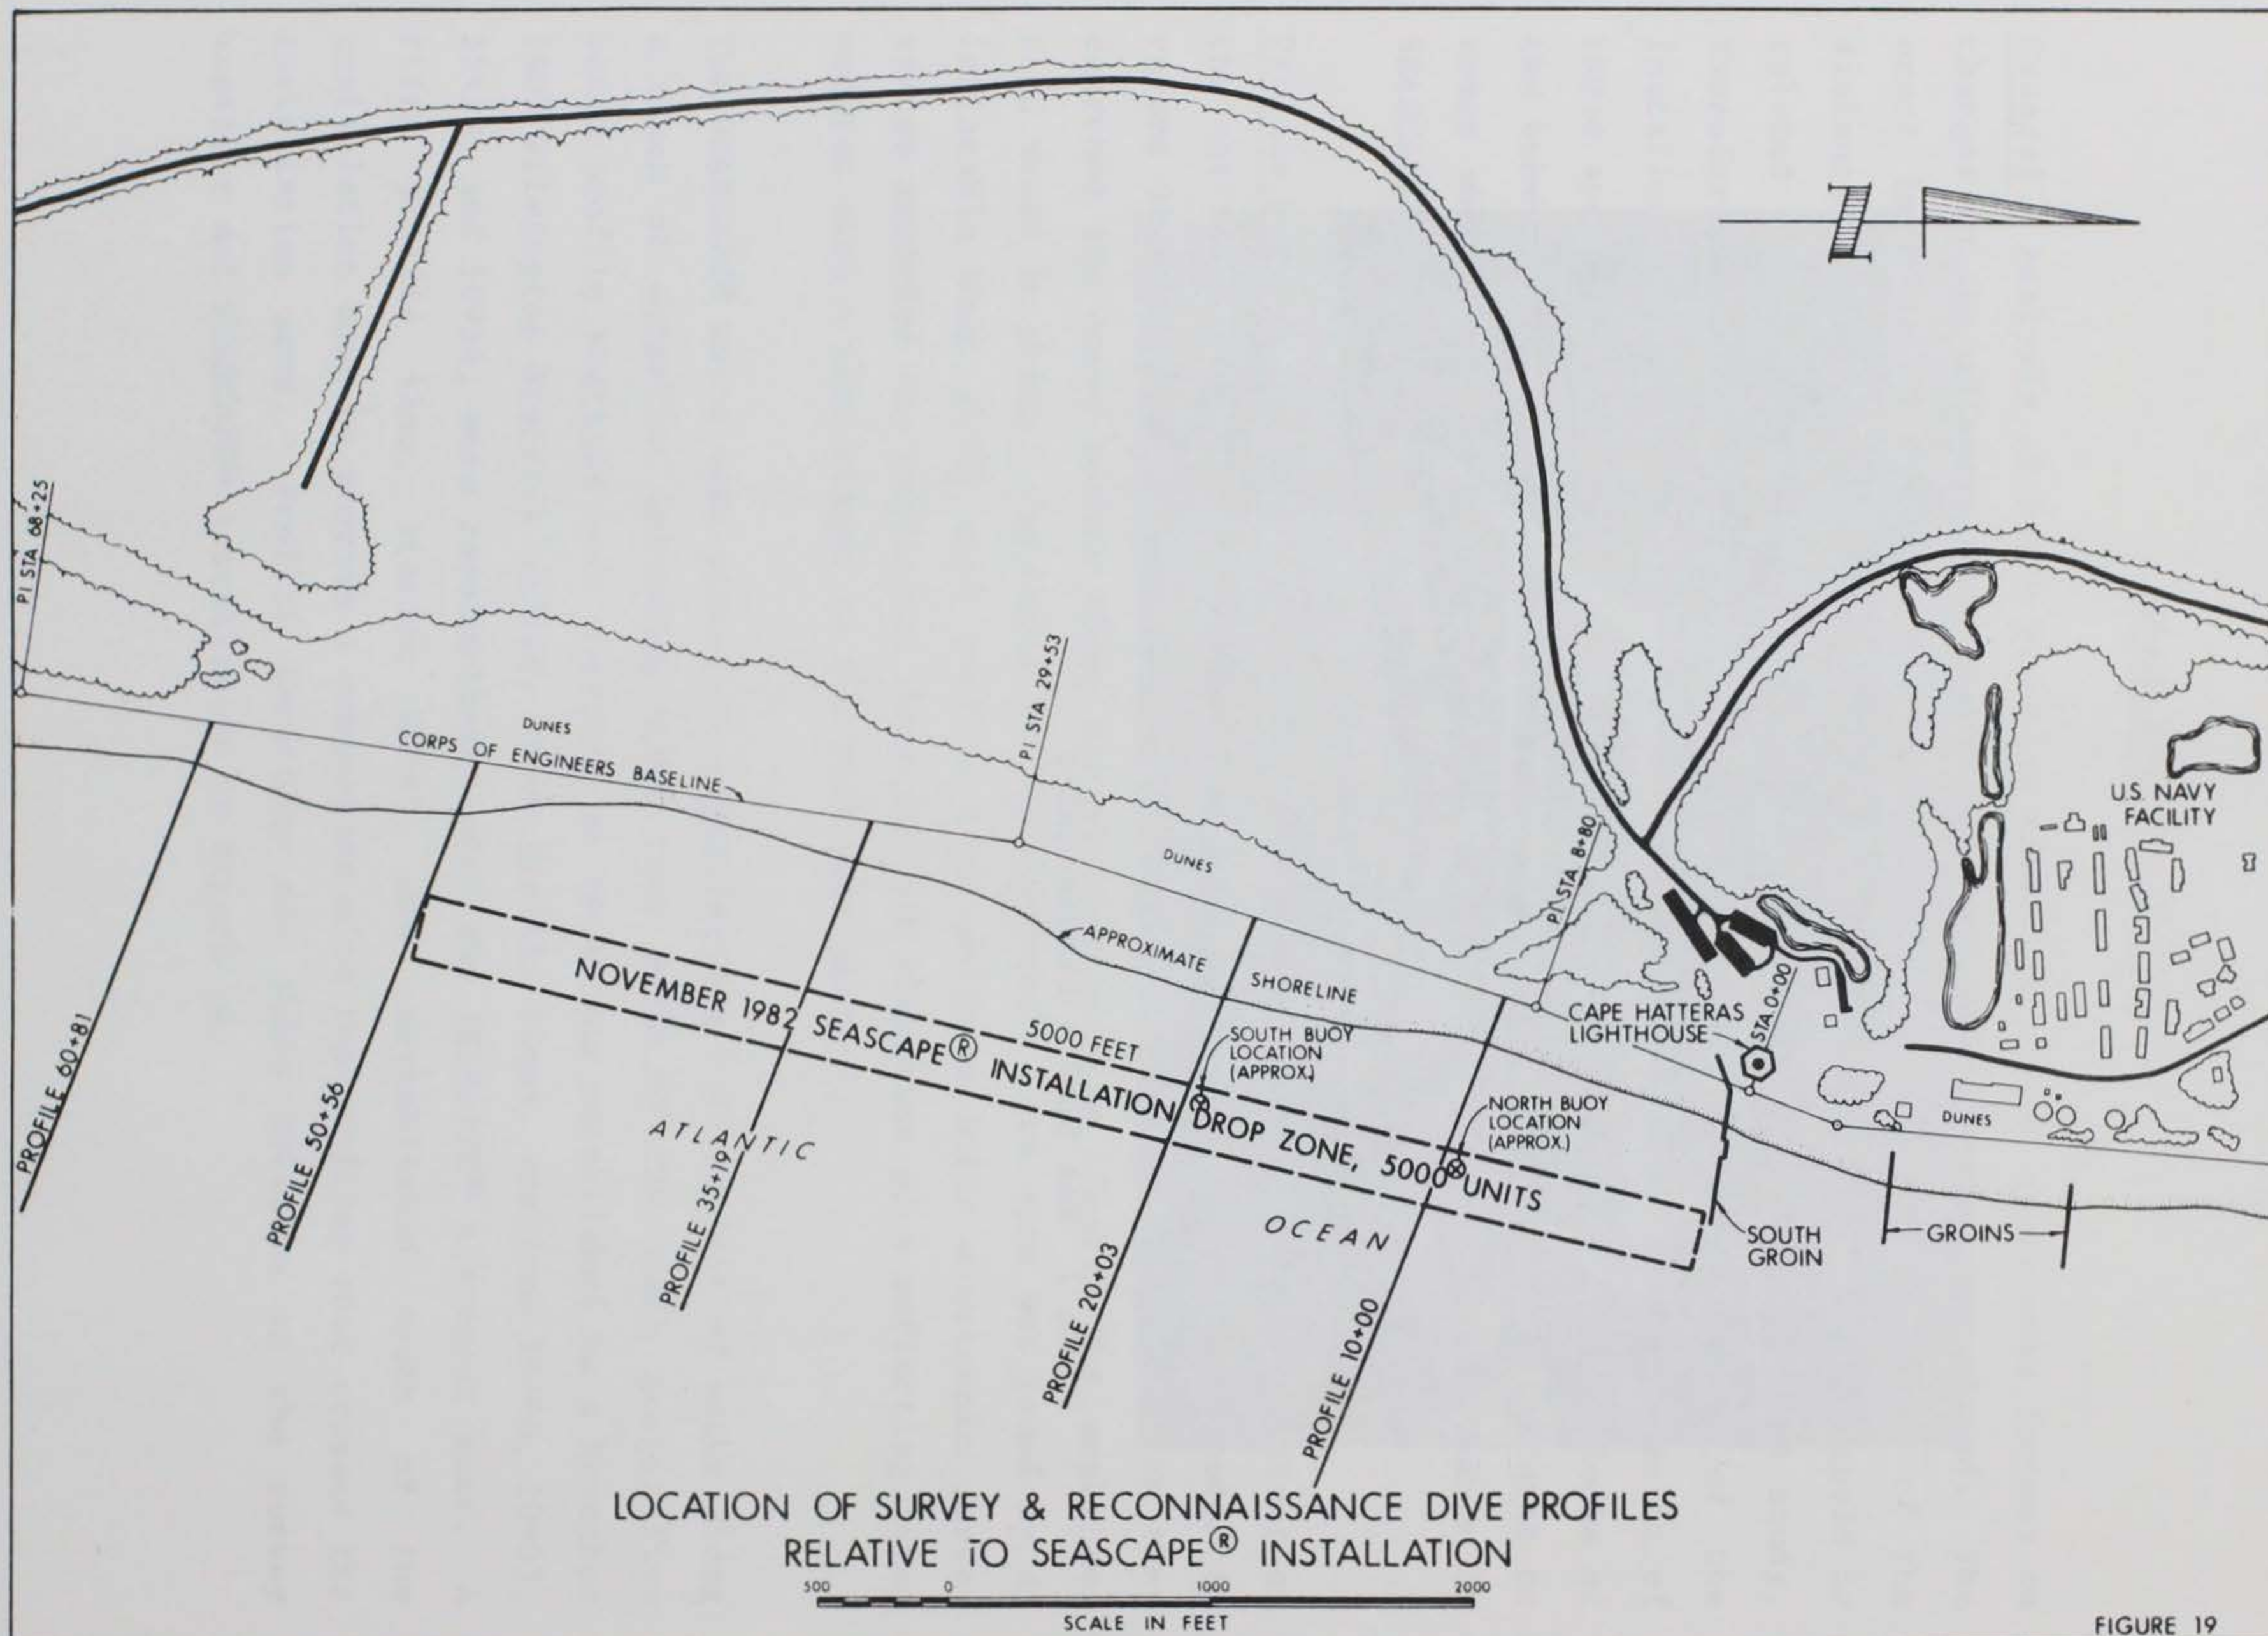
FIGURE 19

The SEASCAPE® units were placed in approximately 6 to 10 feet of water along a reach of shoreline extending 5,000 feet south of the south groin. Five beach profile stations were selected at locations established by a November 1982 Wilmington District survey. Four profile lines, stations 10+00, 20+03, 35+19, and 50+56, were reestablished over the SEASCAPE® placement zone. A fifth profile line, station 60+81, was reestablished south of the installation zone to provide a comparison with the profiles that crossed the installation zone. Profile locations are shown relative to the survey baseline and SEASCAPE® installation on figure 19.

Following the third dive in January 1983, the monitoring plan was revised to include a more quantitative diving plan. Four shore perpendicular transects across the installation zone and one additional transect south of the installation zone were established at baseline stations identified by the November 1982 survey performed by the Wilmington District. As shown in figure 19, the transects extended from the beach offshore to a depth of 20 feet.

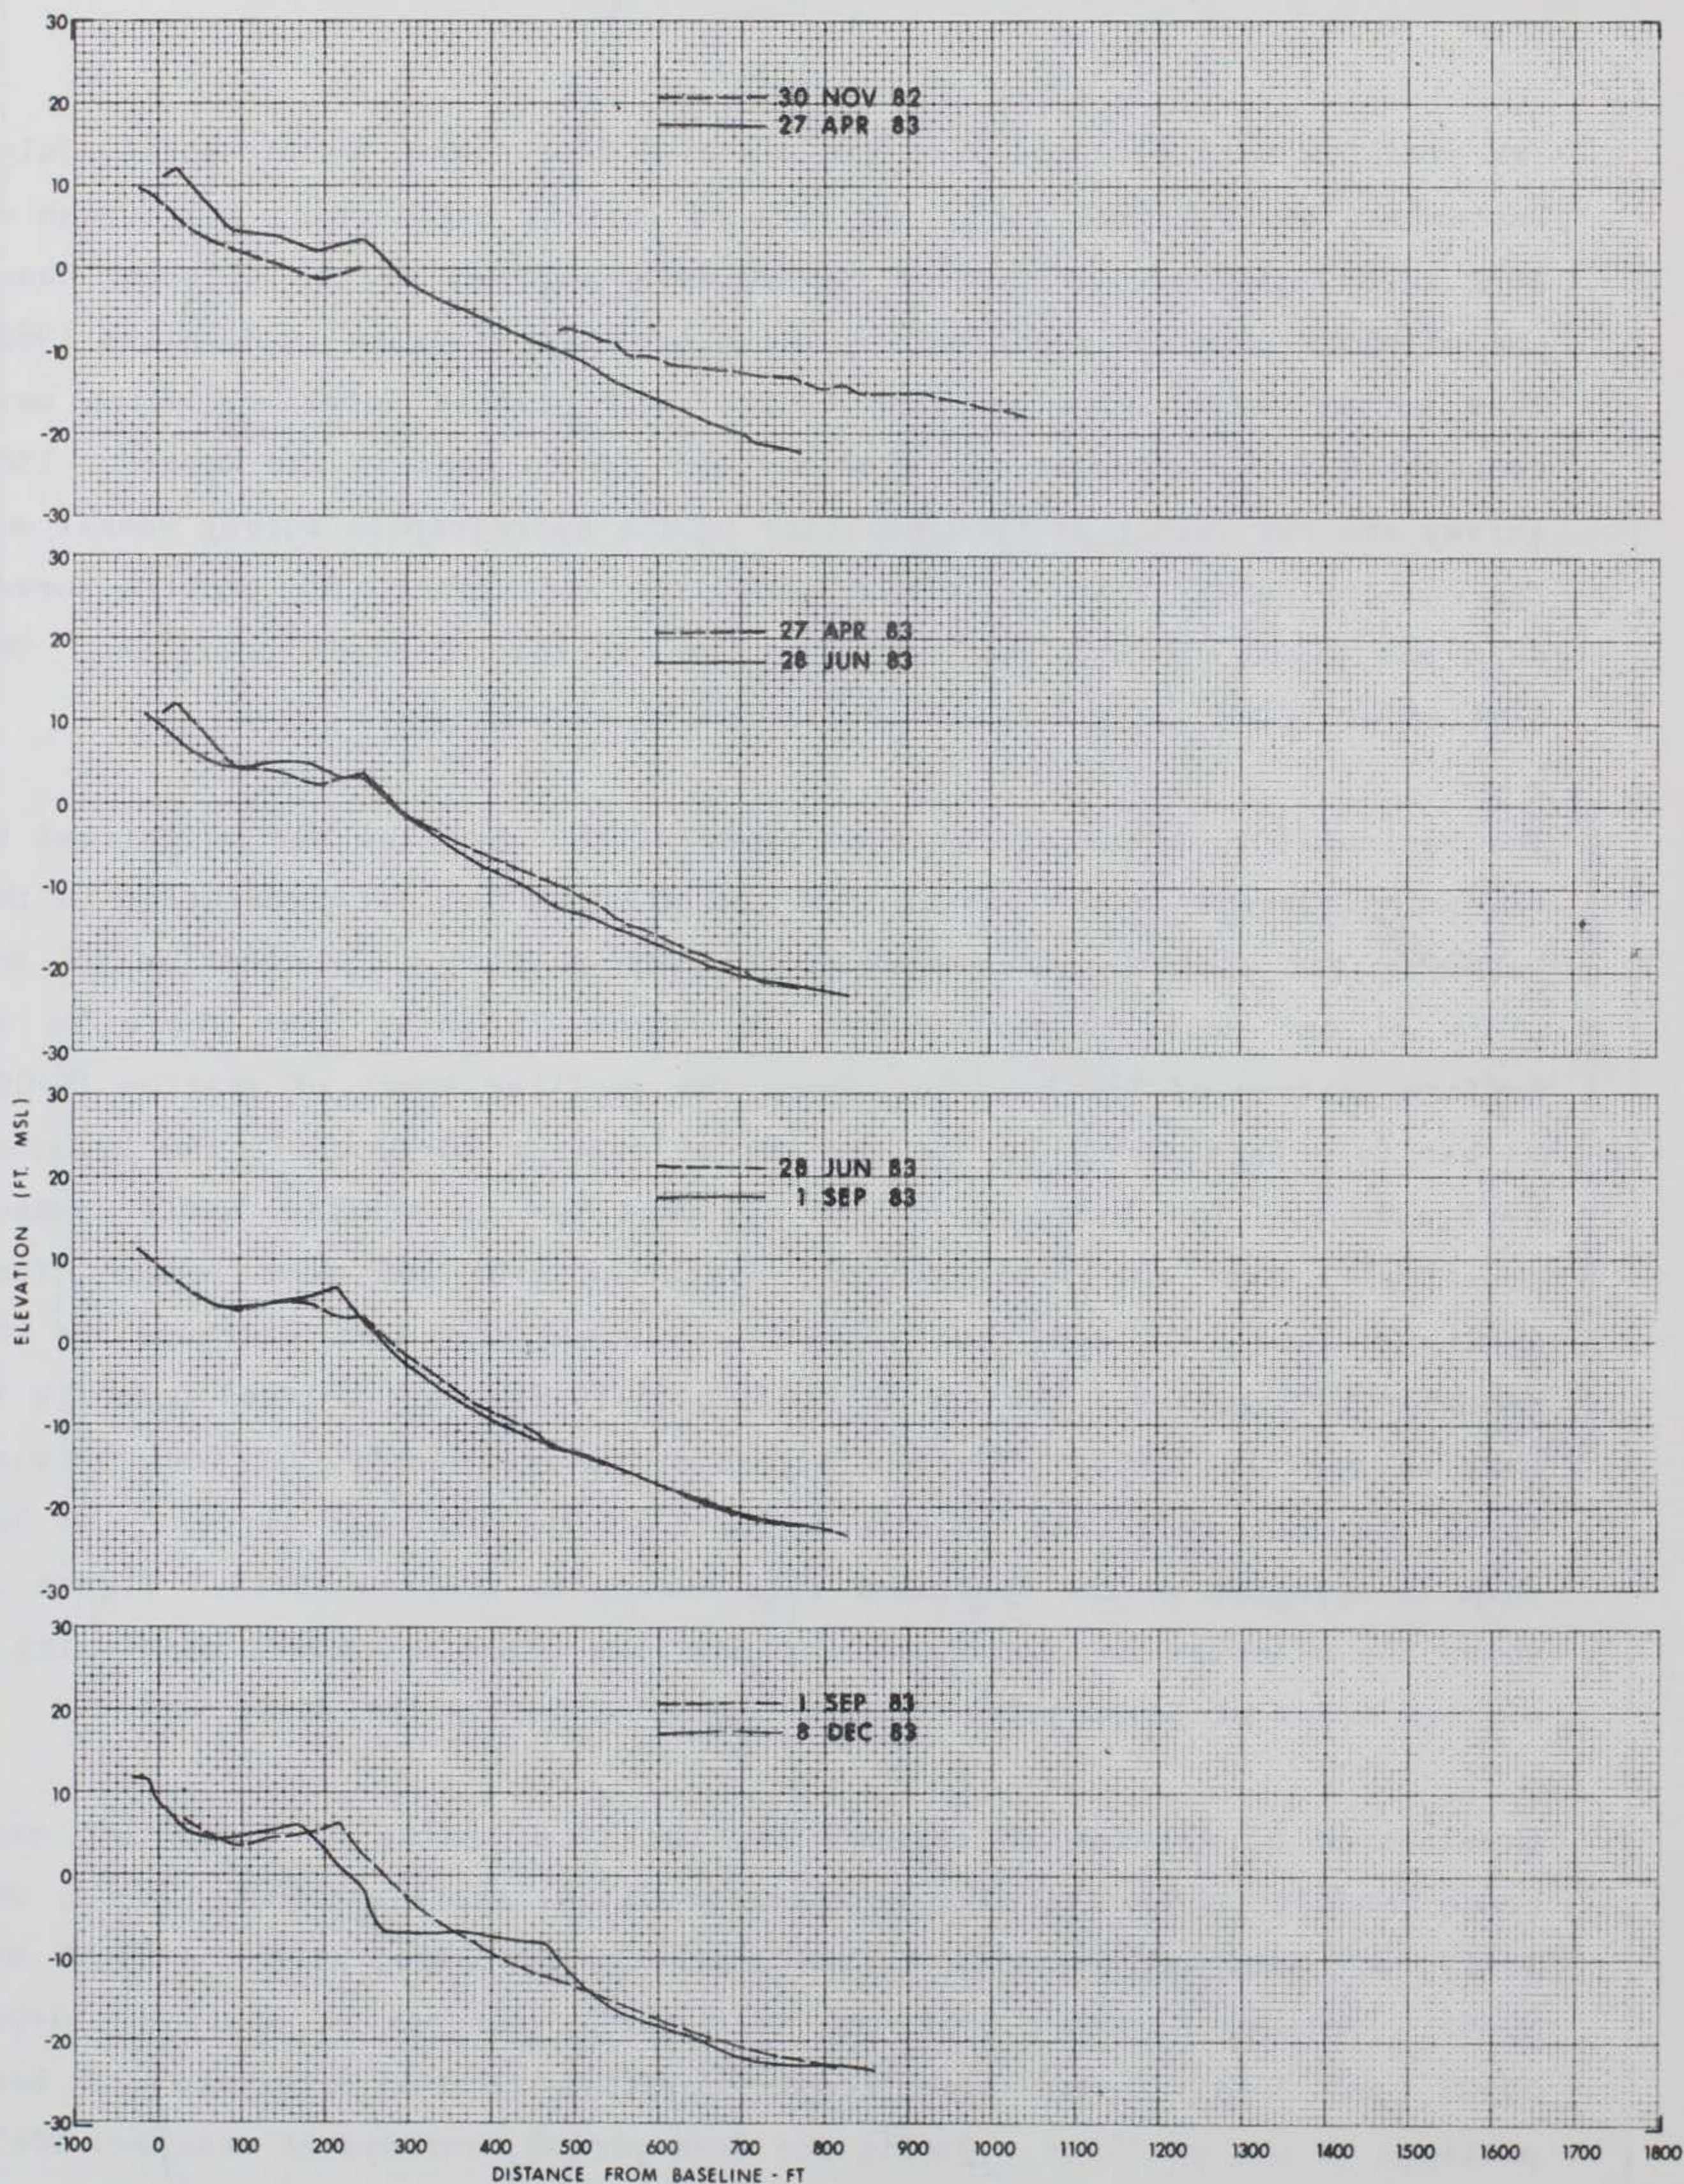
FIGURE 20

Examination of figures 20 through 24, the time series of plots for each beach profile, shows that the northern profiles, stations 10+00, 20+03, and 35+19, act somewhat opposite to the southerly profiles, stations 50+56 and 60+81. Between November 1982 and April 1983, surveys at stations 10+00, 20+03, and 35+19 showed significant accretion of the foreshore and berm portions of the profiles. During the same period, surveys at stations 50+56

COMPARATIVE BEACH PROFILES
CAPE HATTERAS LIGHTHOUSE SEASCAPE® MONITORING
NOVEMBER 1982 TO DECEMBER 1983

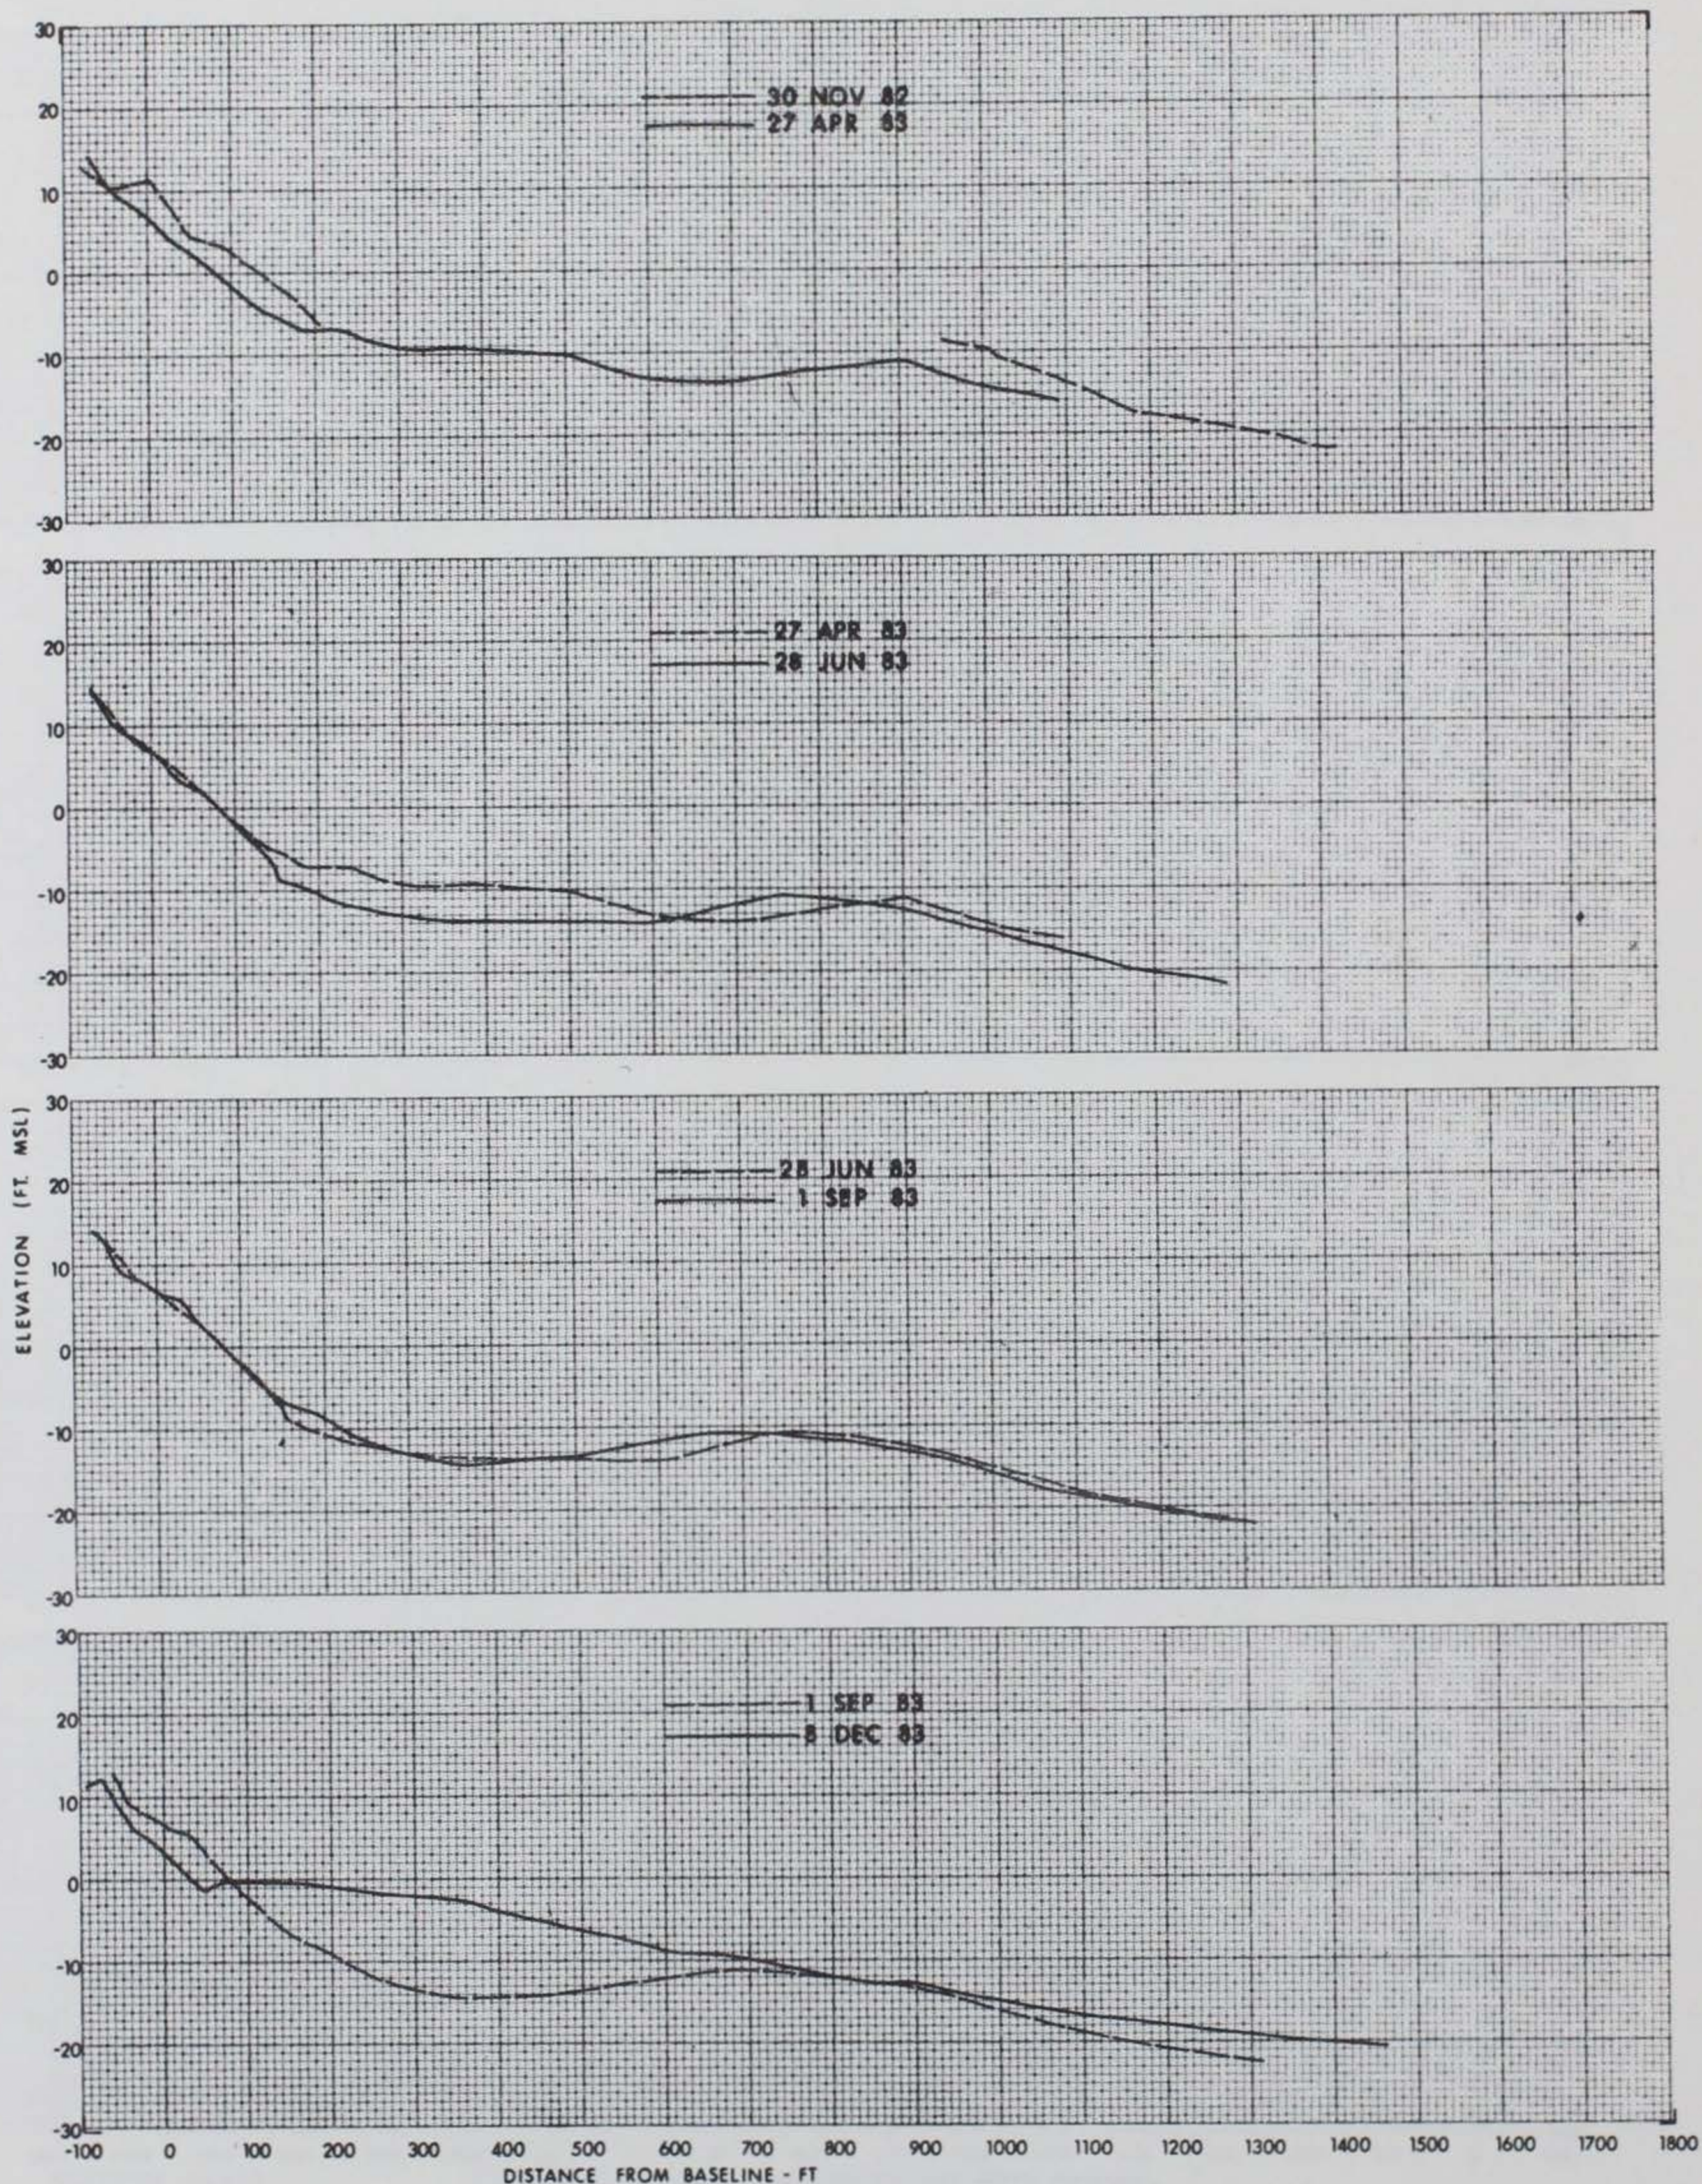
FIGURE 24

COMPARATIVE BEACH PROFILES
CAPE HATTERAS LIGHTHOUSE SEASCAPE® MONITORING
NOVEMBER 1982 TO DECEMBER 1983

The period from September to December 1973 was the period of the greatest change in profile form over the study area. Again, the northern half of the study area exhibited behavior opposite to the southern profiles. The surveys for Stations 10+00, 20+03, and 35+19 all show berm and foreshore erosion accompanied by bar formation close to shore and loss of material from the offshore zone during the September through December period. At station 50+56 there is significant buildup of the berm and foreshore portions of the profile accompanied by loss of material from the offshore zone. At station 60+81, significant filling of the foreshore resulting in gains in elevation of over 12 feet at a point 500 feet from the baseline (see figure 24) is accompanied by losses of material from the berm and offshore zones.

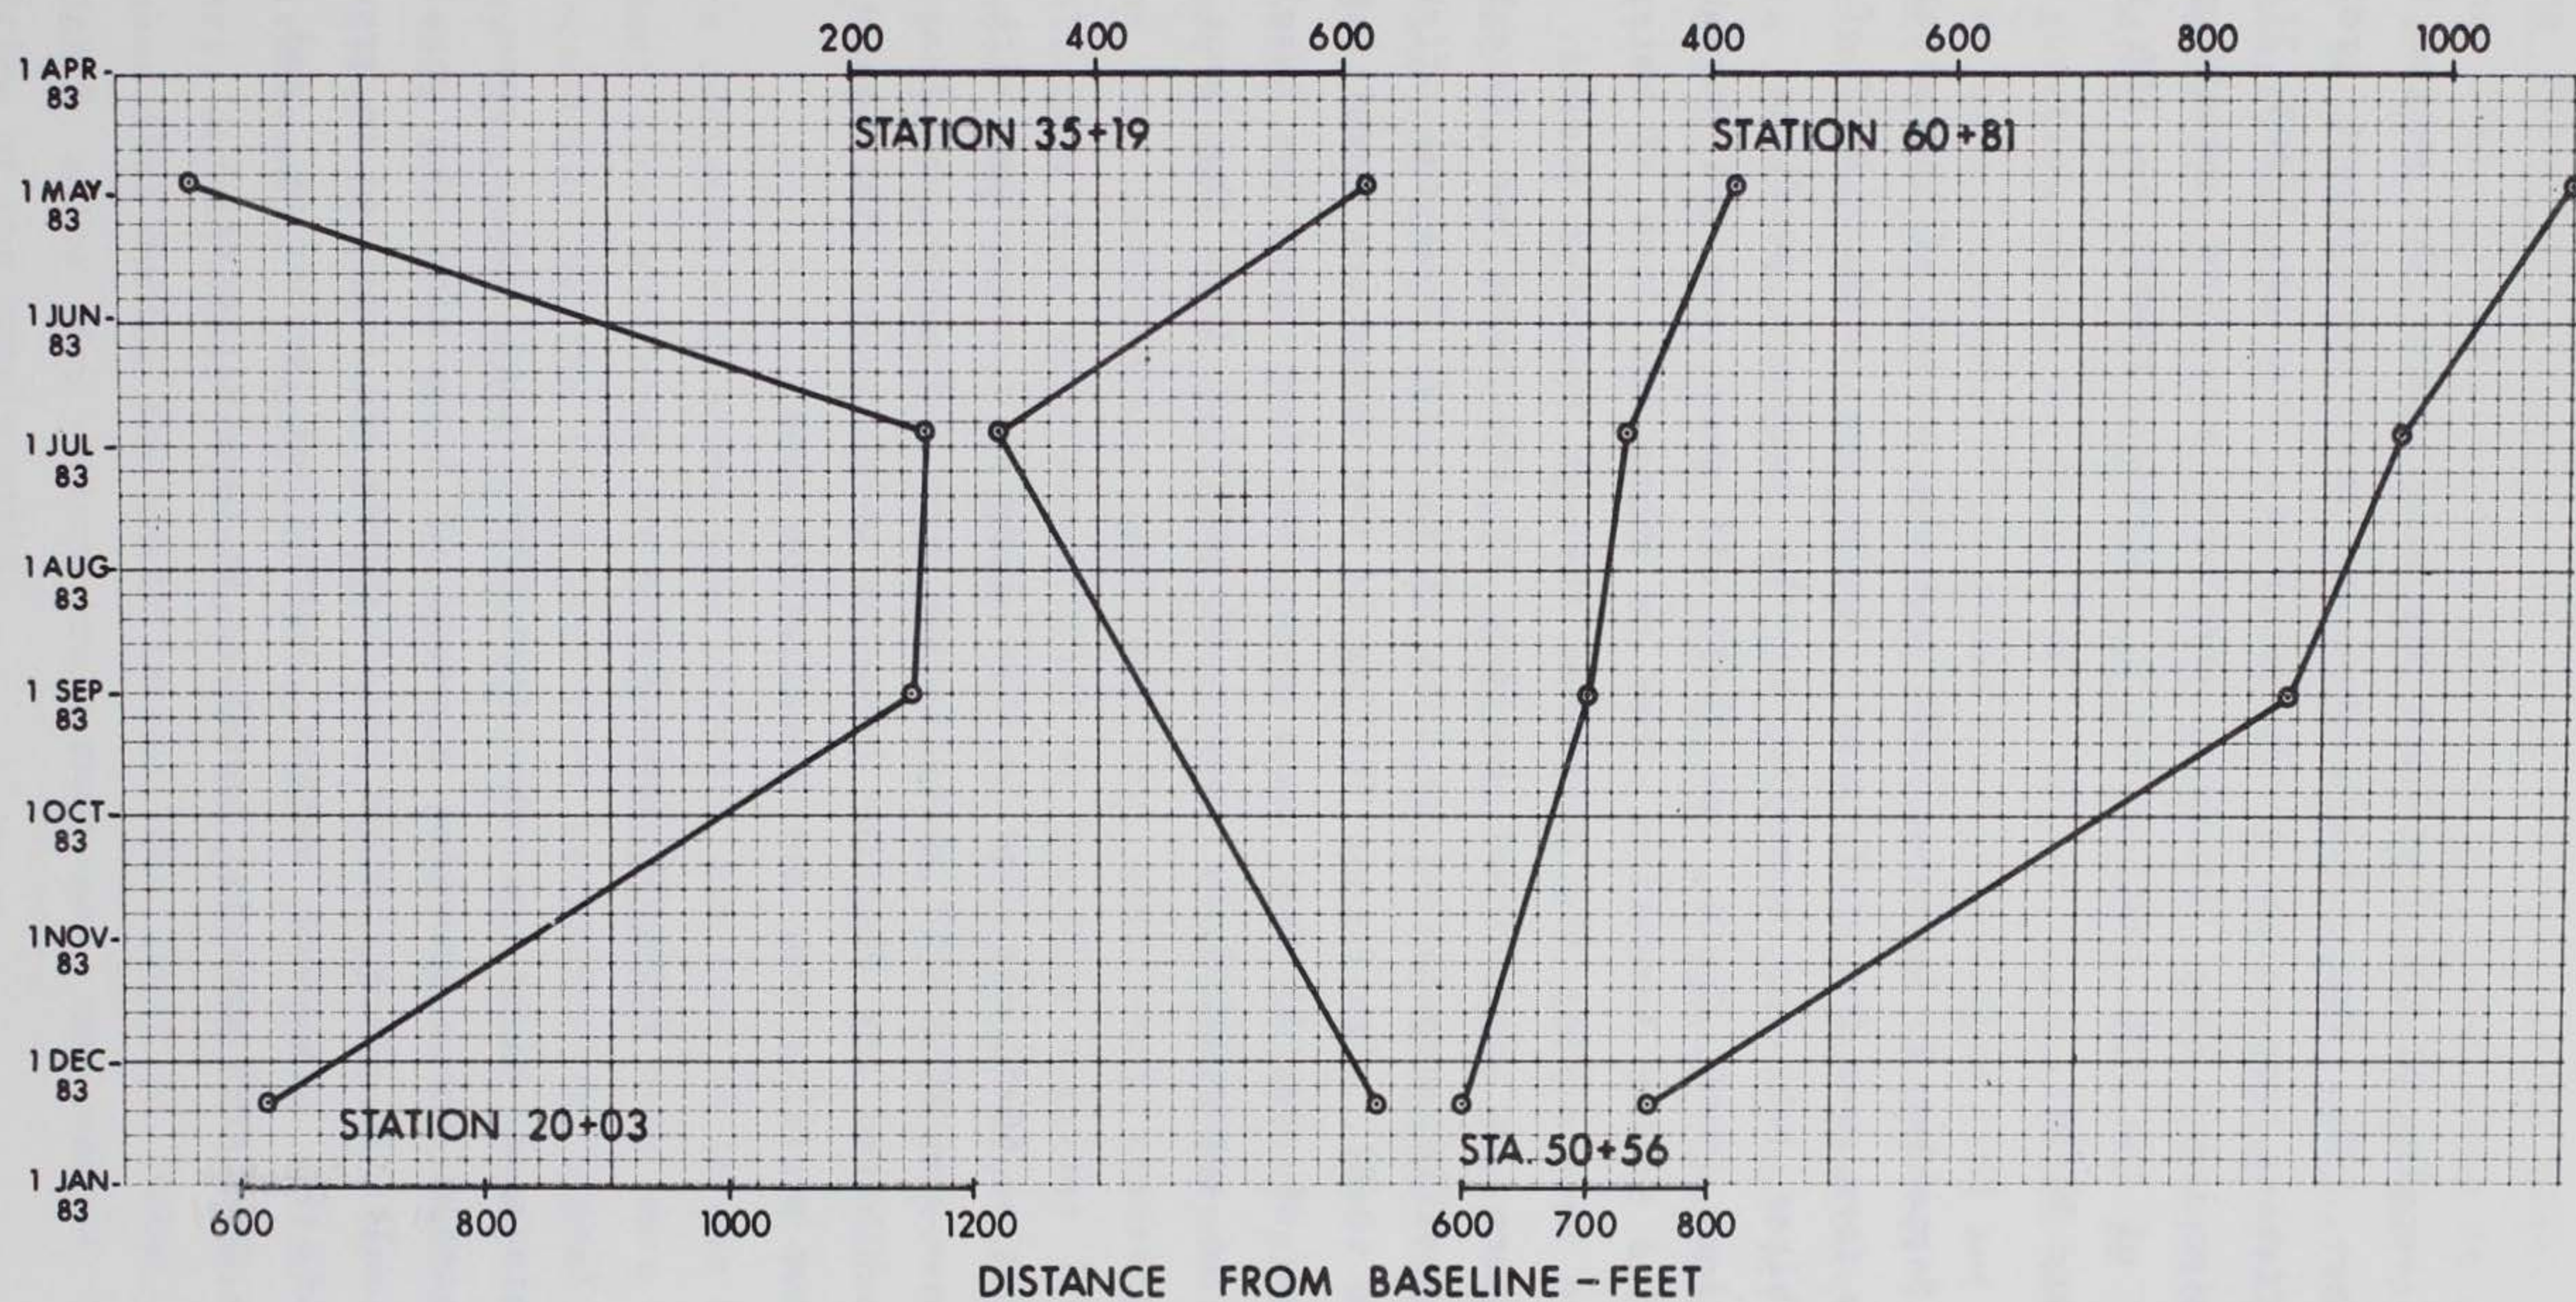
FIGURE 25

The variability of the offshore portions of the profiles was quantified by measuring changes in the position of the offshore bar crest relative to the baseline and plotting the measurements versus time. Examination of the plots of bar position versus time in figure 25 shows that there is no uniform pattern of bar behavior among the profiles south of station 10+00. No bar form is apparent in the profile at station 10+00 until the December 1983 survey. The location of the offshore bar in profile 20+03 changes drastically over the study period, migrating over 500 feet seaward from April to June 1983 and then returning seaward the same distance by the December 1983 survey. The bar in profile 35+19 displays a trend opposite to that in profile 20+03. The bar migrates inshore nearly 300 feet between April and June 1983 then reforms offshore by the December survey. No bar form is apparent in the September 1983 survey at station 35+19. Figure 25 shows the offshore bar locations for profiles 50+56 and 60+81 displaying a similar trend of progressive onshore migration during the study period.

LOCATION OF OFFSHORE BAR
CREST RELATIVE TO BASELINE
