MISCELLANEOUS PAPER CERC-86-2

GENERALIZED MONITORING OF SEASCAPE® INSTALLATION AT CAPE HATTERAS LIGHTHOUSE, NORTH CAROLINA

February 1986

The National Park Service
Cape Hatteras Seashore
North Carolina

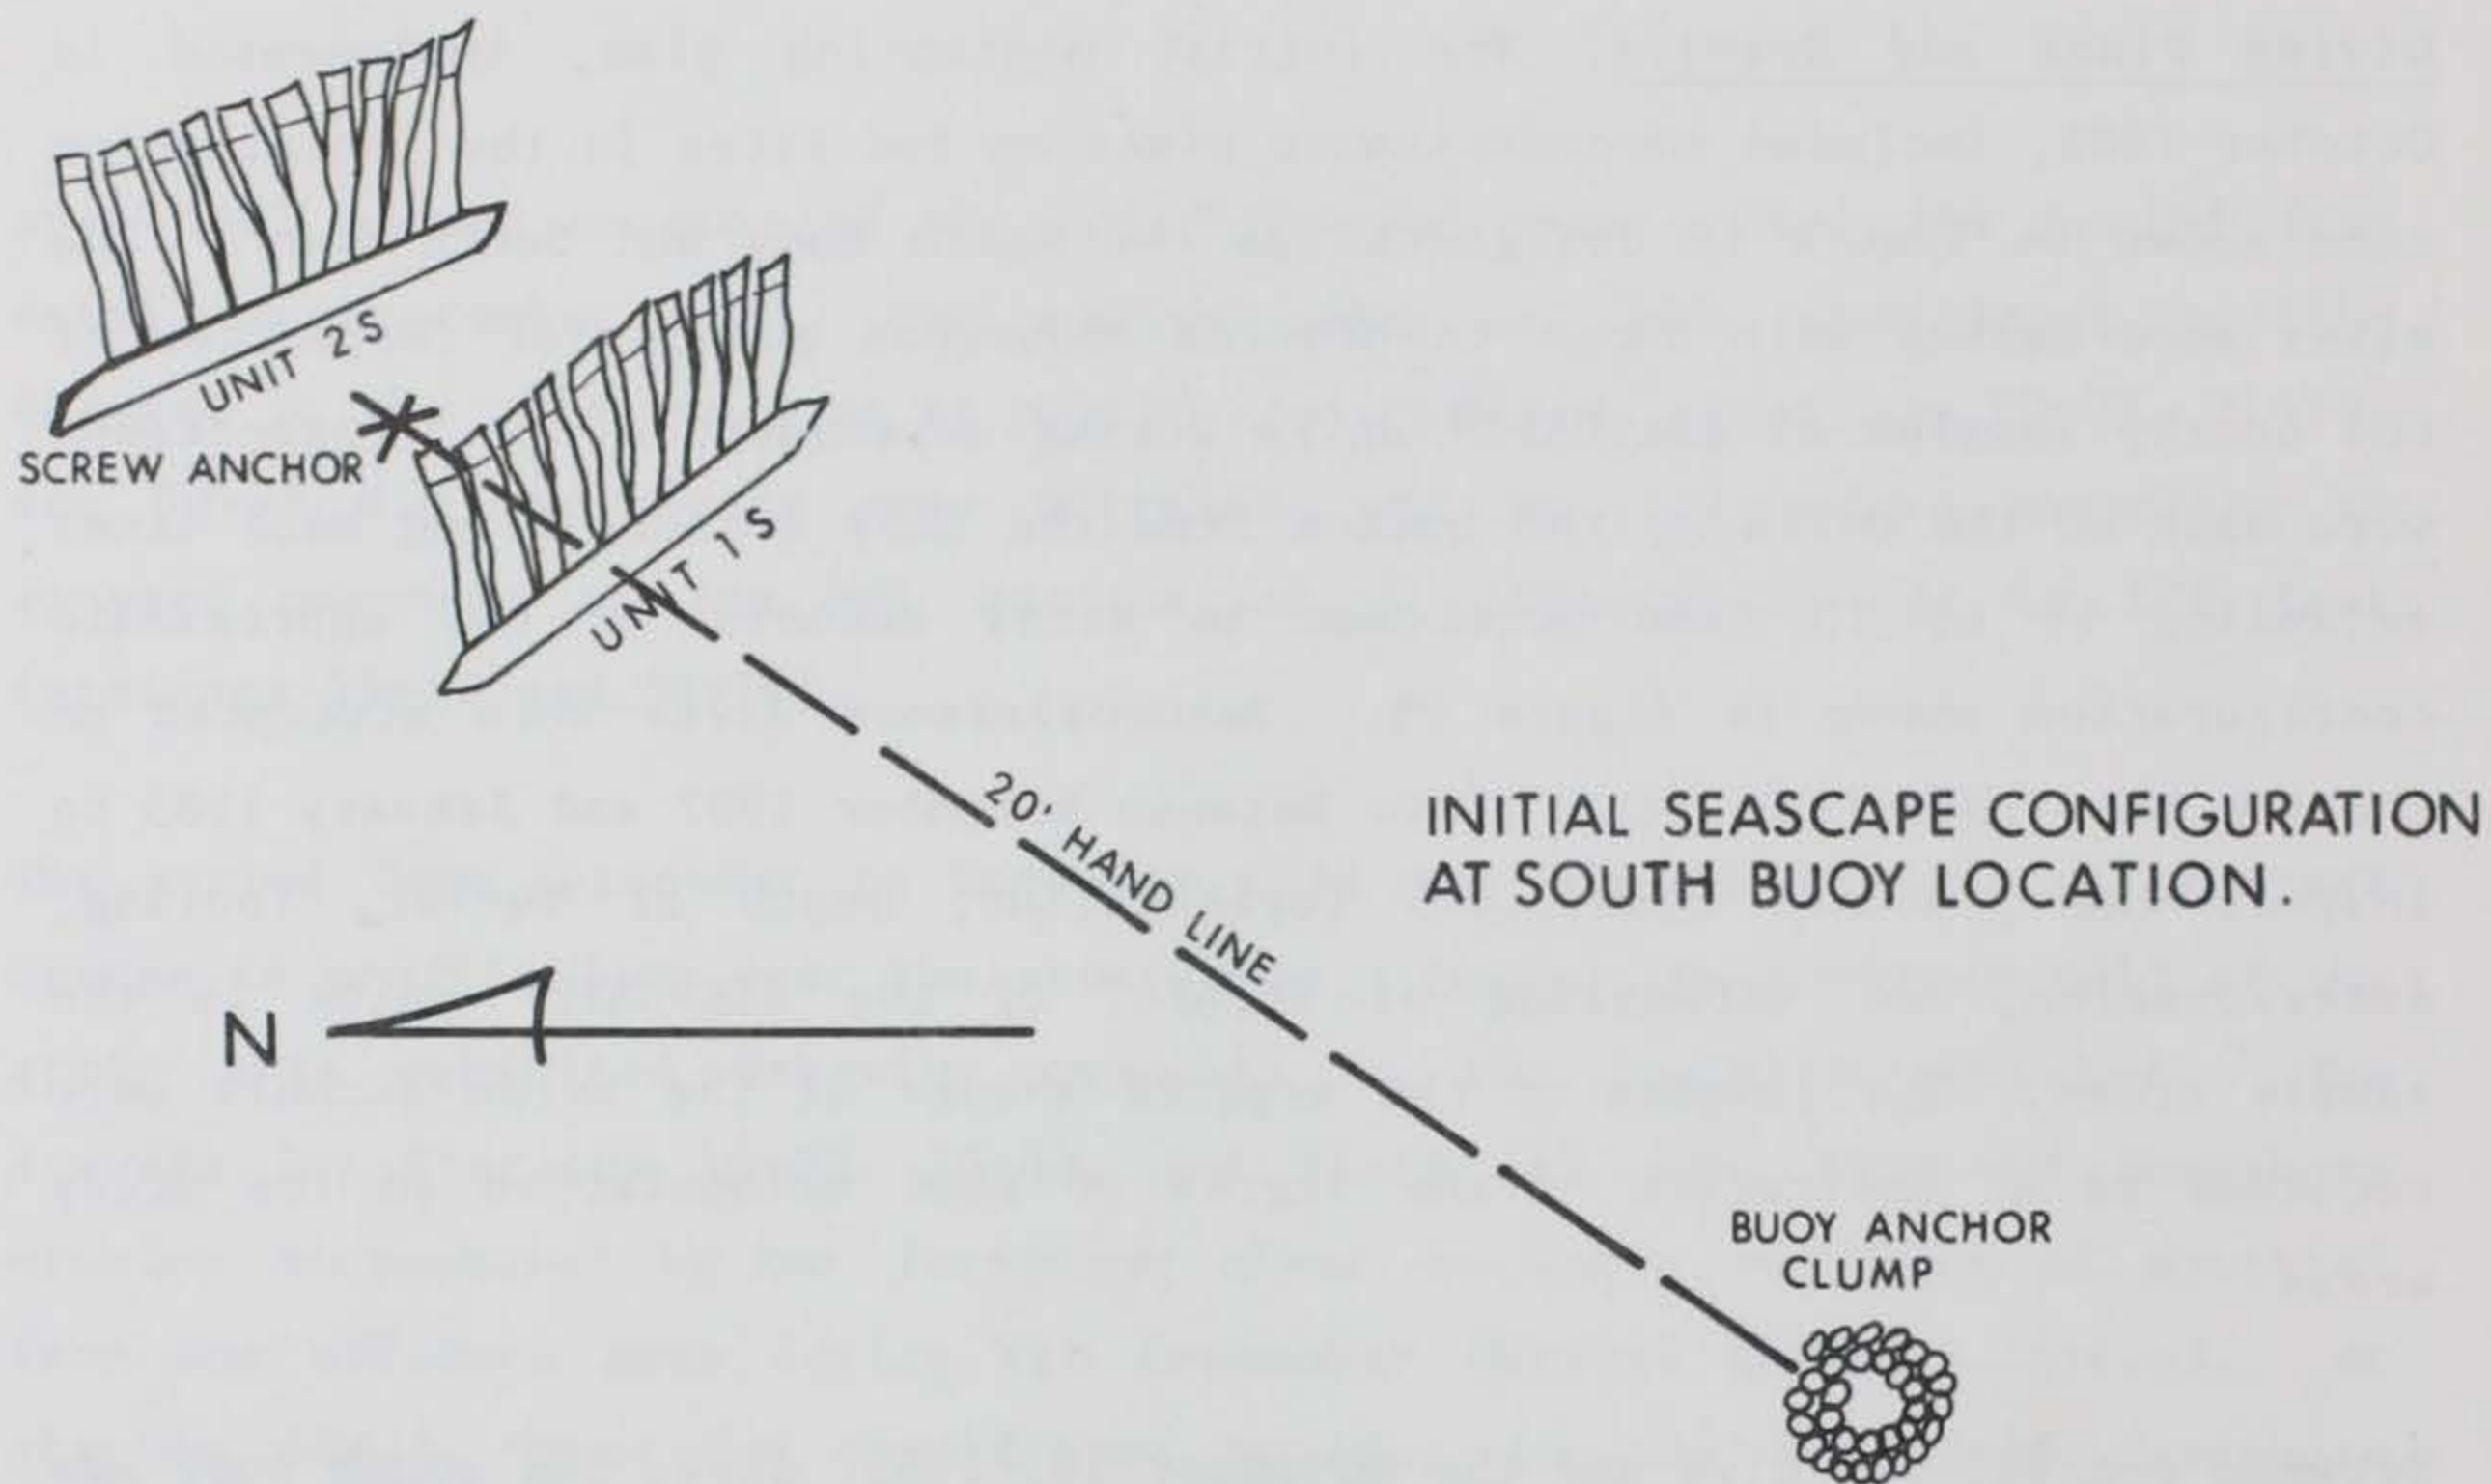
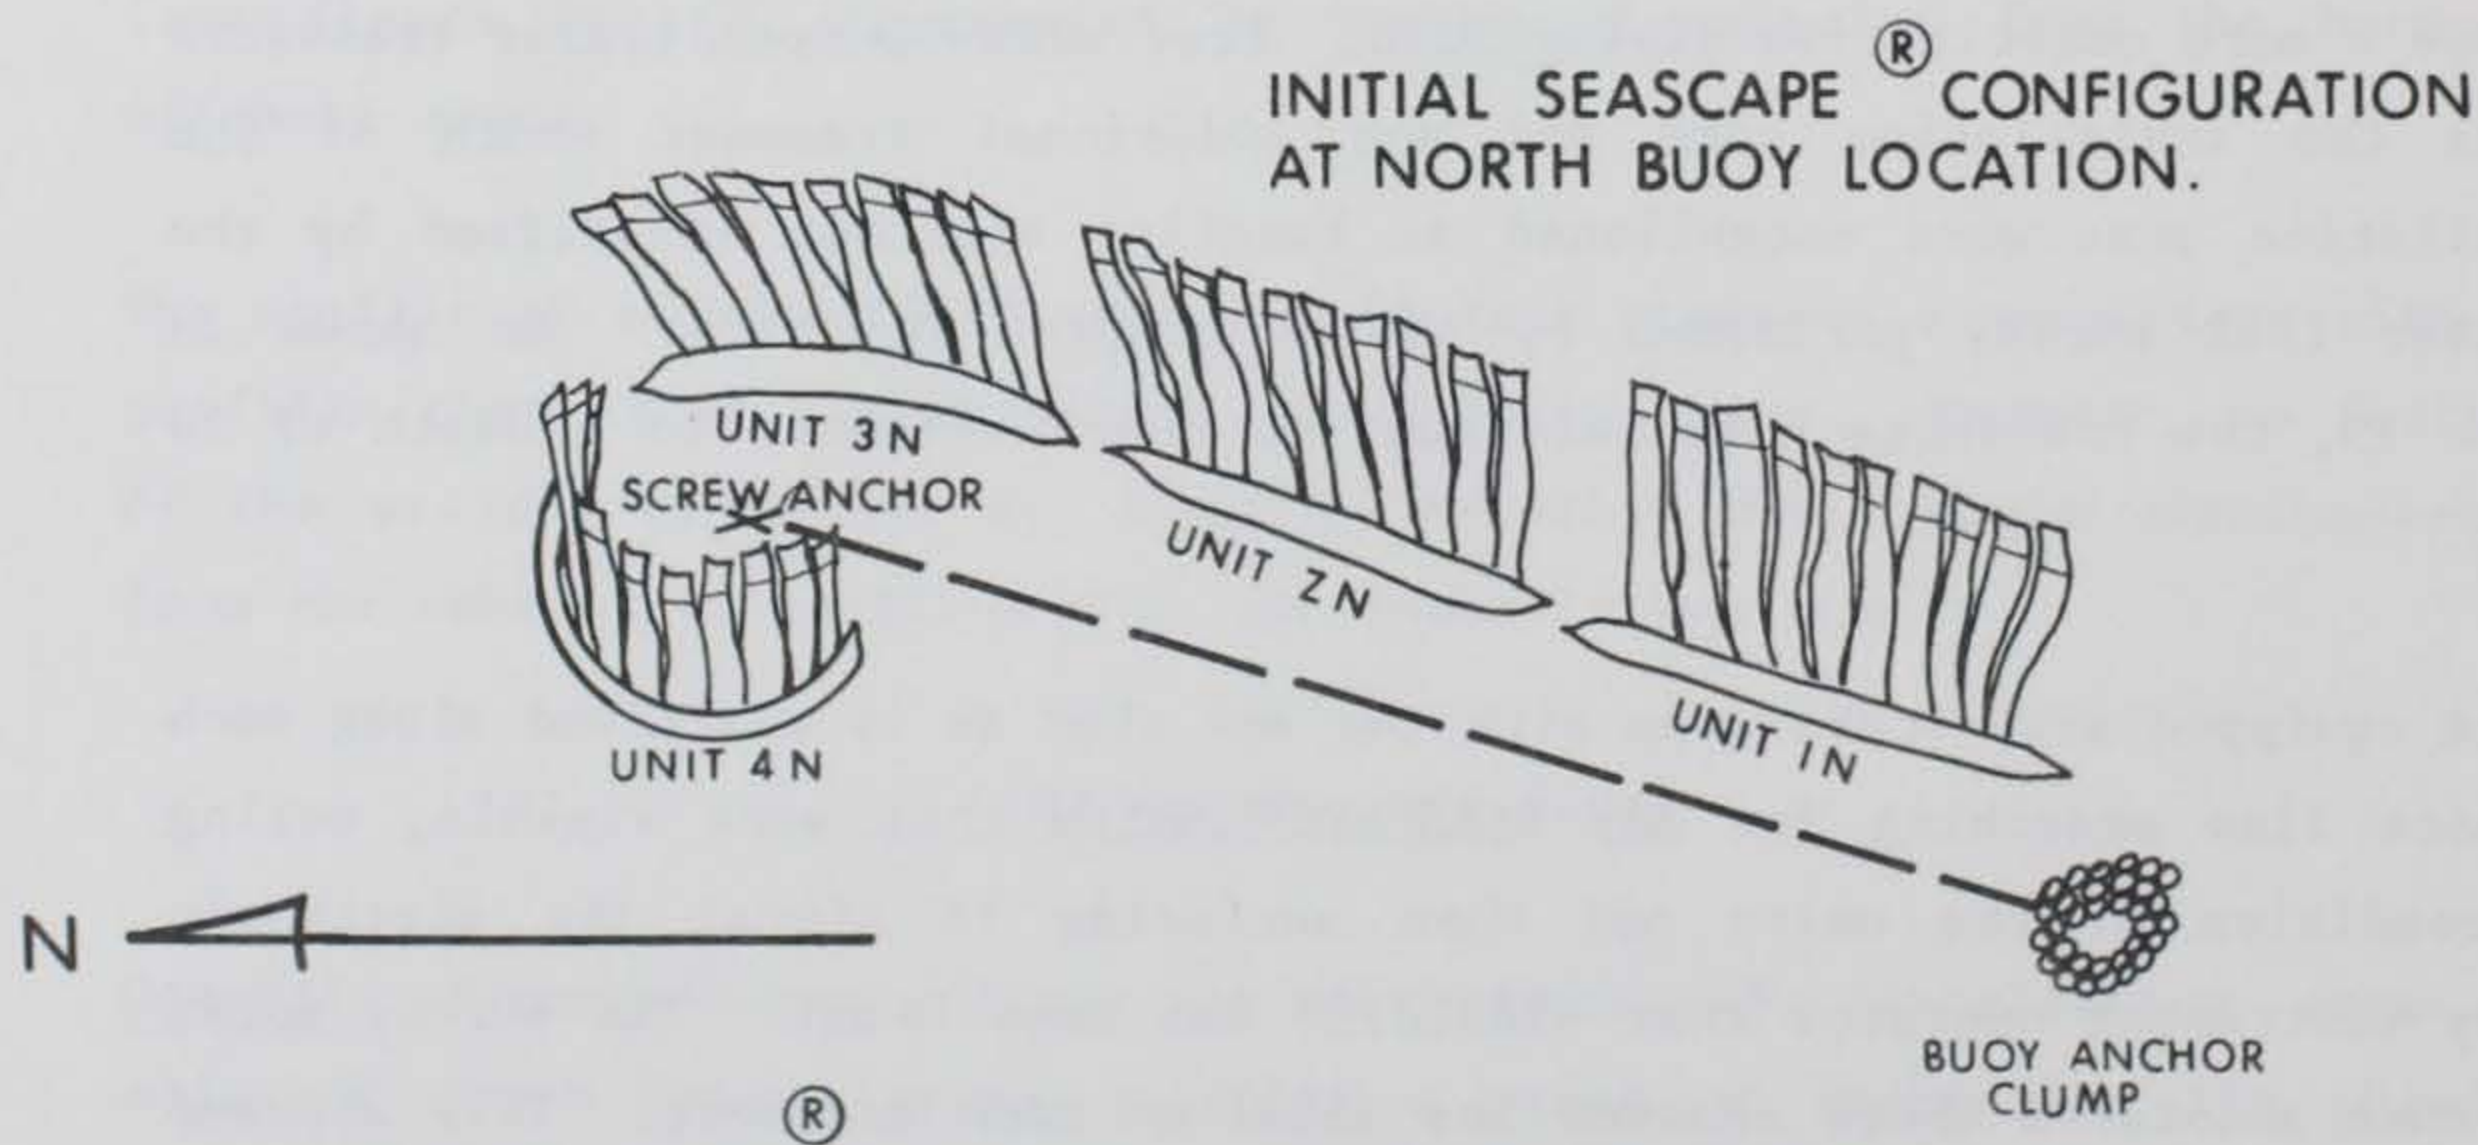
FIGURE 26

SEASCAPE CONFIGURATIONS AT NORTH
AND SOUTH BUOY LOCATIONS

North Buoy Observations: A group of four SEASCAPE® units was in place along the hand line from the buoy anchor to the screw anchor (see figure 26). Limited visibility prevented divers from observing the anchor tube sections of the units; however, divers did observe that the bags were approximately half exposed and the fronds were free and untangled. A spot dive about 20 feet inshore of the north buoy location revealed SEASCAPE® units with only 6 inches of fronds exposed. No attempt was made to determine if the fronds were buried in a vertical position. Most of the material in the anchor tubes was located at one end, leaving 25% of the tube without material.

North Buoy Observations: Due to zero visibility on the bottom, a visual inspection of the area was impossible. However, divers did conduct a "hands on the bottom" search and were able to discover evidence of only one SEASCAPE® unit. Four 4-inch sections of fronds were exposed west of the screw anchor which would indicate that they belonged to unit 4N (see figure 26) identified during the first monitoring dive. None of the ping-pong size subsurface buoys identifying individual units or evidence of the other three units were found. The 2.05 feet of the screw anchor was exposed indicating that there had been an accumulation of sand at the anchor of 1.4 feet since the initial dive.

North Buoy Observation: The sand level was found to have accreted to within 0.20 foot at the top of the screw anchor shank indicating a 1.5-foot sand level rise since the November 30, 1982, installation. Fair visibility allowed a close inspection of the bottom, but no trace of SEASCAPE® units was found. One unit (marked by some floating line used by the contractor) was found approximately 30 feet east of the screw anchor. The tops of 3 fronds were exposed by digging down approximately 1 foot.

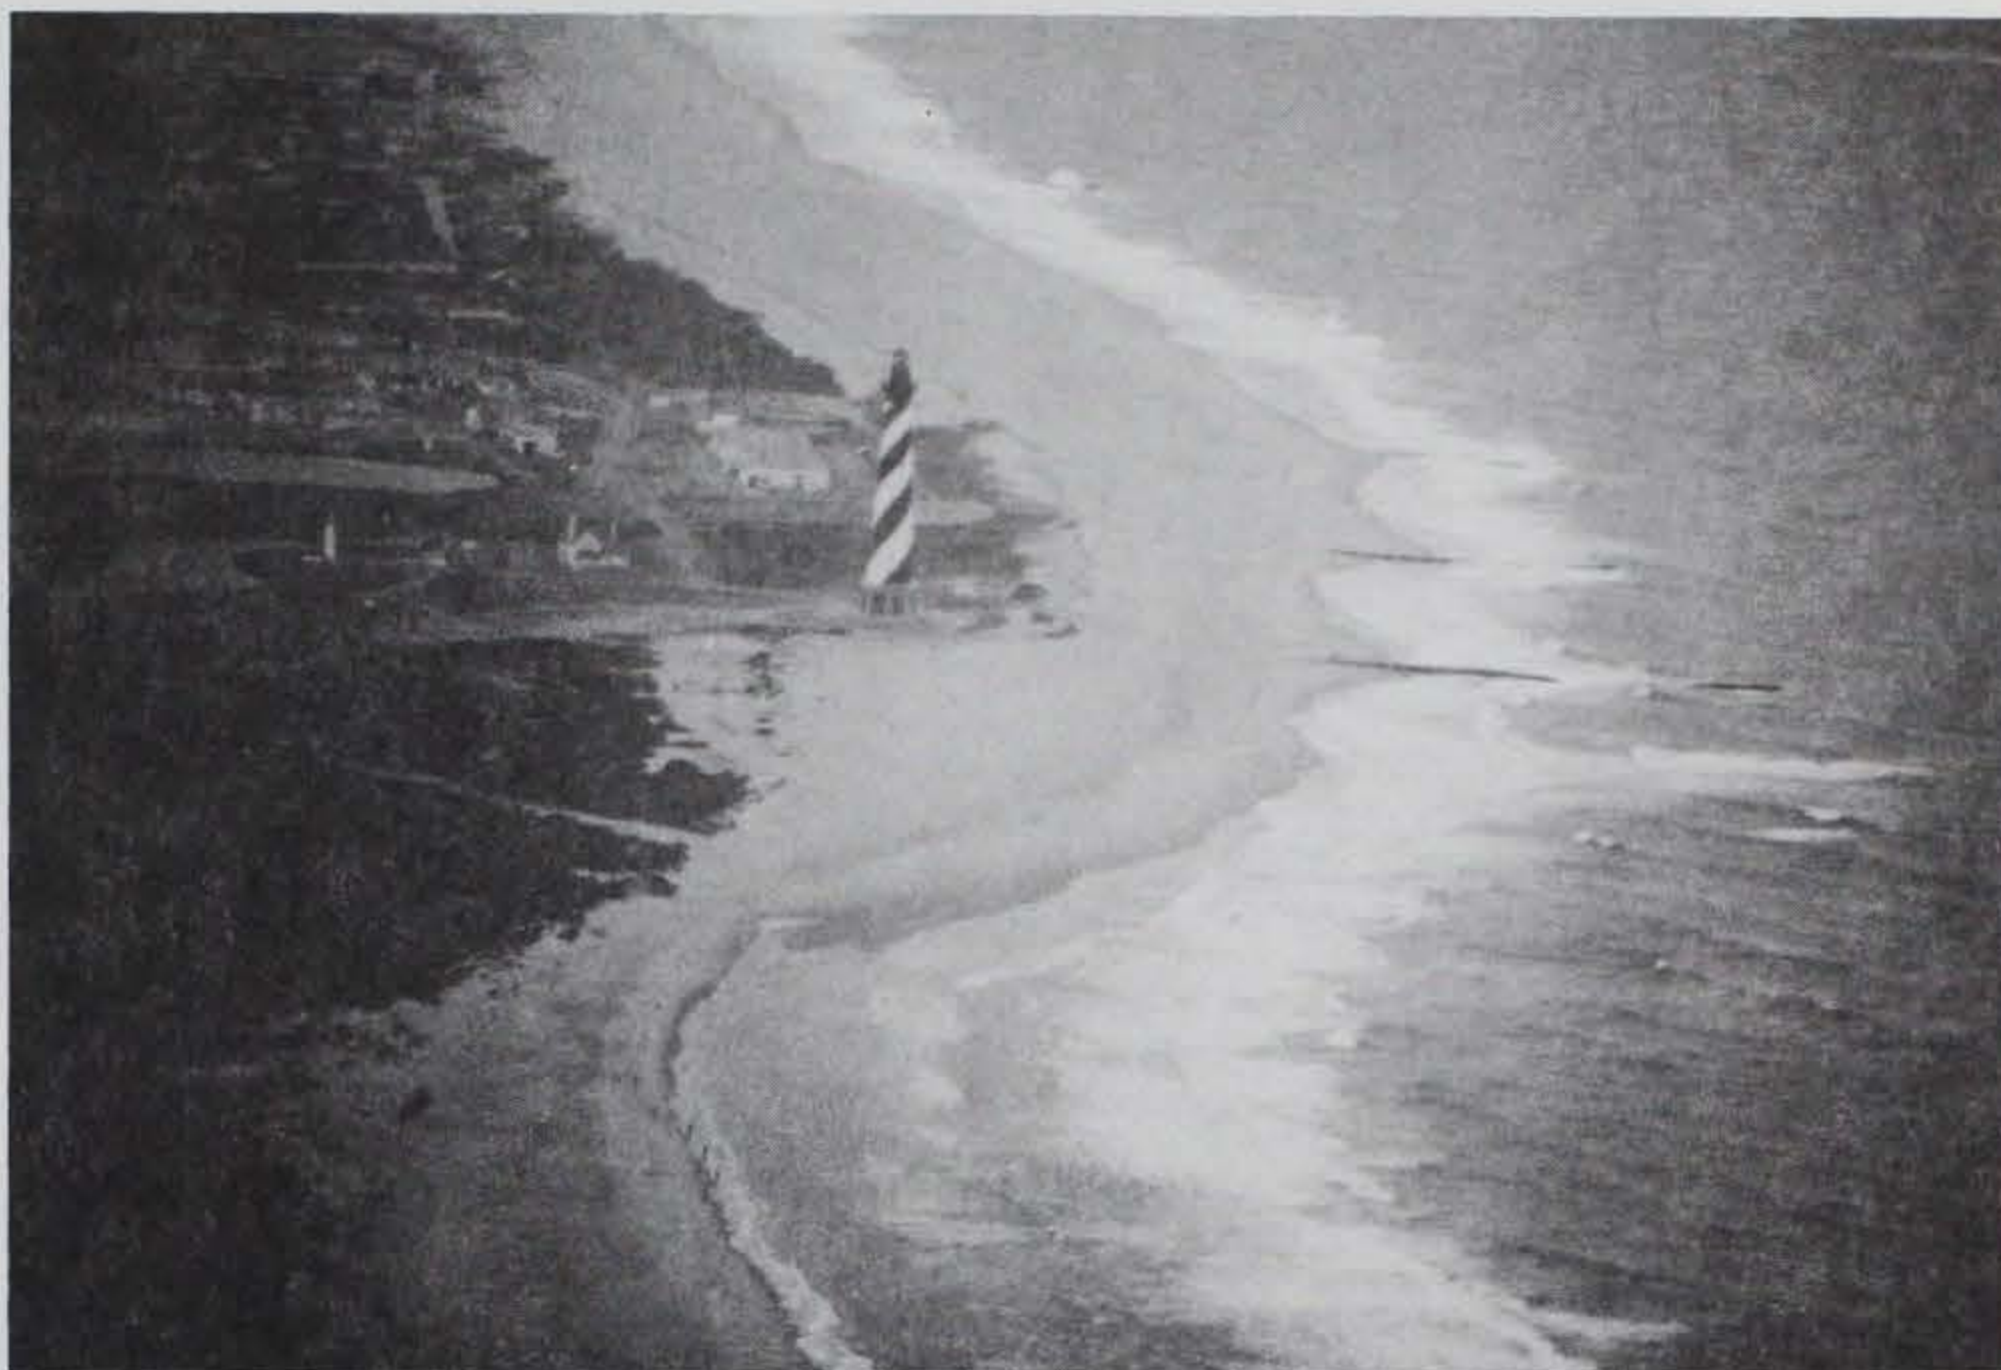
Photo 12 Cape Hatteras Shoreline, Looking Northeast - November 18, 1982

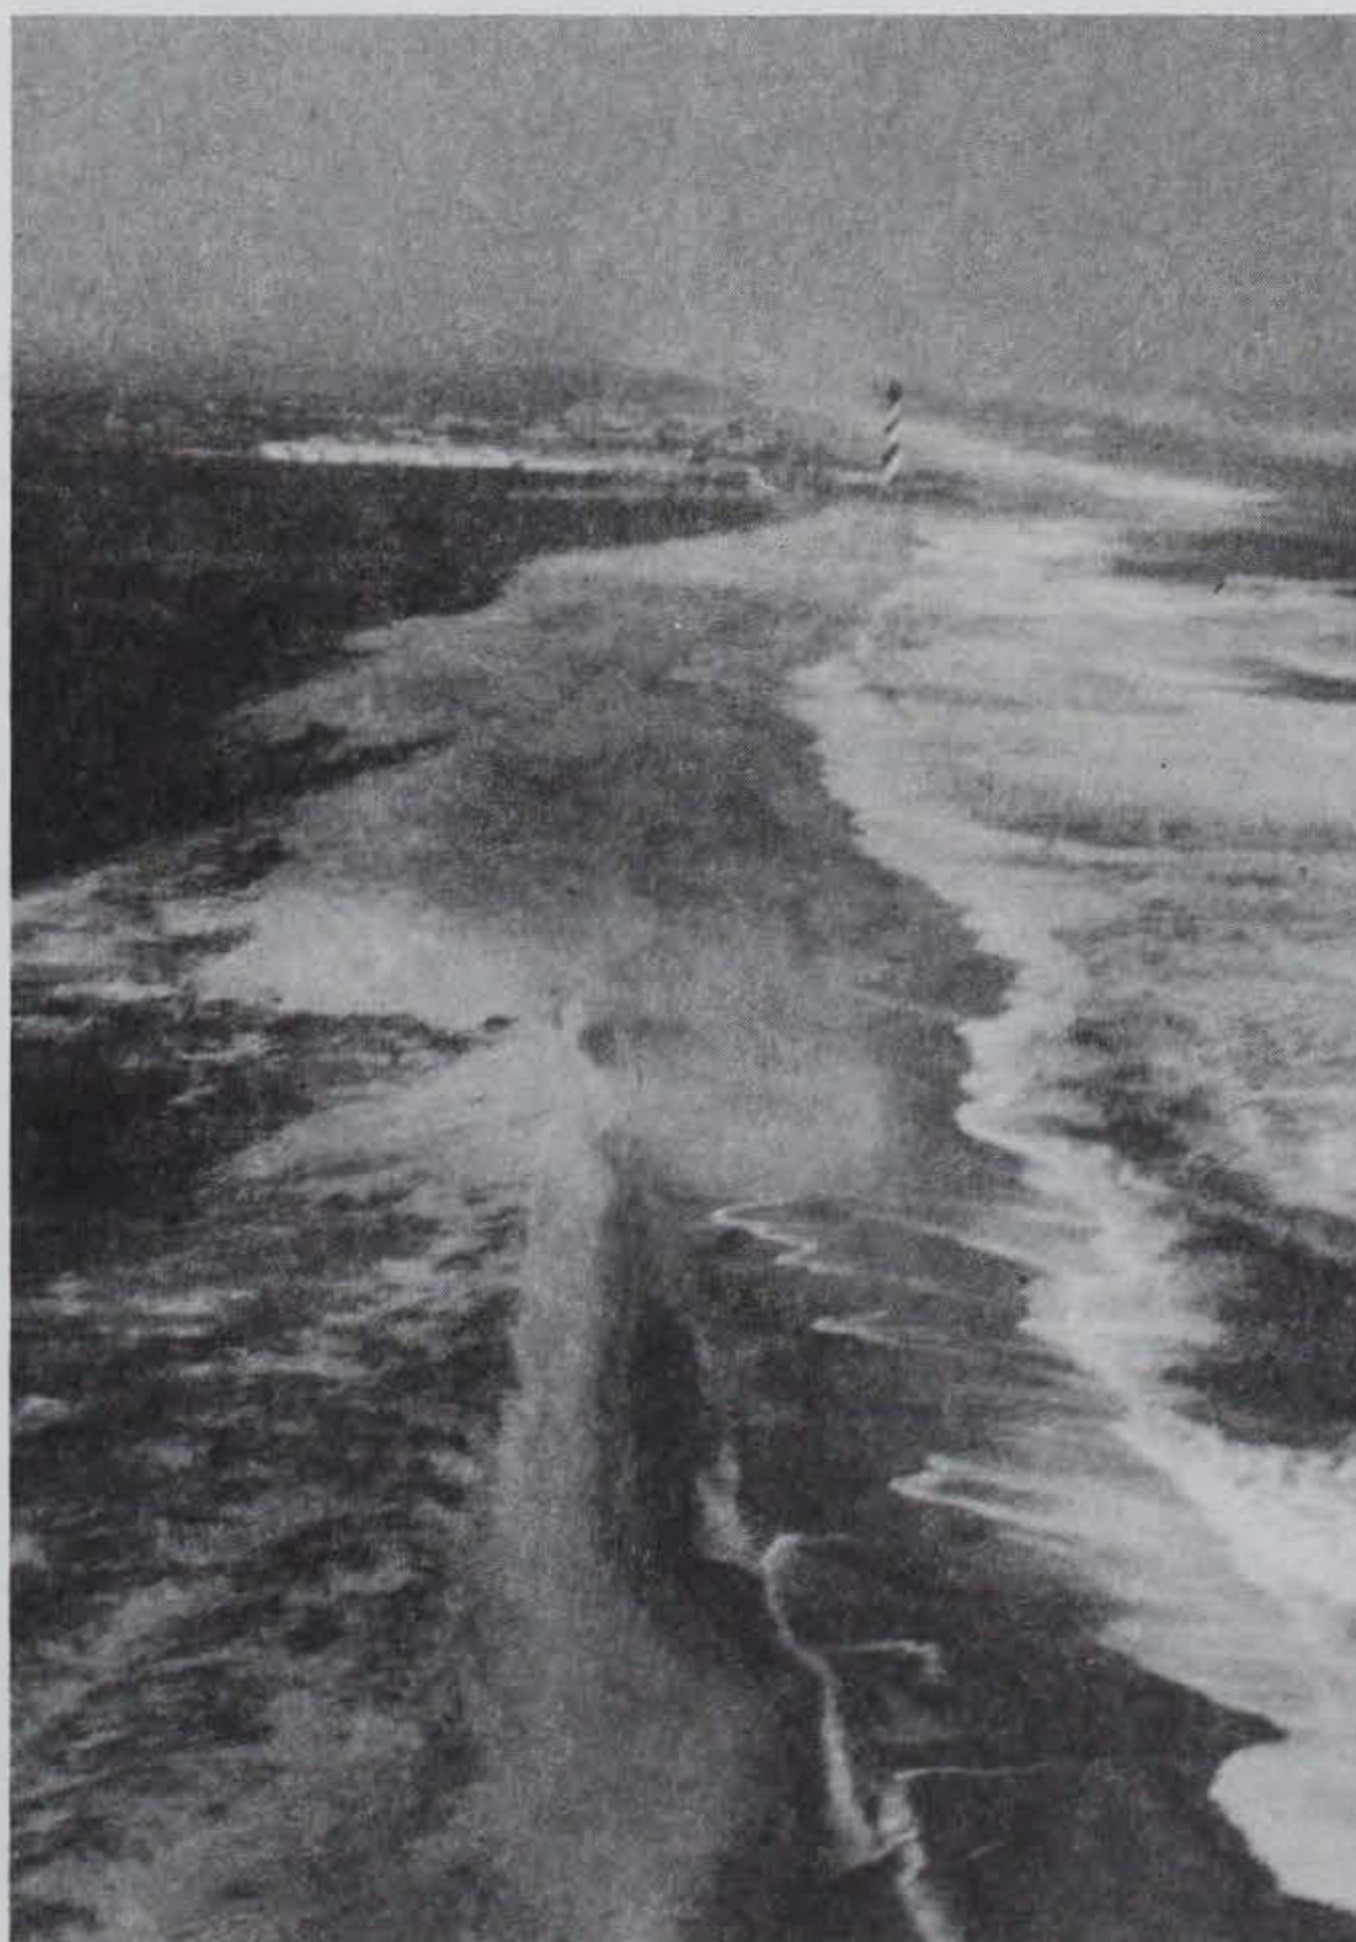
Photo 13 Cape Hatteras Shoreline, Looking North - January 12, 1984

Photos 13 and 14 were taken on a day when wave heights along the Outer Banks exceeded 8 feet. These photos show the highly turbulent nature of the Cape Hatteras shoreline during a typical northeaster. Winds at Cape Hatteras on January 12, 1984, were blowing from the northeast (34°) at an average speed of 20 m.p.h. (5)

Comparison of photos 8 and 9 with photos 13 and 14 shows the accretion of the shoreline immediately south of the groins documented in the vertical aerial photography study.
