ERDC/CERL TR-02-26

# Condition Assessment of William Beaumont General Hospital Historic Buildings at Fort Bliss, Texas

Thomas R. Napier and Sheila A. McCarthy

September 2002

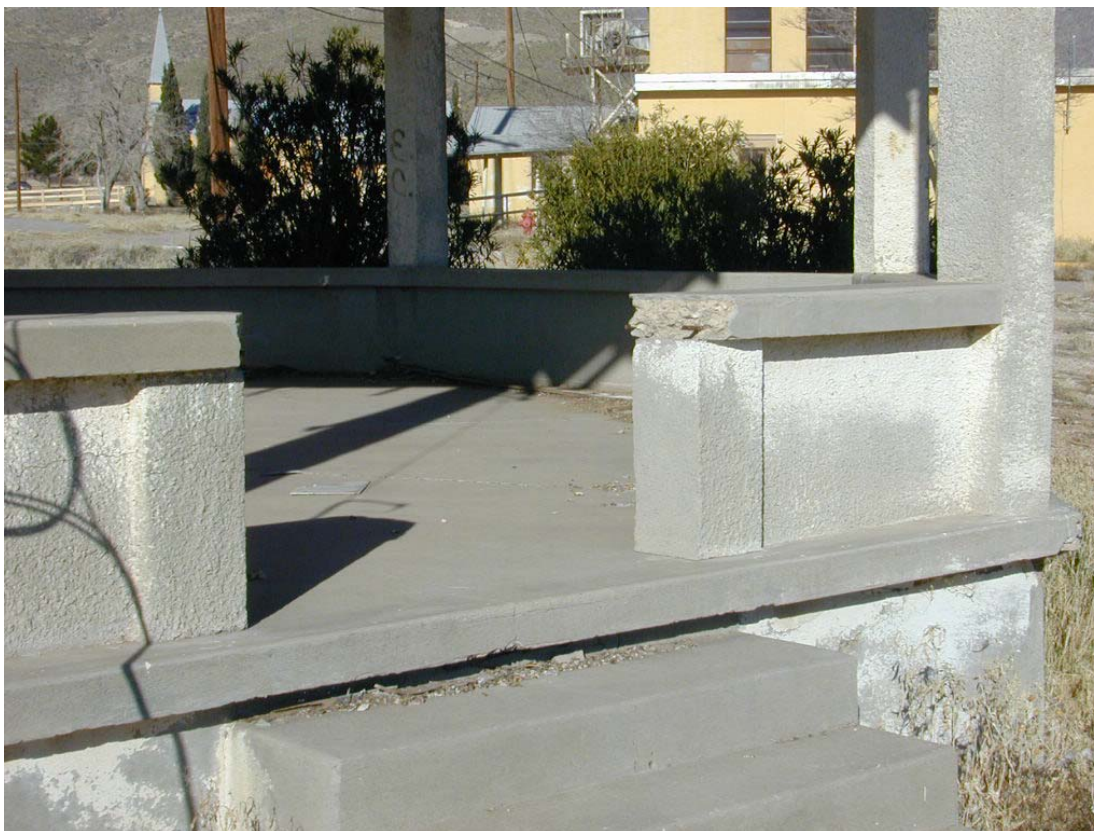
**Photograph 4. Detail of bandstand entrance.**

The entrance at the southeast side of the bandstand has apparently been enlarged by chopping away at the concrete rail. The edges are rough-cut (Drawing 1, F) and will need to be either ground smooth or patched to remove a hazard and improve appearance (Photograph 4).

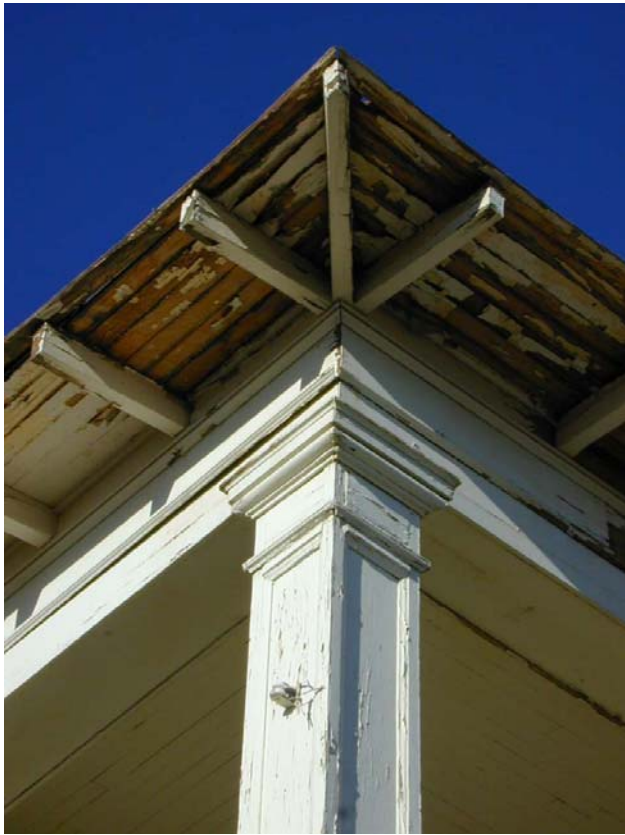
**Photograph 46. Typical barracks porch roof damage.**

The porches' roof structures are enclosed with wood bead board ceilings. Deterioration has occurred over the stairs at the north and south ends of each porch, where water damage to the roofs is most evident (Drawings 5 – 7, I; Photograph 46). Repair and refinishing may be possible, but replacement of some boards is likely to be required. Otherwise, the bead board ceilings appear to be reasonably sound, and rehabilitation may require only scraping, priming, and painting.

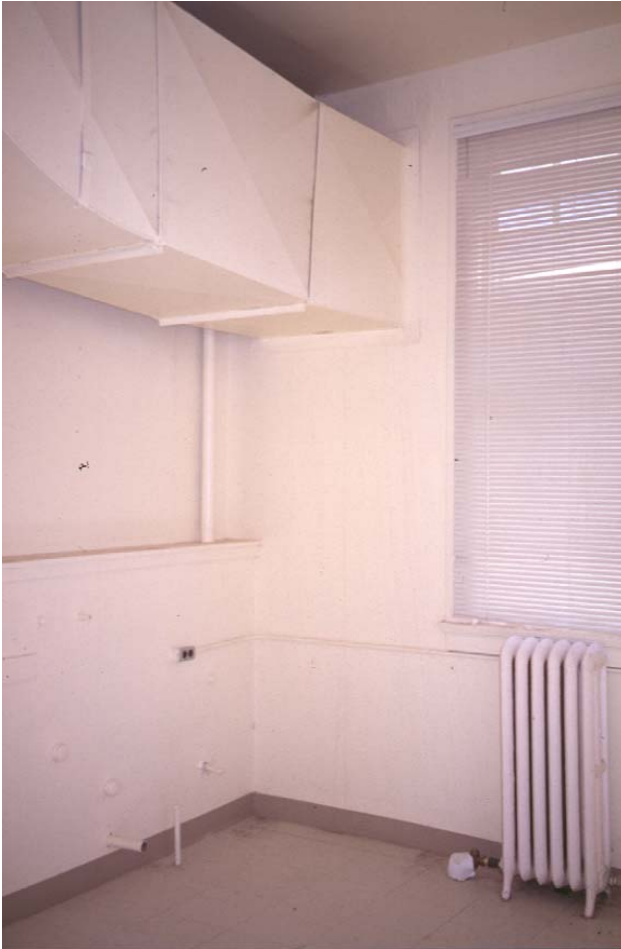
The first floor is serviced by an evaporative cooler located at grade level outside of room 105. A duct enters the room through one window's upper sash, which tees into the supply duct running the length of the building and supplying each room. The second floor is serviced by a cooler mounted on a steel-framed tower at the south end of the building outside of room 202. A duct enters the room through the wall and runs the length of the building, supplying each room. The coolers were installed 5 years ago and are reported by DPW personnel to be serviceable (Photograph 50).

**Photograph 50. Building 7157 cooling equipment.**

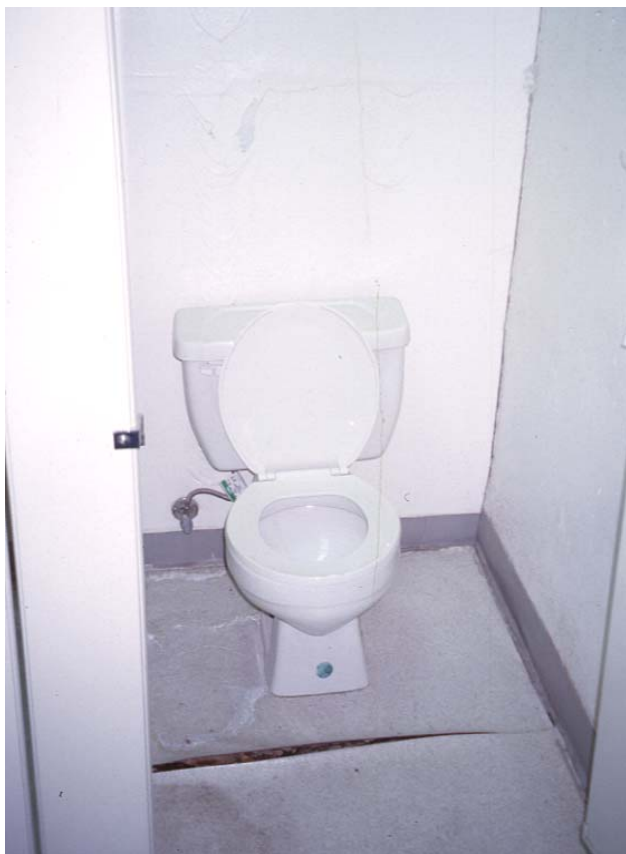
**Photograph 53. Damaged vinyl flooring in Building 7158 washrooms.**

Water leakage and overflow has damaged the plaster in the washroom partitions on both the first and second floors (Drawing 6, Z; Photograph 52). Water leakage has also damaged the vinyl flooring to the extent it is peeling off of the floor (Drawing 6, AA; Photograph 53). These items will require extensive repair.

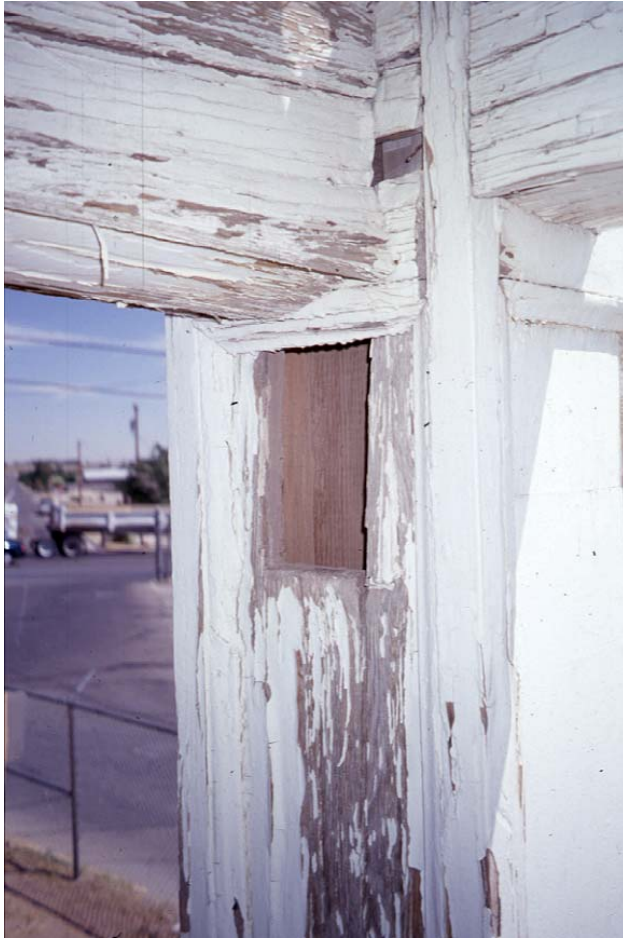
**Photograph 57. Possible structural problem with barracks porch support beam.**

An observation is made about the porch framing. At the north stairwell, the connection of the easternmost beam (exterior, supporting the second floor joists at the outboard ends) and column at the northeast corner is questioned (Drawing 7, GG). A space exists between the beam’s end and the load-bearing member of the column assembly. This space is wide enough to insert one’s hand. The end of the beam could be felt (Photograph 57). There appeared to be no haunch or bracket supporting this beam, suggesting it may be supported only by the column’s enclosure. Again, without removing the enclosure, this conclusion is somewhat speculative. DOE personnel recently observed the demolition of a building with a similar porch,

and no structural problems were evident in the porch's construction. However, caution should still be exercised when removing the column and beam enclosure to ensure that load-carrying members are not supported by trim alone.

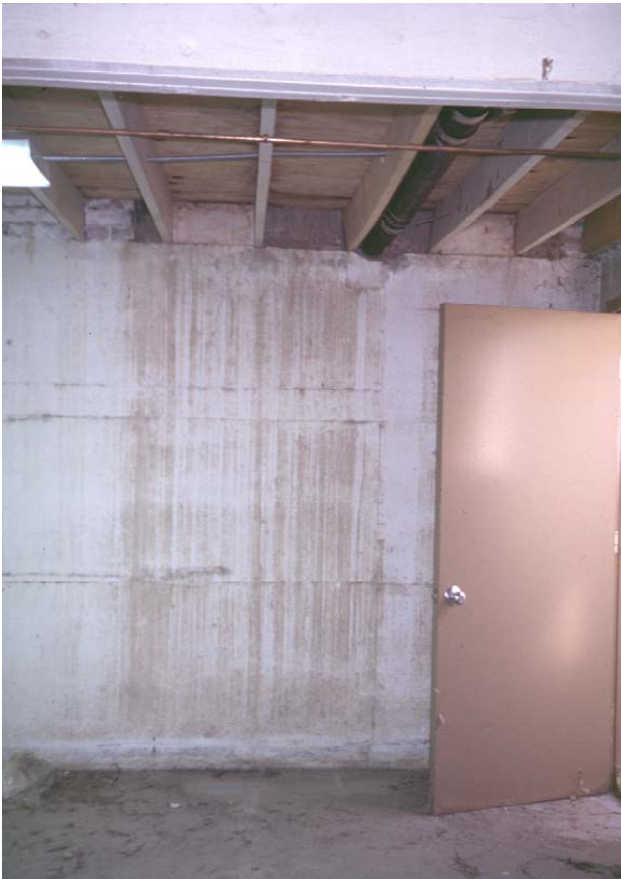
**Photograph 69. Water damage on BOQ basement wall from runoff.**

An exterior slab is present at the north end of the west side of the building, adjacent to an entry (Drawing 8, K). Parking is immediately west of the slab at this entry (Photograph 68). The west entries' thresholds are at grade, which are below the grade and paving to the west. Rainwater runoff flows down Beaumont Drive, over the paving, collects against the building, and leaks into the building through the wall and under the door. Water intrusion under the west entry doors and through

the adjacent wall is evident on the interior finishes. Leakage over the top of the foundation in the northwest corner of the building is evident by the streaking visible on the west basement wall (Photograph 69).

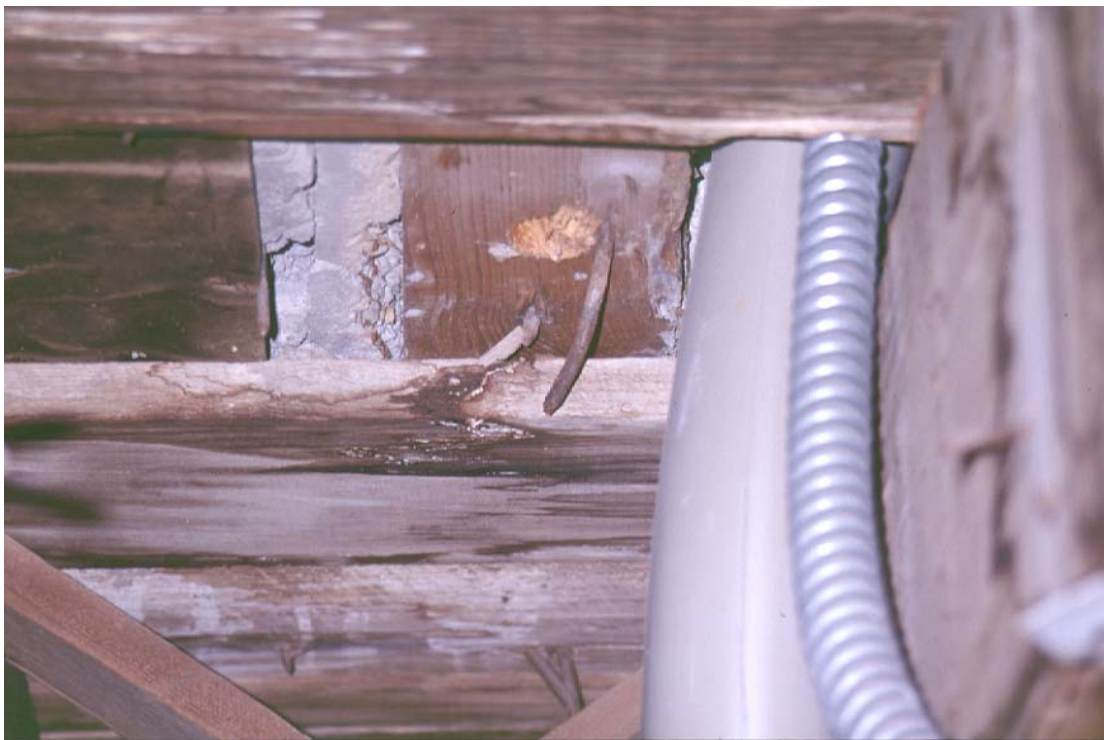
Photograph 77. Cut flooring joists under the spongy floor area.

The floor was spongy only at one area in the utility room on the building's east side (Drawing 9, I; Photograph 76). A utility sink is present at the south wall of this room. An electrical panel box is also mounted adjacent to the sink. The flooring and underlayment have been damaged by water overflow or leakage. Furthermore, joists immediately below this area had been cut to allow conduit servicing the panel box from below (Photograph 77). The conduit should be rerouted and the cut joists repaired in an adaptive use project. Separating the sink from the panel box would also be advisable.

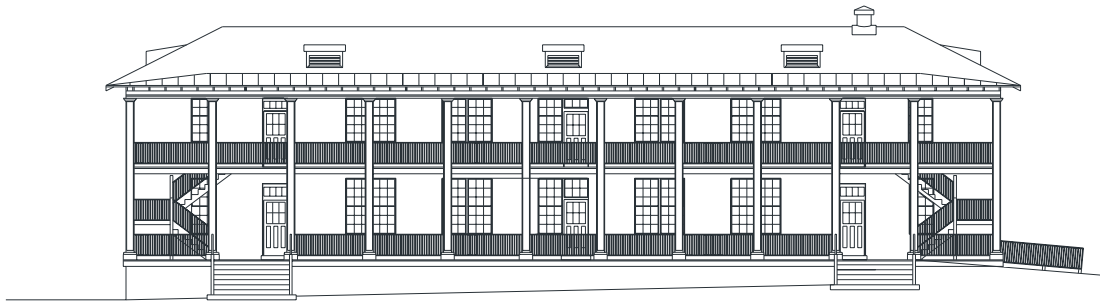
**Apartment Facility East Elevation**

Existing fenestration and entries remain. Historically appropriate doors are shown to replace the current flush doors. The existing transoms remain. A new entry is located at the center of the east elevation on each floor. To maintain the rhythm of the existing elevation, a door/window combination replaces the current double window. The transom detail for the new doorways is consistent with the original entry configuration. An exterior entry is also required in the mechanical space at the west first floor. A door/window combination replaces the current double window in this location as well.

EAST ELEVATION
