Character-Defining Features of Contributing Buildings and Structures in the Fort Gordon, Georgia, Signal School Campus Historic District

Sunny E. Adams and Adam D. Smith

July 2016

Final report

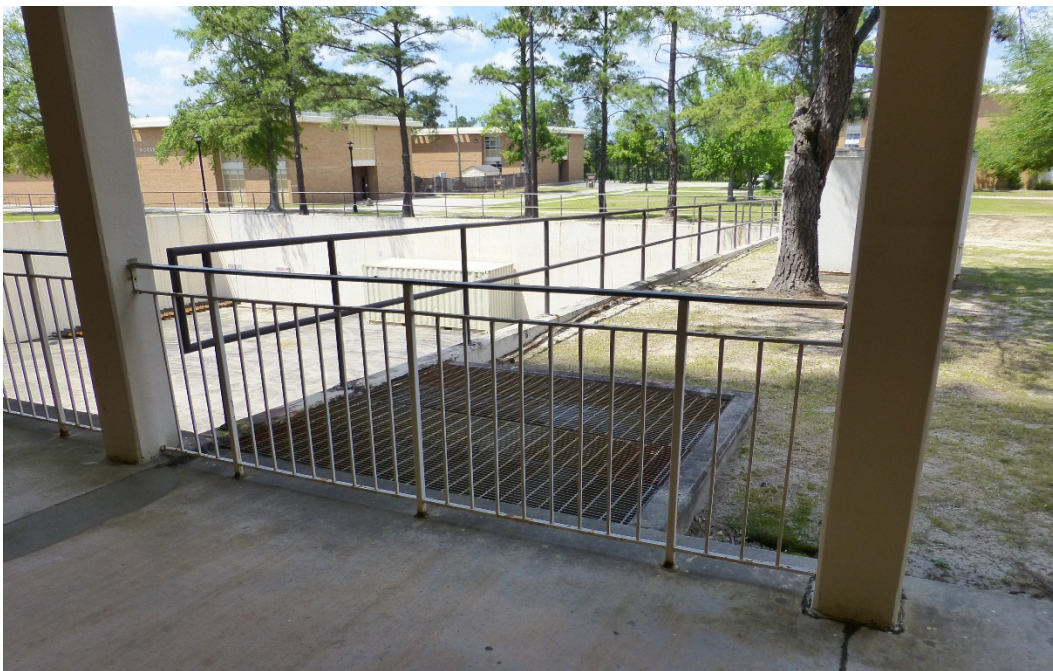
Other metal pipe handrails are located at Building 25810, Brant Hall, near the entries. A metal balustrade is placed between the concrete column supports of the canopy structure surround Building 29808, Signal Towers (Figure 89). However, the majority of this type of railing has been removed.

Figure 89. Metal balustrade placed between concrete supports surrounding Building 29808, Signal Towers (ERDC-CERL, 2015).

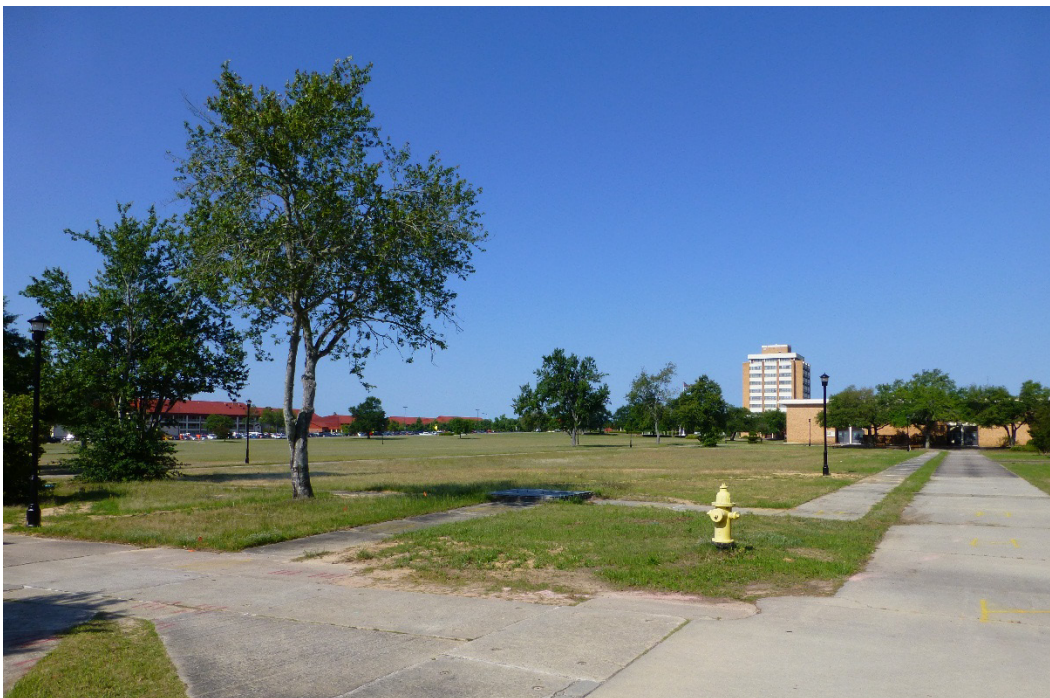
Figure 99. Looking west at the open space of the campus plan, with few of the original trees intact (ERDC-CERL, 2015).

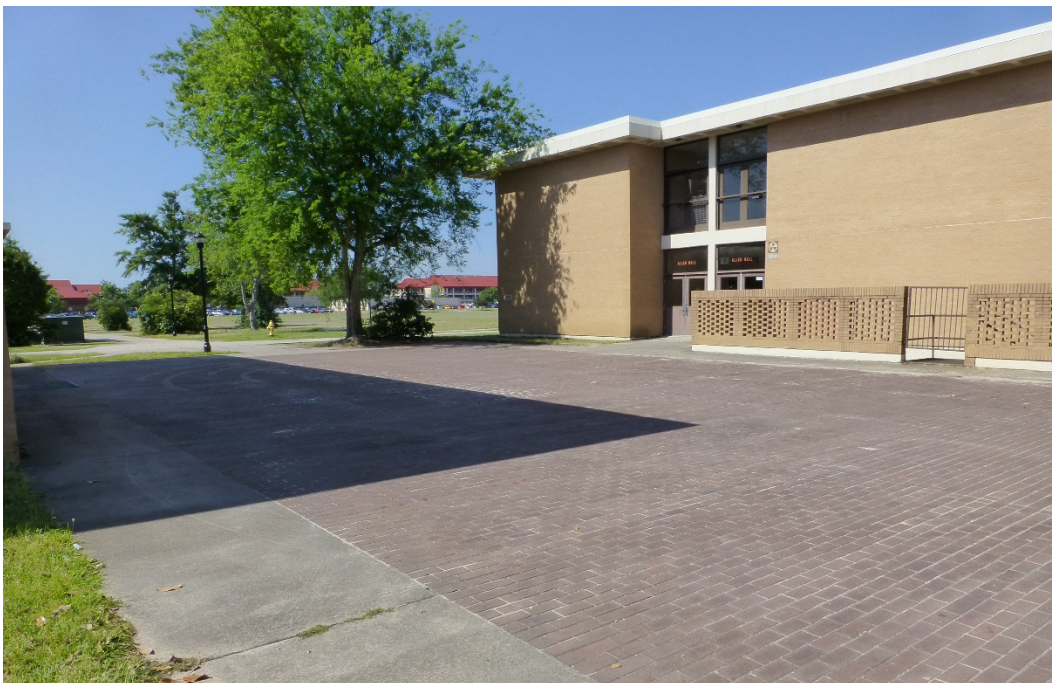
Figure 105. East side of Building 29813, Allen Hall, looking at the brick plaza where all the original trees have been removed (ERDC-CERL, 2015).

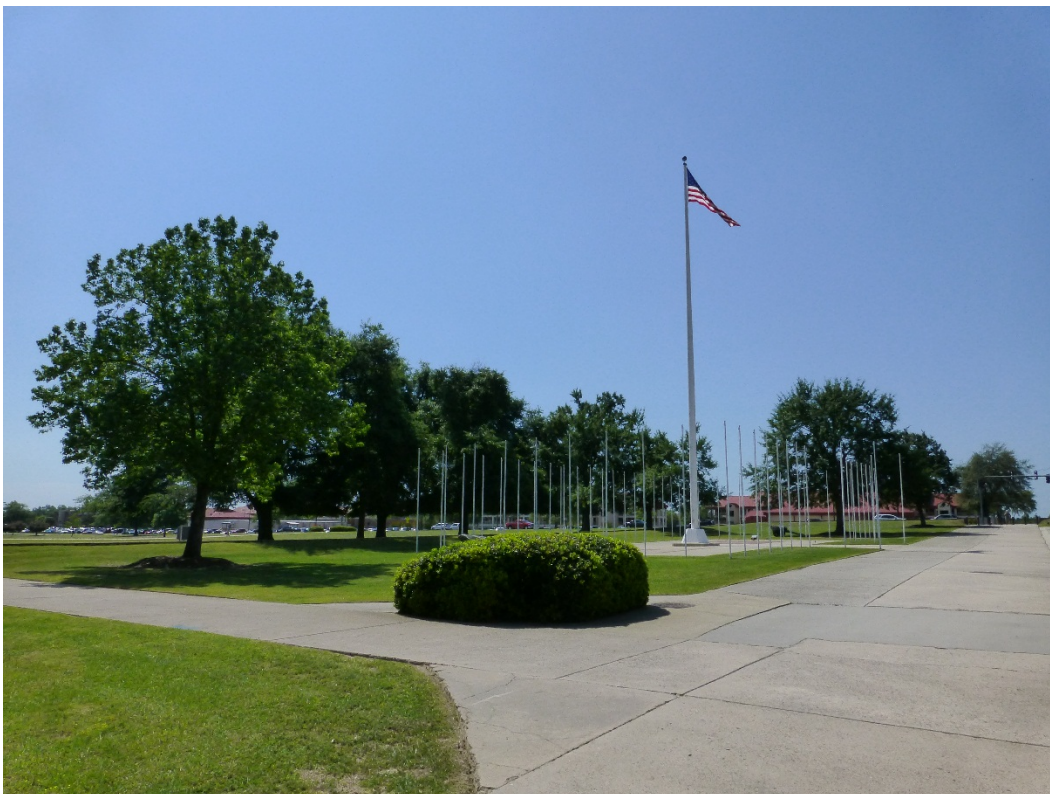
Figure 110. While trees can be found on the landscaping plan from 1966, this large flag plaza is not present on that plan (ERDC-CERL 2015).

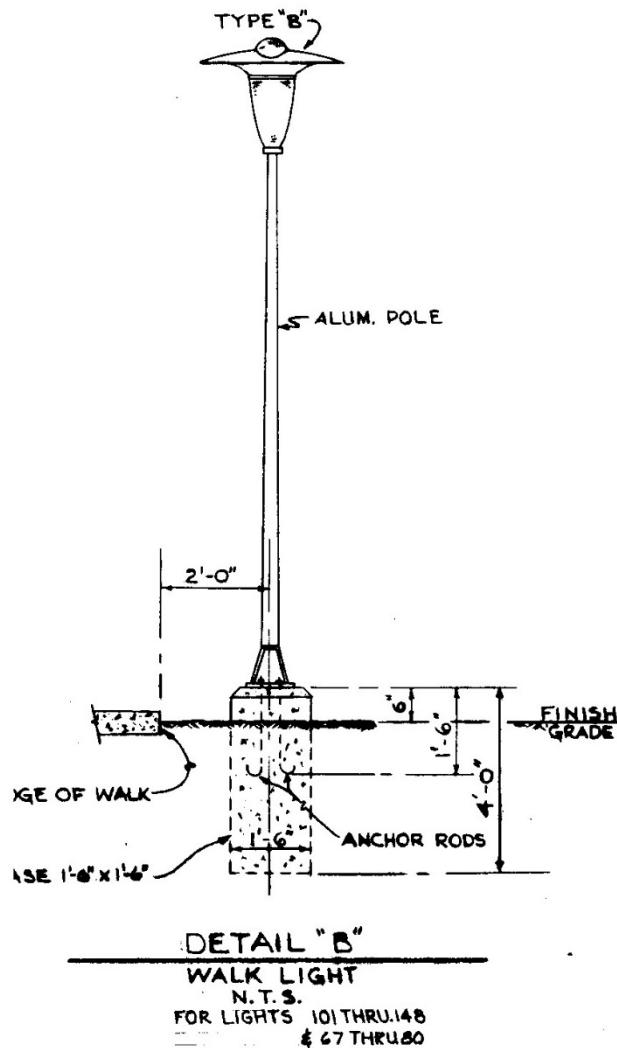
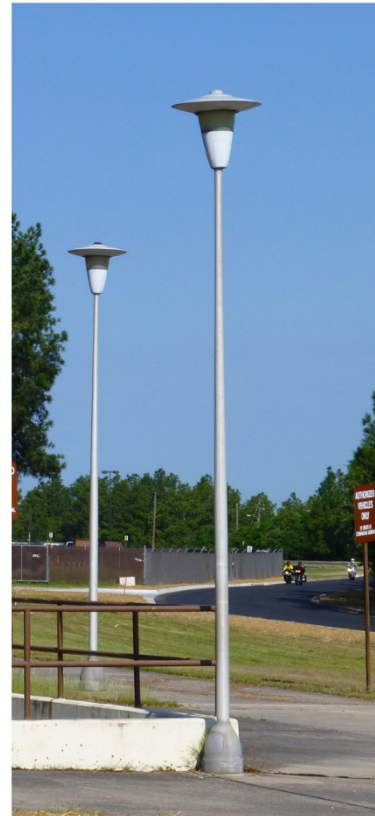
Aeck specified a light standard for illuminating the sidewalks that consisted of an aluminum pole capped by the fixture and then an aluminum “hat” (Figure 119). Some of these are extant, but many of them have been replaced by two types of light standards (Figure 120 and Figure 121).

Figure 119. Comparison of the original design and materials detail drawing of the sidewalk lights from 1966 [left] to the current condition of the same style of light fixture (ERDC-CERL, 2015).

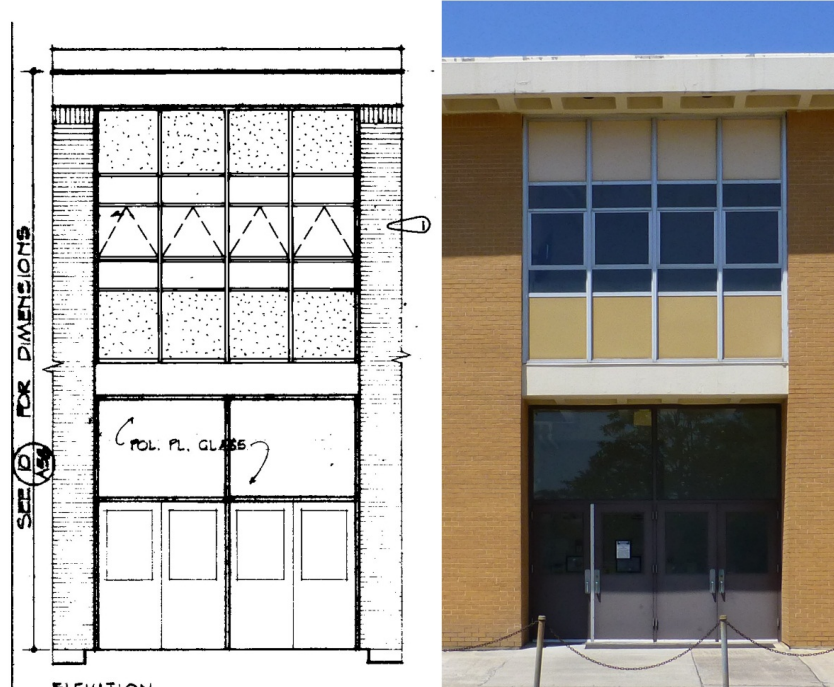
Figure 199. East entrance bay - comparison of the original drawing detail from 1966 [left] to the current condition of metal and glass doors with transom above on the first floor and the bright-aluminum awning windows with panel inserts on the second floor [right] (ERDC-CERL, 2015).

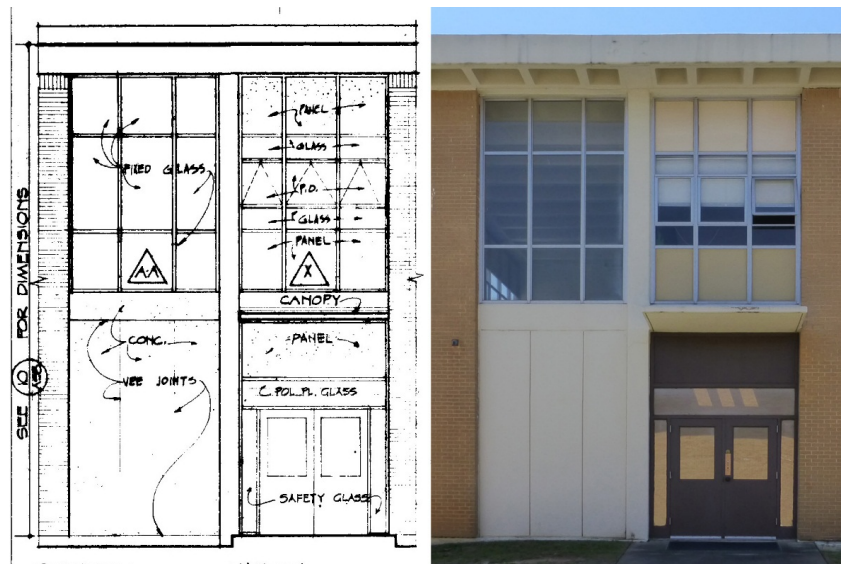
Figure 200. Northeast window/door bay - comparison of the original drawing detail from 1966 [left] to the current condition of concrete panels, metal and glass doors with transom above on the first floor and the bright-aluminum awning windows with panel inserts on the second floor [right] (ERDC-CERL, 2015).

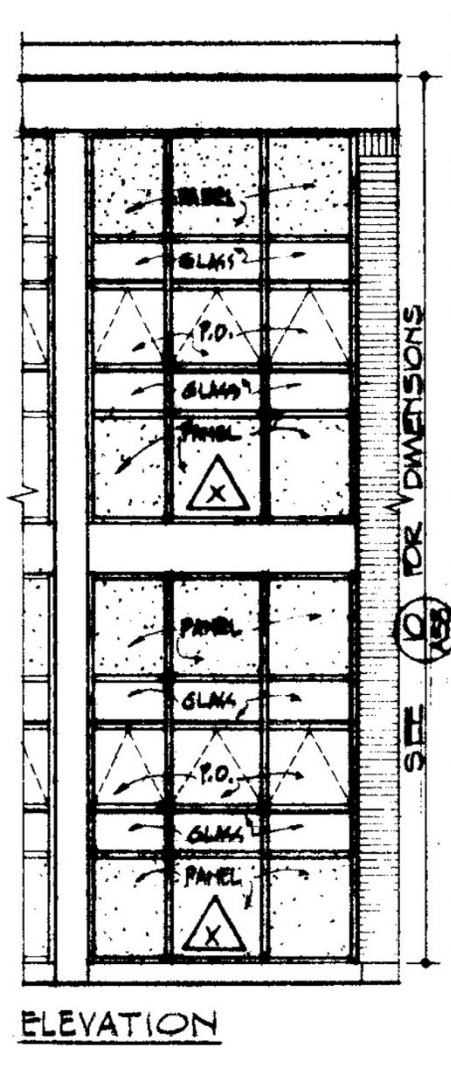
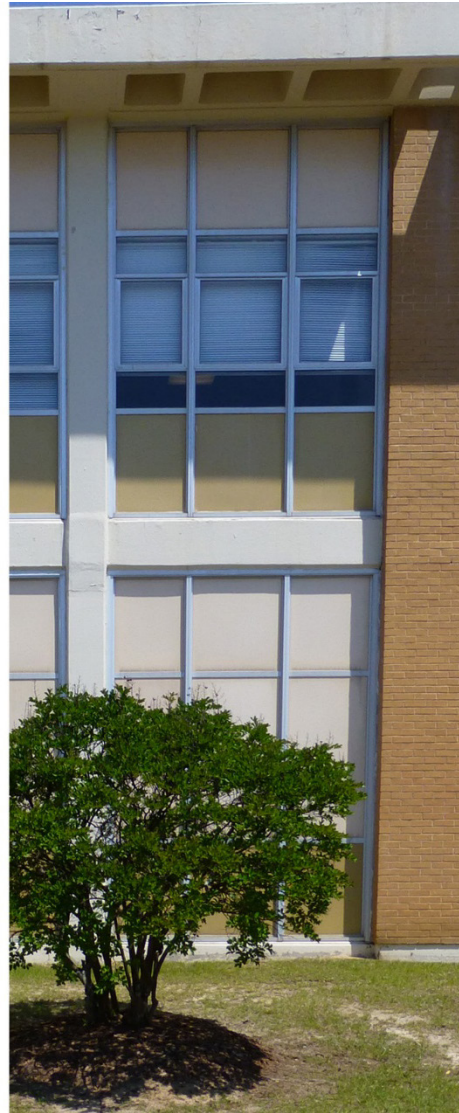
Figure 201. South elevation window bay - comparison of the original drawing detail from 1966 [left] to the current condition of the bright-aluminum awning windows with panel inserts separated by the concrete structure [right] (ERDC-CERL, 2015).

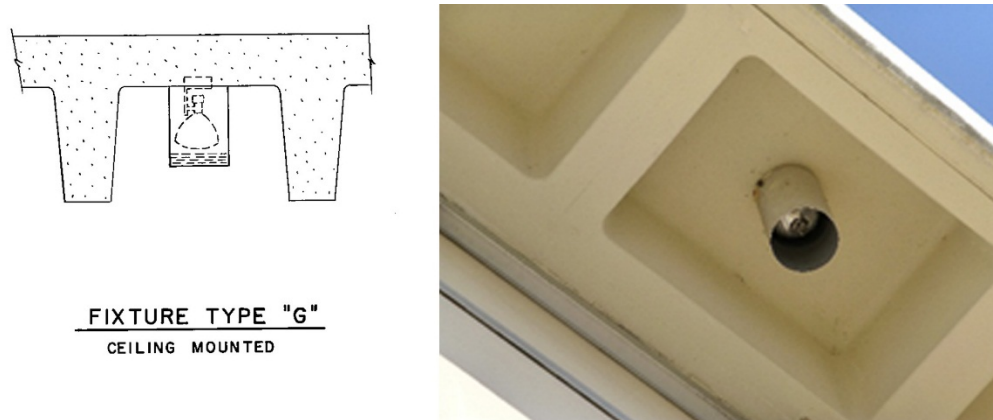
Figure 202. Ceiling mounted light fixture set within the waffle overhang - comparison of the original drawing detail, no date [left] to the current condition of the light fixture [right] (ERDC-CERL, 2015).

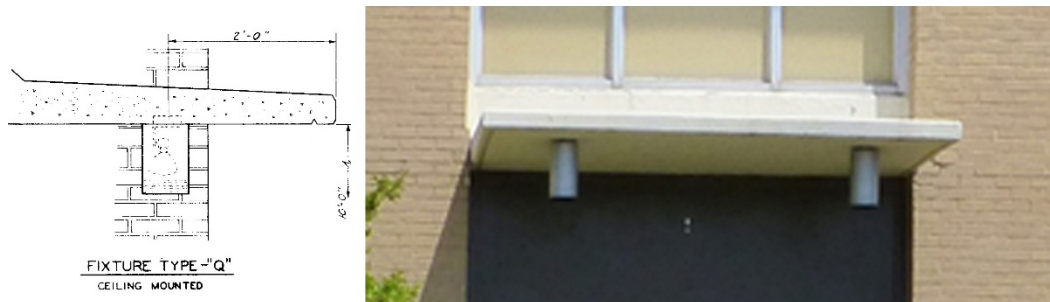
Figure 203. Ceiling mounted light fixture under the concrete canopy - Comparison of the original drawing detail, from 1966 [left] to the current condition of the light fixtures [right] (ERDC-CERL, 2015).

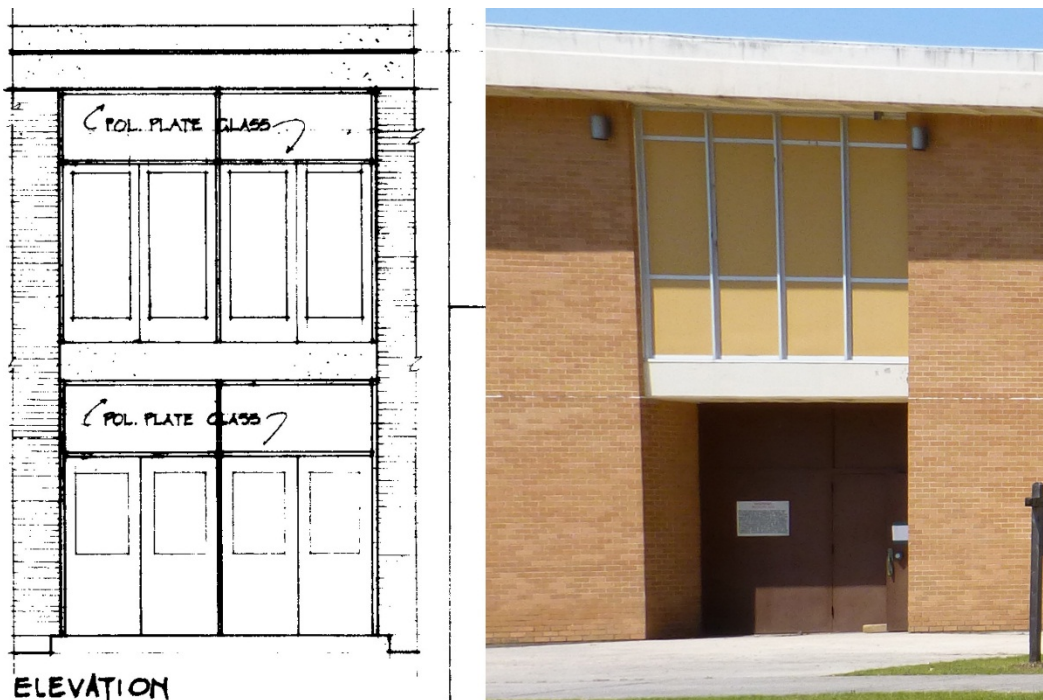
- Windows – according to the original drawings there were metal and plate-glass door on the east and west elevations above the entry doors. These have been removed and replaced with newer framing and panel window system.
- Landscaping has mostly been removed and not replaced.

Figure 211. Entry bays on the east and west elevations - comparison of the original drawing detail from 1966 [left] to the current condition of the bright-aluminum framing panel inserts and the replacement solid metal doors and metal panels [right] (ERDC-CERL, 2015).

Listed below are character-defining features of Building 29802, Moran Hall south, that have been removed or replaced over the years; as future renovations occur, these need to be replaced with elements that replicate the original character-defining features of the building. The original drawings and comparison images (below) will guide this process in coordination with the GA SHPO.

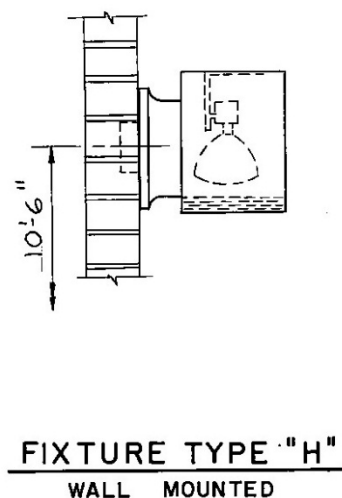
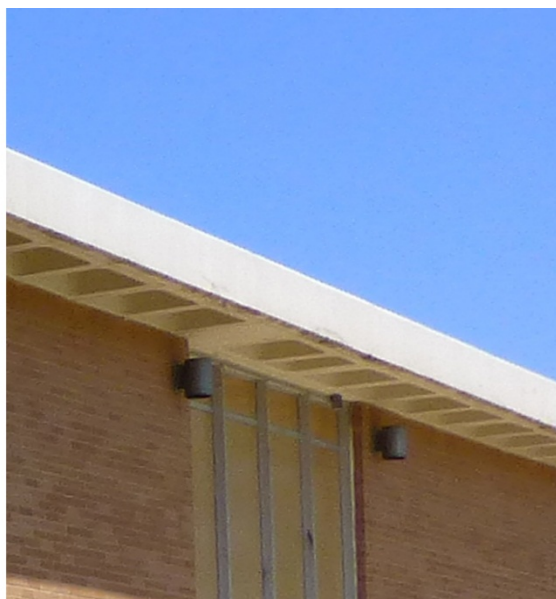
Figure 212. Wall-mounted light fixtures - comparison of the original drawing detail from 1966 [left] to the current condition of the wall-mounted light fixtures on the east and west elevations [right] (ERDC-CERL, 2015).

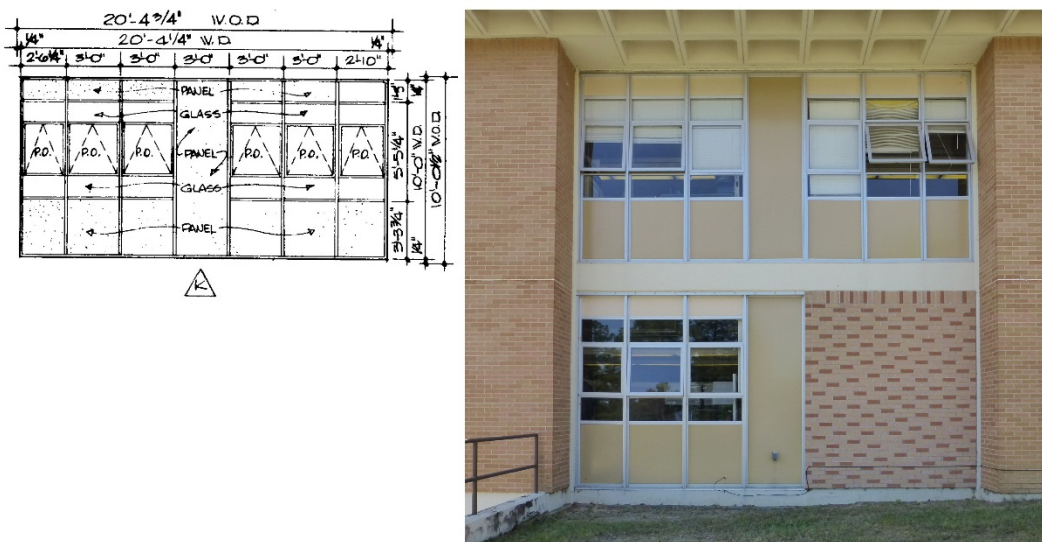
Figure 220. Large group of windows on north elevation - comparison of the original drawing detail from 1966 [left] to the current condition of the bright-aluminum awning windows and panel inserts and the modified brick infill [right] (ERDC-CERL, 2015).

Listed below are character-defining features of Building 29803, Moran Hall north, that have been removed or replaced over the years; as future renovations occur, these need to be replaced with elements that replicate the original character-defining features of the building. The comparison images [below] will guide this process in coordination with the GA SHPO (Figure 220—Figure 223).

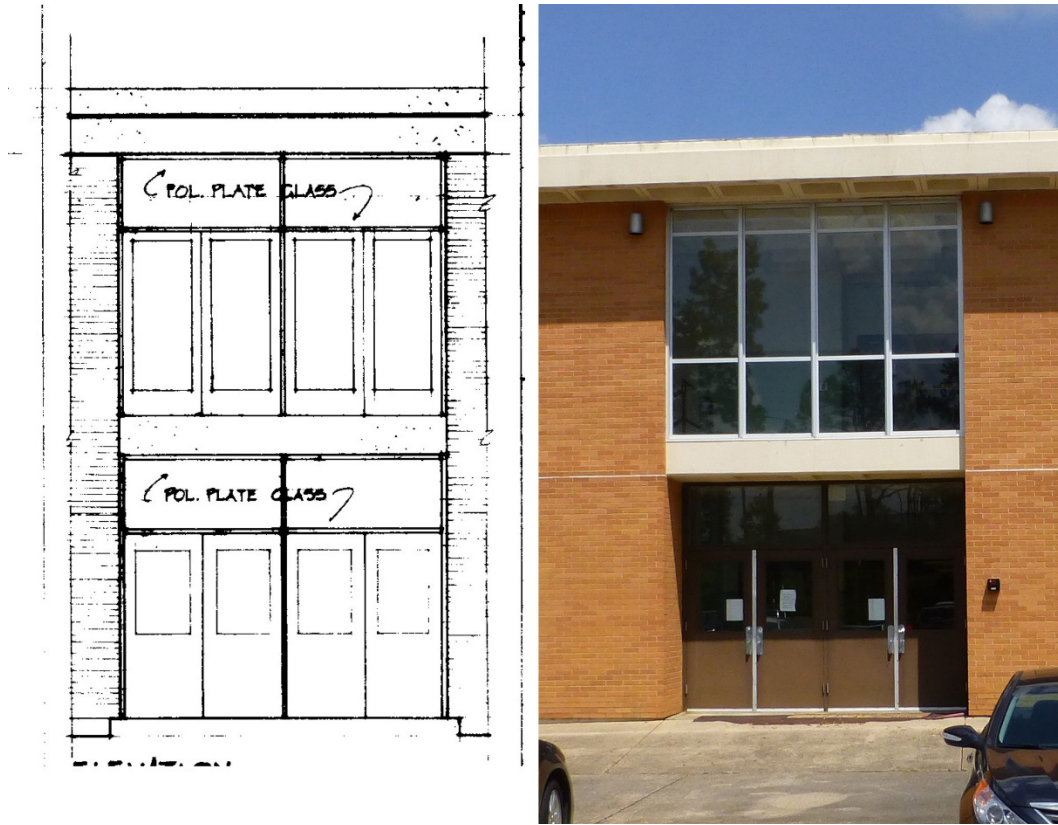
- Windows – according to the original drawings, there were metal and plate-glass doors on the east and west elevations above the entry doors. These have been removed and been replaced with newer framing and window system.

Figure 222. Window bay - comparison of the original drawing detail from 1966 [left] to the current condition of the replacement bright-aluminum windows [right] (ERDC-CERL, 2015).

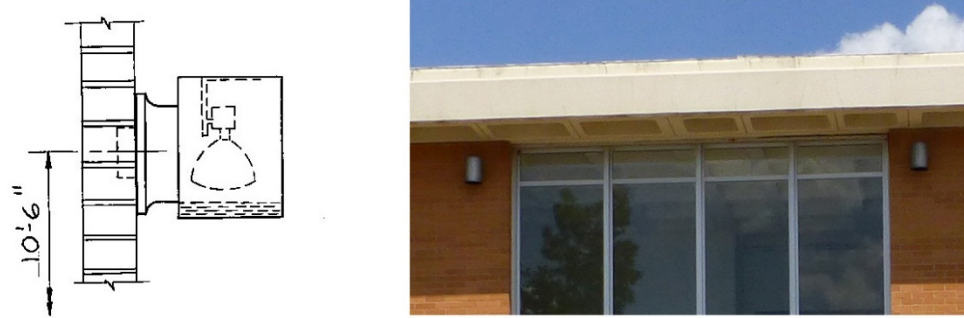
Figure 223. Wall-mounted light fixture – comparison of the original drawing detail from 1966 [left] to the current condition of the wall-mounted light fixtures located on the east and west elevations [right] (ERDC-CERL, 2015).

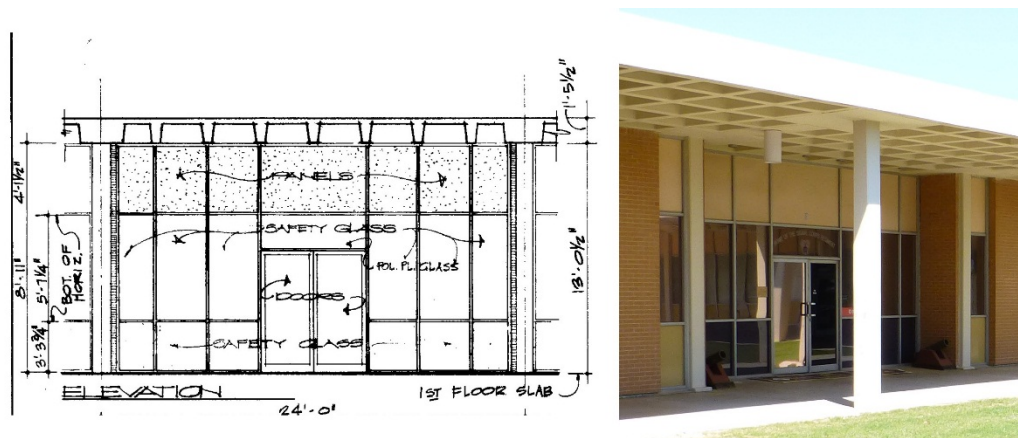
Figure 255. Main entry on the east elevation – comparison of the original drawing detail from 1966 [left] to the current condition of the bright-aluminum and plate-glass entry doors, bright aluminum framed windows and insulated panels [right] (ERDC-CERL, 2015).

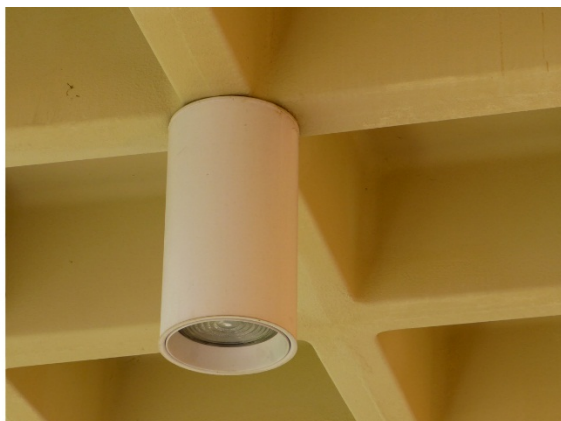
FIXTURE TYPE "G"
CEILING MOUNTED

Figure 256. Ceiling-mounted light fixture – comparison of the original drawing detail from 1966 [left] to the current condition of the ceiling-mounted light fixture under the concrete waffle canopy [right] (ERDC-CERL, 2015).

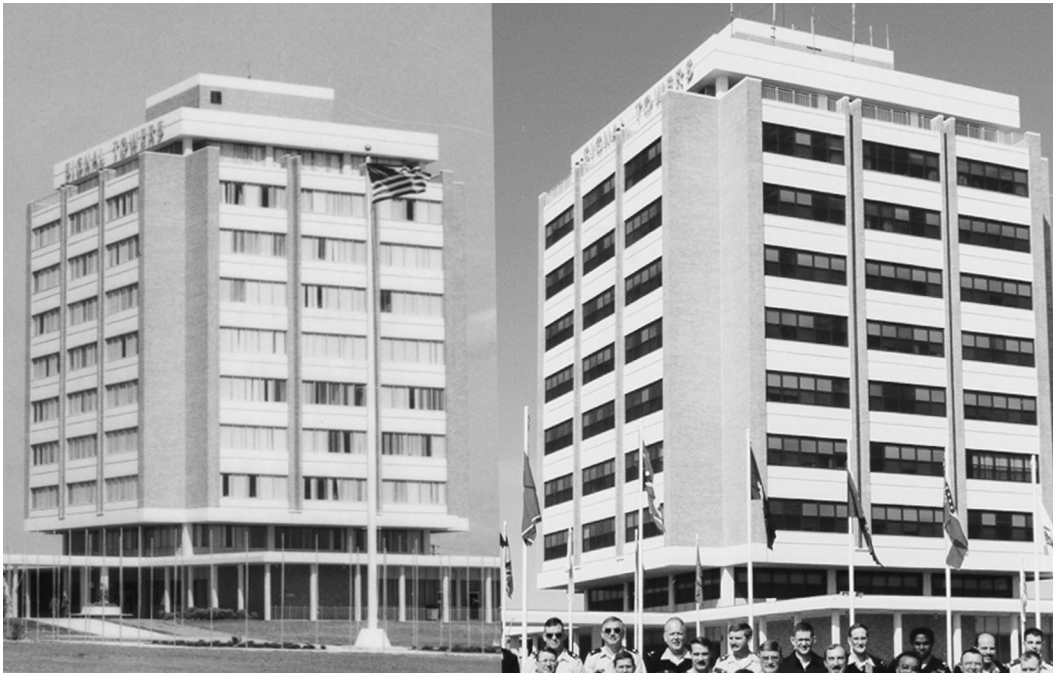
- Windows – original bright-aluminum sash windows on floors 2–11 have been removed and replaced with one-over-one anodized-bronze aluminum windows/
- Metal handrails – some have been removed around the perimeter of the covered walkway.
- Most of the original features in the lobby design have been removed over the years.

Figure 268. Building 29808, Signal Towers, comparison of the original windows [left] and the replacement windows [right] (Signal Corps Historian Office).

Listed below are character-defining features of Building 29808, Signal Towers, that have been removed or replaced over the years; as future renovations occur, these need to be replaced with elements that replicate the original character-defining features of the building. The historic photograph will guide this process in coordination with the GA SHPO.

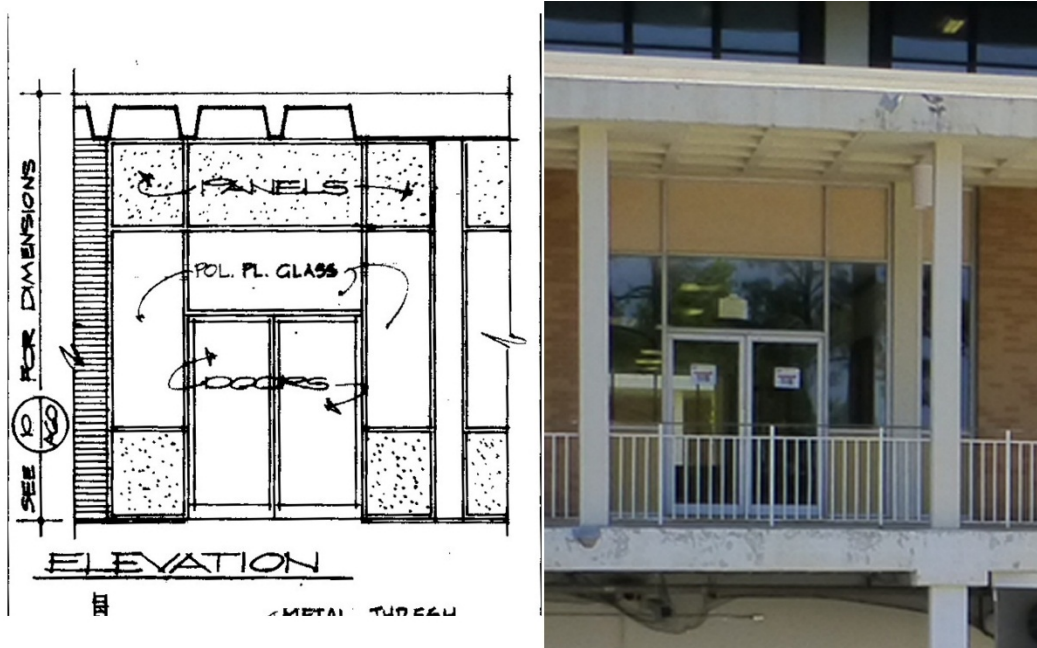
Figure 269. Entry bay for Building 29808, comparison of the original drawing detail from 1966 [left] to the current condition of the bright-aluminum and plate-glass doors and windows with insulated panels [right] (ERDC-CERL, 2015).

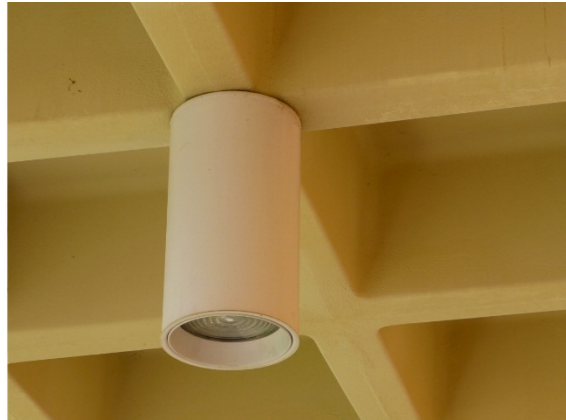
FIXTURE TYPE "G"
CEILING MOUNTED

Figure 270. Ceiling-mounted light fixture – comparison of the original drawing detail from 1966 [left] to the current condition of the ceiling-mounted light fixture under the concrete waffle canopy [right] (ERDC-CERL, 2015).

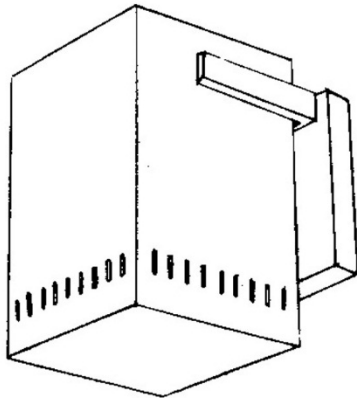
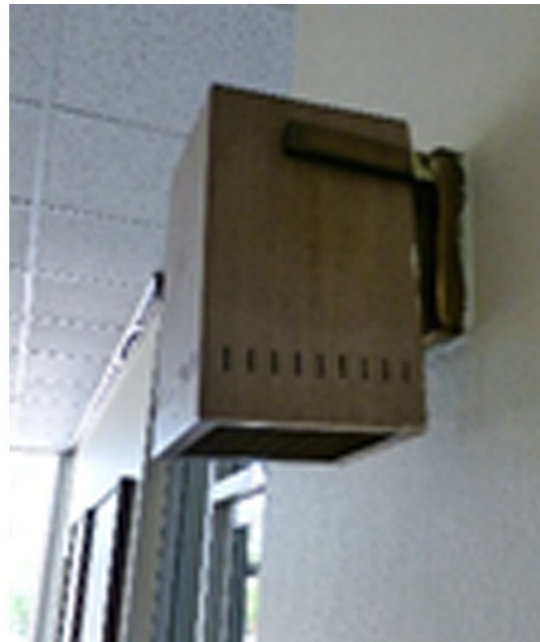
FIXTURE TYPE "AM"

Comparison images utilizing either the original drawings or historic photographs, when juxtaposed against present-day images, are a useful tool in developing the historic “feel” of a property and how much of that historic feeling is still present today. Figure 271 is an example of an original light fixture, but there are not enough of these left to have integrity of the original design (Figure 268—Figure 271).

Figure 271. Wall-mounted light fixture – comparison of the original drawing detail from 1966 [left] to the current condition of the wall-mounted interior light fixture [right] (ERDC-CERL, 2015).

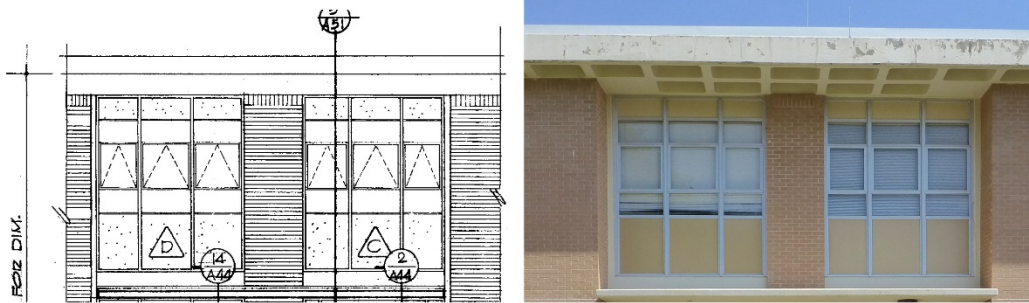
Figure 291. Second-floor window bay on the north and south elevations - comparison of the original design and materials from 1964 [left] to the current condition of bright-aluminum three-pane awning-style-windows and insulated panels [right] (ERDC-CERL, 2015).

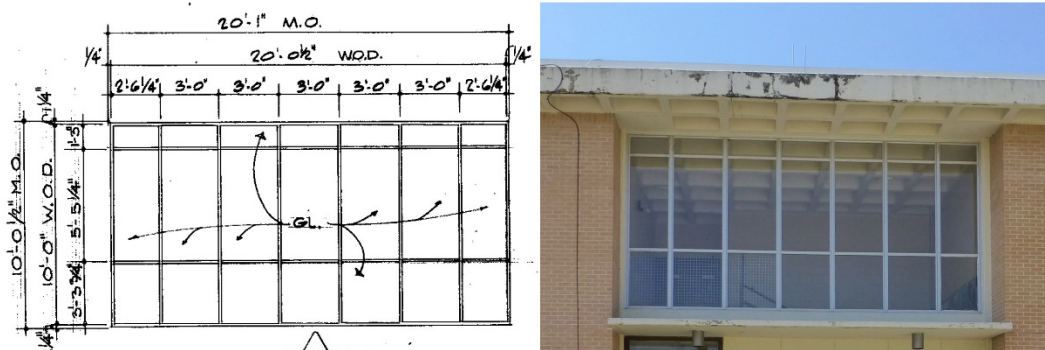
Figure 292. North entry bay second-floor windows - comparison of the original design and materials from 1964 [left] to the current condition of bright-aluminum fixed-pane windows [right] (ERDC-CERL, 2015).

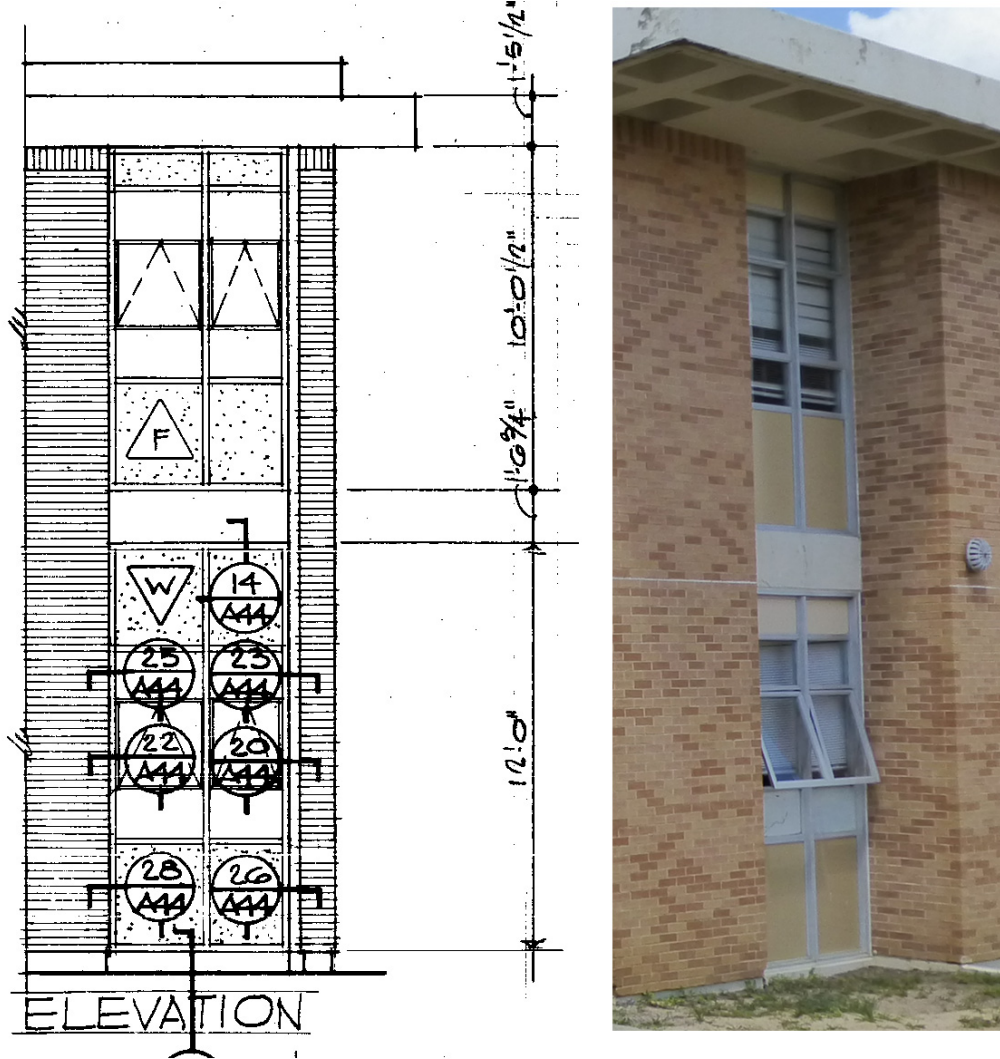
Figure 293. Window bay located on the left and right sides of the north and south elevations - comparison of the original design and materials from 1964 to the current condition of the three-pane awning-style windows sandwiched between insulated panels (ERDC-CERL, 2015).

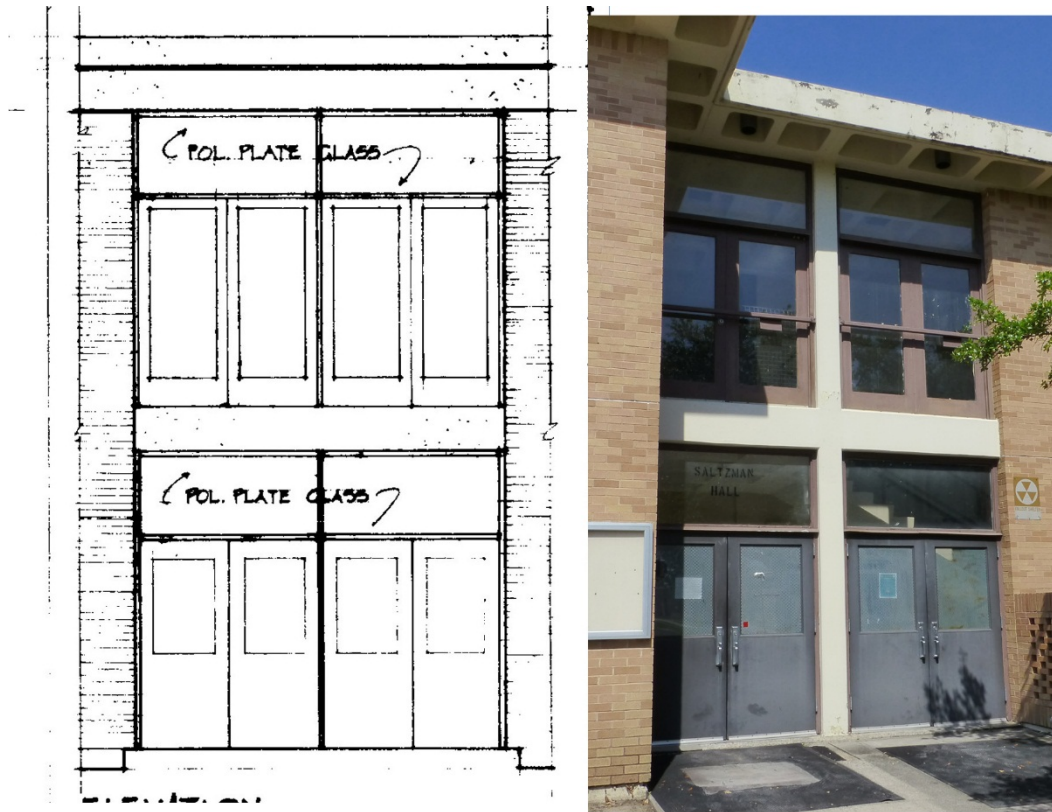
Figure 294. Doors on the east and west elevations – comparison of the original design and materials from 1964 [left] to the current condition of the metal doors with pane and transoms on the first floor and the metal and plate-glass doors with security bars on the second floor [right] (ERDC-CERL, 2015).

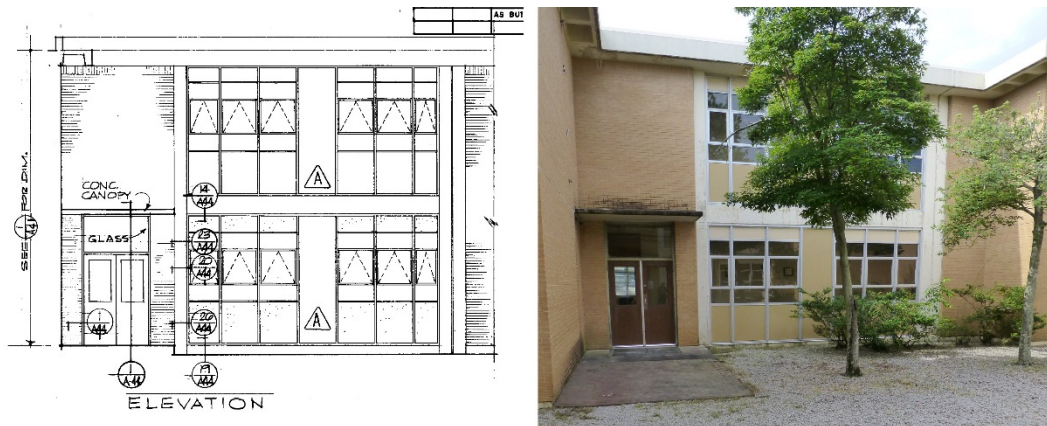
Figure 295. North wall of the right courtyard and south wall of the left courtyard – comparison of the original design and materials from 1964 [left] to the current condition of the metal doors, canopy, and window system [right] (ERDC-CERL, 2015).

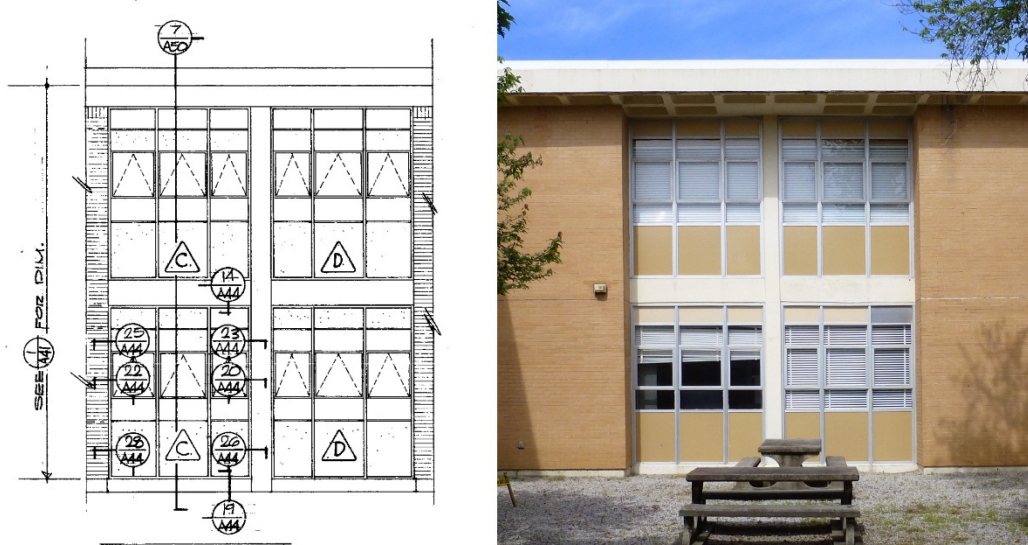
Figure 296. East and west walls of the courtyards – comparison of the original design and materials from 1964 [left] to the current condition of the window system [right] (ERDC-CERL, 2015).

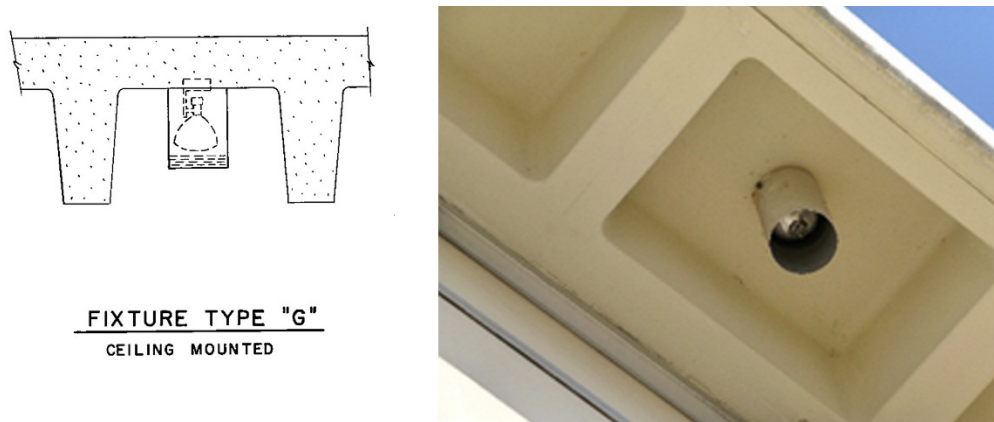
Figure 297. Ceiling-mounted light fixtures under waffle overhang – comparison of the original design and materials from 1966 [left] to the current condition of the ceiling-mounted light fixture [right] (ERDC-CERL, 2015).

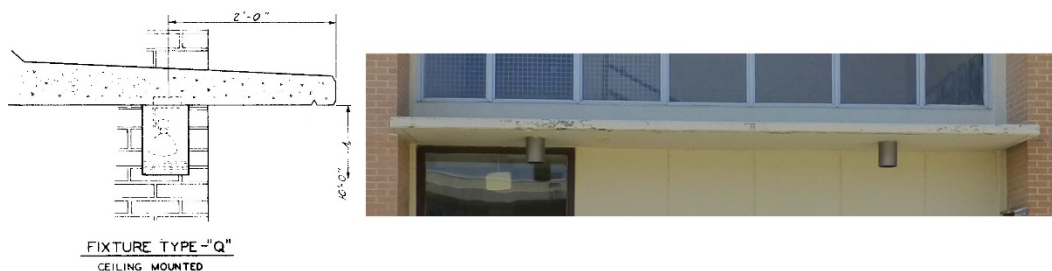
Figure 298. Ceiling-mounted light fixture under flat concrete canopy – comparison of the original design and material from 1966 [left] to the current condition of the ceiling-mounted light fixture [right] (ERDC-CERL, 2015).
