# **Demonstration and Validation of a High-Performance Floor-Sealant System to Reduce Concrete Degradation**

Final Report on Project F10-AR02

Clint A. Wilson and Susan A. Drozd

May 2015

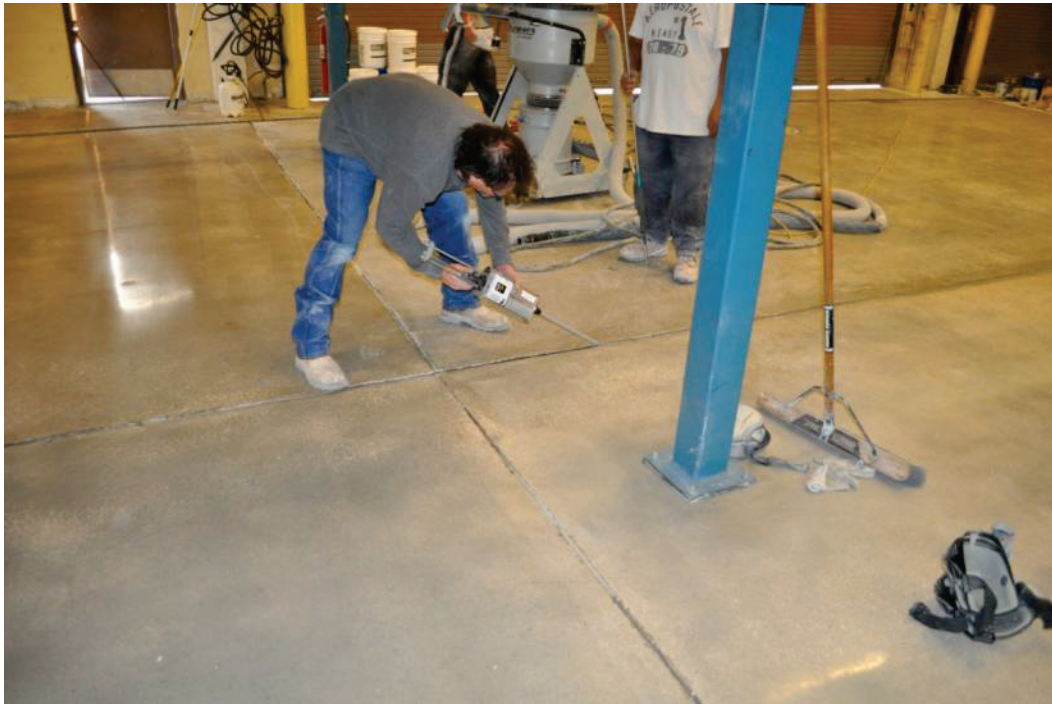
Figure 17. Application of joint sealer.

The final step in the maintenance bay application was to remove the existing seals from the construction joints in the floor and reseal them using a product called Ardex Ardiseal Rapid Joint Seal\* (Figure 17). The old seals were difficult to remove, and the contractor had trouble removing the old material to the depth specified for new joint material.

Joint-sealer materials must be replaced or applied with care. In this project, it was difficult to dig old sealer material out of the joints consistently deep enough to ensure good performance of replacement materials. It is important to provide clear requirements as part of any contracts involving joint-sealer replacement.
