Investigation of Mechanical Processes for Removing Lead-Based Paint (LBP) from Wood Siding

Robert H. Falk, John Janowiak, Richard G. Lampo, Thomas R. Napier, Stephen D. Cosper, Susan A. Drozdz, Steven Larson, and Edgar D. Smith September 2006

Final report

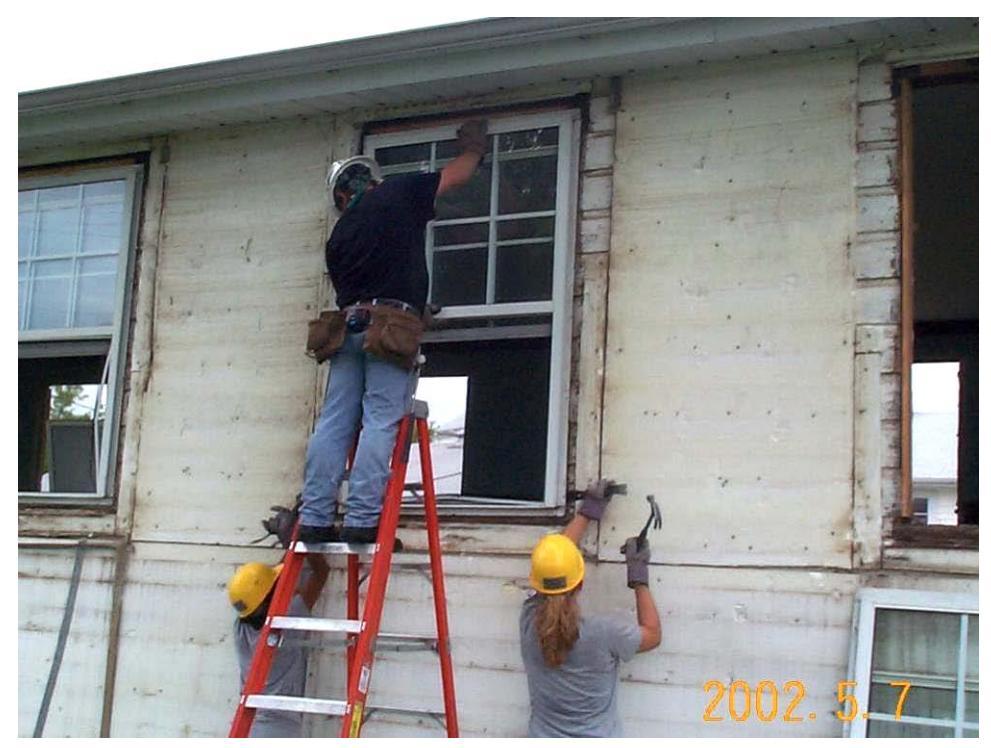
The scheduled deconstruction of five buildings at Fort Campbell (Figure 3) provided another source of wood siding for evaluation. The siding from those buildings was separated from the other salvaged materials because of its LBP content and the poor condition of the paint film. The siding was disposed of as debris except for boards from one two-story barracks building. Those boards were removed, bundled, banded, and shipped to FPL. In order to assess the condition of the siding boards relative to their position on the building, a coding scheme was adopted similar to that used at Fort Ord, with N, E, S, and W indicating compass orientation and a number indicating vertical and horizontal location of each piece. ERDC-CERL personnel coded each siding piece, and the boards were removed by Austin Habitat for Humanity, Austin, TX, the deconstruction contractors for this project.

Figure 3. Deconstruction at Fort Campbell.

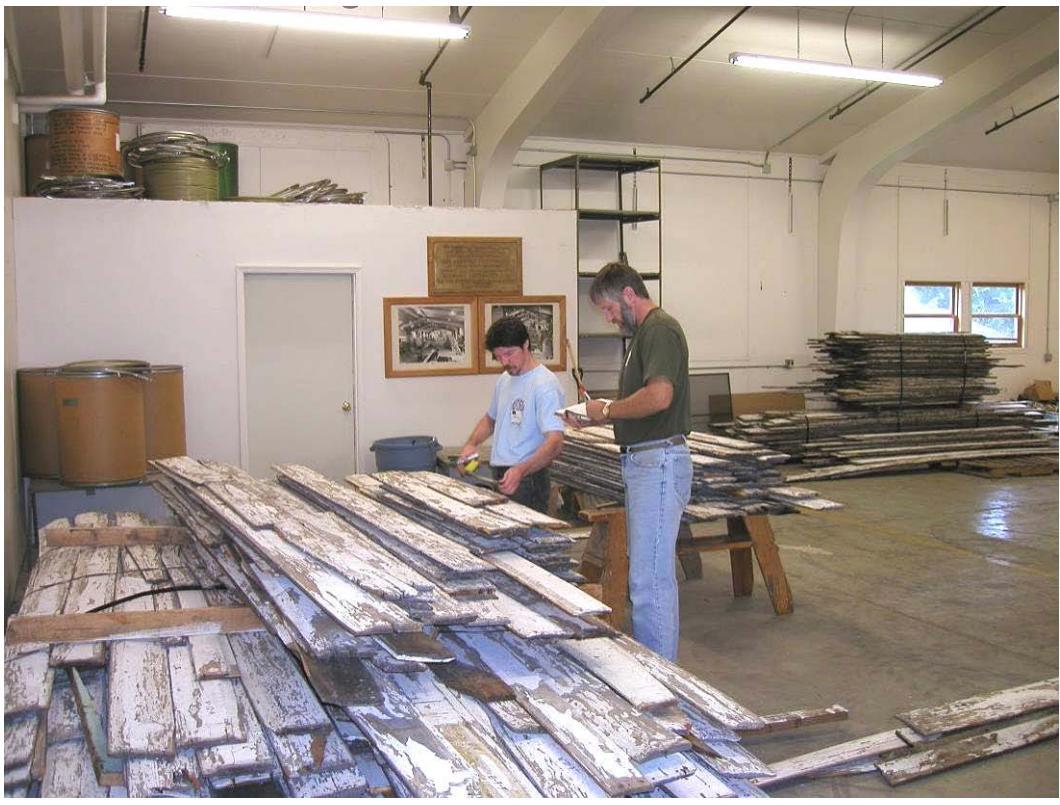
Figure 7. Quantitative inspection of Fort Campbell siding.

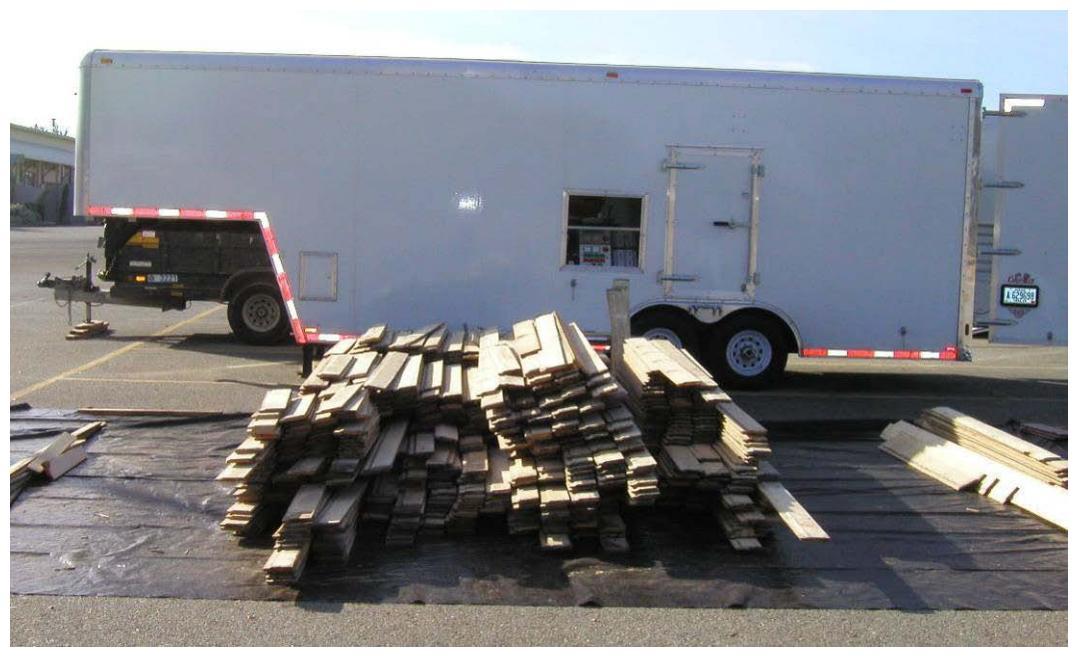
FORA donated 1,226 pieces of siding (7,830 lf) from previous deconstruction projects for use in the demonstration by Auburn Machinery, Inc. (later renamed Auburn Enterprises, Inc., Auburn, ME). The siding had been stored for many years under cover and was left over from a previous deconstruction project. A visual inspection of the wood indicated no discernable difference between this siding and the siding shipped to FPL. For this reason, all conclusions on the quality of the siding evaluated at FPL can be assumed applicable for the siding remilled by Auburn. The siding made available to Auburn at Fort Ord is shown in Figure 8.

Figure 8. Fort Ord siding provided for remanufacture by Auburn.

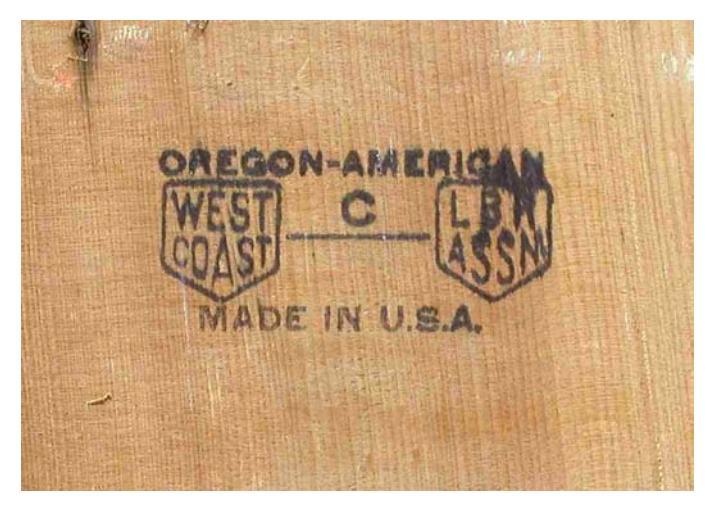
A visual assessment of all pieces indicated that the siding recovered from Fort Ord was manufactured of very high quality Douglas fir. This determination was confirmed by the discovery of old grade stamps on the siding, as shown in Figure 28. This stamp shows that the siding as installed was grade C or better which, at the time, represented the highest grade of Douglas fir siding available. The condition of the siding as recovered was generally very good, with good paint adhesion and relatively little wood damage or degradation.

(C = visual grade, Oregon-American = Mill ID) Figure 28. West Coast Lumber Association grade stamp on sample of salvaged Fort Ord siding.

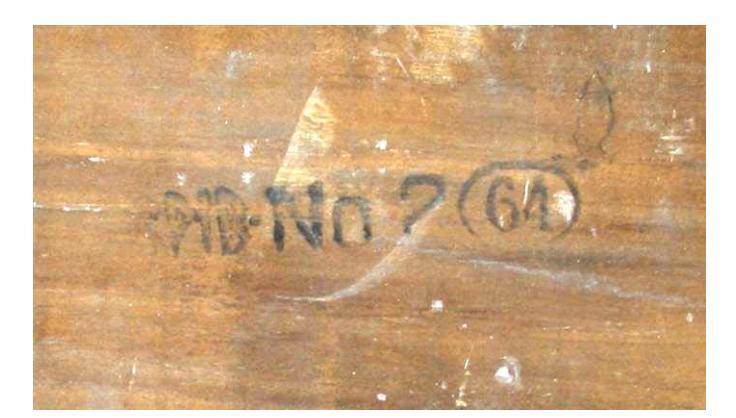
Visual inspection of all the pieces indicated that the Fort Campbell siding was manufactured from Southern Pine and contained many larger knots. The siding was generally in poor condition, with considerable flaking paint, warping and cracking, and a significant amount of deconstruction damage. More importantly, the grade stamps found on the siding indicated that the original wood was only of moderate quality —No. 2 lumber board stock , which allows much larger knots than siding grades. It is likely that, because these barracks were classified as temporary structures with an assumed service life of 3 years, No. 2 stock was considered adequate for the application. The stamp is shown in Figure 29.

(SPIB = Southern Pine Inspection Bureau, No. 2 = visual grade, 64 = mill number.) Figure 29. Southern Pine Inspection Bureau grade stamp on sample of salvaged Fort Campbell siding..

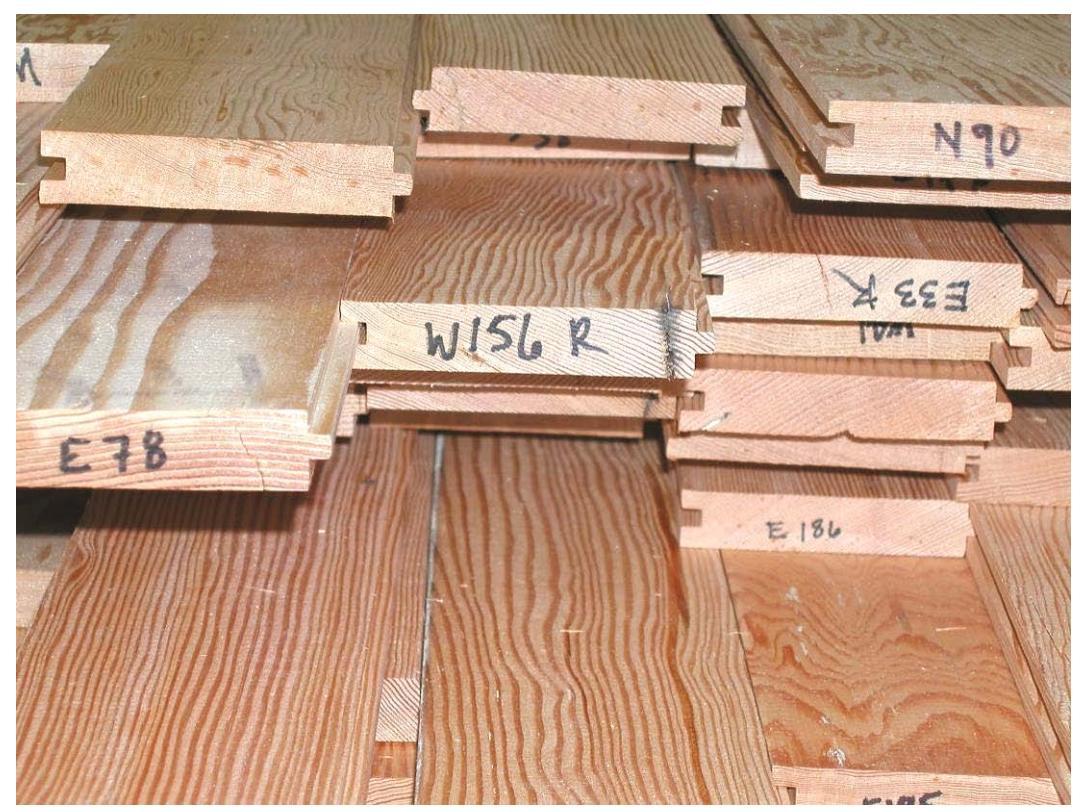
Figure 30. T&G flooring produced from Fort Ord siding.
