Demonstration and Validation of Materials for Corrosion-Resistant Fencing and Guard Railings in Aggressive Climates

Final Report on Project F09-AR02

October 2015

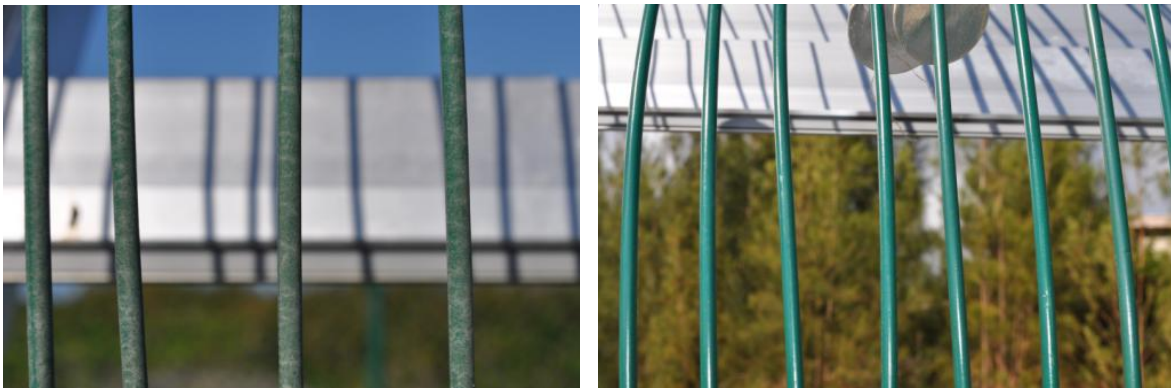
Figure 18. Standard PVC coated galvanized wire coupon at FRF (left) and KTA (right) after 6 months of exposure.

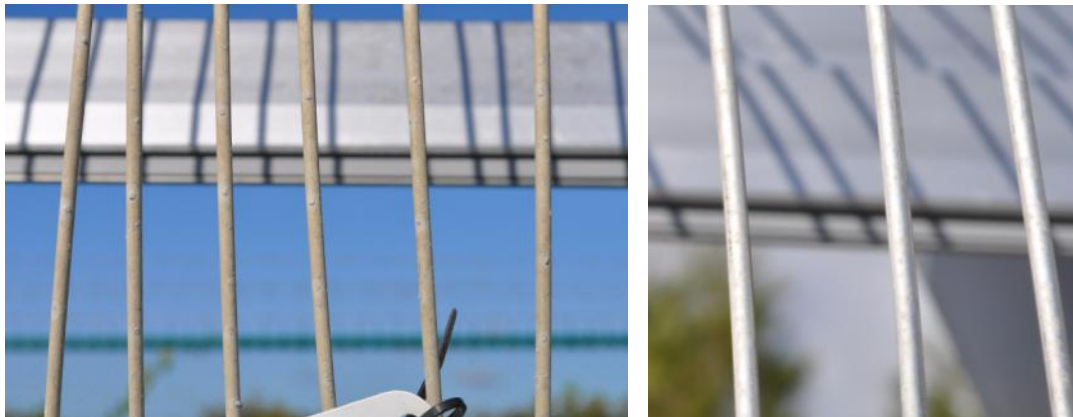
Figure 19. Aluminum wire coupon at FRF (left) and KTA (right) after 6 months of exposure.

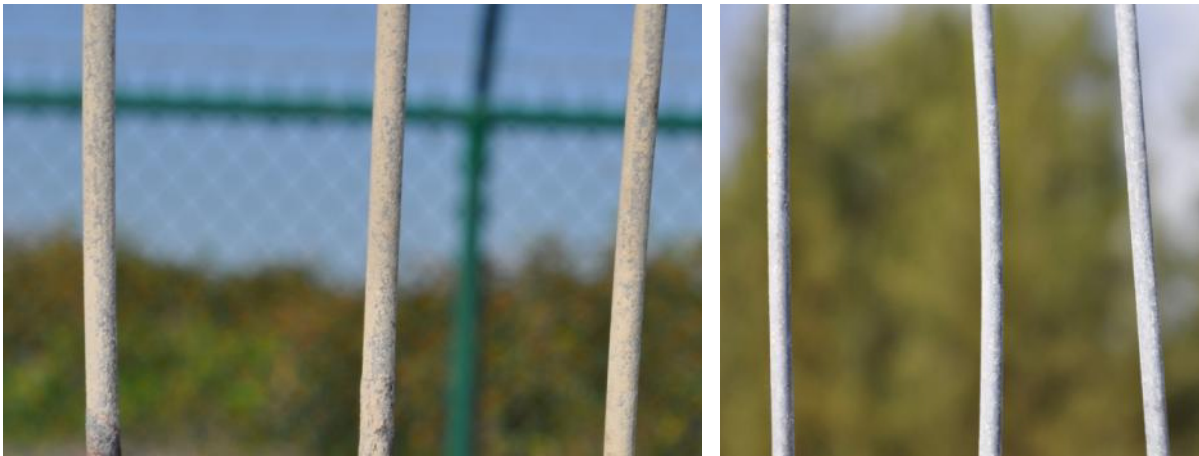
Figure 21. Galvan wire coupon at FRF (left) and KTA (right) after 6 months of exposure

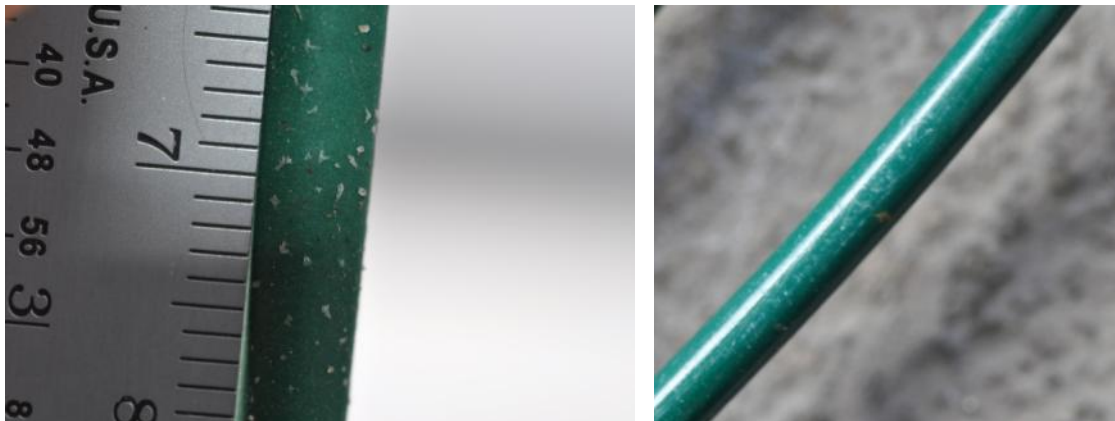
Figure 22. Standard PVC coated galvanized steel wire coupon at FRF (left) and KTA (right) after 12 months of exposure.

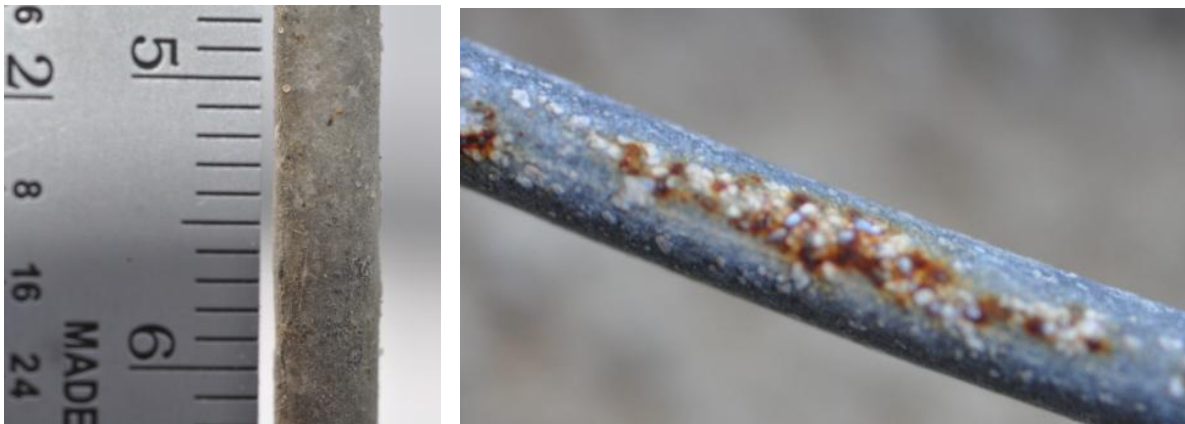
Figure 23. Standard galvanized steel wire coupon at FRF (left) and KTA (right) after 12 months of exposure.

Fencing Material Type	% of Surface Corroded	Type	Comments
Standard PVC coated galvanized	0%	N/A	No visible corrosion
Fuse bonded PVC coated galvanized	0%	N/A	No visible corrosion
Standard galvanized	50%	Oxidation / Rust	50% of the corrosion areas have degraded past the sacrificial zinc coating and have begun to rust.
Stainless steel	100%	Oxidation	Surface oxidation
Aluminum	5%	Pitting	Minor pitting
Galfan	75%	Oxidation / Rust	50% of the corrosion areas have degraded past the sacrificial zinc coating and have begun to rust.
Aluminized steel	<5%	Oxidation	White oxidation of the zinc/AL coating

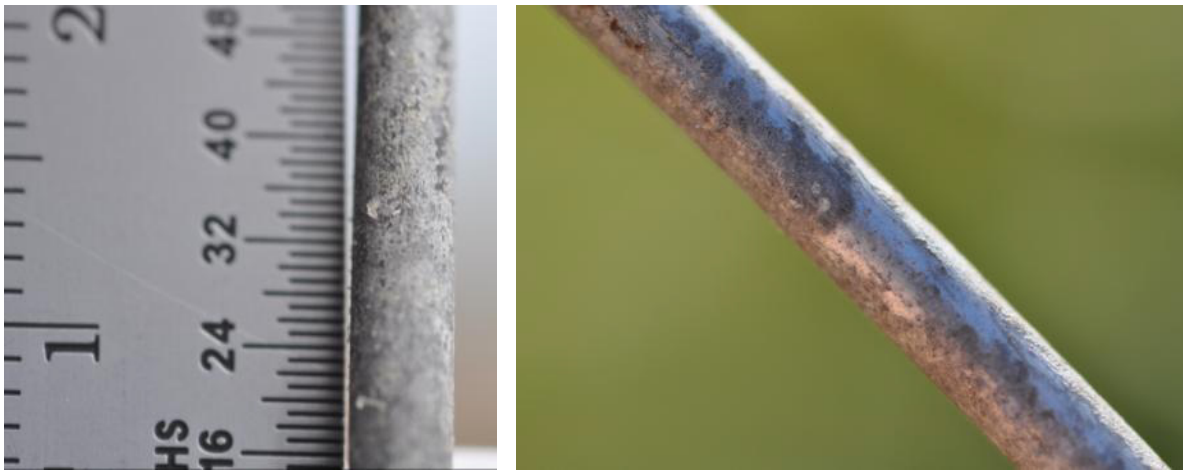
Figure 24. Aluminized steel wire coupon at FRF (left) and KTA (right) after 12 months of exposure.

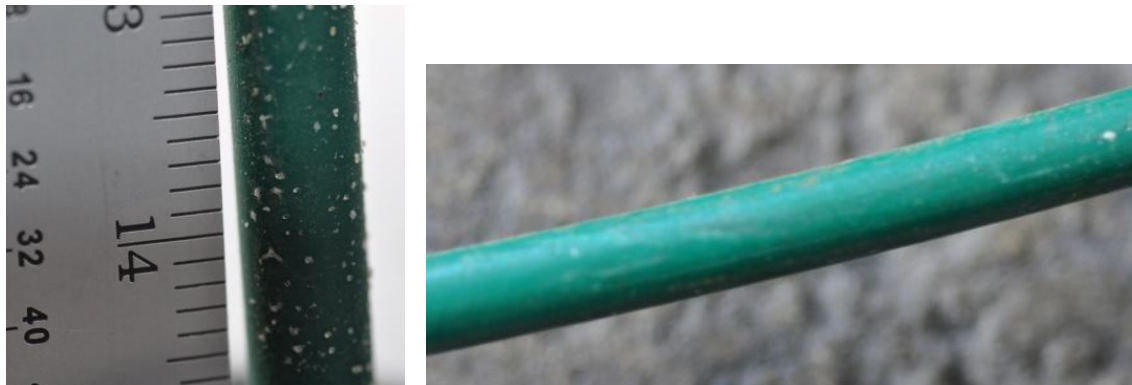
Figure 25. Fuse bonded PVC coated wire coupon at FRF (left) and KTA (right) after 12 months of exposure.

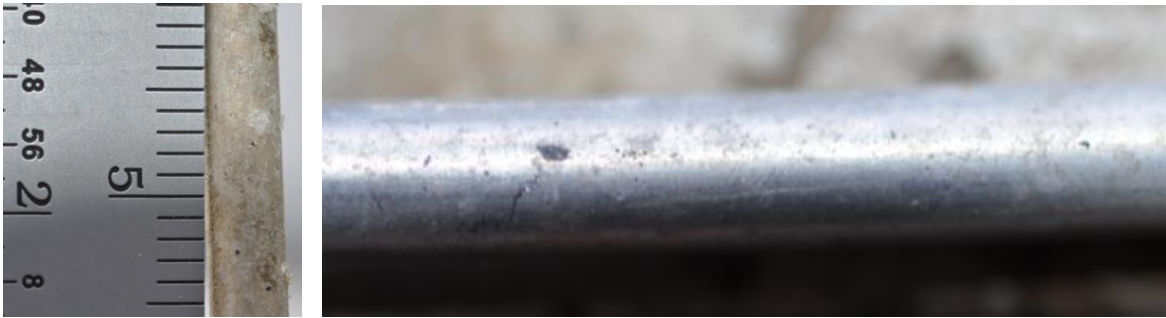
Figure 26. Aluminum wire coupon at the FRF (left) and KTA (right) after 12 months of exposure.

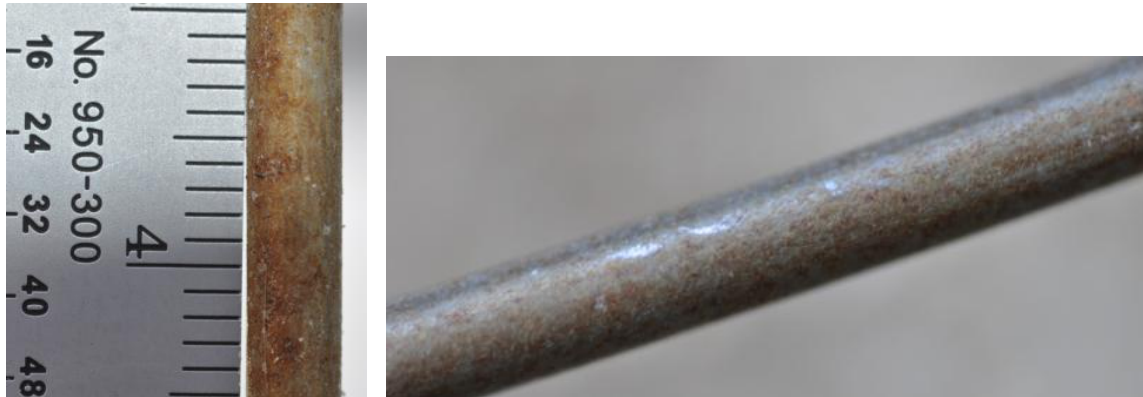
Figure 27. Stainless Steel wire coupon at FRF (left) and KTA (right) after 12 months of exposure.

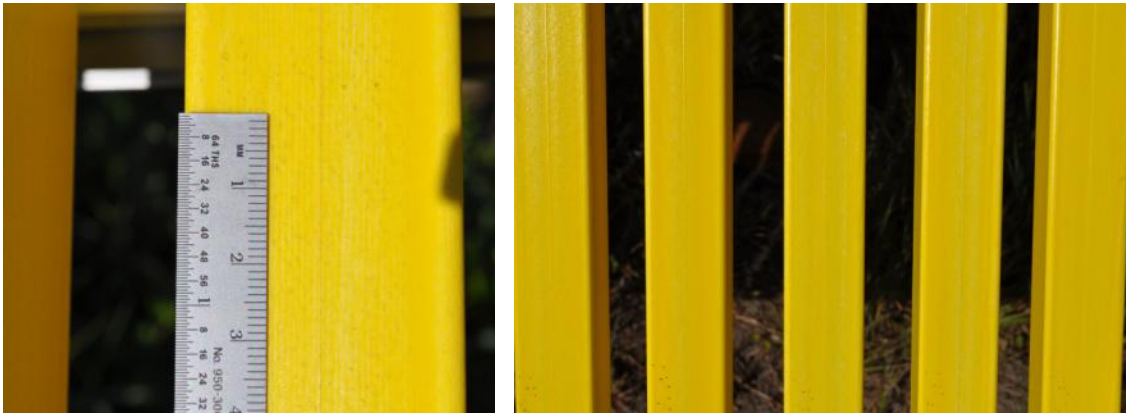
months of exposure. The FRP railings did not show signs of degradation until 6 months of exposure. The sides of railing specimens that face the sun the longest during the day were affected by color fading.

Figure 29. FRP railing coupon at FRF (left) and KTA (right) after 6 months of exposure.

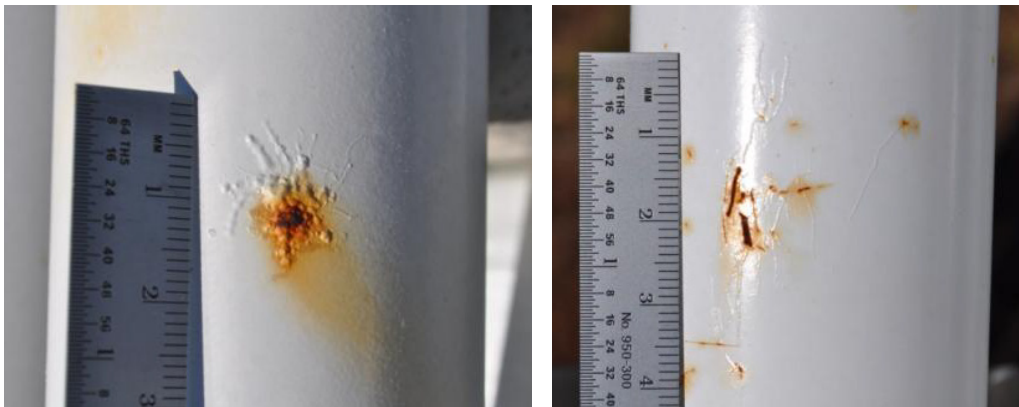
Figure 30. Coated steel railing coupon at FRF (left) and KTA (right) after 6 months of exposure.

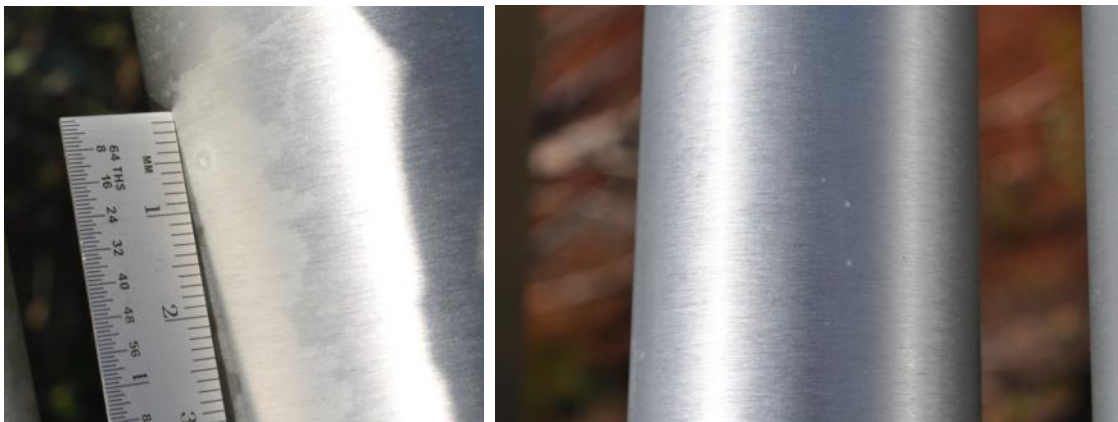
Figure 32. Aluminum railing coupon at FRF (left) and KTA (right) after 6 months of exposure.

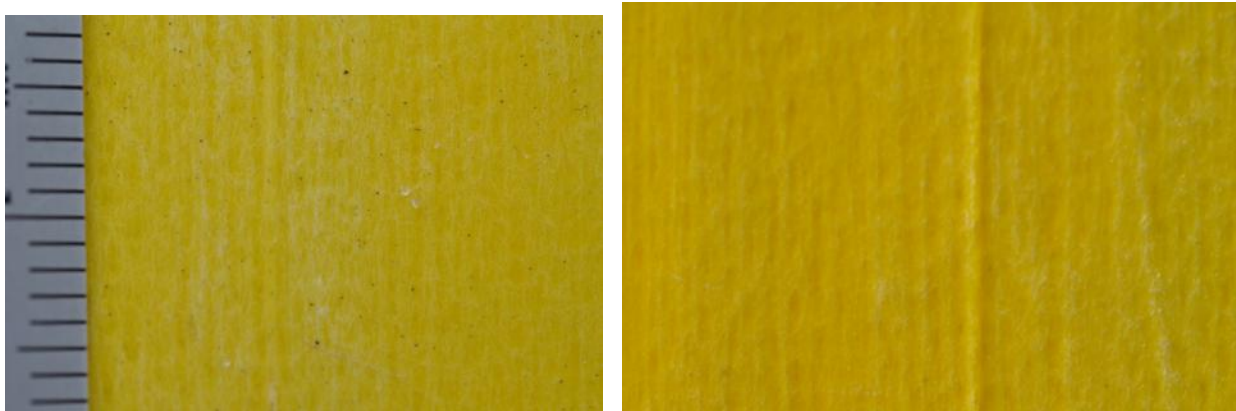
Figure 33. FRP railing coupon at FRF (left) and KTA (right) after 12 months of exposure.

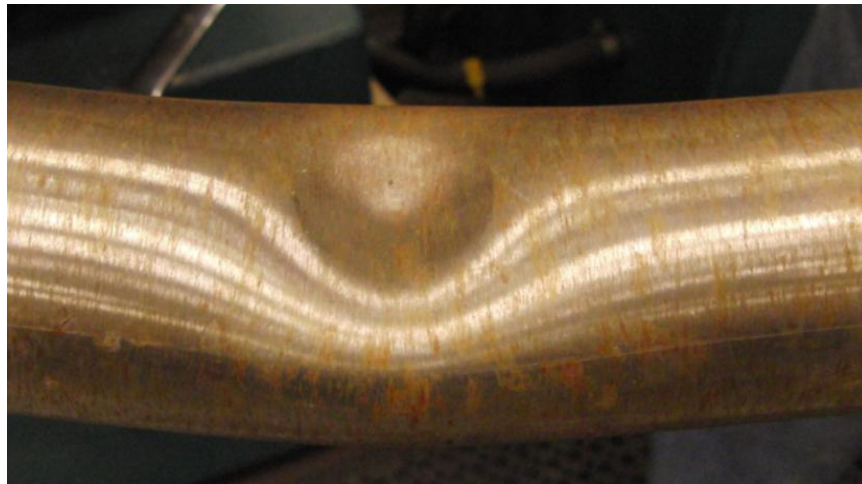
Figure 47. Cross sectional collapse of a stainless steel pipe under flexure testing.

Figure 46 shows a typical graph of steel pipe deformation as a flexure load is applied. It was found that the longitudinal shape of the pipe remained rigid and the circular cross section collapsed before the pipe began to flex, as seen in Figure 47. This same behavior was not observed in the aluminum or FRP railing specimens. The aluminum specimens were relatively ductile in comparison with steel and stainless steel, and therefore began to deform in both the cross section and longitudinally at the same time. The FRP railing had a square cross section and is not very ductile compared to either steel or aluminum, so its failure was different than the metallic specimens. Figure 48 – Figure 50 represent the change in the tangent modulus throughout the exposure period for each test site. More data can be found in Appendix E.

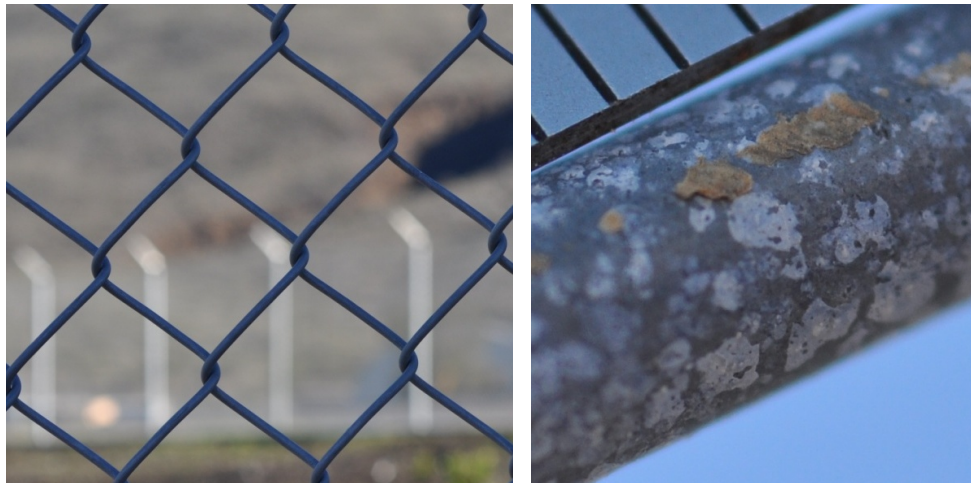
Figure A16. Galvan showing localized corrosion on 10% of its total surface after 12 months exposure.

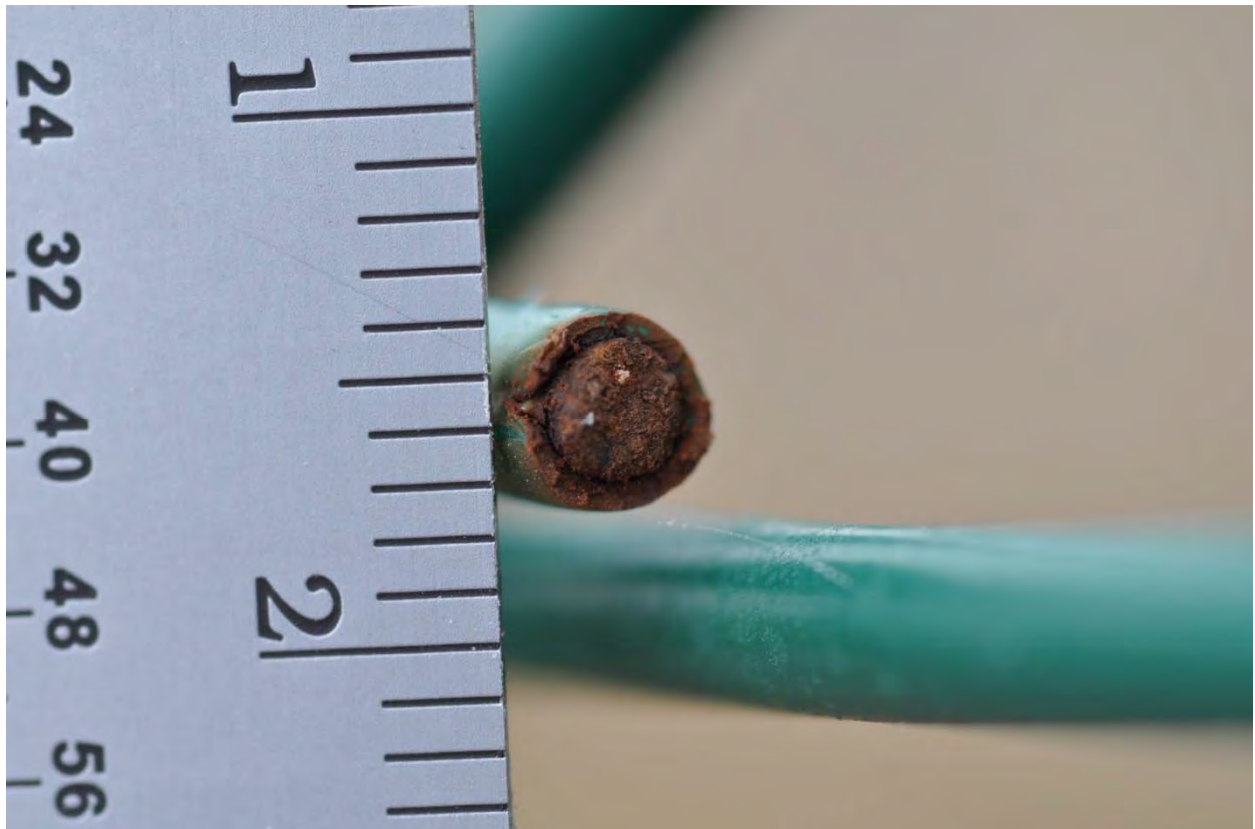
Figure B64. Fuse Bonded PVC Coated Galvanized Wire Fencing Cut Ends

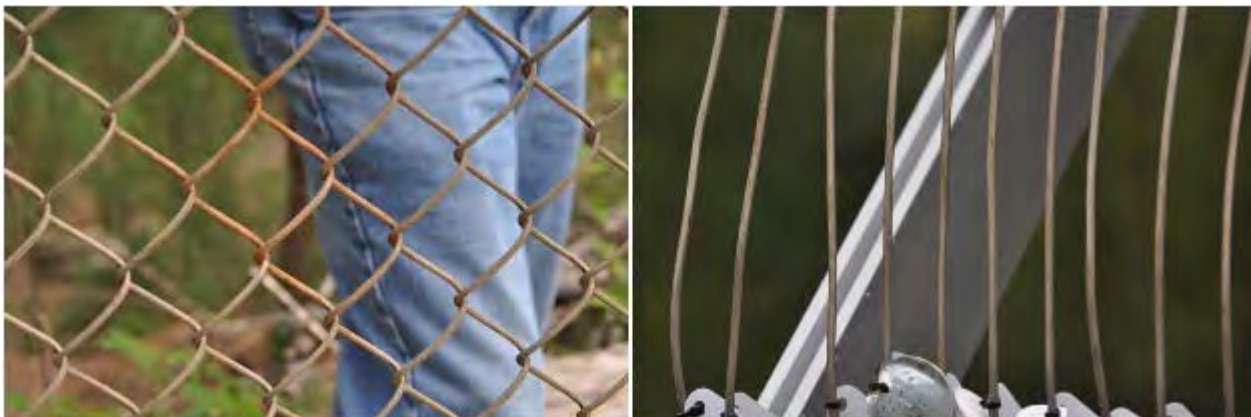
Figure B71. (Left) Fused bonded PVC coated galvanized steel formation damage. (Right) PVC coated galvanized steel wire coupons
